Report Number: 214-TRC-04-004

Safety Compliance Testing For FMVSS 214

Side Impact Protection

2005 Scion TC 2-door

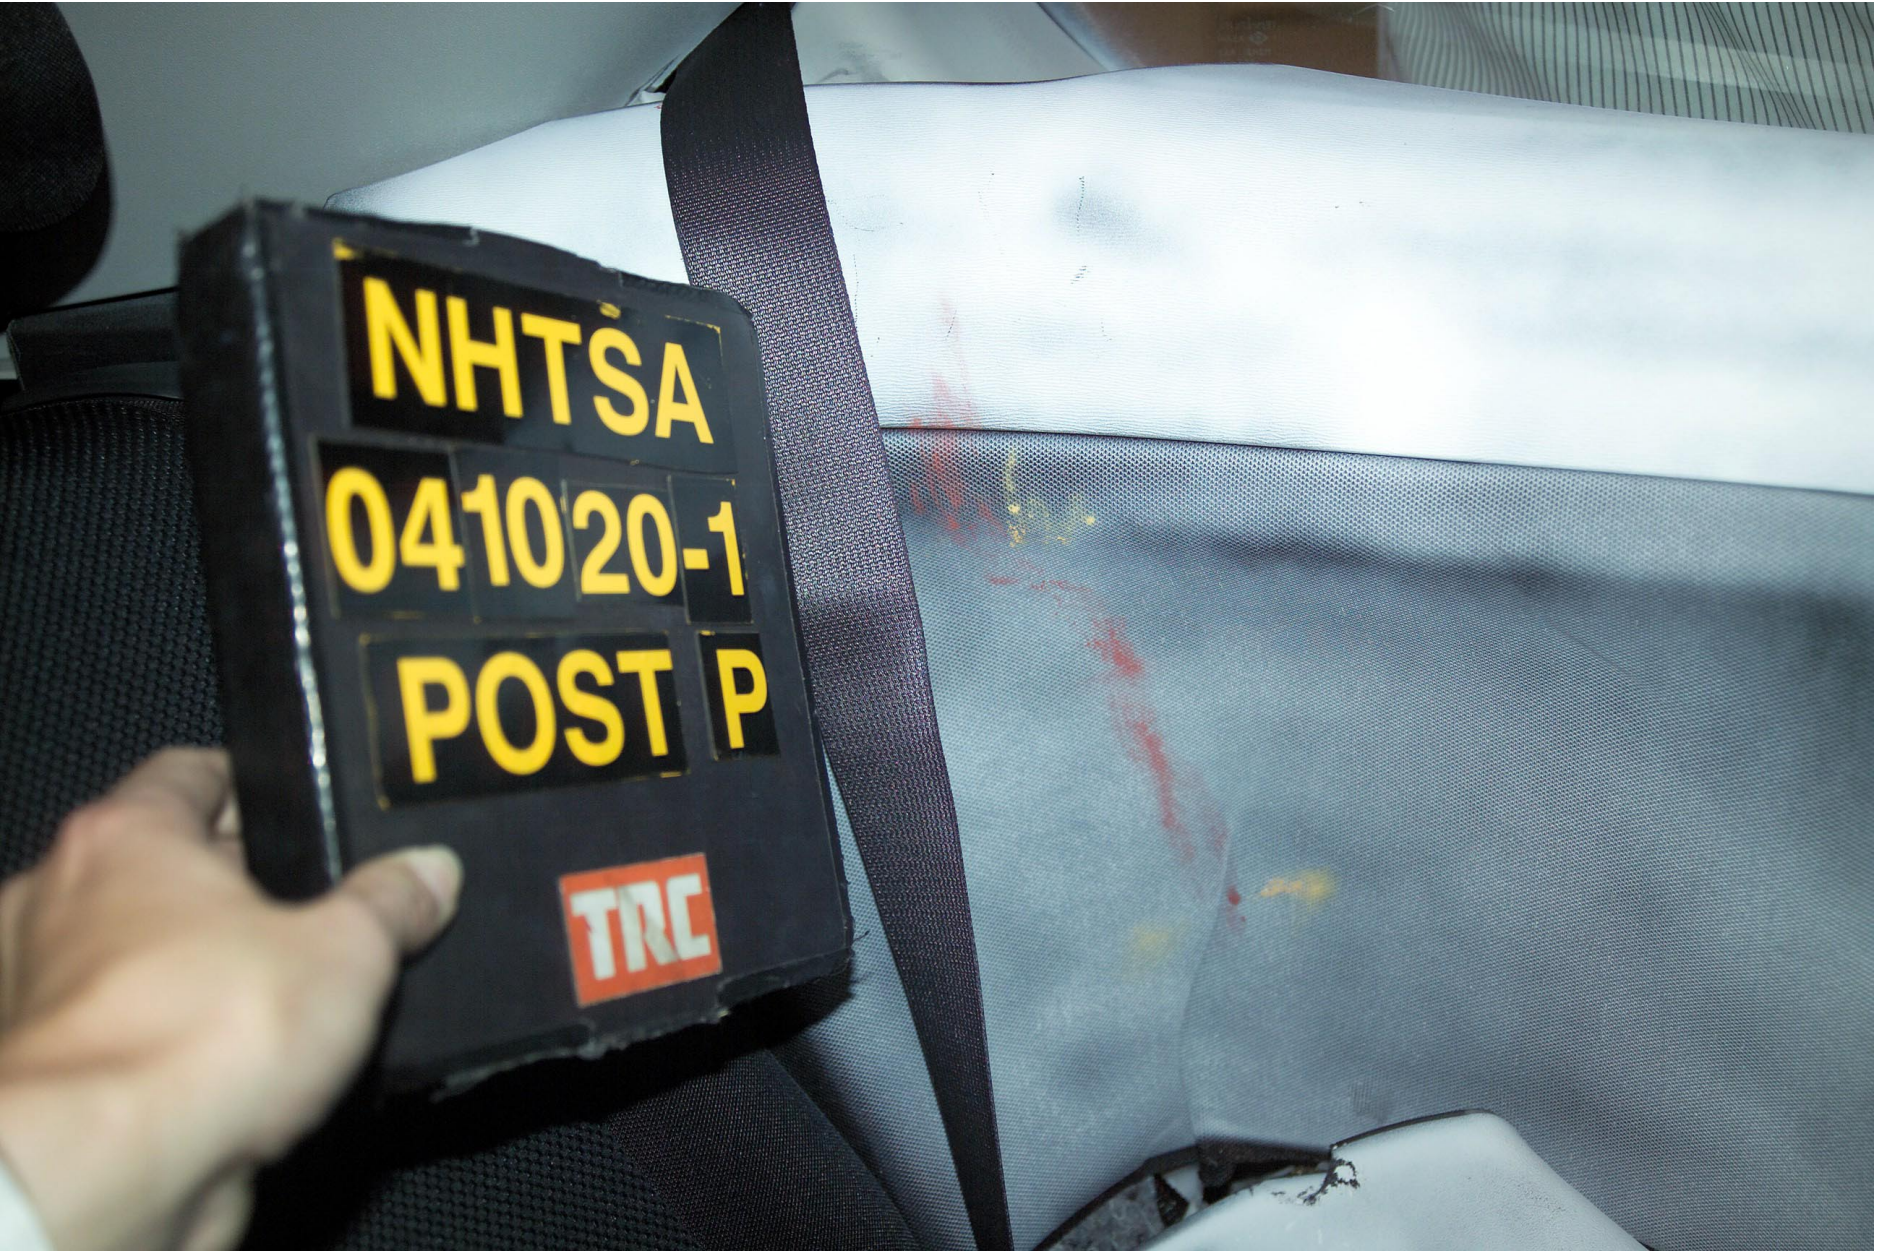
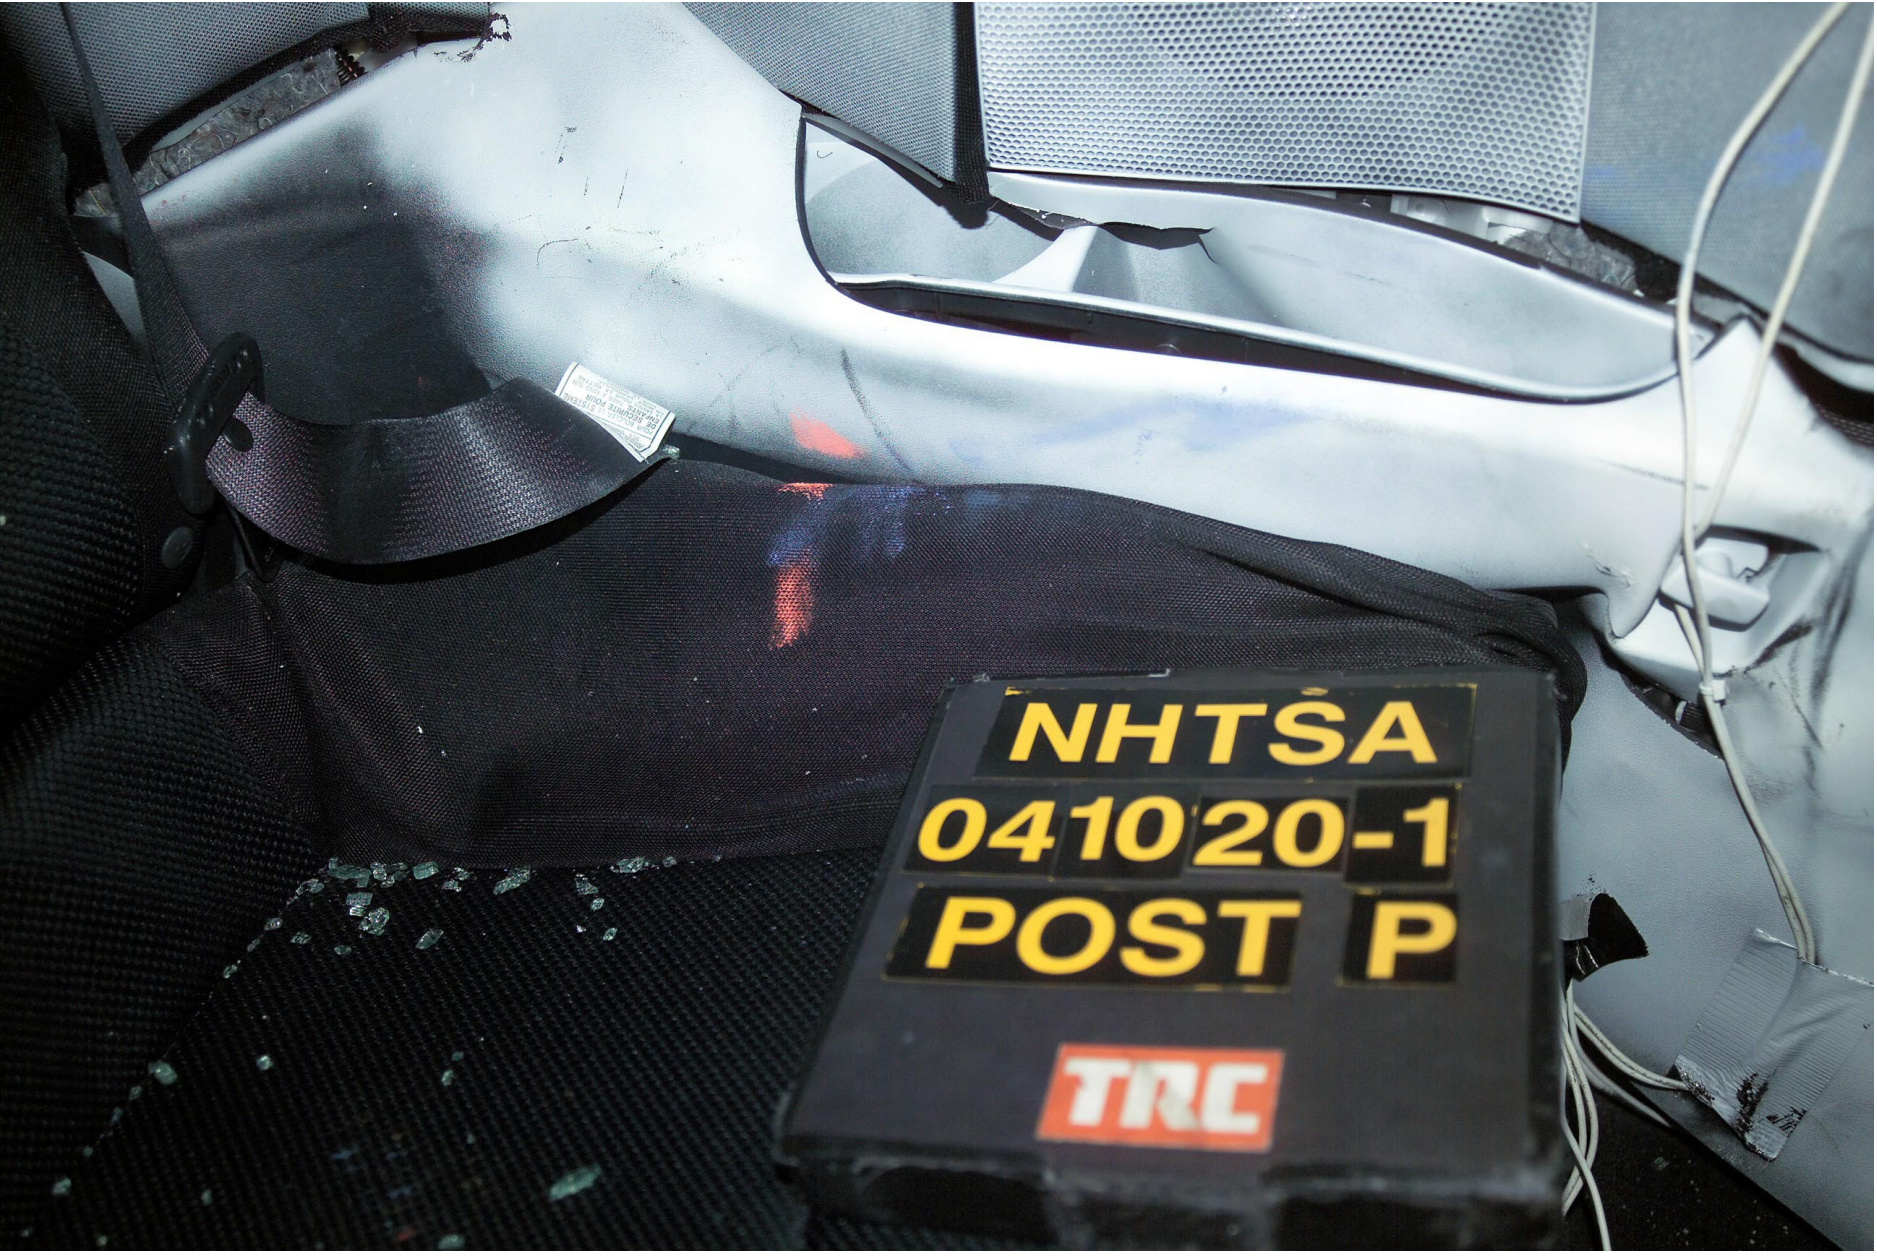
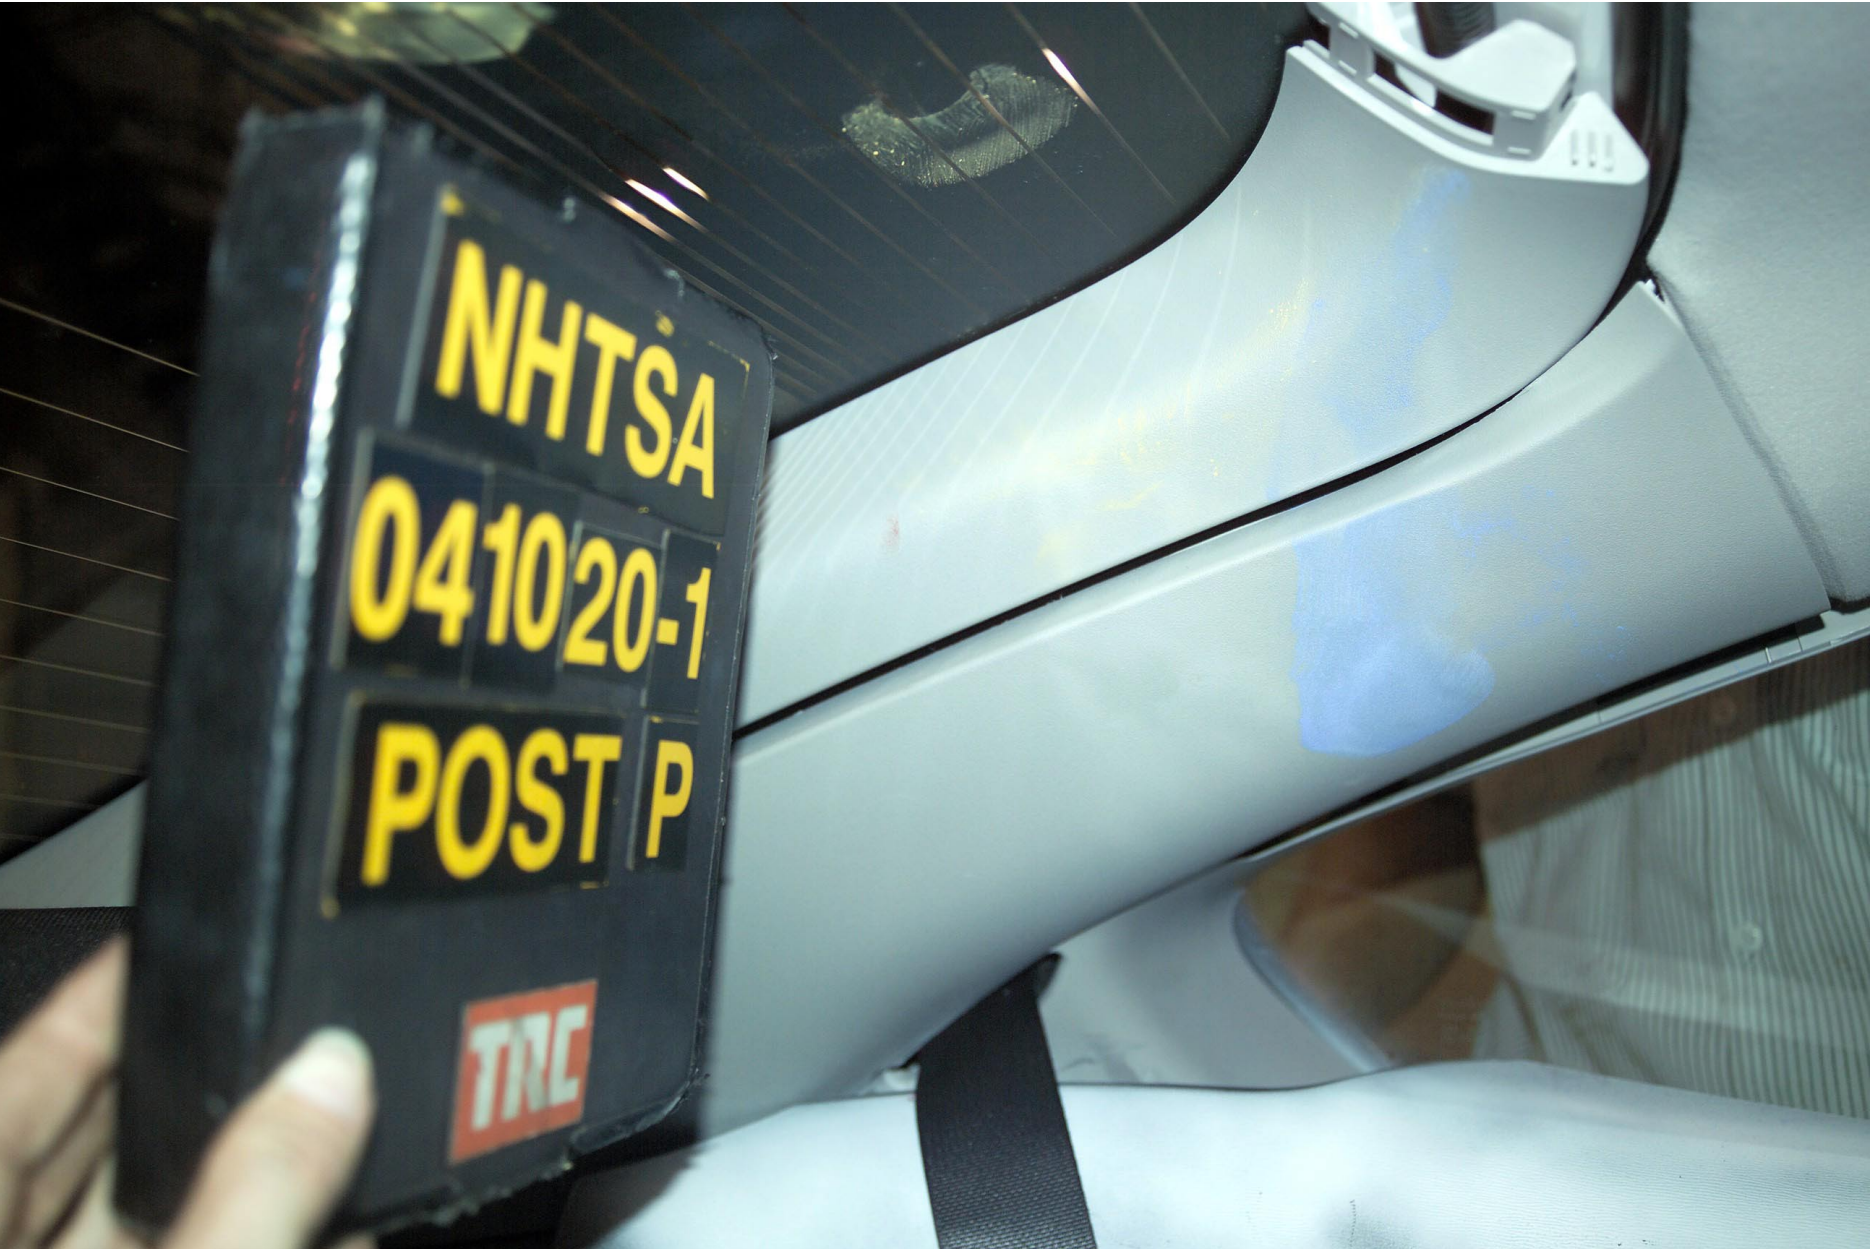
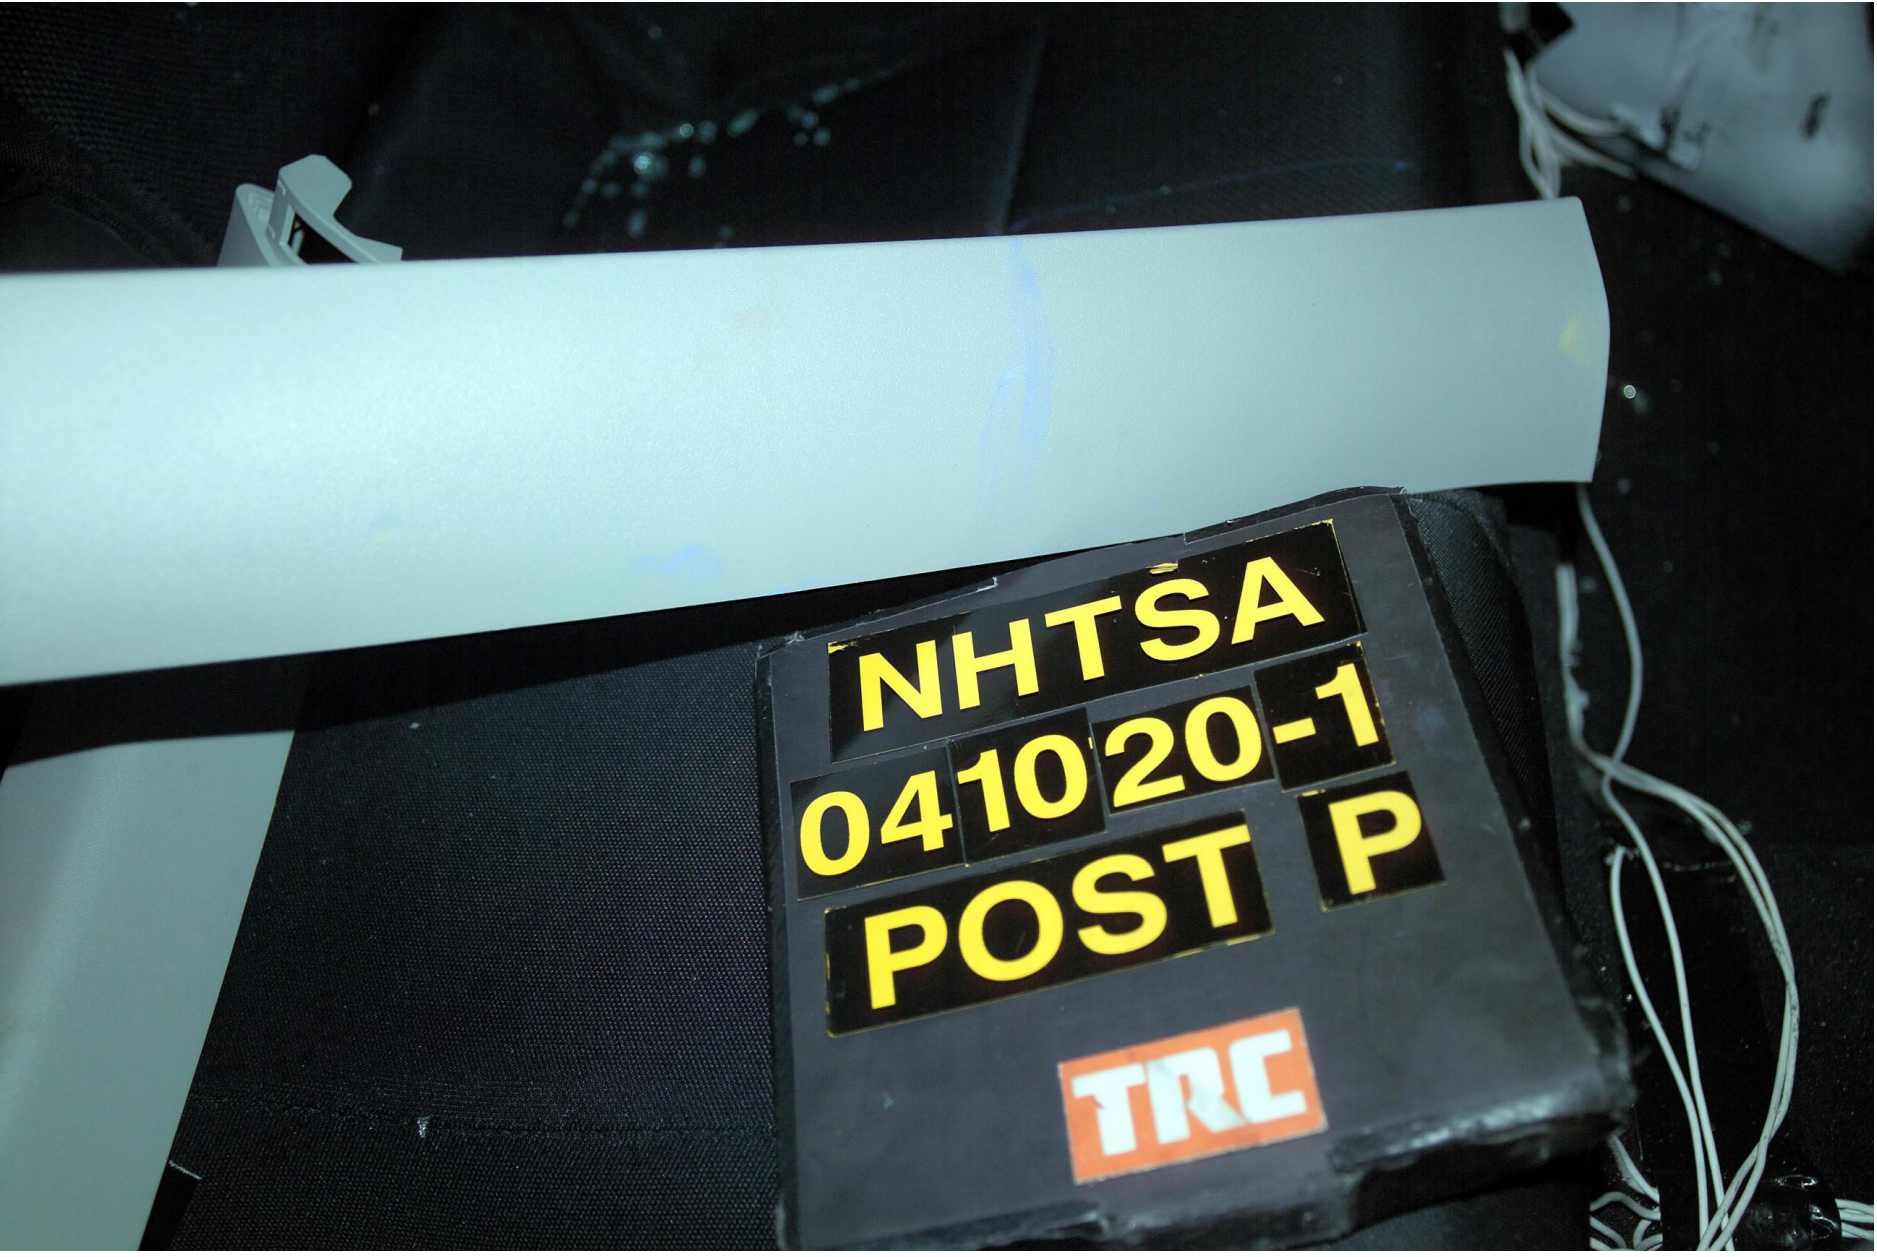
Figure A-41 Post-Test Rear SID HIII Contact - View 1
A-45

Figure A-42 Post-Test Rear SID HIII Contact - View 2

Figure A-43 Post-Test Rear SID HIII Contact - View 3
A-47

Figure A-44 Post-Test Rear SID HIII Contact - View 4
A-48

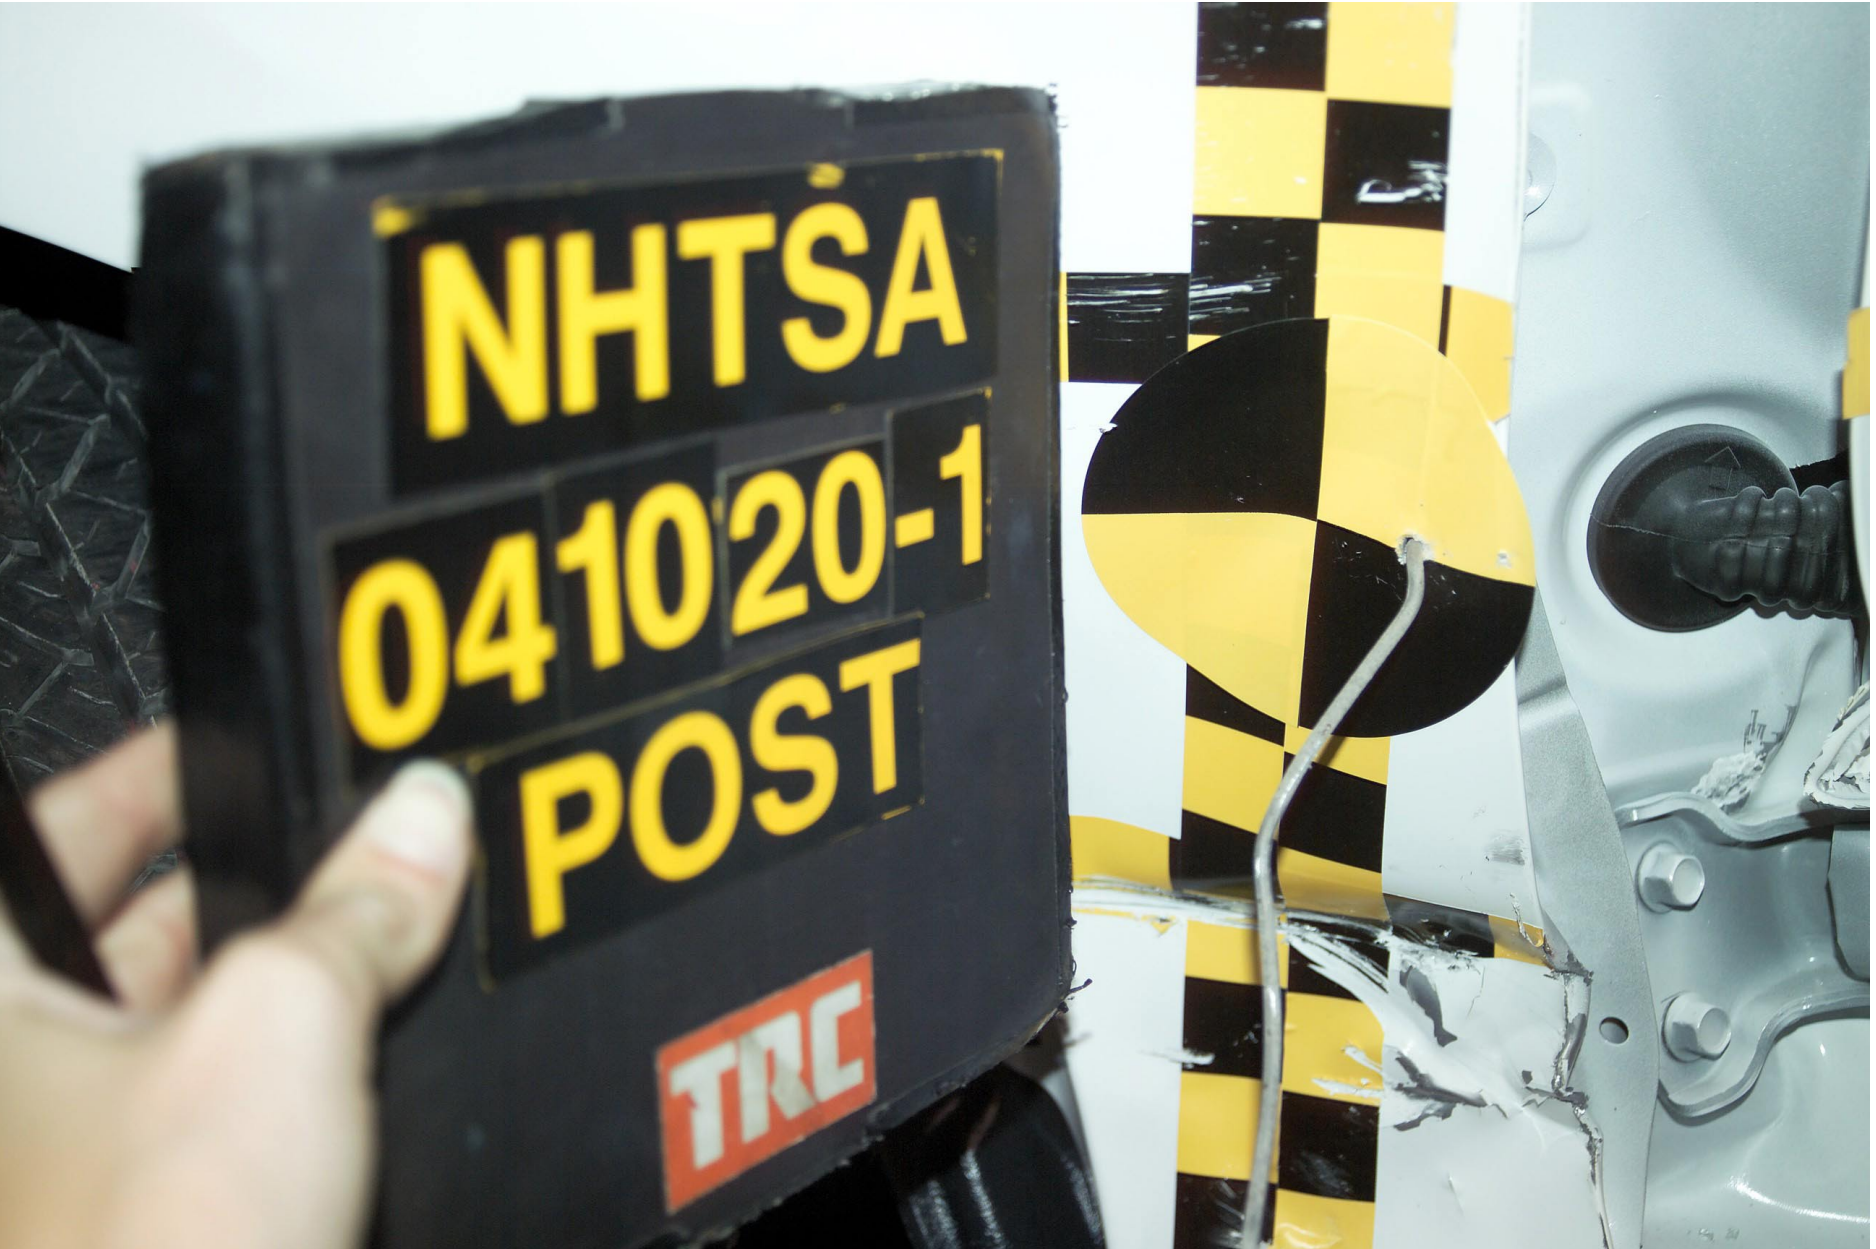
Figure A-48 Post-Test Primary Impact Point View
A-52

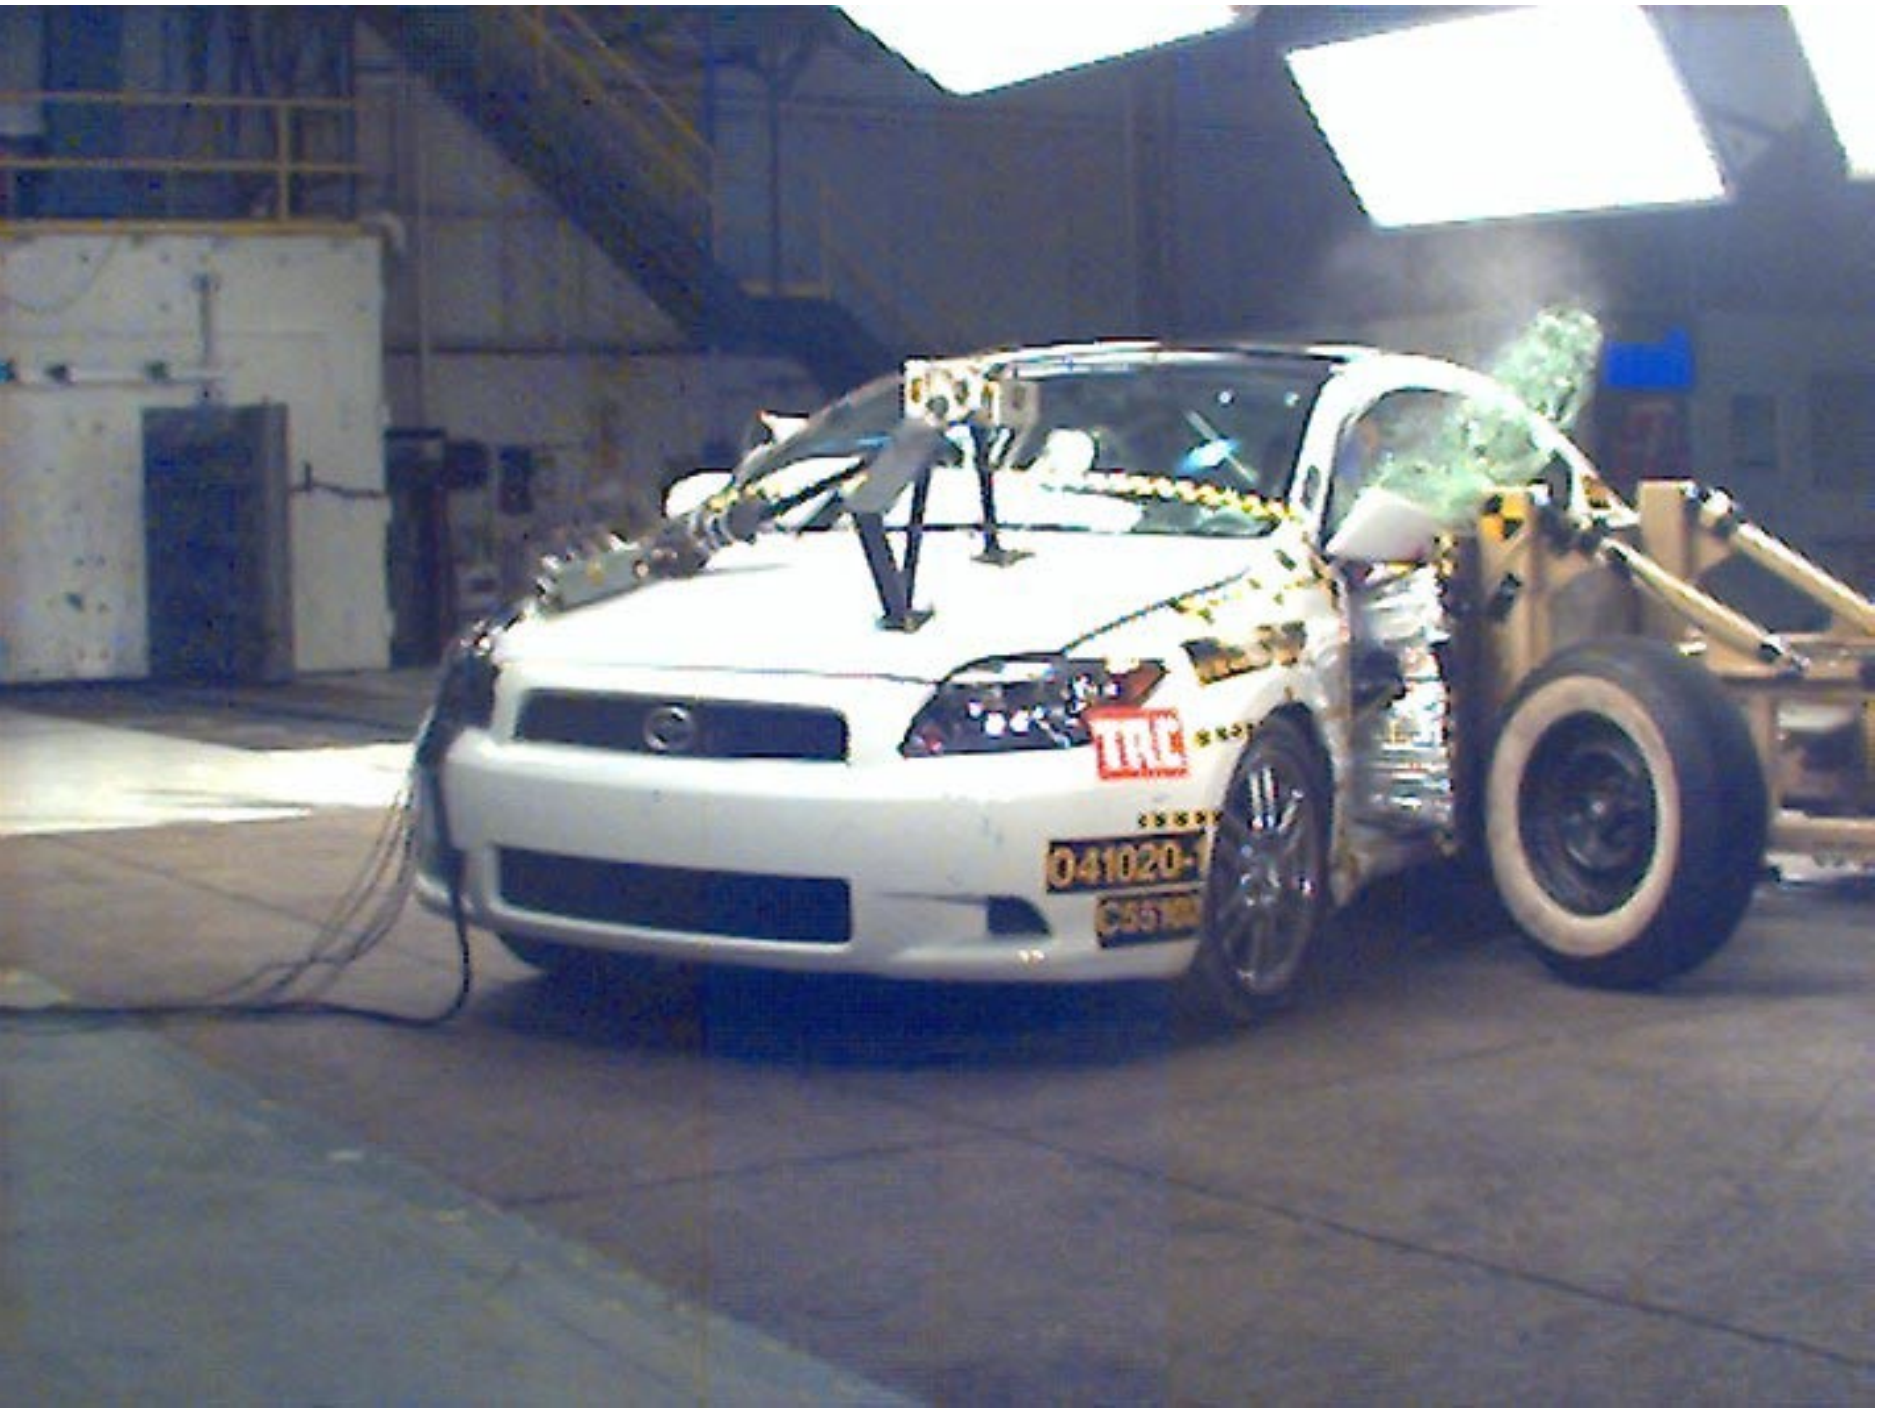
Figure A-56 Impact Event
A-60
