Report Number: 214-TRC-04-004

Safety Compliance Testing For FMVSS 214

Side Impact Protection

2005 Scion TC 2-door

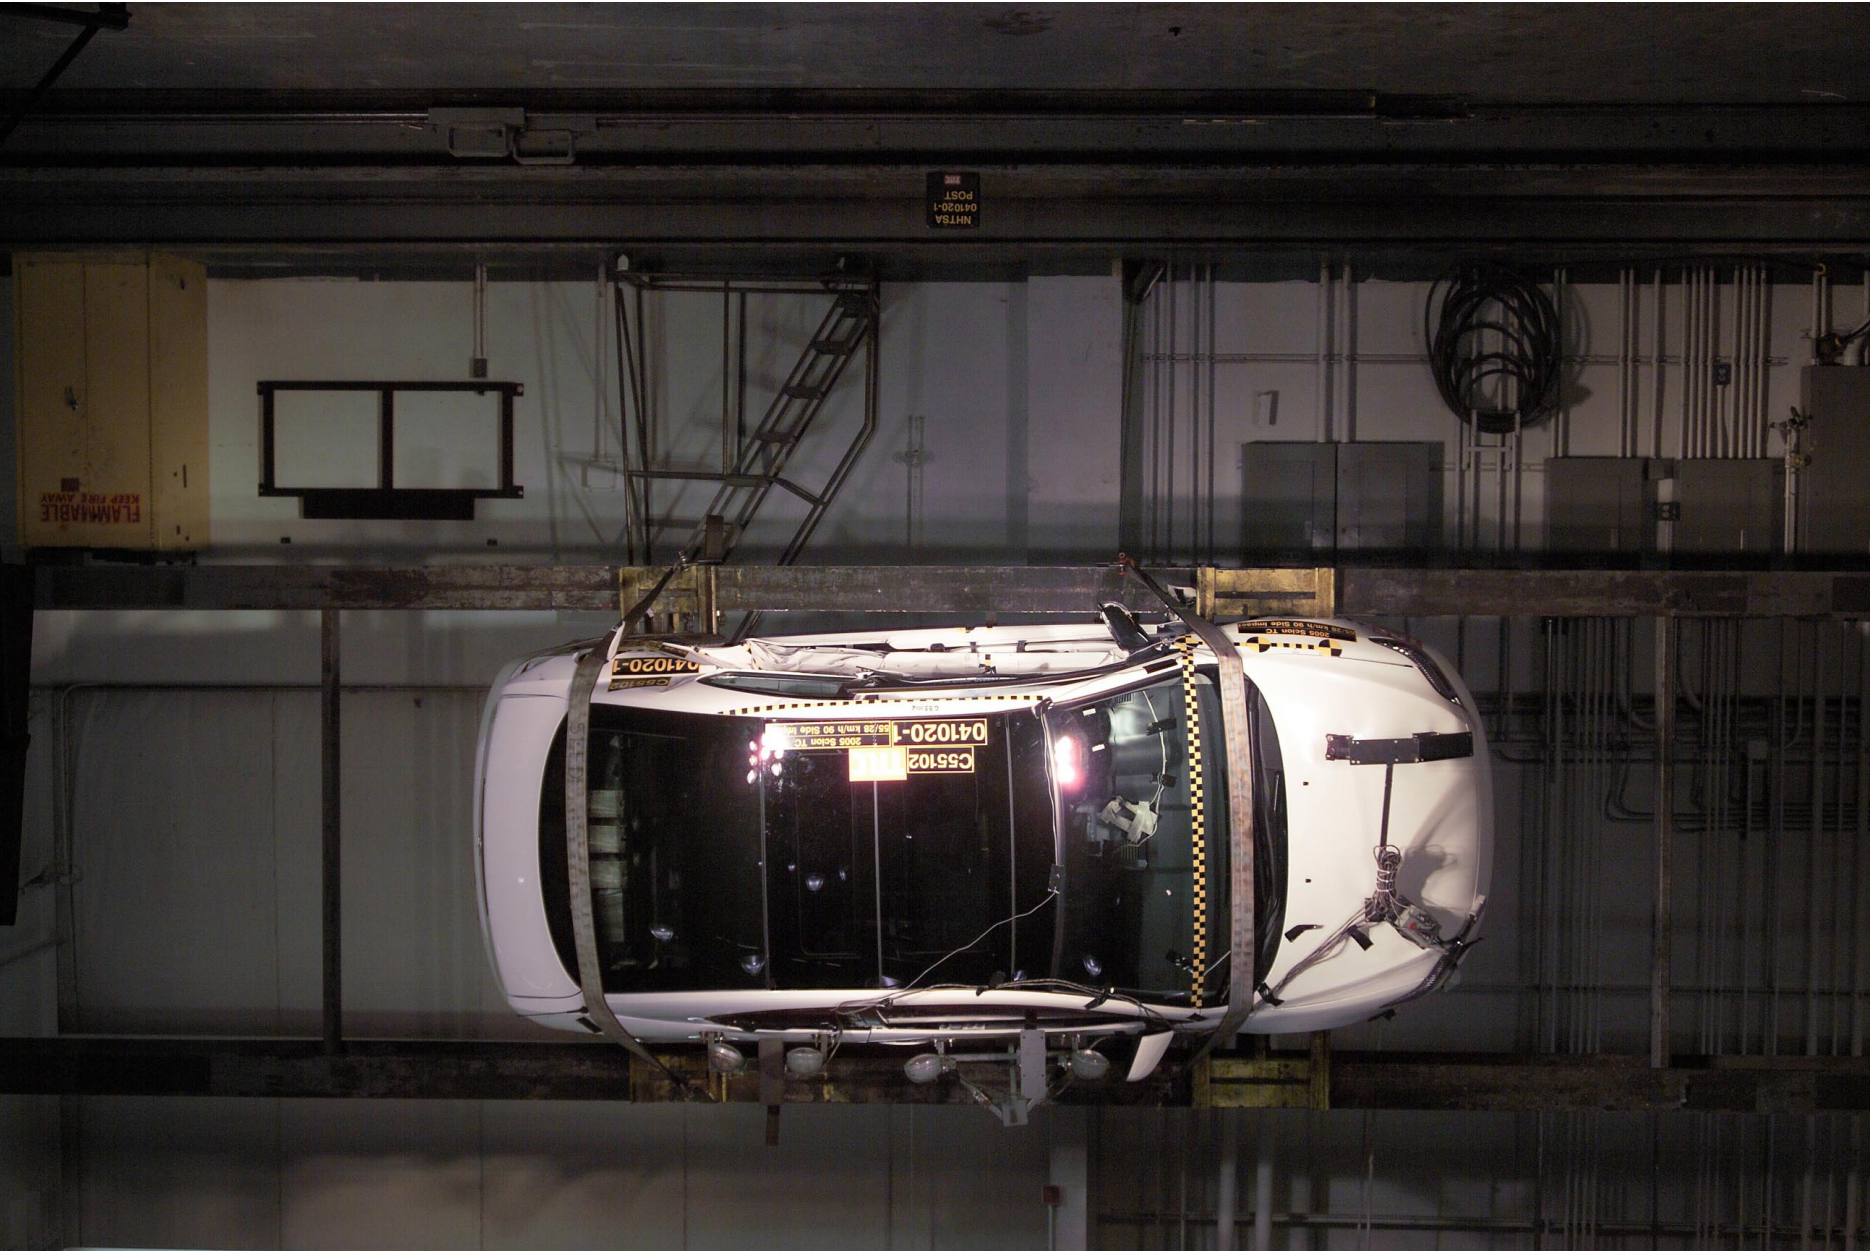
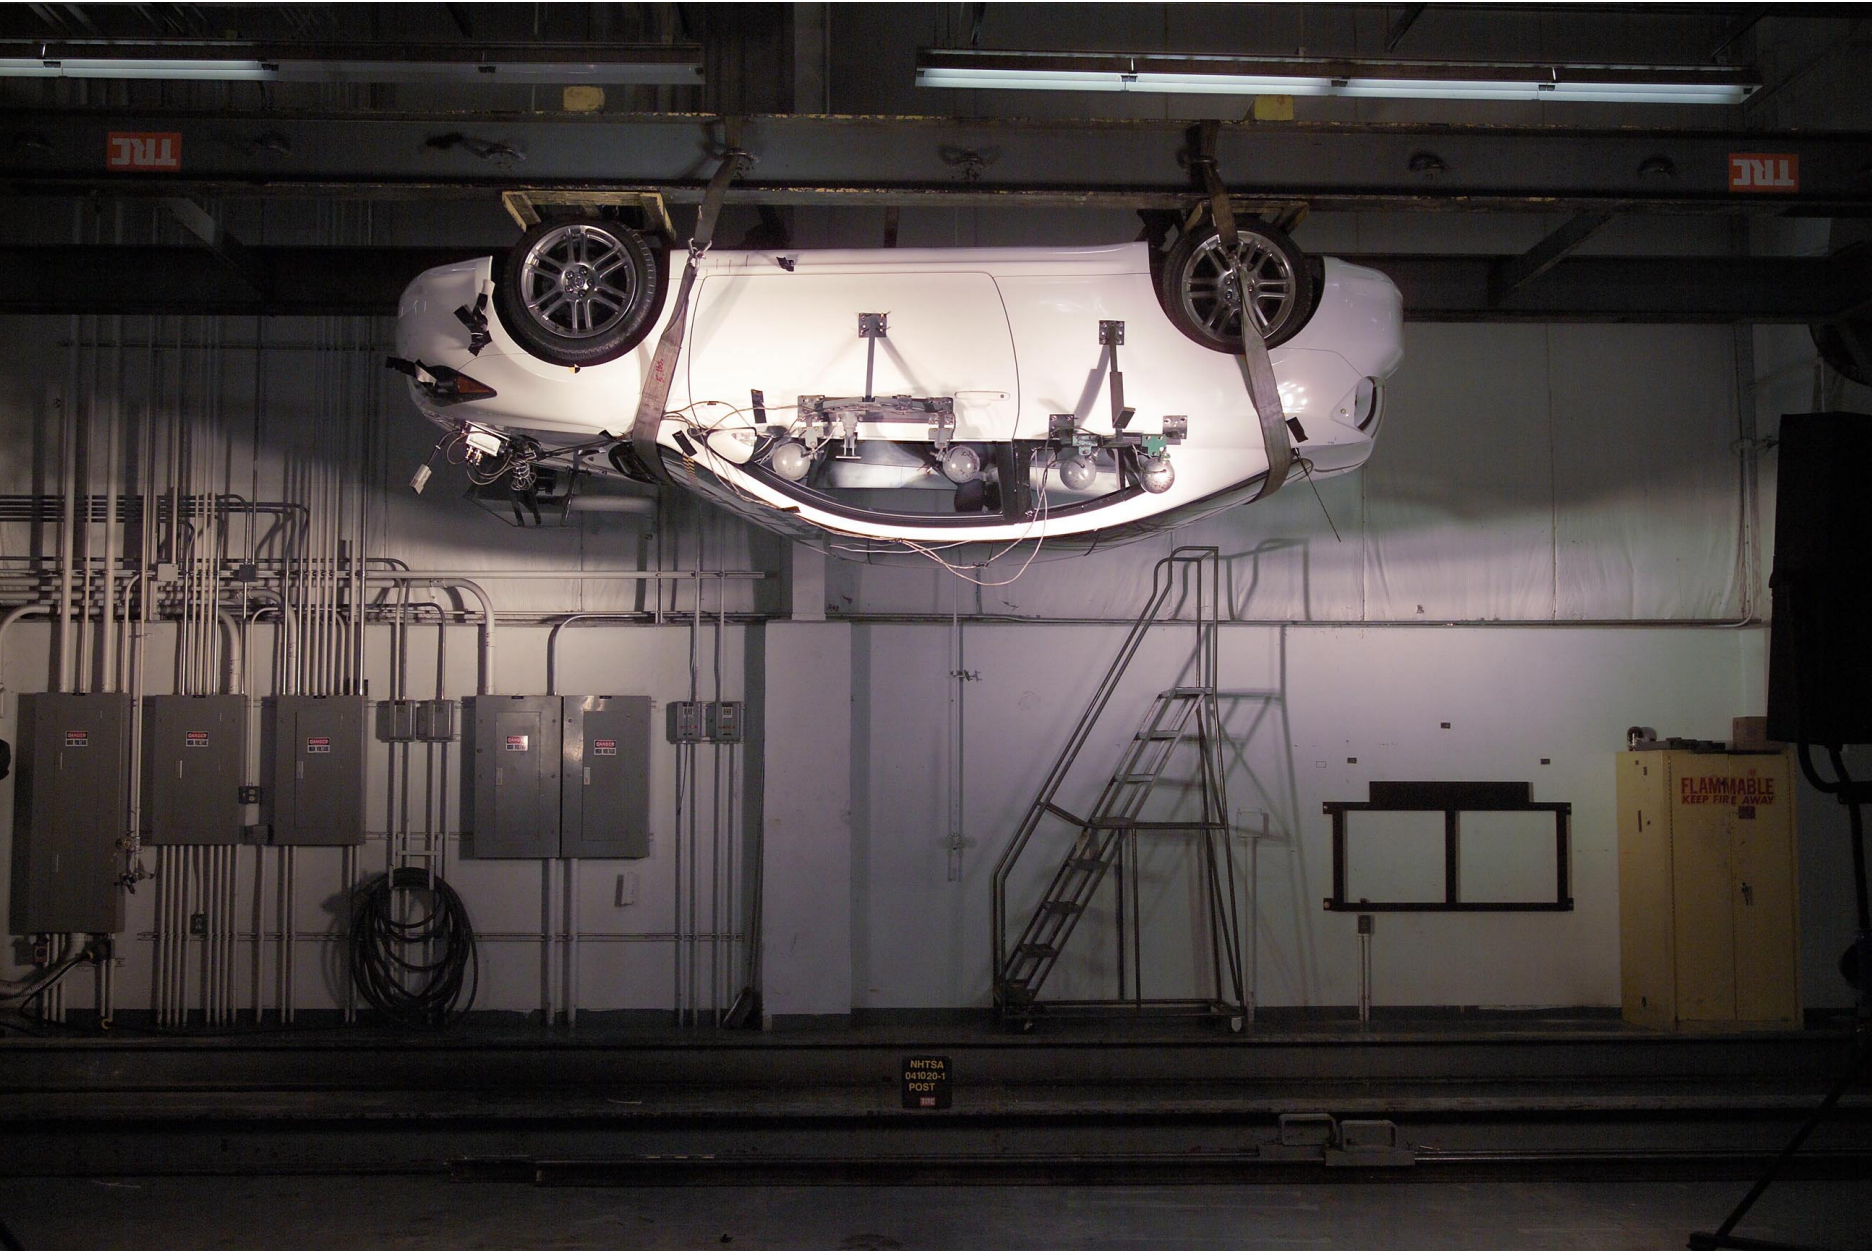
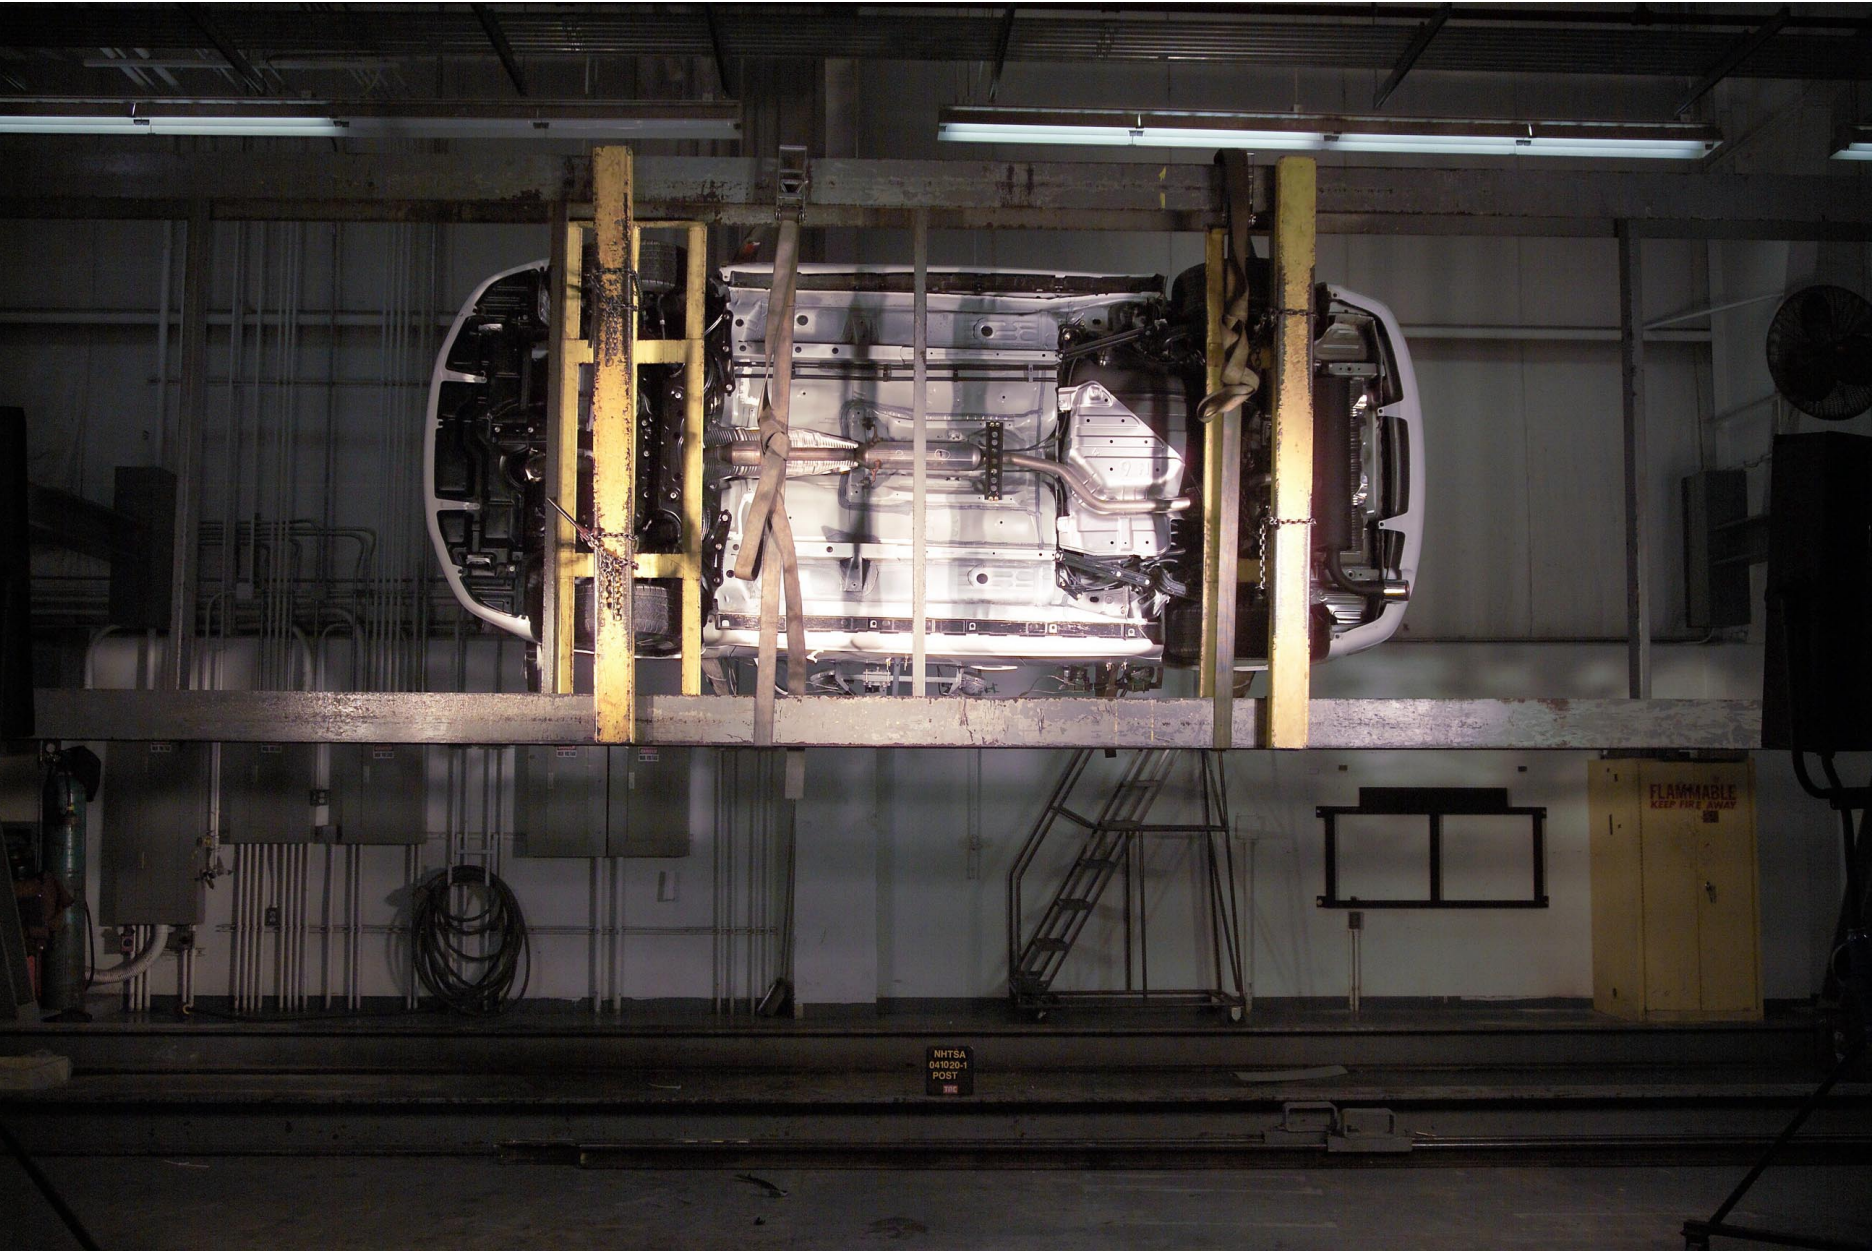
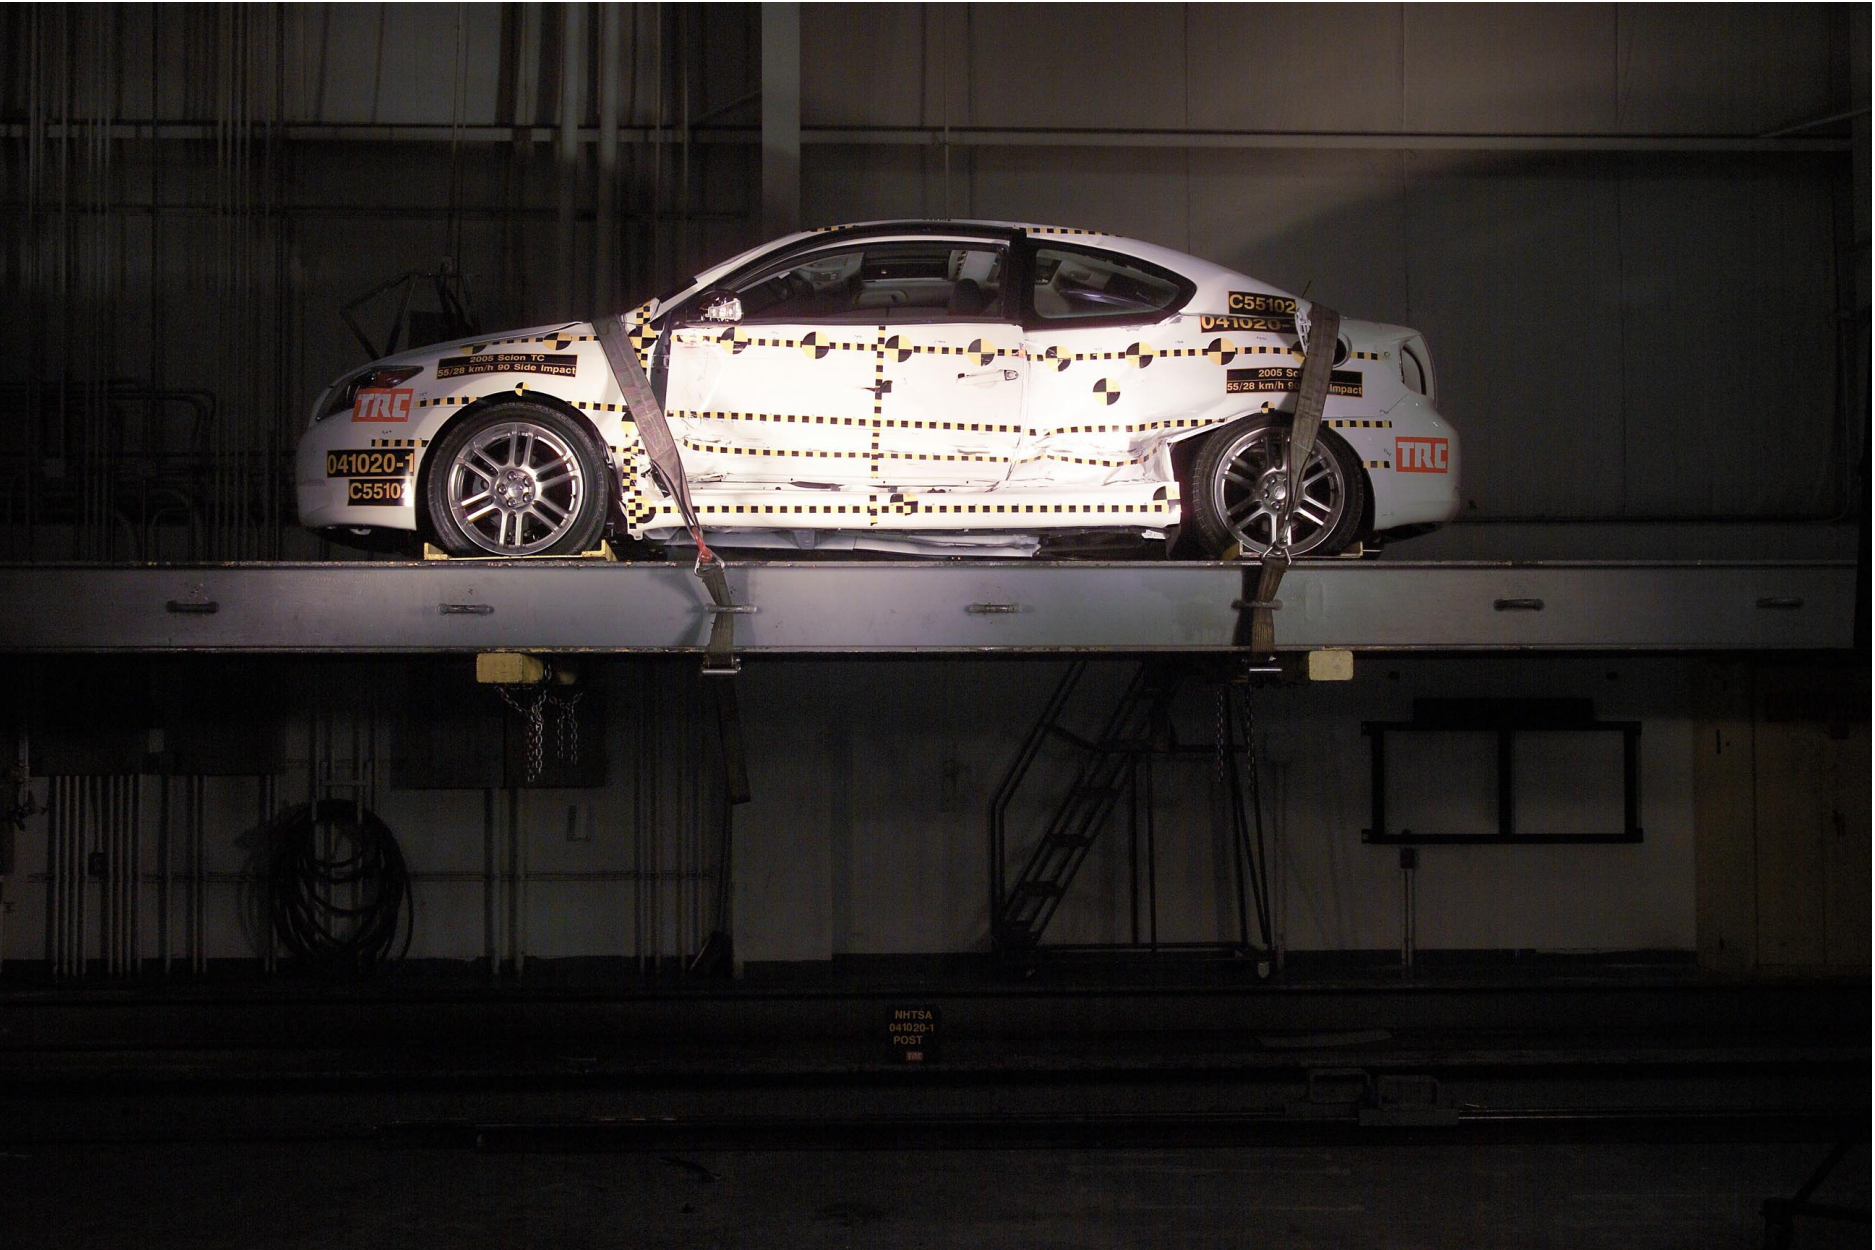
Figure A-59 FMVSS 301 Rollover View at 90°
A-63

Figure A-60 FMVSS 301 Rollover View at 180°

Figure A-61 FMVSS 301 Rollover View at 270°

Figure A-62 FMVSS 301 Rollover View at 360°
