REPORT NO. MCW-DOT-05SN02

**NEW CAR ASSESSMENT PROGRAM  
SIDE IMPACT TESTING**

MITSUBISHI MOTORS  
2005 MITSUBISHI GALANT ES 4-DOOR SEDAN

FINAL REPORT

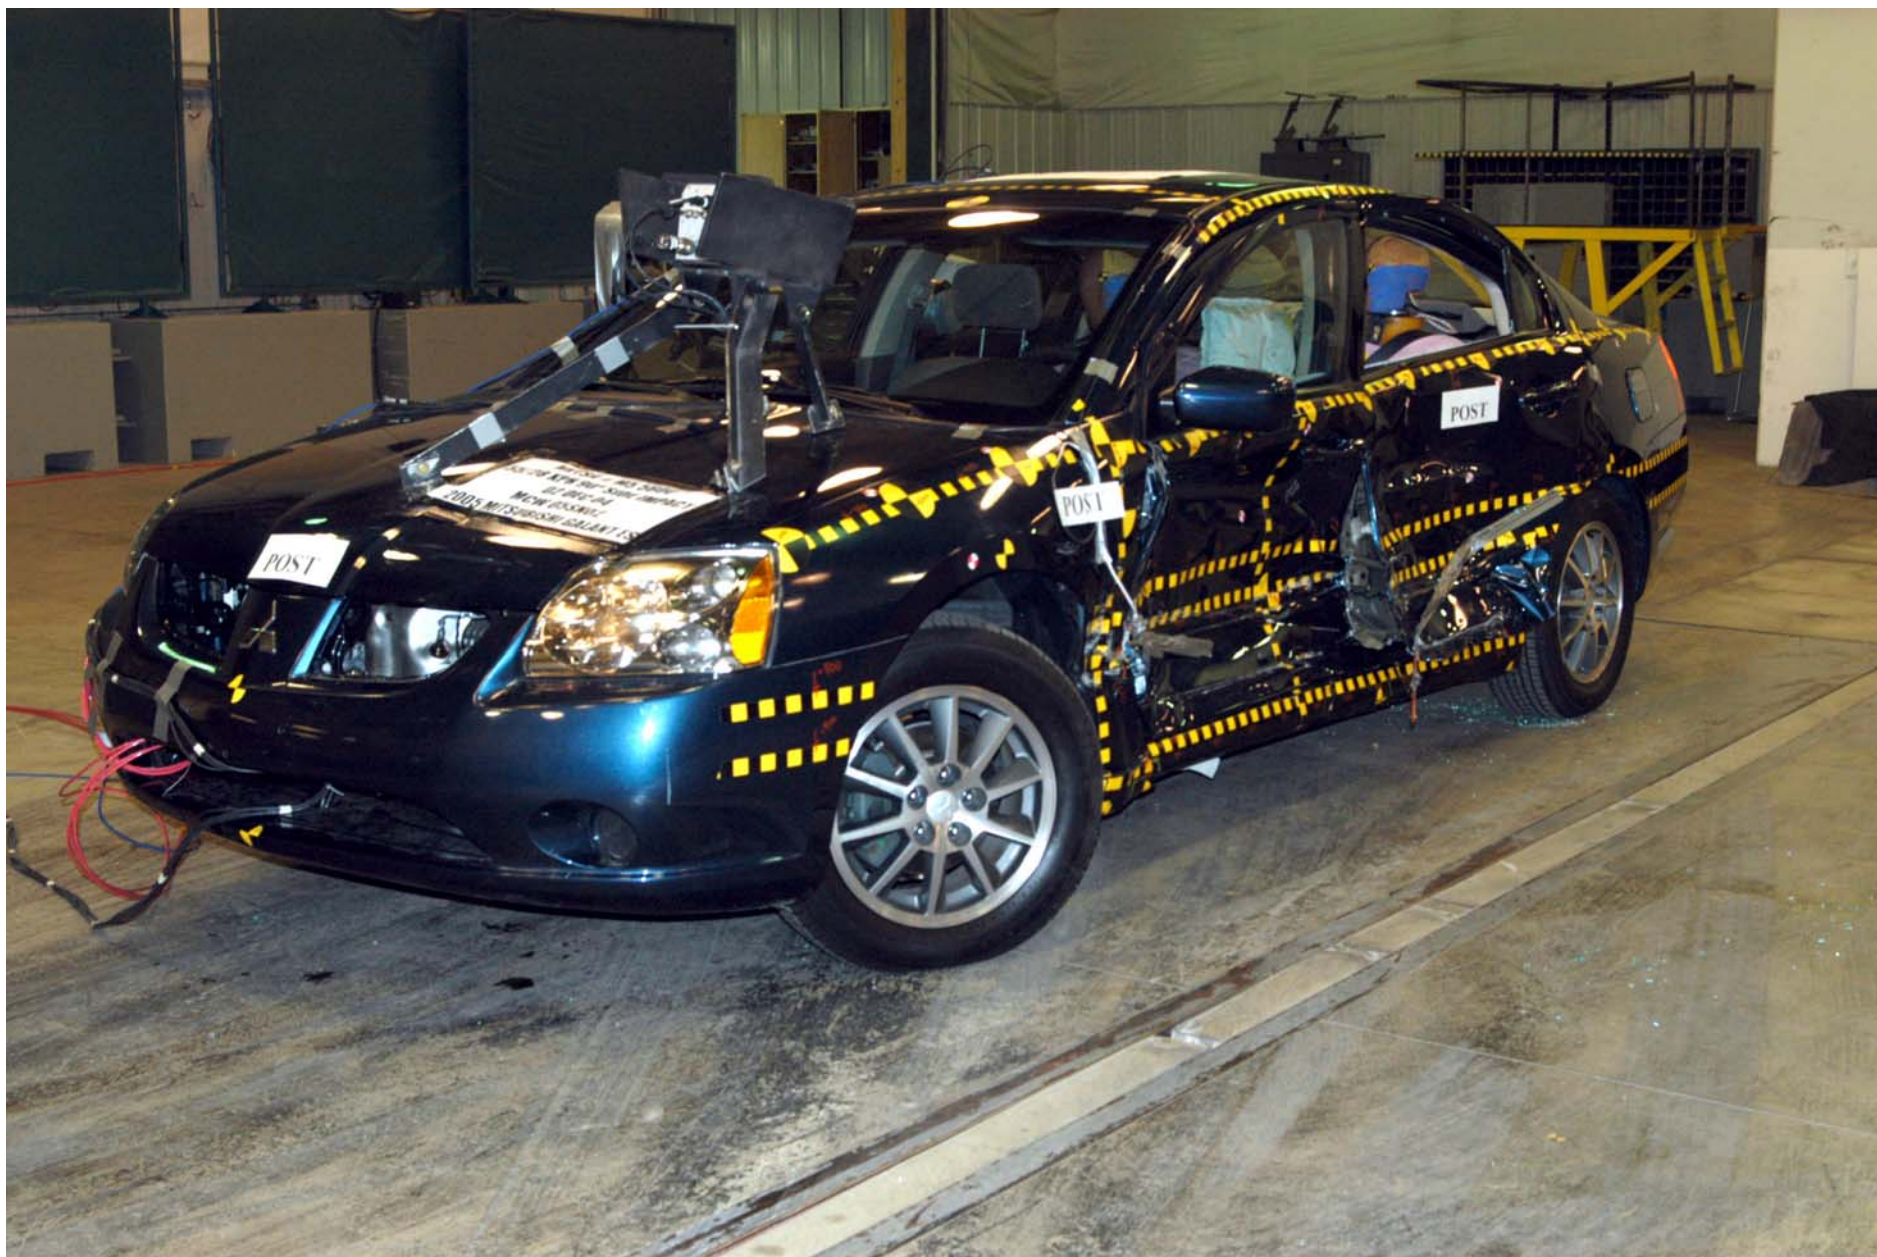
Figure A-4: POST-TEST LEFT FRONT VIEW OF TEST VEHICLE

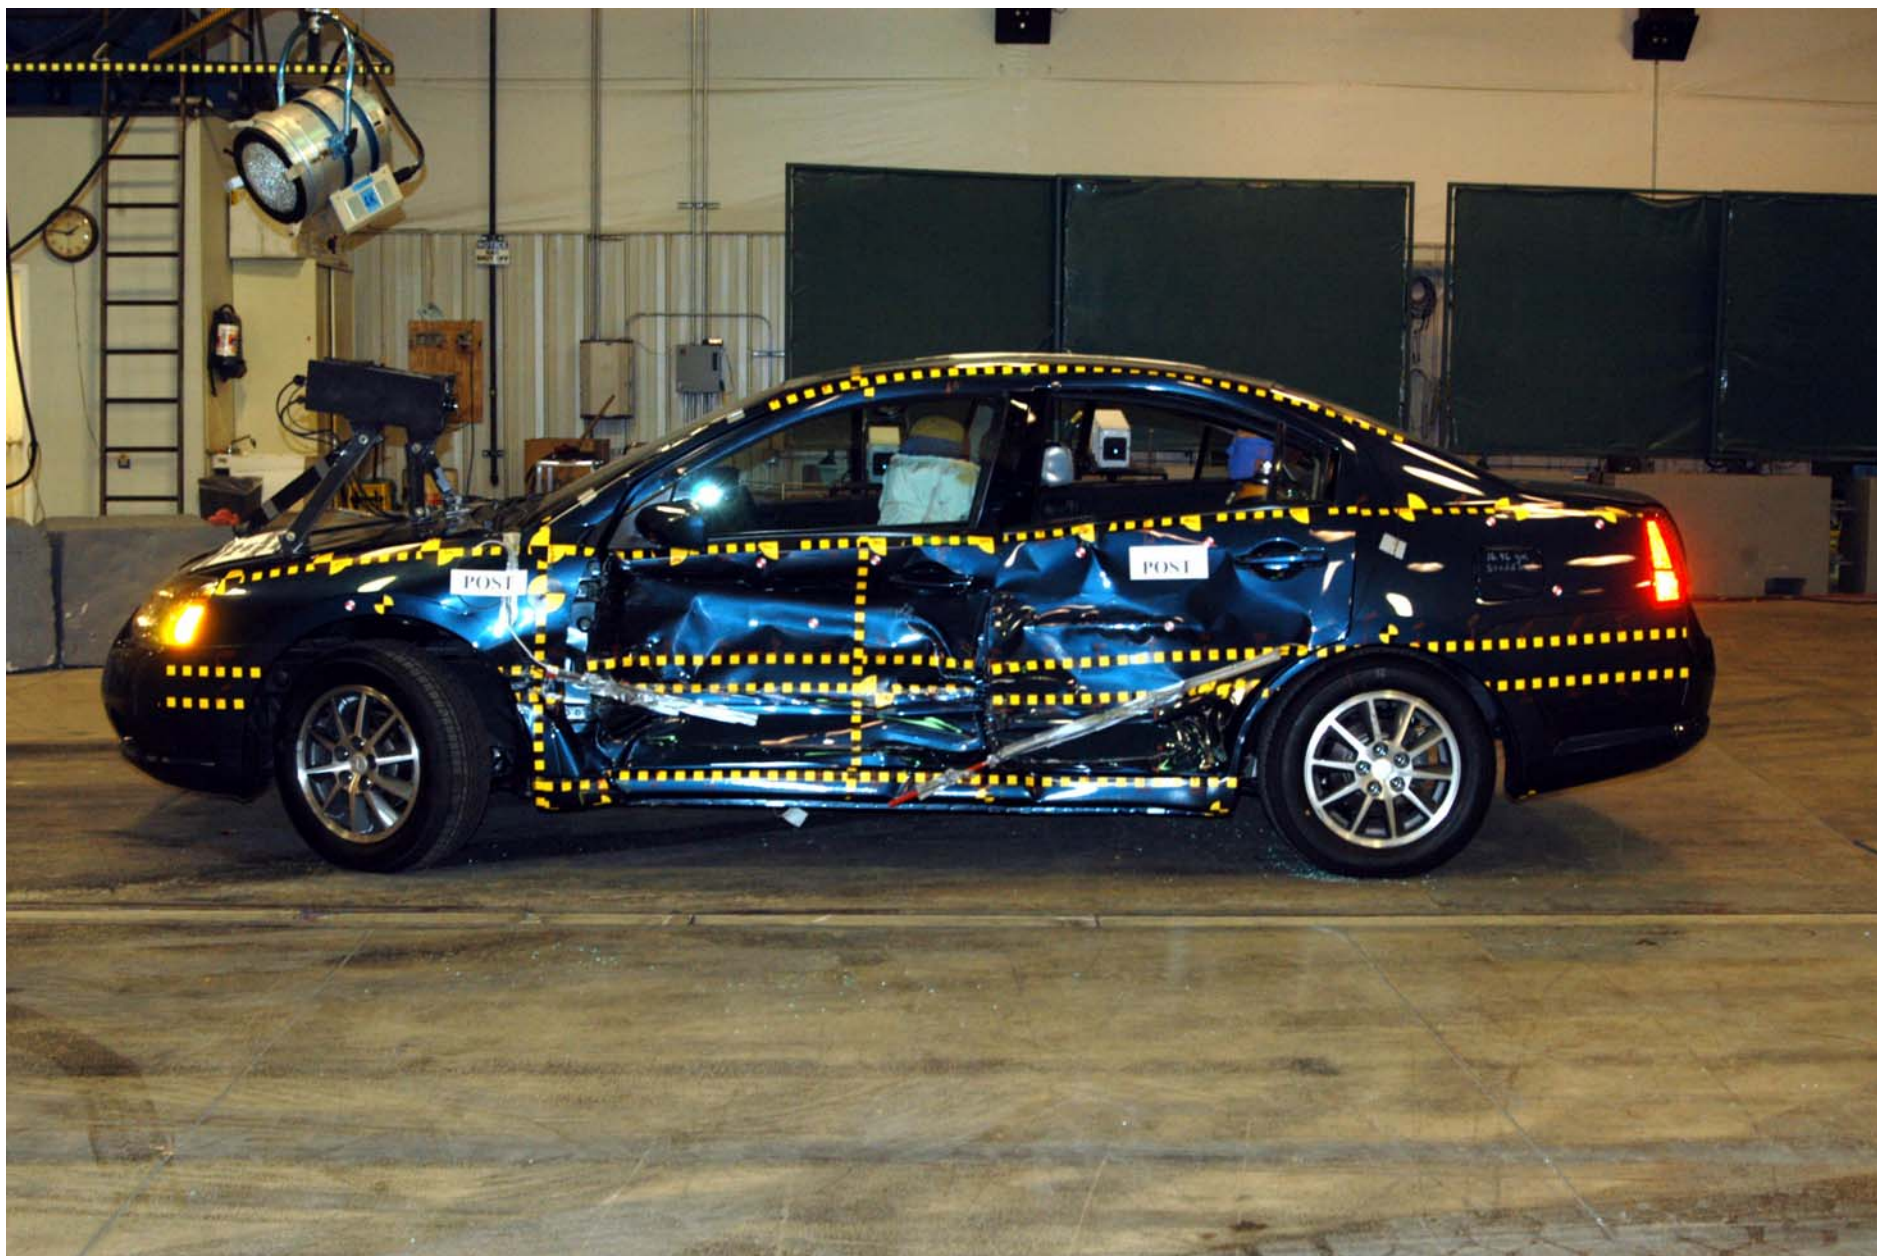
Figure A-6: POST-TEST LEFT SIDE VIEW OF TEST VEHICLE

Maximum Post-Test intrusion at Level 2 is 230 mm

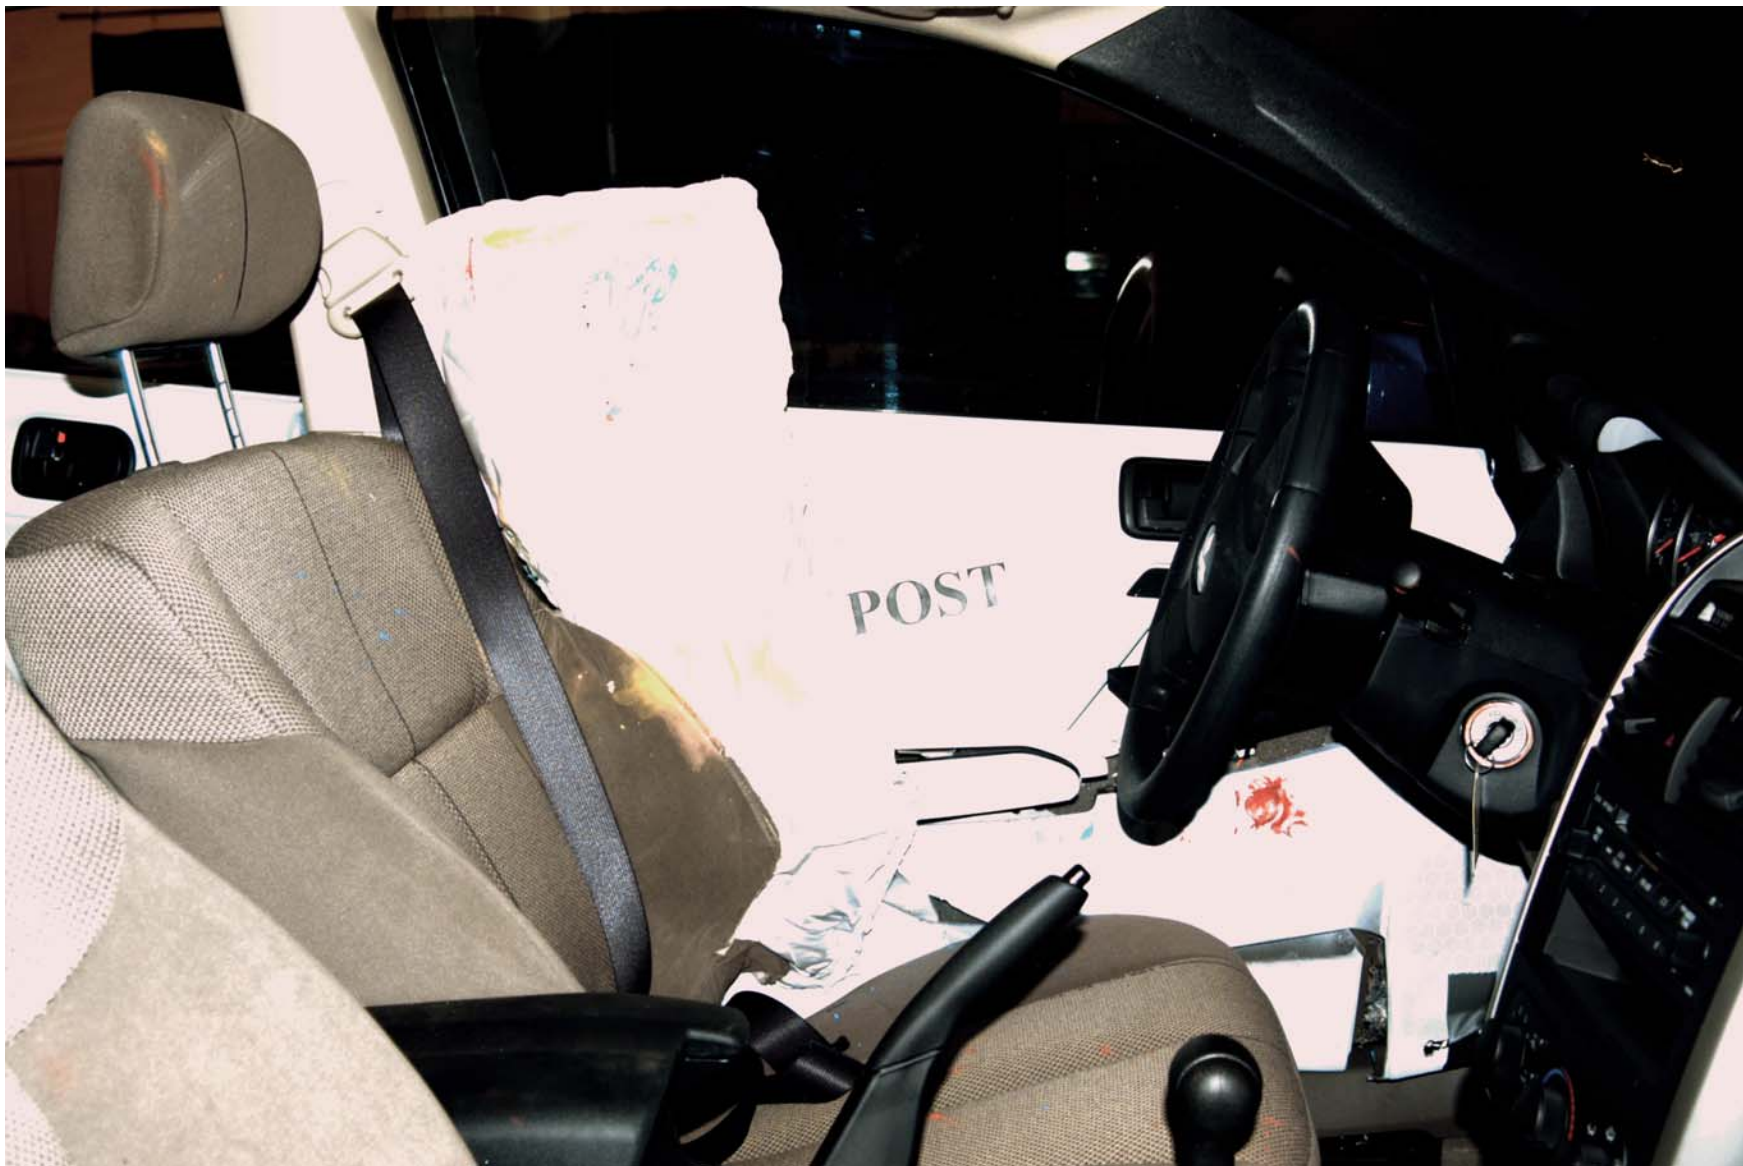
Figure A-26: POST-TEST INTERIOR OF FRONT DOOR SHOWING SID H3 IMPACT LOCATIONS

| | <u>LEFT FRONT SID H3</u> | <u>LEFT REAR SID H3</u> |
|---|---|---|
| Head | To side airbag | To side header at C-Pillar |
| Upper Torso | To side airbag | To left rear door panel ~ 160 mm below window sill |
| Lower Torso | To side airbag | To left rear door panel ~40 mm above arm rest |
| Left Knee | To left front door panel ~50 mm below arm rest | To left rear door panel at arm rest |
| Left Leg | To left front door panel ~100 mm below arm rest | To left rear door panel ~30 mm below arm rest |

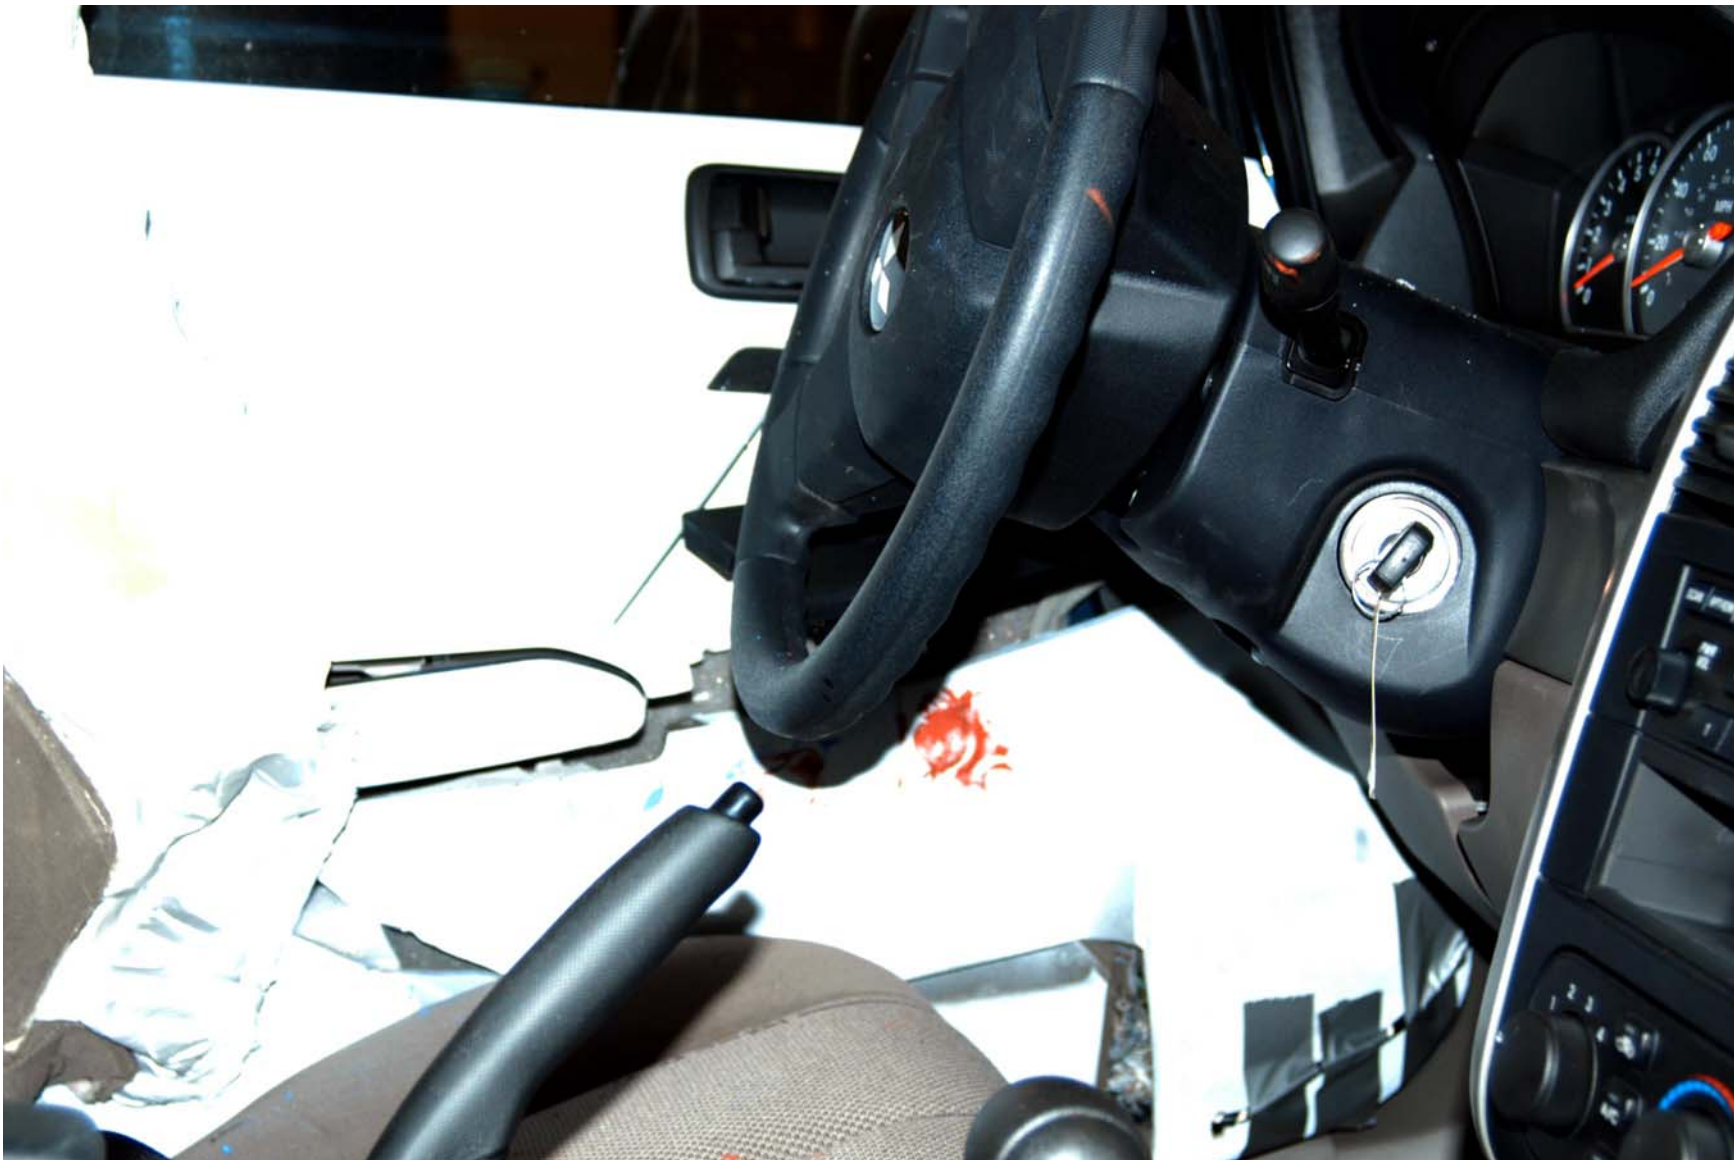
Figure A-27: POST-TEST INTERIOR OF FRONT DOOR SHOWING SID H3 IMPACT LOCATIONS 2

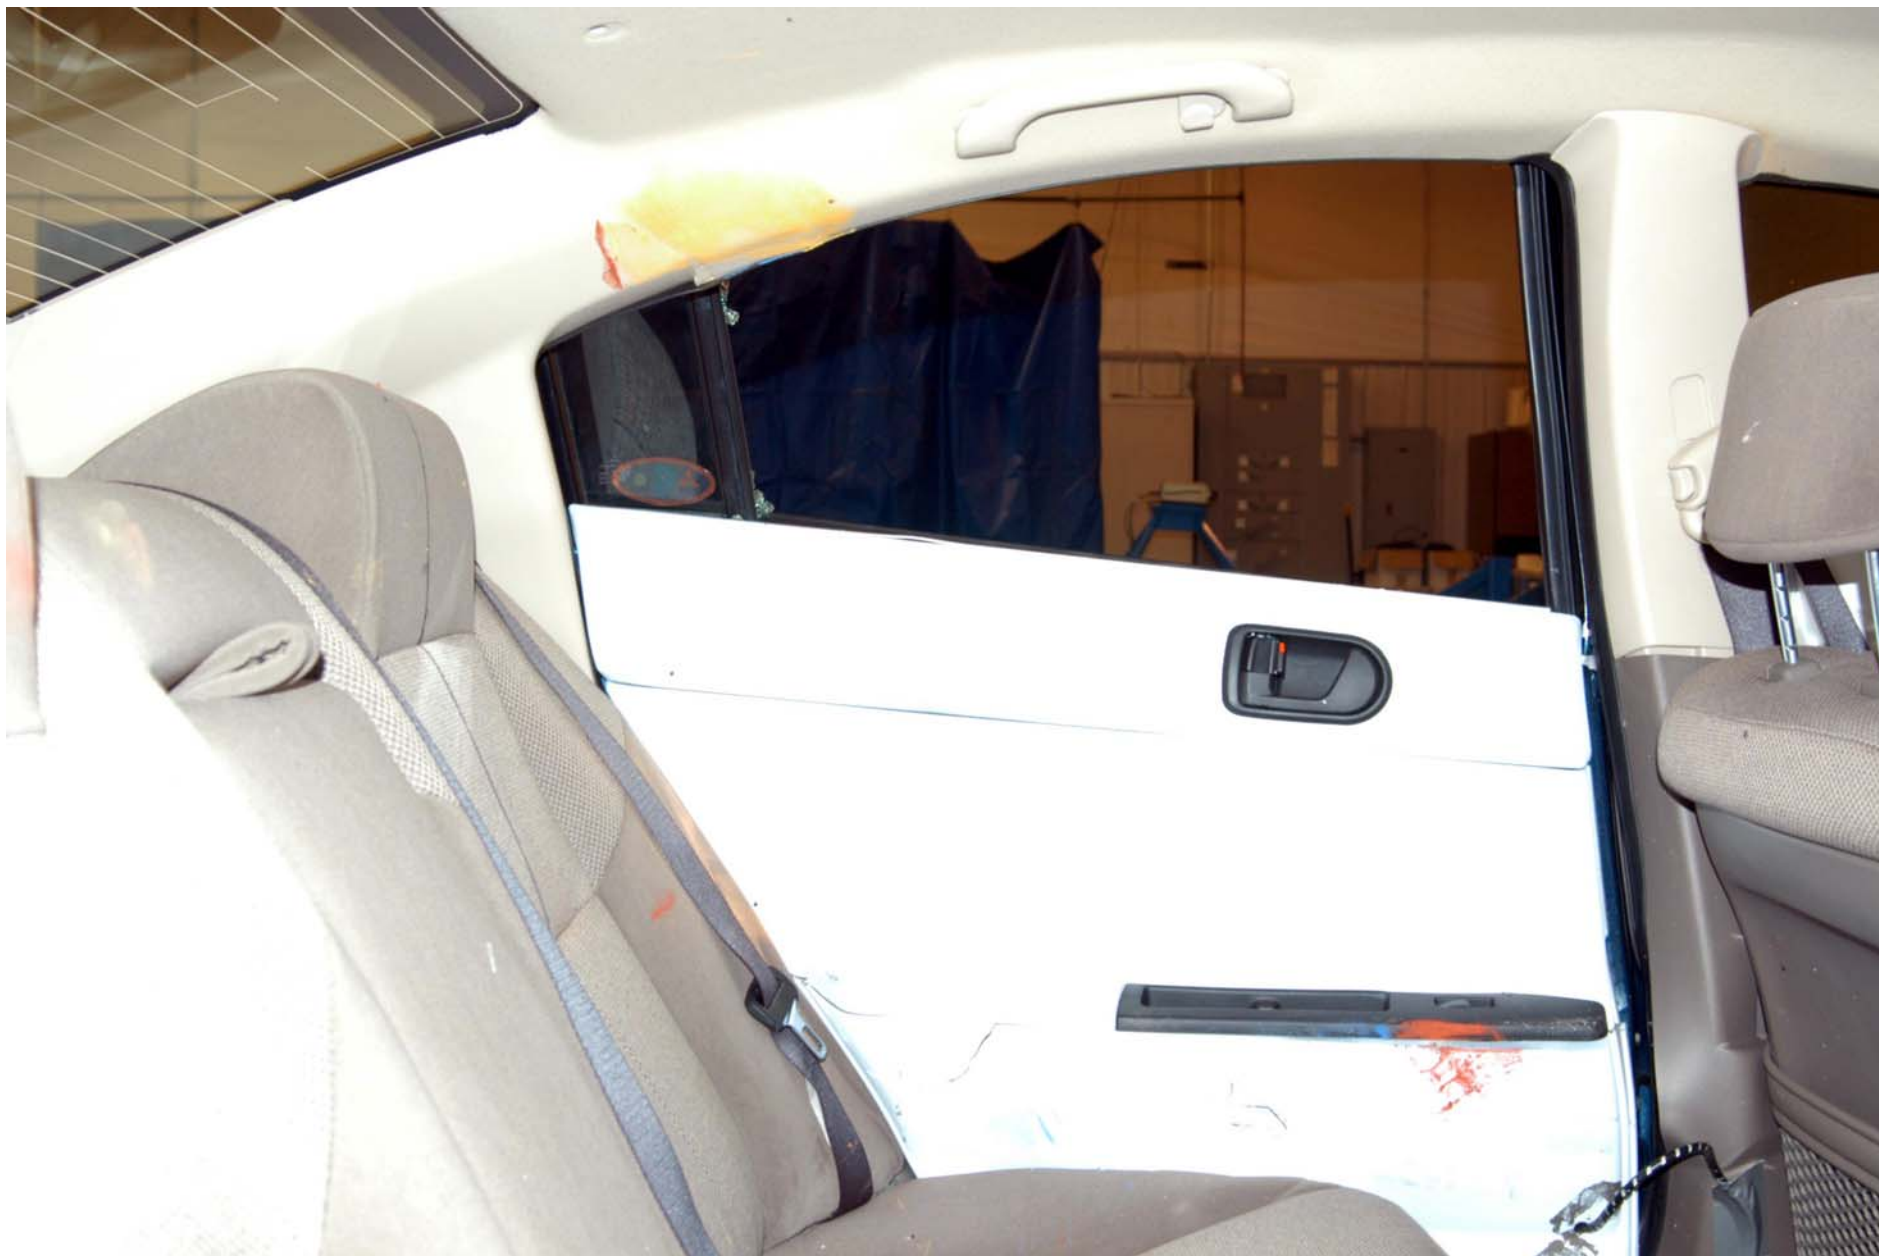
Figure A-29: POST-TEST INTERIOR OF REAR DOOR SHOWING SID H3 IMPACT LOCATIONS

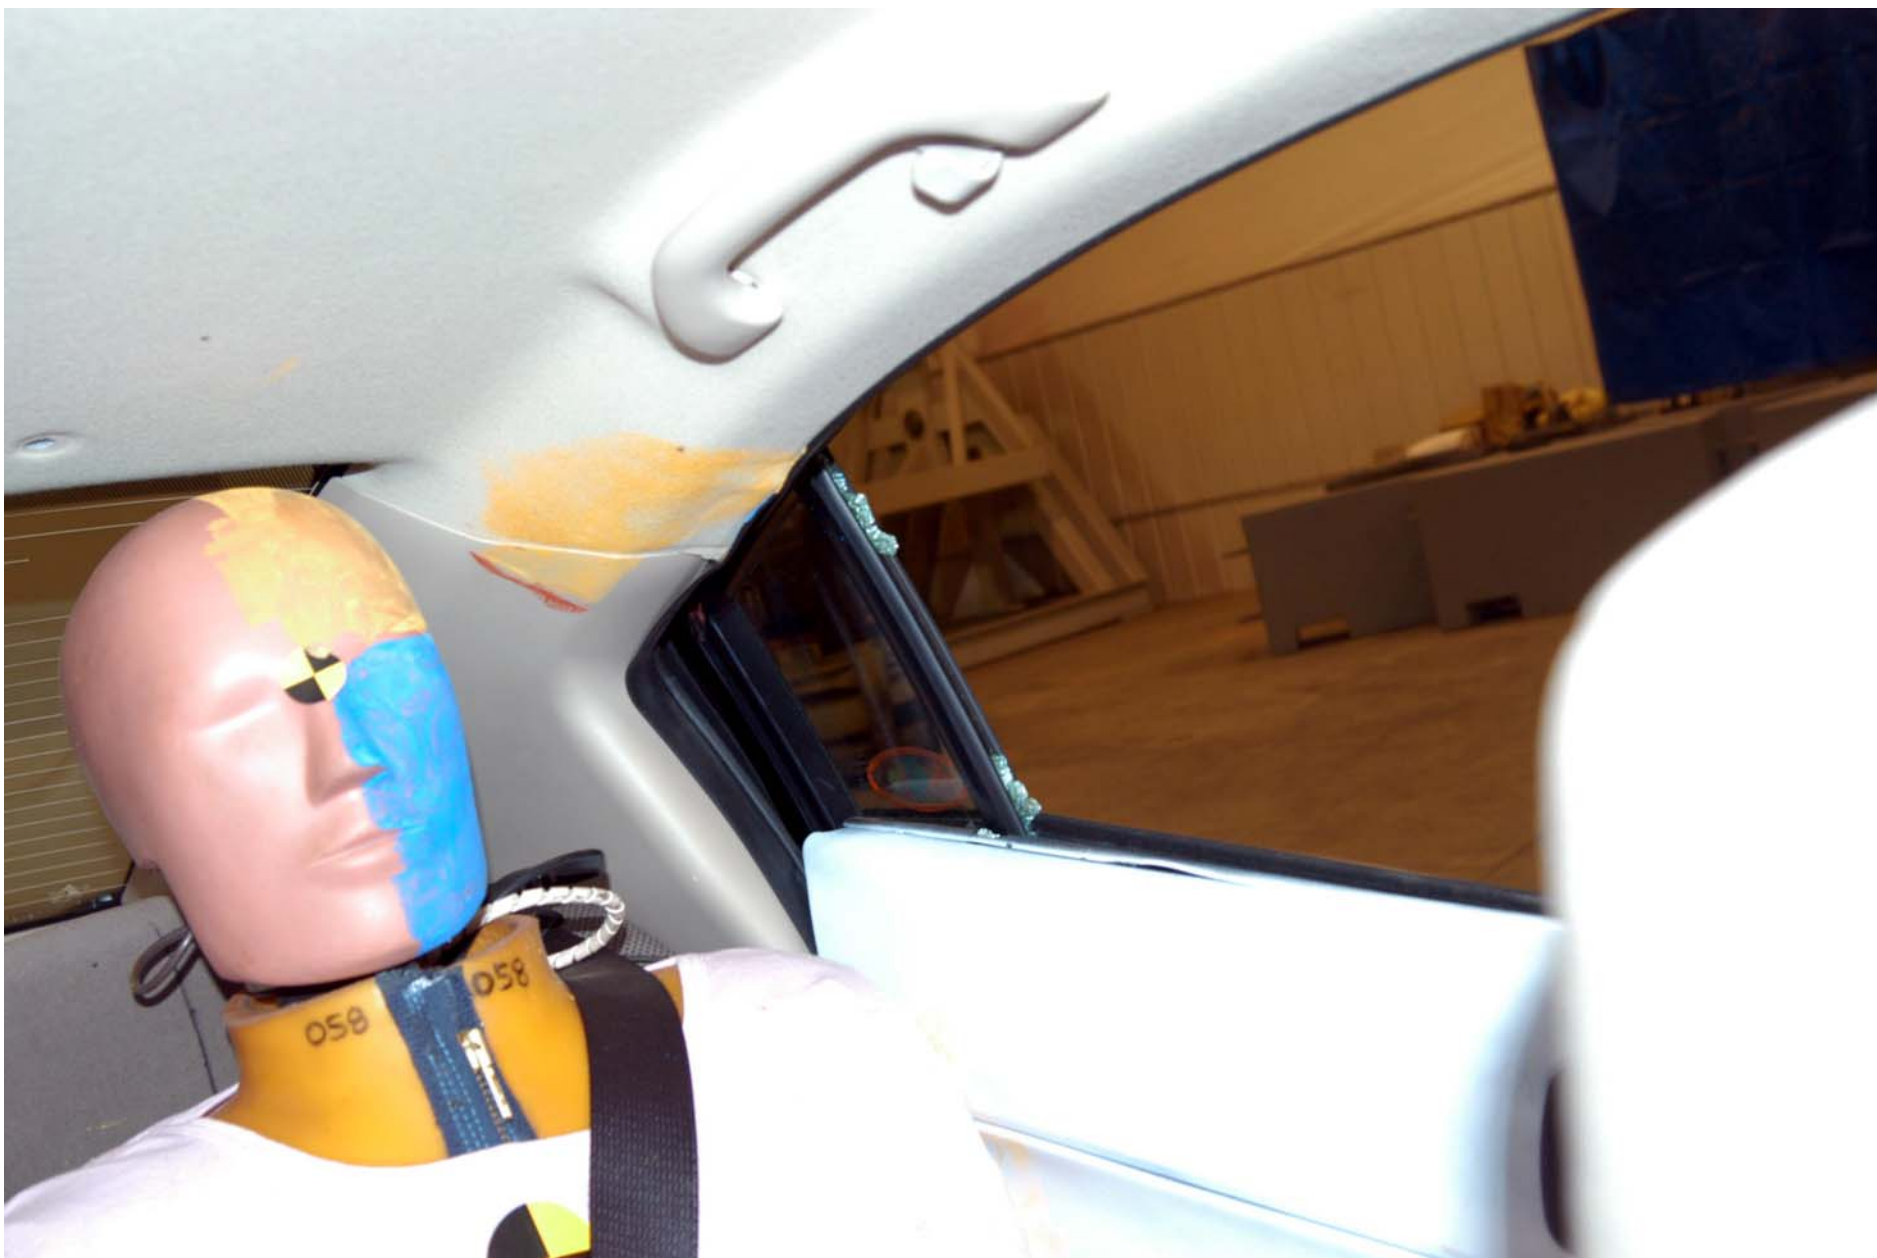
Figure A-30: POST-TEST INTERIOR OF REAR DOOR SHOWING SID H3 IMPACT LOCATIONS 2

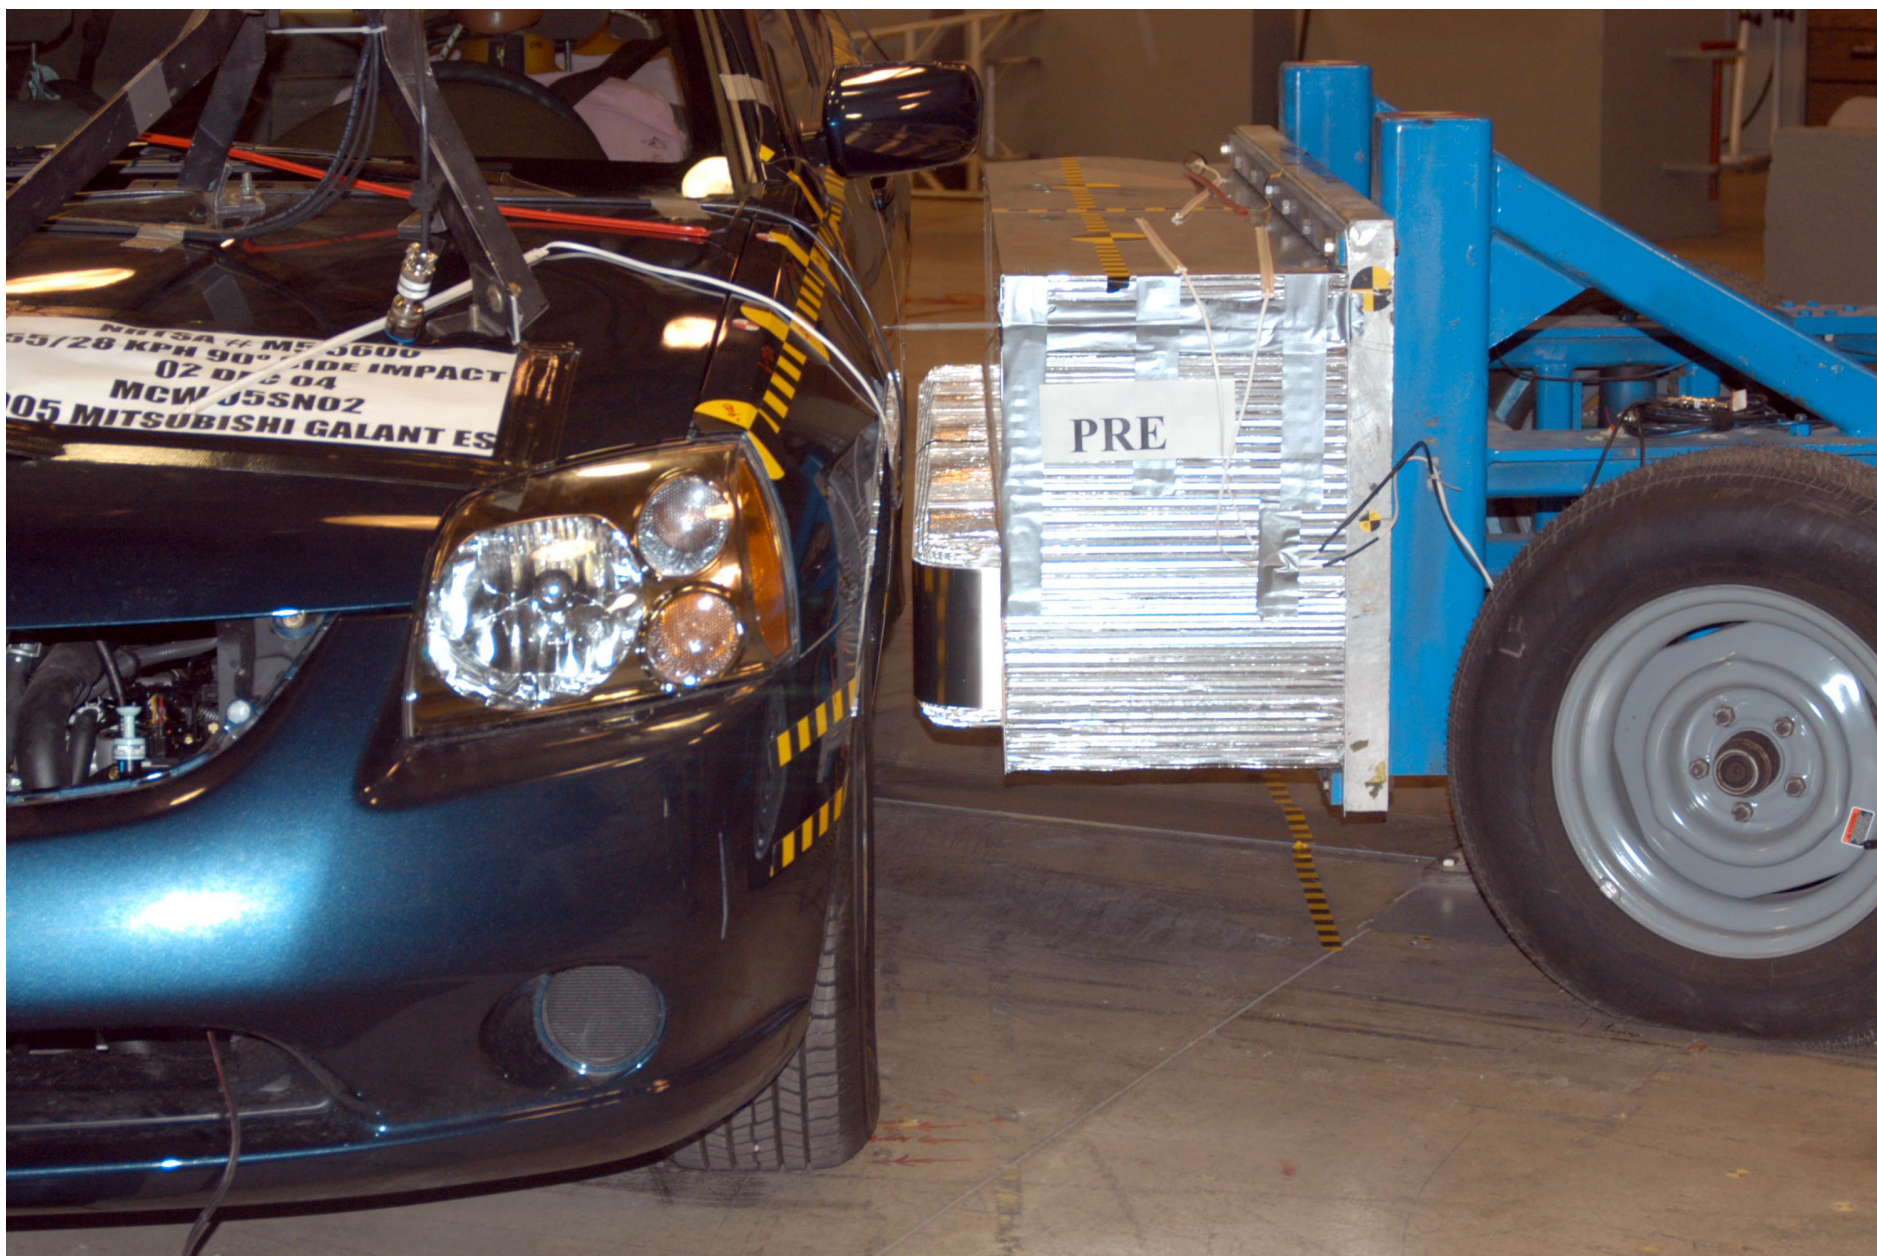
Figure A-31: PRE TEST LEFT SIDE VIEW OF MDB IN IMPACT POSITION

Crabbed 27° to the left

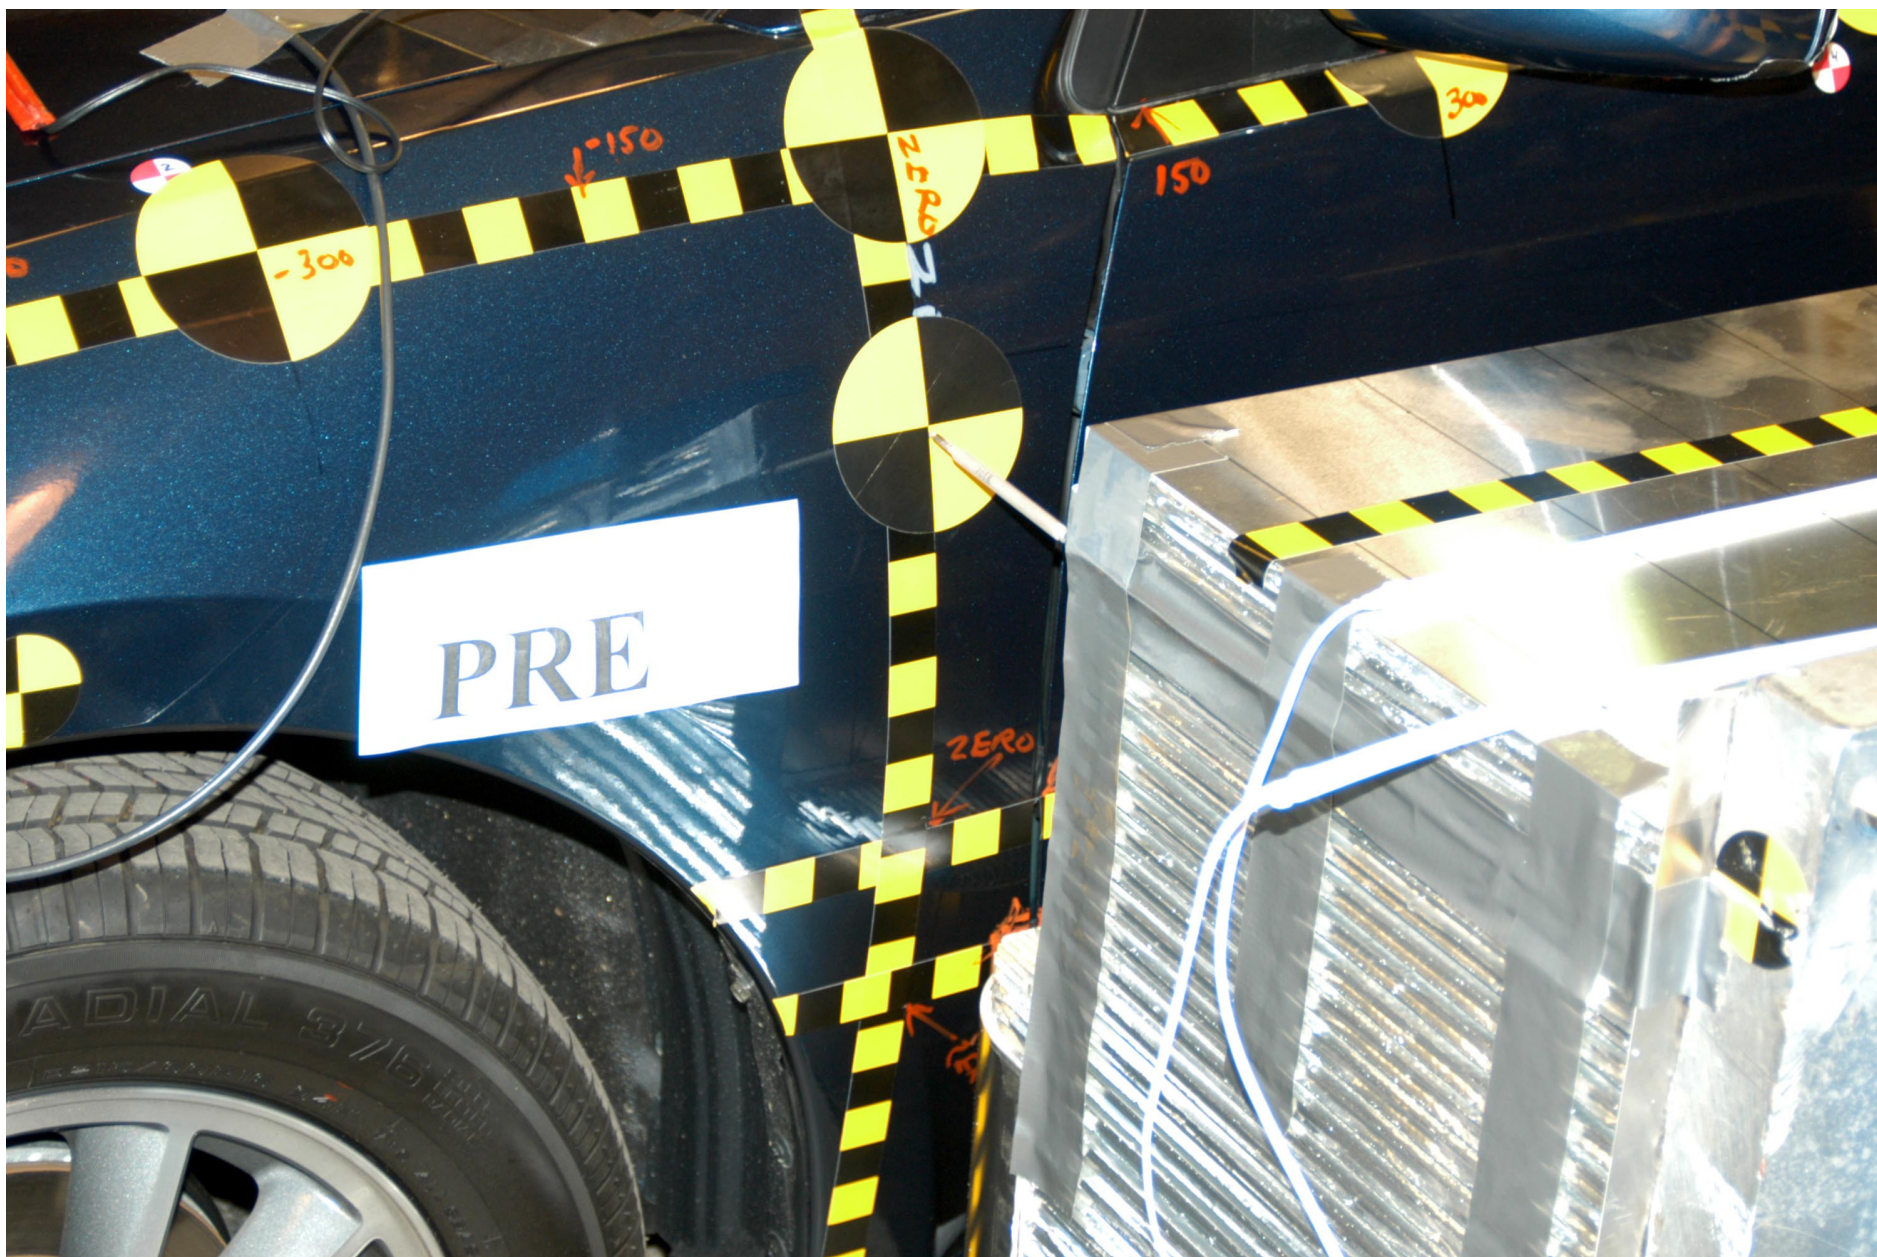
Figure A-37: PRE TEST CLOSE-UP OF IMPACT POINT TARGET SHOWING WELDING ROD

Actual Impact Point is 8 mm below and 12 mm forward of nominal impact point

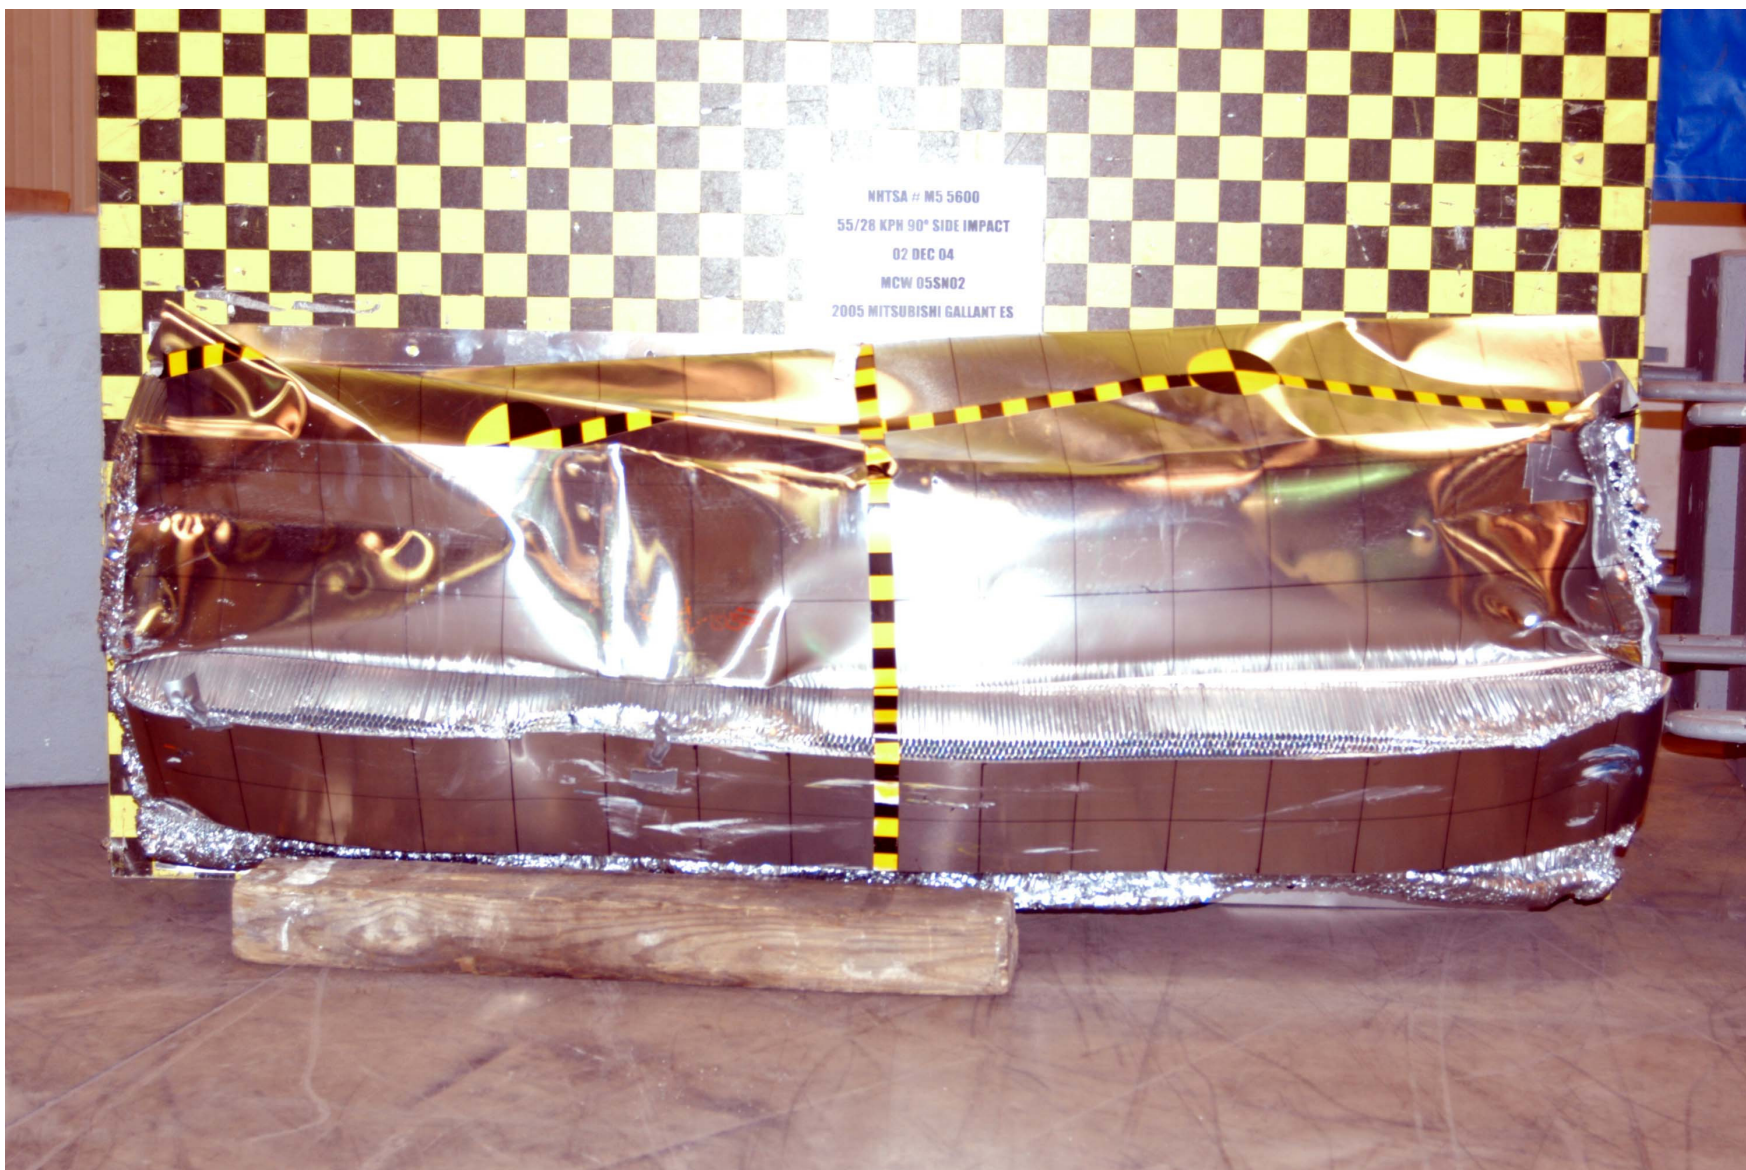
Figure A-48: POST-TEST ALUMINUM BARRIER FRONT

**MAXIMUM STATIC CRUSH OF HONEYCOMB IMPACT FACE:**

| 1. Row A Center of Bumper | = | 240 | mm |
| 2. Row B Top of Bumper | = | 153 | mm |
| 3. Row C Mid-Level | = | 153 | mm |
| 4. Row D Top of Stack | = | 175 | mm |
