**REPORT NUMBER: NCAP-MGA-2005-005**

**NEW CAR ASSESSMENT PROGRAM  
FRONTAL BARRIER IMPACT TEST**

**FORD MOTOR COMPANY  
2005 Ford Mustang  
NHTSA NUMBER: M50206**

**PREPARED BY:  
MGA RESEARCH CORPORATION  
5000 WARREN ROAD  
BURLINGTON, WI 53105**

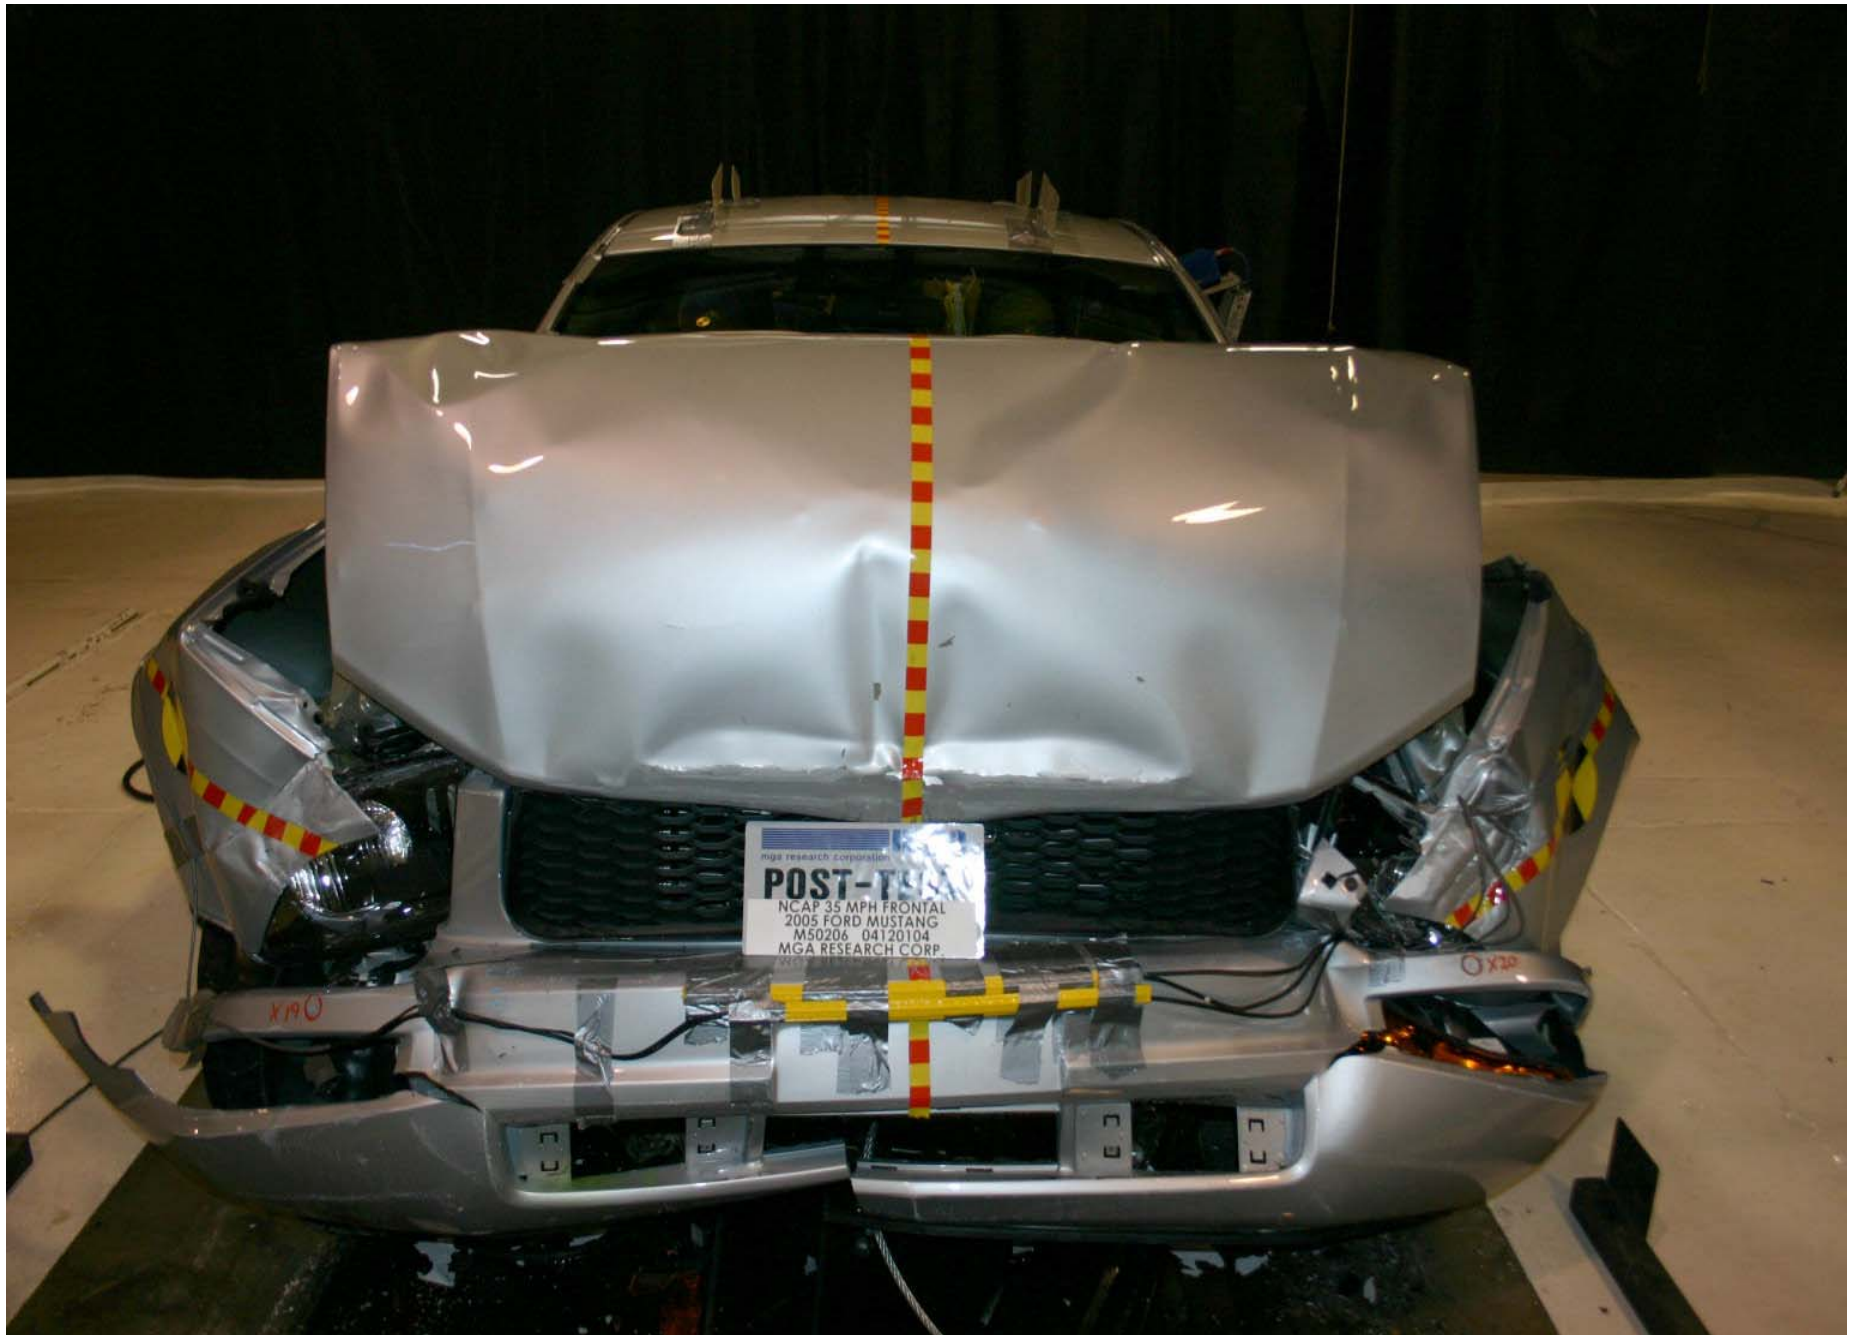
Post-Test Front View of Test Vehicle

The maximum static crush of the vehicle was 499 mm and both the driver and passenger side doors remained closed and latched during the impact event and were operable after the impact.

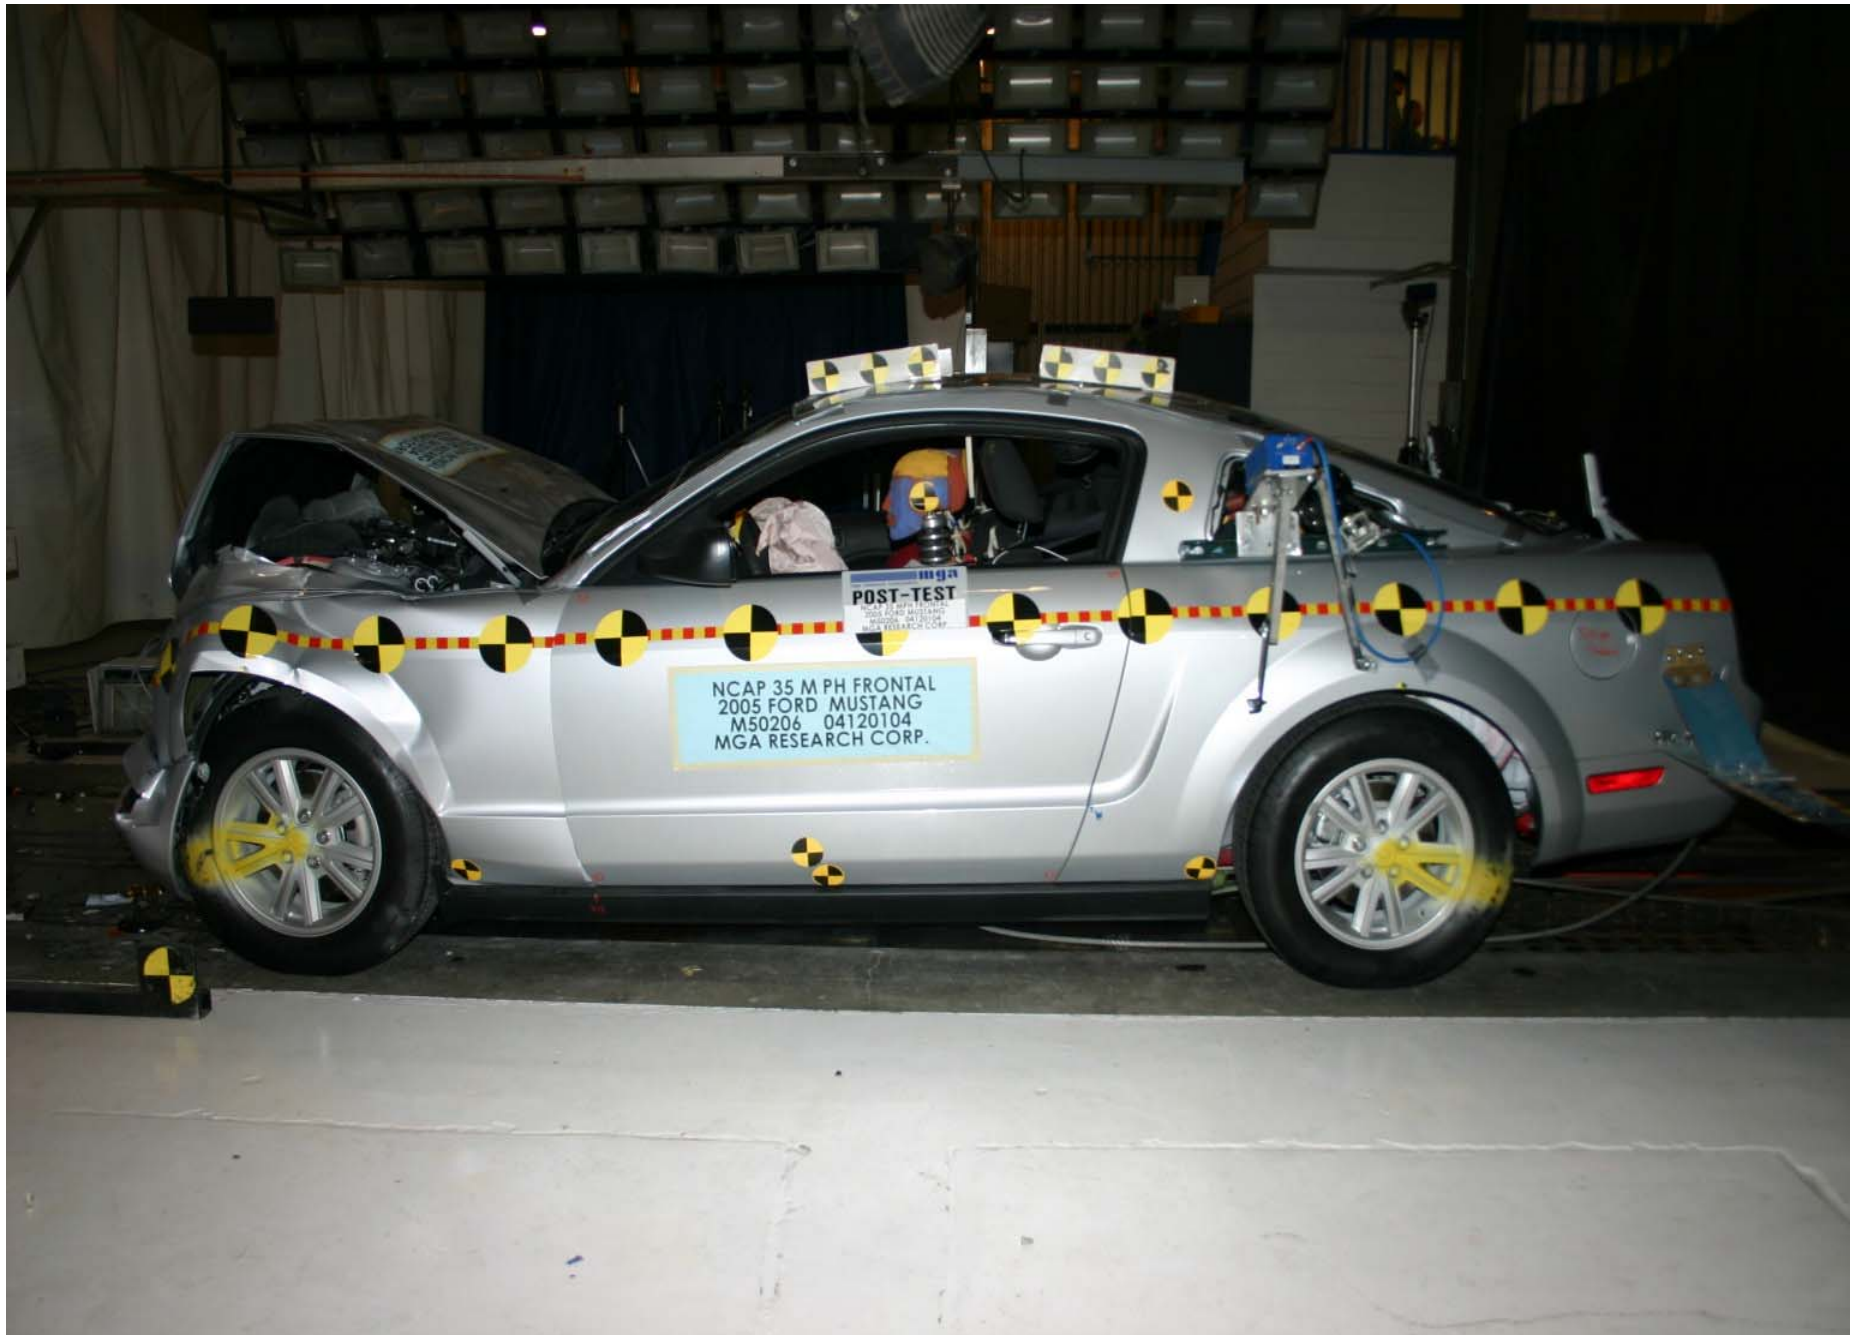
Post-Test Left Side View of Test Vehicle

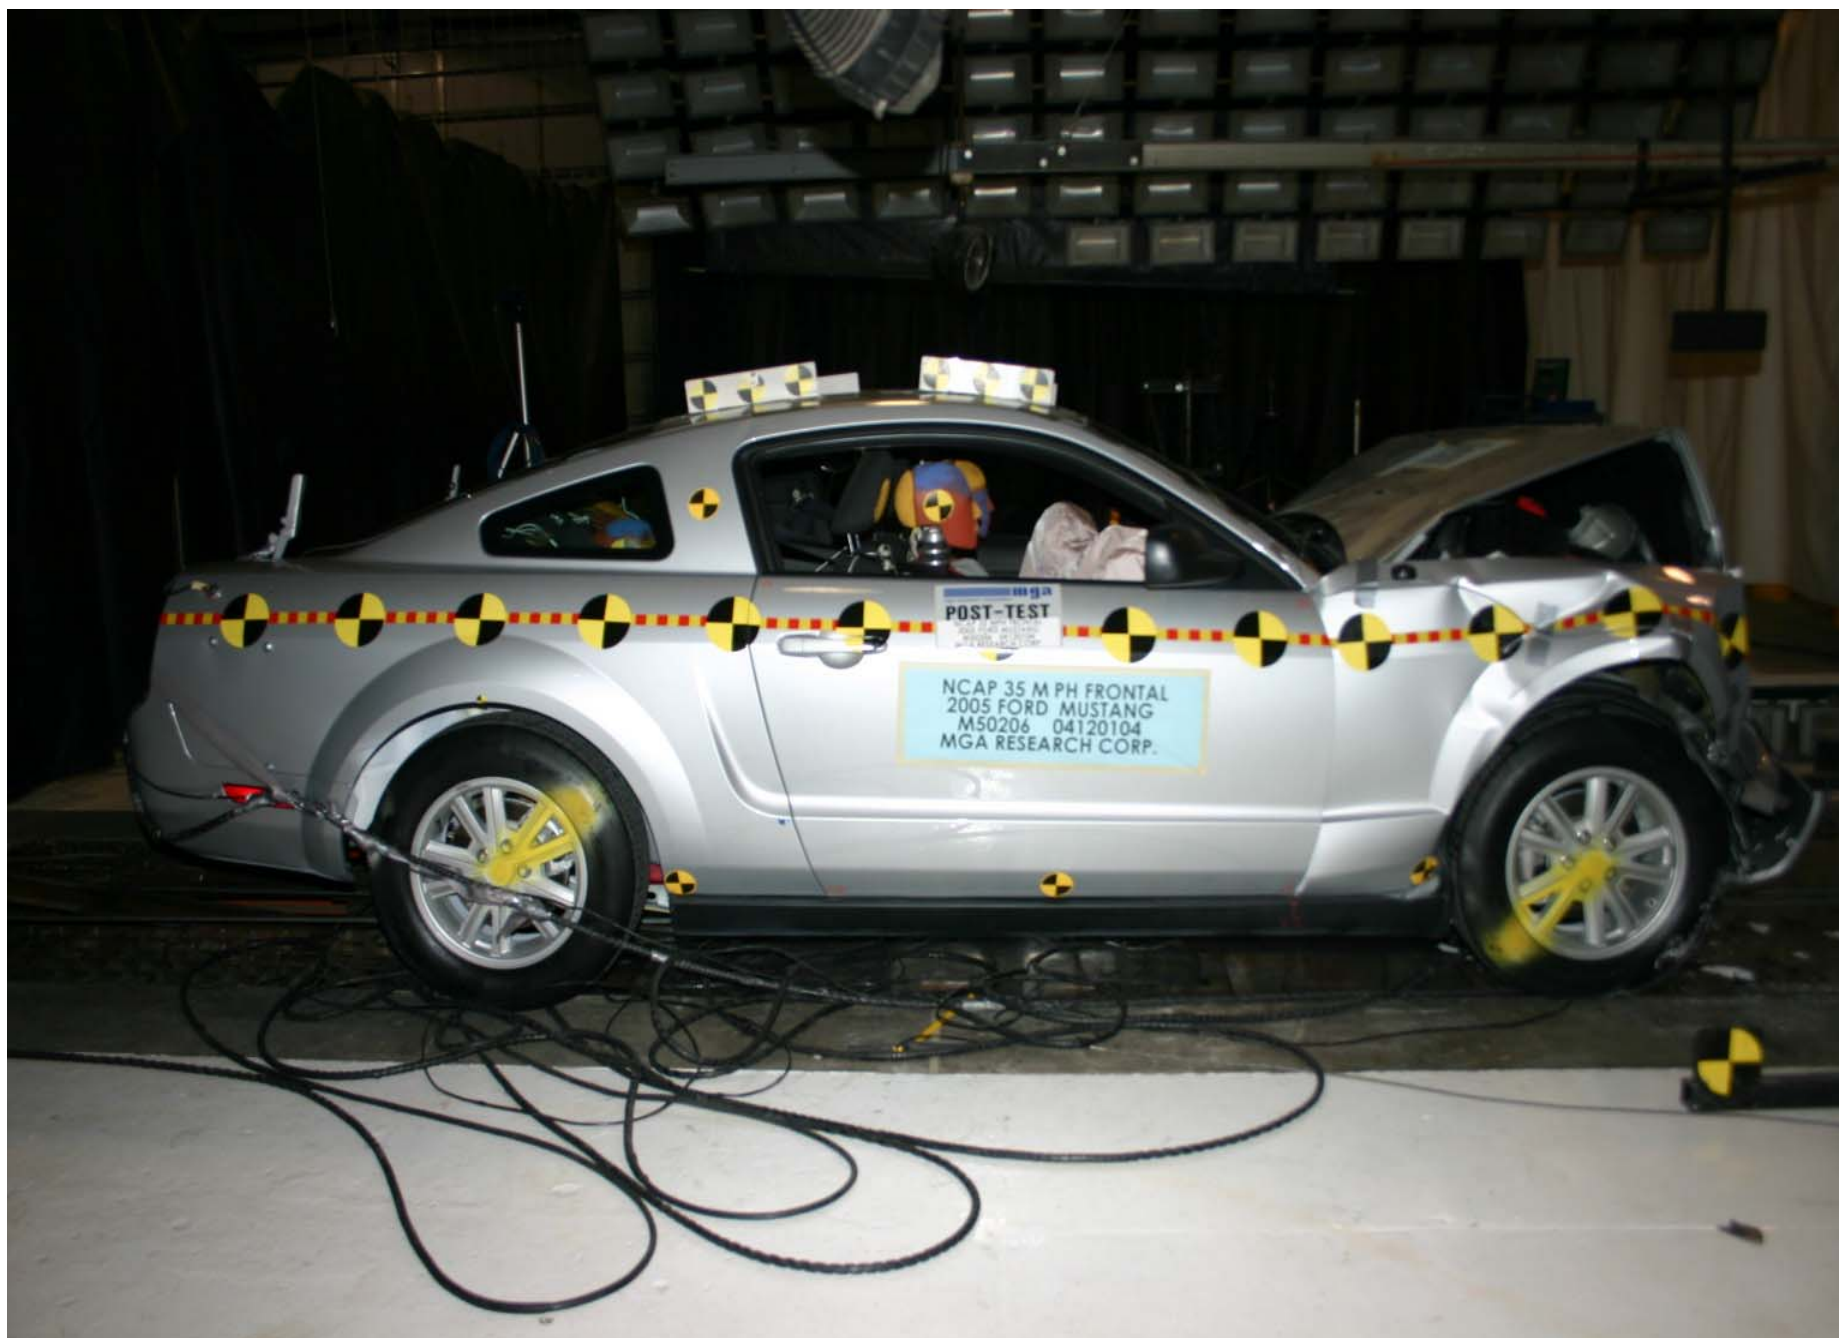
Post-Test Right Side View of Test Vehicle

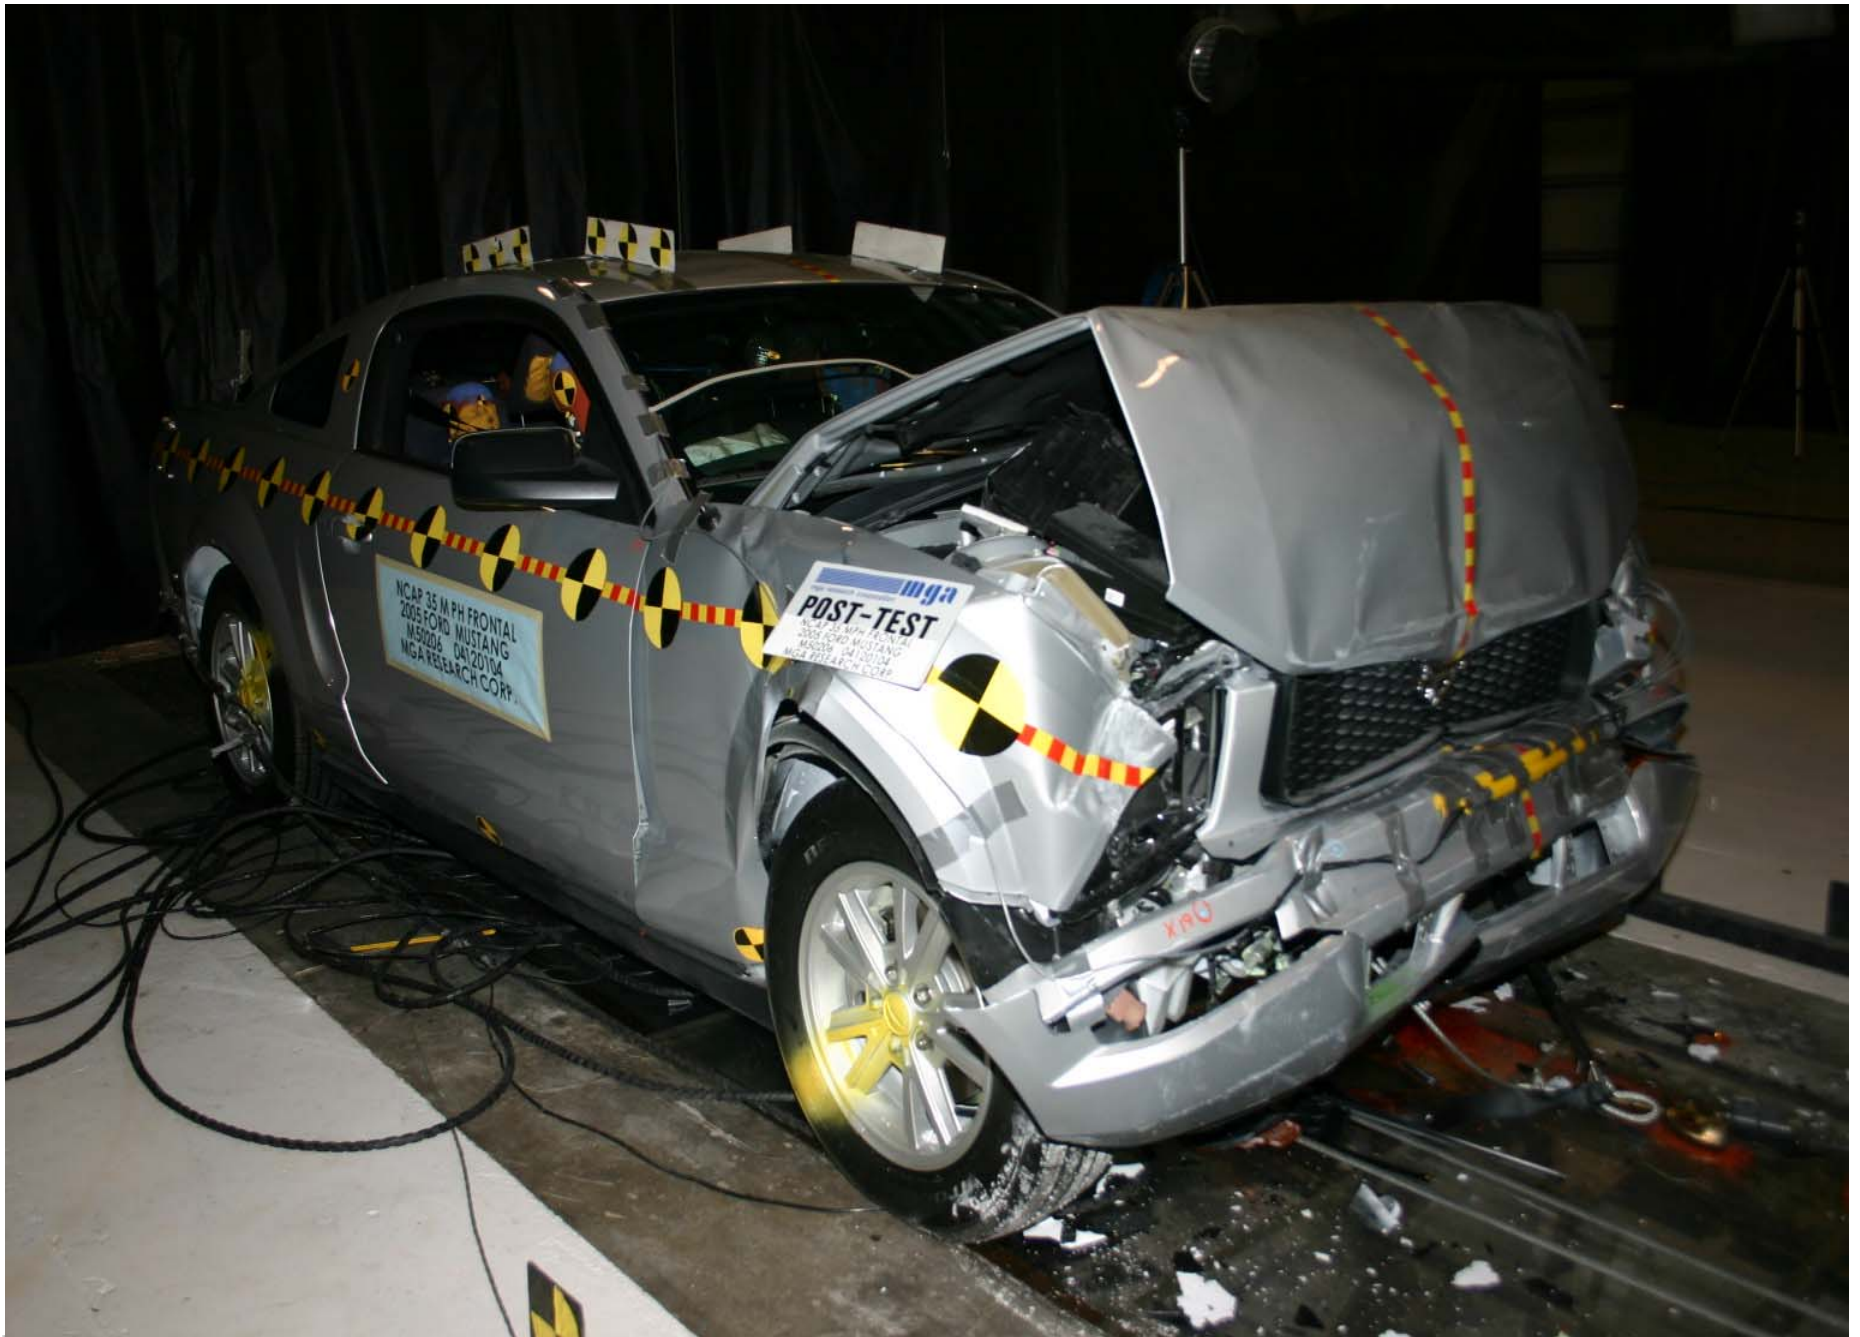
Post-Test Right Front Three-Quarter View of Test Vehicle

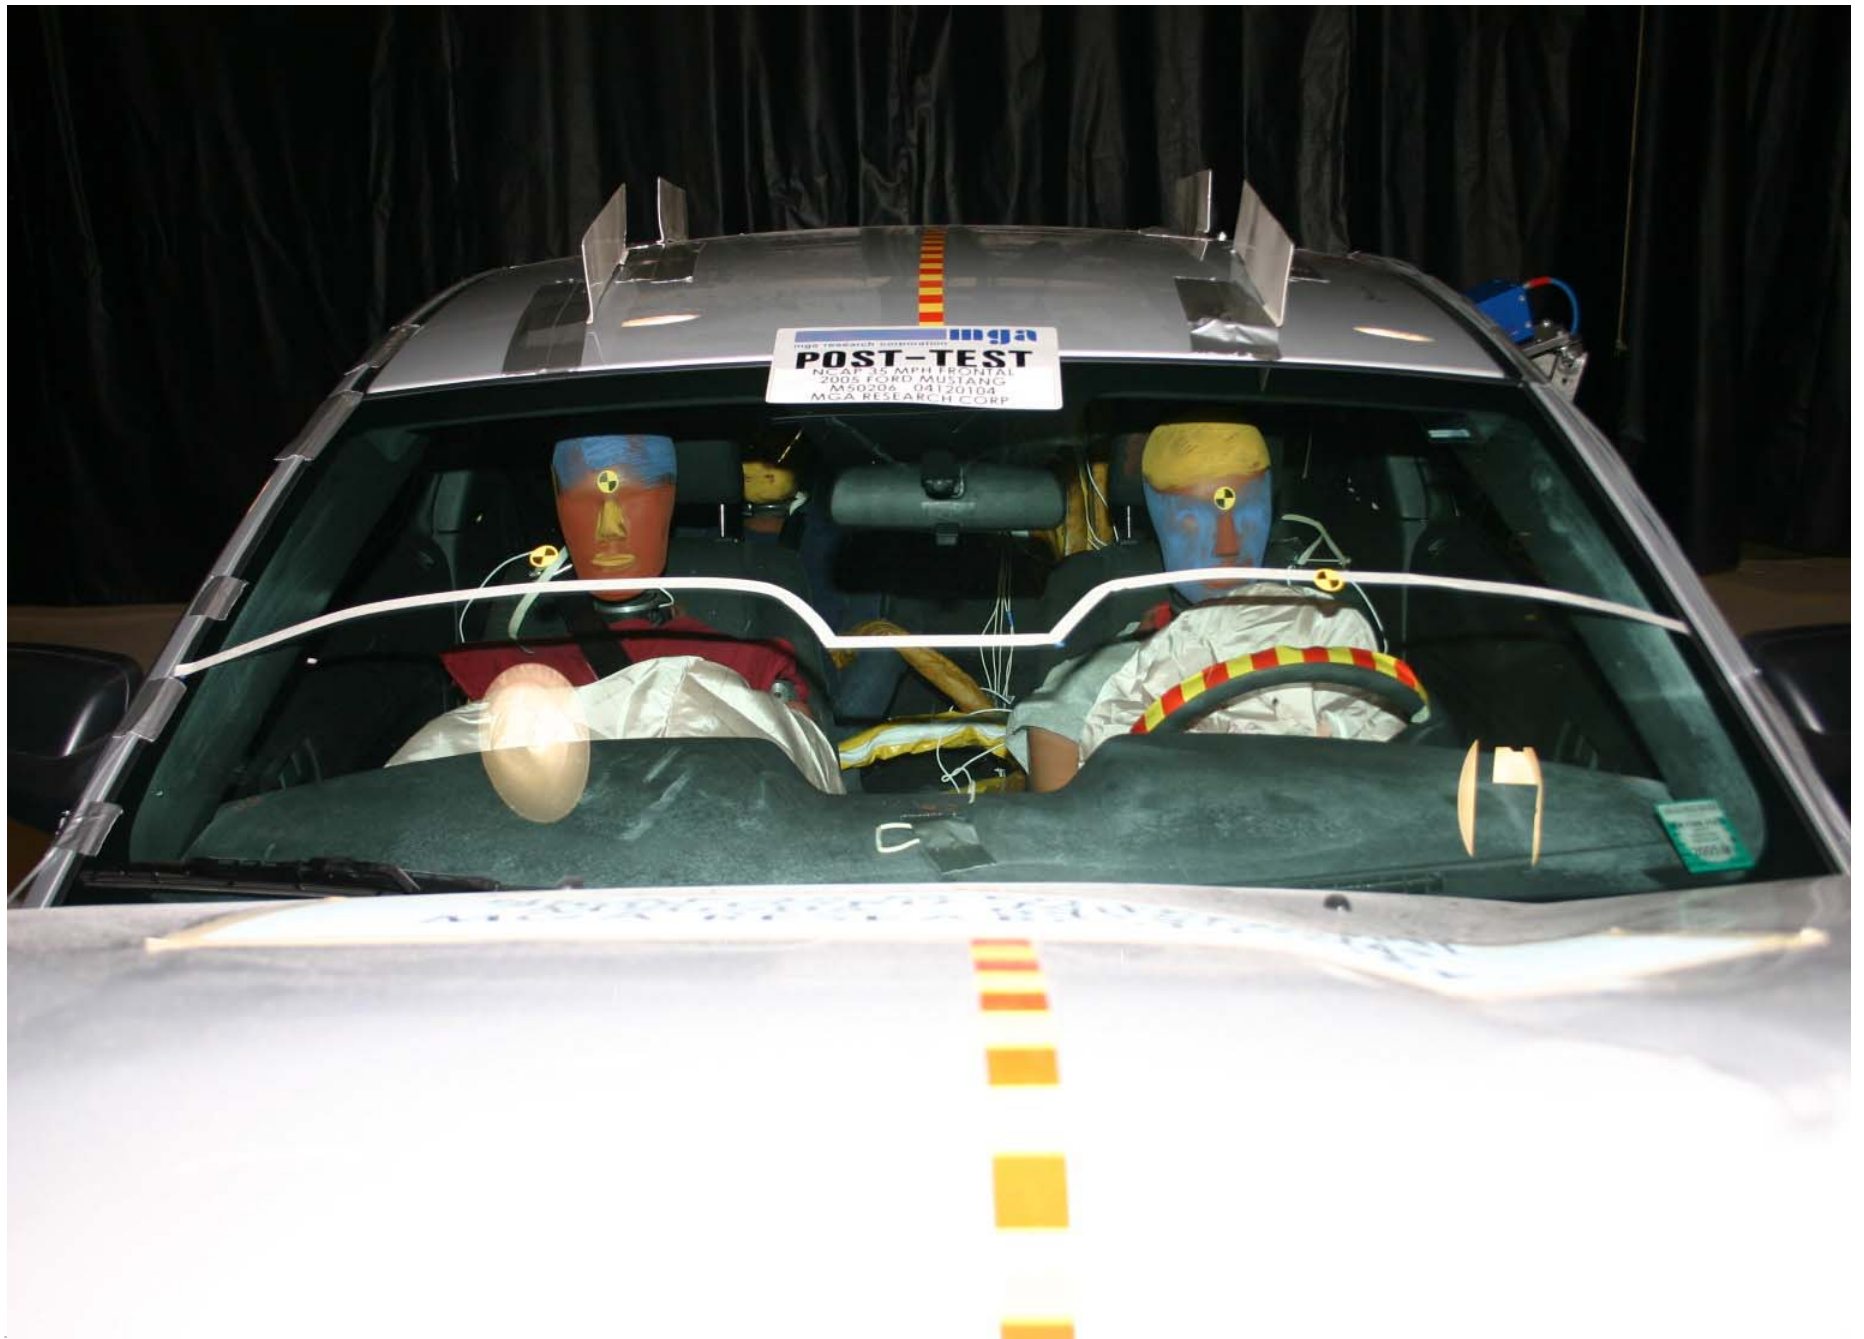
Post-Test Windshield View

There was 100 percent windshield retention and no intrusion into the protected zone of the windshield during the event. There was no Stoddard Solvent leakage after the event or during any phase of the static rollover.

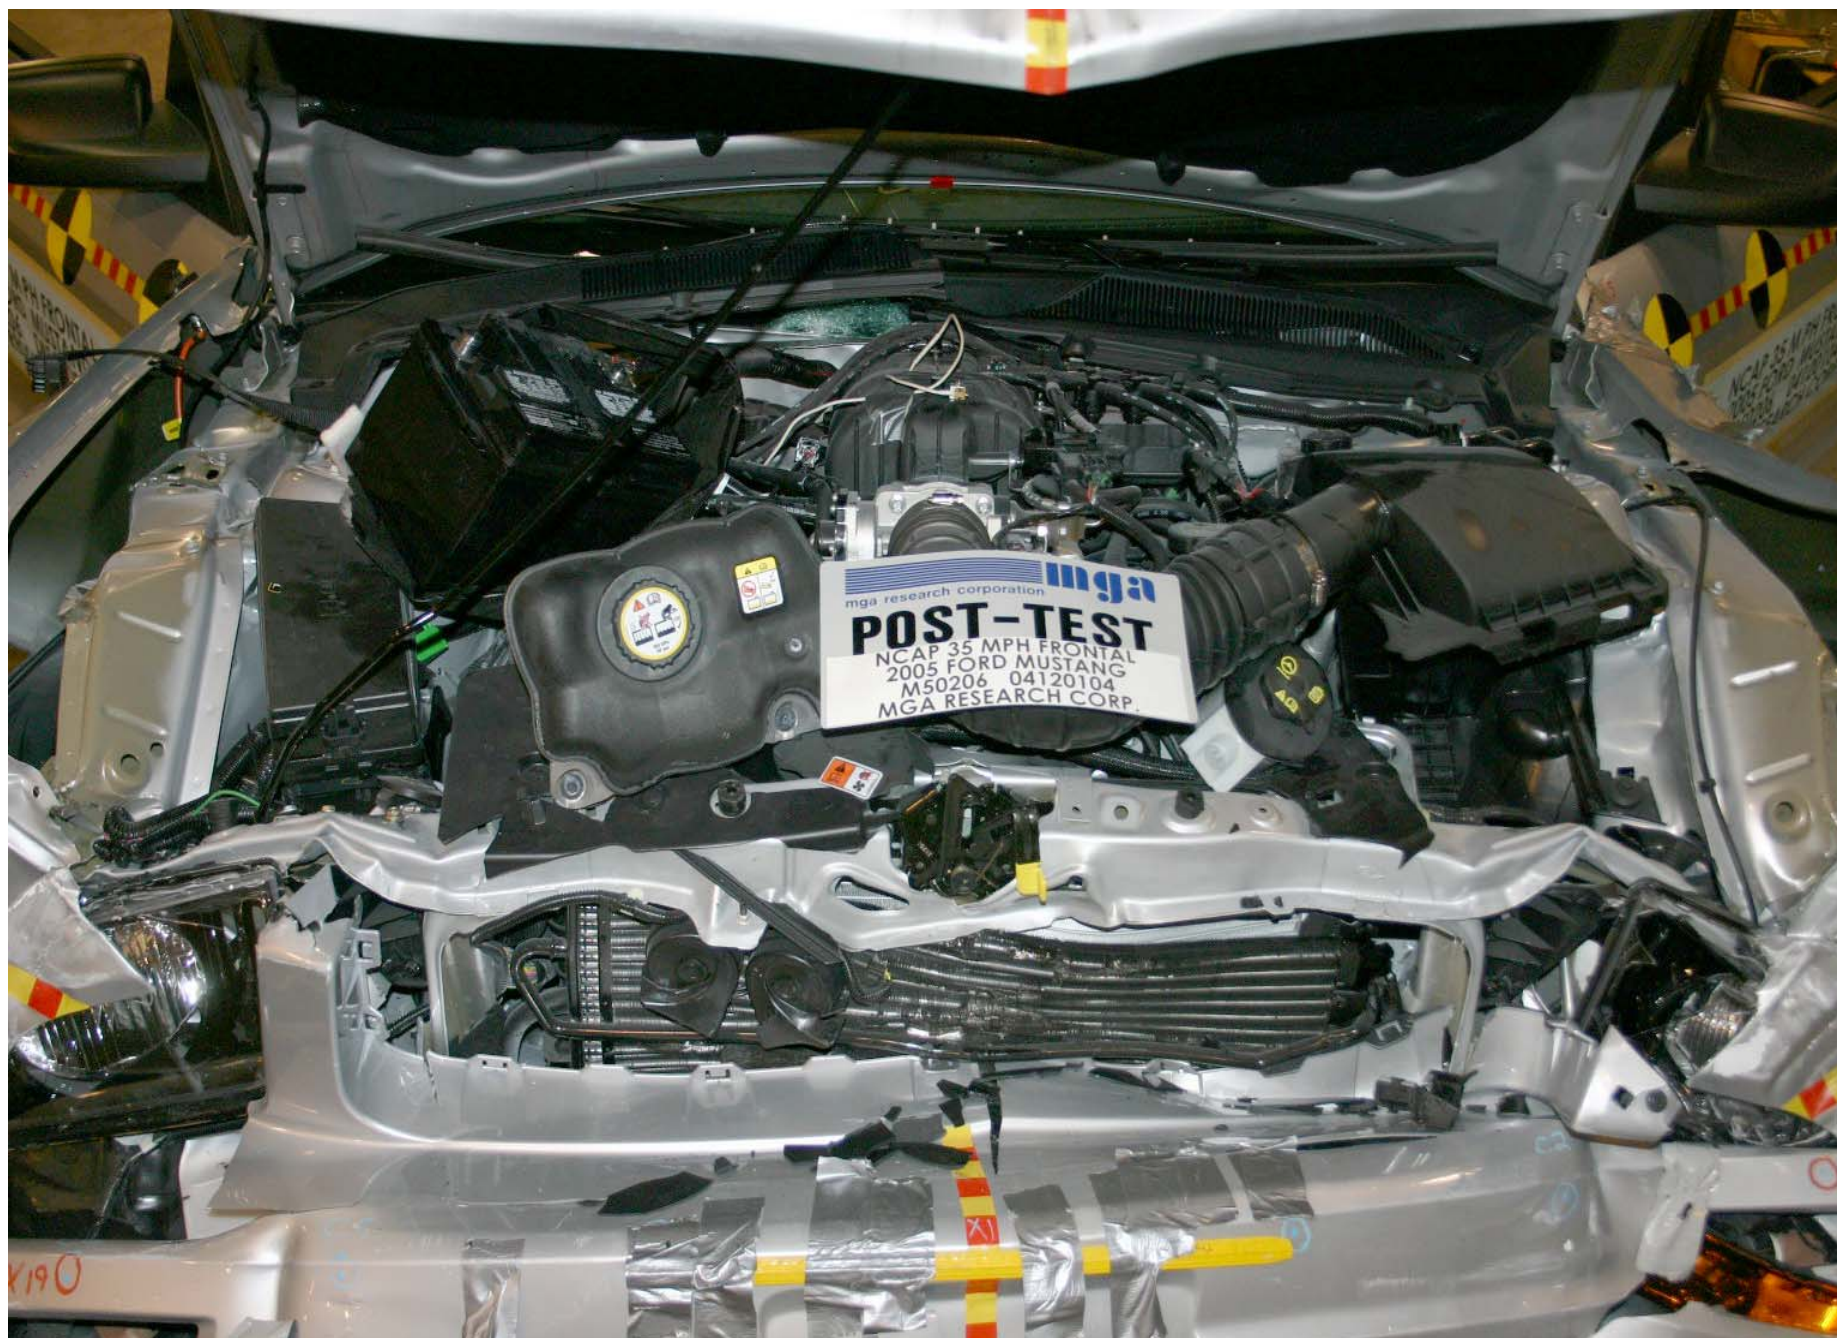
Post-Test Engine Compartment View

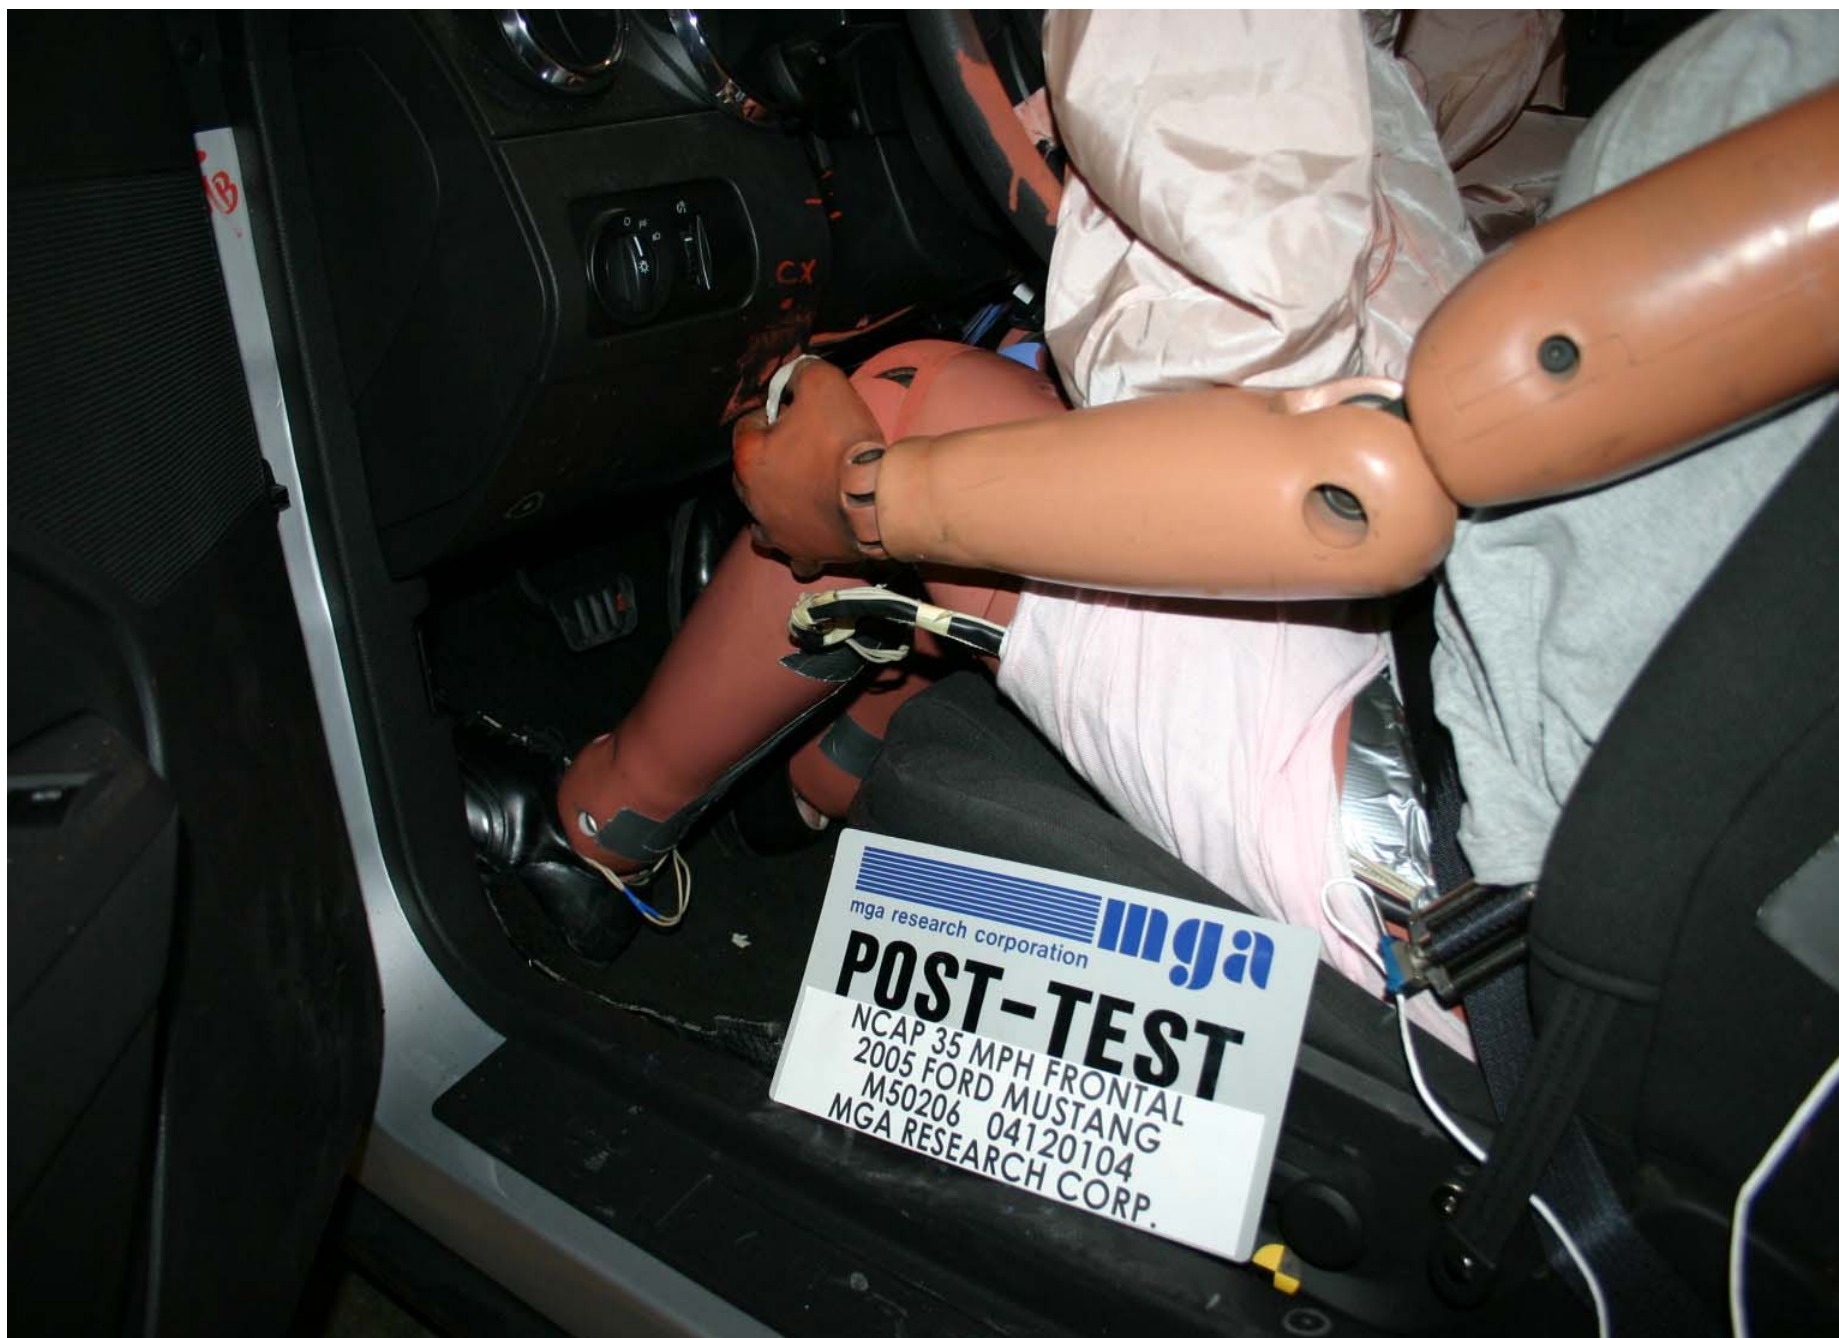
Post-Test Driver Side Knee Bolster View

The driver's head, chest, and abdomen contacted the airbag. The driver's head also contacted the headrest. The driver's knees contacted the bolster. The passenger's head, chest and abdomen contacted the airbag. The passenger's head contacted the headrest. The passenger's knees contacted the glove box.

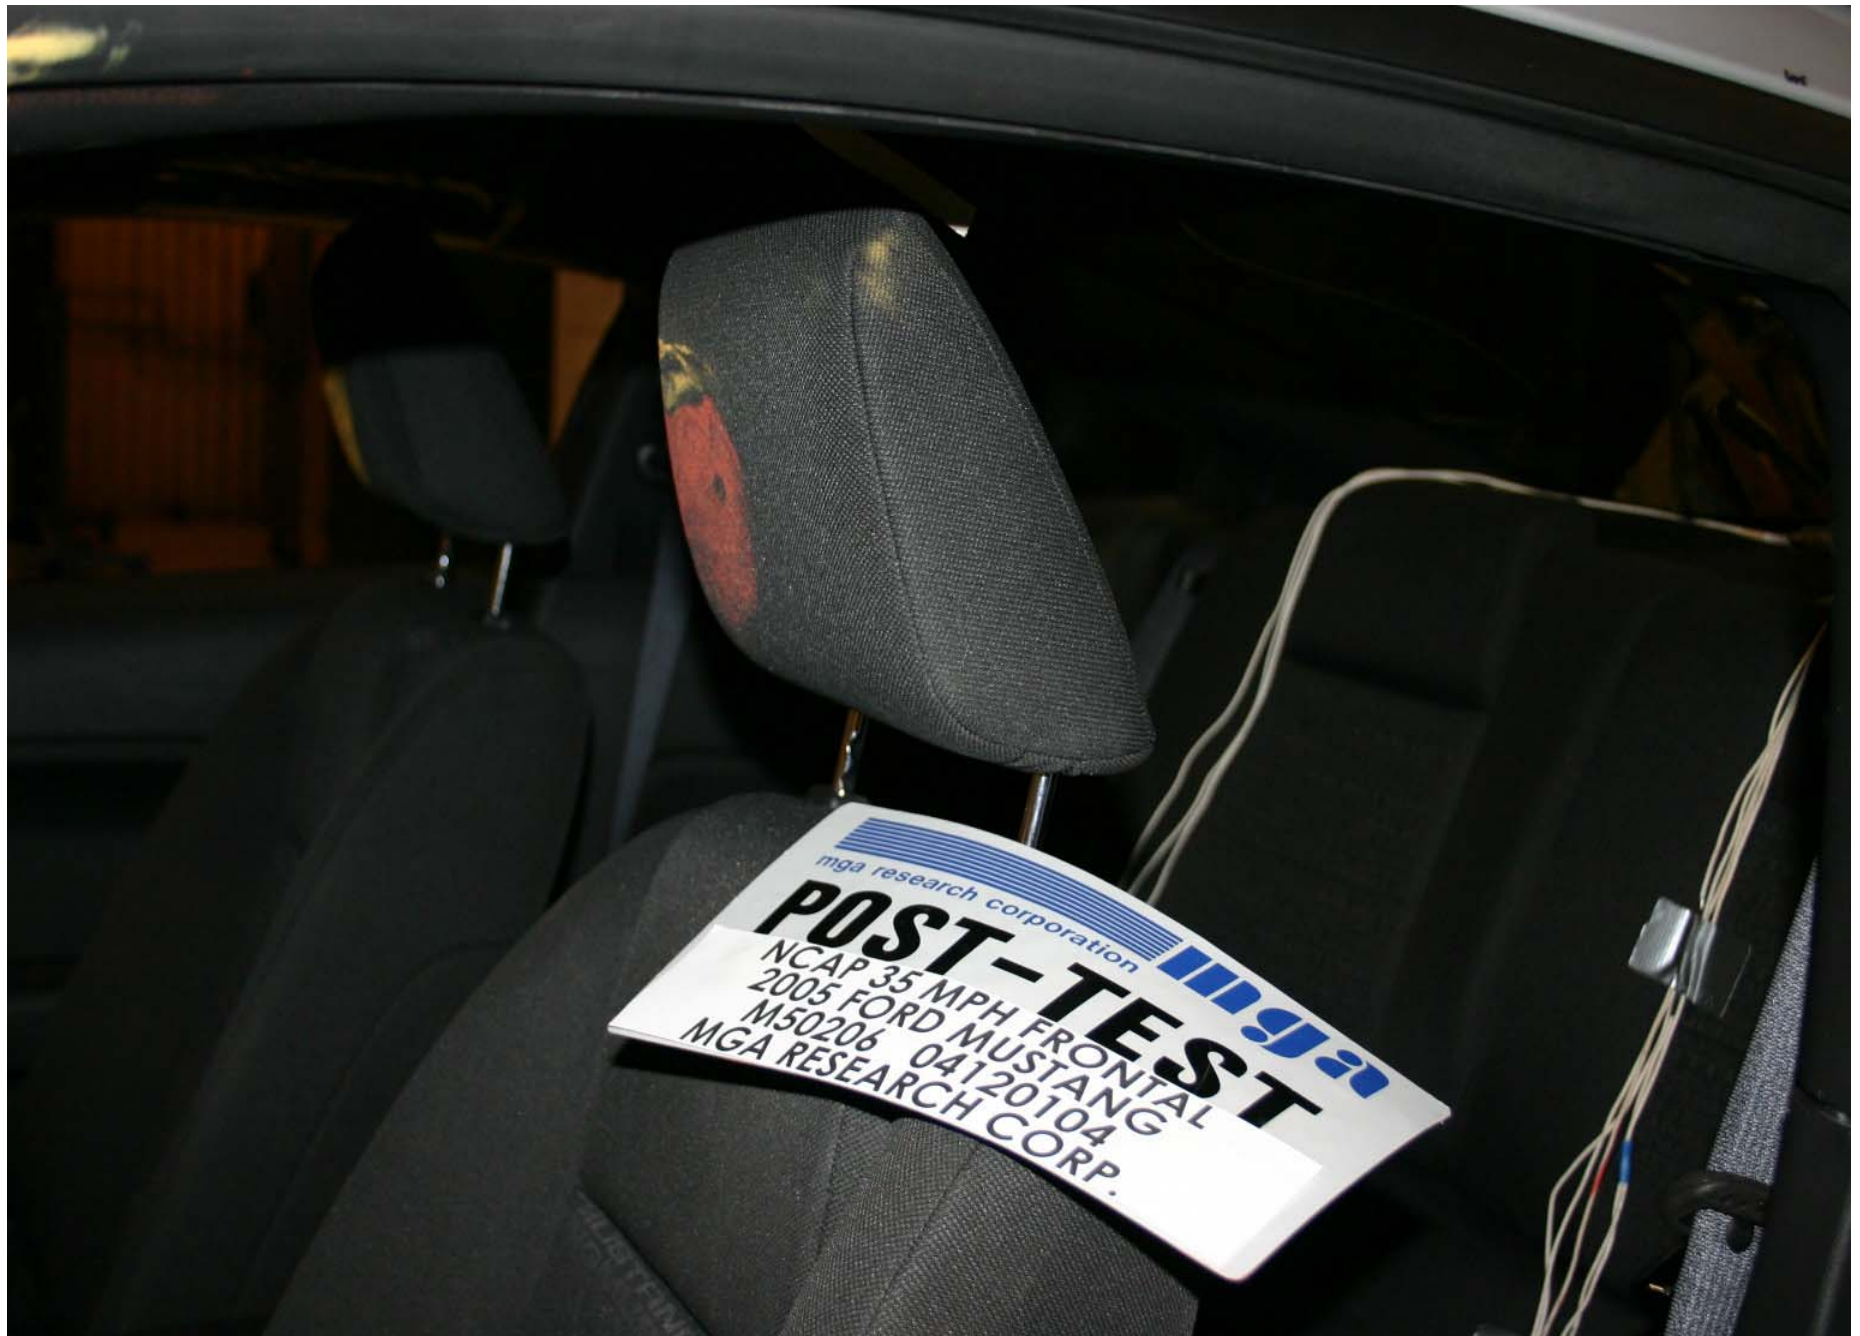
Post-Test Driver Dummy Head Contact

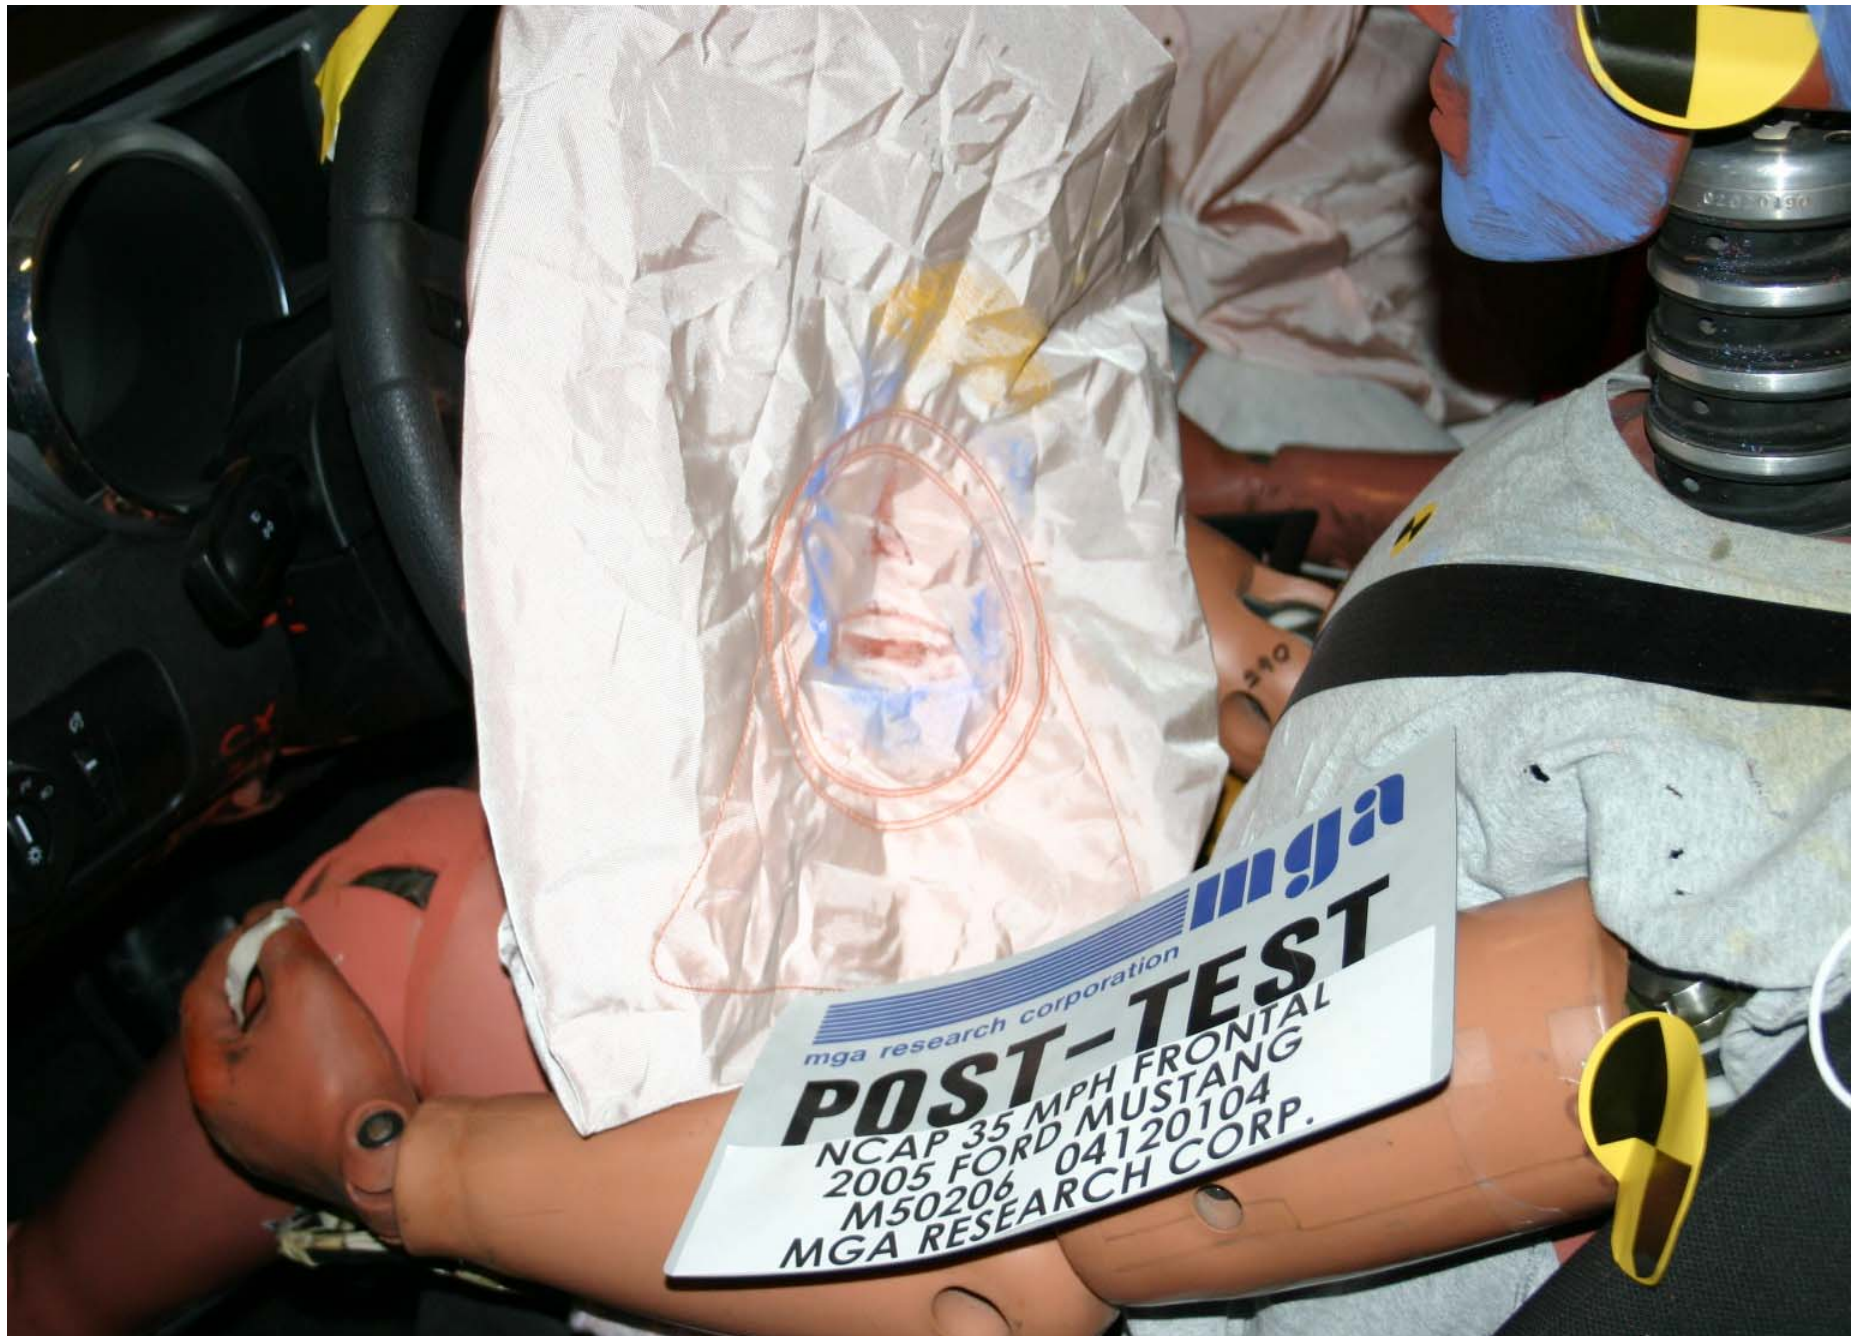
Post-Test Driver Dummy Airbag Contact
