**REPORT NUMBER: NCAP-MGA-2005-005**

**NEW CAR ASSESSMENT PROGRAM  
FRONTAL BARRIER IMPACT TEST**

**FORD MOTOR COMPANY  
2005 Ford Mustang  
NHTSA NUMBER: M50206**

**PREPARED BY:  
MGA RESEARCH CORPORATION  
5000 WARREN ROAD  
BURLINGTON, WI 53105**

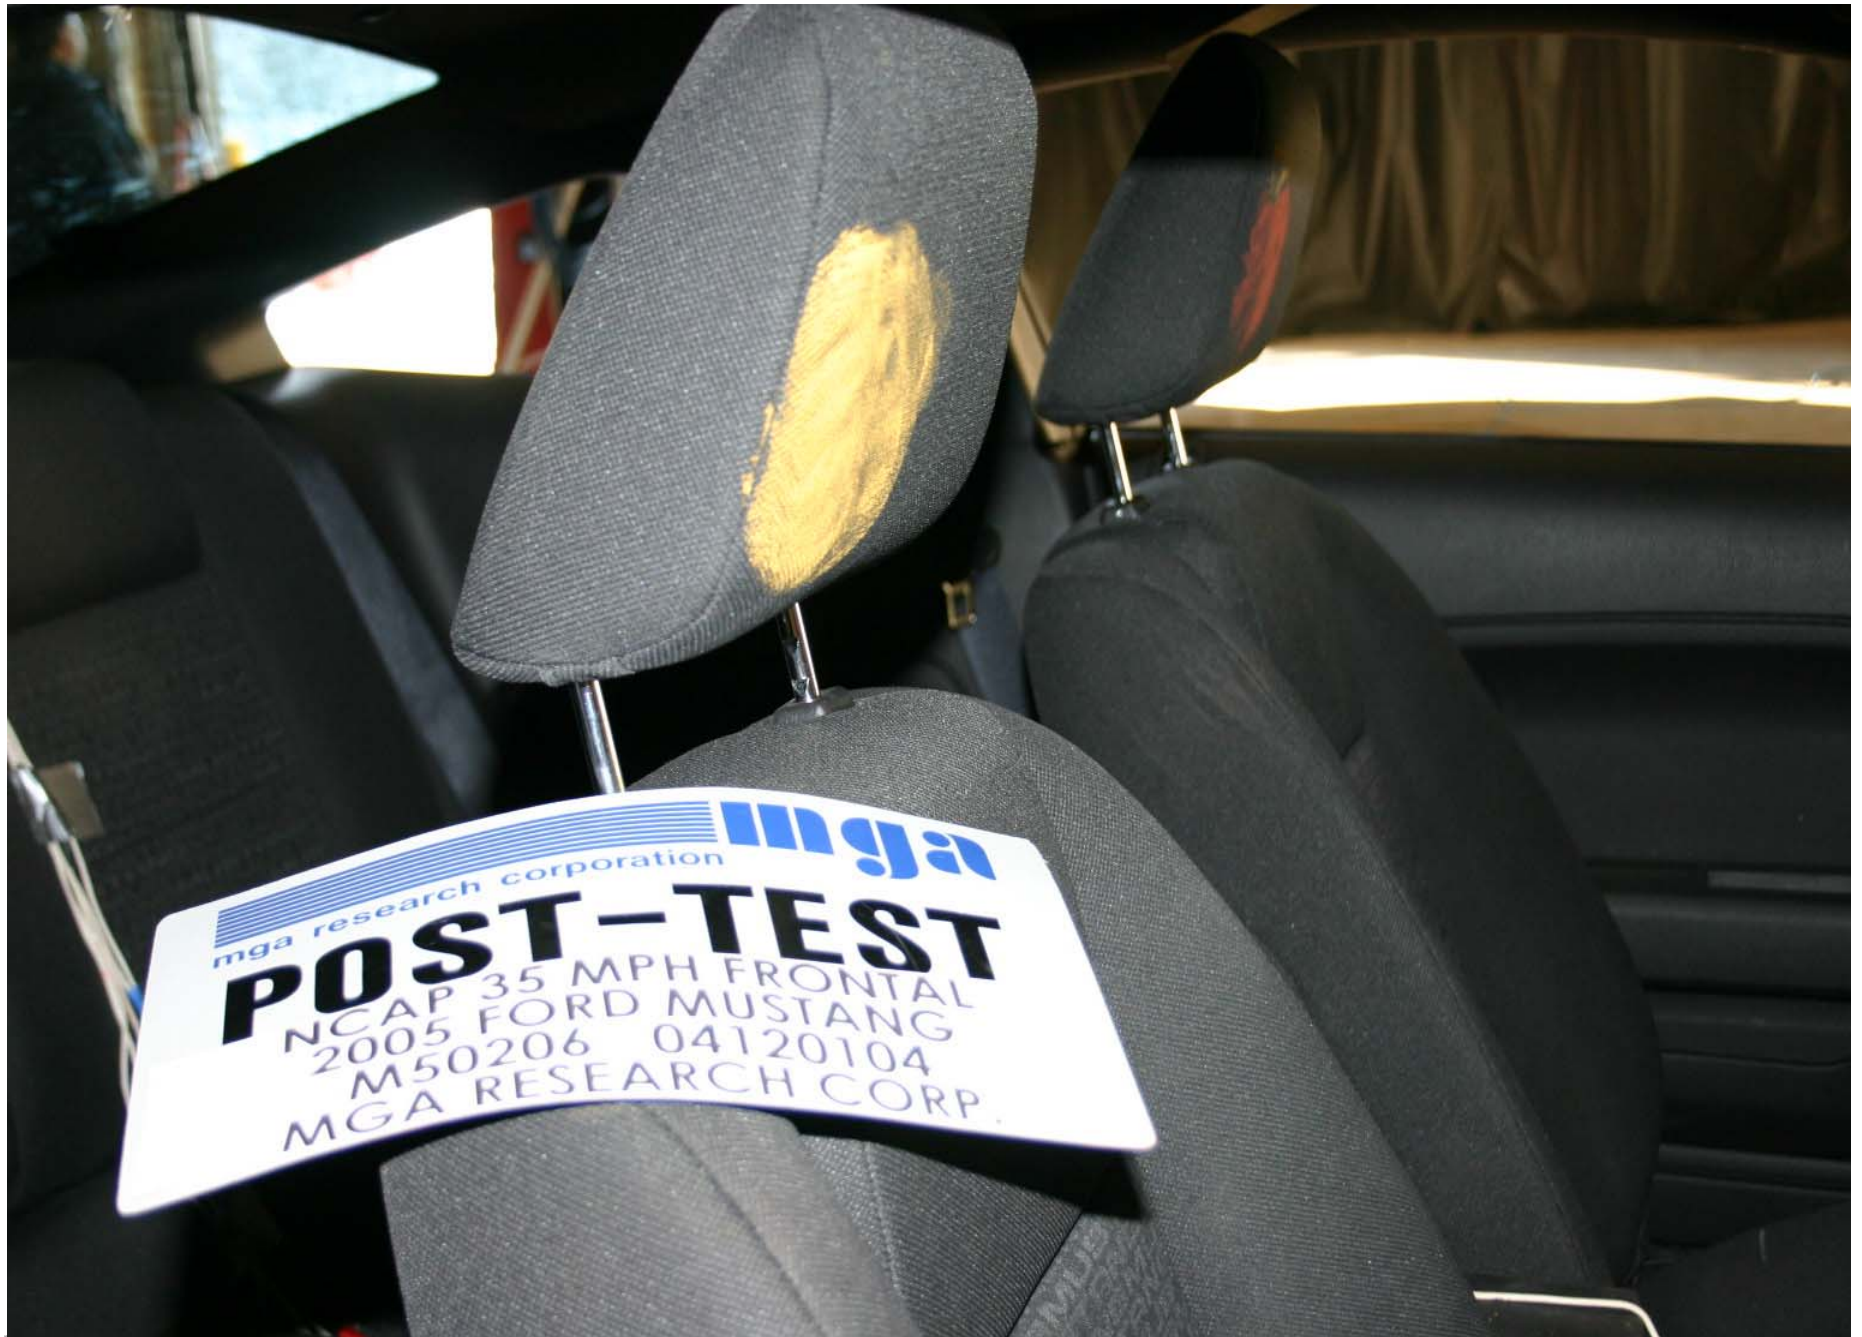
Post-Test Passenger Dummy Head Contact

The driver's head, chest, and abdomen contacted the airbag. The driver's head also contacted the headrest. The driver's knees contacted the bolster. The passenger's head, chest and abdomen contacted the airbag. The passenger's head contacted the headrest. The passenger's knees contacted the glove box.

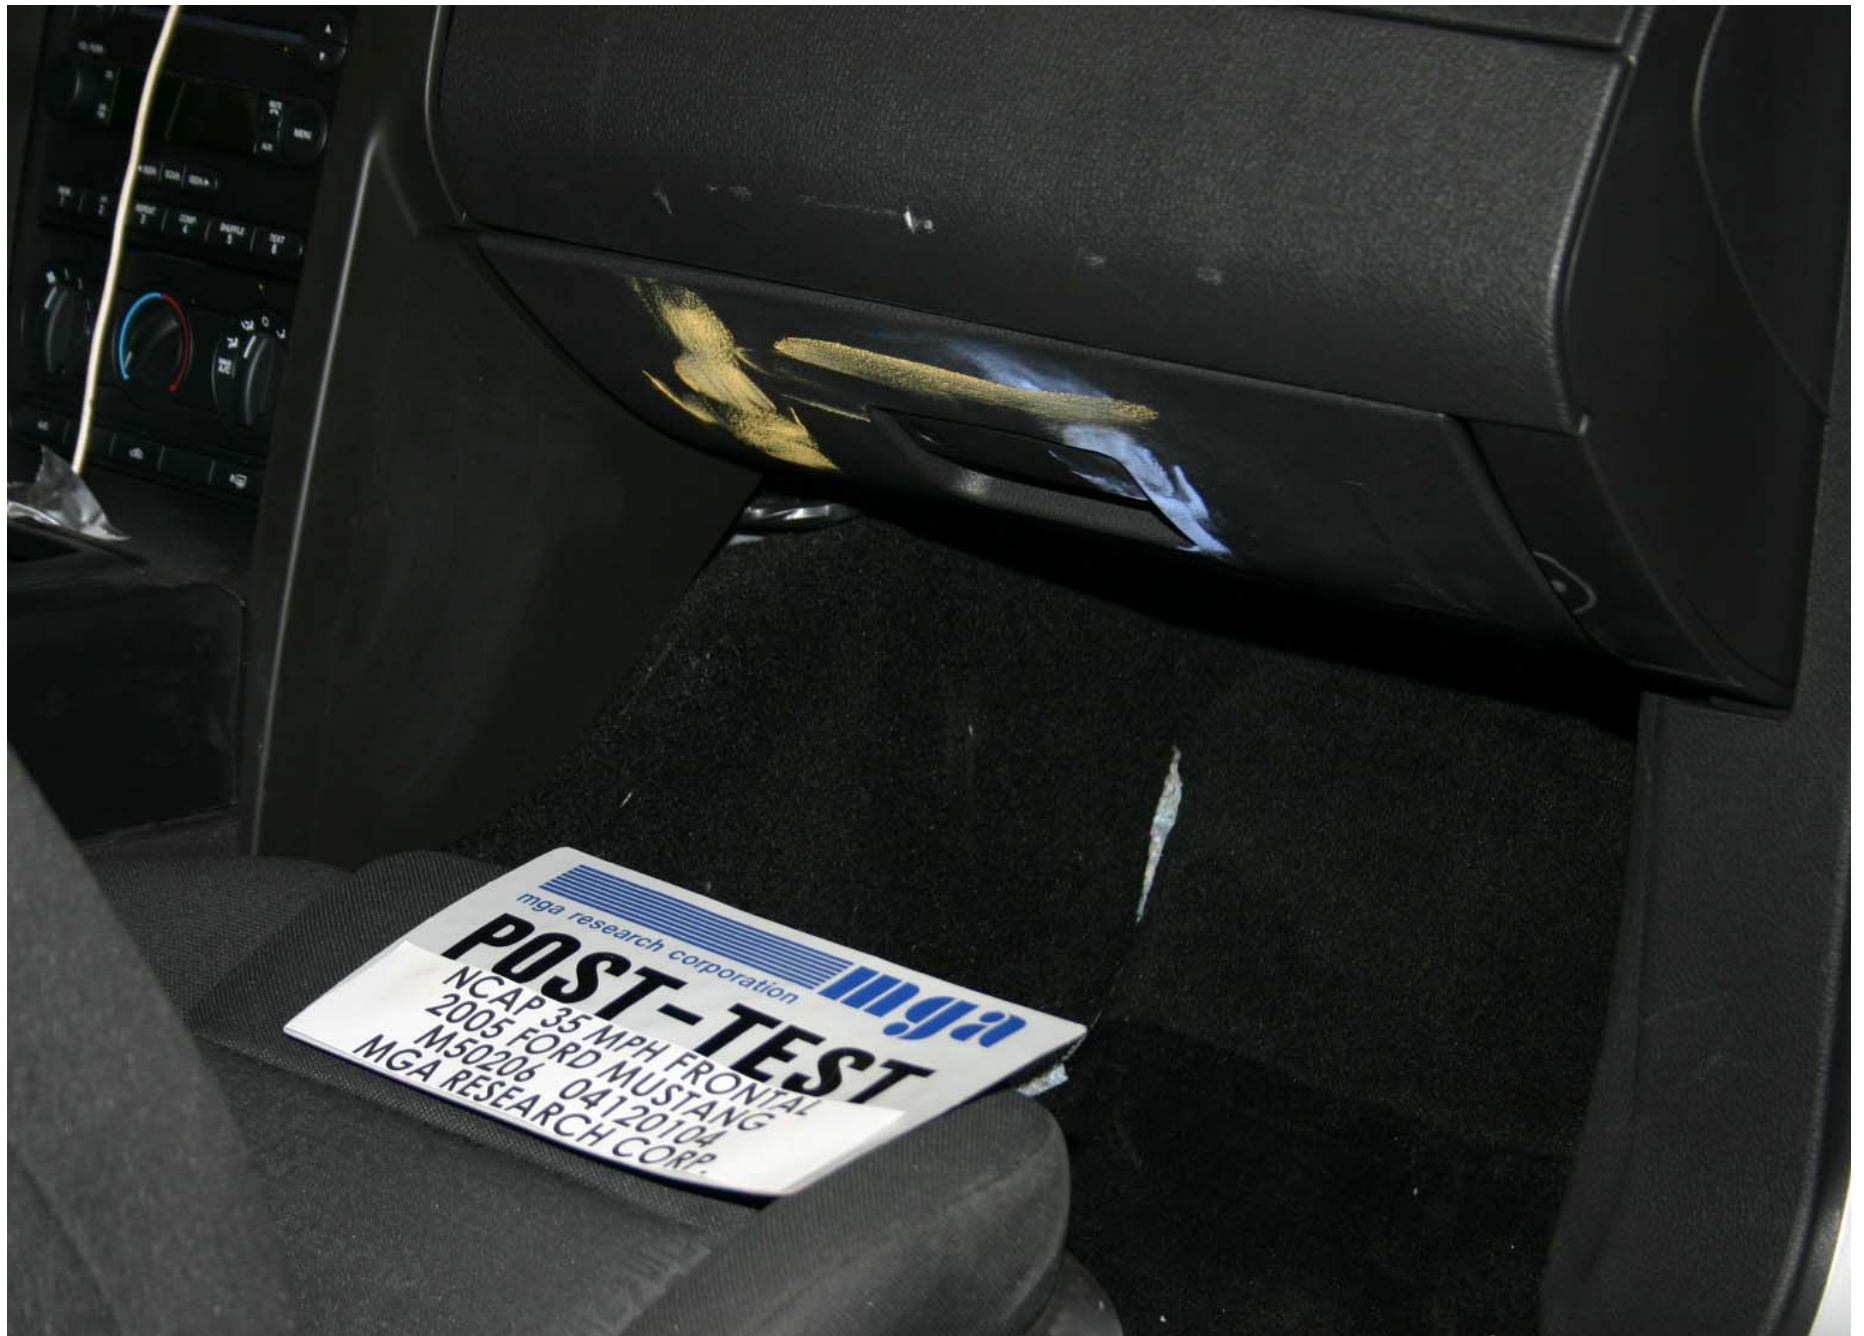
Post-Test Passenger Dummy Knee Contact

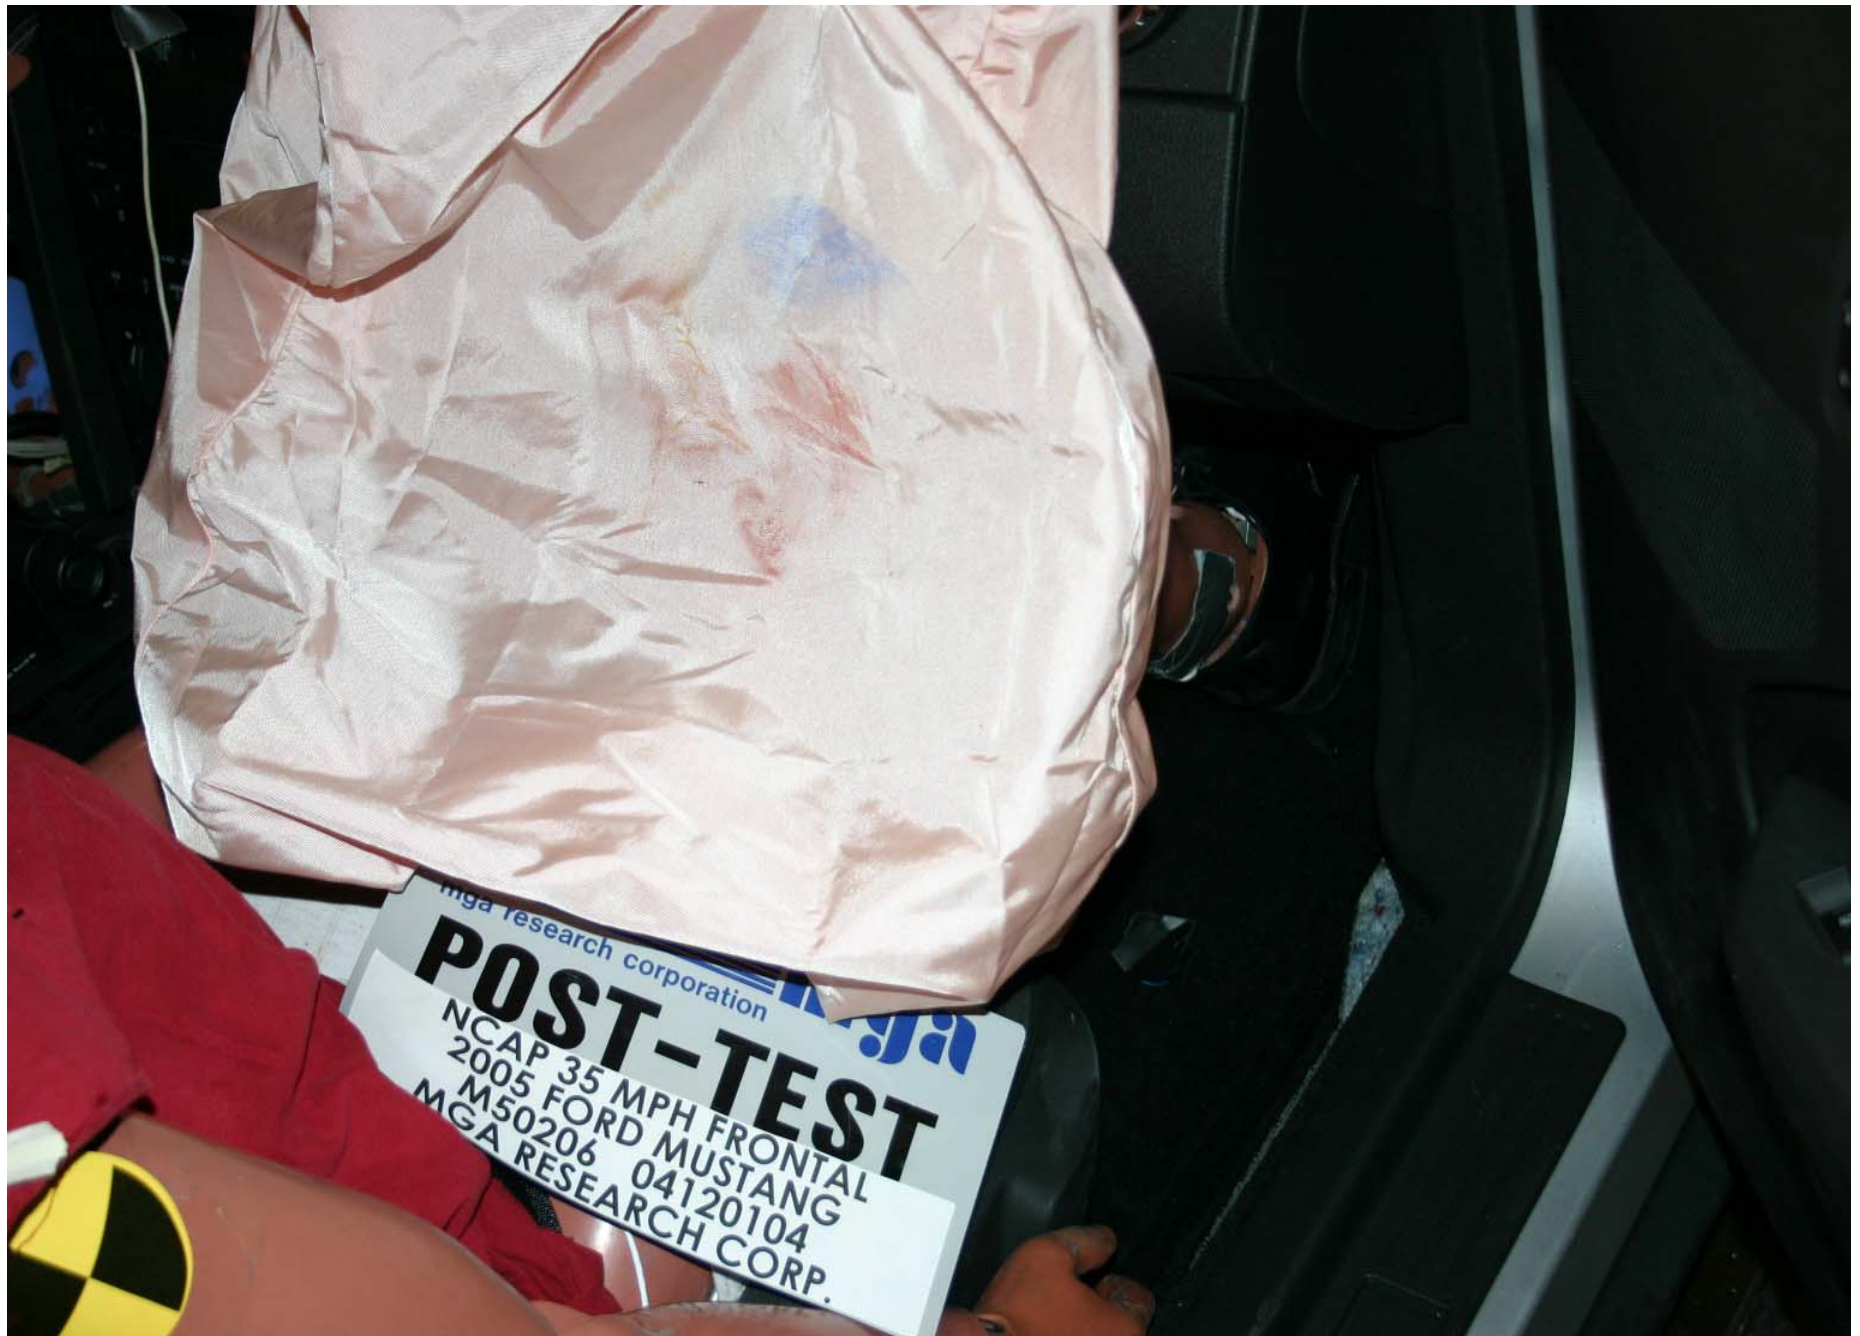
Post-Test Passenger Dummy Airbag Contact

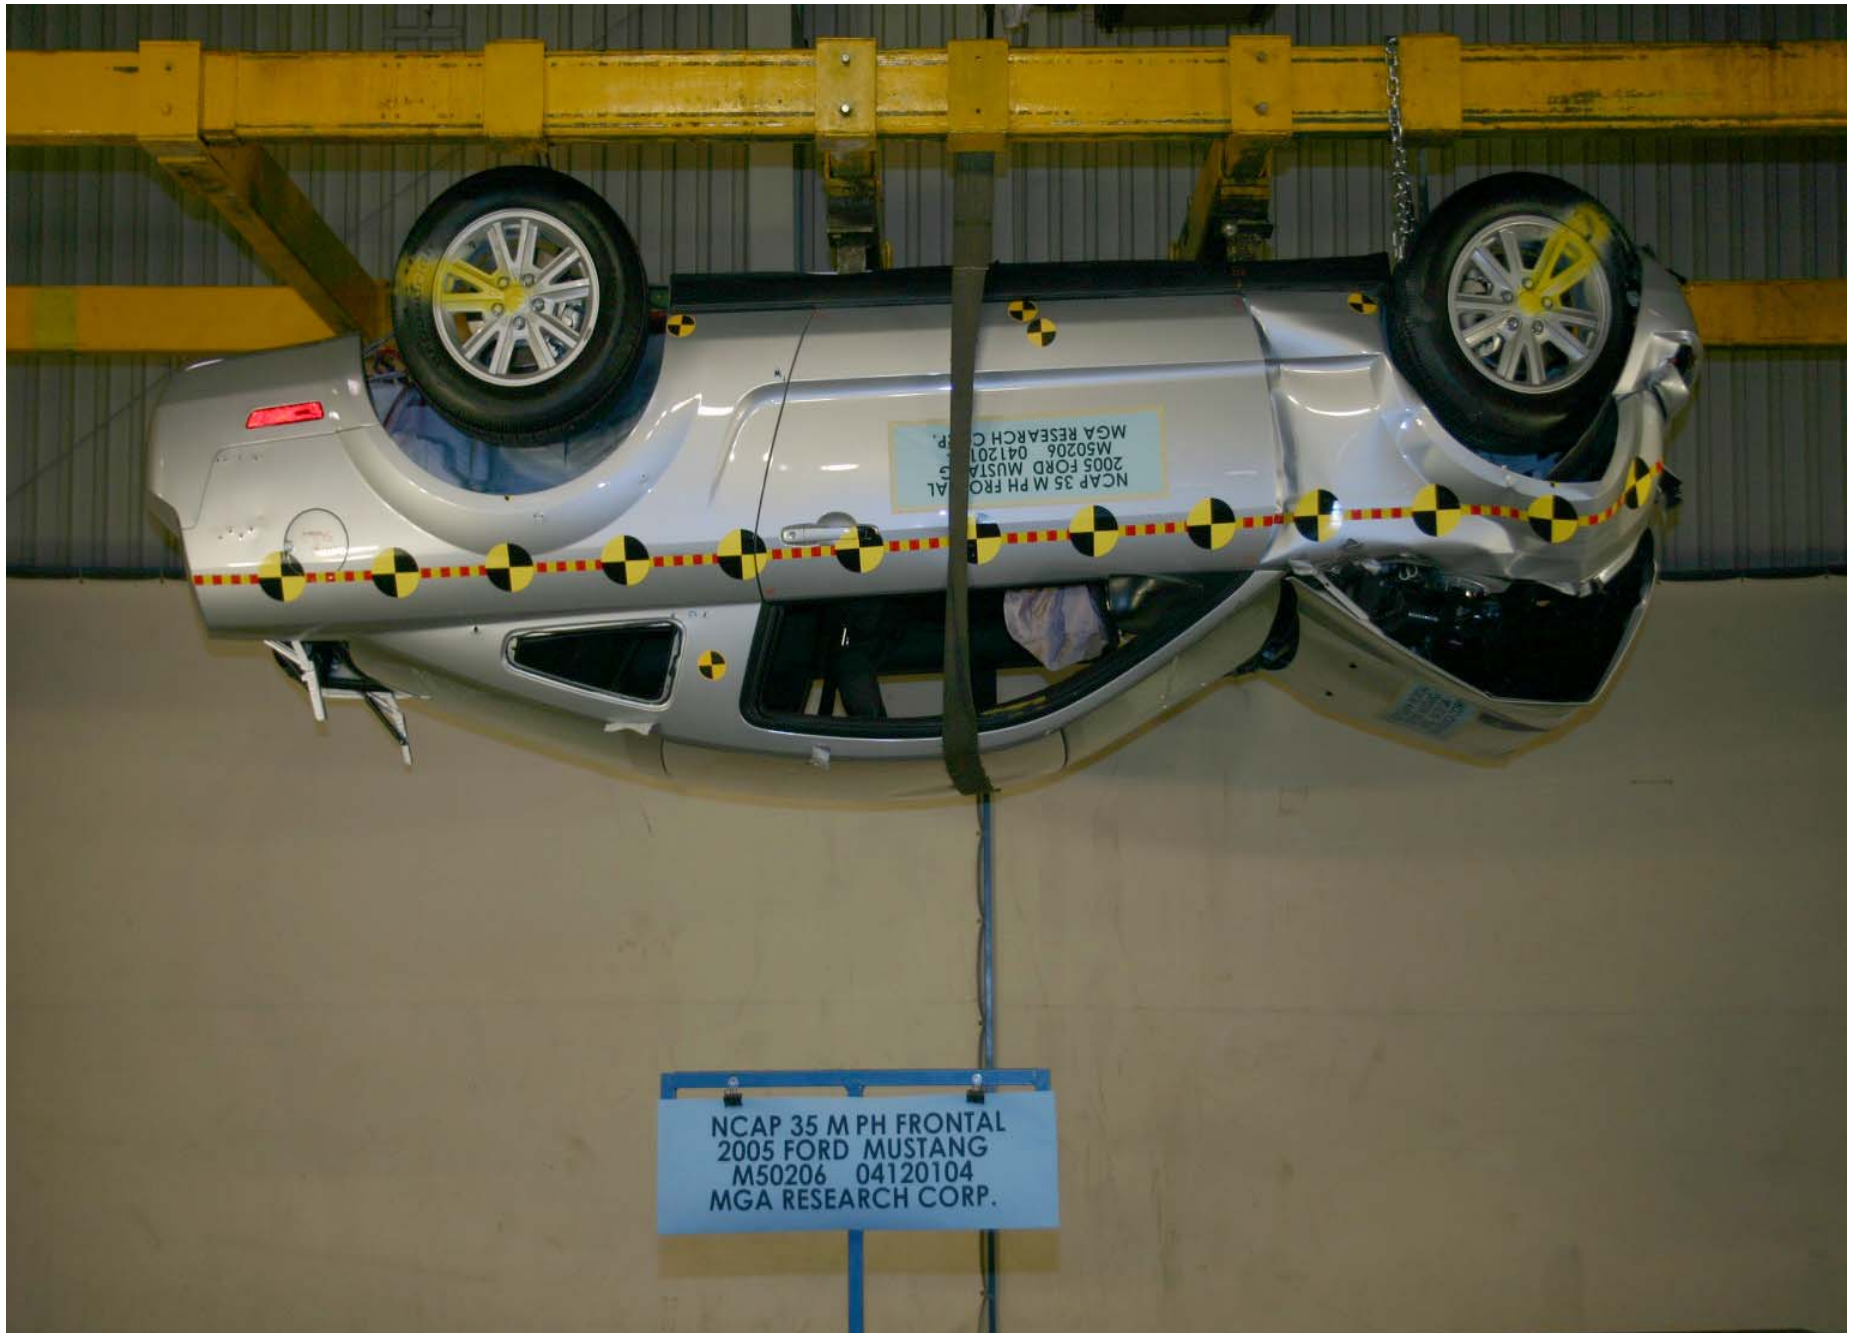
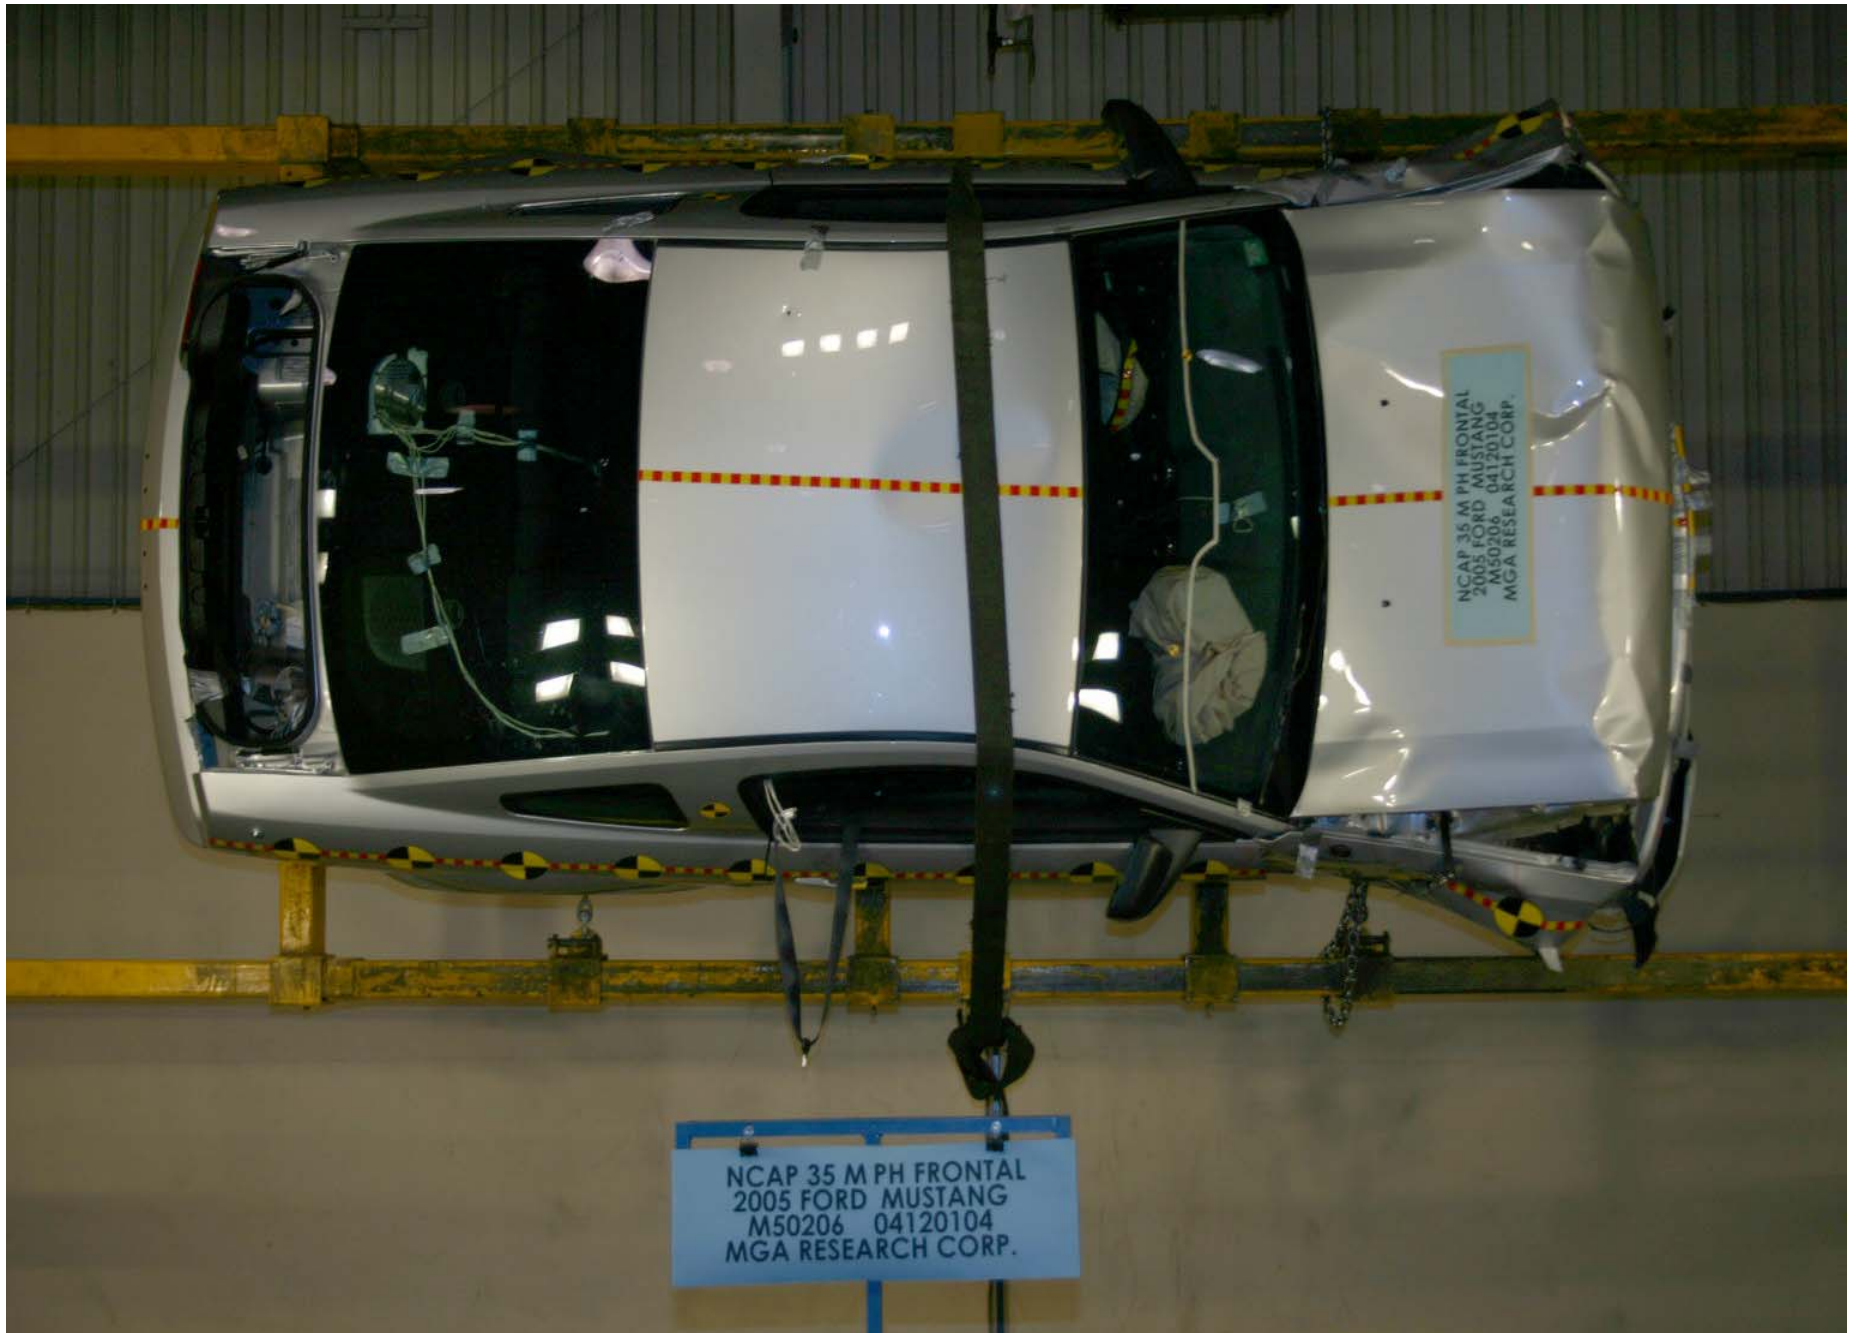
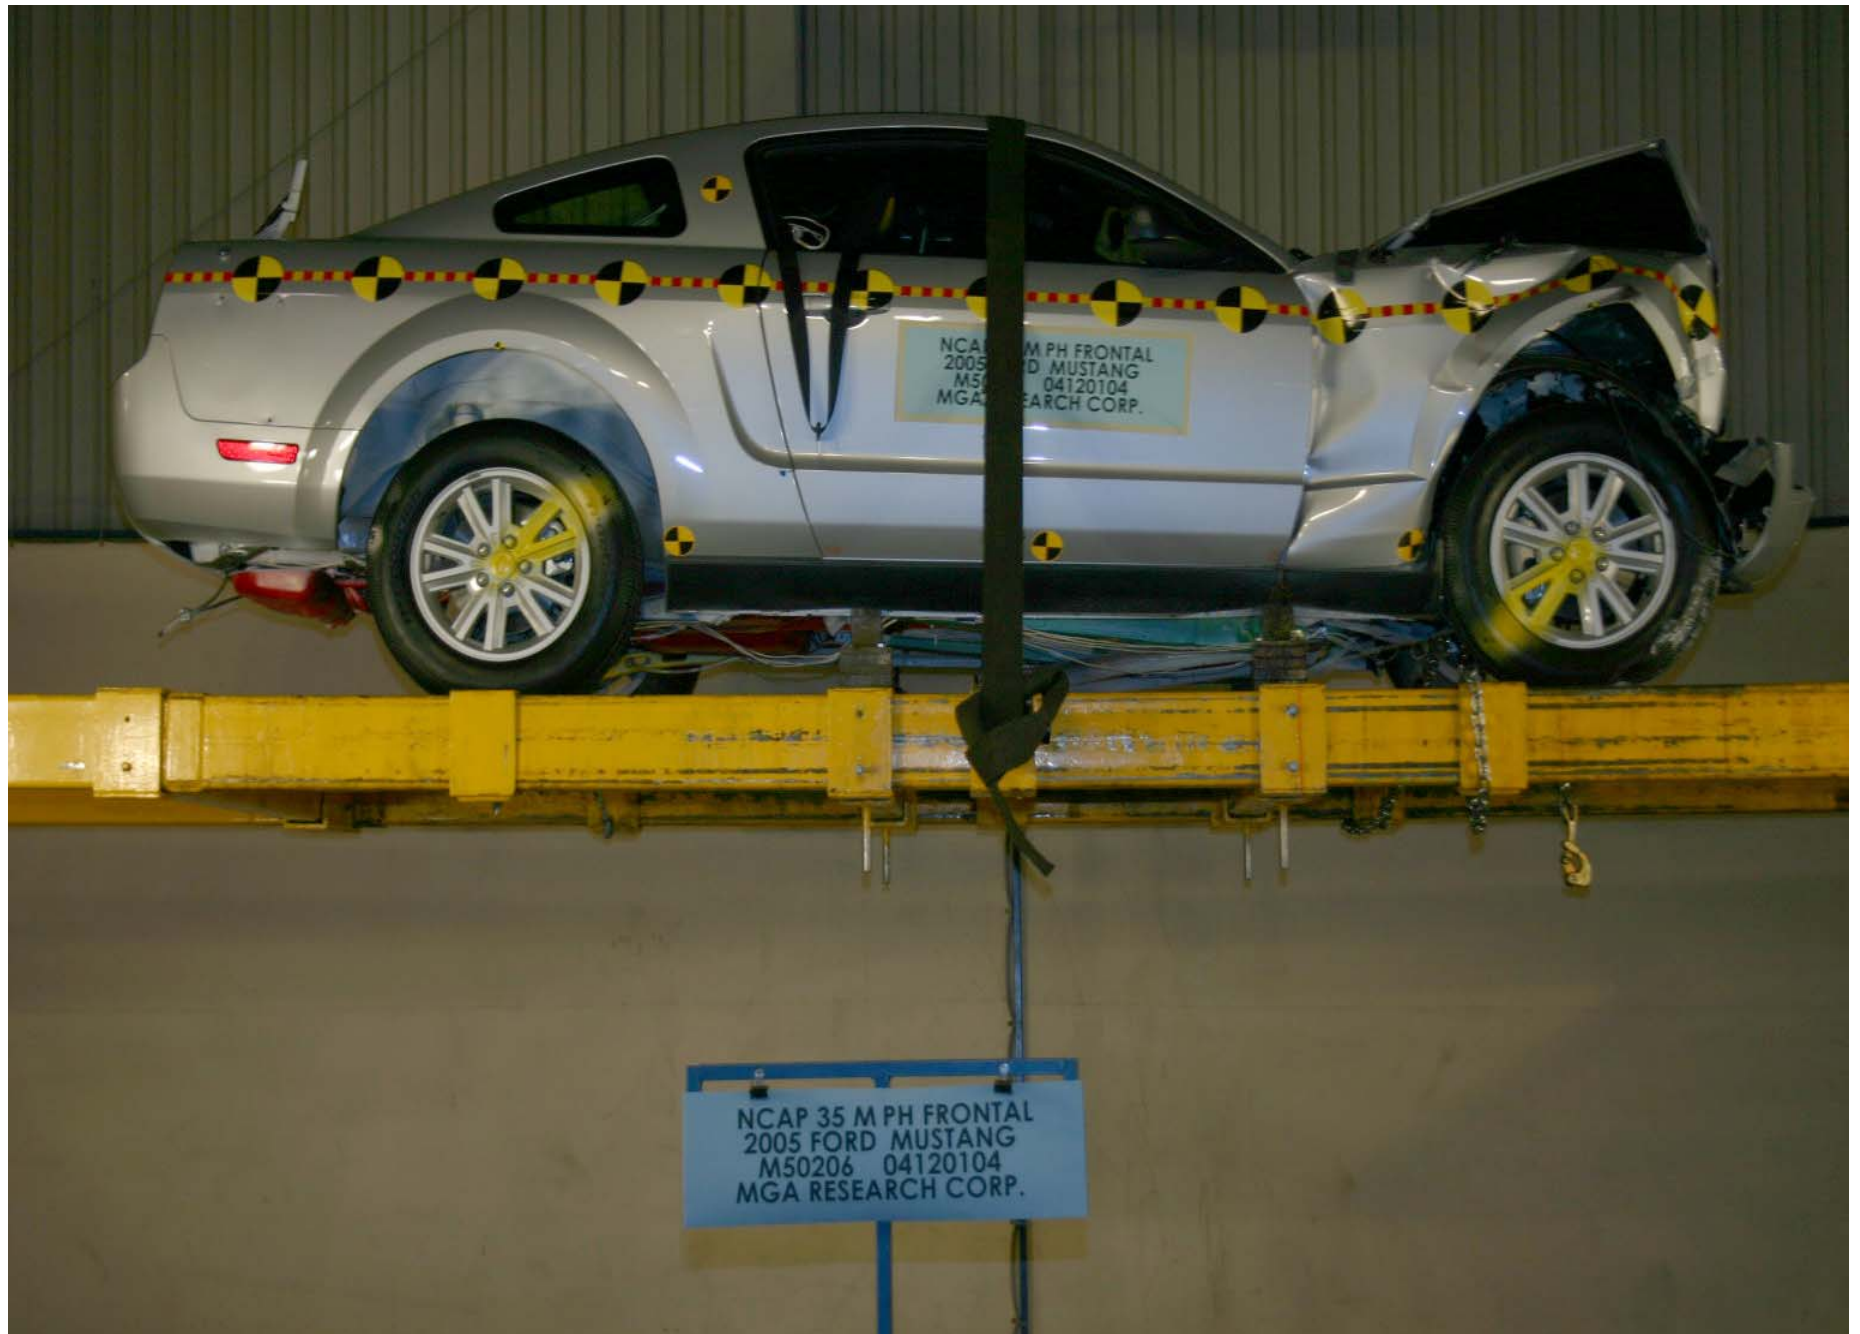
Rollover 90 Degrees

Rollover 180 Degrees

Rollover 270 Degrees

Rollover 360 Degrees

There was 100 percent windshield retention and no intrusion into the protected zone of the windshield during the event. There was no Stoddard Solvent leakage after the event or during any phase of the static rollover.
