**REPORT NUMBER: NCAP-MGA-2005-007**

**NEW CAR ASSESSMENT PROGRAM  
FRONTAL BARRIER IMPACT TEST**

**Daimler Chrysler  
2005 Chrysler Town and Country  
NHTSA NUMBER: D50310**

**PREPARED BY:  
MGA RESEARCH CORPORATION  
5000 WARREN ROAD  
BURLINGTON, WI 53105**

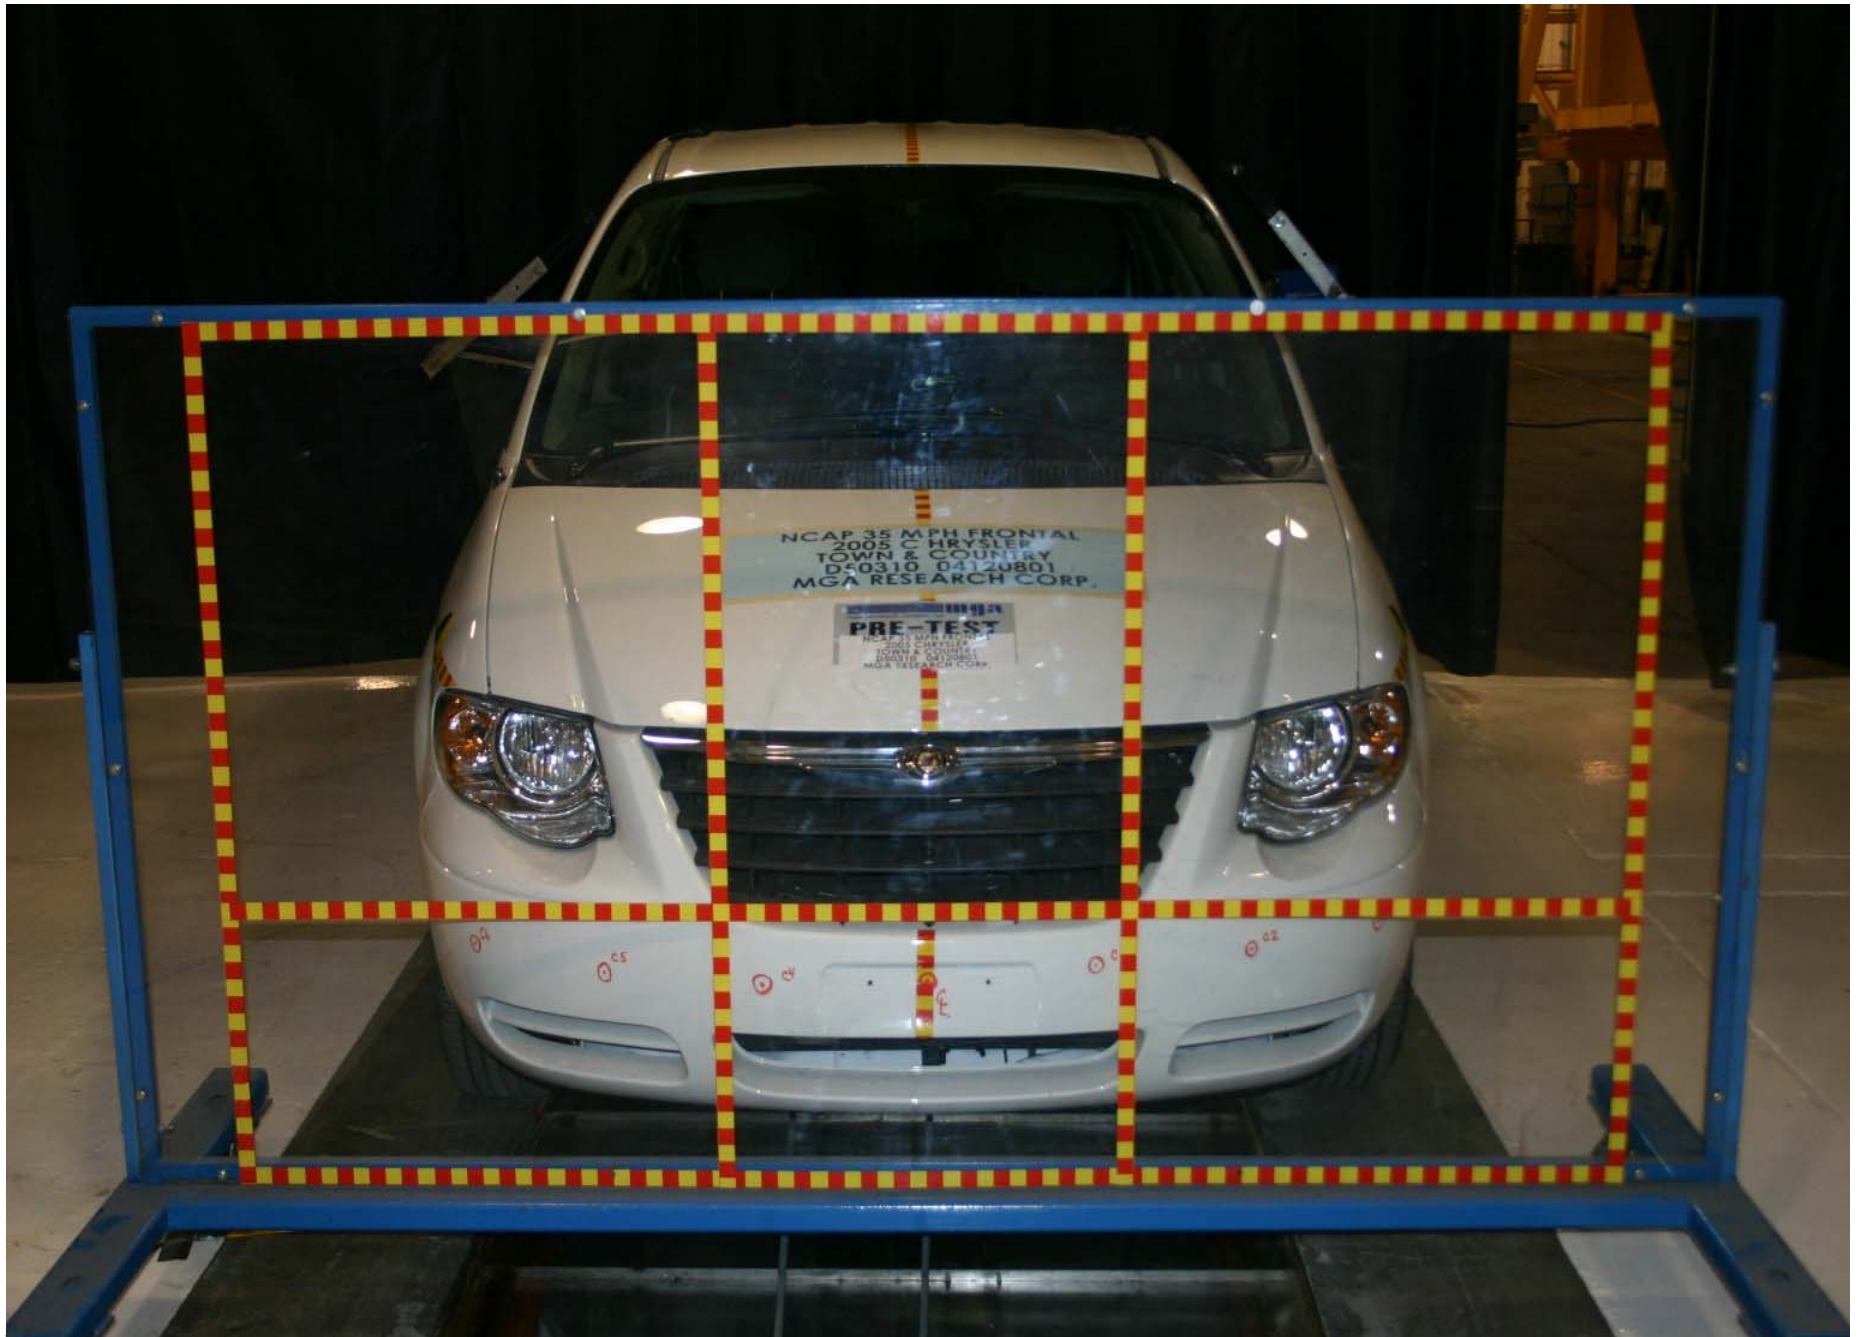
A-1.

Load Cell Location

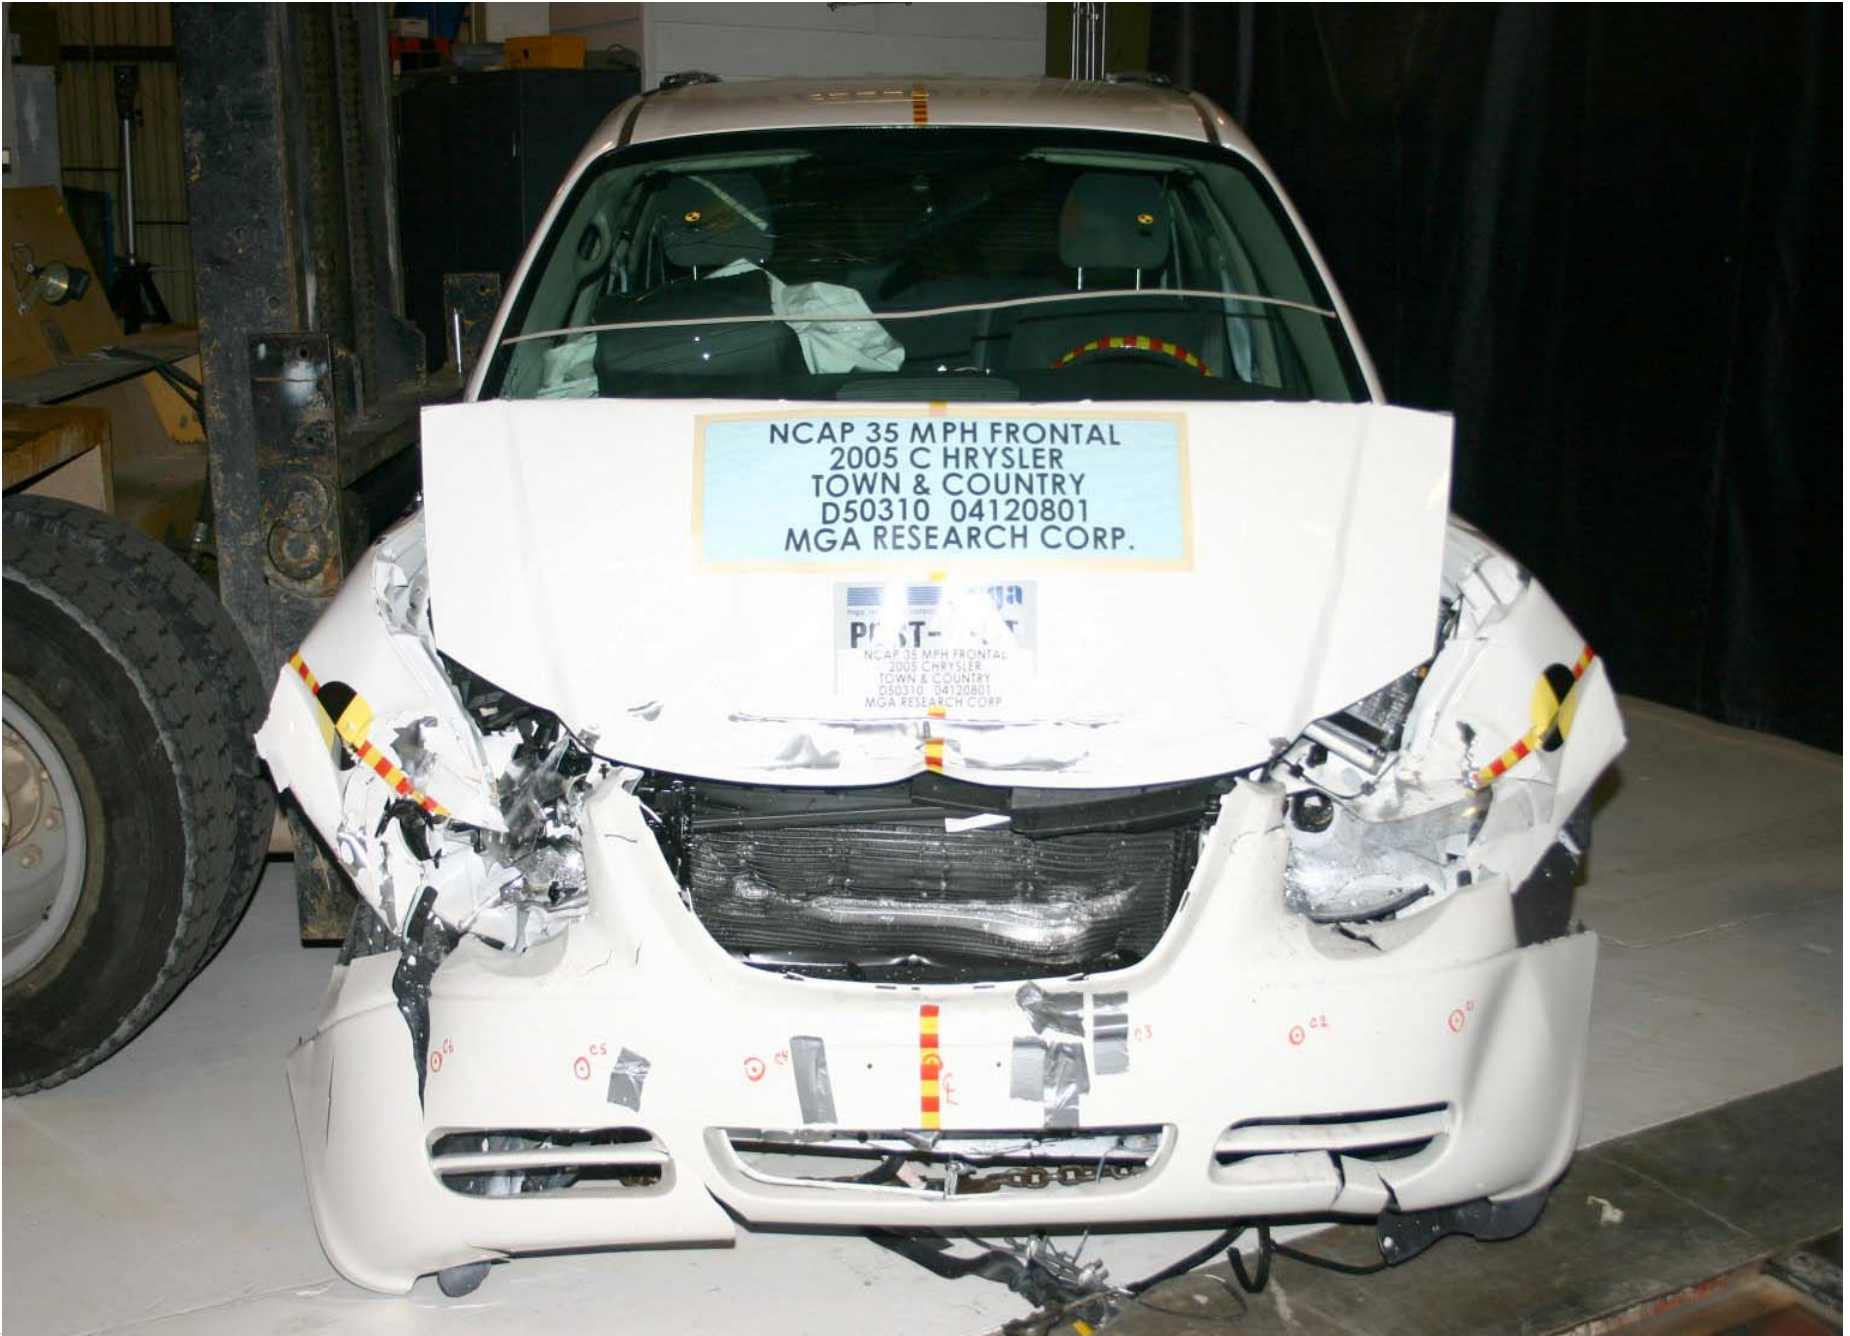
Post-Test Front View of Test Vehicle

The maximum static crush of the vehicle was 692 mm and both the driver and passenger side doors remained closed and latched during the impact event and were operable after the impact.

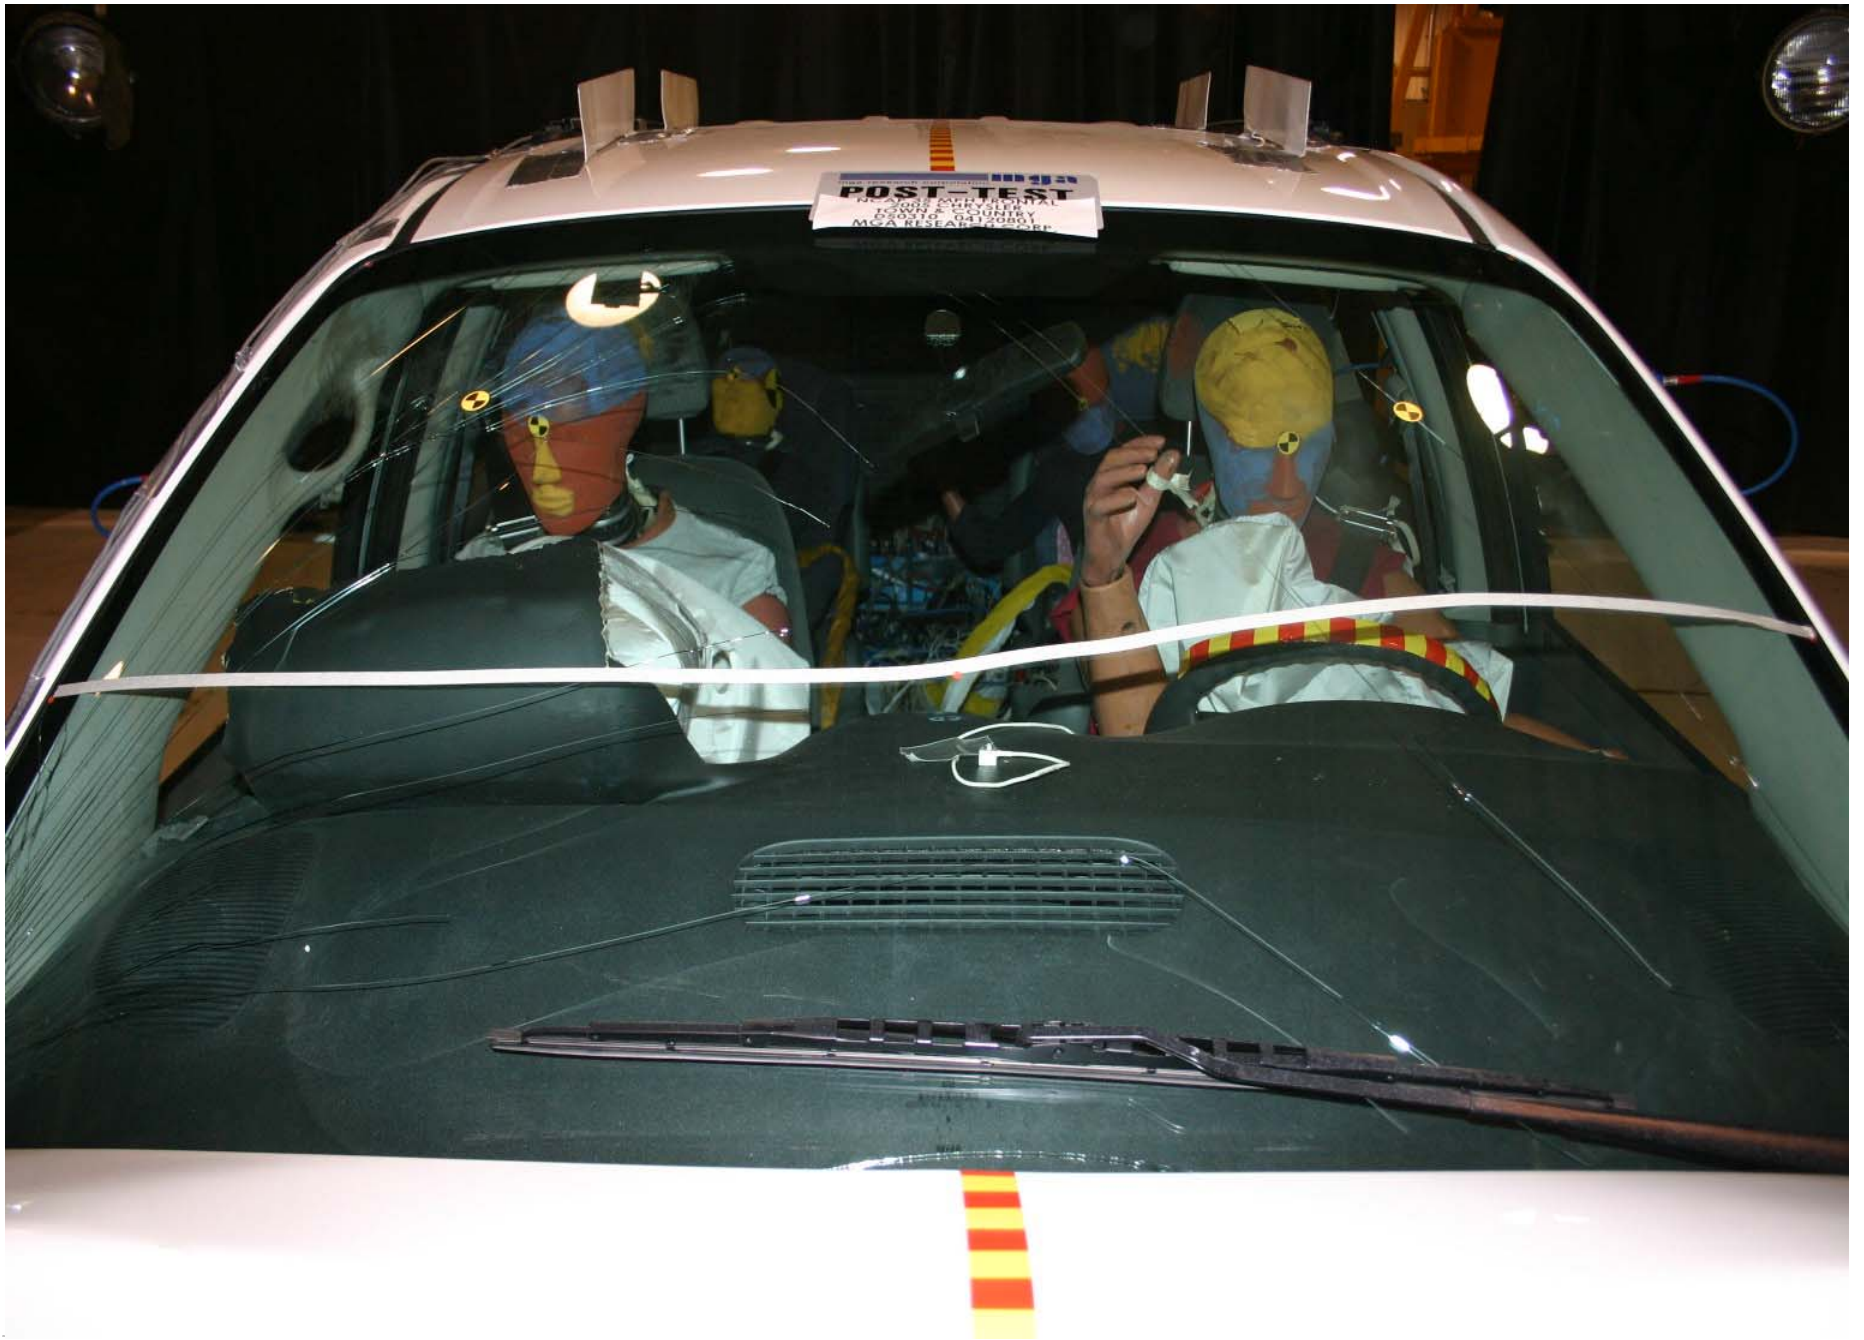
A-21.

Post-Test Windshield View

There was 100 percent windshield retention and no intrusion into the protected zone of the windshield during the event. There was no Stoddard Solvent leakage after the event or during any phase of the static rollover.

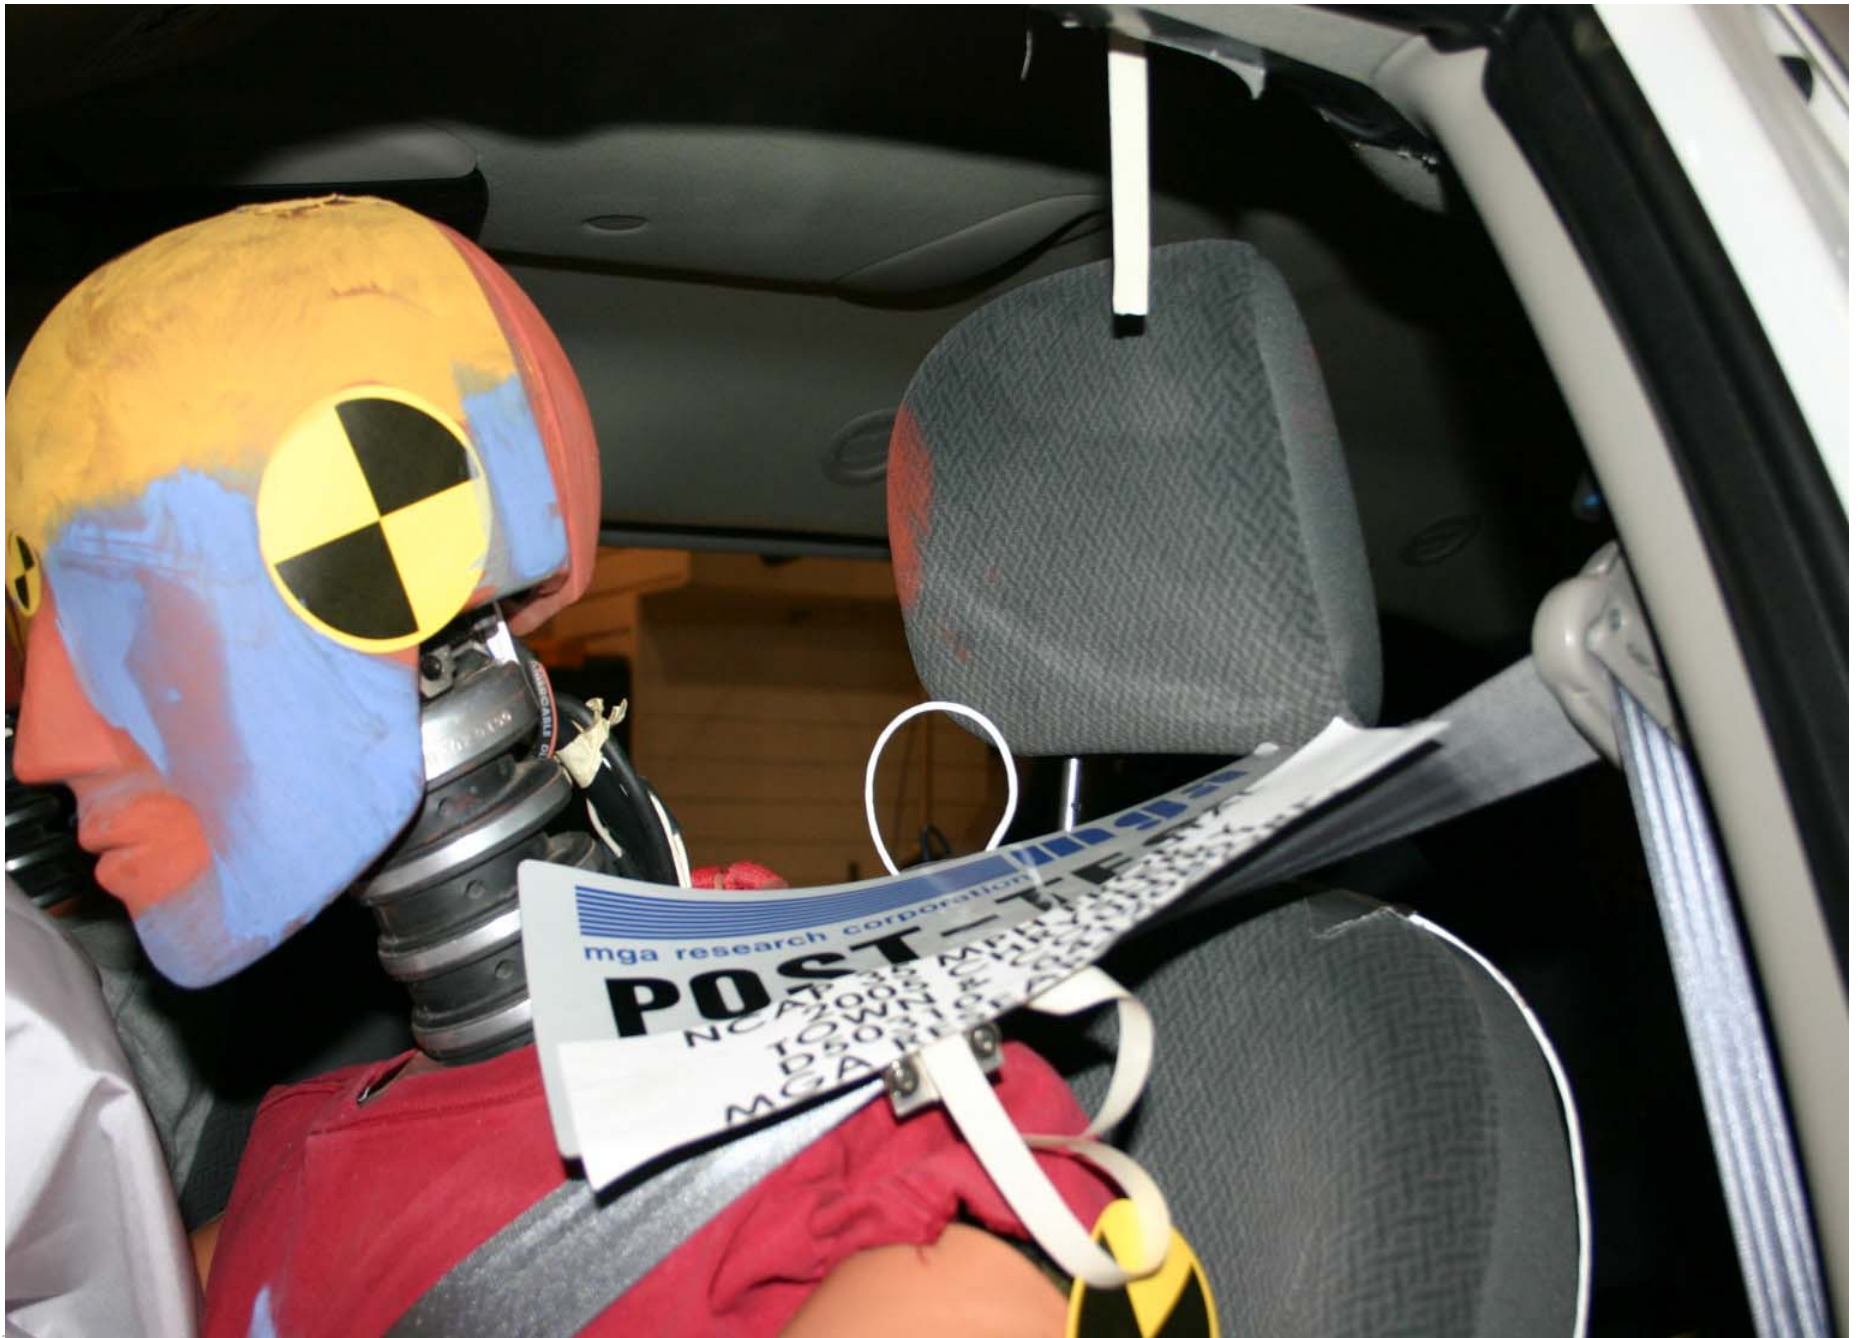
Post-Test Driver Dummy Head Contact

The driver's head and chest contacted the airbag. The driver's head also contacted the headrest. The driver's knees contacted the bolster. The driver's abdomen contacted the airbag. The passenger's head, chest and abdomen contacted the airbag. The passenger's head contacted the headrest. The passenger's knees contacted the glove box.

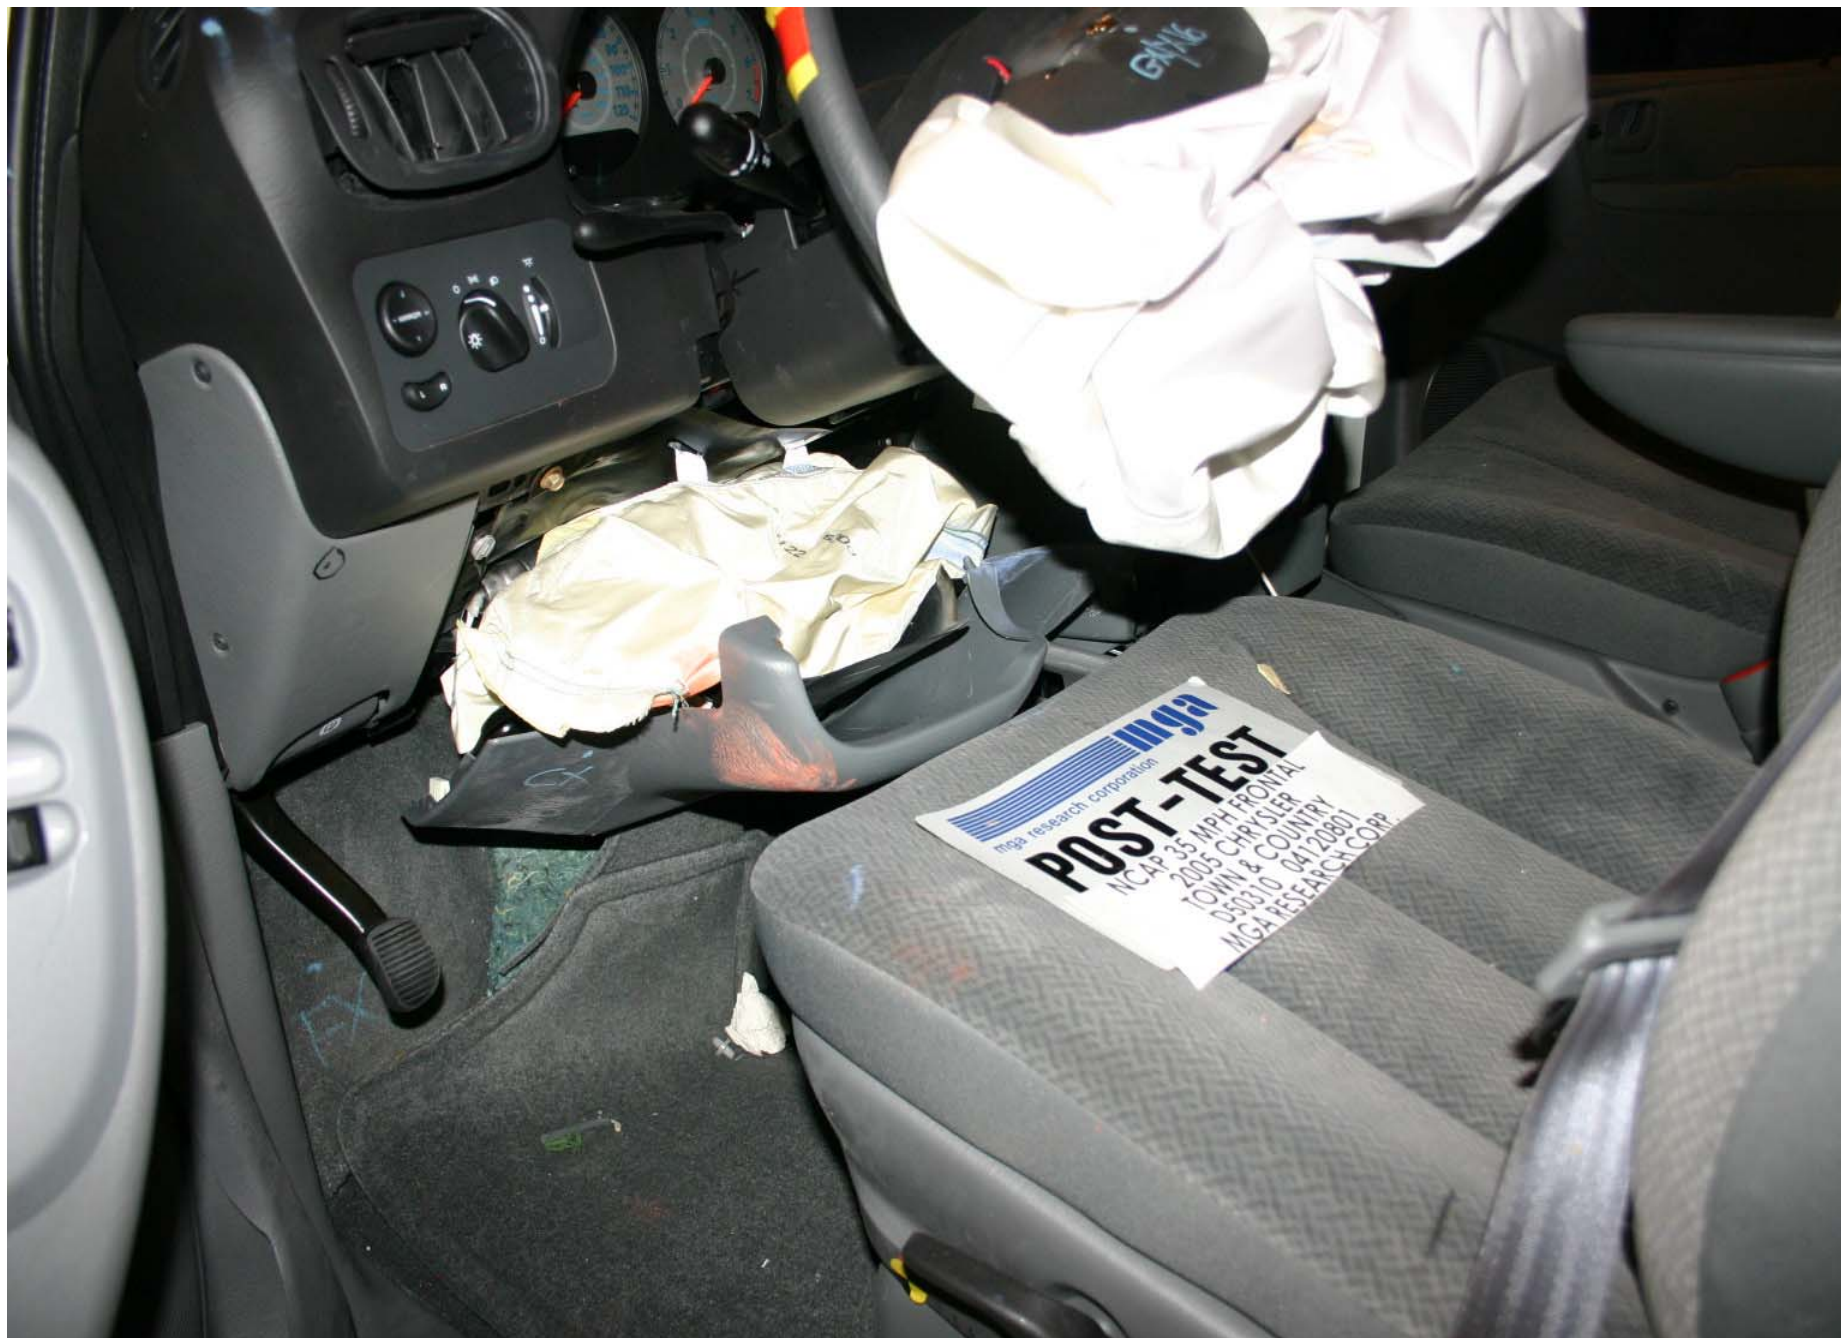
Post-Test Driver Dummy Knee Contact

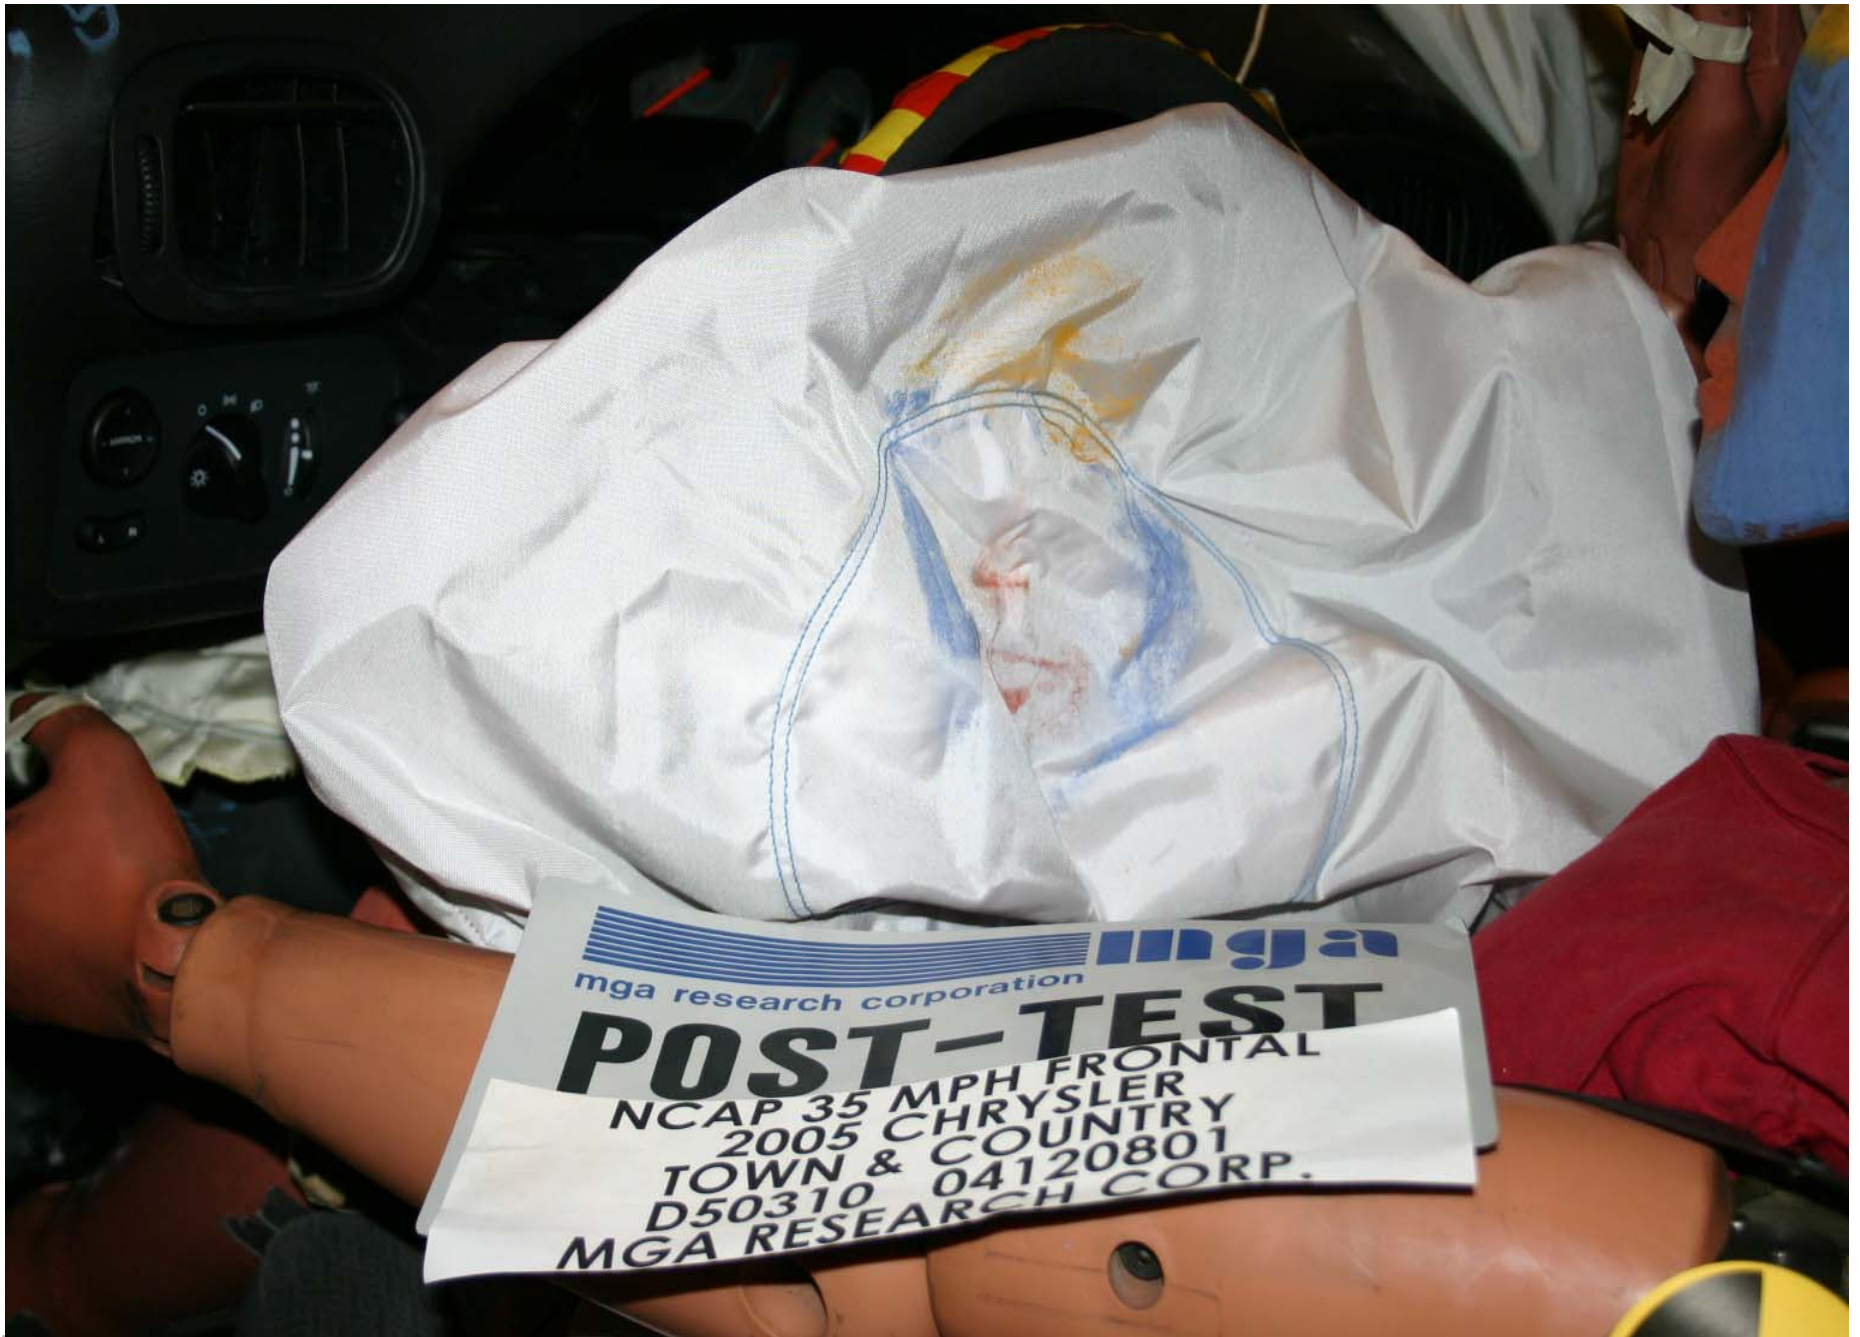
Post-Test Driver Dummy Airbag Contact

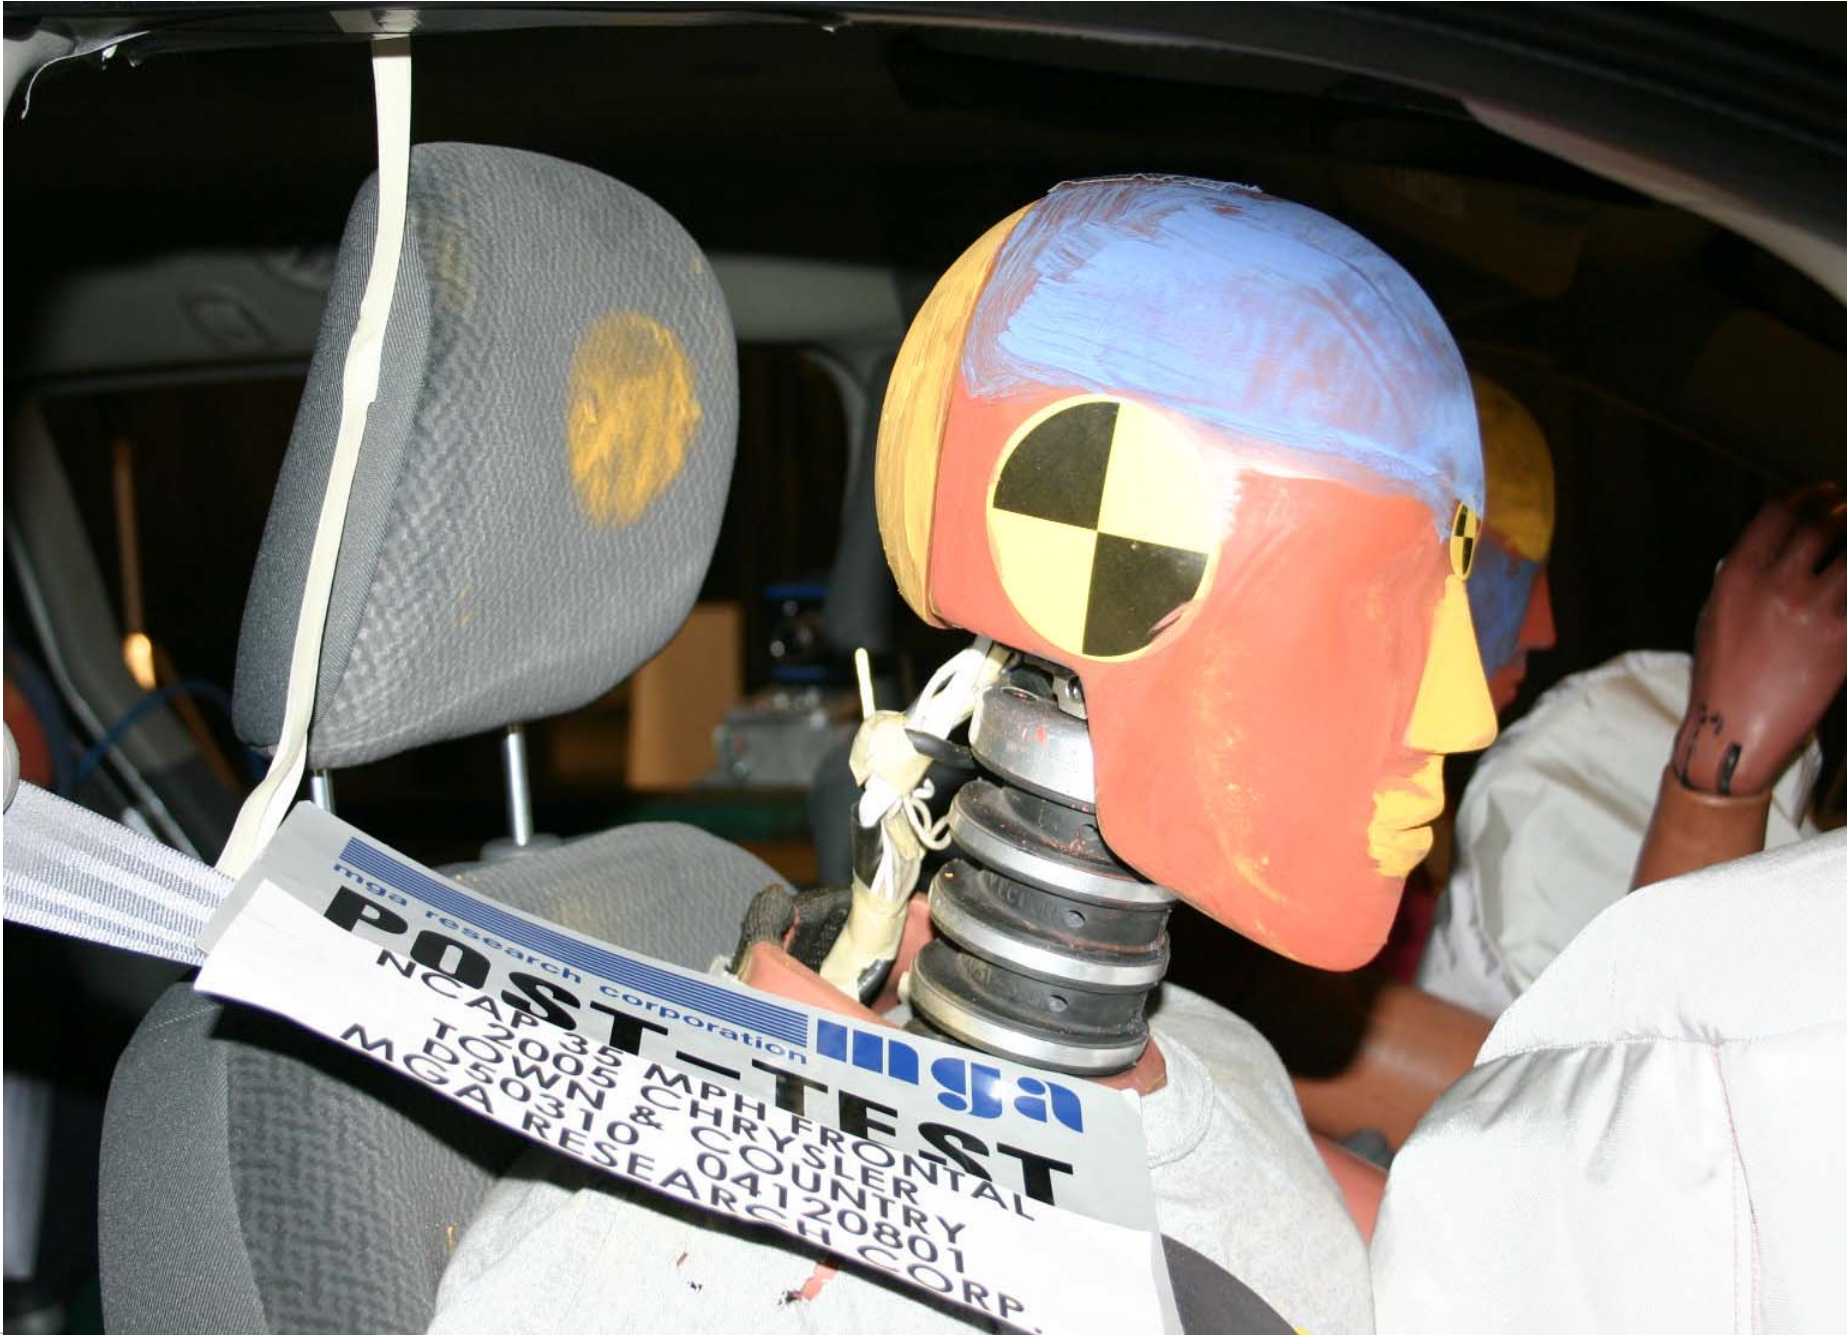
Post-Test Passenger Dummy Head Contact

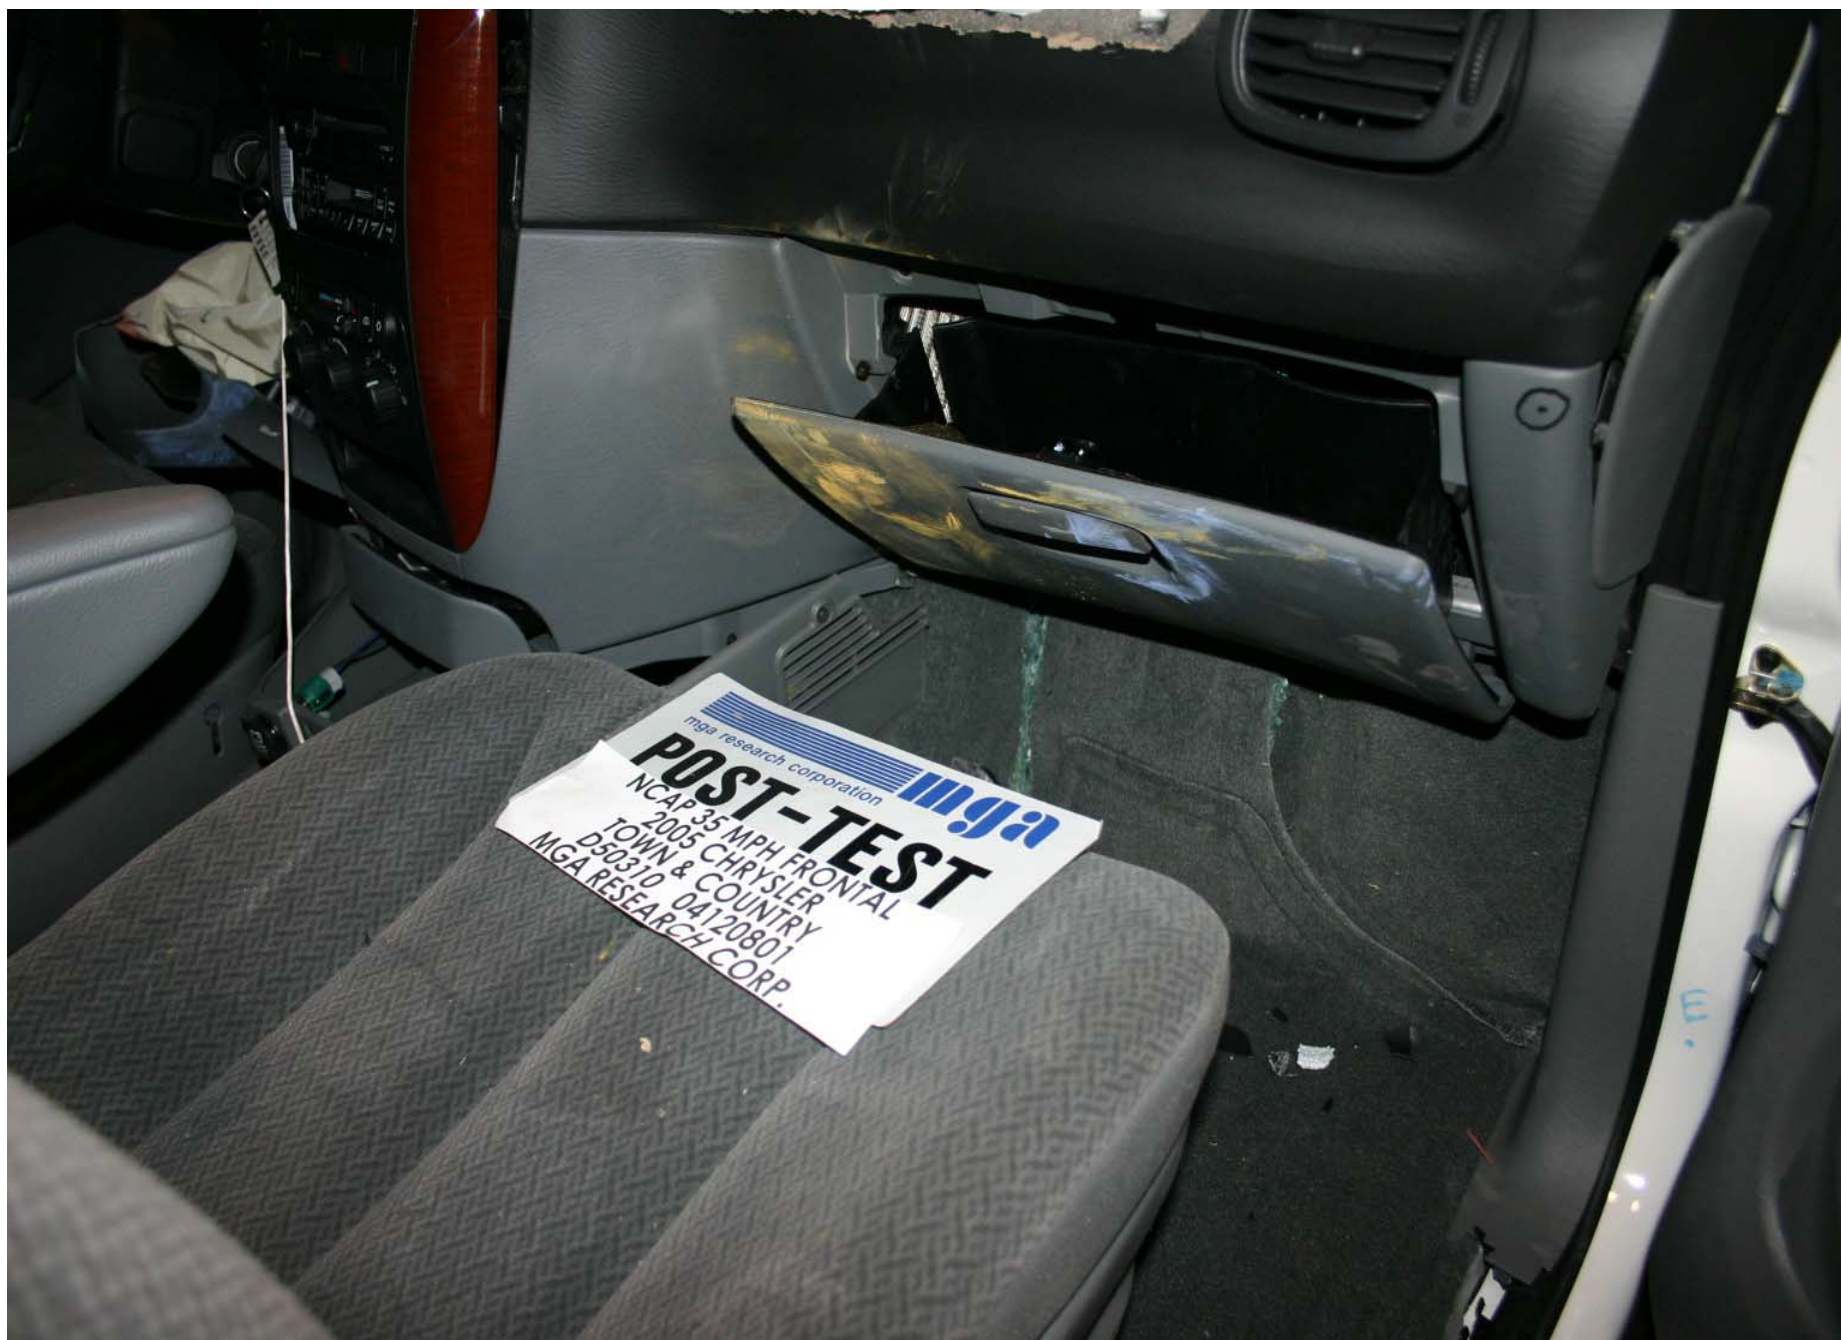
A-65.

Post-Test Passenger Dummy Knee Contact

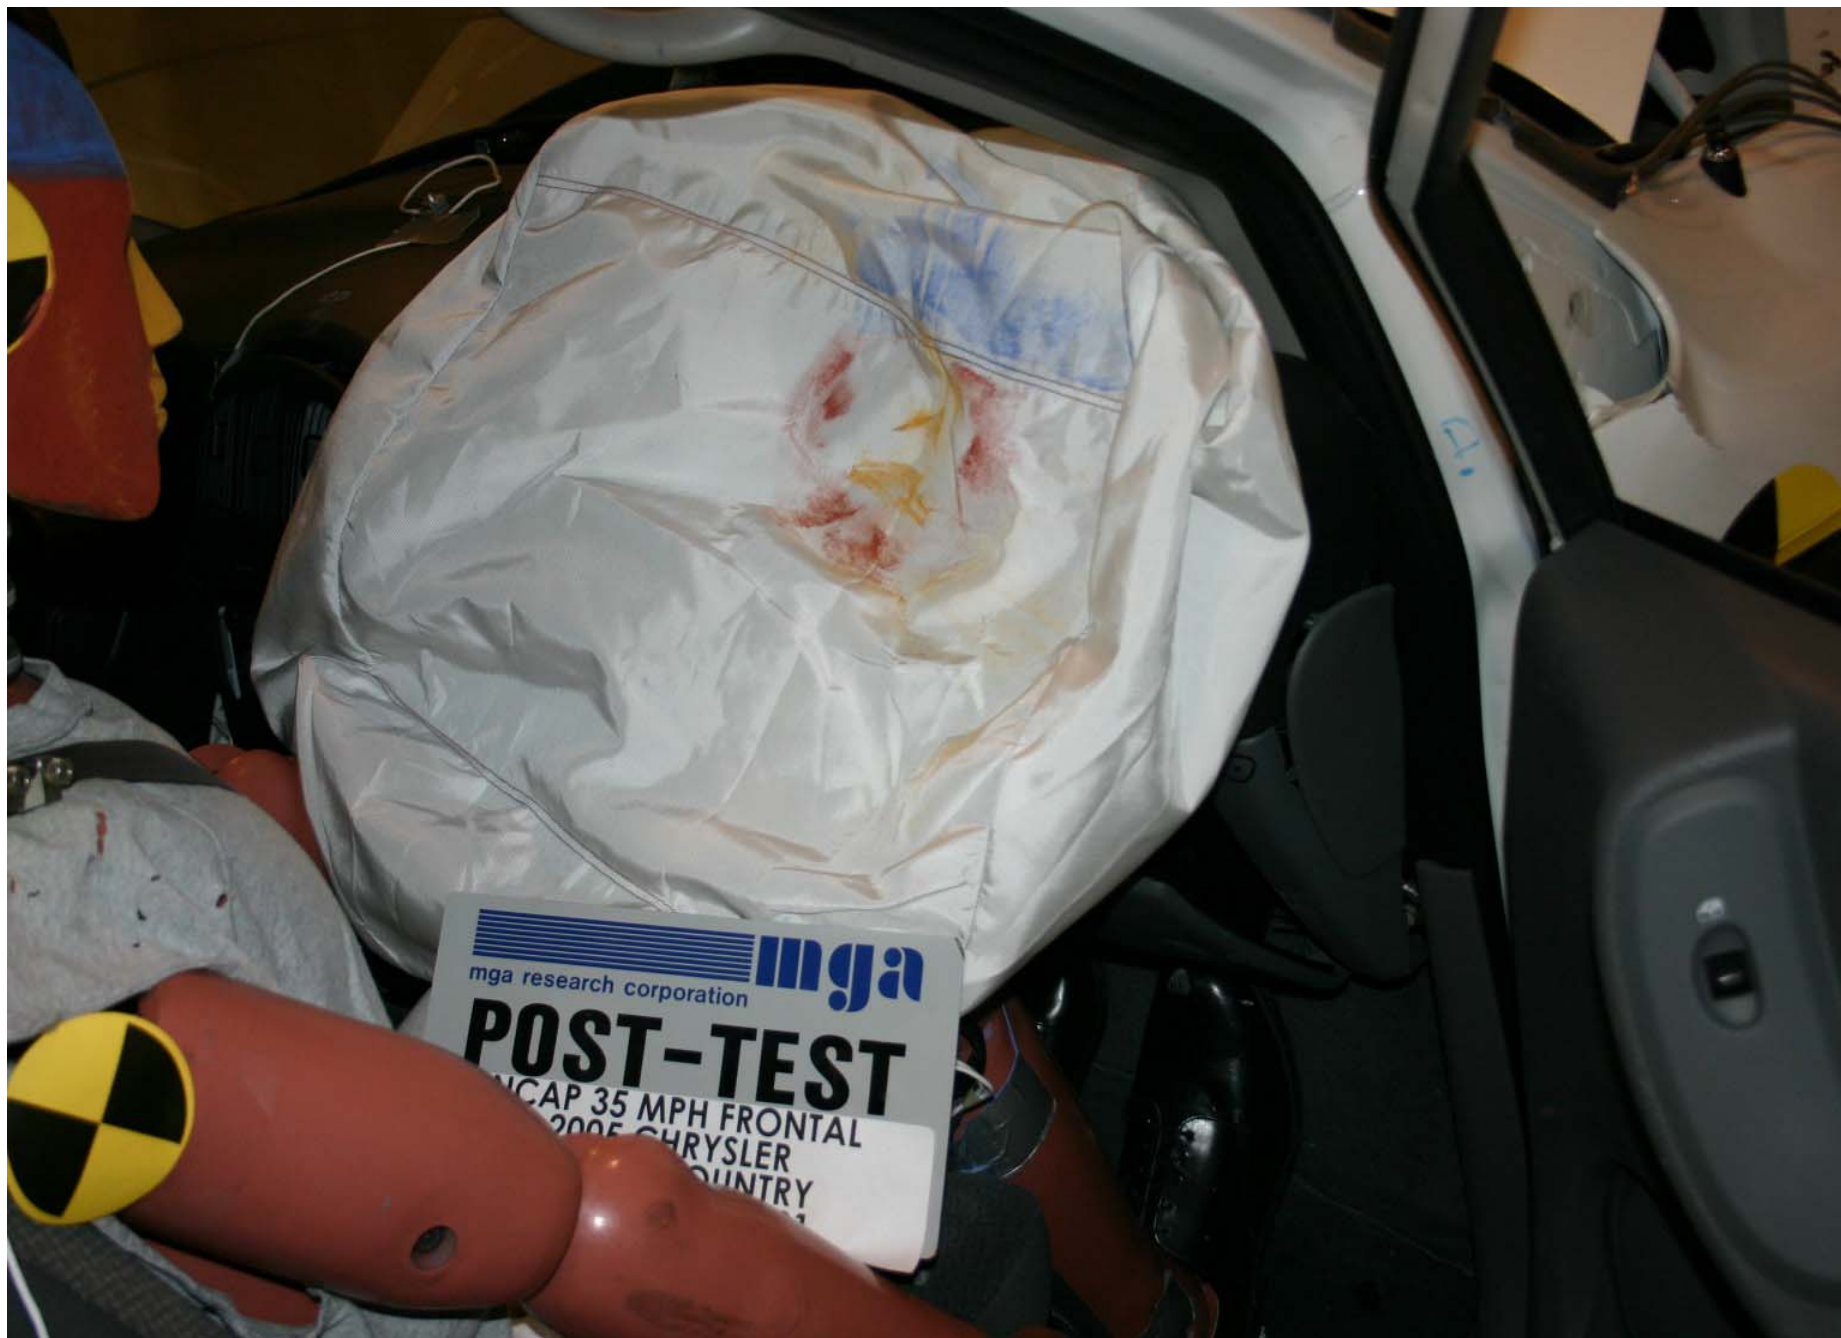
A-66.

Post-Test Passenger Dummy Airbag Contact
