**REPORT NUMBER: NCAP-MGA-2005-007**

**NEW CAR ASSESSMENT PROGRAM  
FRONTAL BARRIER IMPACT TEST**

**Daimler Chrysler  
2005 Chrysler Town and Country  
NHTSA NUMBER: D50310**

**PREPARED BY:  
MGA RESEARCH CORPORATION  
5000 WARREN ROAD  
BURLINGTON, WI 53105**

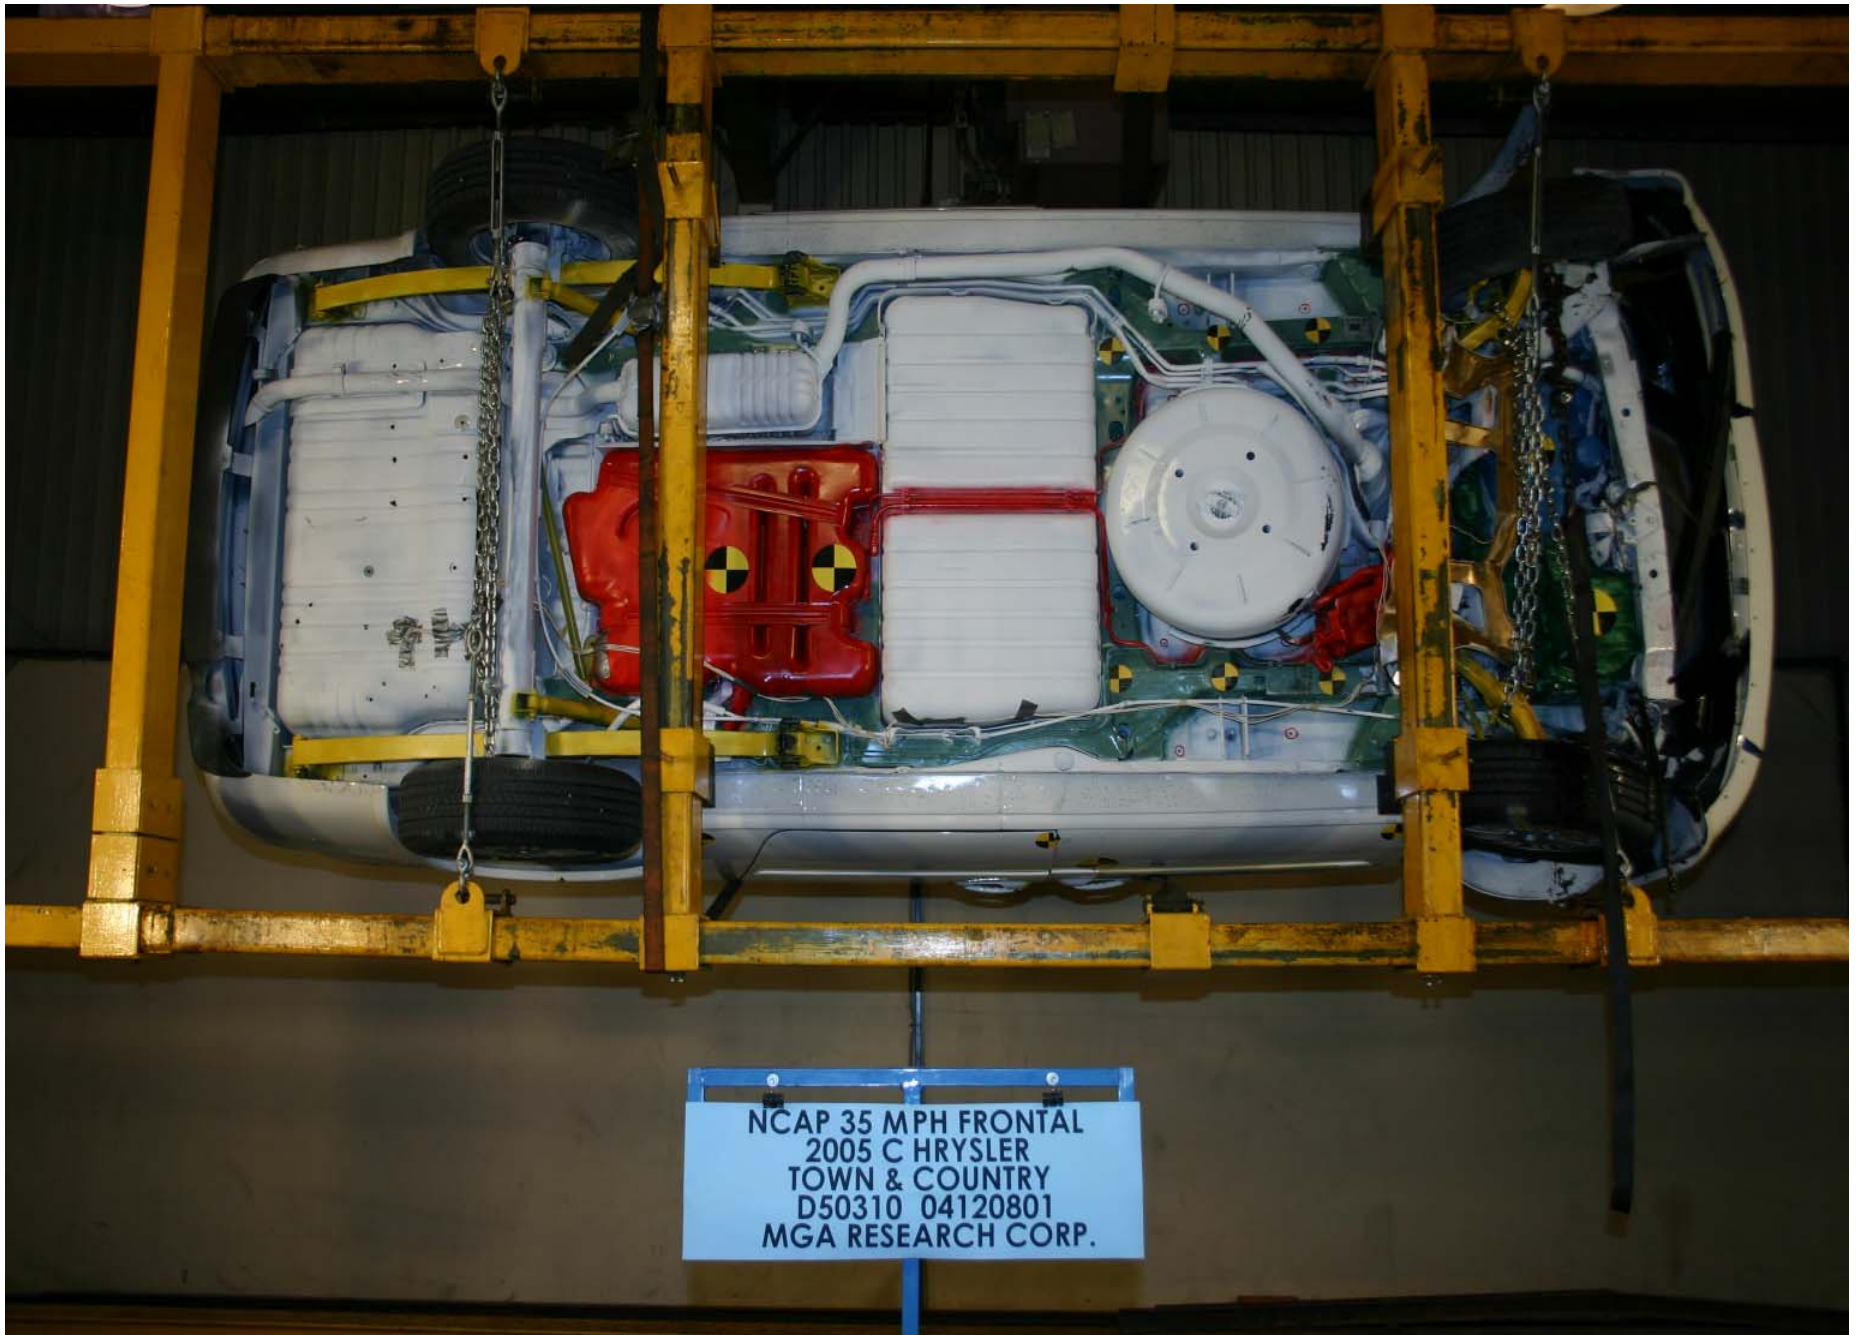
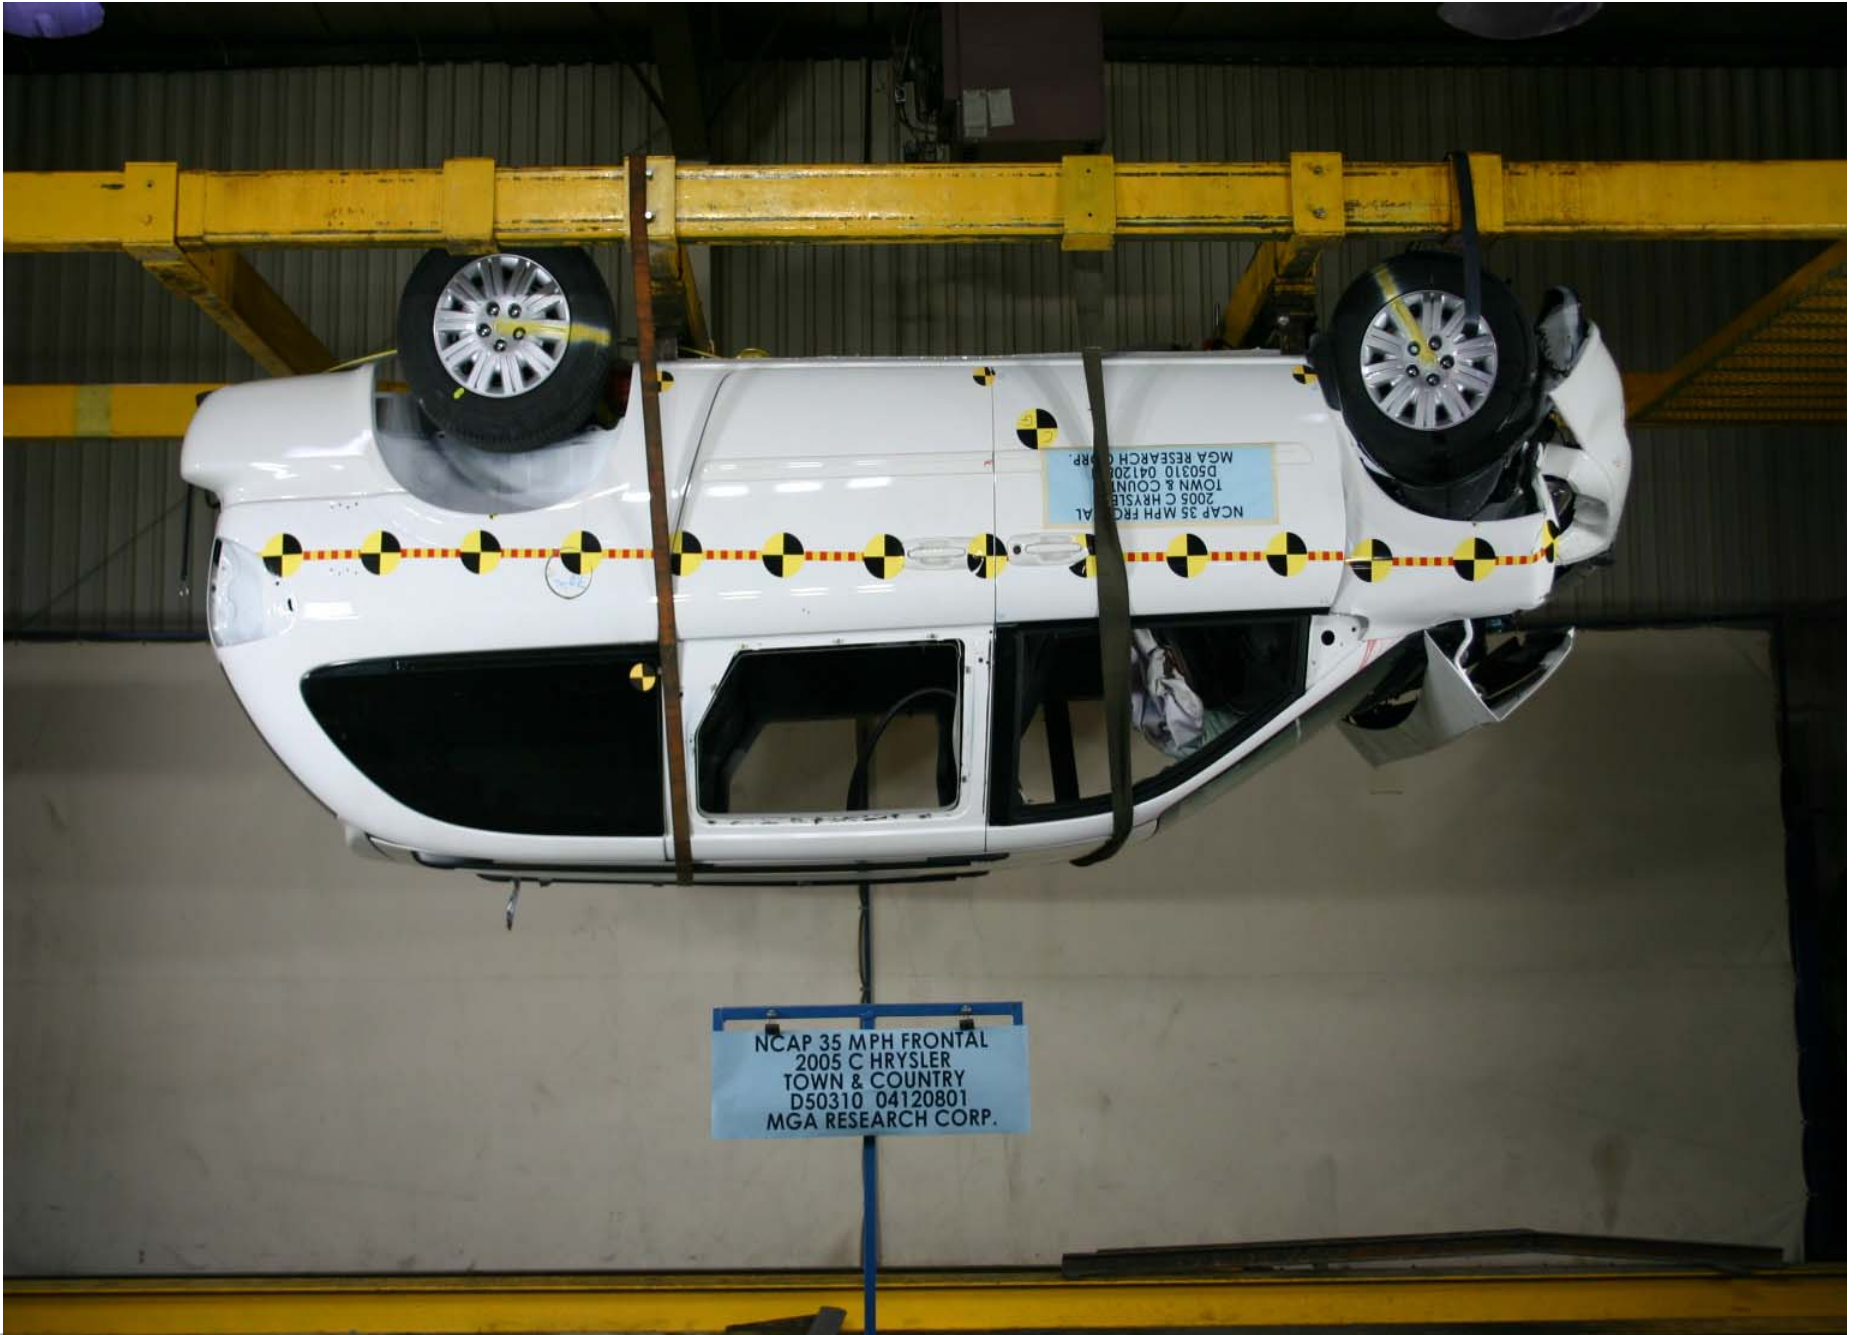
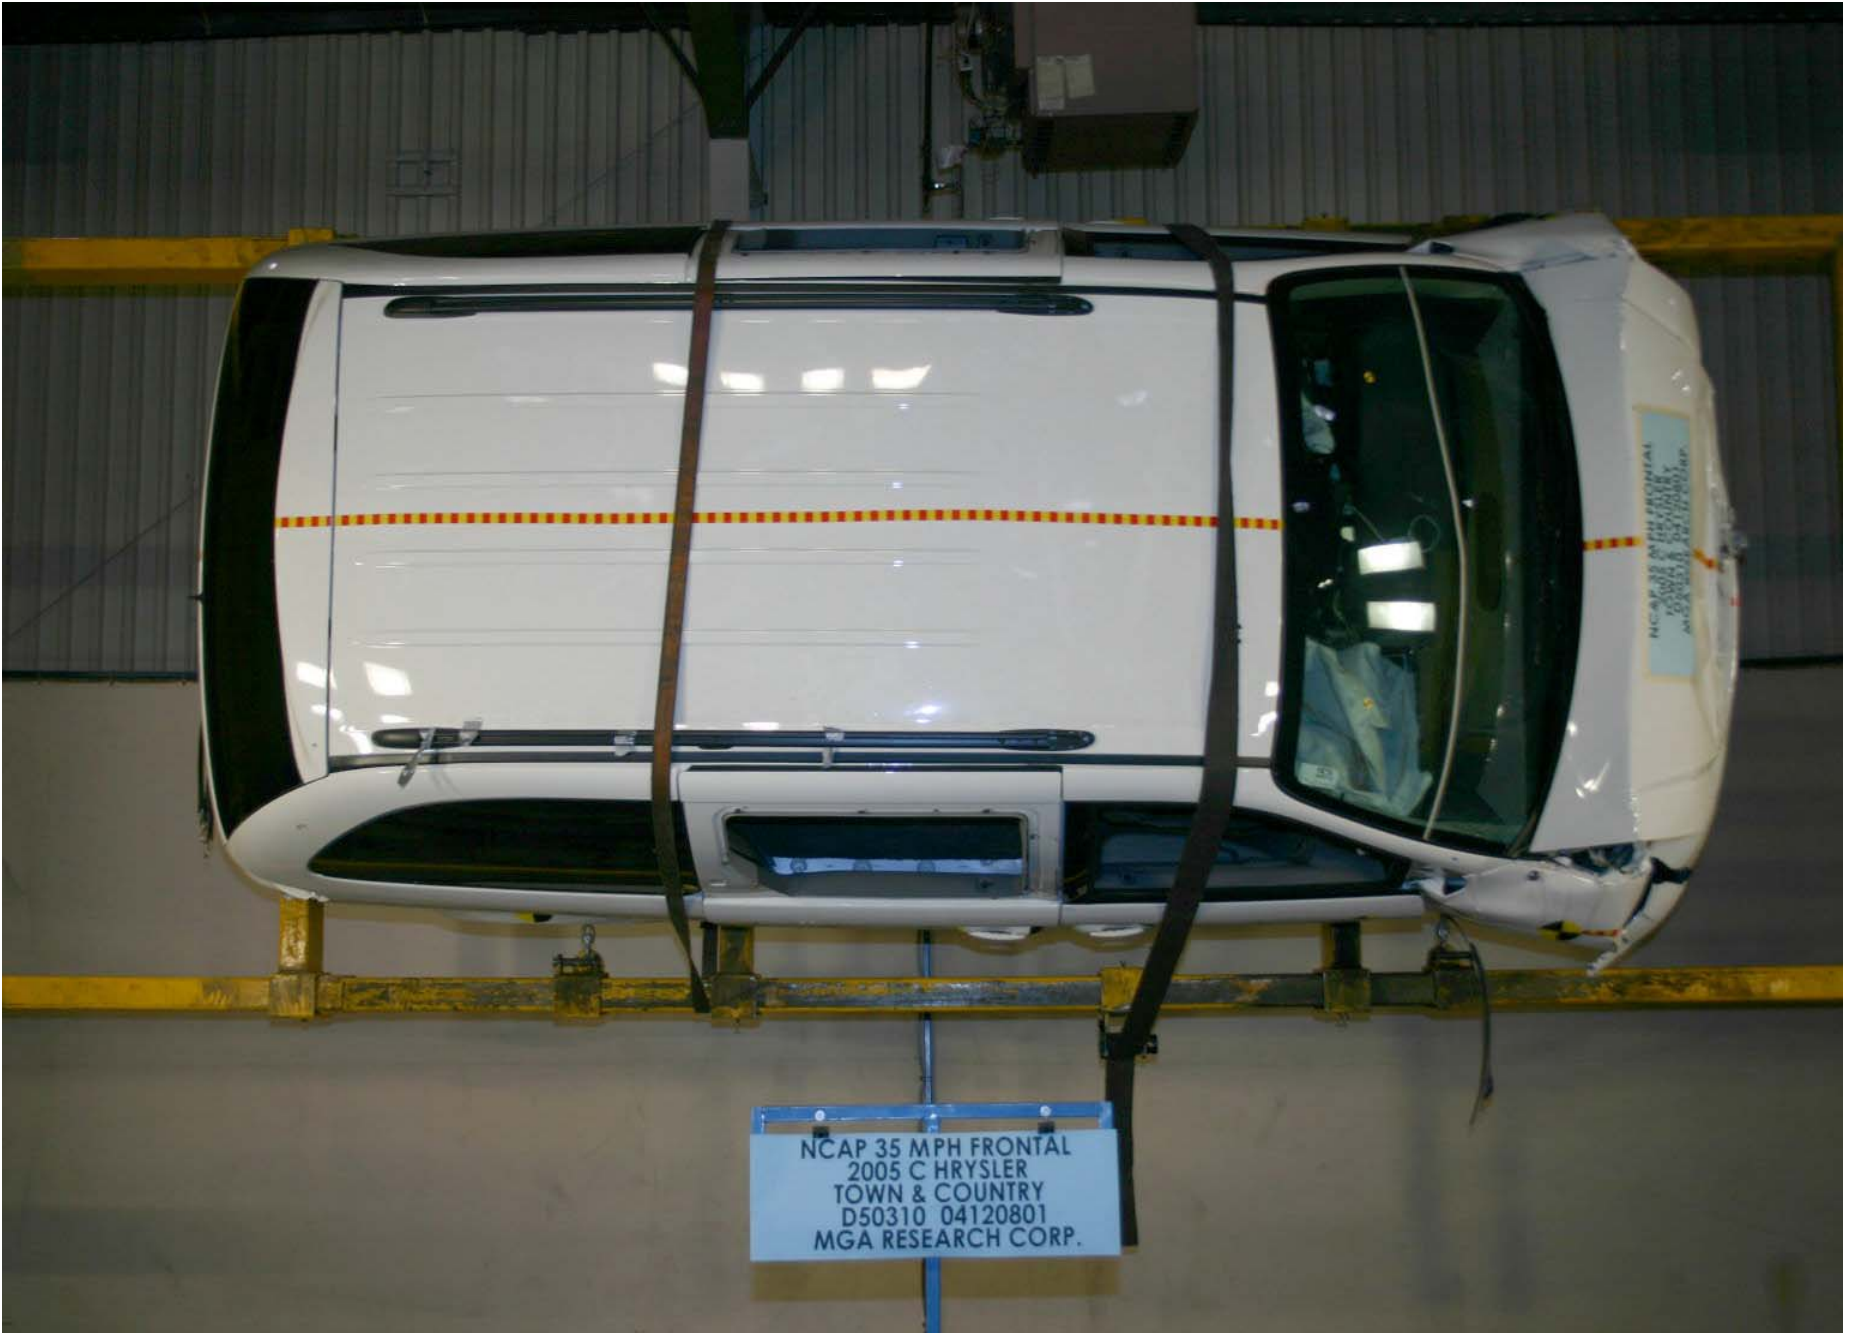
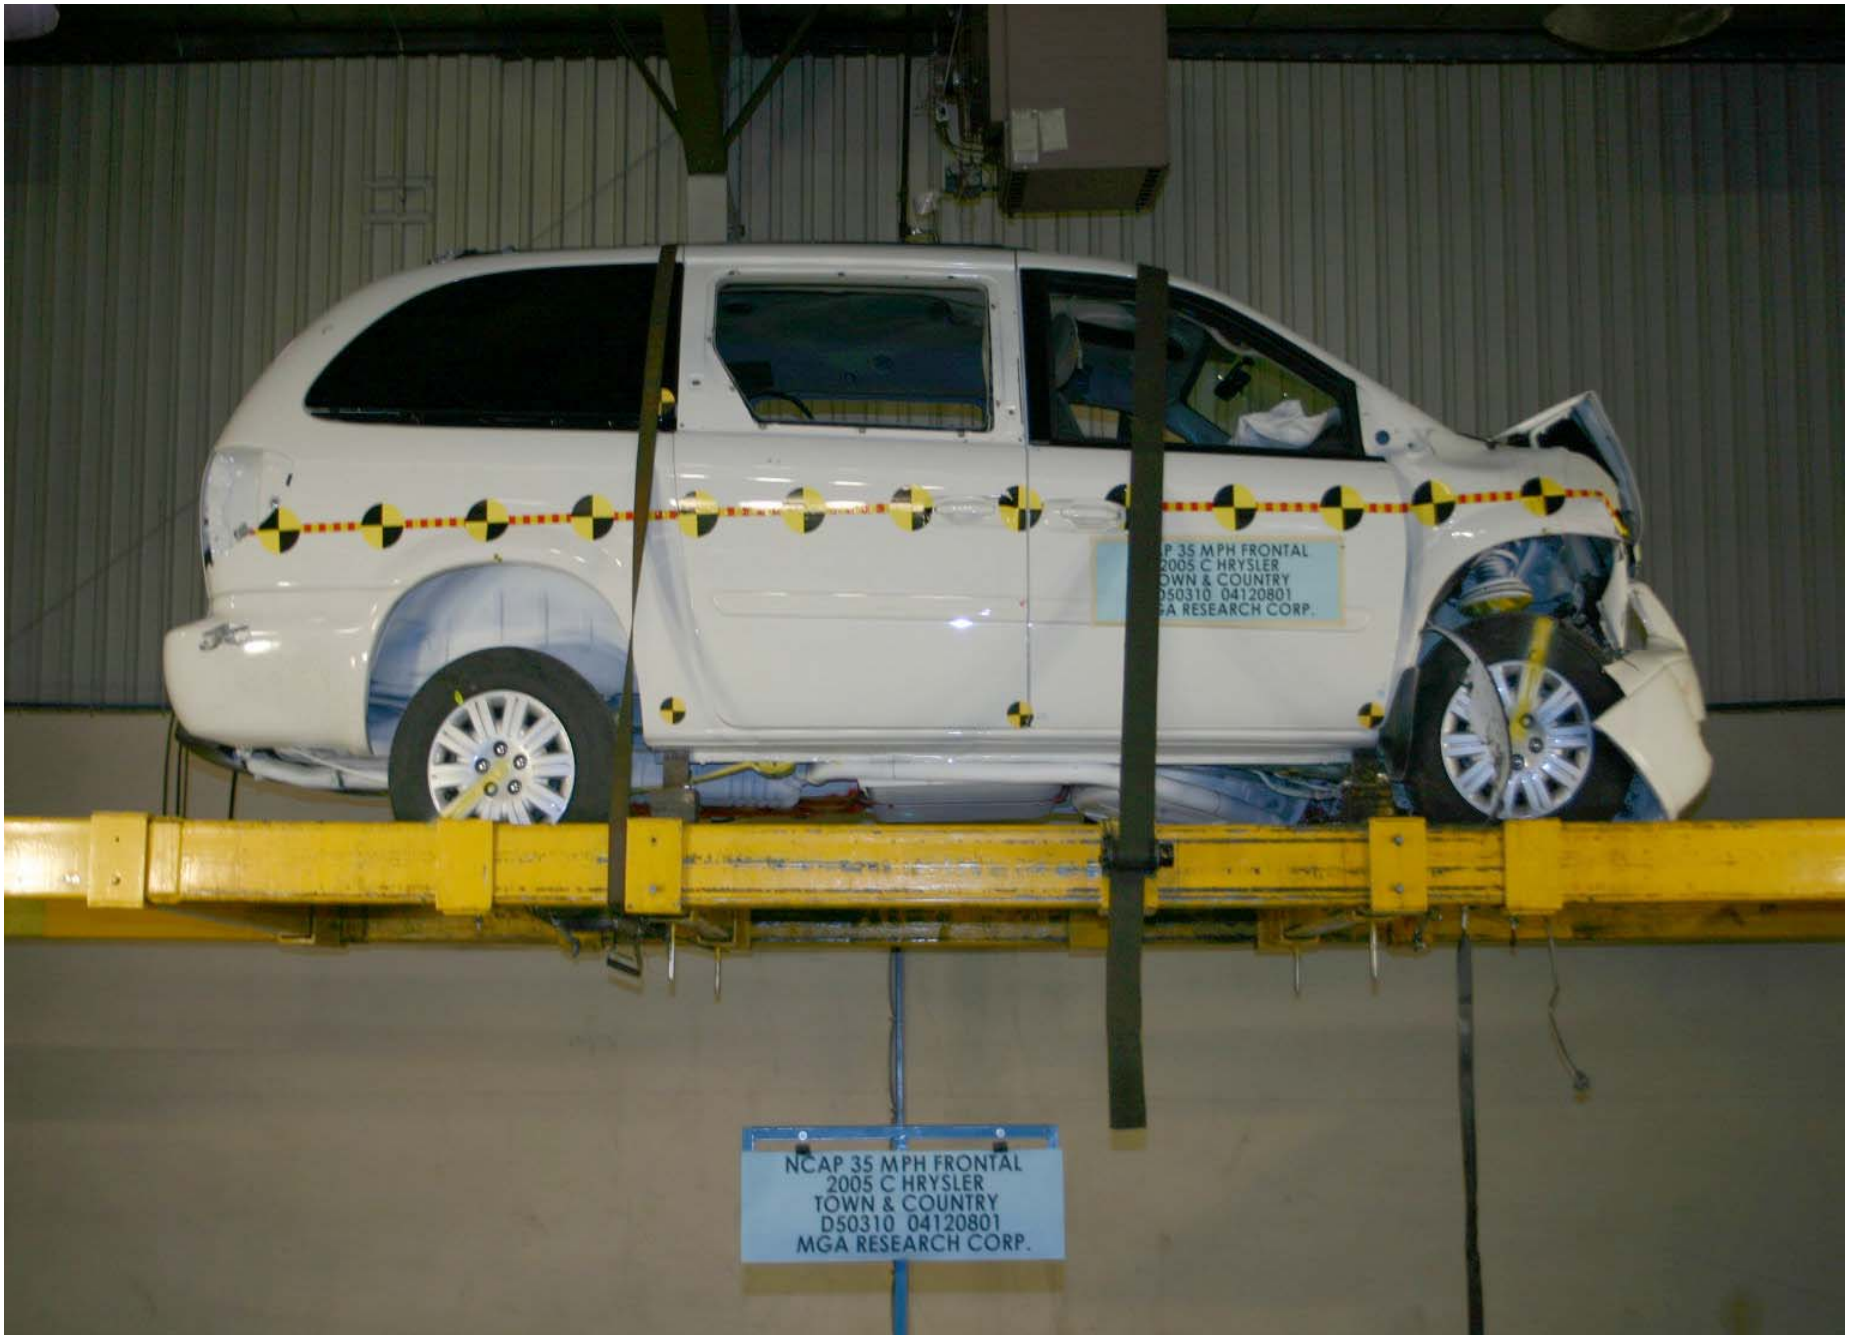
Rollover 90 Degrees

Rollover 180 Degrees

Rollover 270 Degrees

Rollover 360 Degrees

There was 100 percent windshield retention and no intrusion into the protected zone of the windshield during the event. There was no Stoddard Solvent leakage after the event or during any phase of the static rollover.

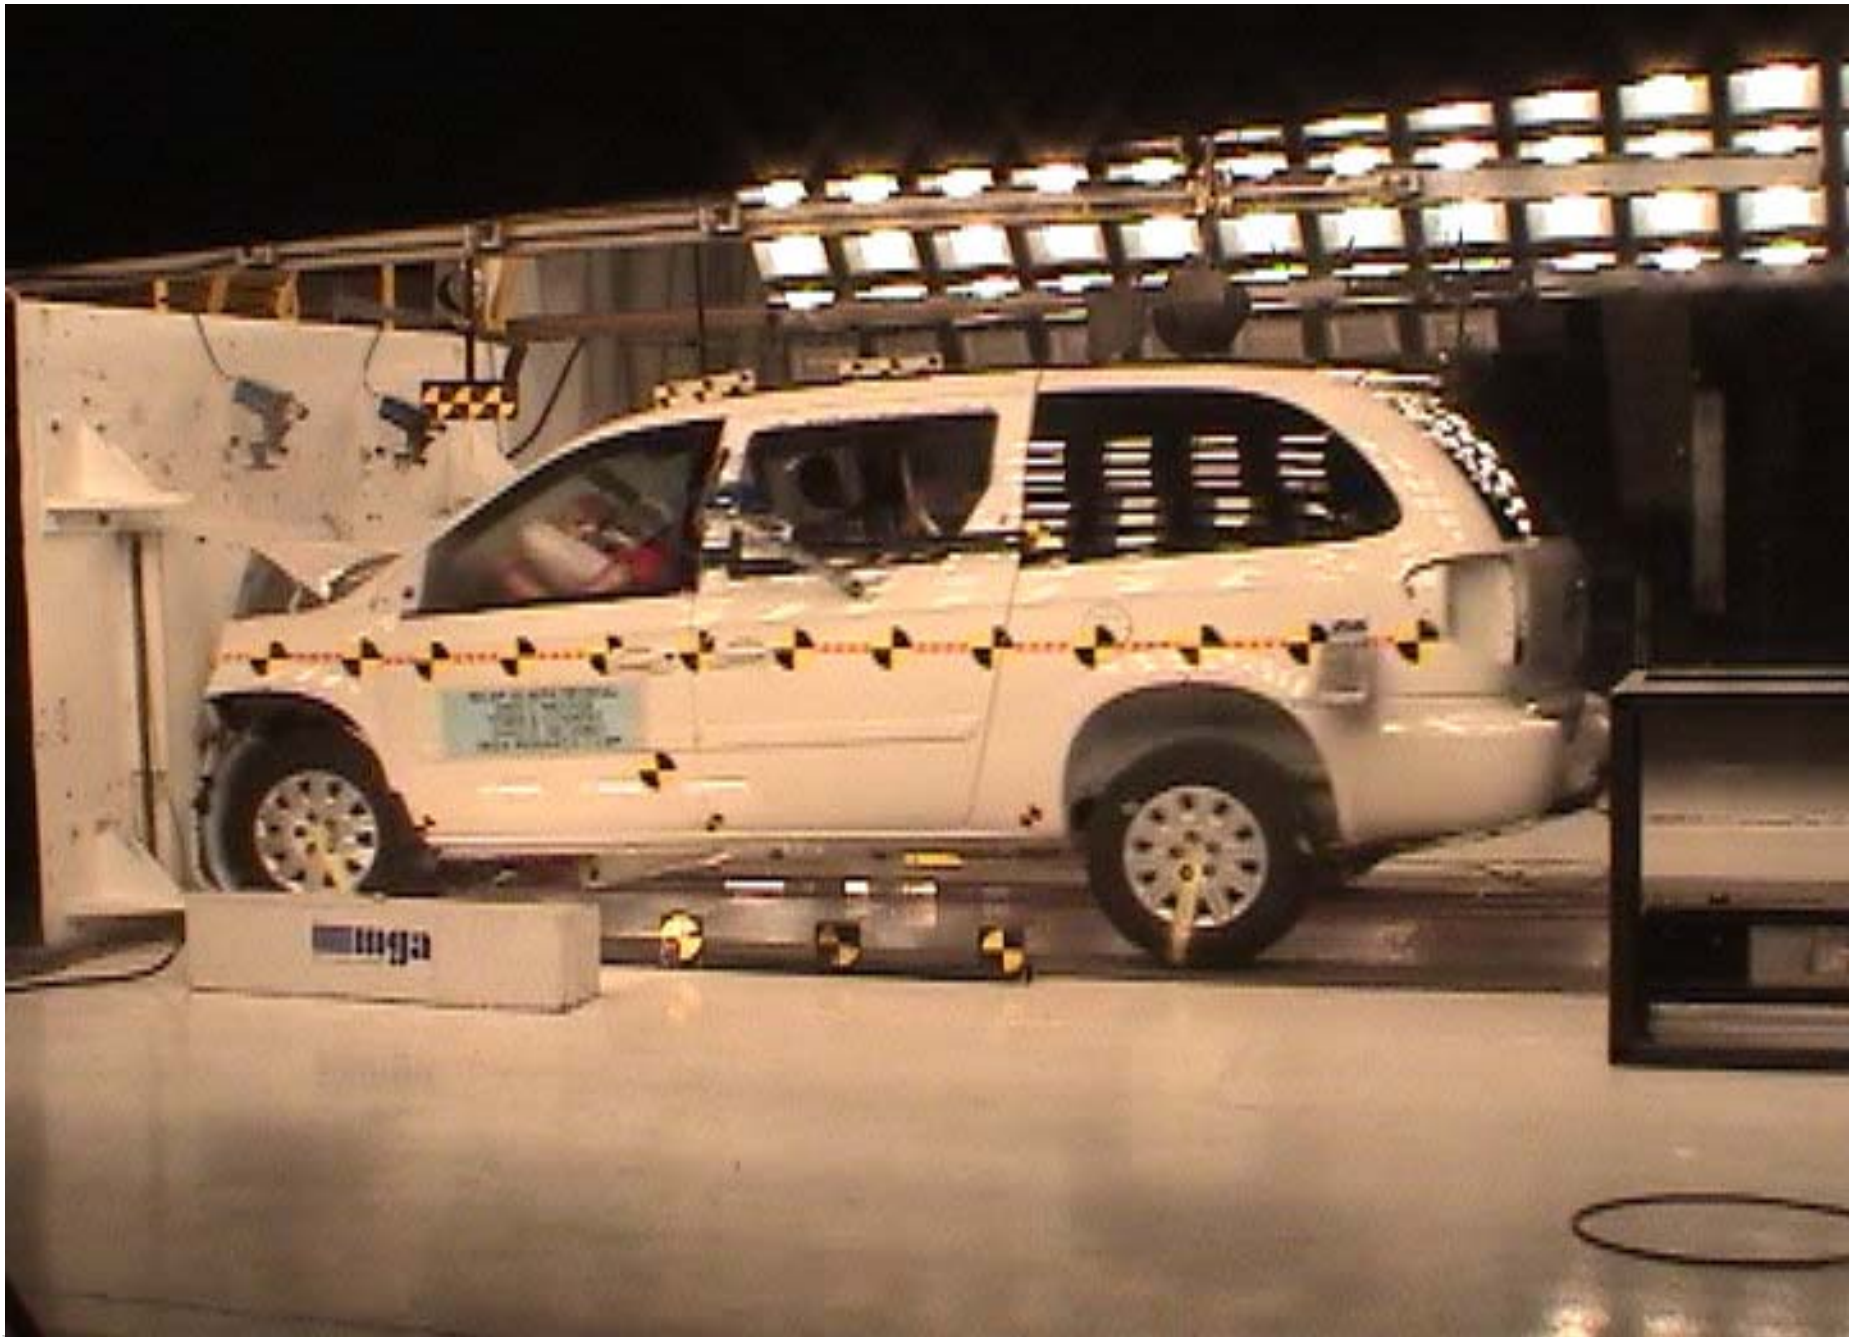
A-71.

Vehicle Impact

A load cell barrier consisting of 30 load cells was impacted by a 2005 Chrysler Town and Country at a velocity of 56.6 kph. The test was performed at MGA Research Corporation on December 8, 2004. Pre-and post-test photographs of the vehicle and dummies can be found in Appendix A.
