REPORT NUMBER TR-P24161-01-NC

**NEW CAR ASSESSMENT PROGRAM
SIDE IMPACT TEST**

**GENERAL MOTORS CORPORATION
2005 CHEVROLET MALIBU
4-DOOR SEDAN**

NHTSA NUMBER: G50101

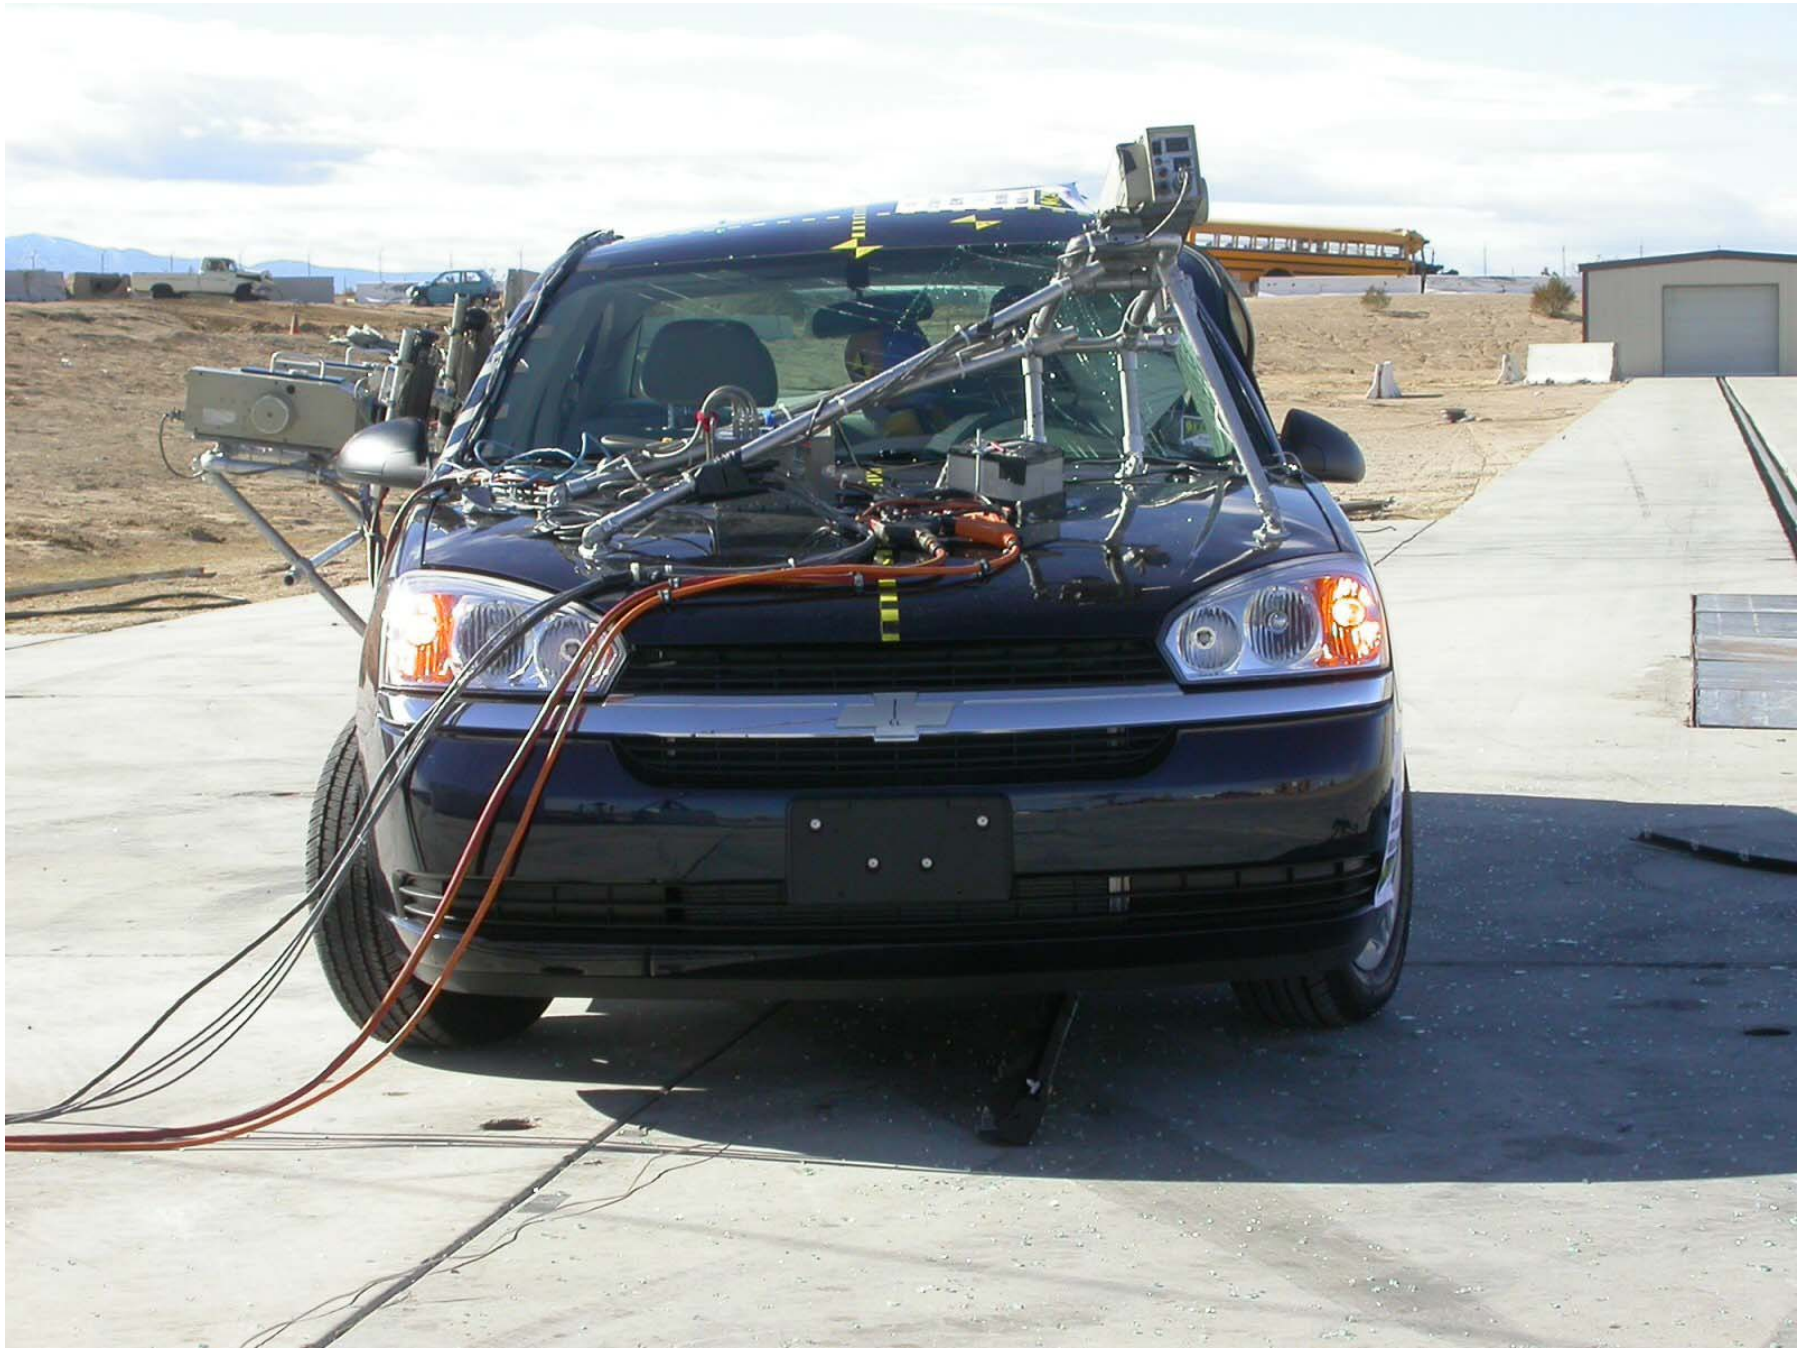
Figure A-6: Post-Test Front View

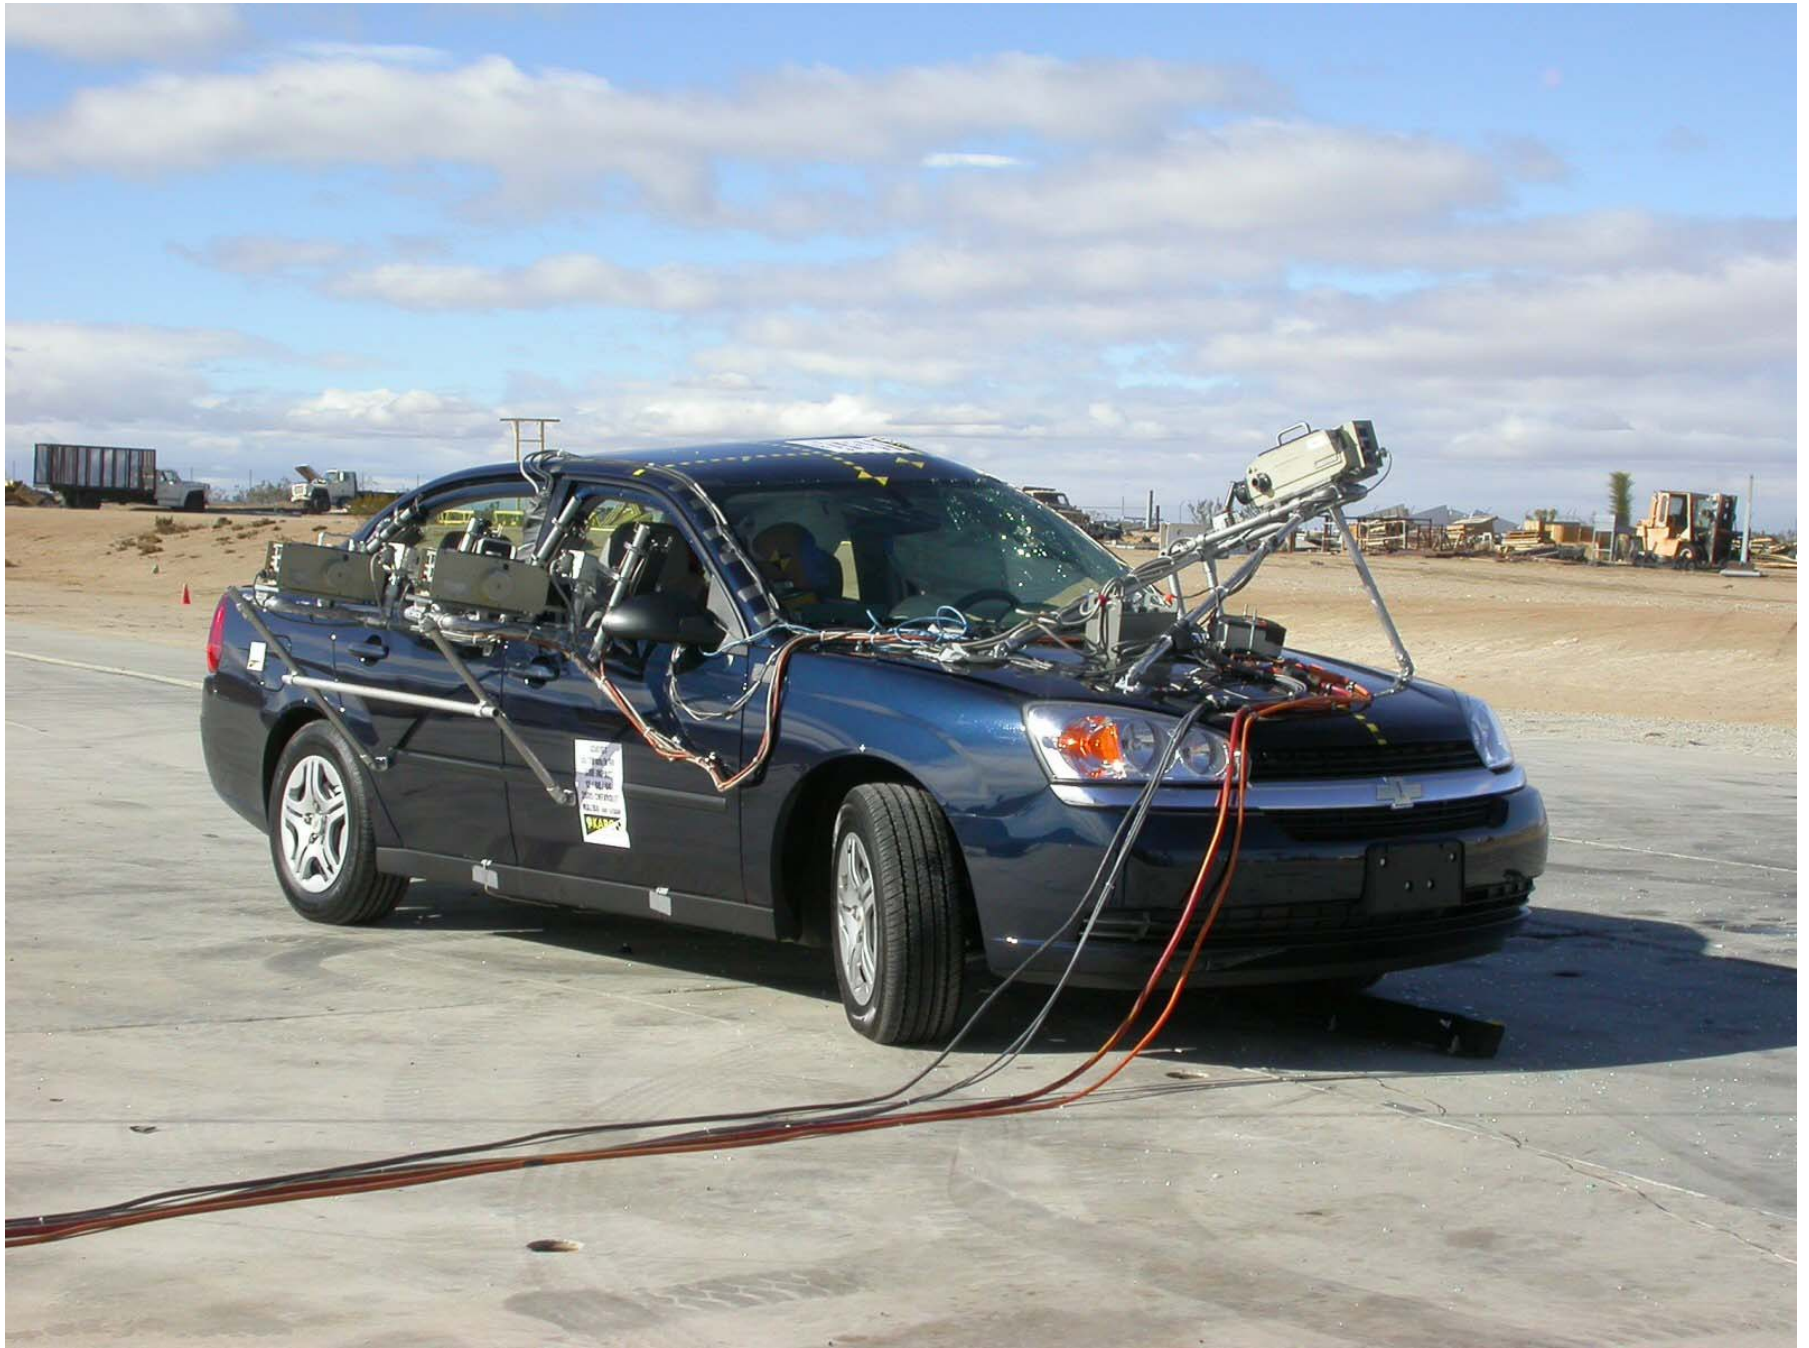
Figure A-20: Post-Test Right Front $\frac{3}{4}$ View

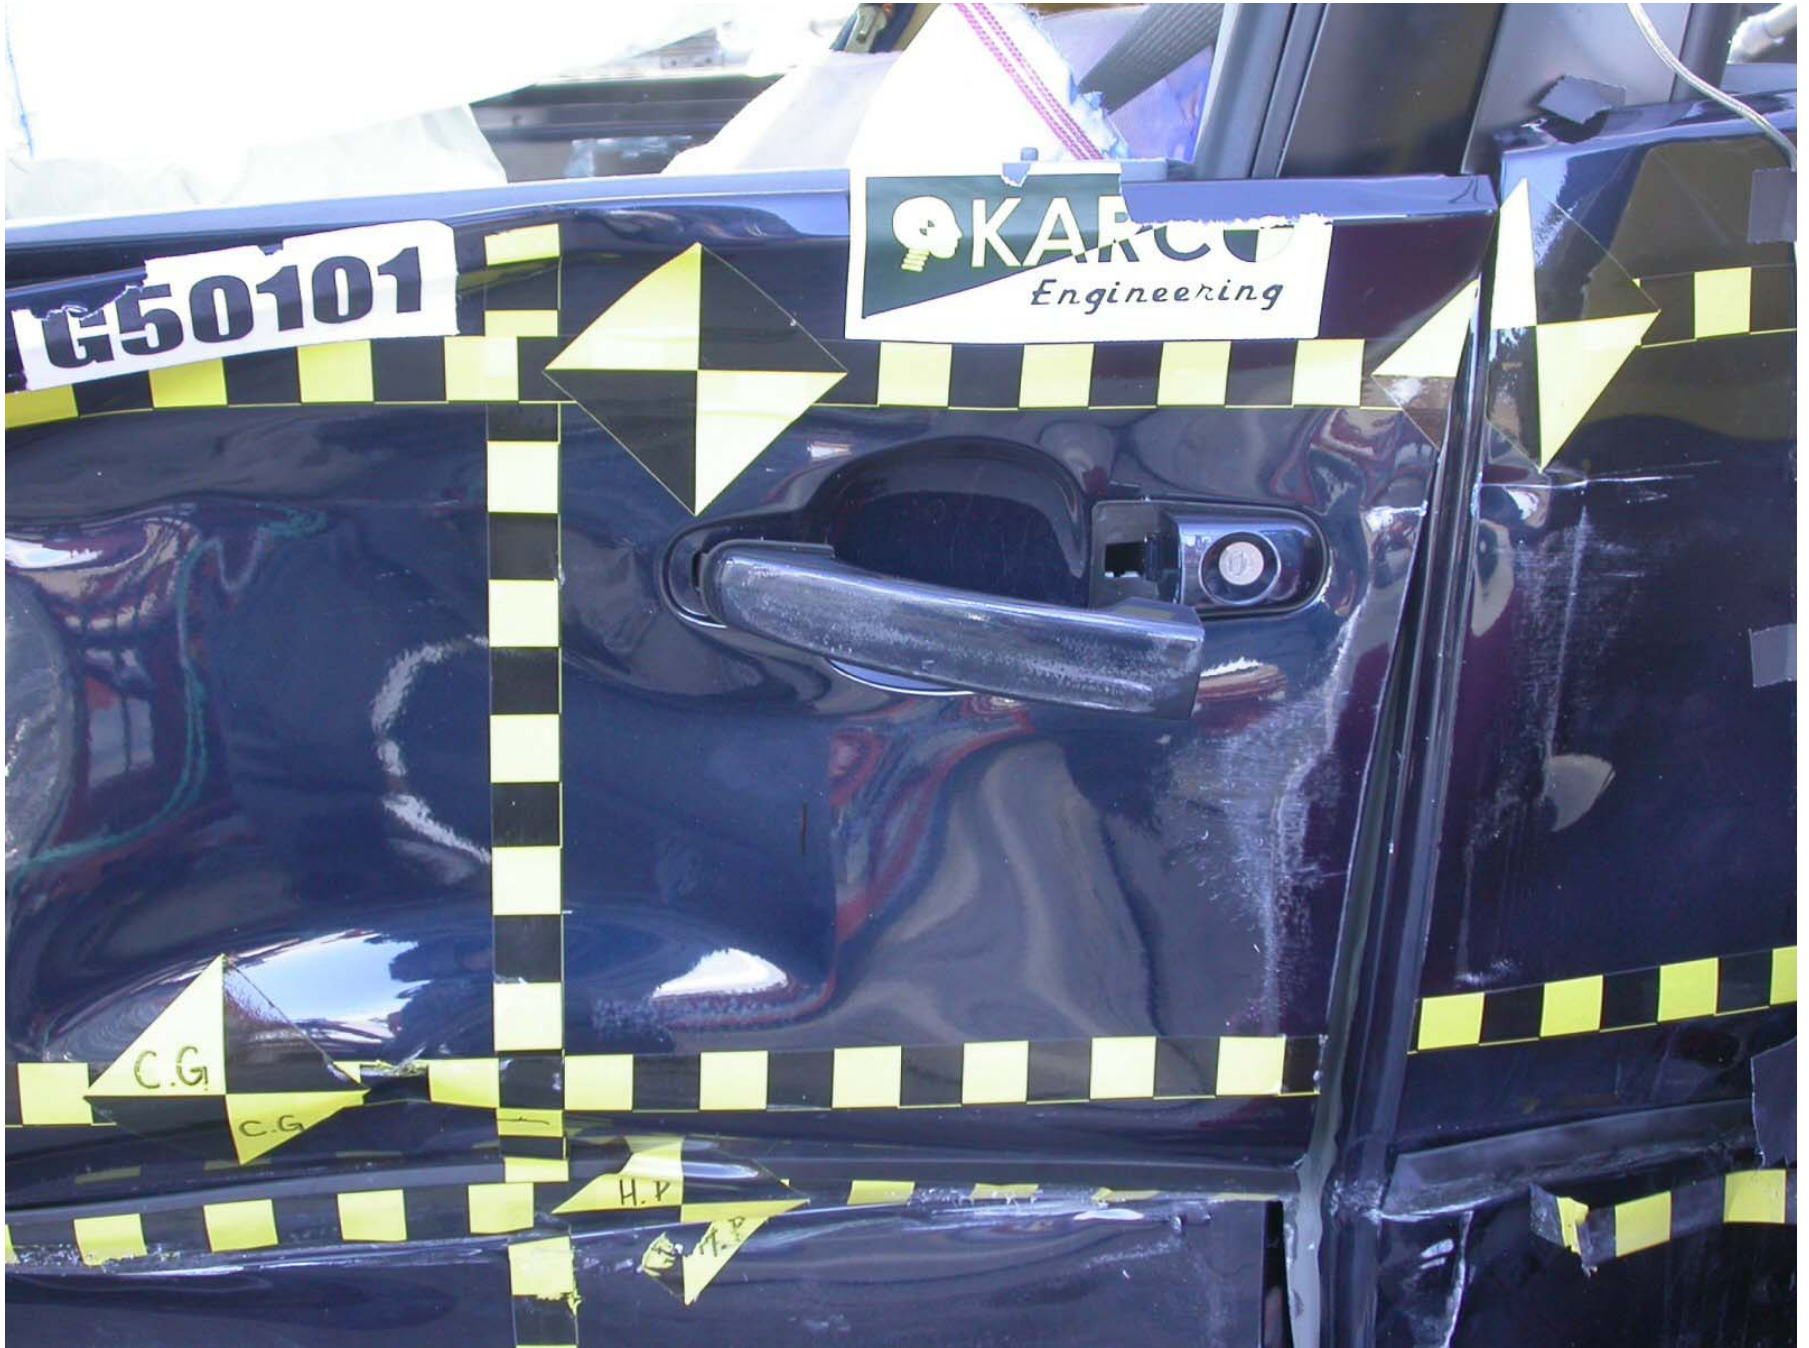
Figure A-34: Post-Test Left Front Door

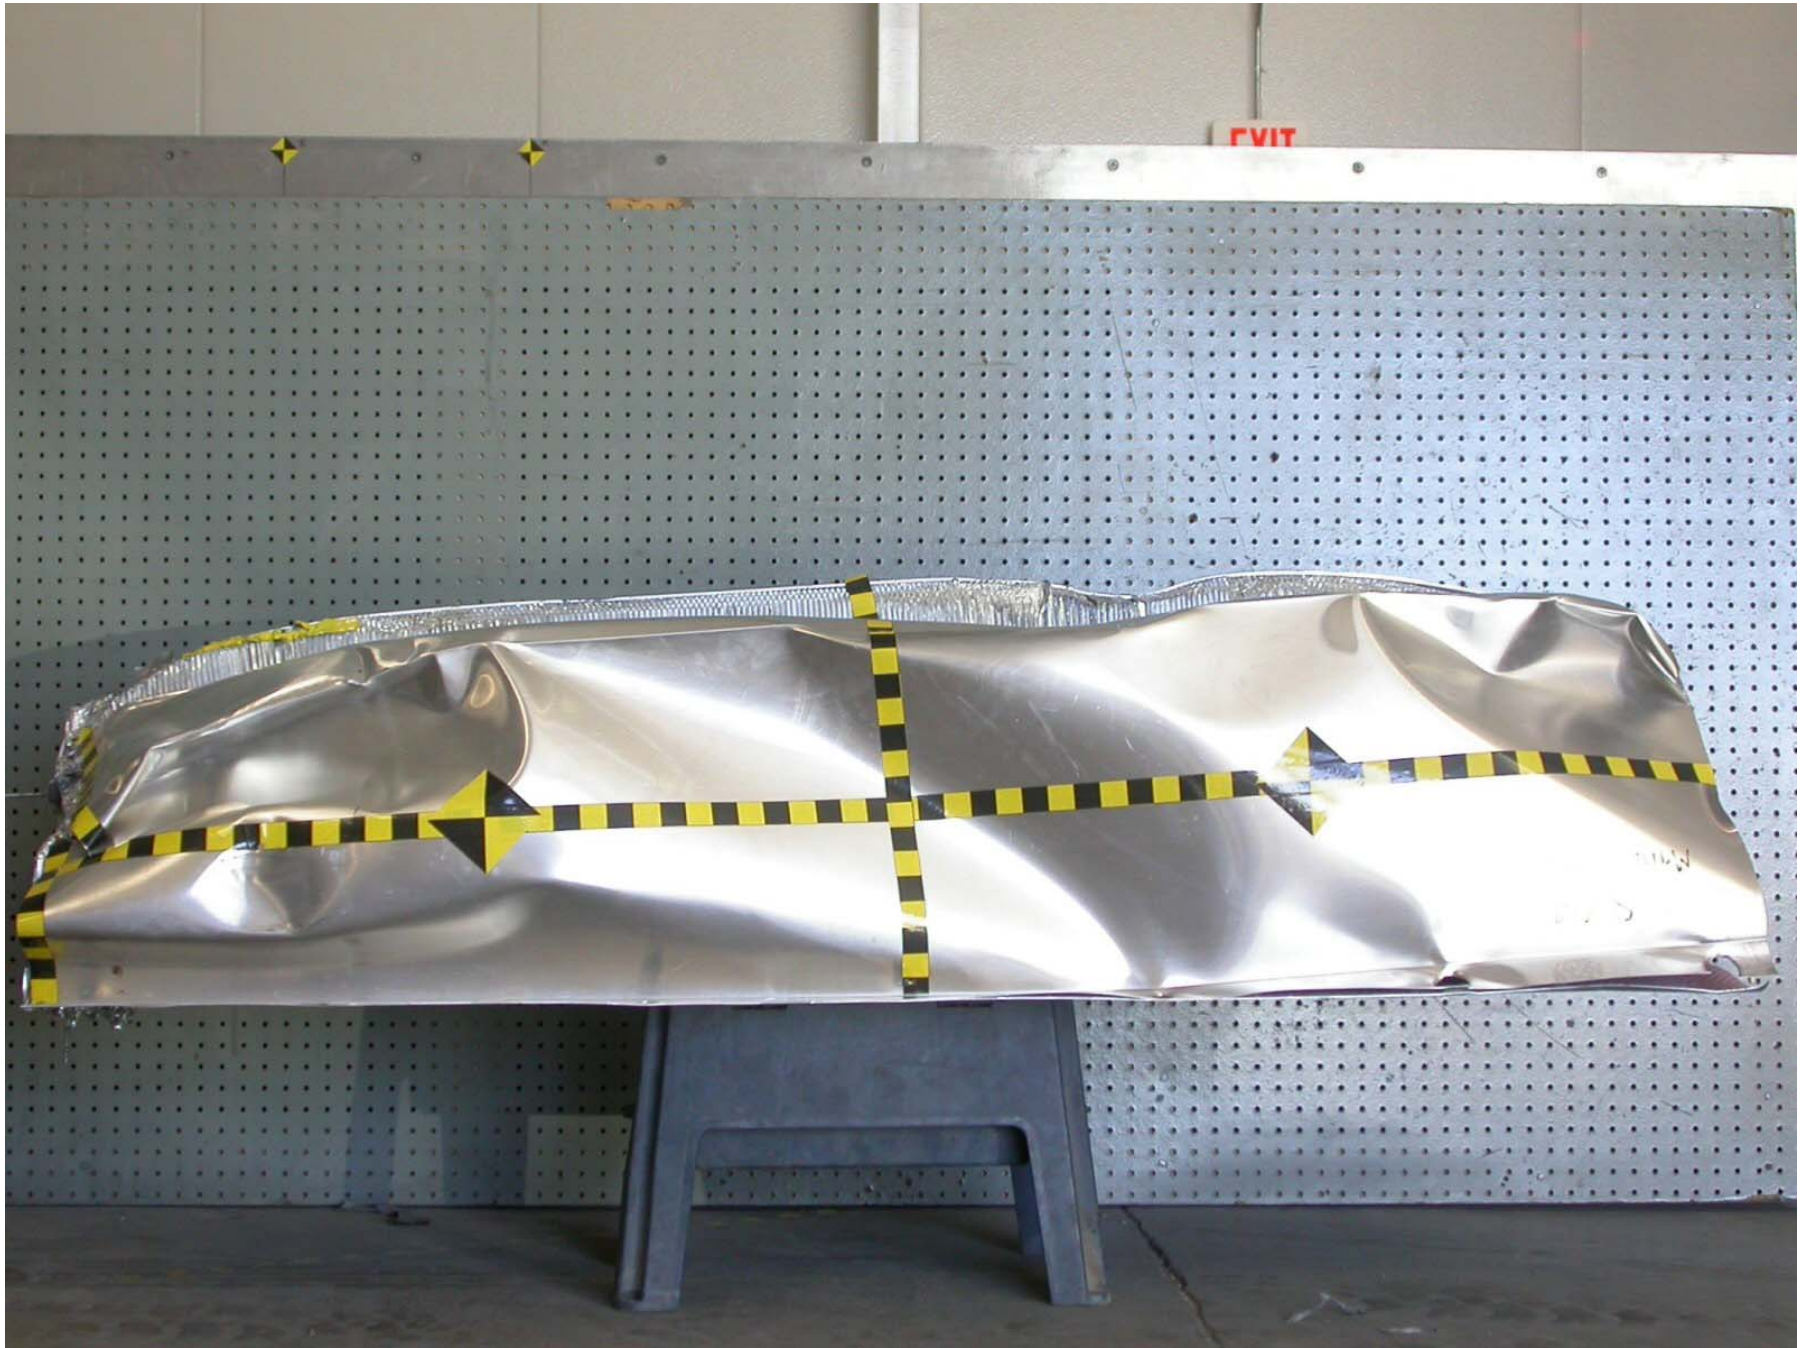
Figure A-58: Post-Test Top View of Deformable Barrier

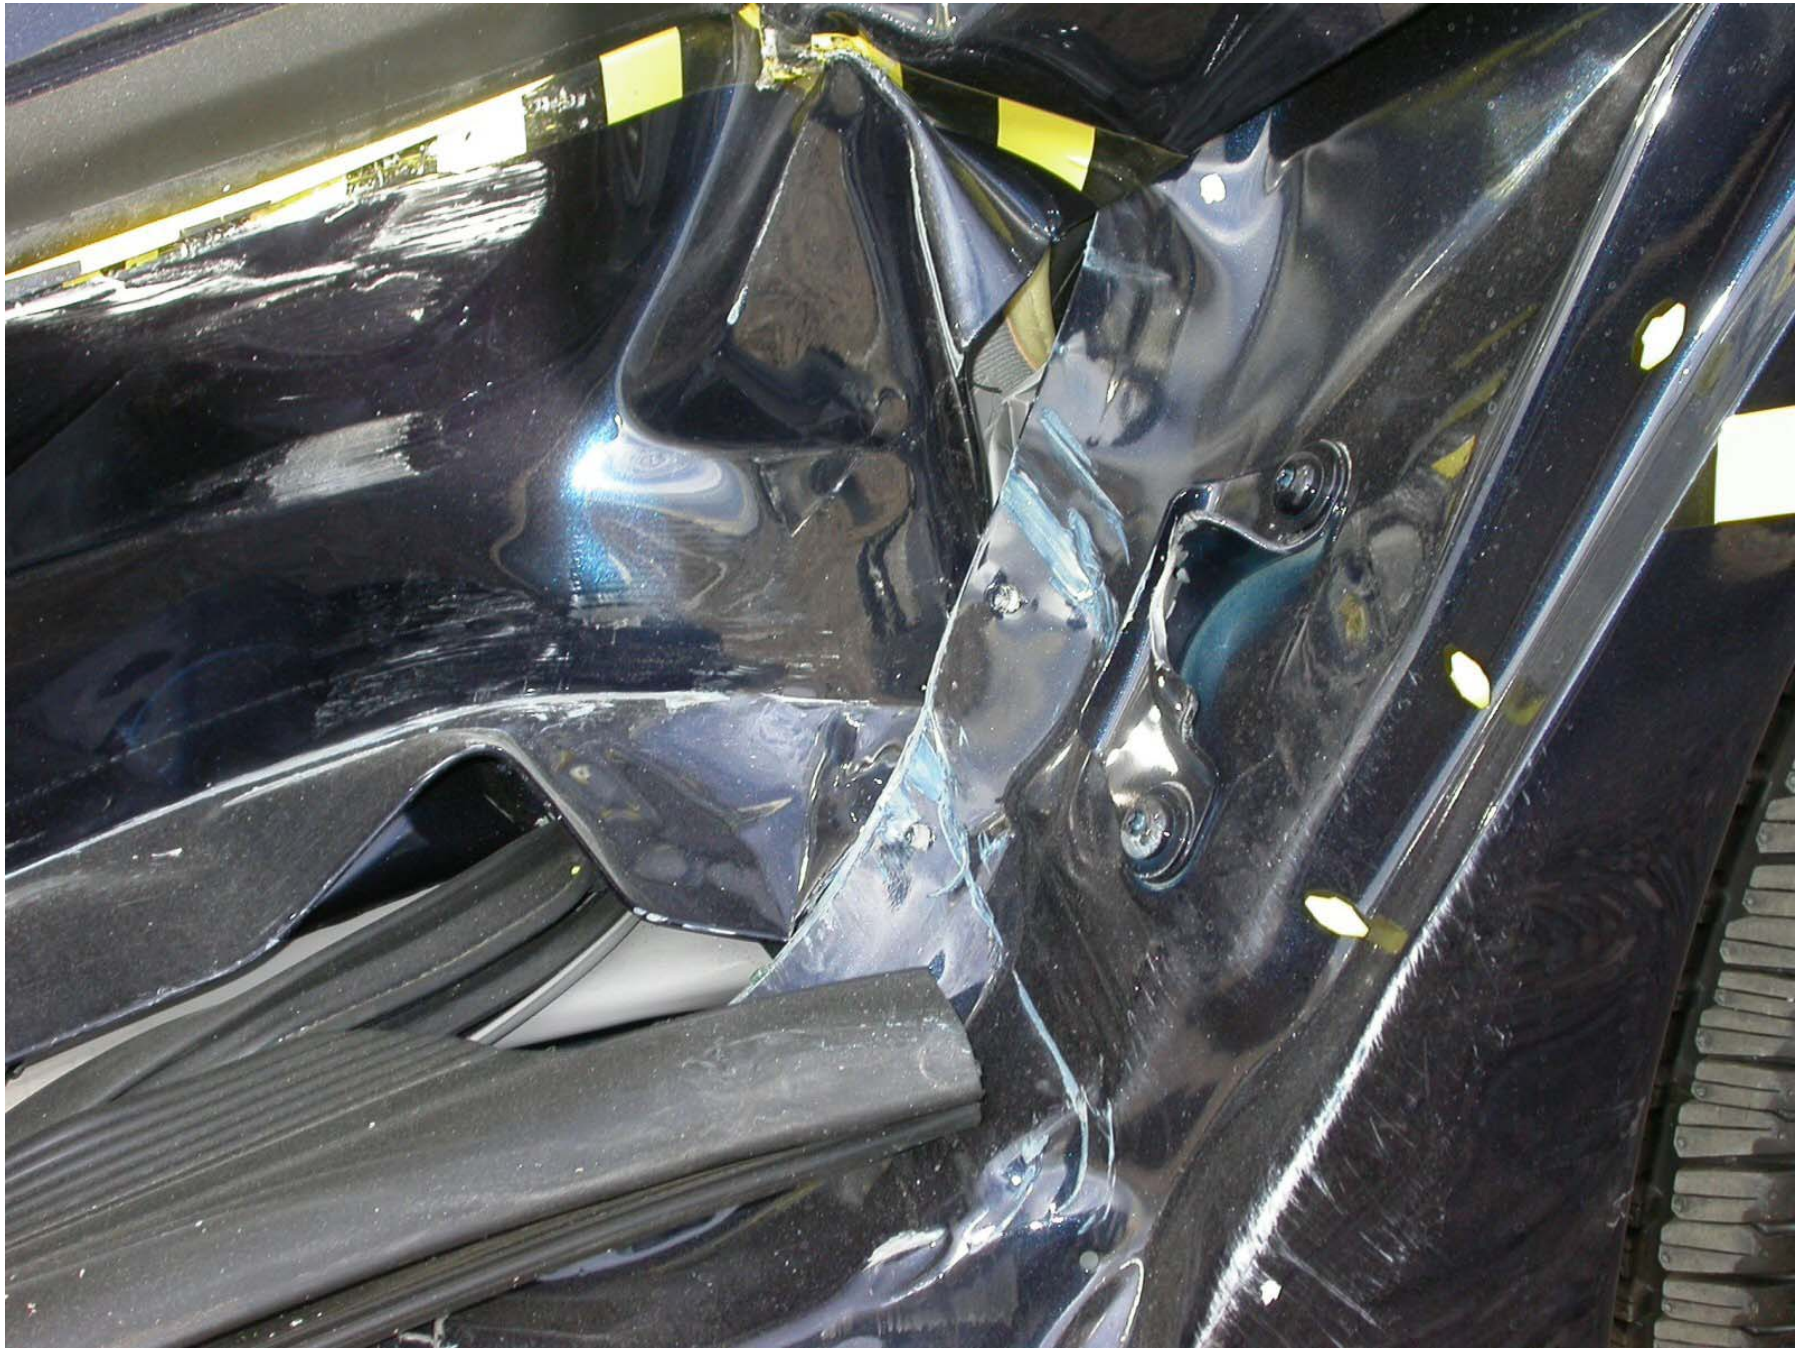
Figure A-69: Post-Test Impacted Rear Door Interlock

The driver door remained closed. The passenger door remained latched, although it separated near the top sill (Figure 68, Appendix A). The test vehicle sustained a maximum static crush of 335 mm at level 2 and level 3, 1350 mm and 1500 mm rearward of the left vertical impact point respectively. The driver SID/Hybrid III, Serial No. 274 and the passenger SID/Hybrid III, Serial No. 275 were calibrated prior to this test. The SID/Hybrid III injury criteria is summarized as follows:
