**REPORT NUMBER: NCAP-MGA-2005-008**

**NEW CAR ASSESSMENT PROGRAM  
FRONTAL BARRIER IMPACT TEST**

**DAIMLERCHRYSLER CORPORATION  
2005 DODGE DAKOTA CLUB CAB ST  
NHTSA NUMBER: M50303**

**PREPARED BY:  
MGA RESEARCH CORPORATION  
5000 WARREN ROAD  
BURLINGTON, WI 53105**

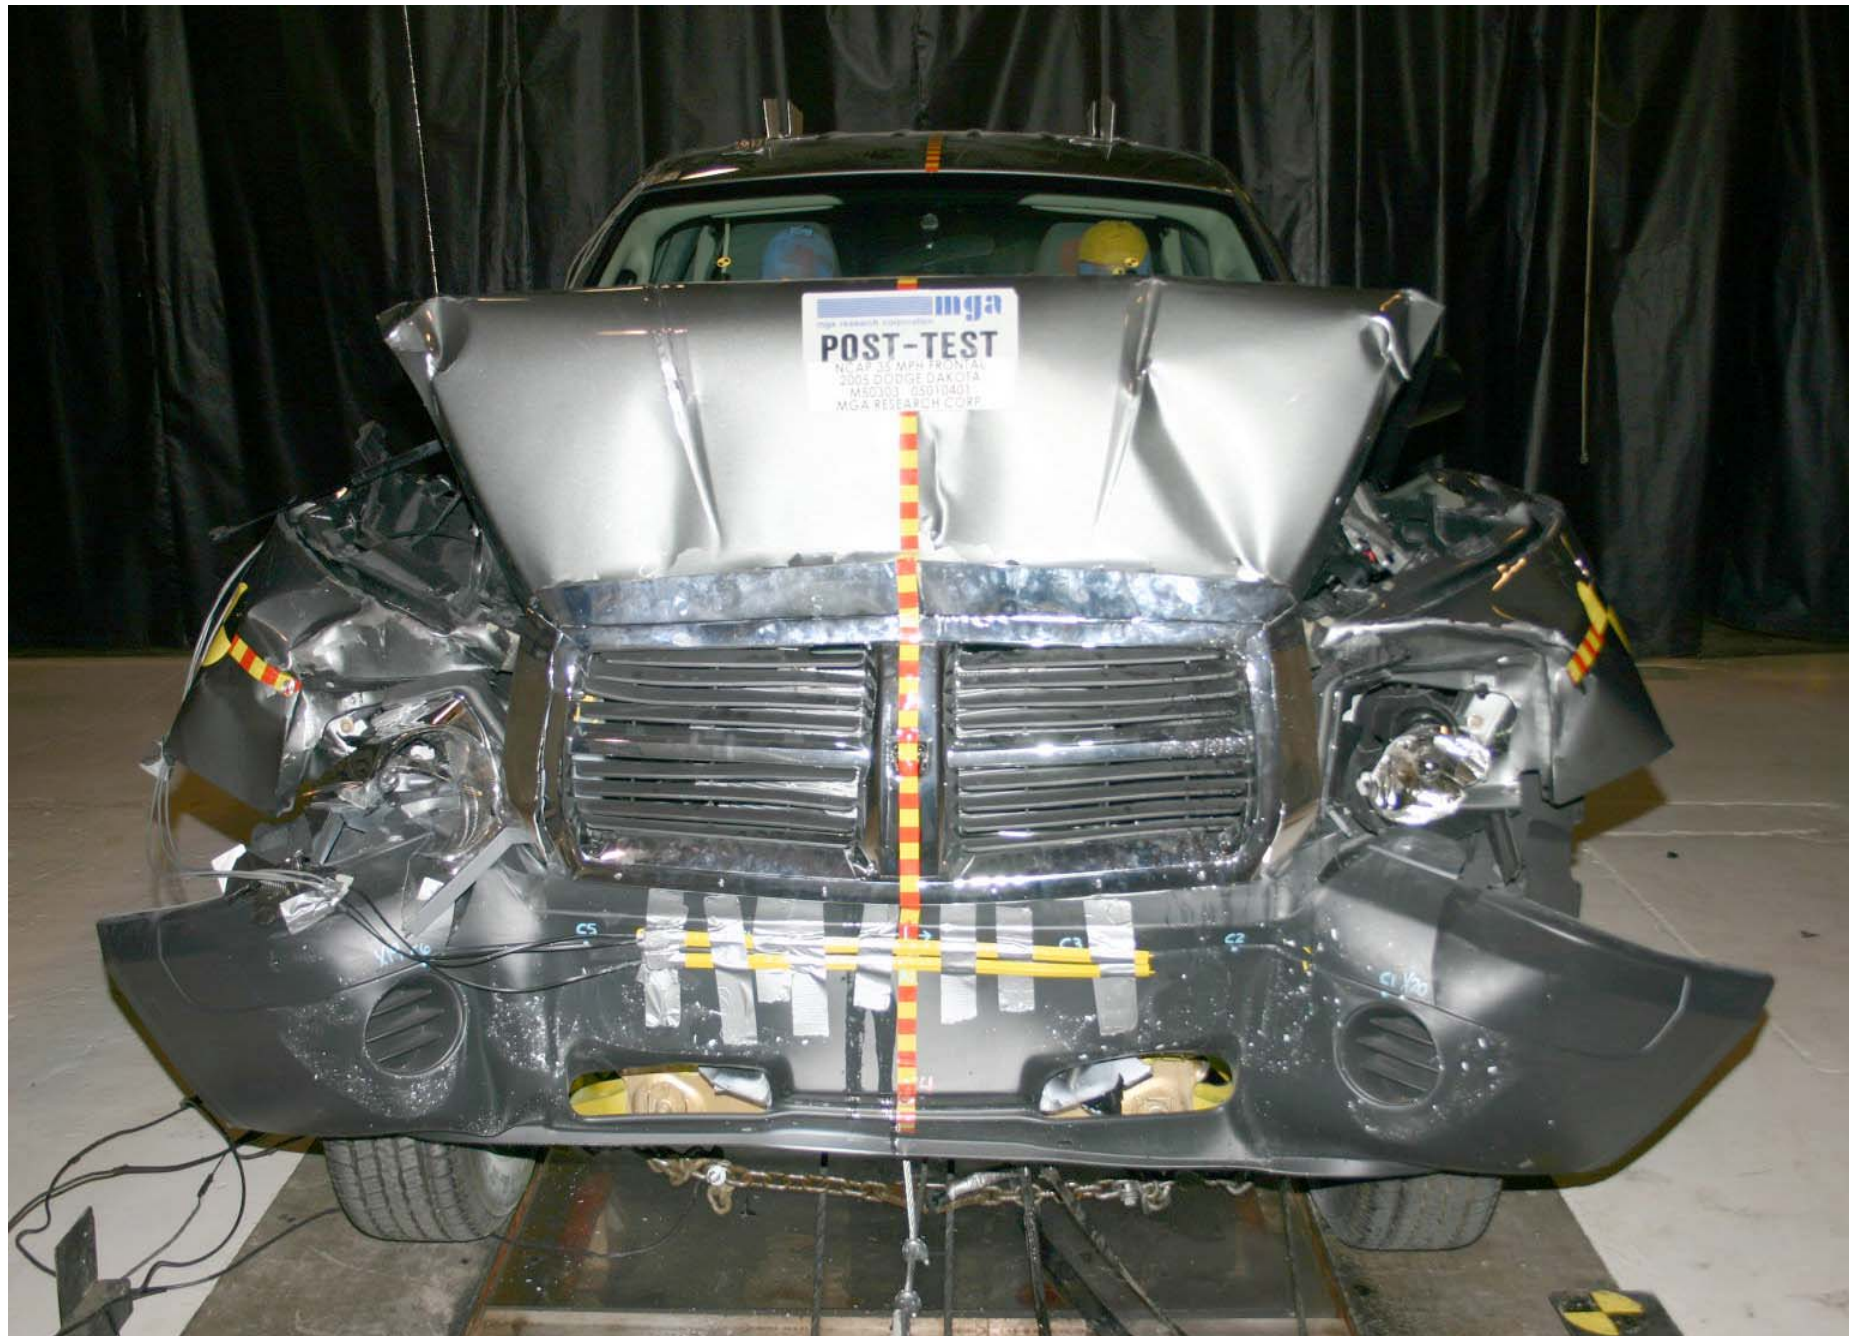
Post-Test Front View of Test Vehicle

The maximum static crush of the vehicle was 470 mm and both the driver and passenger side doors remained closed and latched during the impact event and were operable after the impact.

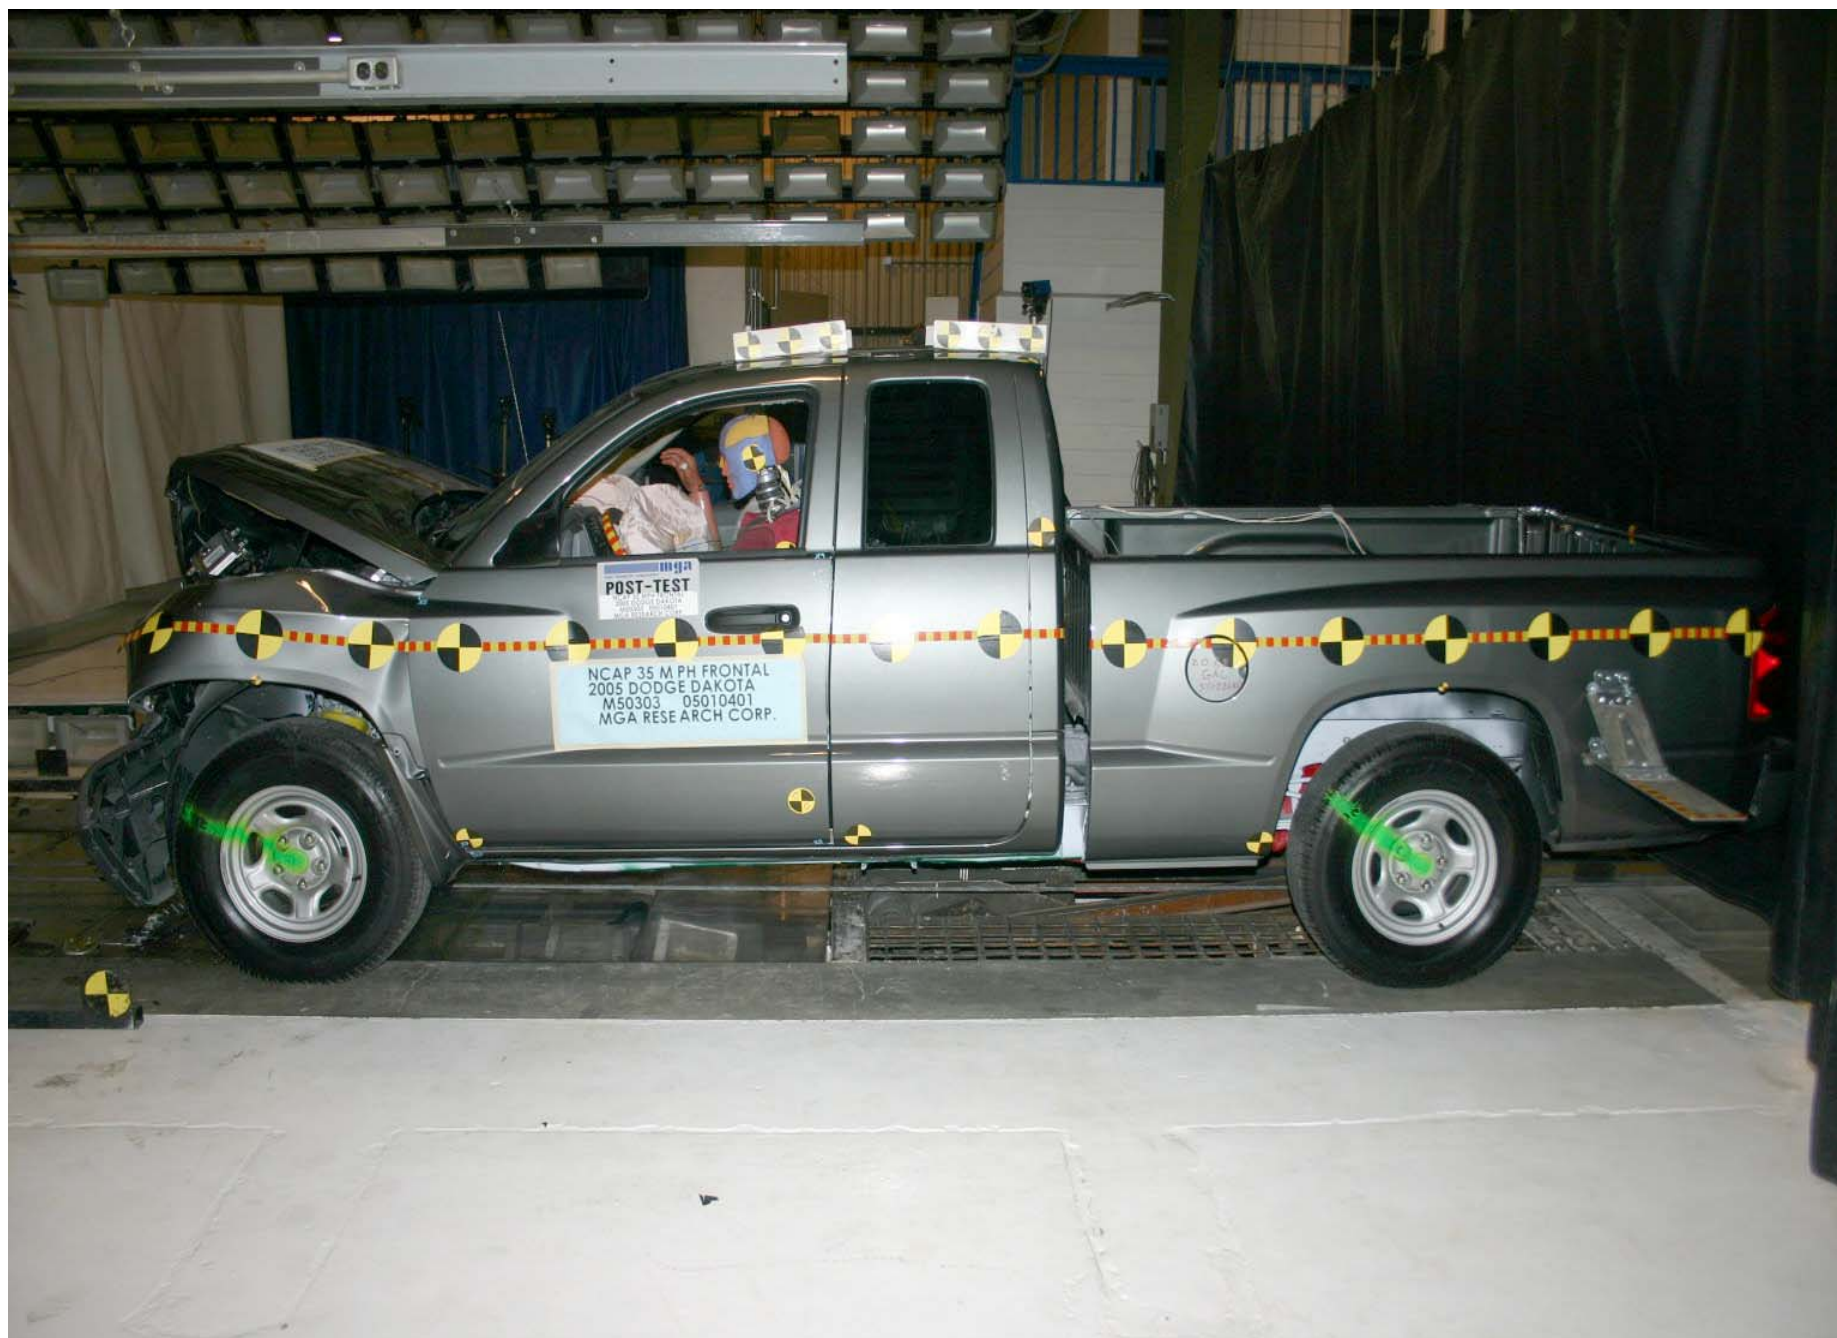
Post-Test Left Side View of Test Vehicle

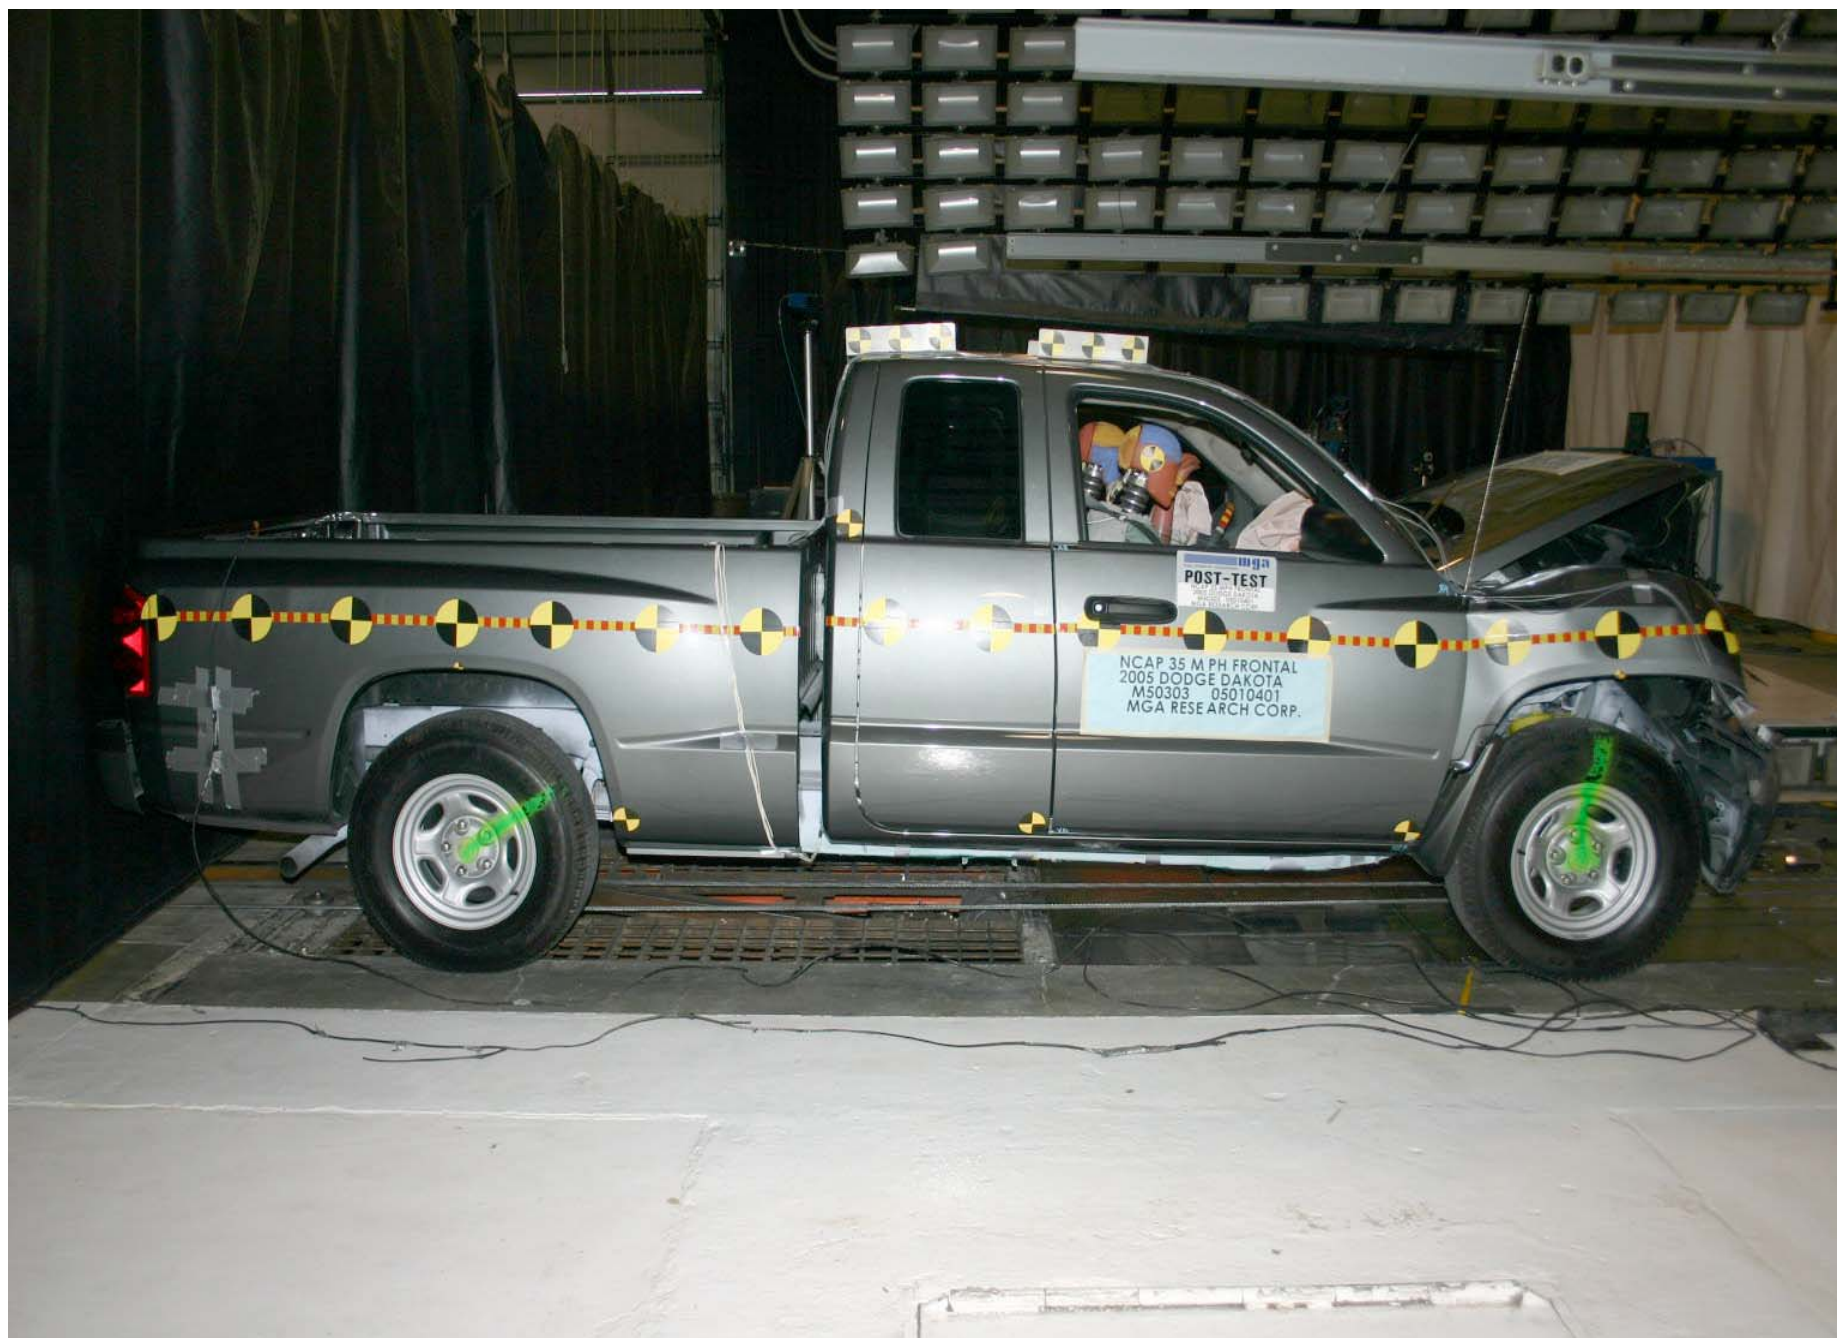
Post-Test Right Side View of Test Vehicle

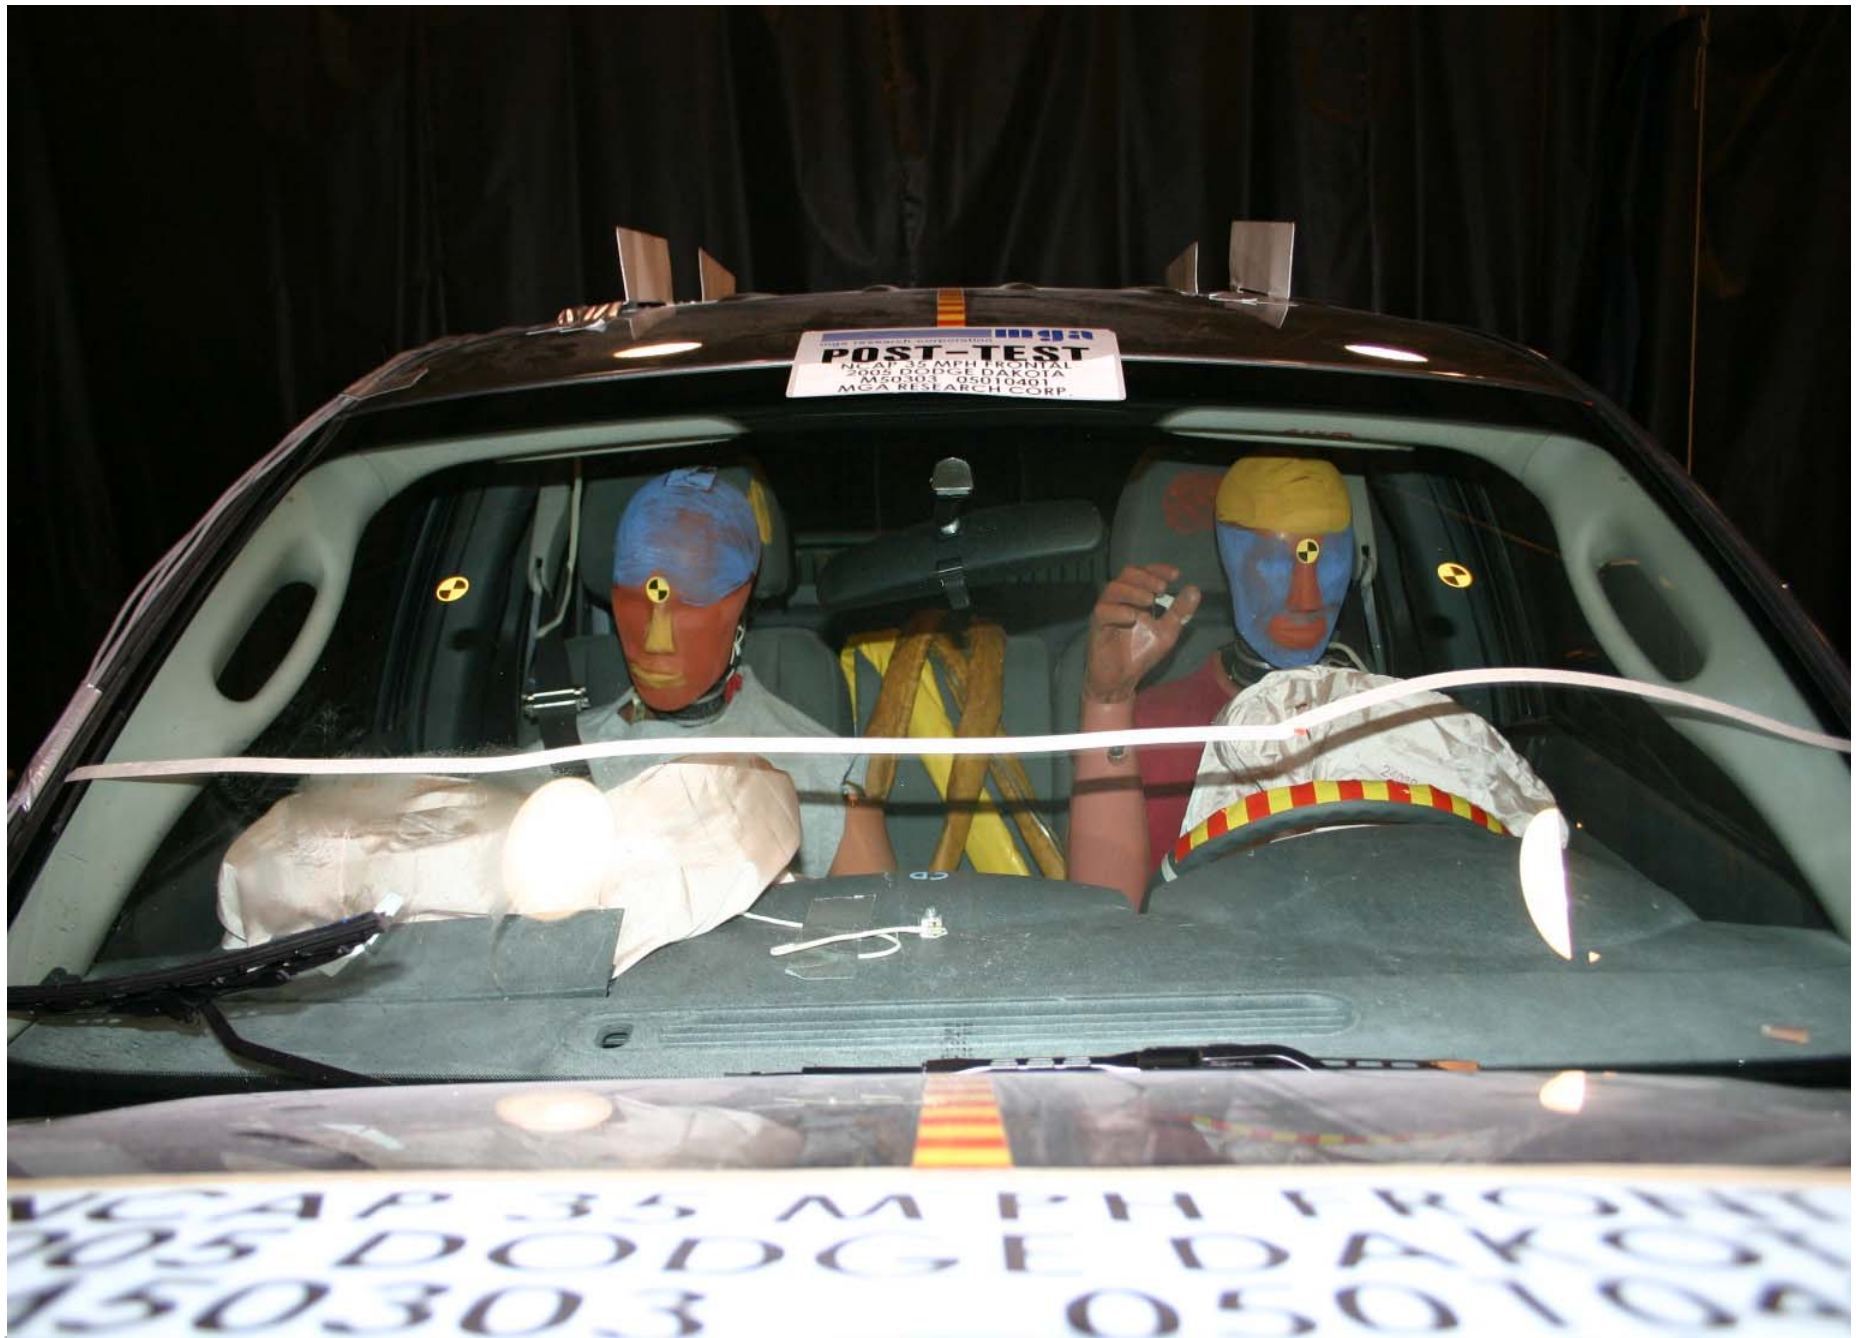
Post-Test Windshield View

There was 100 percent windshield retention and no intrusion into the protected zone of the windshield during the event. There was no Stoddard Solvent leakage after the event or during any phase of the static rollover.

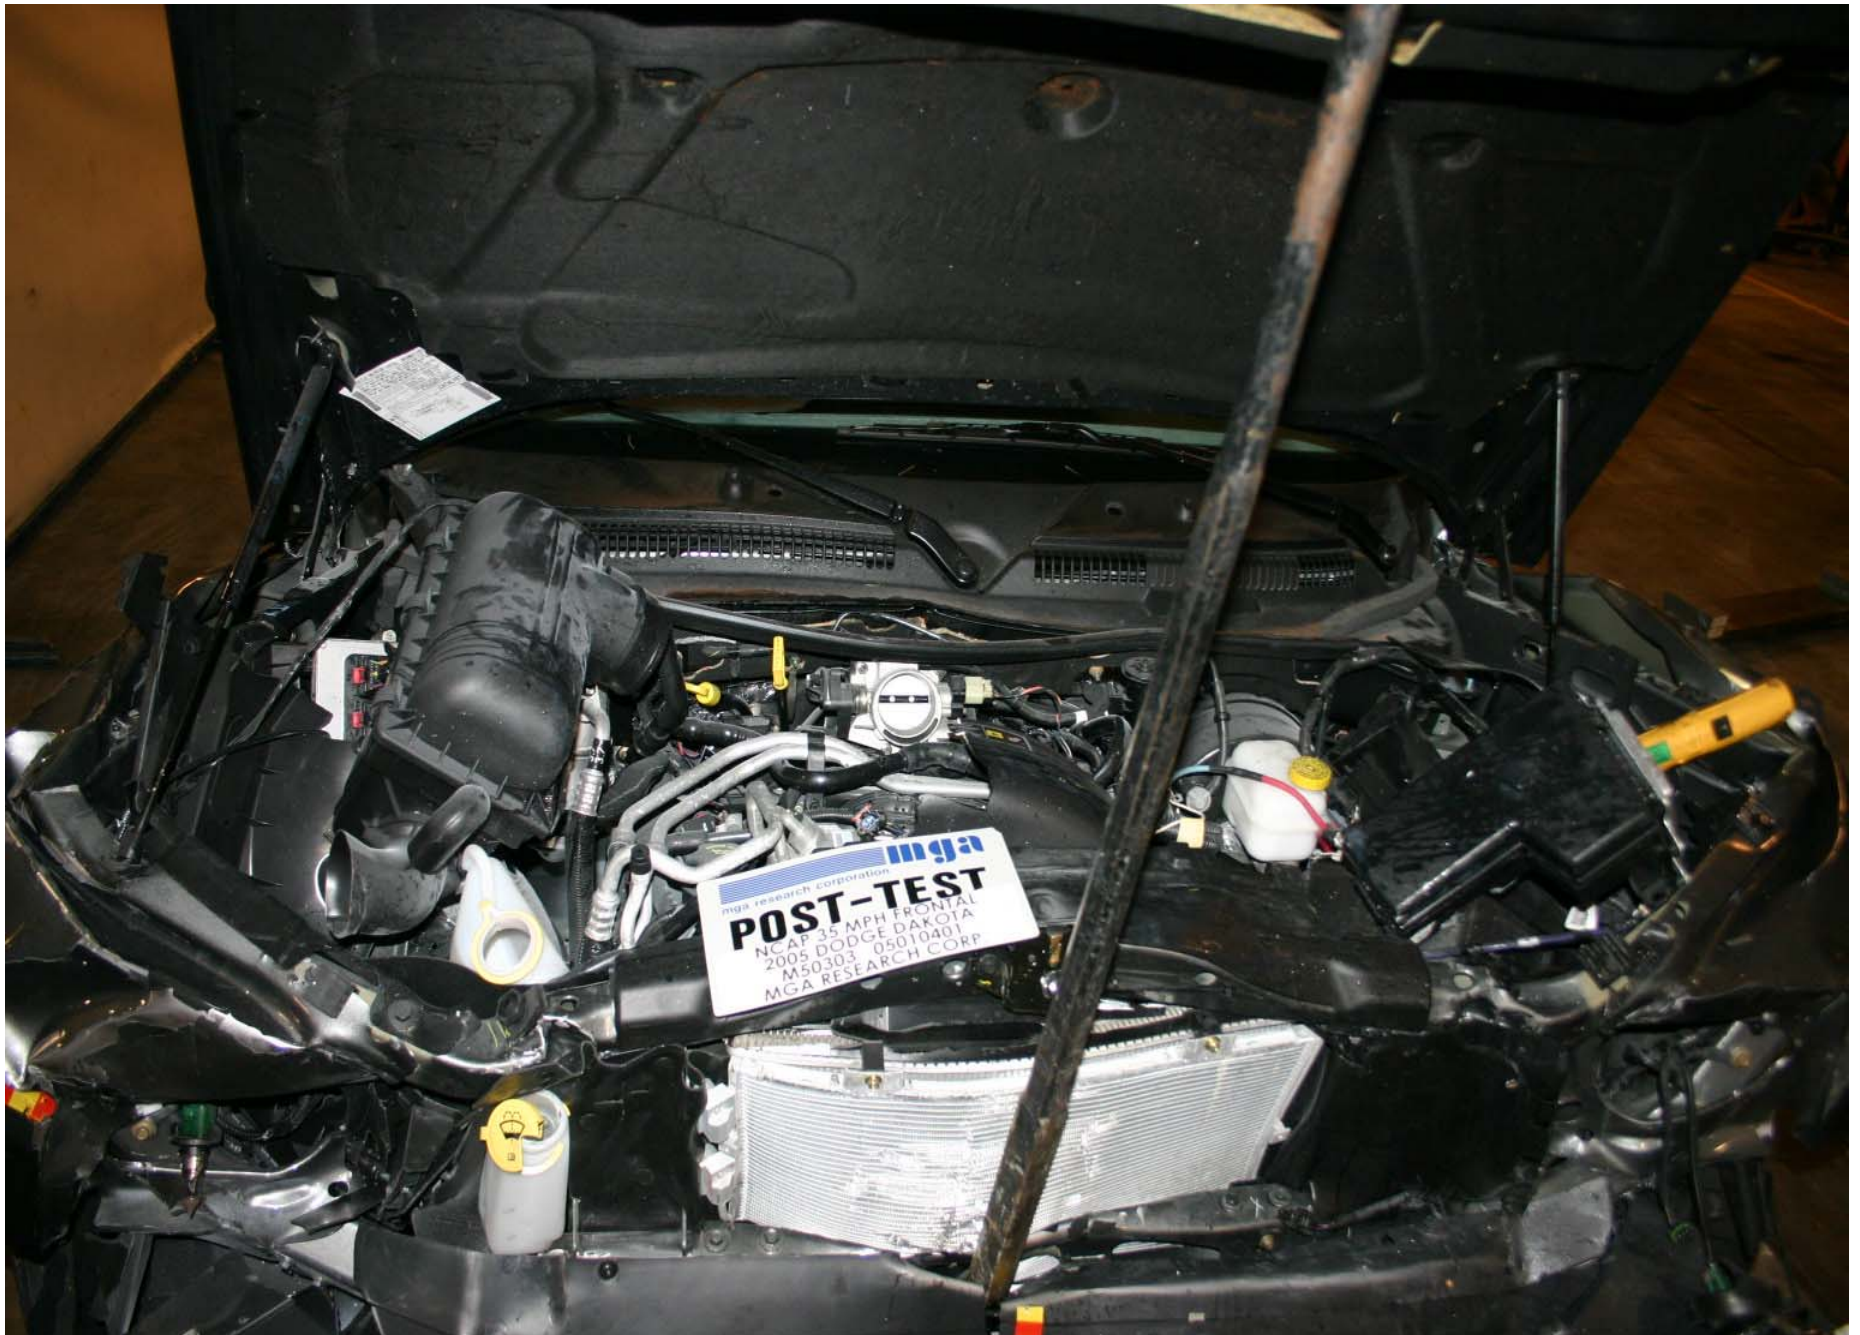
Post-Test Engine Compartment View

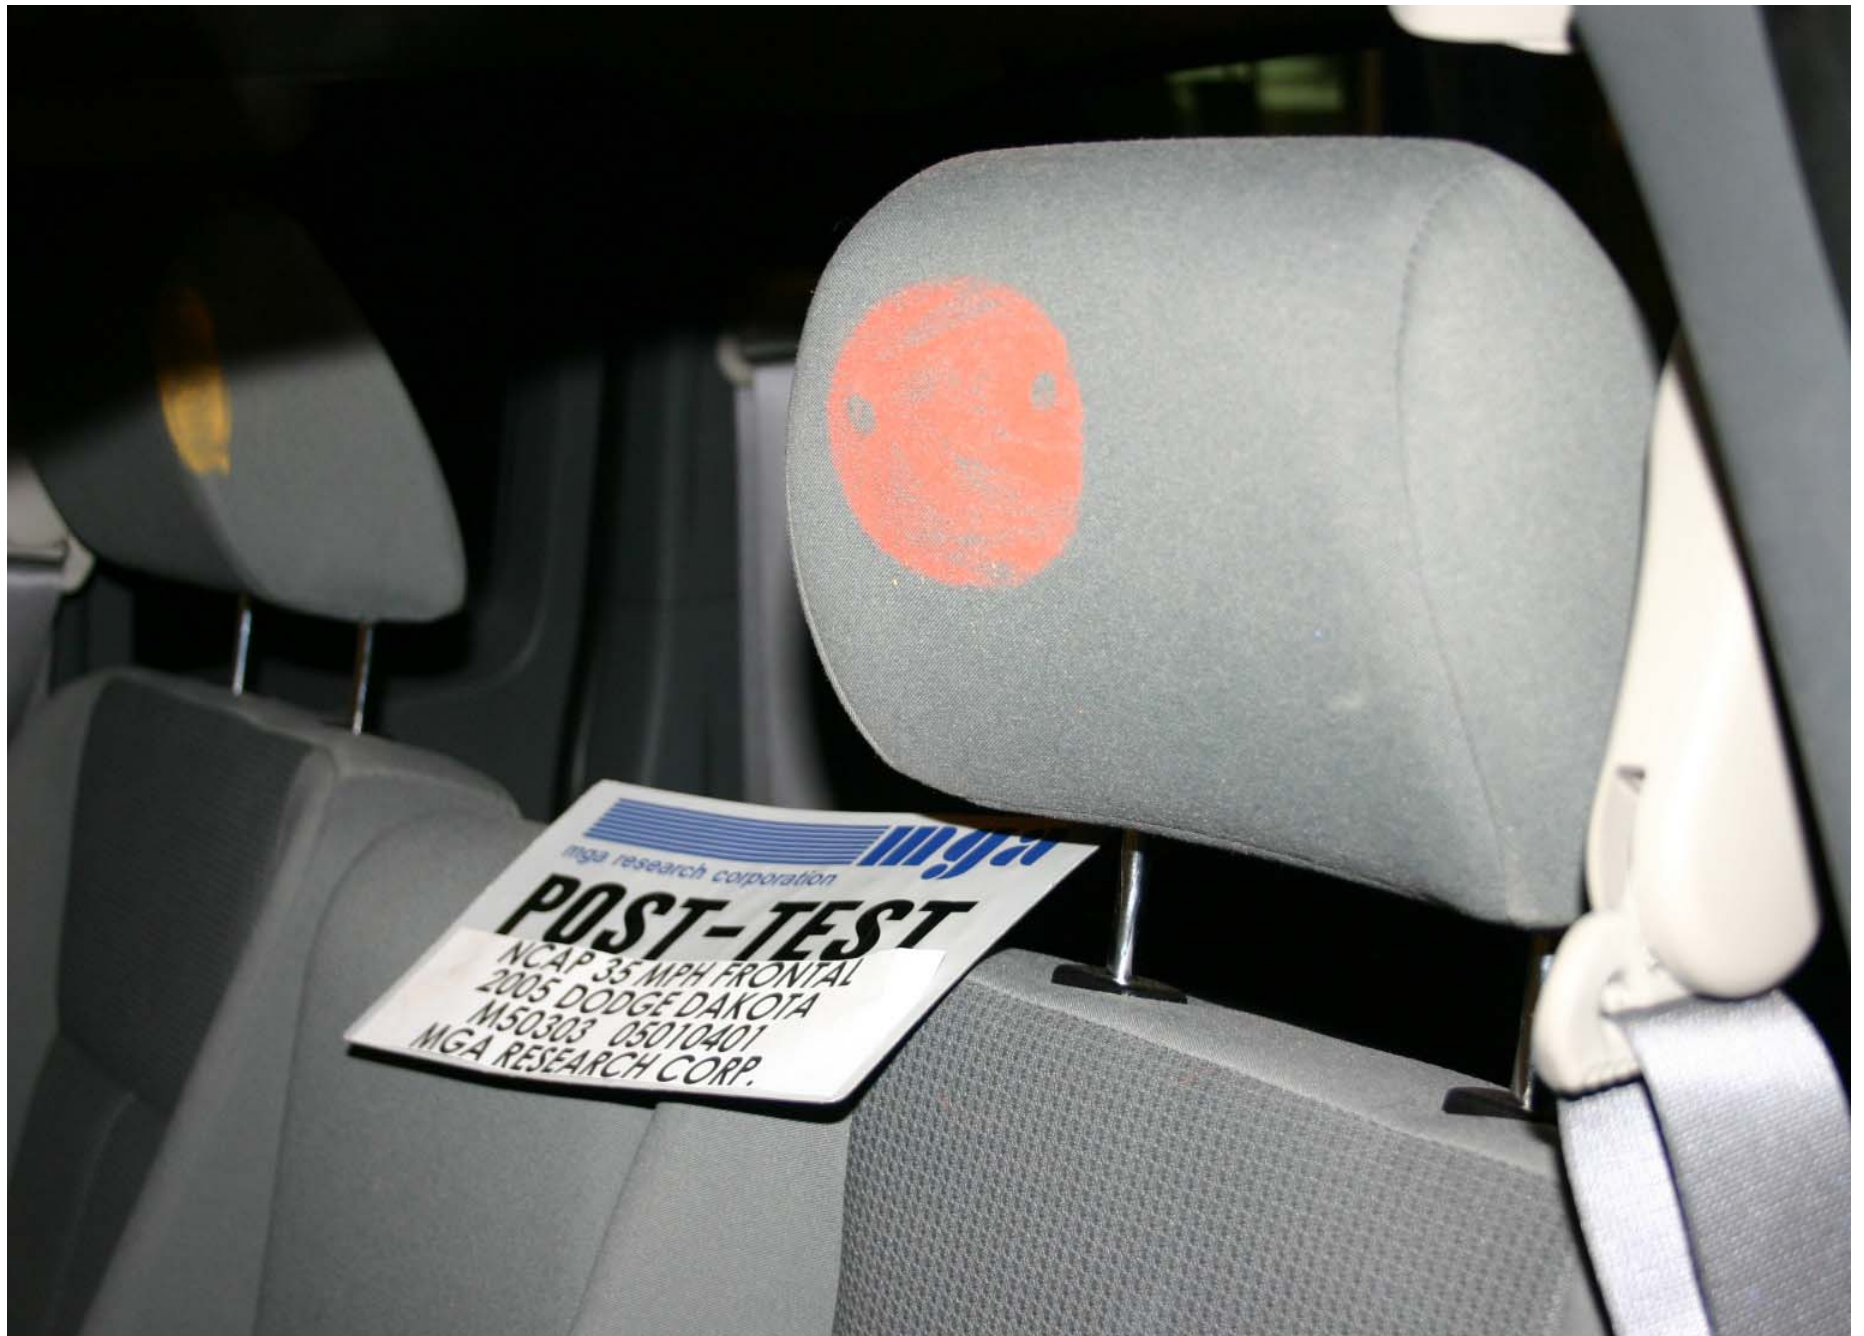
Post-Test Driver Dummy Head Contact

The driver's head, chest, and abdomen contacted the airbag. The driver's head also contacted the headrest. The driver's knees contacted the bolster. The passenger's head, chest and abdomen contacted the airbag. The passenger's head contacted the headrest. The passenger's knees contacted the glove box.

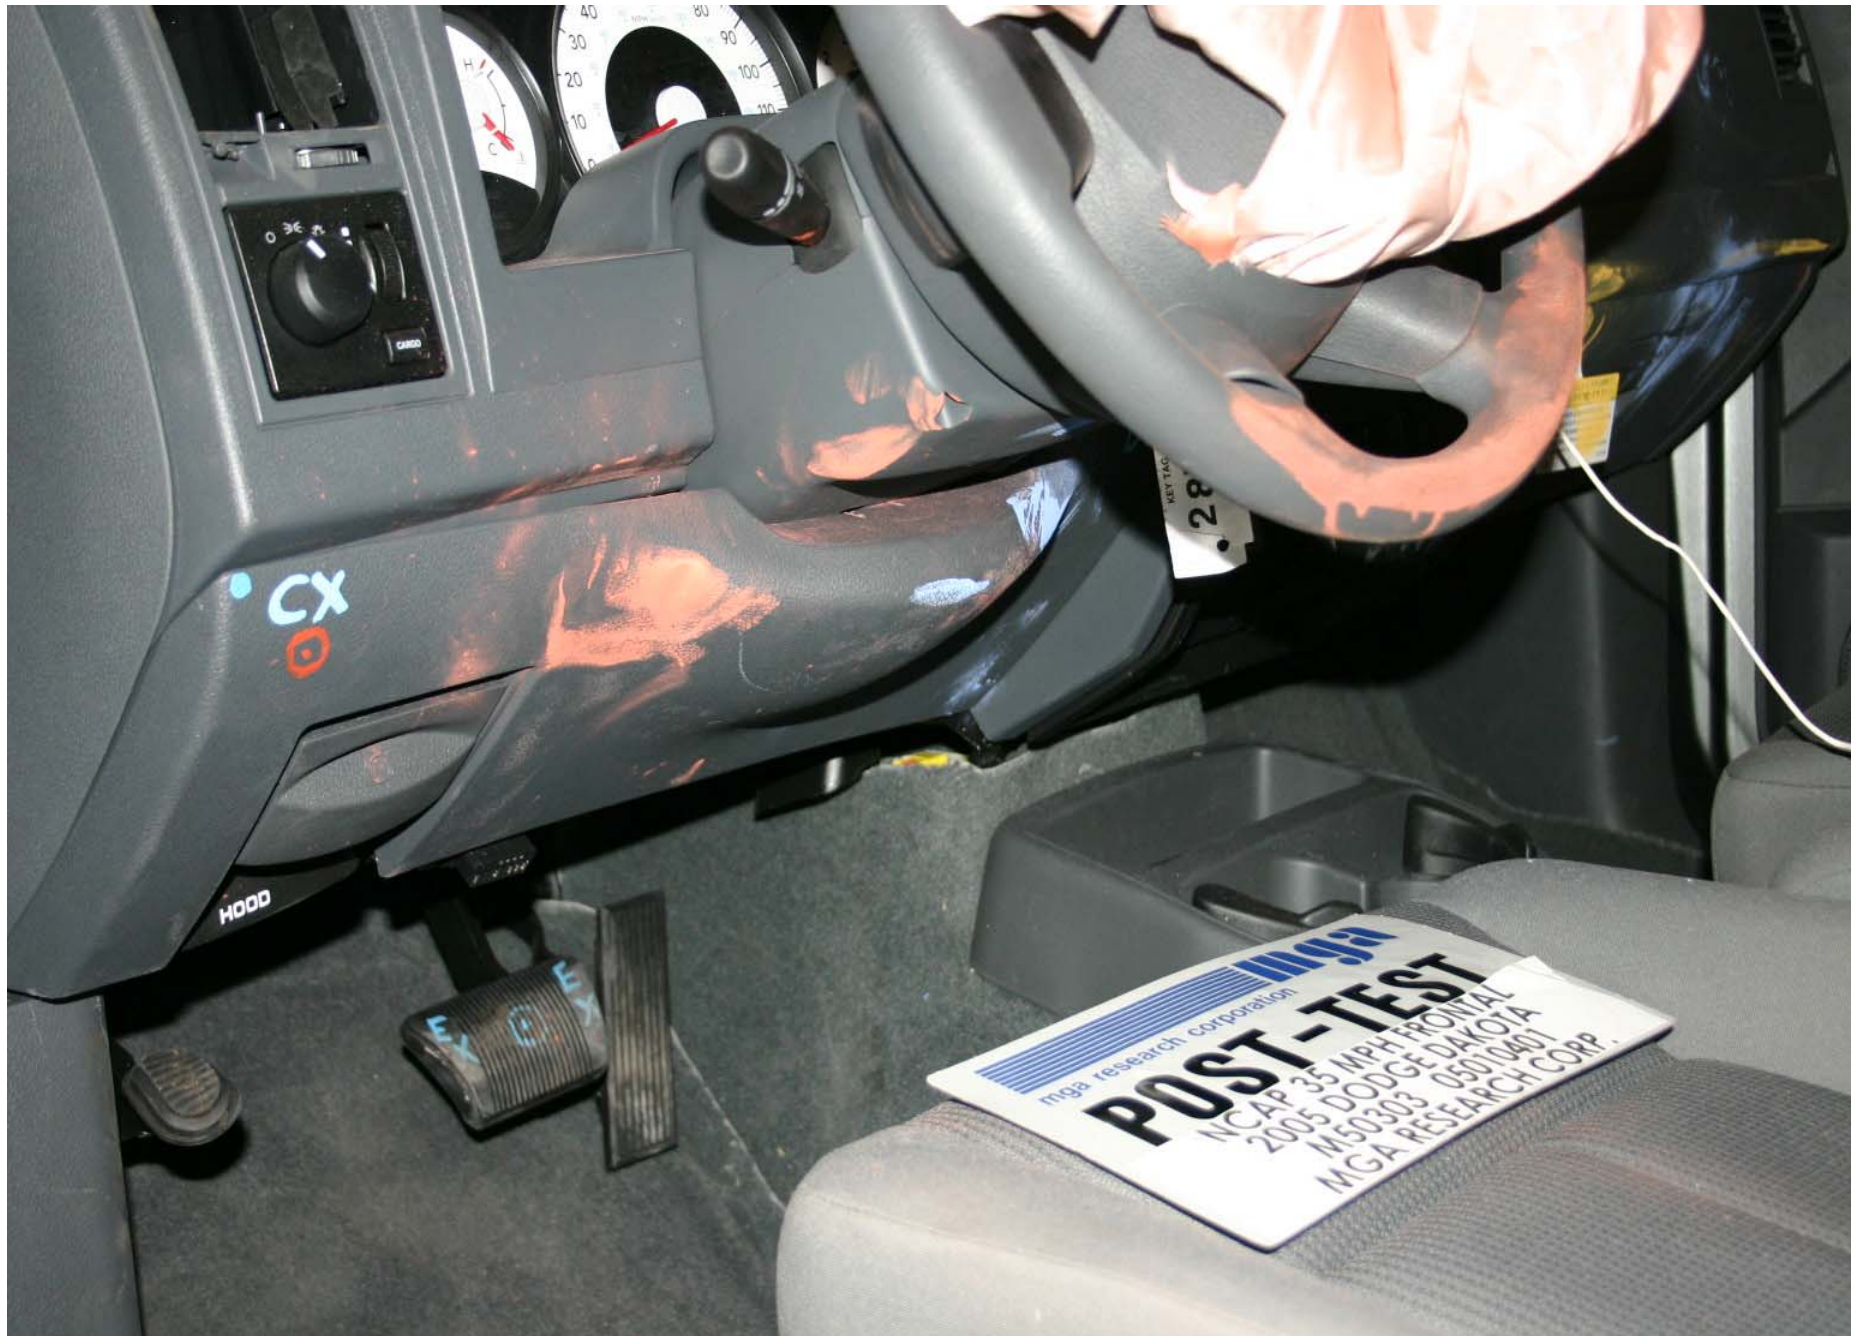
Post-Test Driver Dummy Knee Contact

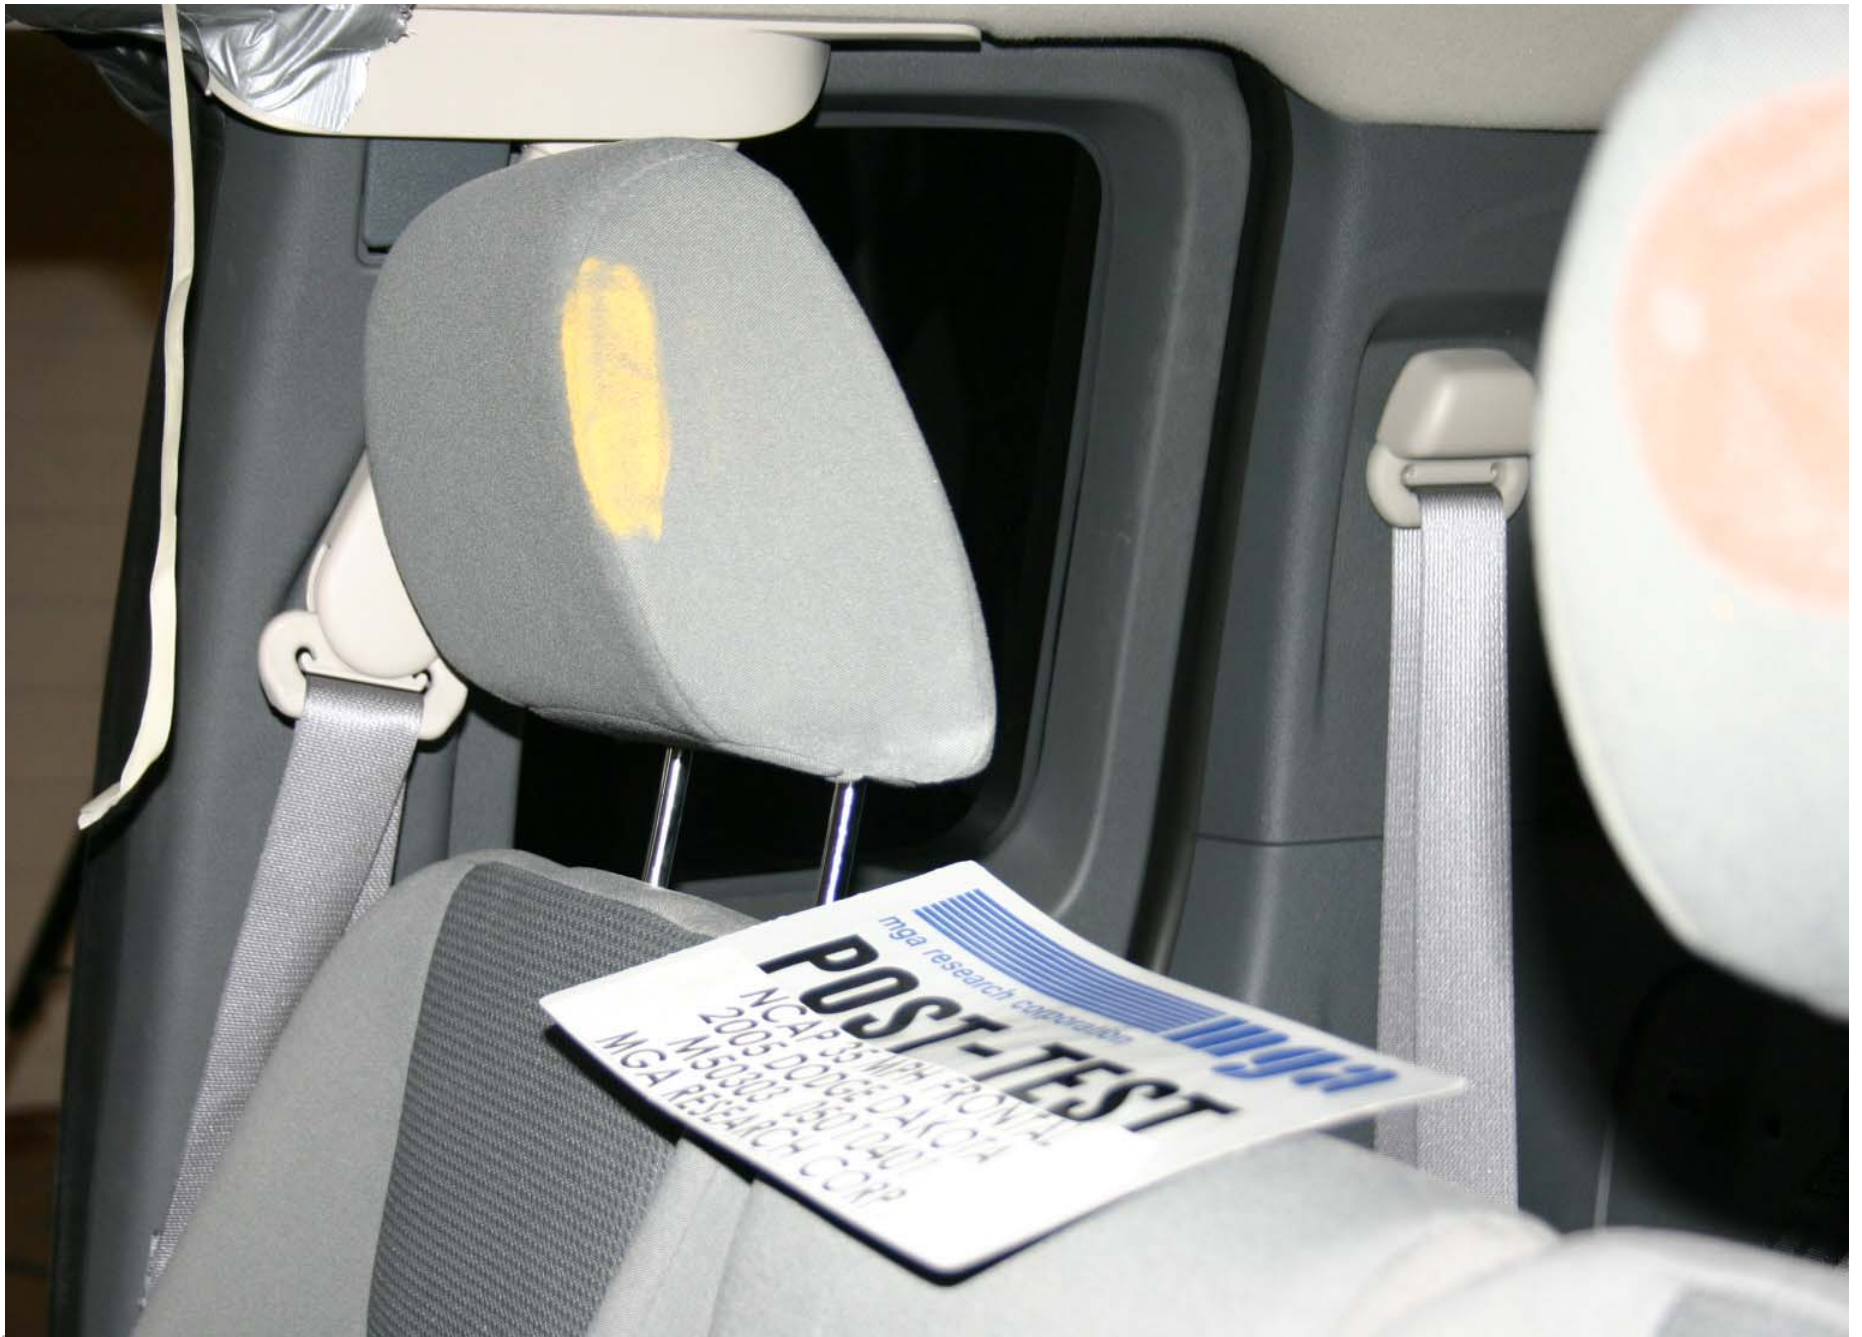
Post-Test Passenger Dummy Head Contact

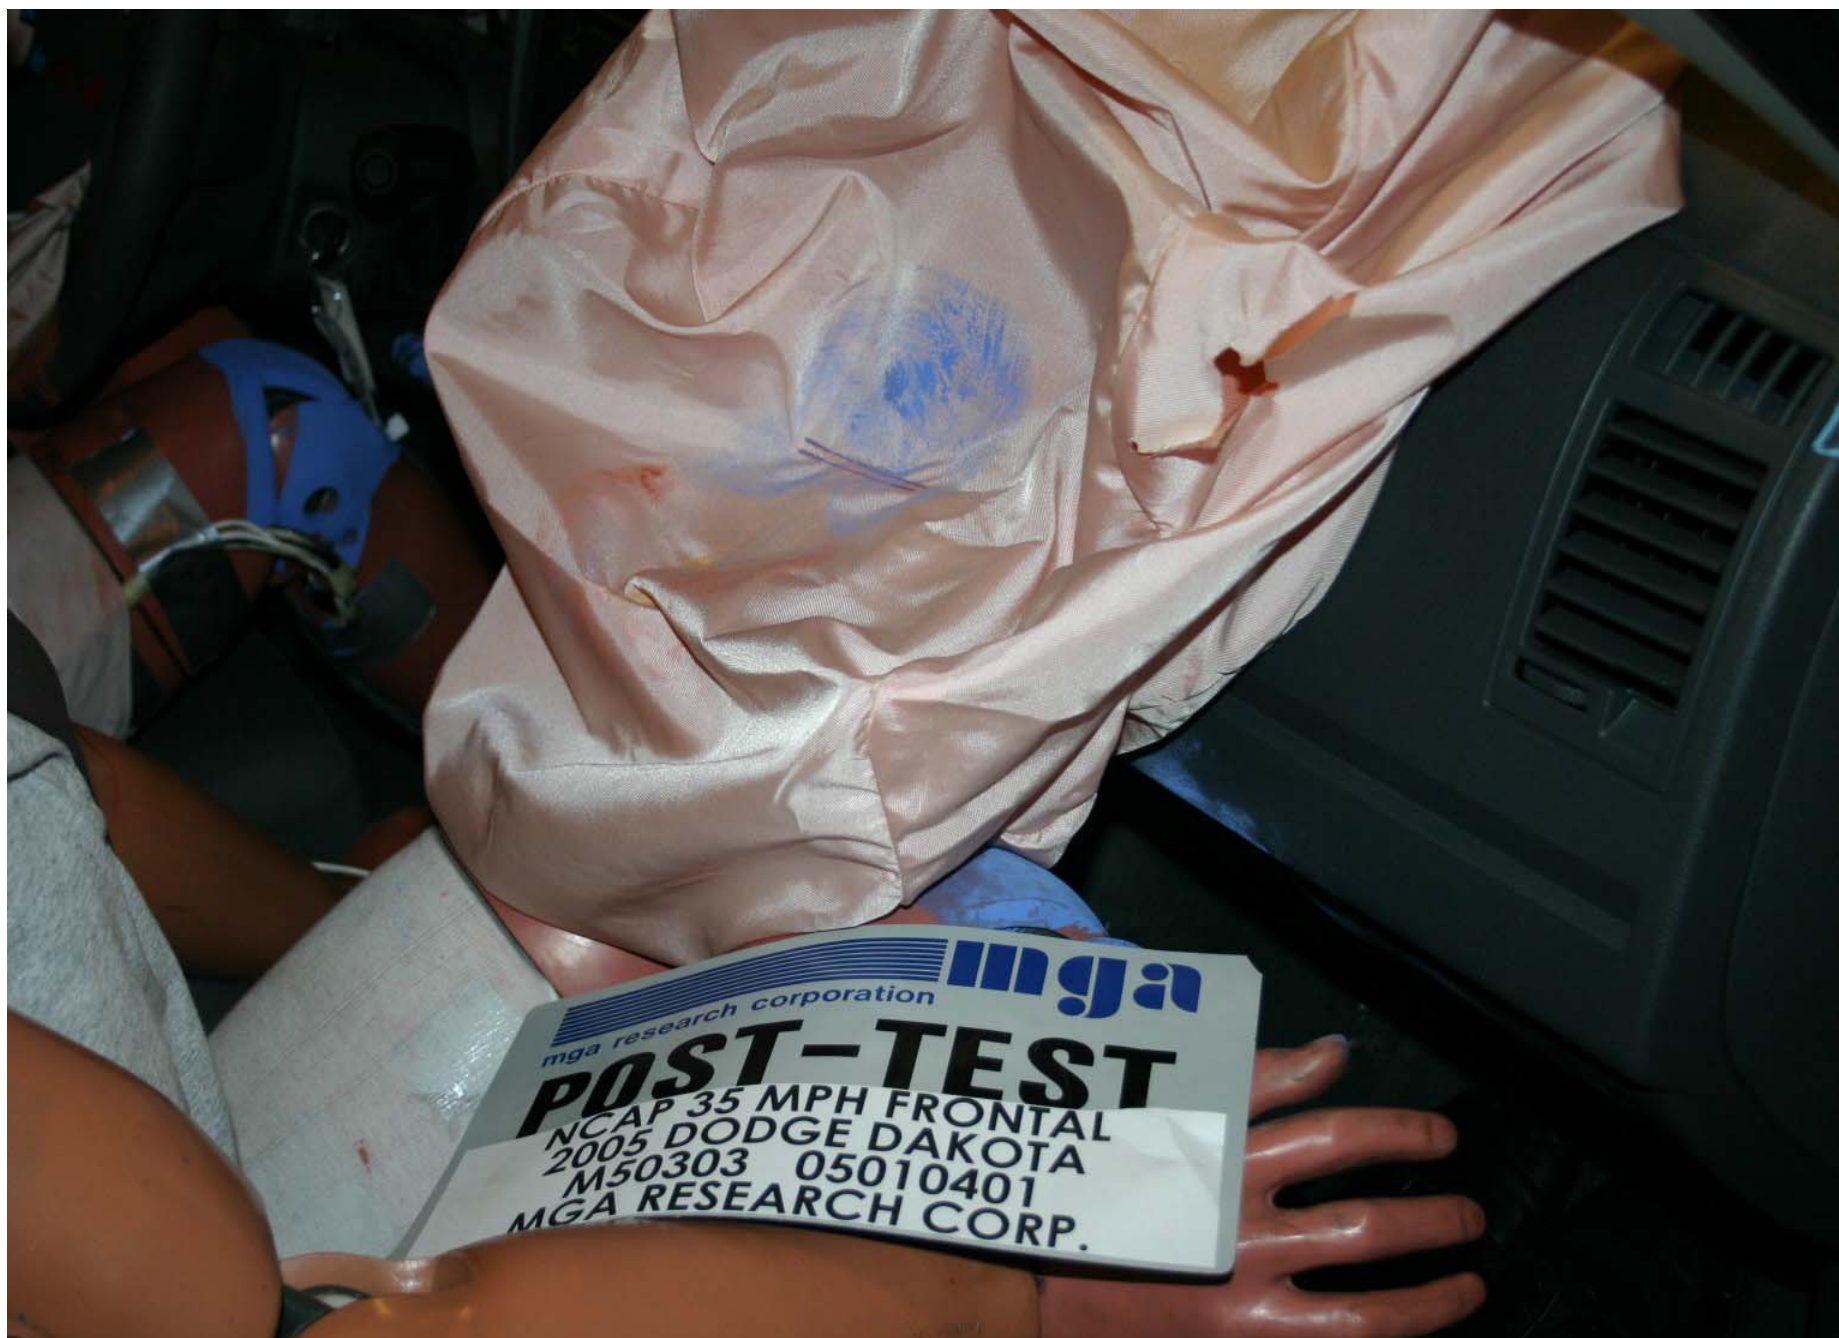
Post-Test Passenger Dummy Airbag Contact
