**REPORT NUMBER: NCAP-MGA-2005-008**

**NEW CAR ASSESSMENT PROGRAM  
FRONTAL BARRIER IMPACT TEST**

**DAIMLERCHRYSLER CORPORATION  
2005 DODGE DAKOTA CLUB CAB ST  
NHTSA NUMBER: M50303**

**PREPARED BY:  
MGA RESEARCH CORPORATION  
5000 WARREN ROAD  
BURLINGTON, WI 53105**

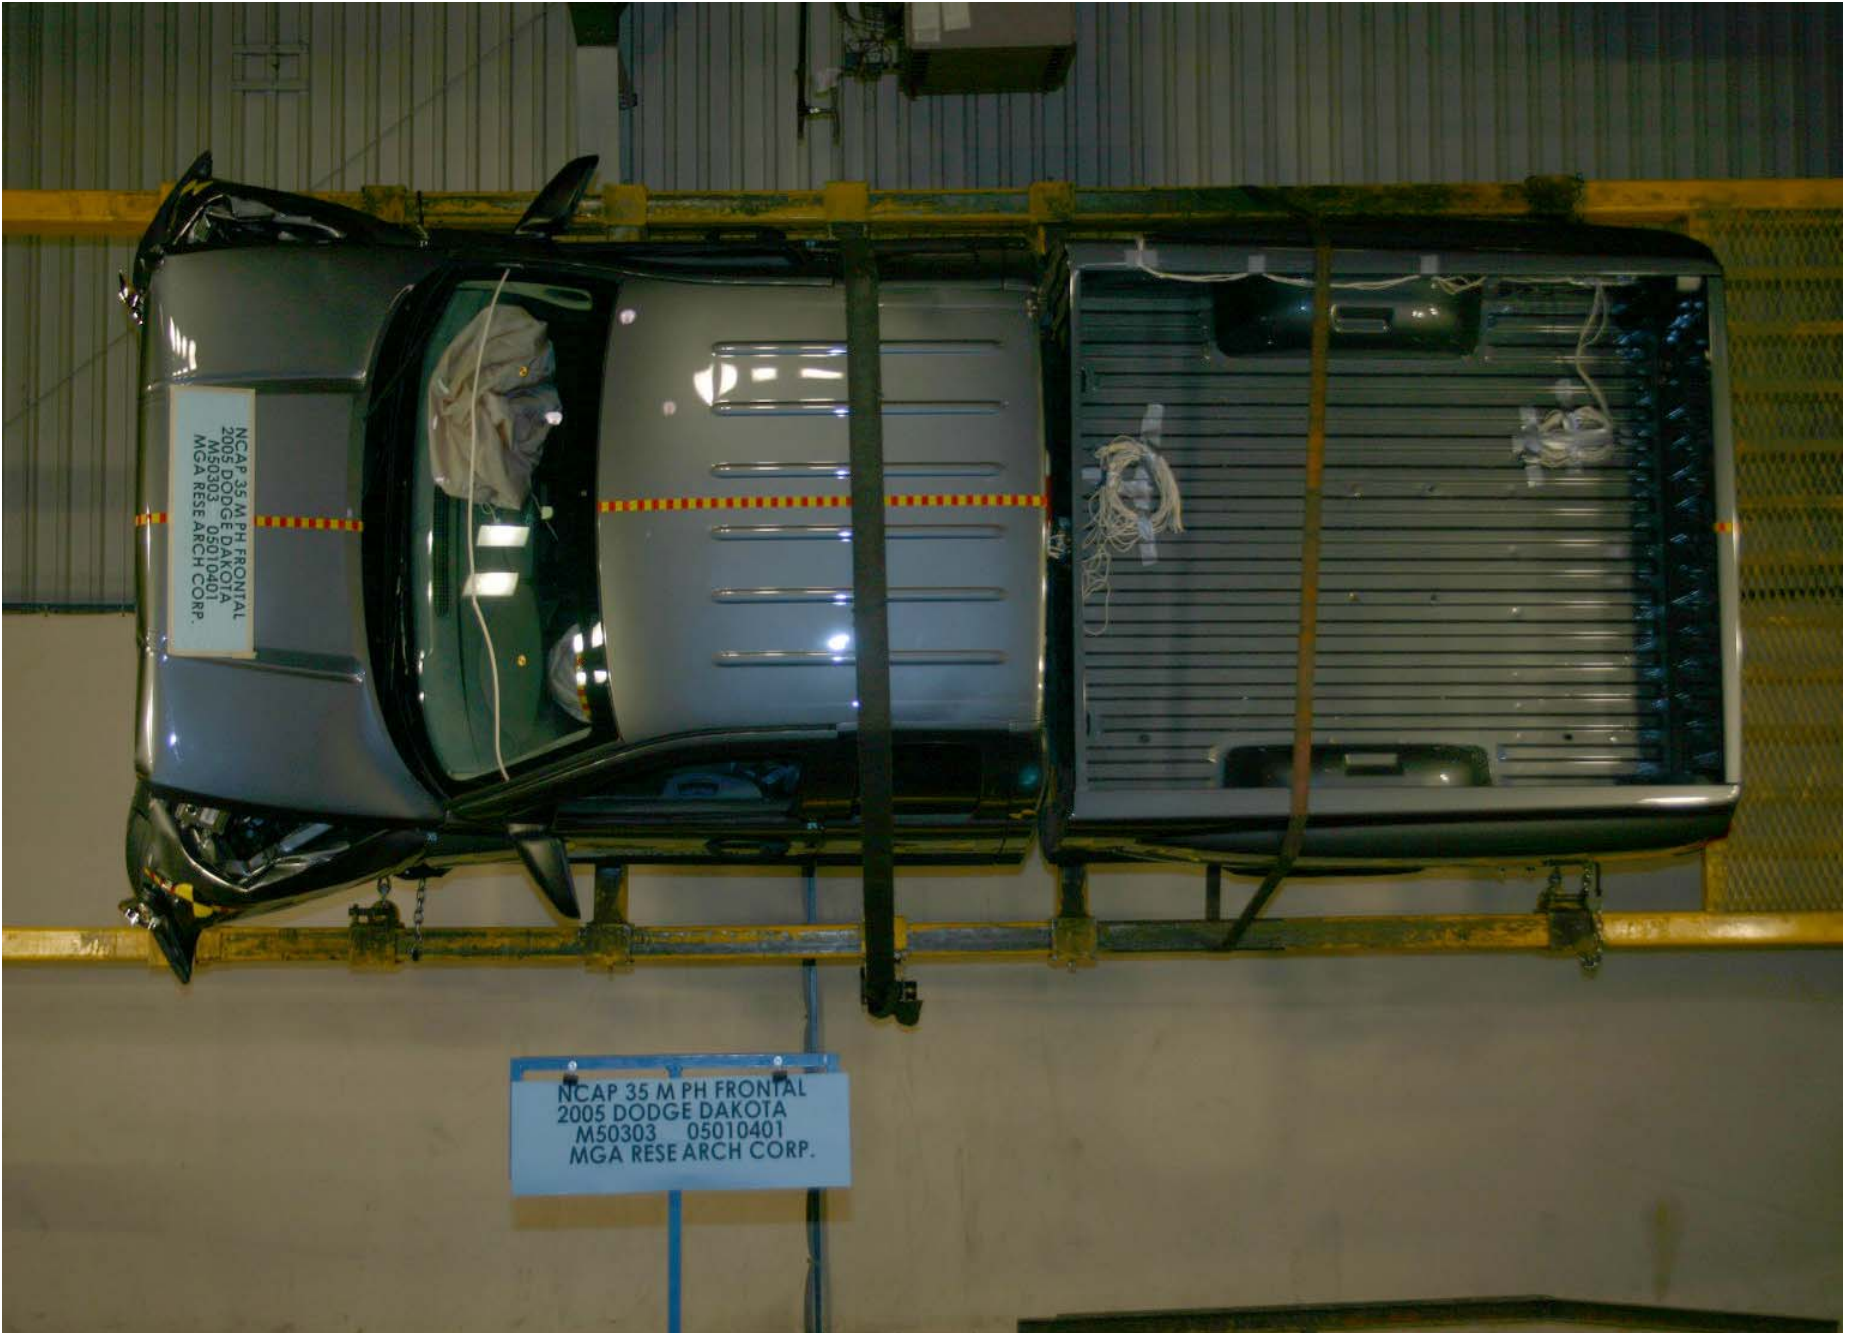
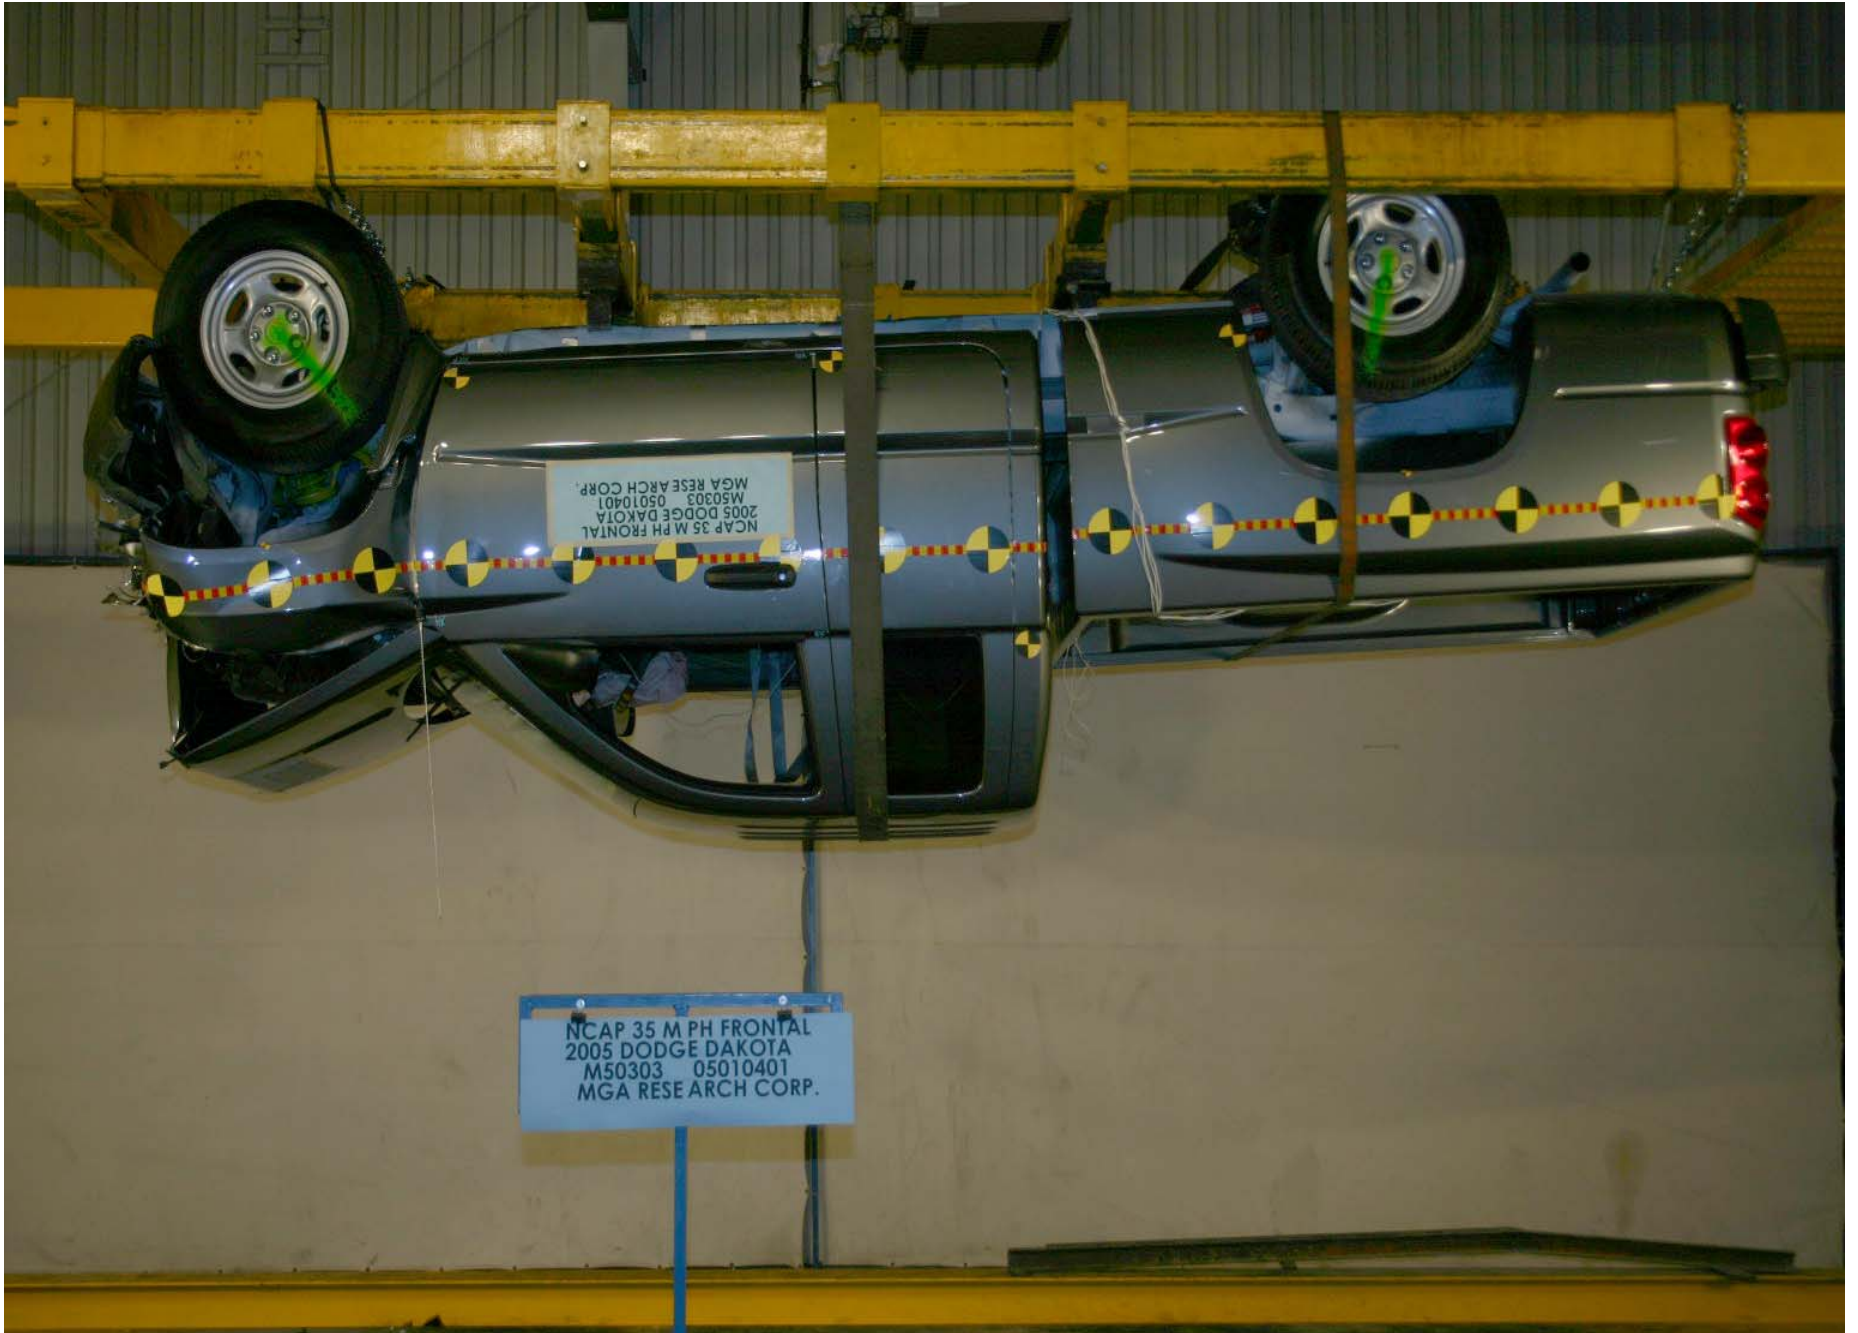
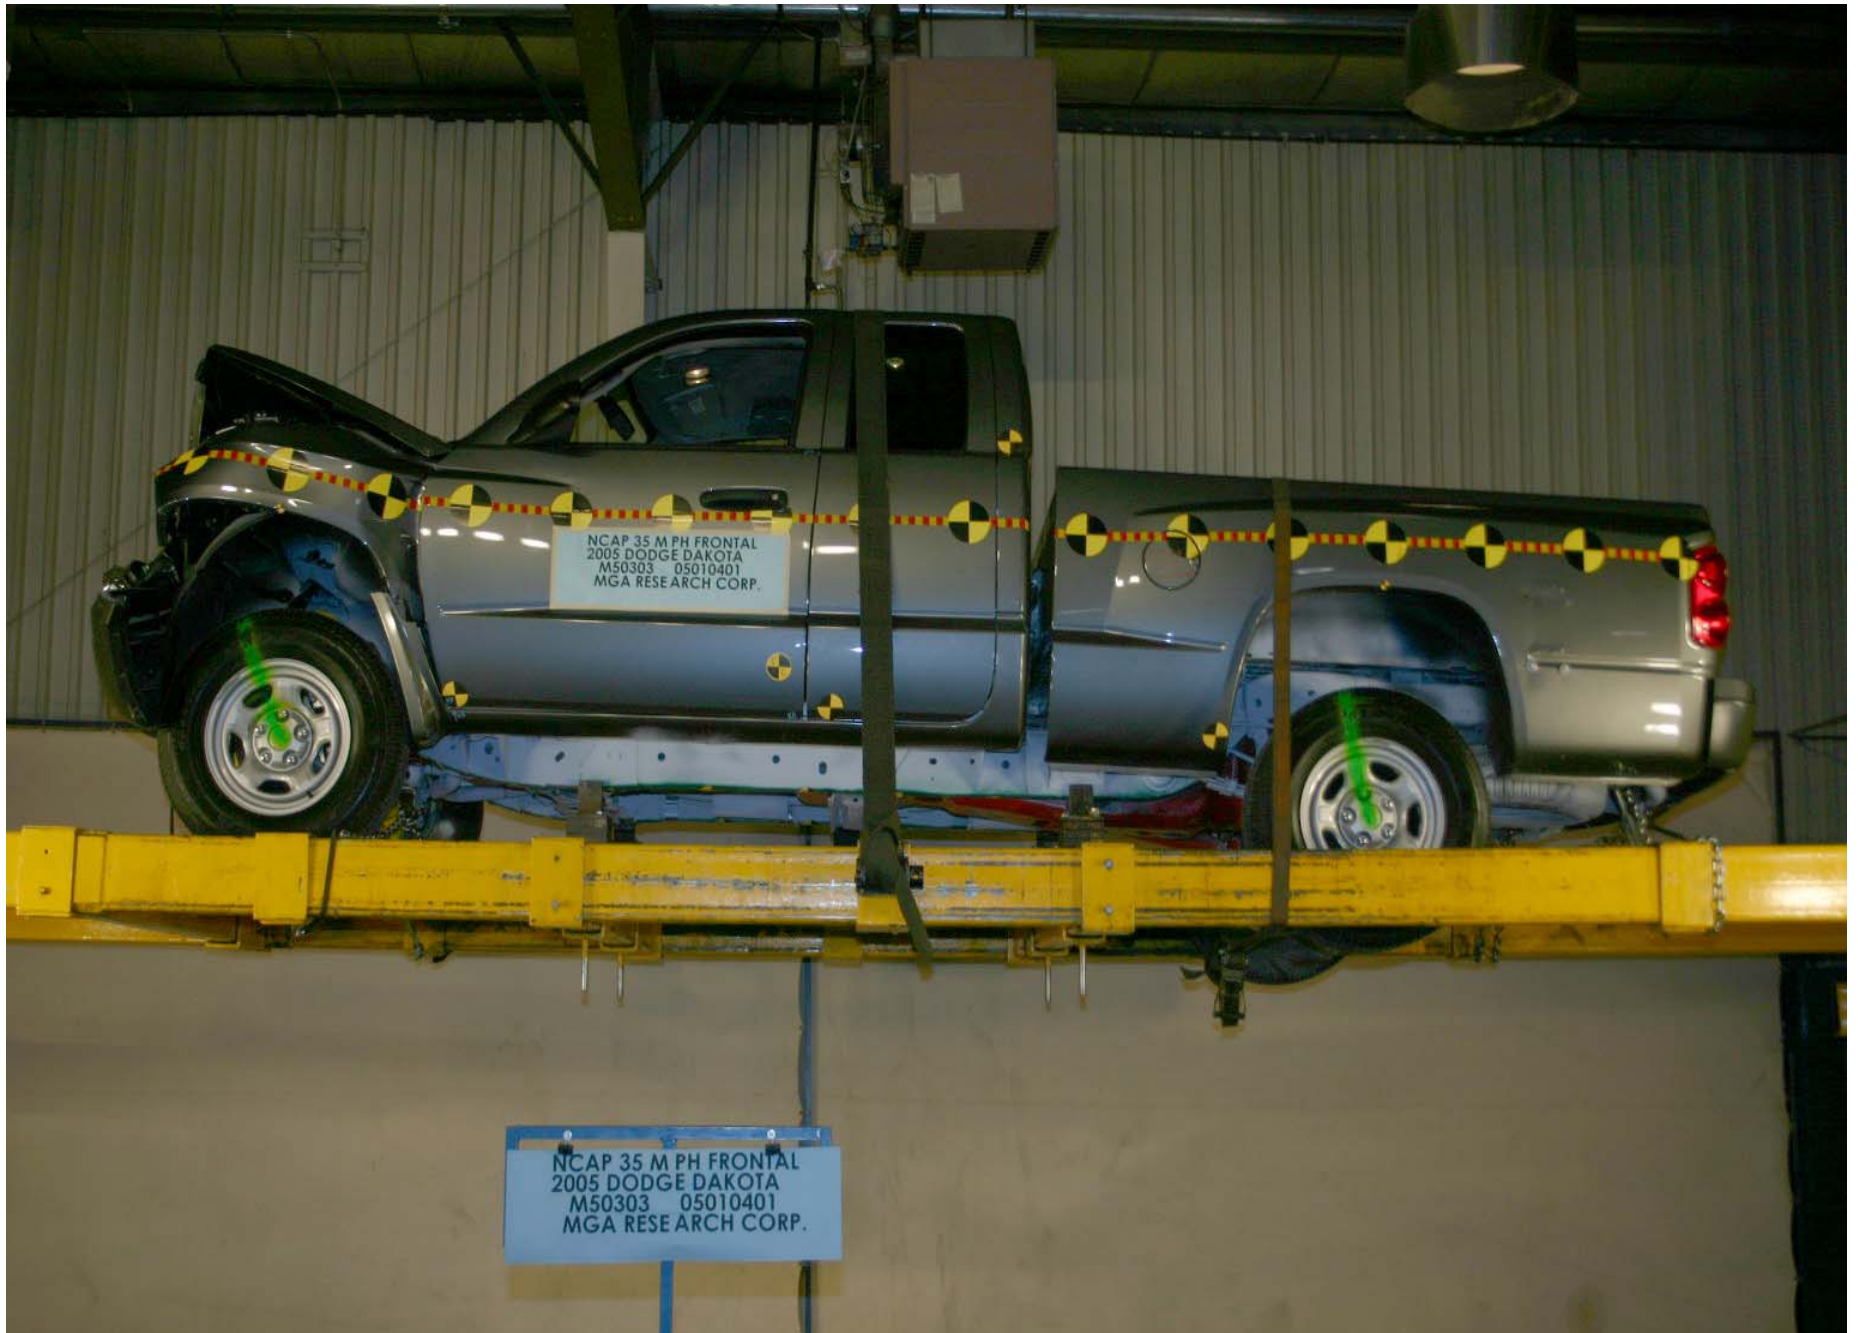
Rollover 90 Degrees

Rollover 180 Degrees

Rollover 270 Degrees

Rollover 360 Degrees

There was 100 percent windshield retention and no intrusion into the protected zone of the windshield during the event. There was no Stoddard Solvent leakage after the event or during any phase of the static rollover.
