**REPORT NUMBER: NCAPSIDE-MGA-2005-004**

**NEW CAR ASSESSMENT PROGRAM  
SIDE IMPACT TEST**

**DAIMLER CHRYSLER CORPORATION  
2005 DODGE DAKOTA CLUB CAB SLT  
NHTSA NUMBER: M50304**

**PREPARED BY:  
MGA RESEARCH CORPORATION  
5000 WARREN ROAD  
BURLINGTON, WI 53105**

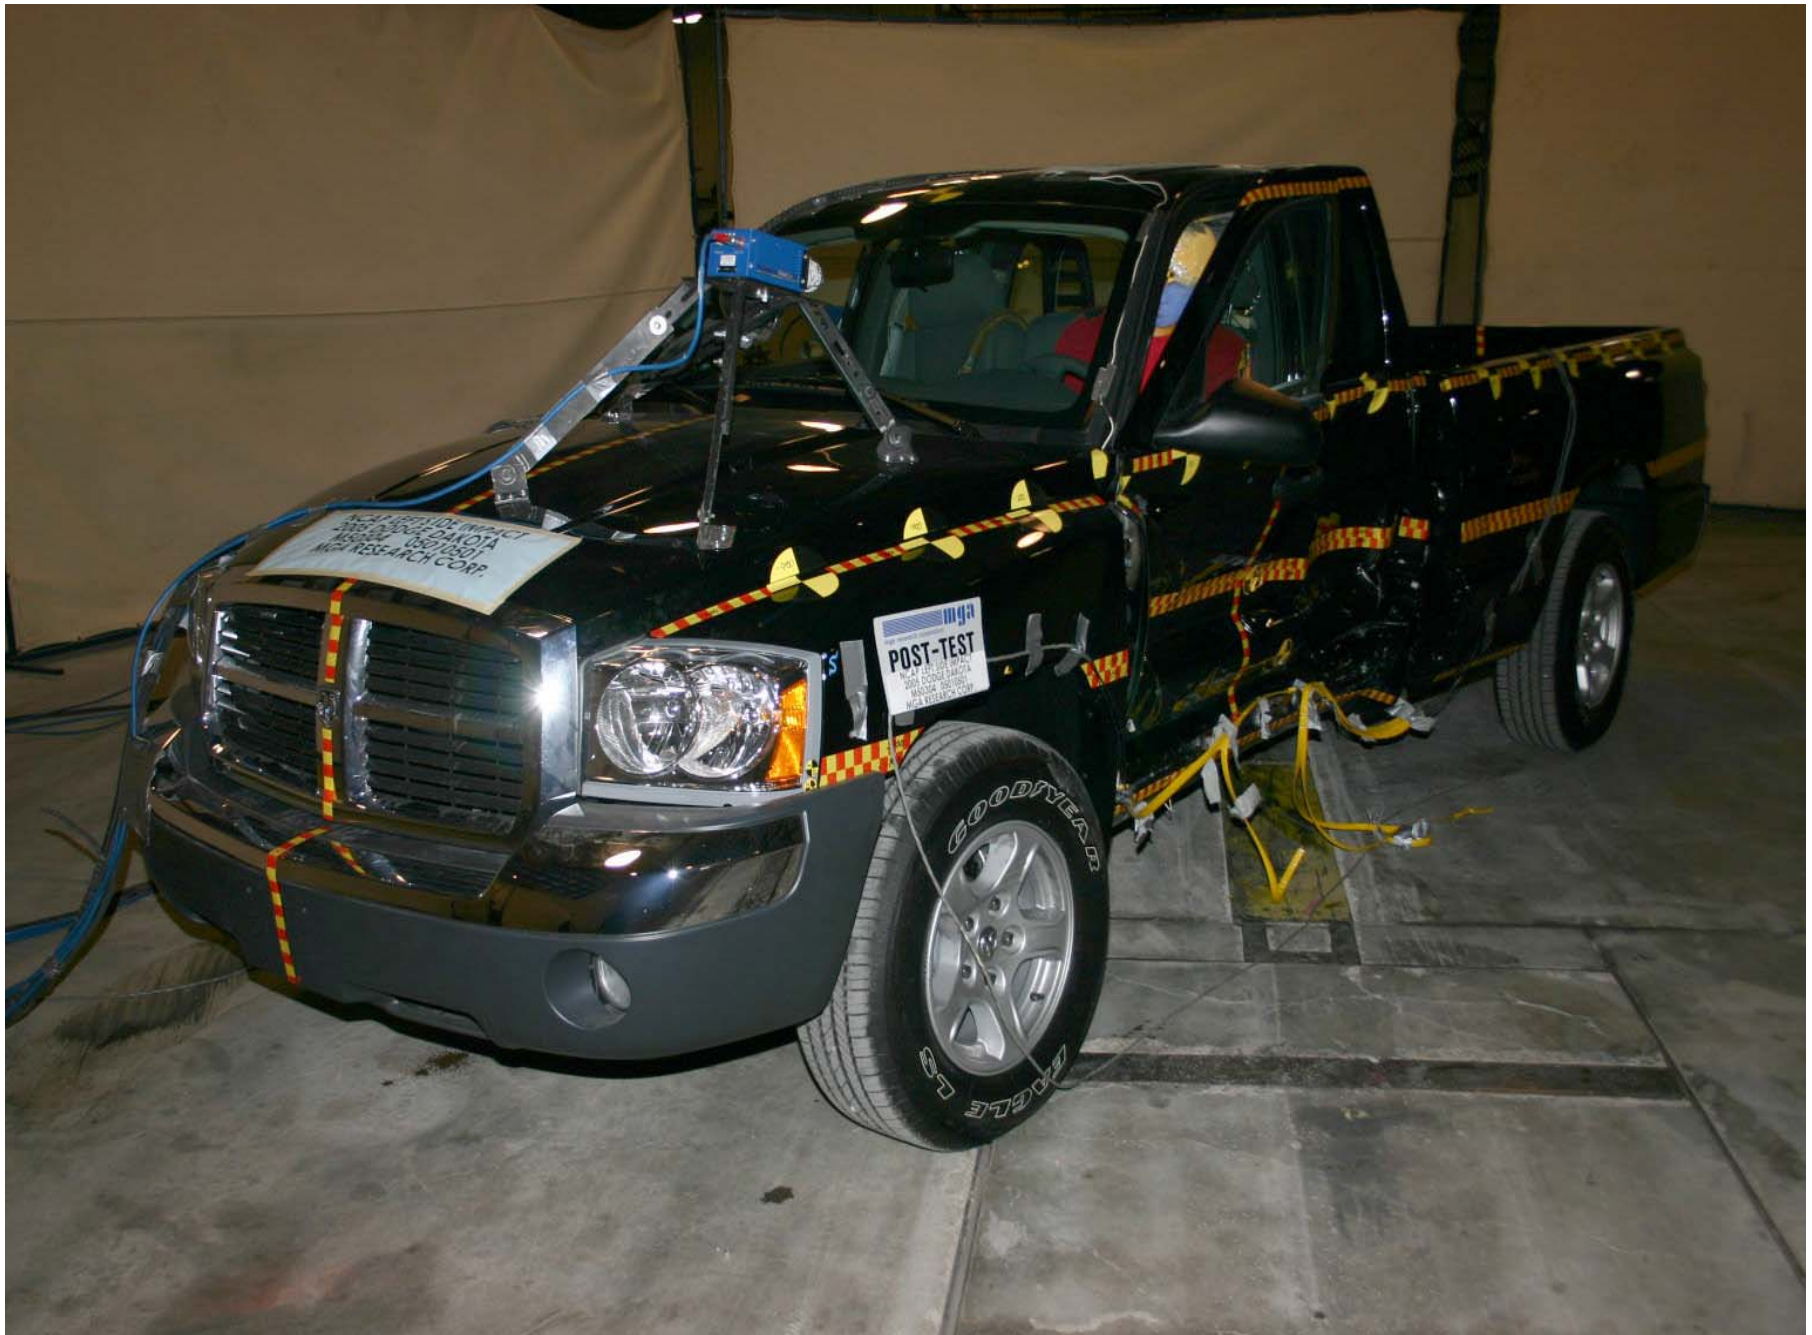
Post-Test Left Front  $\frac{3}{4}$  View of Test Vehicle

The test vehicle sustained a maximum static crush of 328 mm at level 2, 1350 mm rearward of the left vertical impact point. The driver SID/HIII, Serial No. 904 was calibrated just prior to this test. The SID/HIII's injury criteria are summarized as follows:

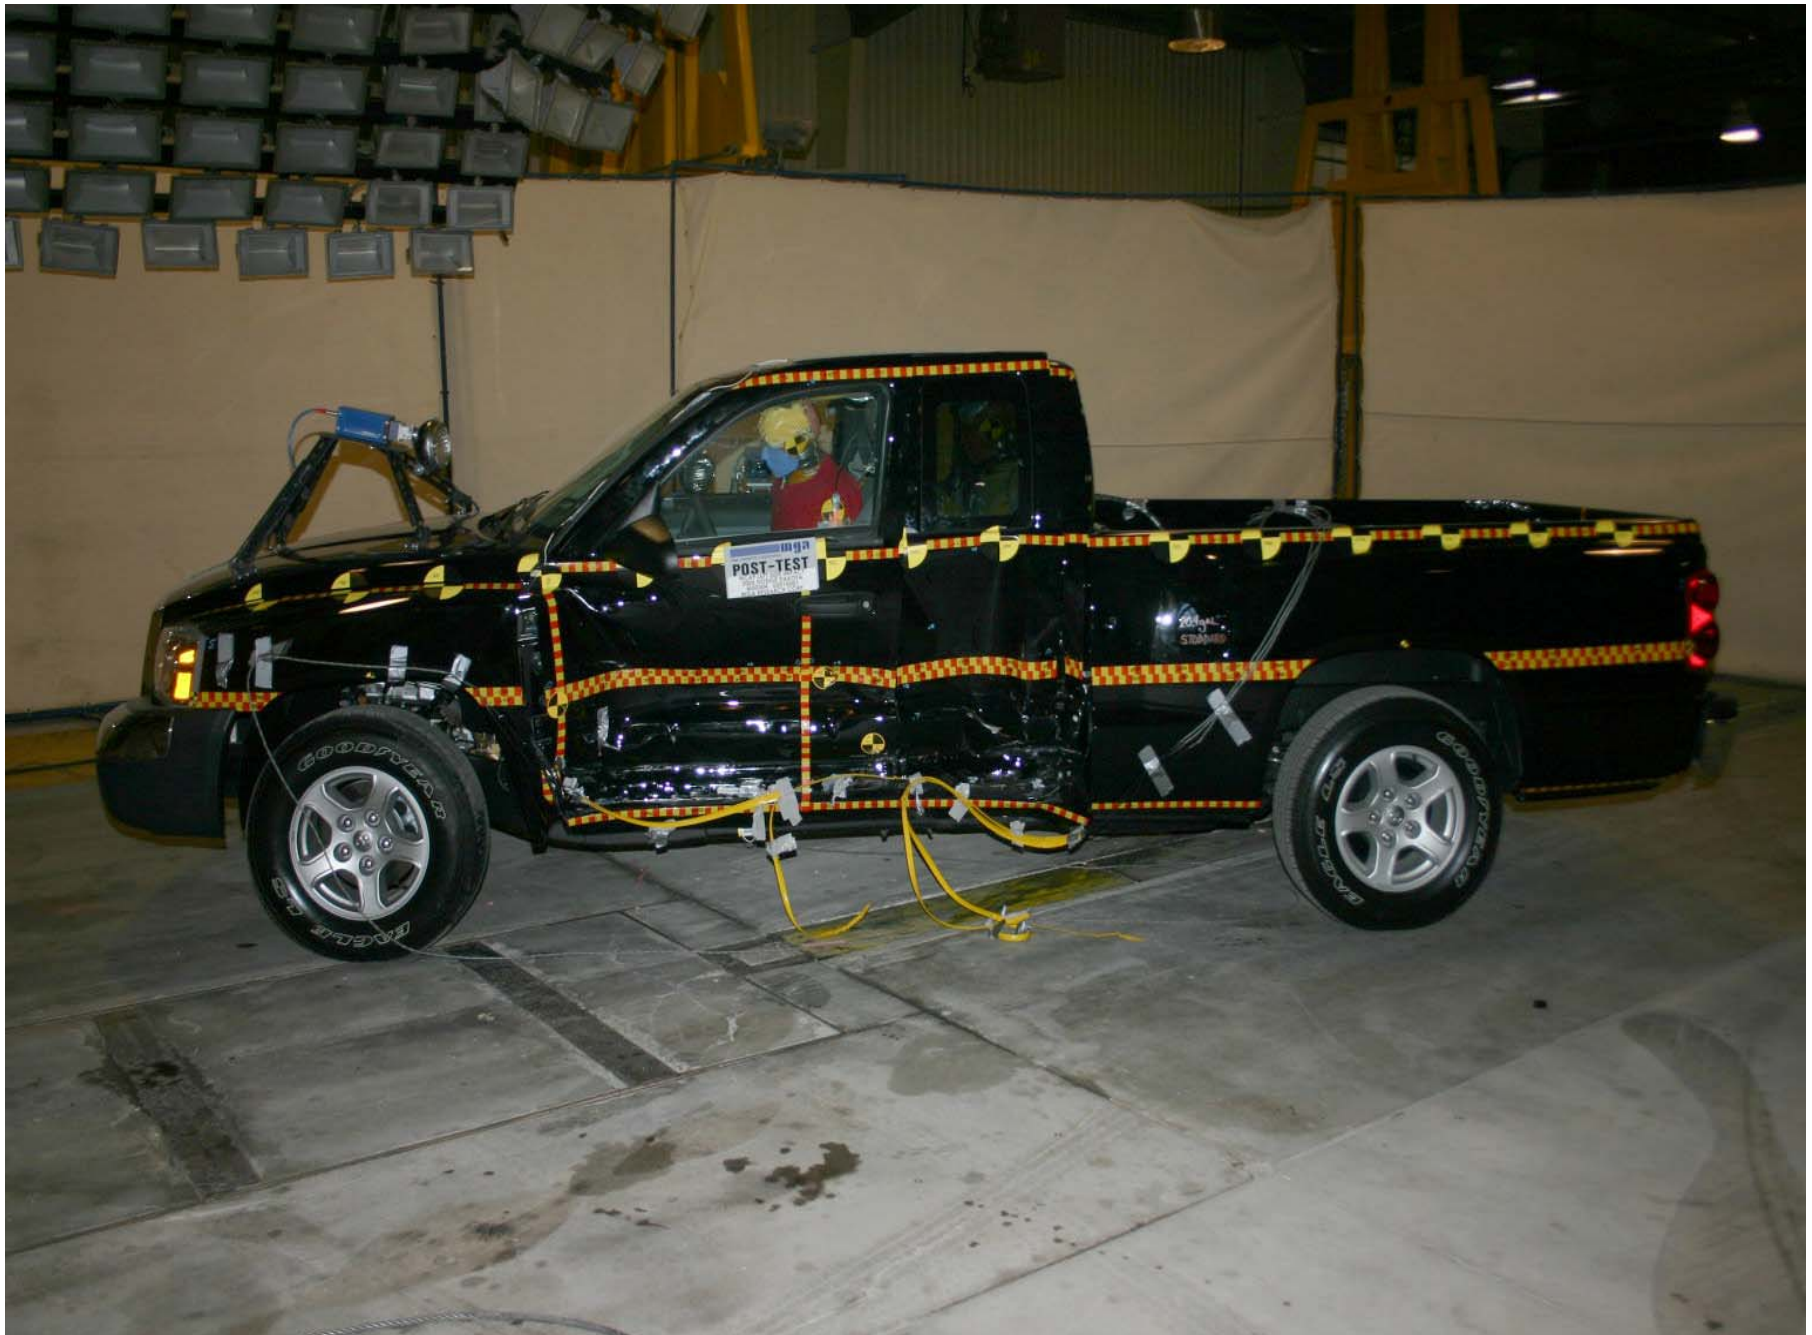
Post-Test Left Side View of Test Vehicle

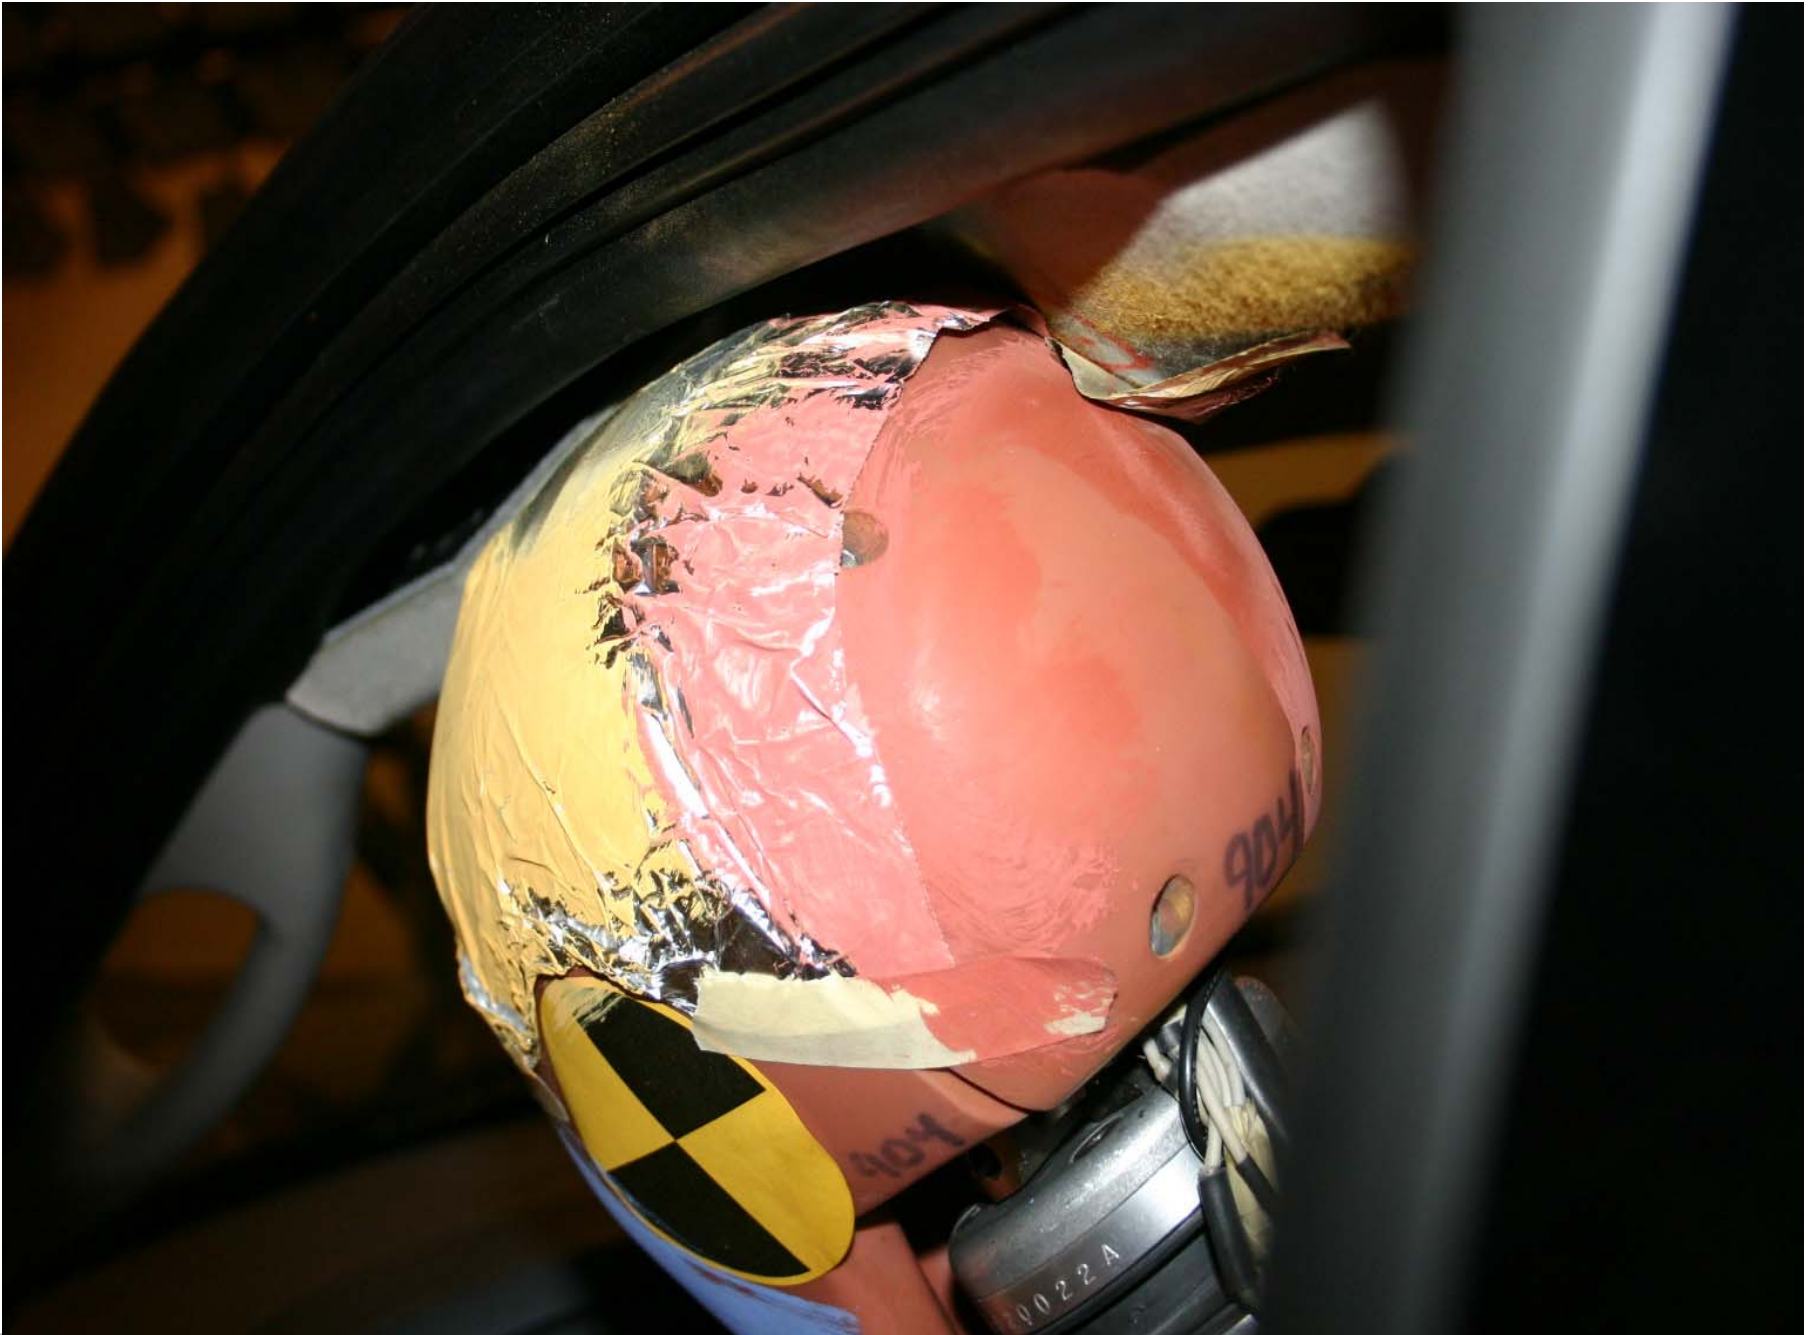
Post-Test Driver Dummy Head Contact

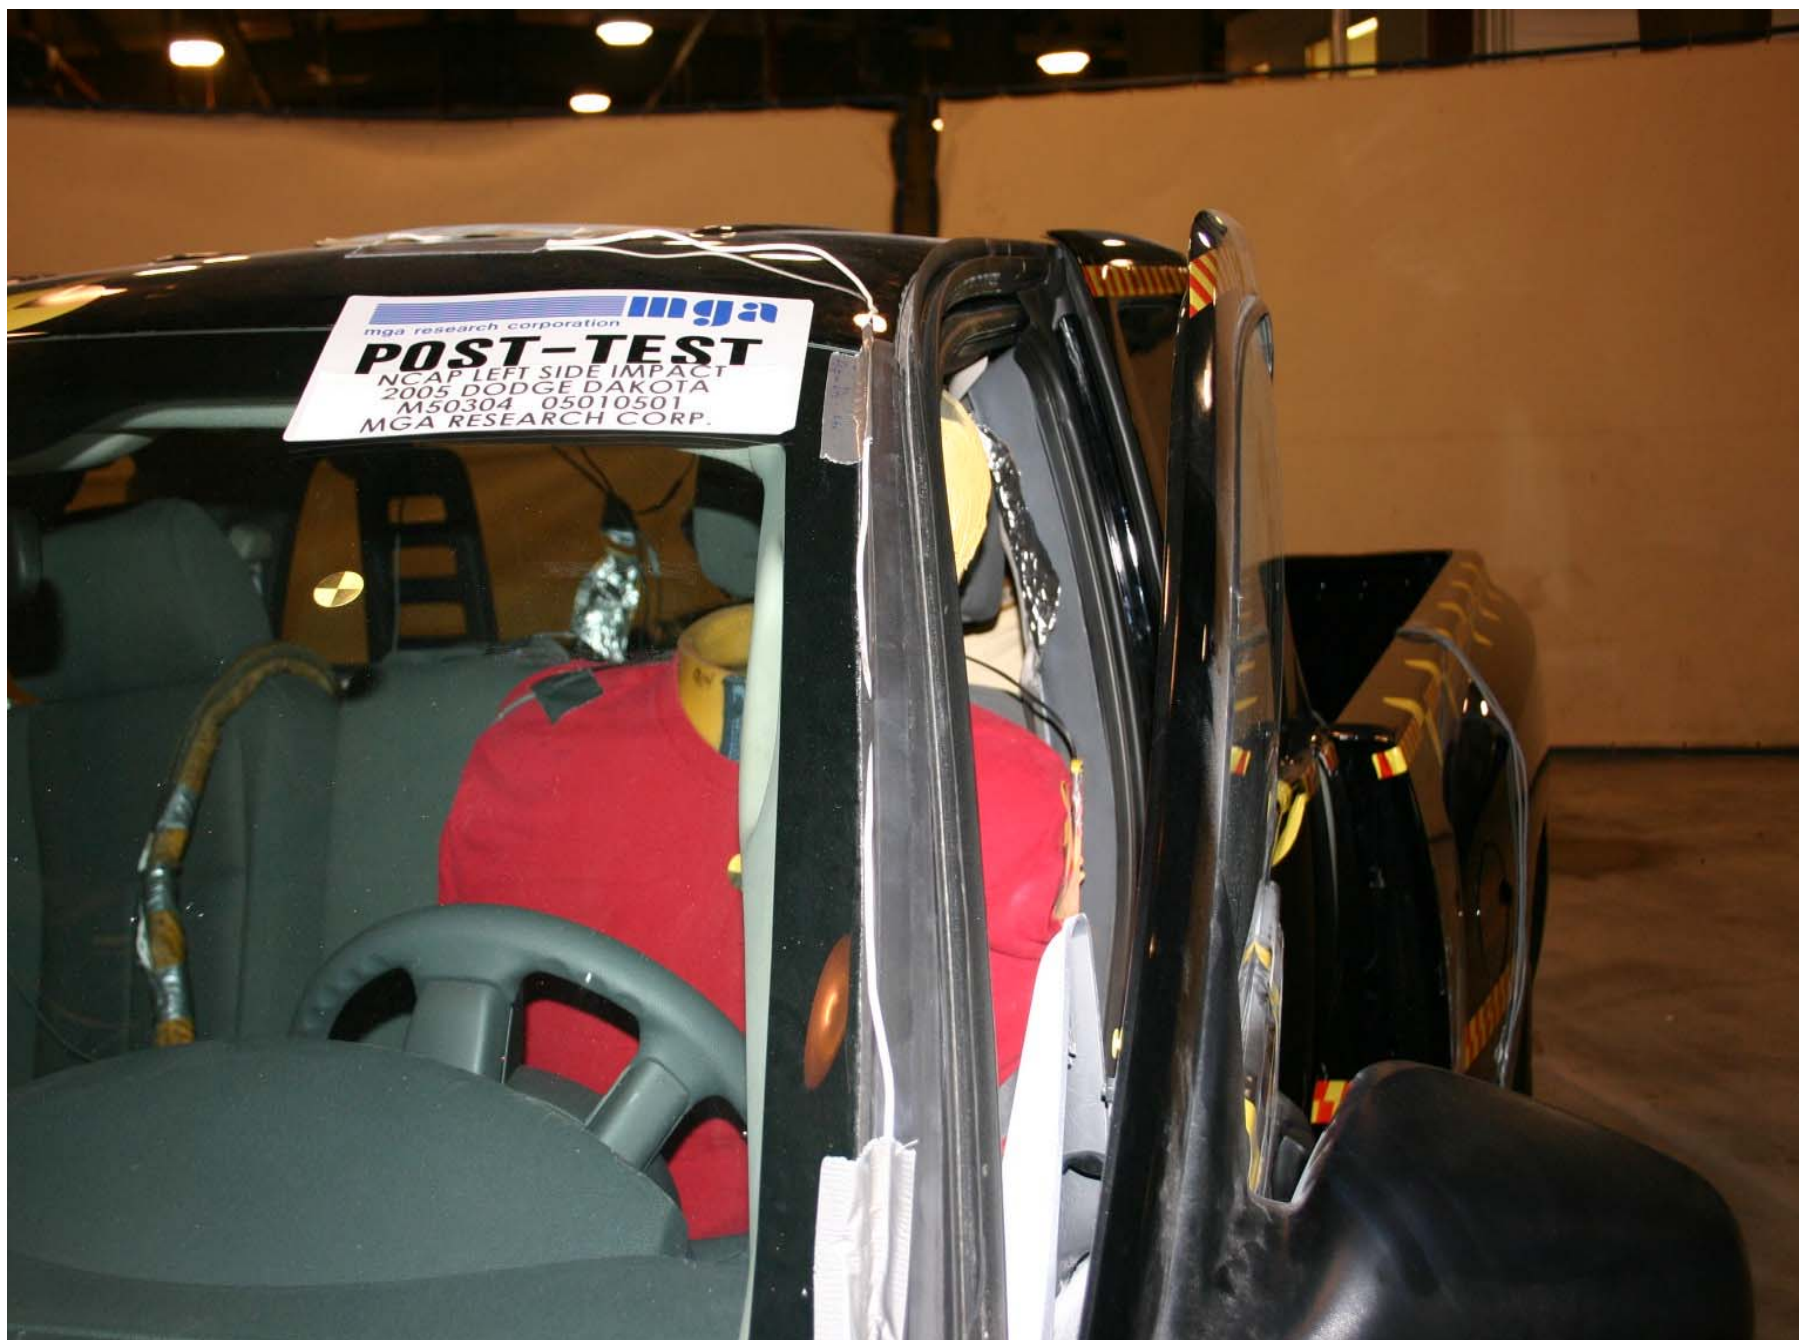
Post-Test Left Front Door Opening

Driver Door Opening of approximately 290 mm.
