REPORT NUMBER: NCAPSIDE-MGA-2005-005

**NEW CAR ASSESSMENT PROGRAM
SIDE IMPACT TEST**

**NISSAN MOTOR COMPANY
2005 NISSAN PATHFINDER SE-OR
NHTSA NUMBER: M55206**

**PREPARED BY:
MGA RESEARCH CORPORATION
5000 WARREN ROAD
BURLINGTON, WI 53105**

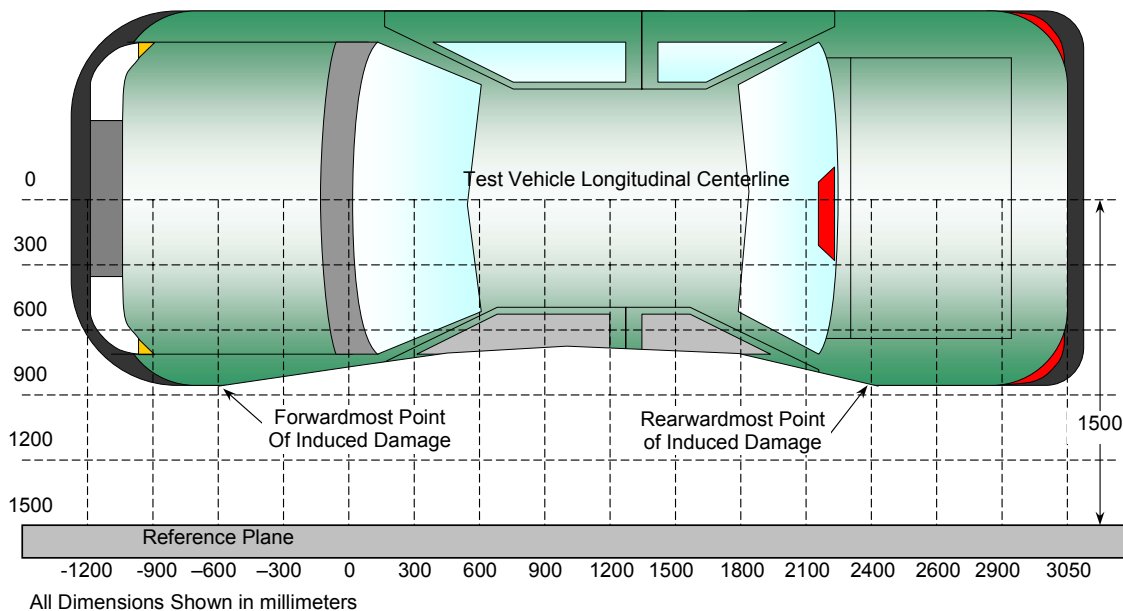
DATA SHEET NO. 13
VEHICLE DAMAGE PROFILE DISTANCES

TOP VIEW

DAMAGE PROFILE DISTANCES

The test vehicle sustained a maximum static crush of 155 mm at level 3, 900 mm rearward of the left vertical impact point. The driver and passenger SID/HIII's, Serial Nos. 271 and 904 respectively, were calibrated just prior to this test. The SID/HIII's injury criteria are summarized as follows:

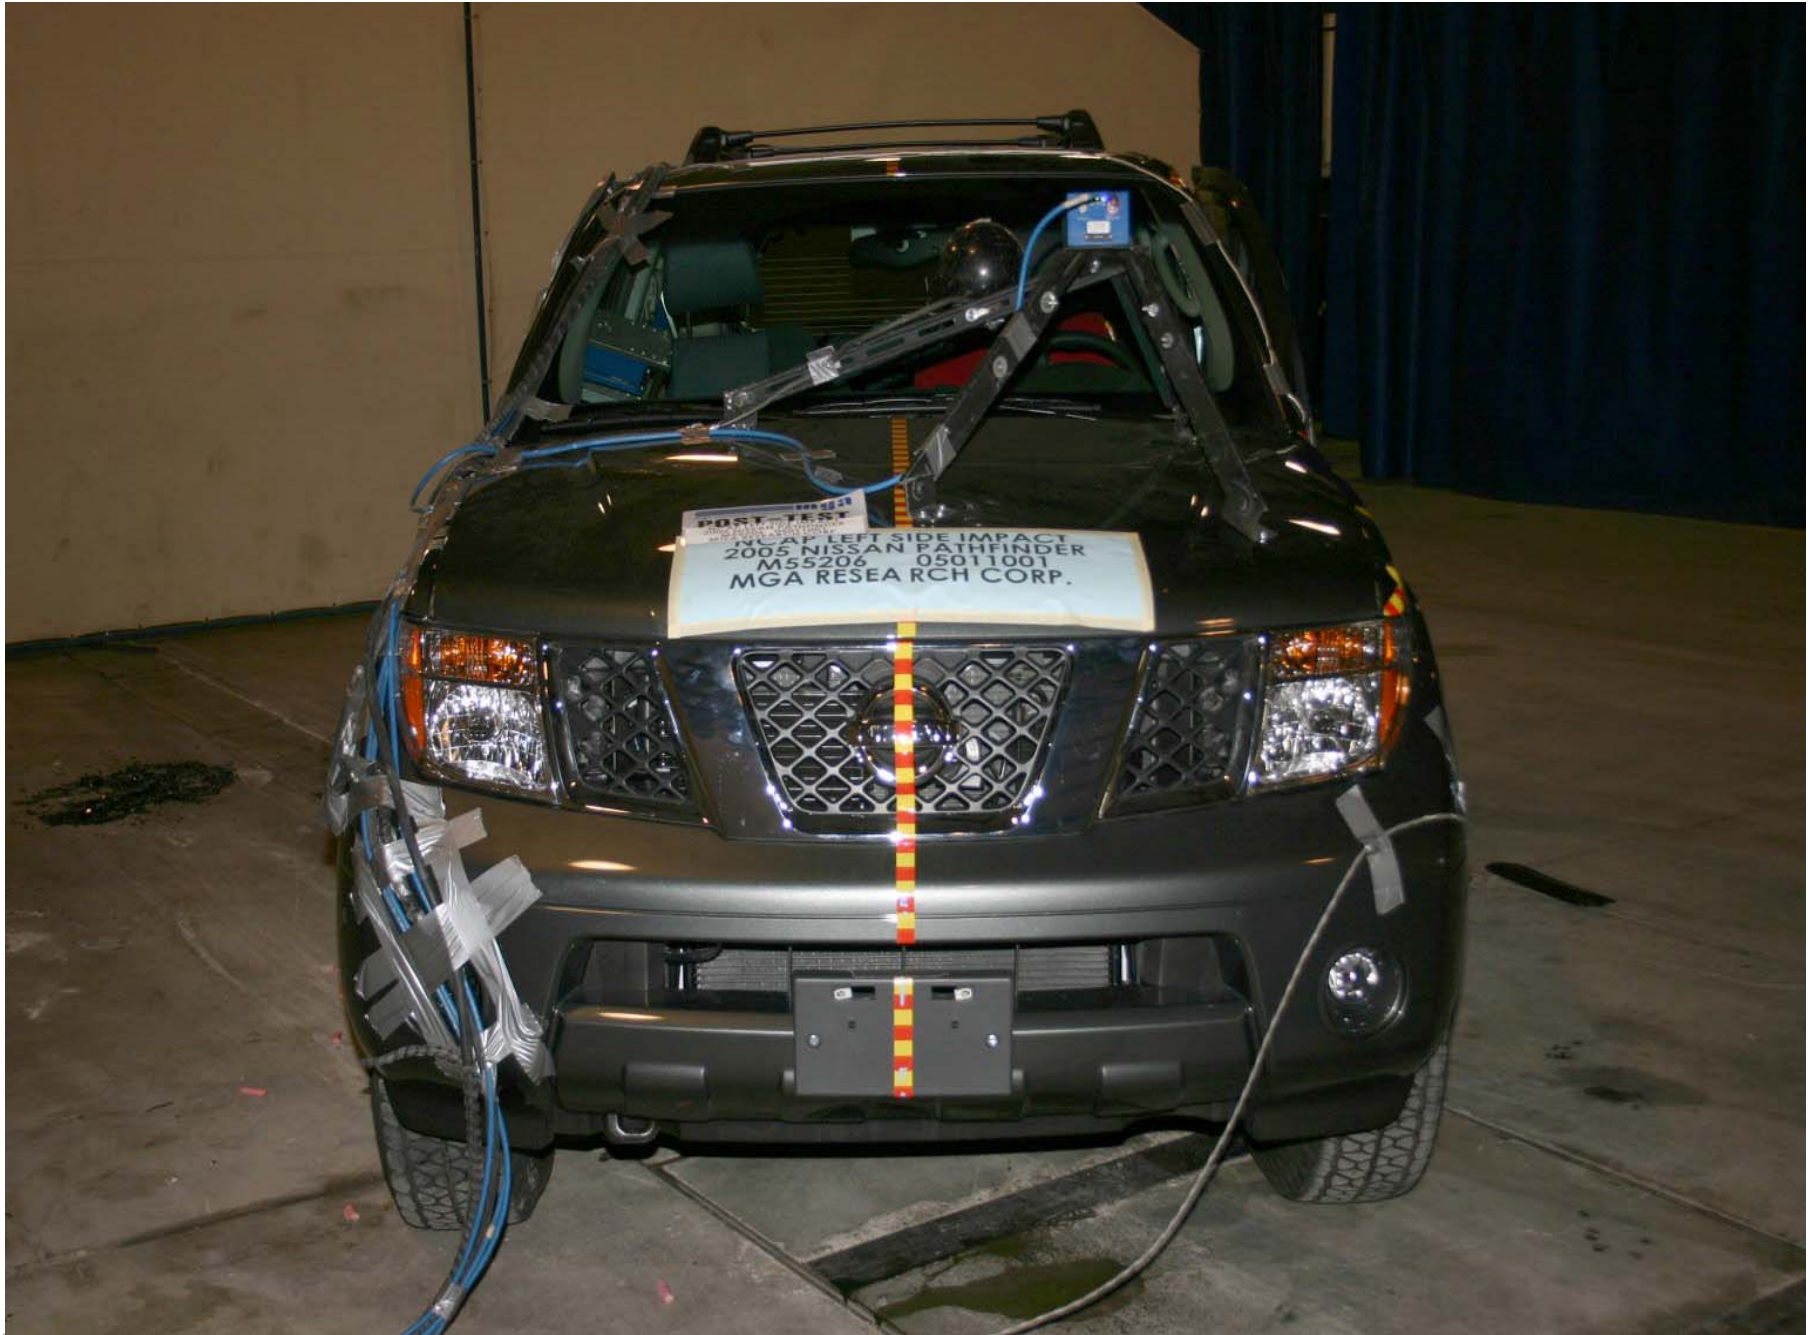
A-6.

Post-Test Front View of Test Vehicle

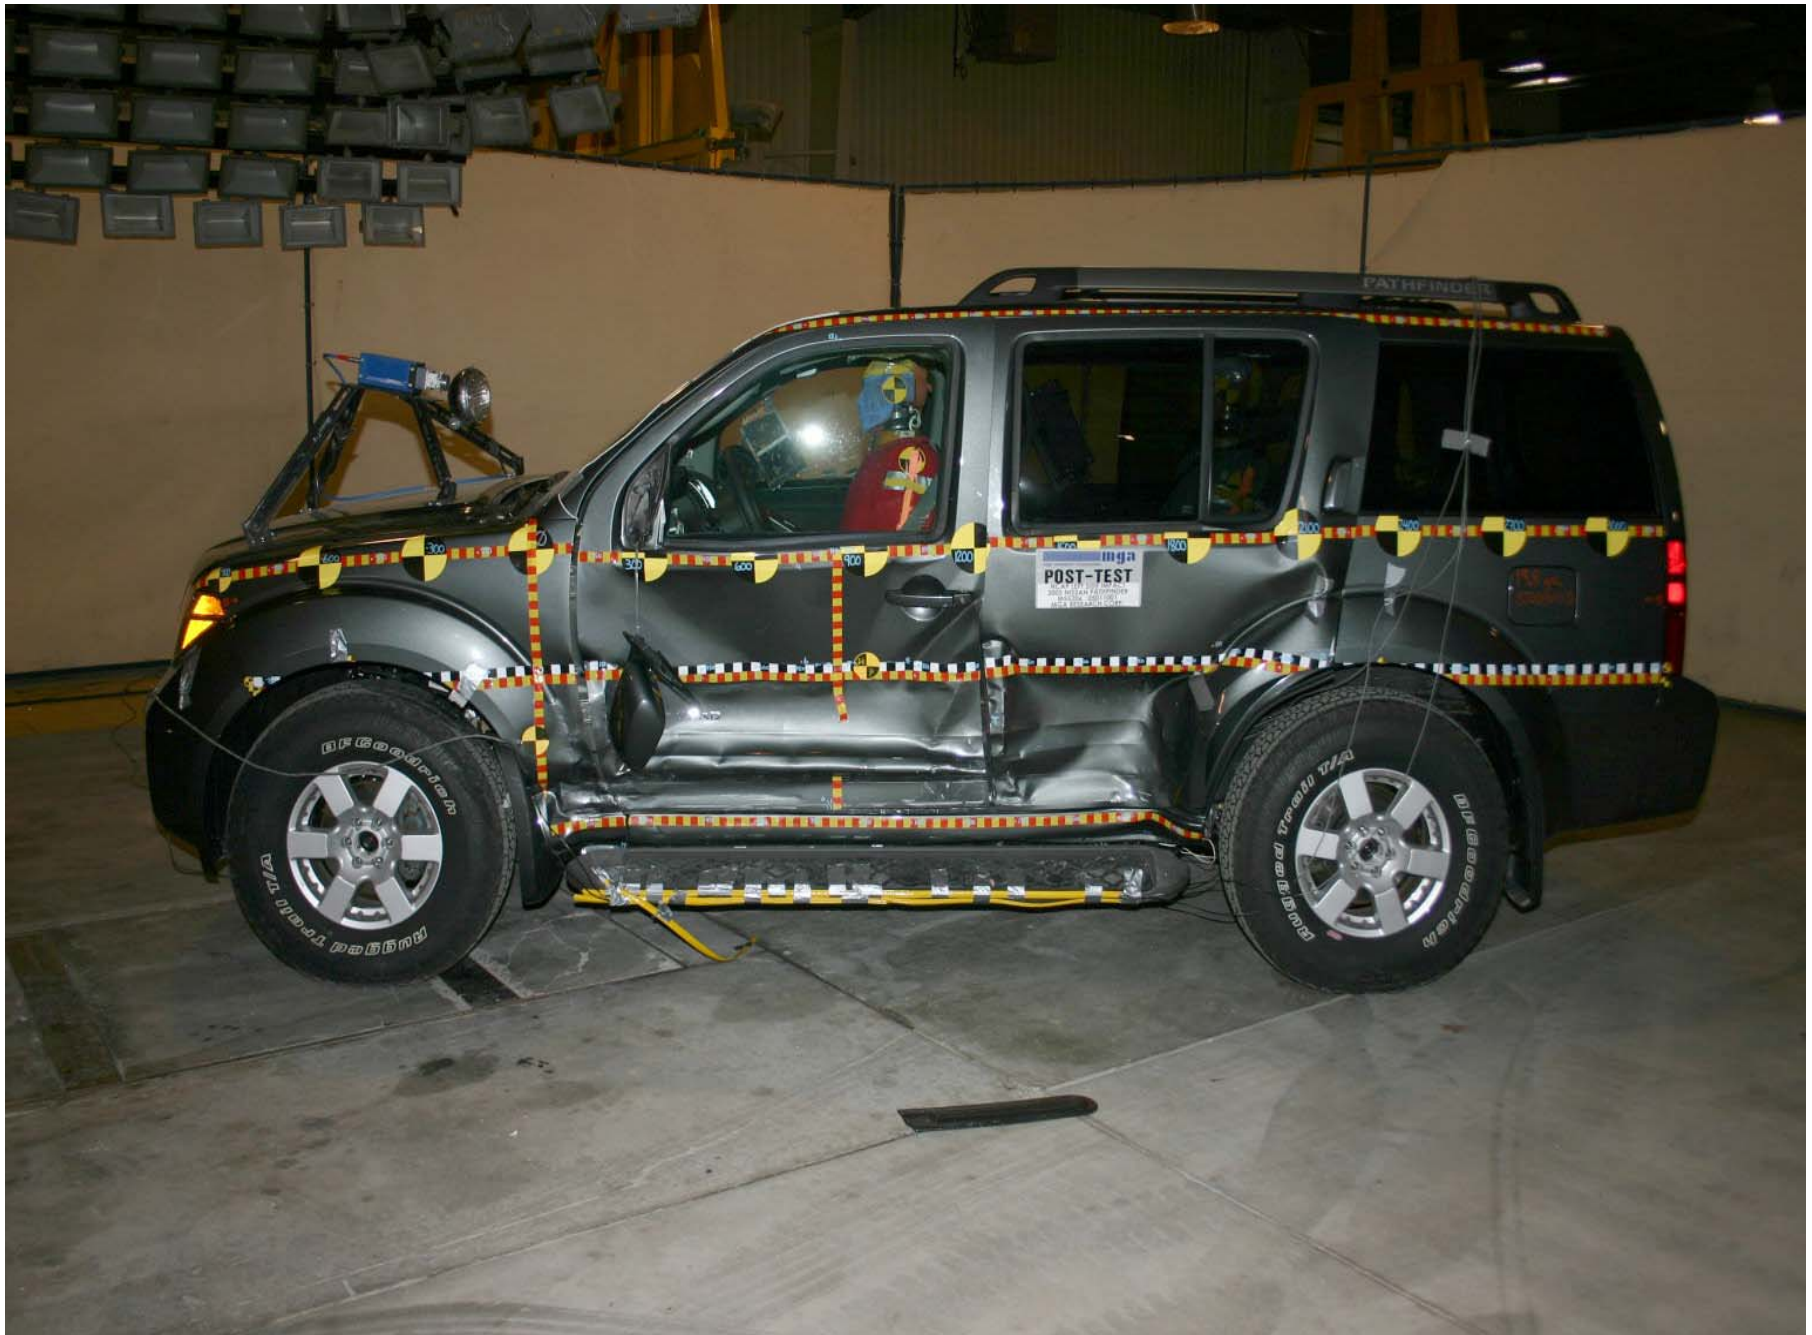
A-12.

Post-Test Left Side View of Test Vehicle

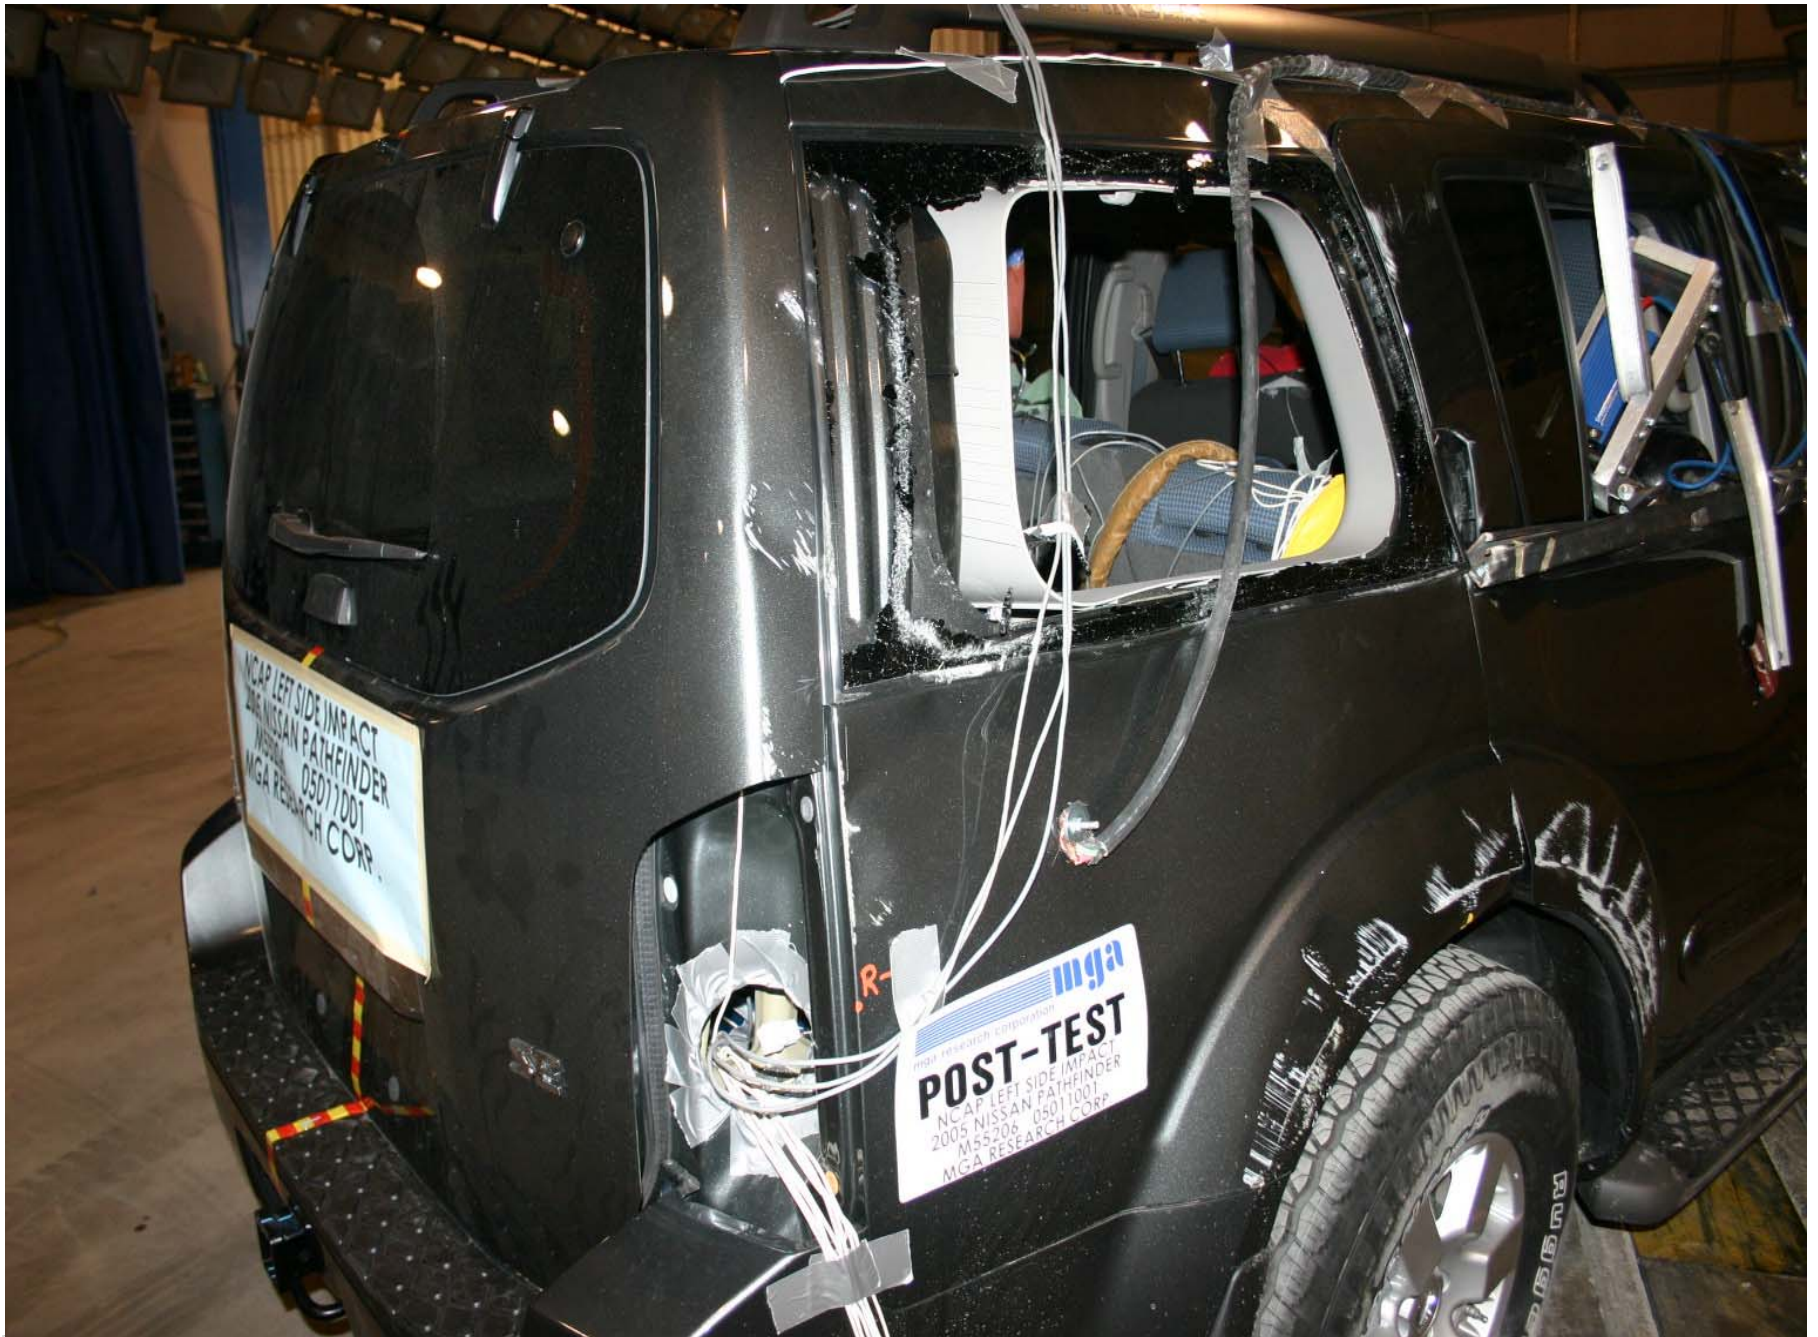
Post-Test Right Rear 3/4 View of Test Vehicle (window broken)

Critical Areas of Performance	Observations and Conclusions
Pillar Performance	No Separation
Sill Separation	None
Windshield Damage	None
Window Damage	Right Rear Window broke
Other Notable Effects	The vehicle rolled onto its right side during impact.

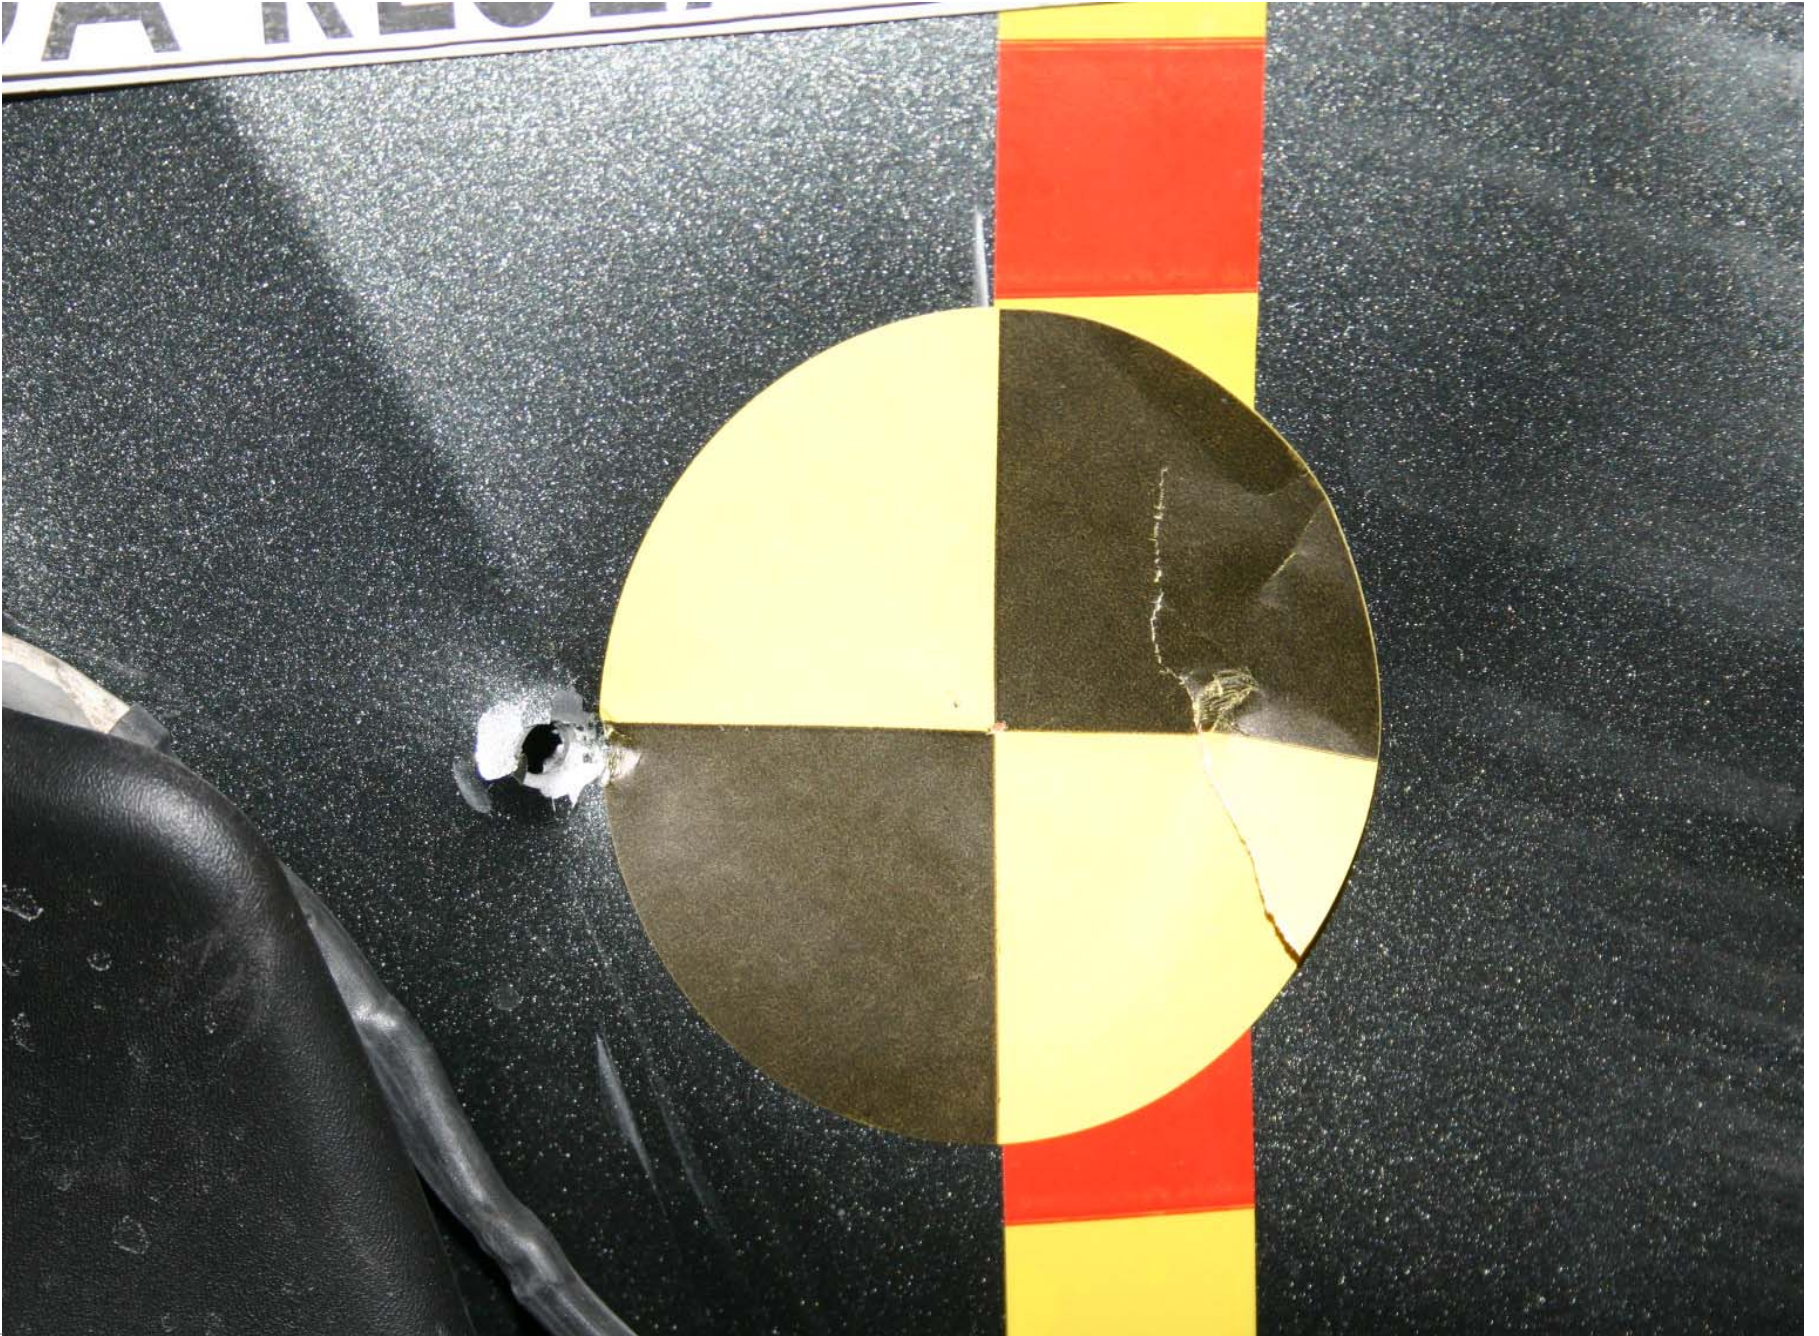
A-26.

Post-Test Impact Point on Vehicle

The size of the target used for the impact point was 76.2 mm diameter (3 inch target). The actual impact point was 41 mm rear. This point was outside the target but within the 50 mm tolerance.

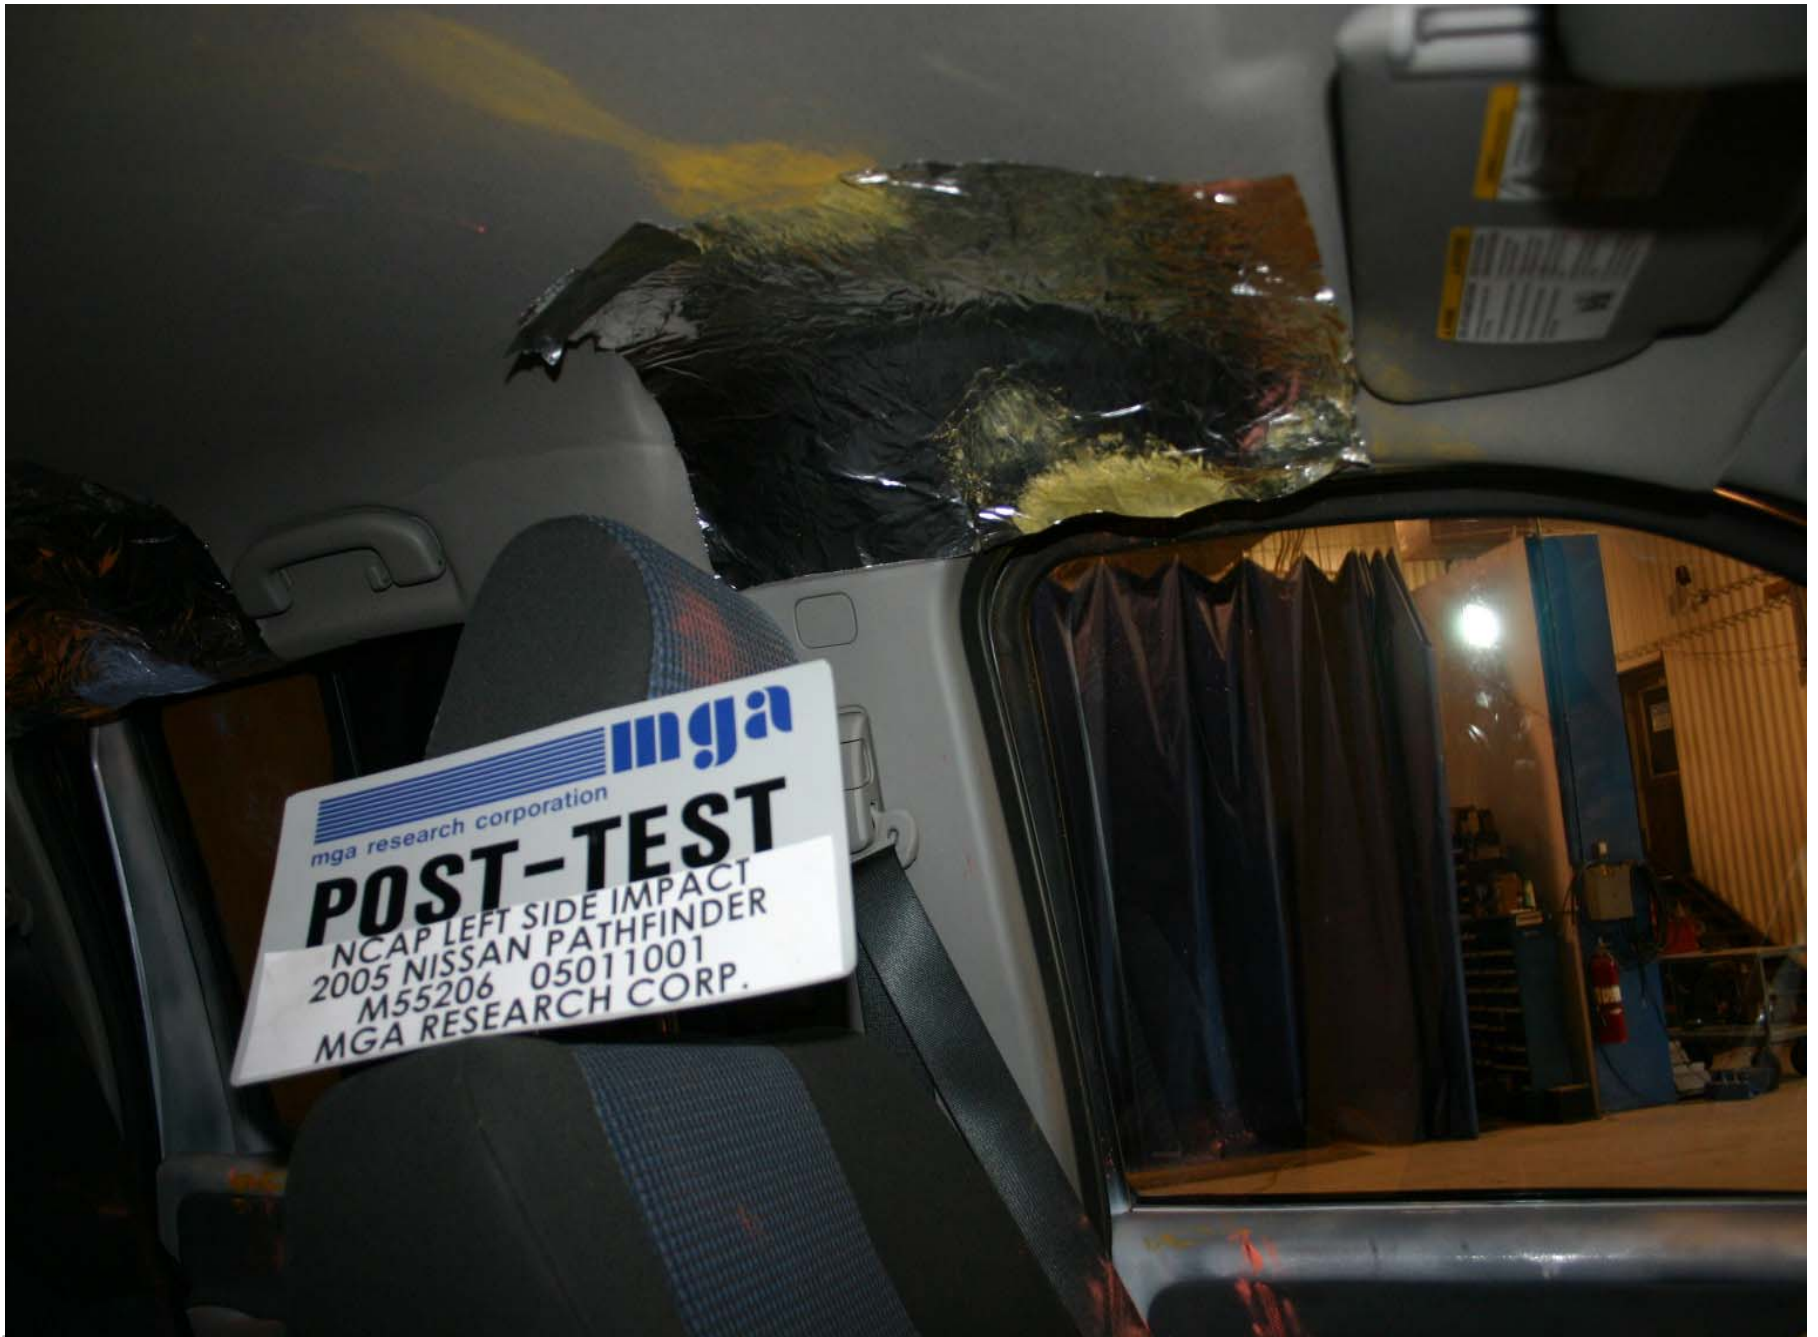
Post-Test Driver Dummy Head Contact (side header)

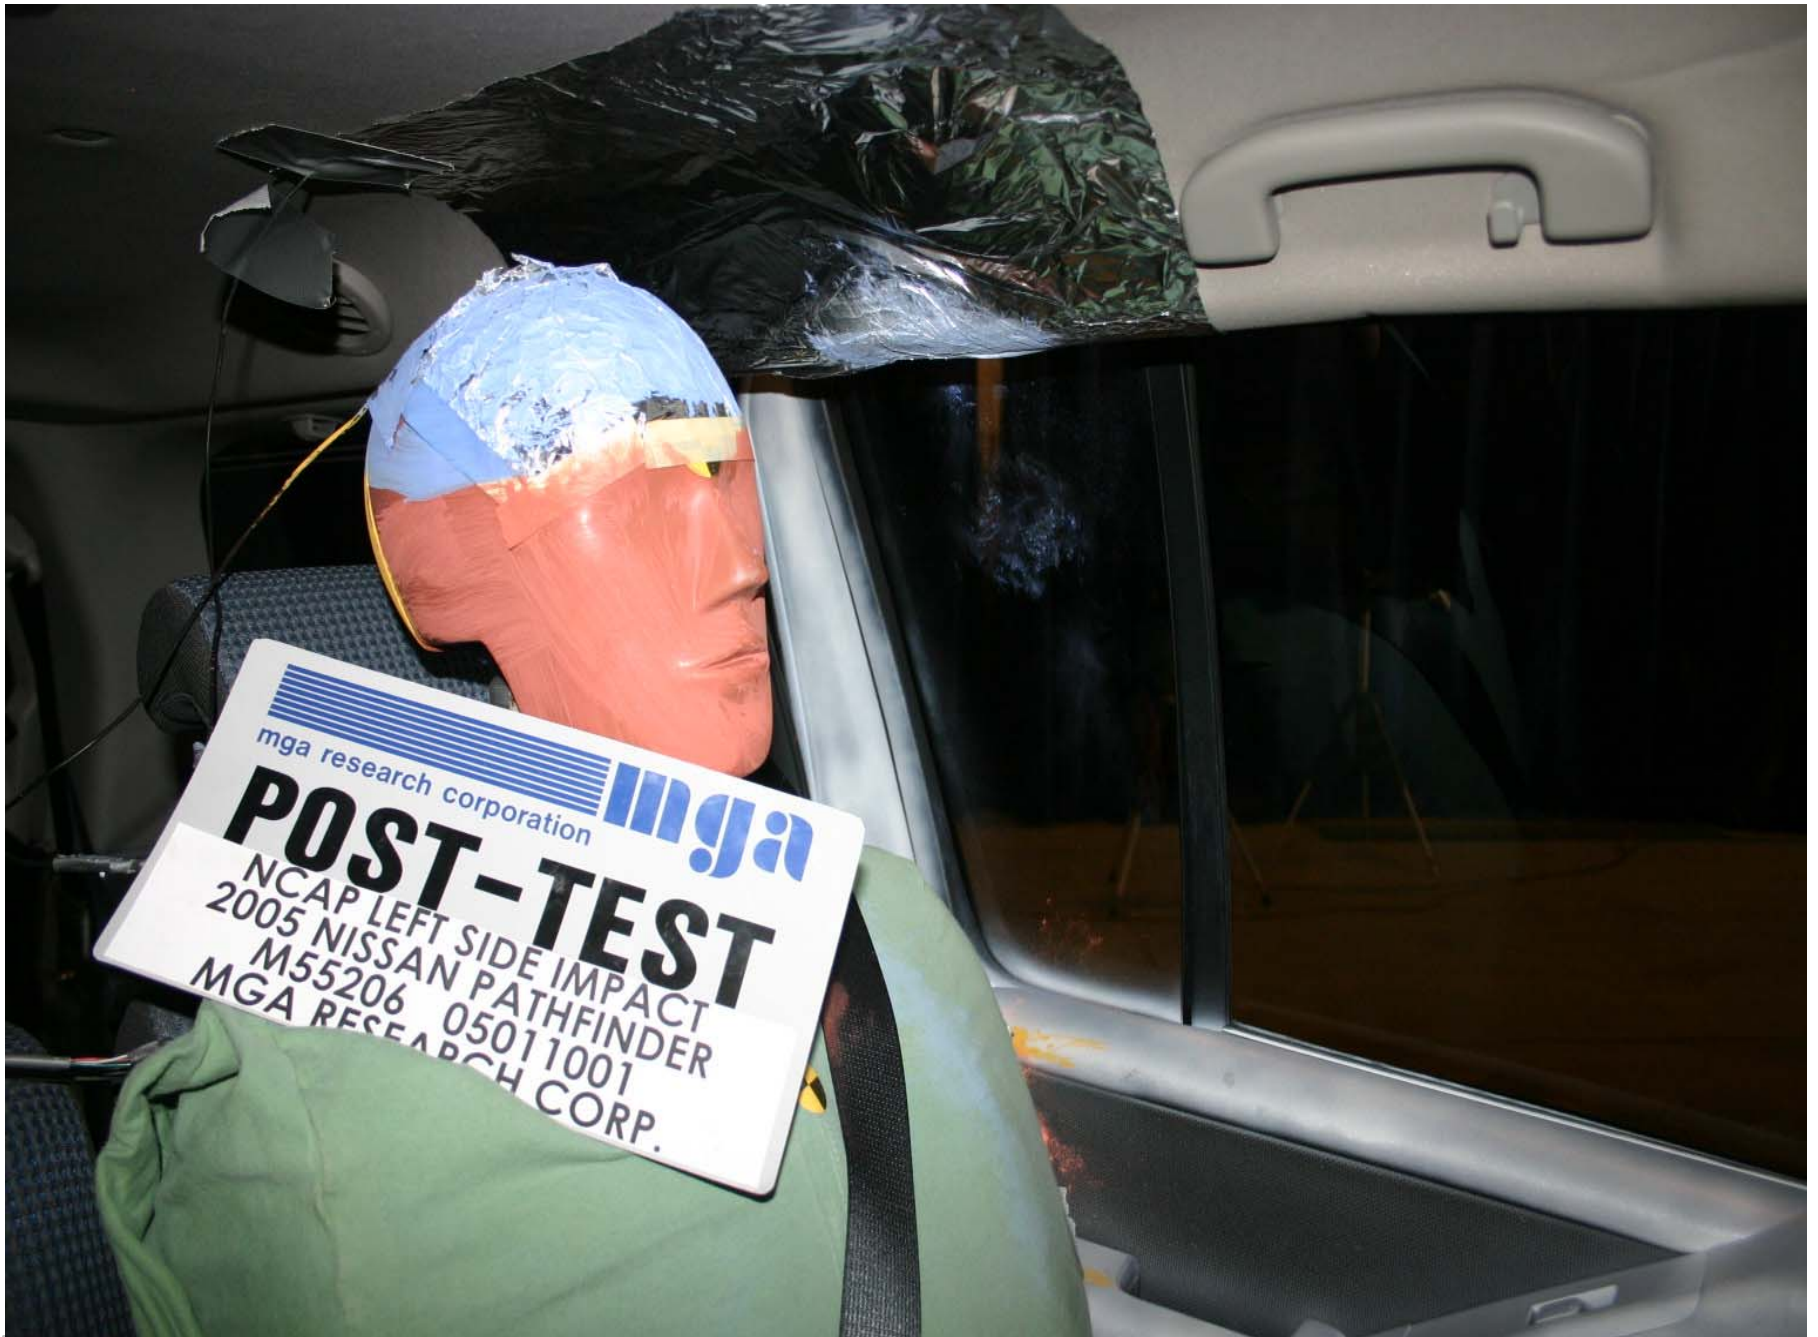
Post-Test Passenger Dummy Head Contact (side header)

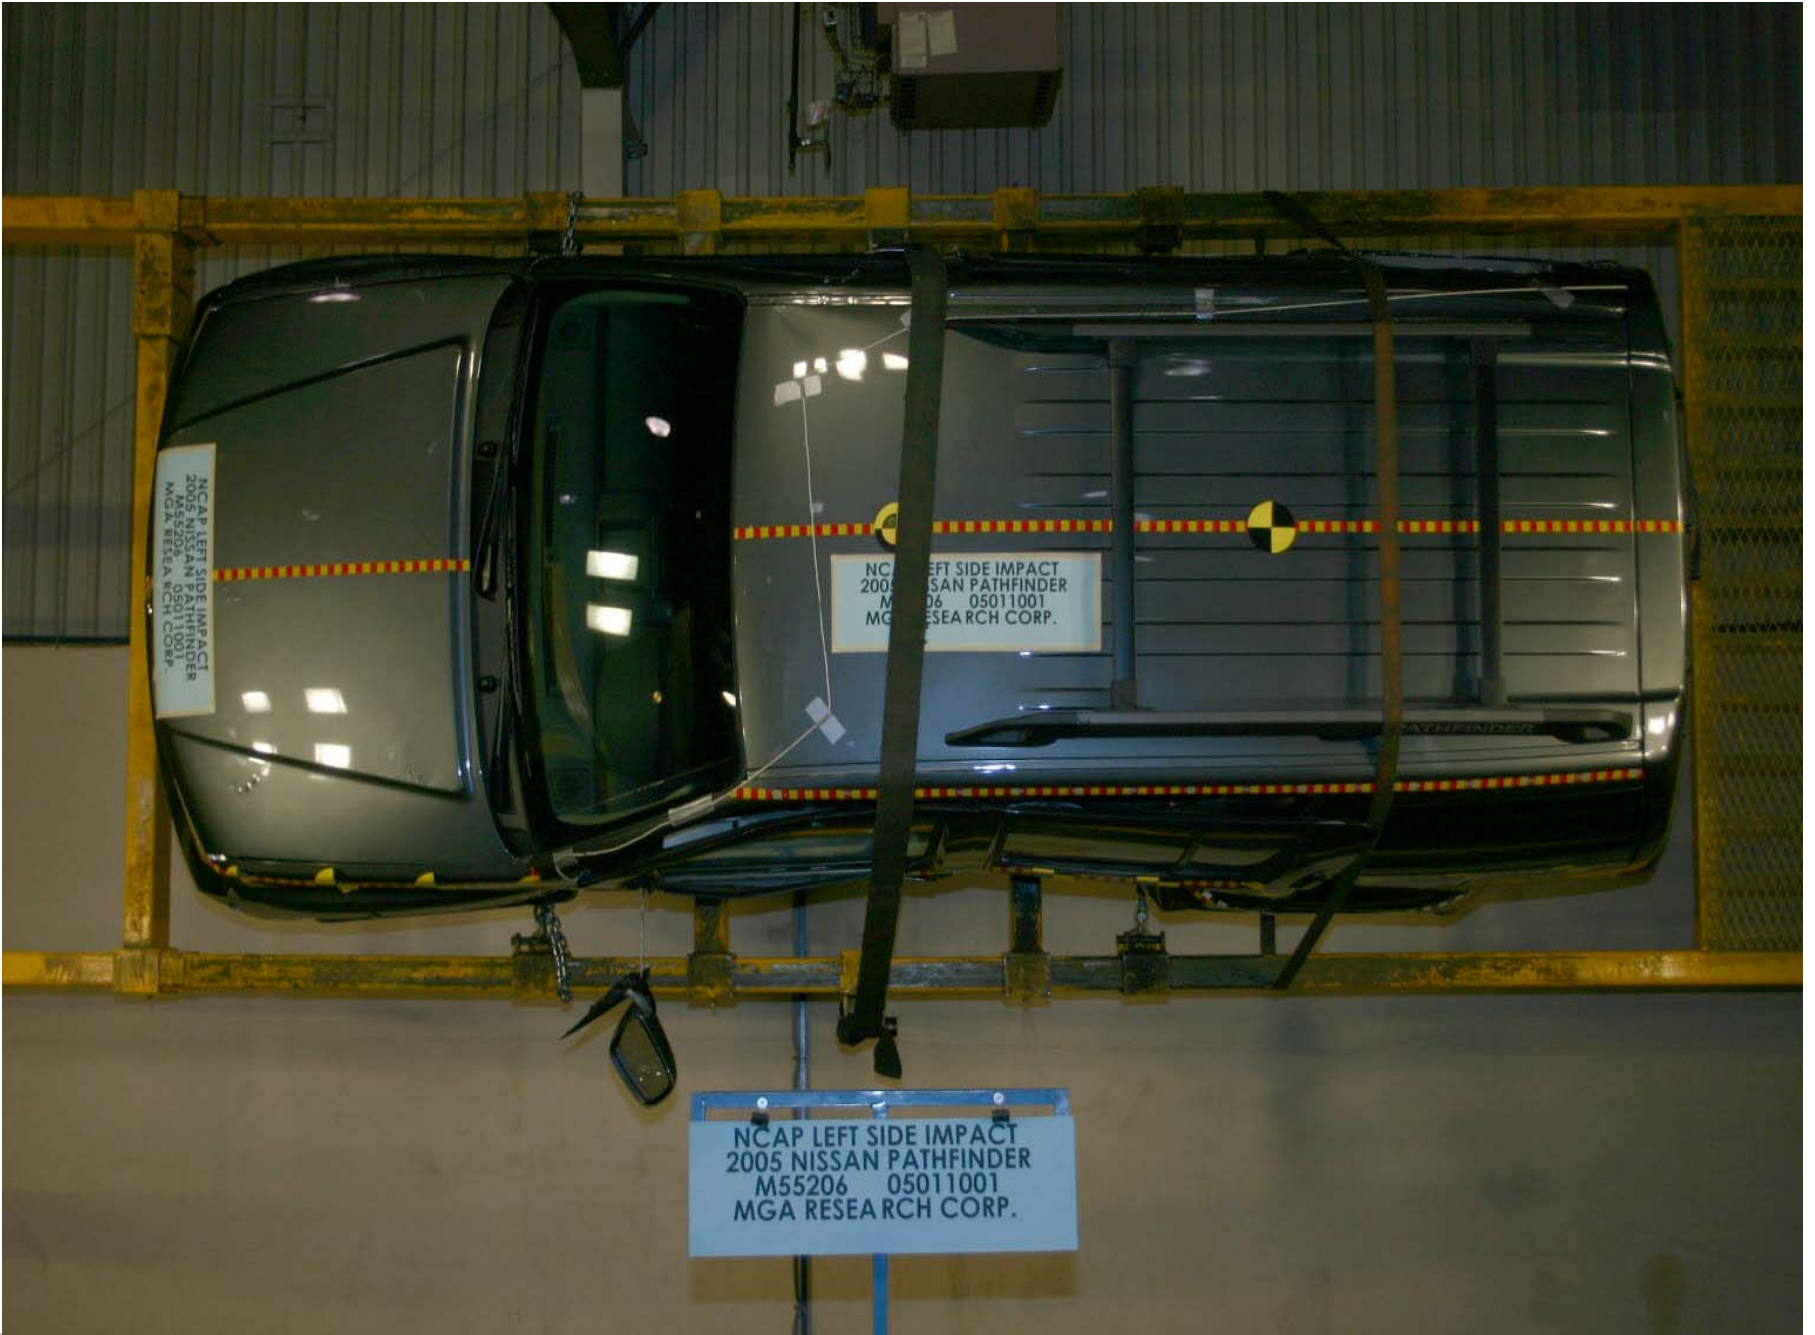
A-59.

Rollover 90 Degrees

The vehicle rolled onto its right side during impact. See Appendix B for photos.

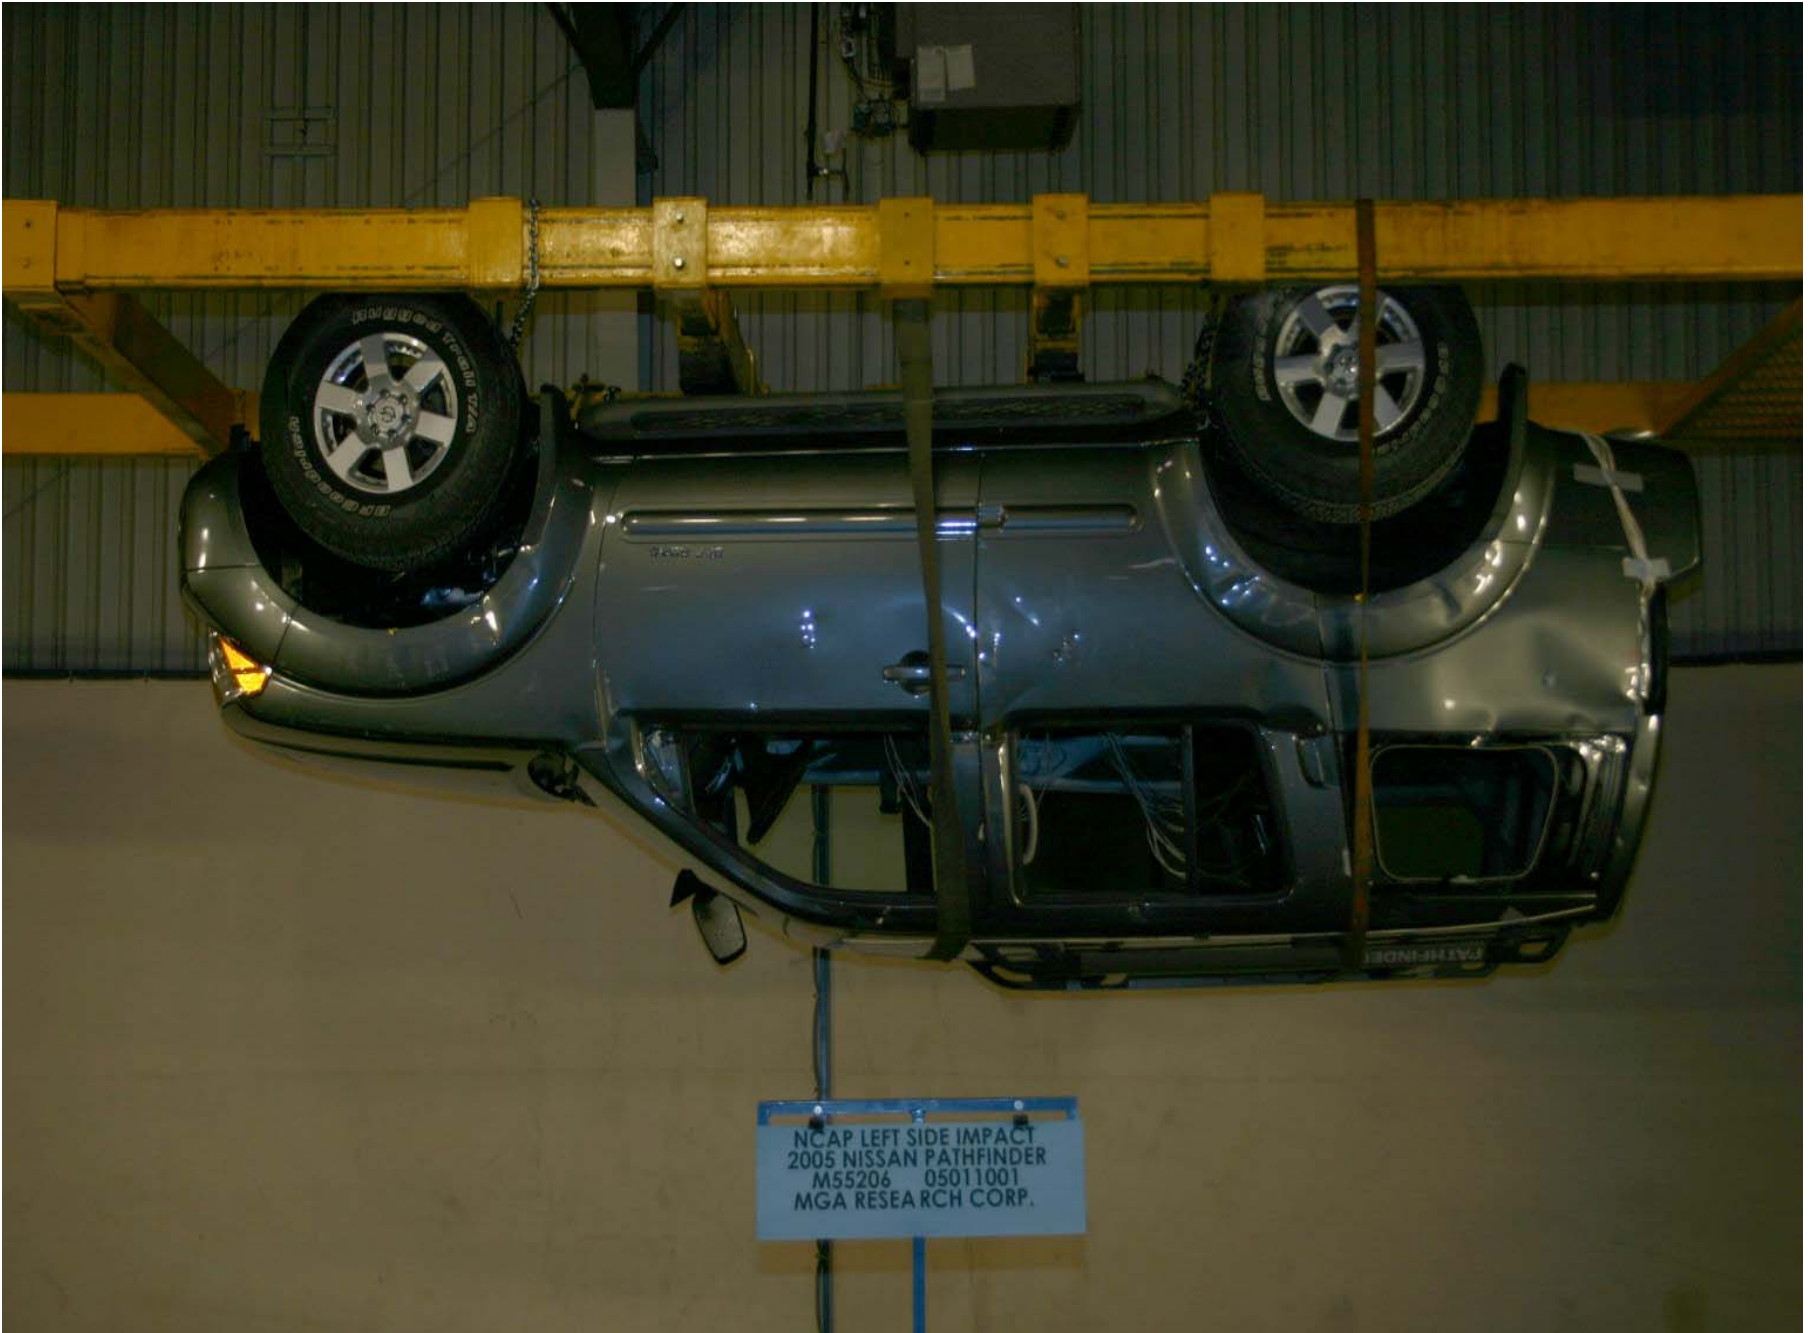
A-60.

Rollover 180 Degrees

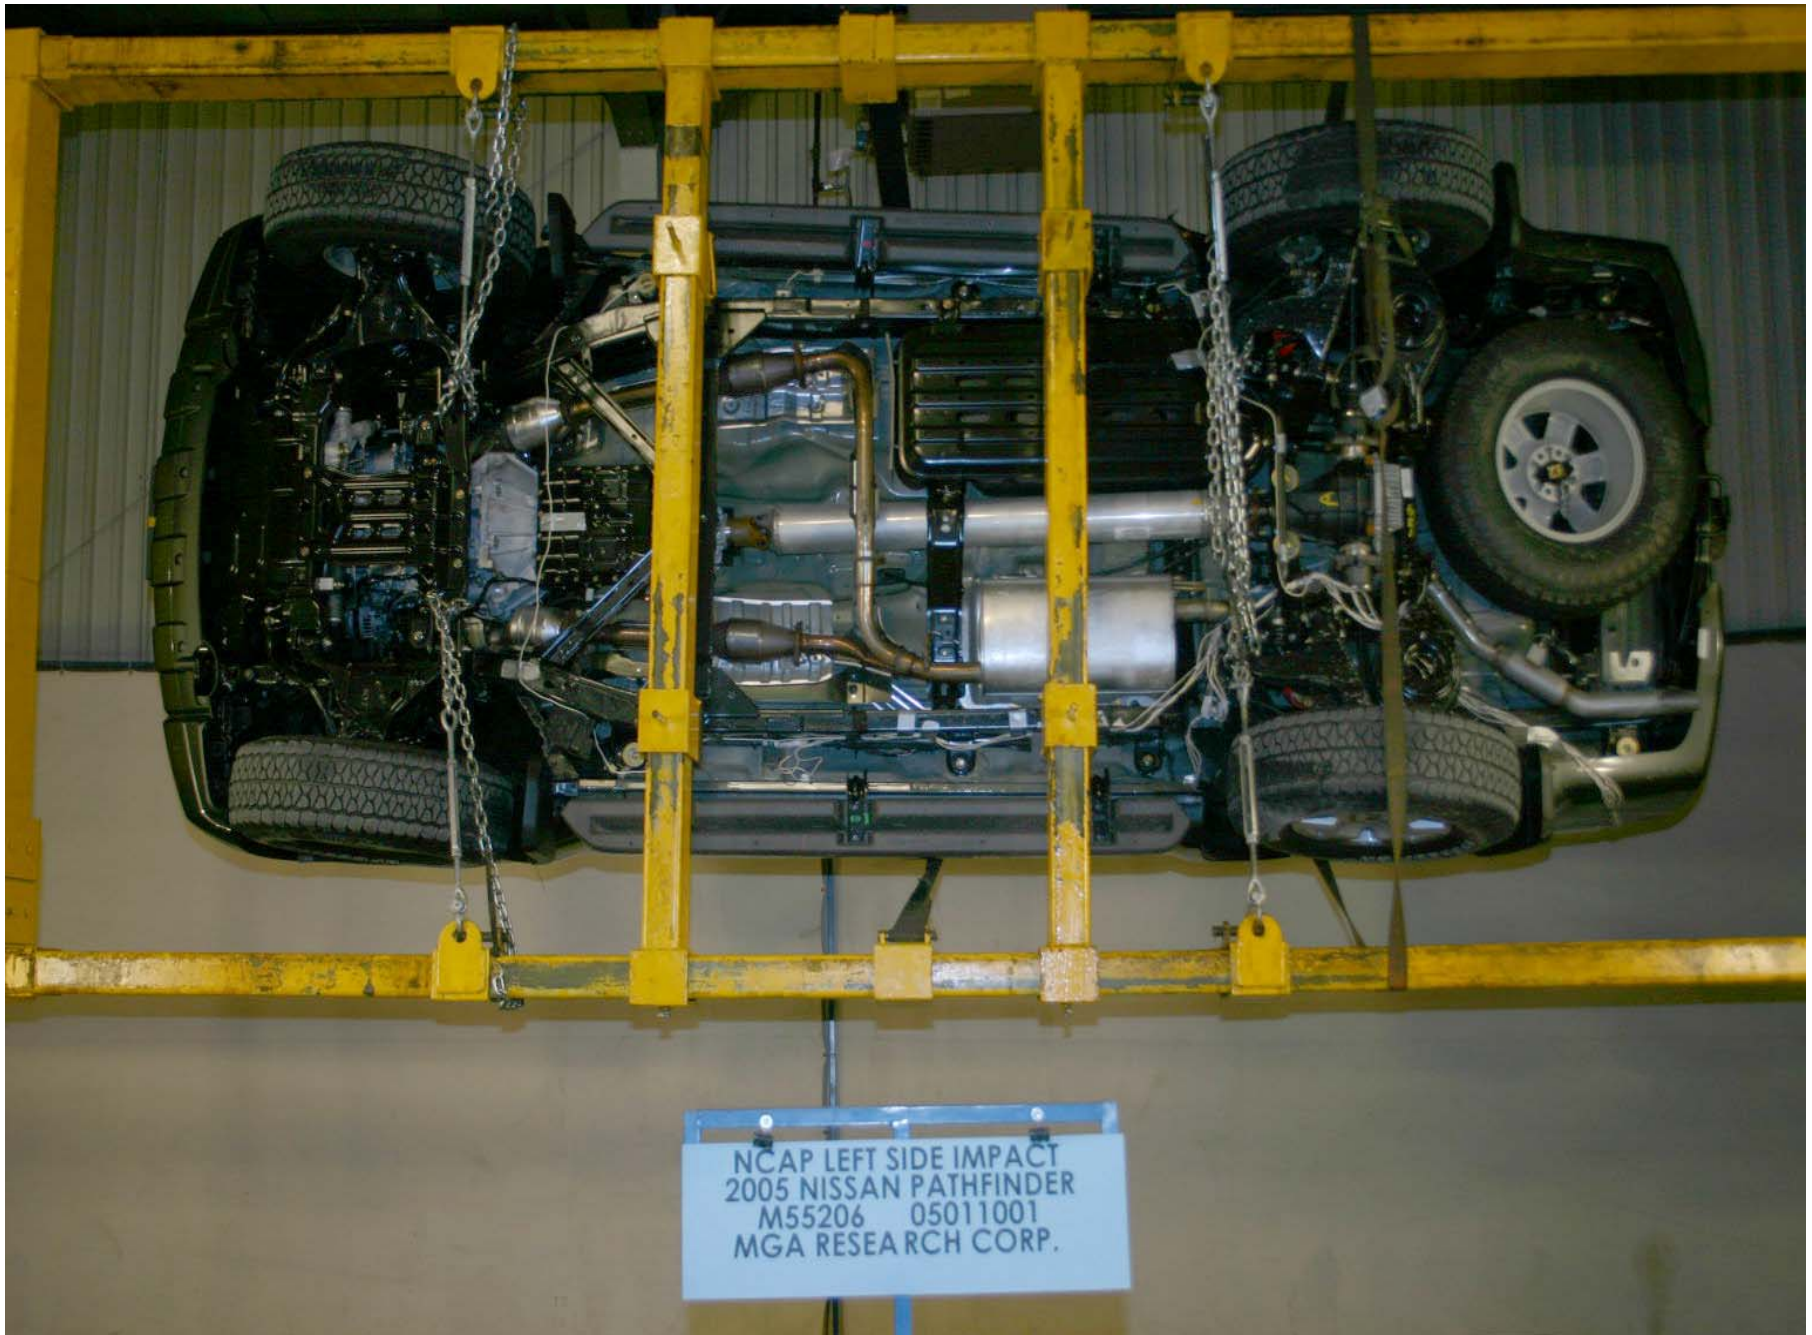
A-61.

Rollover 270 Degrees
