REPORT NUMBER: NCAPSIDE-MGA-2005-005

**NEW CAR ASSESSMENT PROGRAM
SIDE IMPACT TEST**

**NISSAN MOTOR COMPANY
2005 NISSAN PATHFINDER SE-OR
NHTSA NUMBER: M55206**

**PREPARED BY:
MGA RESEARCH CORPORATION
5000 WARREN ROAD
BURLINGTON, WI 53105**

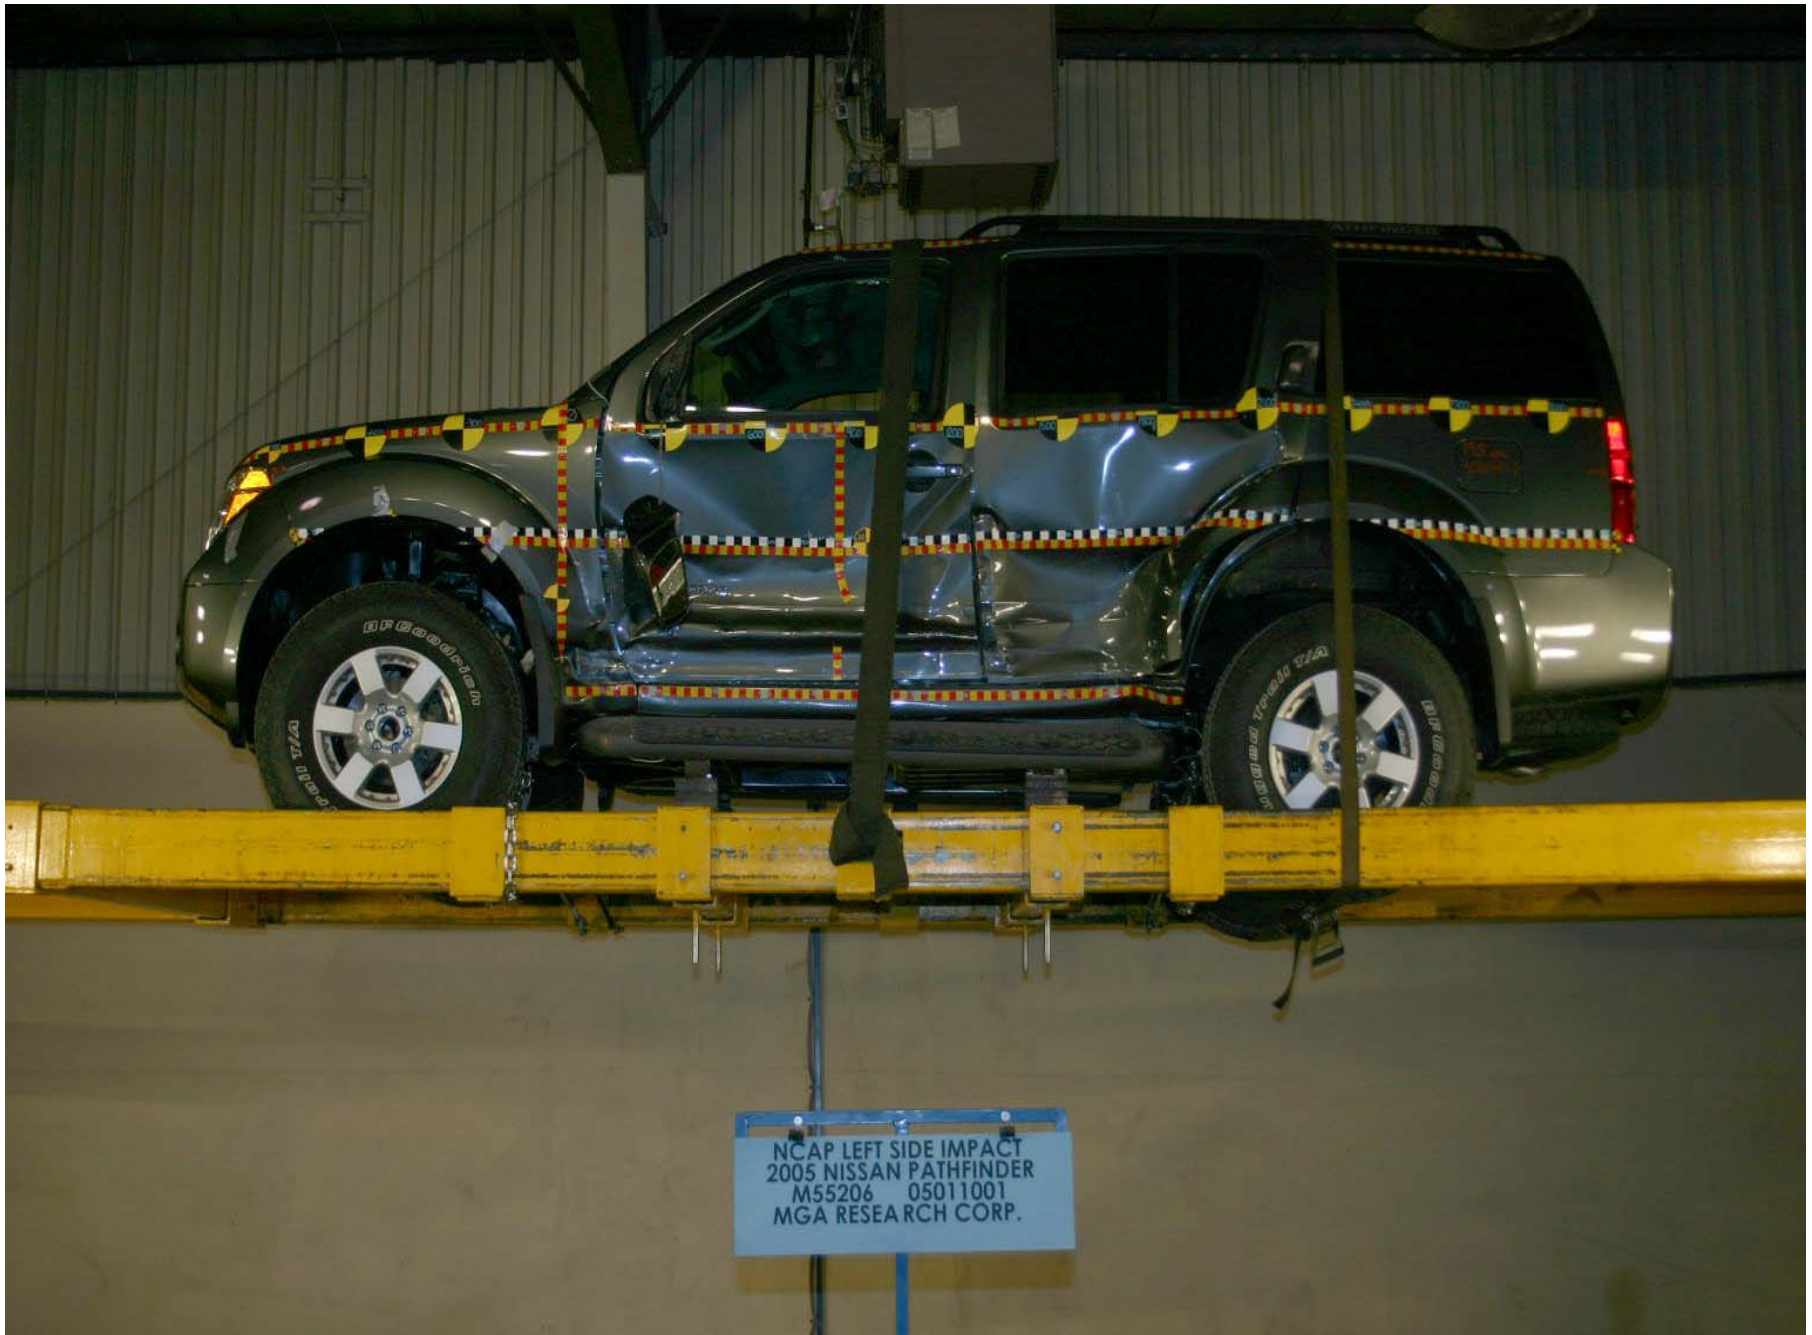
A-62.

Rollover 360 Degrees

The vehicle rolled onto its right side during impact. See Appendix B for photos.
