**REPORT NUMBER TR-P25003-03-NC**

**NEW CAR ASSESSMENT PROGRAM  
SIDE IMPACT TEST**

**GENERAL MOTORS CORPORATION  
2005 CHEVROLET COLORADO  
2-DOOR TRUCK**

**FINAL REPORT**

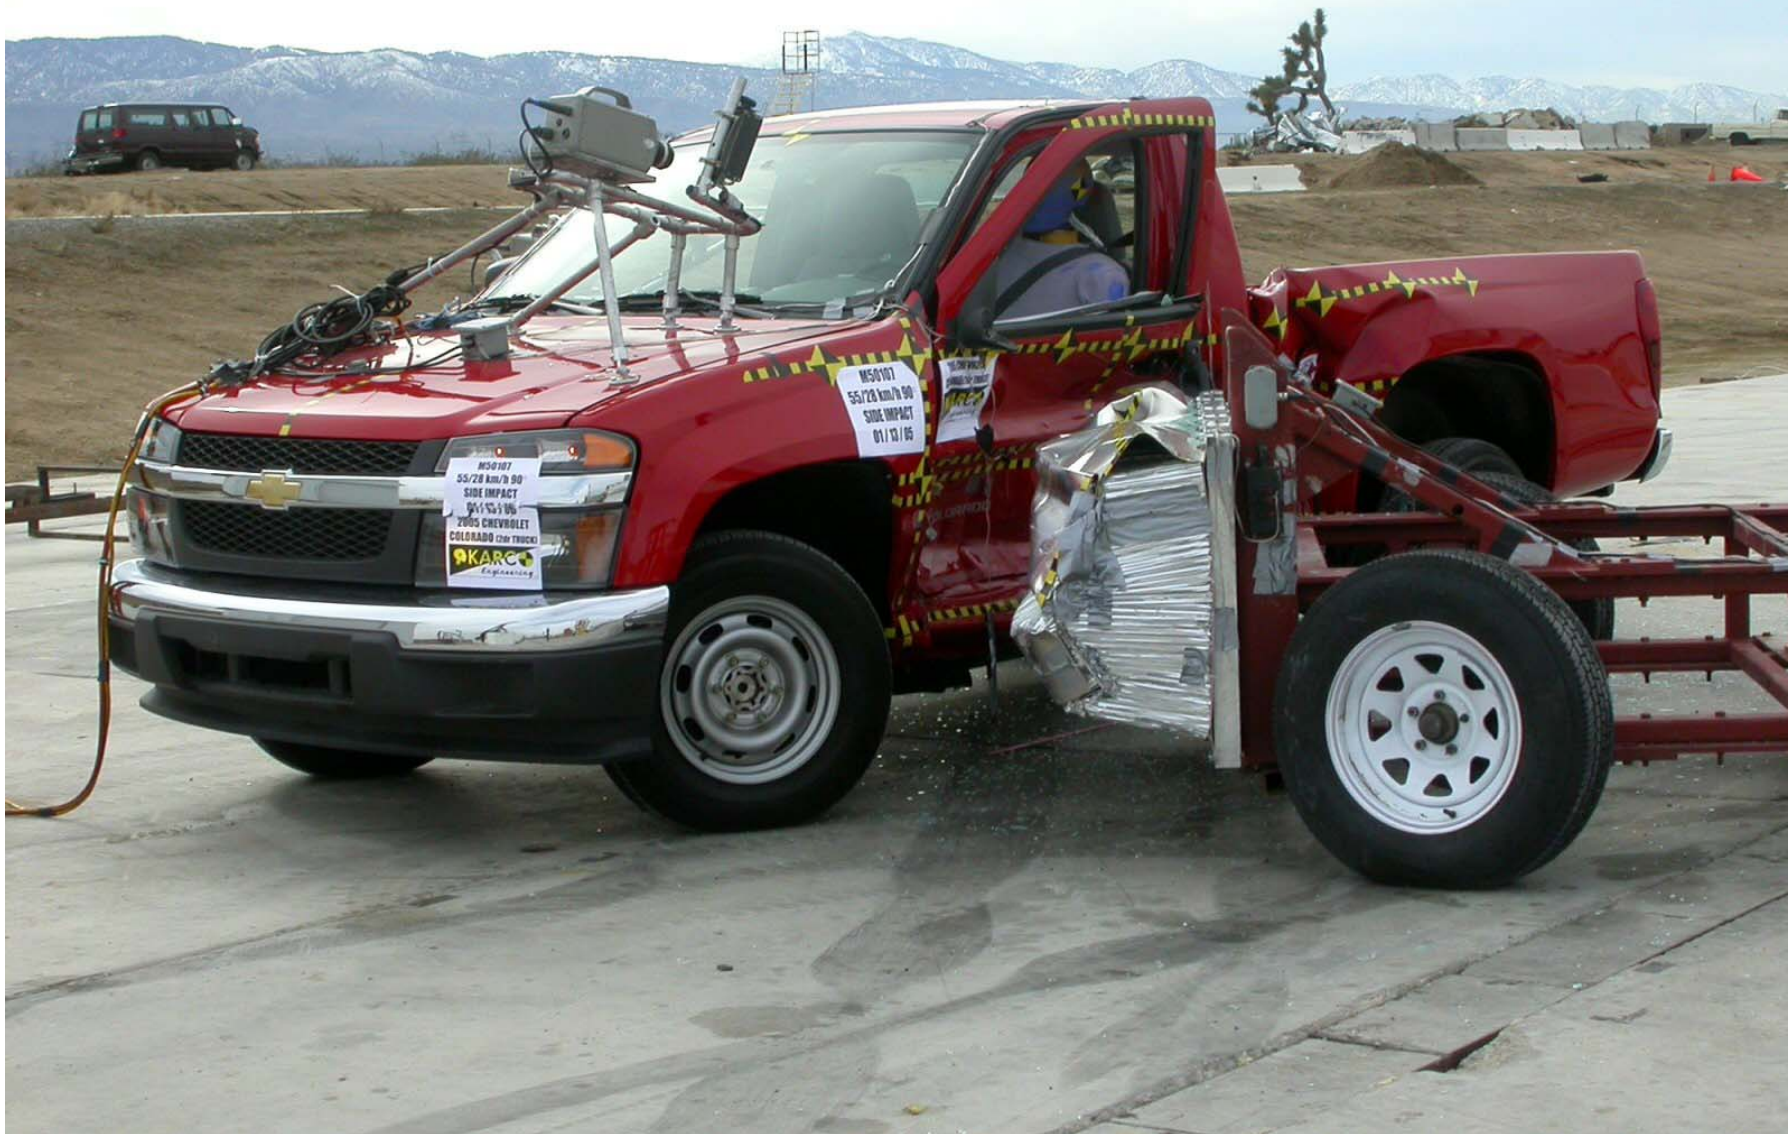
Figure A-8: Post-Test Left Front  $\frac{3}{4}$  View

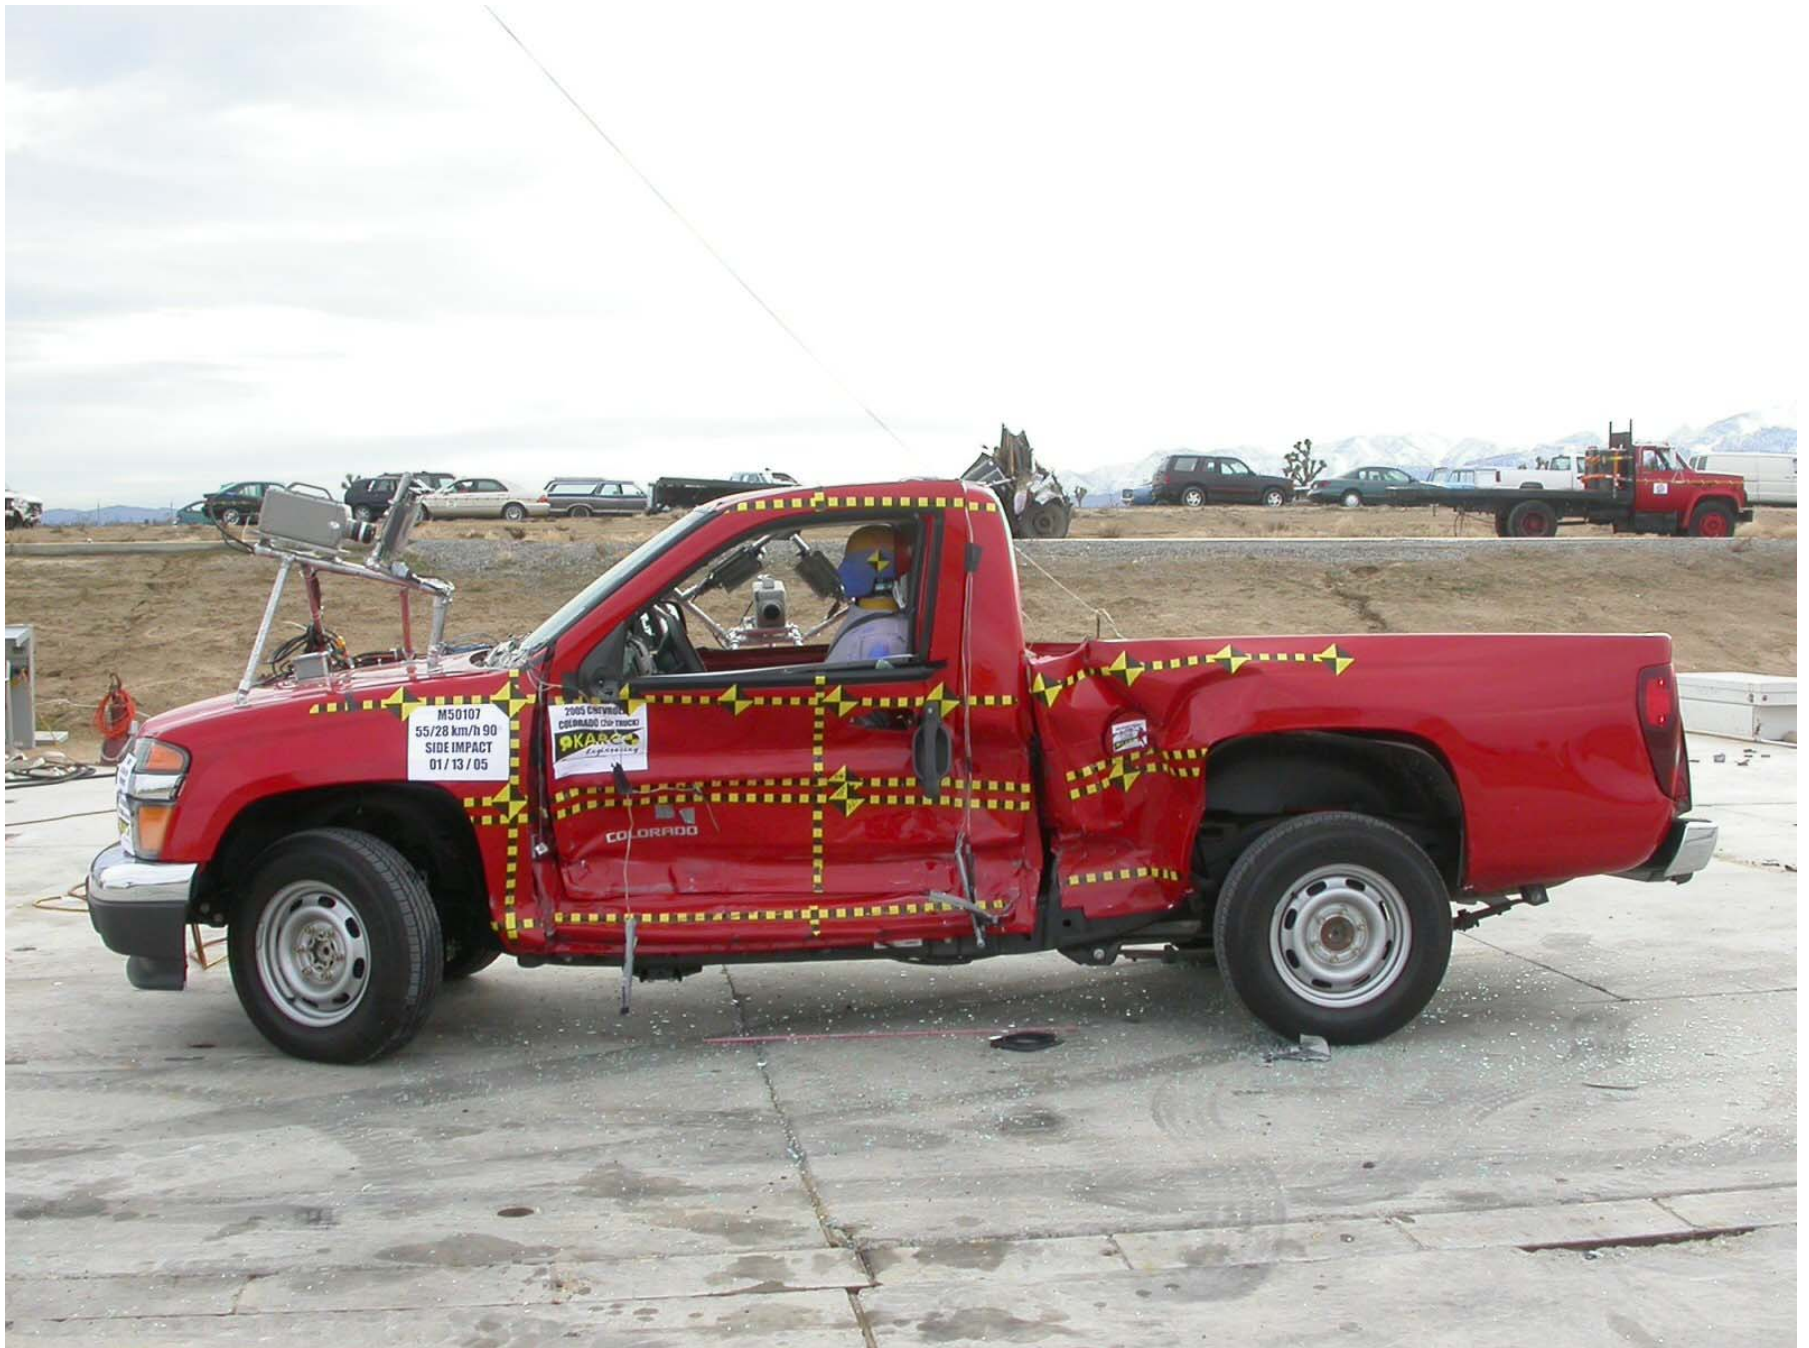
Figure A-10: Post-Test Left Side View

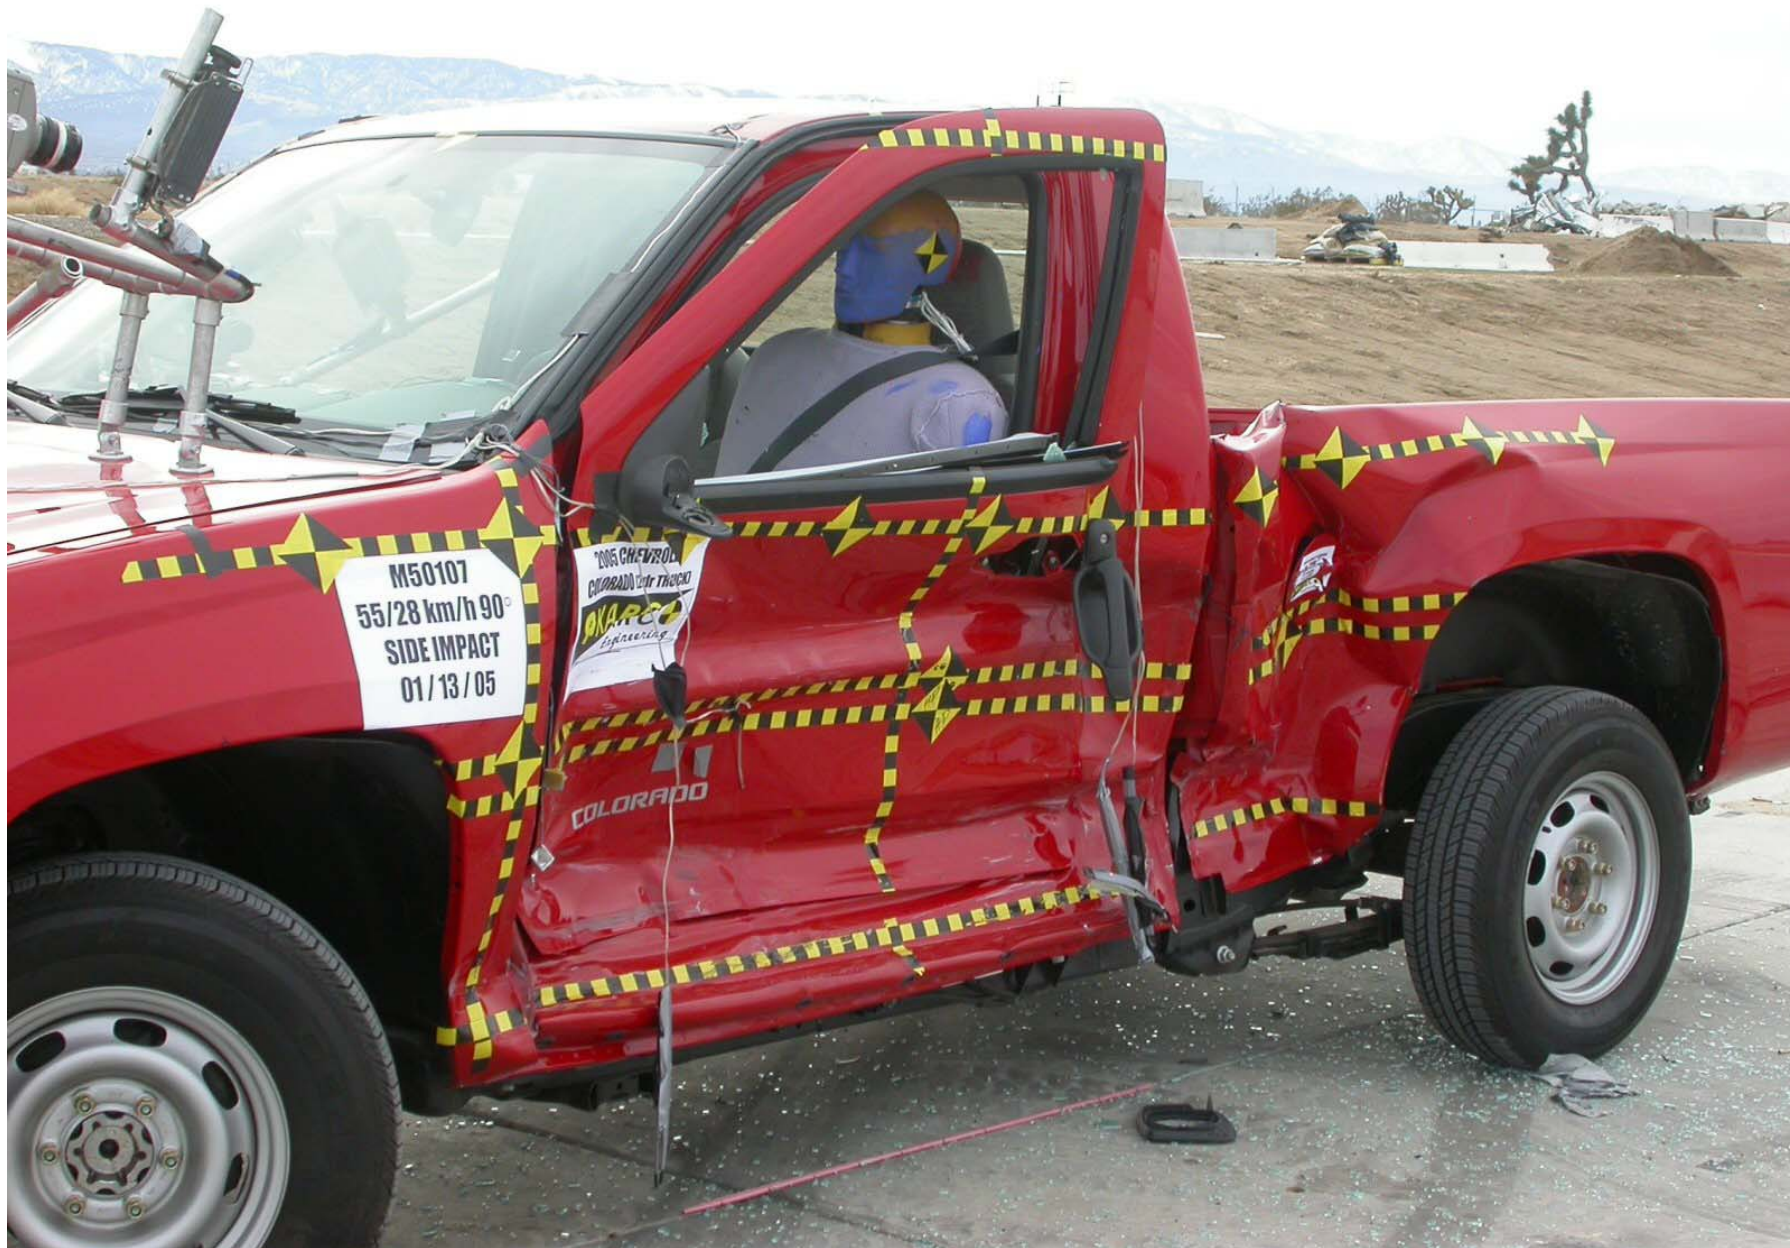
Figure A-30: Post-Test Front ¾ View of Left Side Door

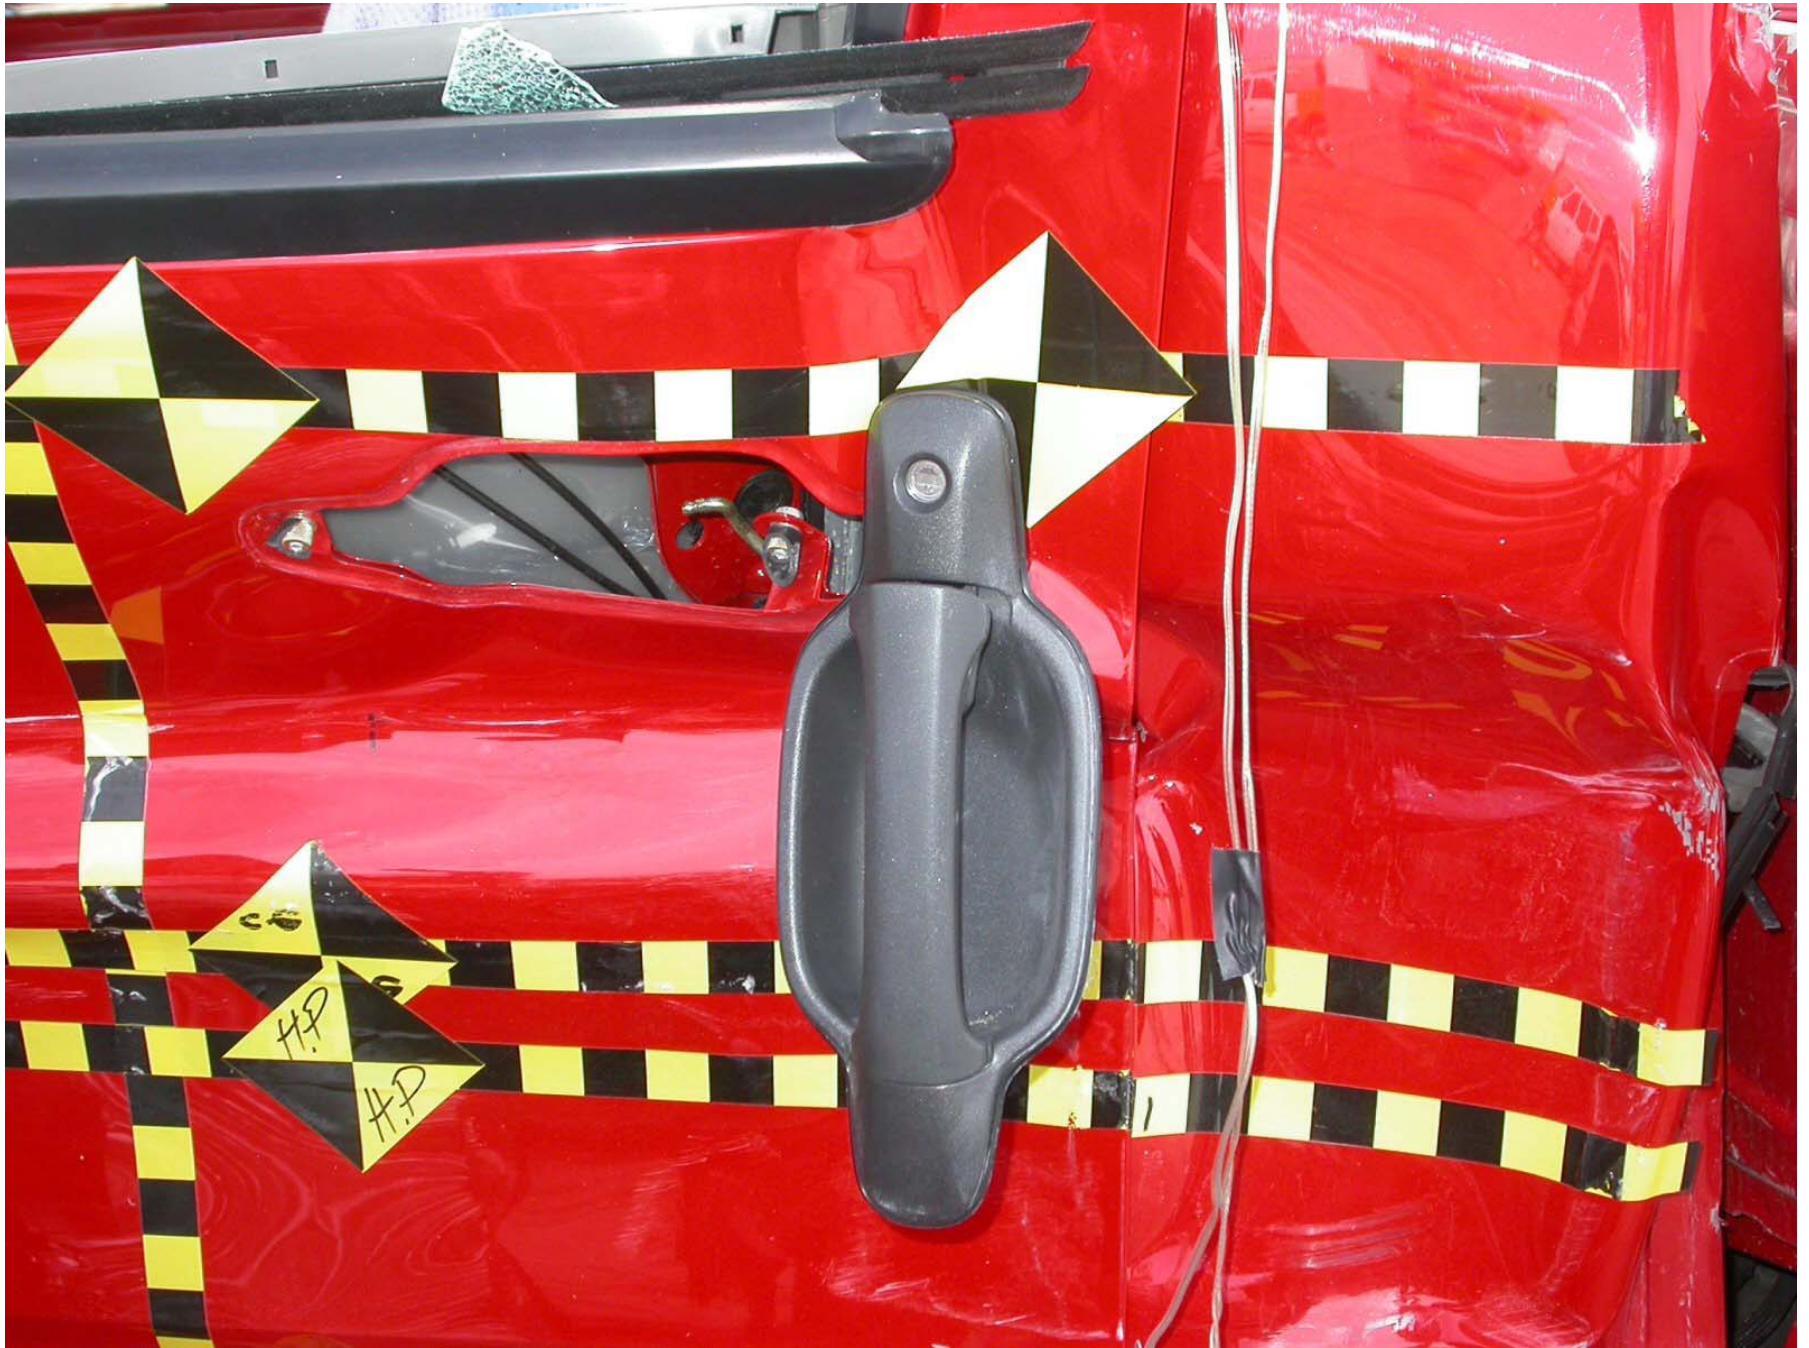
Figure A-34: Post-Test Left Front Door

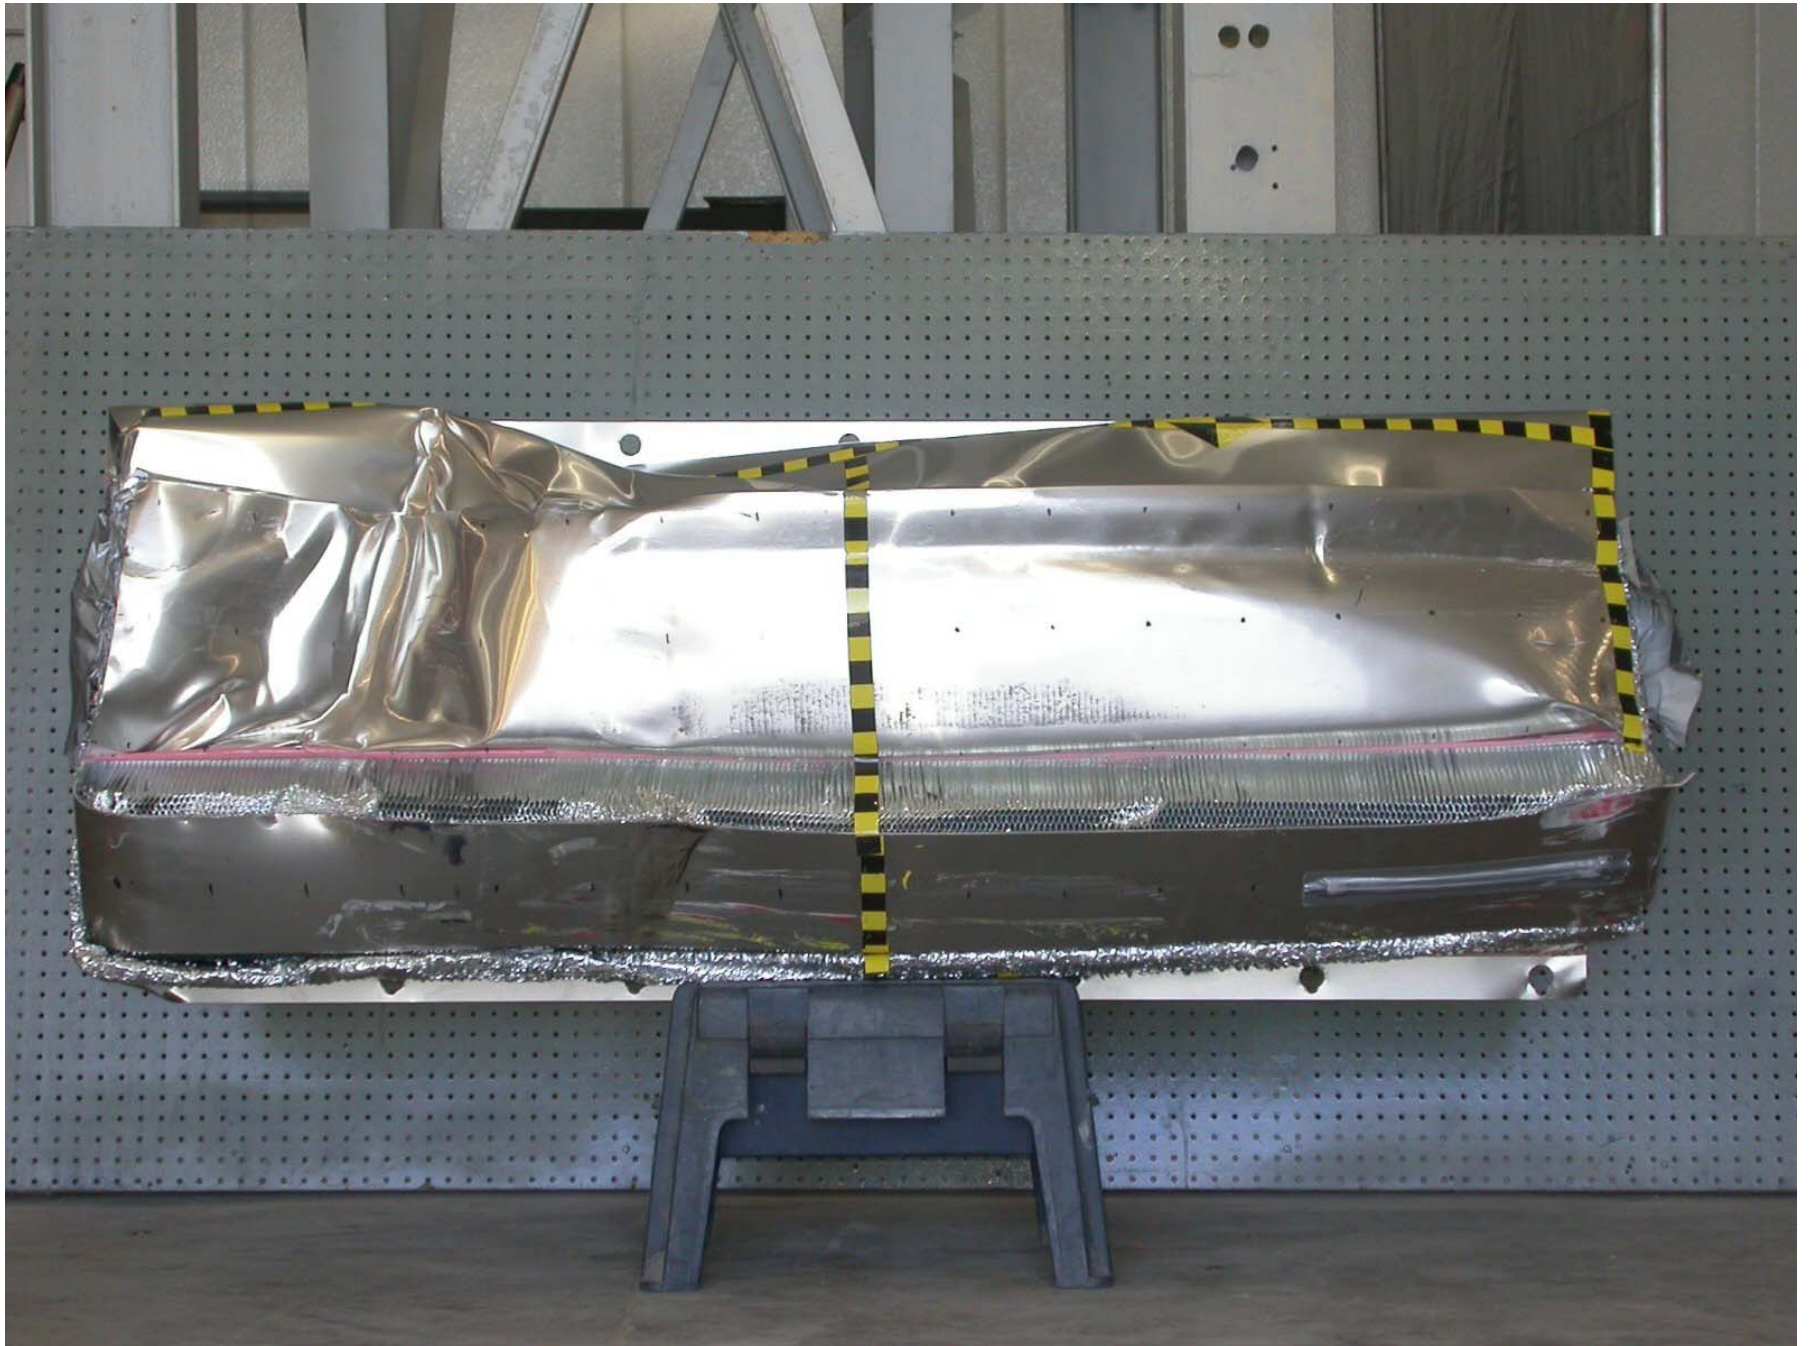
Figure A-45: Post-Test Front View of Deformable Barrier

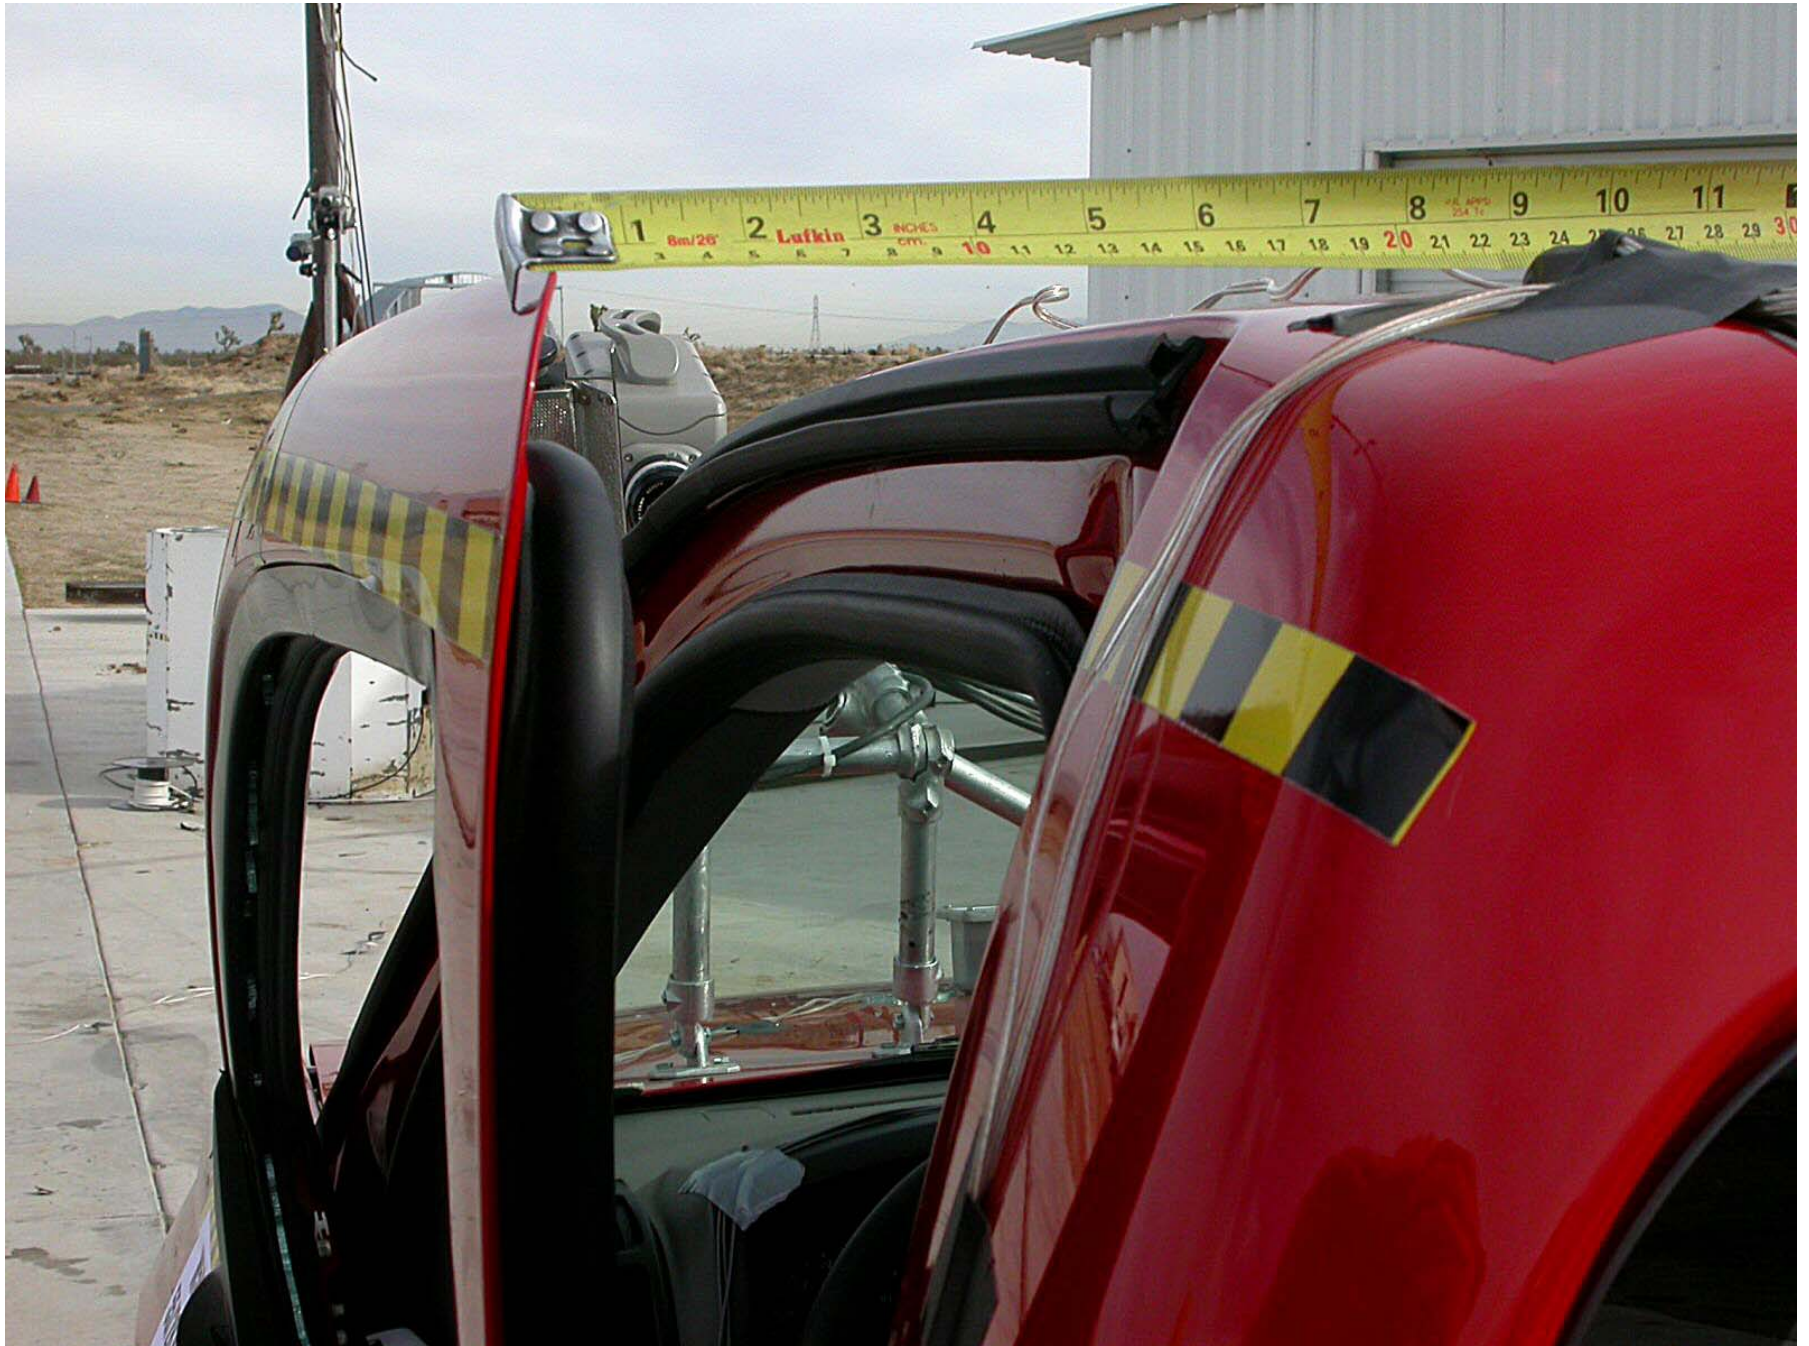
Figure A-57: Post-Test Driver Door

The driver door remained latched, although it separated near top sill (Figure No. 57). The test vehicle sustained a maximum static crush of 321 mm at level 2, 750 mm rearward of the left vertical impact point. The driver SID/Hybrid III, Serial No. 275 was calibrated prior to this test. The SID/Hybrid III injury criteria is summarized as follows:
