REPORT NUMBER: SNCAP-CAL-05-04

**NEW CAR ASSESSMENT PROGRAM  
SIDE IMPACT TEST**

GM DAEWOO AUTO & TECHNOLOGY COMPANY  
2005 SUZUKI VERONA  
4-DOOR SEDAN

**FINAL REPORT**

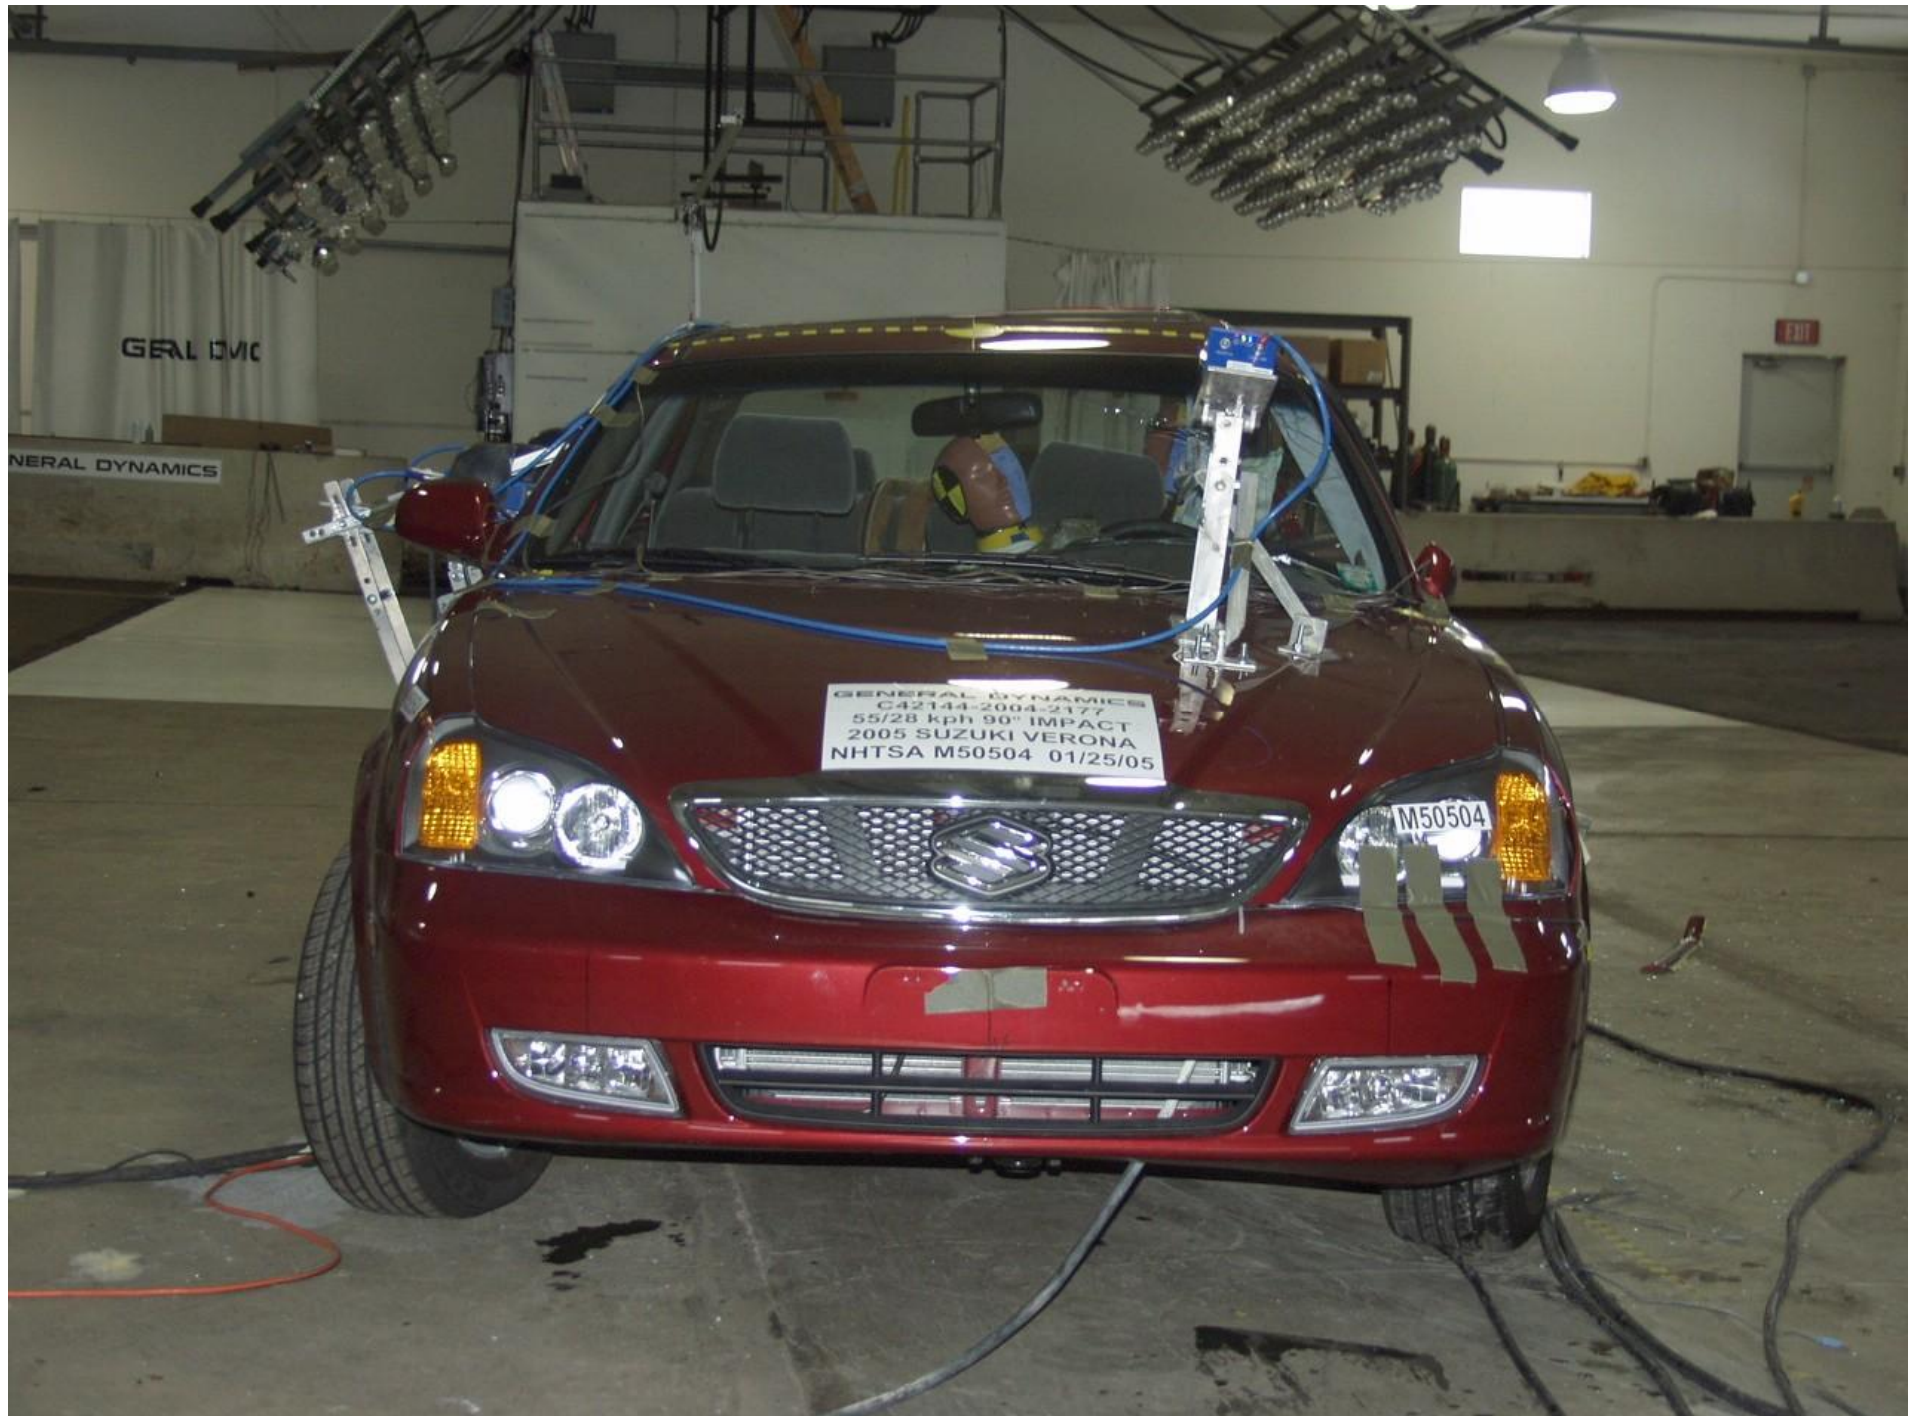
Figure A-2 POST-TEST FRONTAL VIEW OF TEST VEHICLE

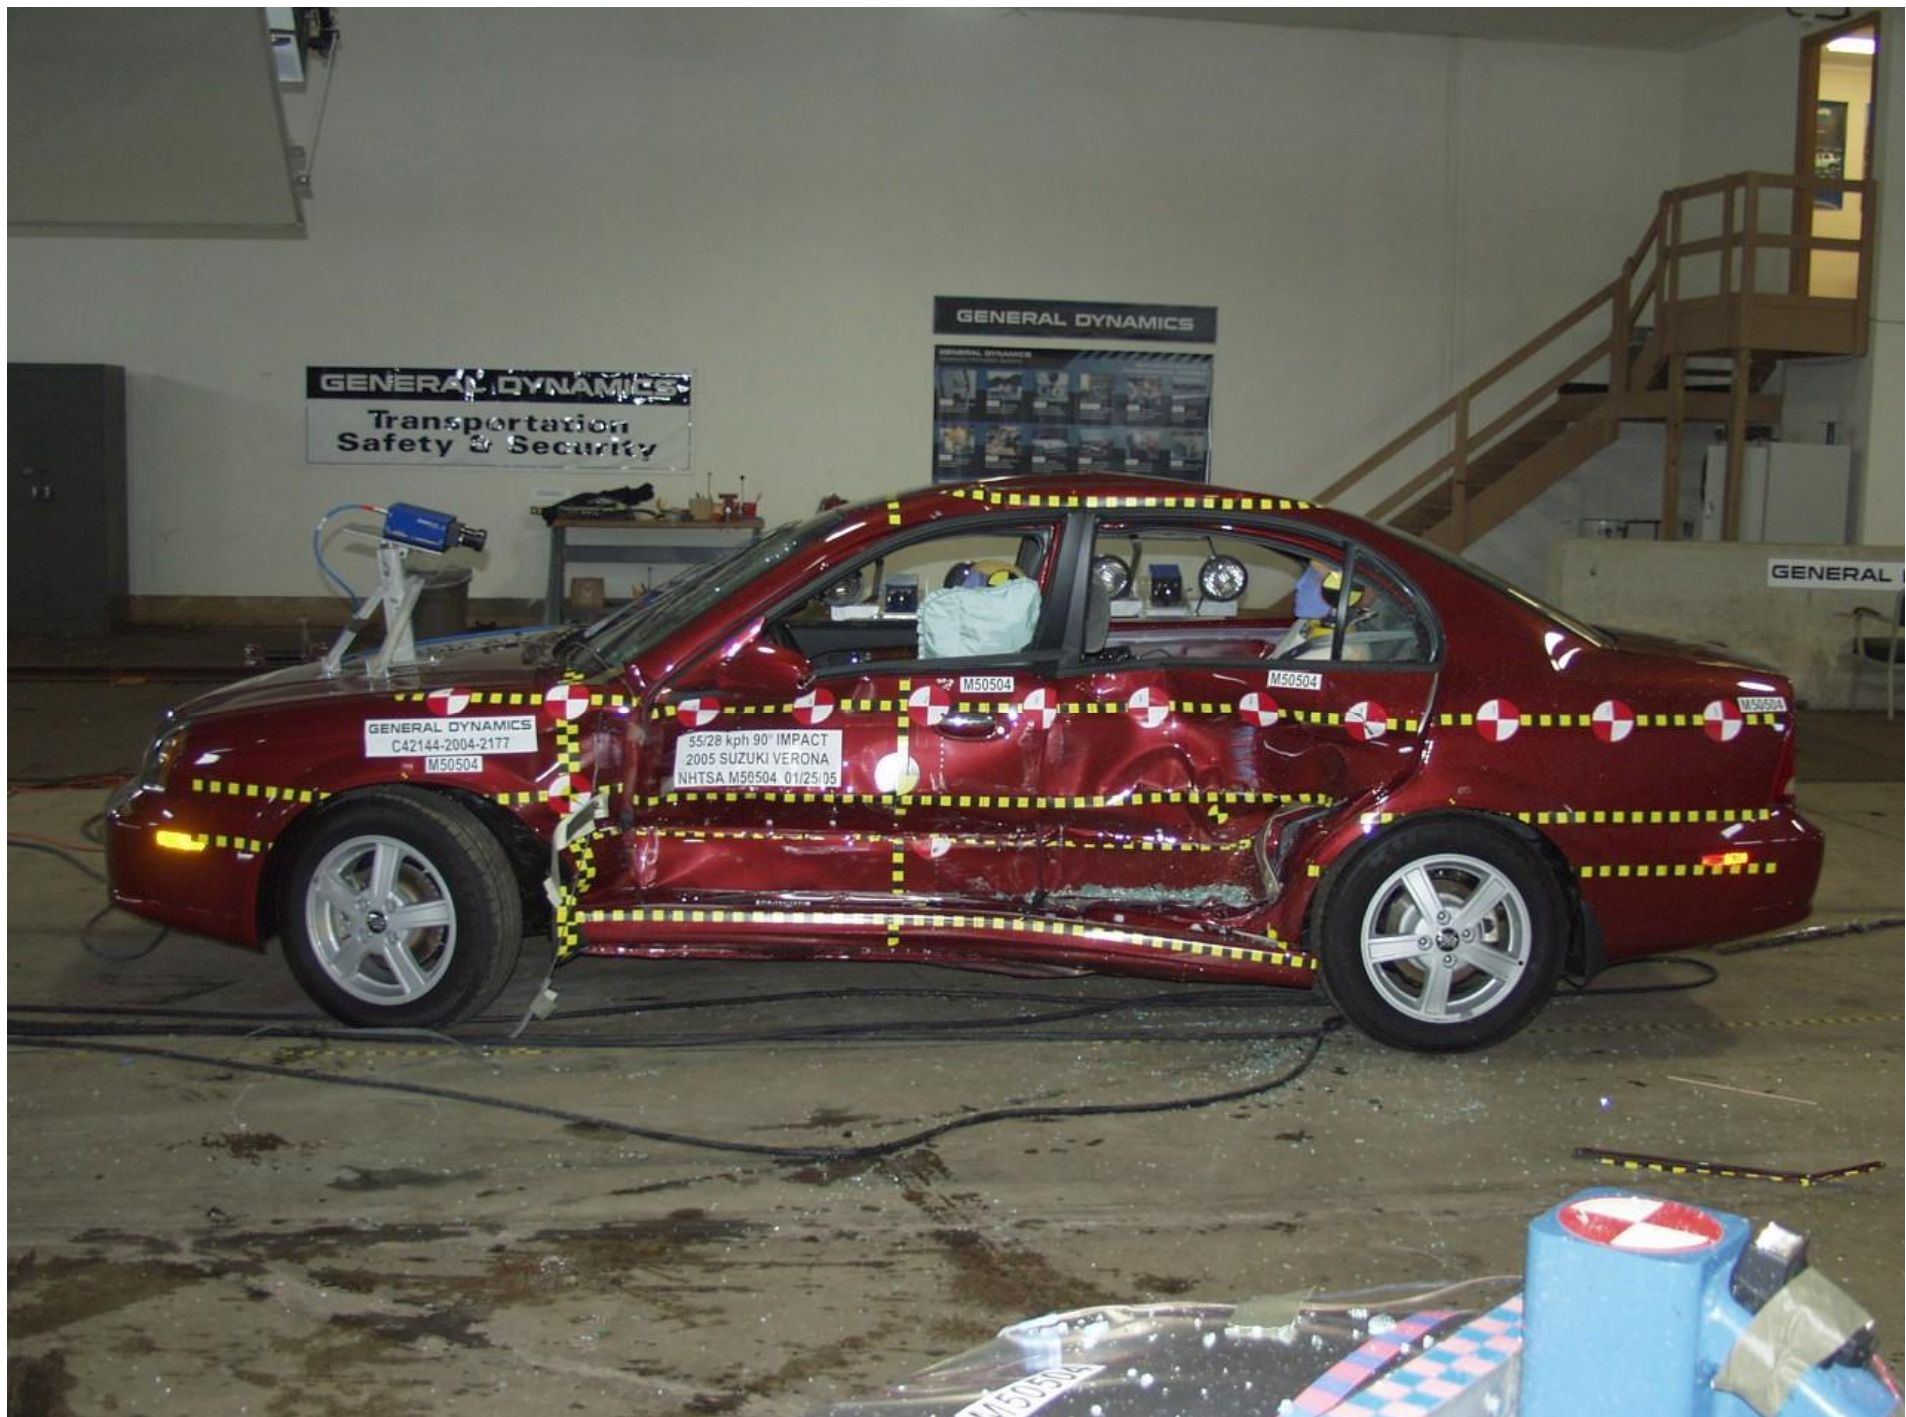
Figure A-6 POST-TEST IMPACTED SIDE VIEW OF TEST VEHICLE

| CRITICAL AREAS OF PERFORMANCE | |
|---|---|
| Windshield Damage | Cracked along the A-Pillar during the event |
| Window Damage | The driver side window and left rear passenger side window shattered during the event. |

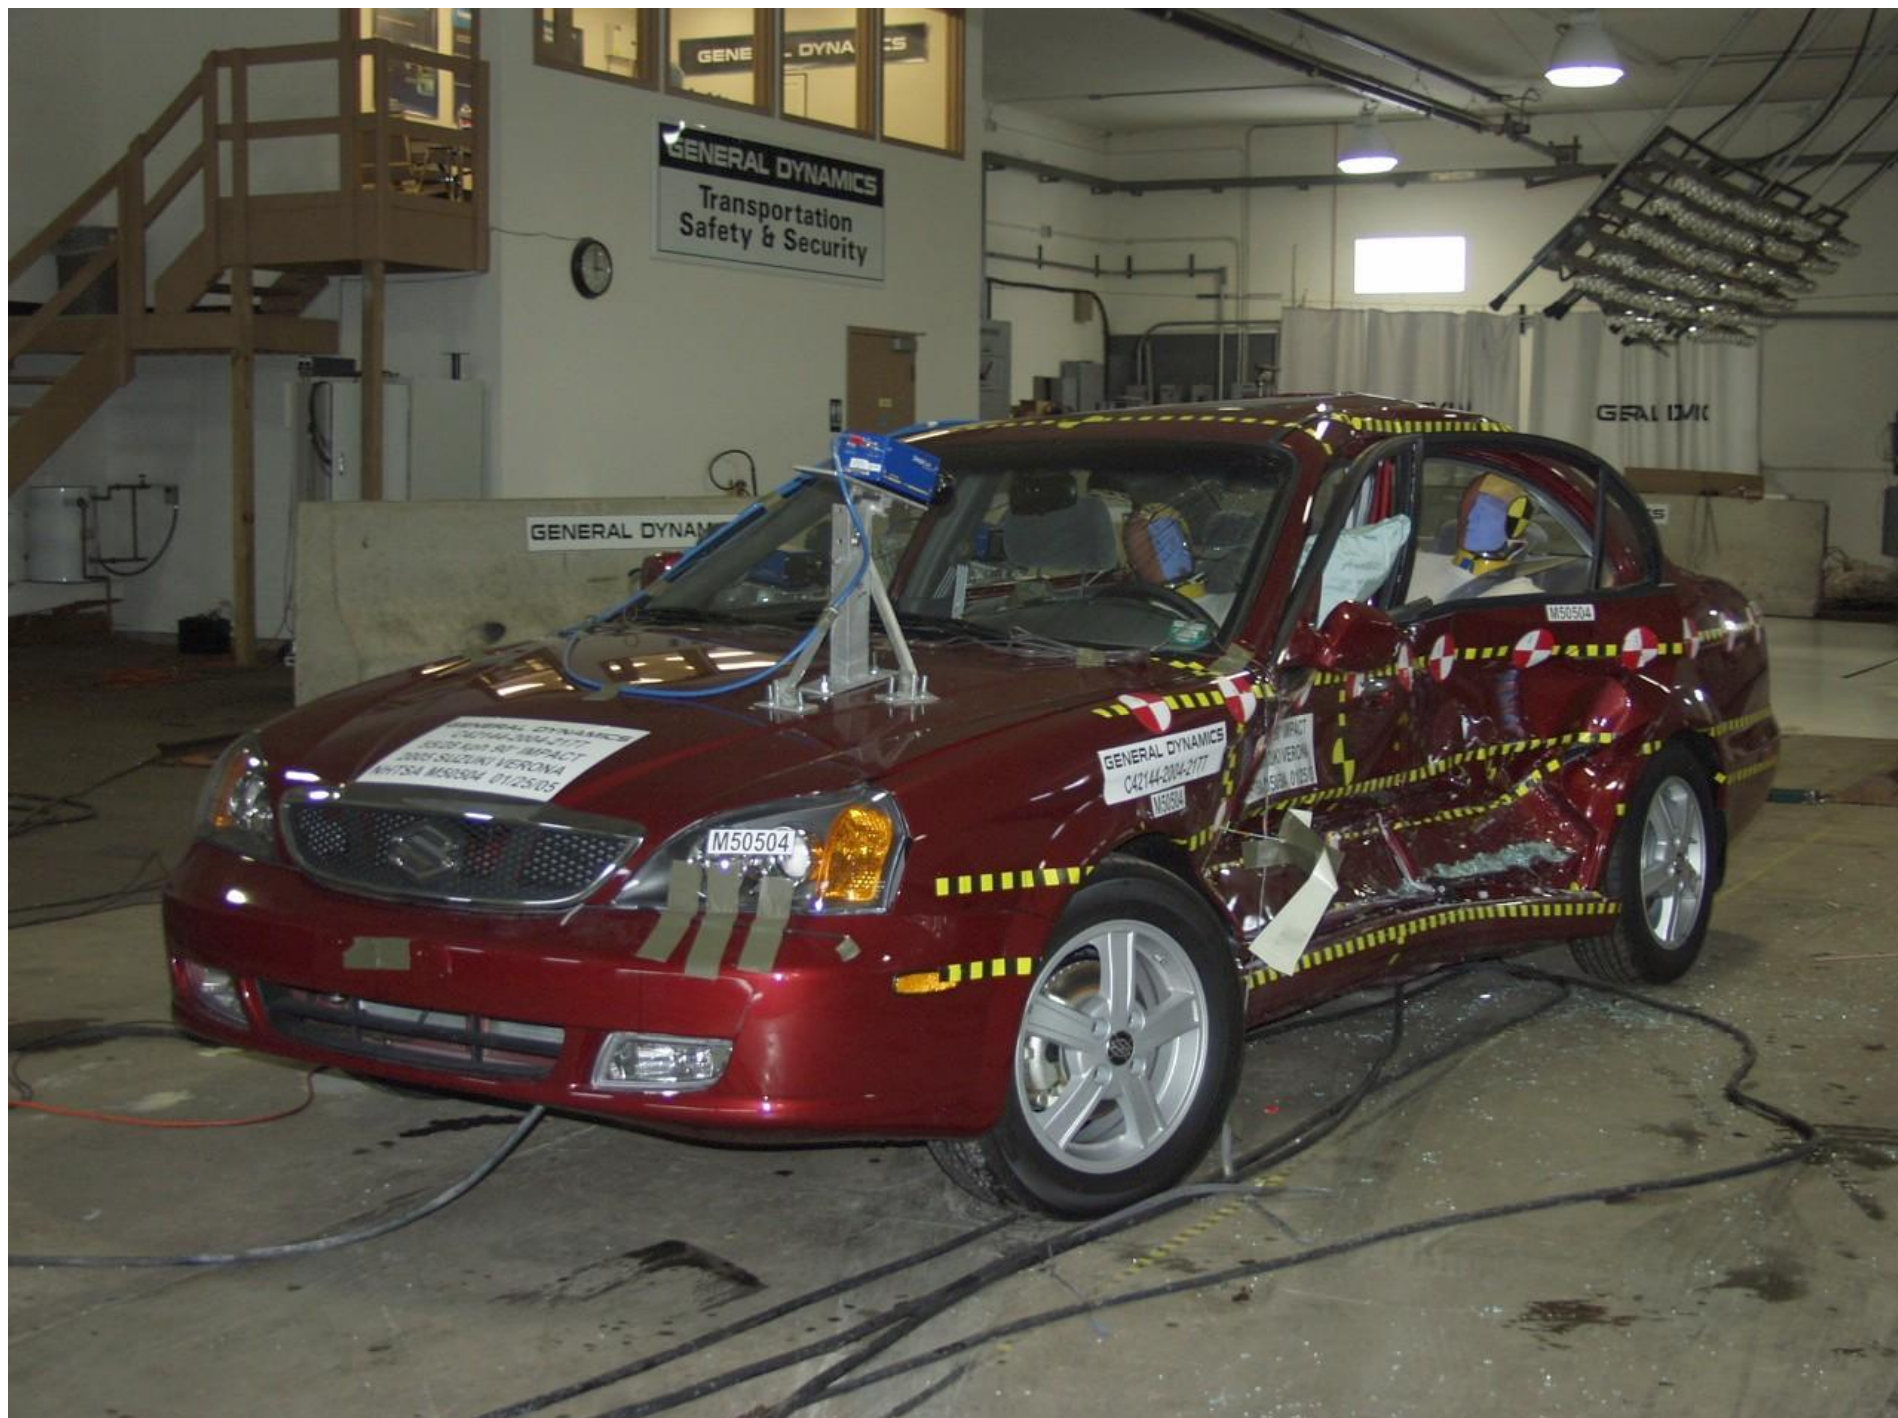
Figure A-8 POST-TEST LEFT FRONT VIEW OF TEST VEHICLE

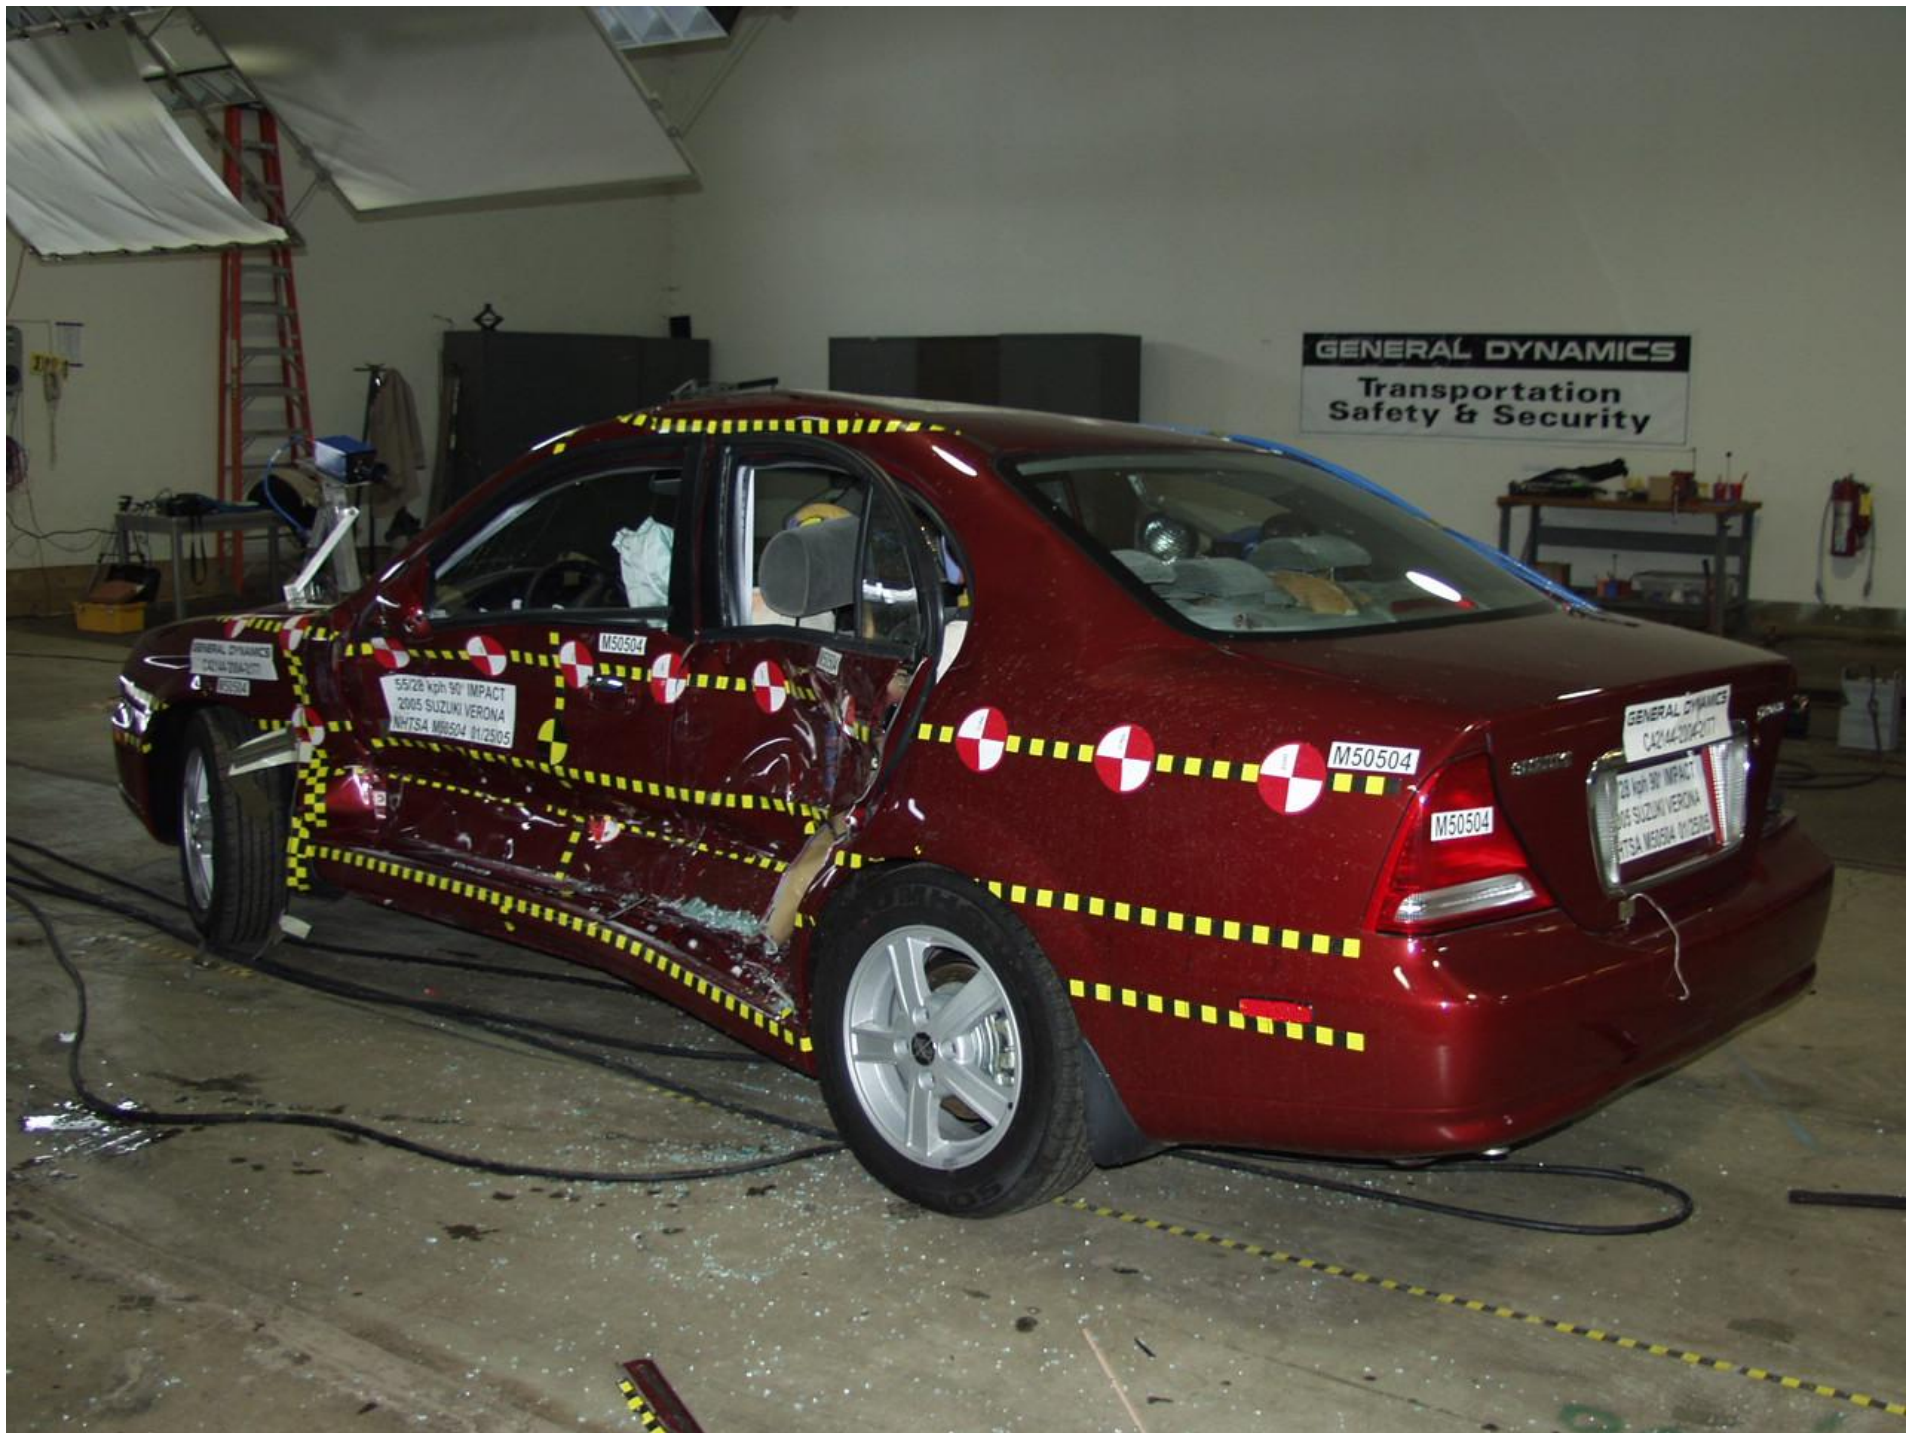
Figure A-10 POST-TEST LEFT REAR VIEW OF TEST VEHICLE

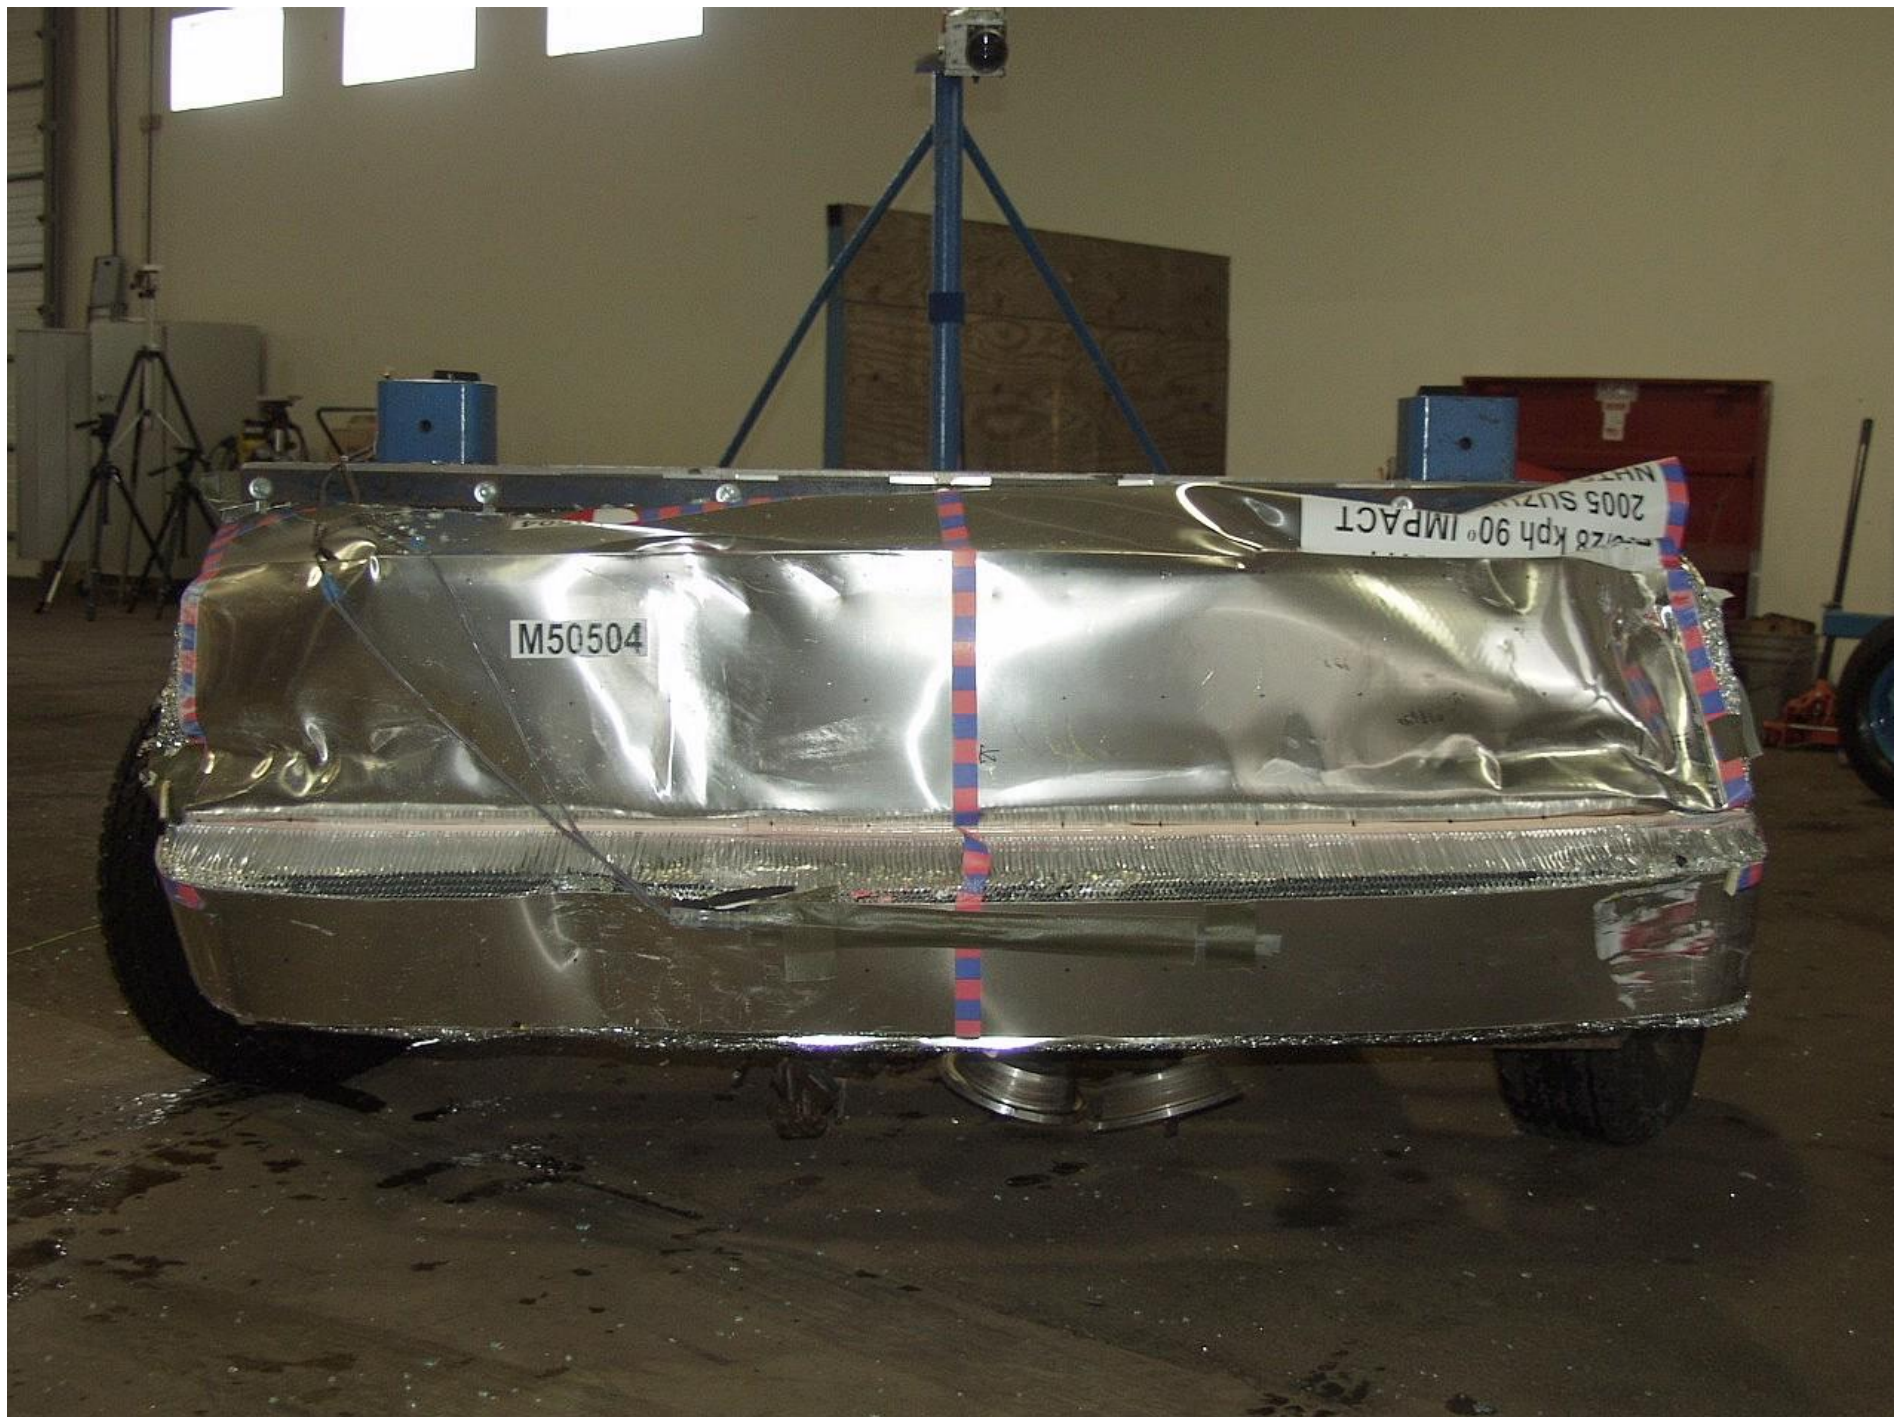
Figure A-16 POST-TEST FRONTAL VIEW OF IMPACTOR FACE

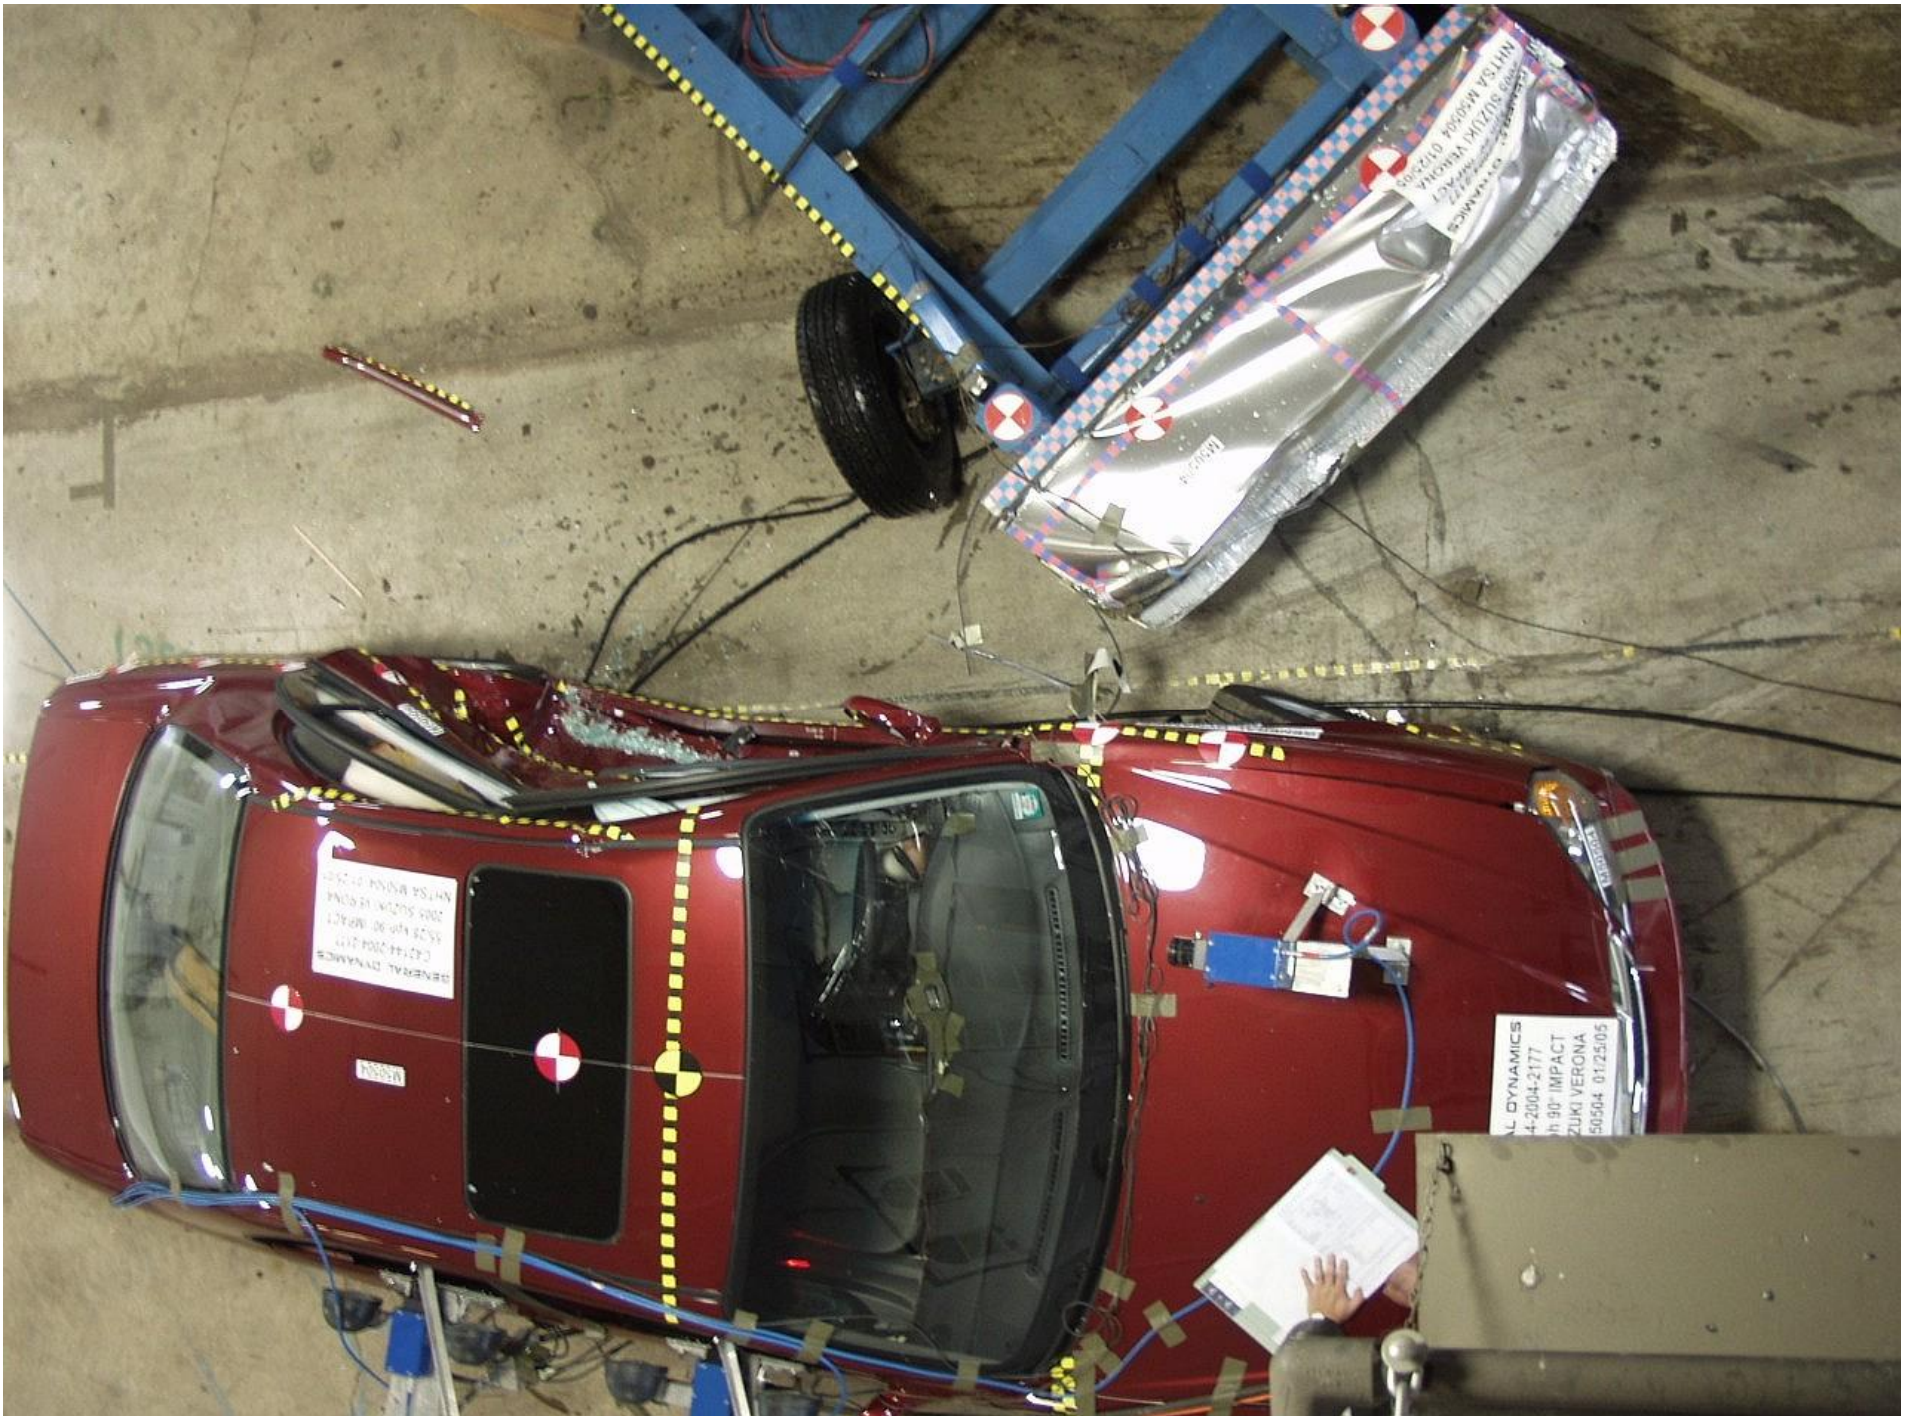
Figure A-24 POST-TEST OVERHEAD VIEW OF MDB AND VEHICLE

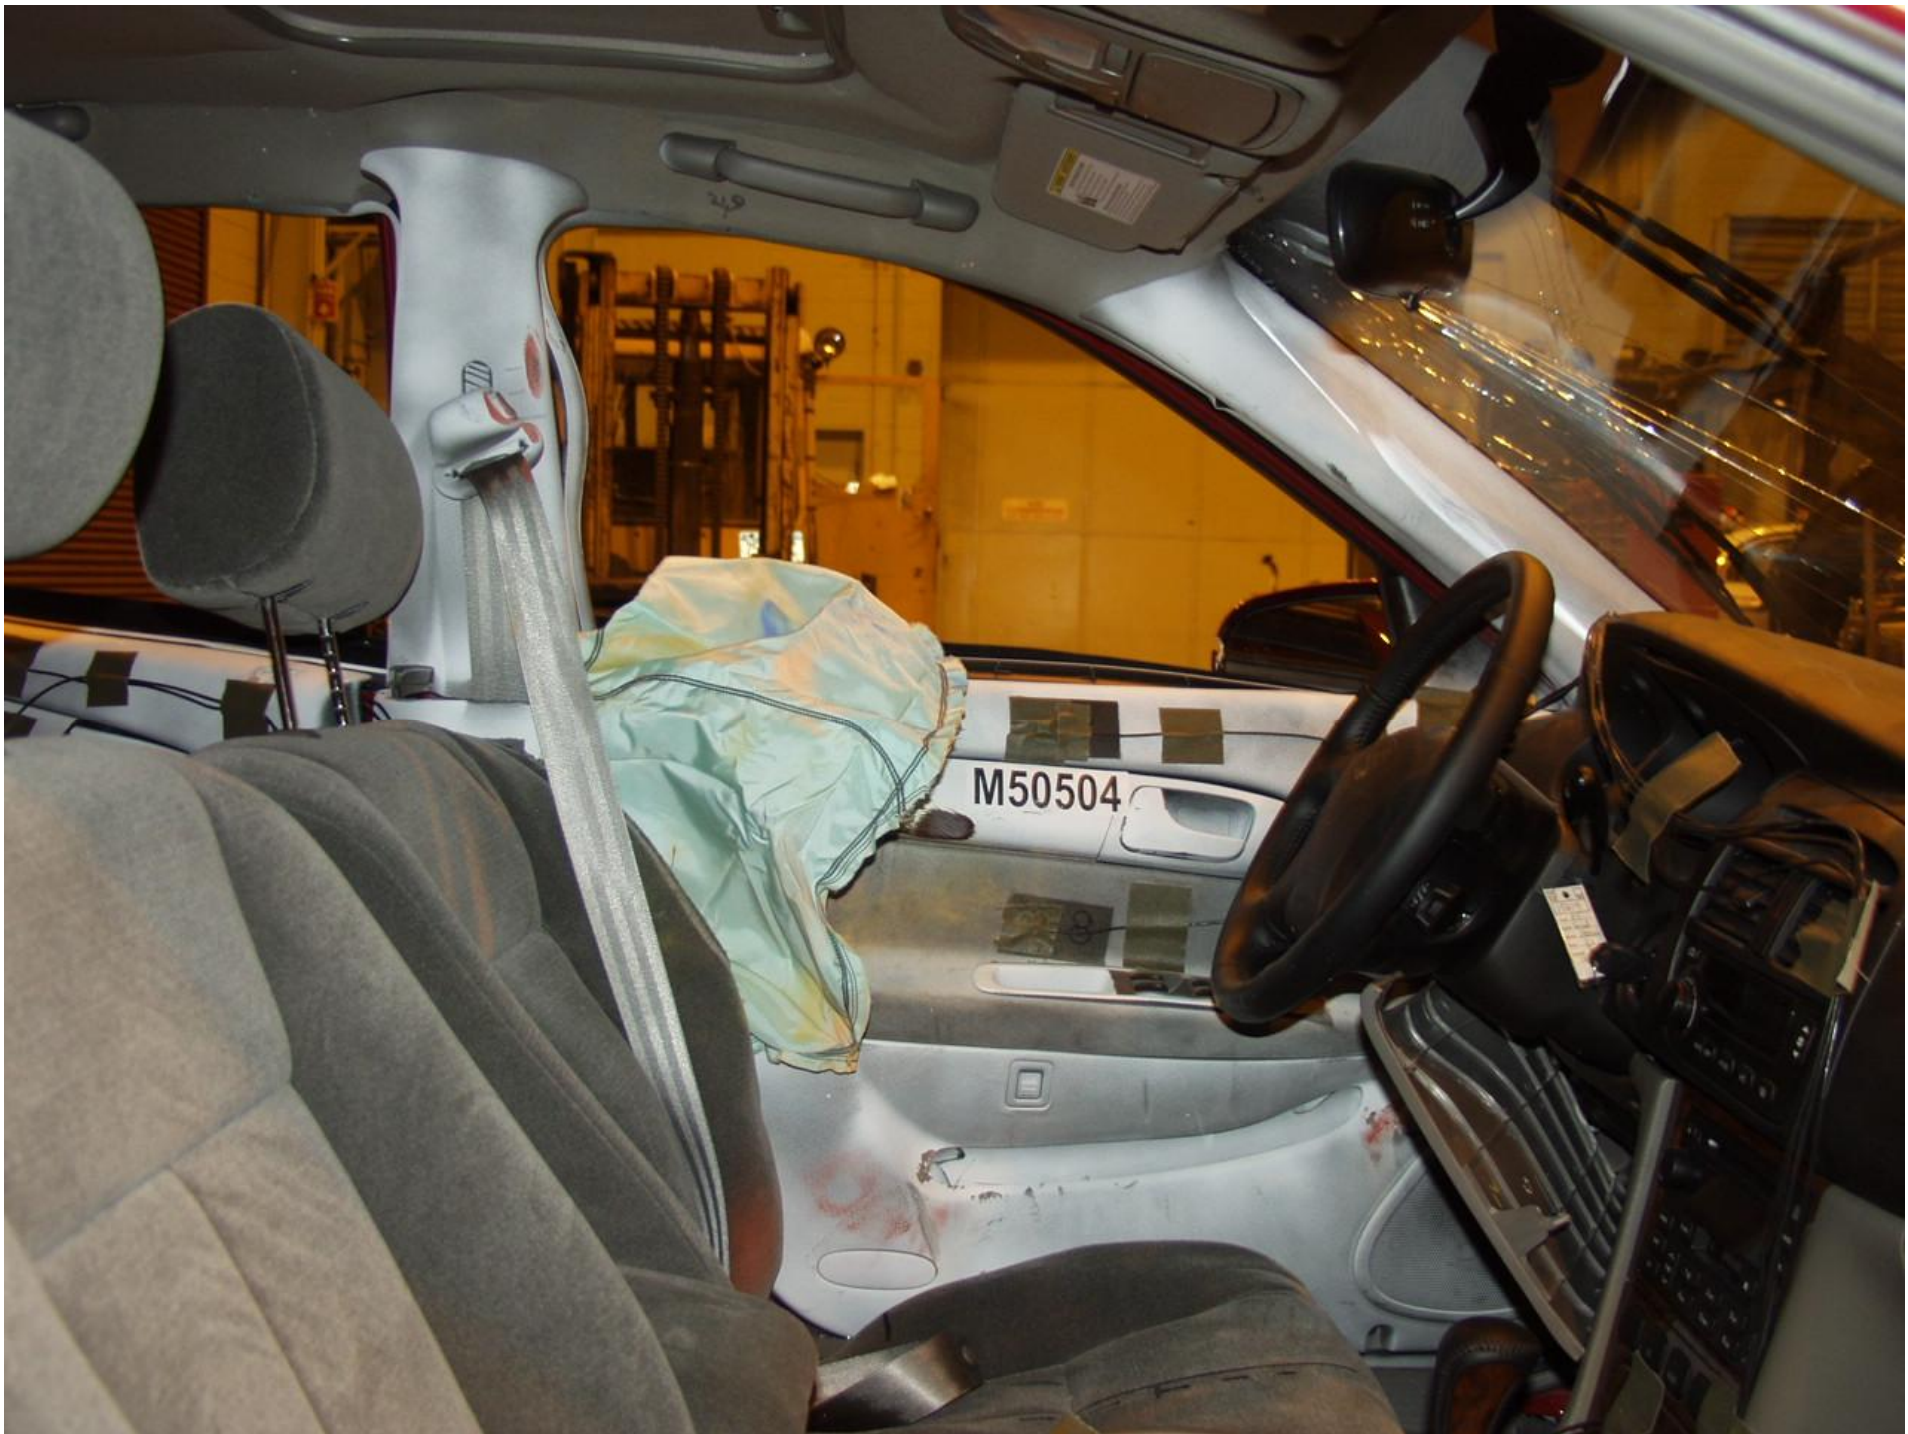
Figure A-34 POST-TEST INTERIOR OF FRONT DOOR SHOWING SID H3 IMPACT LOCATIONS

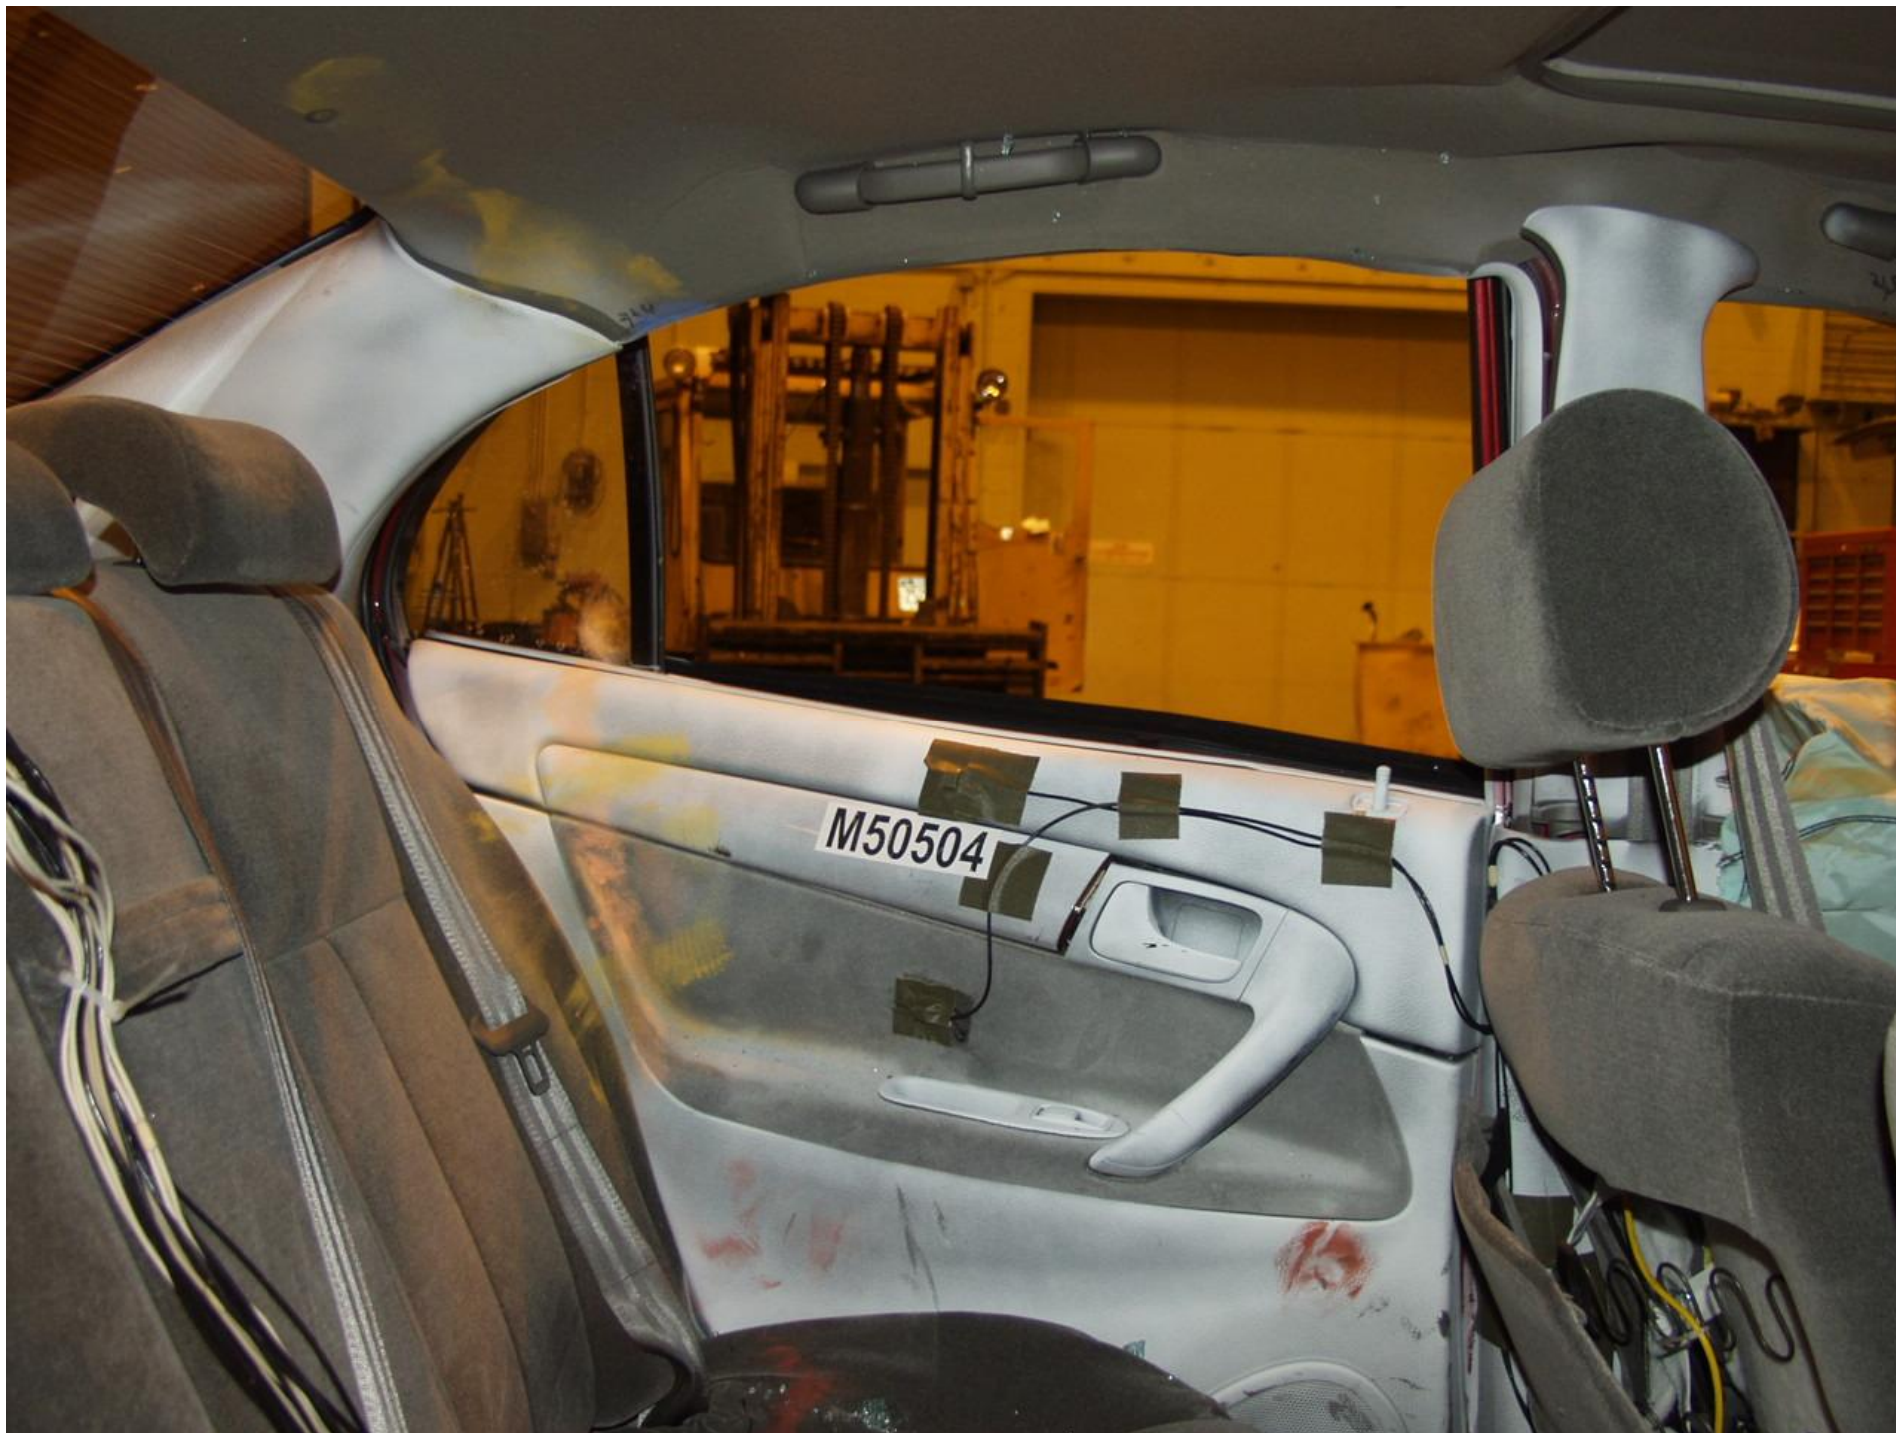
Figure A-36 POST-TEST INTERIOR OF REAR DOOR SHOWING SID H3 IMPACT LOCATIONS
