REPORT NUMBER: SNCAP-CAL-05-04

**NEW CAR ASSESSMENT PROGRAM  
SIDE IMPACT TEST**

GM DAEWOO AUTO & TECHNOLOGY COMPANY  
2005 SUZUKI VERONA  
4-DOOR SEDAN

**FINAL REPORT**

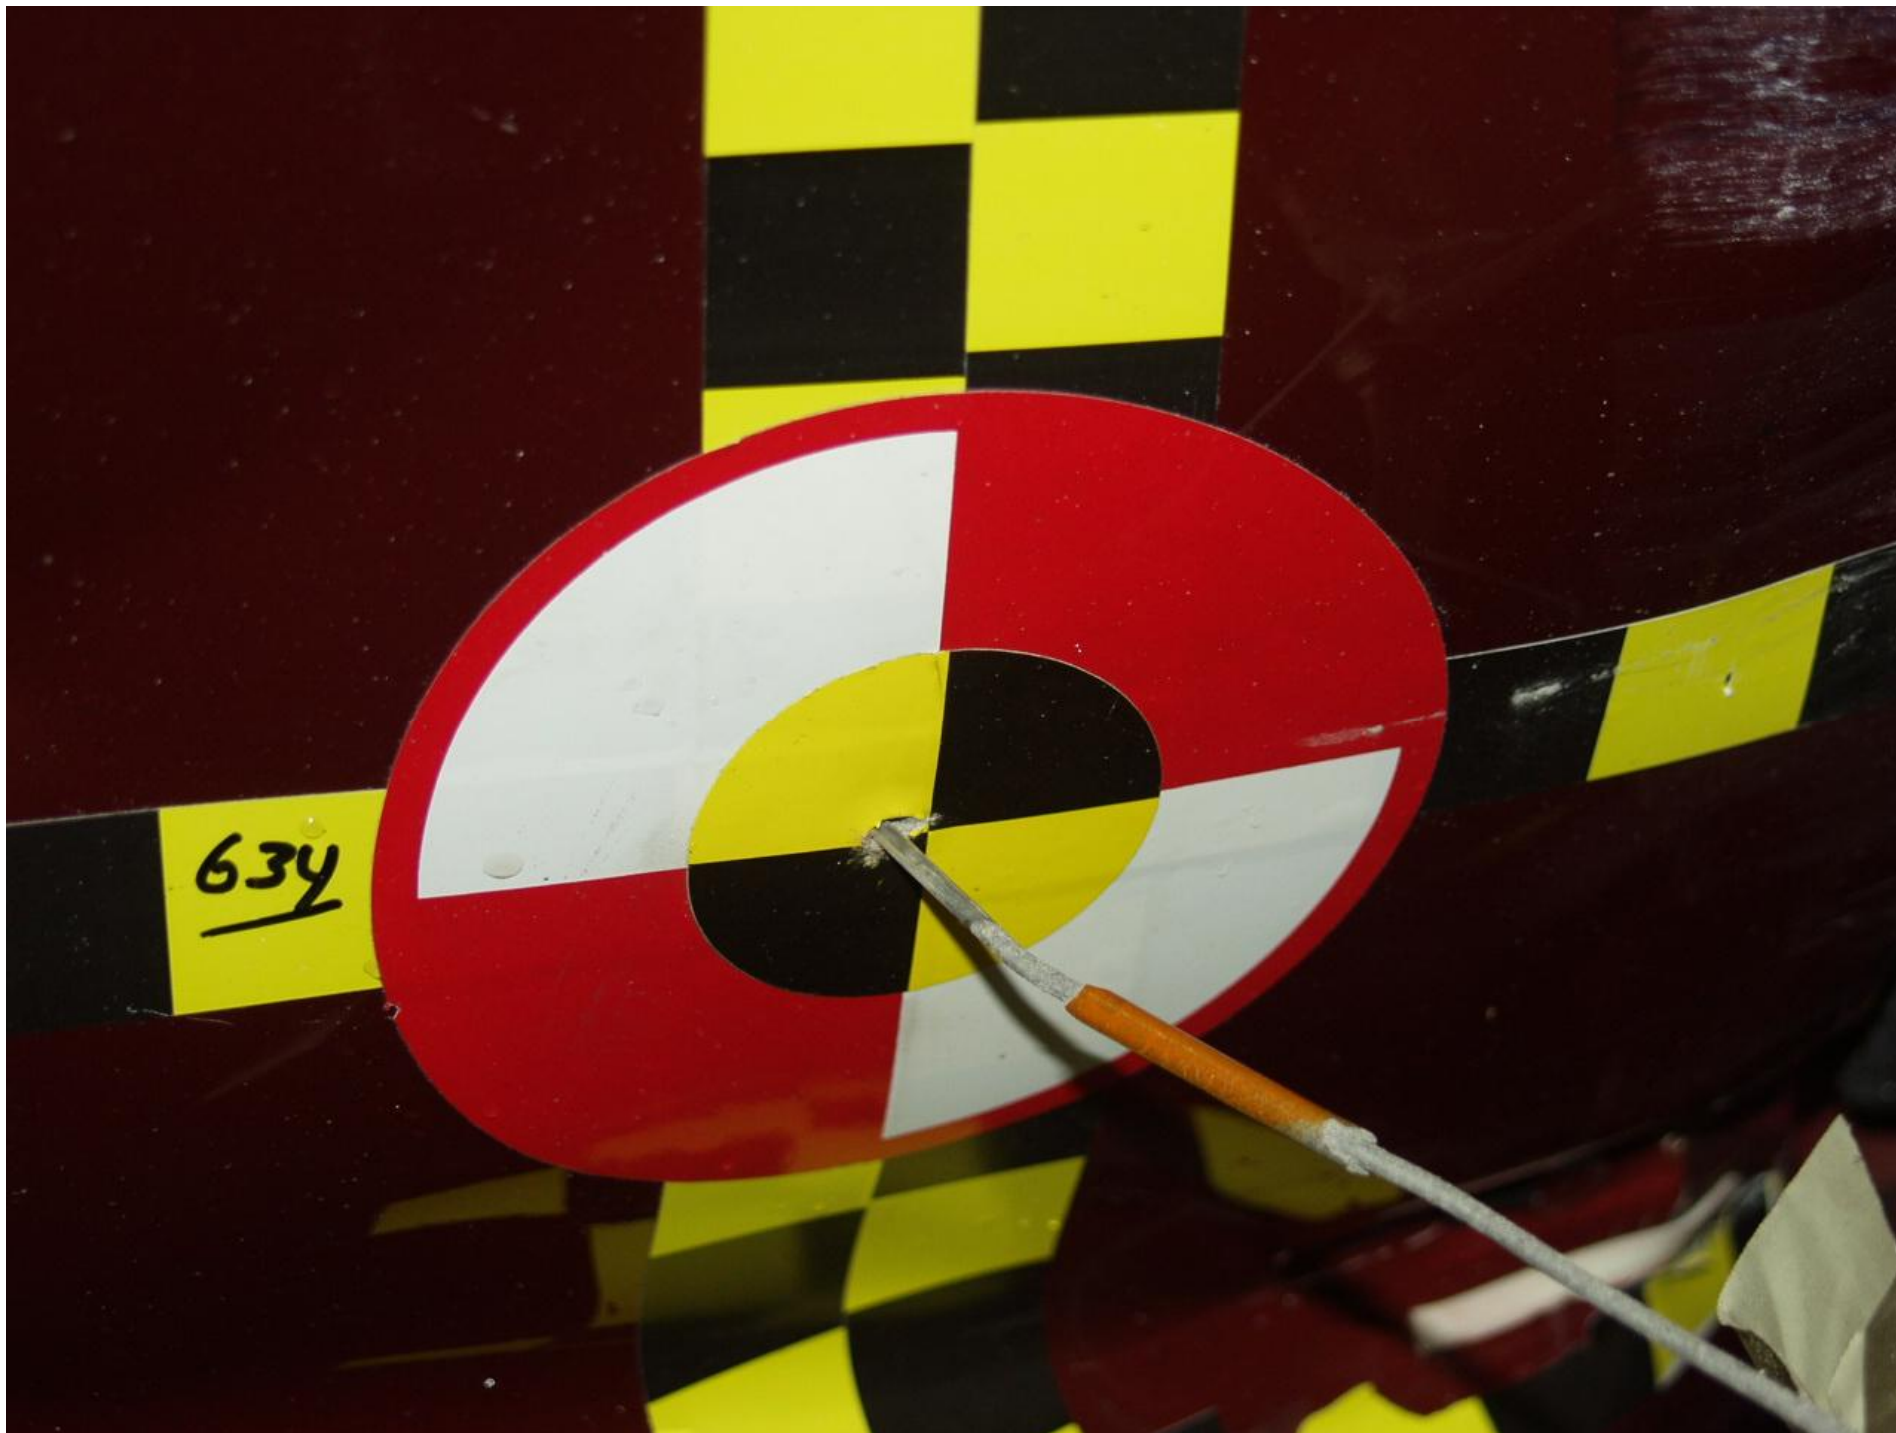
Figure A-39 POST-TEST CLOSE-UP VIEW OF IMPACT POINT TARGET

Actual Impact Point is 4 mm forward of nominal impact ref. line (Lateral)

Actual Impact Point is 1 mm below nominal impact point (Vertical)

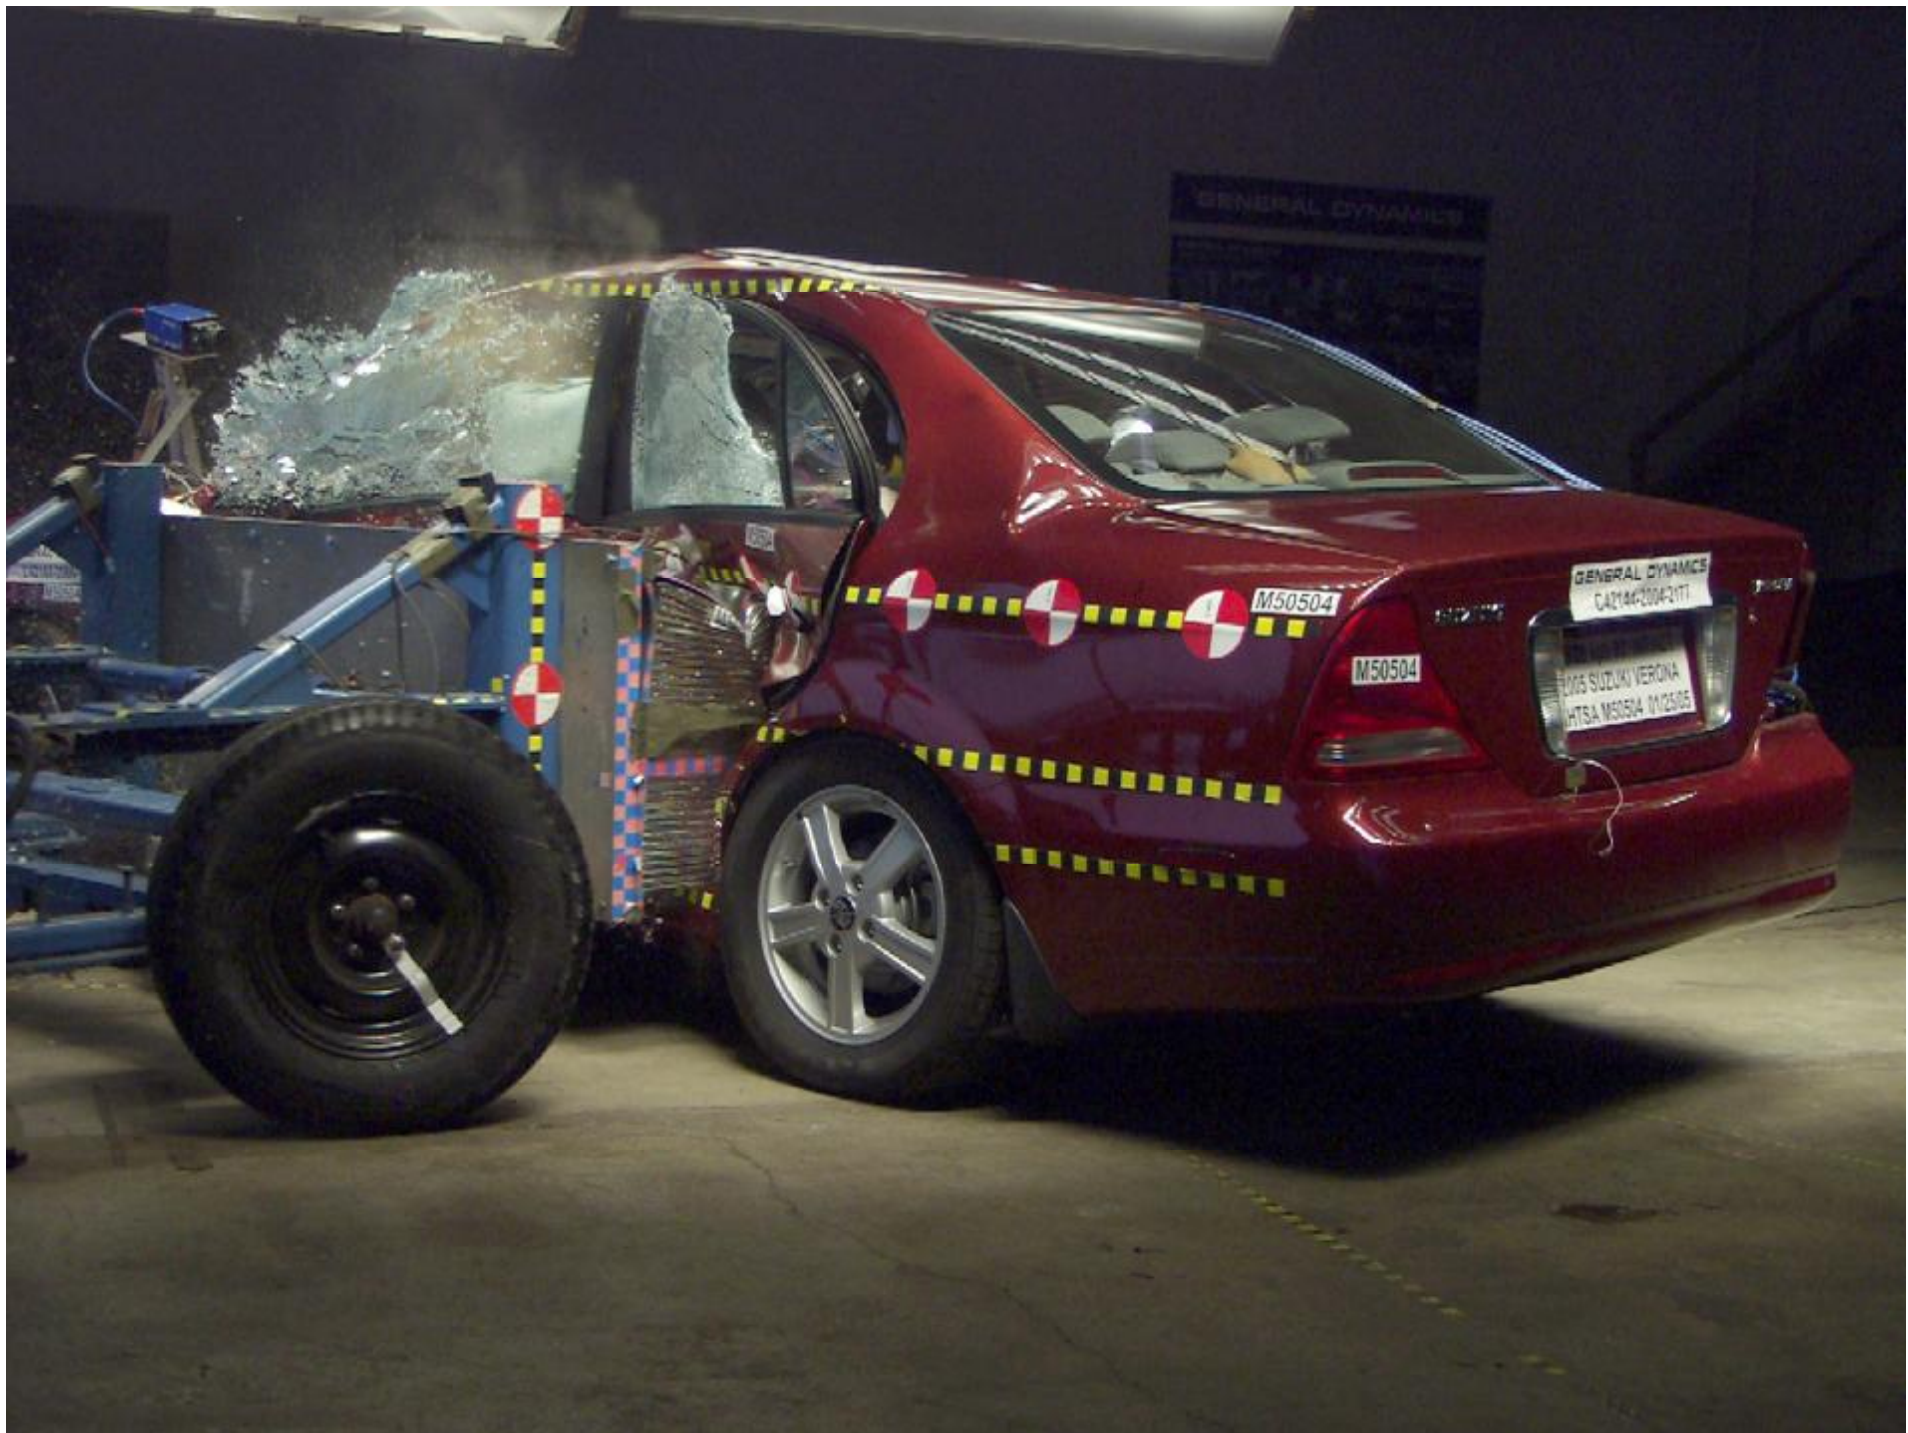
Figure A-42 IMPACT PHOTO
