**REPORT NUMBER: NCAPSIDE-MGA-2005-006**

**NEW CAR ASSESSMENT PROGRAM  
SIDE IMPACT TEST**

**NISSAN MOTOR COMPANY Ltd.  
2005 NISSAN FRONTIER  
NHTSA NUMBER: M55211**

**PREPARED BY:  
MGA RESEARCH CORPORATION  
5000 WARREN ROAD  
BURLINGTON, WI 53105**

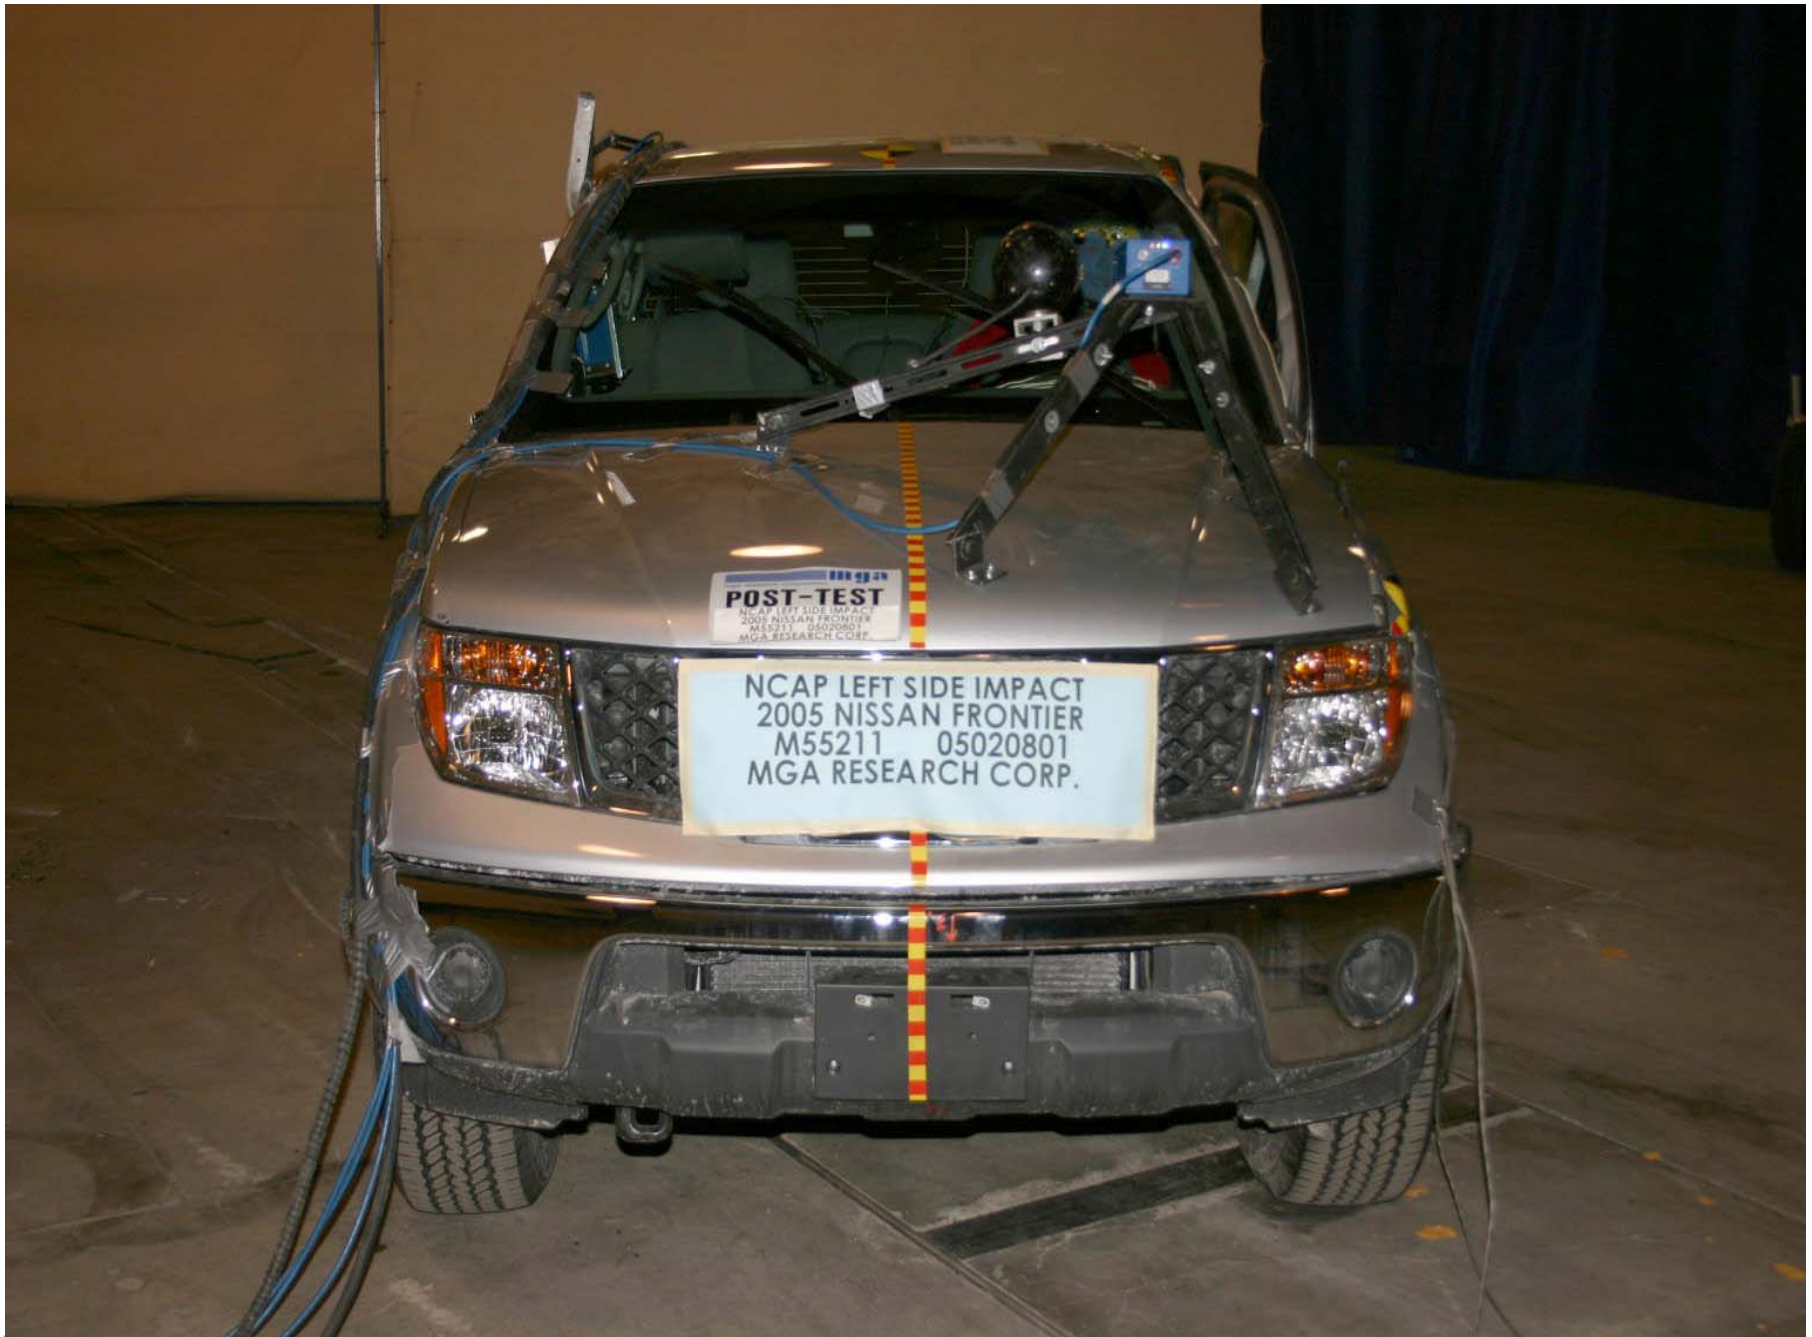
Post-Test Front View of Test Vehicle

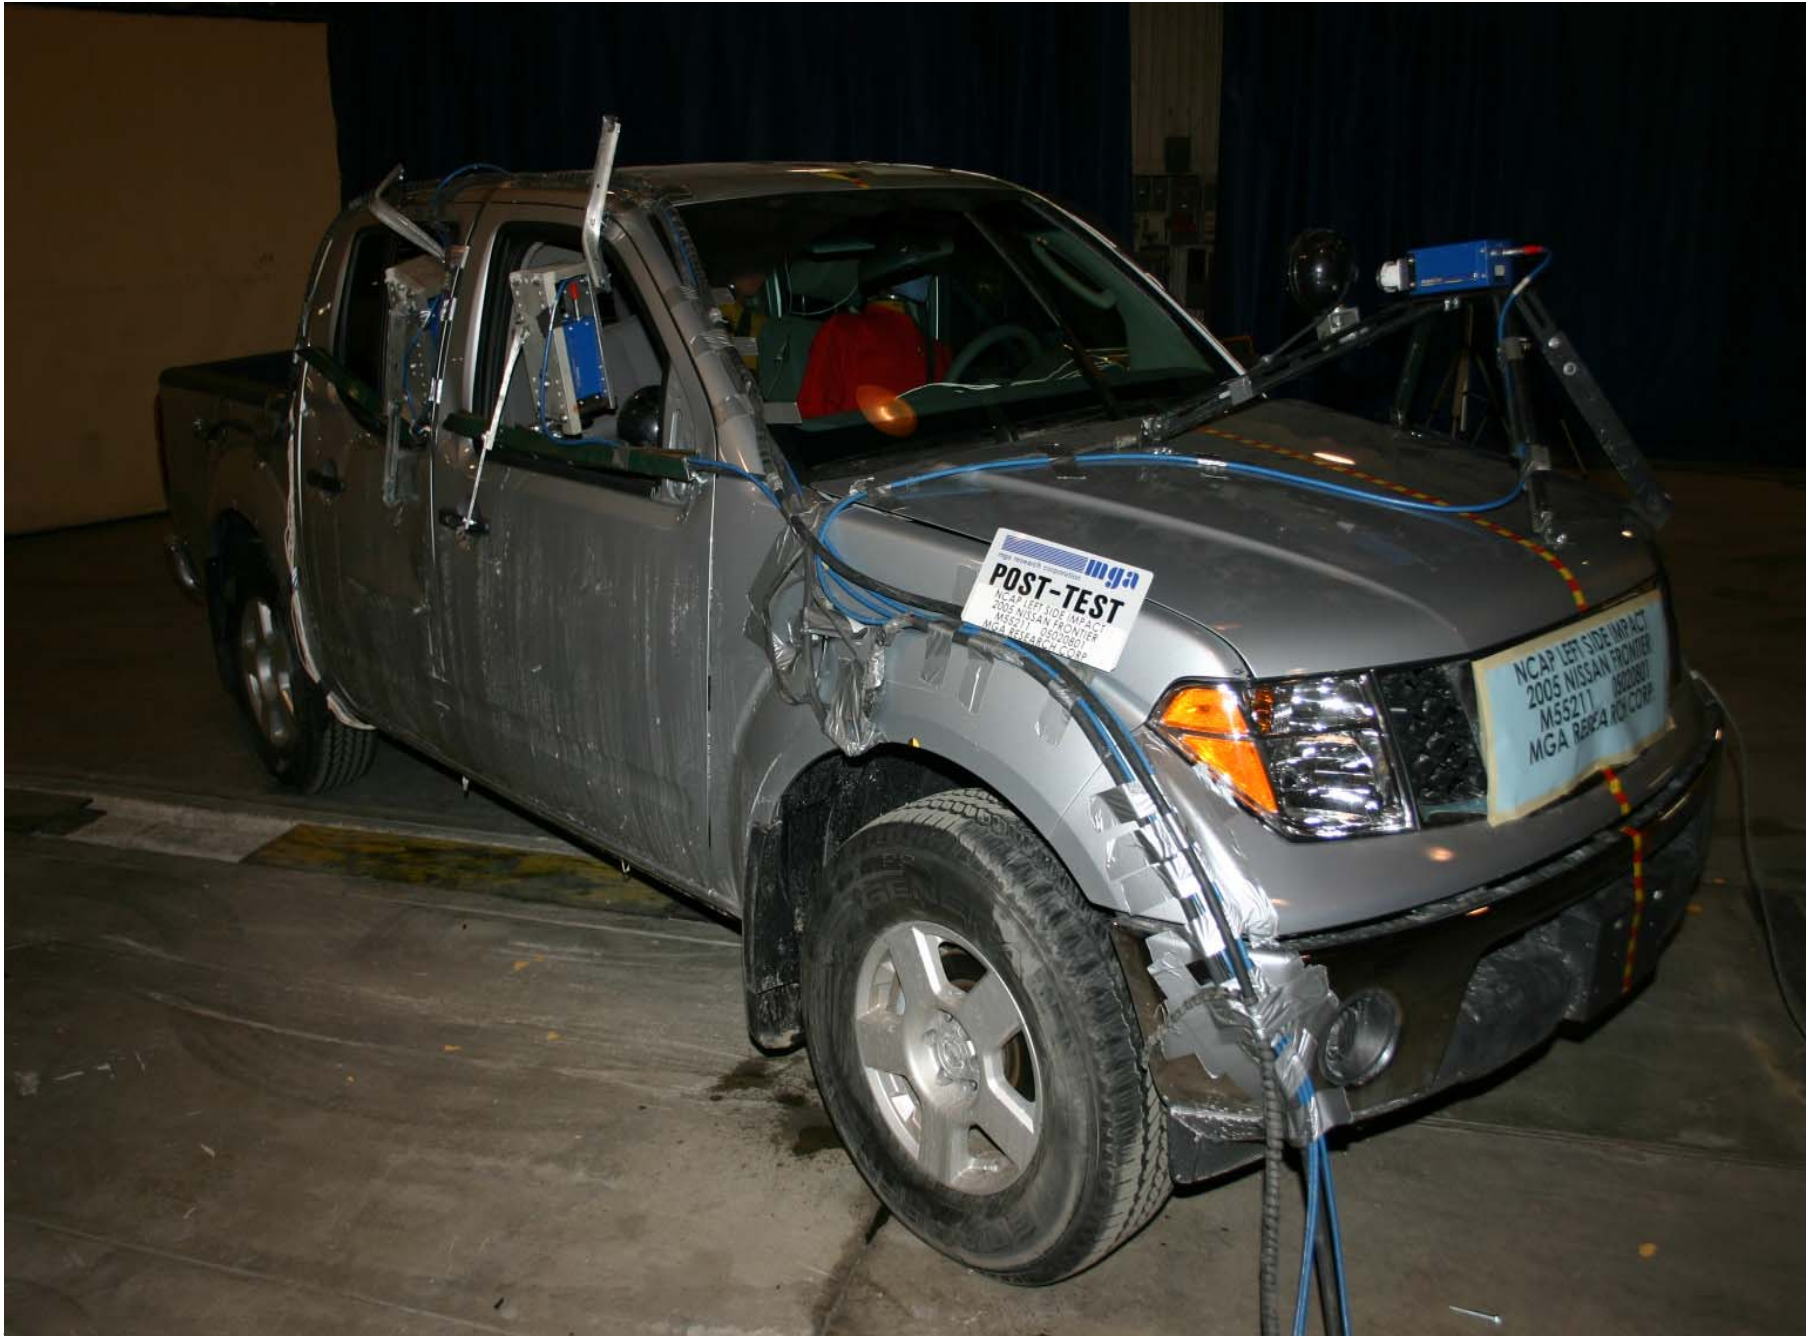
Post-Test Right Front ¾ View of Test Vehicle

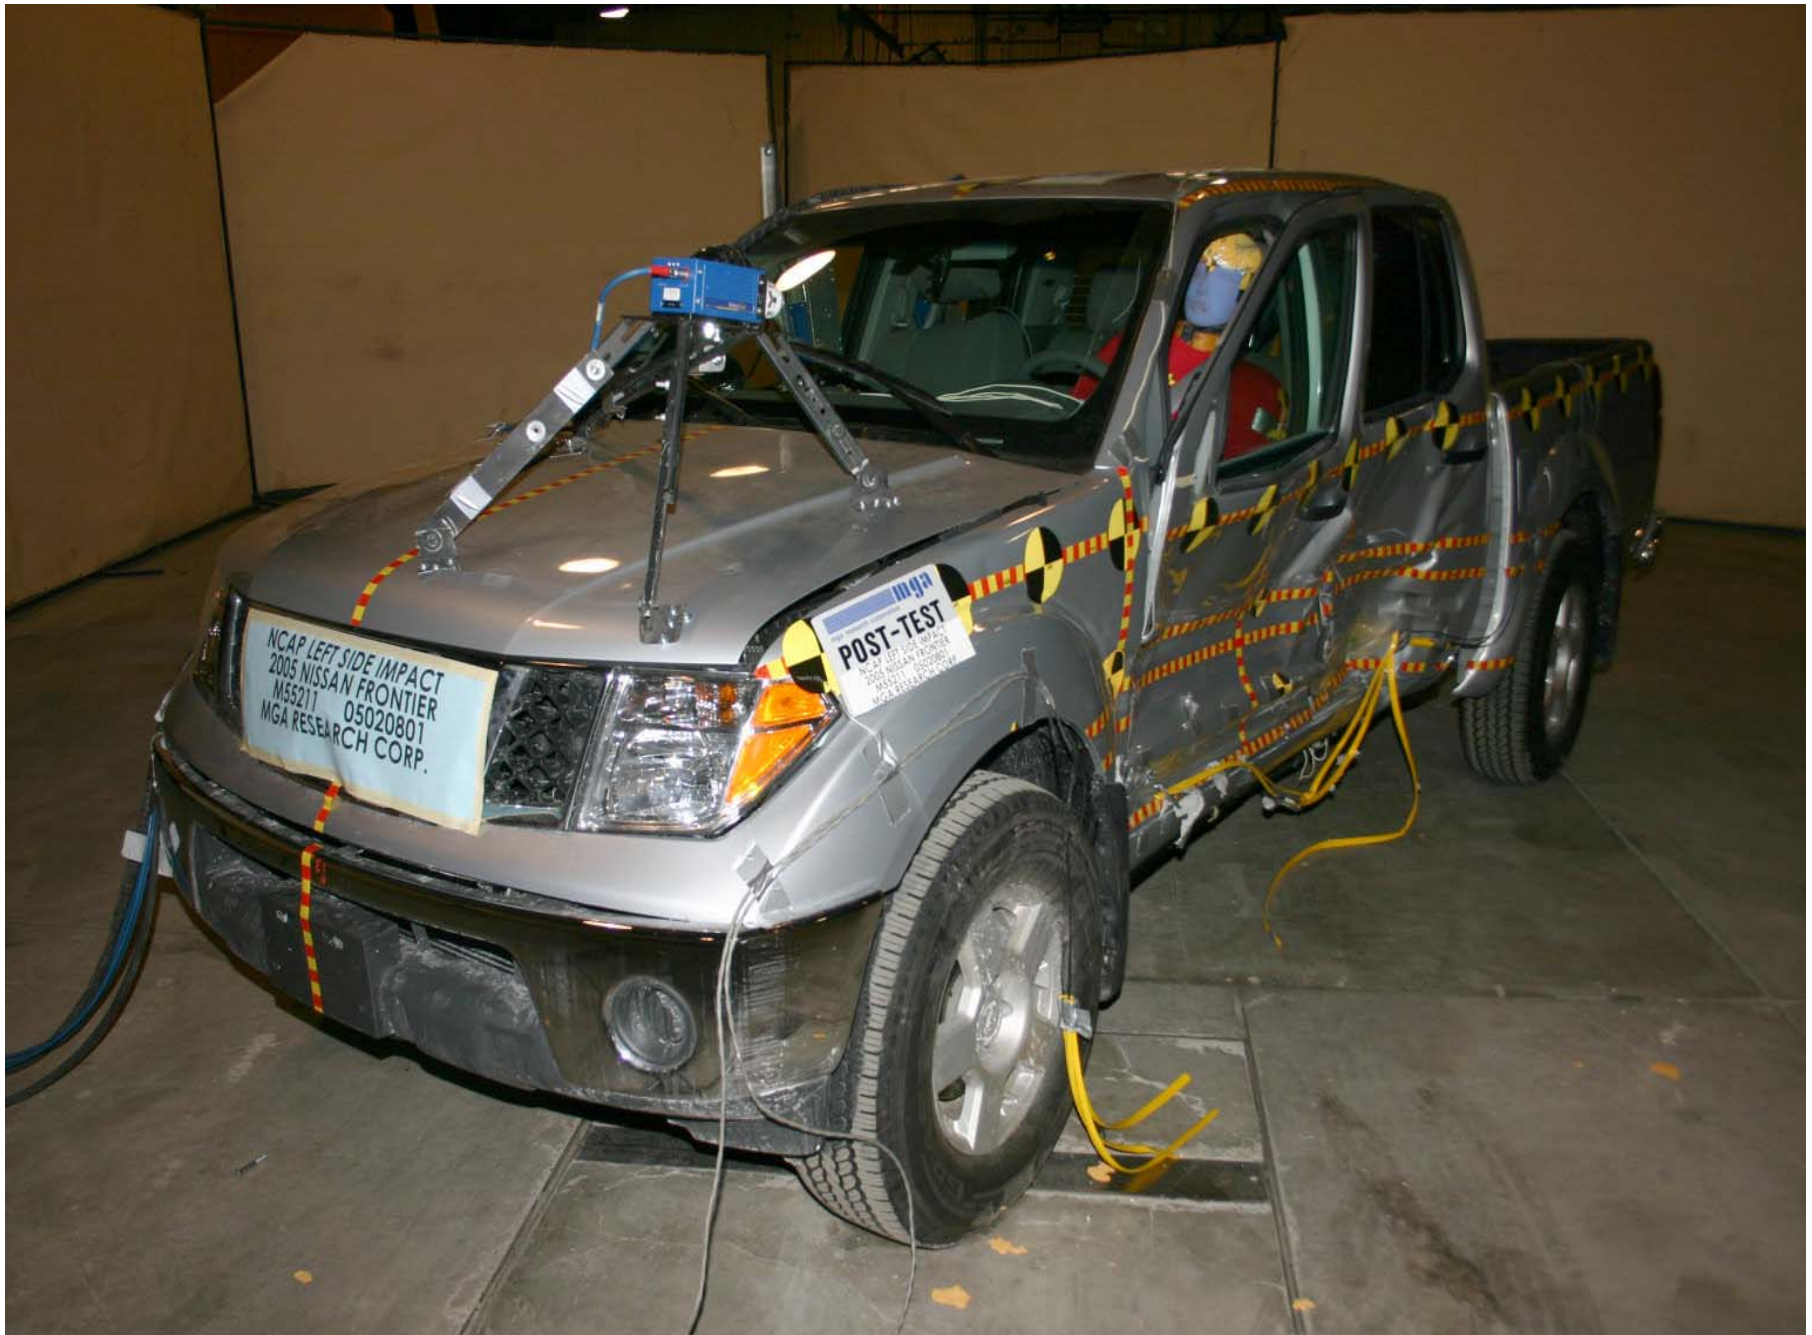
A-10.

Post-Test Left Front  $\frac{3}{4}$  View of Test Vehicle

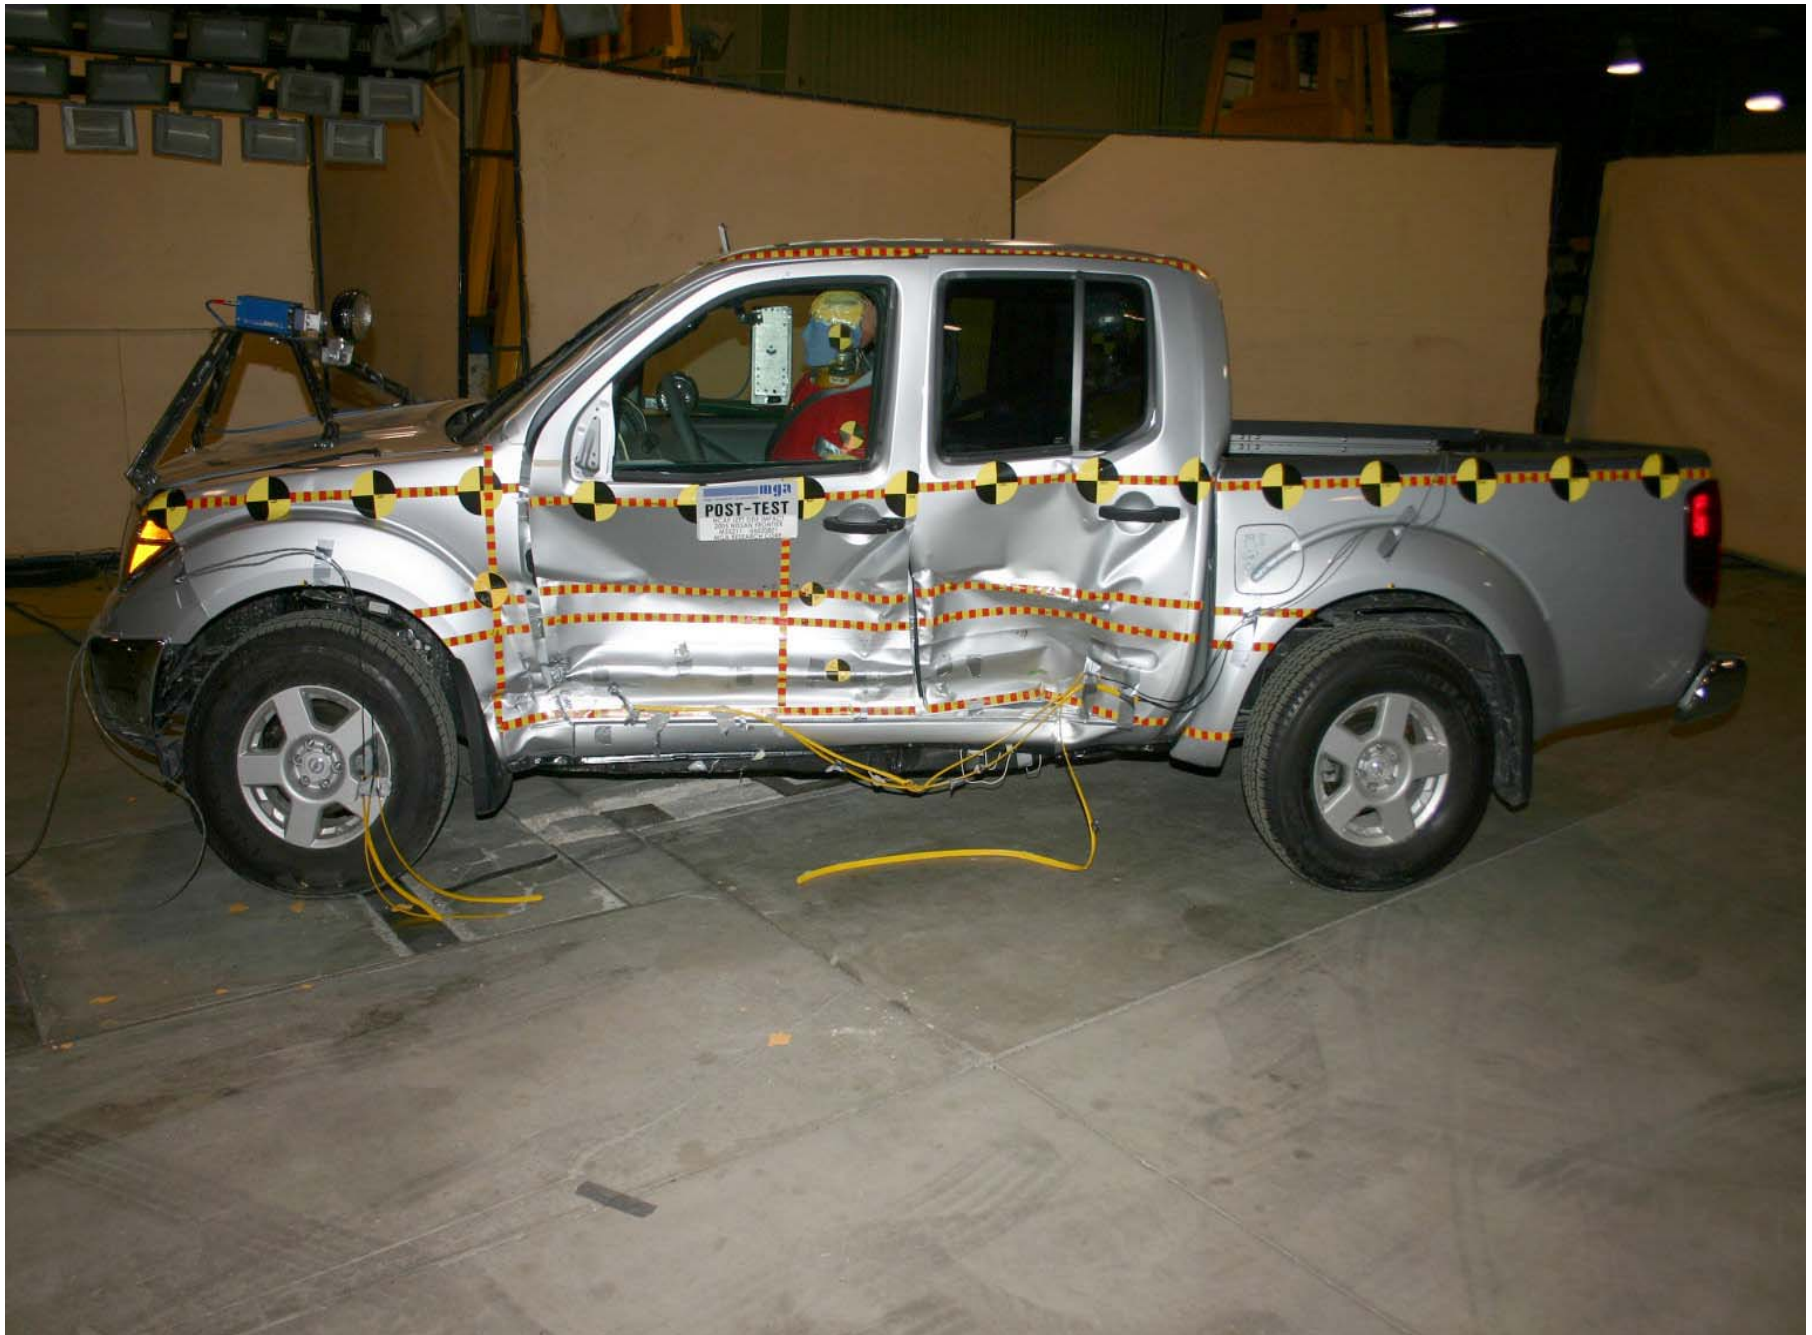
A-12.

Post-Test Left Side View of Test Vehicle

The test vehicle sustained a maximum static crush of 303 mm at level 2, 1500 mm rearward of the left vertical impact point. The driver and passenger SID/HIII's, Serial Nos. 904 and 271 respectively, were calibrated just prior to this test. The SID/HIII's injury criteria are summarized as follows:

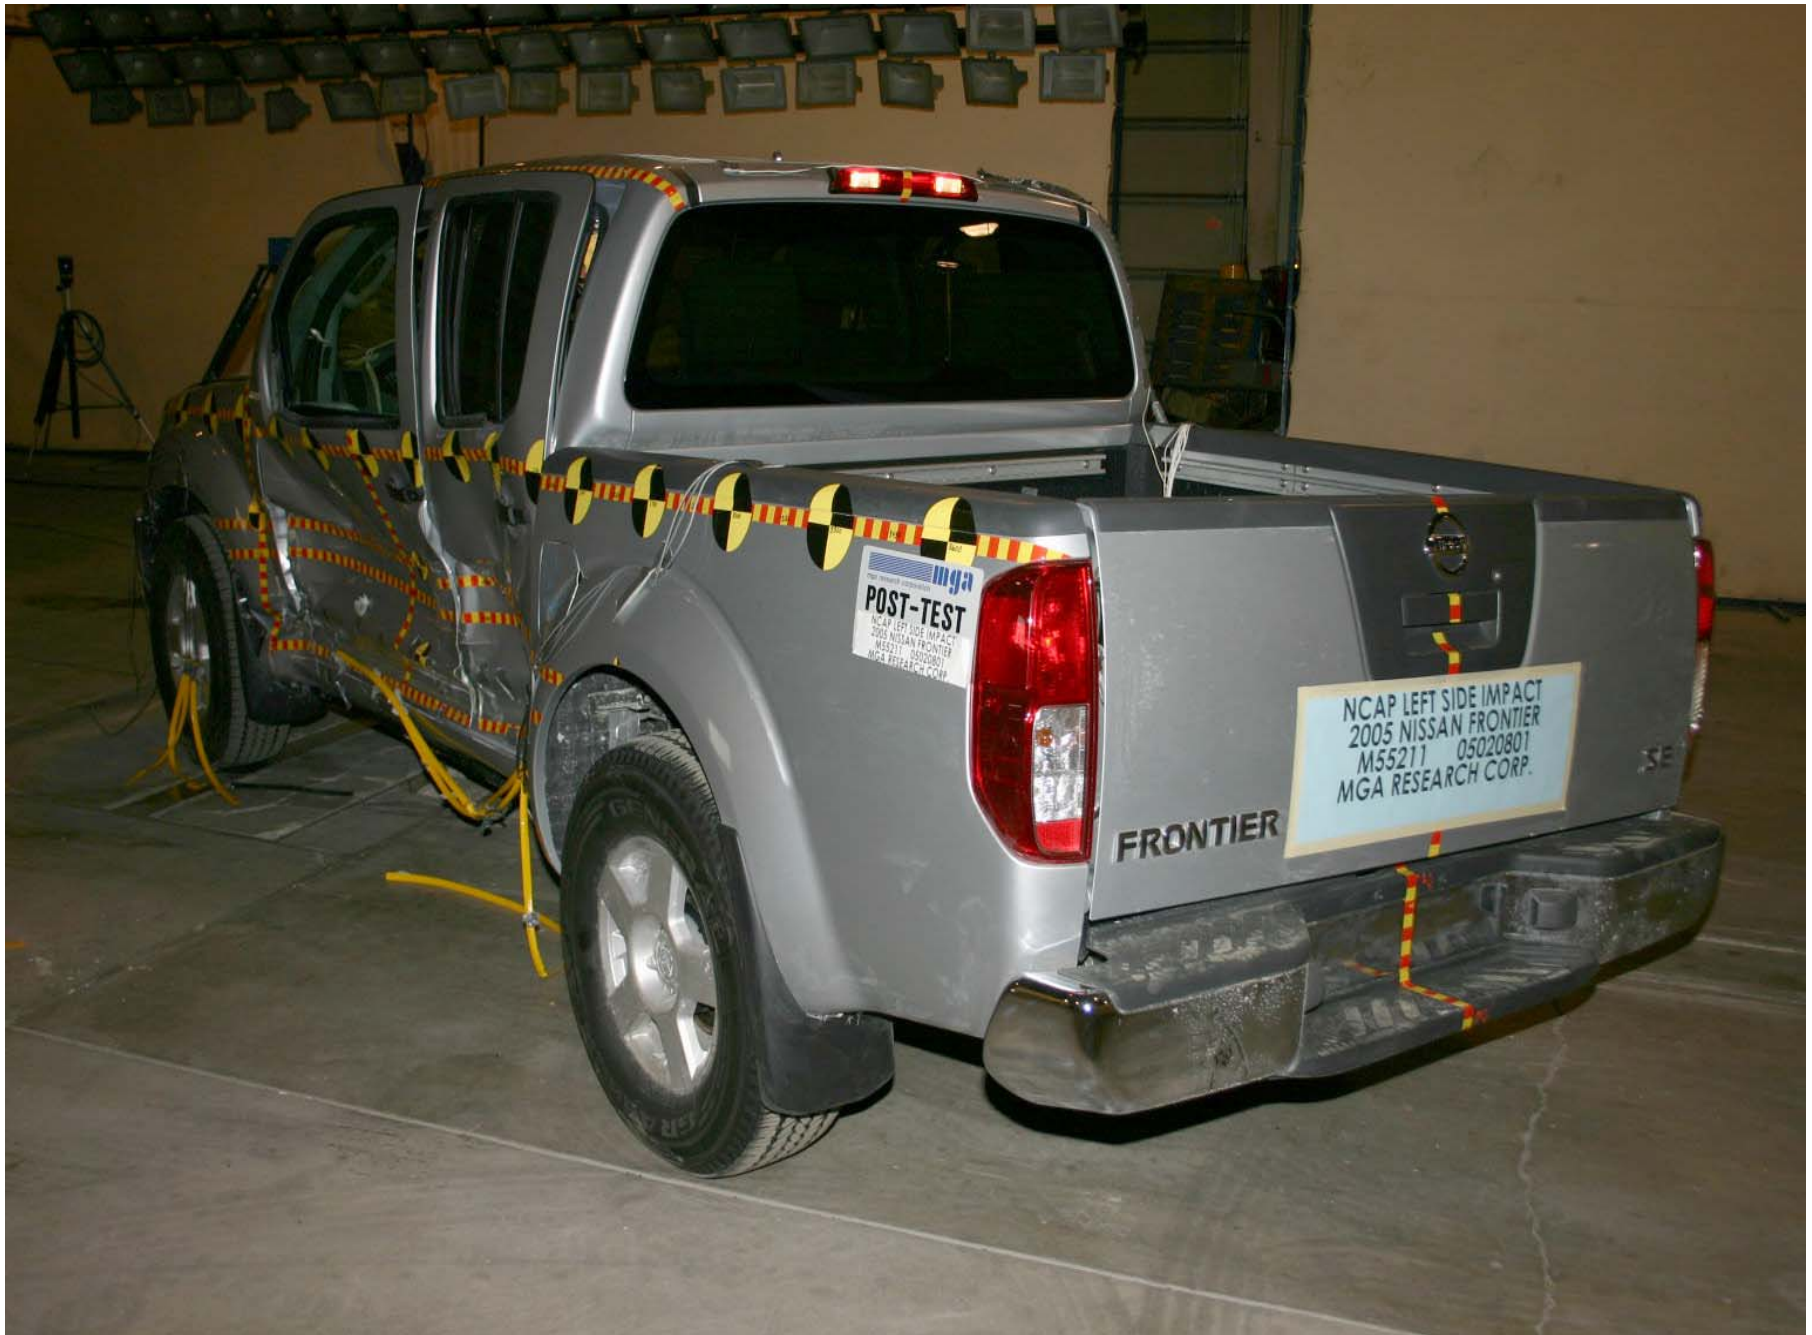
Post-Test Left Rear  $\frac{3}{4}$  View of Test Vehicle

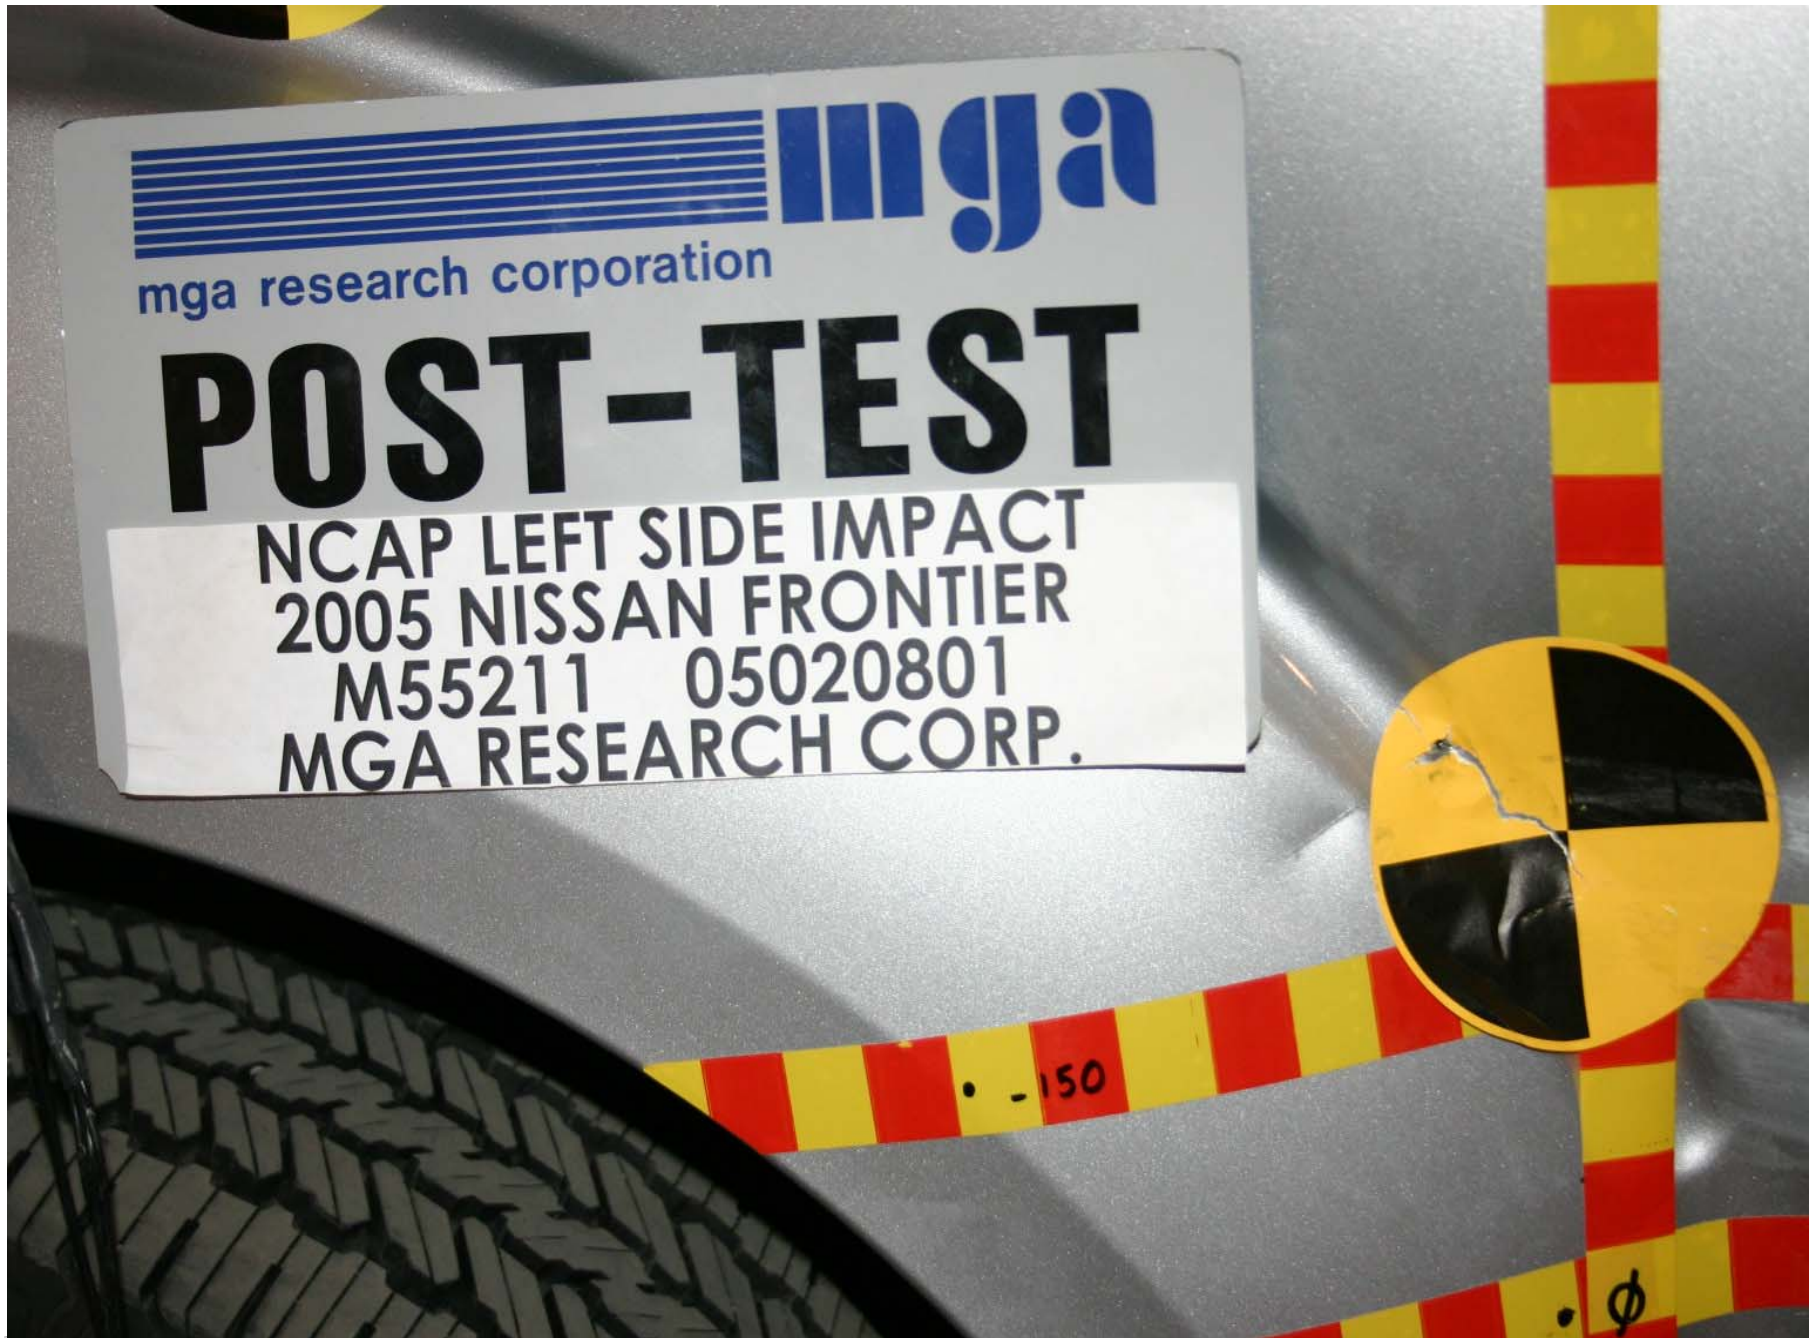
Post-Test Impact Point on Vehicle

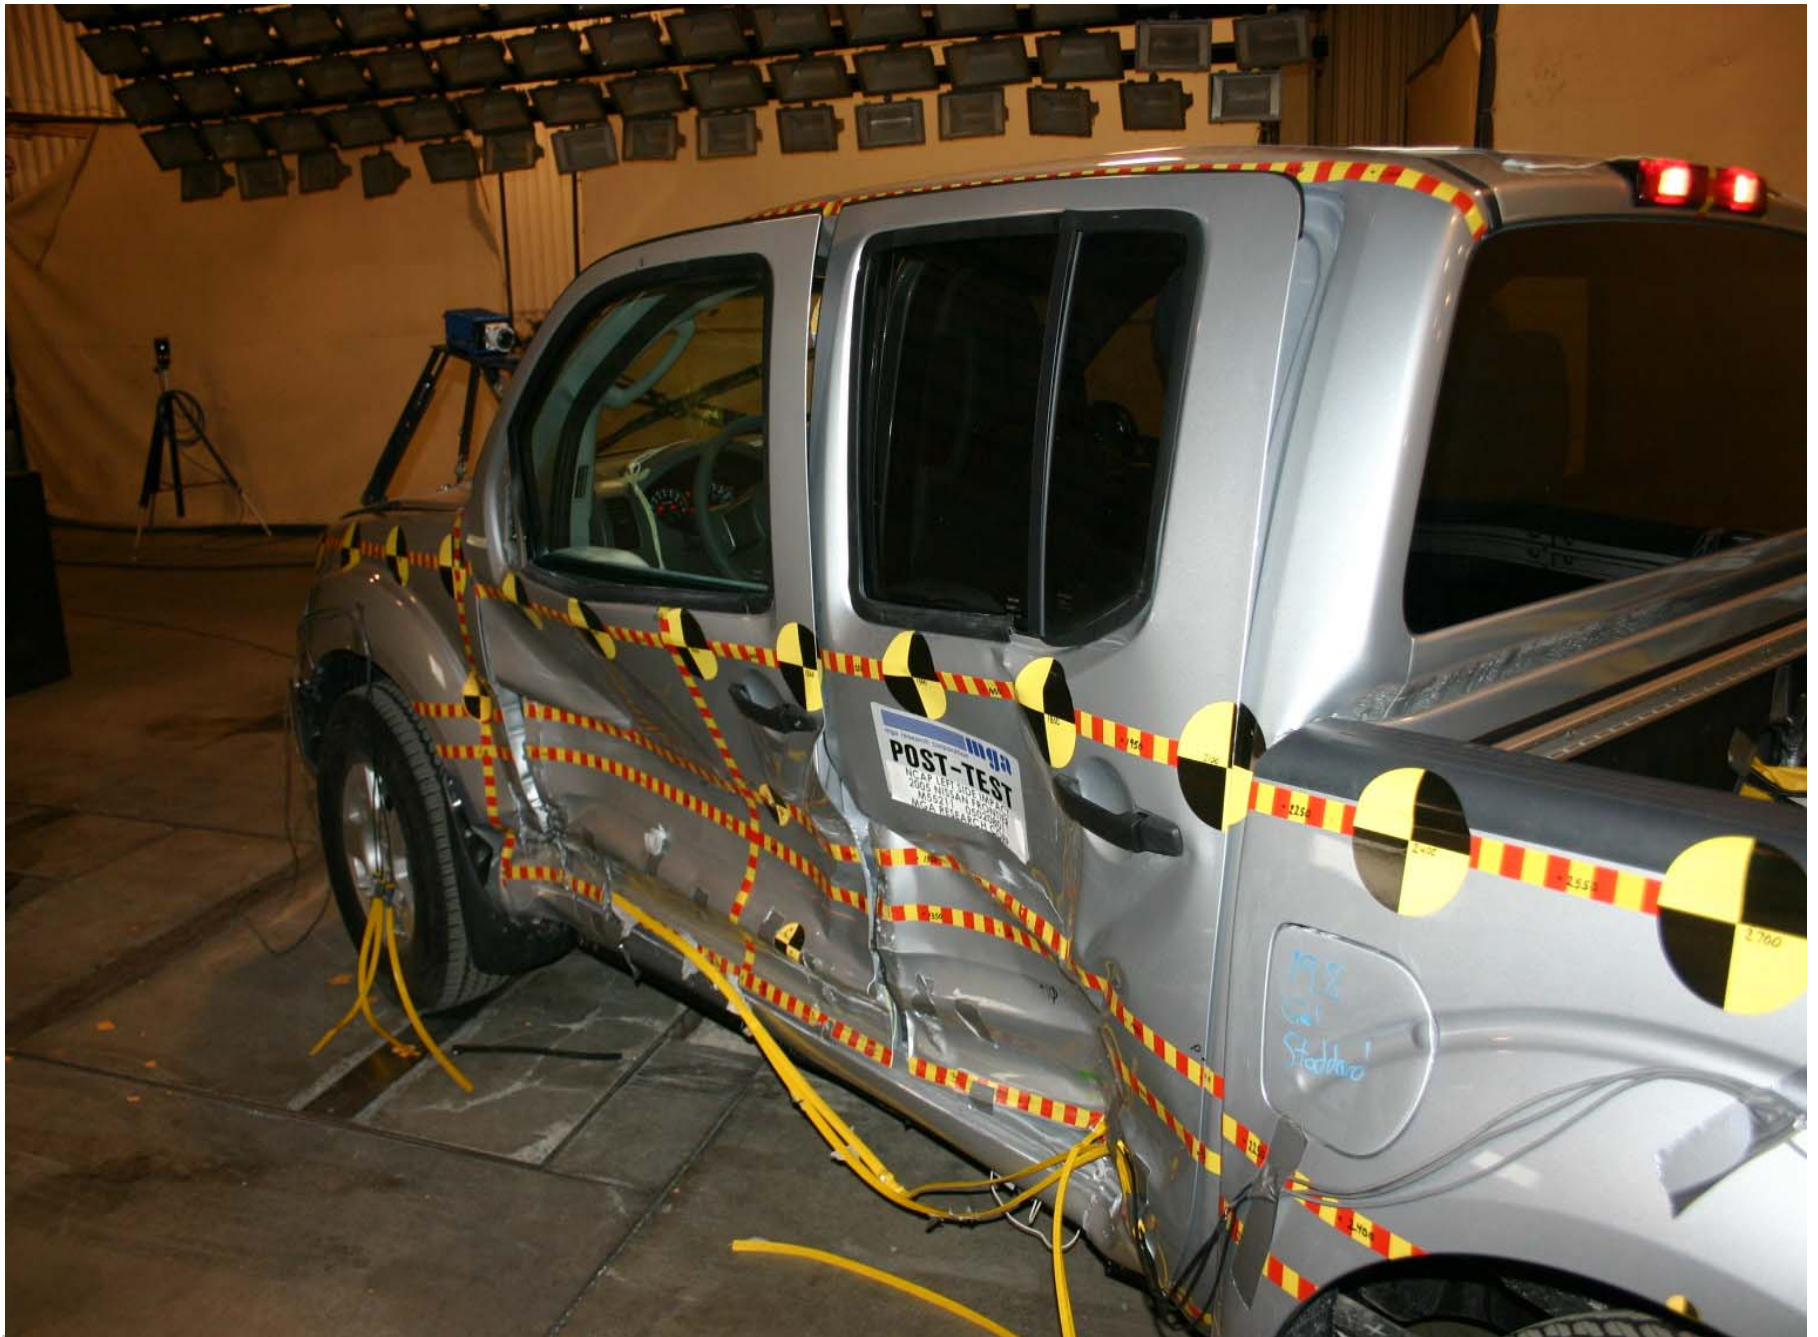
Post-Test Three-Quarter View of Left Side Doors of Test Vehicle

Description	Front	Rear
Locked/Unlocked Doors	Doors were unlocked	Doors were unlocked
Left Side Door Opening	Door remained closed and latched	Door remained closed and latched
Right Side Door Opening	Door remained closed and latched; Door opened without tools	Door remained closed and latched; Door opened without tools
Seat Movement	0	0
Seat Back Failure	None	None

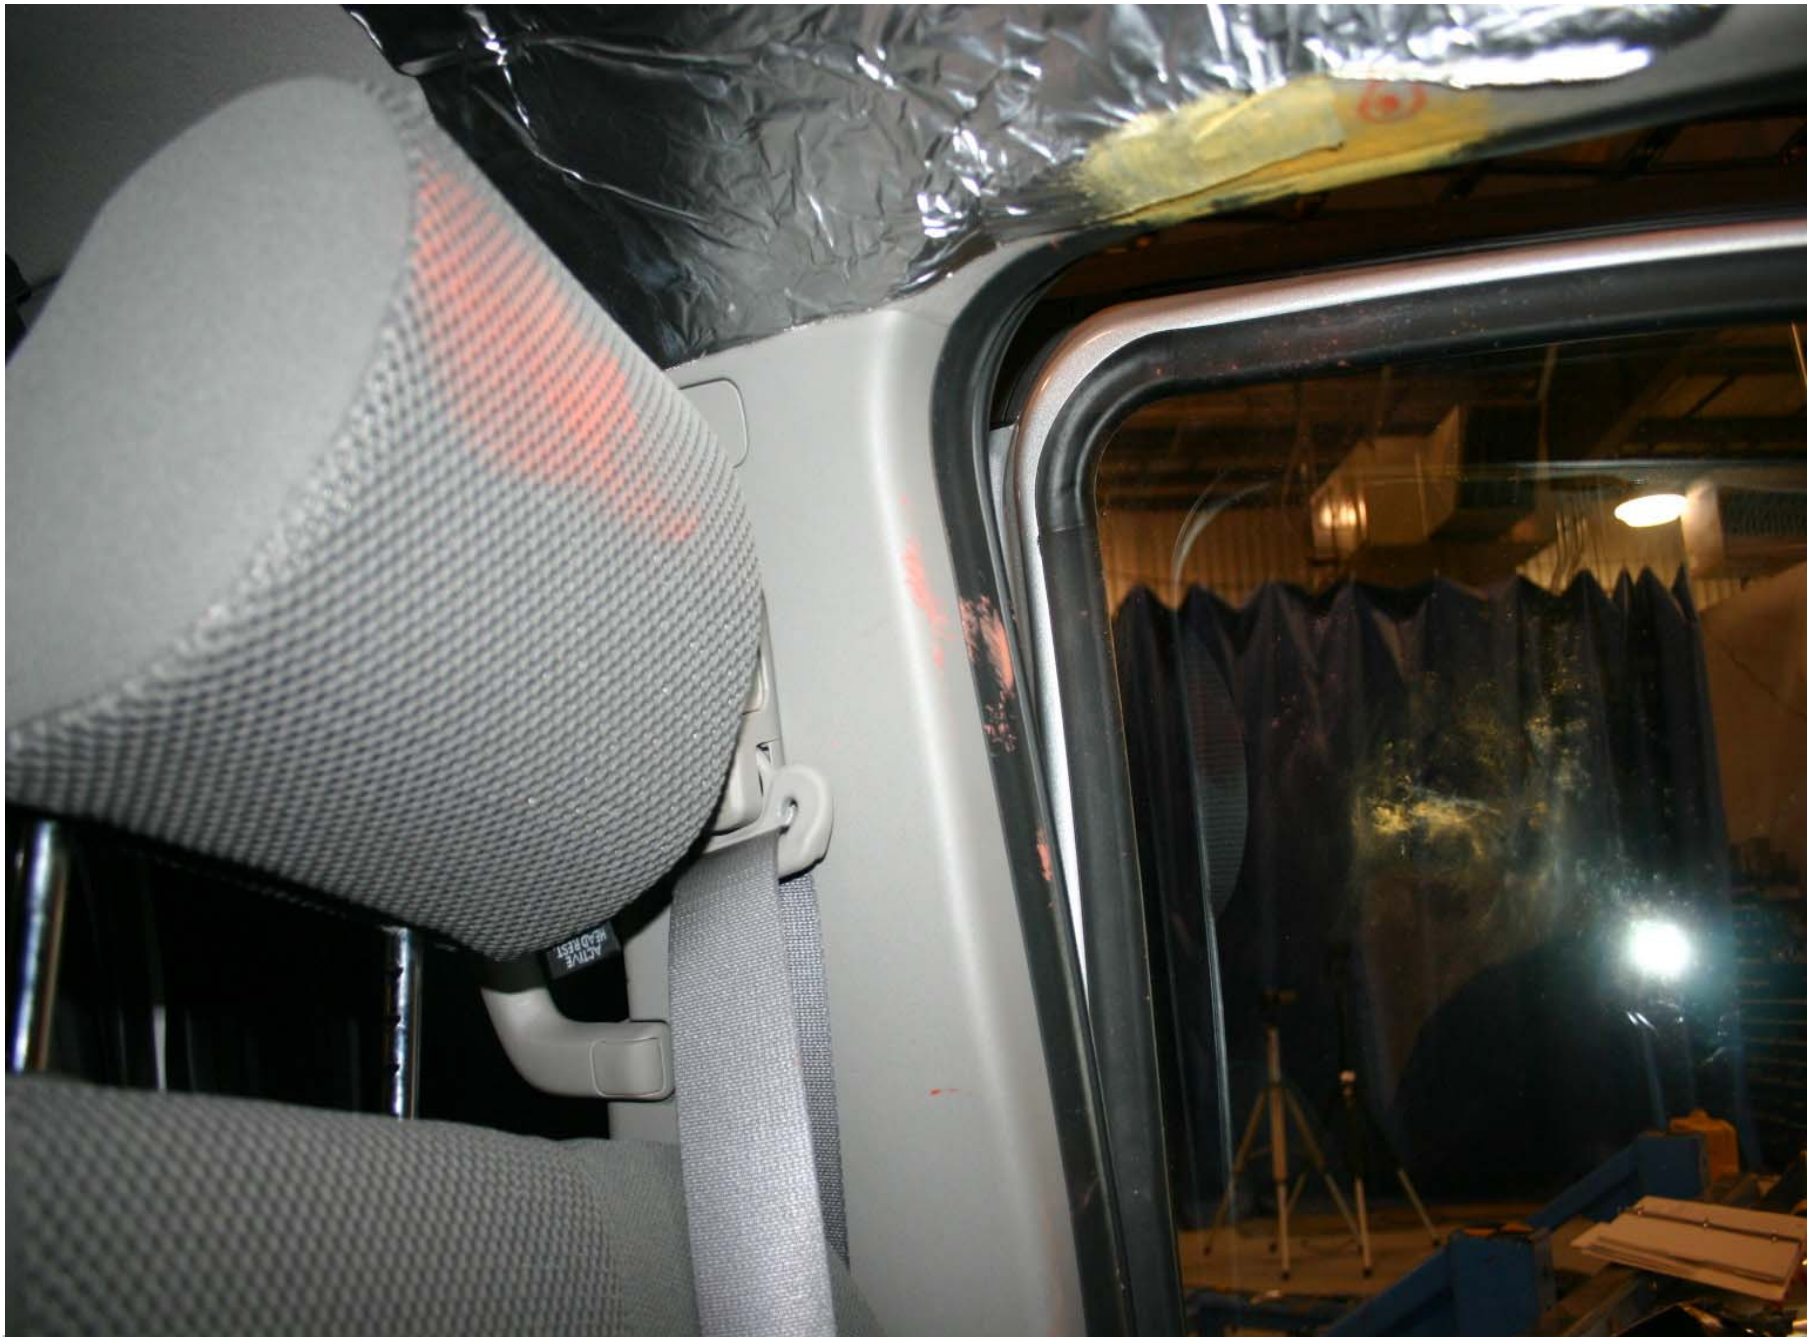
A-39.

Post-Test Driver Dummy Head Contact (side header & headrest)

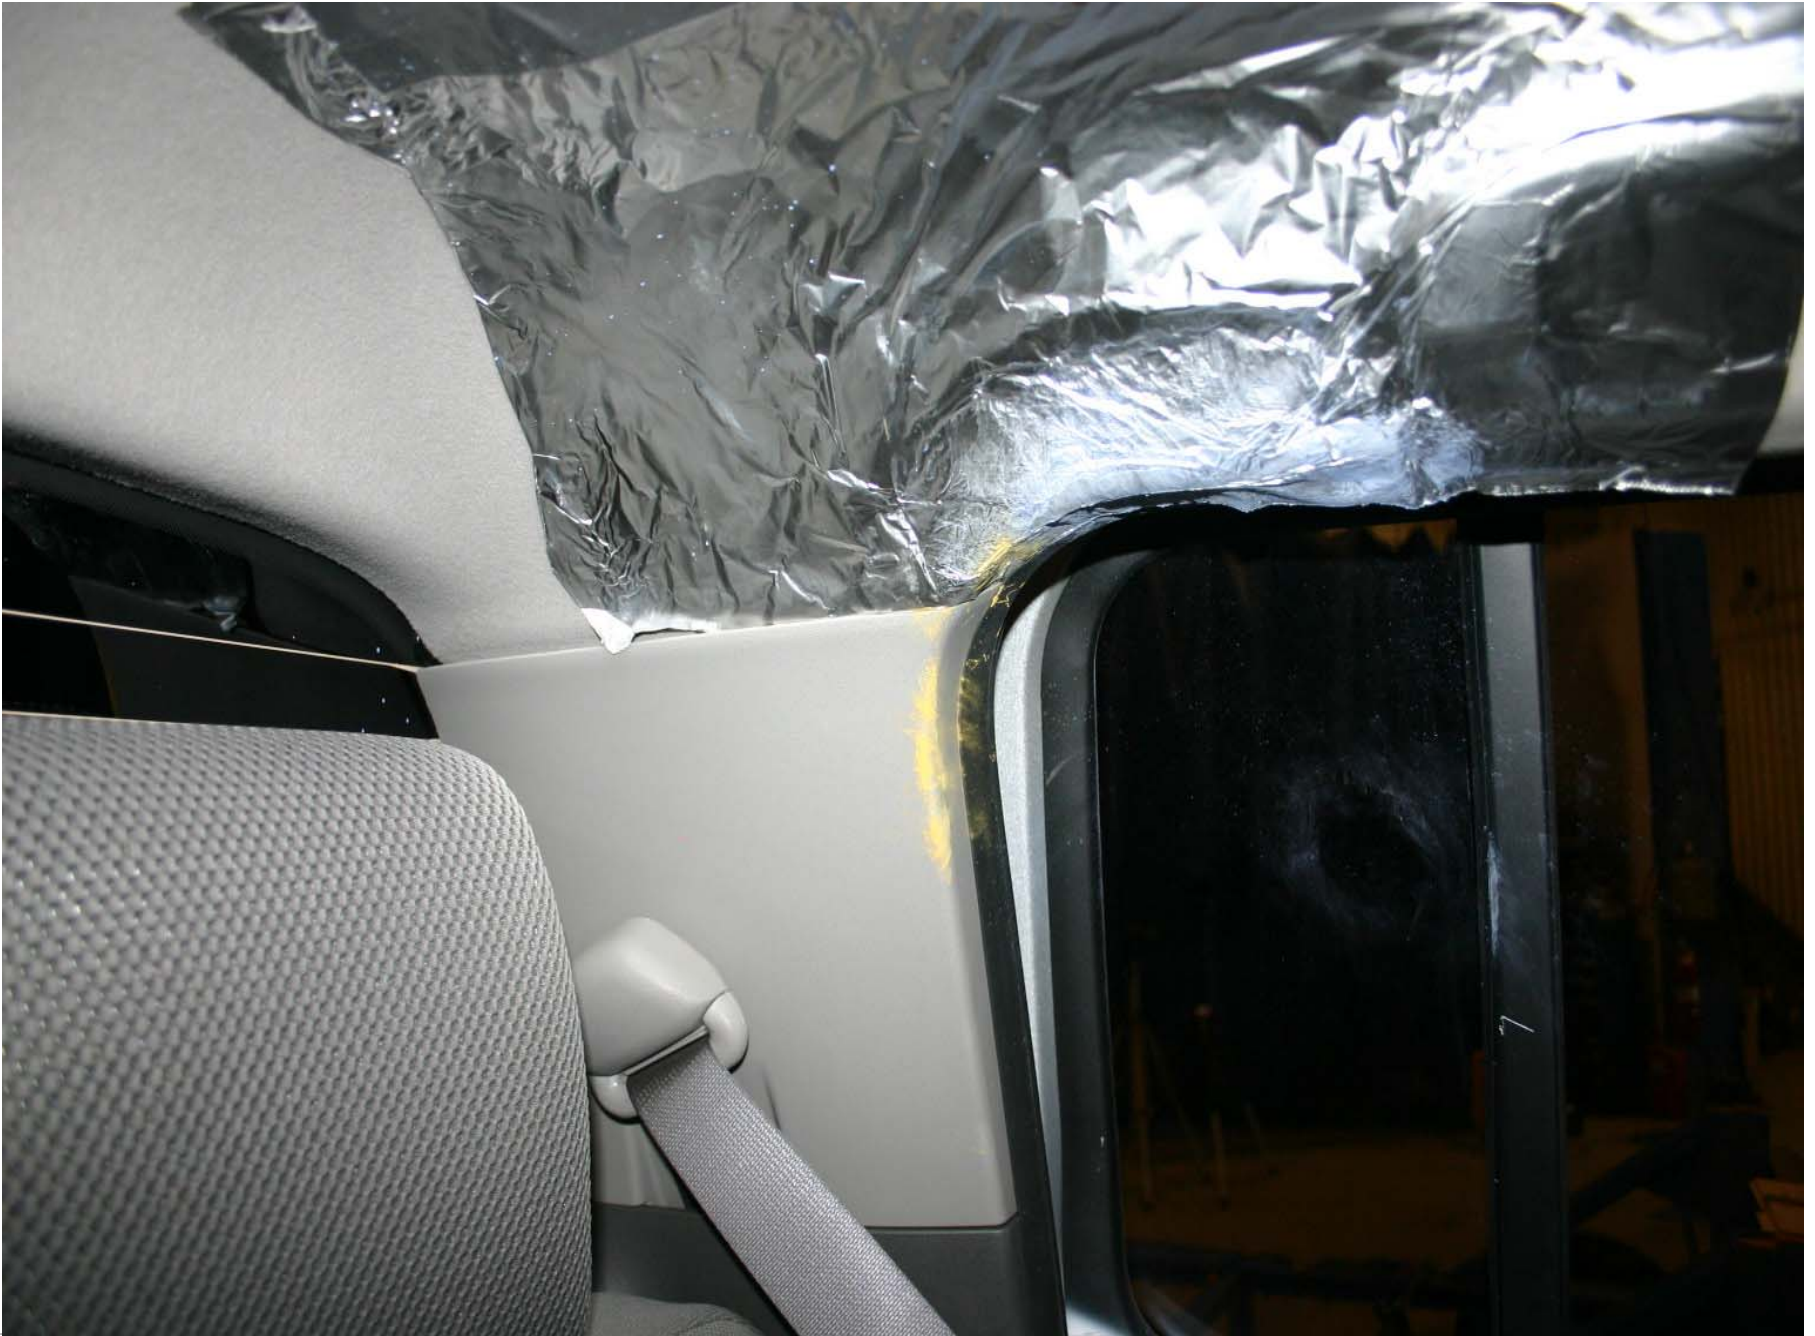
A-48.

Post-Test Passenger Dummy Head Contact (side header)
