**REPORT NUMBER: NCAPSIDE-MGA-2005-006**

**NEW CAR ASSESSMENT PROGRAM  
SIDE IMPACT TEST**

**NISSAN MOTOR COMPANY Ltd.  
2005 NISSAN FRONTIER  
NHTSA NUMBER: M55211**

**PREPARED BY:  
MGA RESEARCH CORPORATION  
5000 WARREN ROAD  
BURLINGTON, WI 53105**

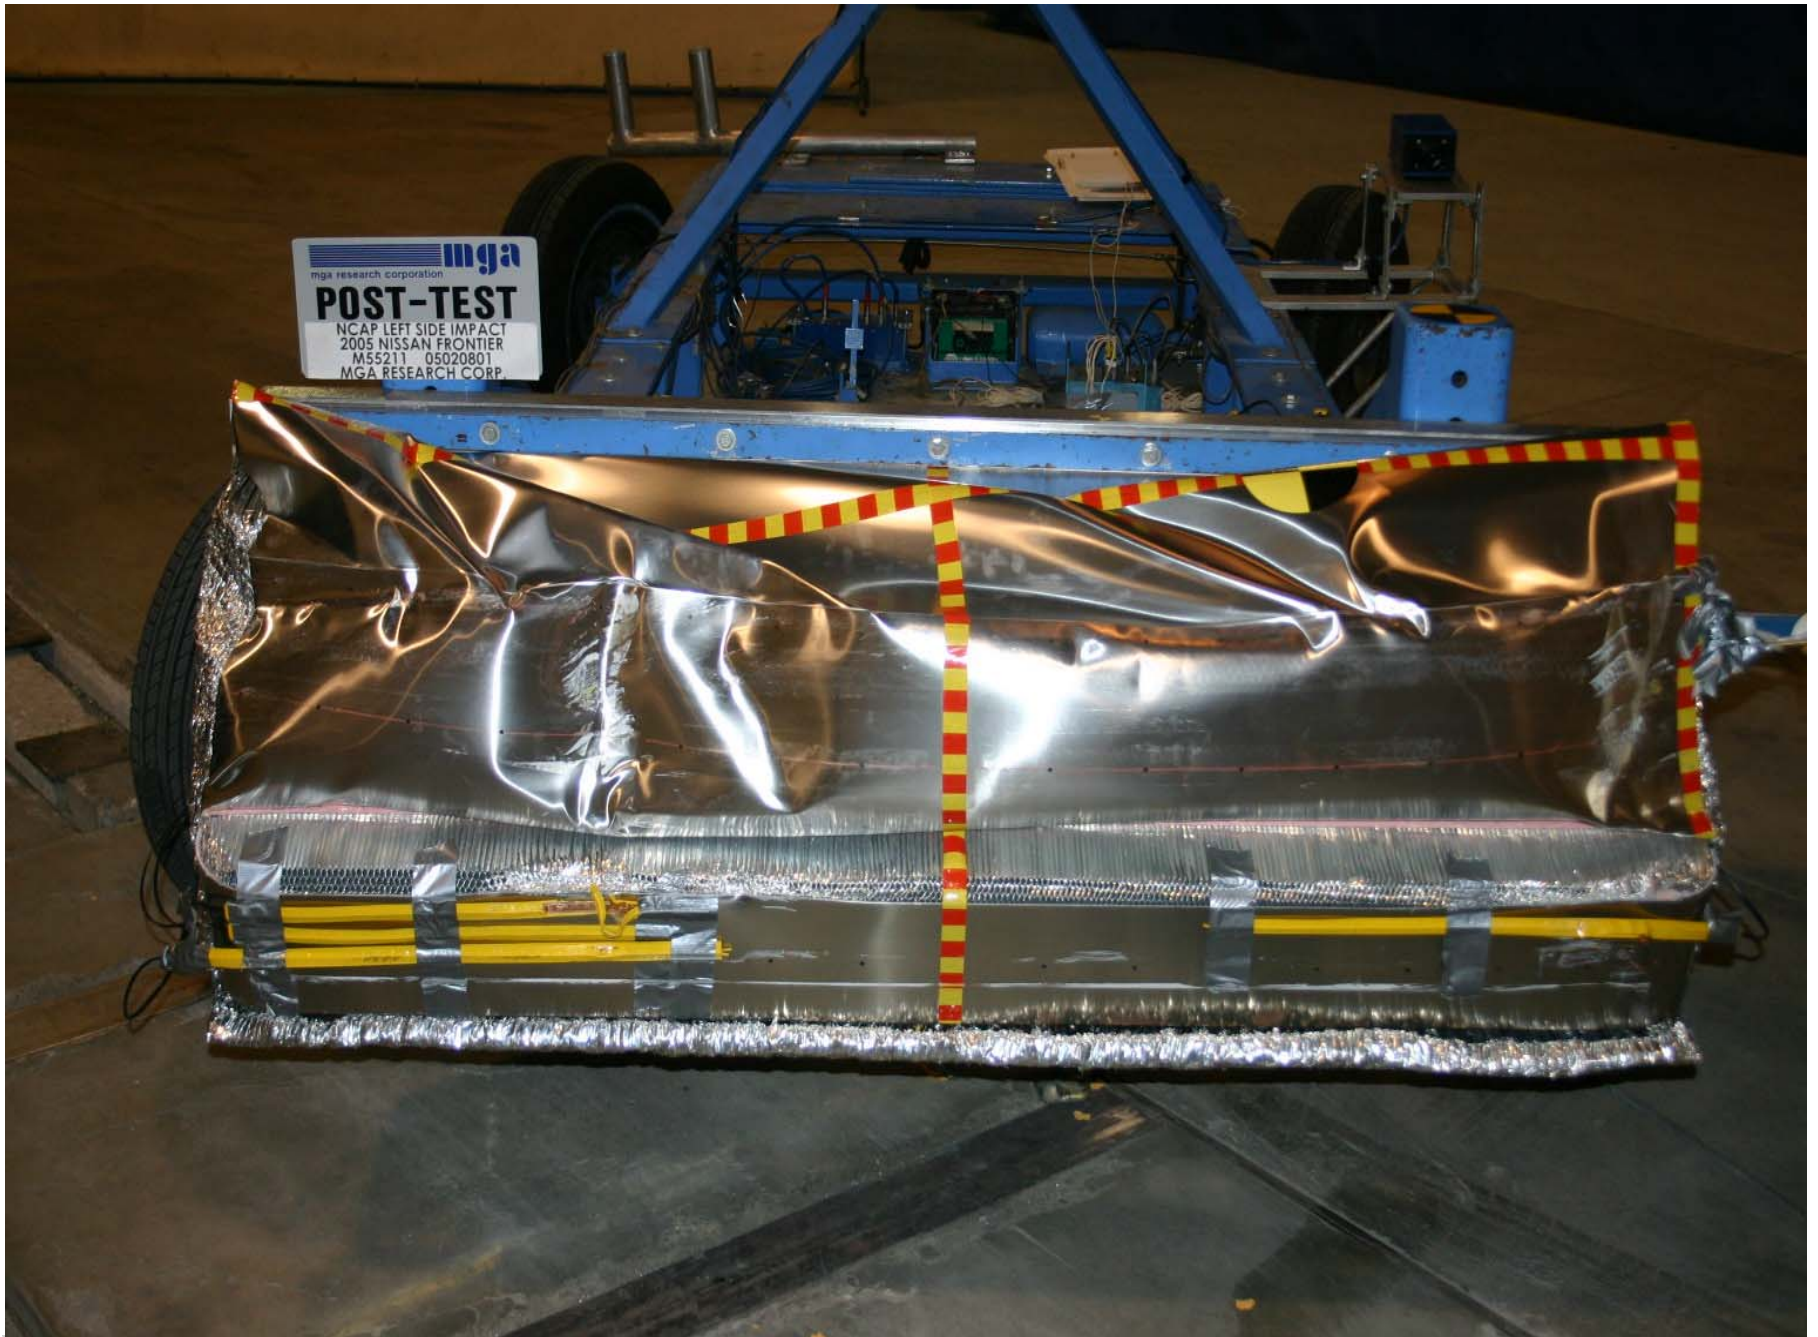
A-51.

Post-Test MDB Front View

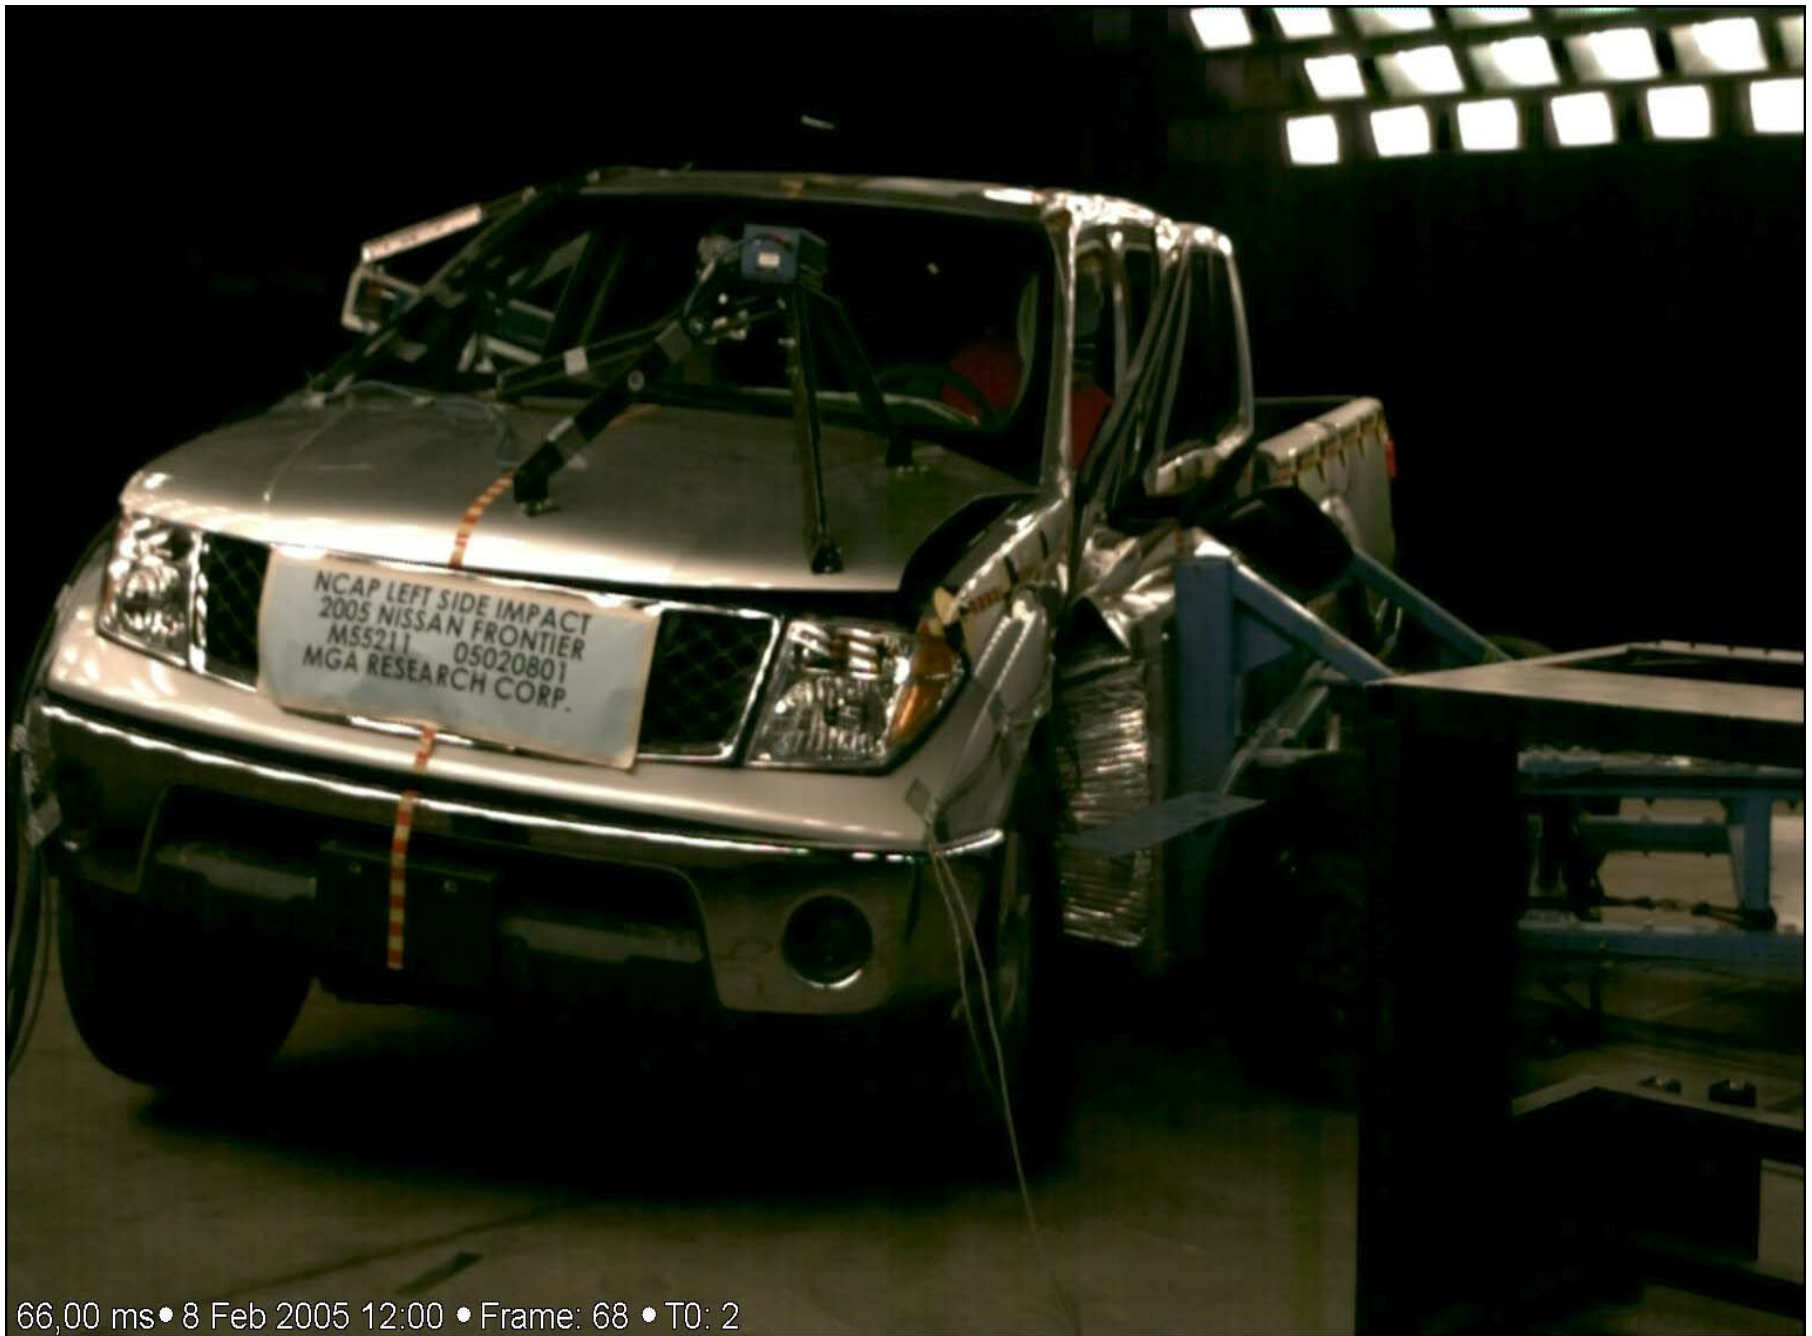
A-61.

Vehicle Impact

A model year 2005 Nissan Frontier was impacted on the left (driver's) side by a Moving Deformable Barrier (MDB) which was moving forward in a 27° crabbed position to the tow road guidance system at a velocity of 61.8 km/h. The specified impact velocity range is from 61.1 to 62.7 km/h. The test (target) vehicle was stationary and positioned 63° to the line of forward motion. The weight of the vehicle as tested was 2339.7 kg and the test weight of the MDB was 1361.2 kg. The test was conducted at MGA Research Corporation in Burlington, Wisconsin, on February 8, 2005.
