**REPORT NUMBER: NCAP-MGA-2005-013**

**NEW CAR ASSESSMENT PROGRAM  
FRONTAL BARRIER IMPACT TEST**

**HYUNDAI MOTOR COMPANY  
2005 HYUNDAI SANTA FE  
NHTSA NUMBER: M50500**

**FINAL REPORT**

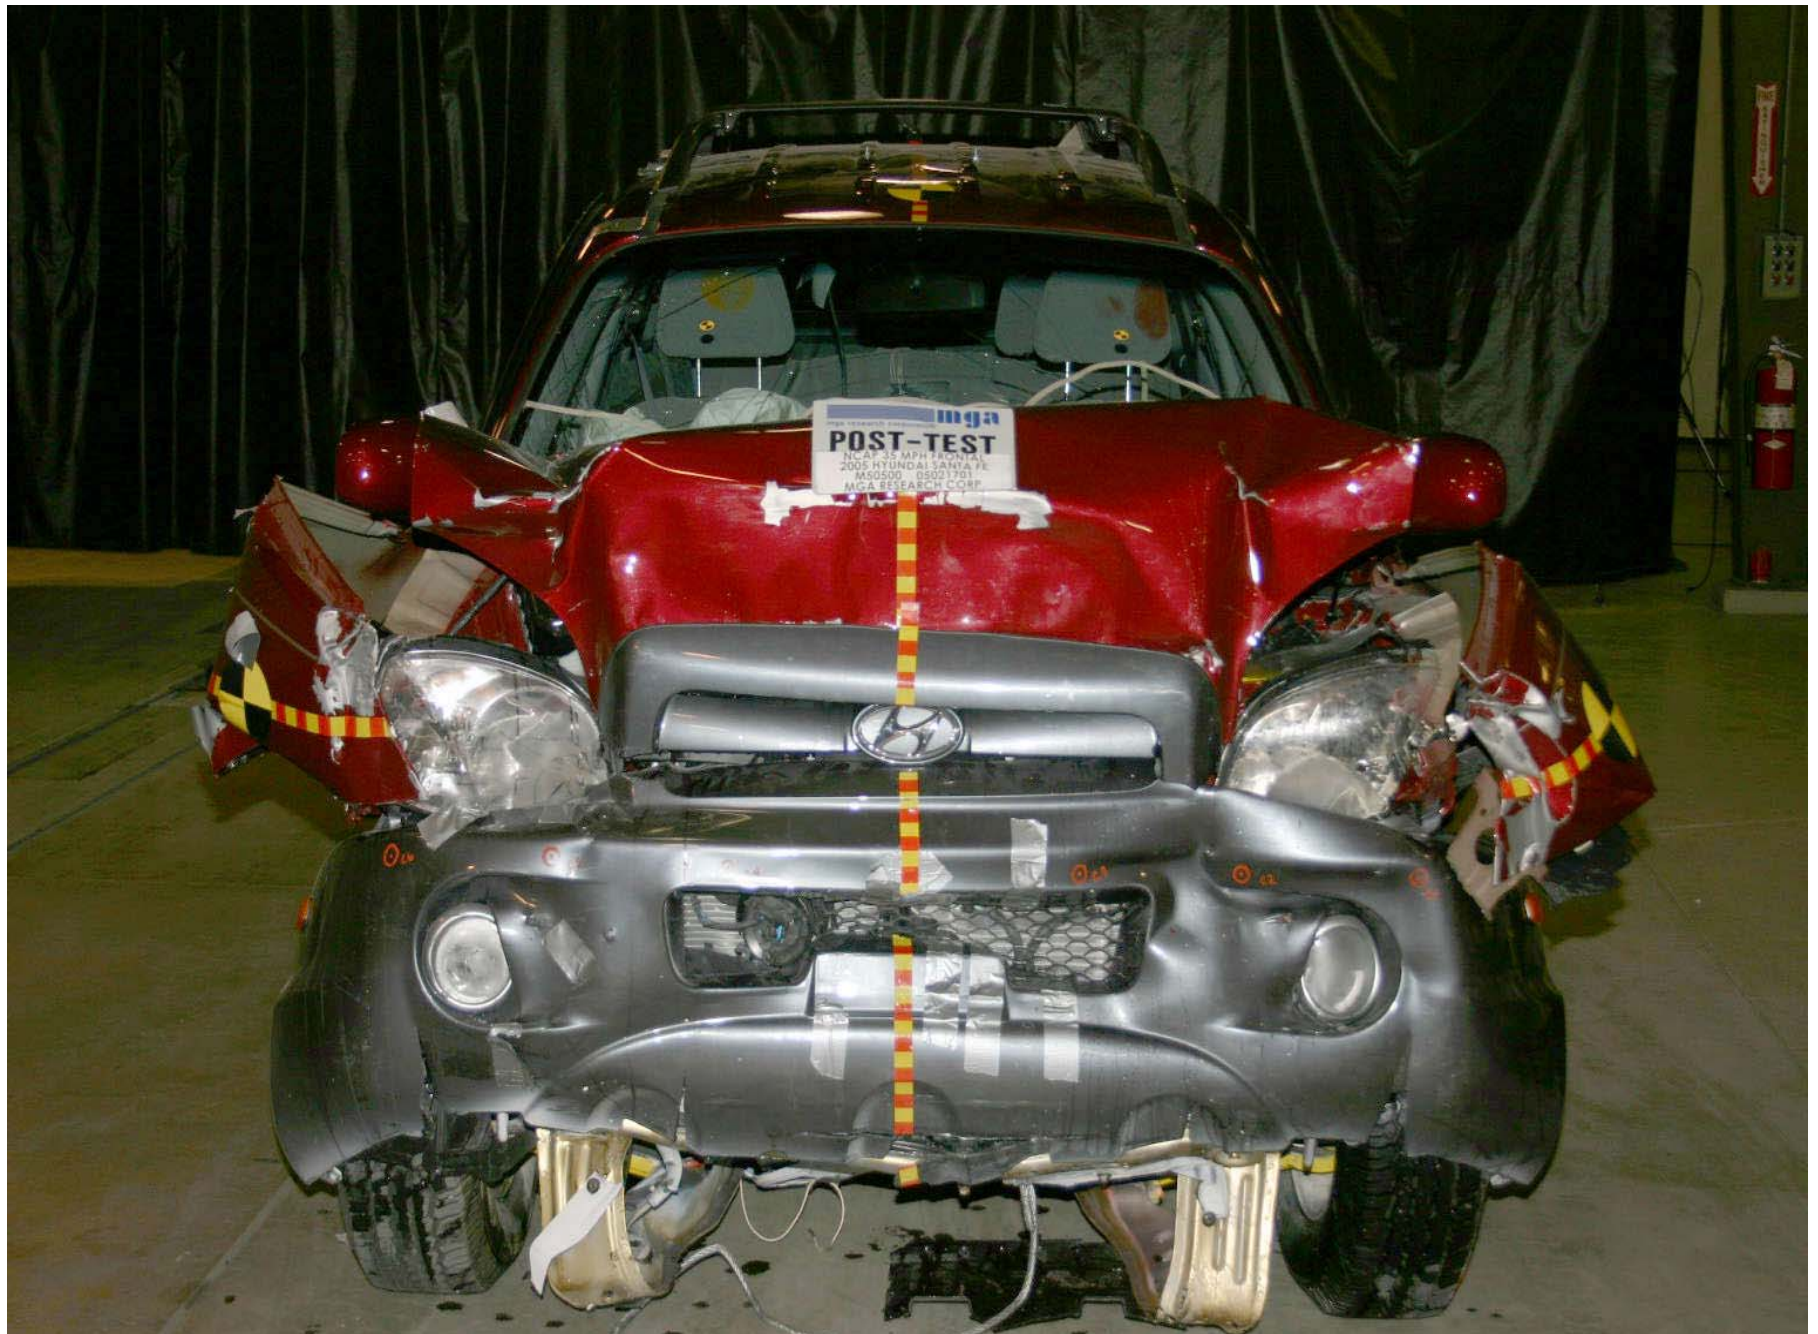
Post-Test Front View of Test Vehicle

The maximum static crush of the vehicle was 583mm and both the driver and passenger side doors remained closed and latched during the impact event and were operable after the impact.

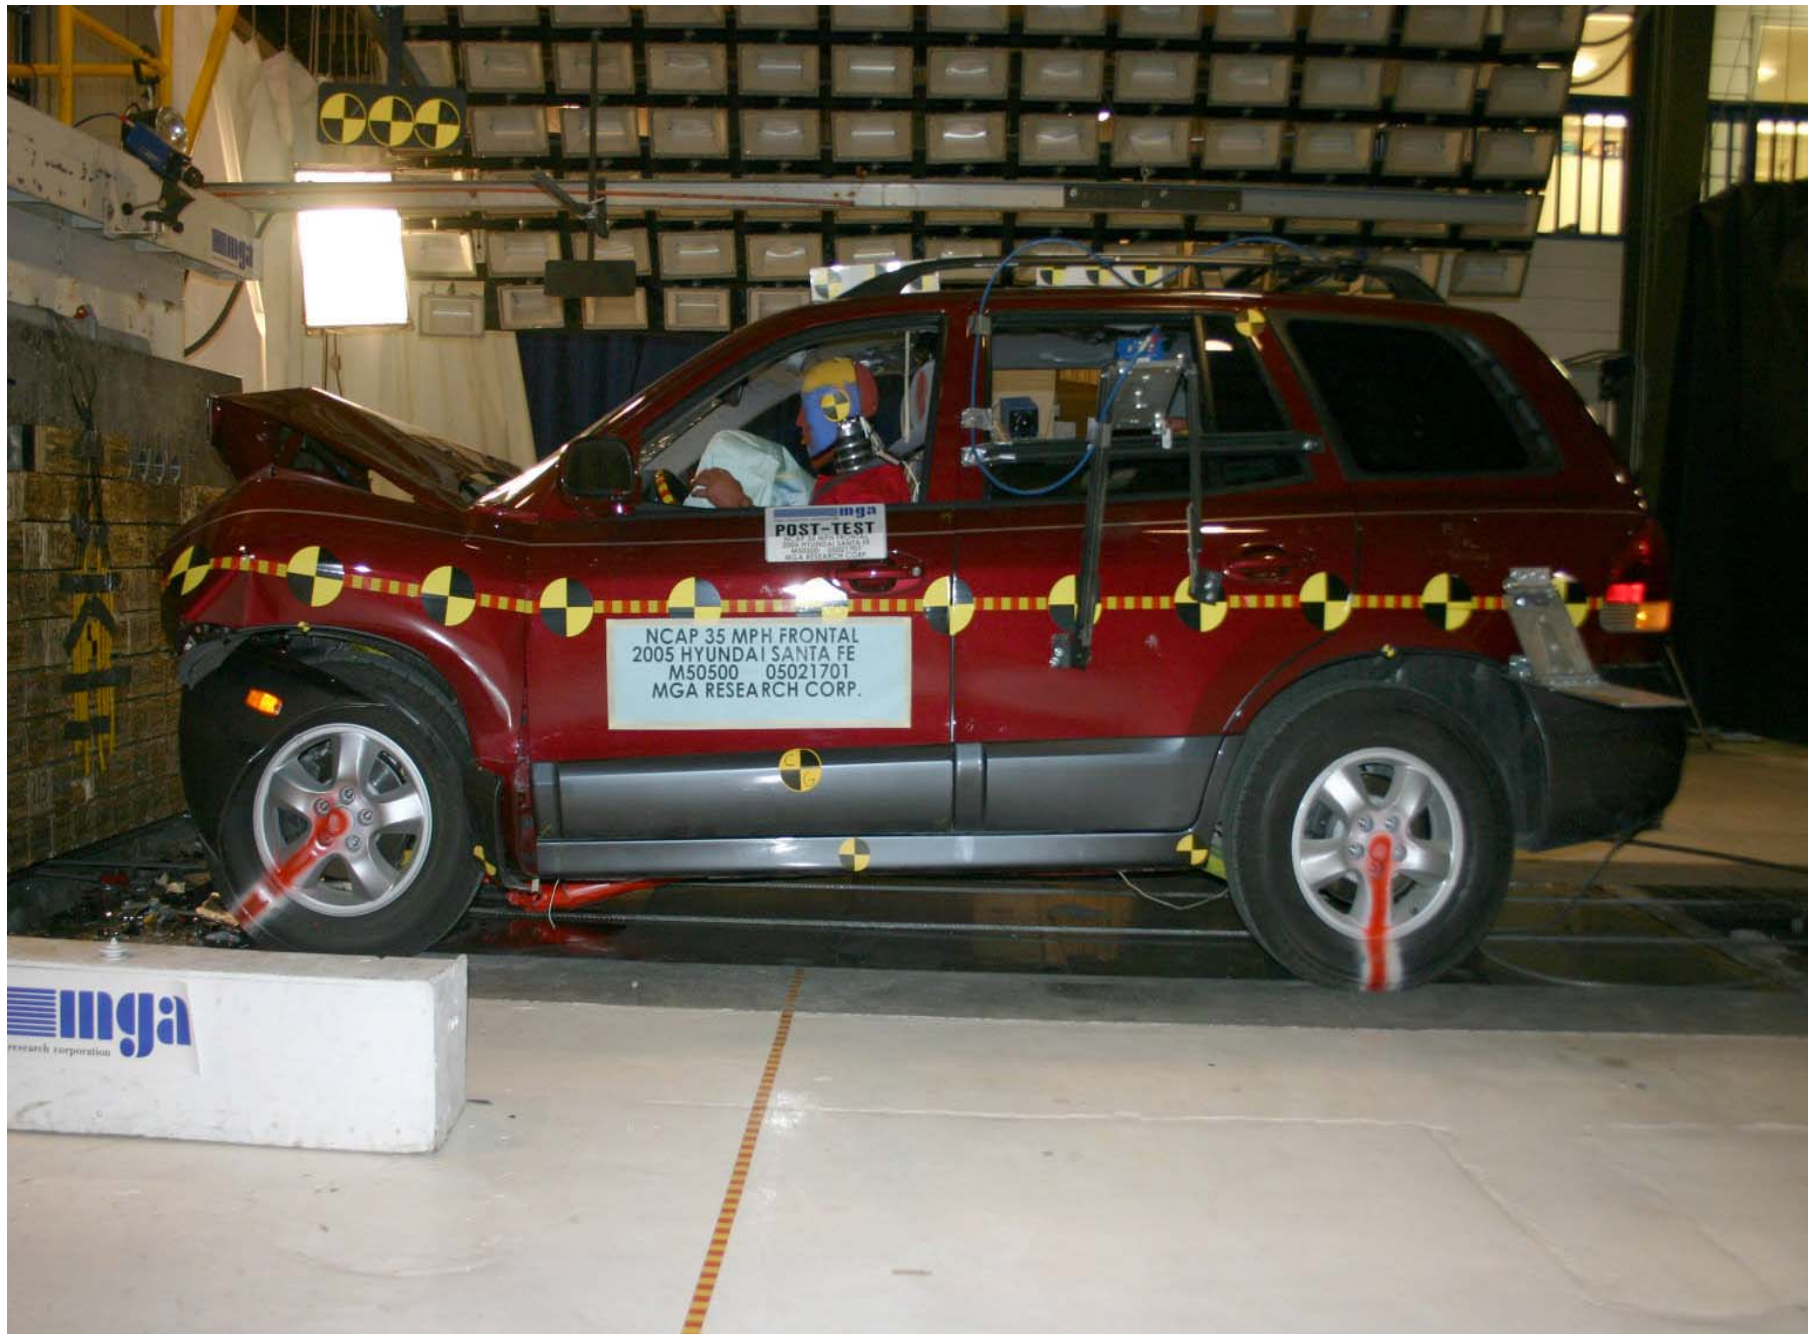
Post-Test Left Side View of Test Vehicle

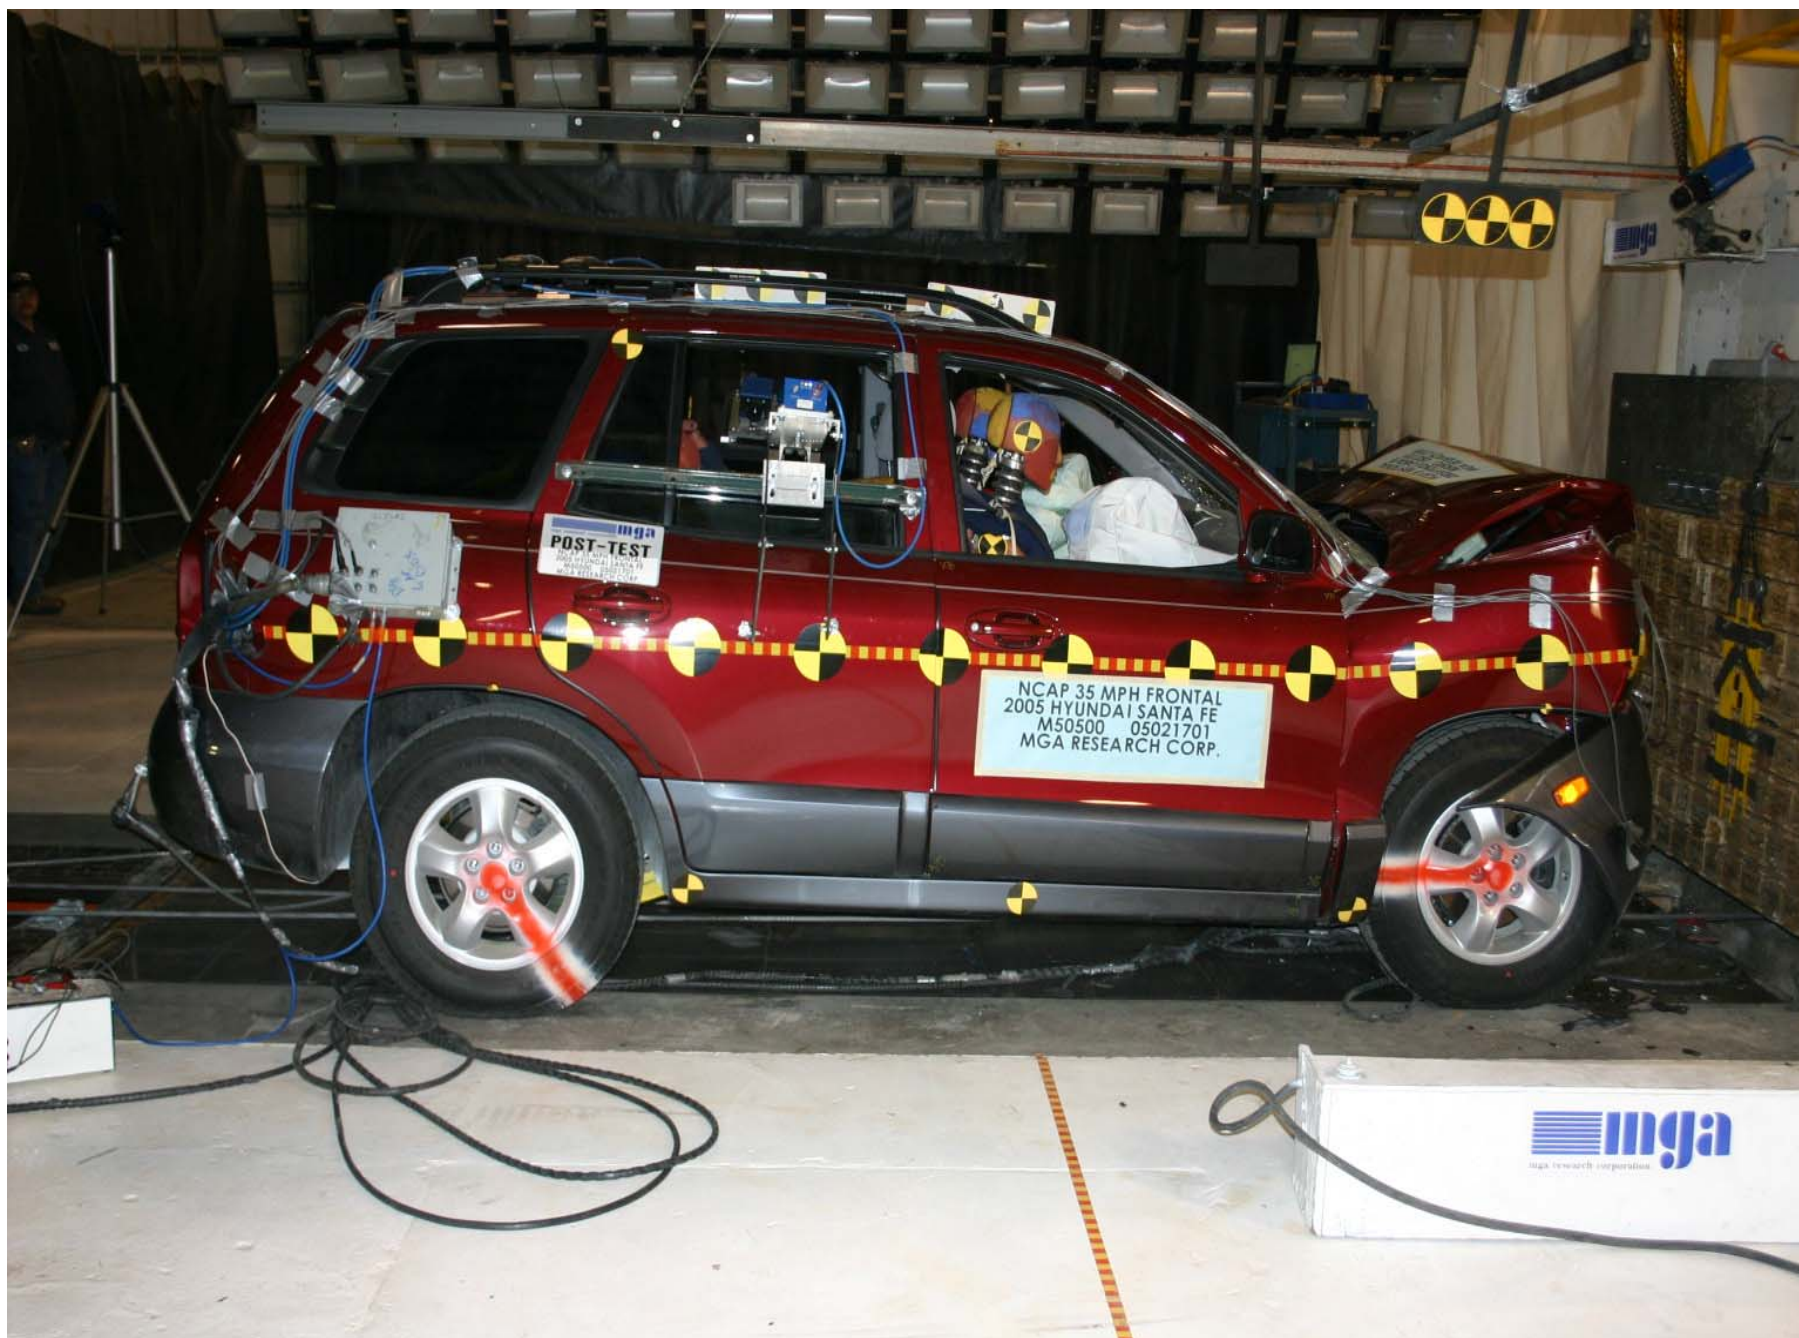
Post-Test Right Side View of Test Vehicle

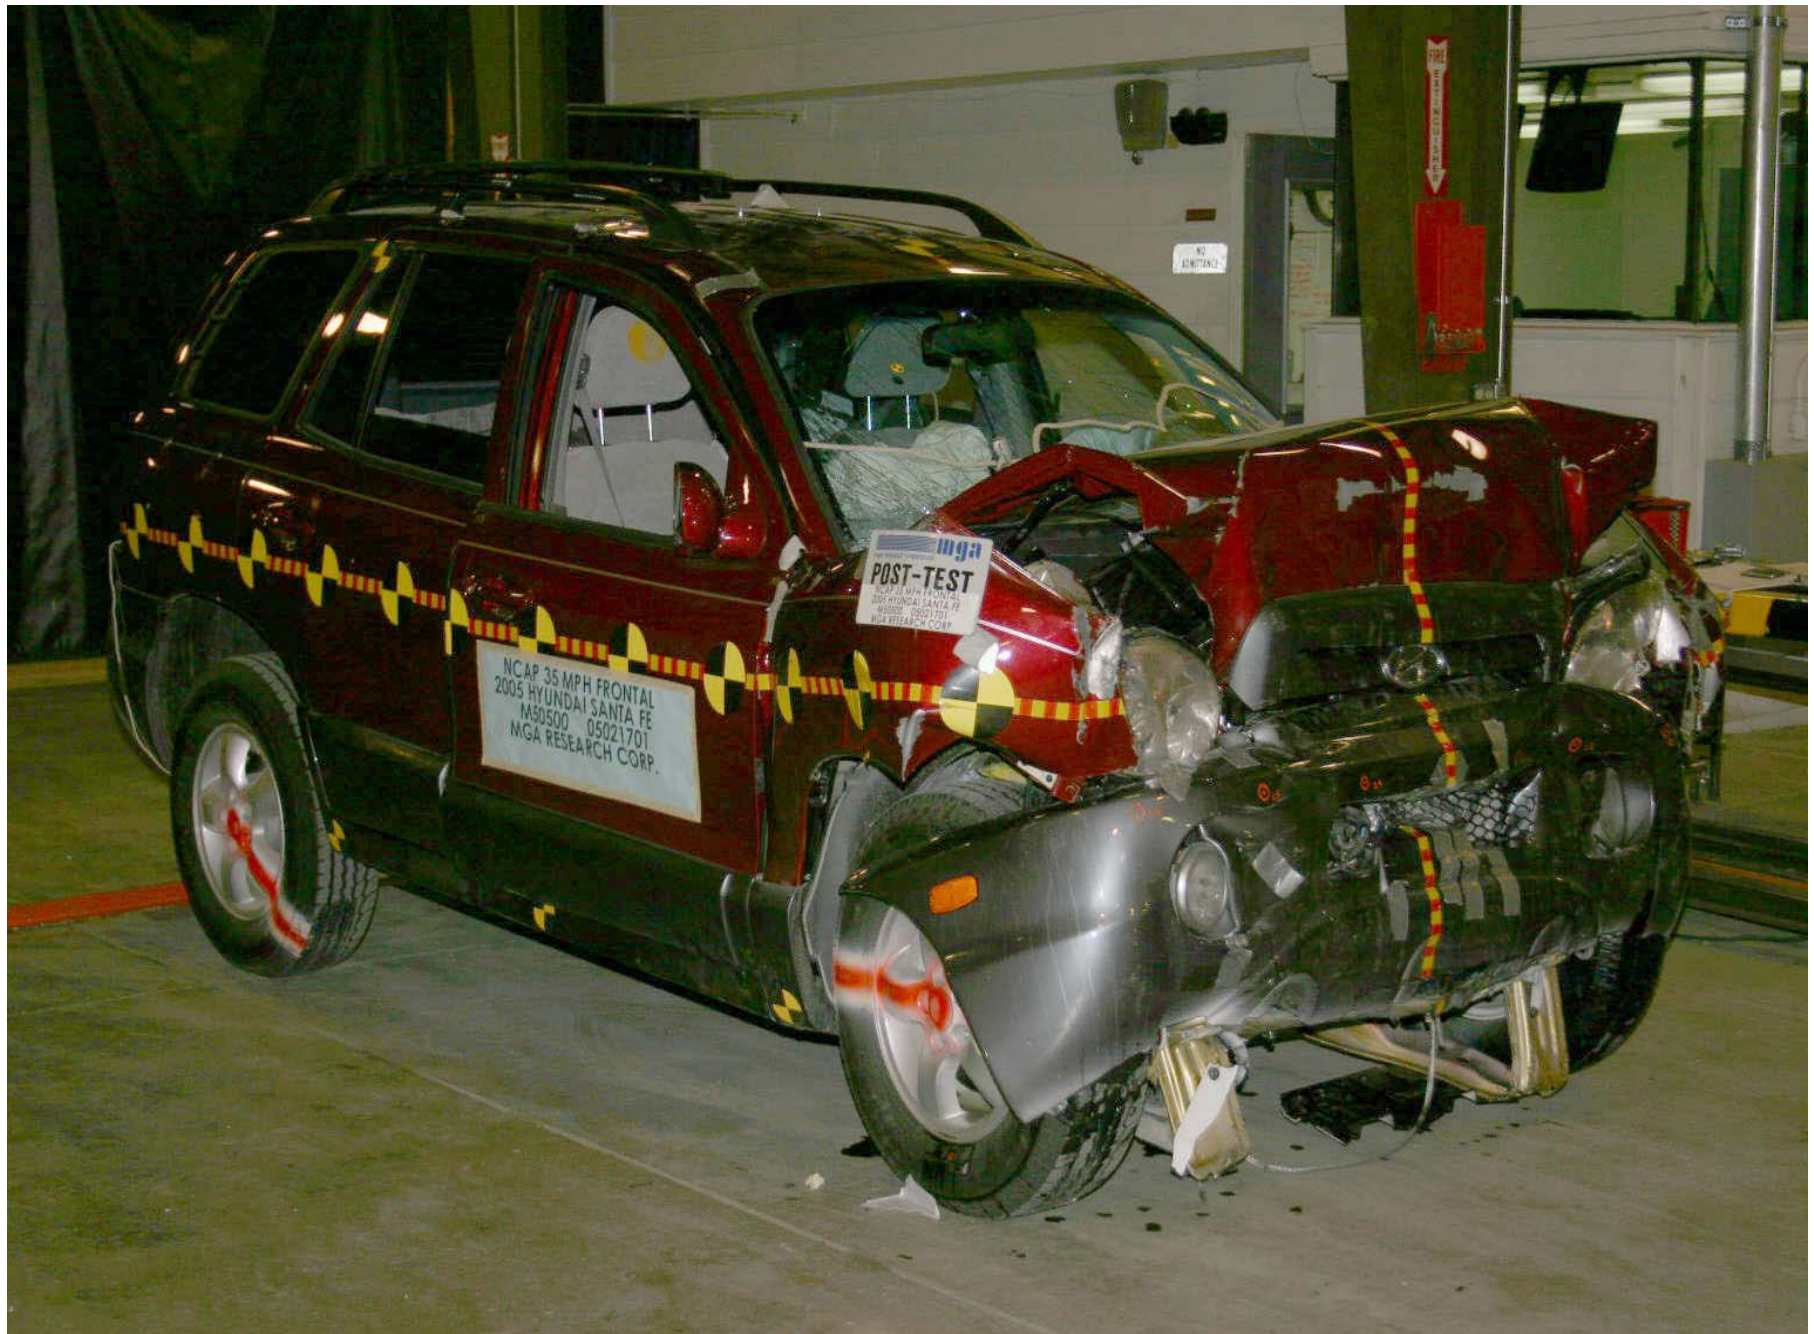
Post-Test Right Front Three-Quarter View of Test Vehicle

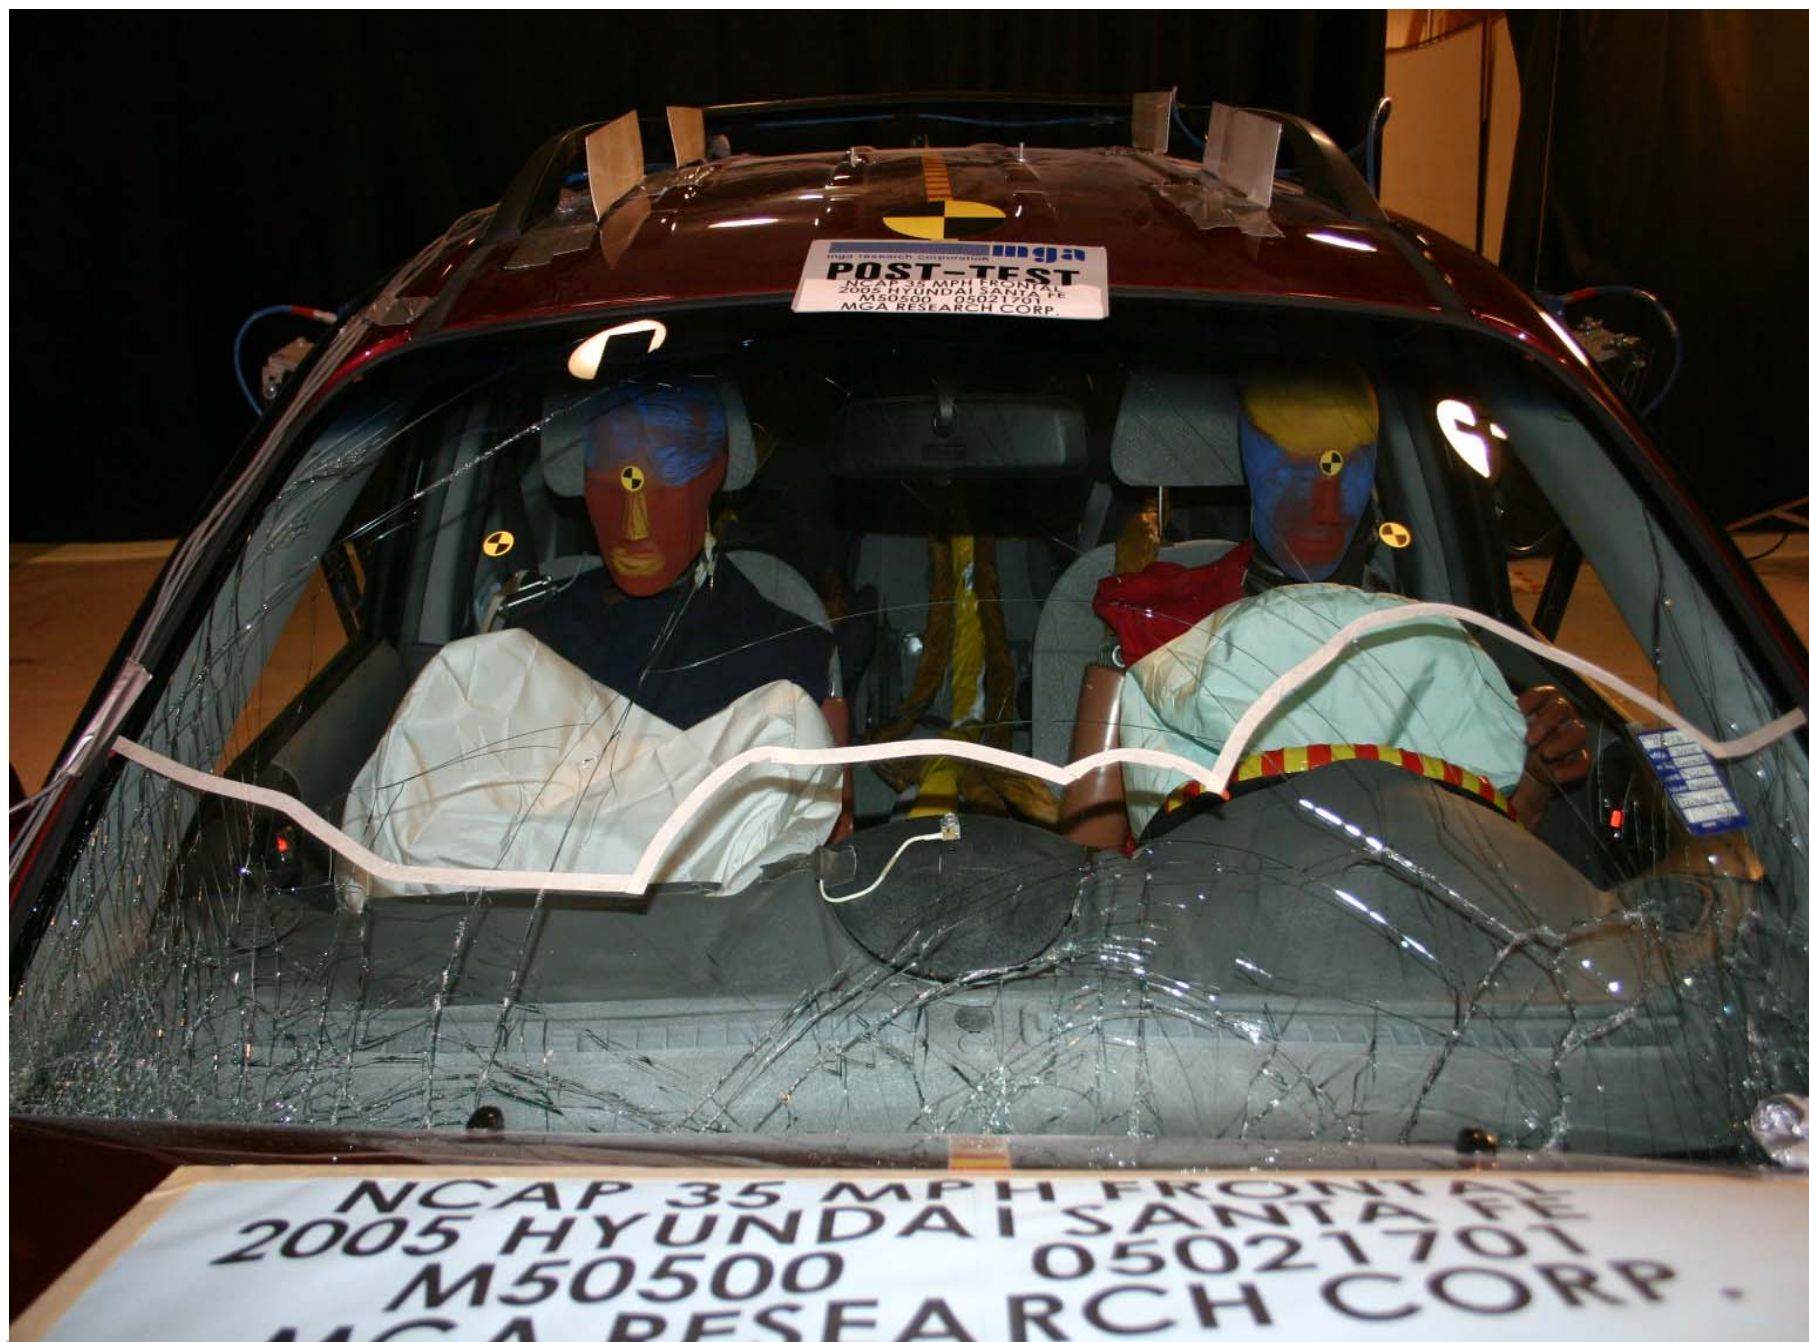
Post-Test Windshield View

There was 100 percent windshield retention and no intrusion into the protected zone of the windshield during the event. There was no Stoddard Solvent leakage after the event or during any phase of the static rollover.

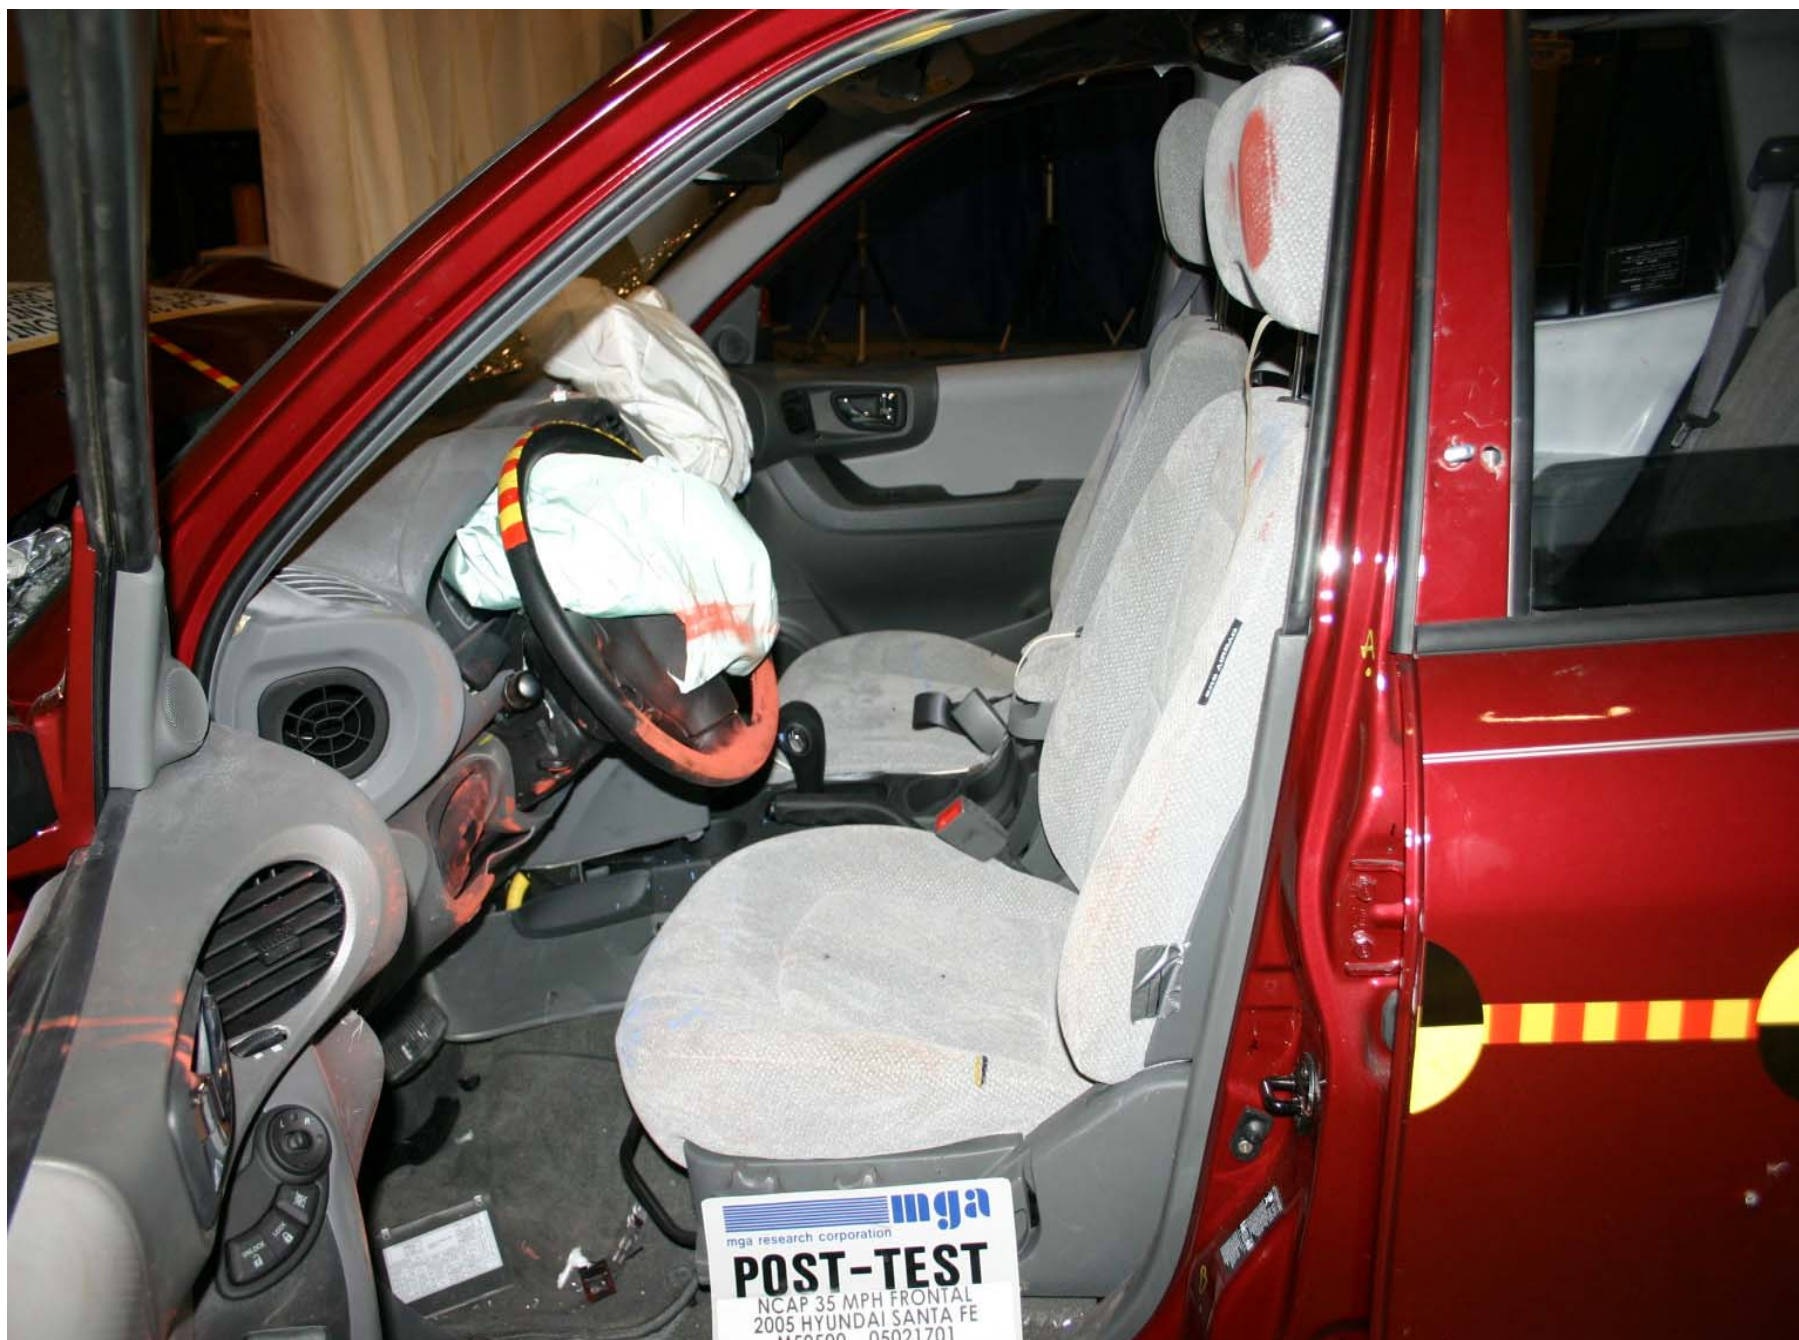
Post-Test Driver Dummy Knee Contact

The driver's head, chest, and abdomen contacted the airbag. The driver's head also contacted the headrest and headliner. The driver's knees contacted the bolster. The passenger's head and chest contacted the airbag. The passenger's head also contacted the headrest and visor. The passenger's knees contacted the glove box.

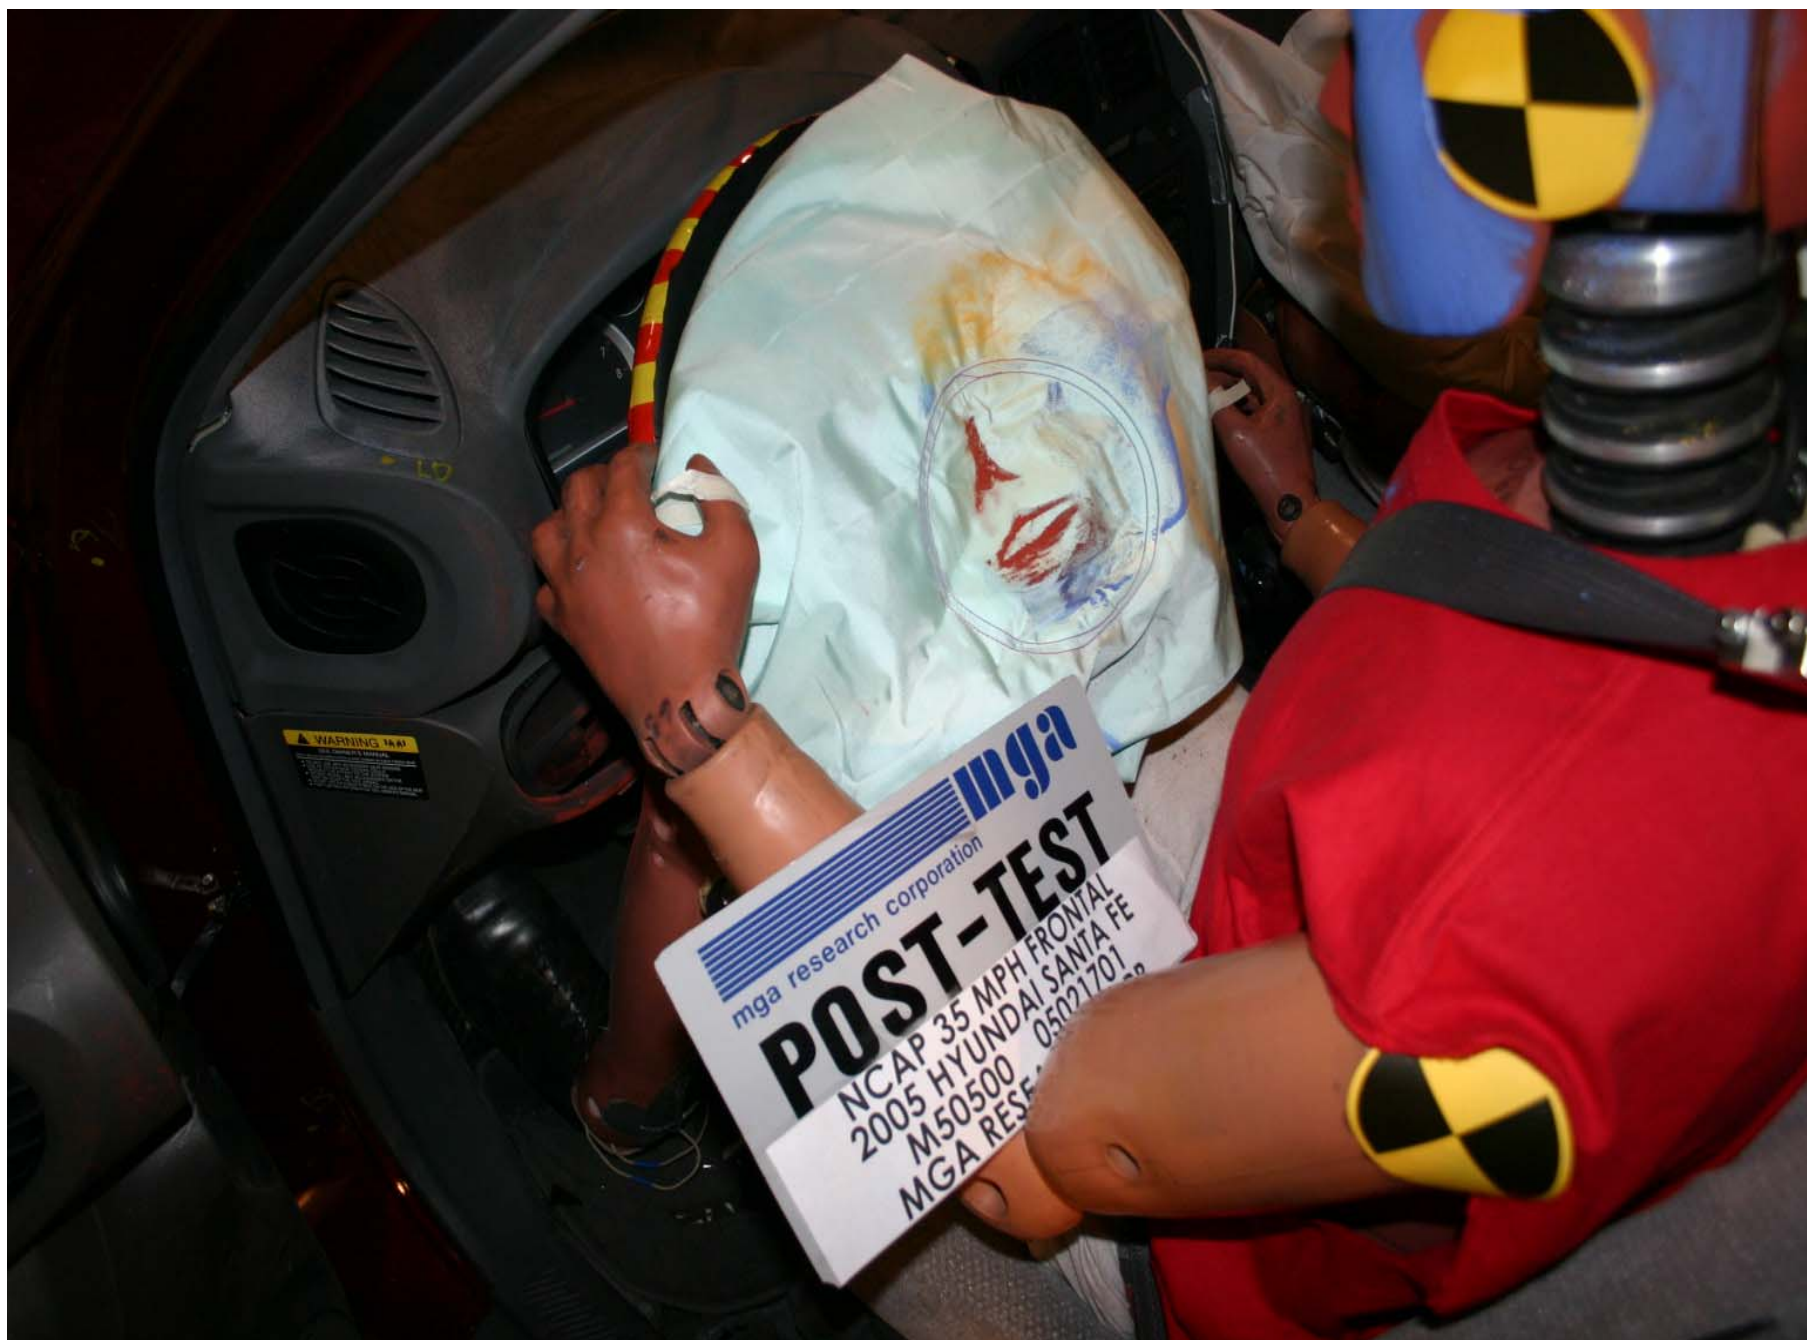
Post-Test Driver Dummy Airbag Contact

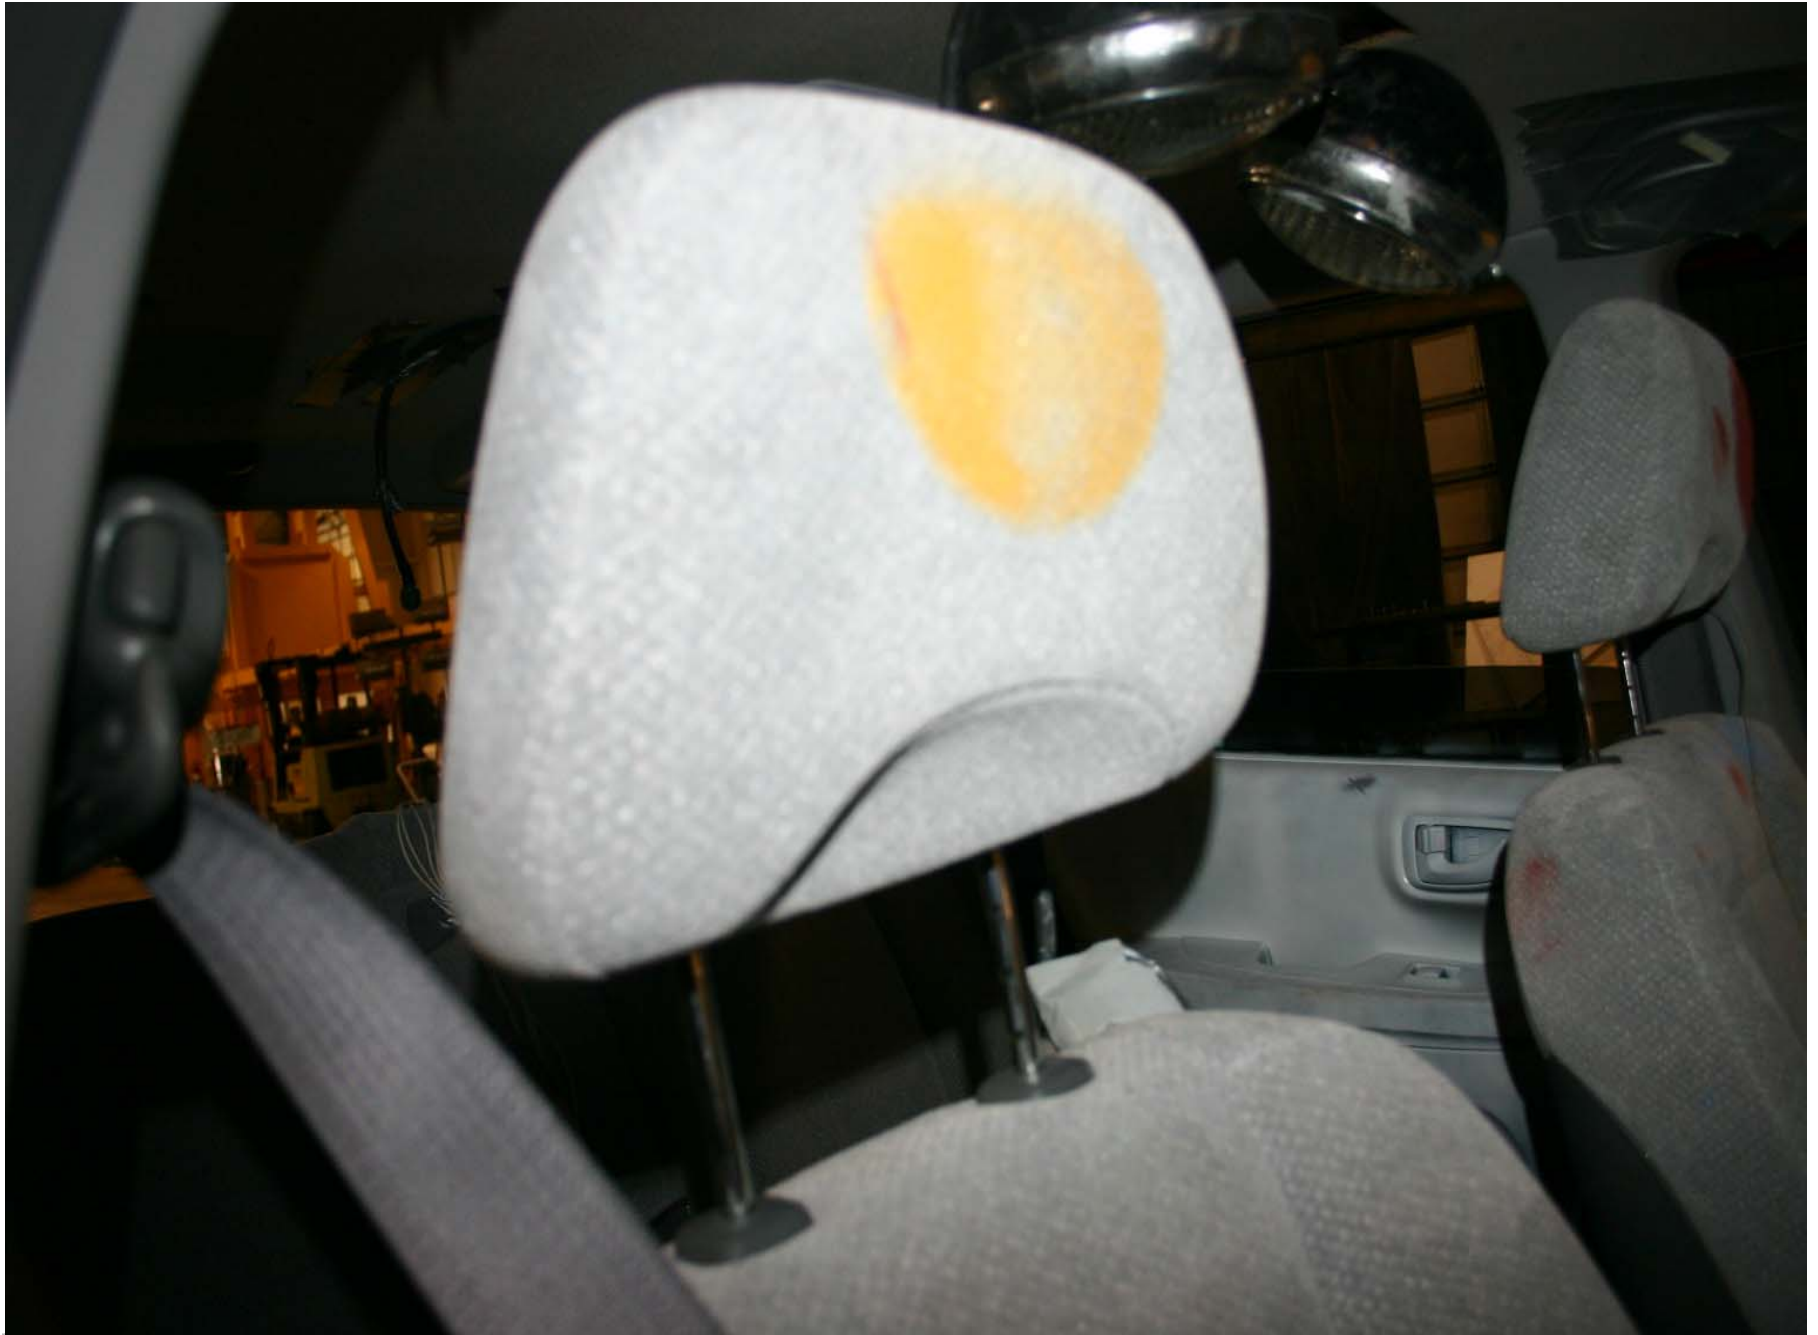
Post-Test Passenger Dummy Head Contact

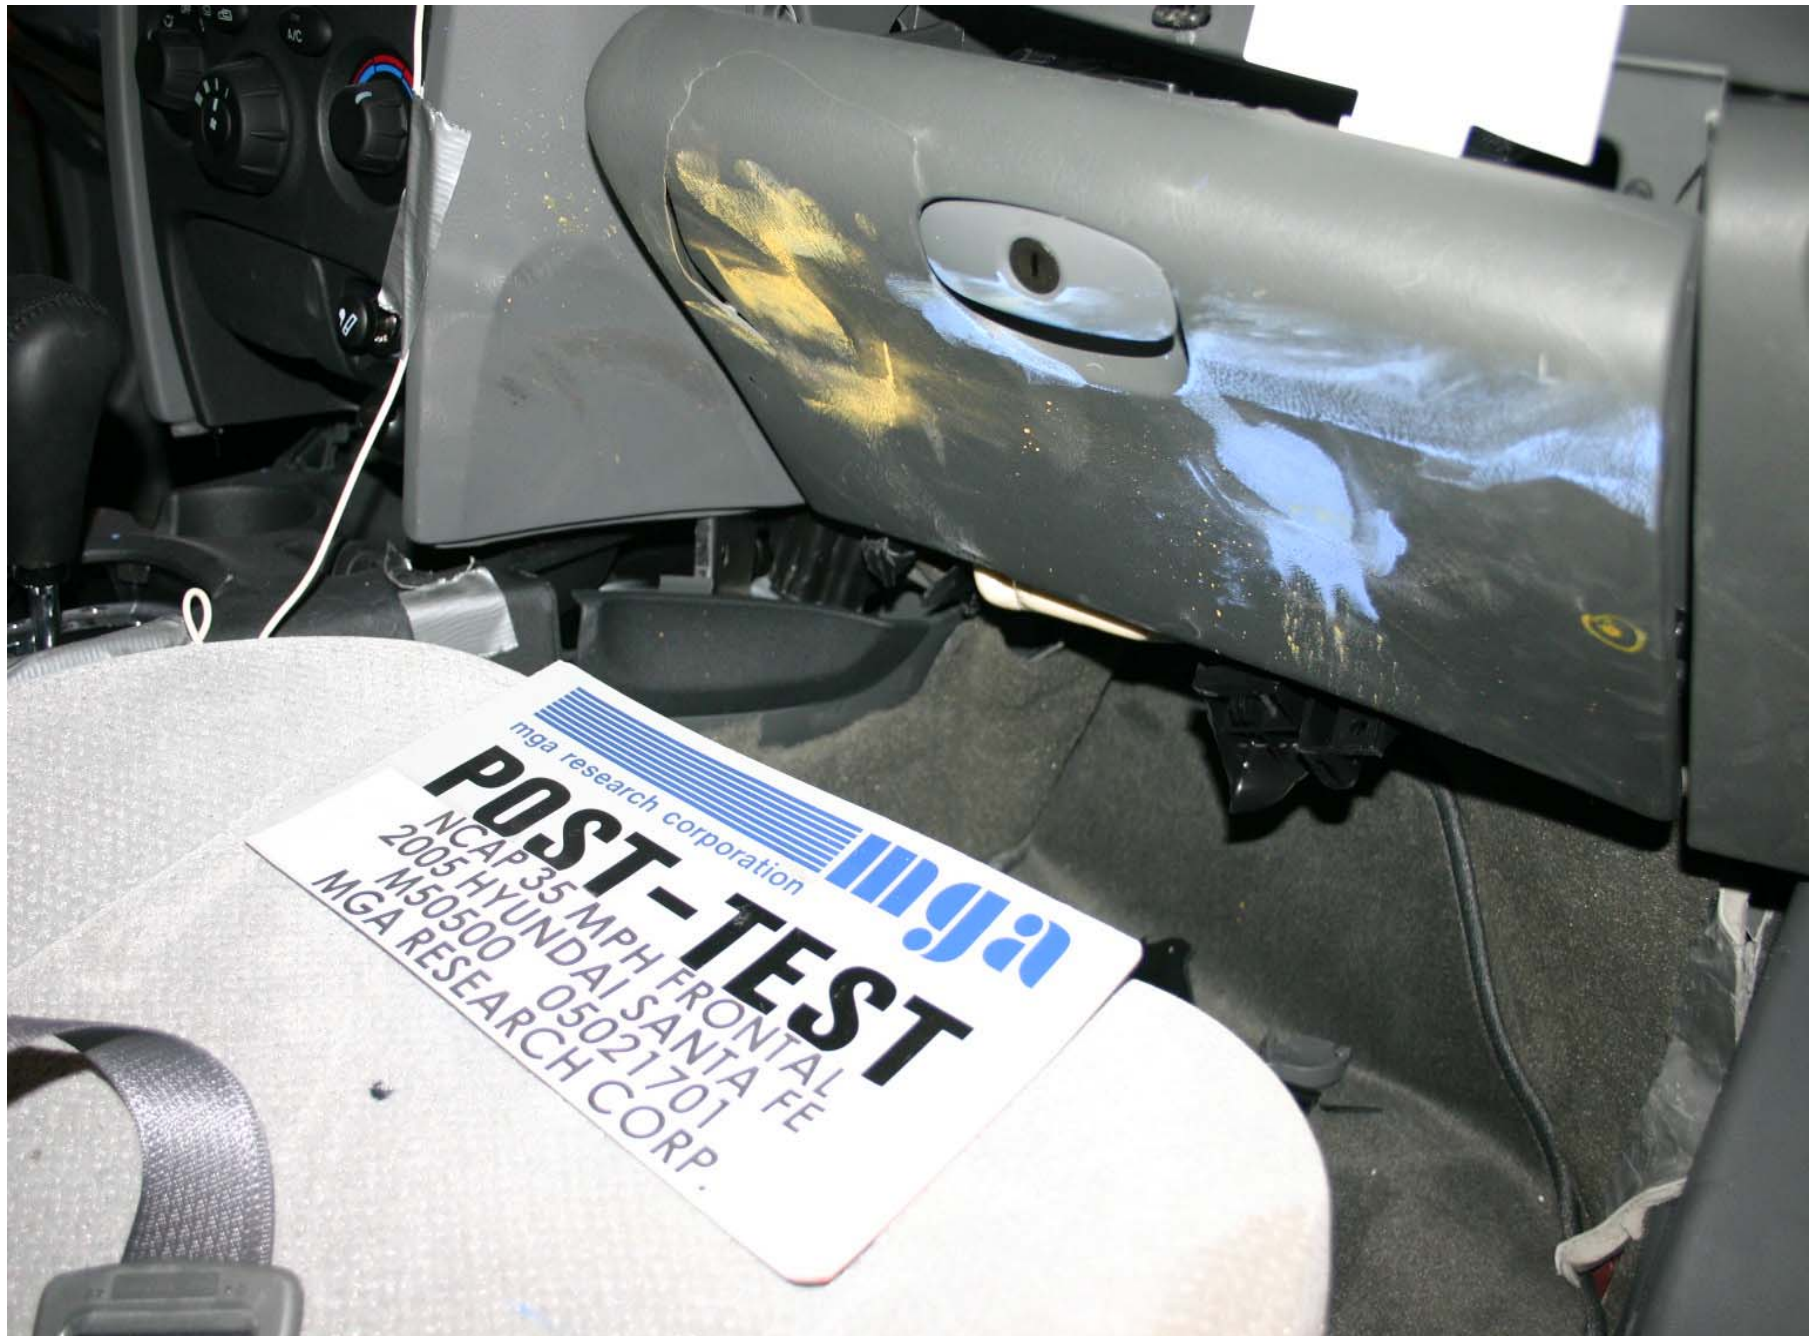
Post-Test Passenger Dummy Knee Contact
