**REPORT NUMBER: NCAP-MGA-2005-013**

**NEW CAR ASSESSMENT PROGRAM  
FRONTAL BARRIER IMPACT TEST**

**HYUNDAI MOTOR COMPANY  
2005 HYUNDAI SANTA FE  
NHTSA NUMBER: M50500**

**FINAL REPORT**

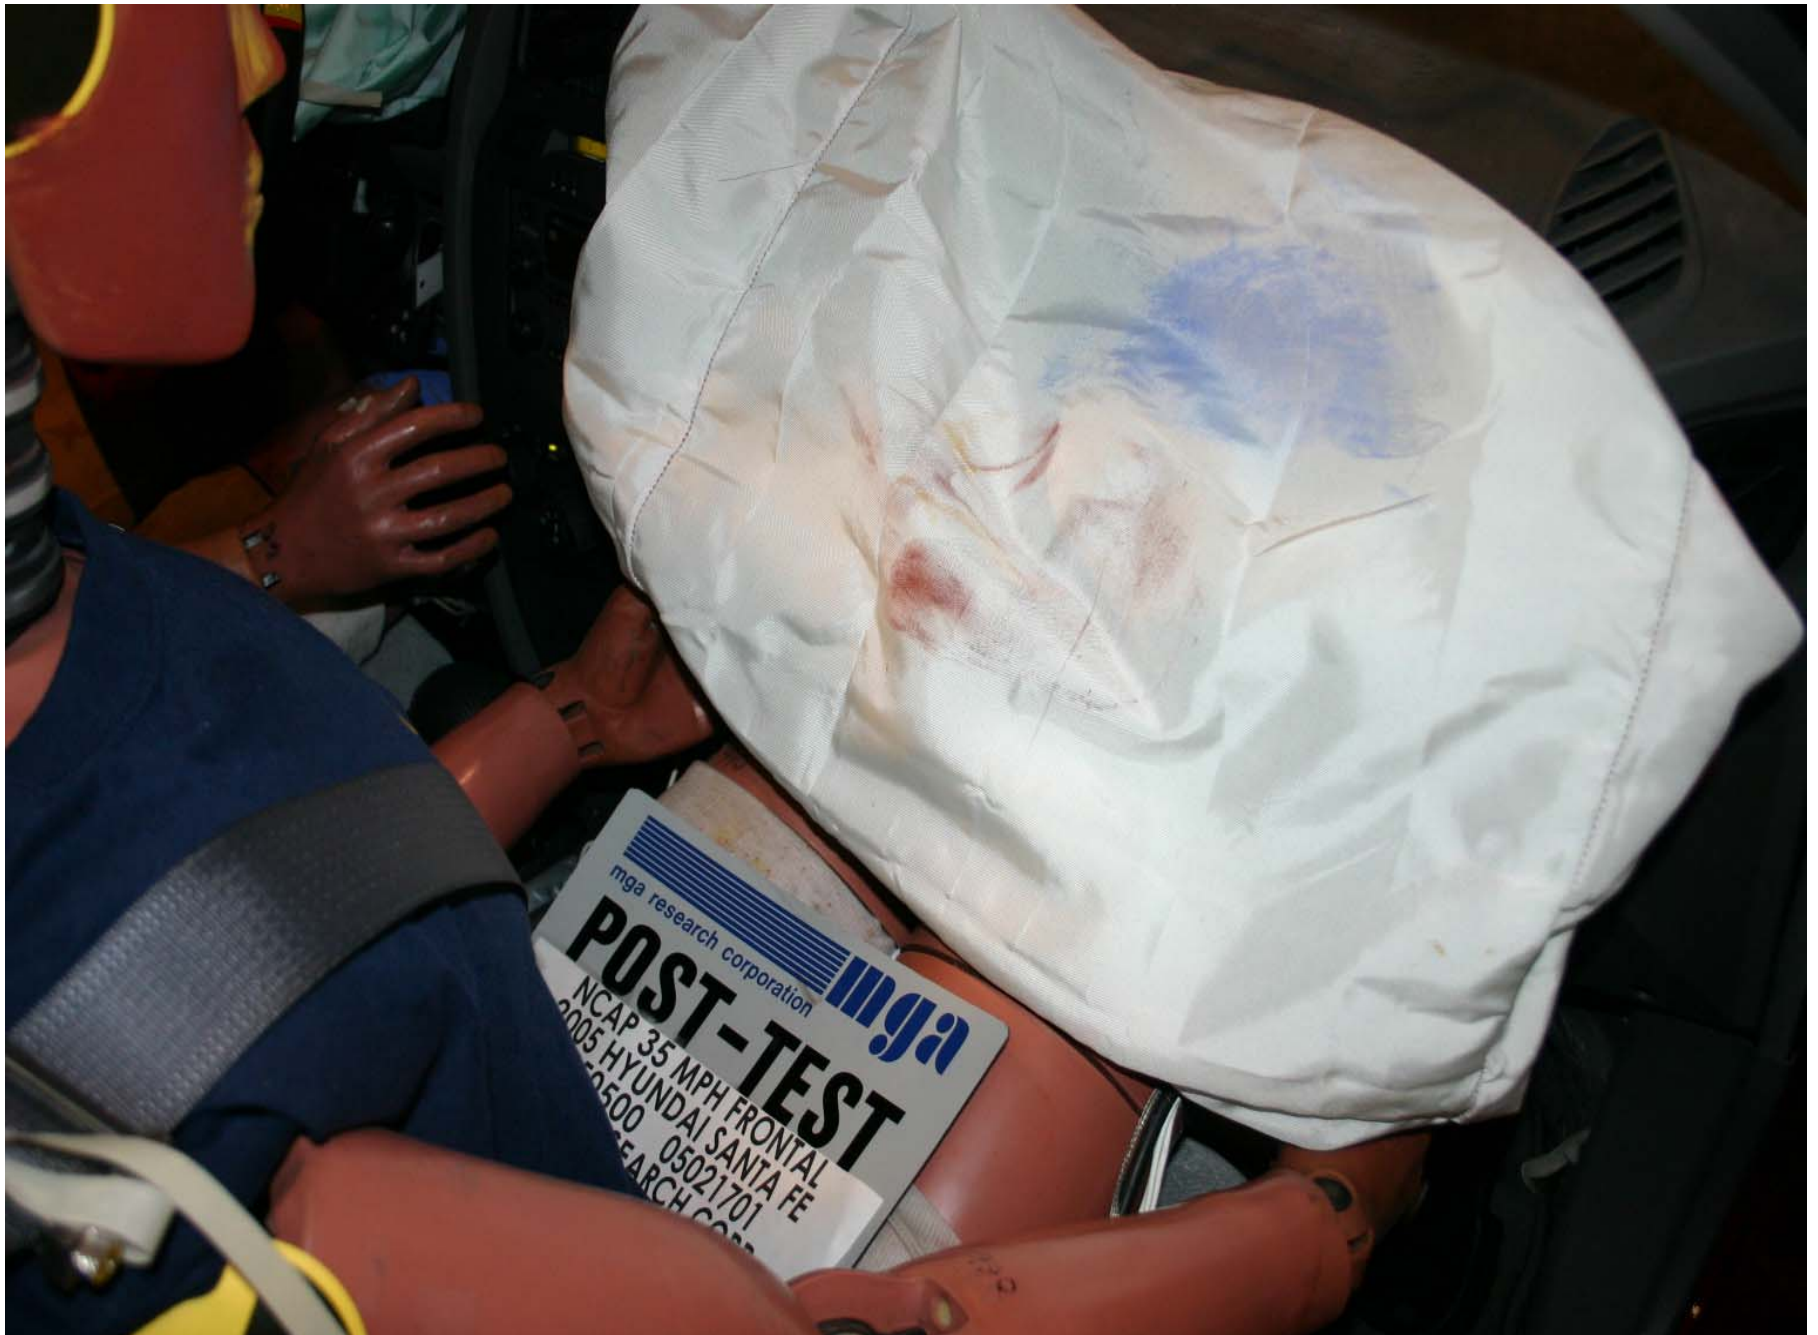
Post-Test Passenger Dummy Airbag Contact

The driver's head, chest, and abdomen contacted the airbag. The driver's head also contacted the headrest and headliner. The driver's knees contacted the bolster. The passenger's head and chest contacted the airbag. The passenger's head also contacted the headrest and visor. The passenger's knees contacted the glove box.

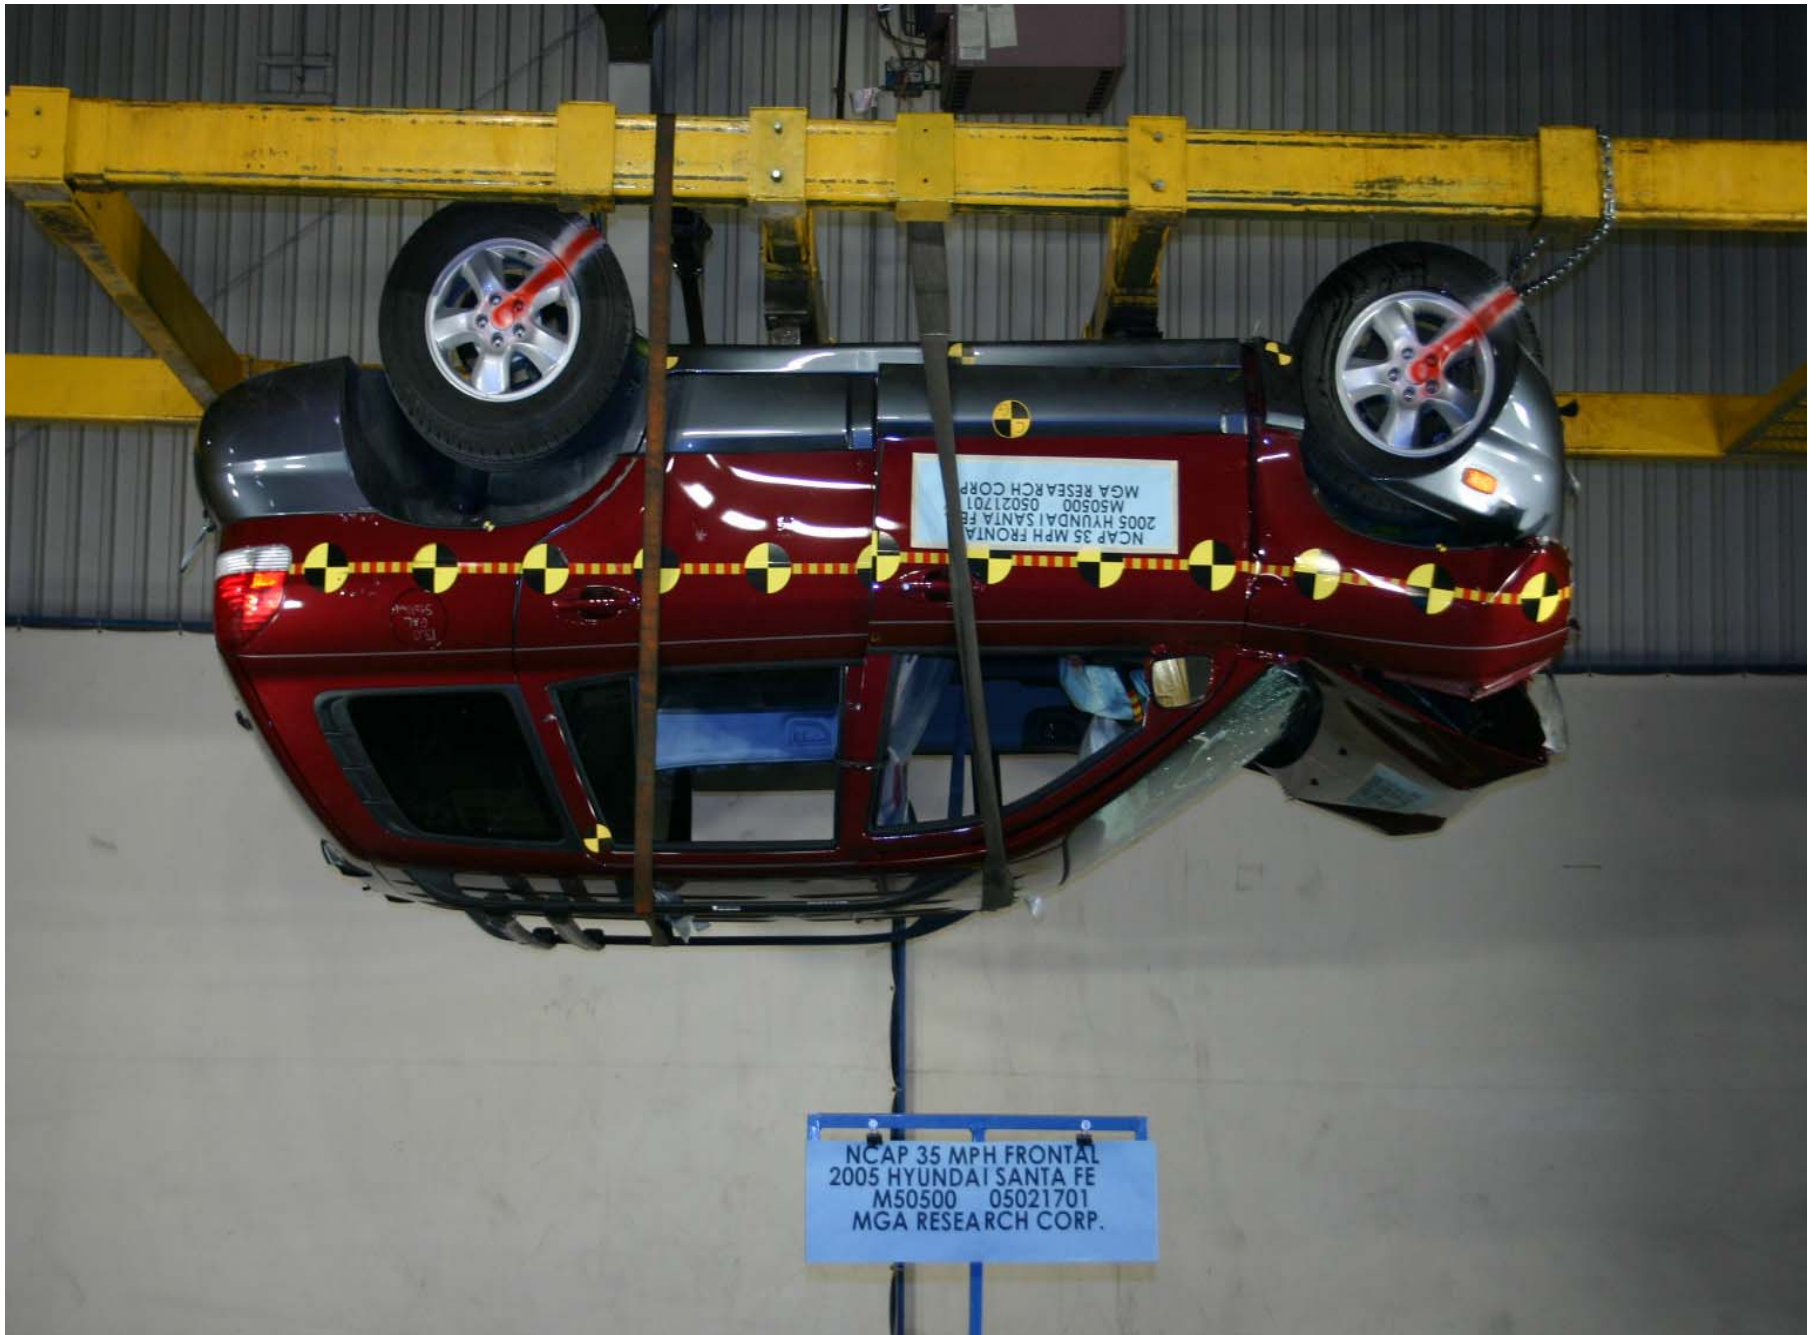
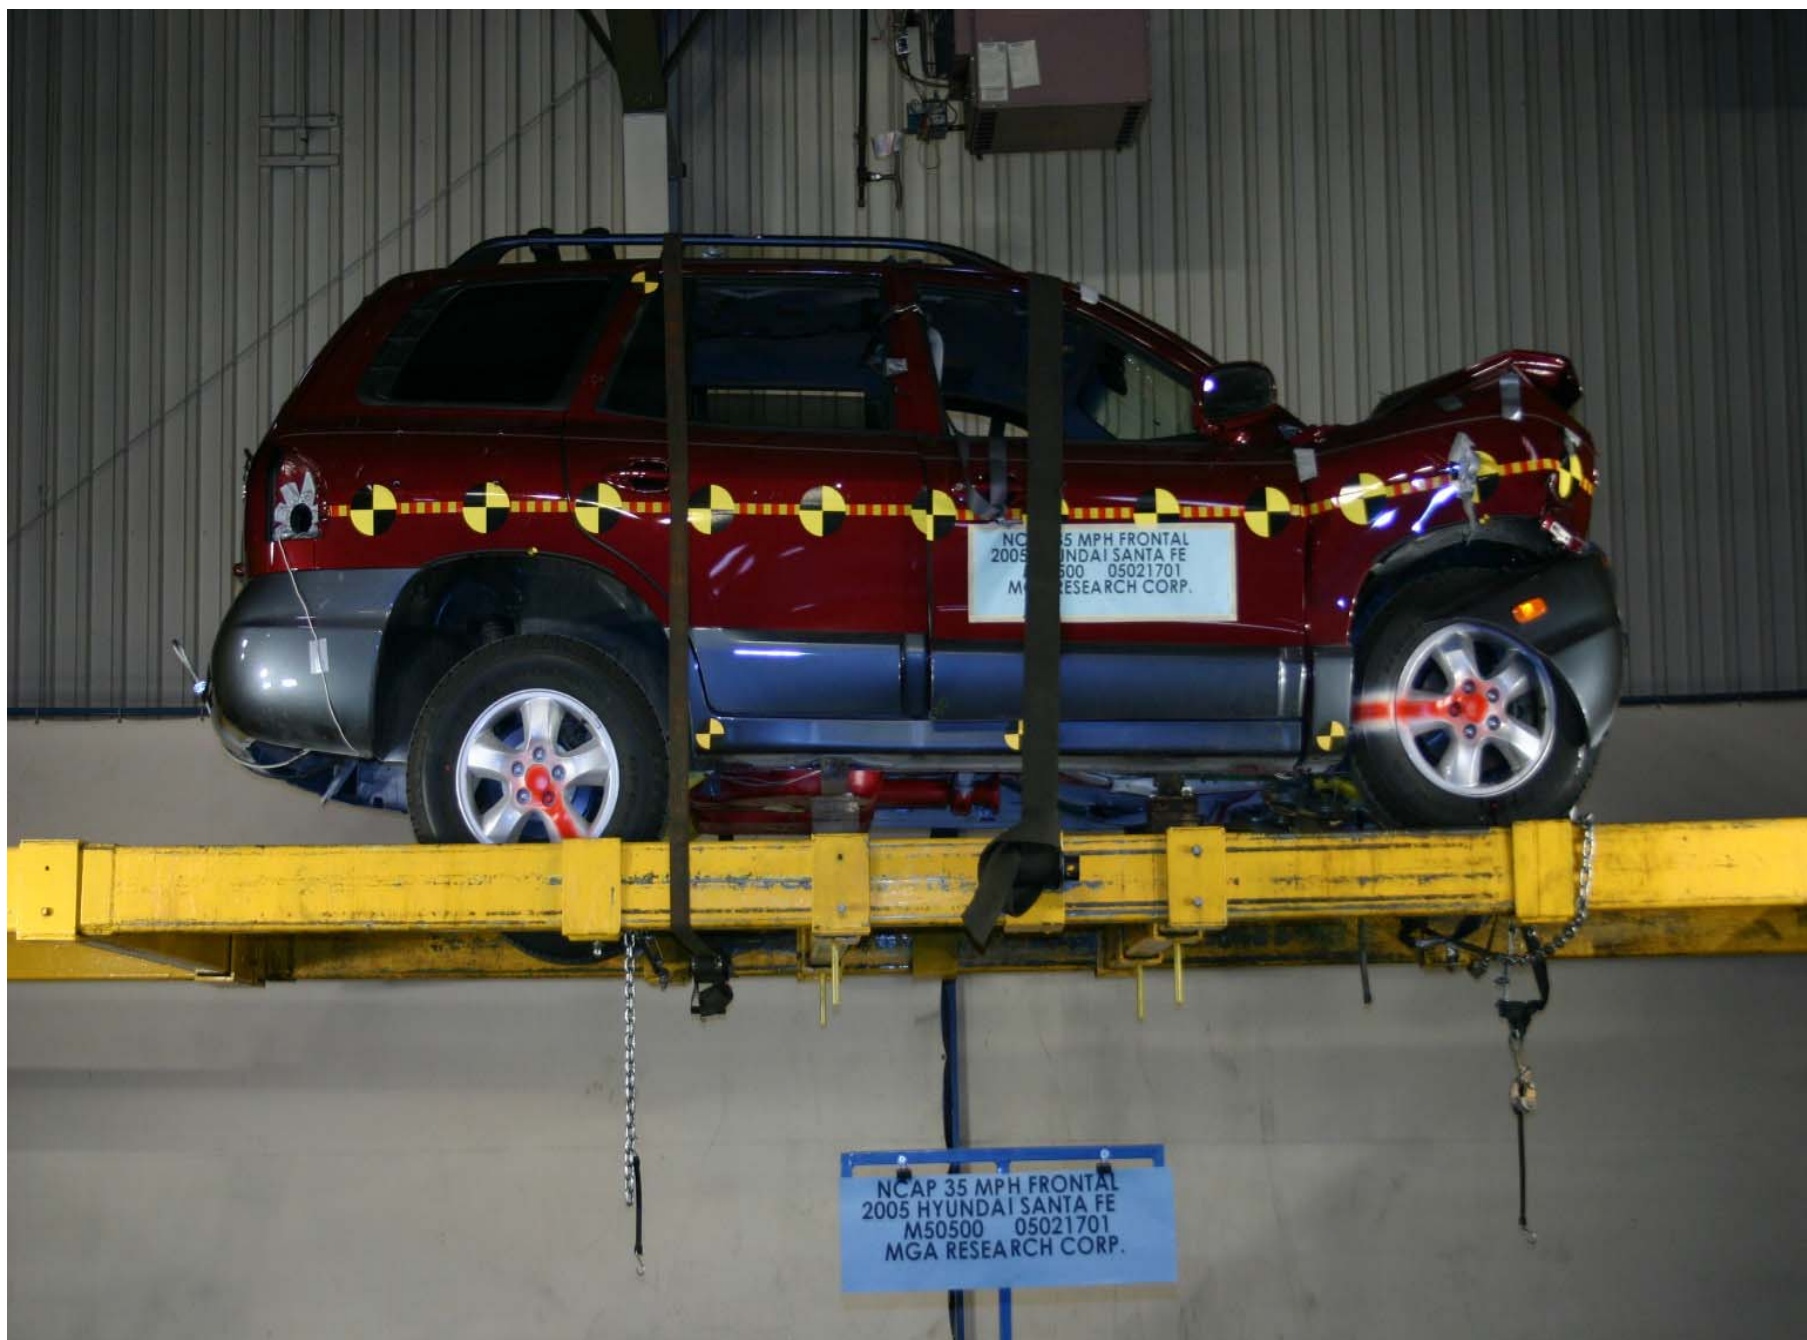
Rollover 90 Degrees

Rollover 180 Degrees

Rollover 270 Degrees

Rollover 360 Degrees

There was 100 percent windshield retention and no intrusion into the protected zone of the windshield during the event. There was no Stoddard Solvent leakage after the event or during any phase of the static rollover.

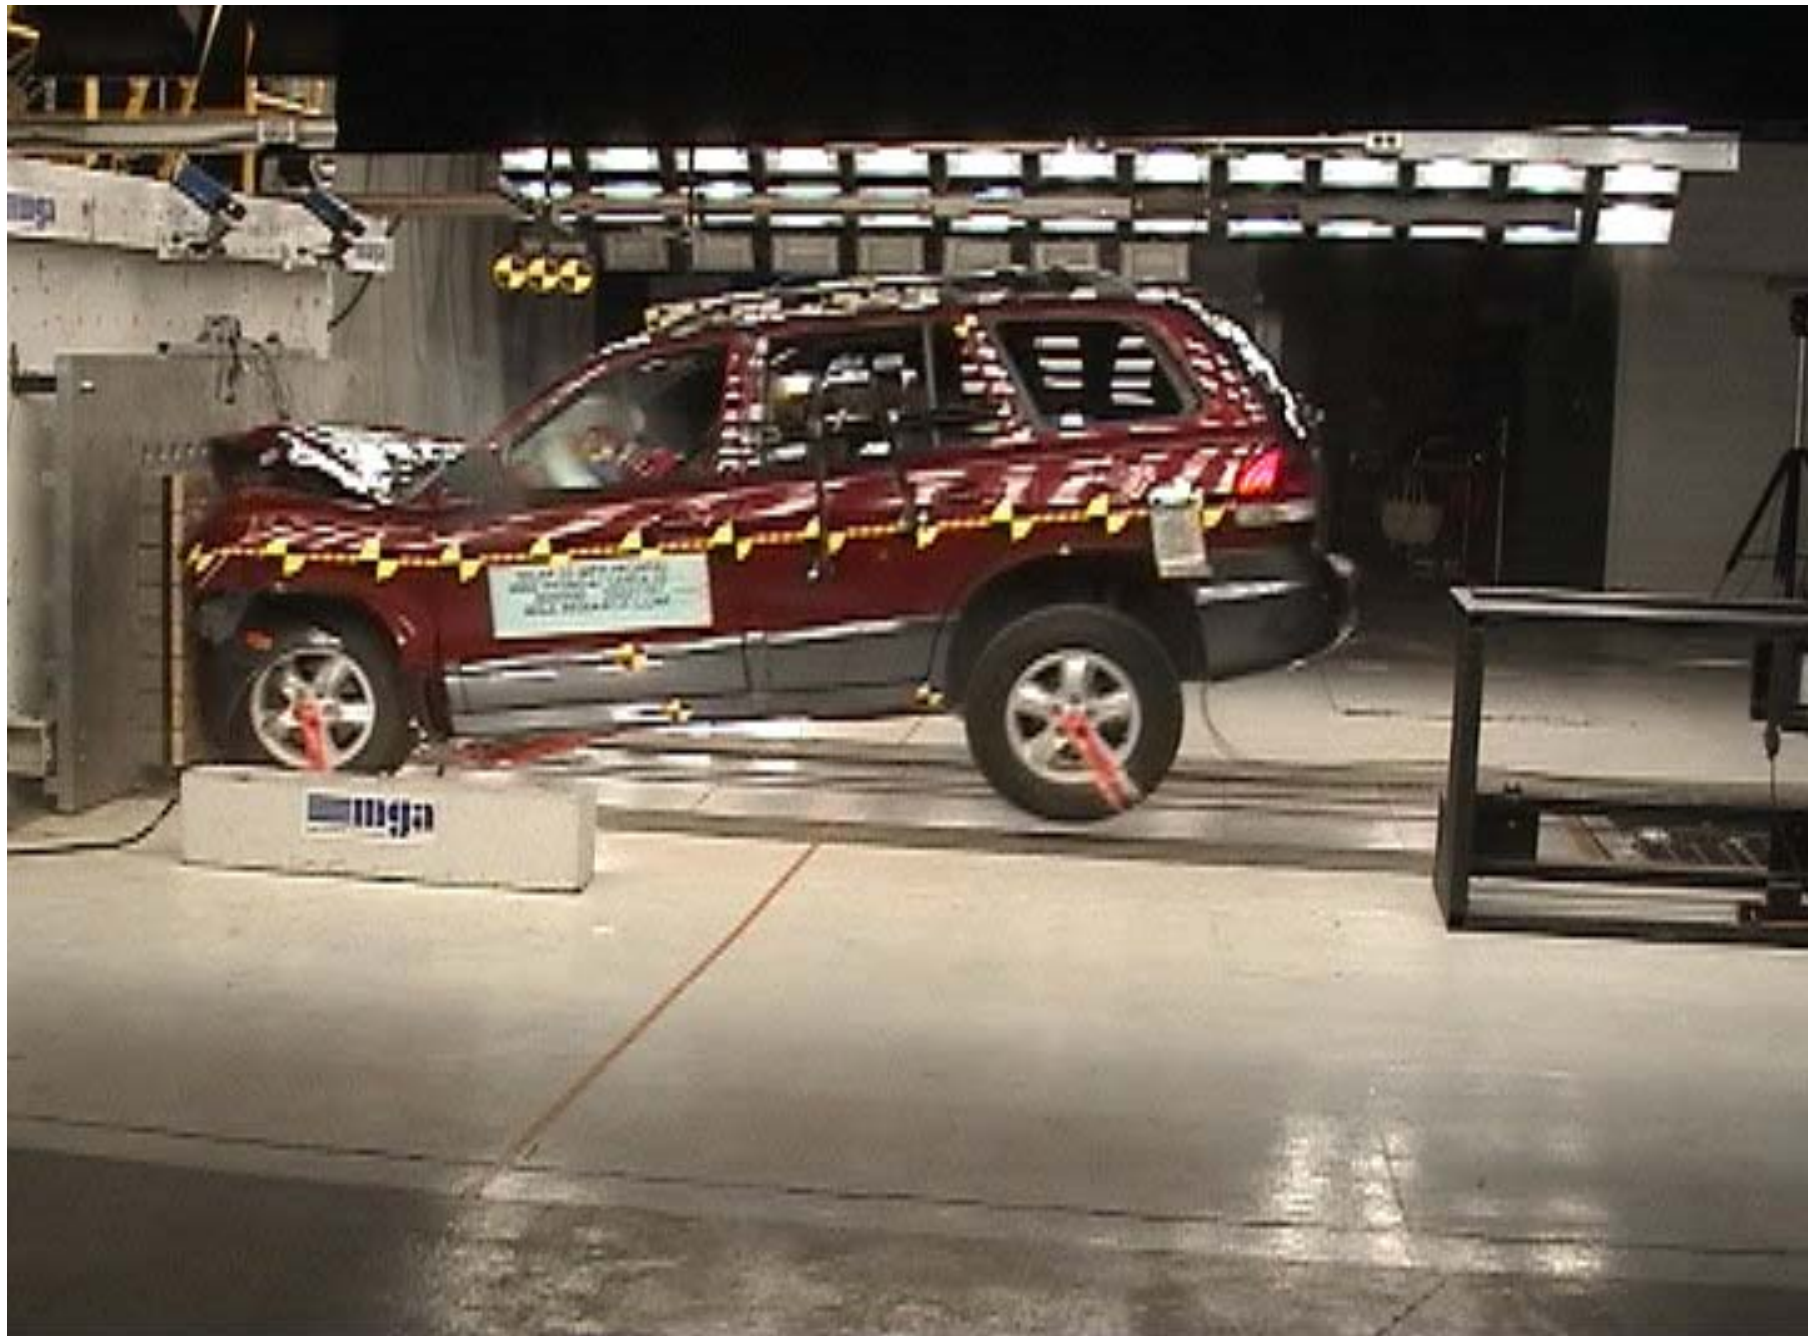
Vehicle Impact

A load cell barrier consisting of 30 load cells was impacted by a 2005 Hyundai Santa Fe at a velocity of 56.6 kph. The test was performed at MGA Research Corporation on February 17, 2005. Pre-and post-test photographs of the vehicle and dummies can be found in Appendix A.
