REPORT NUMBER TR-P25003-05-NC

**NEW CAR ASSESSMENT PROGRAM
SIDE IMPACT TEST**

**NISSAN MOTOR CORPORATION, LTD
2005 NISSAN XTERRA
5-DOOR MPV**

NHTSA NUMBER: M55209

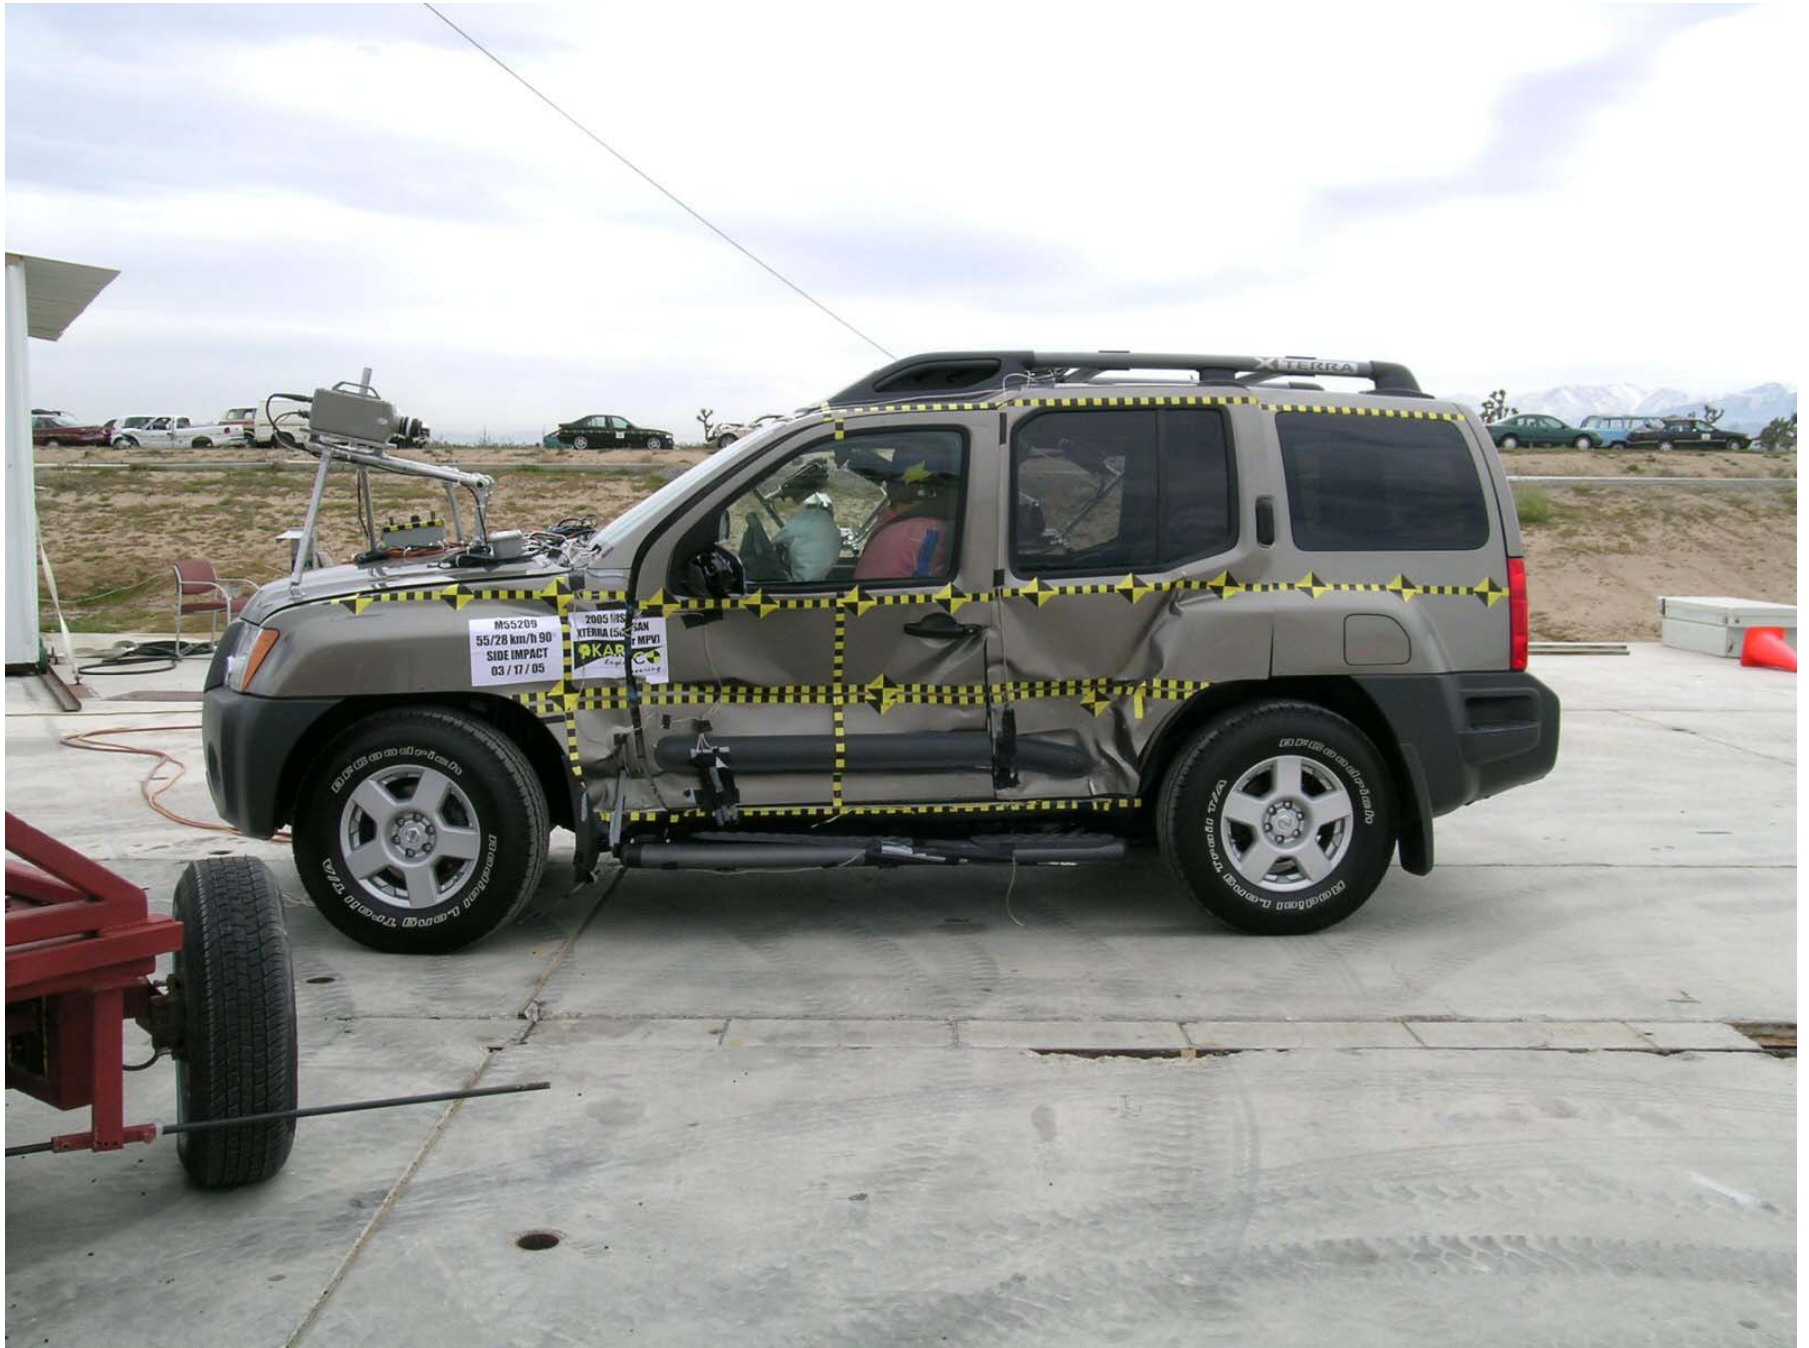
Figure A-10: Post-Test Left Side View

The driver and passenger doors remained closed. The test vehicle sustained a maximum static crush of 243 mm at level 3, 1200 mm rearward of the left vertical impact point. The driver SID/Hybrid III, Serial No. 274 and the passenger SID/Hybrid III, Serial No. 275 were calibrated prior to this test. The SID/Hybrid III injury criteria is summarized as follows:

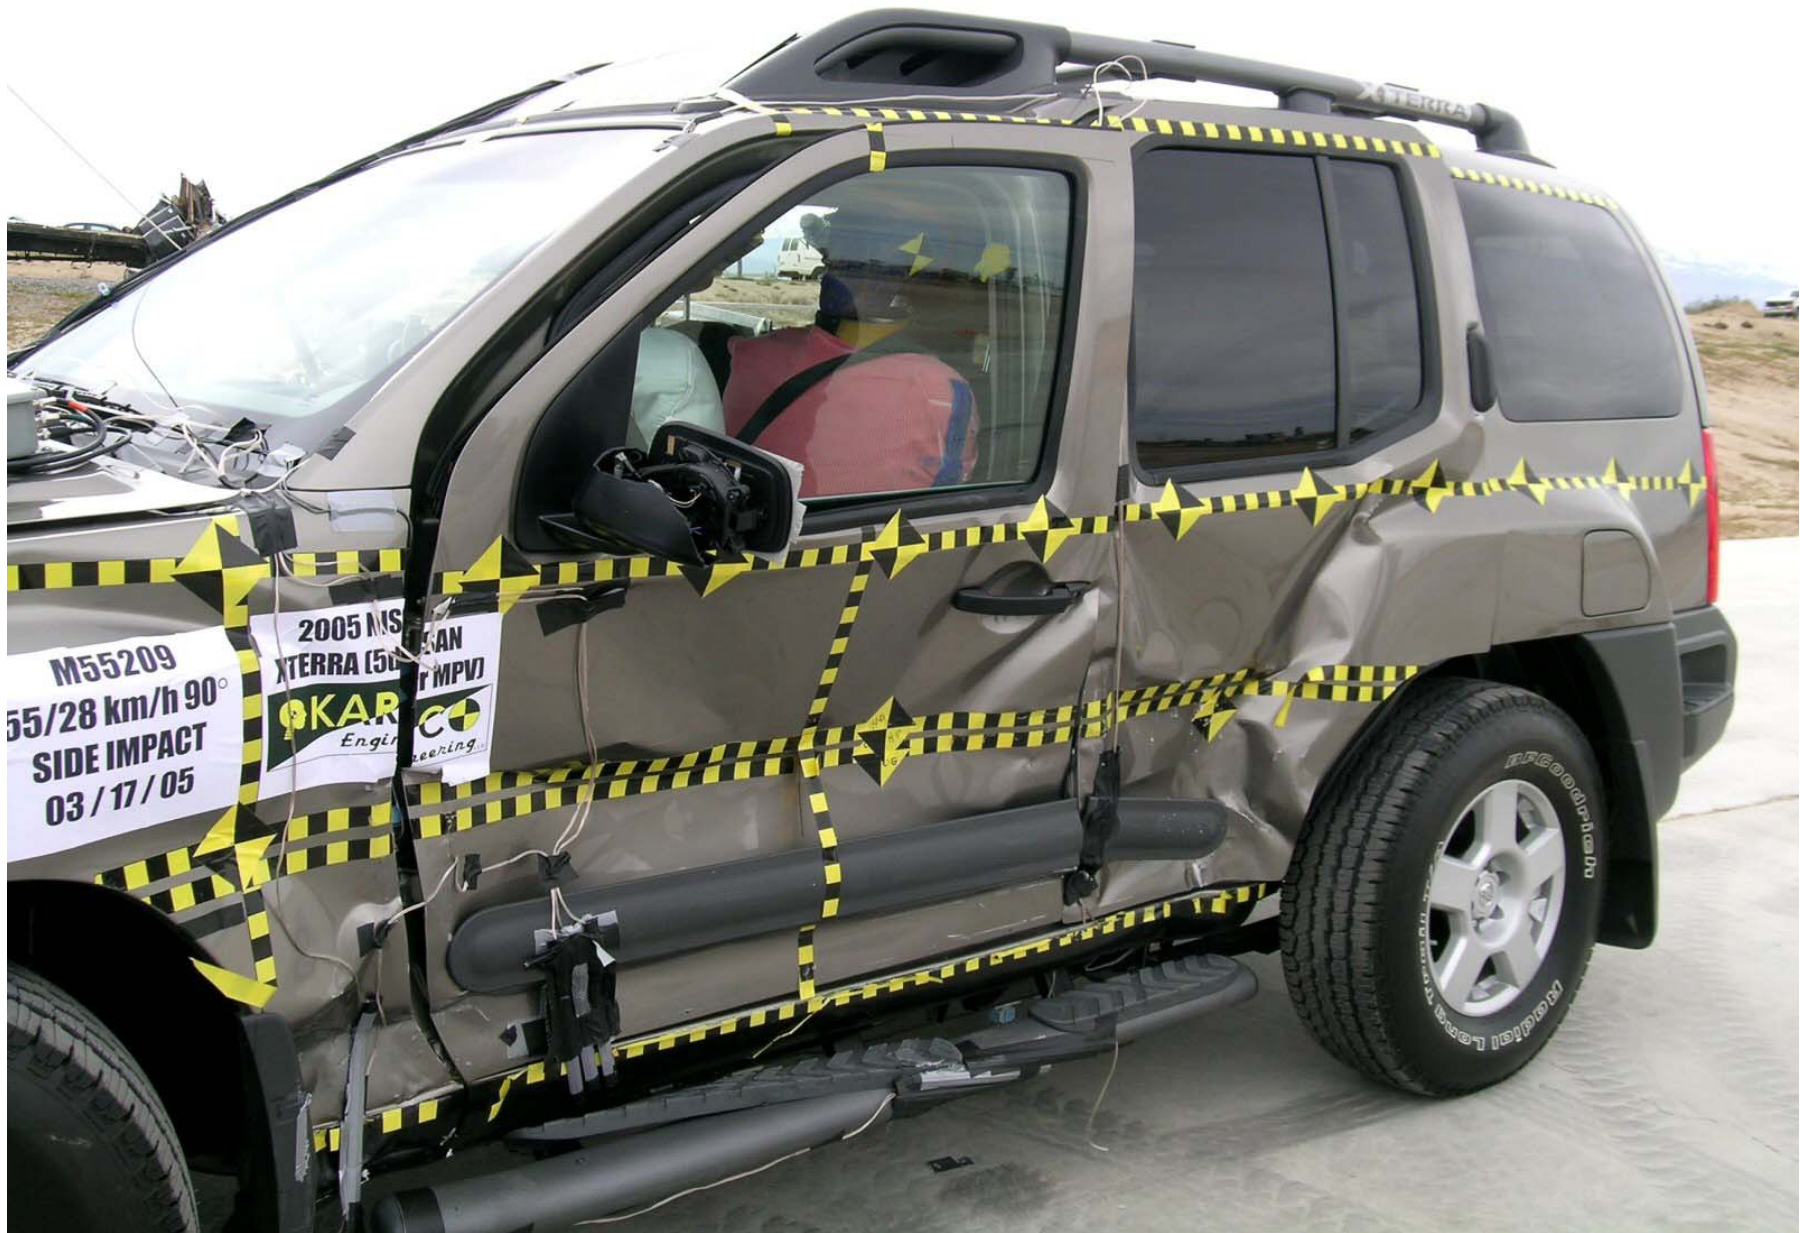
Figure A-28: Post-Test Front ¾ View of Left Side Doors

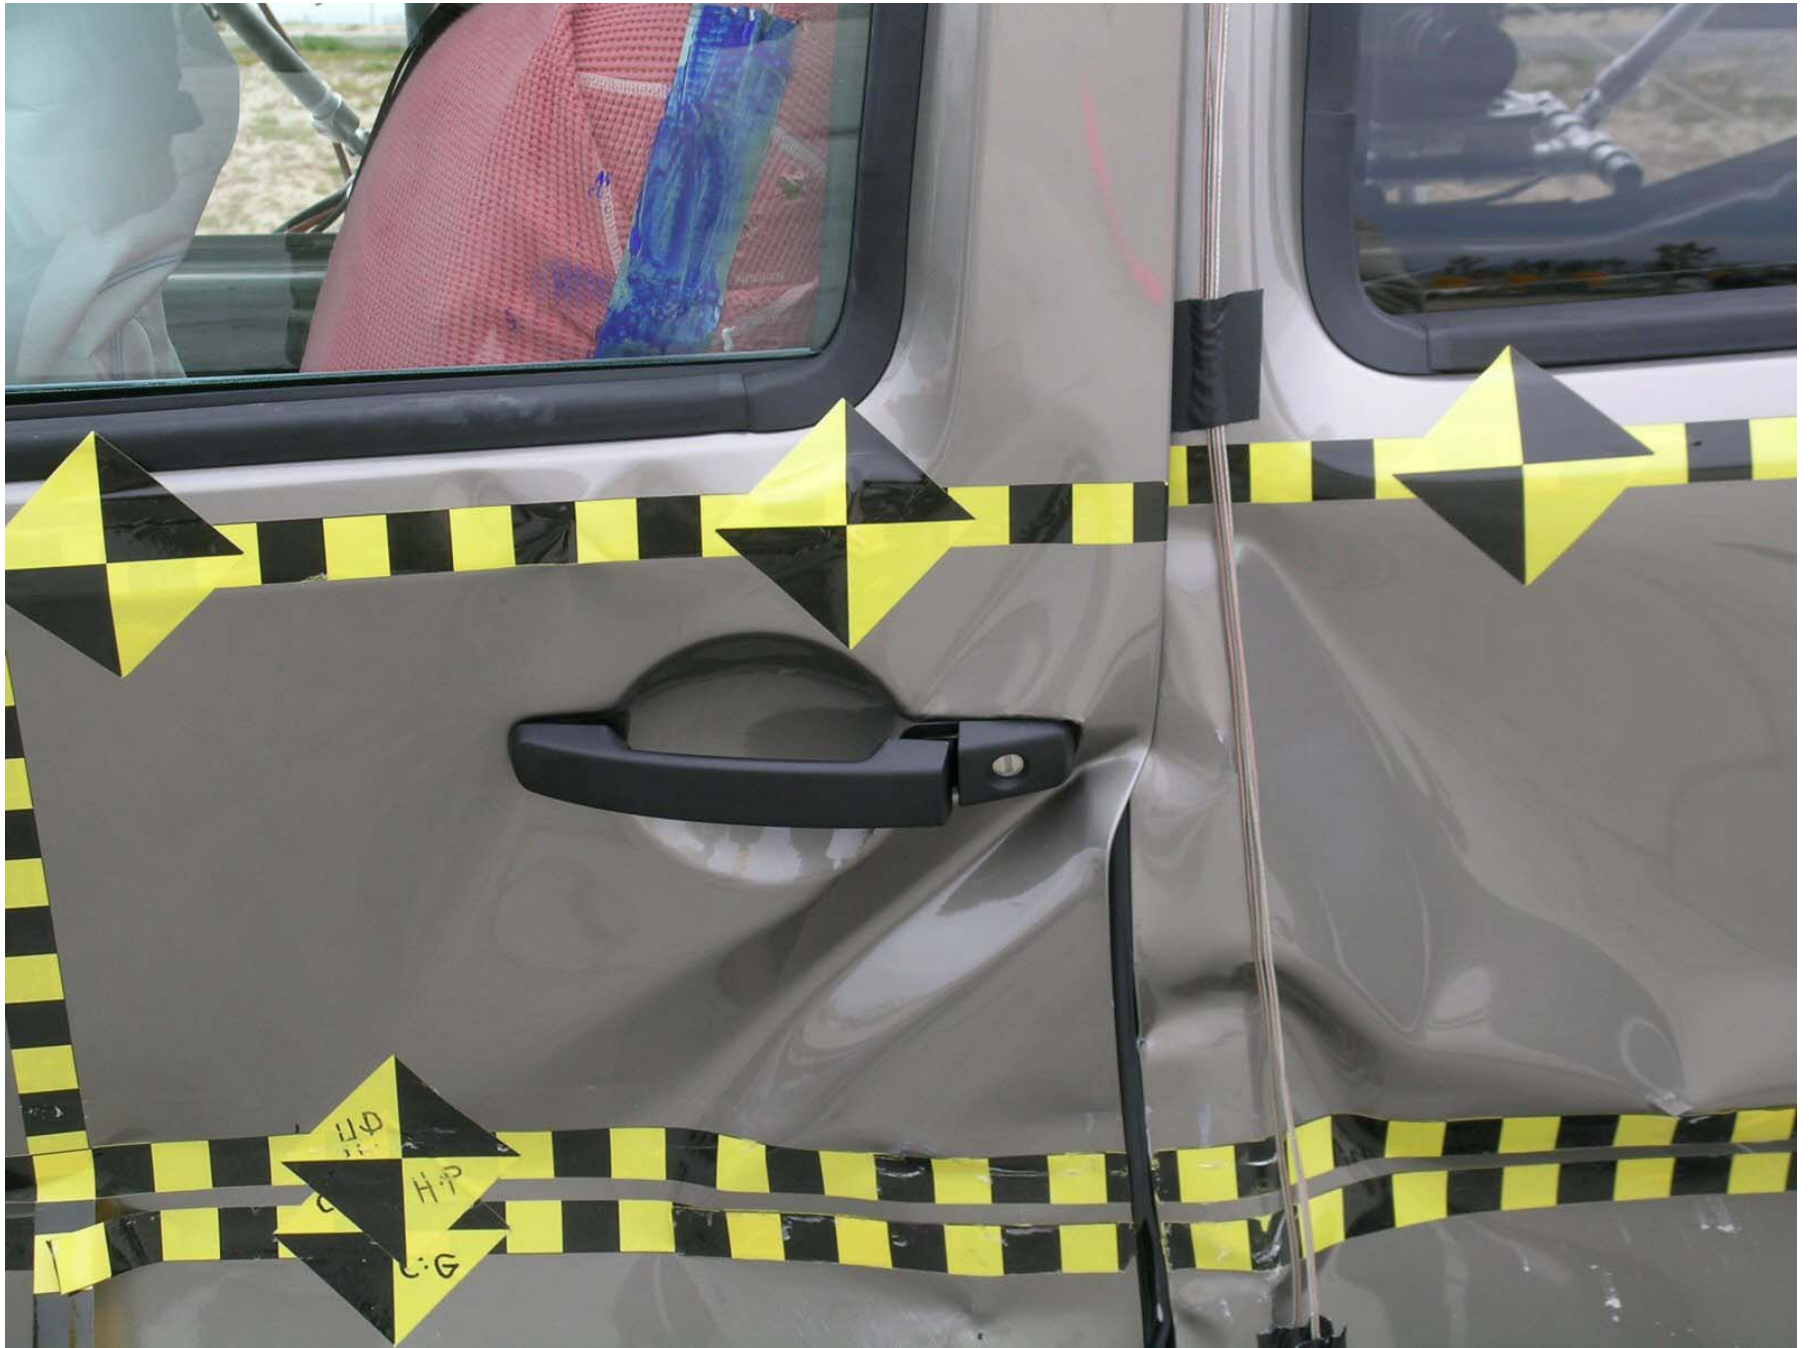
Figure A-32: Post-Test Left Front Door

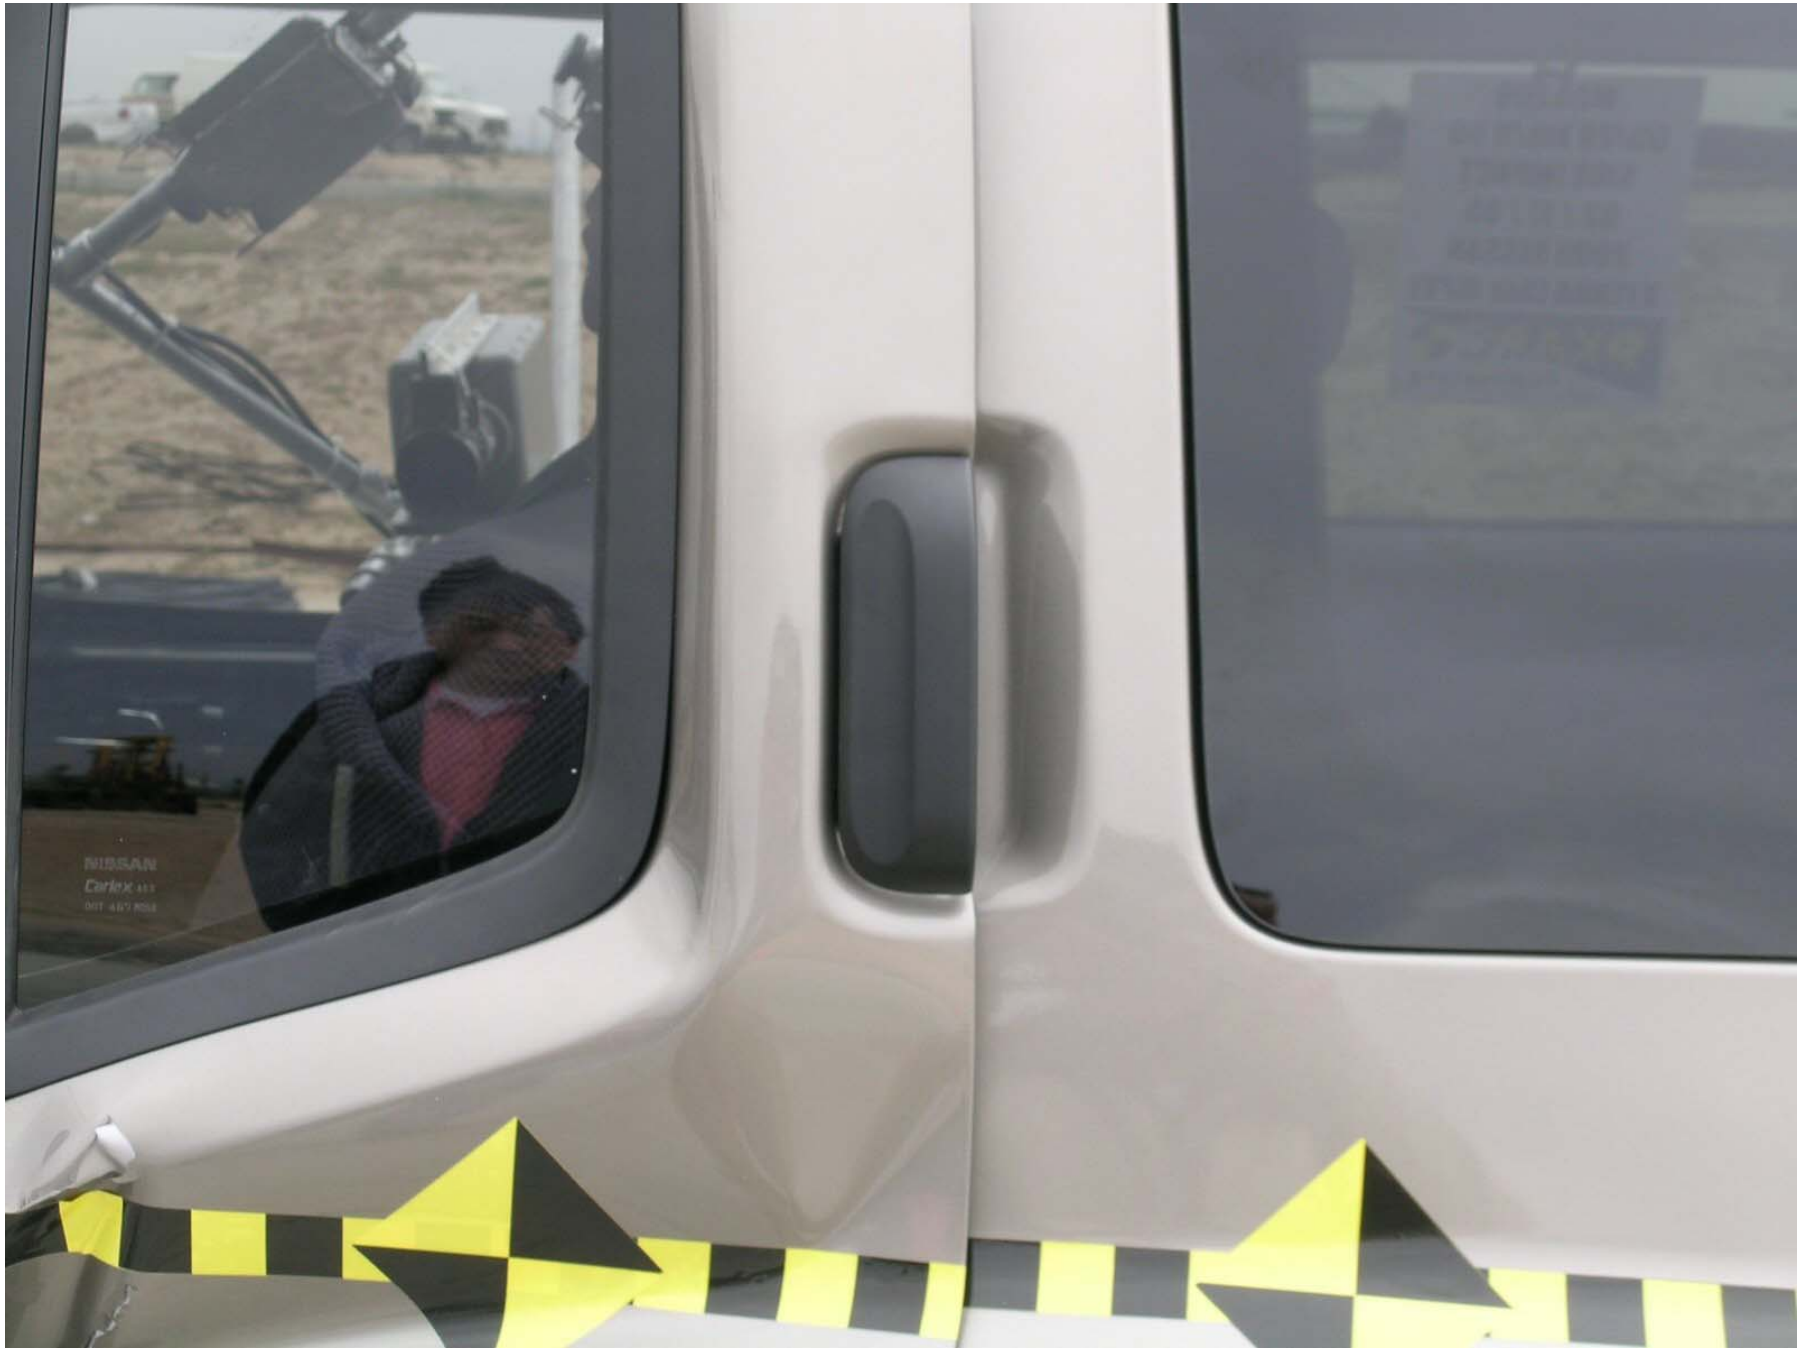
Figure A-34: Post-Test Left Rear Door

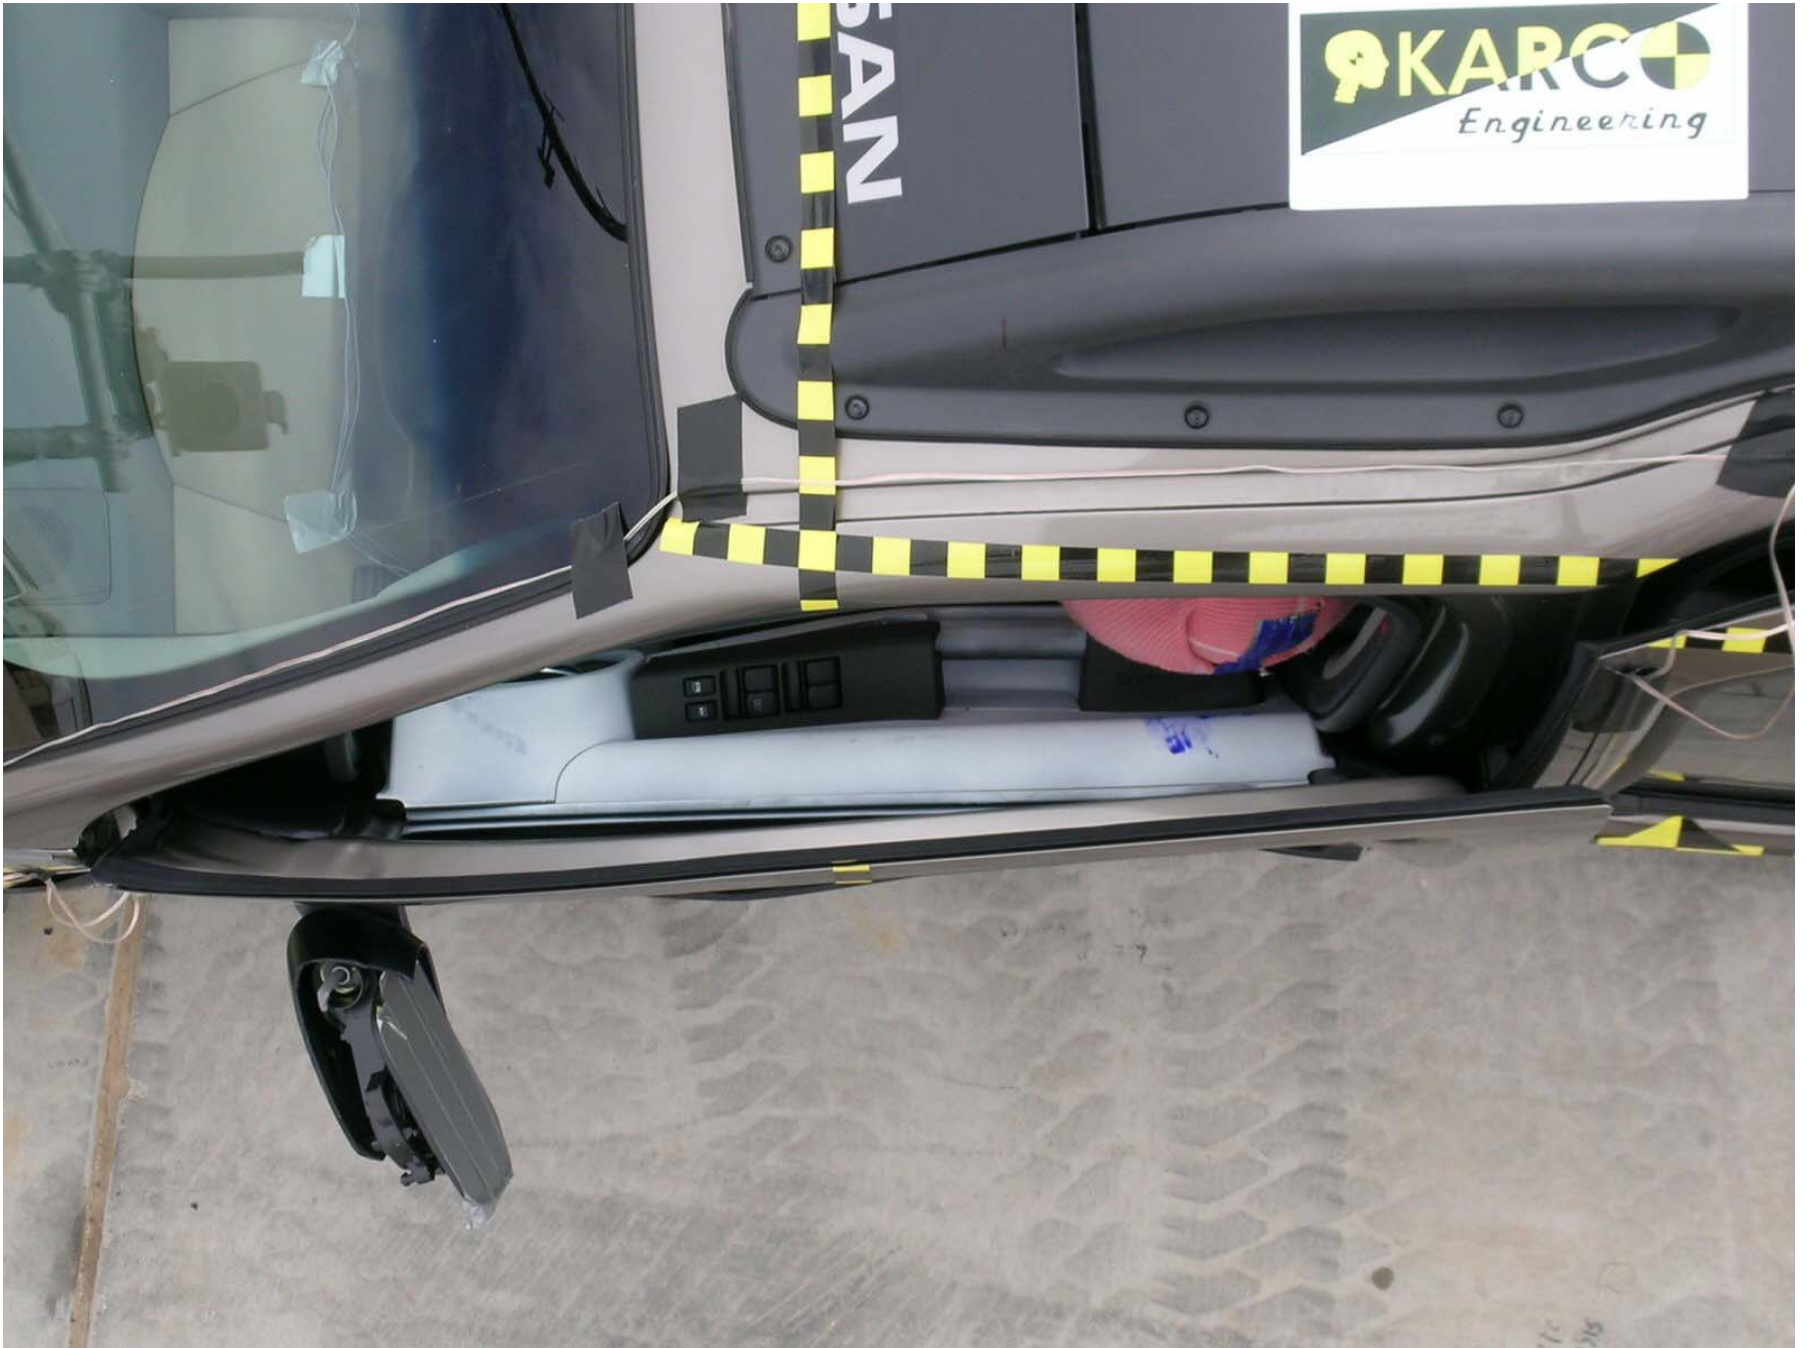
Figure A-39: Post-Test Driver Dummy Clearance From Door

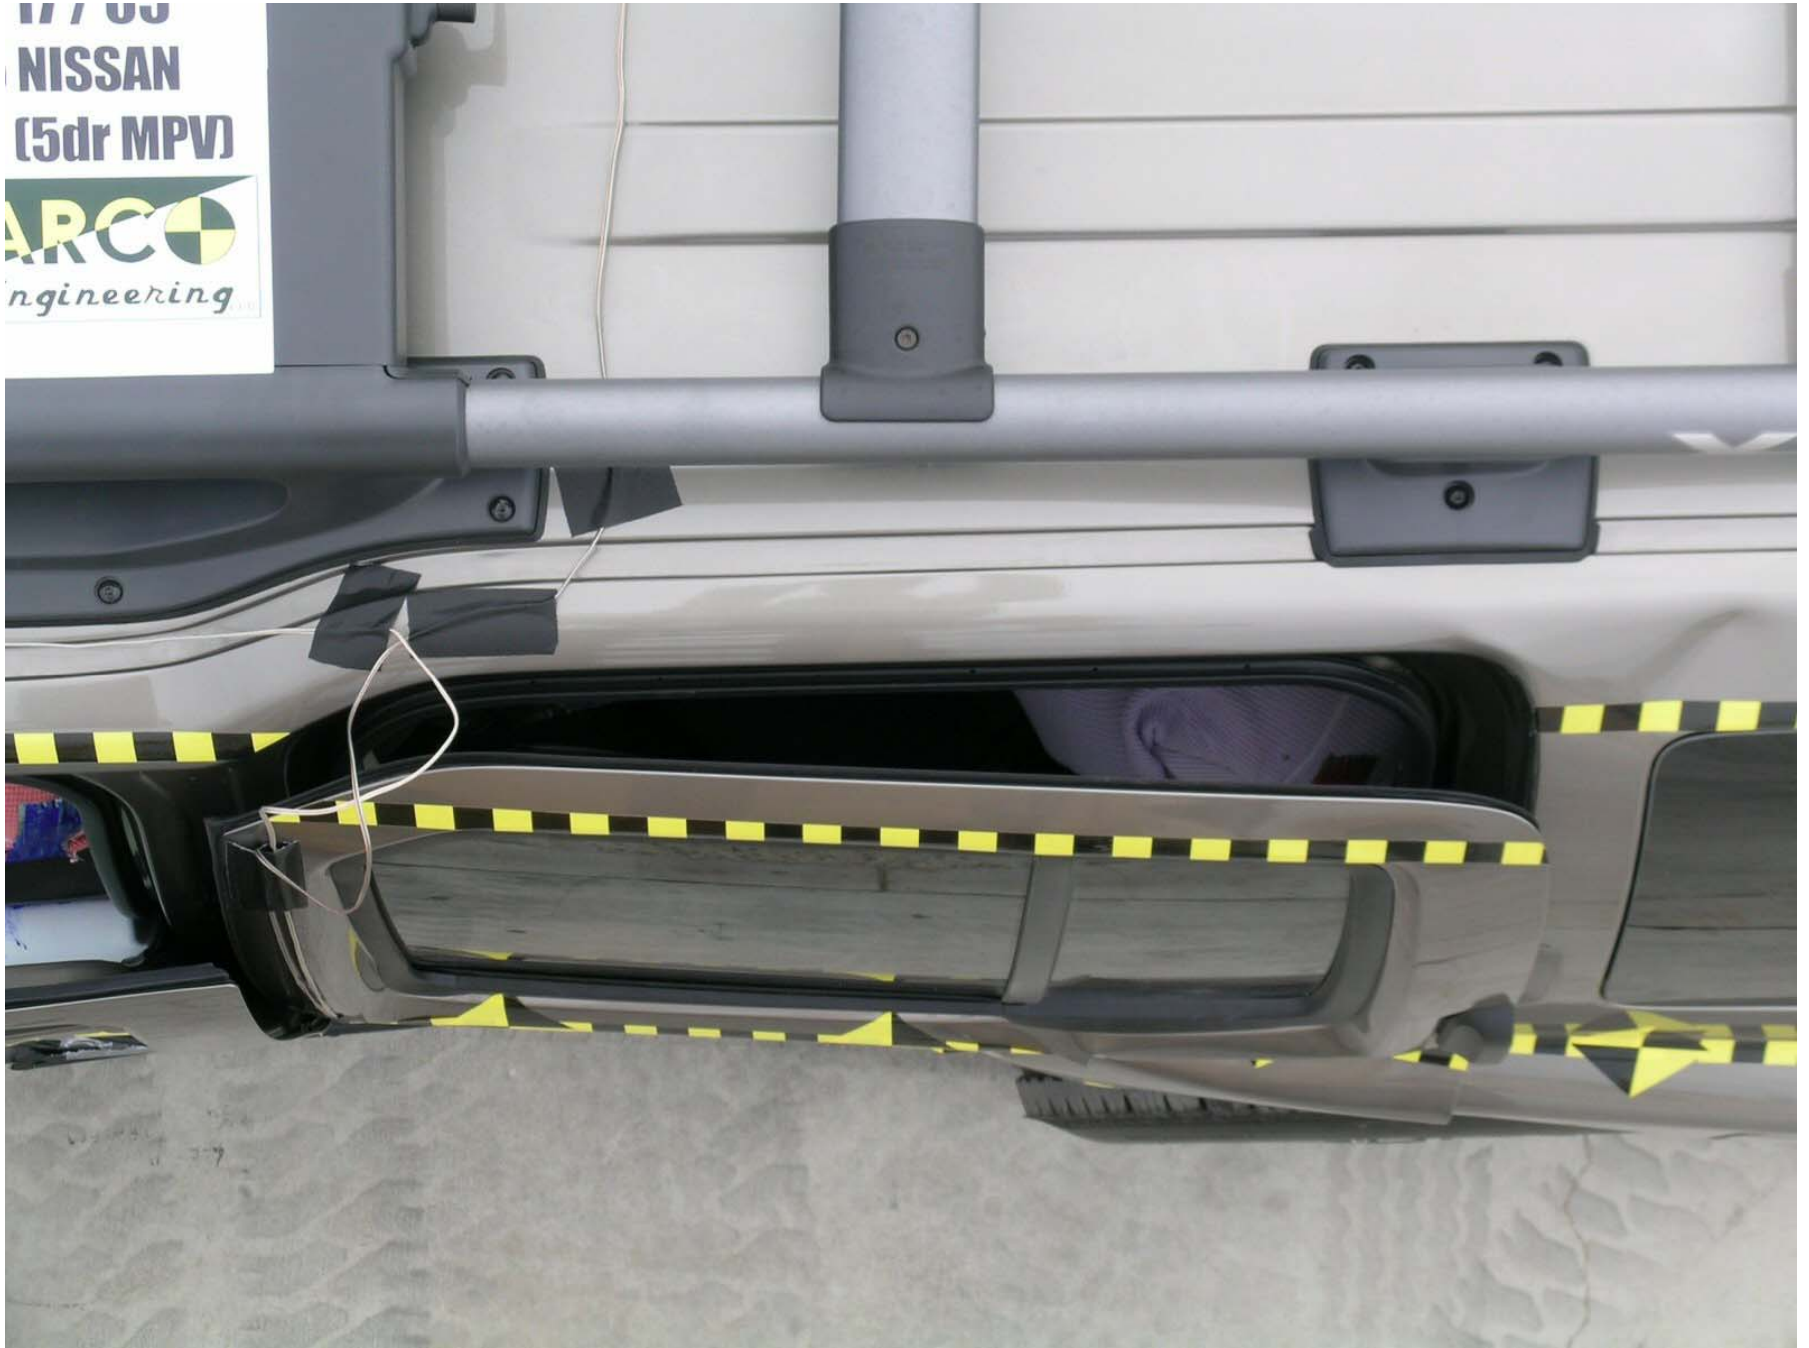
Figure A-48: Post-Test Passenger Dummy Clearance From Door

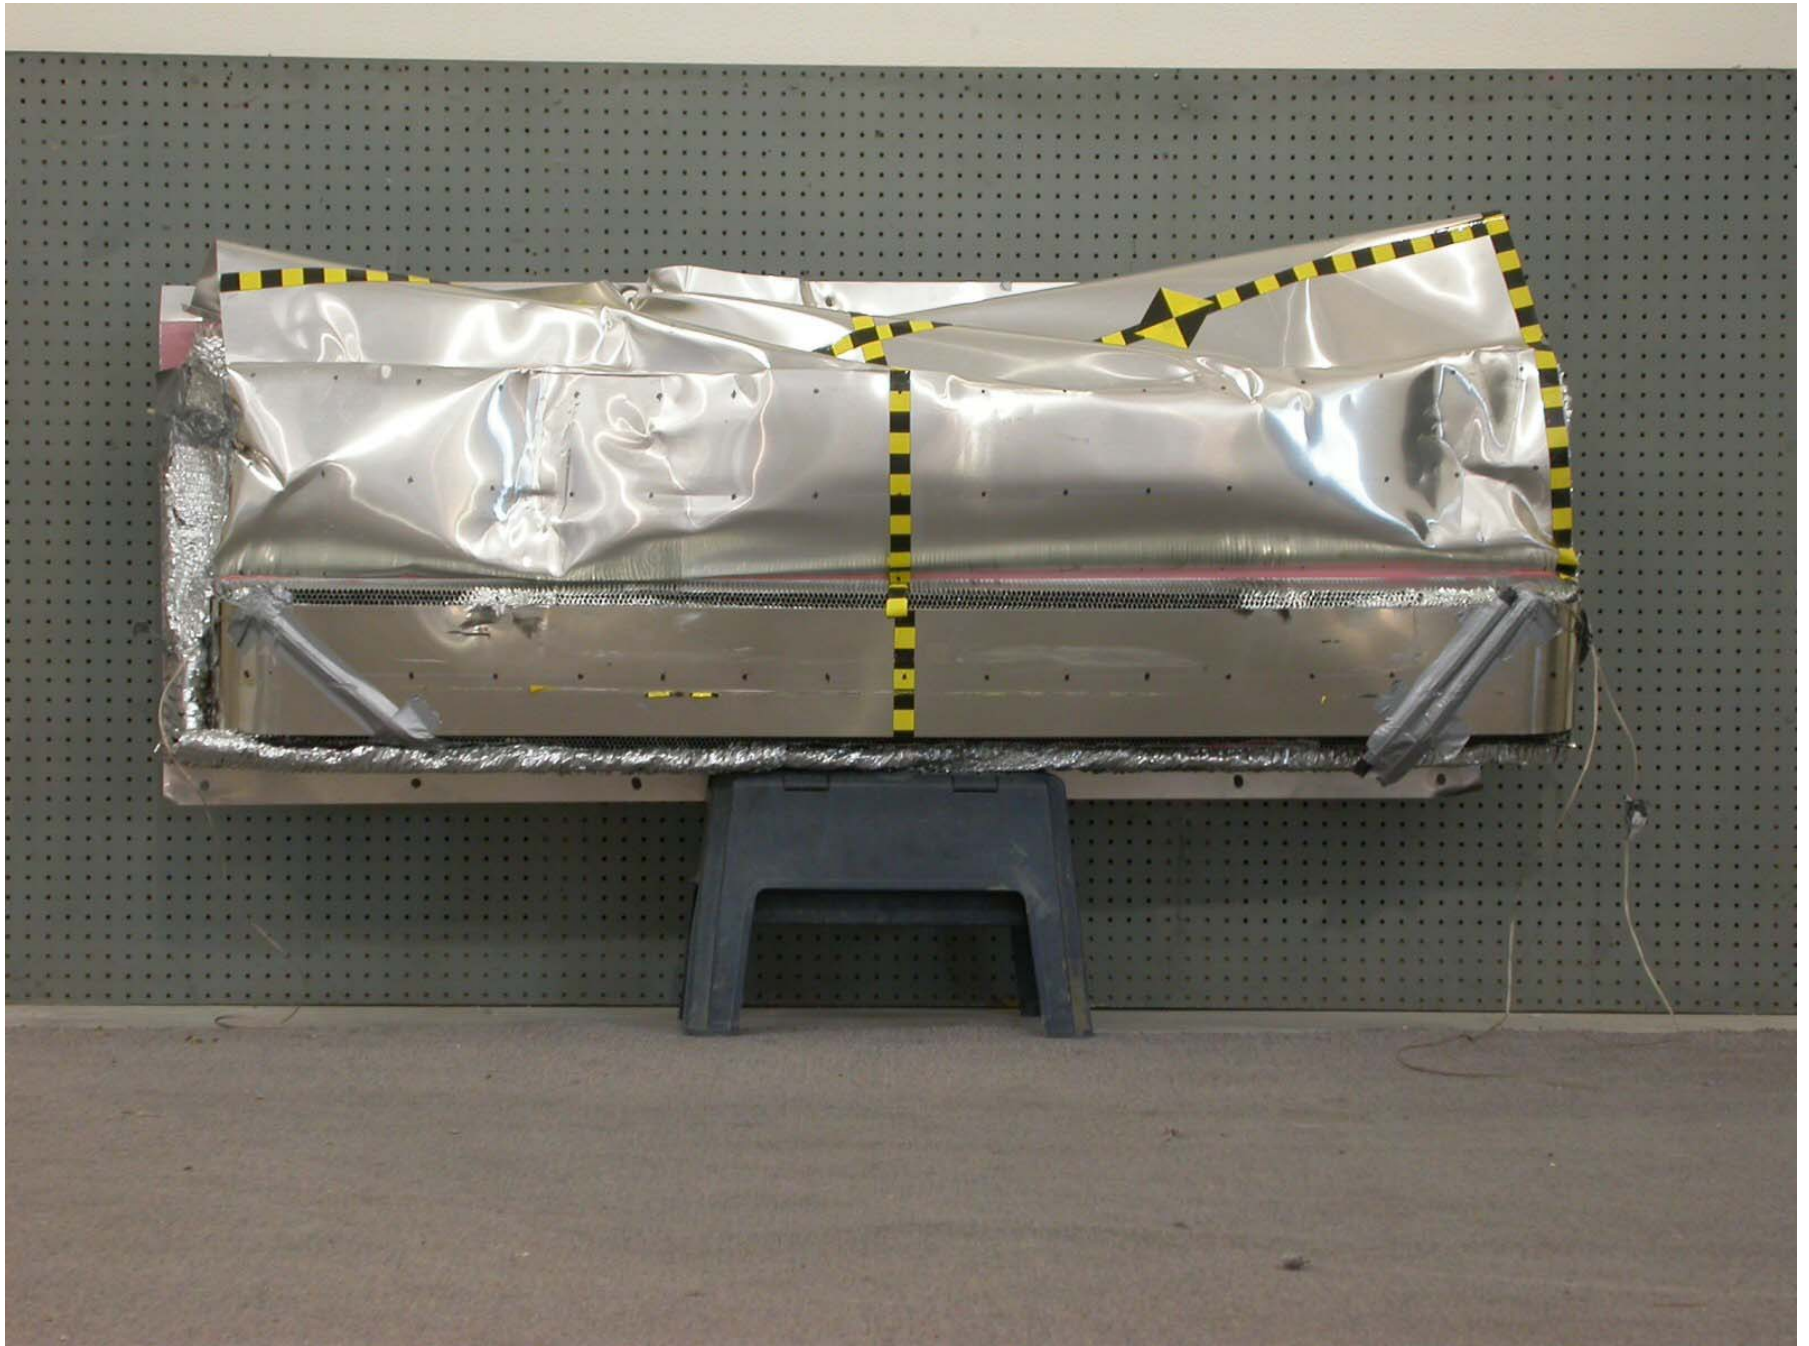
Figure A-54: Post-Test Front View of Deformable Barrier
