REPORT NUMBER TR-P25003-05-NC

**NEW CAR ASSESSMENT PROGRAM
SIDE IMPACT TEST**

**NISSAN MOTOR CORPORATION, LTD
2005 NISSAN XTERRA
5-DOOR MPV**

NHTSA NUMBER: M55209

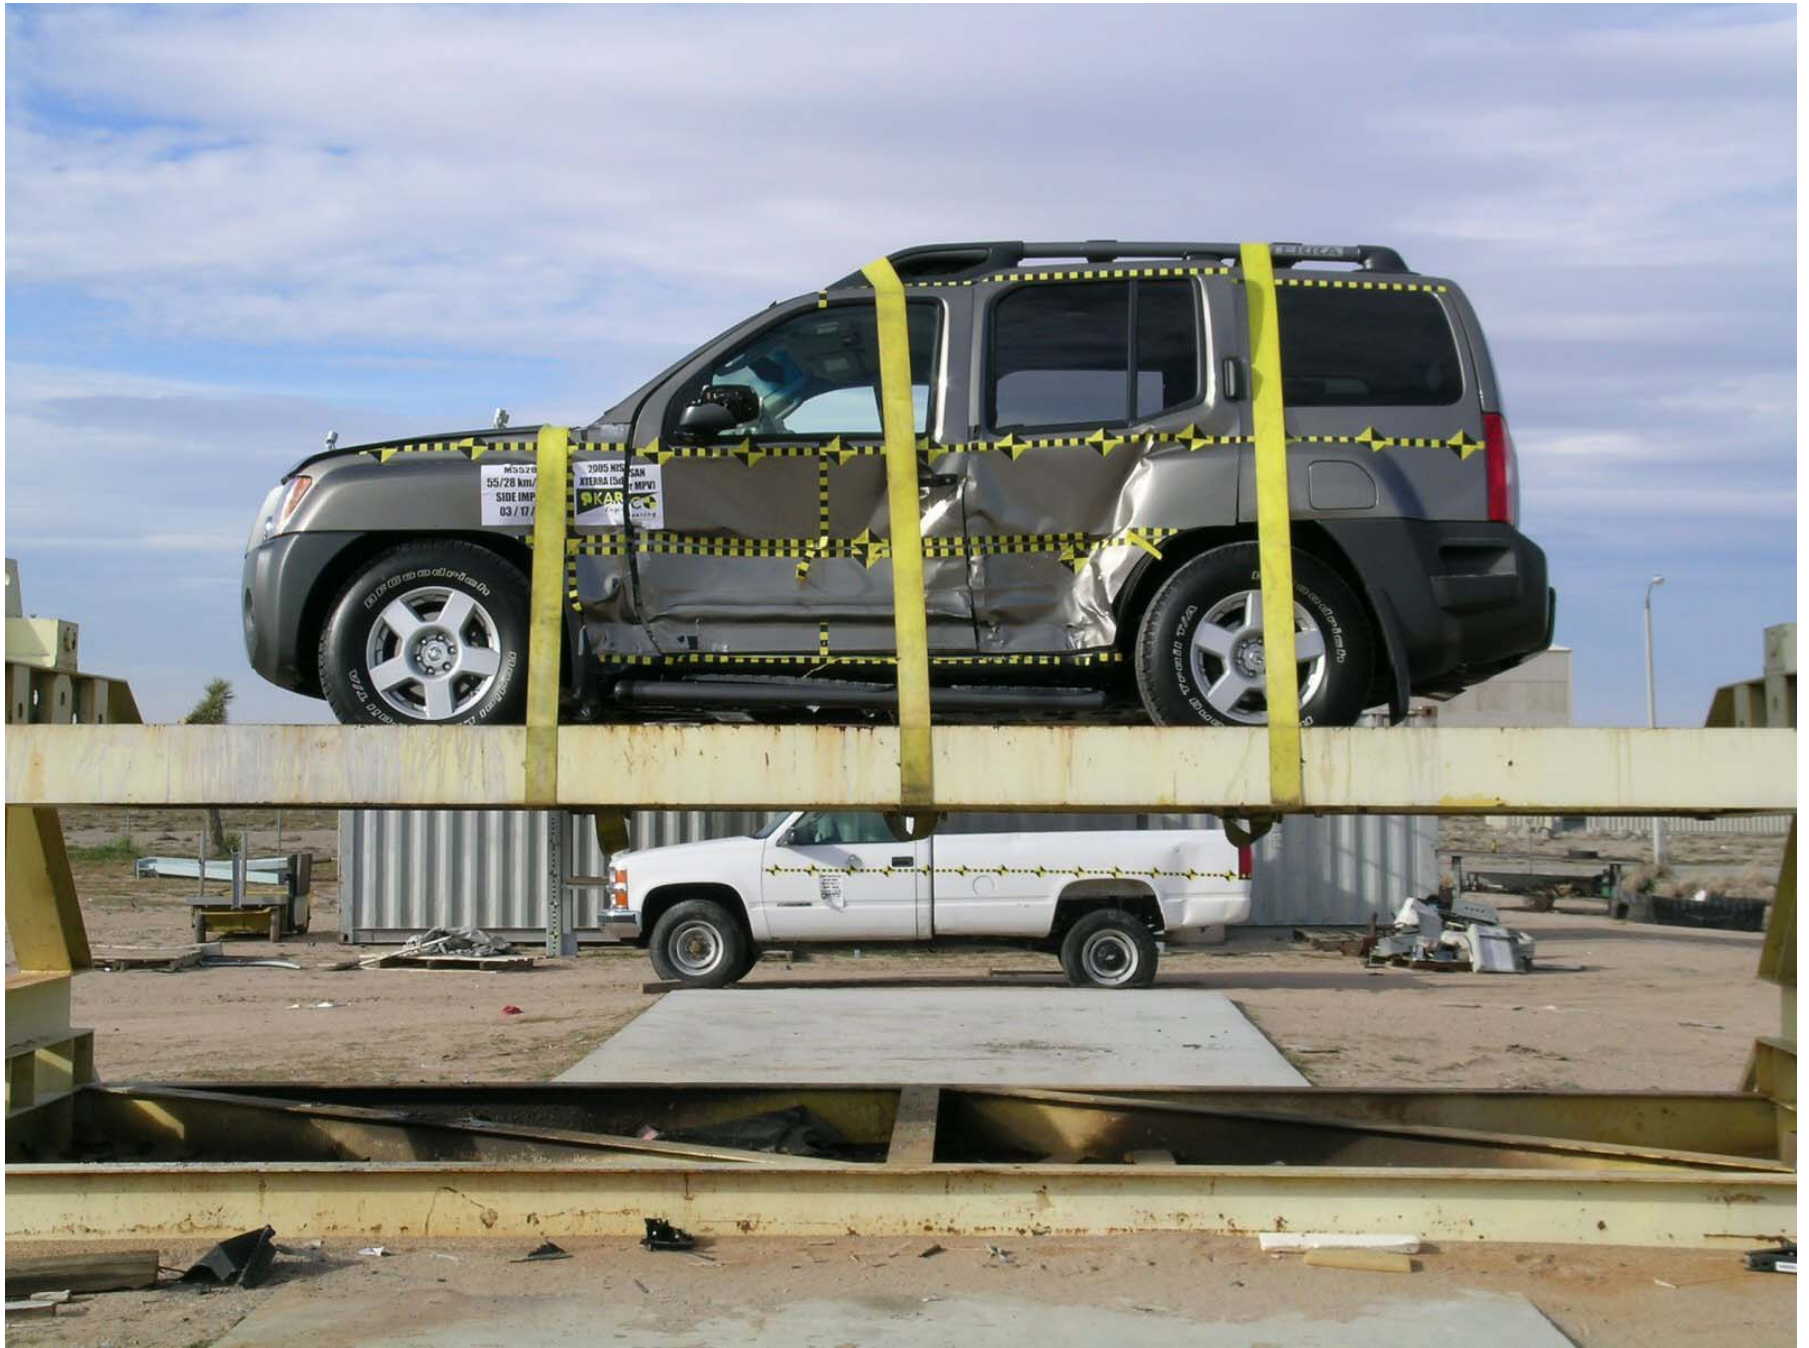
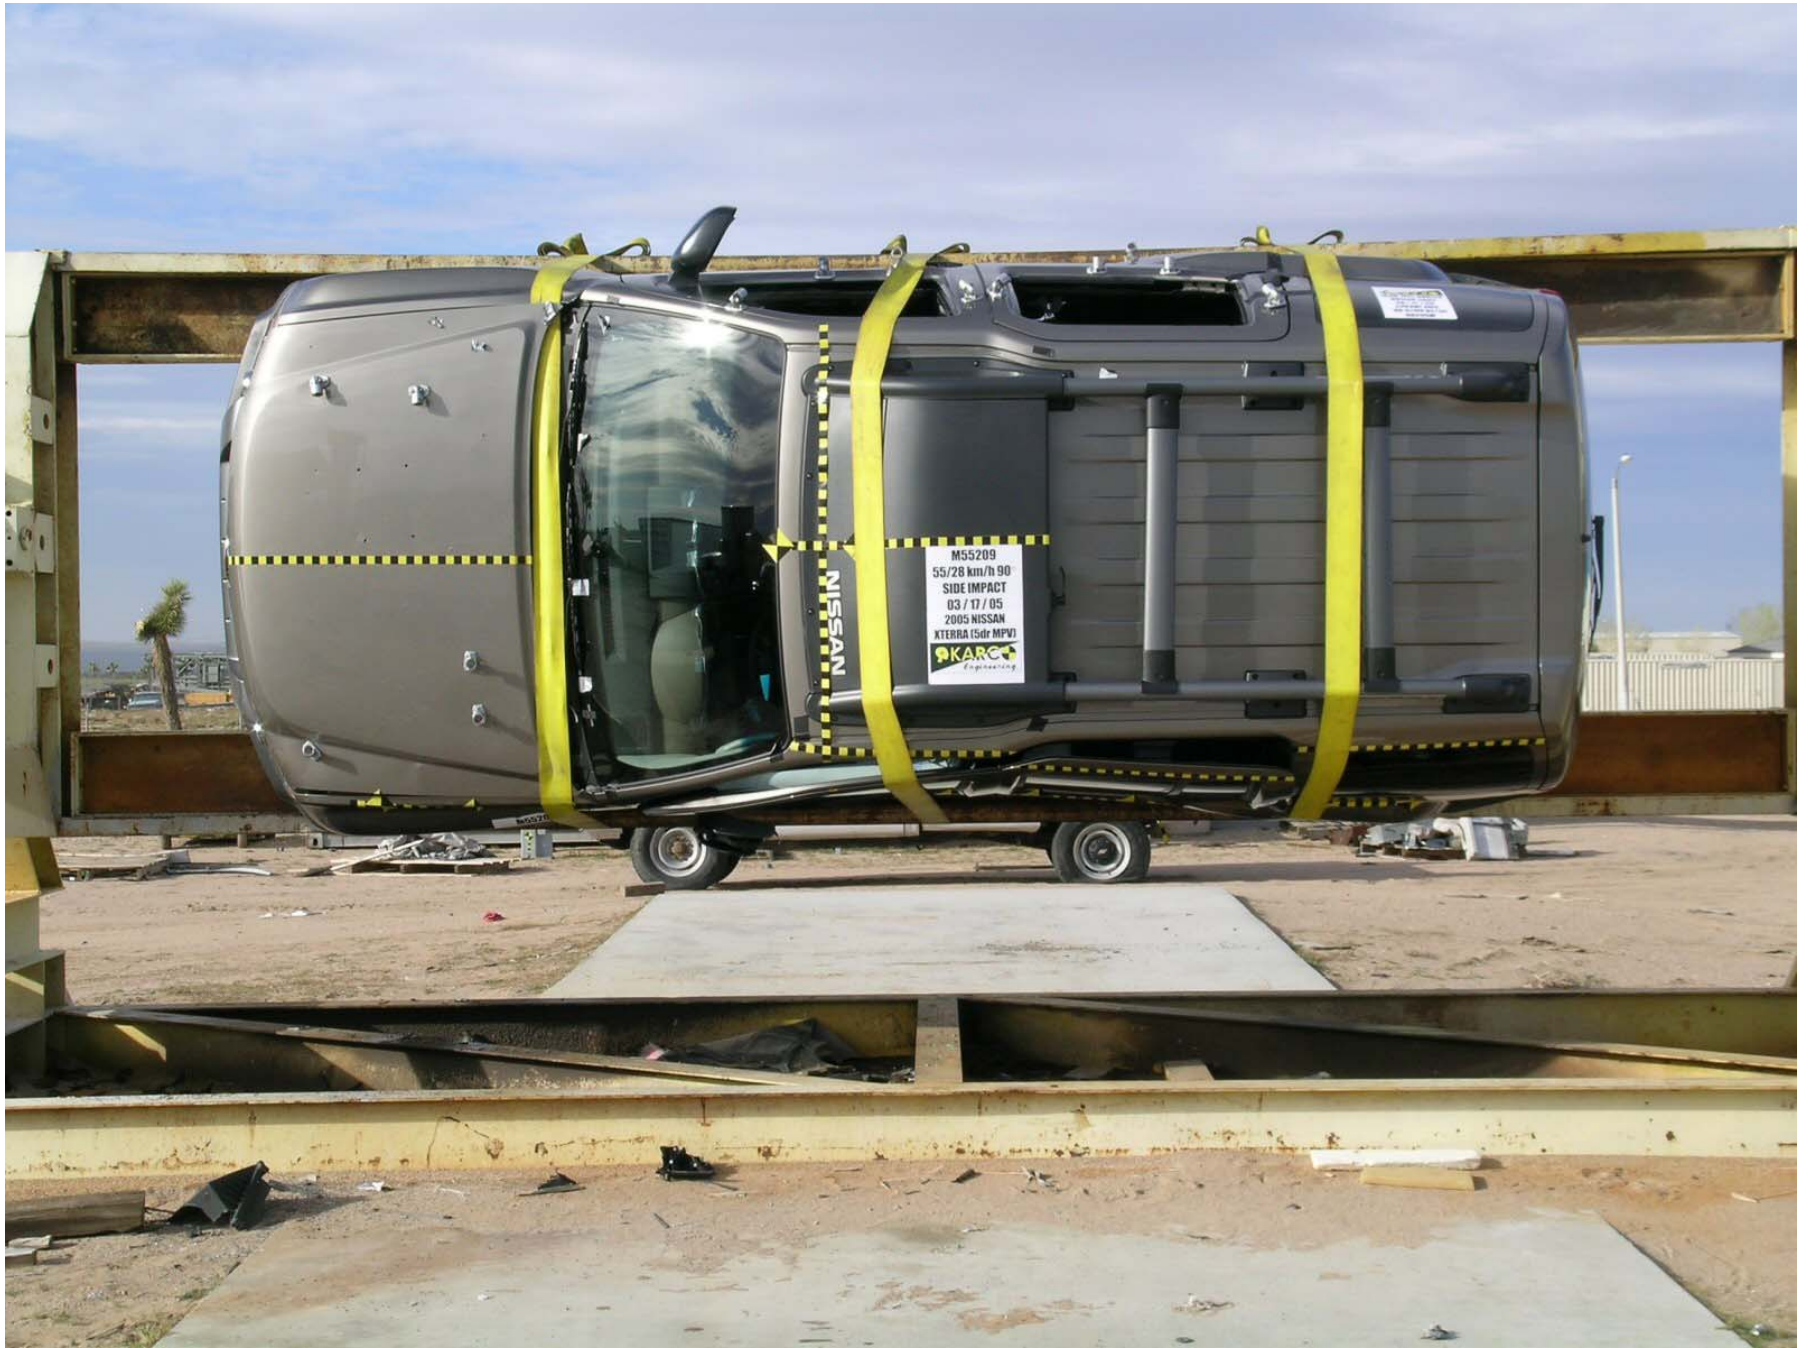
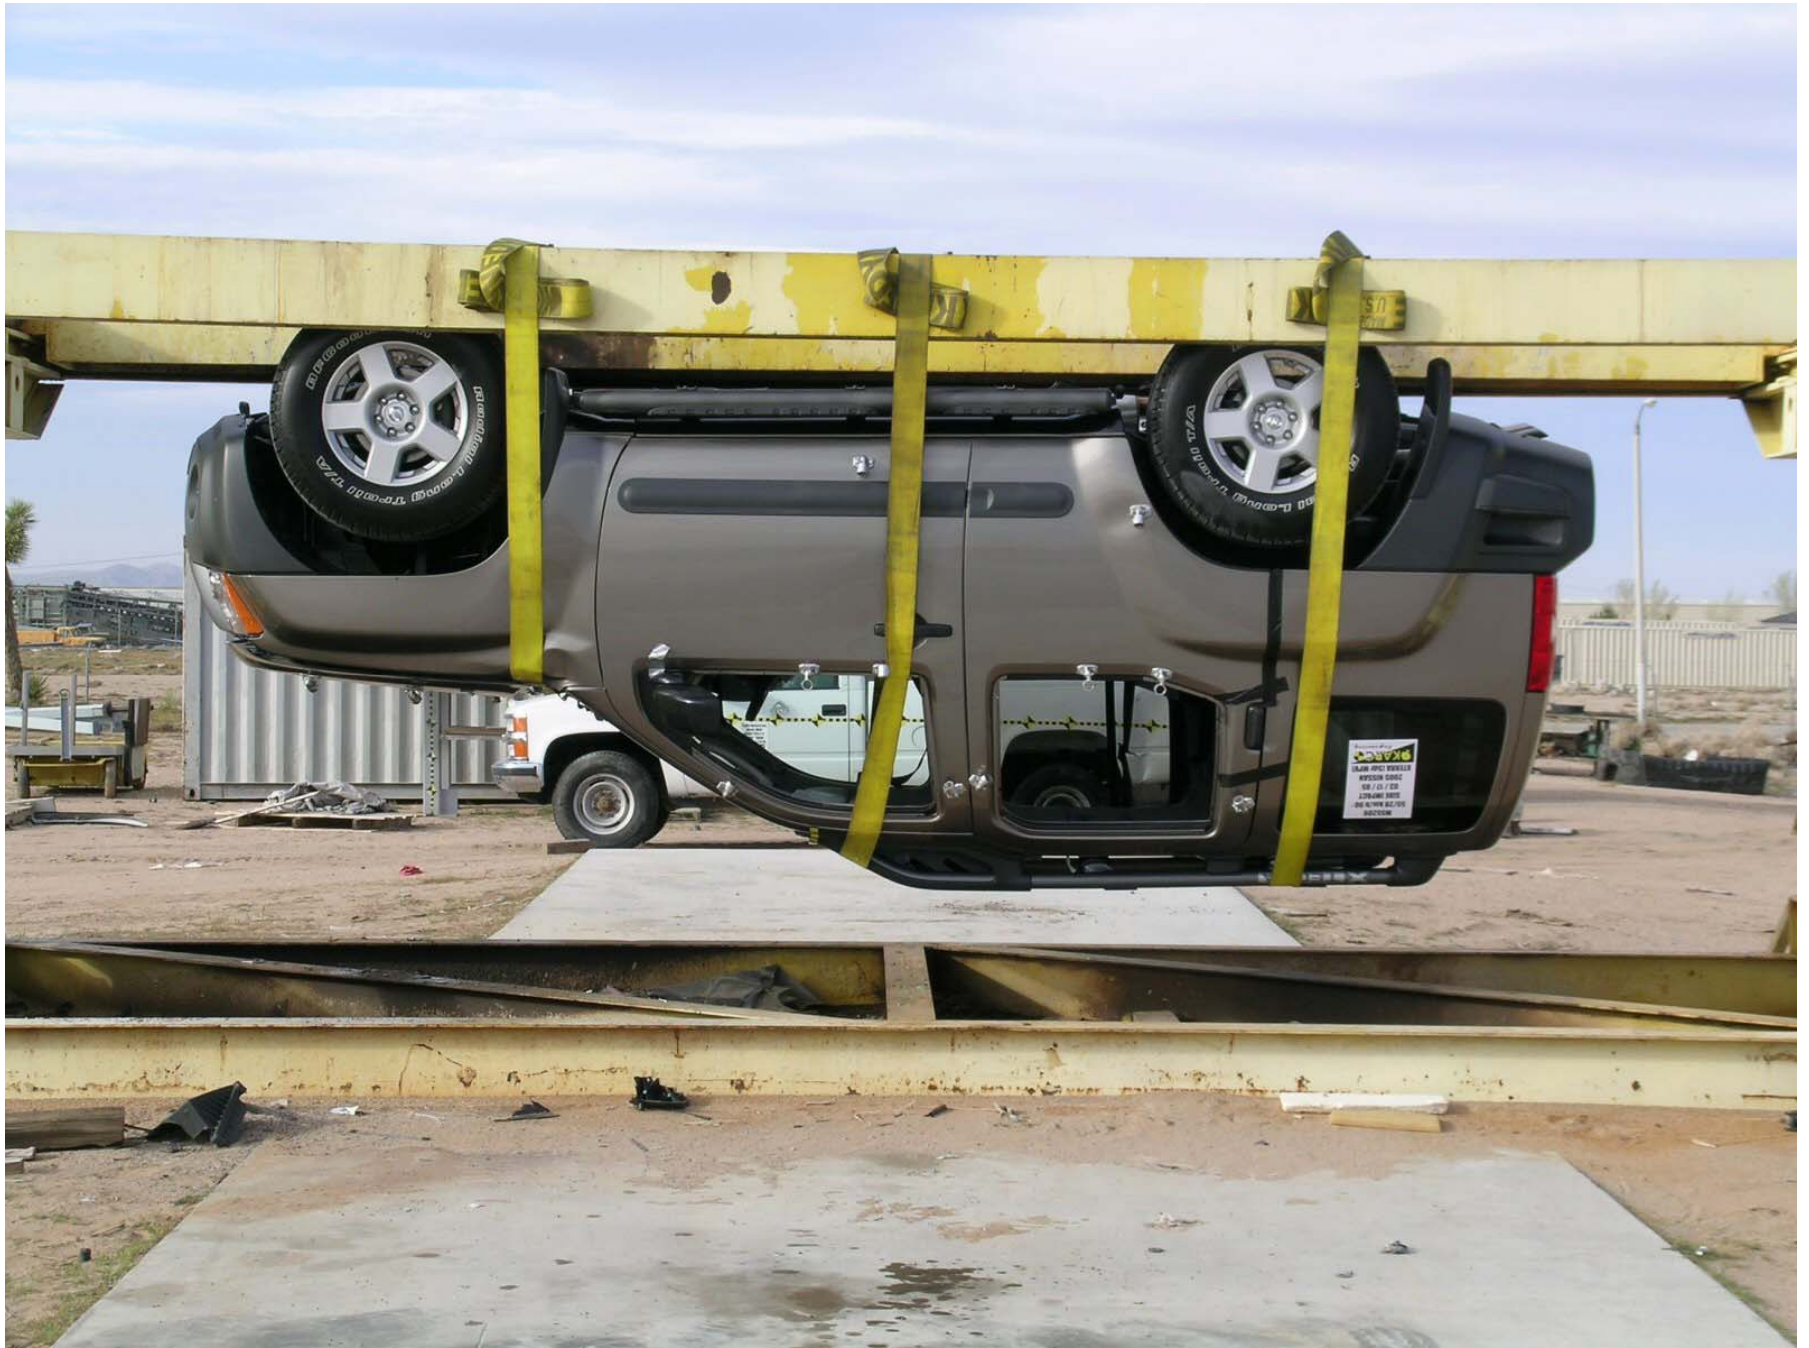
Figure A-61: Vehicle on Rollover Device (0°)

Figure A-62: Vehicle on Rollover Device (90°)

Figure A-63: Vehicle on Rollover Device (180°)

Figure A-64: Vehicle on Rollover Device (270°)

No solvent leakage occurred during static rollover testing.

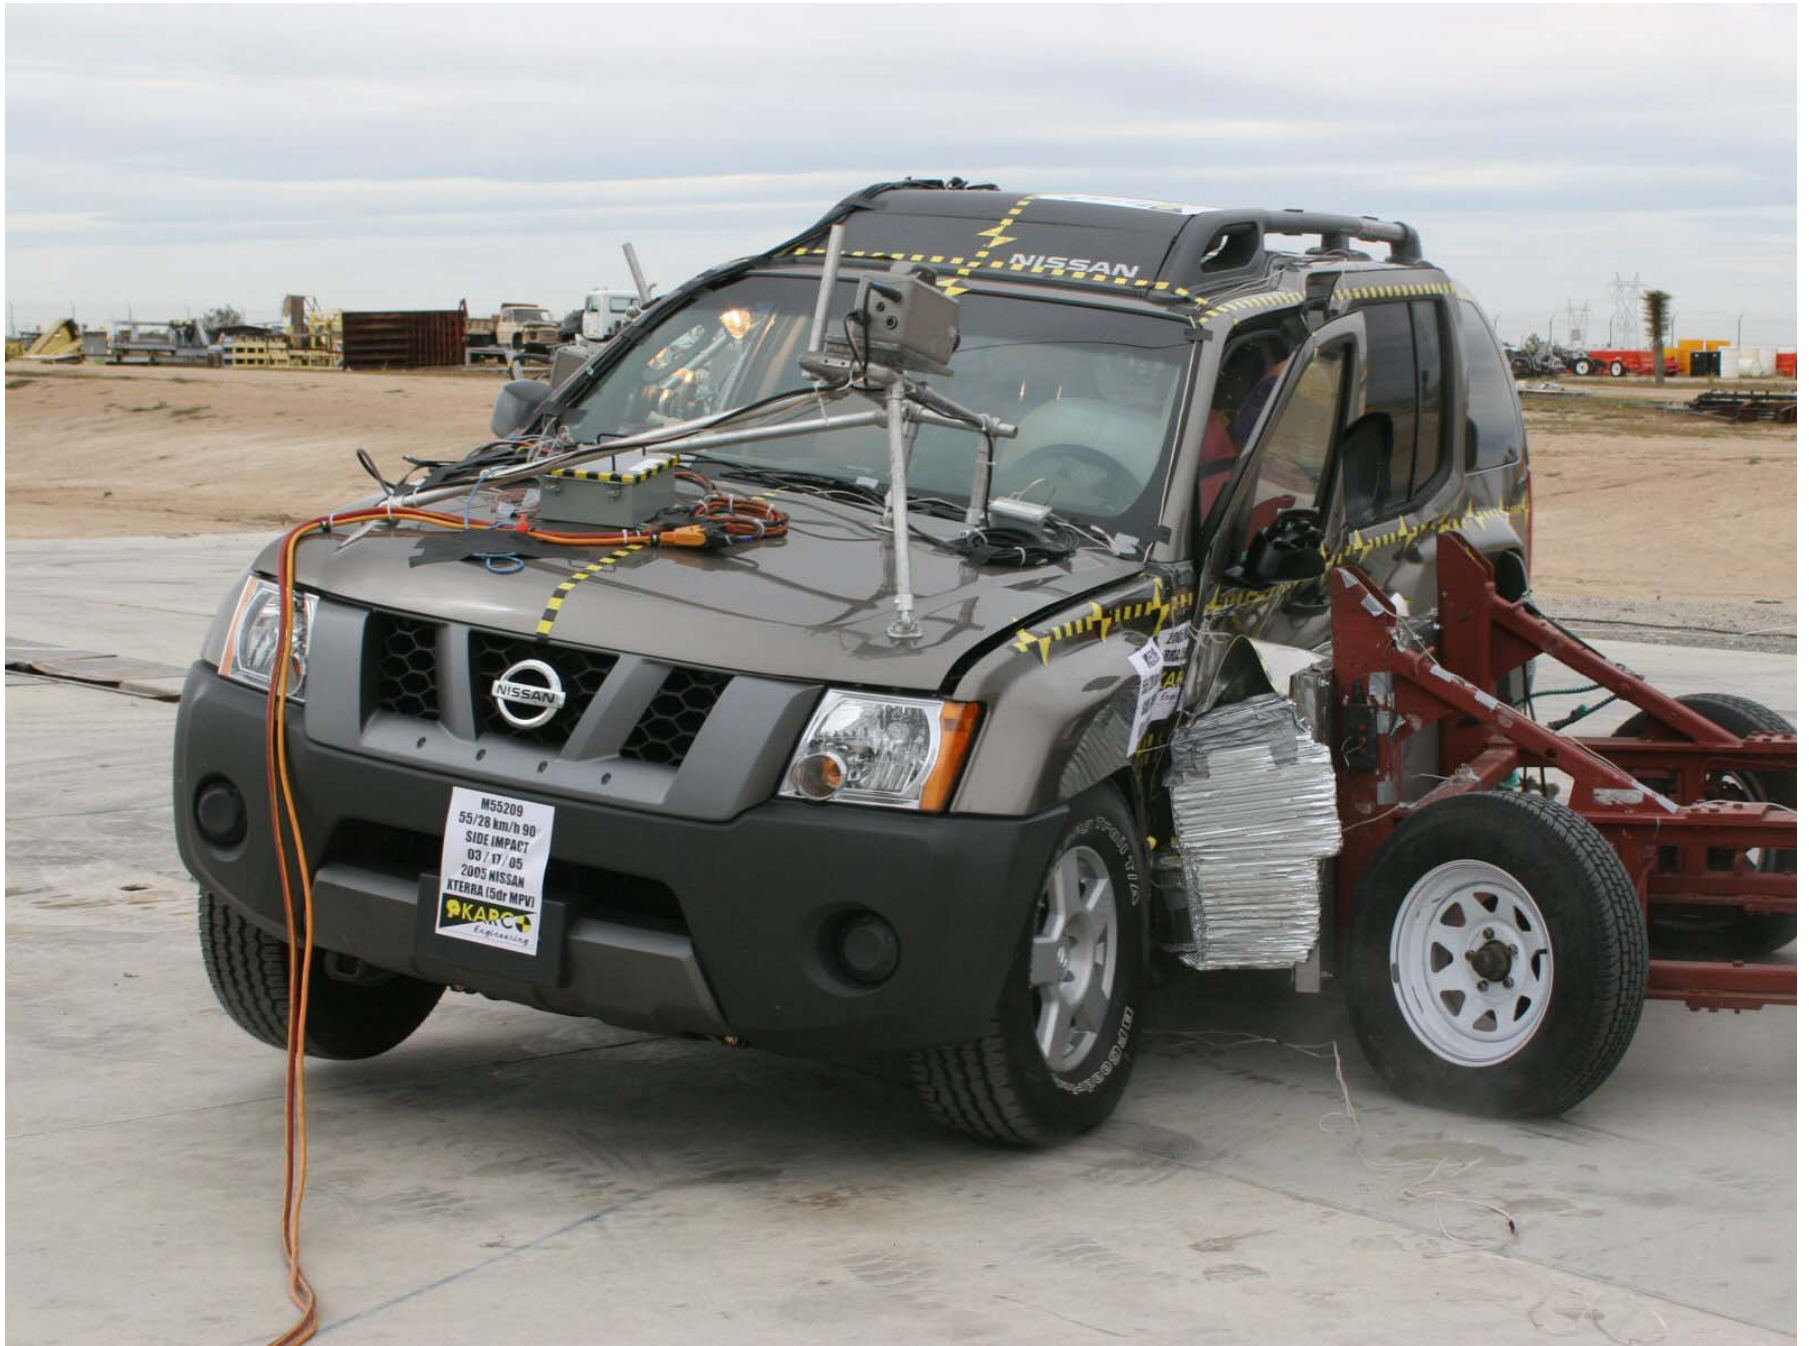
Figure A-65: Vehicle Impact

A model year 2005 Nissan Xterra 5-Door MPV was impacted on the left (driver's) side by a Moving Deformable Barrier (MDB) which was moving forward in a 27° crabbed position to the tow road guidance system at a velocity of 62.00 km/h. The specified impact velocity range is from 61.14 to 62.75 km/h. The test (target) vehicle was stationary and positioned 63° to the line of forward motion. The weight of the vehicle as tested was 2175 kg and the test weight of the MDB was 1361 kg. The test was conducted at KARCO Engineering, LLC in Adelanto, California, on March 17, 2005.
