**NEW CAR ASSESSMENT PROGRAM (NCAP)**  
SIDE AIRBAG OUT-OF-POSITION INJURY TESTING

2005 BUICK RENDEZVOUS  
MULTIPURPOSE VEHICLE

NHTSA NUMBER: M50104TWG2

CALSPAN CORPORATION TEST NUMBER: 8642-TWG-10

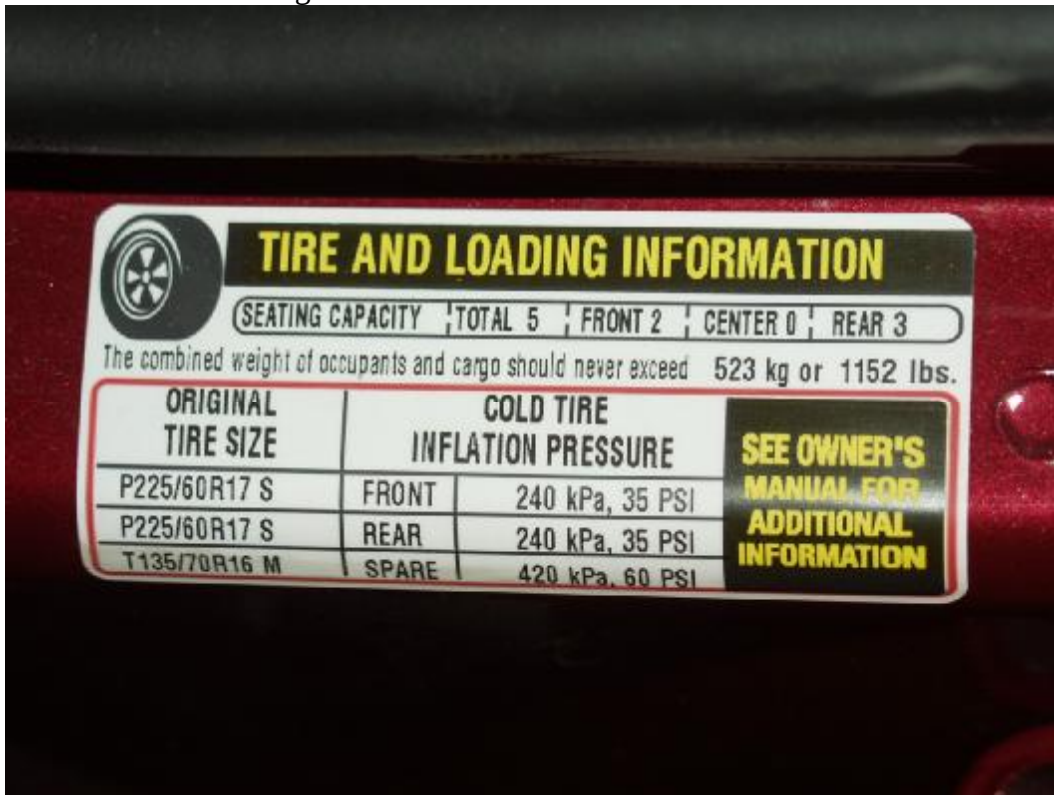
Figure A-4: Vehicle Tire Placard

Recommended Tire Size: P255/60R17 S

\* Recommended Cold Tire Pressure: 240 kPa FRONT; 240 kPa REAR
