REPORT NUMBER: TWG-CAL05-07

NEW CAR ASSESSMENT PROGRAM (NCAP)
SIDE AIRBAG OUT-OF-POSITION INJURY TESTING

2005 PONTIAC G6
FOUR DOOR SEDAN

NHTSA NUMBER: M50114TWG2

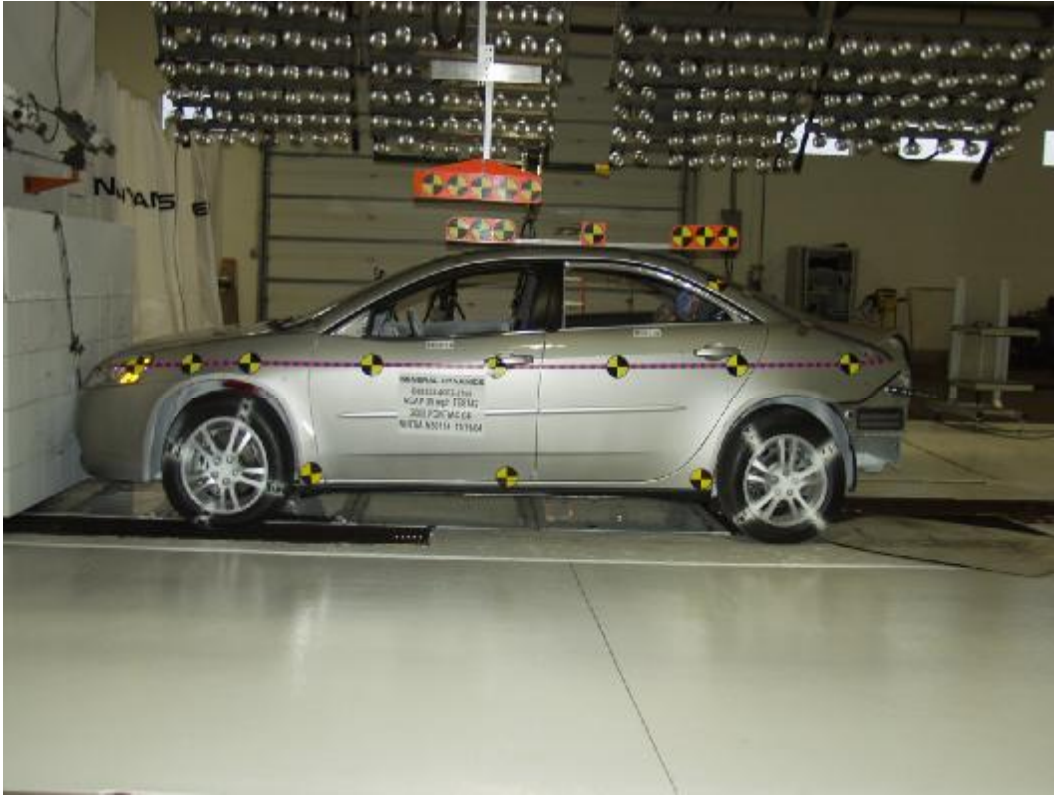
Figure A-1: Pre-Test Vehicle Left Side View

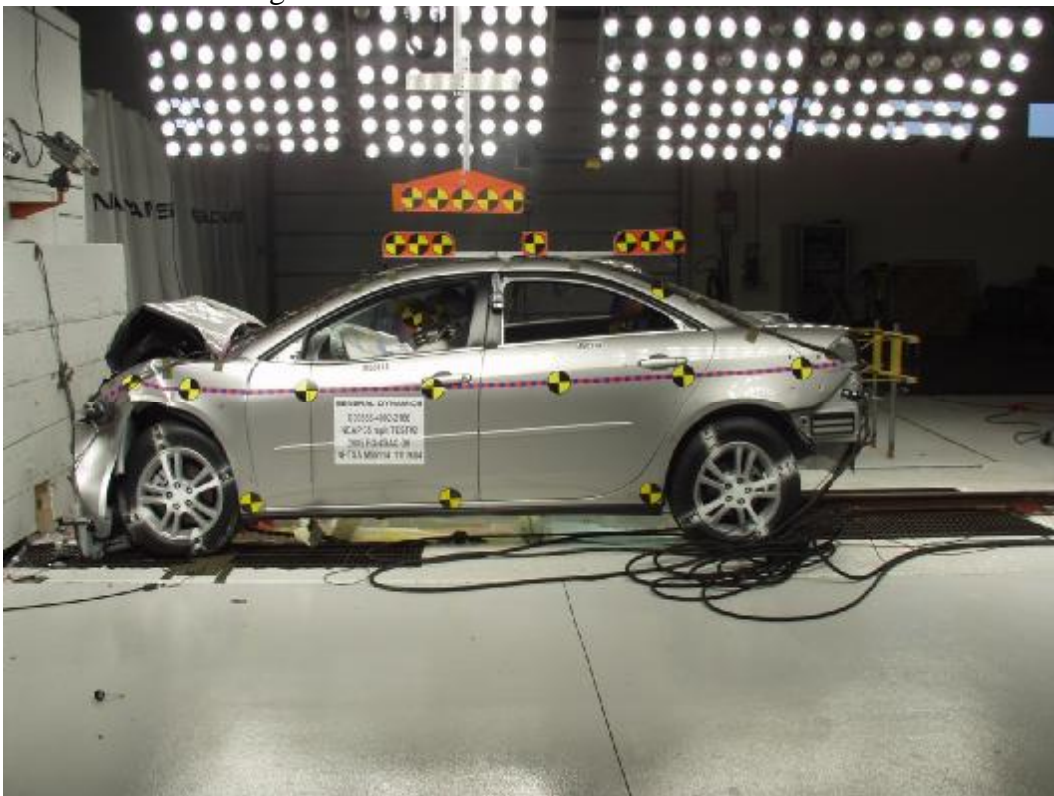
Figure A-2: Post-Test Vehicle Left Side View

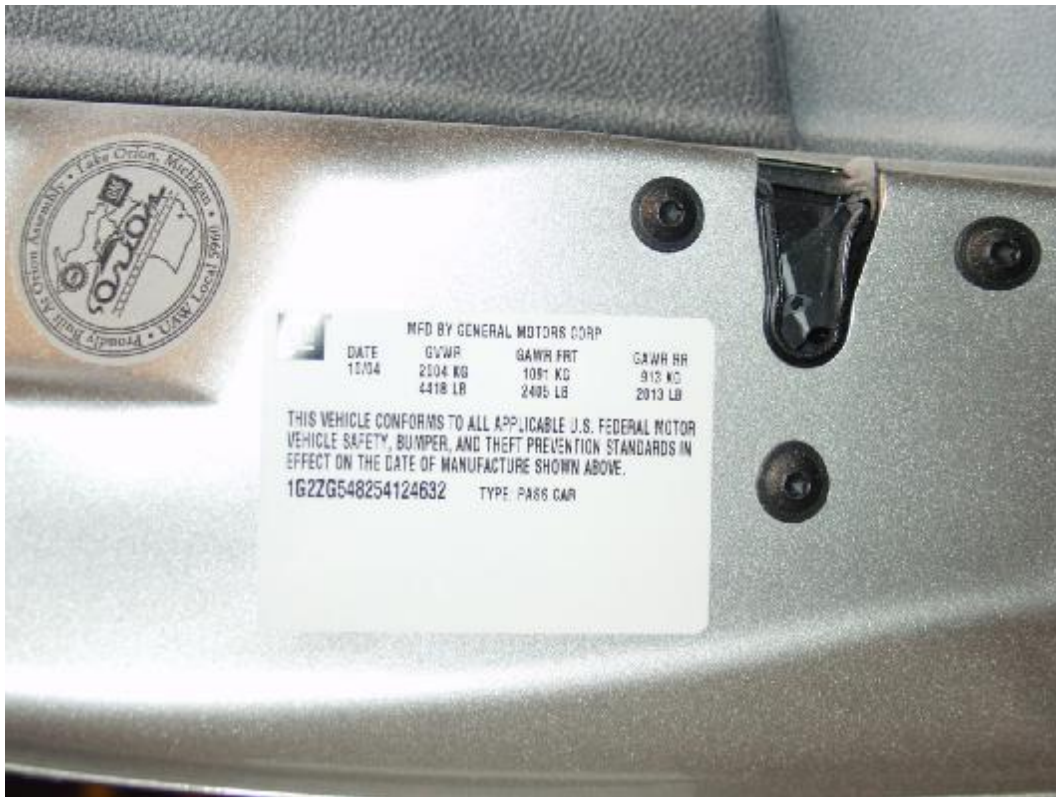
Figure A-3: Vehicle Certification Placard

Vehicle Manufactured by: General Motors Corp

Date of Manufacture 10/04

GVWR: 2004 kg; GAWR: 1091 kg FRONT; 913 kg REAR

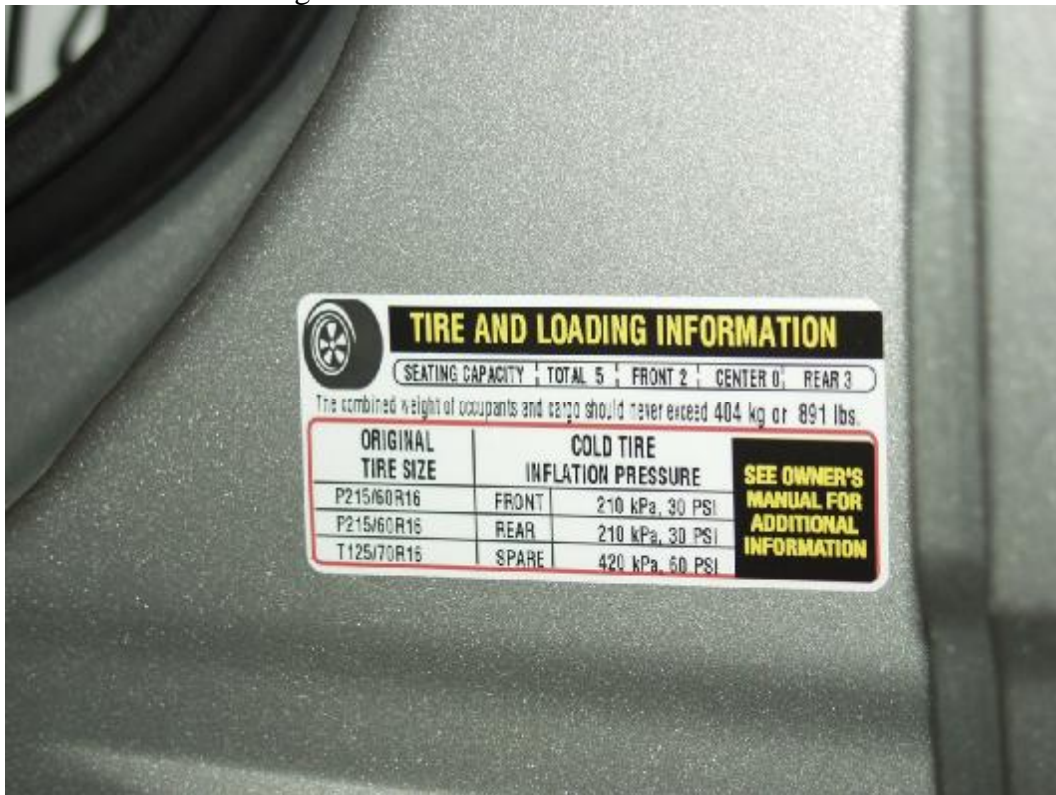
Figure A-4: Vehicle Tire Placard

Recommended Tire Size: P215/60R16

* Recommended Cold Tire Pressure: 210 kPa FRONT; 210 kPa REAR

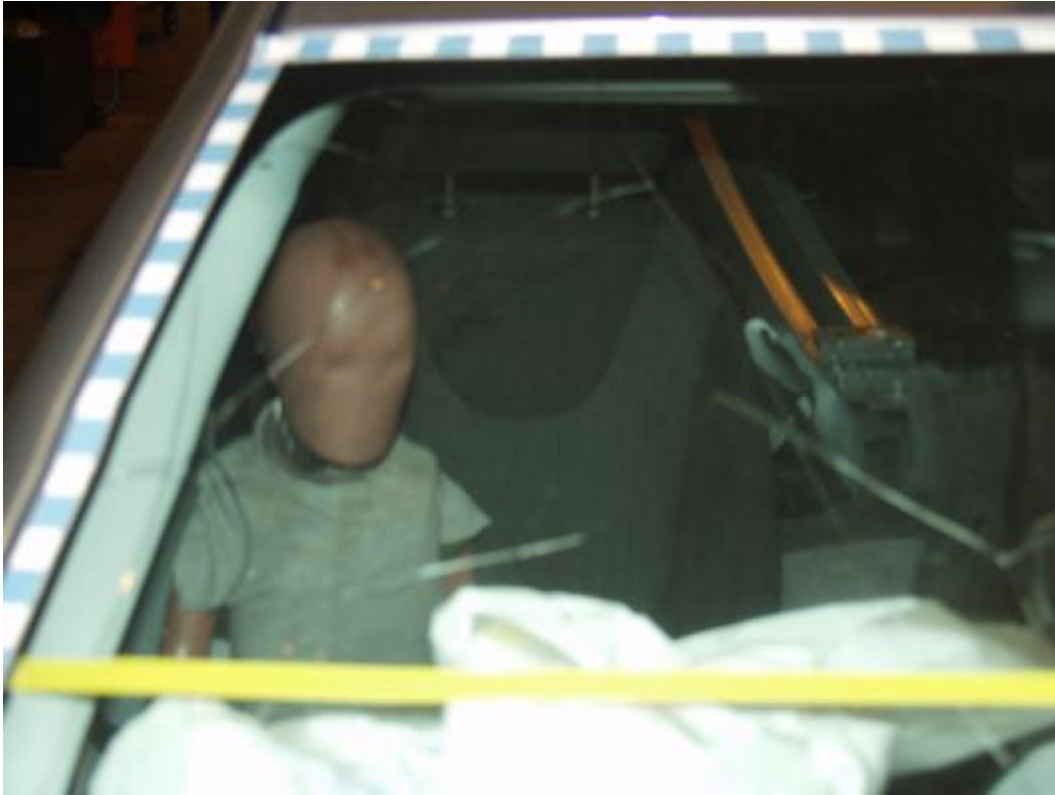
Figure A-5: Pre-Test Dummy Frontal View

The six-year old child dummy was placed on the outboard edge of foam block, aligning the upper spine with the deployment trajectory of the airbag. The dummy's head was placed in between the seat bolster and pillar trim to minimize the fore-aft clearance between the neck and the seatback. The head remained in its neutral orientation. The legs were aligned such that they crossed the heel placement points but the feet did overhang the seat cushion. The dummy was then positioned so the dummy's neck/torso junction was aligned vertically with the top edge of the airbag module. While maintaining the neck/torso top of the airbag module alignment, the vehicle door was closed and the pelvis was moved outboard until it made contact the door trim/armrest. The outboard forearm was placed on the armrest. The inboard arm was positioned such that the upper arm contacted the seat back and the fingertips contacted the booster seat. The dummy's arms were then bent at the elbow until the fingers contacted the booster seat. This orientation complies with section 3.3.3.5 of the TWG Recommended Procedures for Evaluating Occupant Injury Risk from Deploying Side Airbags as defined by Lund, et al and the Technical Working Group First Revision dated July, 2003.

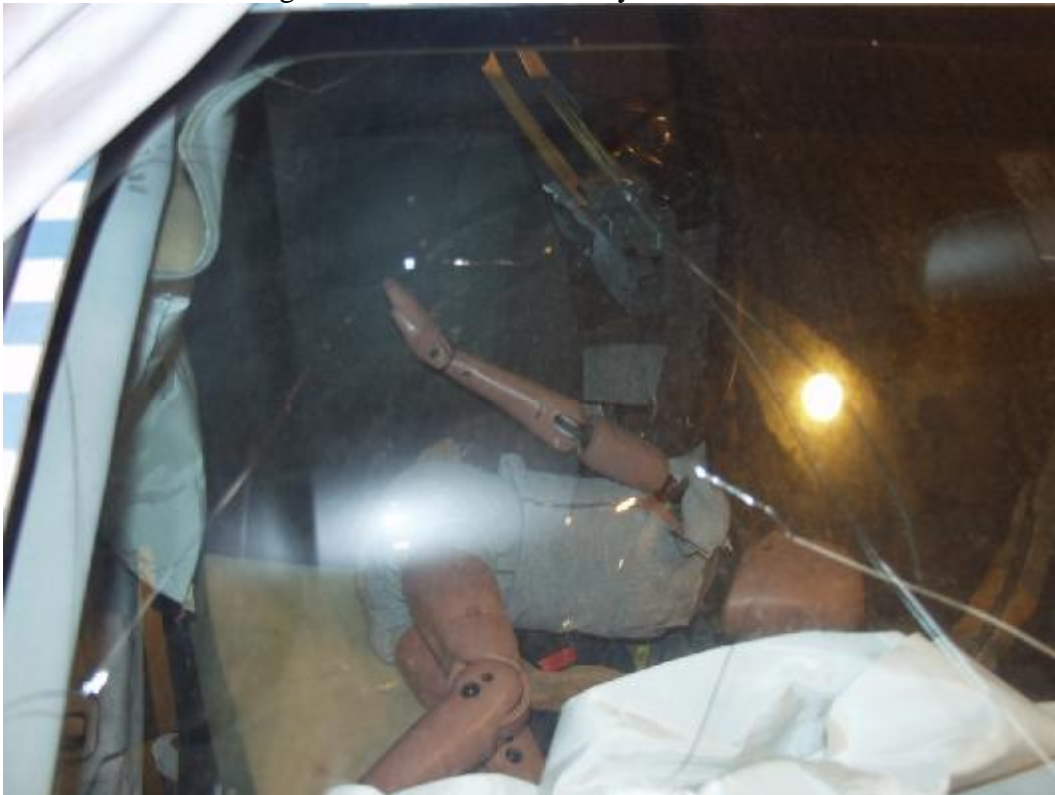
Figure A-6: Post-Test Dummy Frontal View

The Hybrid III six-year-old child dummy's visible contact points were as follows: The seat airbag to the right scapula and right side of the posterior thorax and pelvis and the curtain airbag to the top and the back of the head.

Head Contact:	The back (occipital) and the top (parietal) of the head by the side curtain.
Upper Torso Contact:	Side airbag to the right scapula and right side of the posterior thorax
Lower Torso Contact:	Side airbag to the right side of the pelvis (ilium)
Left Knee Contact:	None
Right Knee Contact:	None

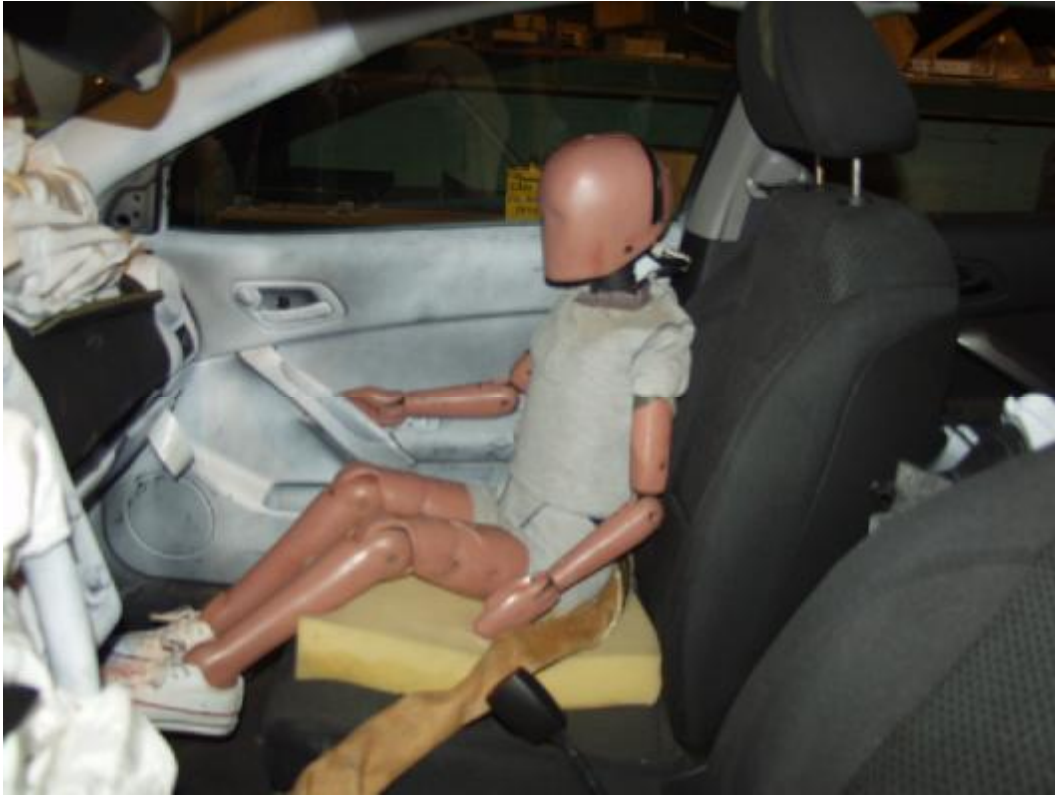
Figure A-7: Pre-Test Left Side of Dummy View

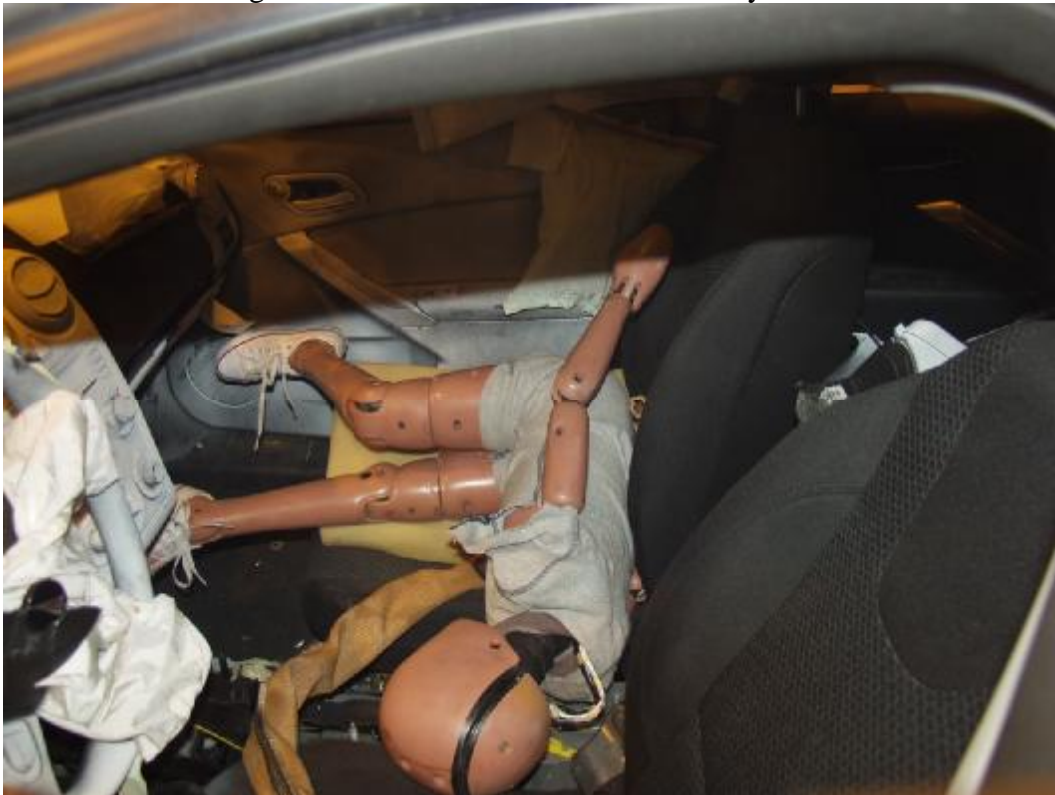
Figure A-8: Post-Test Left Side of Dummy View

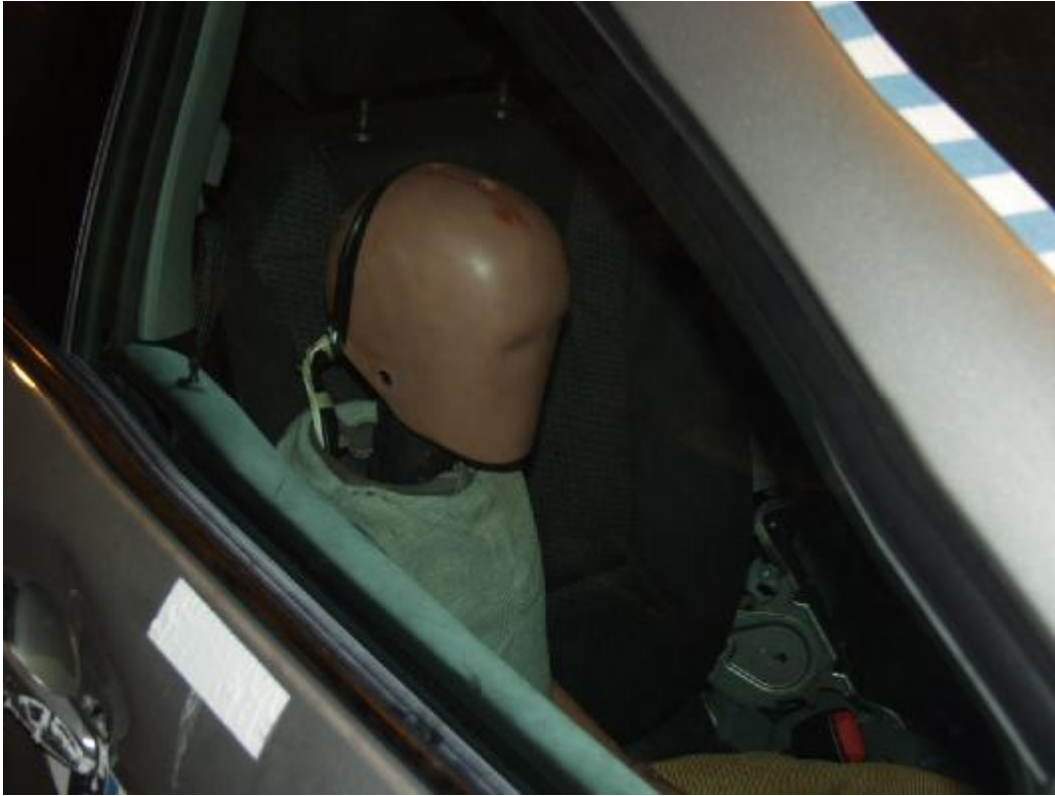
Figure A-9: Pre-Test Right Side of Dummy View

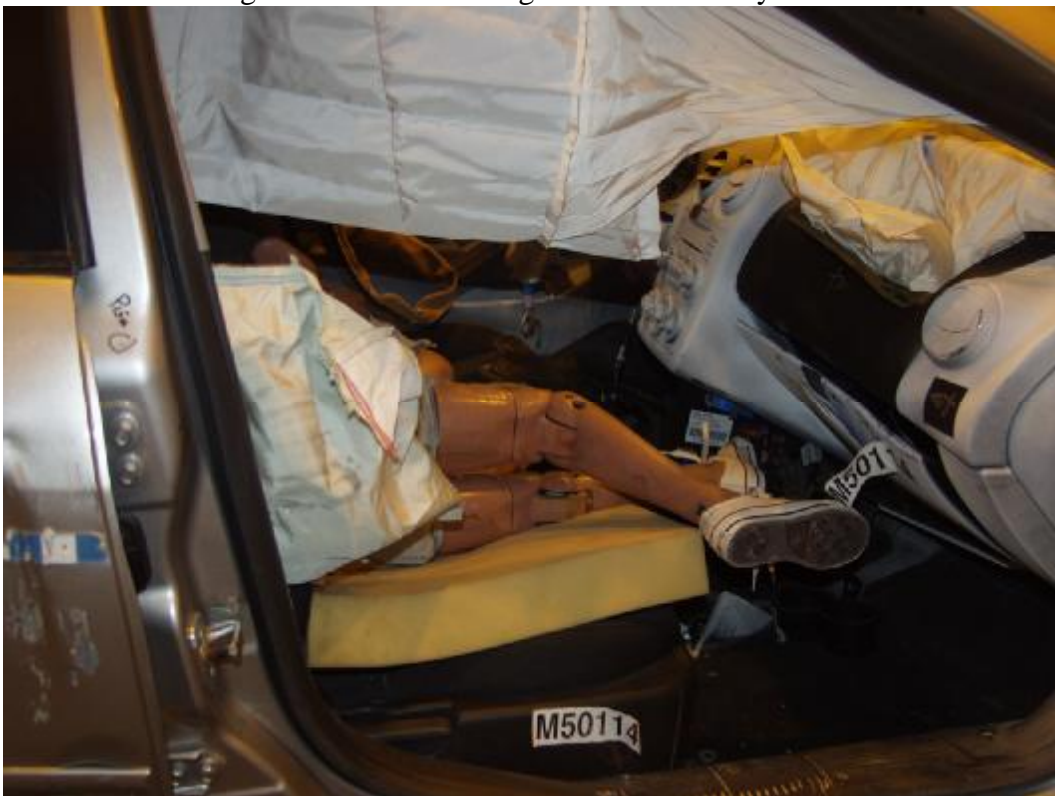
Figure A-9: Post-Test Right Side of Dummy View
