**REPORT NUMBER: TO1-MGA-2004-013**

**OBLIQUE RIGID SIDE POLE IMPACT  
ES-2RE DRIVER POSITION  
TEST DATE: May 11, 2005  
Task Order #T0001 / RFP #0004**

**2005 FORD EXPEDITION  
NHTSA NUMBER: R50613**

**PREPARED BY:  
MGA RESEARCH CORPORATION  
5000 WARREN ROAD  
BURLINGTON, WI 53105**

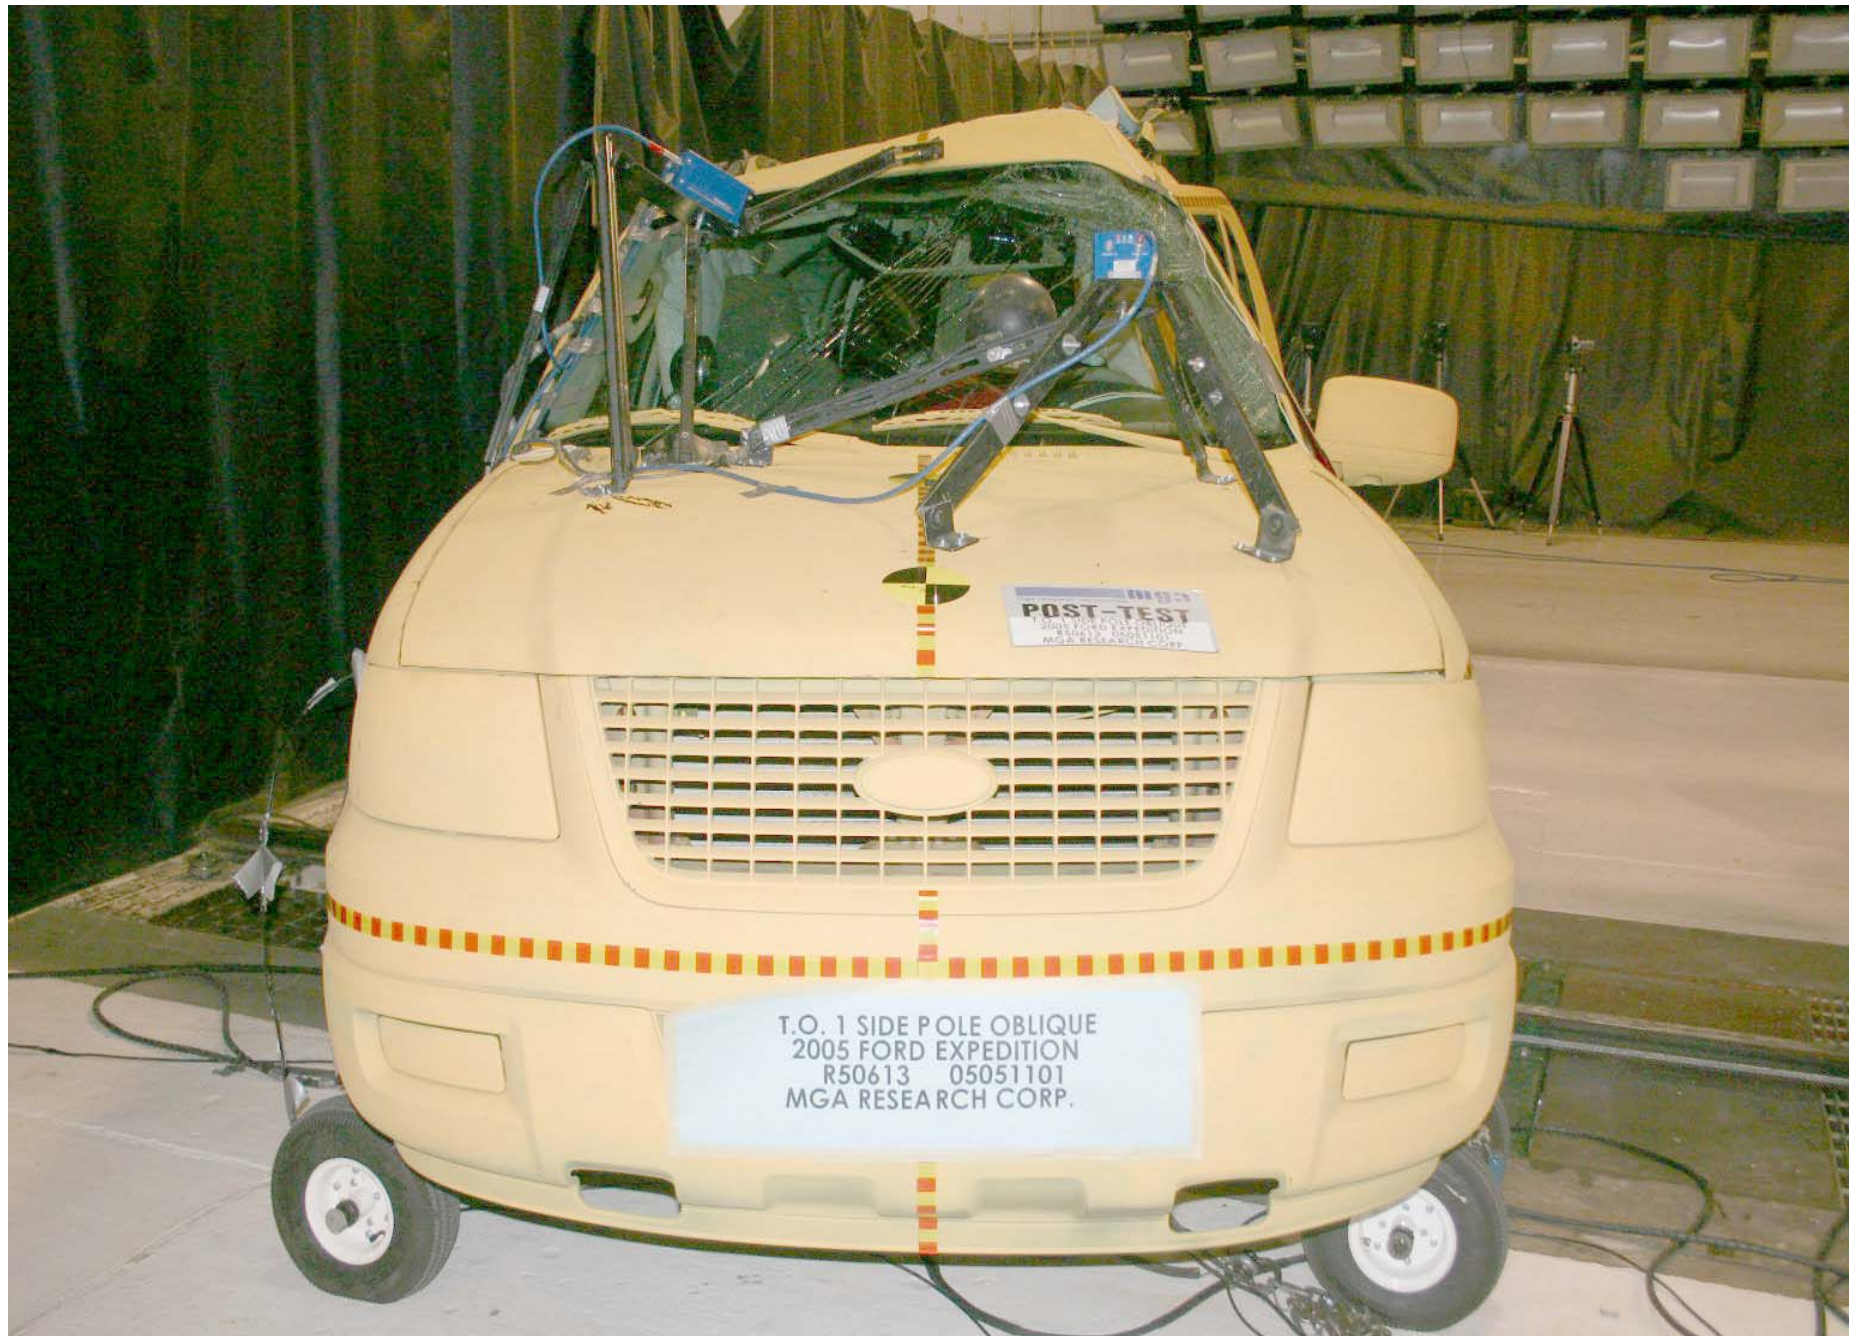
Post-Test Front View of Test Vehicle

| Critical Areas of Performance | Observations and Conclusions |
|---|---|
| Windshield Damage | Windshield Broke |

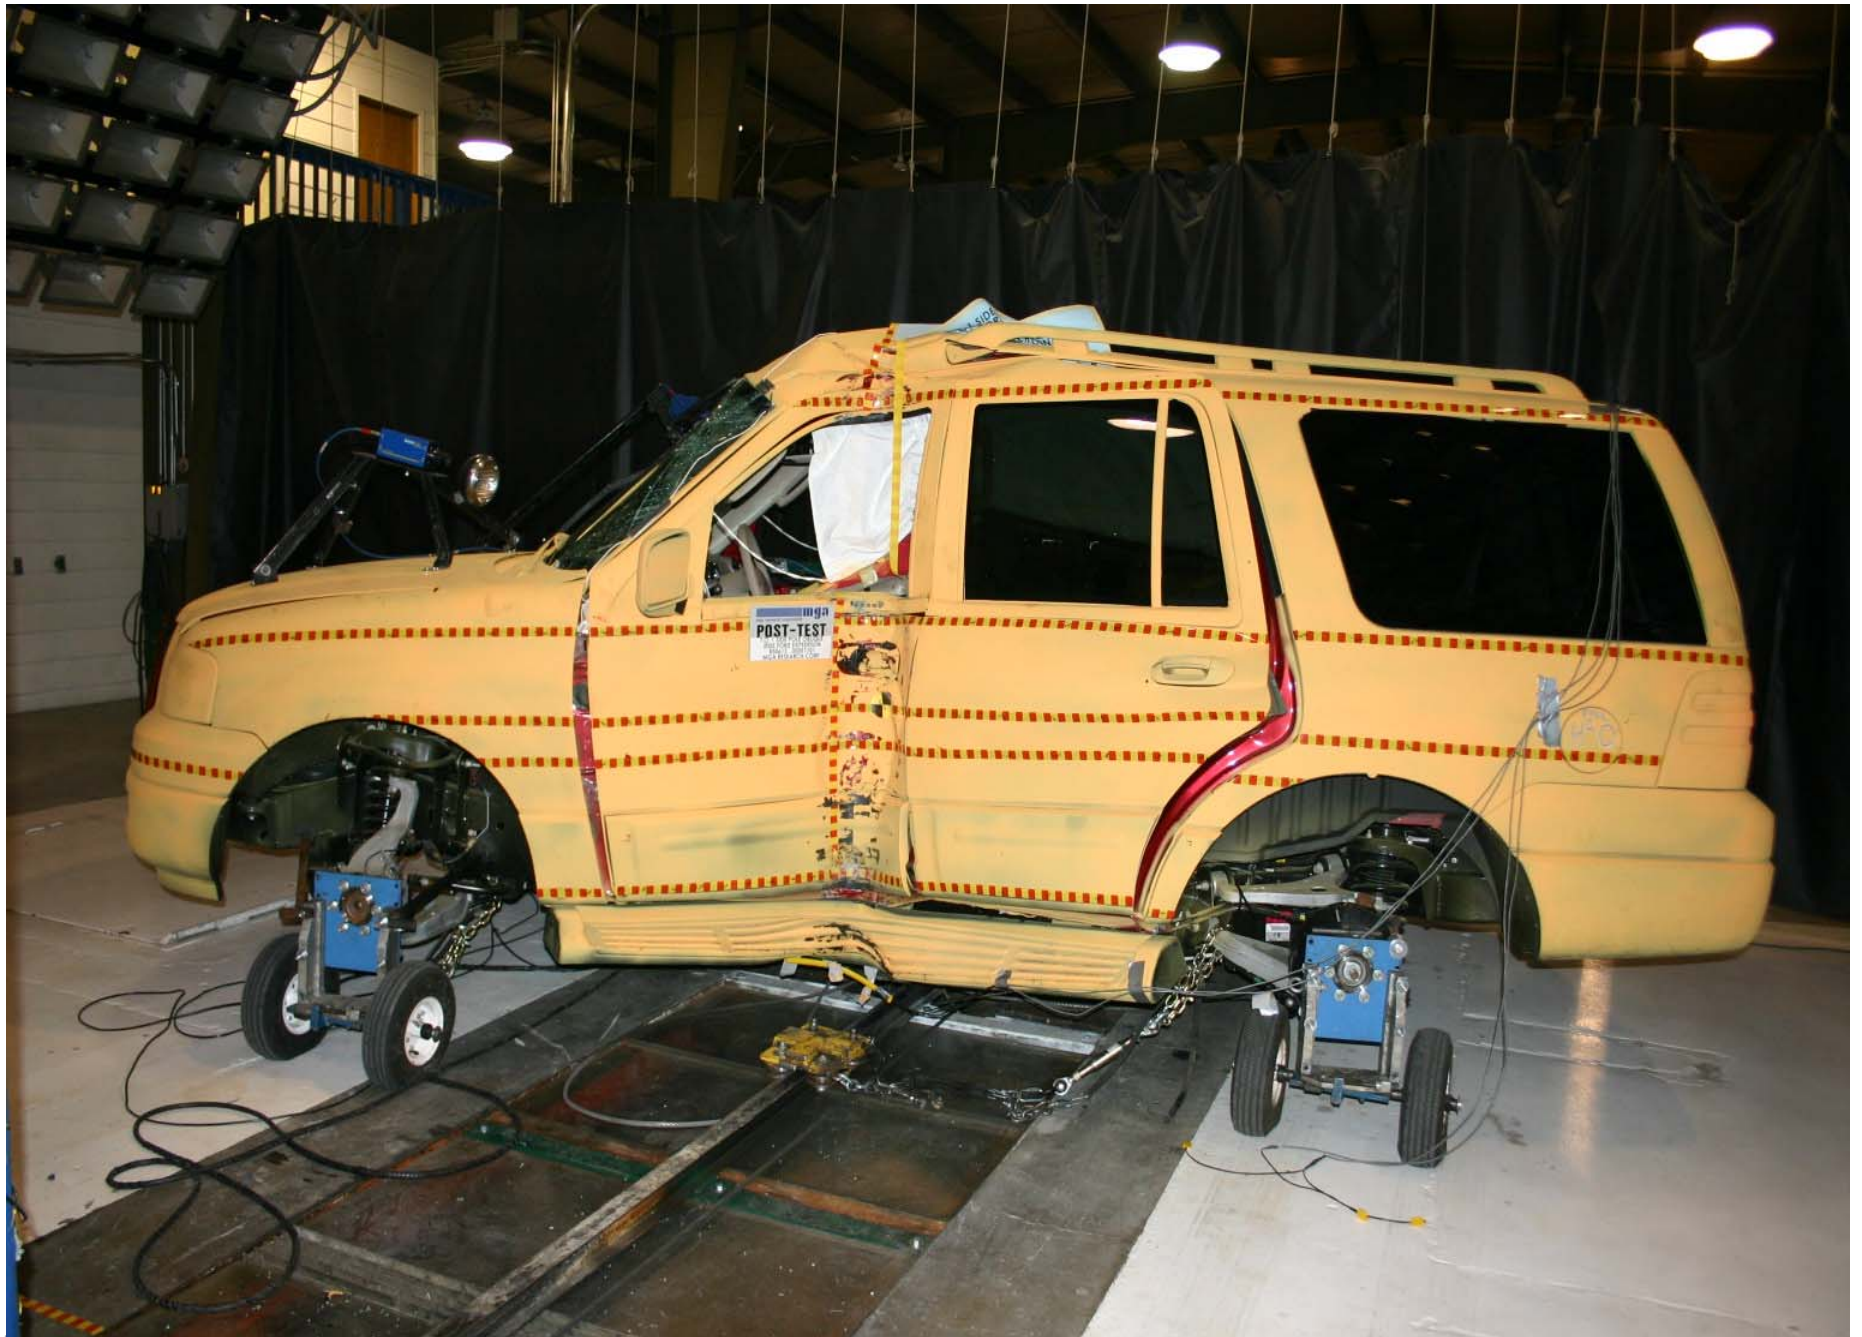
Post-Test Left Side View of Test Vehicle

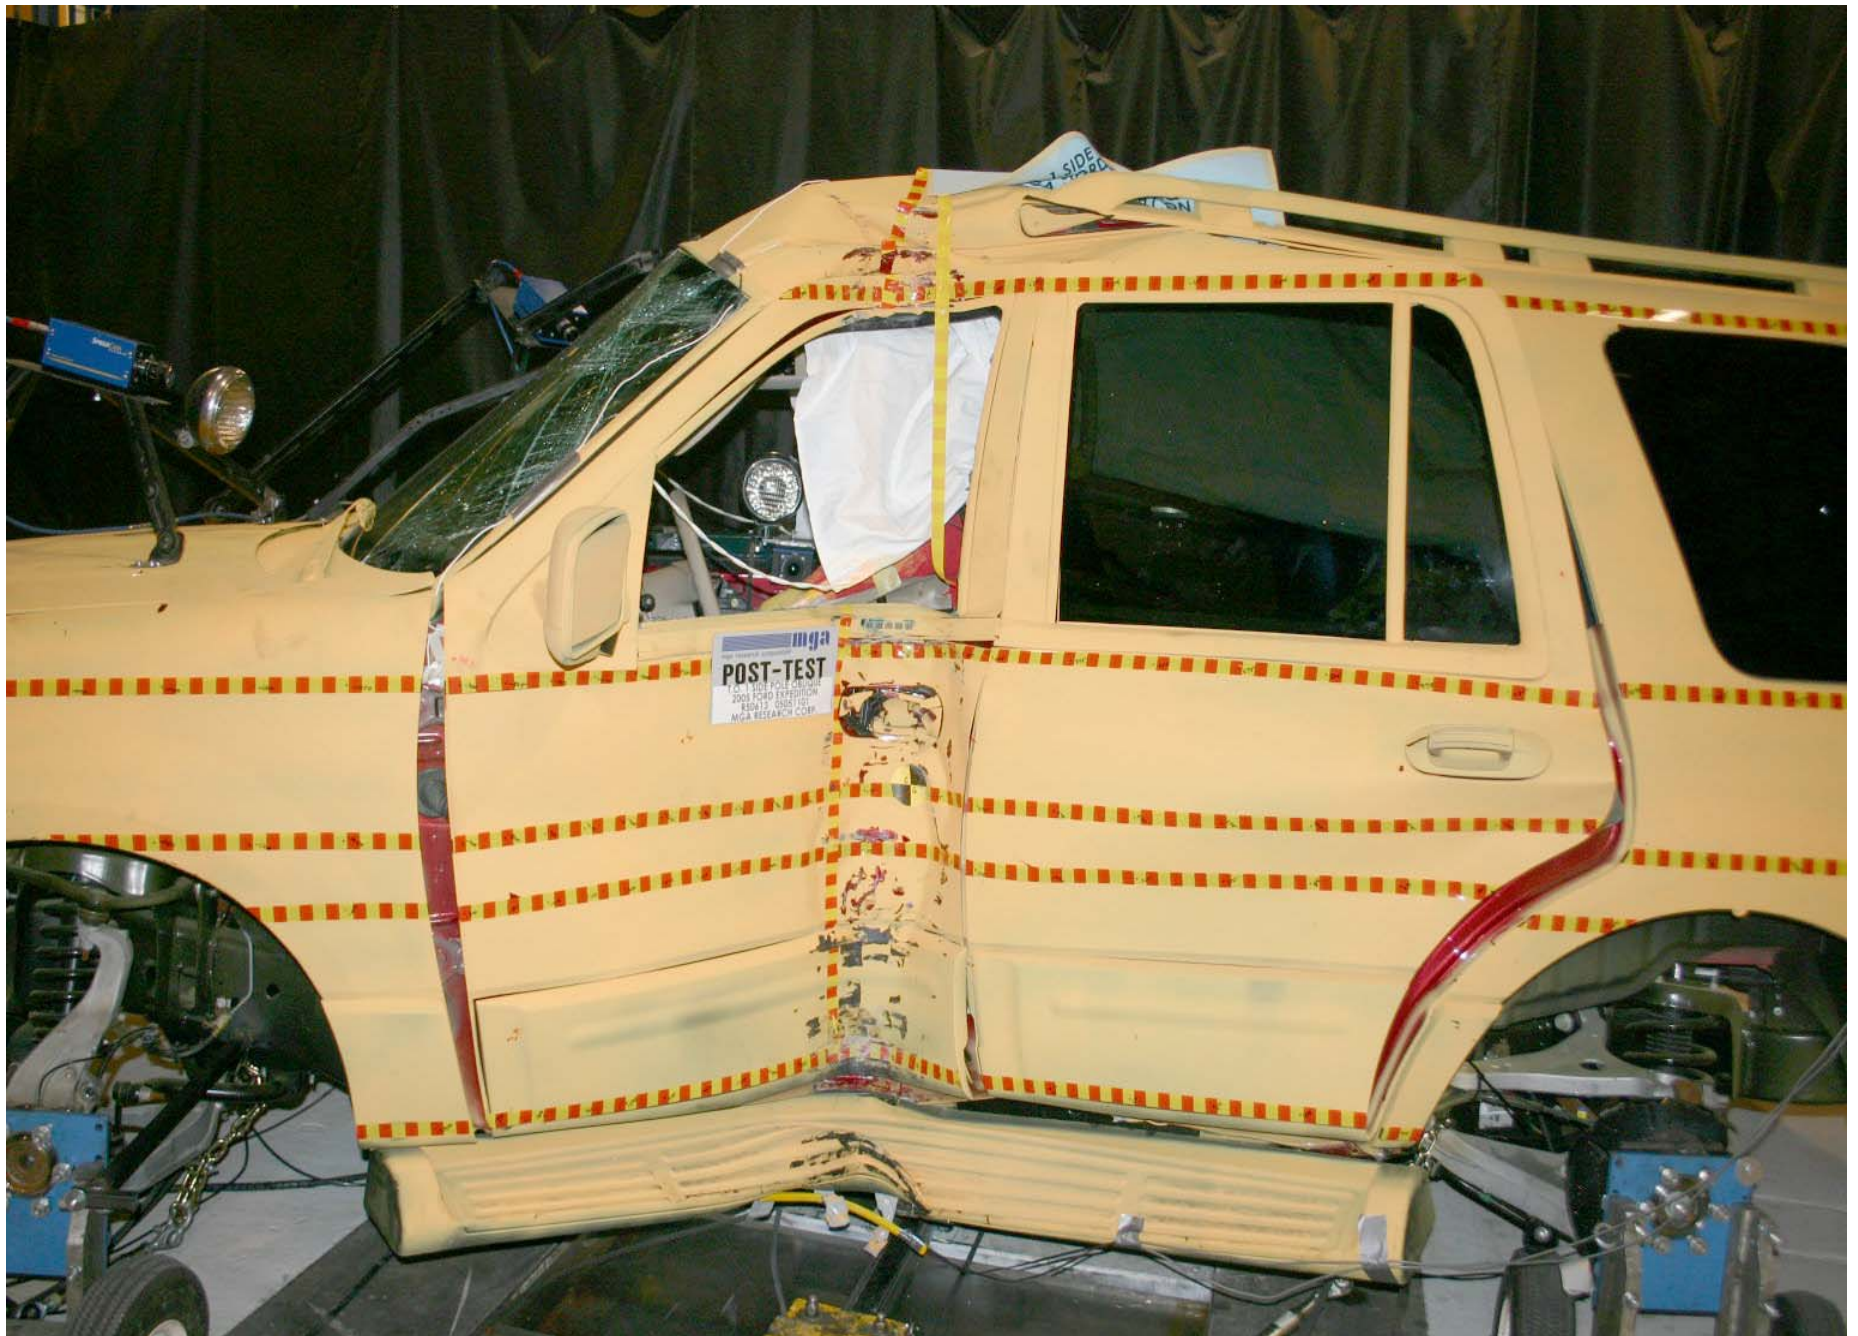
Post-Test Left Side View of Test Vehicle (Close-Up)

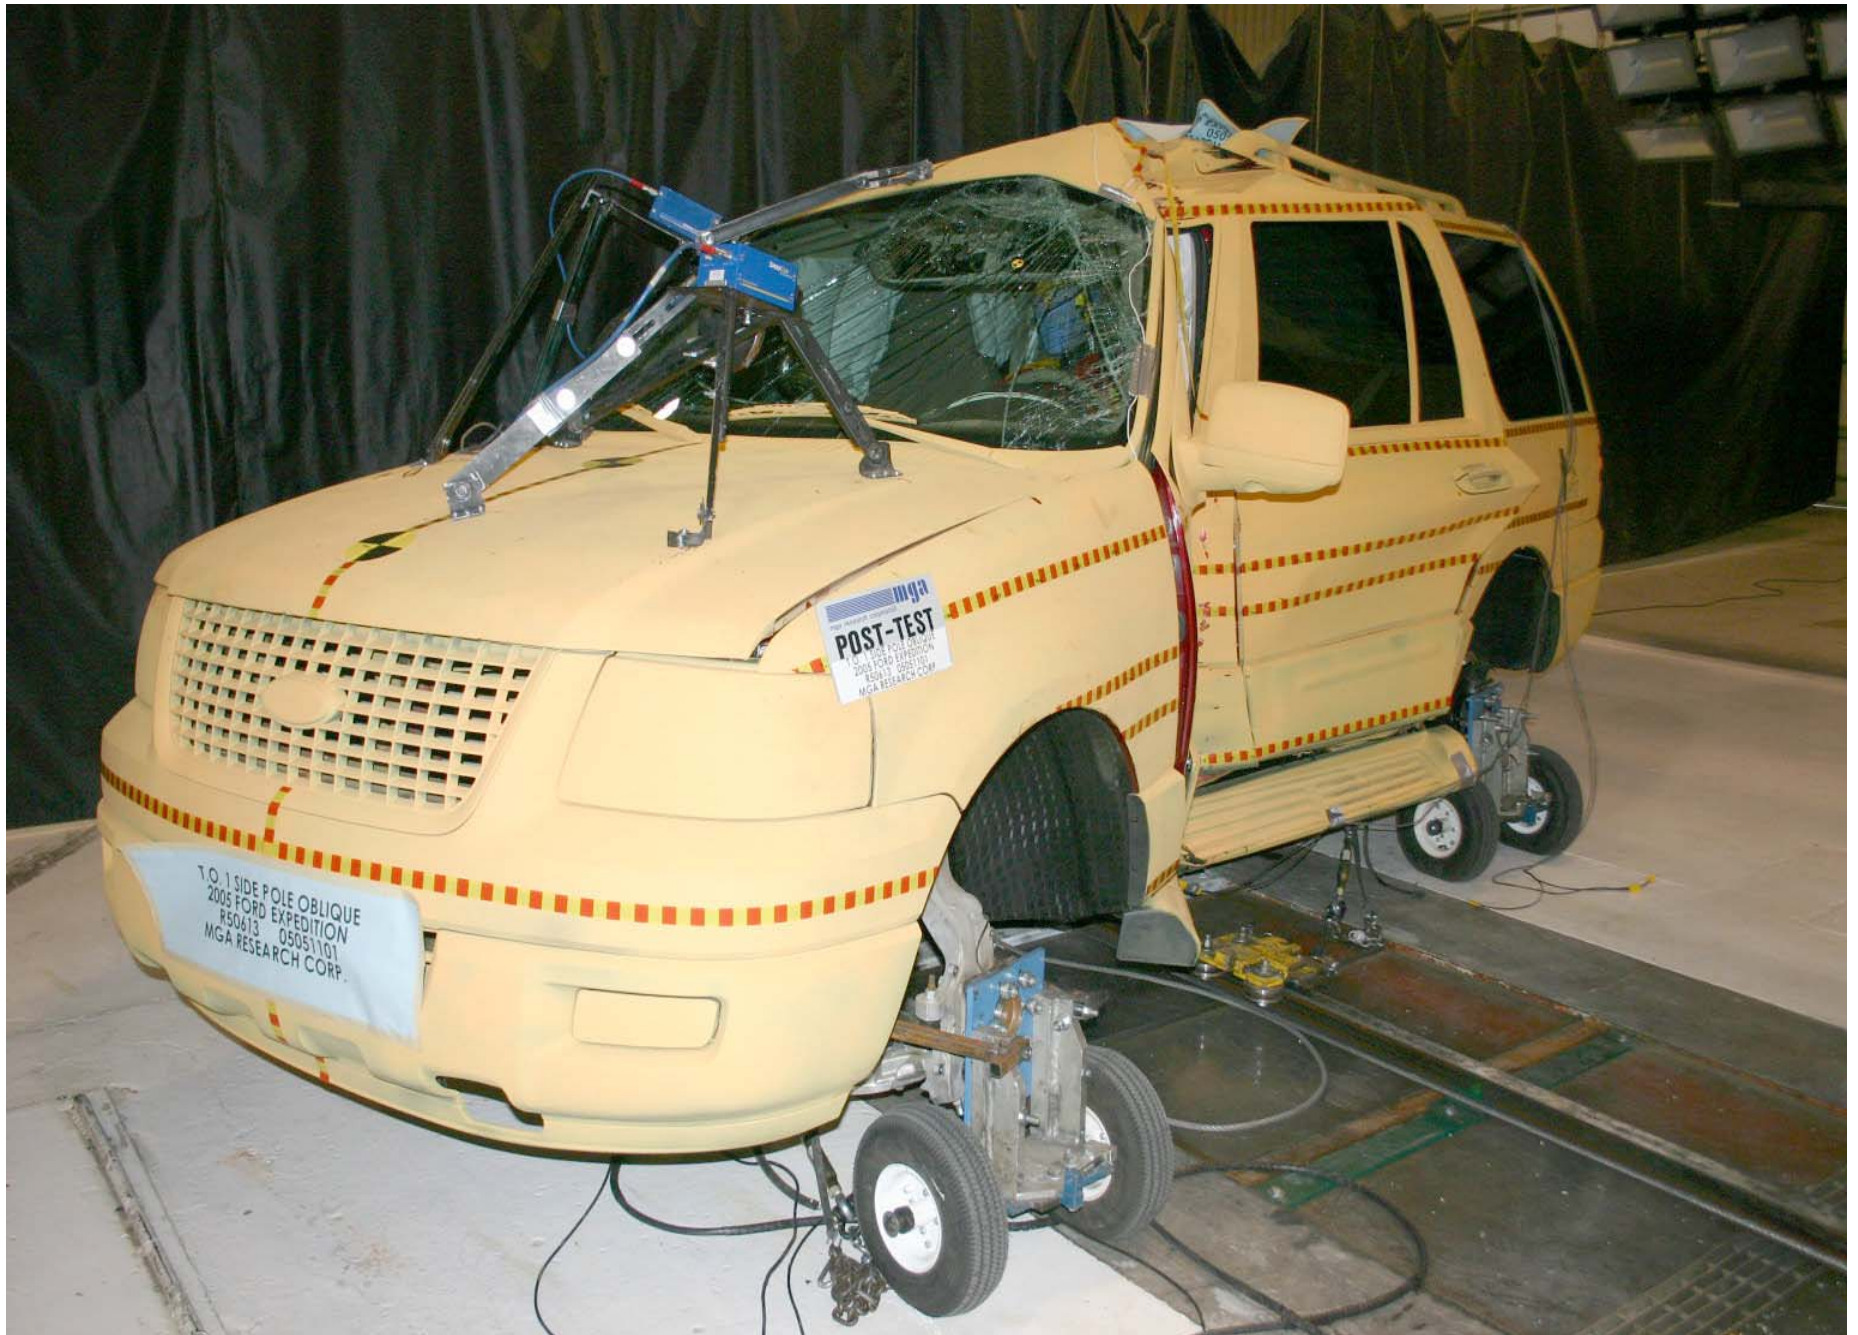
Post-Test Left  $\frac{3}{4}$  Front View of Test Vehicle

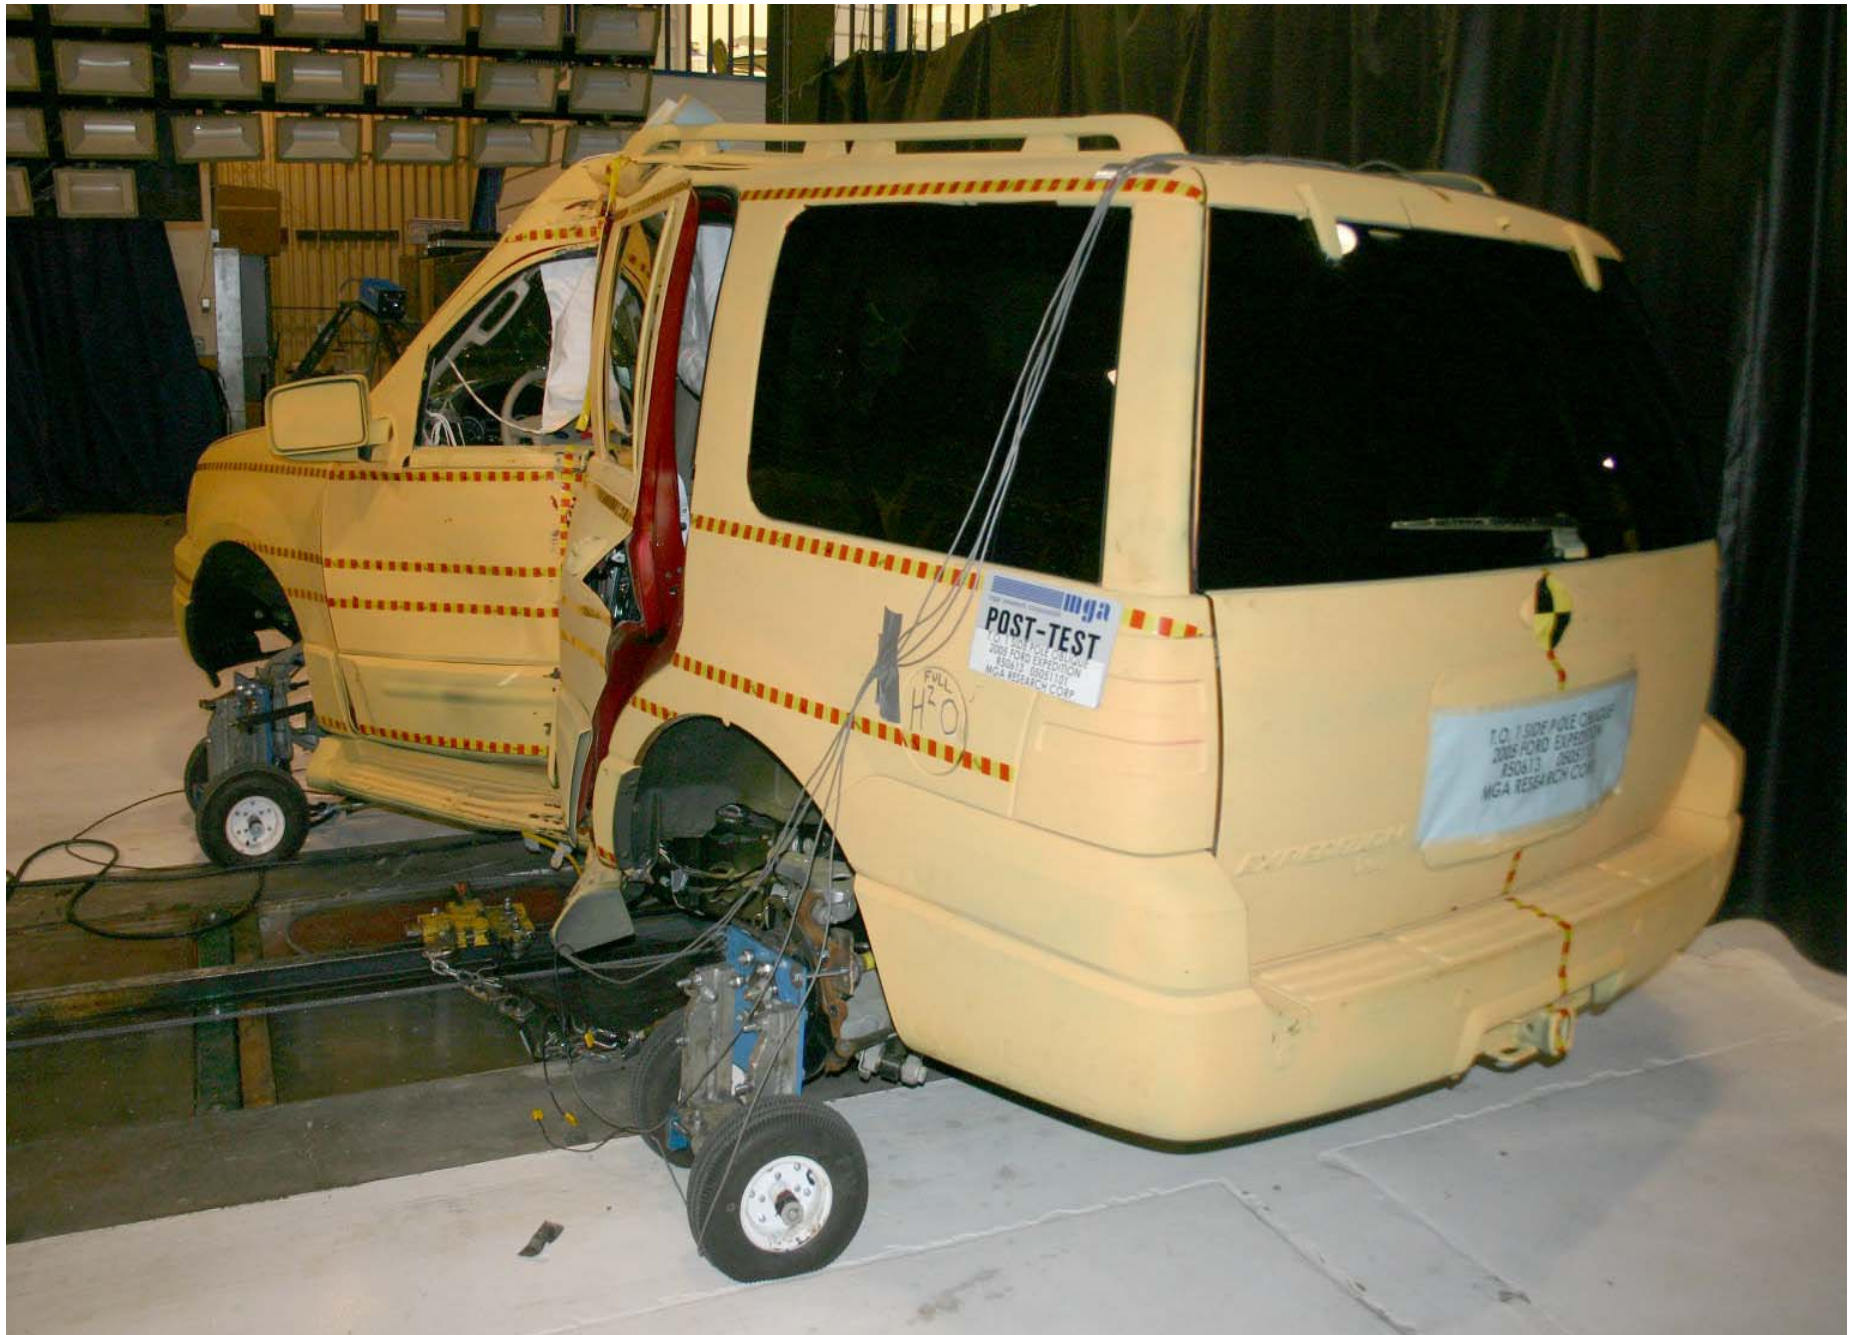
Post-Test Left  $\frac{3}{4}$  Rear View of Test Vehicle

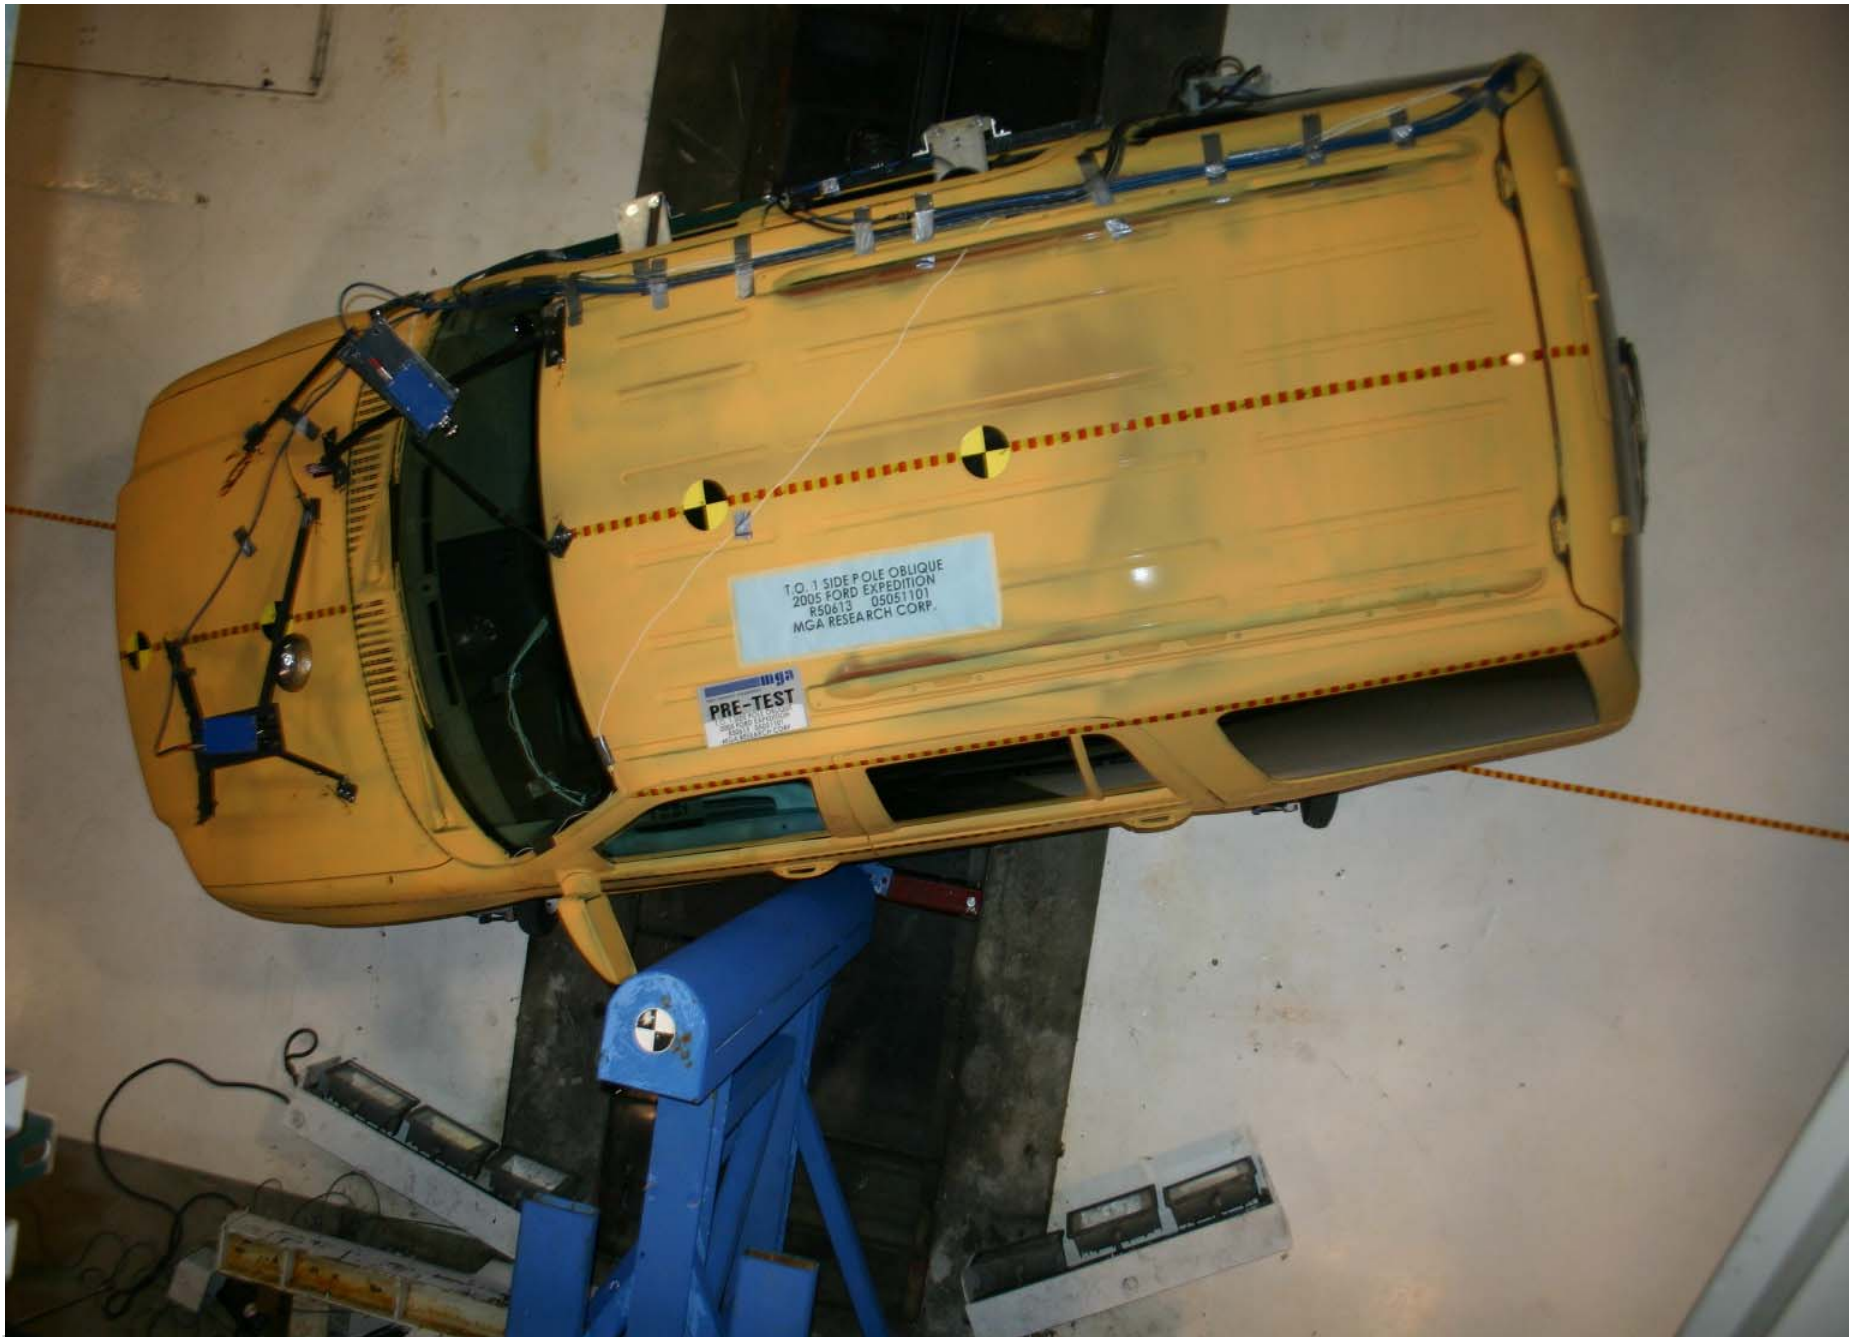
Pre-Test Vehicle Overhead View Positioned Against Pole

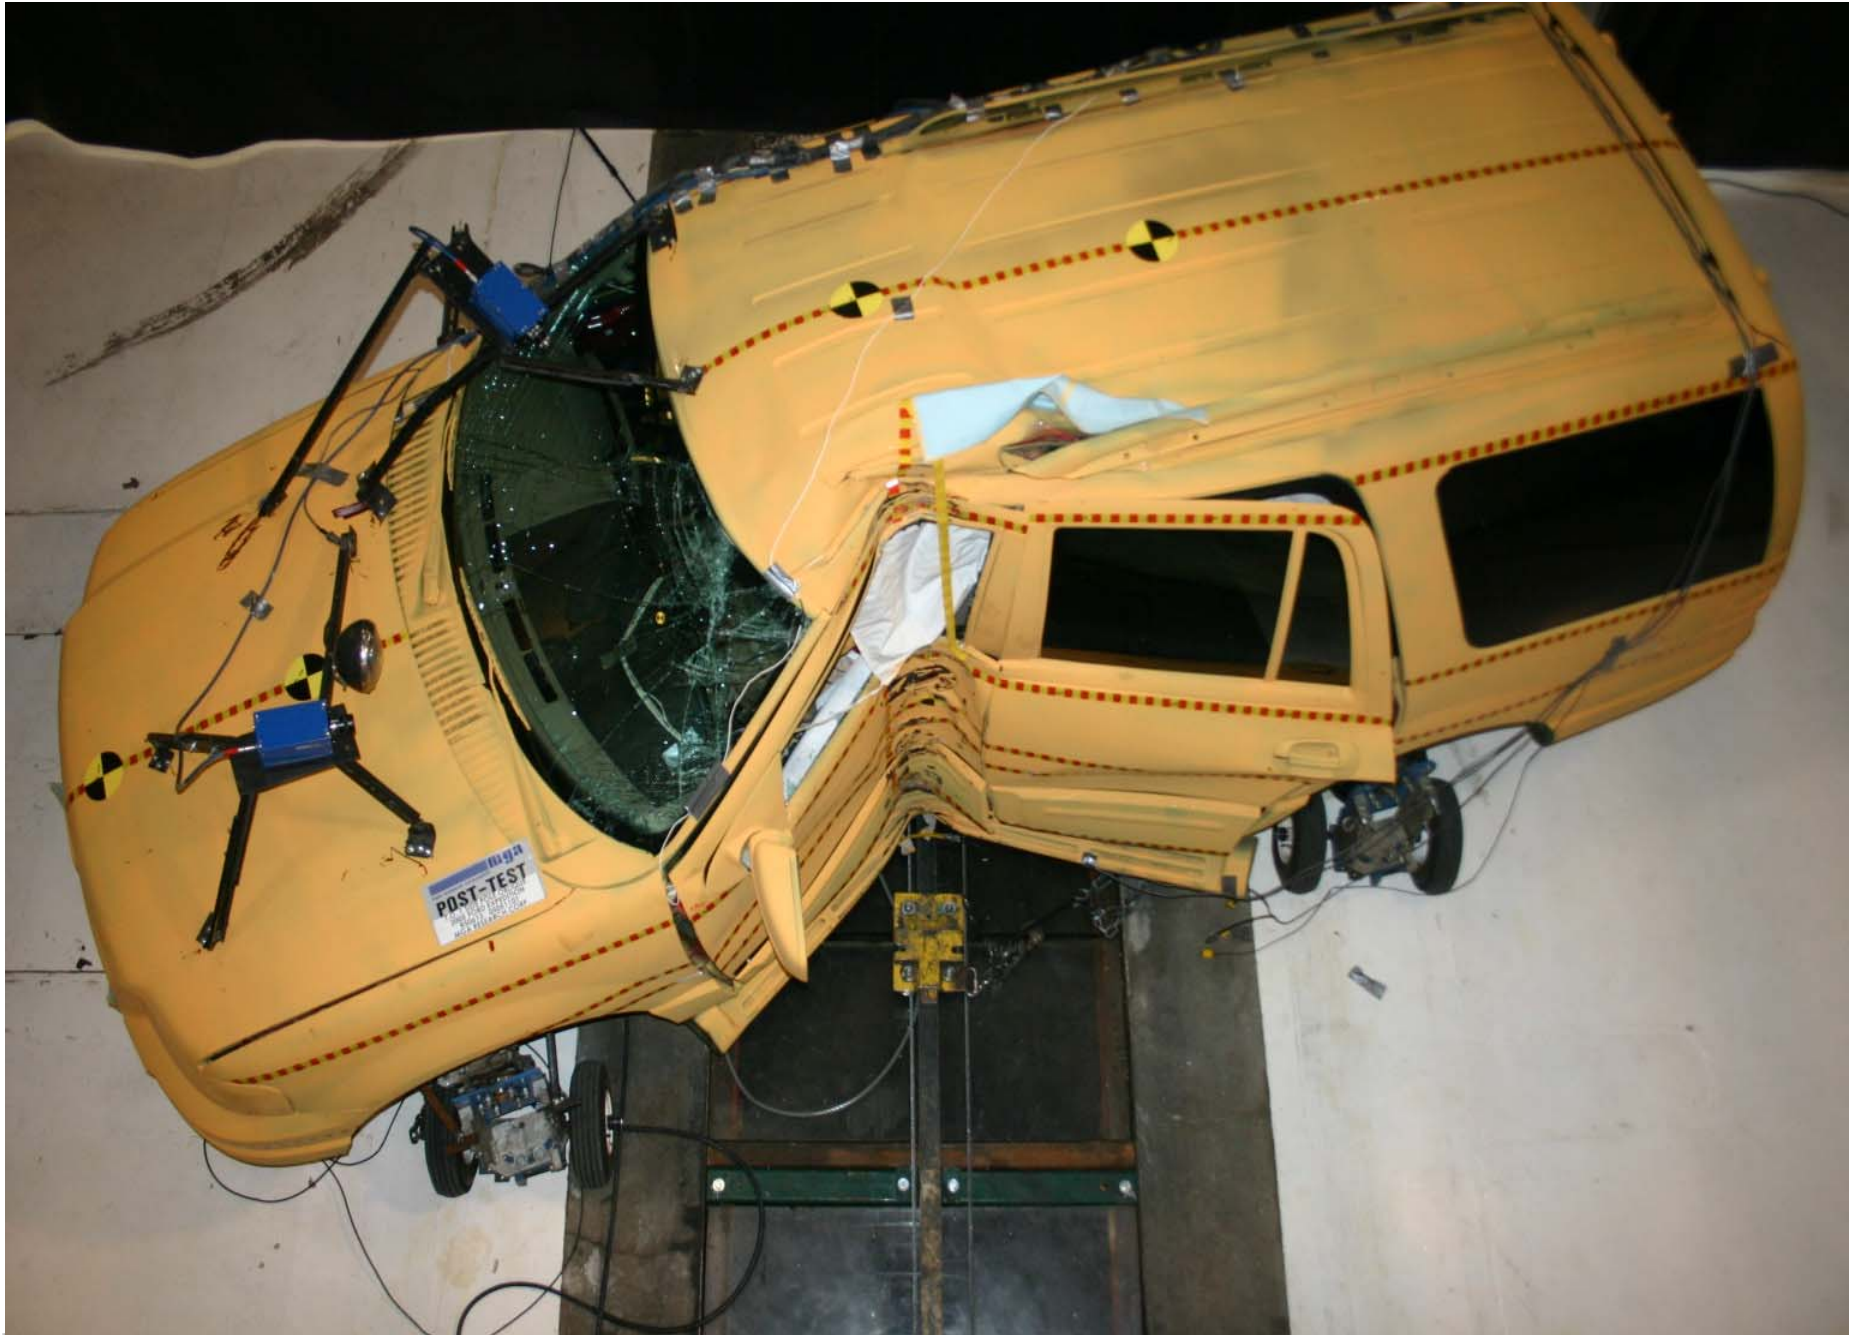
Post-Test Vehicle Overhead View

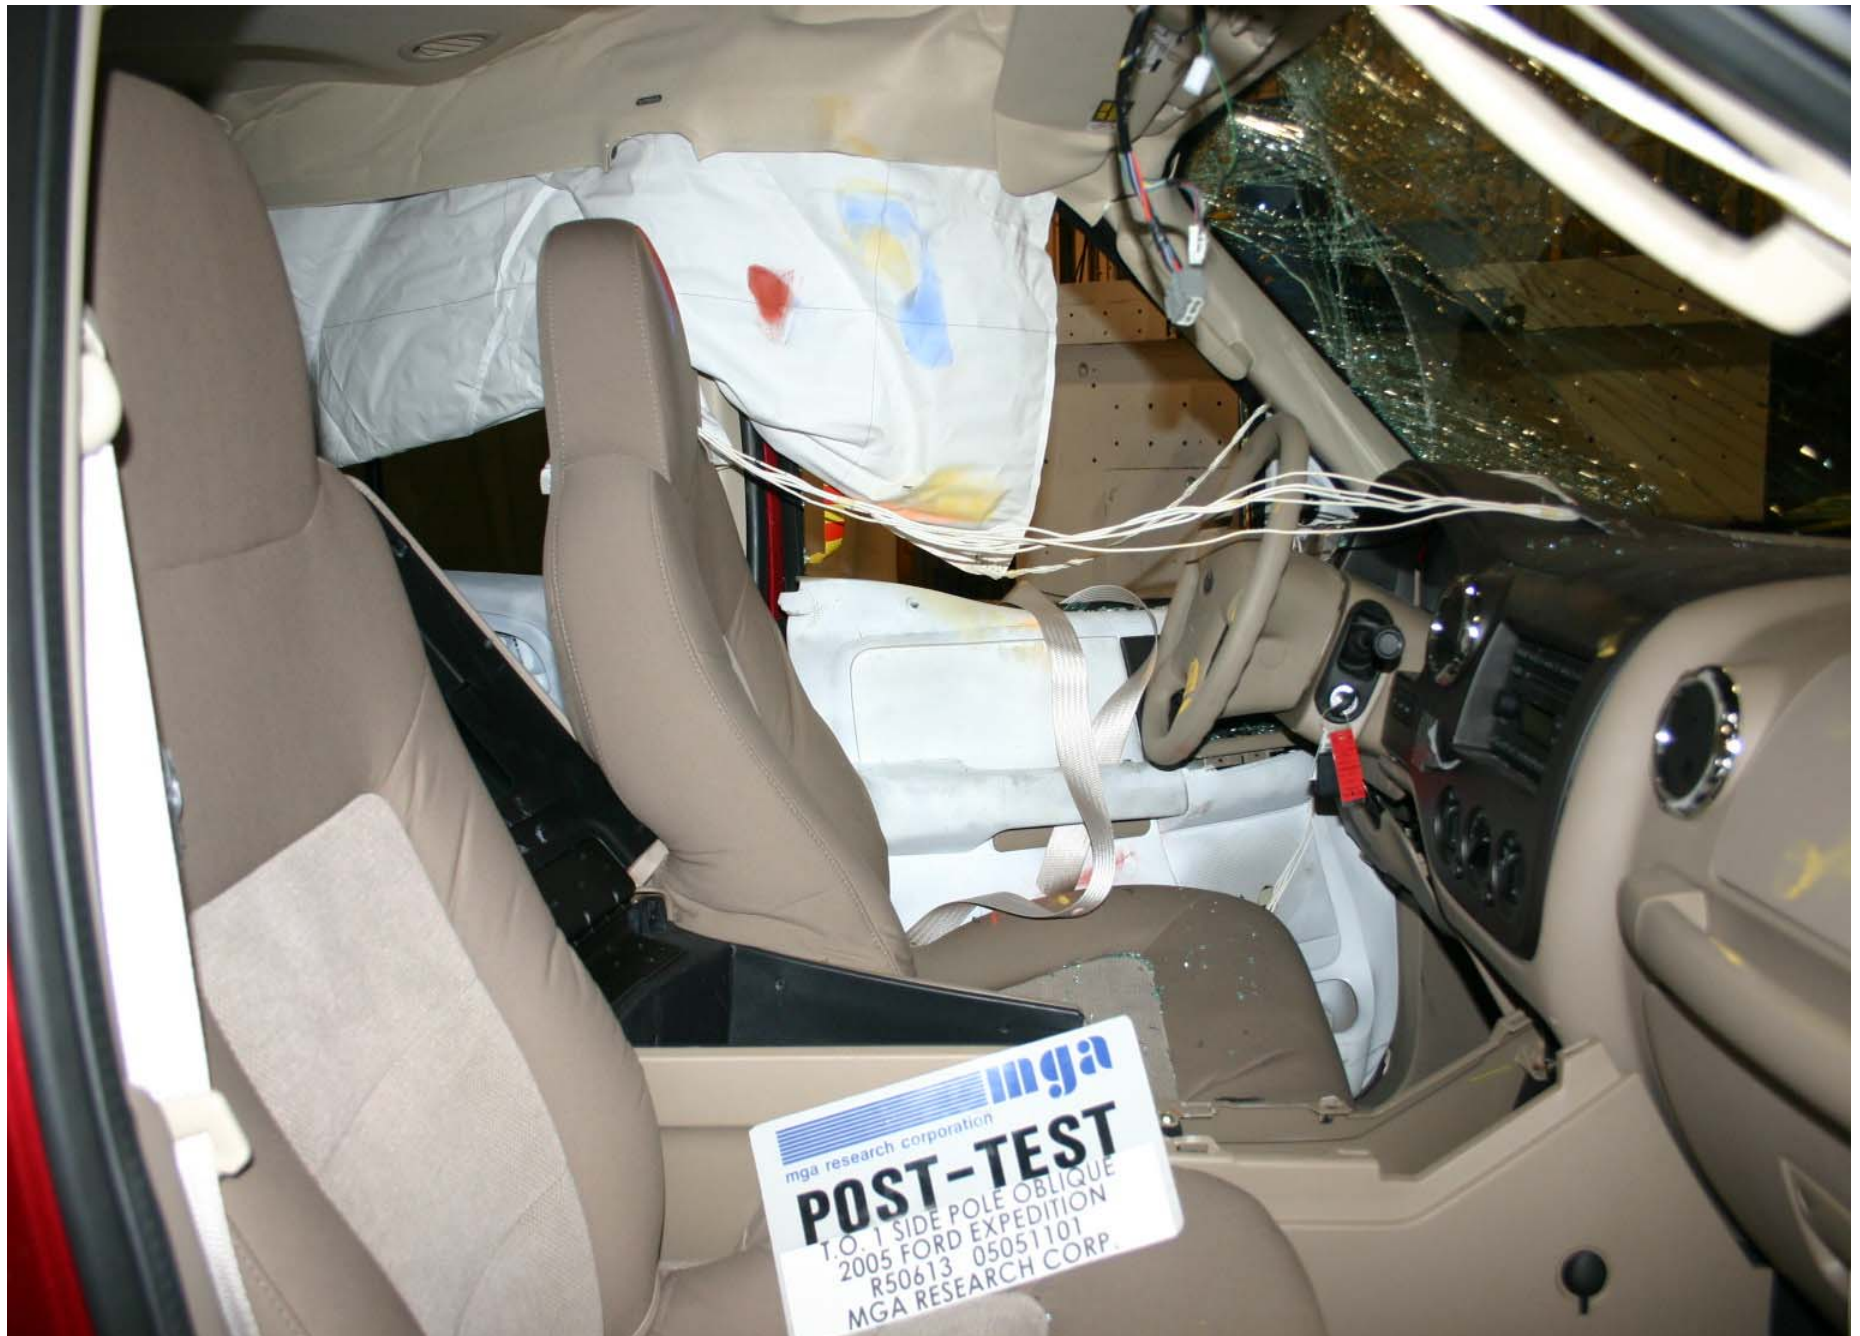
Post-Test Driver Dummy Contact

| Description | Left Front |
|---|---|
| Head Contact | Curtain bag, Overhead Center Console, Headrest |
| Upper Torso Contact | Curtain bag, Door Panel |
| Lower Torso Contact | Door Panel |

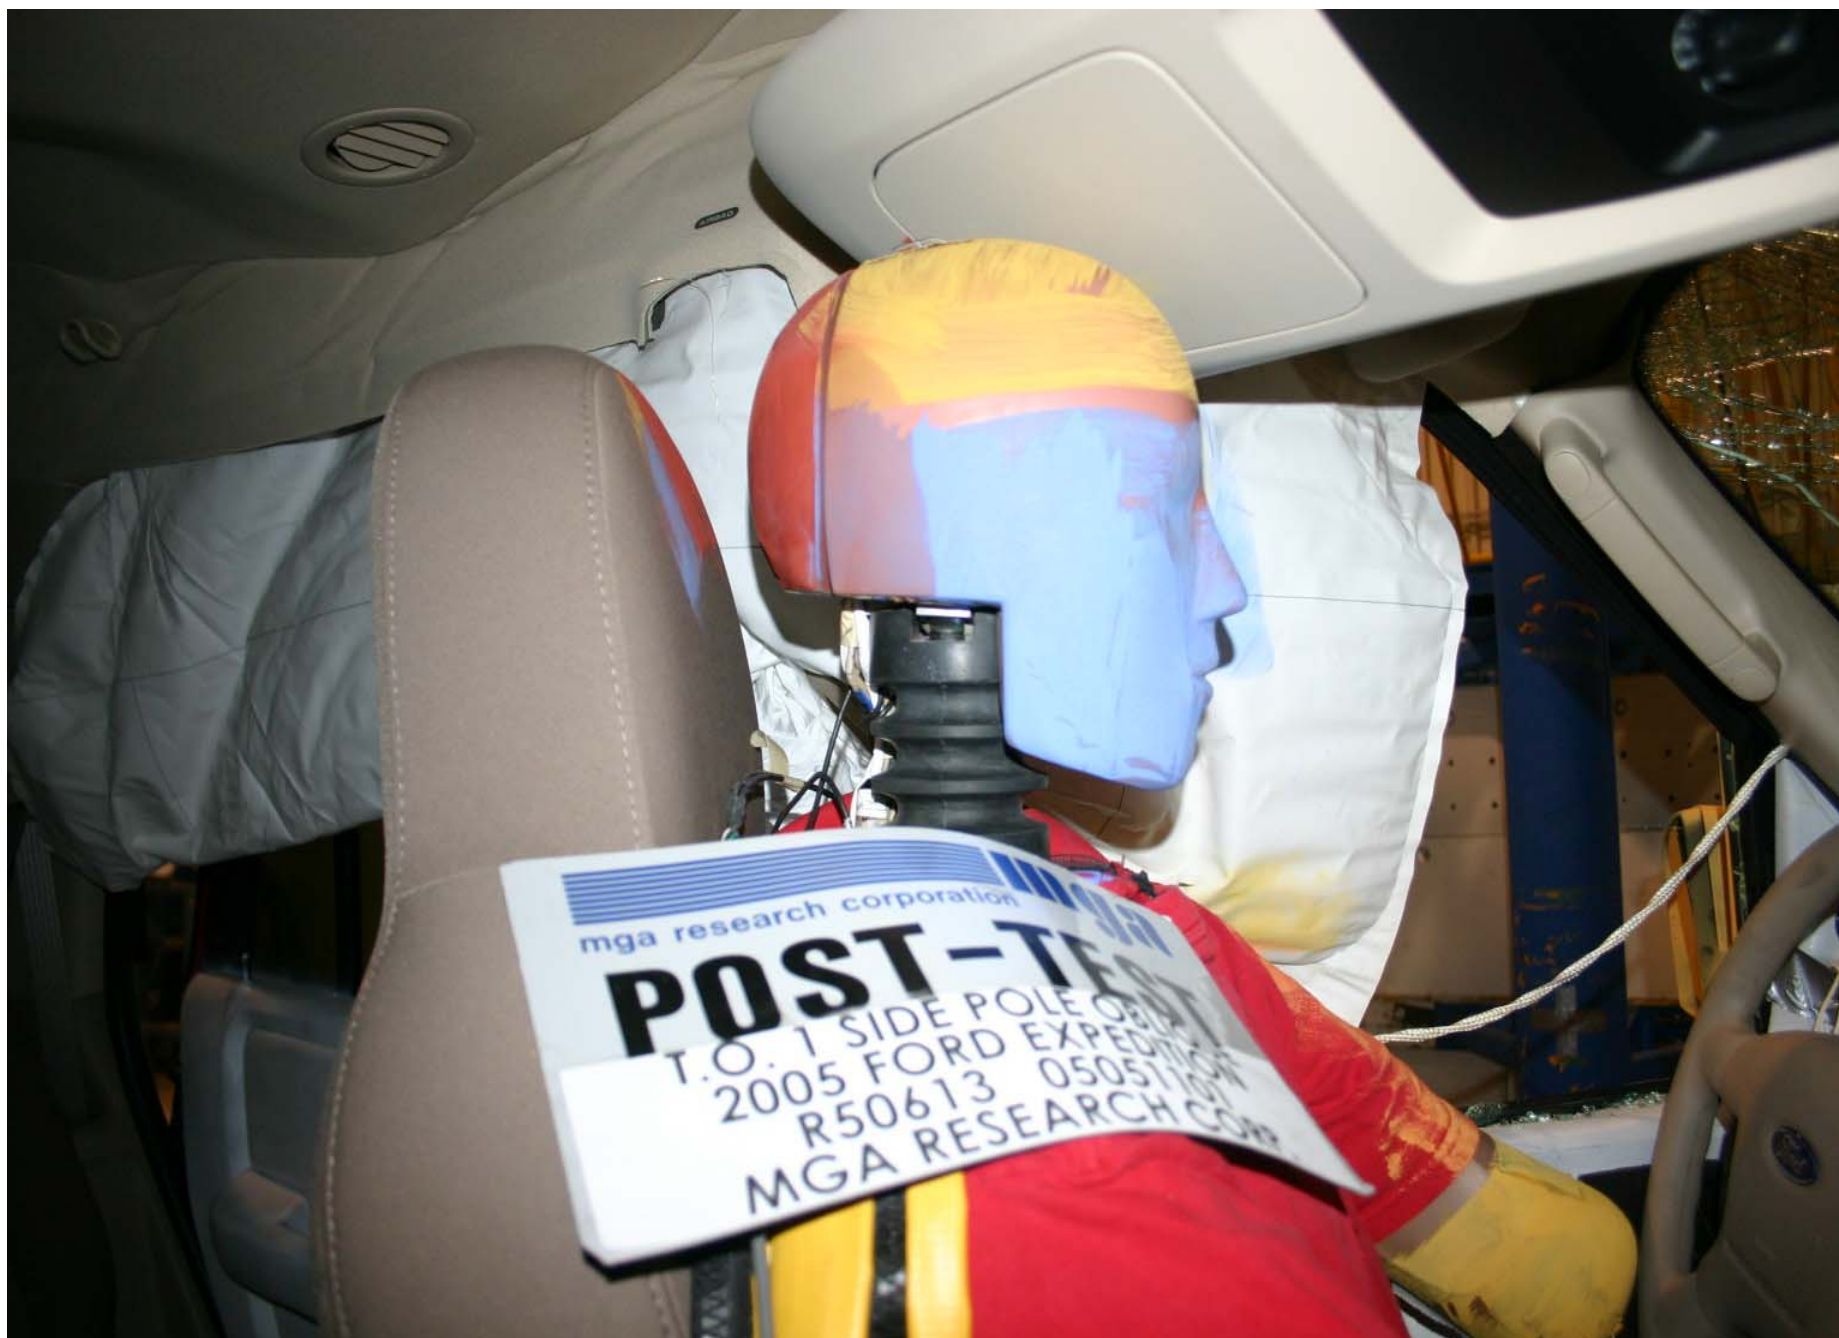
Post-Test Driver Dummy Head Contact
