**REPORT NUMBER: TO1-MGA-2004-013**

**OBLIQUE RIGID SIDE POLE IMPACT  
ES-2RE DRIVER POSITION  
TEST DATE: May 11, 2005  
Task Order #T0001 / RFP #0004**

**2005 FORD EXPEDITION  
NHTSA NUMBER: R50613**

**PREPARED BY:  
MGA RESEARCH CORPORATION  
5000 WARREN ROAD  
BURLINGTON, WI 53105**

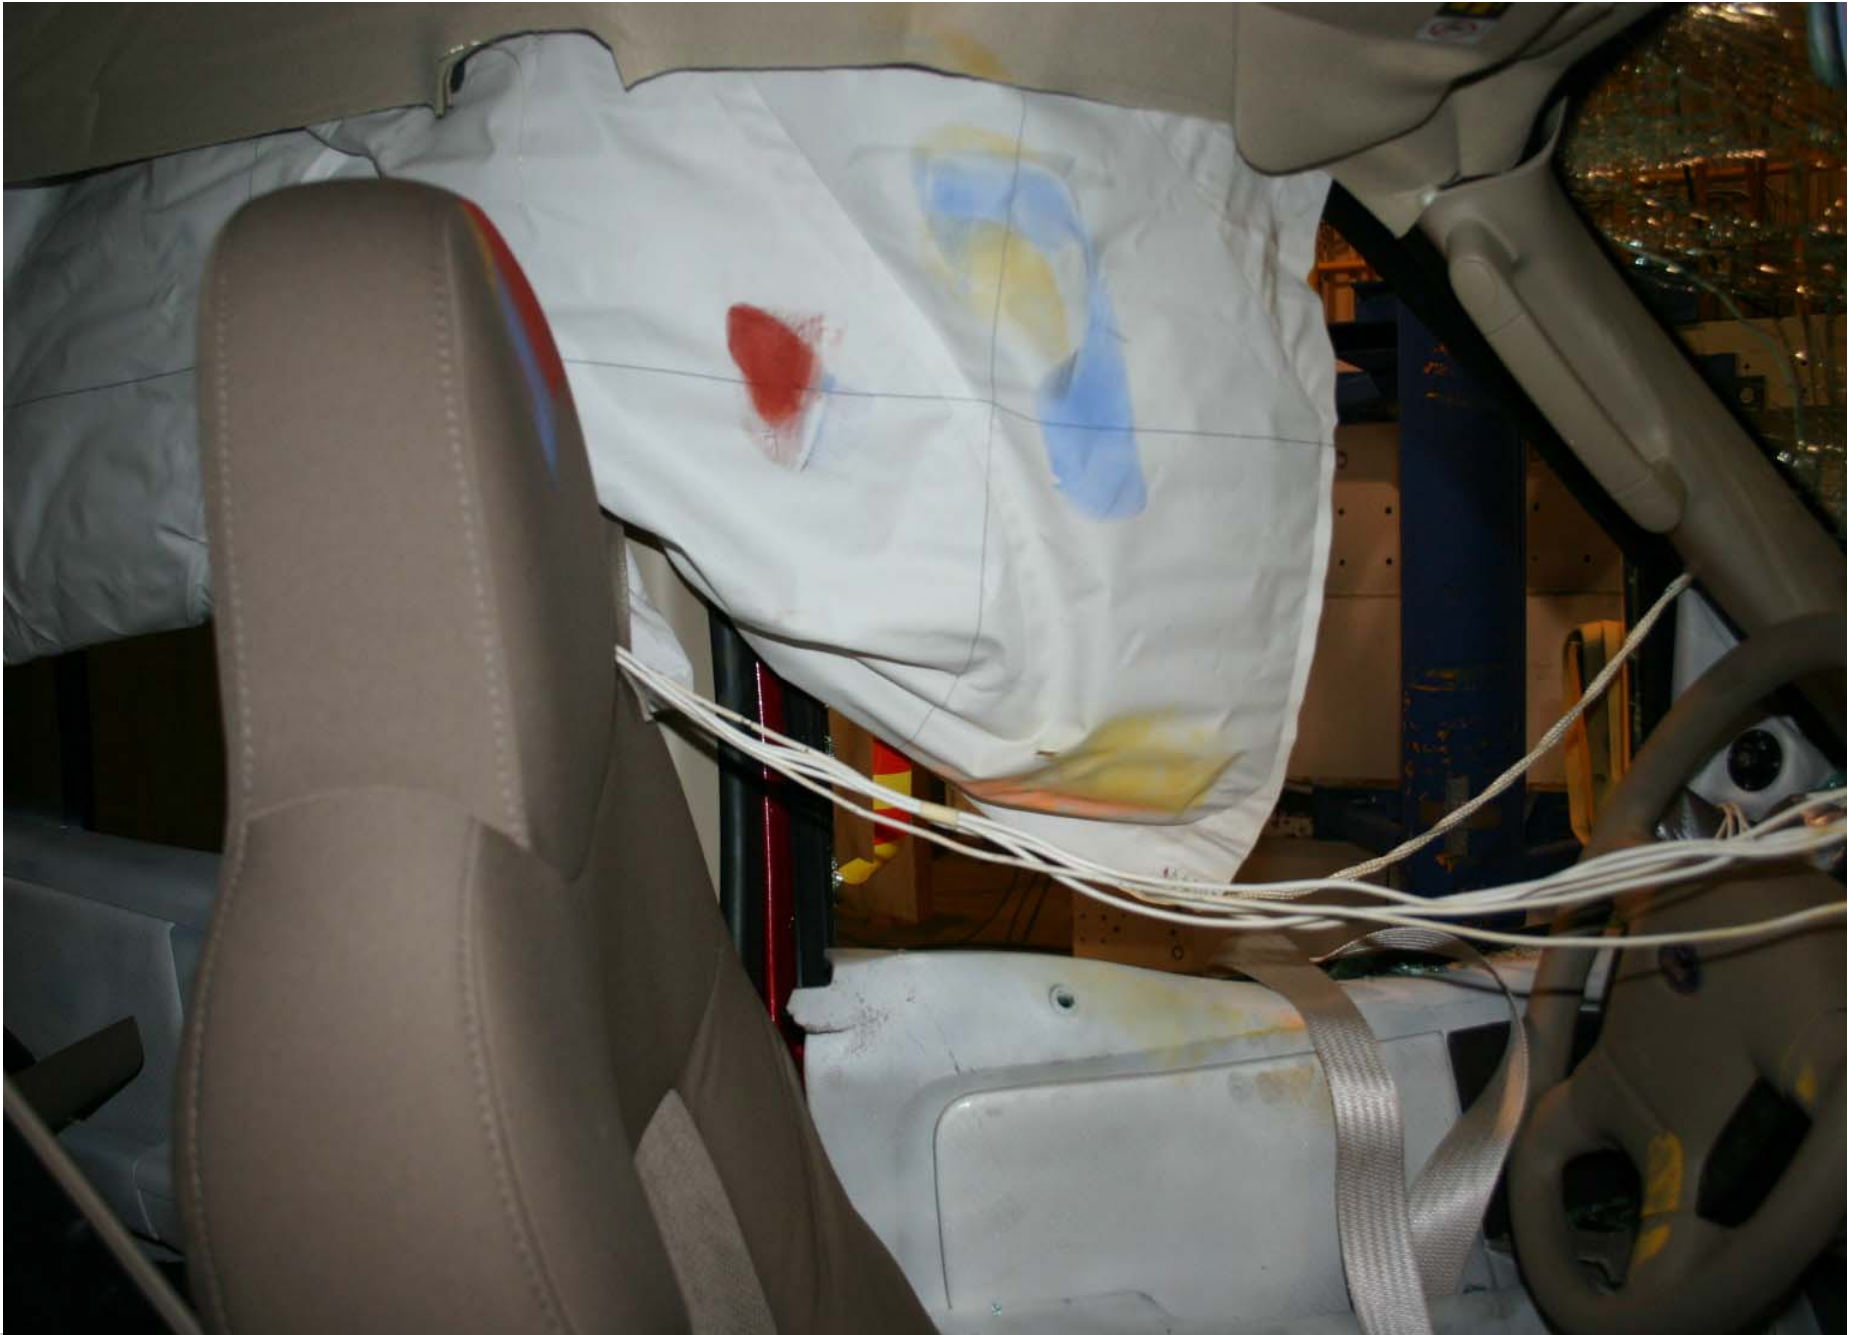
Post-Test Driver Dummy Head Contact

| Description | Left Front |
|---|---|
| Head Contact | Curtain bag, Overhead Center Console, Headrest |

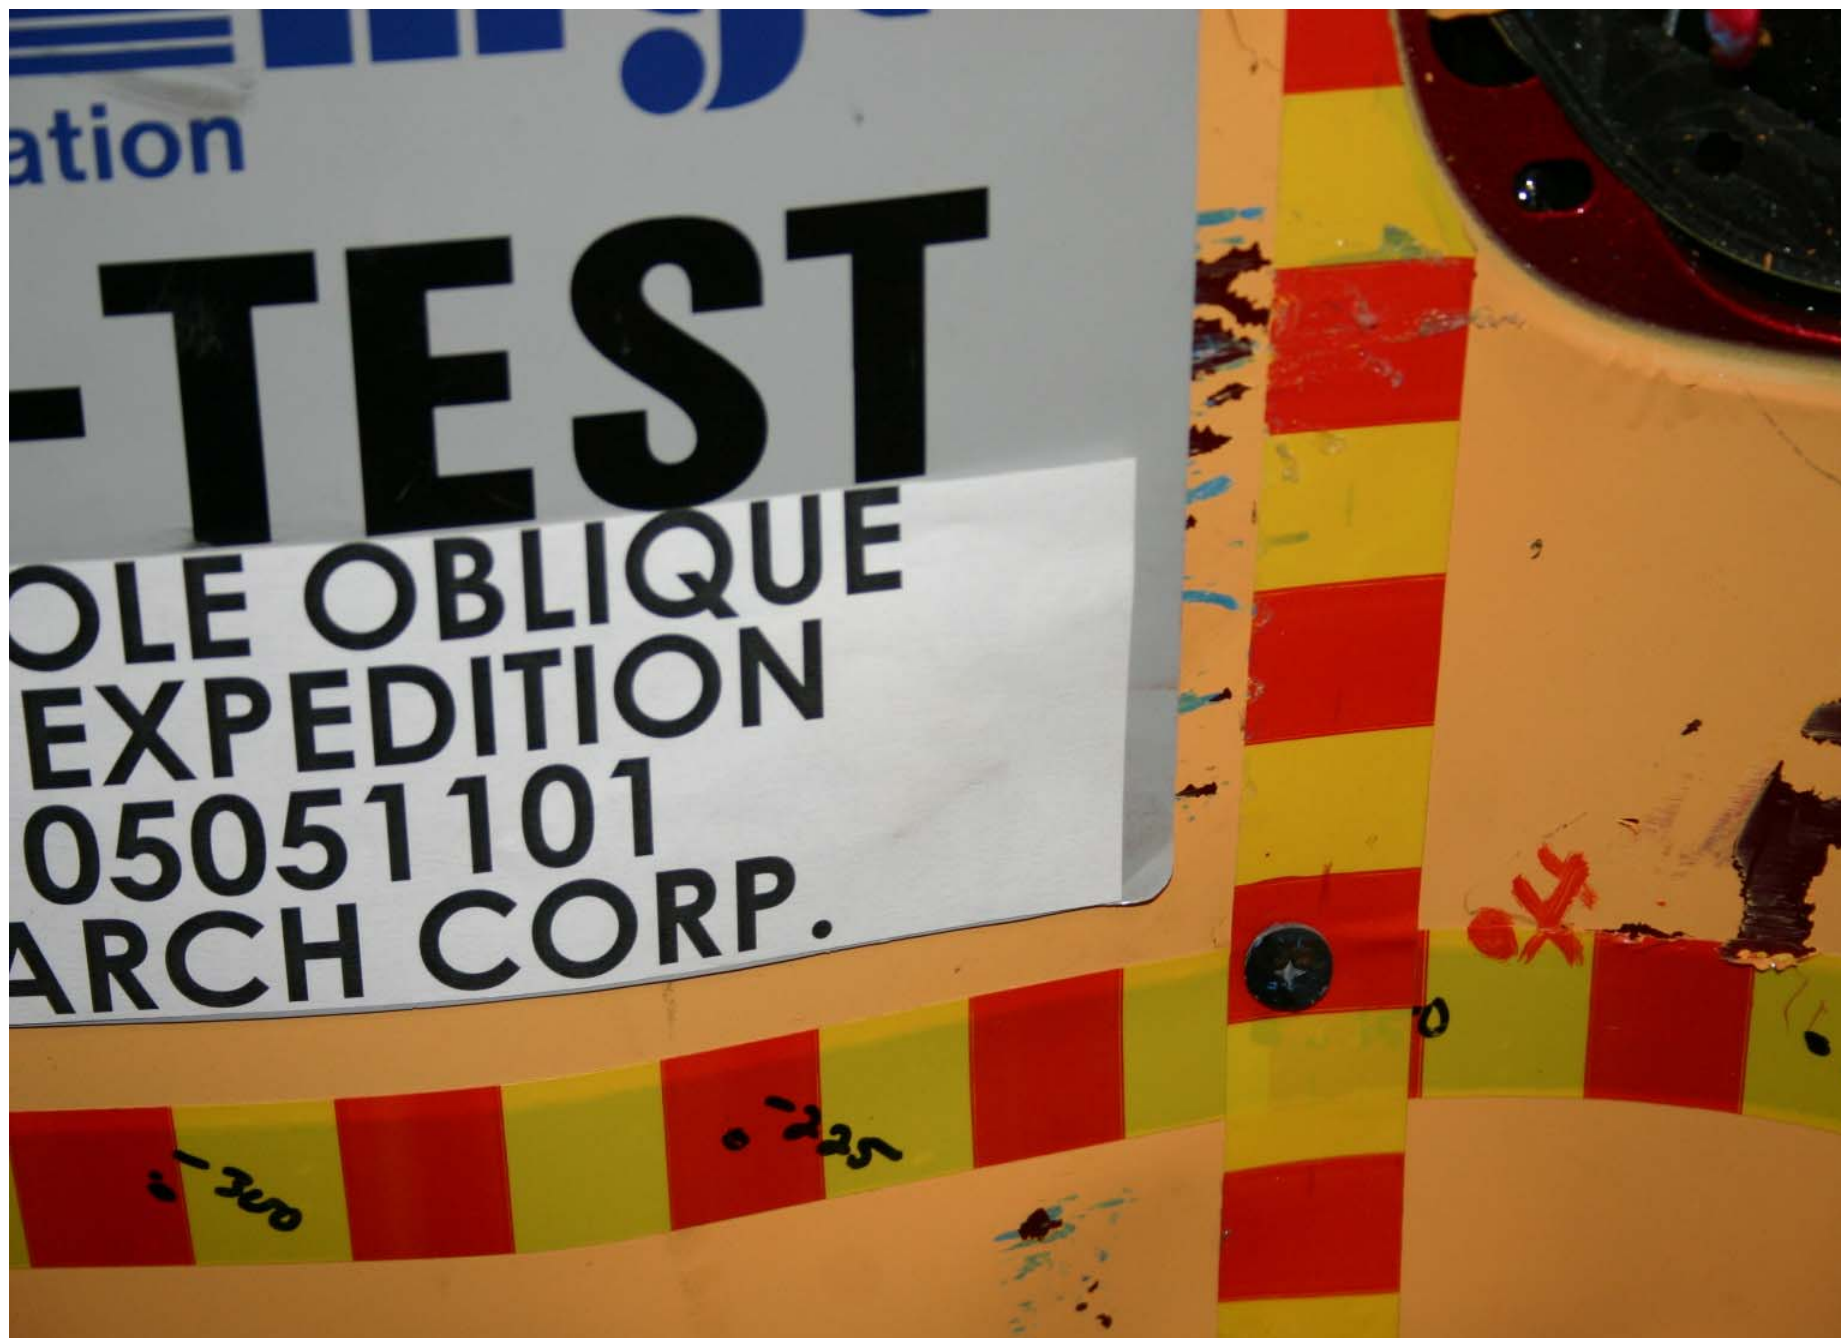
Post-Test Impact Point on Vehicle

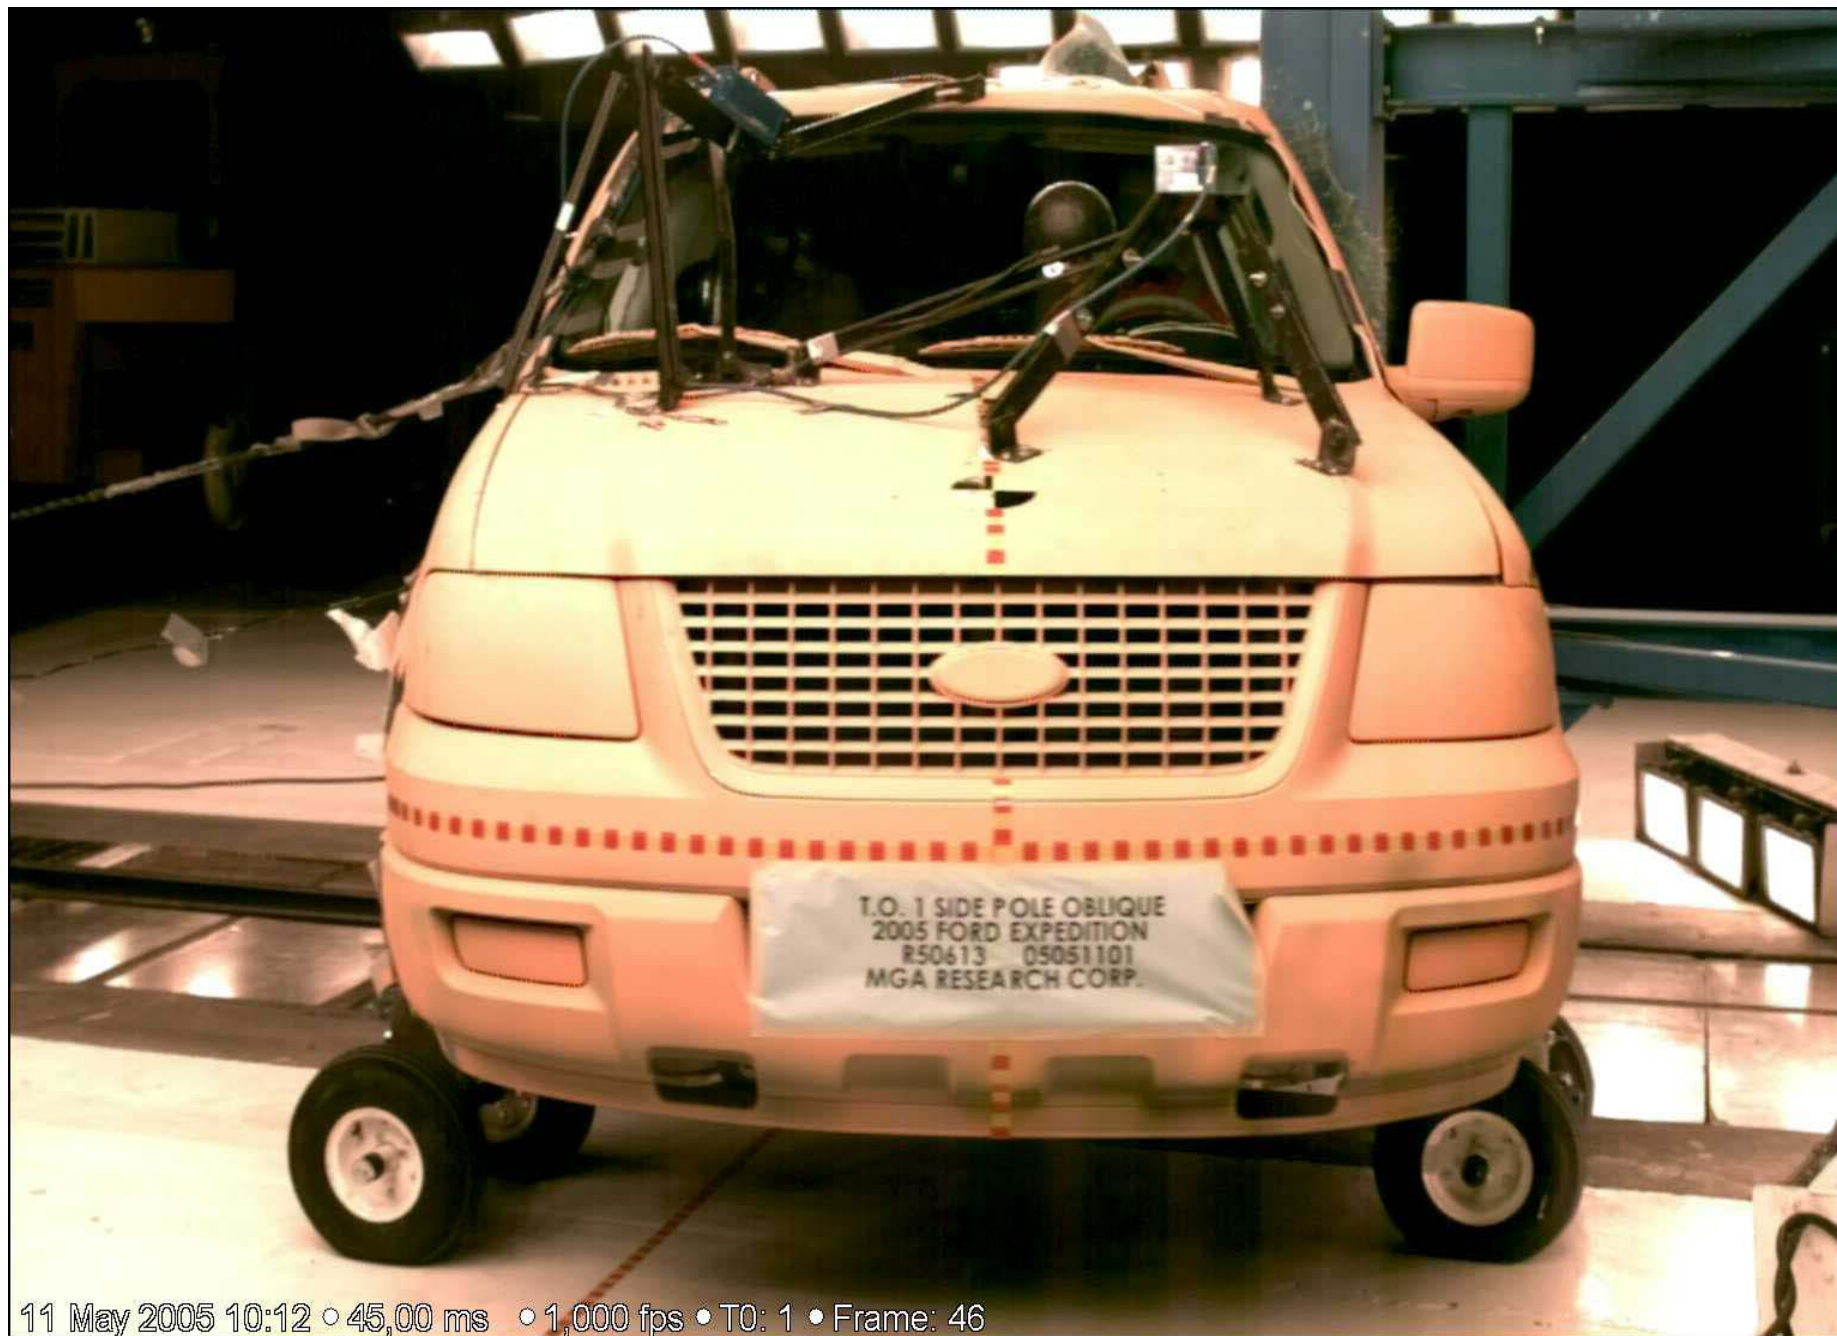
### Post-Test Point of Impact View

11 May 2005 10:12 • 45,00 ms • 1,000 fps • T0: 1 • Frame: 46
