**NEW CAR ASSESSMENT PROGRAM
SIDE IMPACT TEST**

MERCEDES-BENZ US INTL, INC.
2006 MERCEDES-BENZ ML350
MULTIPURPOSE VEHICLE

CALSPAN TEST NUMBER: 8765-SNCAP-11

FINAL REPORT

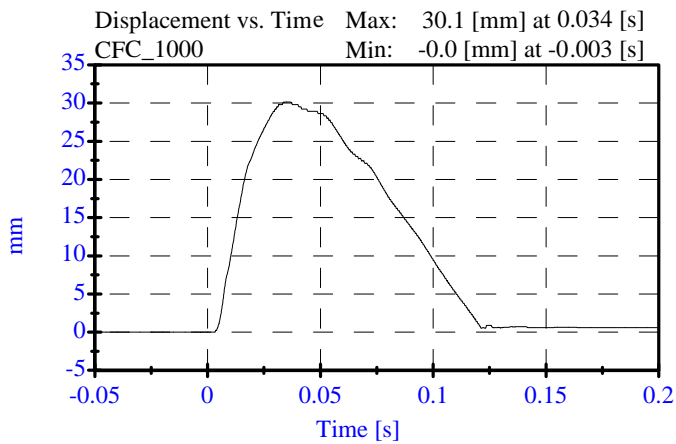
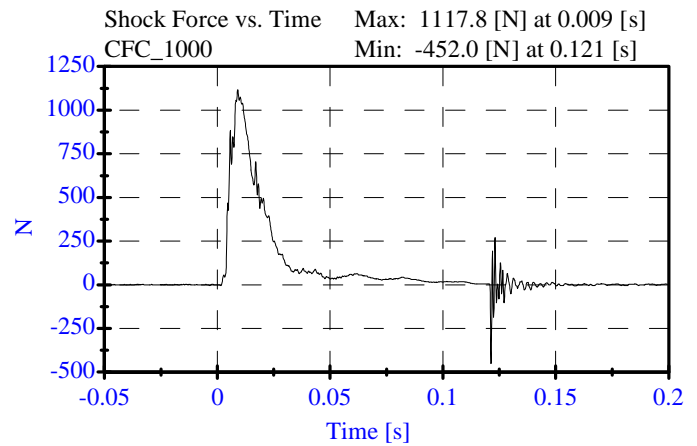
<u>TEST PARAMETER</u>	<u>SPECIFICATION</u>	<u>TEST RESULTS</u>	<u>STATUS</u>
Lab Temperature:	18.9-25.5 C	21.1 C	Passed
Lab Humidity:	10-70 %	31.00 %	Passed
Displacement:	30.00-35.00 mm	30.15 mm	Passed
Maximum Force:	836.00-1125.00 N	1117.76 N	Passed
Impact Test Velocity:	3.05 m/s		
Damper Identification:	905		
Damper Setting:	5

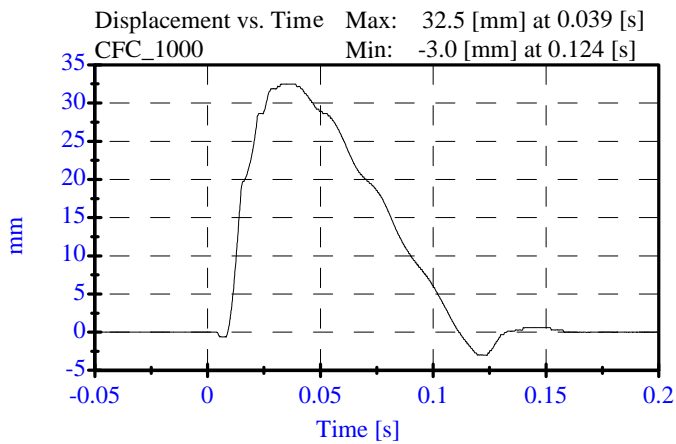
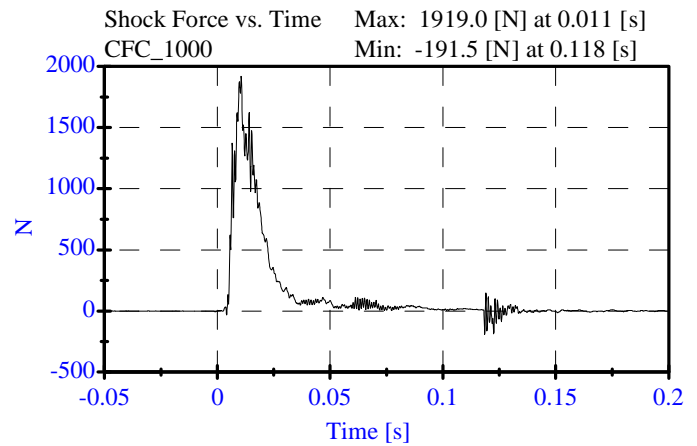
<u>TEST PARAMETER</u>	<u>SPECIFICATION</u>	<u>TEST RESULTS</u>	<u>STATUS</u>
Lab Temperature:	18.9-25.5 C	21.1 C	Passed
Lab Humidity:	10-70 %	31.00 %	Passed
Displacement:	32.00-37.00 mm	32.50 mm	Passed
Maximum Force:	1730.00-2099.00 N	1918.95 N	Passed
Impact Test Velocity:	4.27 m/s		
Damper Identification:	905		
Damper Setting:	5

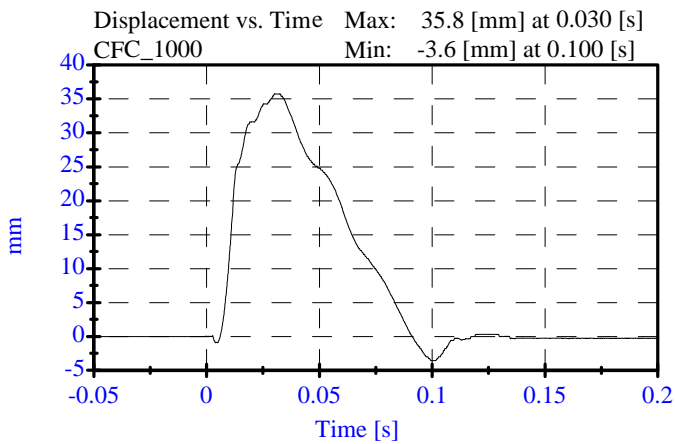
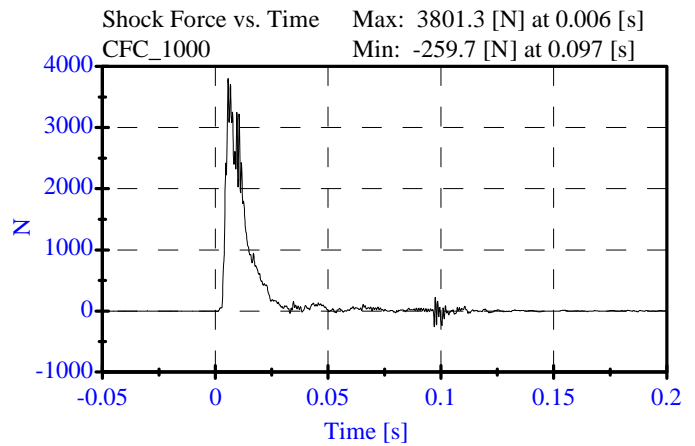
<u>TEST PARAMETER</u>	<u>SPECIFICATION</u>	<u>TEST RESULTS</u>	<u>STATUS</u>
Lab Temperature:	18.9-25.5 C	21.1 C	Passed
Lab Humidity:	10-70 %	31.00 %	Passed
Displacement:	33.00-40.00 mm	35.75 mm	Passed
Maximum Force:	3741.00-4448.00 N	3801.26 N	Passed
Impact Test Velocity:	6.10 m/s		
Damper Identification:	905		
Damper Setting:	5

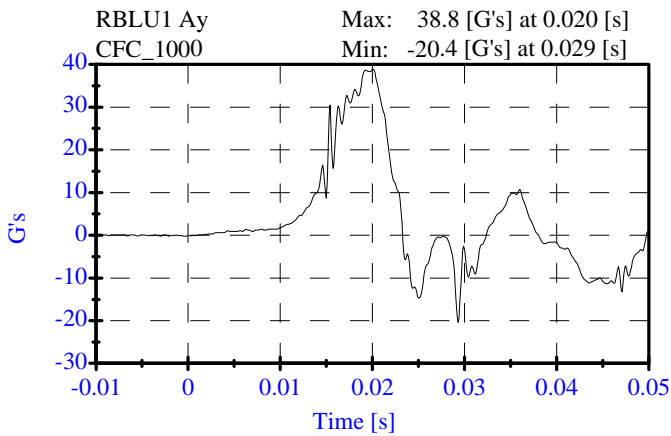
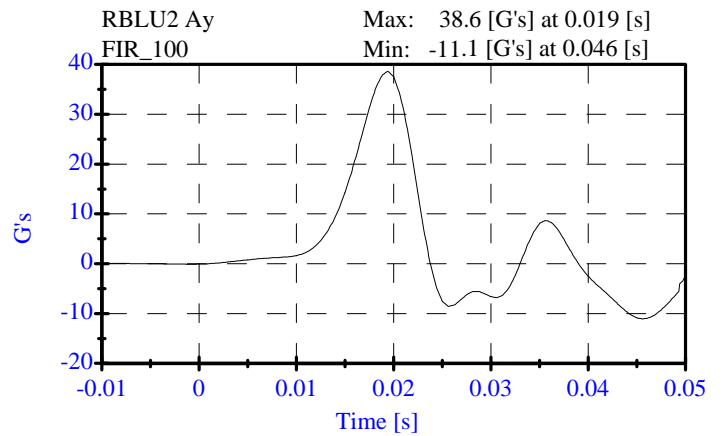
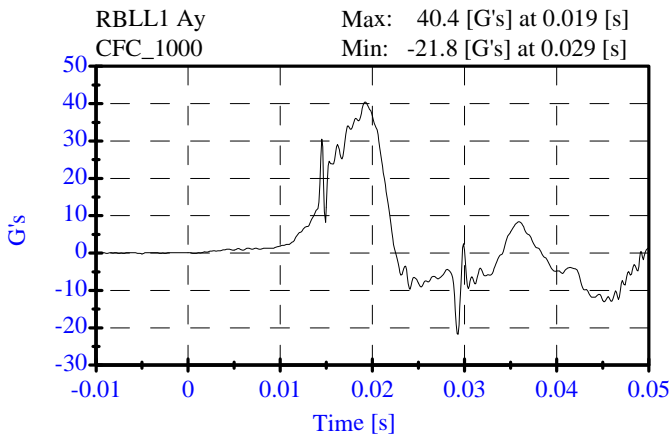
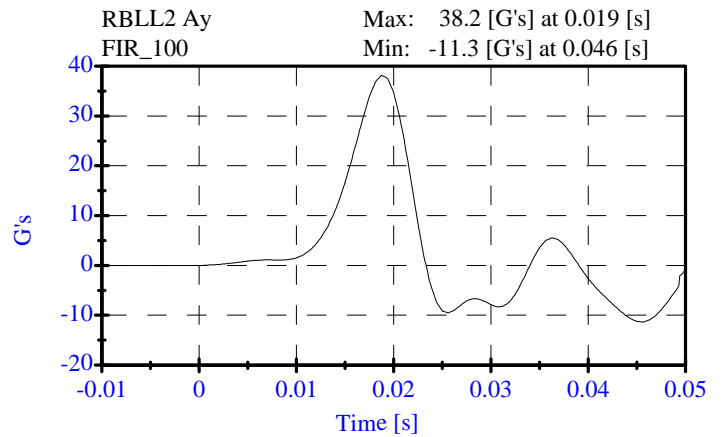
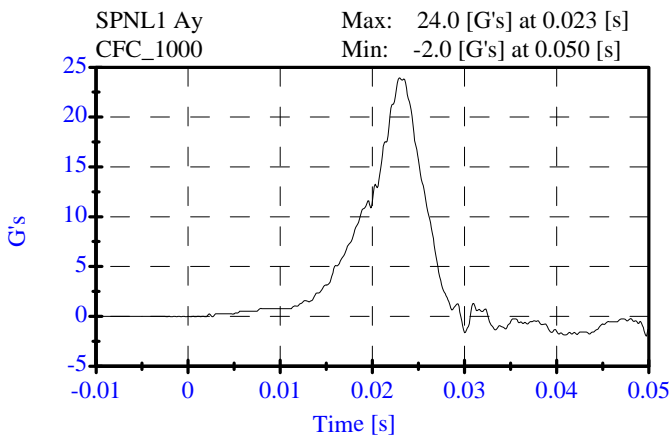
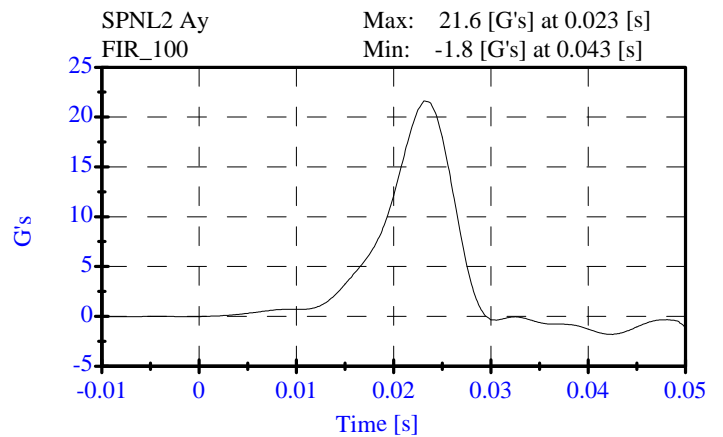
**Thorax Impact
Pre-Test
CONFIGURED FOR LEFT SIDE IMPACT**

<u>TEST PARAMETER</u>	<u>SPECIFICATION</u>	<u>TEST RESULTS</u>	<u>STATUS</u>
Lab Temperature:	18.9-25.5 C	21.1 C	Passed
Lab Humidity:	10-70 %	31.00 %	Passed
Probe Velocity:	4.27- 4.33 m/s	4.29 m/s	Passed
Upper Rib Acceleration:	37.00-46.00 G's	38.63 G's	Passed
Lower Rib Acceleration:	37.00-46.00 G's	38.18 G's	Passed
Lower Spine Acceleration:	15.00-22.00 G's	21.62 G's	Passed

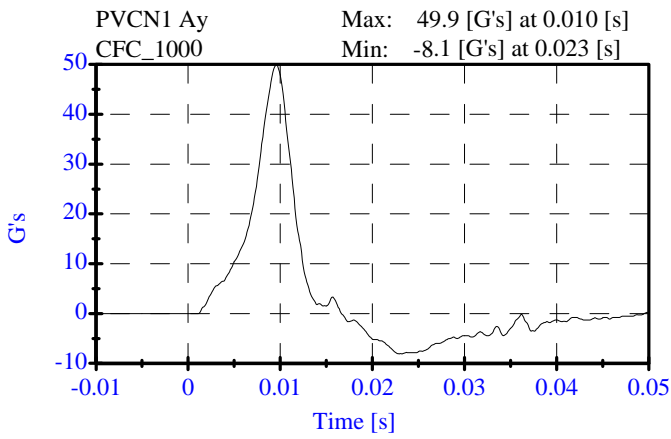
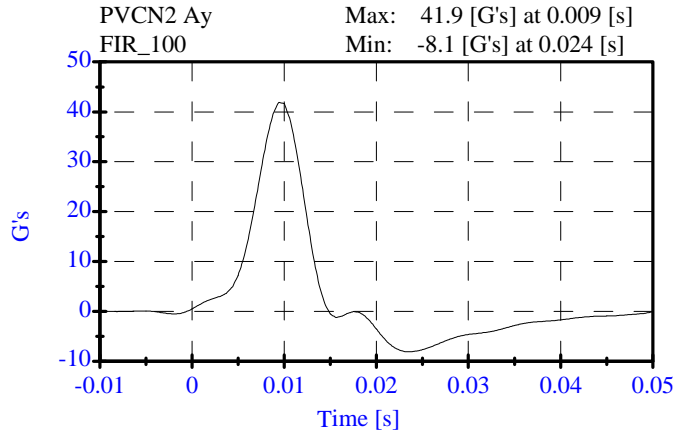
**Pelvic Impact
Pre-Test**

<u>TEST PARAMETER</u>	<u>SPECIFICATION</u>	<u>TEST RESULTS</u>	<u>STATUS</u>
Lab Temperature:	18.9-25.5 C	21.1 C	Passed
Lab Humidity:	10-70 %	31.00 %	Passed
Probe Velocity:	4.27- 4.33 m/s	4.30 m/s	Passed
Pelvis Y Acceleration:	40.00-60.00 G's	41.91 G's	Passed
Time Above 20 Gs	3.0-7.0 ms	5.7 ms	Passed

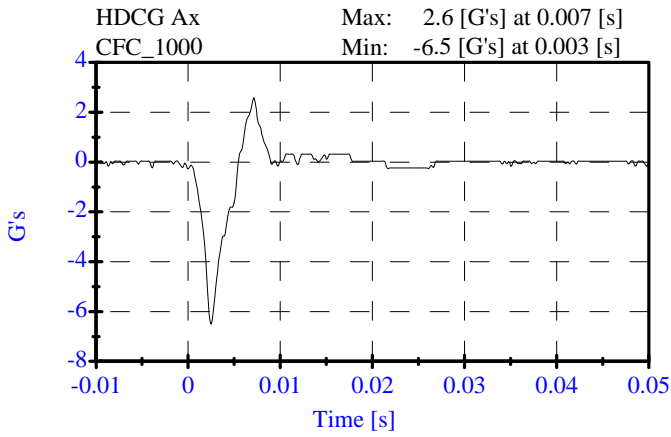
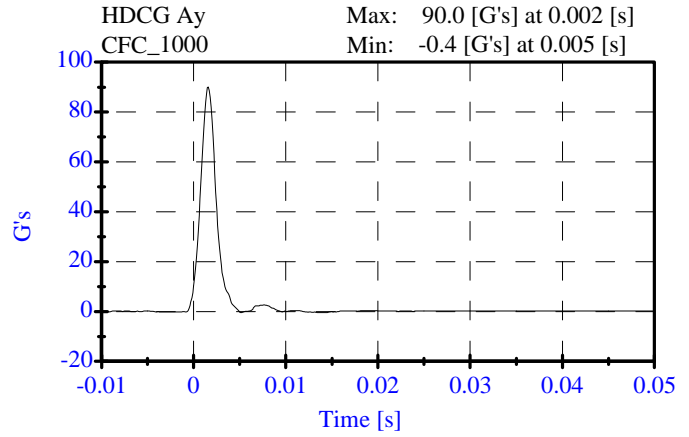
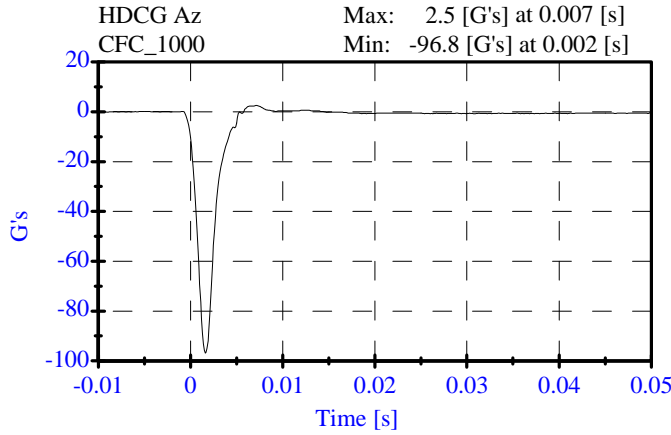
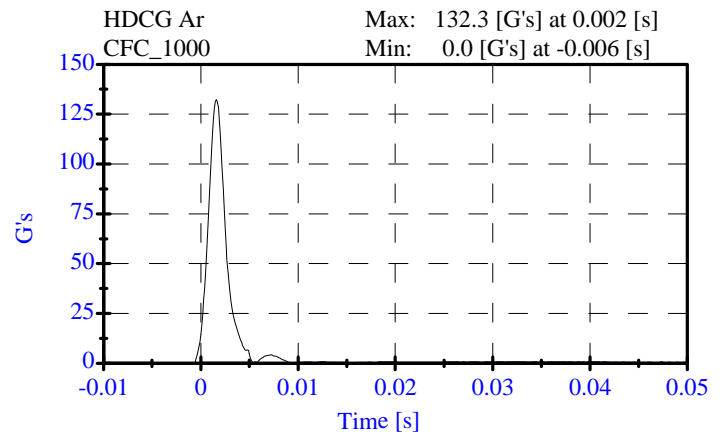
**Head Drop
Pre-Test**

<u>TEST PARAMETER</u>	<u>SPECIFICATION</u>	<u>TEST RESULTS</u>	<u>STATUS</u>
Lab Temperature:	18.9-25.6 C	21.1 C	Passed
Lab Humidity:	10-70 %	37.00 %	Passed
Peak Resultant Accel.:	120-150 Gs	132.25 Gs	Passed
Peak Lateral Accel.:	15 Gs Max	2.58 Gs	Passed
Curve PerCent NonModal:	< 15%	5.08 %	Passed

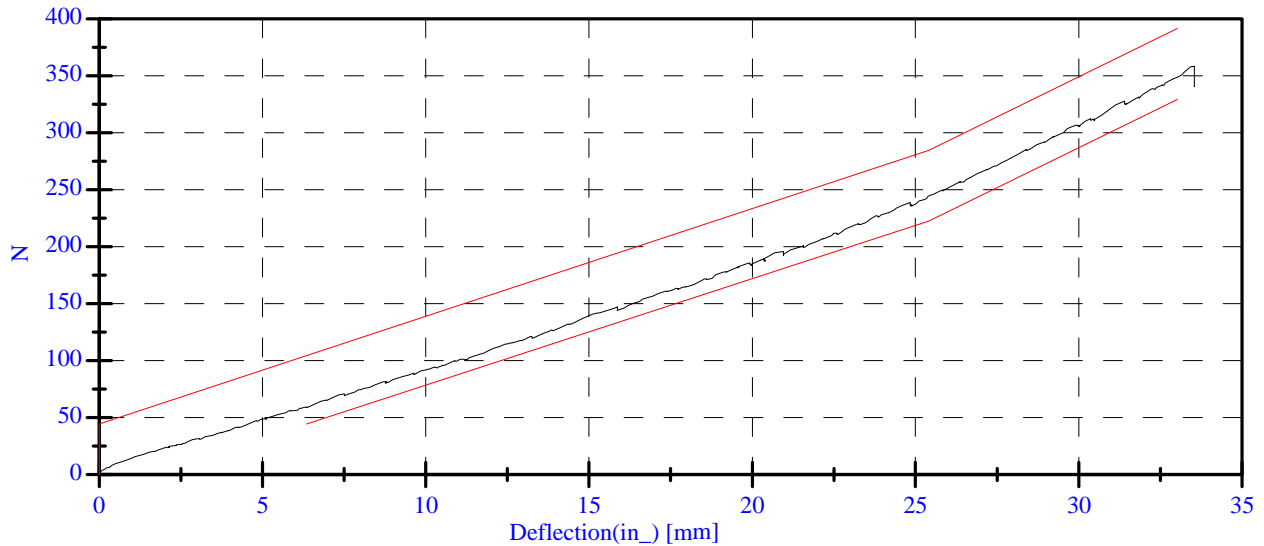
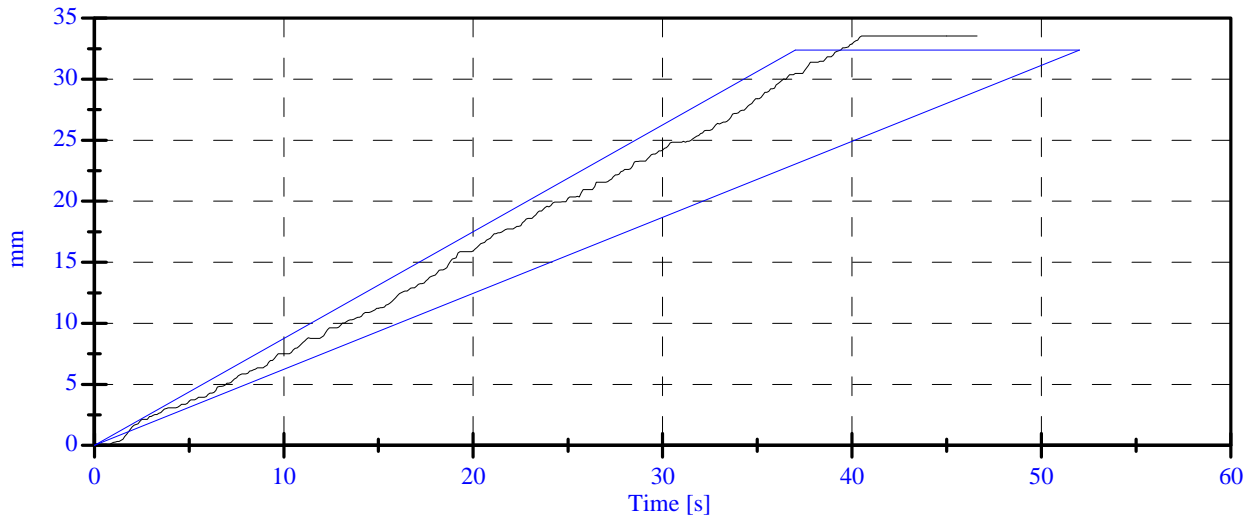
ABDOMINAL COMPRESSION TEST

<u>TEST PARAMETER</u>	<u>SPECIFICATION</u>	<u>TEST RESULTS</u>	<u>STATUS</u>
Lab Temperature:	18.9-25.5 C	21.1 C	Passed
Lab Humidity:	10-70 %	30.00 %	Passed
Force at 12.95 mm :	104.00-162.00 N	117.88 N	Passed
Force at 19.05 mm :	162.98-220.99 N	177.69 N	Passed
Force at 25.40 mm :	221.97-280.02 N	244.39 N	Passed
Force at 33.02 mm :	324.99-391.00 N	349.14 N	Passed

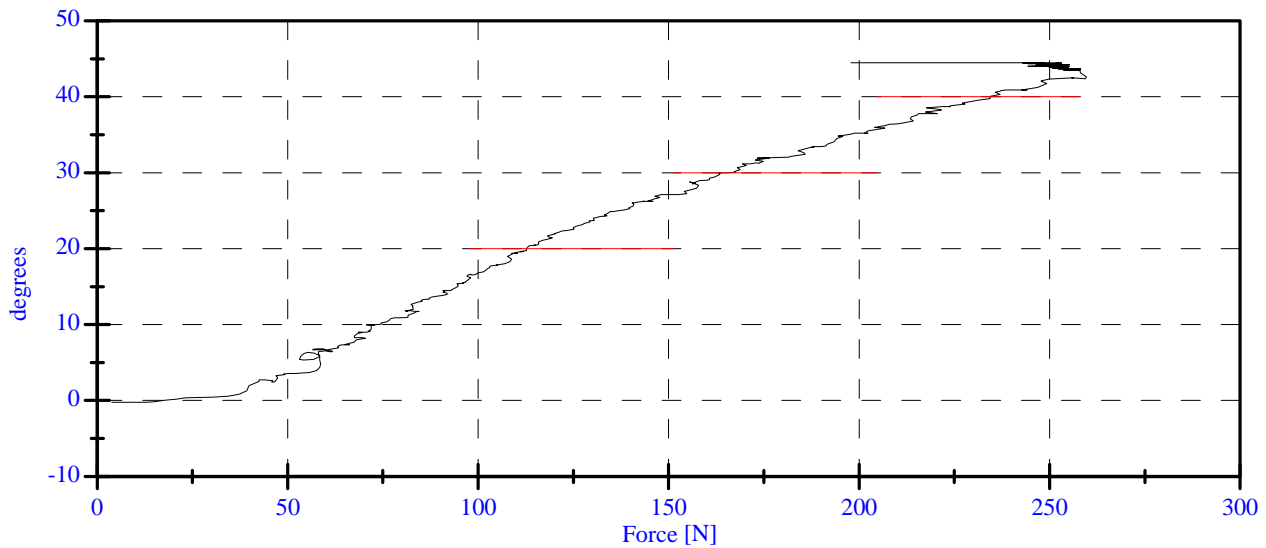
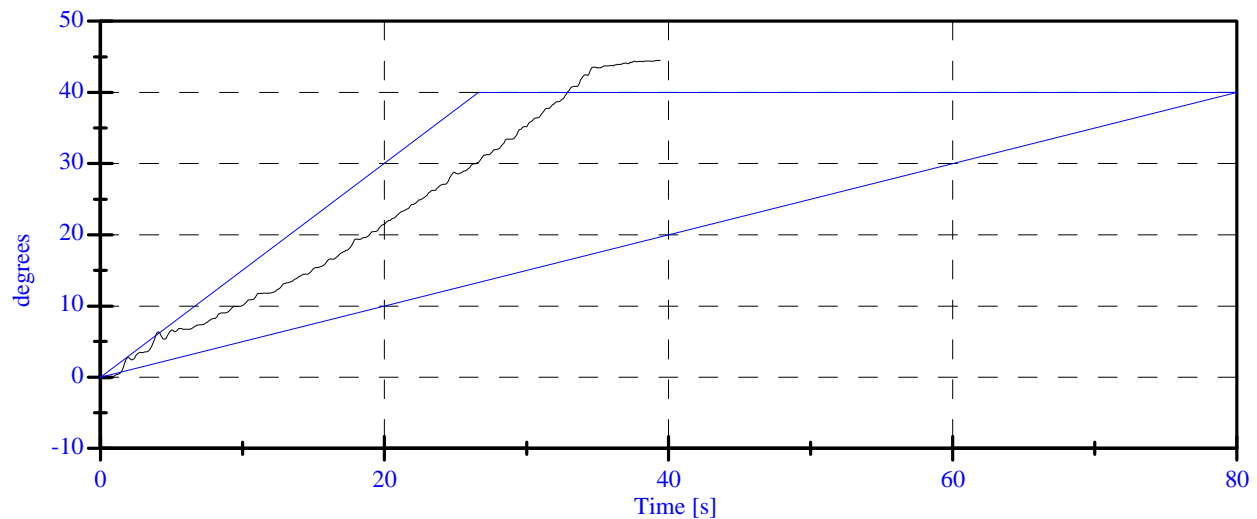
LUMBAR SPINE FLEXION TEST

<u>TEST PARAMETER</u>	<u>SPECIFICATION</u>	<u>TEST RESULTS</u>	<u>STATUS</u>
Lab Temperature:	18.9-25.5 C	21.1 C	Passed
Lab Humidity:	10-70 %	30.00 %	Passed
Force at 0 Deg:	0.00-26.69 N	17.37 N	Passed
Force at 20 Deg:	97.86-151.24 N	112.69 N	Passed
Force at 30 Deg:	151.24-204.62 N	163.10 N	Passed
Force at 40 Deg:	204.62-258.00 N	234.39 N	Passed
Return Angle	12 Deg Max	4.53 deg	Passed

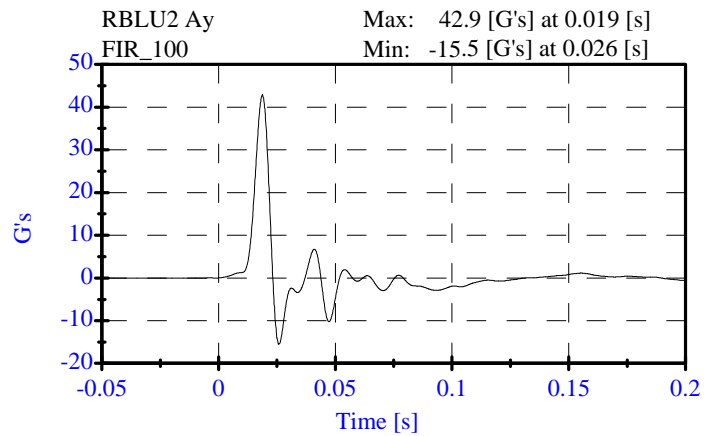
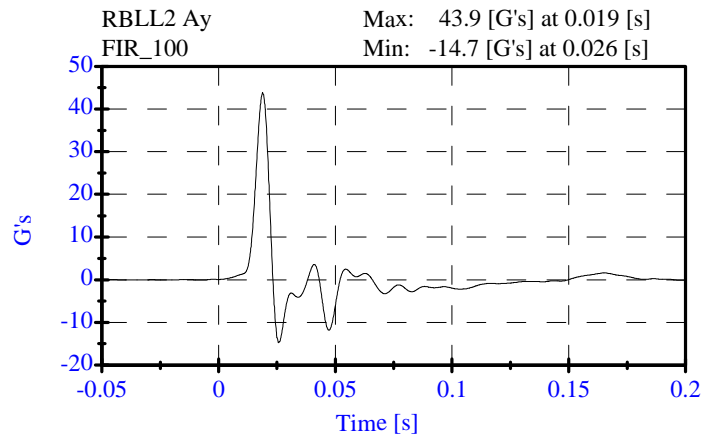
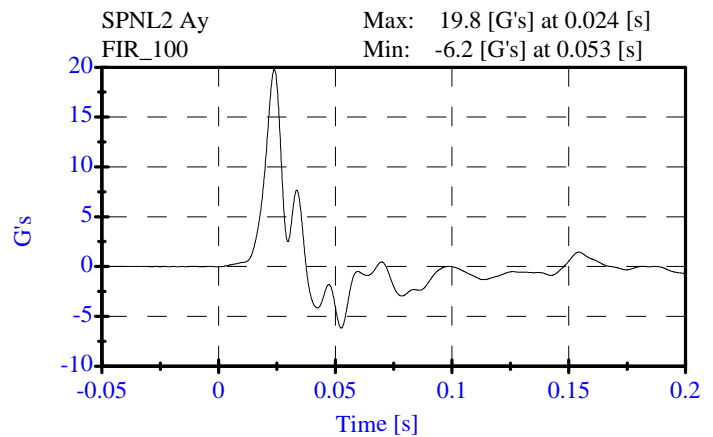
**Thorax Impact
Pre-Test
CONFIGURED FOR LEFT SIDE IMPACT**

<u>TEST PARAMETER</u>	<u>SPECIFICATION</u>	<u>TEST RESULTS</u>	<u>STATUS</u>
Lab Temperature:	18.9-25.5 C	21.1 C	Passed
Lab Humidity:	10-70 %	31.00 %	Passed
Probe Velocity:	4.27- 4.33 m/s	4.29 m/s	Passed
Upper Rib Acceleration:	37.00-46.00 G's	42.93 G's	Passed
Lower Rib Acceleration:	37.00-46.00 G's	43.86 G's	Passed
Lower Spine Acceleration:	15.00-22.00 G's	19.82 G's	Passed

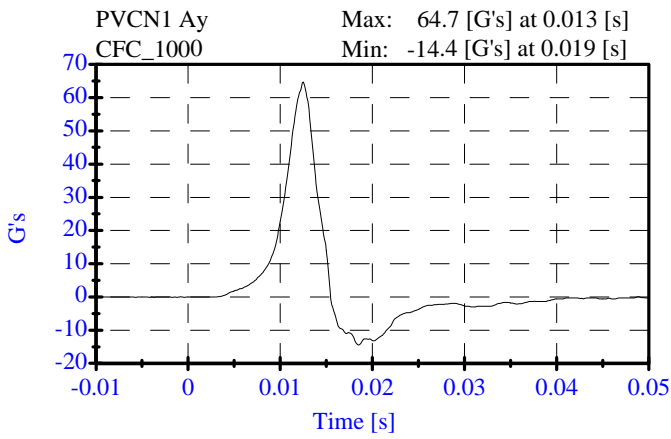
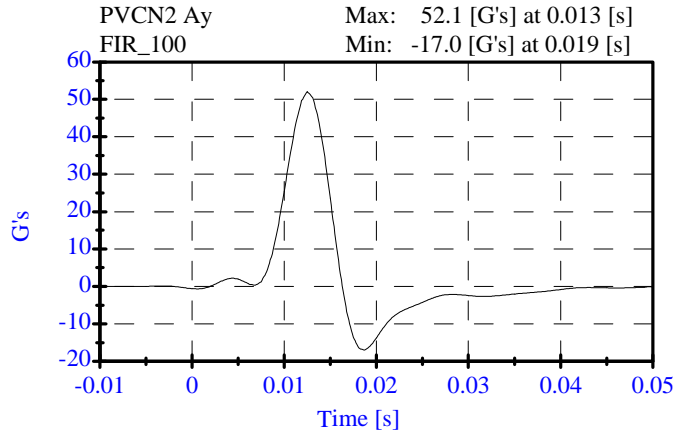
**Pelvic Impact
Pre-Test**

<u>TEST PARAMETER</u>	<u>SPECIFICATION</u>	<u>TEST RESULTS</u>	<u>STATUS</u>
Lab Temperature:	18.9-25.5 C	21.1 C	Passed
Lab Humidity:	10-70 %	31.00 %	Passed
Probe Velocity:	4.27- 4.33 m/s	4.29 m/s	Passed
Pelvis Y Acceleration:	40.00-60.00 G's	52.11 G's	Passed
Time Above 20 Gs	3.0-7.0 ms	5.6 ms	Passed

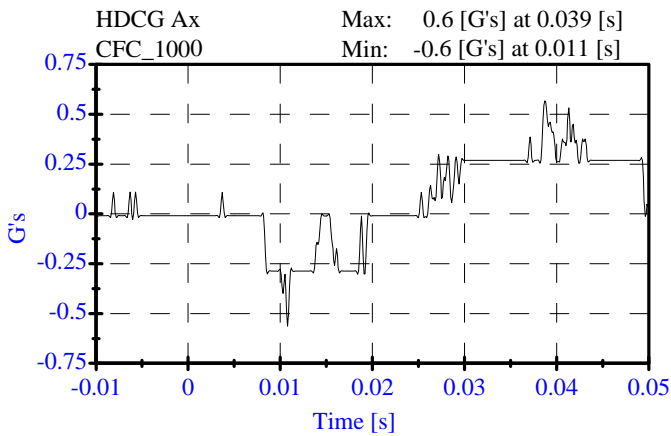
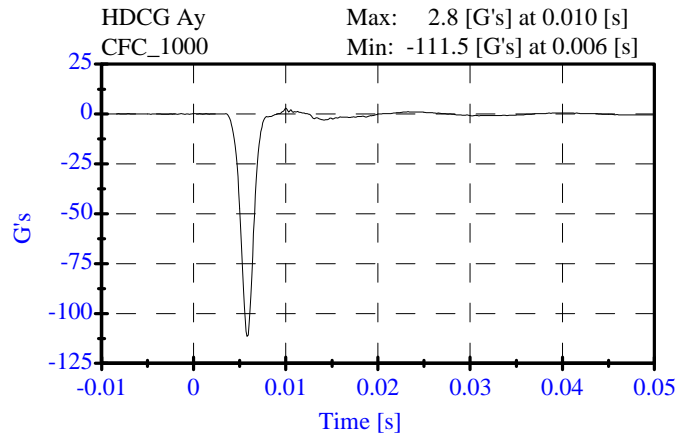
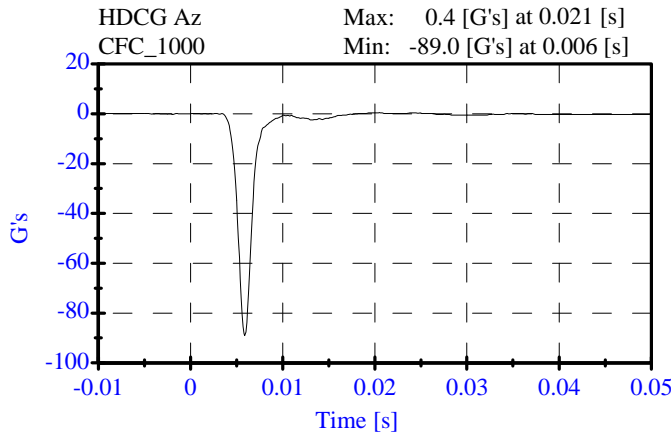
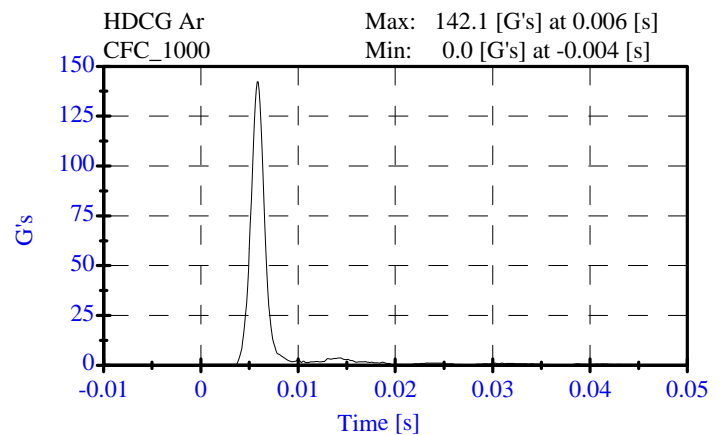
**Head Drop
Pre-Test**

<u>TEST PARAMETER</u>	<u>SPECIFICATION</u>	<u>TEST RESULTS</u>	<u>STATUS</u>
Lab Temperature:	18.9-25.6 C	21.1 C	Passed
Lab Humidity:	10-70 %	37.00 %	Passed
Peak Resultant Accel.:	120-150 Gs	142.15 Gs	Passed
Peak Lateral Accel.:	15 Gs Max	0.57 Gs	Passed
Curve PerCent NonModal:	< 15%	2.63 %	Passed

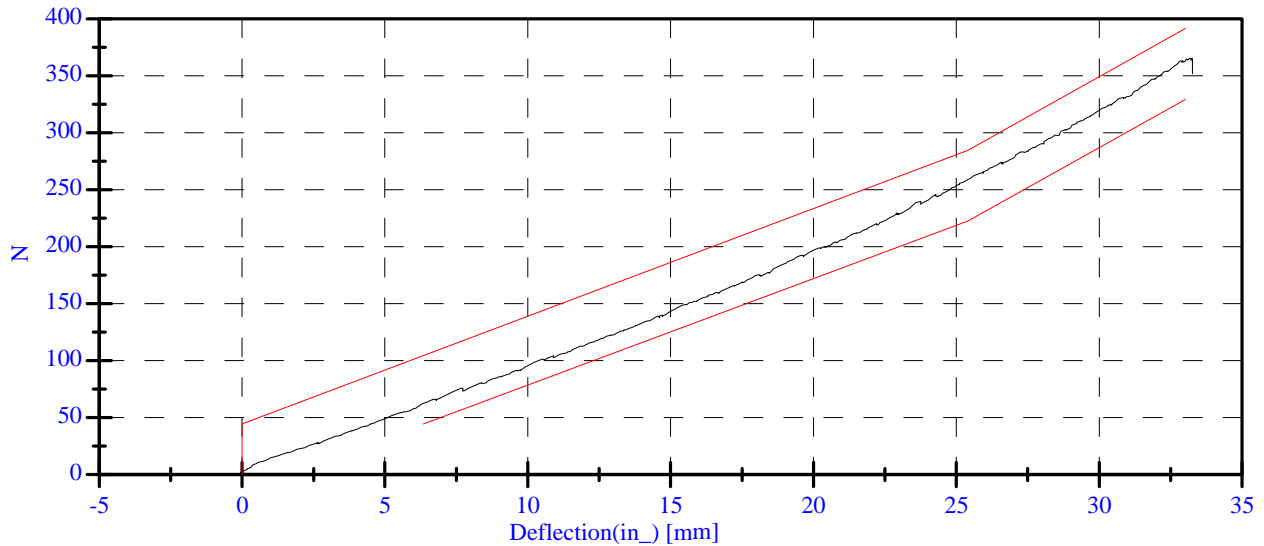
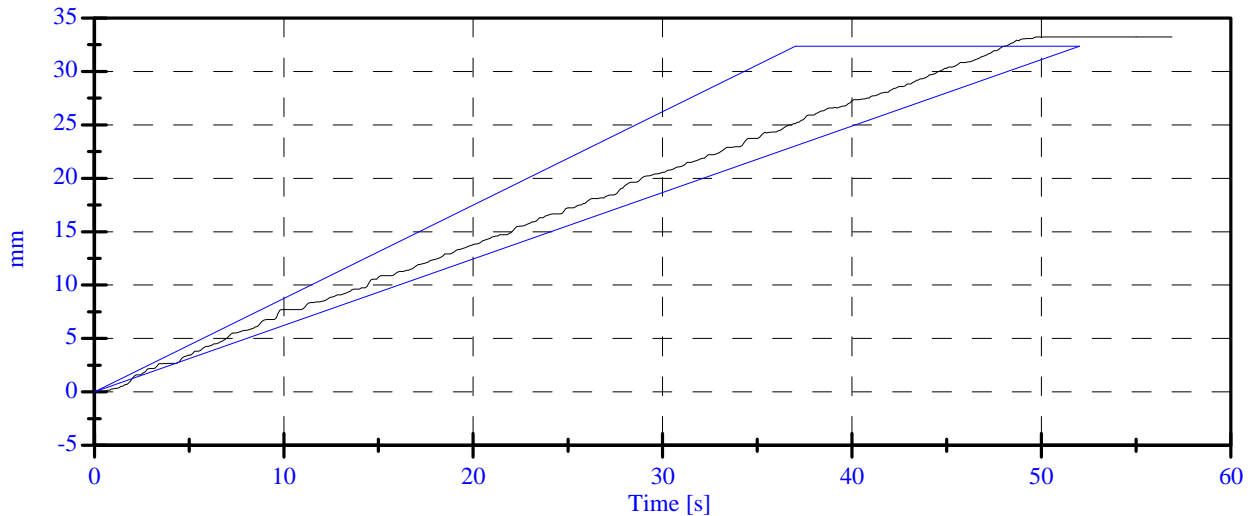
ABDOMINAL COMPRESSION TEST

<u>TEST PARAMETER</u>	<u>SPECIFICATION</u>	<u>TEST RESULTS</u>	<u>STATUS</u>
Lab Temperature:	18.9-25.5 C	21.1 C	Passed
Lab Humidity:	10-70 %	30.00 %	Passed
Force at 12.95 mm :	104.00-162.00 N	122.59 N	Passed
Force at 19.05 mm :	162.98-220.99 N	185.66 N	Passed
Force at 25.40 mm :	221.97-280.02 N	258.52 N	Passed
Force at 33.02 mm :	324.99-391.00 N	364.37 N	Passed

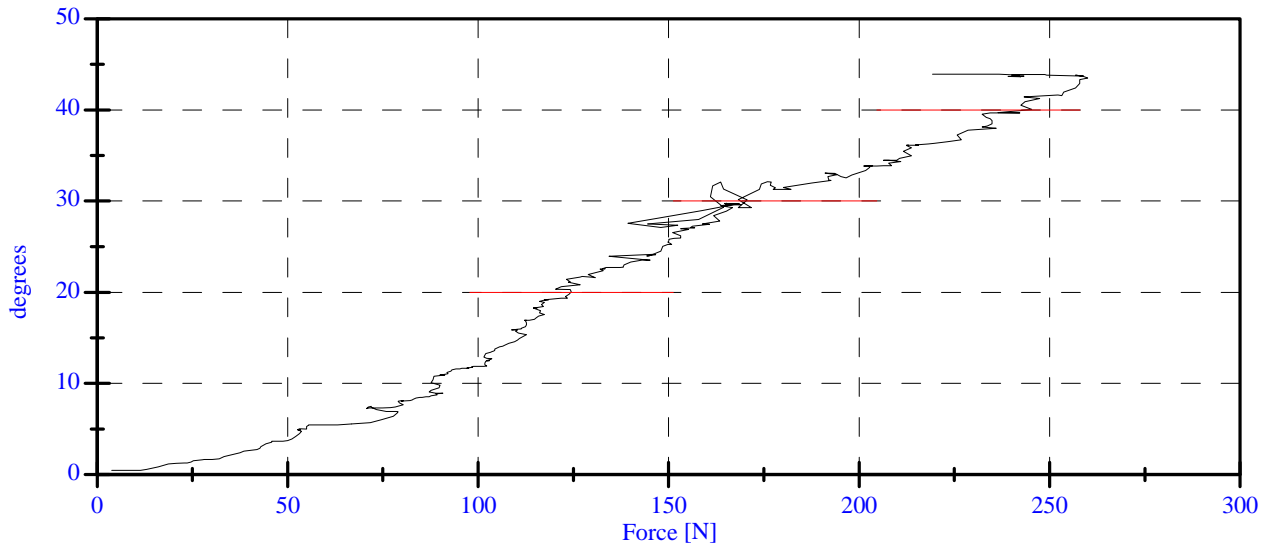
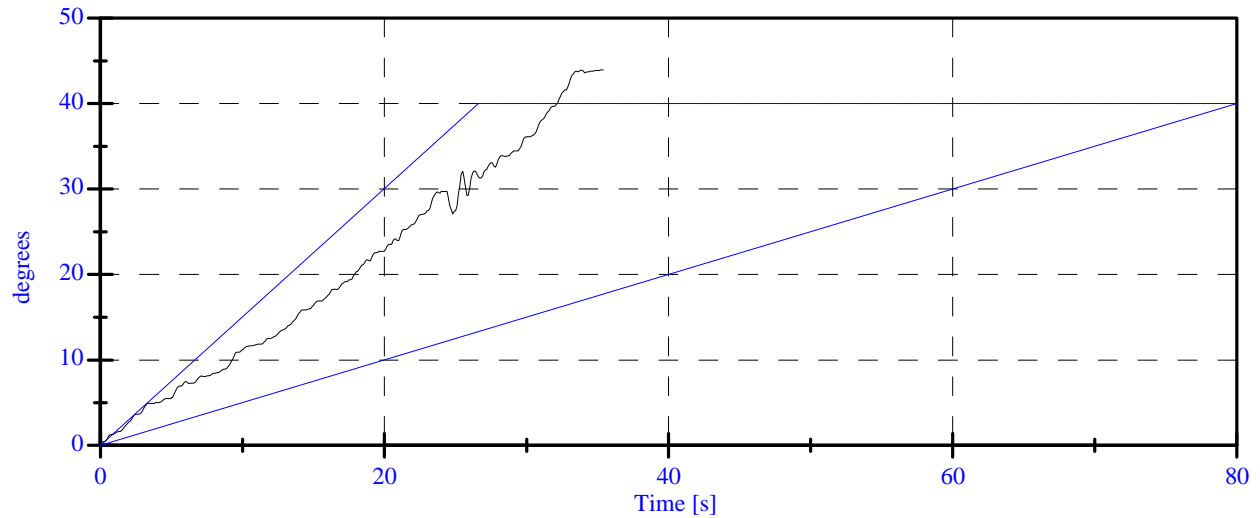
LUMBAR SPINE FLEXION TEST

<u>TEST PARAMETER</u>	<u>SPECIFICATION</u>	<u>TEST RESULTS</u>	<u>STATUS</u>
Lab Temperature:	18.9-25.5 C	21.1 C	Passed
Lab Humidity:	10-70 %	30.00 %	Passed
Force at 0 Deg:	0.00-26.69 N	3.79 N	Passed
Force at 20 Deg:	97.86-151.24 N	124.44 N	Passed
Force at 30 Deg:	151.24-204.62 N	170.67 N	Passed
Force at 40 Deg:	204.62-258.00 N	242.22 N	Passed
Return Angle	12 Deg Max	2.40 deg	Passed

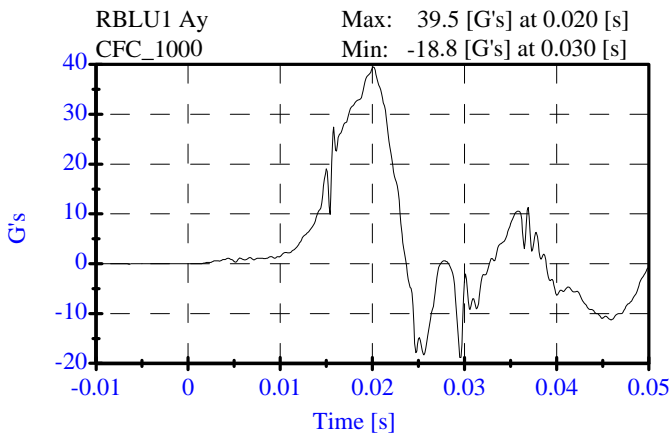
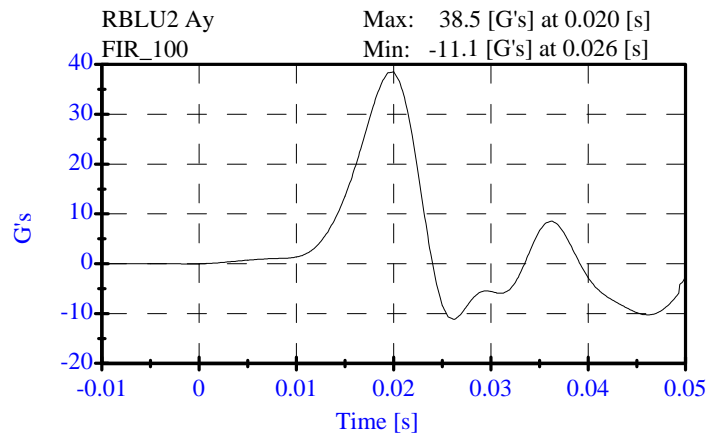
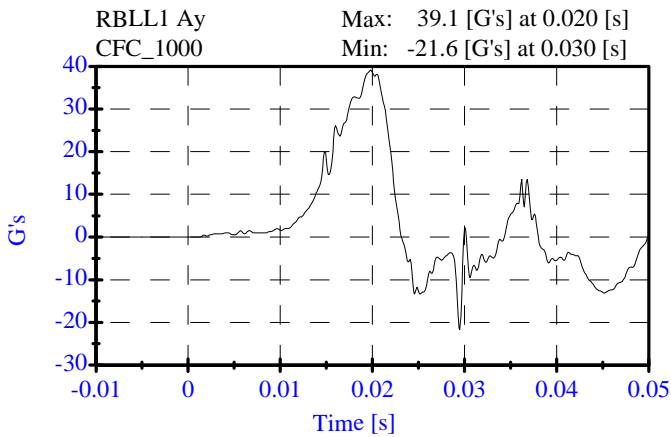
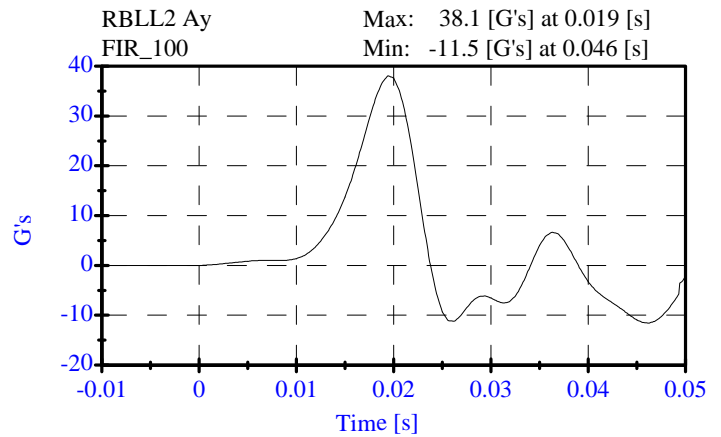
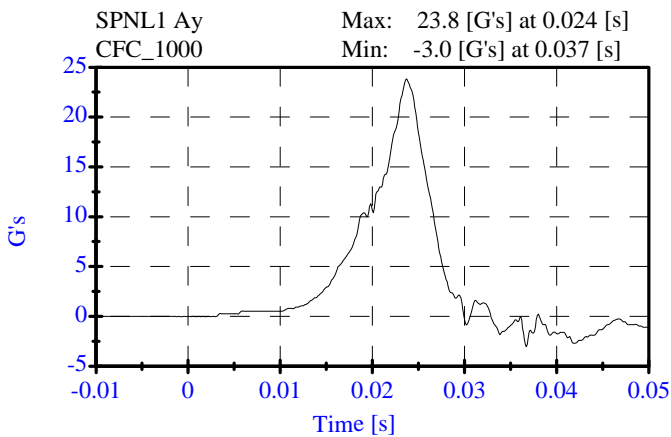
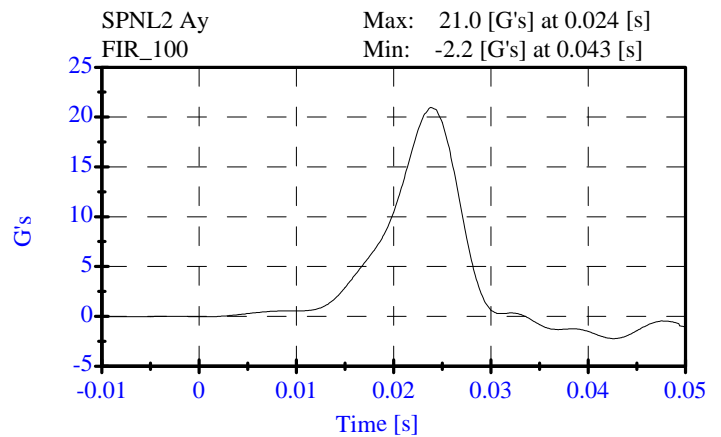
<u>TEST PARAMETER</u>	<u>SPECIFICATION</u>	<u>TEST RESULTS</u>	<u>STATUS</u>
Lab Temperature:	18.9-25.5 C	21.1 C	Passed
Lab Humidity:	10-70 %	37.00 %	Passed
Probe Velocity:	4.27- 4.33 m/s	4.32 m/s	Passed
Upper Rib Acceleration:	37.00-46.00 G's	38.49 G's	Passed
Lower Rib Acceleration:	37.00-46.00 G's	38.08 G's	Passed
Lower Spine Acceleration:	15.00-22.00 G's	20.98 G's	Passed

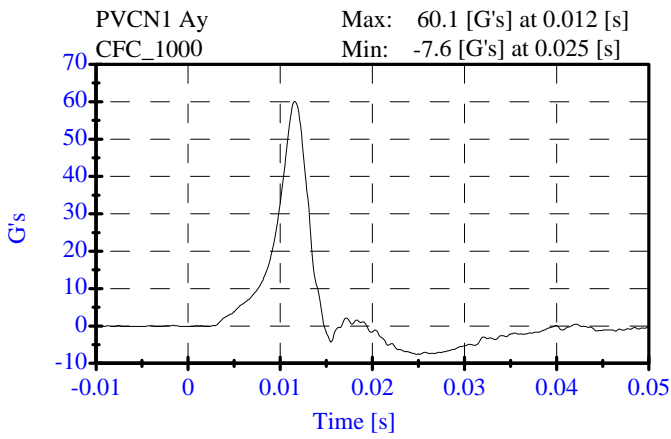
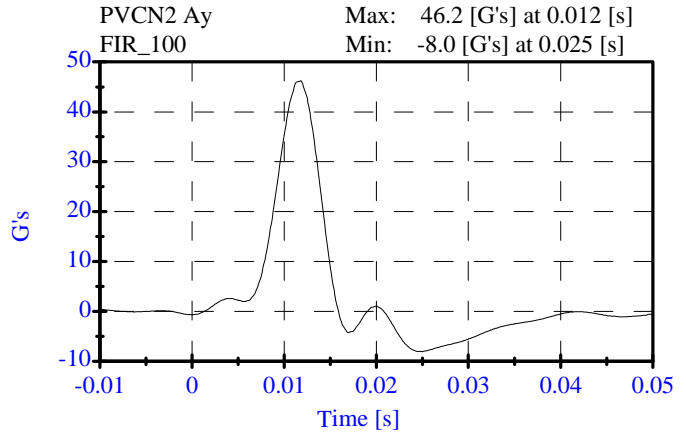
**Pelvic Impact
Post-Test**

<u>TEST PARAMETER</u>	<u>SPECIFICATION</u>	<u>TEST RESULTS</u>	<u>STATUS</u>
Lab Temperature:	18.9-25.5 C	21.1 C	Passed
Lab Humidity:	10-70 %	37.00 %	Passed
Probe Velocity:	4.27- 4.33 m/s	4.27 m/s	Passed
Pelvis Y Acceleration:	40.00-60.00 G's	46.22 G's	Passed
Time Above 20 Gs	3.0-7.0 ms	5.4 ms	Passed

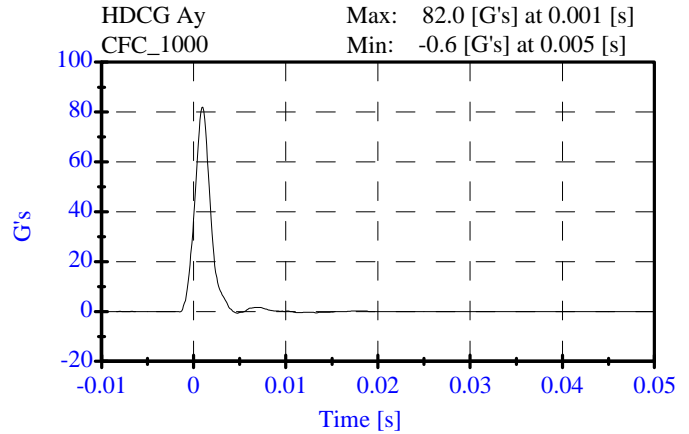
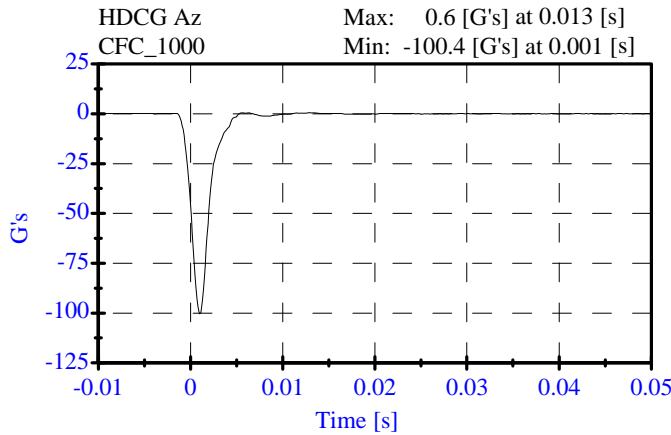
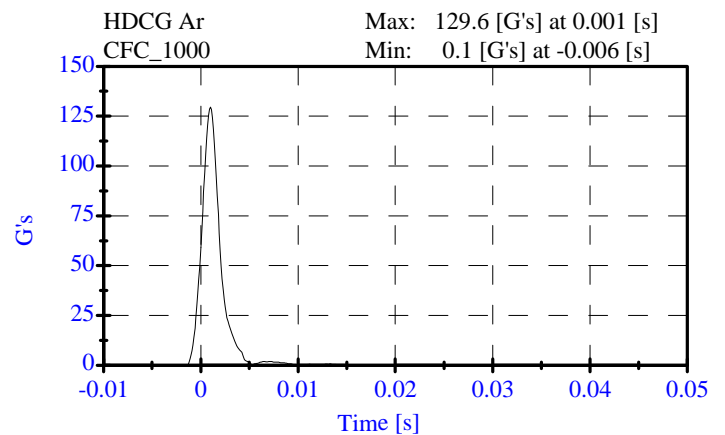
**Head Drop
Post-Test**

<u>TEST PARAMETER</u>	<u>SPECIFICATION</u>	<u>TEST RESULTS</u>	<u>STATUS</u>
Lab Temperature:	18.9-25.6 C	21.1 C	Passed
Lab Humidity:	10-70 %	35.00 %	Passed
Peak Resultant Accel.:	120-150 Gs	129.60 Gs	Passed
Peak Lateral Accel.:	15 Gs Max	3.42 Gs	Passed
Curve PerCent NonModal:	< 15%	1.45 %	Passed

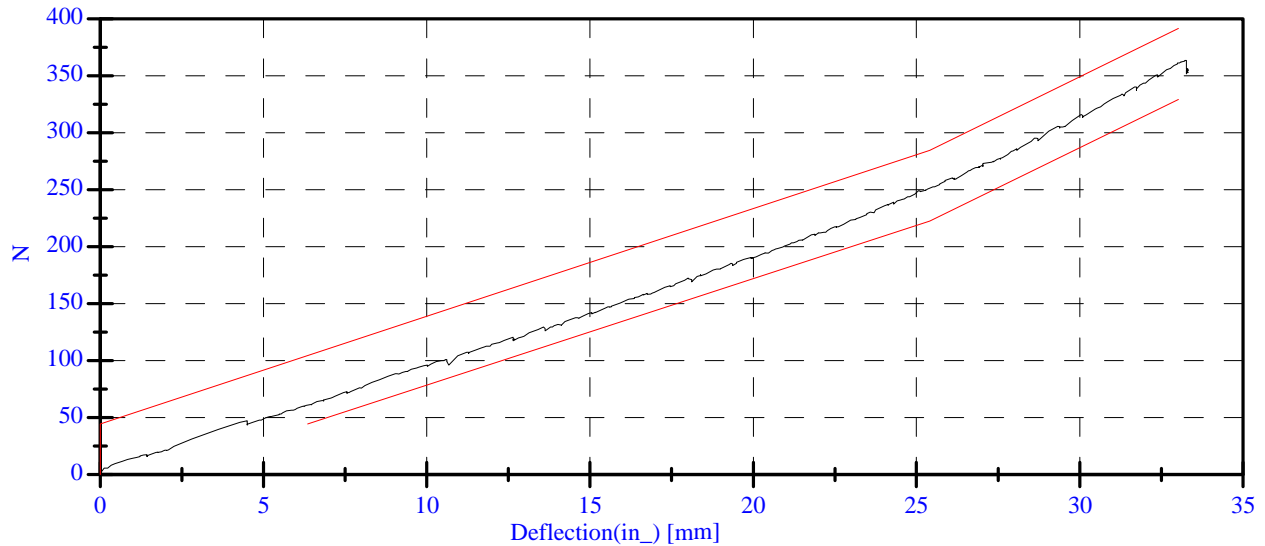
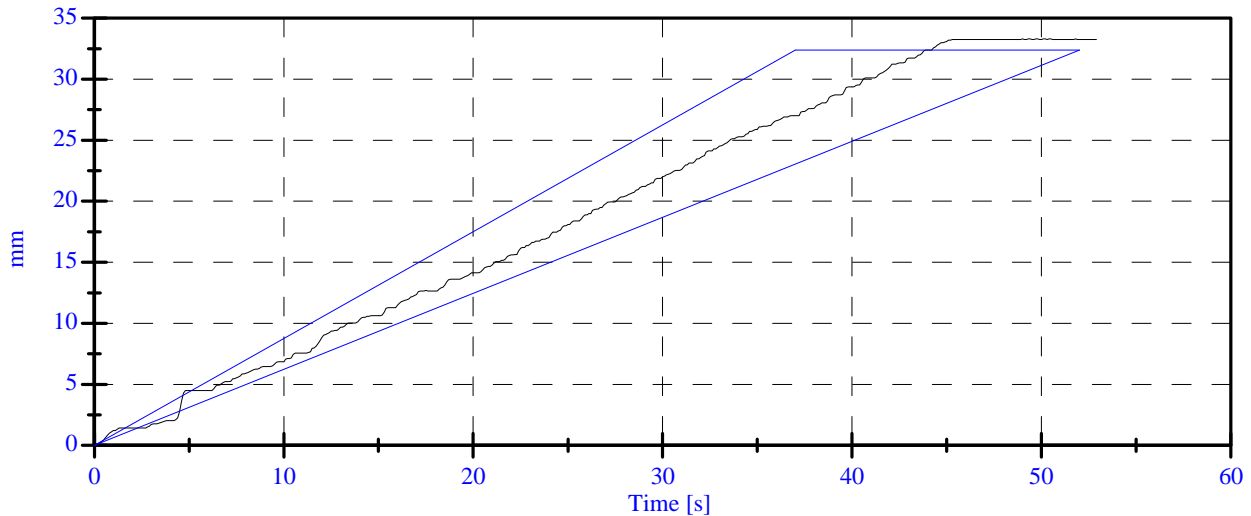
ABDOMINAL COMPRESSION TEST

<u>TEST PARAMETER</u>	<u>SPECIFICATION</u>	<u>TEST RESULTS</u>	<u>STATUS</u>
Lab Temperature:	18.9-25.5 C	21.1 C	Passed
Lab Humidity:	10-70 %	37.00 %	Passed
Force at 12.95 mm :	104.00-162.00 N	121.50 N	Passed
Force at 19.05 mm :	162.98-220.99 N	180.23 N	Passed
Force at 25.40 mm :	221.97-280.02 N	250.55 N	Passed
Force at 33.02 mm :	324.99-391.00 N	361.11 N	Passed

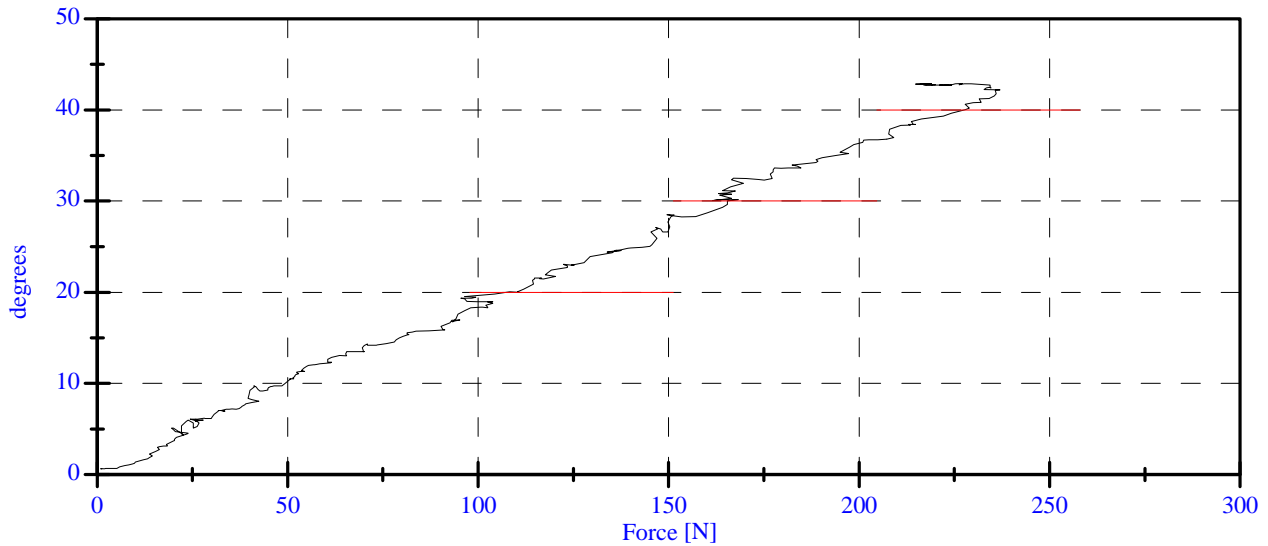
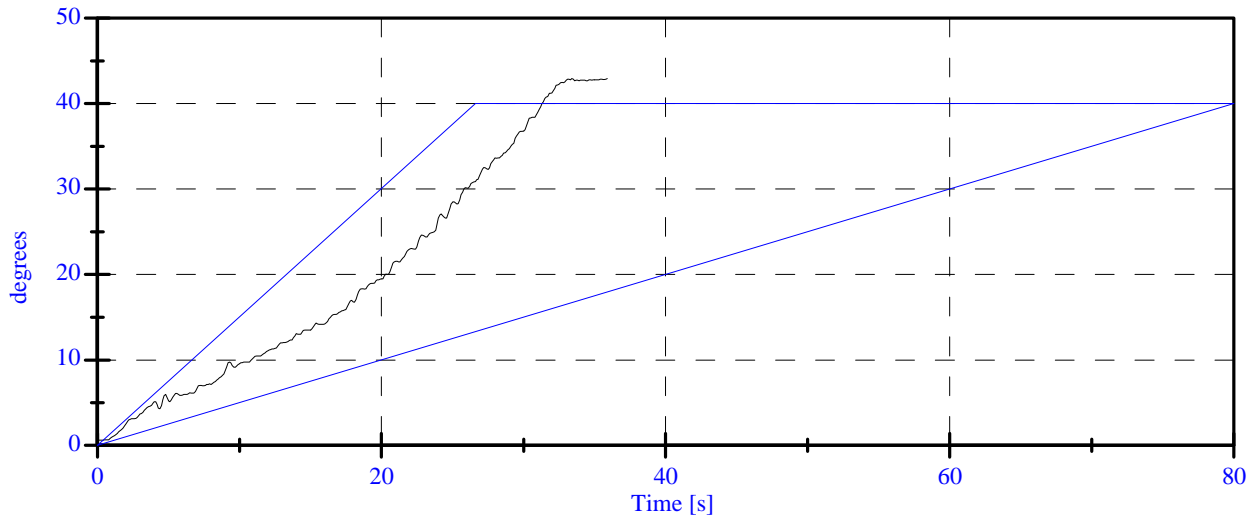
LUMBAR SPINE FLEXION TEST

<u>TEST PARAMETER</u>	<u>SPECIFICATION</u>	<u>TEST RESULTS</u>	<u>STATUS</u>
Lab Temperature:	18.9-25.5 C	21.1 C	Passed
Lab Humidity:	10-70 %	36.00 %	Passed
Force at 0 Deg:	0.00-26.69 N	1.18 N	Passed
Force at 20 Deg:	97.86-151.24 N	110.86 N	Passed
Force at 30 Deg:	151.24-204.62 N	165.45 N	Passed
Force at 40 Deg:	204.62-258.00 N	227.86 N	Passed
Return Angle	12 Deg Max	2.98 deg	Passed

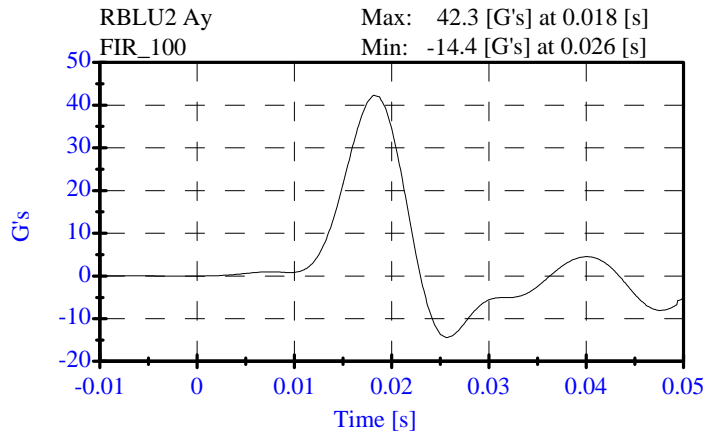
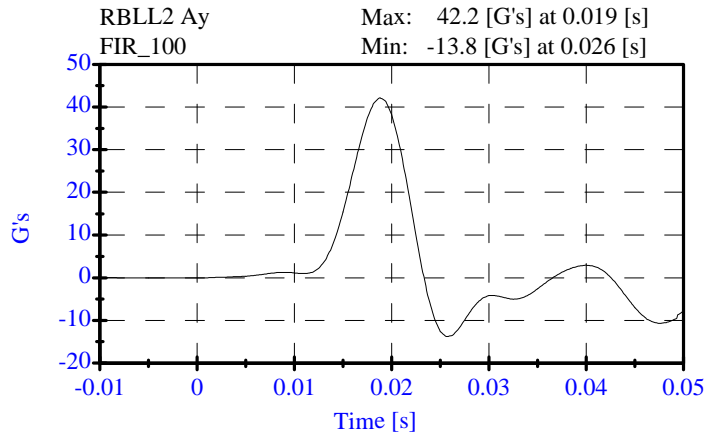
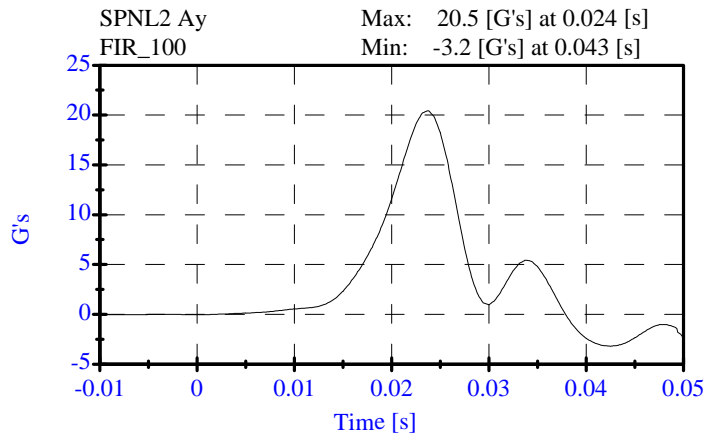
<u>TEST PARAMETER</u>	<u>SPECIFICATION</u>	<u>TEST RESULTS</u>	<u>STATUS</u>
Lab Temperature:	18.9-25.5 C	21.1 C	Passed
Lab Humidity:	10-70 %	40.00 %	Passed
Probe Velocity:	4.27- 4.33 m/s	4.32 m/s	Passed
Upper Rib Acceleration:	37.00-46.00 G's	42.30 G's	Passed
Lower Rib Acceleration:	37.00-46.00 G's	42.16 G's	Passed
Lower Spine Acceleration:	15.00-22.00 G's	20.46 G's	Passed

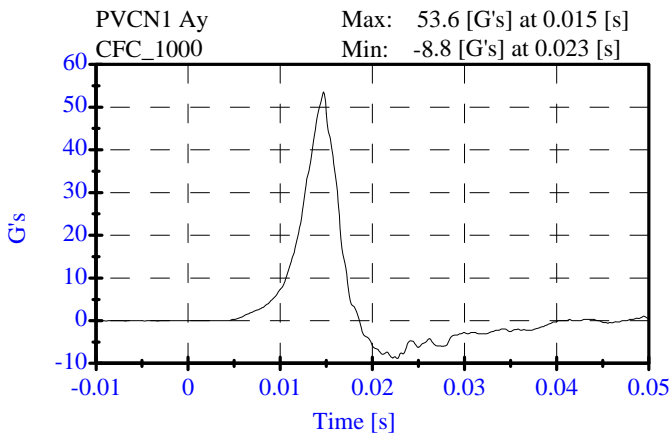
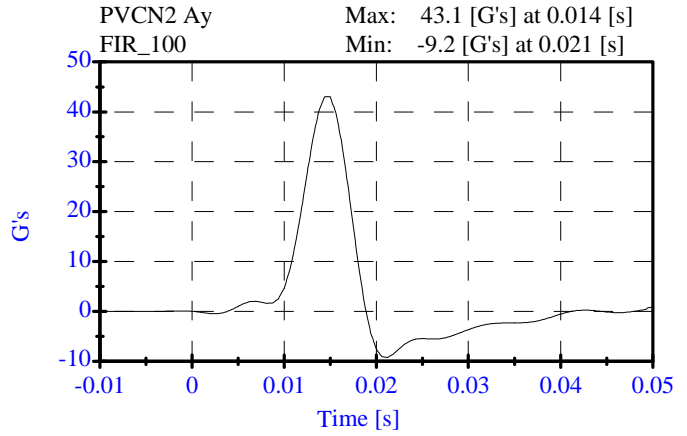
**Pelvic Impact
Post-Test**

<u>TEST PARAMETER</u>	<u>SPECIFICATION</u>	<u>TEST RESULTS</u>	<u>STATUS</u>
Lab Temperature:	18.9-25.5 C	21.1 C	Passed
Lab Humidity:	10-70 %	40.00 %	Passed
Probe Velocity:	4.27- 4.33 m/s	4.31 m/s	Passed
Pelvis Y Acceleration:	40.00-60.00 G's	43.06 G's	Passed
Time Above 20 Gs	3.0-7.0 ms	5.5 ms	Passed
