**NEW CAR ASSESSMENT PROGRAM
SIDE IMPACT TEST**

MERCEDES-BENZ US INTL, INC.
2006 MERCEDES-BENZ ML350
MULTIPURPOSE VEHICLE

CALSPAN TEST NUMBER: 8765-SNCAP-11

FINAL REPORT

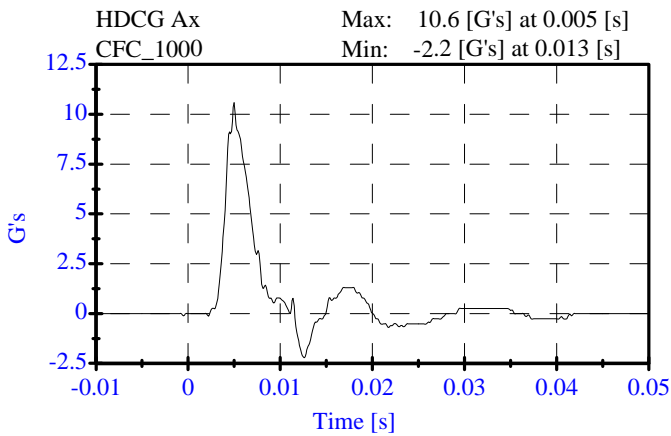
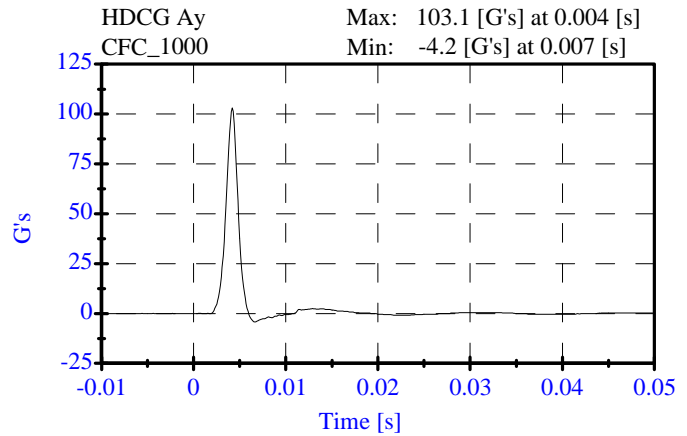
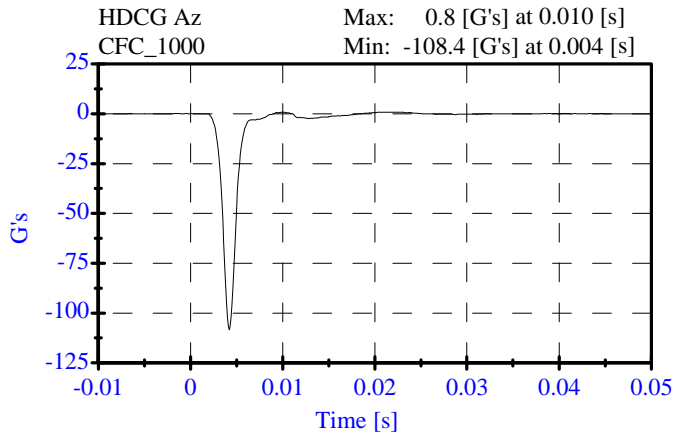
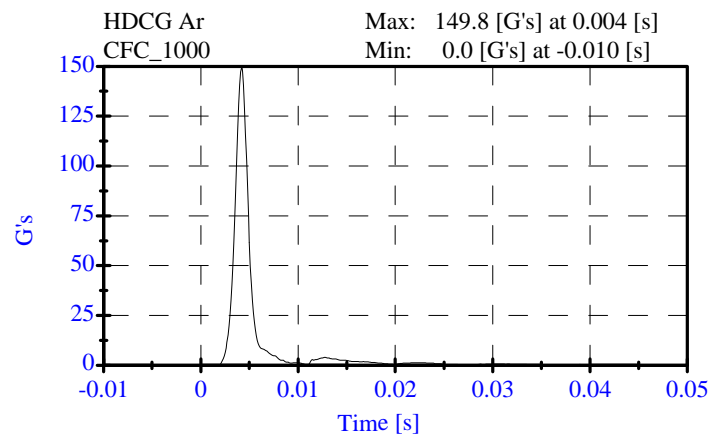
**Head Drop
Post-Test**

<u>TEST PARAMETER</u>	<u>SPECIFICATION</u>	<u>TEST RESULTS</u>	<u>STATUS</u>
Lab Temperature:	18.9-25.6 C	21.1 C	Passed
Lab Humidity:	10-70 %	35.00 %	Passed
Peak Resultant Accel.:	120-150 Gs	149.81 Gs	Passed
Peak Lateral Accel.:	15 Gs Max	10.57 Gs	Passed
Curve PerCent NonModal:	< 15%	3.25 %	Passed

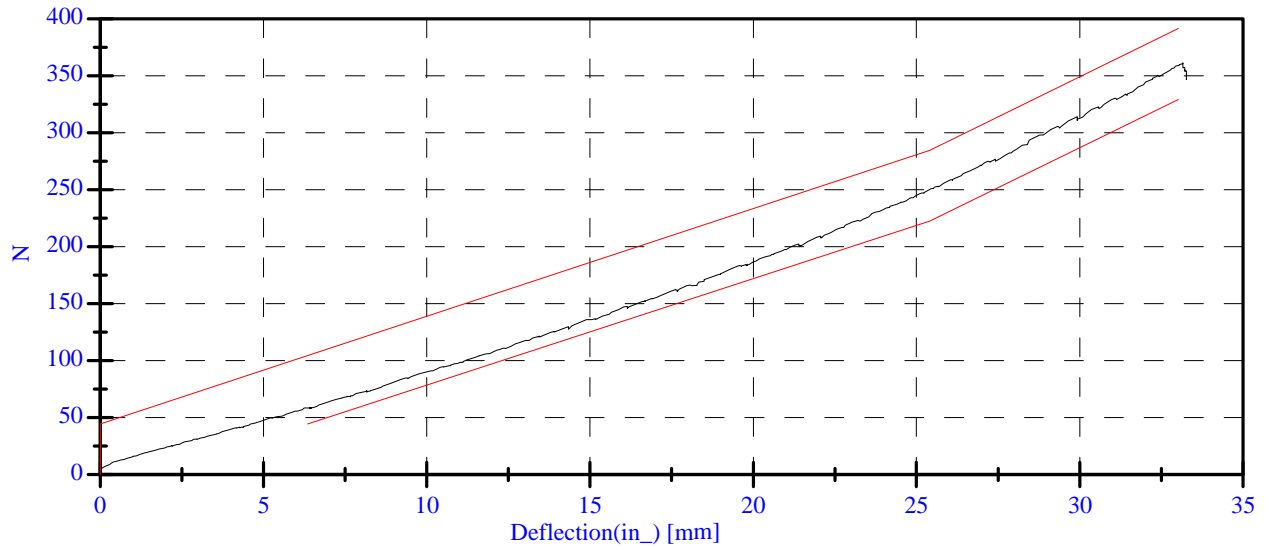
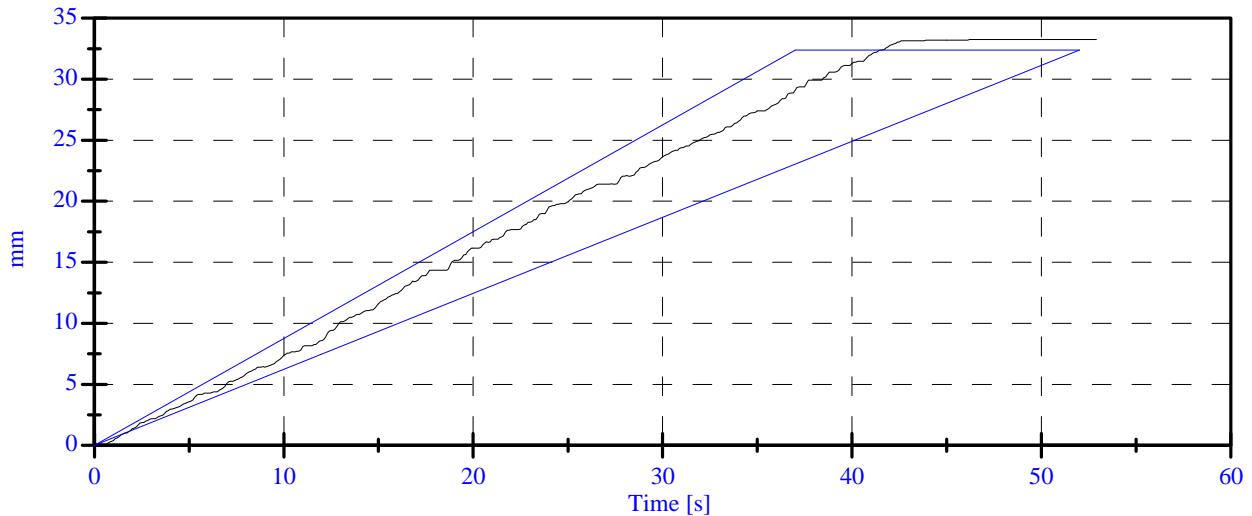
ABDOMINAL COMPRESSION TEST

<u>TEST PARAMETER</u>	<u>SPECIFICATION</u>	<u>TEST RESULTS</u>	<u>STATUS</u>
Lab Temperature:	18.9-25.5 C	21.1 C	Passed
Lab Humidity:	10-70 %	37.00 %	Passed
Force at 12.95 mm :	104.00-162.00 N	117.88 N	Passed
Force at 19.05 mm :	162.98-220.99 N	175.88 N	Passed
Force at 25.40 mm :	221.97-280.02 N	250.91 N	Passed
Force at 33.02 mm :	324.99-391.00 N	359.29 N	Passed

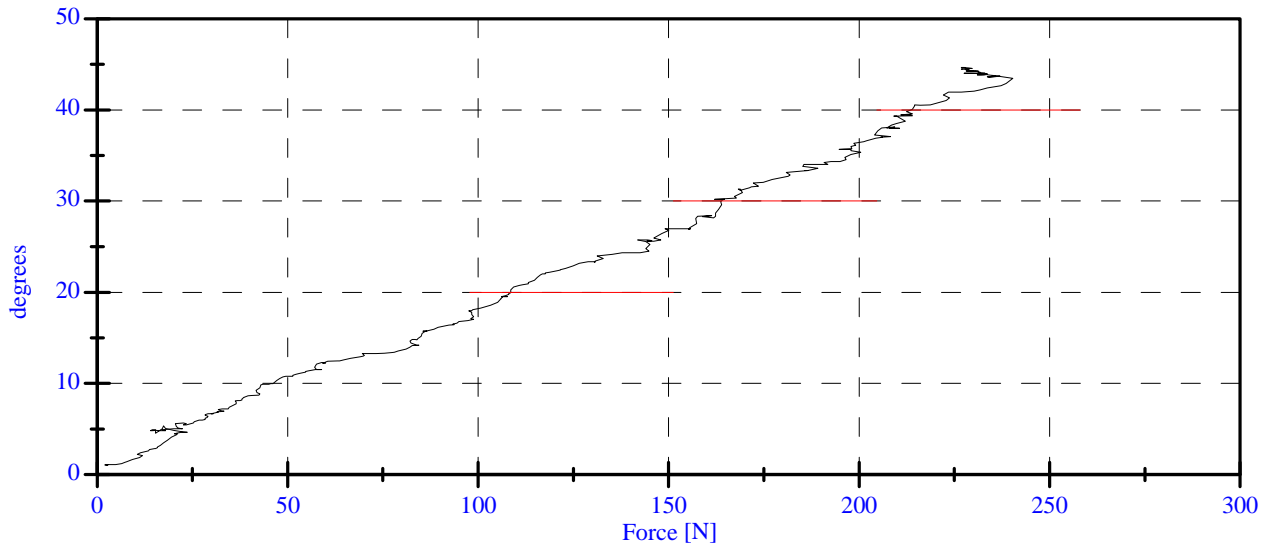
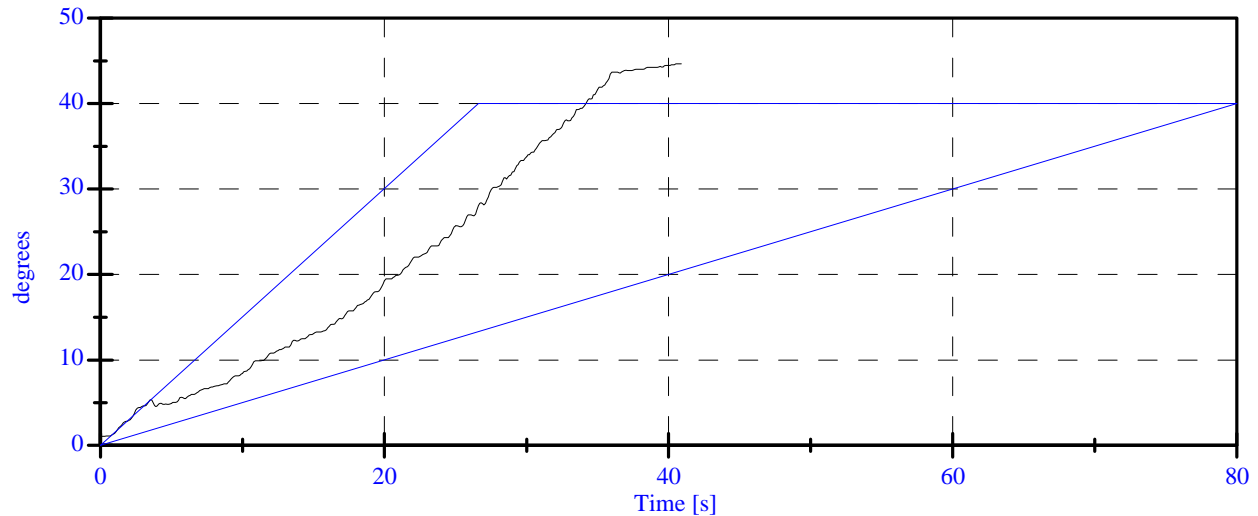
LUMBAR SPINE FLEXION TEST

<u>TEST PARAMETER</u>	<u>SPECIFICATION</u>	<u>TEST RESULTS</u>	<u>STATUS</u>
Lab Temperature:	18.9-25.5 C	21.1 C	Passed
Lab Humidity:	10-70 %	36.00 %	Passed
Force at 0 Deg:	0.00-26.69 N	1.96 N	Passed
Force at 20 Deg:	97.86-151.24 N	108.51 N	Passed
Force at 30 Deg:	151.24-204.62 N	163.62 N	Passed
Force at 40 Deg:	204.62-258.00 N	214.02 N	Passed
Return Angle	12 Deg Max	3.60 deg	Passed

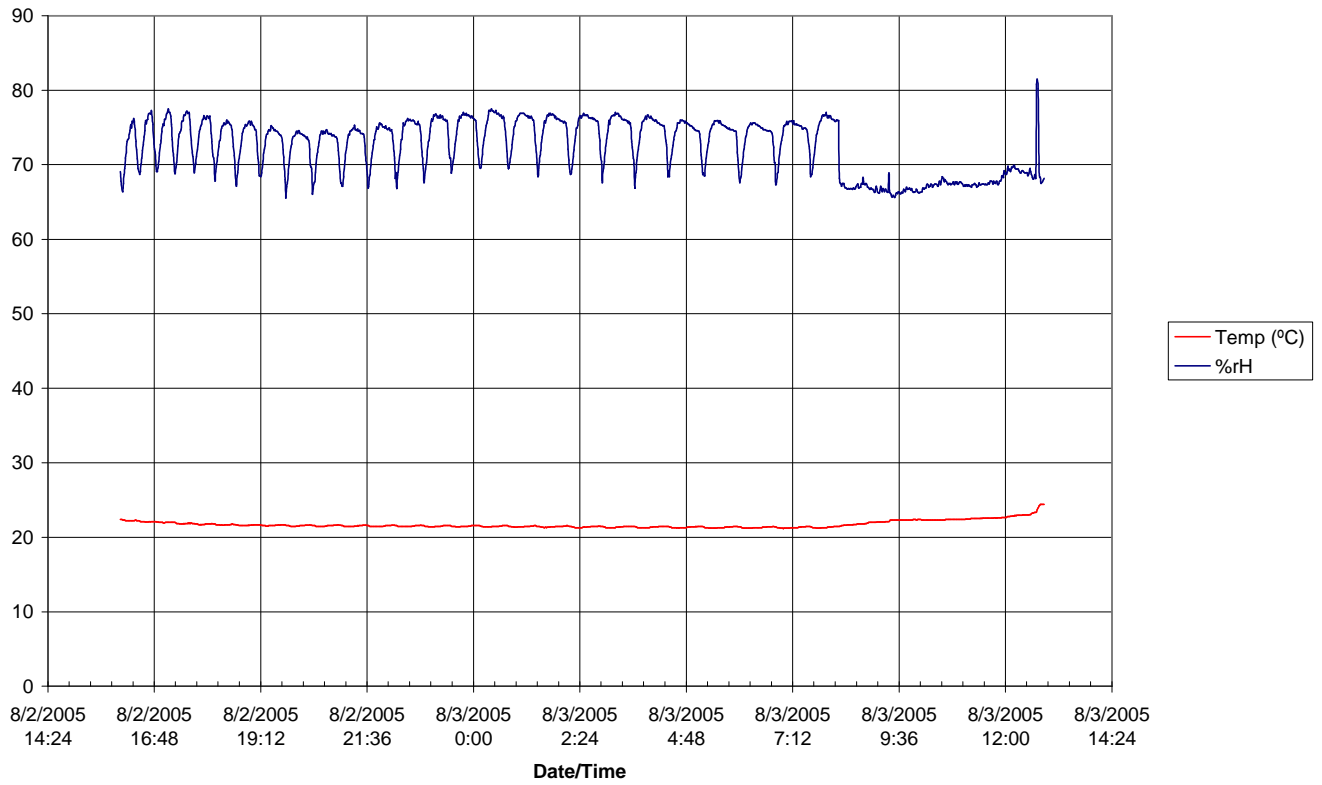
TEMPERATURE TRACE

Mercedes ML350 M60516 Environmental Conditions
