**REPORT NUMBER TR-P25108-01-NC**

**NEW CAR ASSESSMENT PROGRAM  
SIDE IMPACT TEST**

**GENERAL MOTORS CORPORATION  
2005 CHEVROLET COBALT  
4-DOOR SEDAN**

**FINAL REPORT**

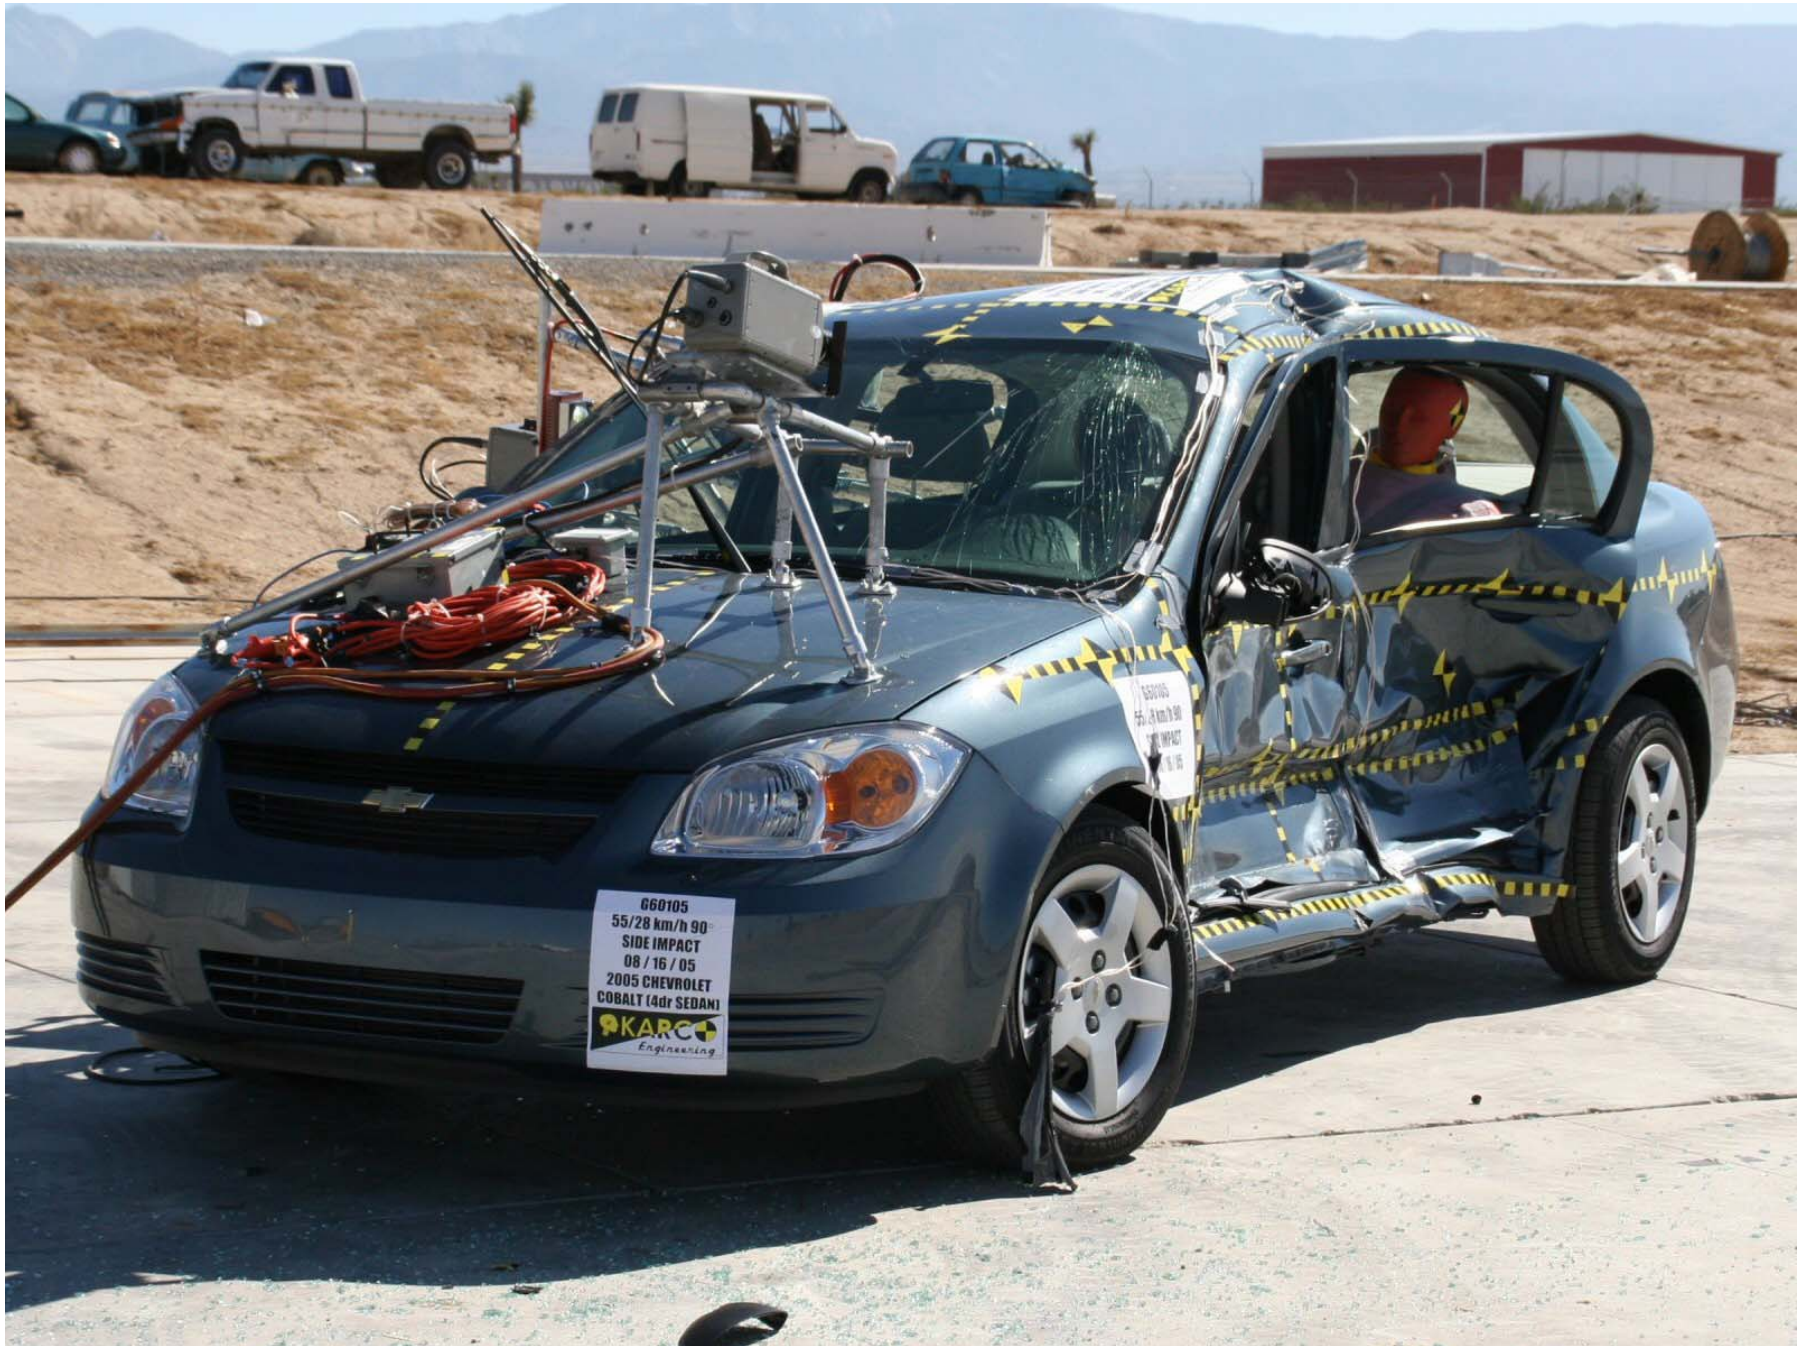
Figure A-8: Post-Test Left Front  $\frac{3}{4}$  View

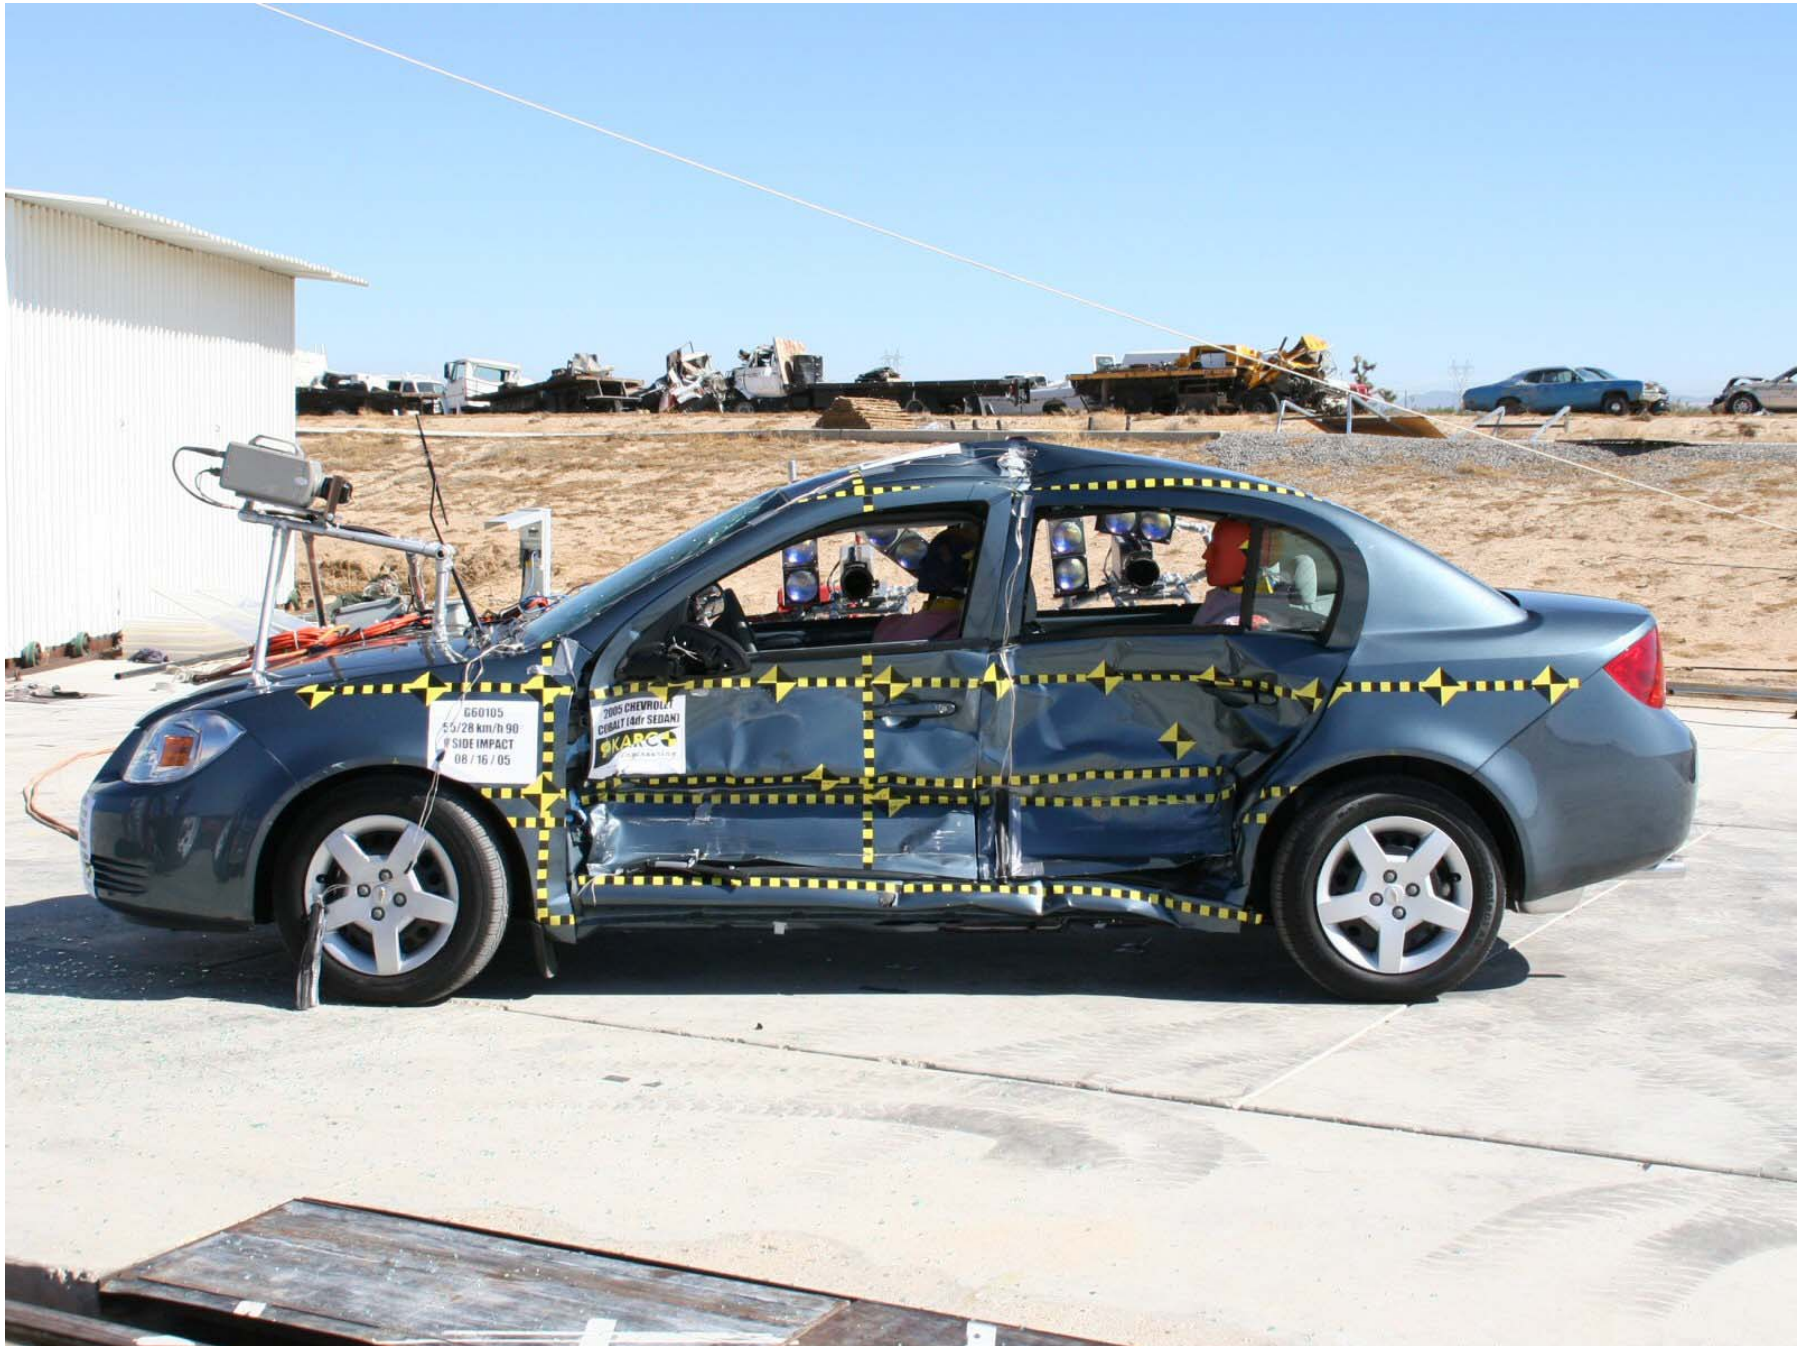
Figure A-10: Post-Test Left Side View

The driver and passenger doors remained closed during impact. The test vehicle sustained a maximum static crush of 323 mm at level 2, 750-950 mm rearward of the left vertical impact point. The driver SID/Hybrid III, Serial No. 274 and the passenger SID/Hybrid III, Serial No. 275 were calibrated prior to this test. The SID/Hybrid III injury criteria is summarized as follows:

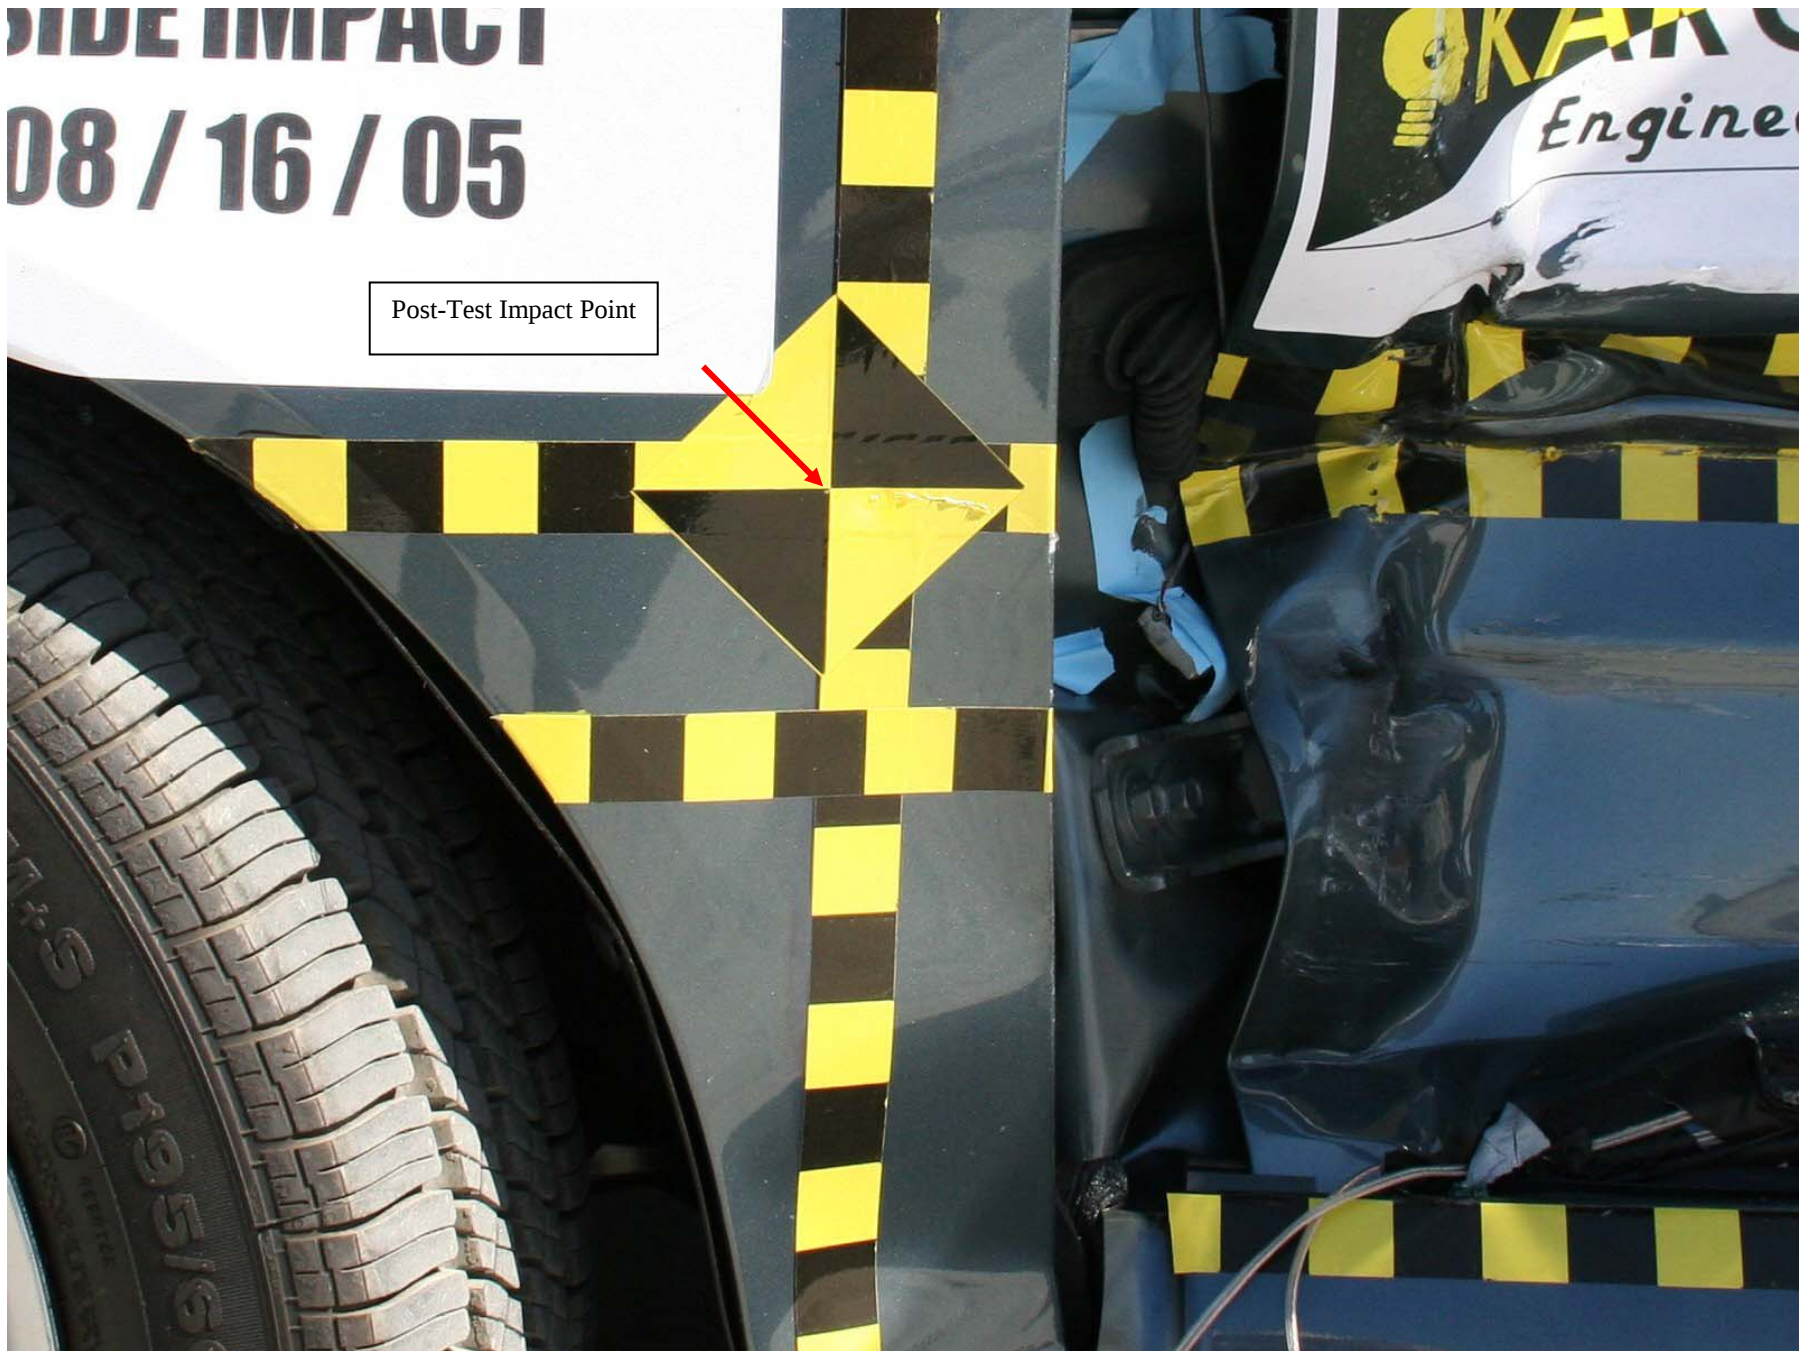
Figure A-26: Post-Test Left Impact Point

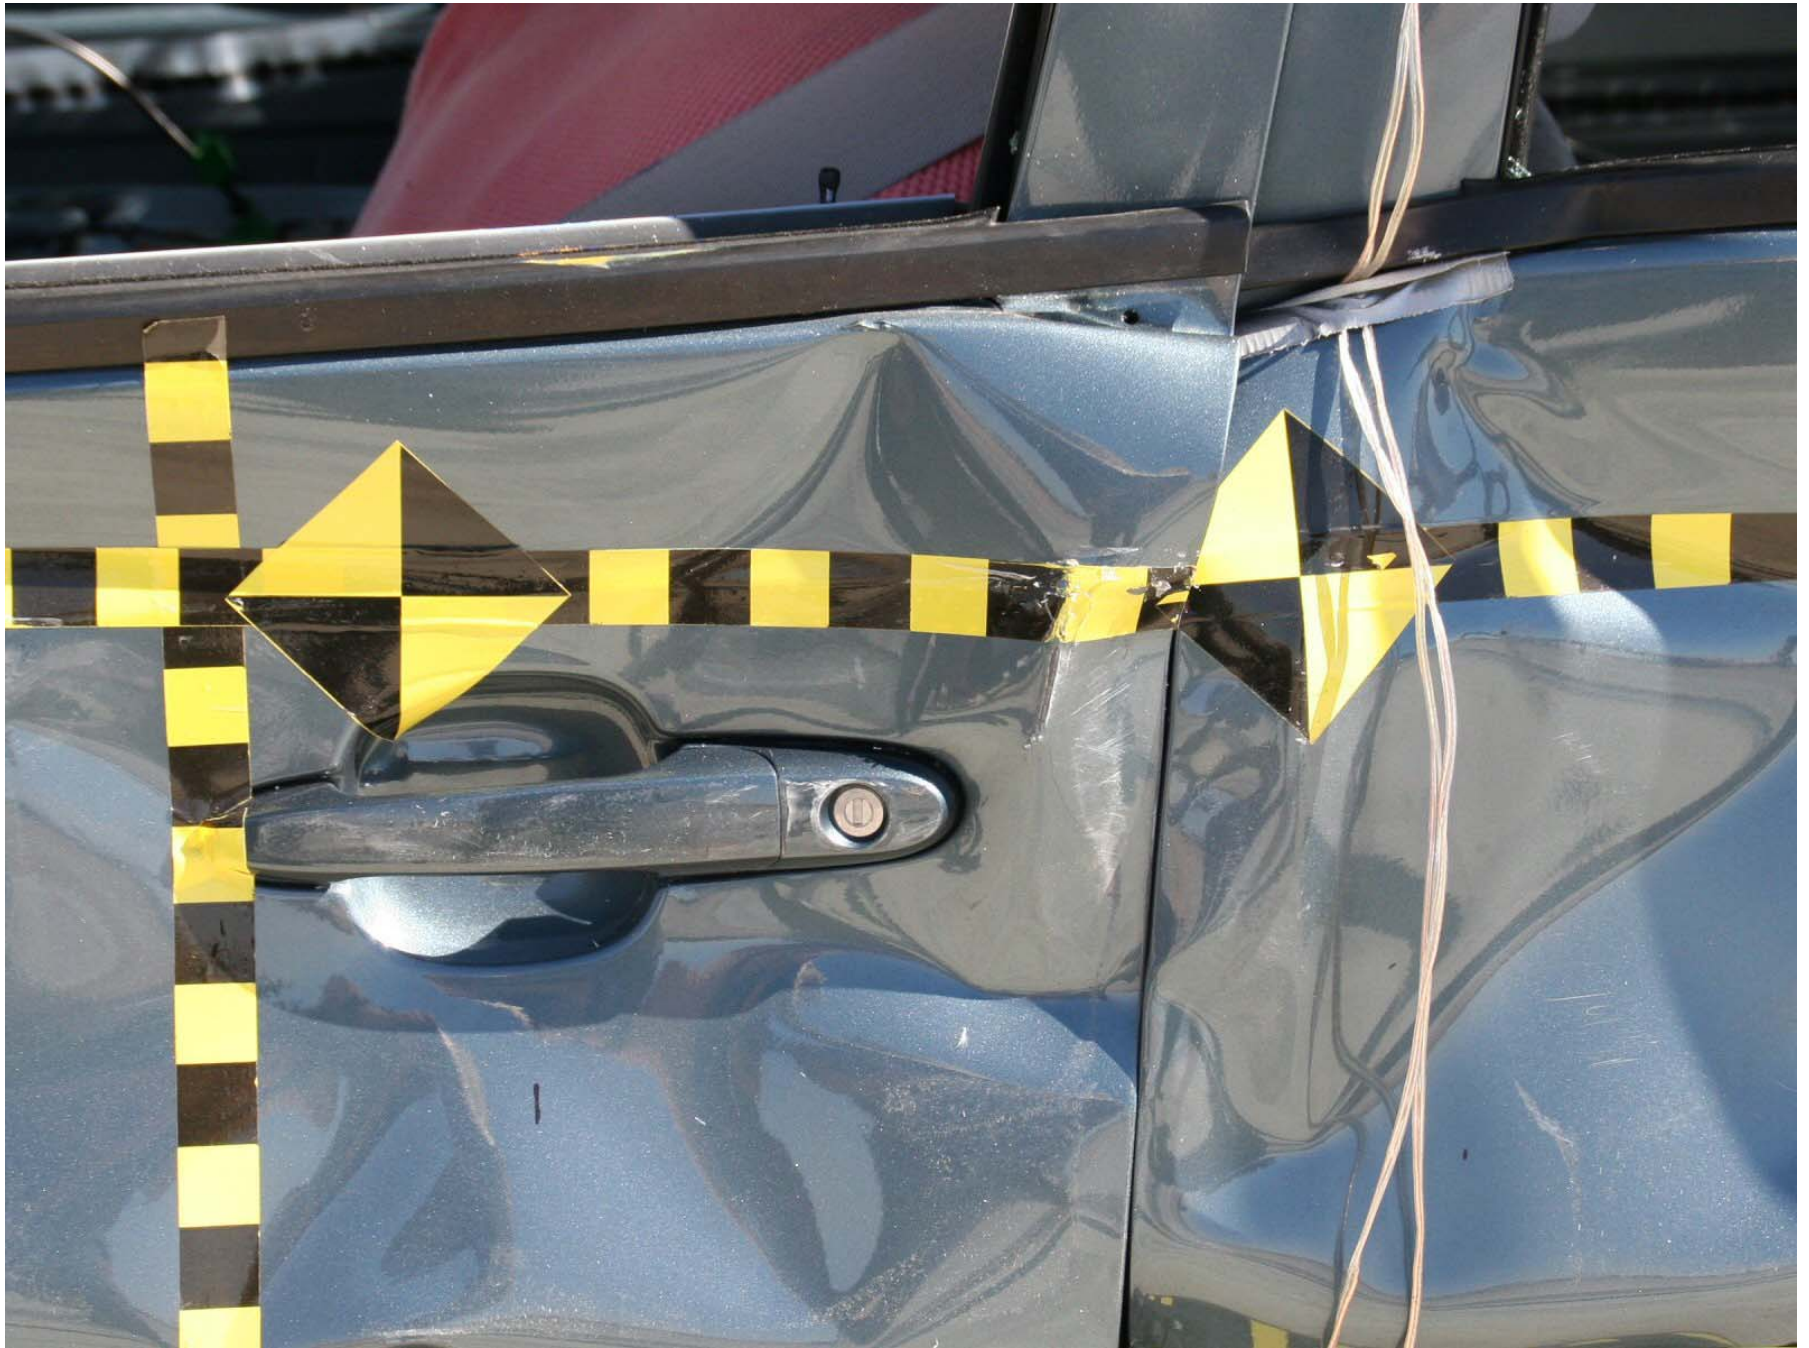
Figure A-32: Post-Test Left Front Door

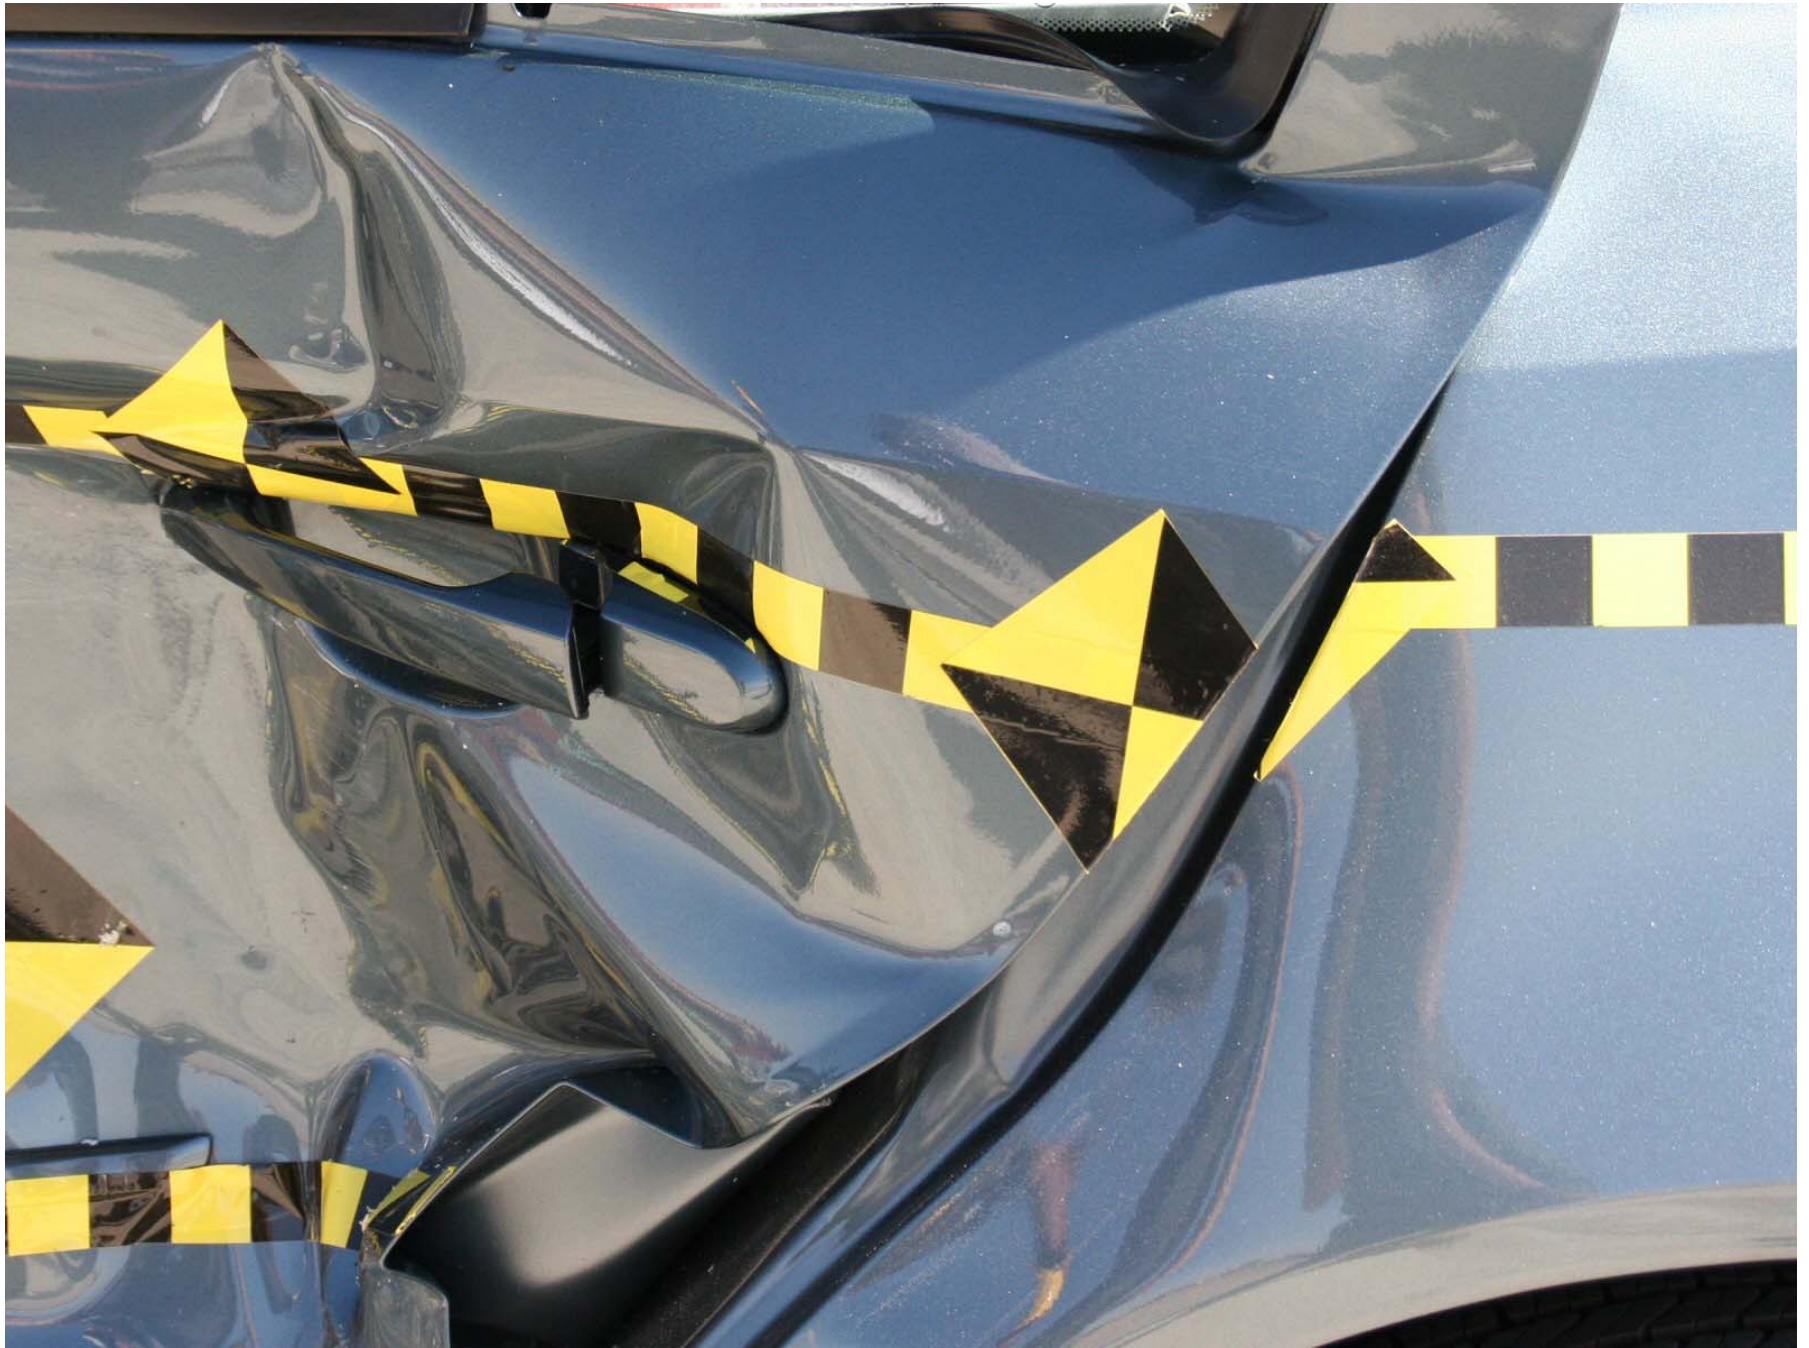
Figure A-34: Post-Test Left Rear Door

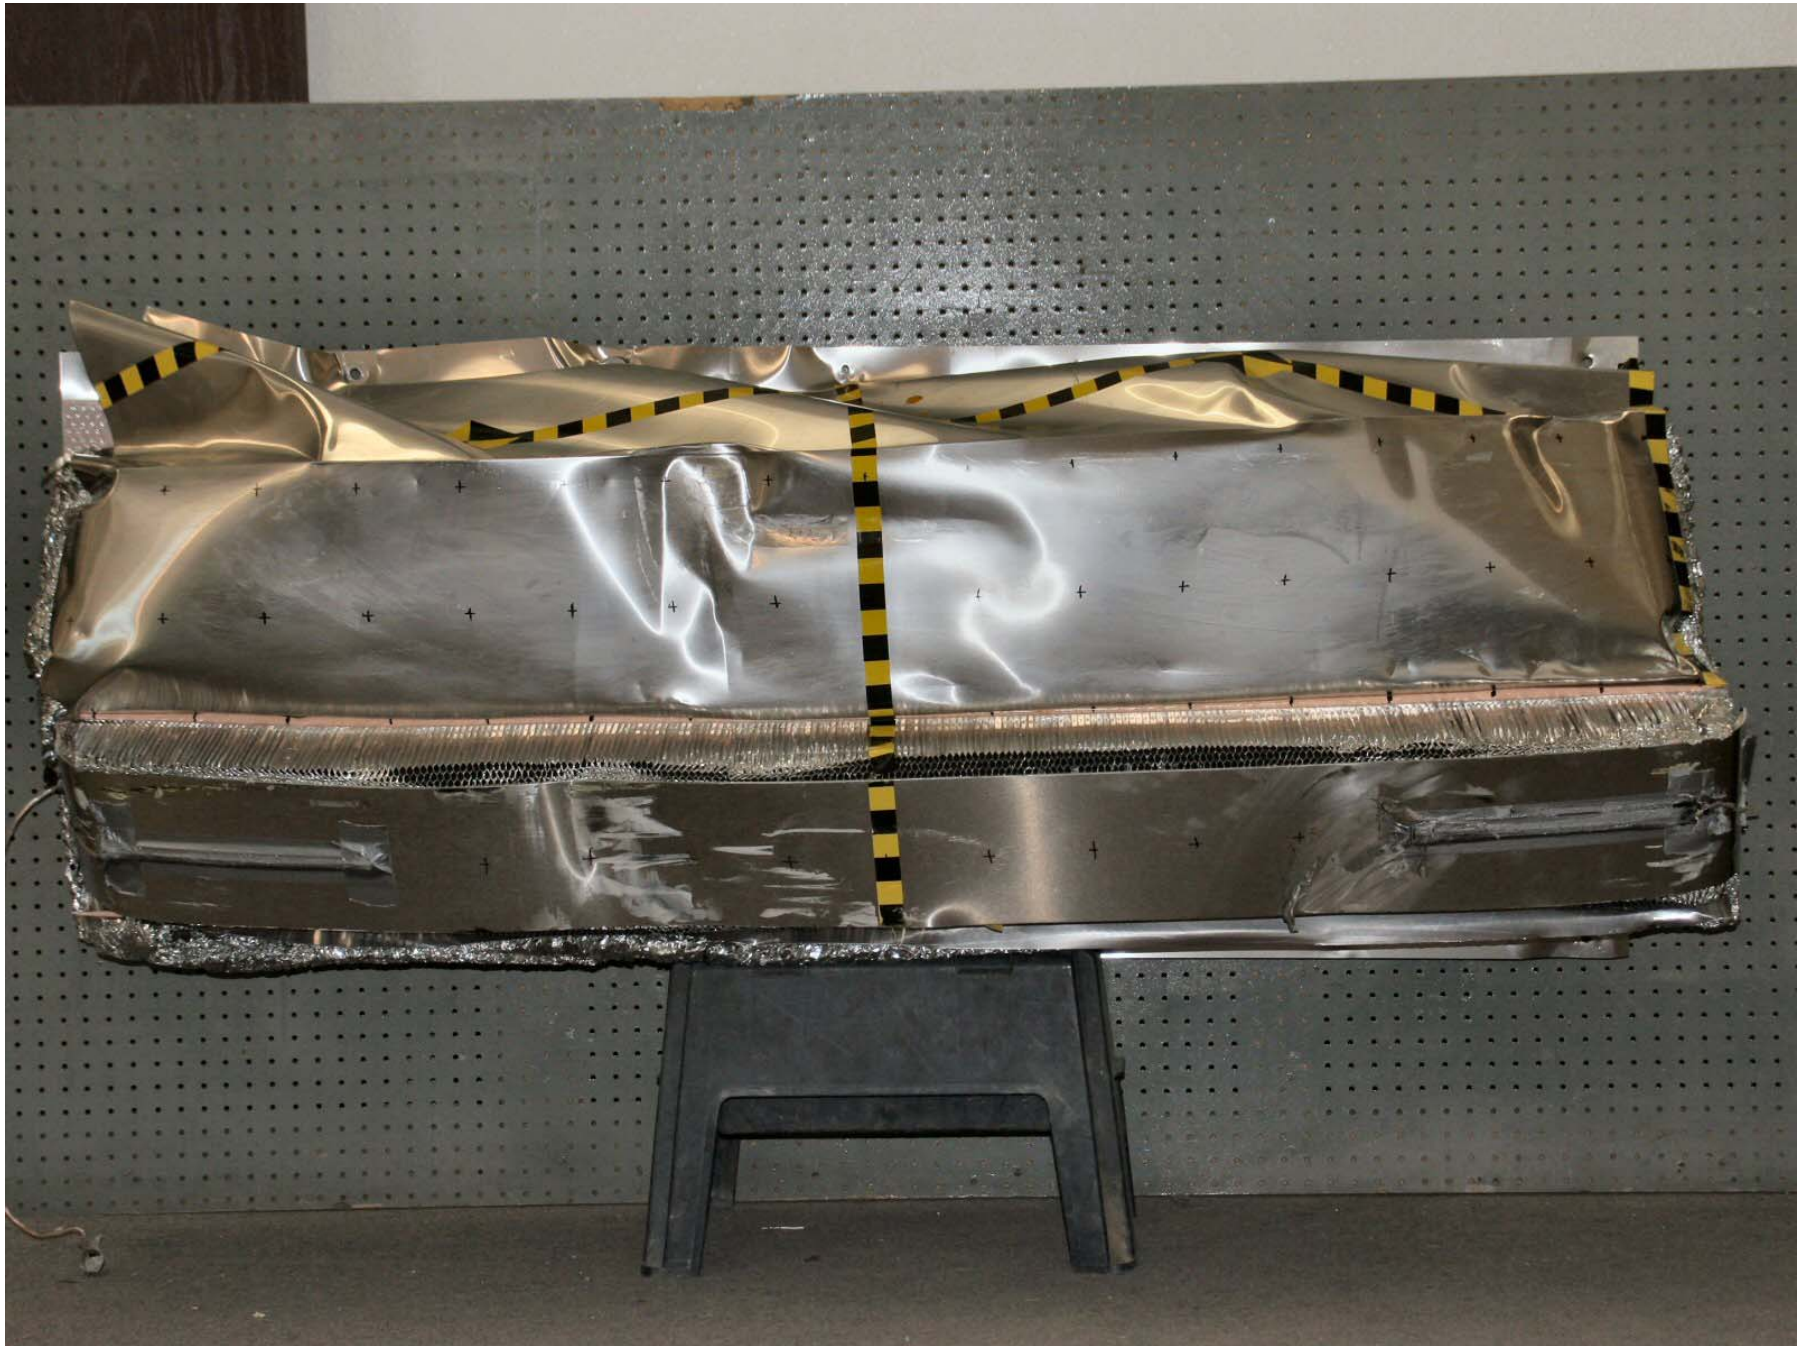
Figure A-54: Post-Test Front View of Deformable Barrier

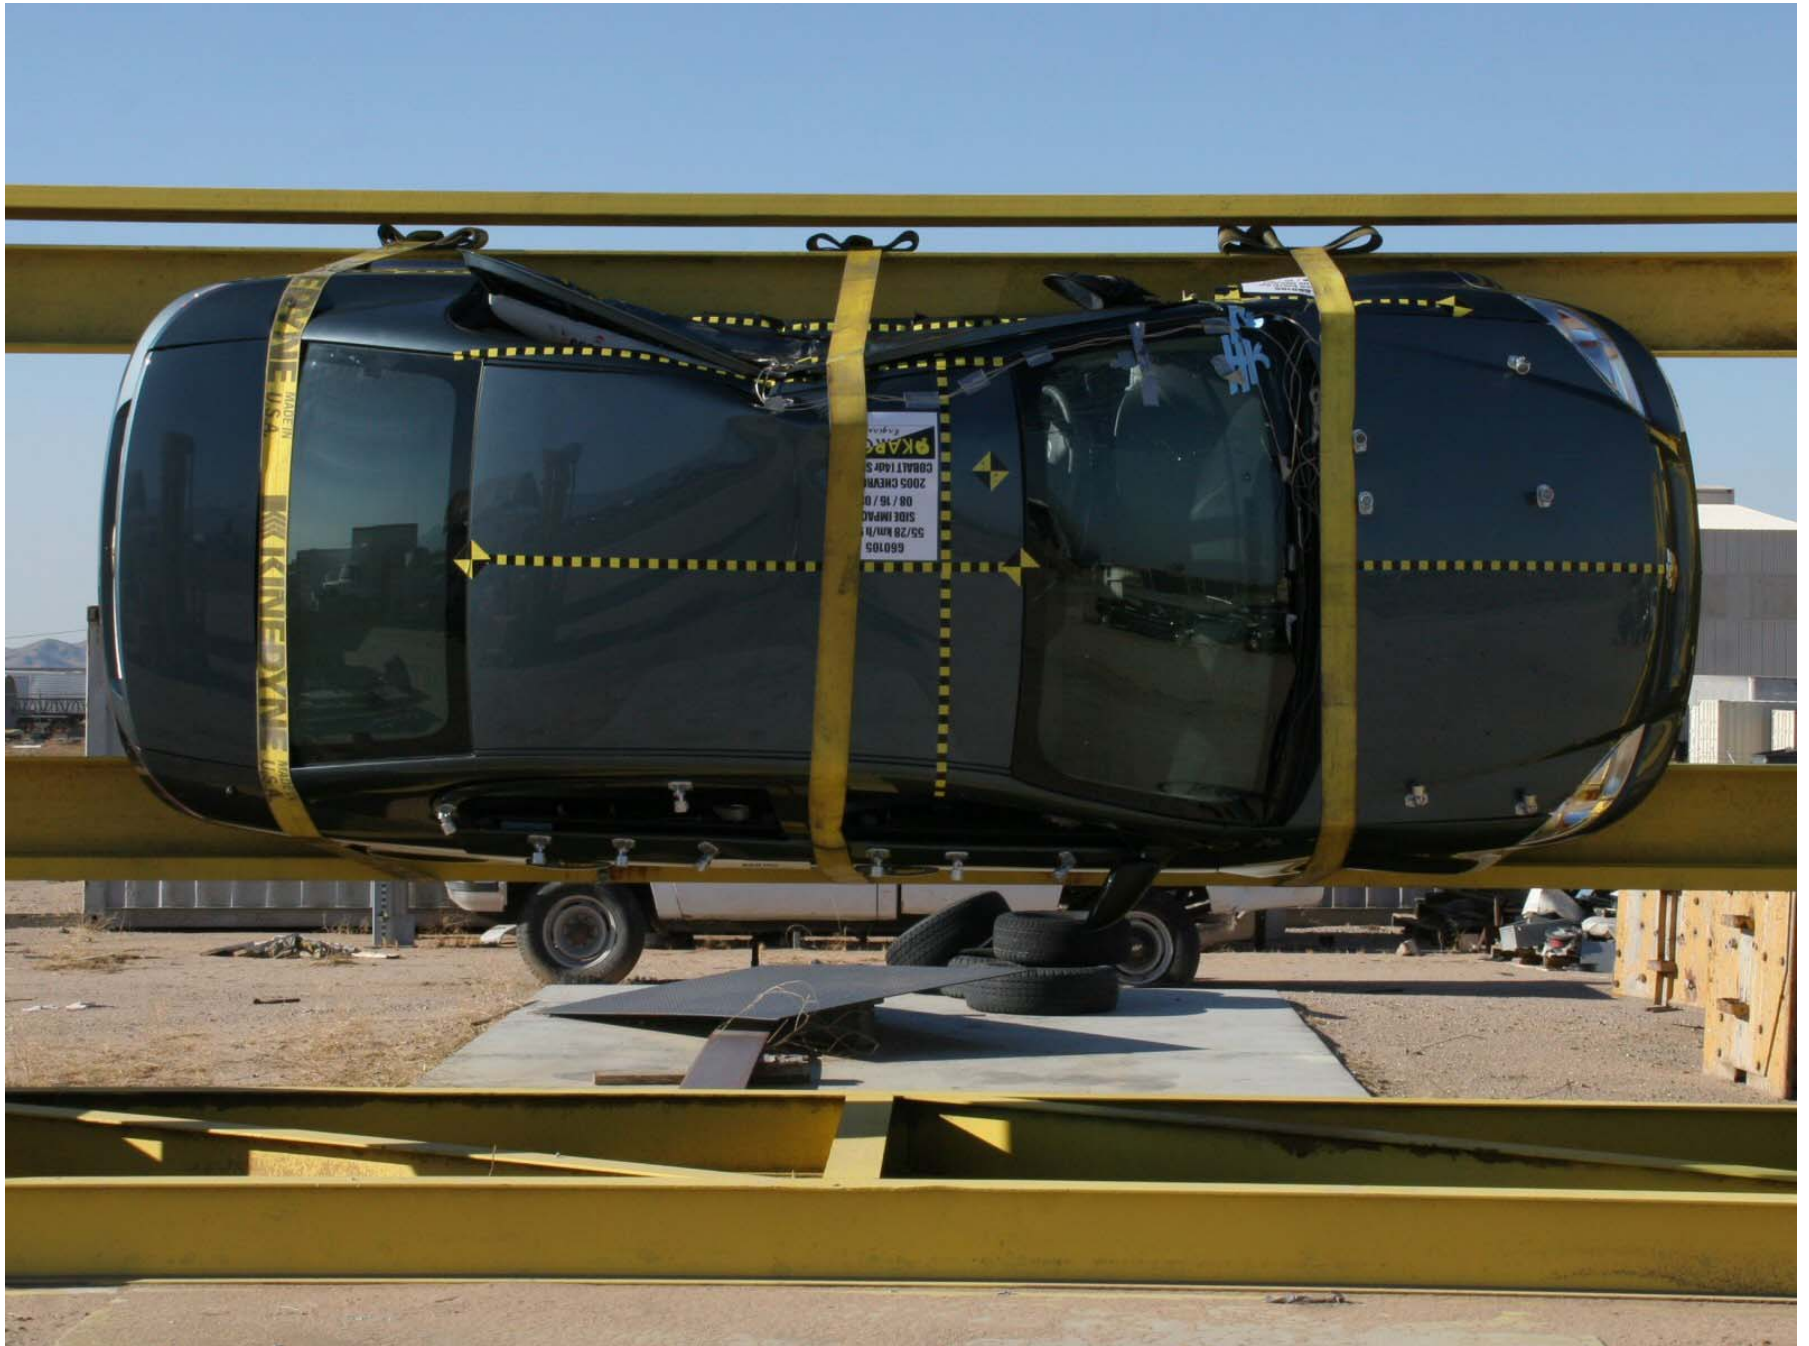
Figure A-62: Vehicle on Rollover Device (90°)

1. The specified fixture rollover rate for each 90° of rotation is 60 to 120 seconds.
  2. The position hold time at each position is 300 seconds (minimum).
  3. Details of Stoddard Solvent spillage locations.
- No solvent leakage occurred during static rollover testing.

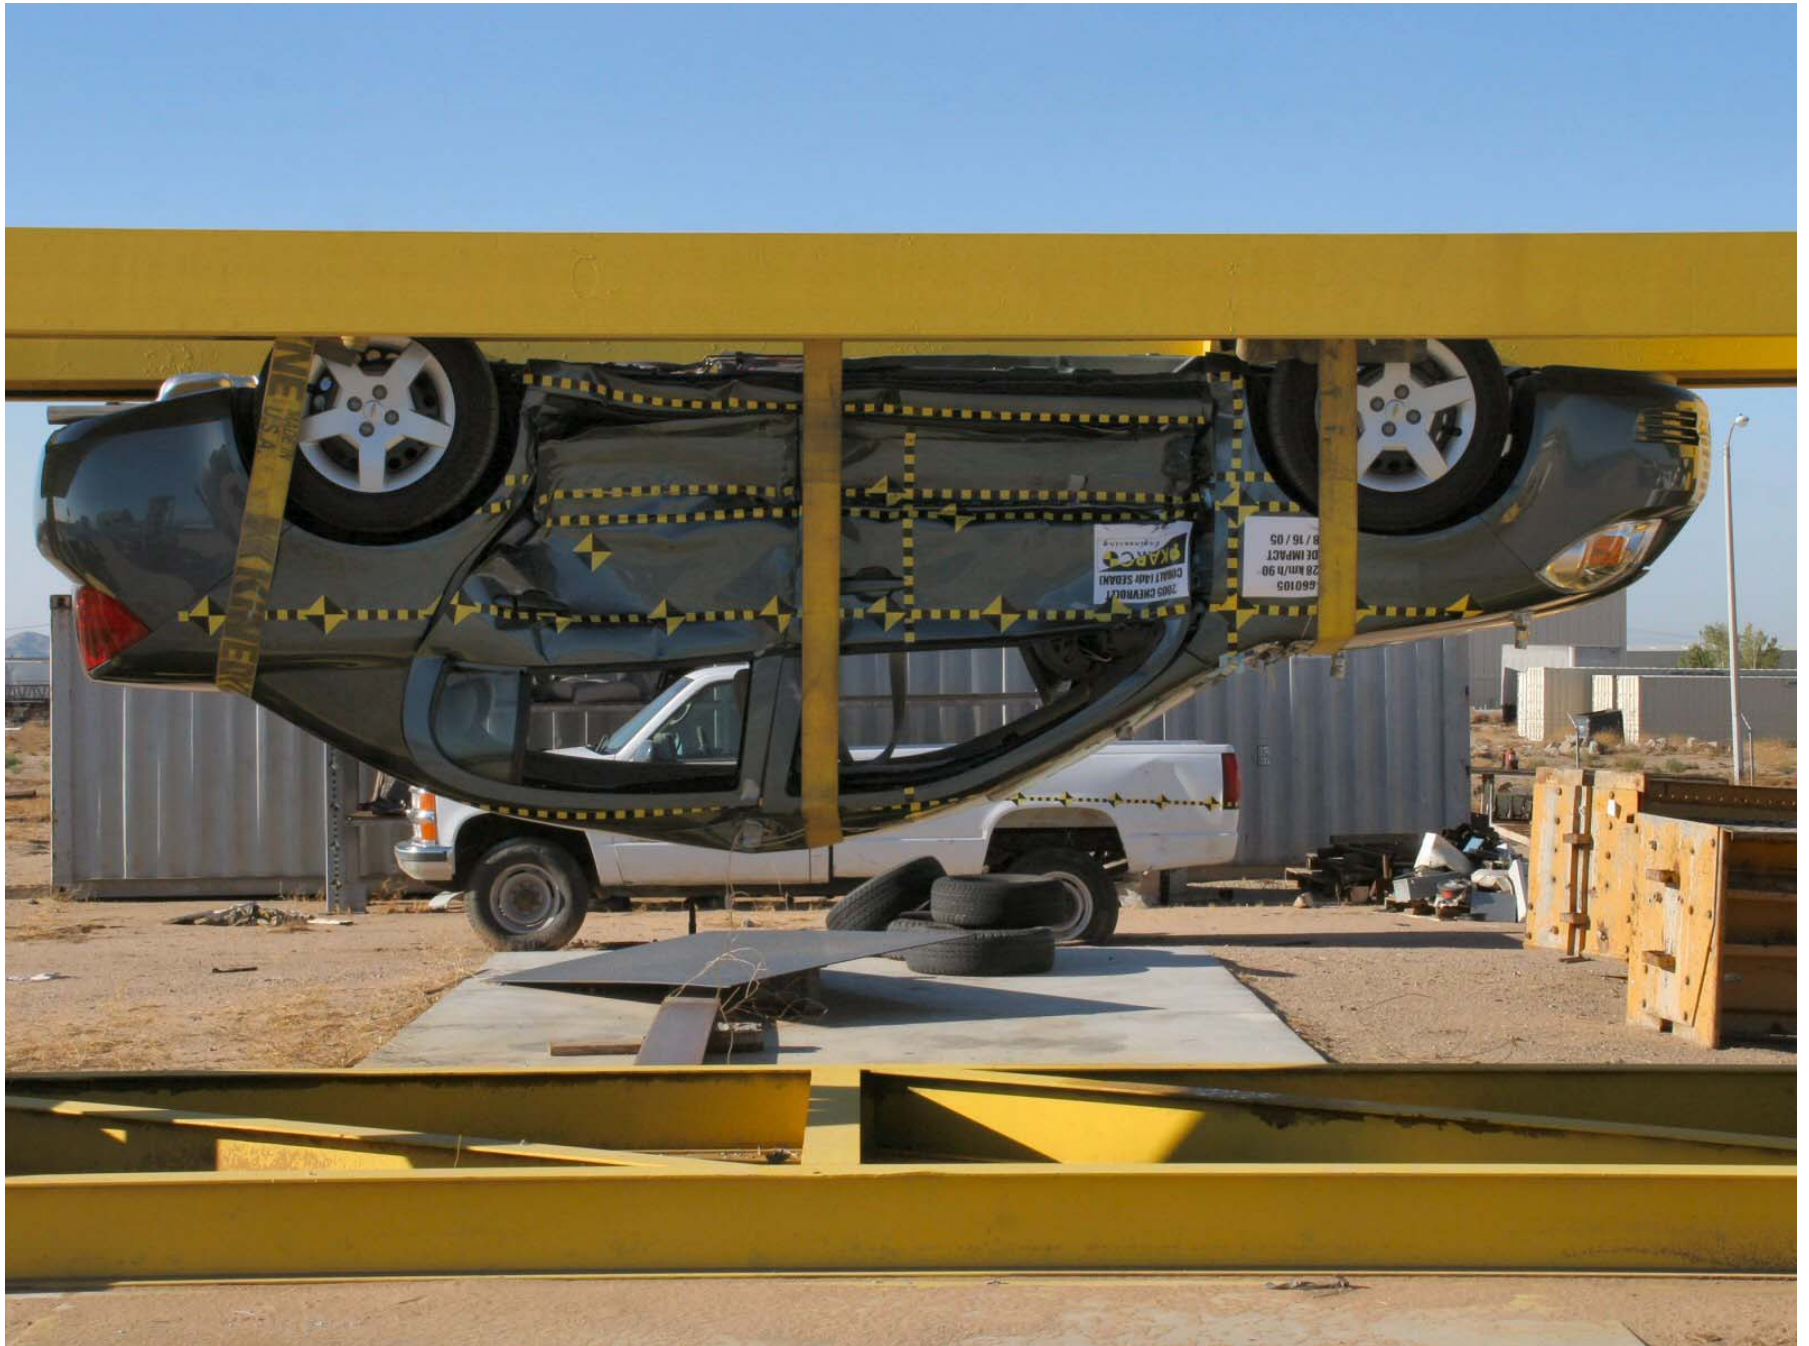
Figure A-63: Vehicle on Rollover Device (180°)

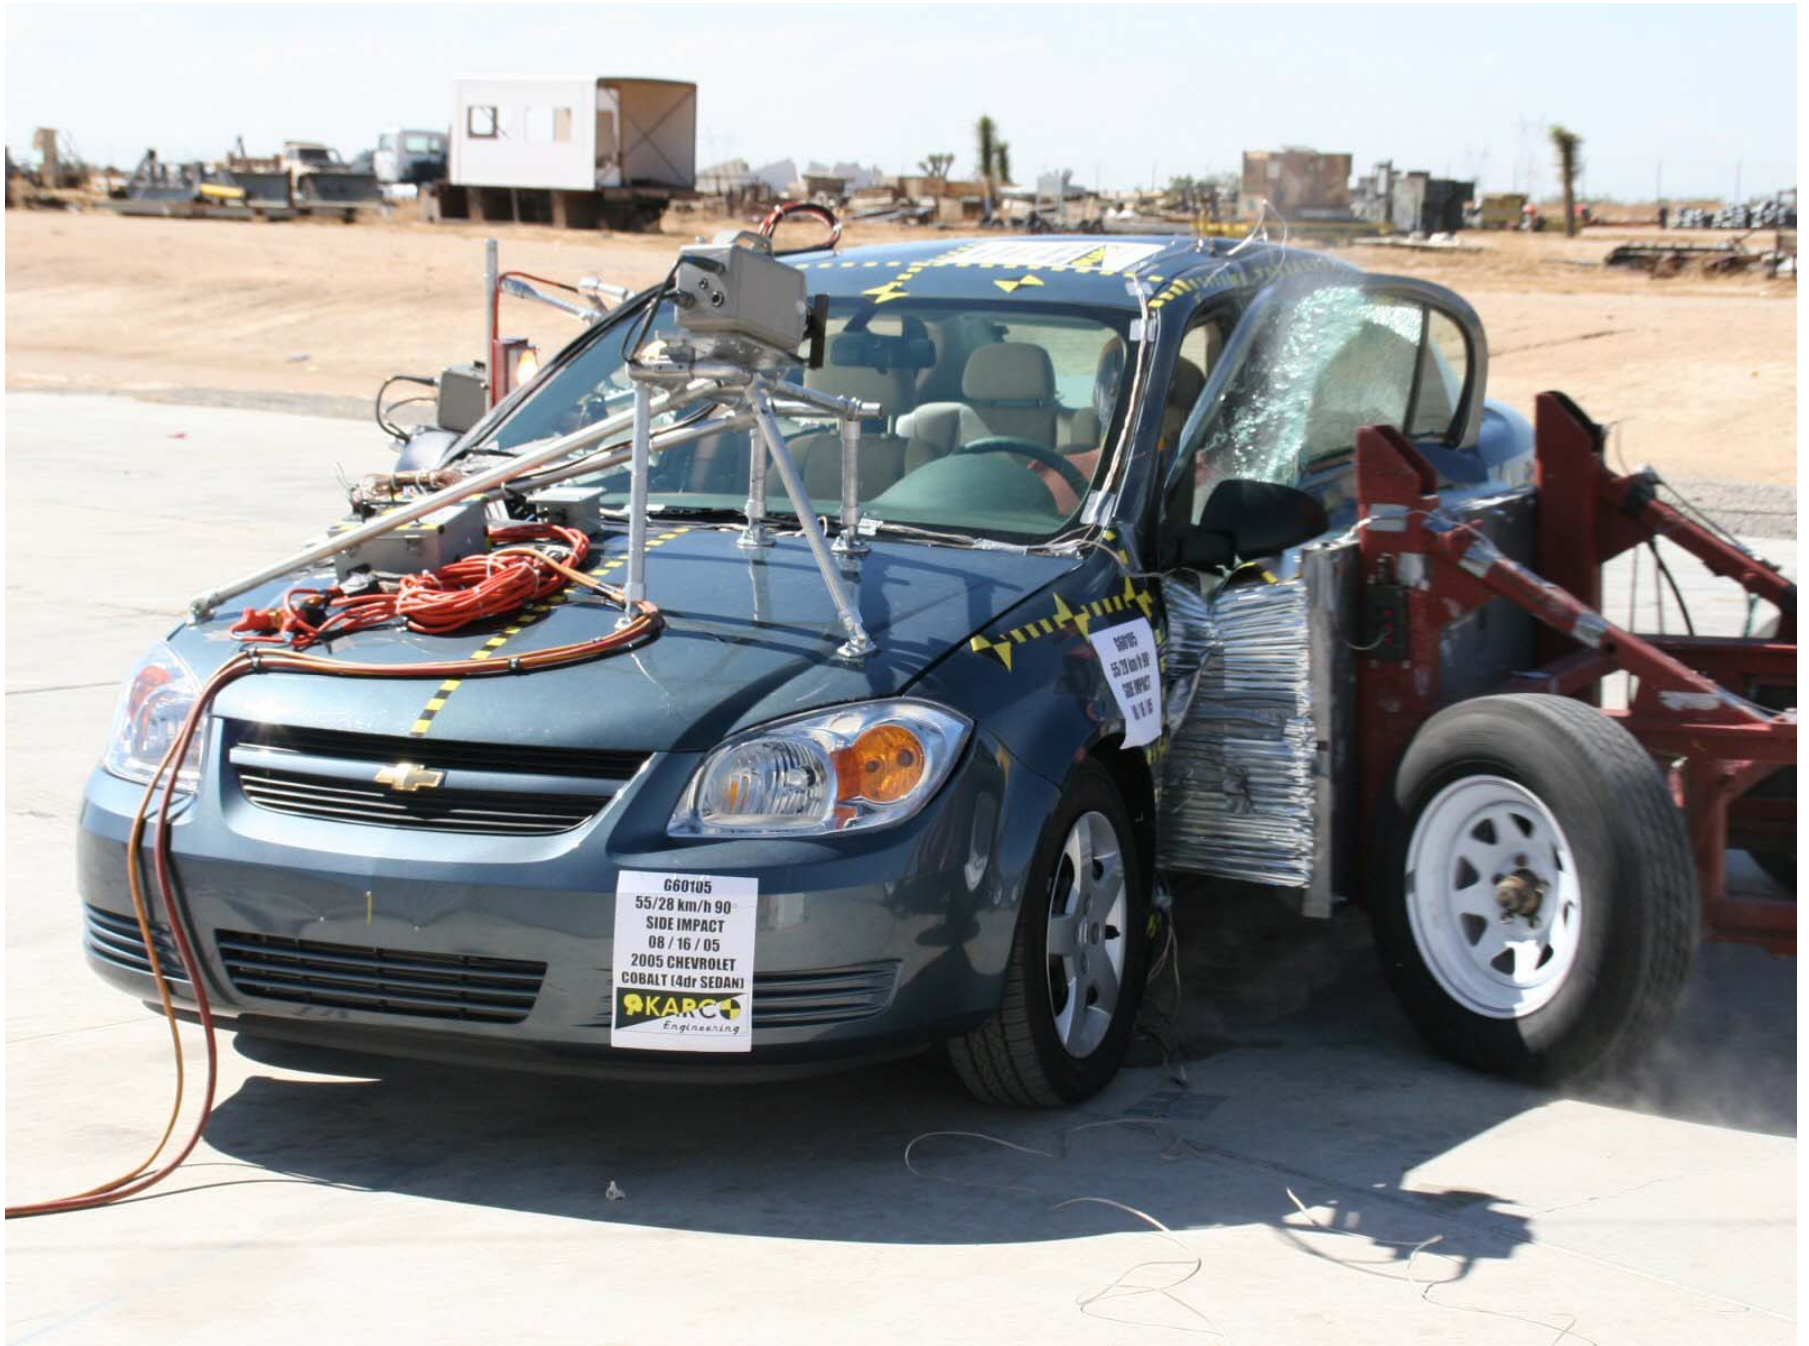
Figure A-65: Vehicle Impact

A model year 2005 Chevrolet Cobalt 4-Door Sedan was impacted on the left (driver's) side by a Moving Deformable Barrier (MDB) which was moving forward in a 27° crabbed position to the tow road guidance system at a velocity of 62.02 km/h. The specified impact velocity range is from 61.14 to 62.75 km/h. The test (target) vehicle was stationary and positioned 63° to the line of forward motion. The weight of the vehicle as tested was 1496 kg and the test weight of the MDB was 1361 kg. The test was conducted at KARCO Engineering, LLC in Adelanto, California, on August 16, 2005.
