REPORT NUMBER: CAL-06-02

**NEW CAR ASSESSMENT PROGRAM (NCAP)  
FRONTAL BARRIER IMPACT TEST**

HYUNDAI MOTOR COMPANY  
2006 HYUNDAI SONATA  
FOUR-DOOR SEDAN

CALSPAN TEST NUMBER: 8642-NCAP-62

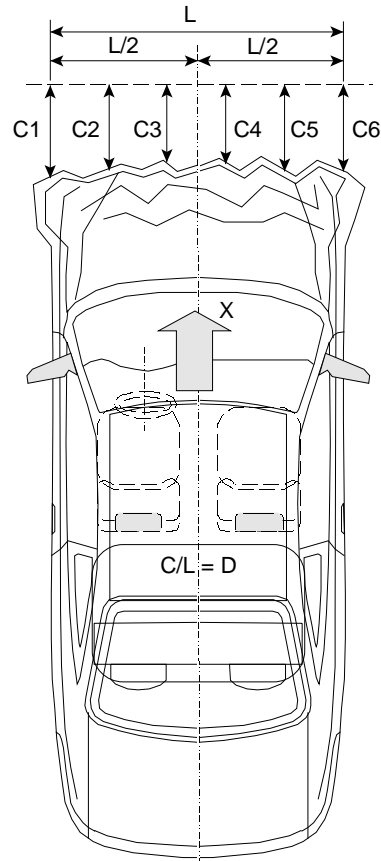
Crush Depth Dimensions

PRE (mm)	POST (mm)	DIFF (mm)
C1 =	4601	4310	291
C2 =	4737	4312	425
C3 =	4793	4401	392
C4 =	4793	4422	371
C5 =	4736	4393	343
C6 =	4599	4270	329

Midpoint of Damage: D = Vehicle Centerline (Longitudinal)

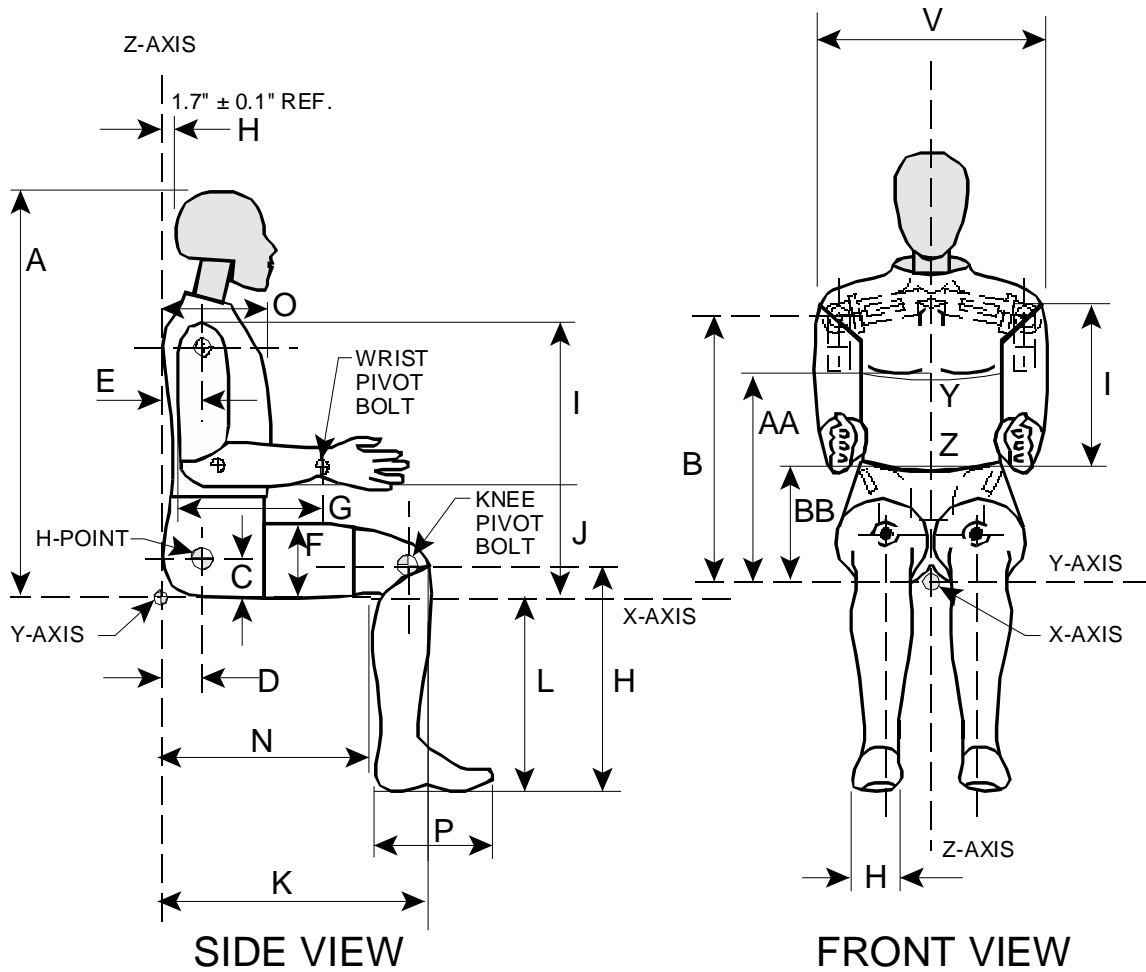
# EXTERNAL DIMENSIONS SPECIFICATIONS

NOTE: Figure is referenced to the erect seated position. The curved lumbar does not allow the Hybrid III to be positioned in a perfect erect attitude. (REF: S572.31(A)(6))

TEST PARAMETER		SPECIFICATION	TEST RESULTS
Temperature			70
Relative Humidity			35
Location for Chest Circumference	AA	16.9 - 17.1 in	17.0
Location for Waist Circumference	BB	8.9 - 9.1 in	9.0
Total Sitting Height	A	34.6 - 35.0 in	35.0
Shoulder Pivot Height	B	19.9 - 20.5 in	20.4
H-Point Height	C	3.3 - 3.5 in	3.5
H-Point from Backline	D	5.3 - 5.5 in	5.3
Shoulder Pivot from Backline	E	3.3 - 3.7 in	3.7
Thigh Clearance	F	5.5 - 6.1 in	6.0
Back of Elbow to Wrist Pivot	G	11.4 - 12.0 in	11.5
Skull Cap to Backline	H	1.6 - 1.8 in	1.7
Shoulder - Elbow Length	I	13.0 - 13.6 in	13.5
Elbow Rest Height	J	7.5 - 8.3 in	8.25
Buttock Knee Length	K	22.8 - 23.8 in	23.5
Popliteal Height	L	16.9 - 17.9 in	17.75
Knee Pivot Height	M	19.1 - 19.7 in	19.25
Buttock Popliteal Length	N	17.8 - 18.8 in	18.75
Chest Depth	O	8.4 - 9.0 in	9.0
Foot Length	P	9.9 - 10.5 in	10.25
Shoulder Breadth	V	16.6 - 17.2 in	16.9
Foot Breadth	W	3.6 - 4.2 in	4.0
Chest Circumference (With Jacket)	Y	38.2 - 39.4 in	38.75

TEST PARAMETER		SPECIFICATION	TEST RESULTS
Temperature			70.0
Relative Humidity			35.0
Location for Chest Circumference	AA	16.9 - 17.1 in	17.0
Location for Waist Circumference	BB	8.9 - 9.1 in	9.0
Total Sitting Height	A	34.6 - 35.0 in	34.8
Shoulder Pivot Height	B	19.9 - 20.5 in	20.1
H-Point Height	C	3.3 - 3.5 in	3.4
H-Point from Backline	D	5.3 - 5.5 in	5.5
Shoulder Pivot from Backline	E	3.3 - 3.7 in	3.7
Thigh Clearance	F	5.5 - 6.1 in	6.0
Back of Elbow to Wrist Pivot	G	11.4 - 12.0 in	11.5
Skull Cap to Backline	H	1.6 - 1.8 in	1.7
Shoulder - Elbow Length	I	13.0 - 13.6 in	13.2
Elbow Rest Height	J	7.5 - 8.3 in	8.1
Buttock Knee Length	K	22.8 - 23.8 in	23.5
Popliteal Height	L	16.9 - 17.9 in	17.8
Knee Pivot Height	M	19.1 - 19.7 in	19.5
Buttock Popliteal Length	N	17.8 - 18.8 in	18.4
Chest Depth	O	8.4 - 9.0 in	9.0
Foot Length	P	9.9 - 10.5 in	10.2
Shoulder Breadth	V	16.6 - 17.2 in	16.9
Foot Breadth	W	3.6 - 4.2 in	4.0
Chest Circumference (With Jacket)	Y	38.2 - 39.4 in	39.0
