**REPORT NUMBER: SNCAP-CAL-06-02**

**NEW CAR ASSESSMENT PROGRAM  
SIDE IMPACT TEST**

**HYUNDAI MOTOR COMPANY  
2006 HYUNDAI SONATA GL  
4-DOOR SEDAN**

**FINAL REPORT**

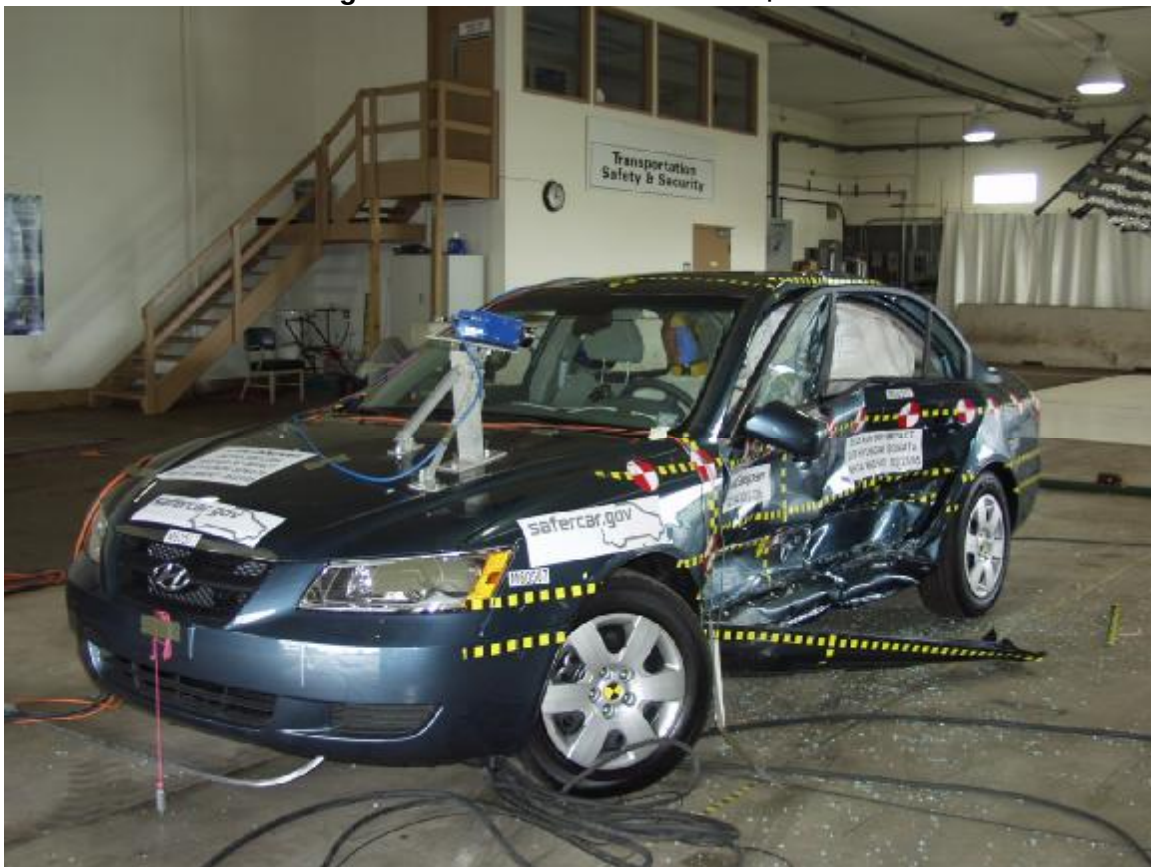
**Figure A-8: Post-Test Left Front  $\frac{3}{4}$  View**

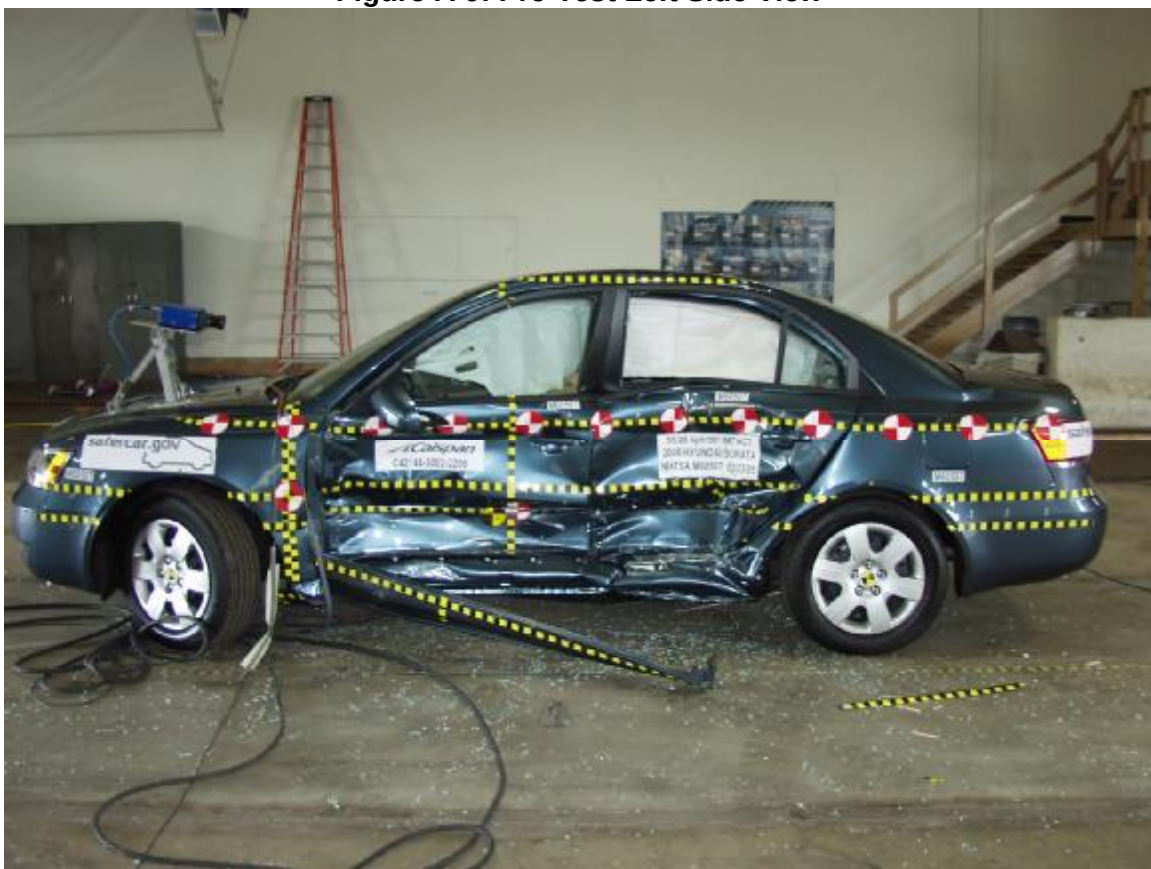
**Figure A-10: Post-Test Left Side View**

The test vehicle sustained a maximum static crush of 350 mm at level 2, 1350 mm rearward of the left vertical impact point. The driver and passenger SID/HIII's, Serial Nos. 905 and 906 respectively, were calibrated just prior to this test.

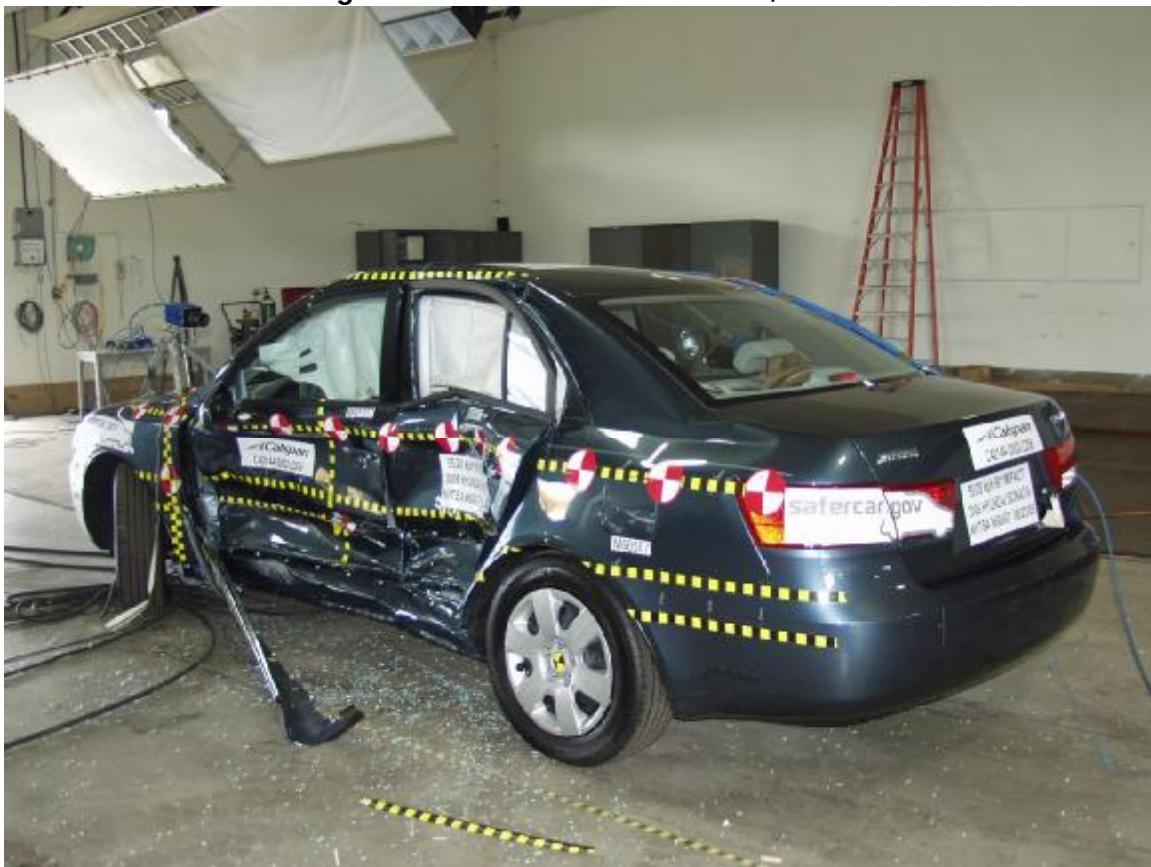
**Figure A-12: Post-Test Left Rear  $\frac{3}{4}$  View**

| Critical Areas of Performance | Observations and Conclusions |
|---|---|
| Window Damage | Left rear passenger window shattered |

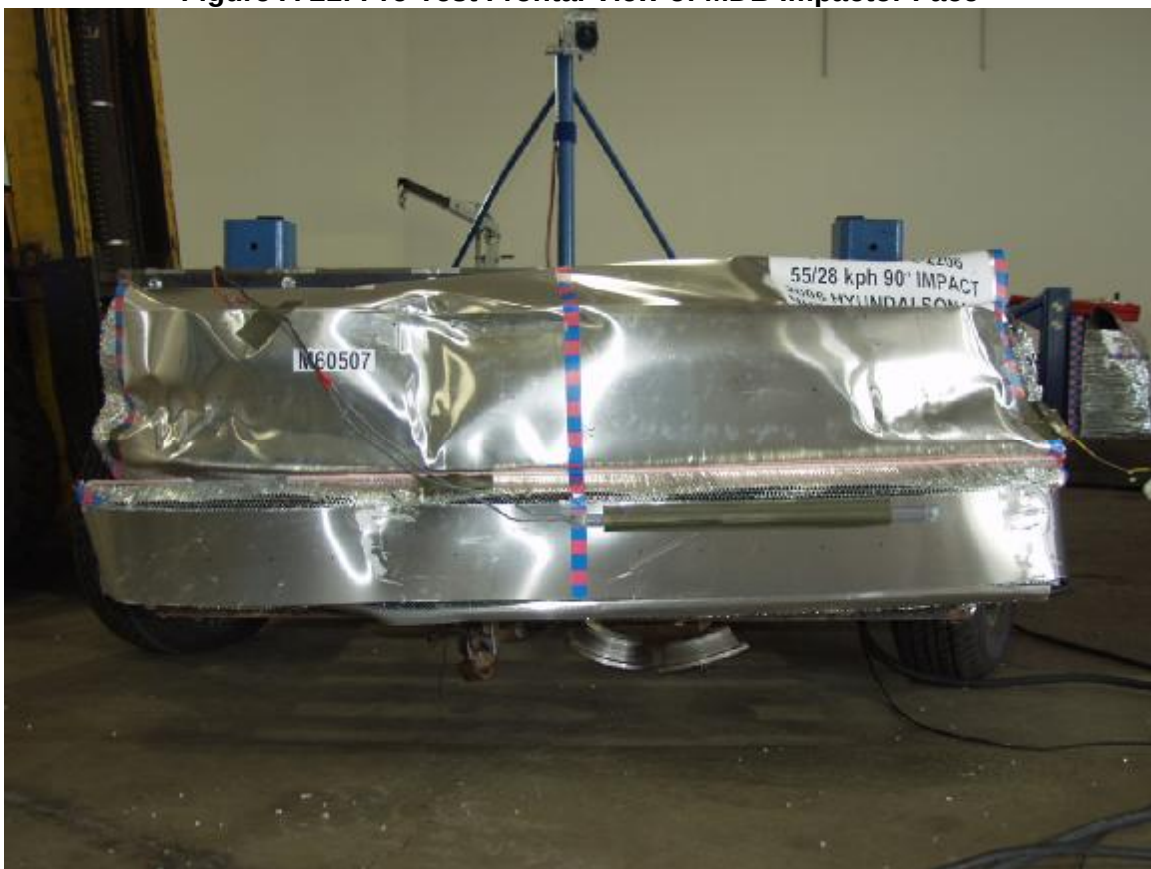
**Figure A-22: Post-Test Frontal View of MDB Impactor Face**

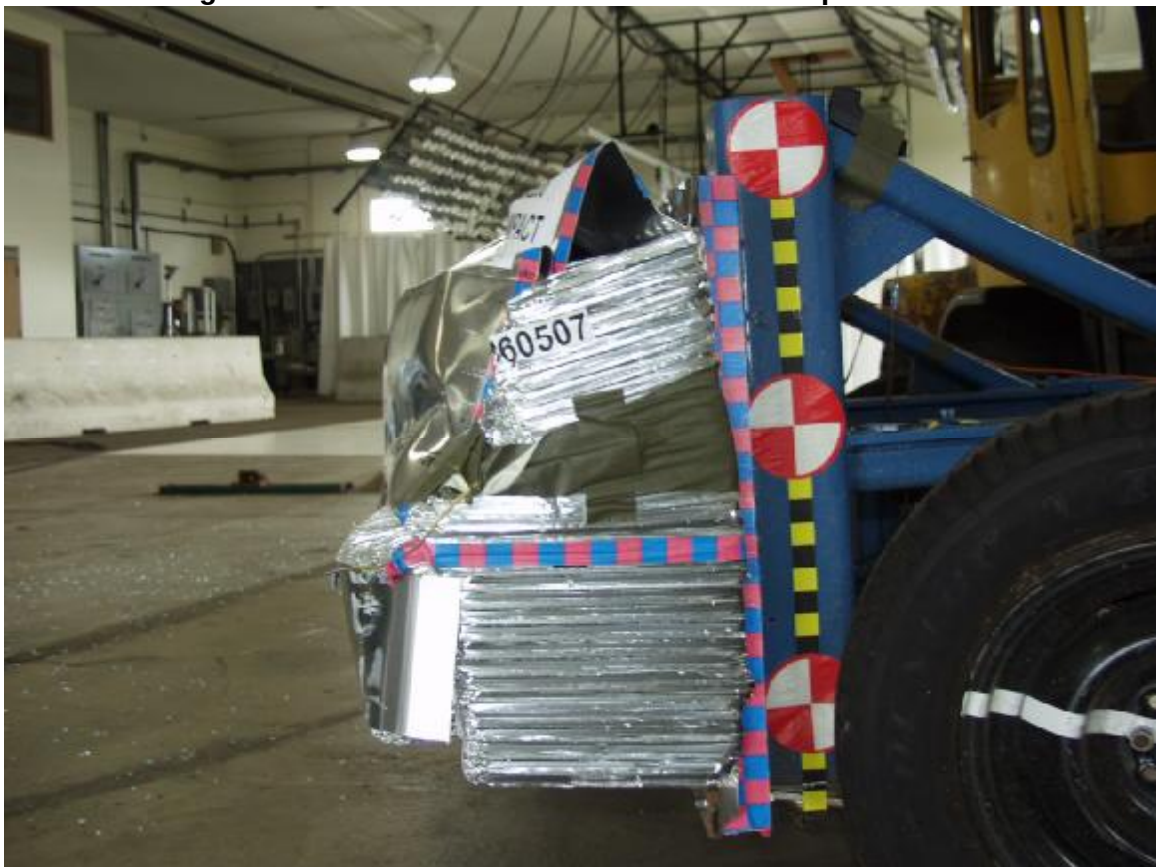
**Figure A-24: Post-Test Left Side View of MDB Impactor Face**

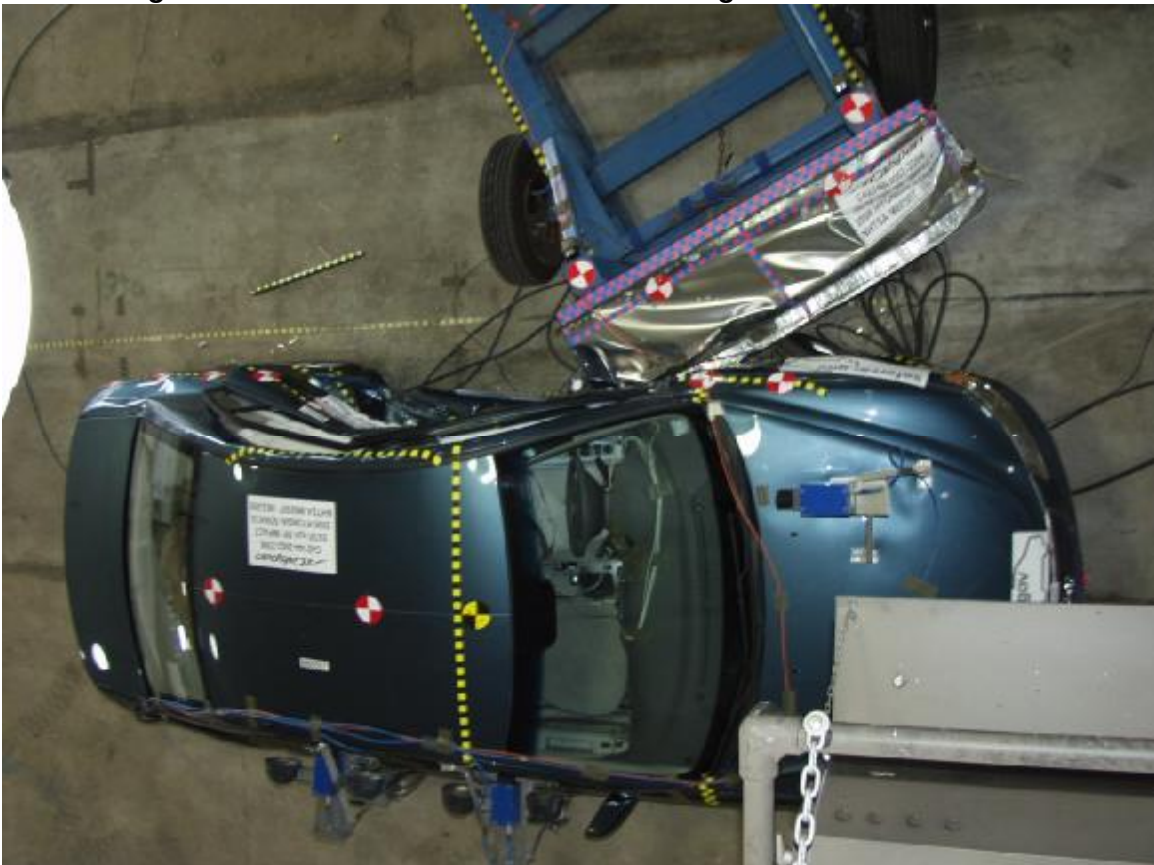
**Figure A-32: Post-Test Overhead View of MDB and Vehicle**

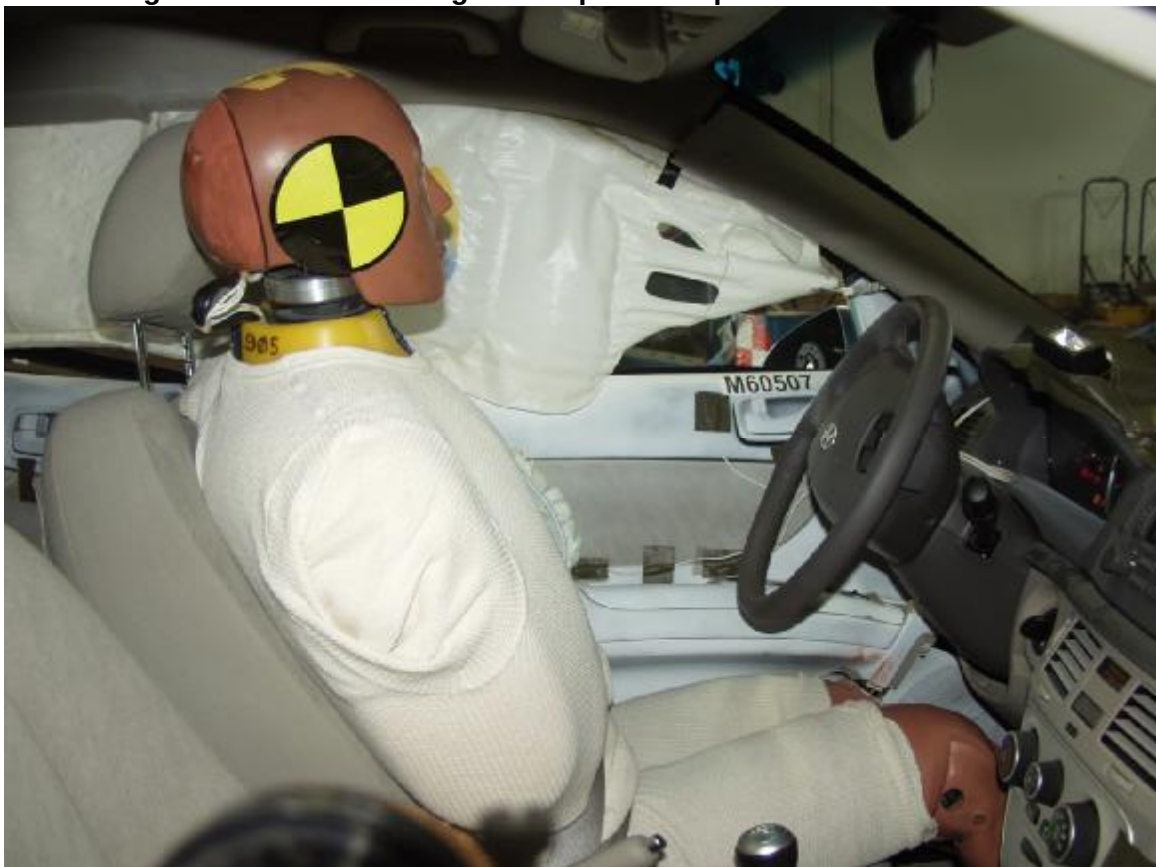
**Figure A-36: Post-Test Right Occupant Compartment View of Driver**

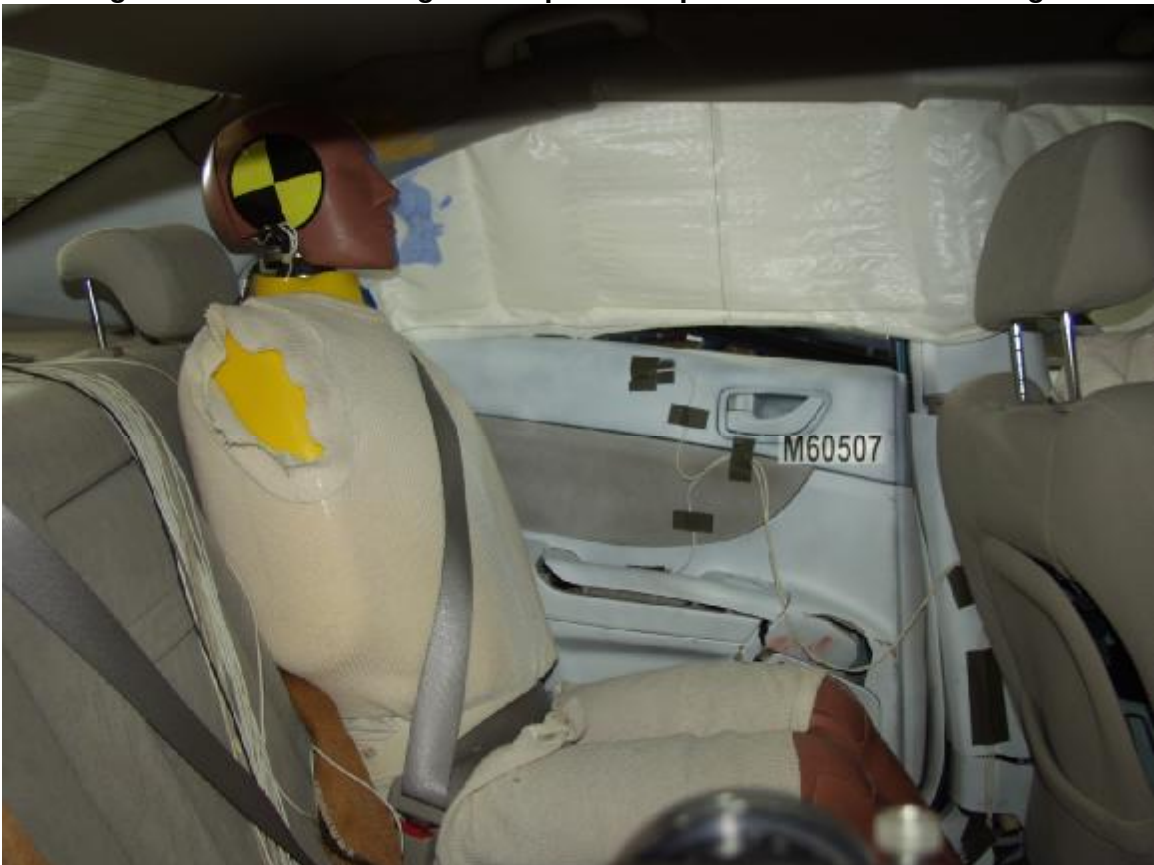
**Figure A-38: Post-Test Right Occupant Compartment View of Passenger**

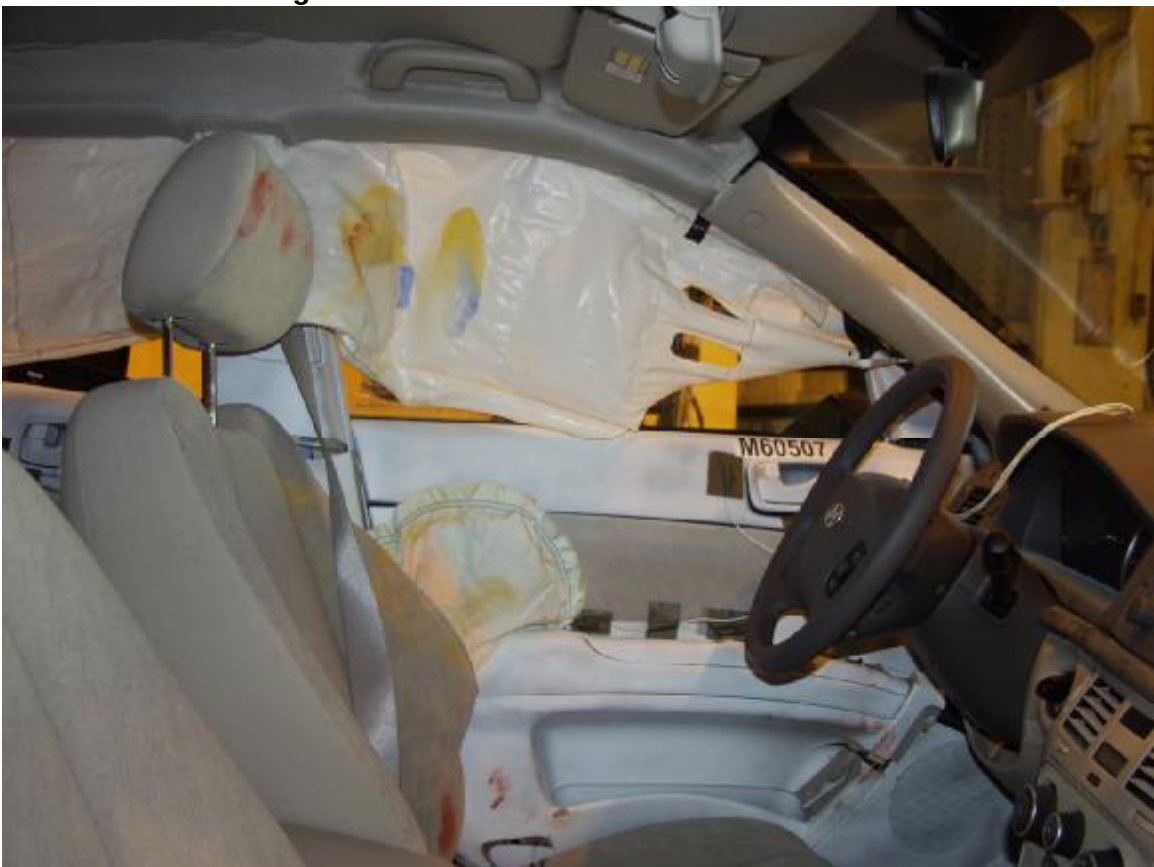
**Figure A-44: Post-Test Left Front Interior Trim**

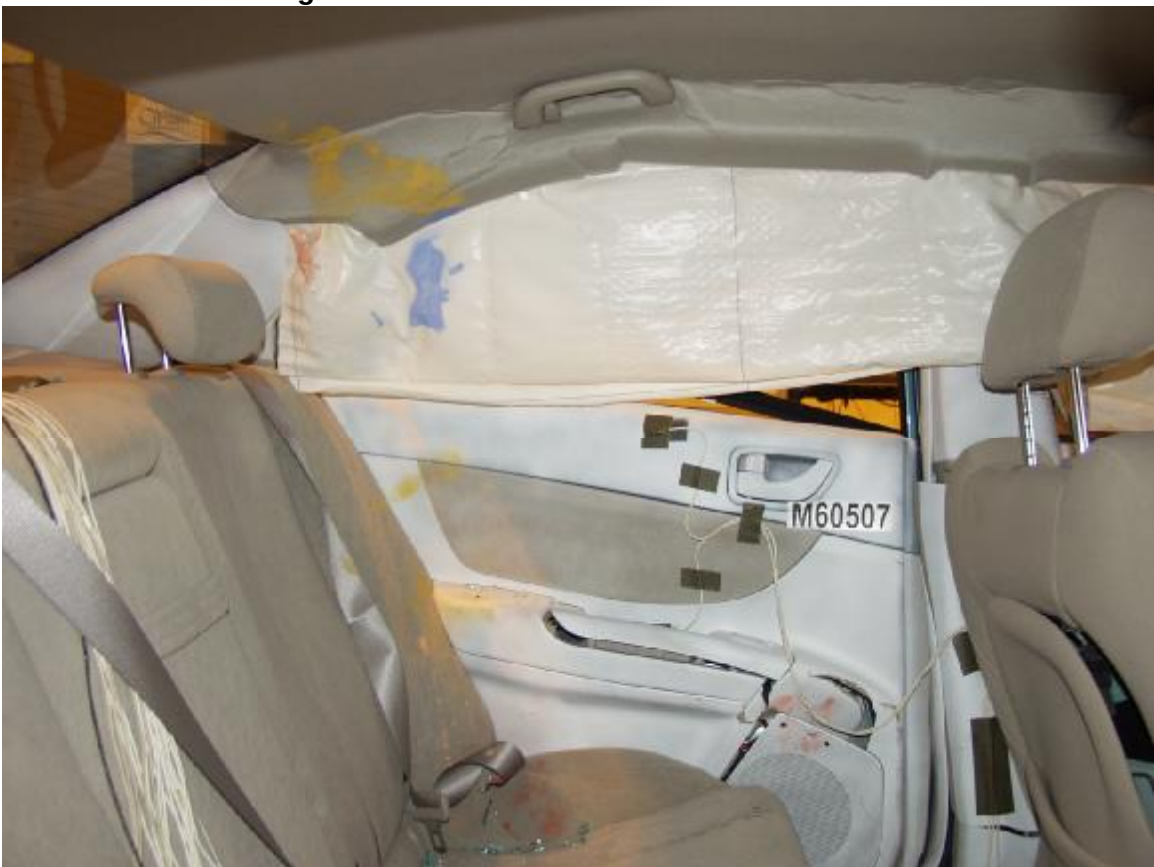
**Figure A-46: Post-Test Left Rear Interior Trim**

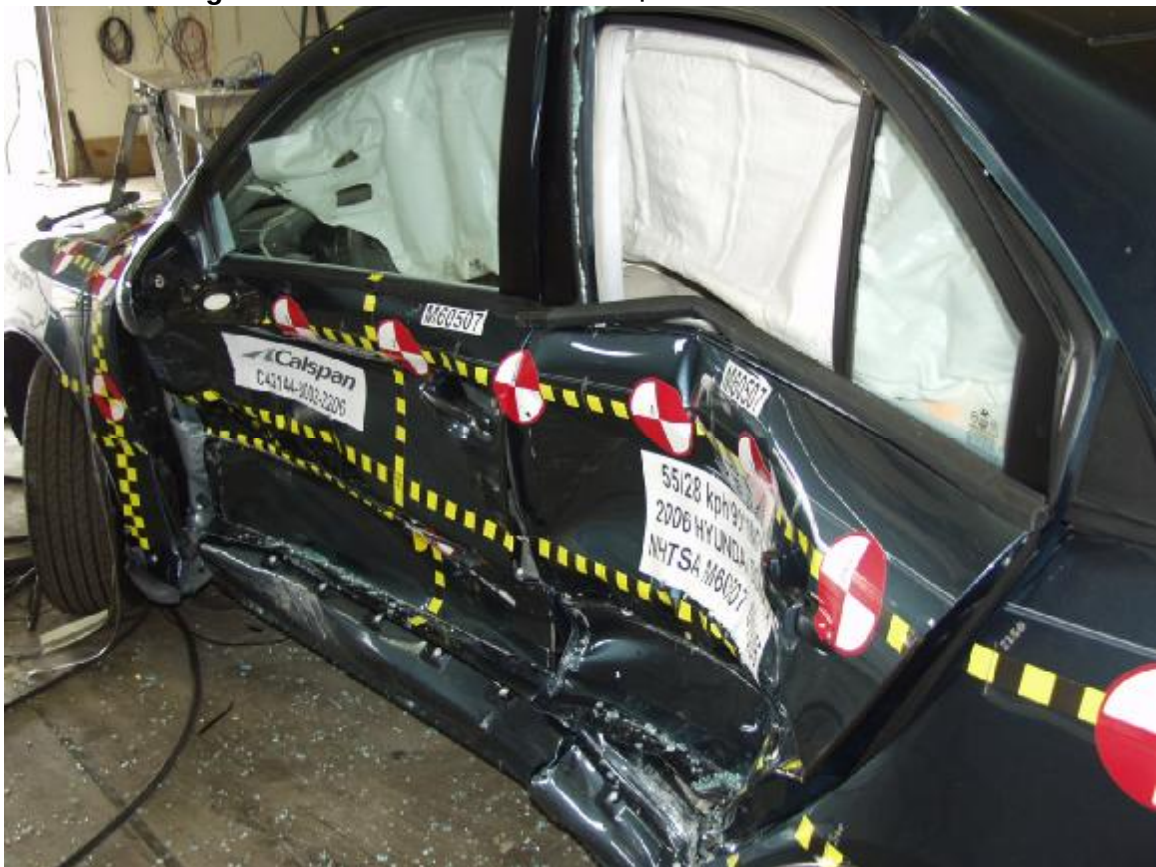
**Figure A-50: Post-Test Left Rear  $\frac{3}{4}$  View of Left Side Doors**
