**NEW CAR ASSESSMENT PROGRAM  
FRONTAL BARRIER IMPACT TEST**

**FUJI HEAVY INDUSTRIES LTD.  
2006 SUBARU B9 TRIBECA  
5-DOOR MPV**

**NHTSA NUMBER: M65500**

**FINAL REPORT**

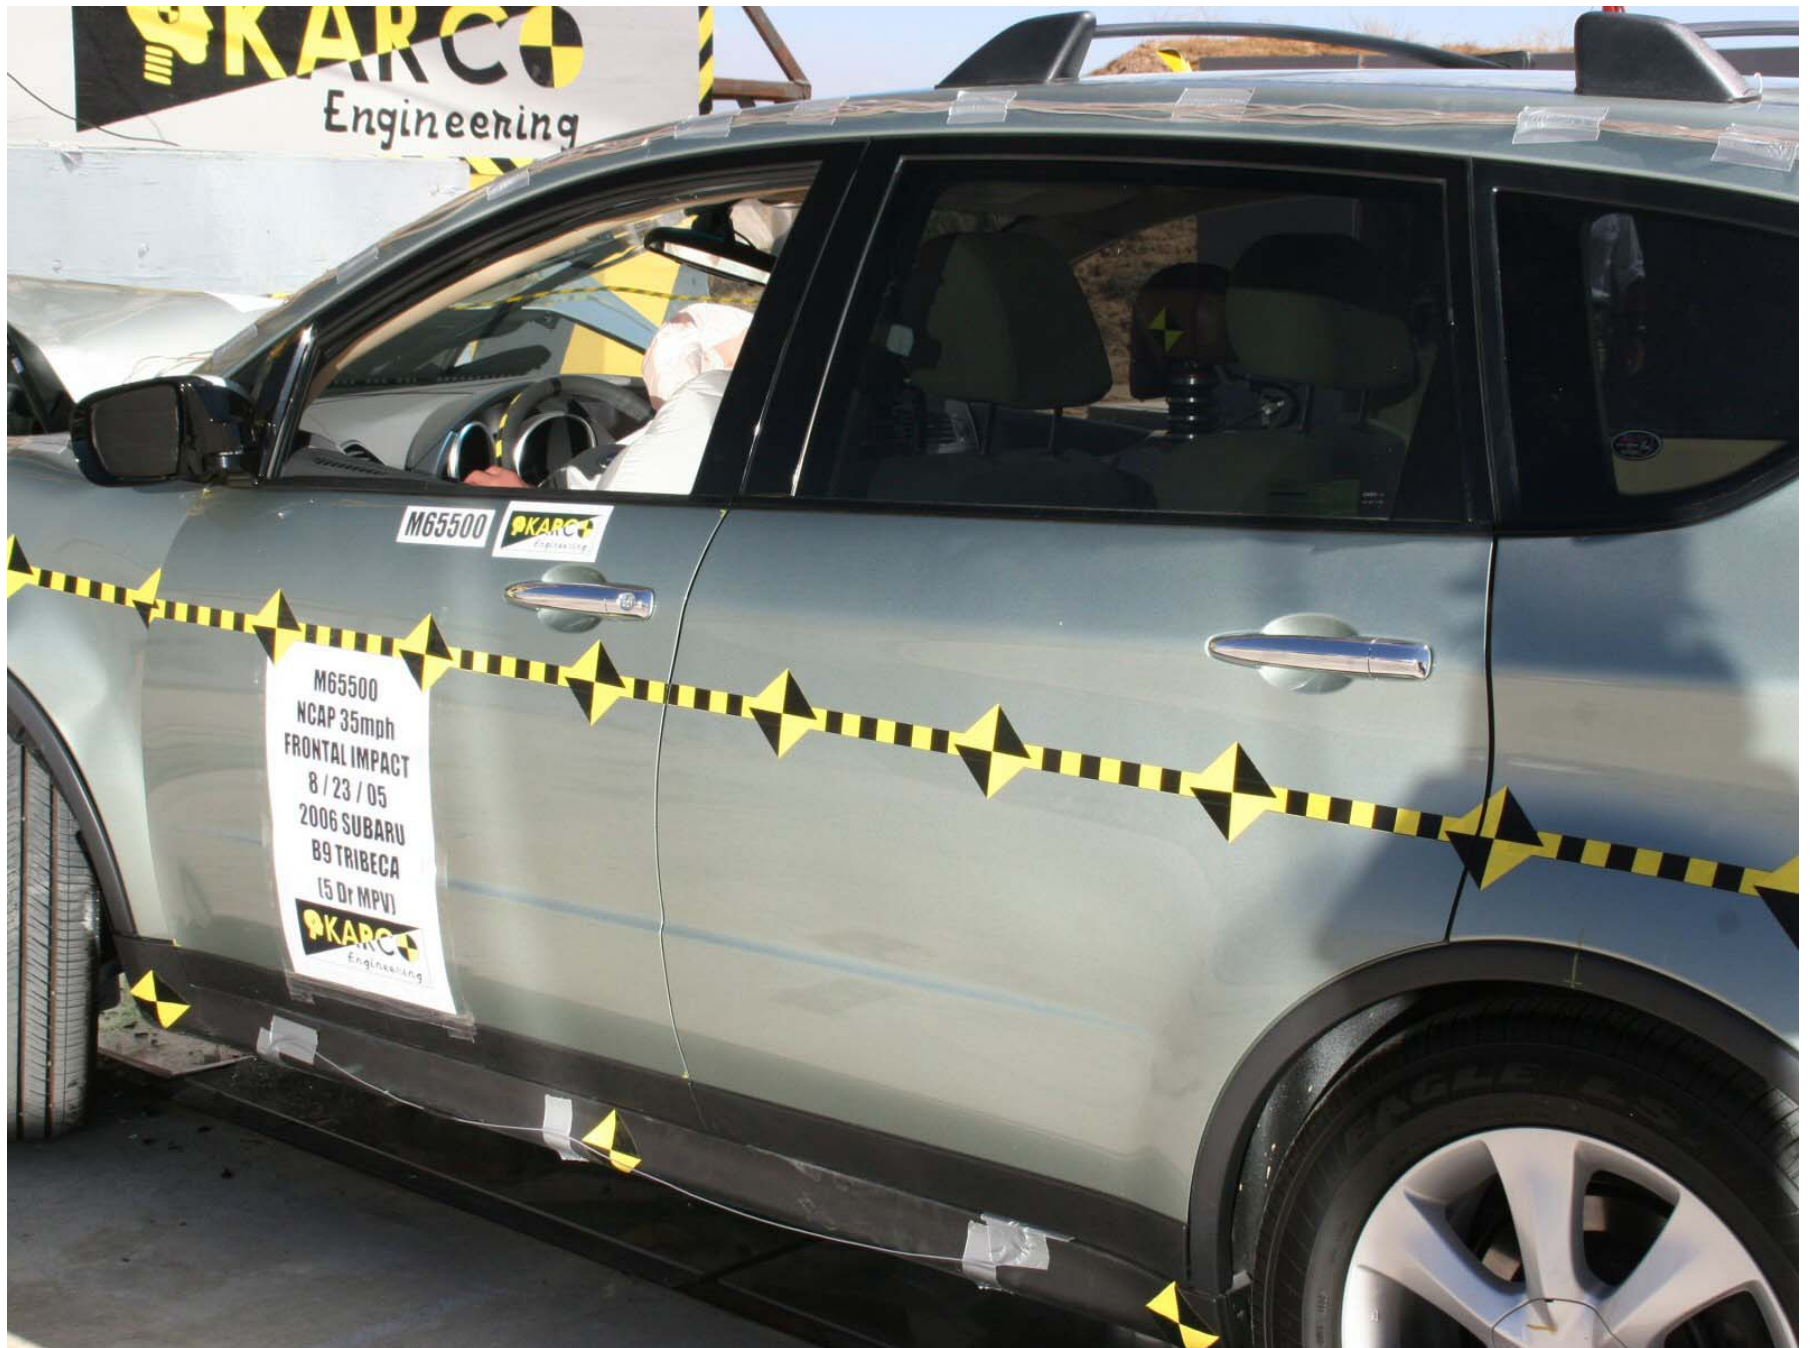
Figure A-16: Post-Test Left Side  $\frac{3}{4}$  View of Doors After Impact

The maximum static crush of the vehicle was 555 mm and both the driver and the passenger side doors remained closed and latched during the impact event and were operable after the impact.

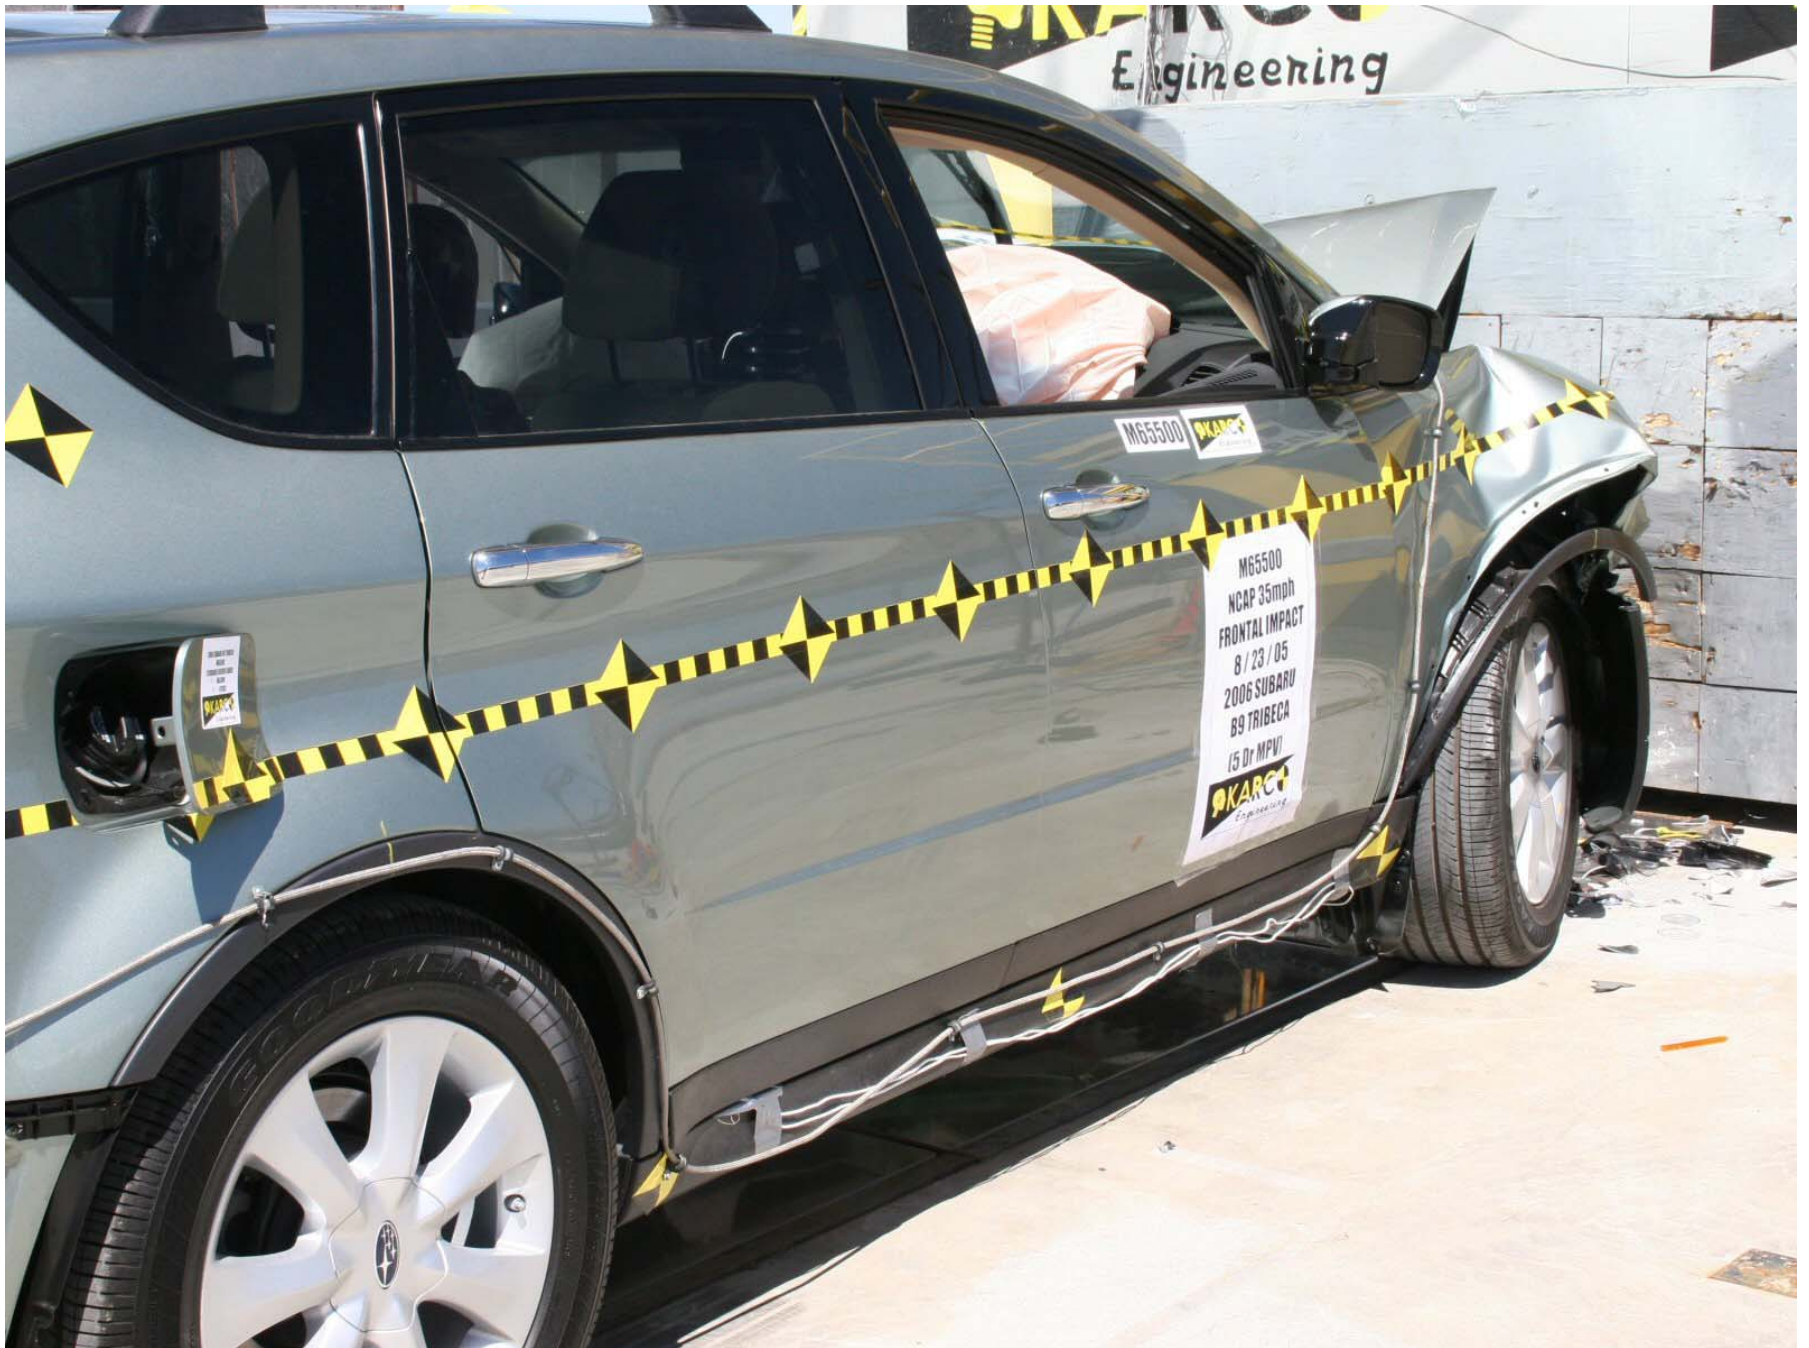
Figure A-17: Post-Test Right Side  $\frac{3}{4}$  View of Doors After Impact

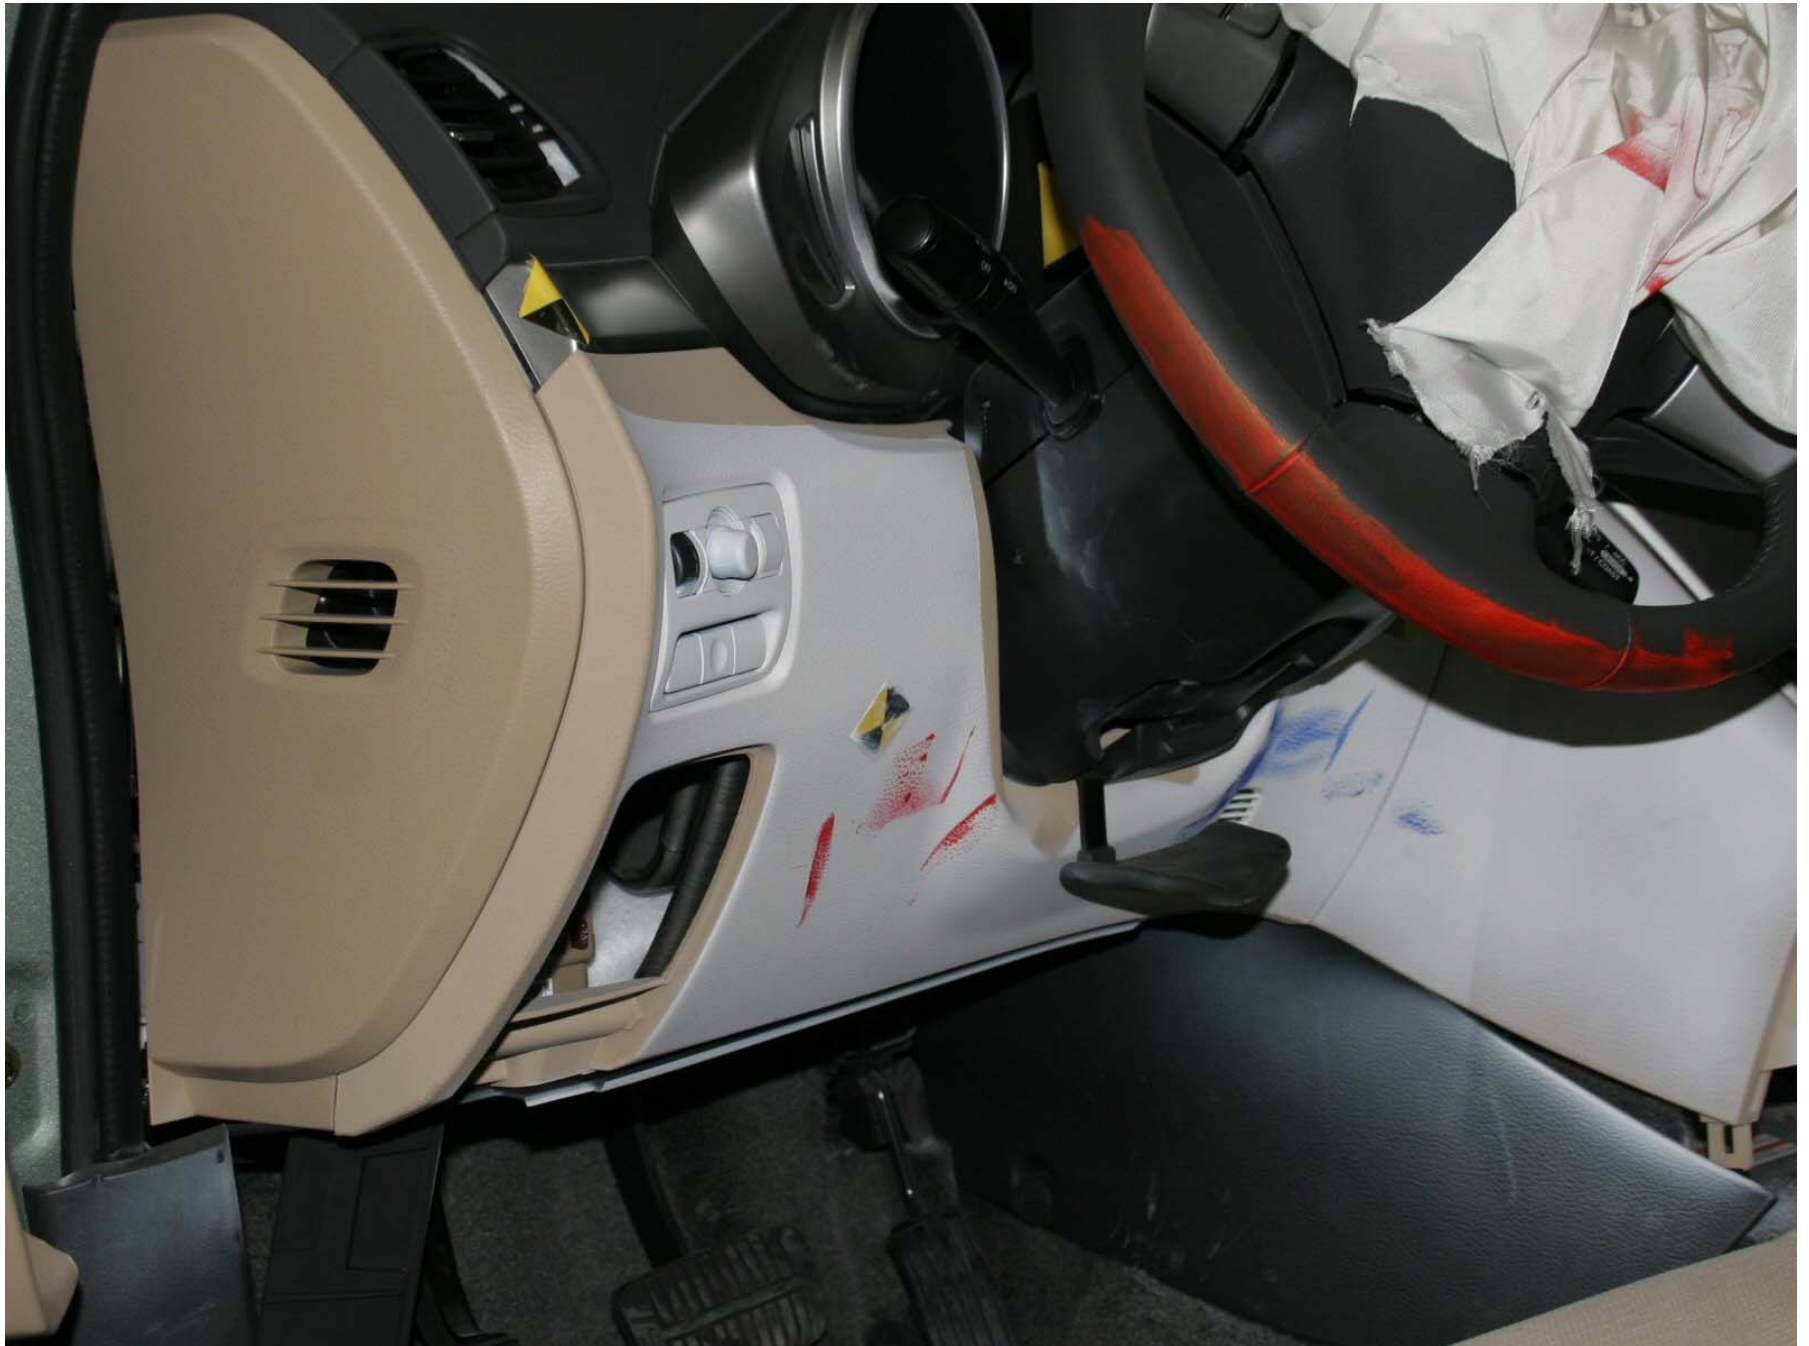
Figure A-39: Post-Test Driver Side Knee Bolster

The driver's visible contact points were as follows: The driver ATD's head contacted the airbag, its chest and abdomen had no contact. Both knees contacted the knee bolster.

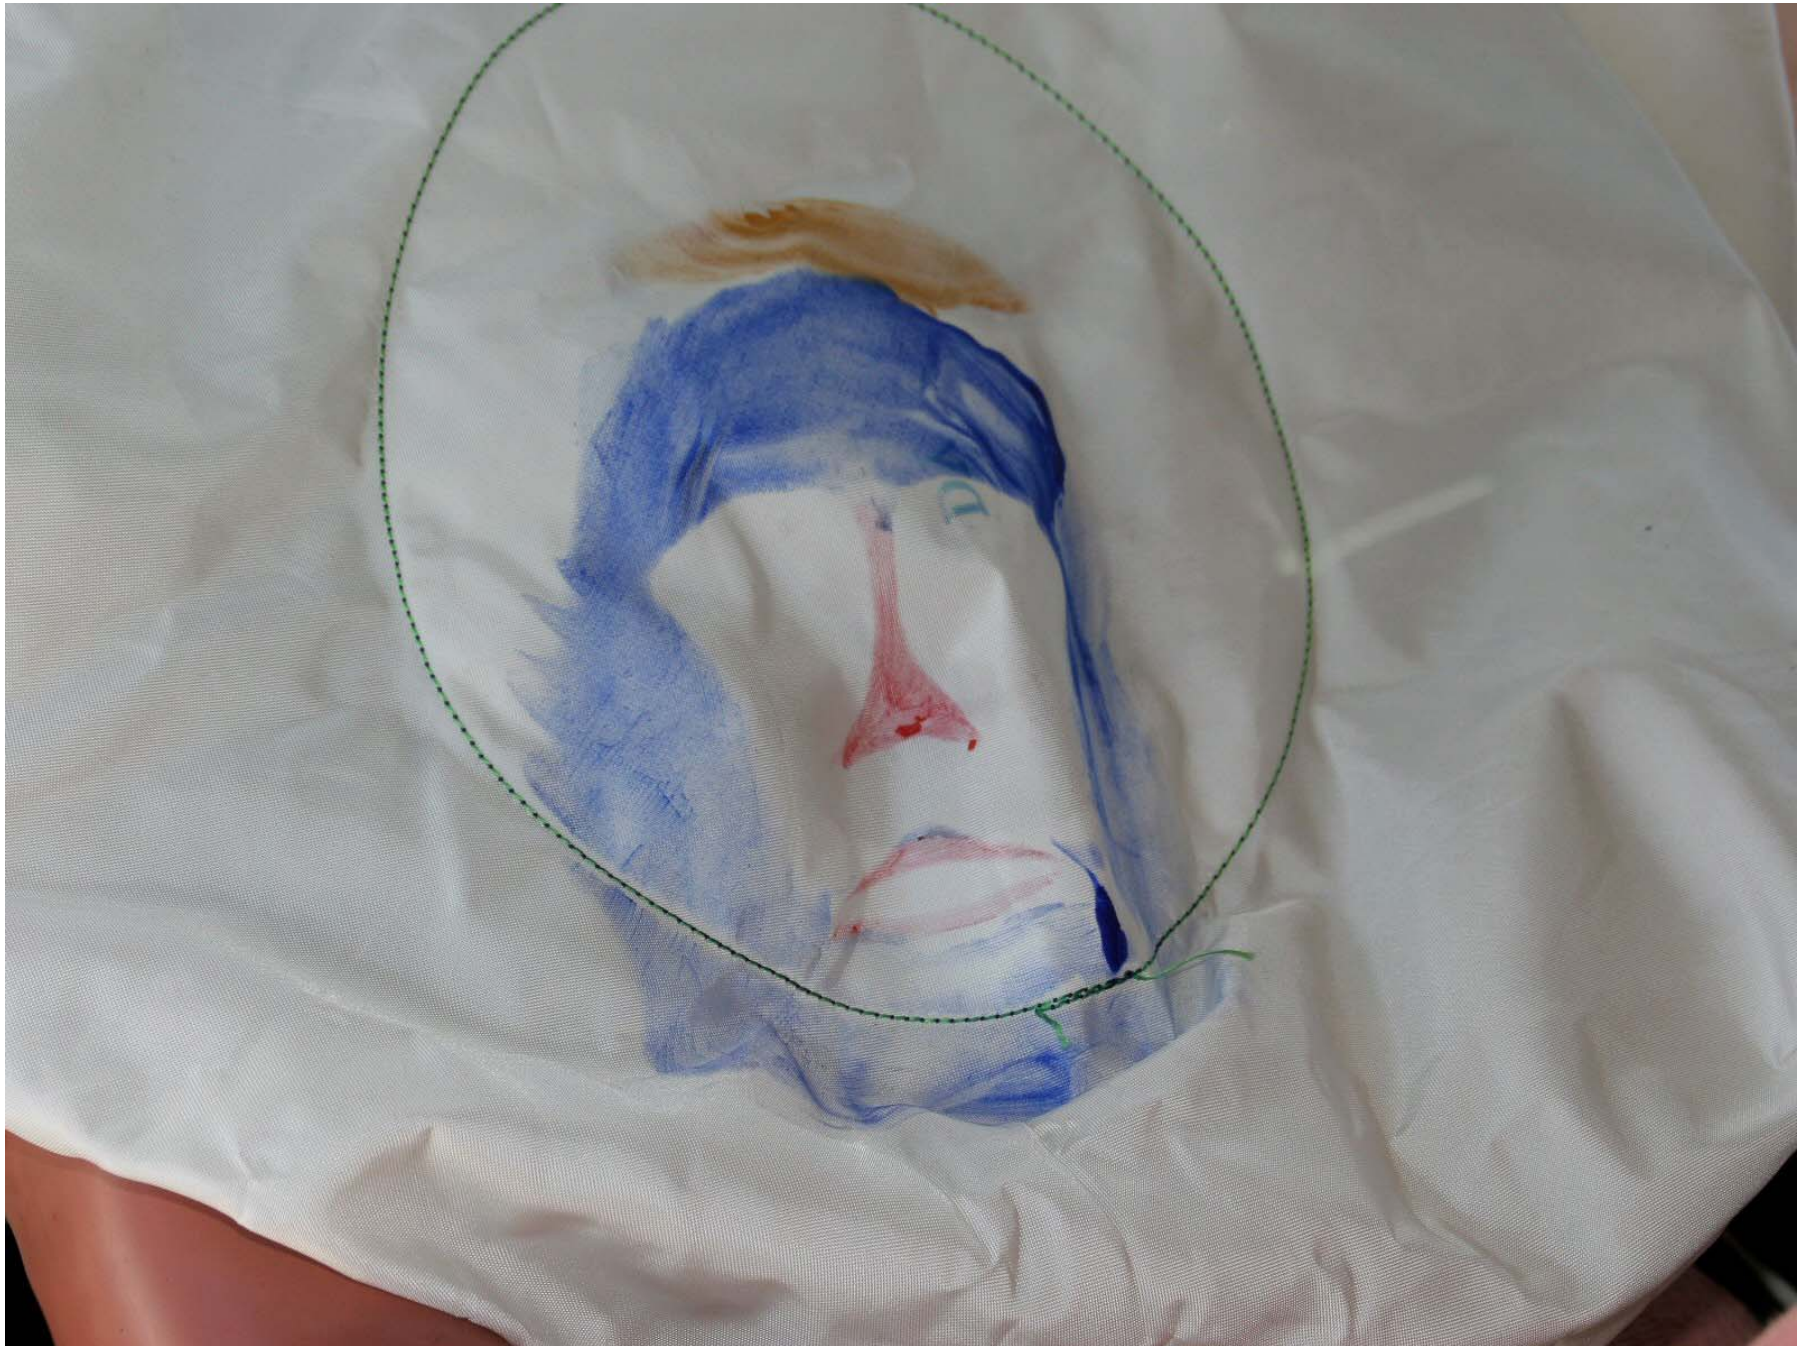
Figure A-43: Post-Test Driver Dummy Airbag Contact

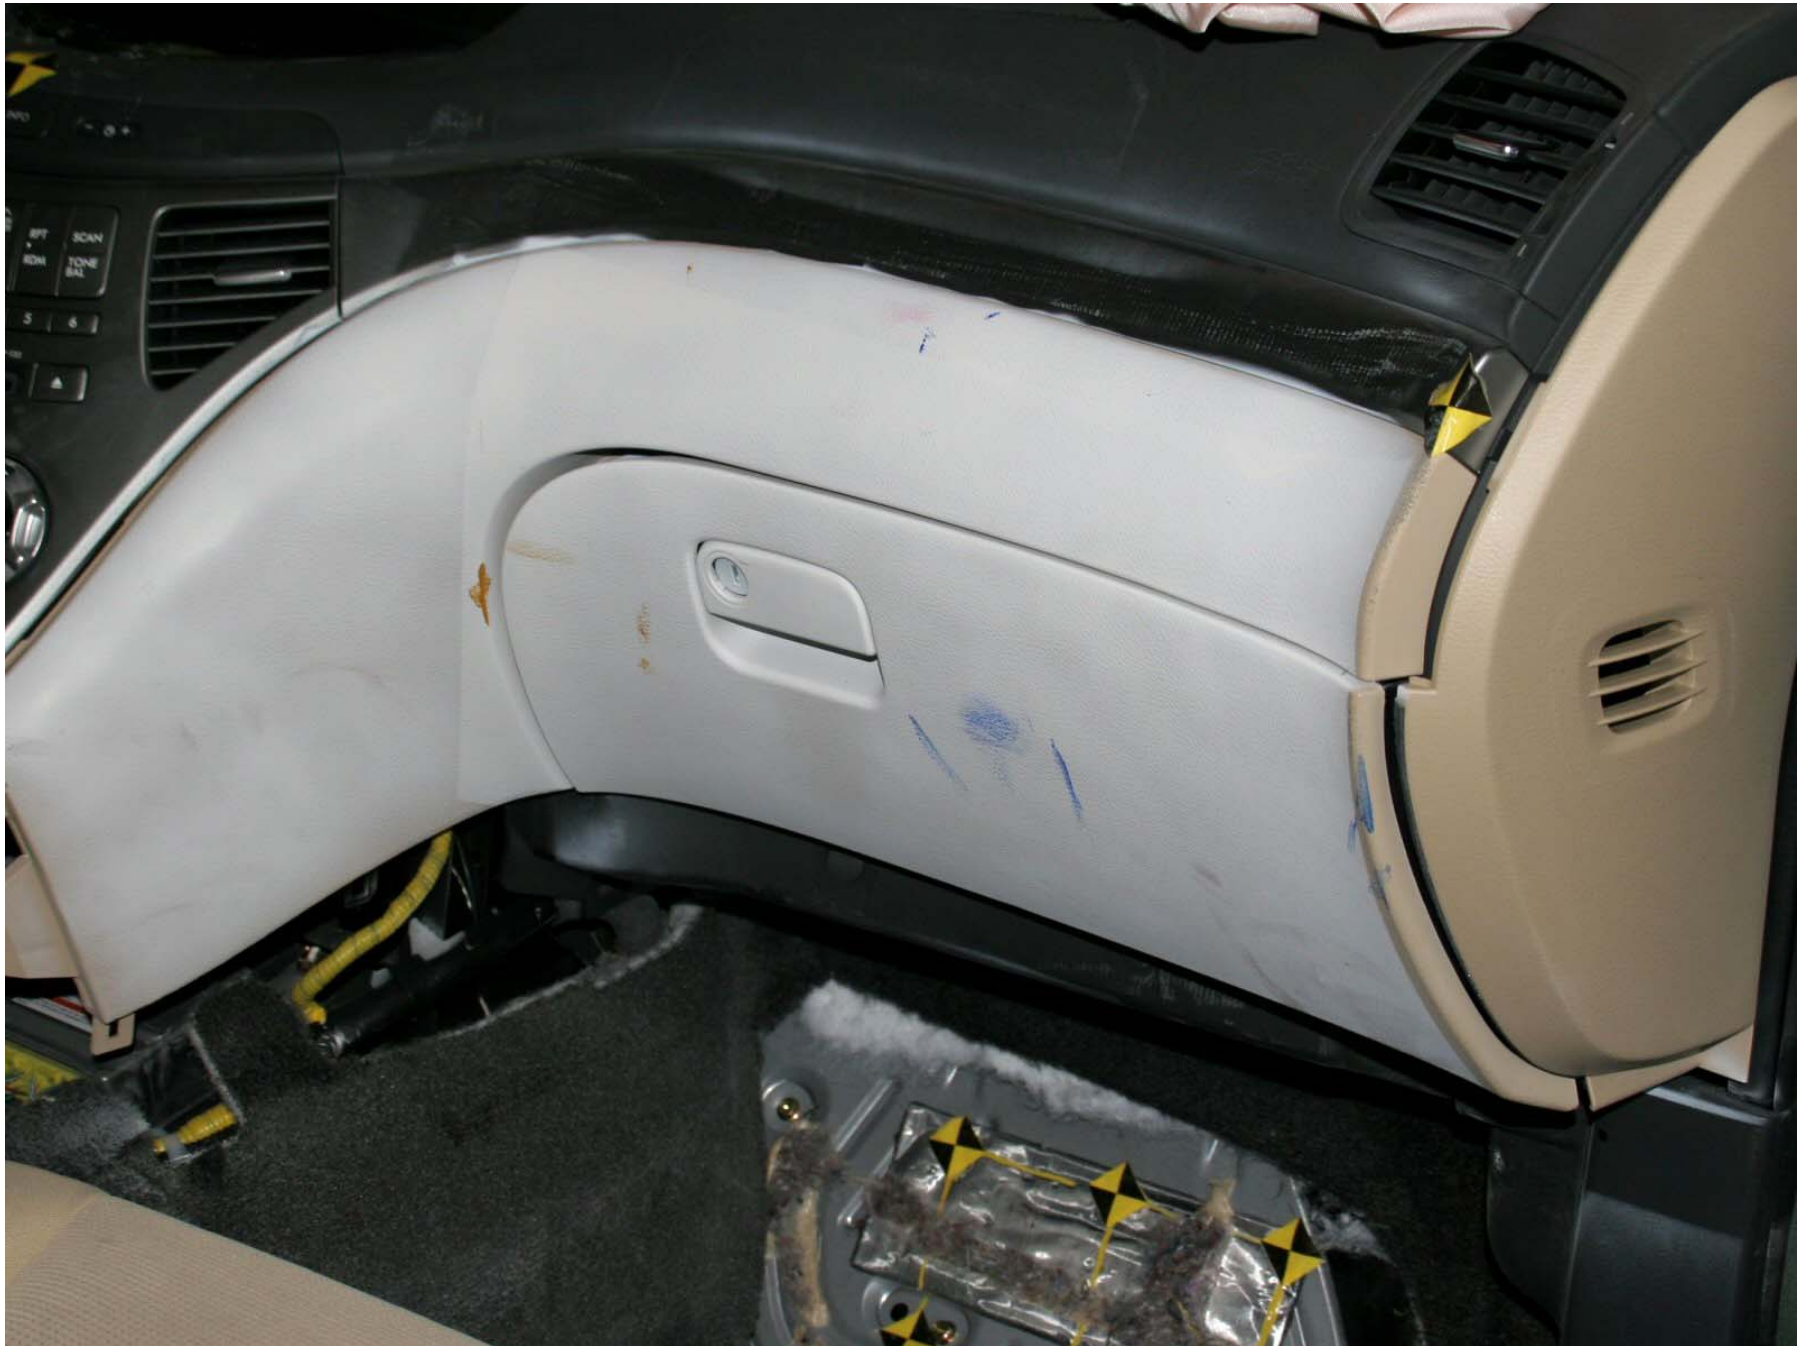
Figure A-53: Post-Test Passenger Side Glove Box

The passenger's visible contact points were as follows: The passenger ATD's head contacted the airbag. The chest contacted the airbag and the abdomen had no contact. Both knees contacted the glove box.

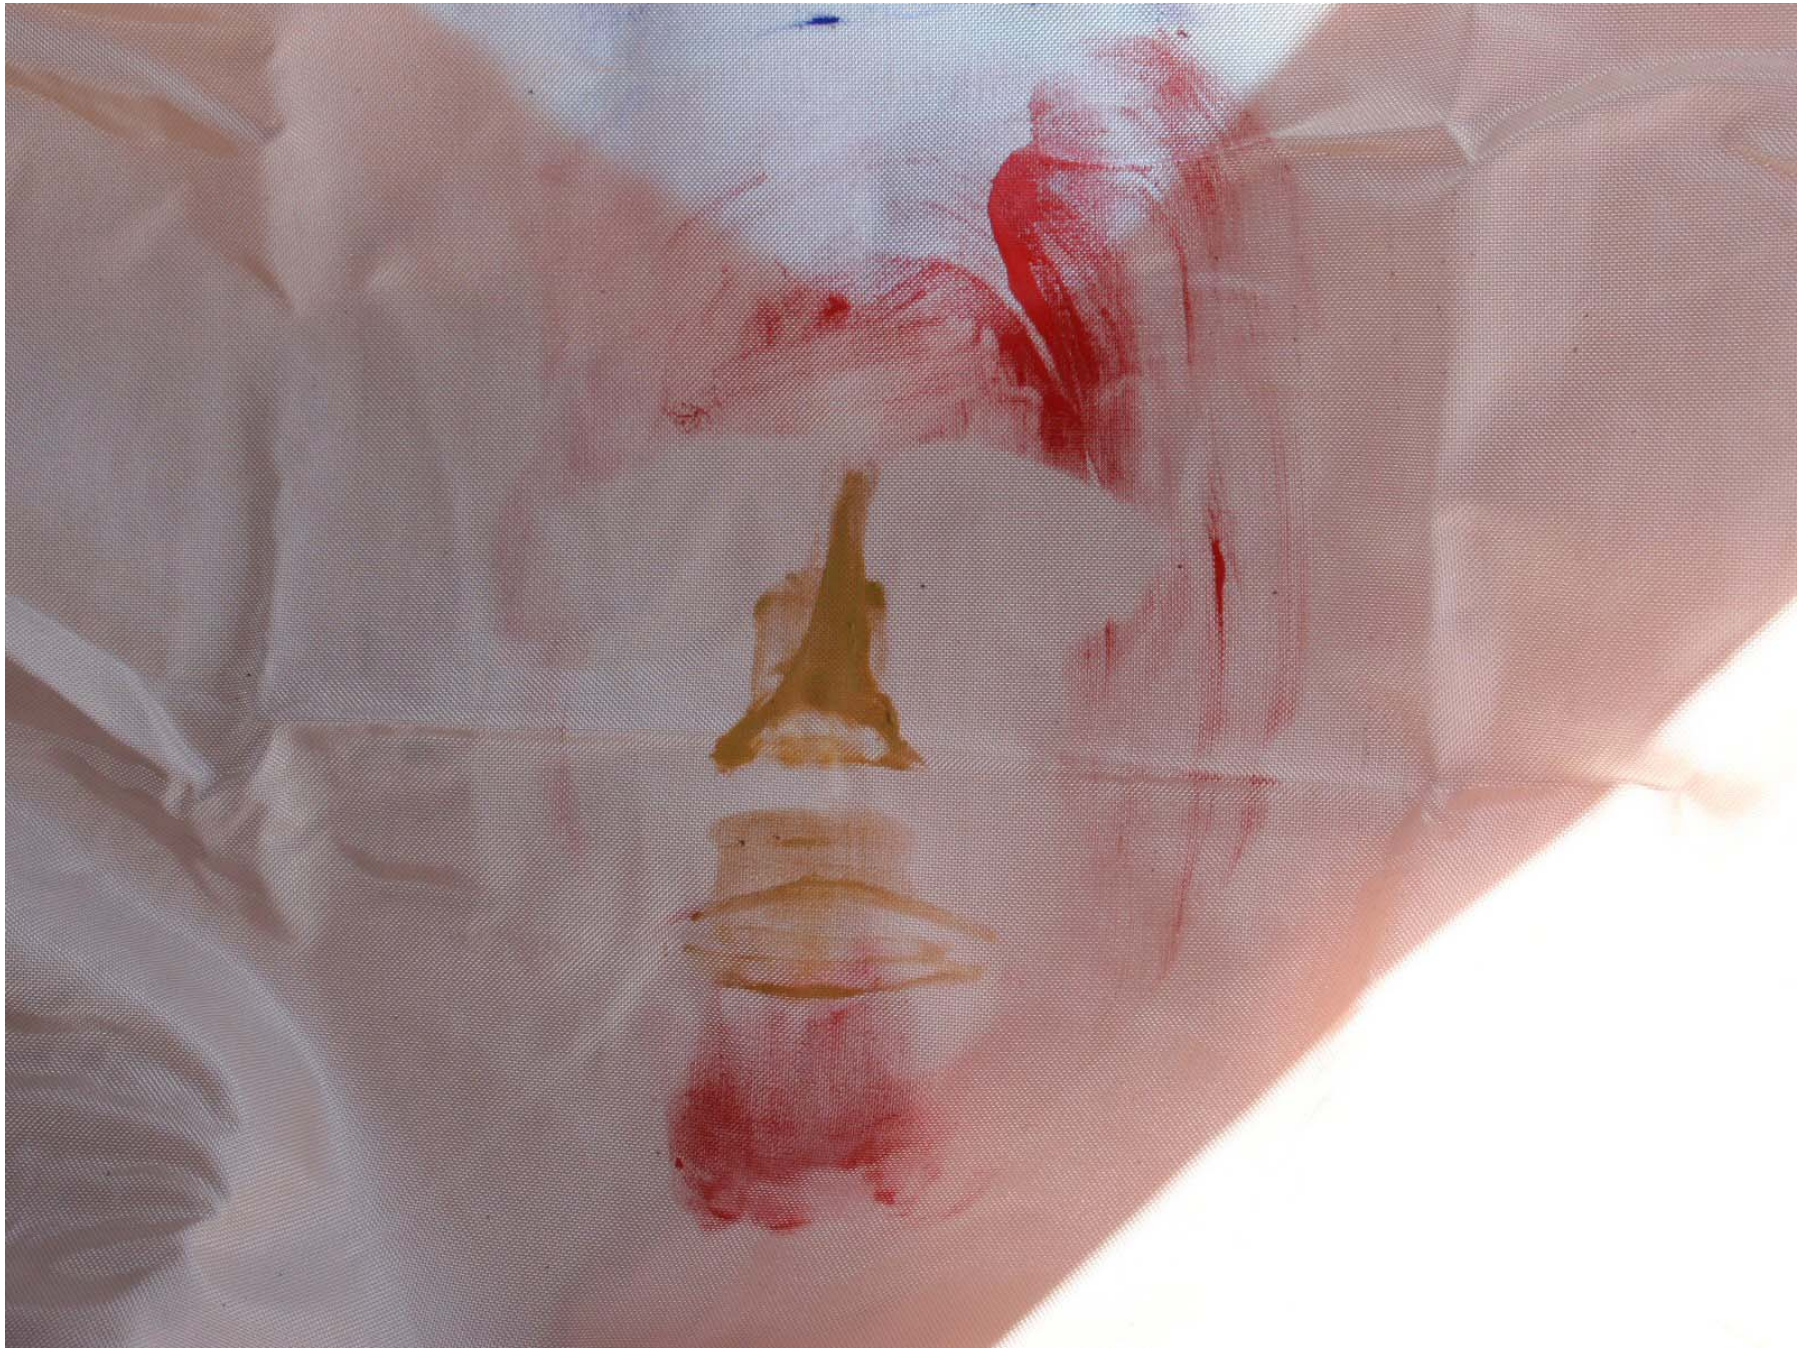
Figure A-57: Post-Test Passenger Dummy Airbag Contact
