**REPORT NUMBER: TO1-MGA-2004-026**

**FULL SCALE SIDE IMPACT TESTS**

**214 LEFT SIDE IMPACT  
DRIVER SIDIIIsD  
PASSENGER SIDIIIsD  
TEST DATE: August 9, 2005  
Task Order # T0001 / RFP # 0004**

**2005 SATURN ION  
NHTSA NUMBER # R50168**

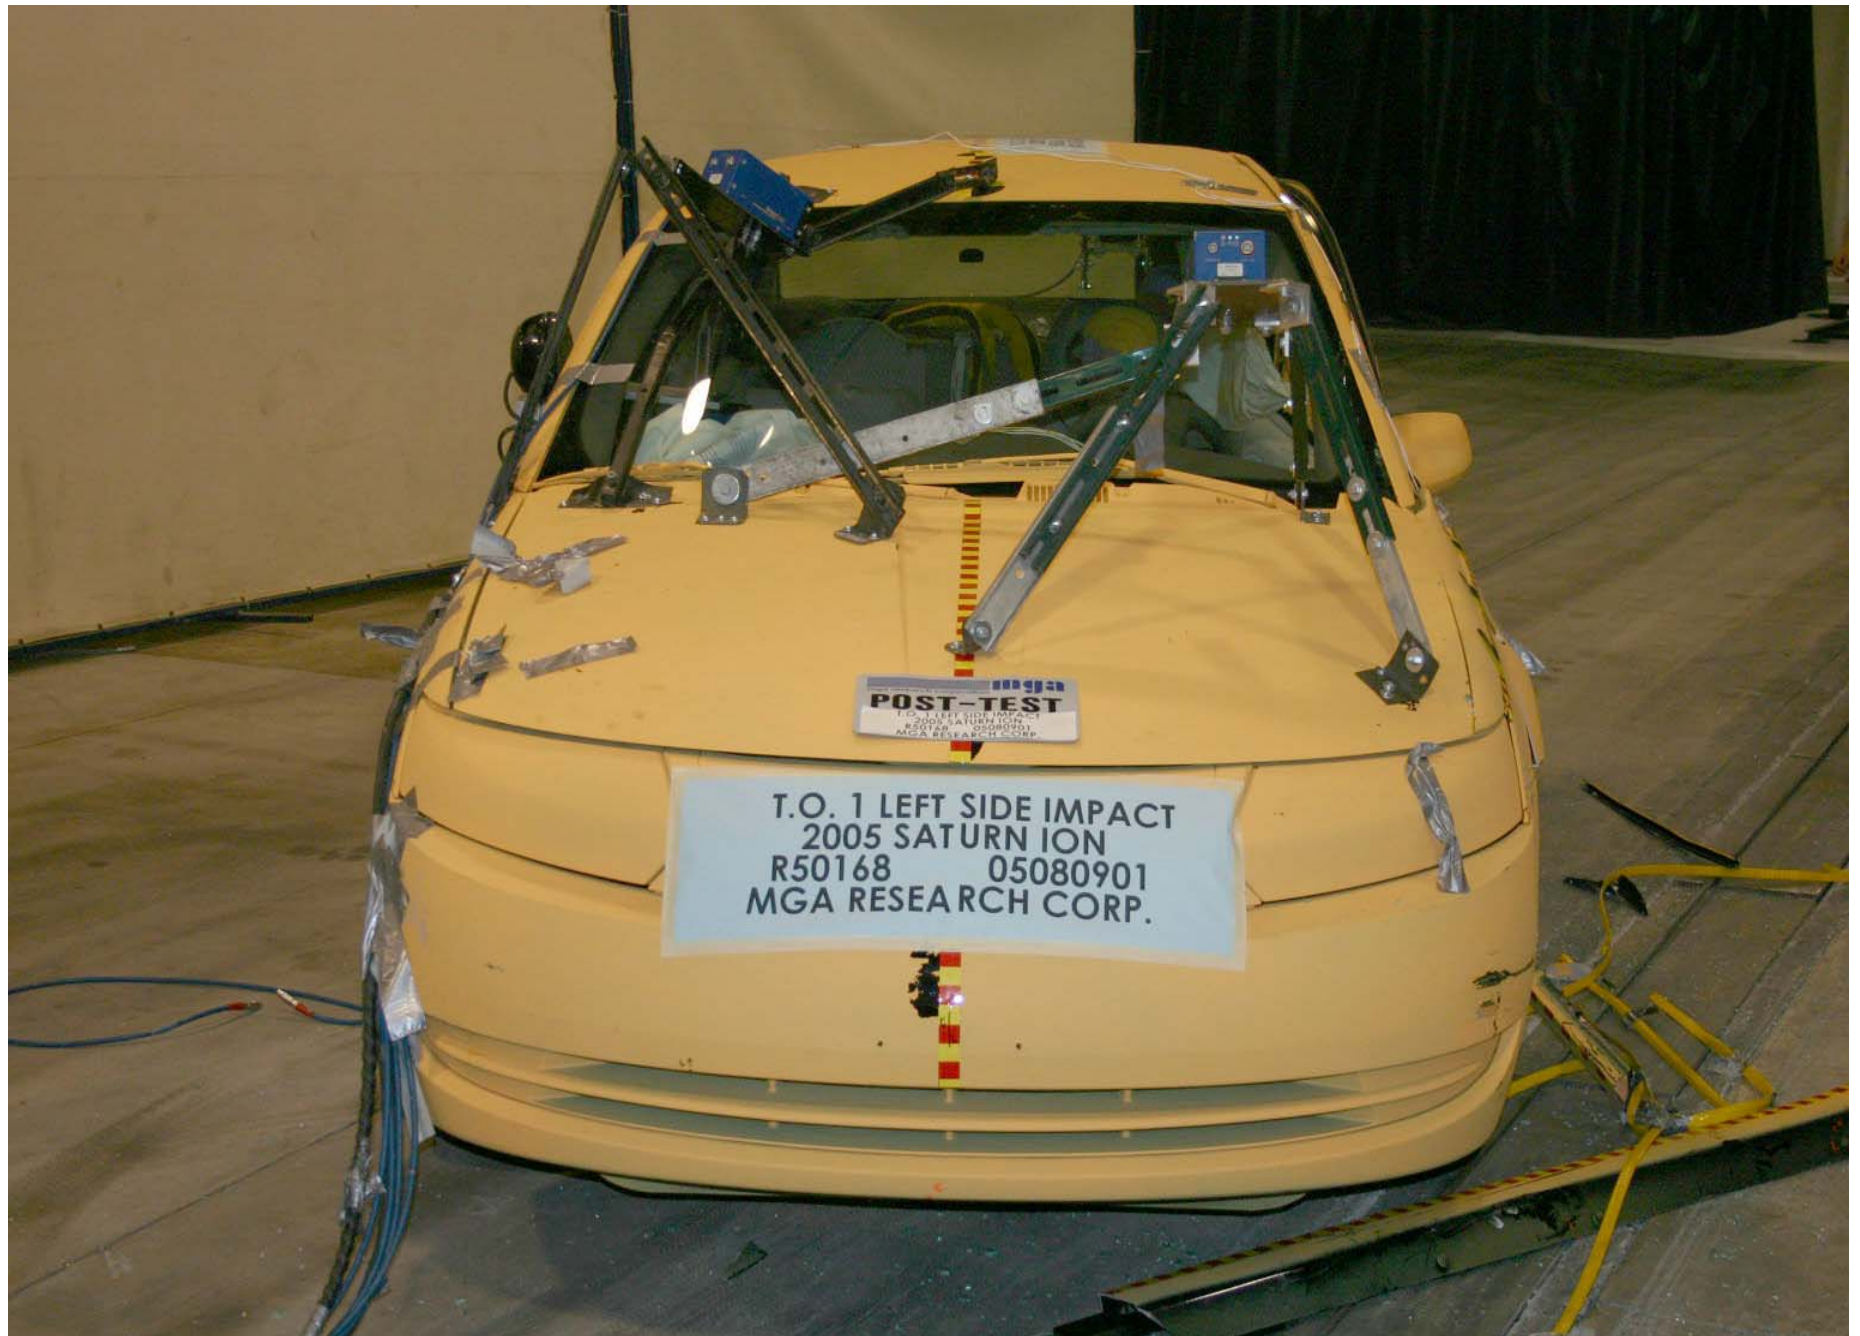
Post-Test Front View of Test Vehicle

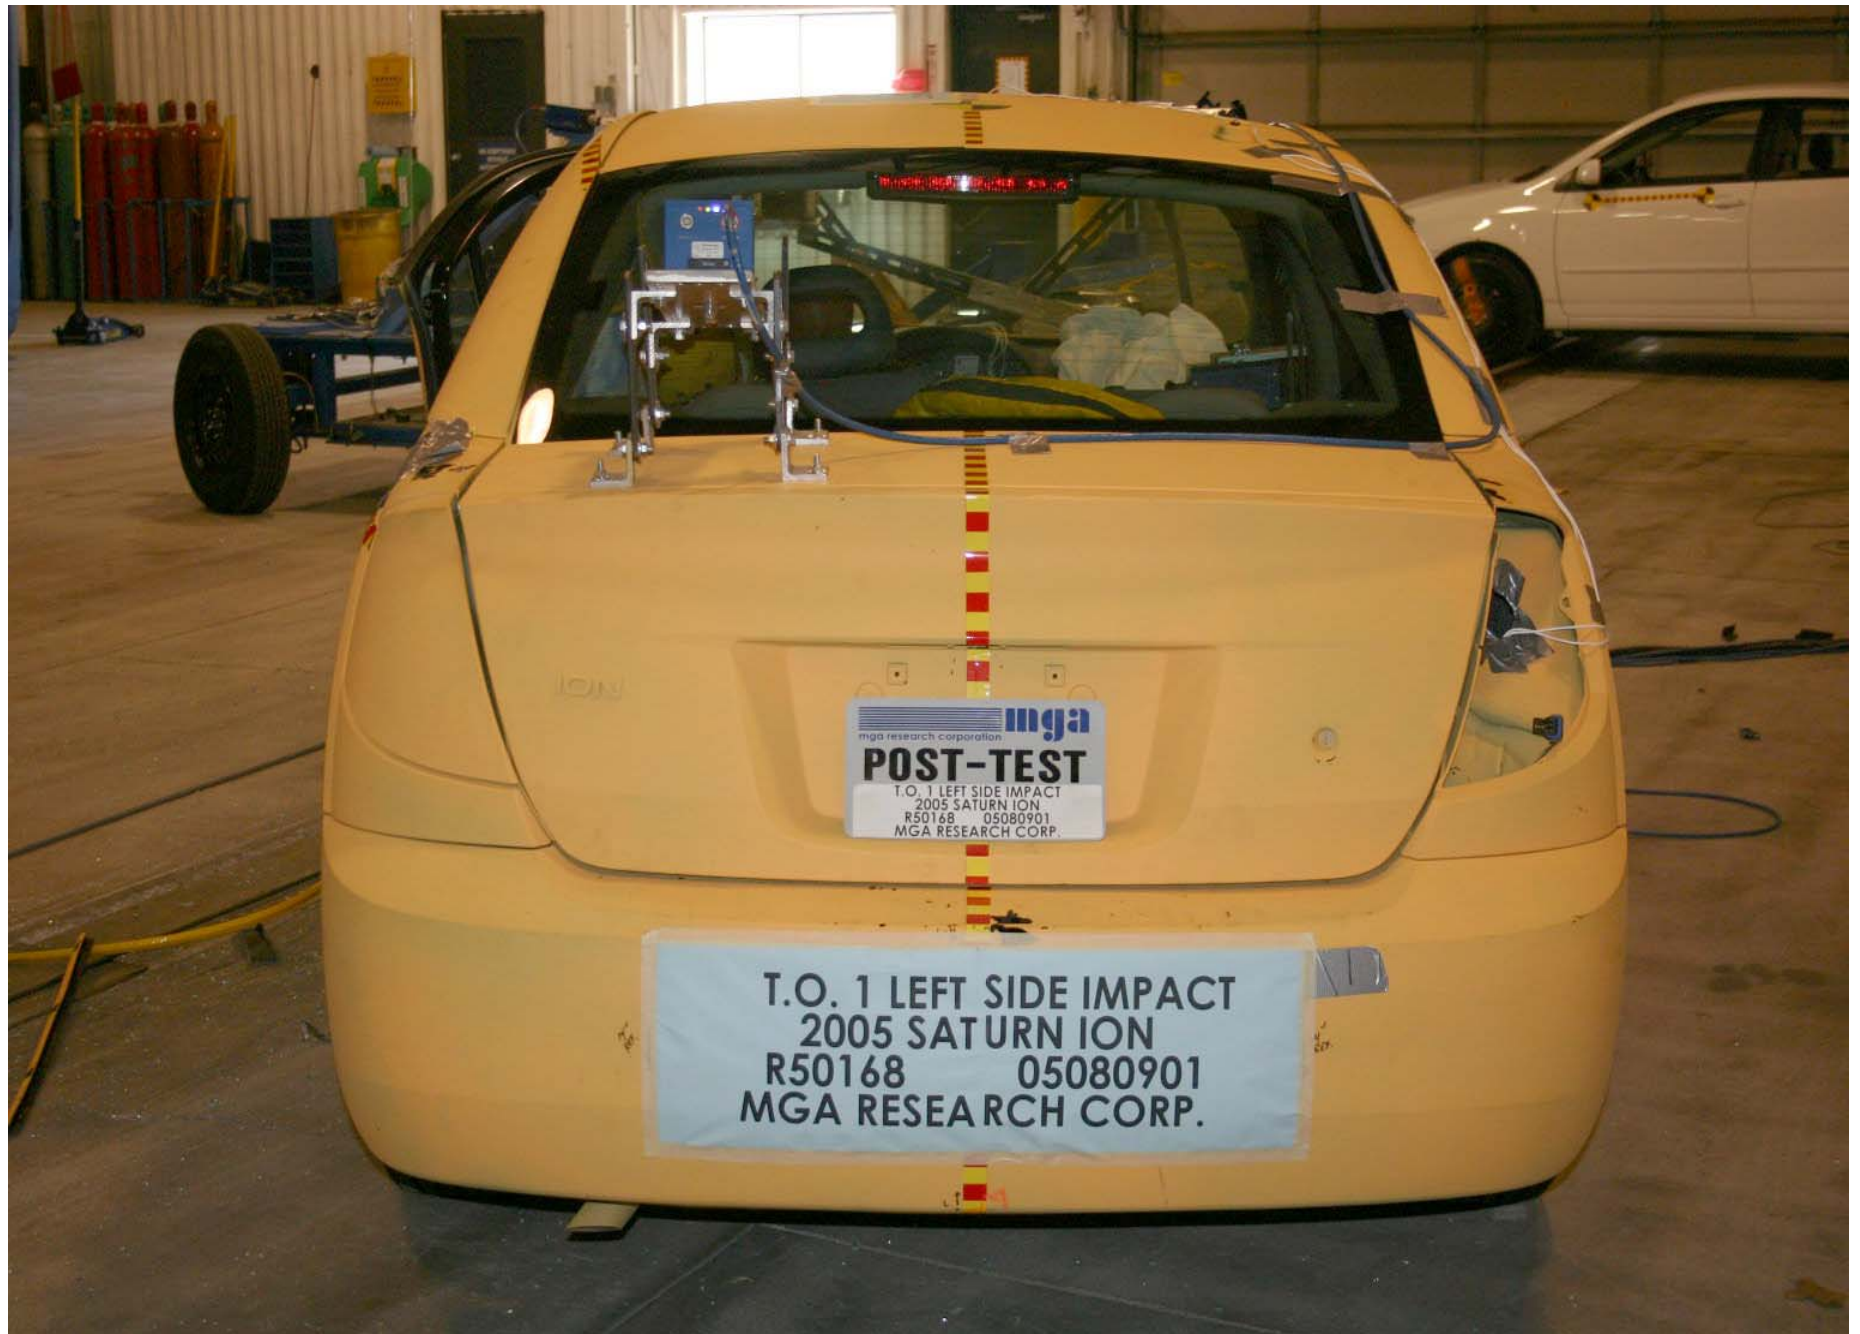
Post-Test Rear View of Test Vehicle

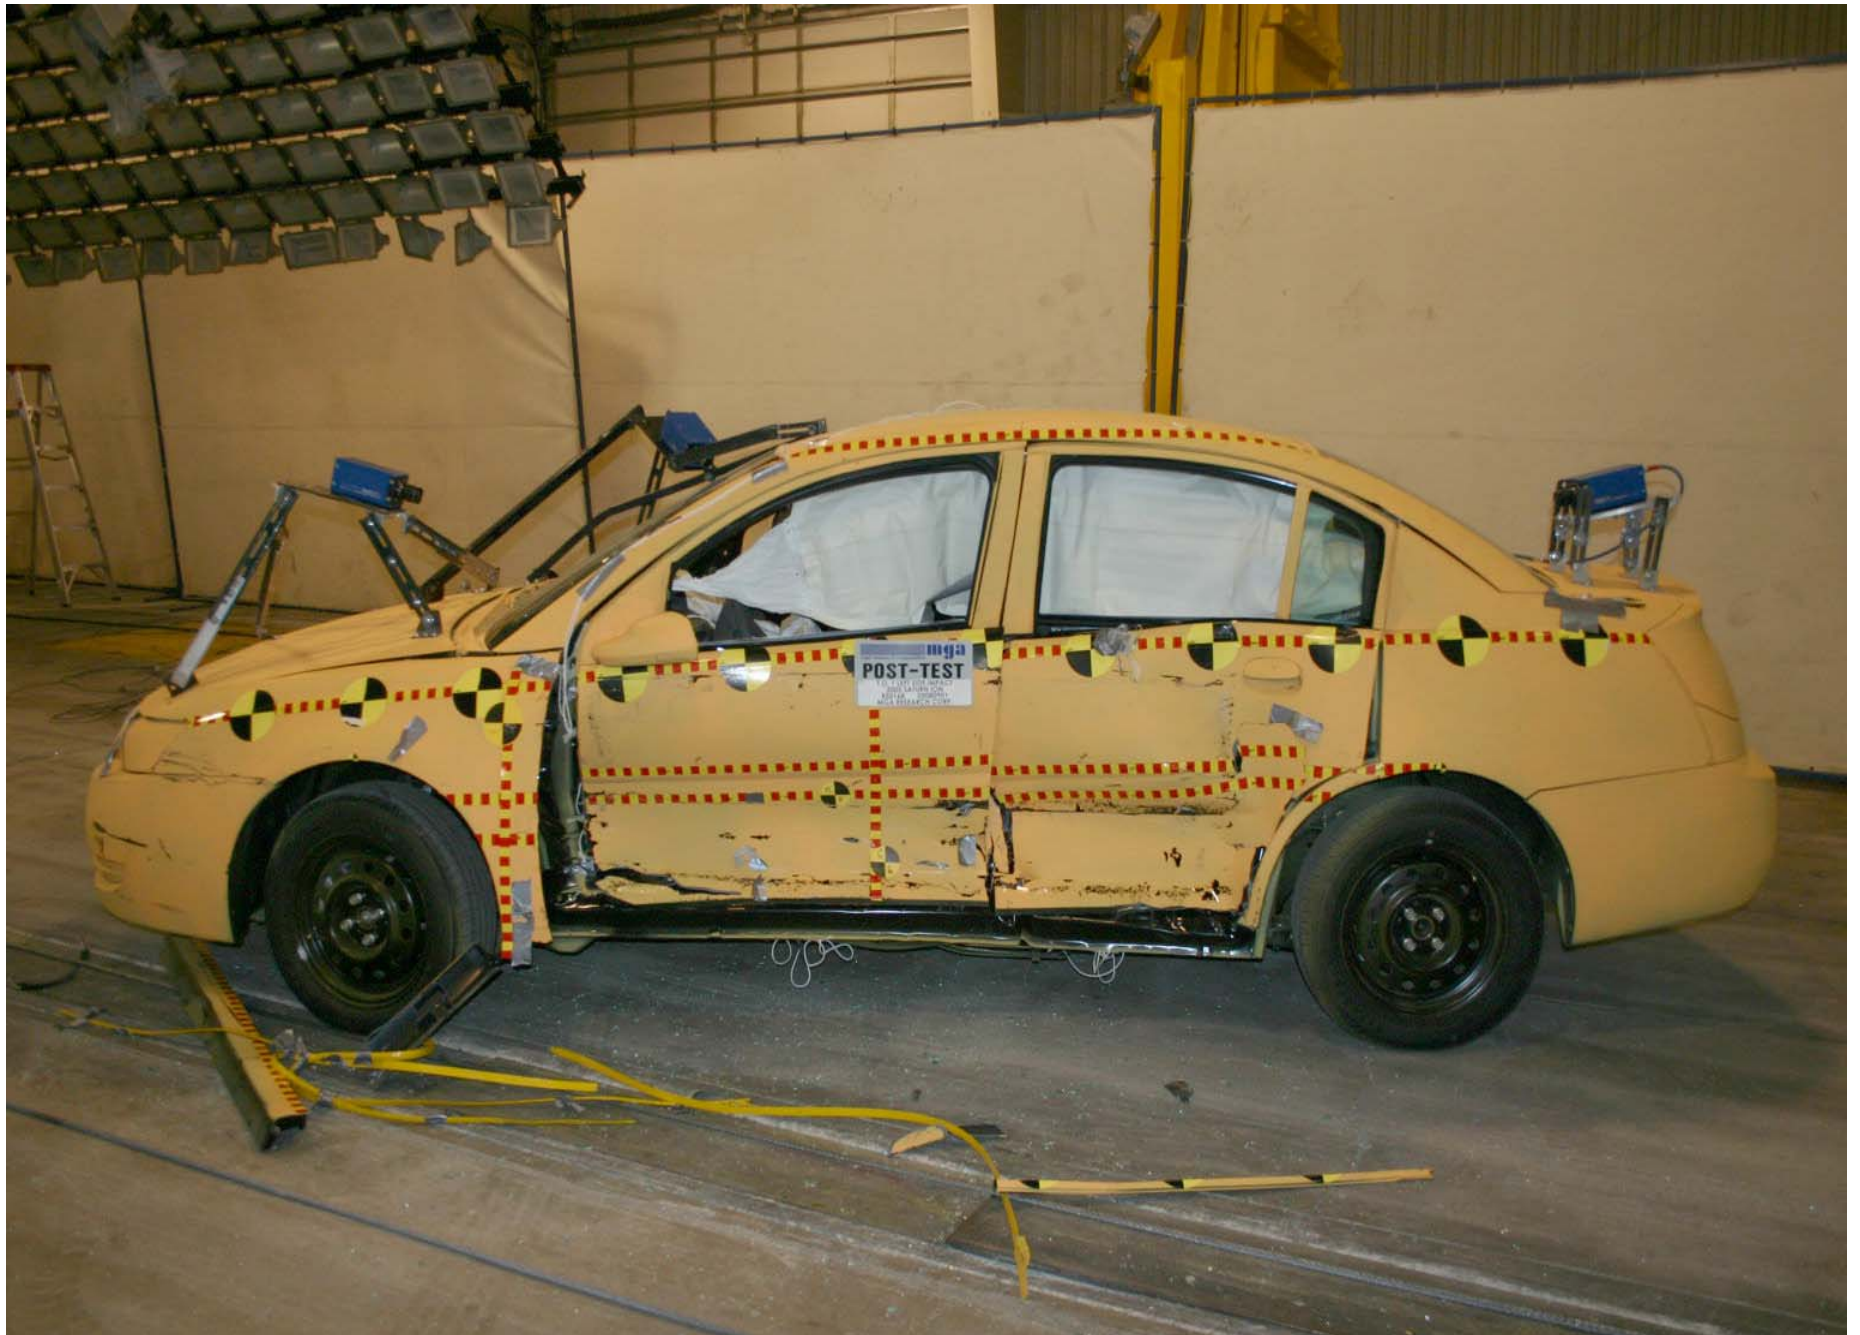
A-6.

Post-Test Left Side View of Test Vehicle

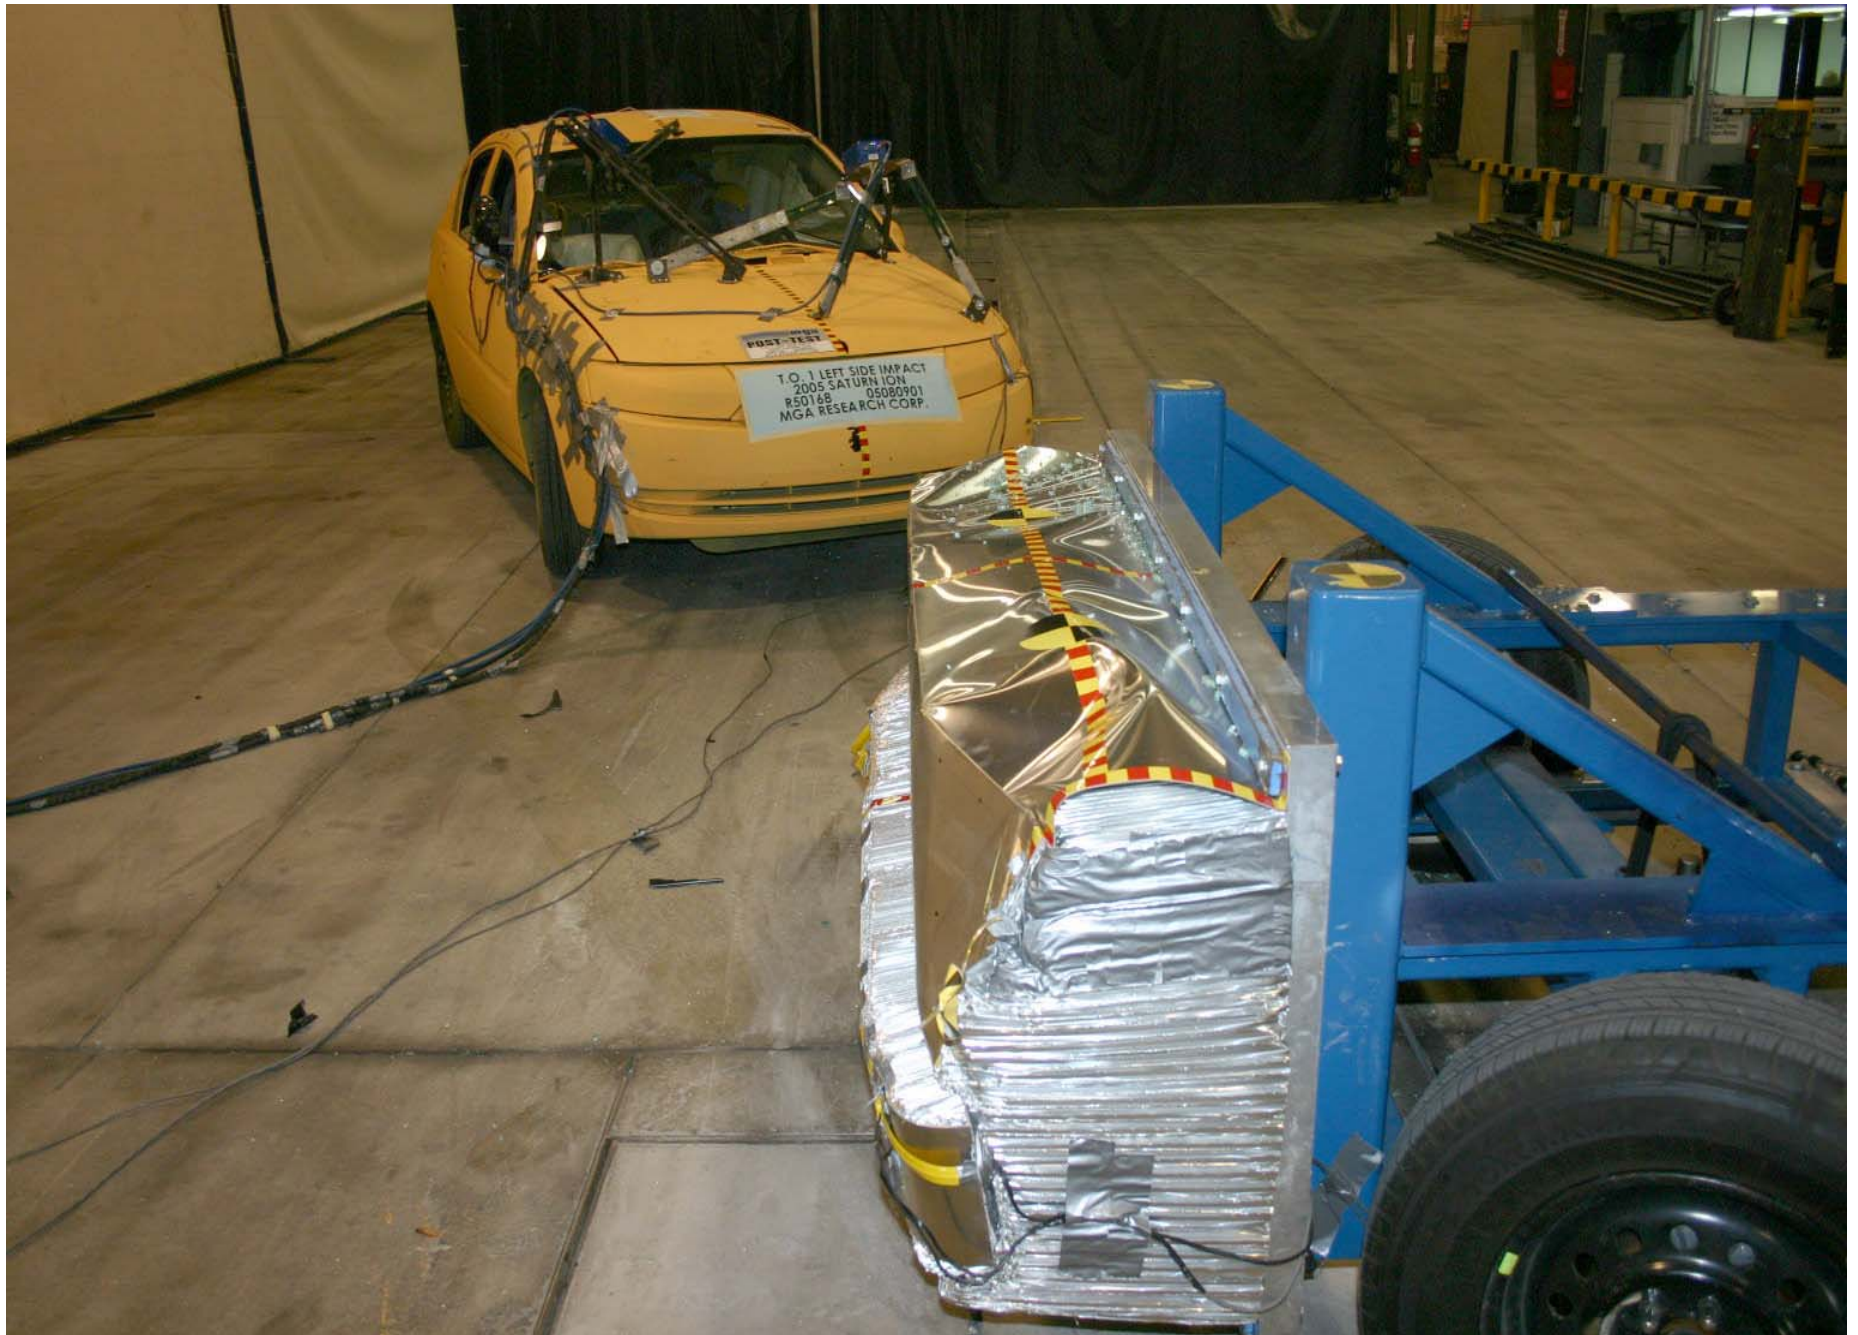
Post-Test MDB and Vehicle

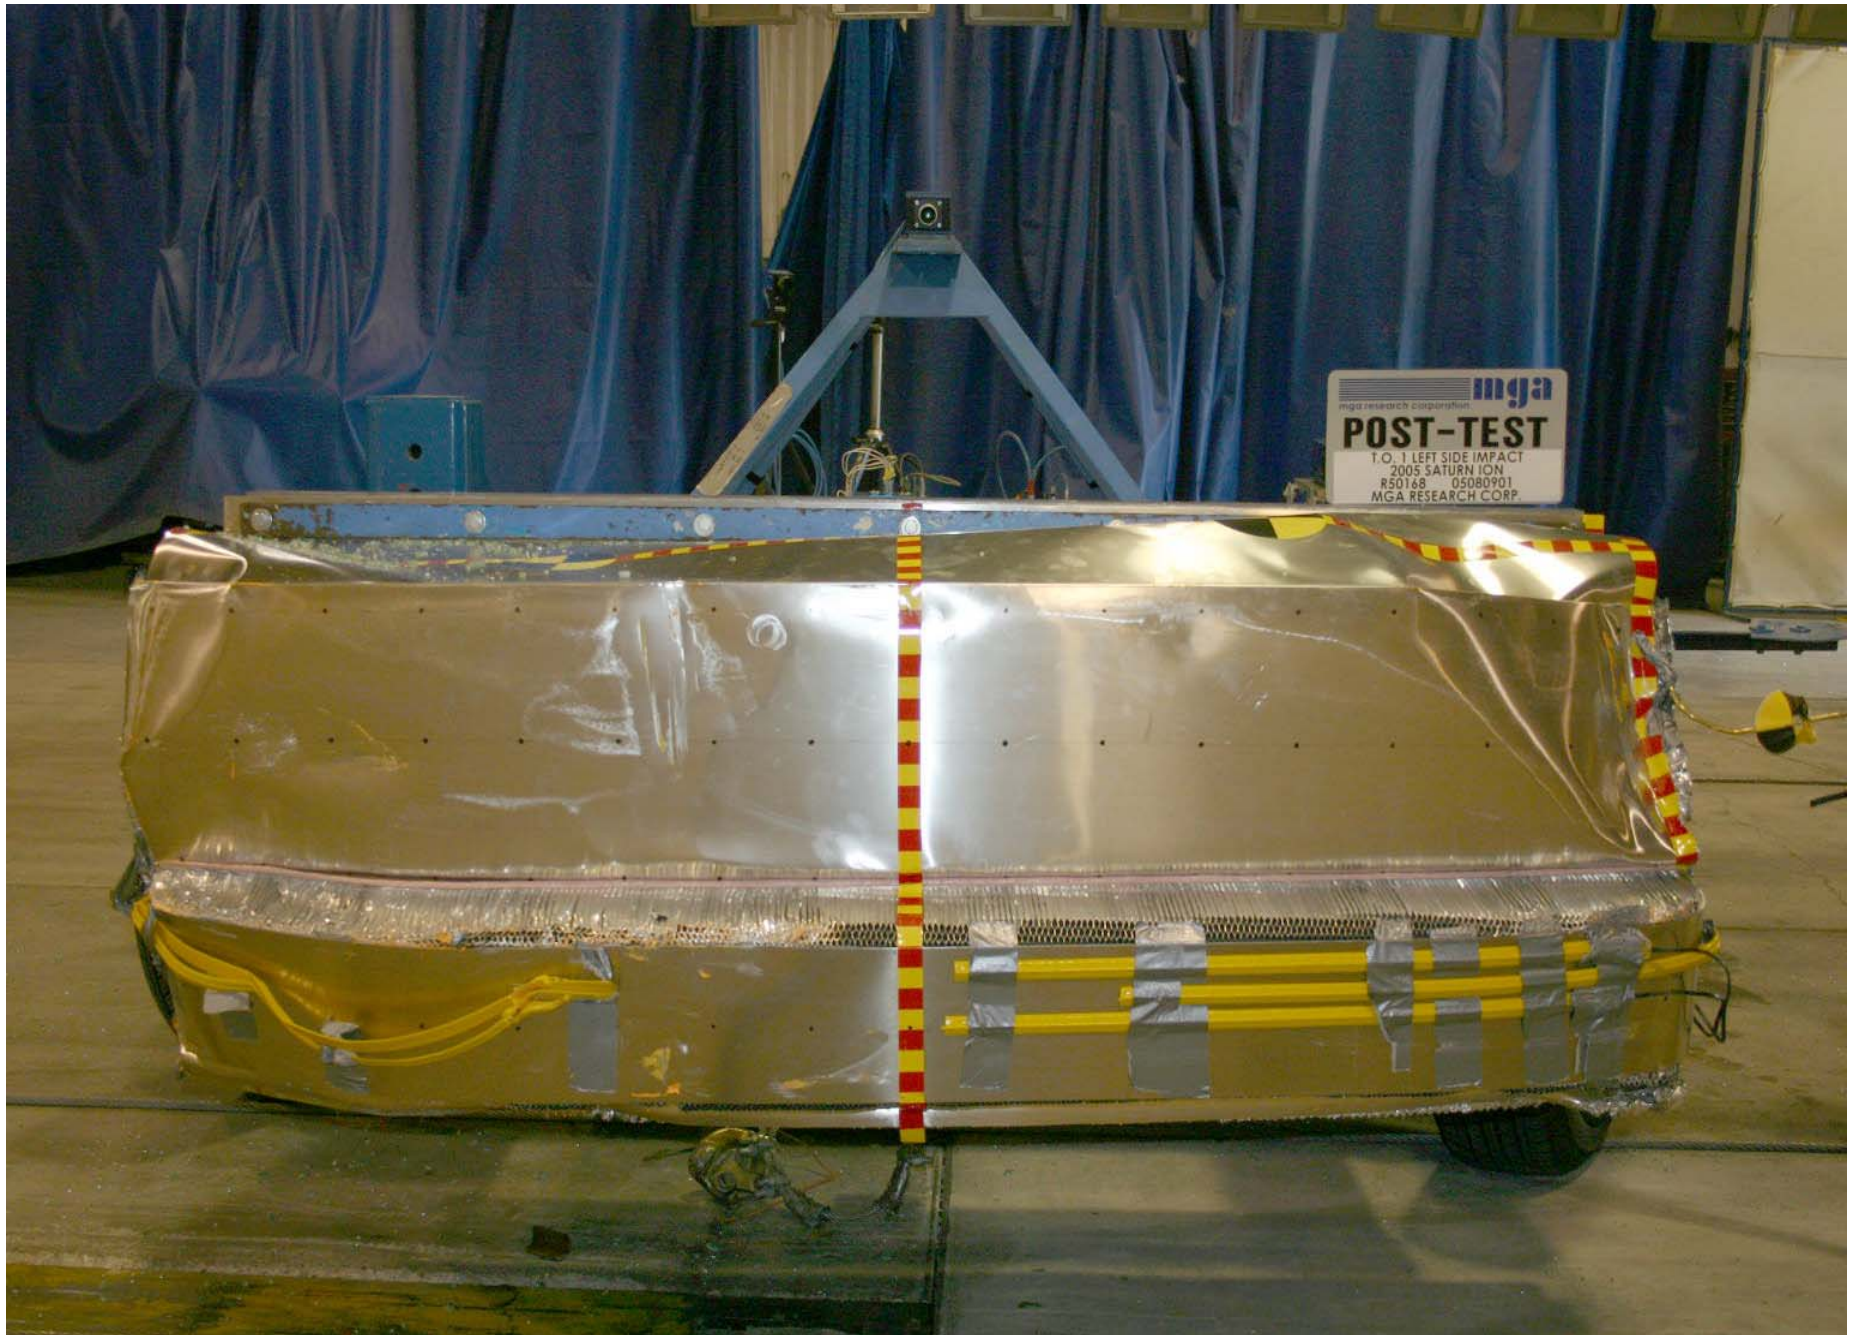
Post-Test MDB Front View

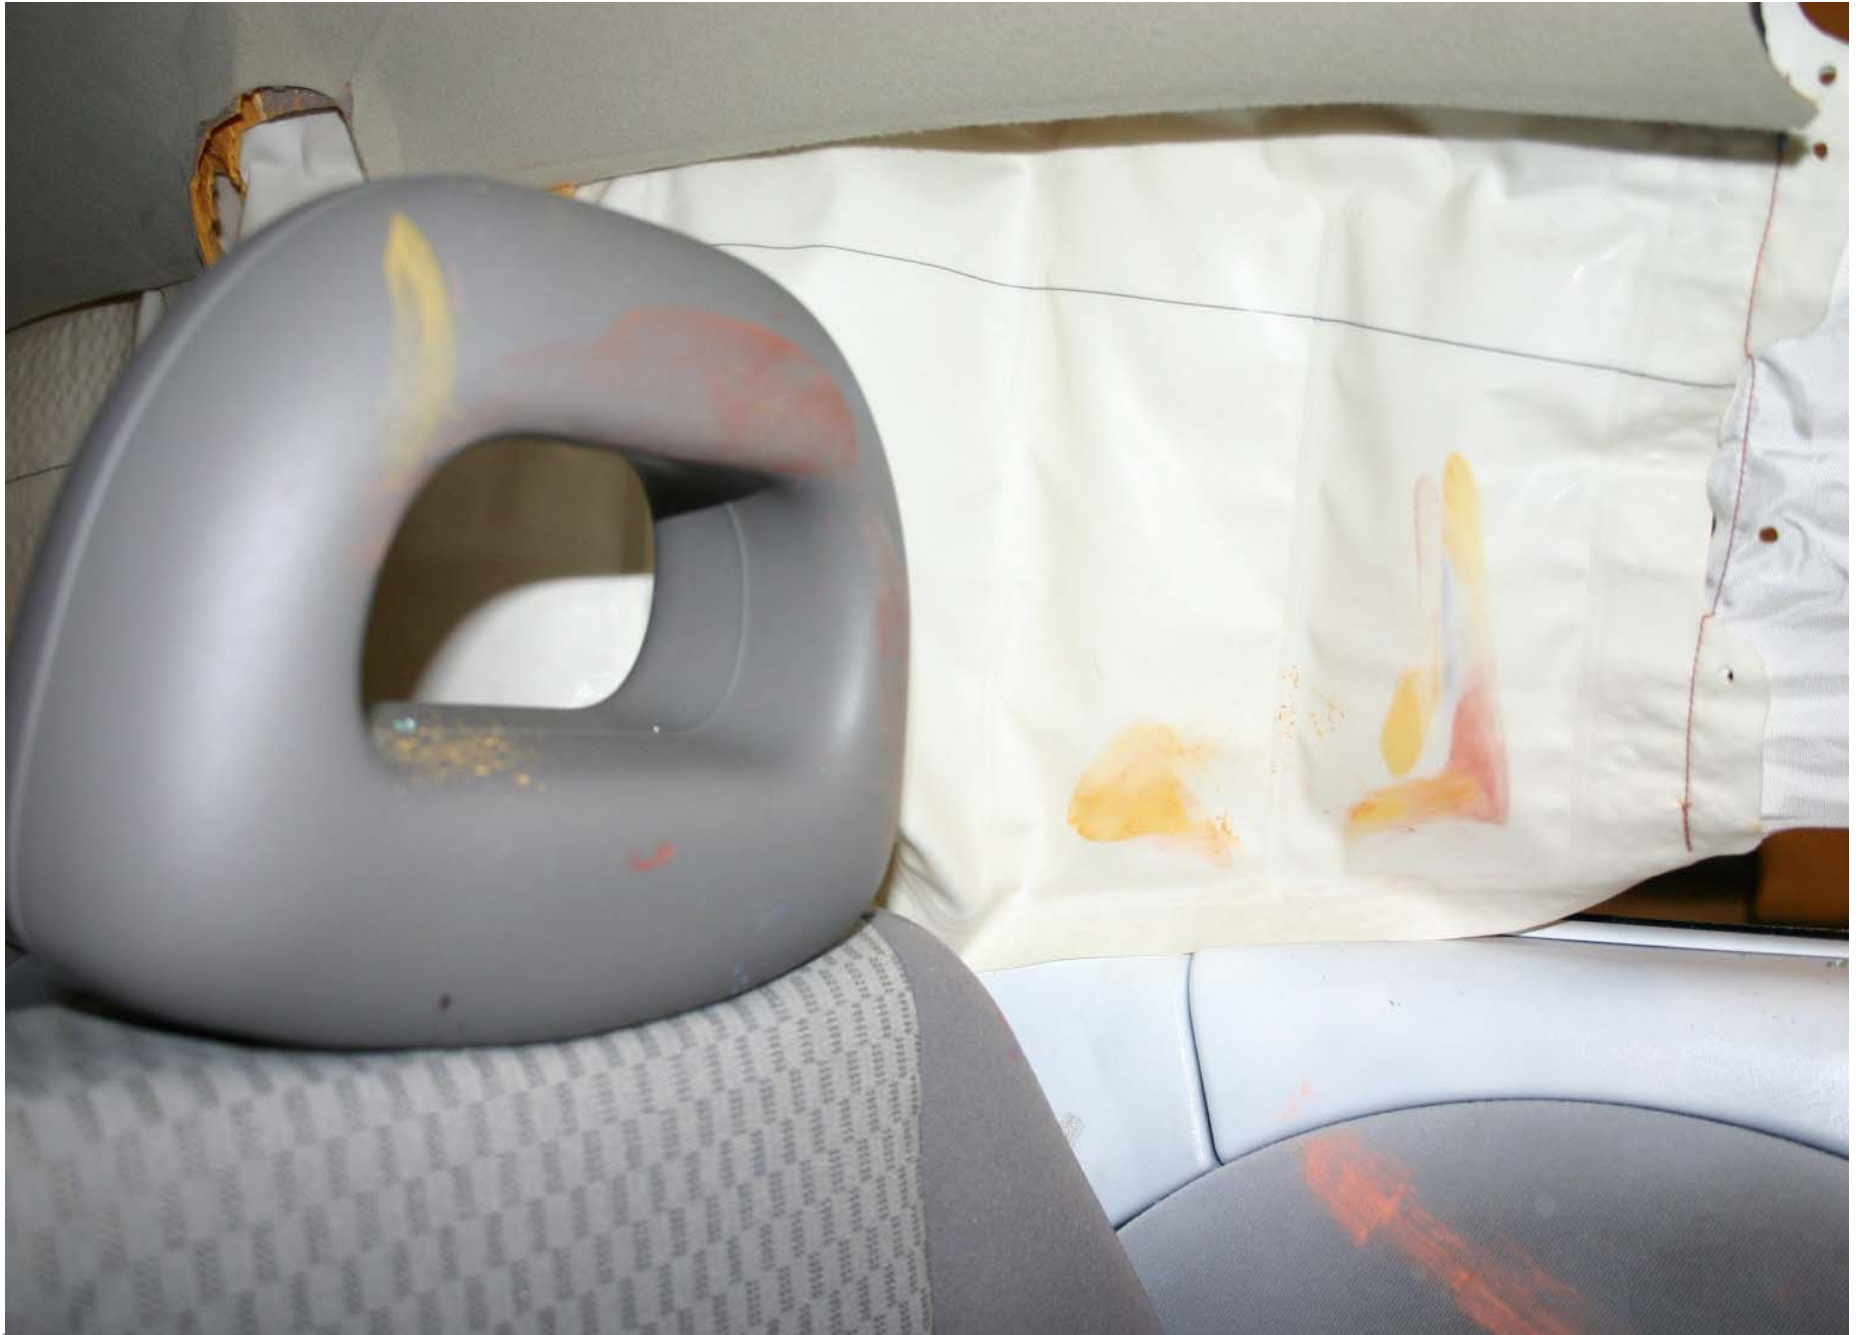
Post-Test Driver Dummy Head Contact

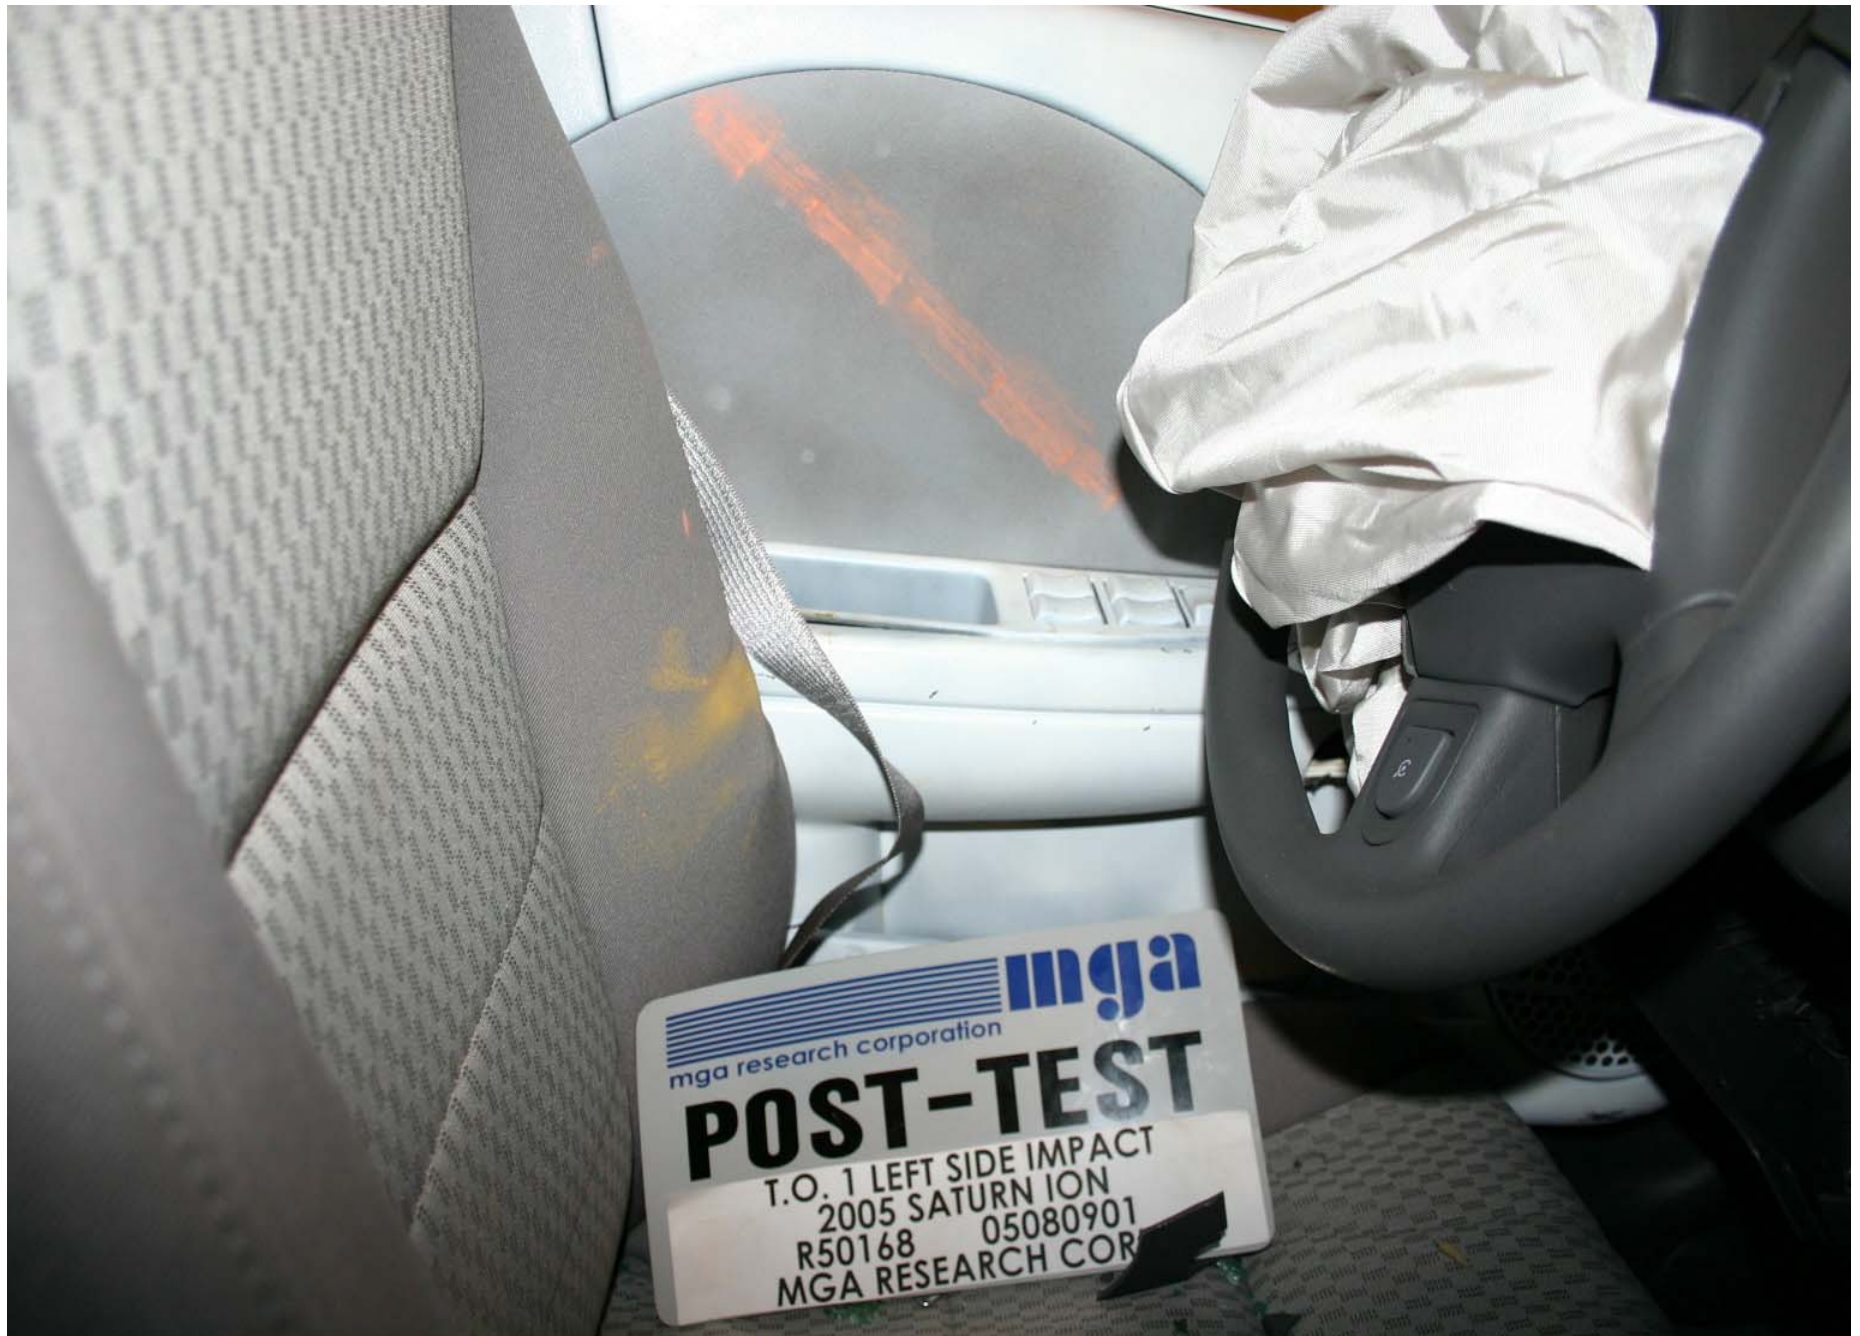
Post-Test Driver Dummy Lower Body Contact

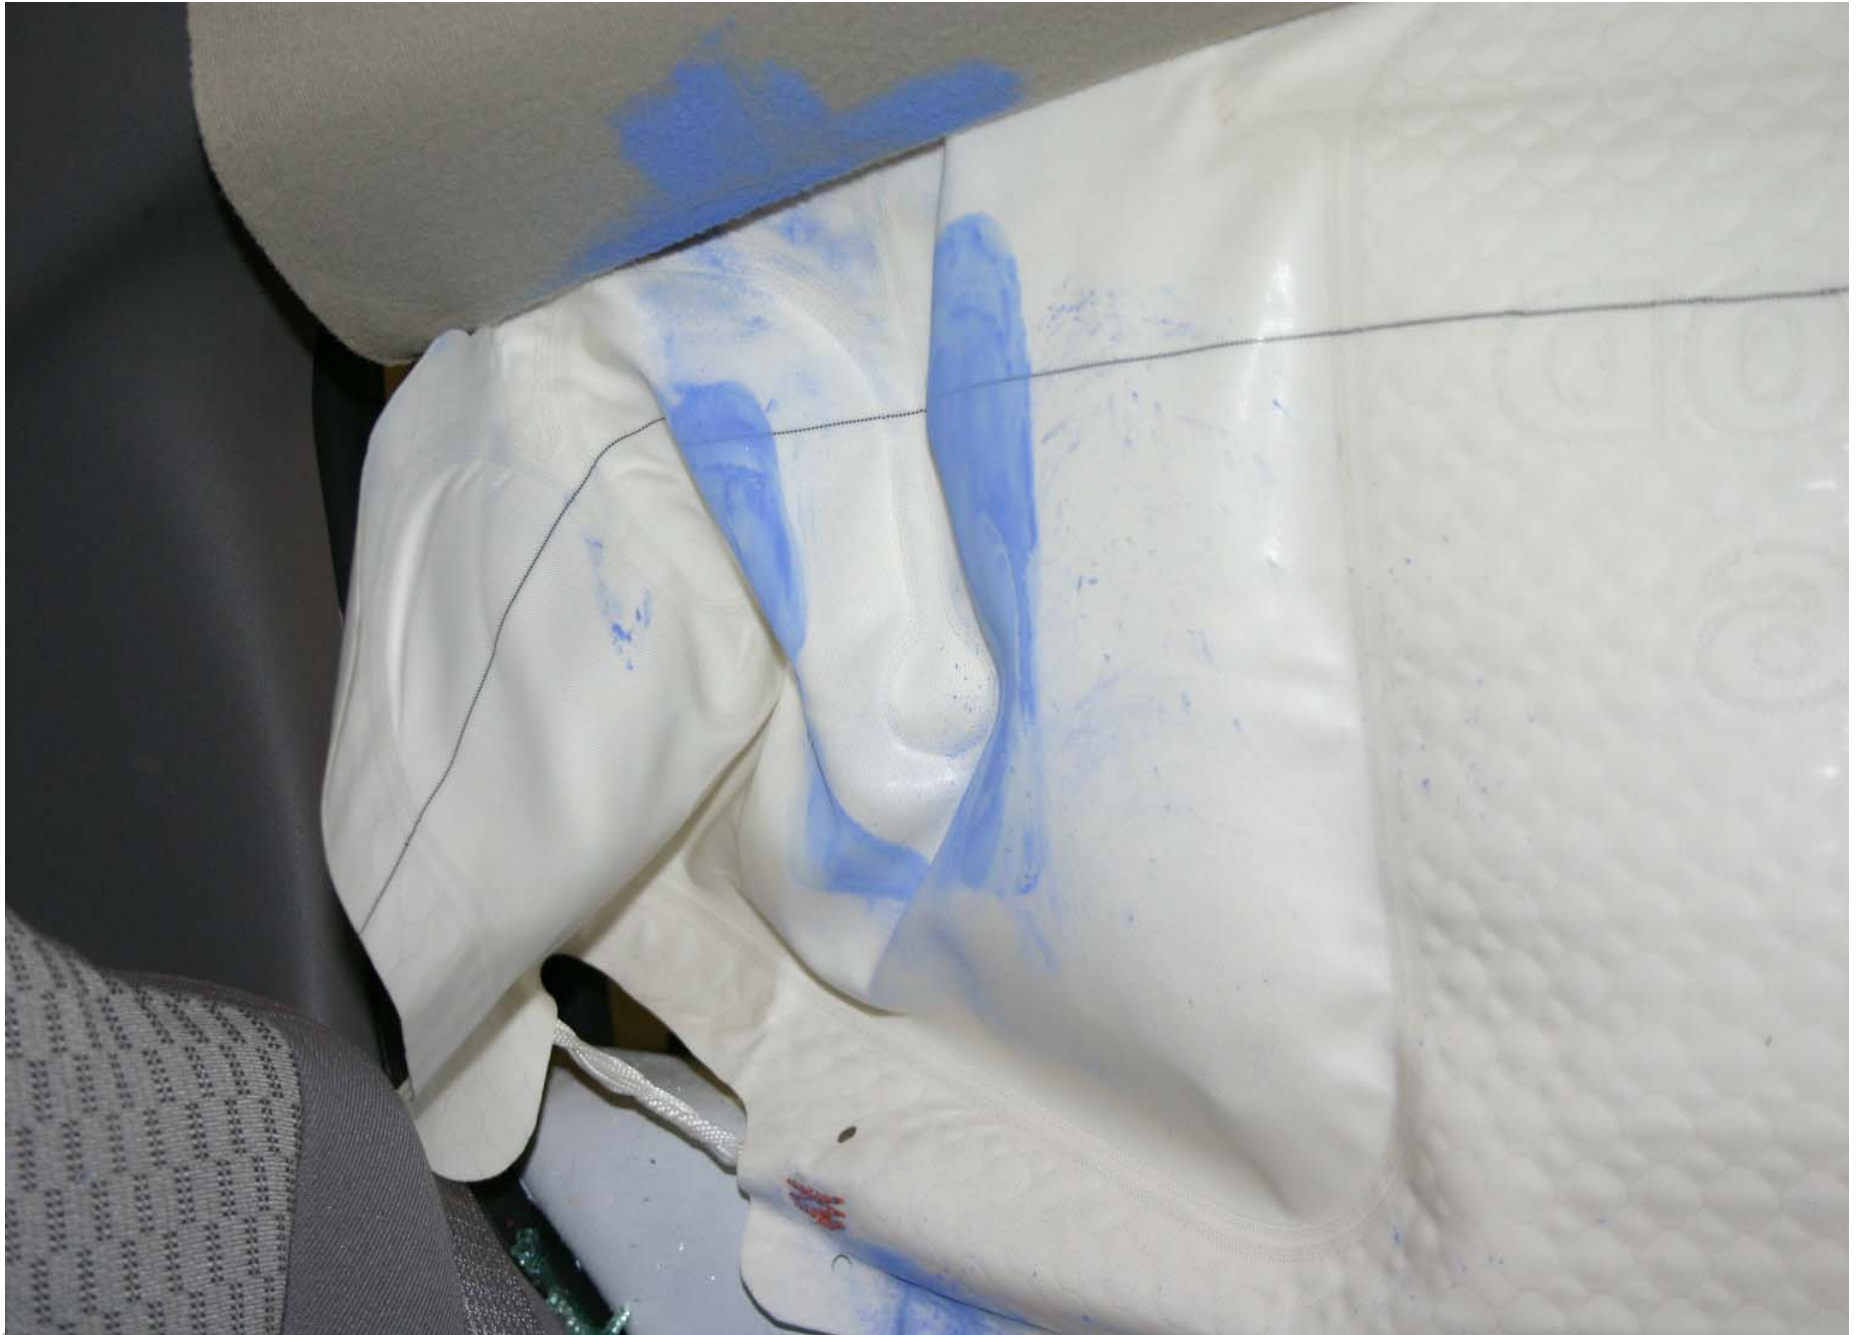
A-35.

Post-Test Passenger Dummy Head Contact

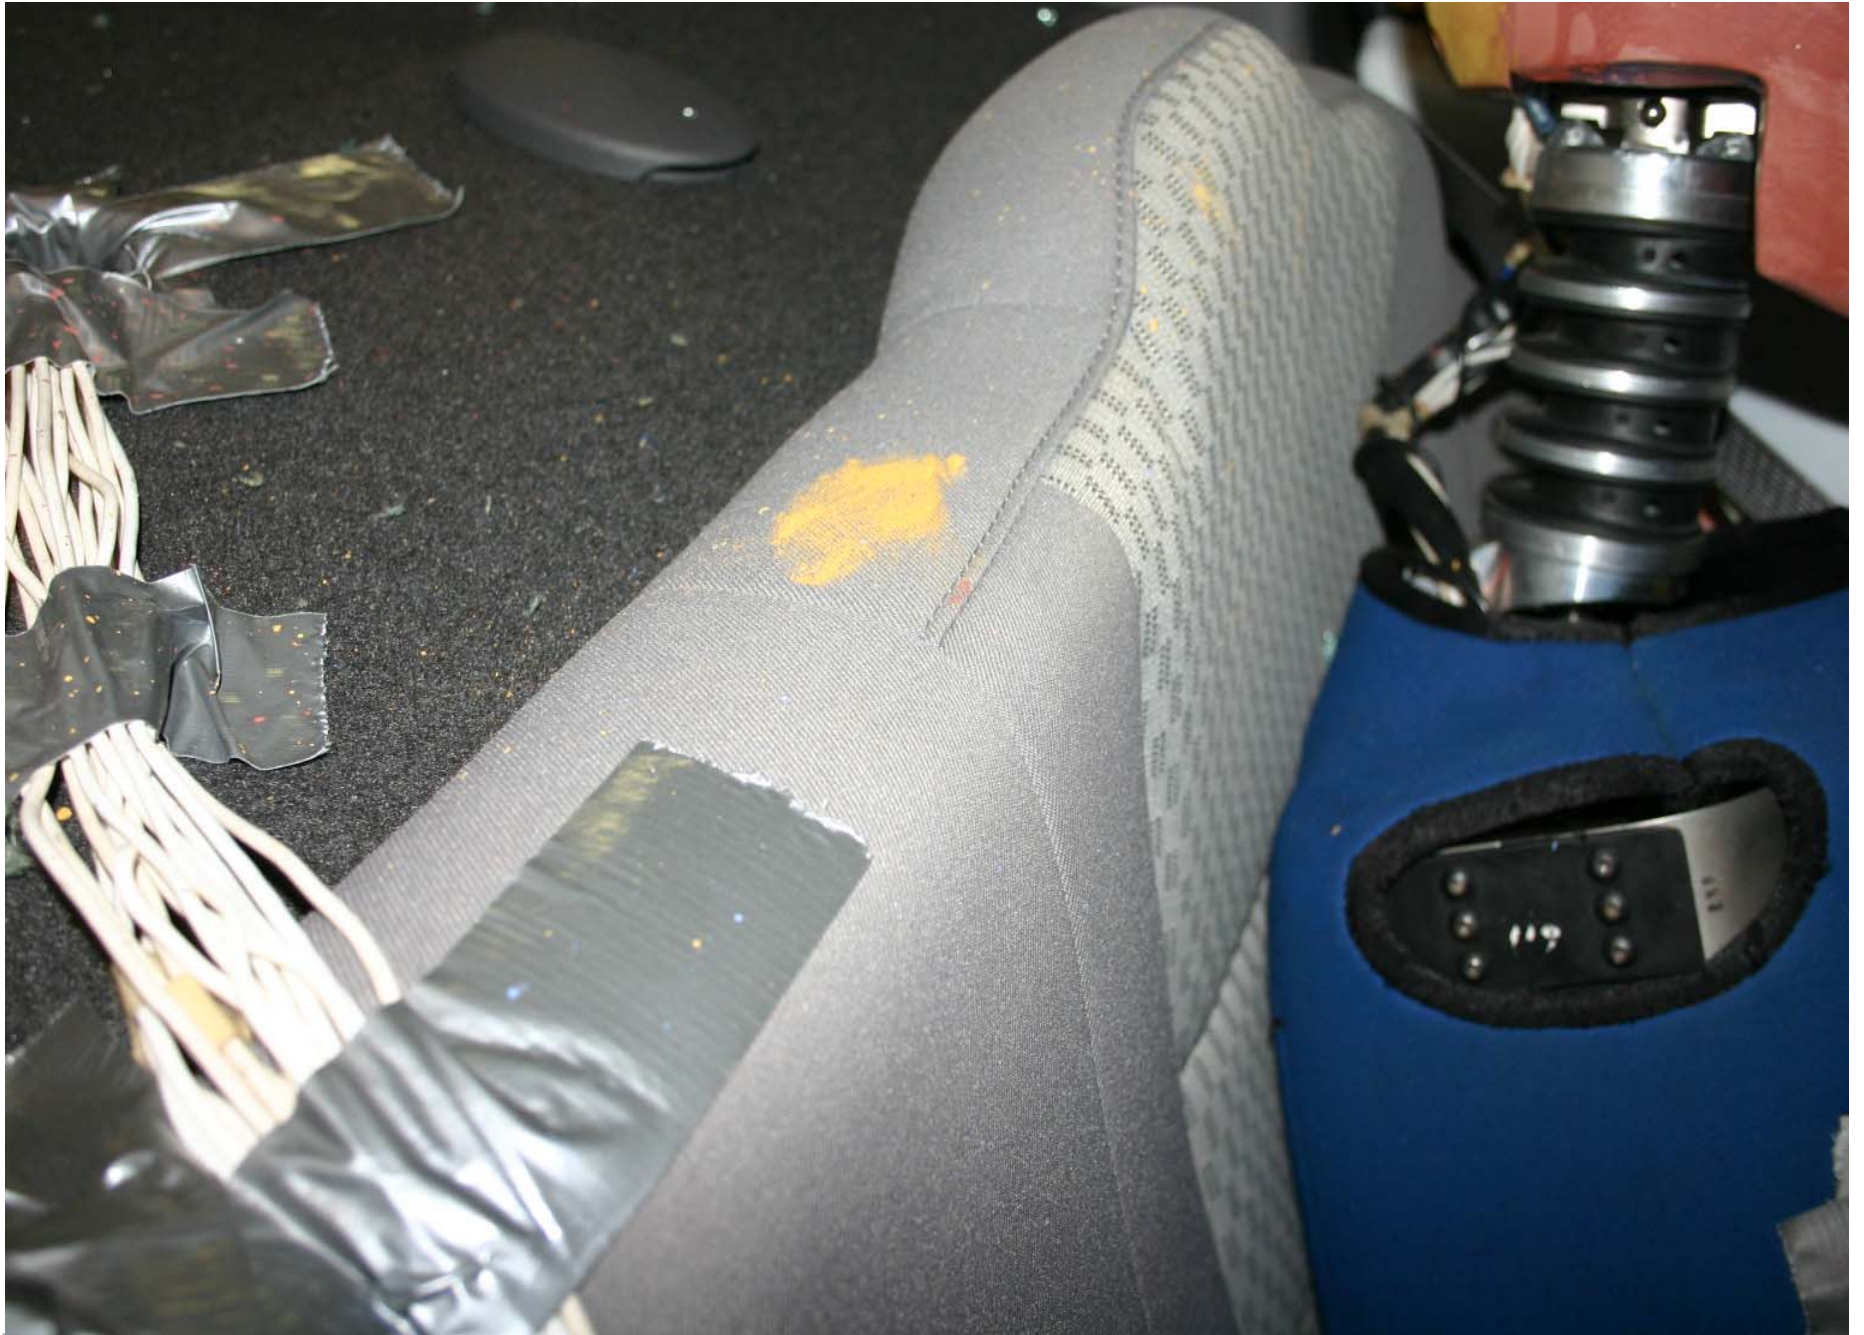
Post-Test Passenger Dummy Head Contact
