**REPORT NUMBER: TO1-MGA-2004-026**

**FULL SCALE SIDE IMPACT TESTS**

**214 LEFT SIDE IMPACT  
DRIVER SIDIIIsD  
PASSENGER SIDIIIsD  
TEST DATE: August 9, 2005  
Task Order # T0001 / RFP # 0004**

**2005 SATURN ION  
NHTSA NUMBER # R50168**

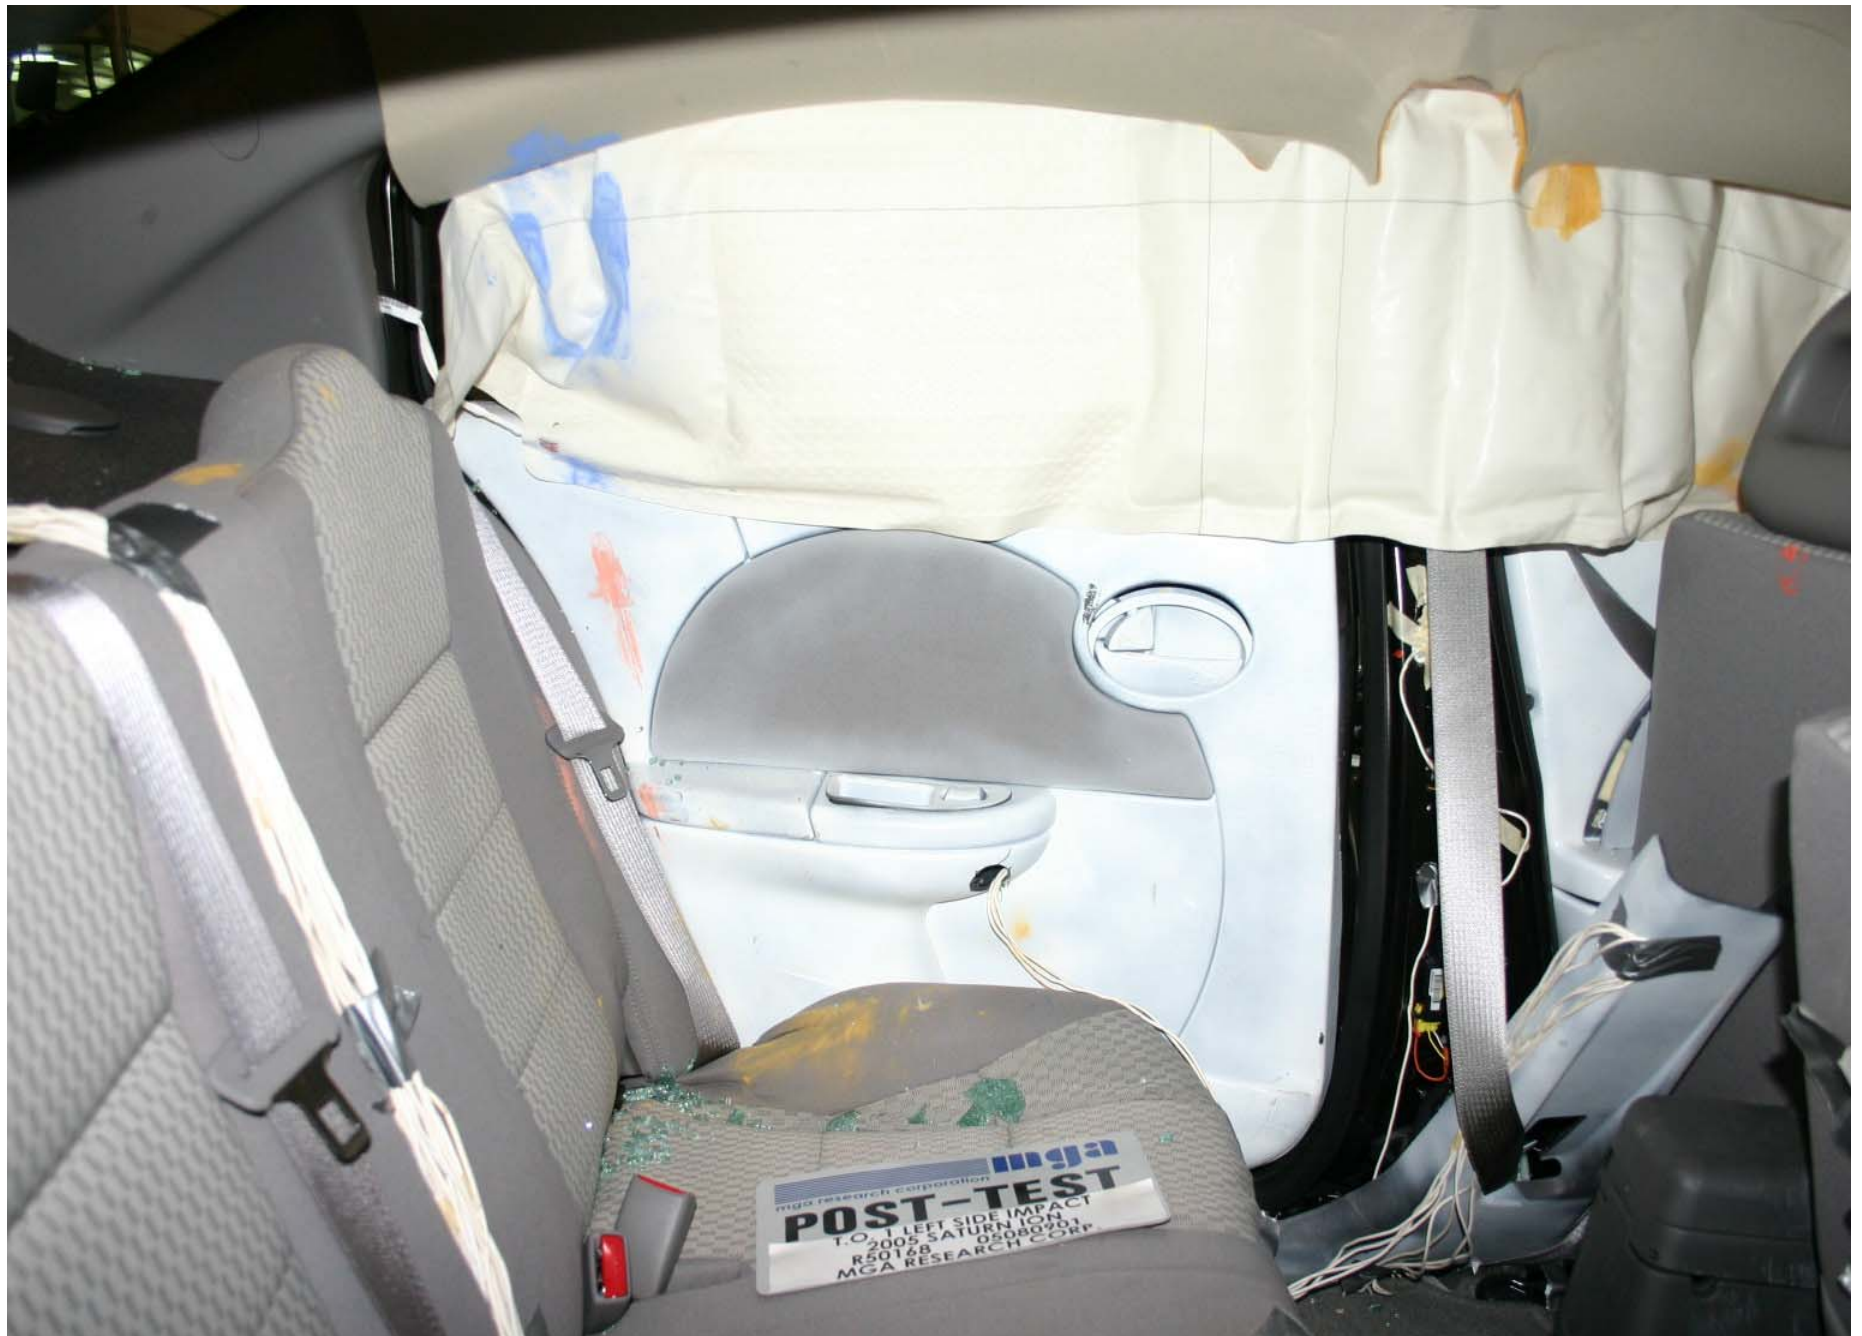
Post-Test Passenger Dummy Contact

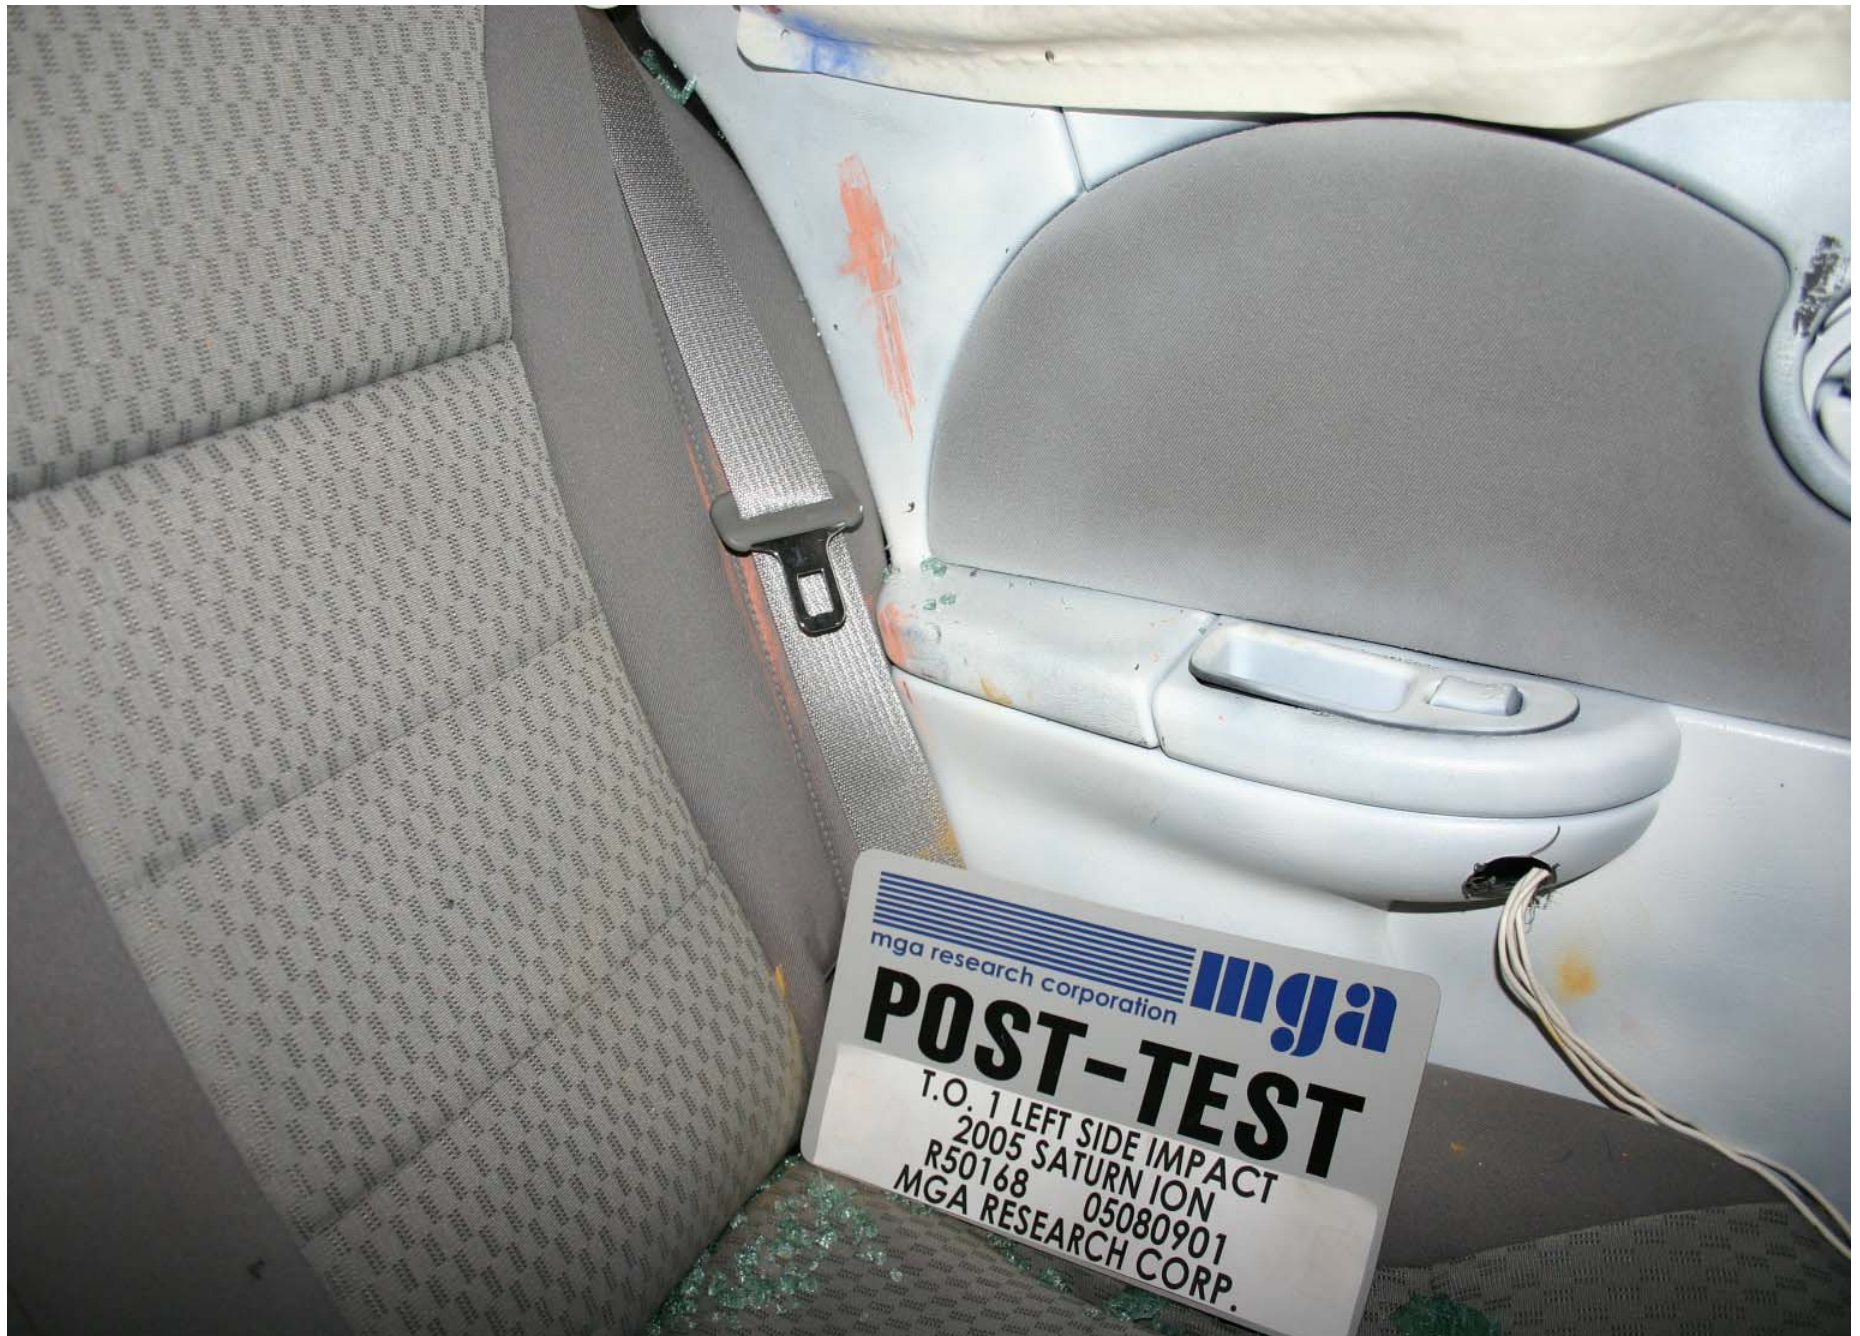
Post-Test Passenger Dummy Lower Body Contact

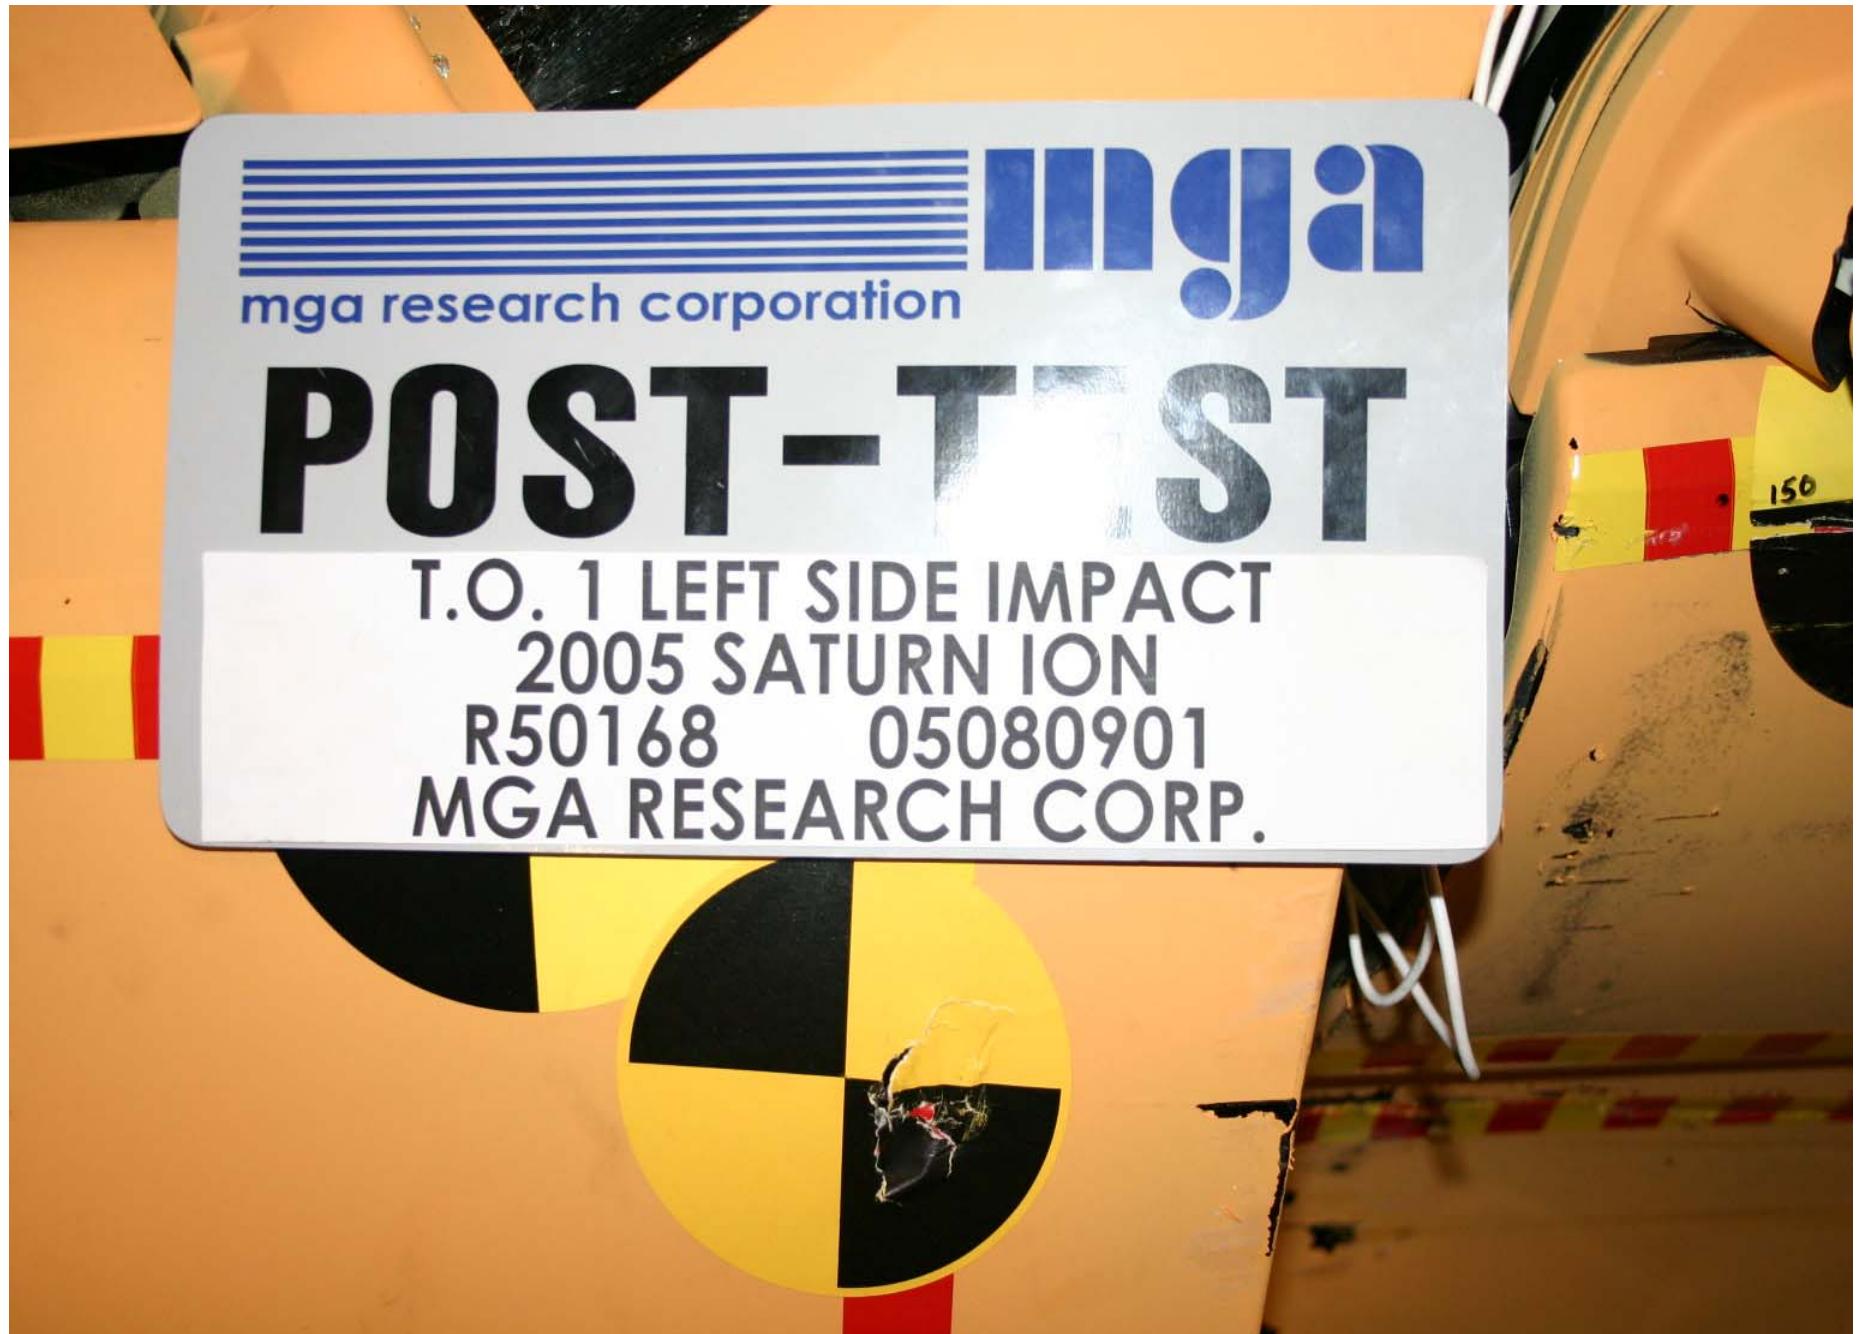
Post-Test Impact Point View
