REPORT NUMBER: CAL-06-03

**NEW CAR ASSESSMENT PROGRAM (NCAP)
FRONTAL BARRIER IMPACT TEST**

MERCEDES-BENZ U.S. INTL., INC.
2006 MERCEDES-BENZ ML350
MPV

CALSPAN TEST NUMBER: 8642-NCAP-63

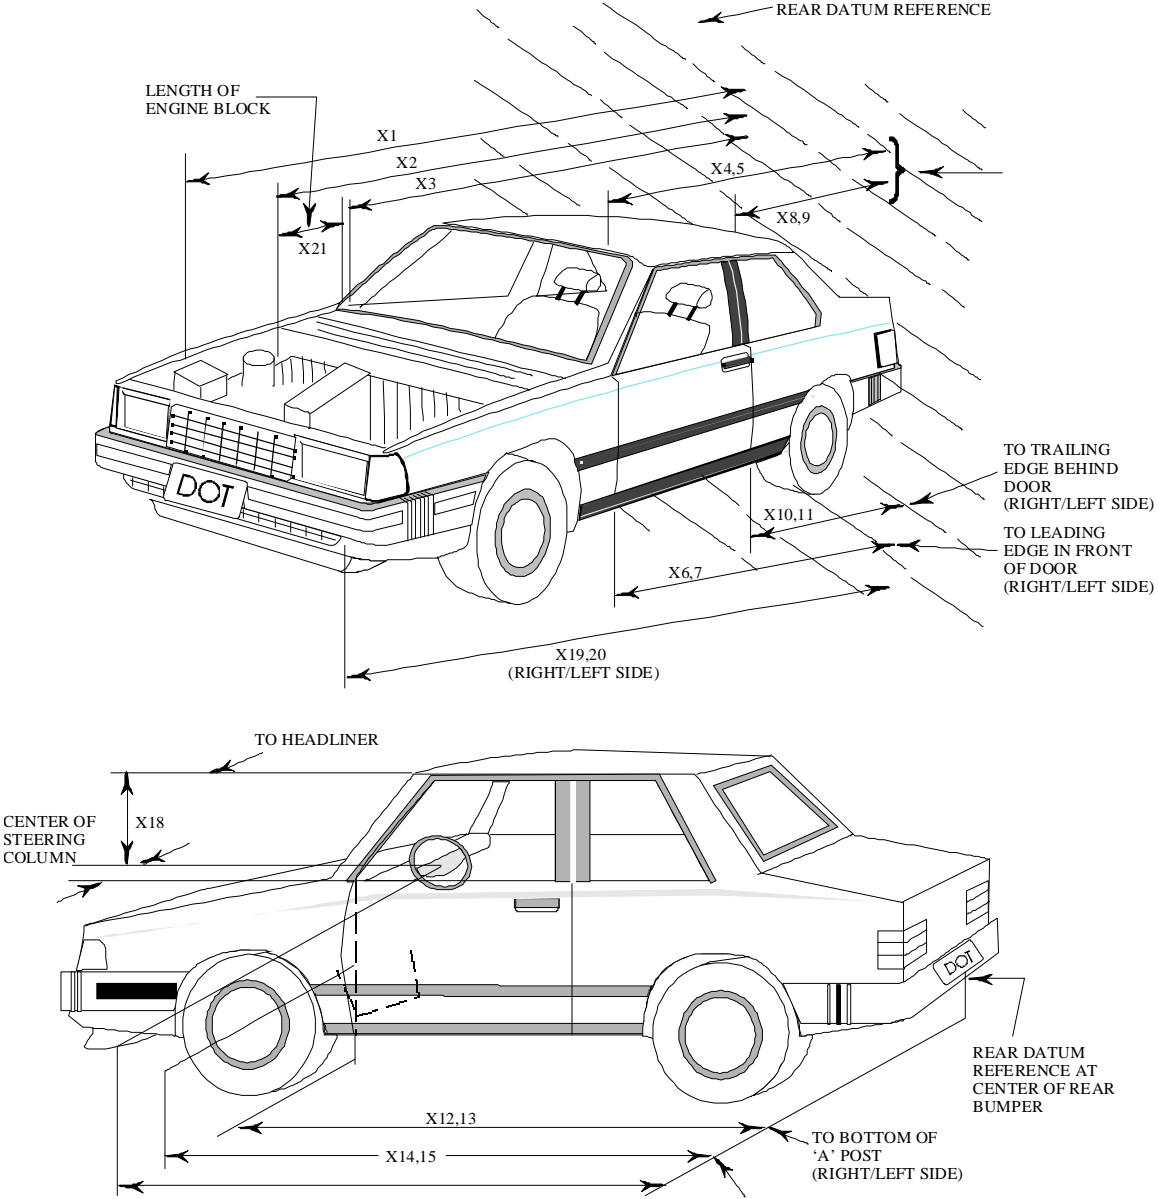
DATA SHEET NO. 10
TEST VEHICLE MEASUREMENTS

Elements	Pre-Test (mm)
1	Total length	4781
2	Total Width	1930 (max), 1884 (at B-pillar)
3	Bumper Top Height	590
4	Bumper Bottom Height	410
5	Longitudinal Member Top Height	NA
6	Distance Between Longitudinal Members	NA
7	Longitudinal Member Width	NA
8	Engine top height	980
9	Engine bottom height	380
10	Engine and gearbox width	NA
11	Front bumper-engine distance	629
12	Front shock absorber fixing height	NA
13	Bonnet leading edge height	840
14	Front shock absorber fixing width	NA
15	Front bumper – front axle distance	863
16	Front axle – A pillar distance	521
17	A-pillar – B pillar distance	1104 (at floor sill); 1120 (at beltline)
18	B-pillar – rear axle distance	2170
19	B-pillar – C Pillar distance	641 (at floor sill); 1104 (at beltline)
20	Roof sill bottom height	1641
21	Roof sill top height	1716
22	Floor sill bottom height	290
23	Floor sill top height	425

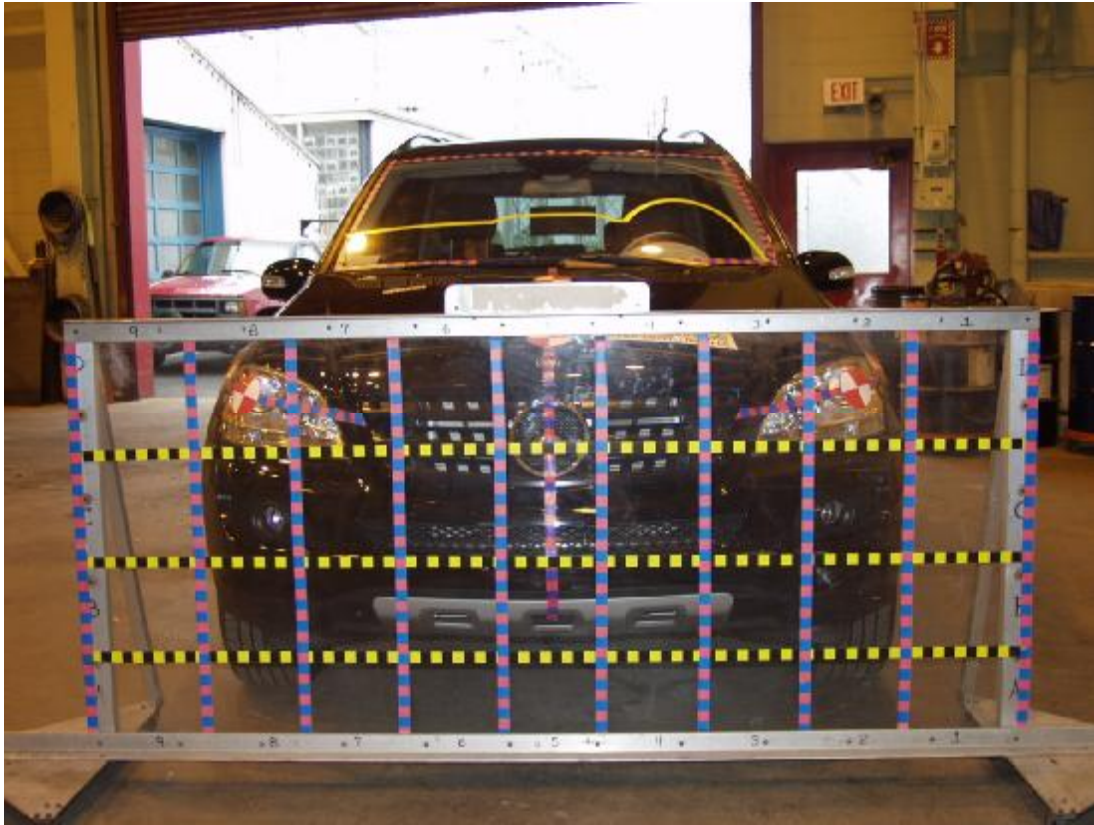
Figure A-1: Load Cell Locations

A load cell barrier consisting of 36 load cells was impacted by a 2006 Mercedes-Benz ML350 MPV at a velocity of 56.49 kph. The test was performed at Calspan on August 30, 2005. Pre- and post-test photographs of the vehicle and dummies can be found in Appendix A.

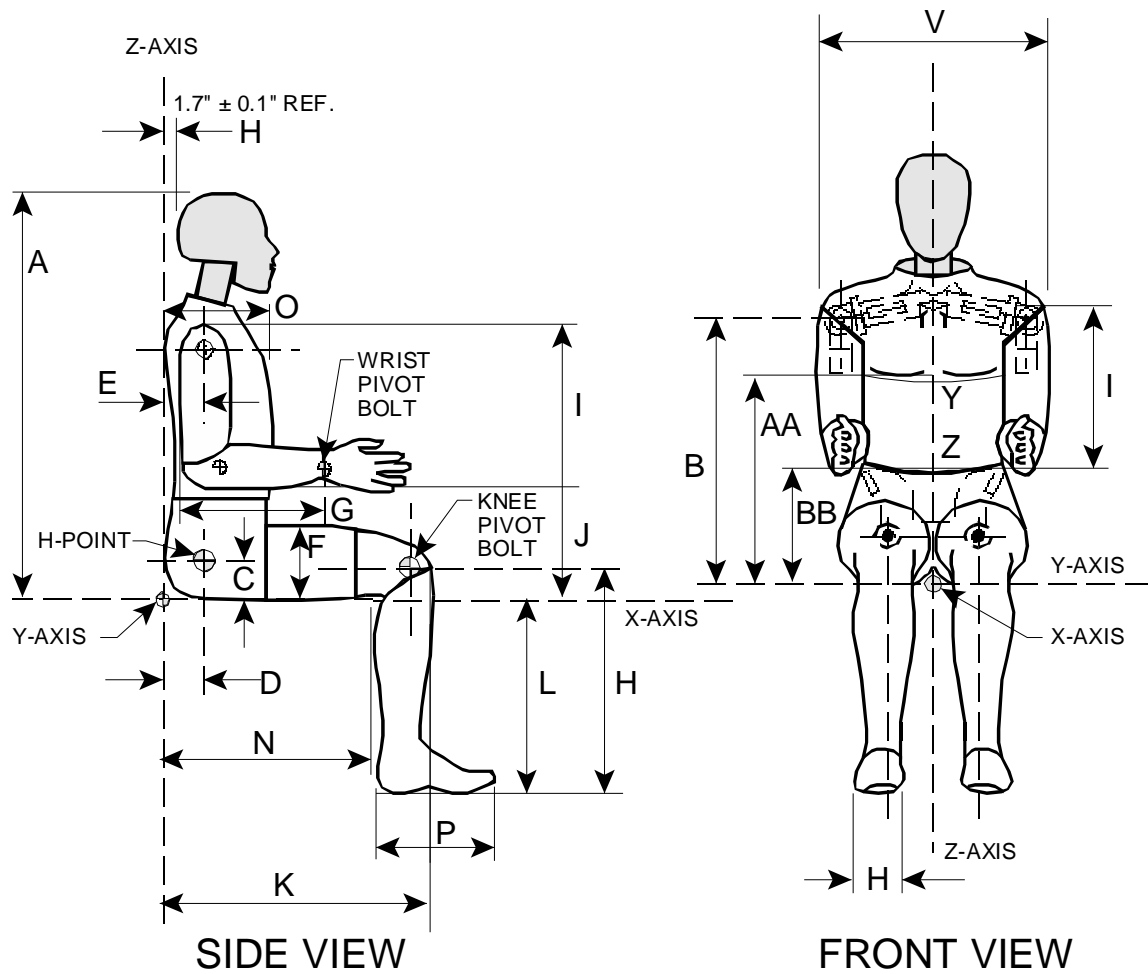
EXTERNAL DIMENSIONS SPECIFICATIONS

NOTE: Figure is referenced to the erect seated position. The curved lumbar does not allow the Hybrid III to be positioned in a perfect erect attitude. (REF: S572.31(A)(6))

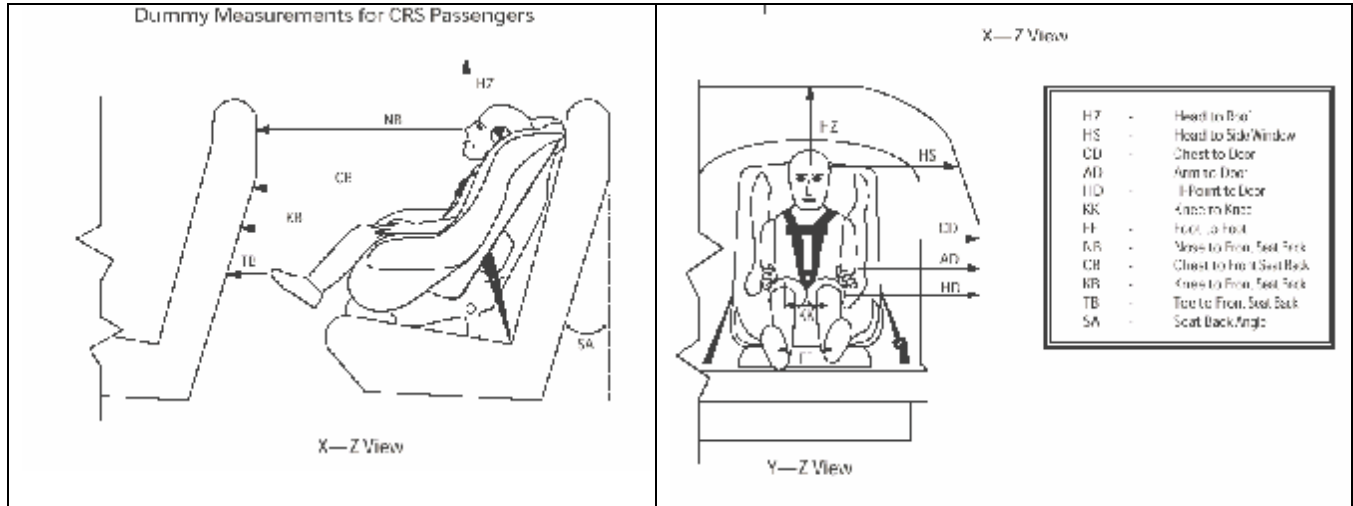
Measurement	Pre-Test (mm)	
	P3 (ATD No. : D009)	P4 (ATD No. :011)
SA	22.1	22.1
HS	370	340
CD	351	335
AD	133	110
HD	178	172
HZ	360	230
NB	538	620
CB	583	540
KK	118	148
FF	133	150
KB – LEFT	383	325
KB – RIGHT	383	328
TB – LEFT	0	45
TB – RIGHT	0	45
Top Tether Anchor to CRS		
Angle	N/A	N/A
Length	N/A	N/A
X	N/A	N/A
Y	N/A	N/A
Z	N/A	N/A

All dimensions in mm (unless noted)
