**REPORT NUMBER: NCAPSIDE-MGA-2006-001**

**NEW CAR ASSESSMENT PROGRAM  
SIDE IMPACT TEST**

**HYUNDAI MOTOR COMPANY  
2005 HYUNDAI TUCSON  
NHTSA NUMBER: M50509**

**PREPARED BY:  
MGA RESEARCH CORPORATION  
5000 WARREN ROAD  
BURLINGTON, WI 53105**

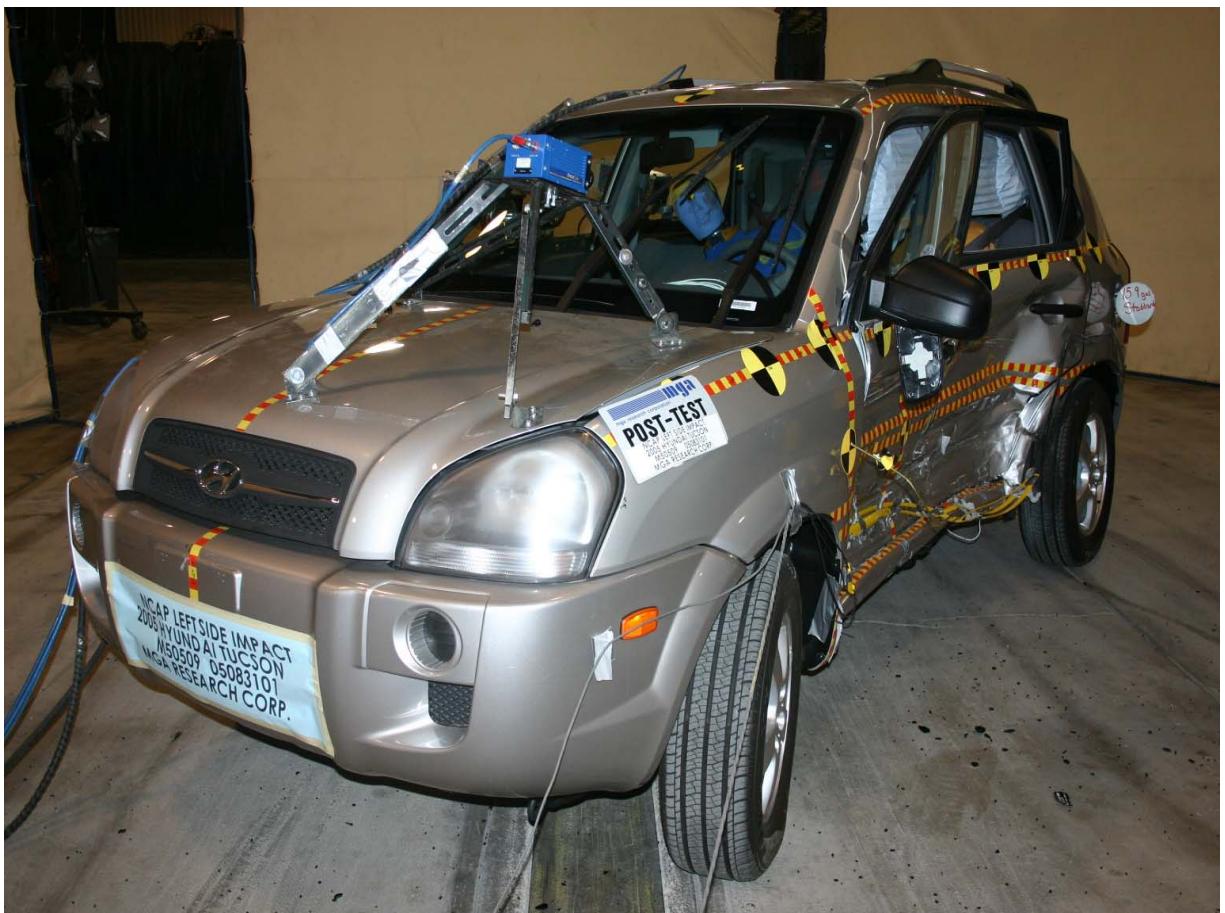
Post-Test Left Front  $\frac{3}{4}$  View

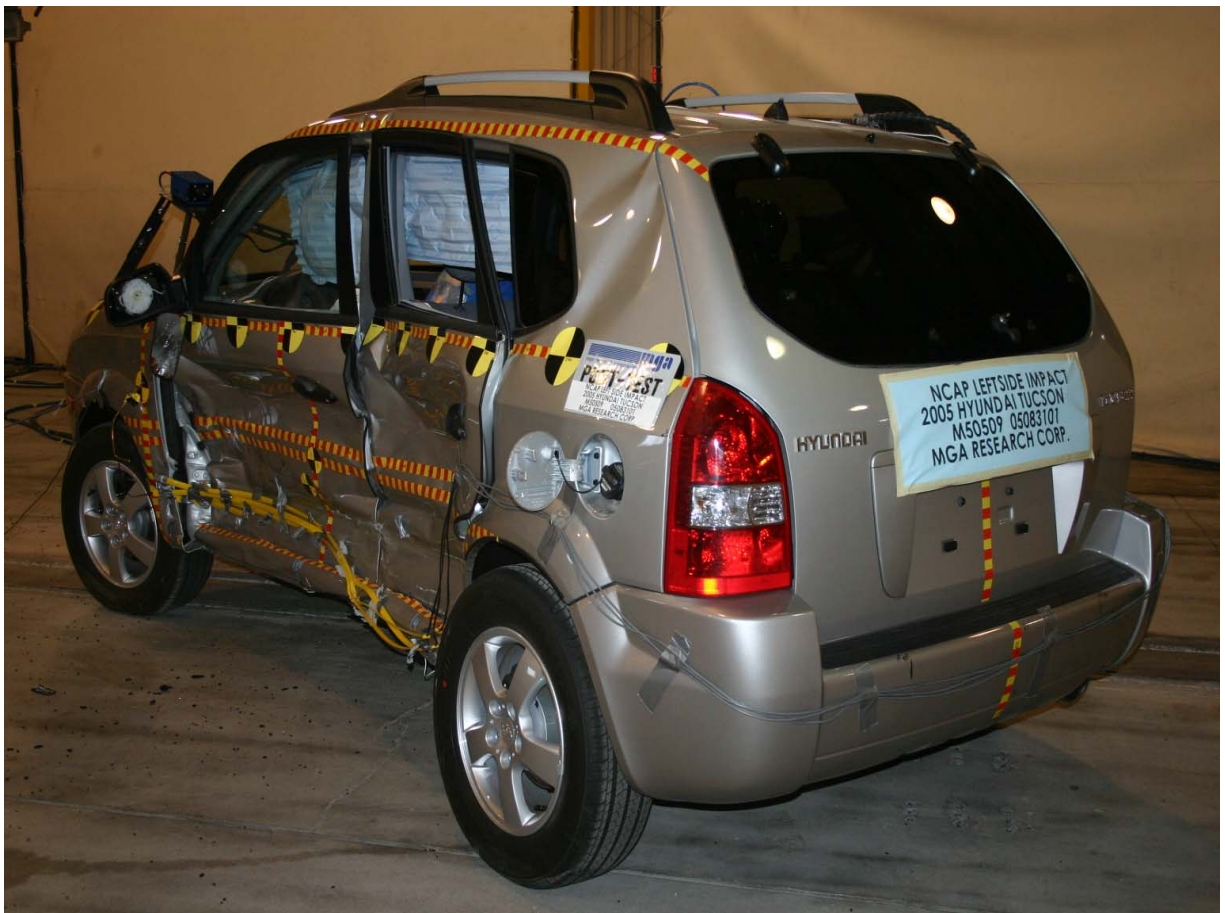
Post-Test Left Rear  $\frac{3}{4}$  View

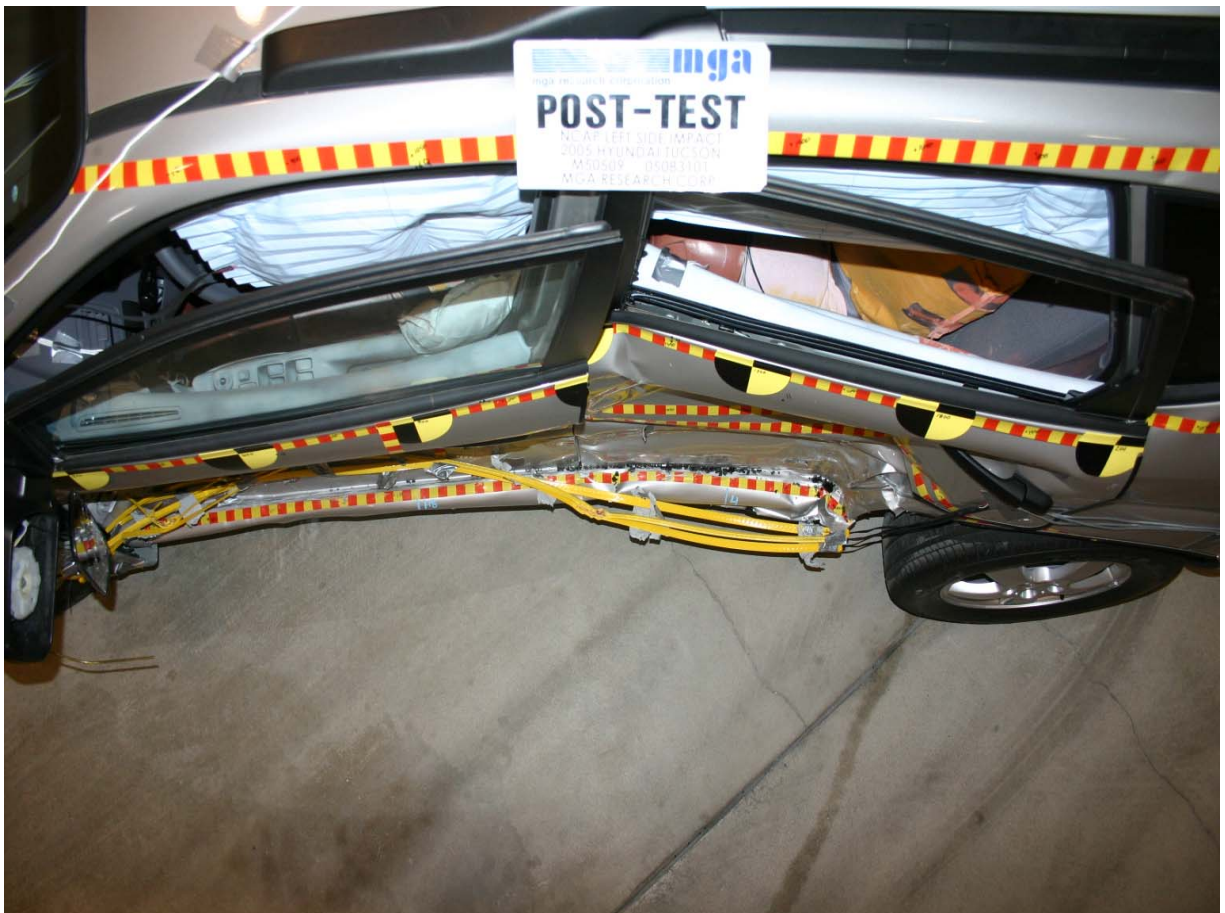
Post-Test Overhead Close-up View

The test vehicle sustained a maximum static crush of 288 mm at level 3, 1350 mm rearward of the left vertical impact point. The driver and passenger SID/HIIIs, Serial Nos. 271 and 904 respectively, were calibrated just prior to this test.

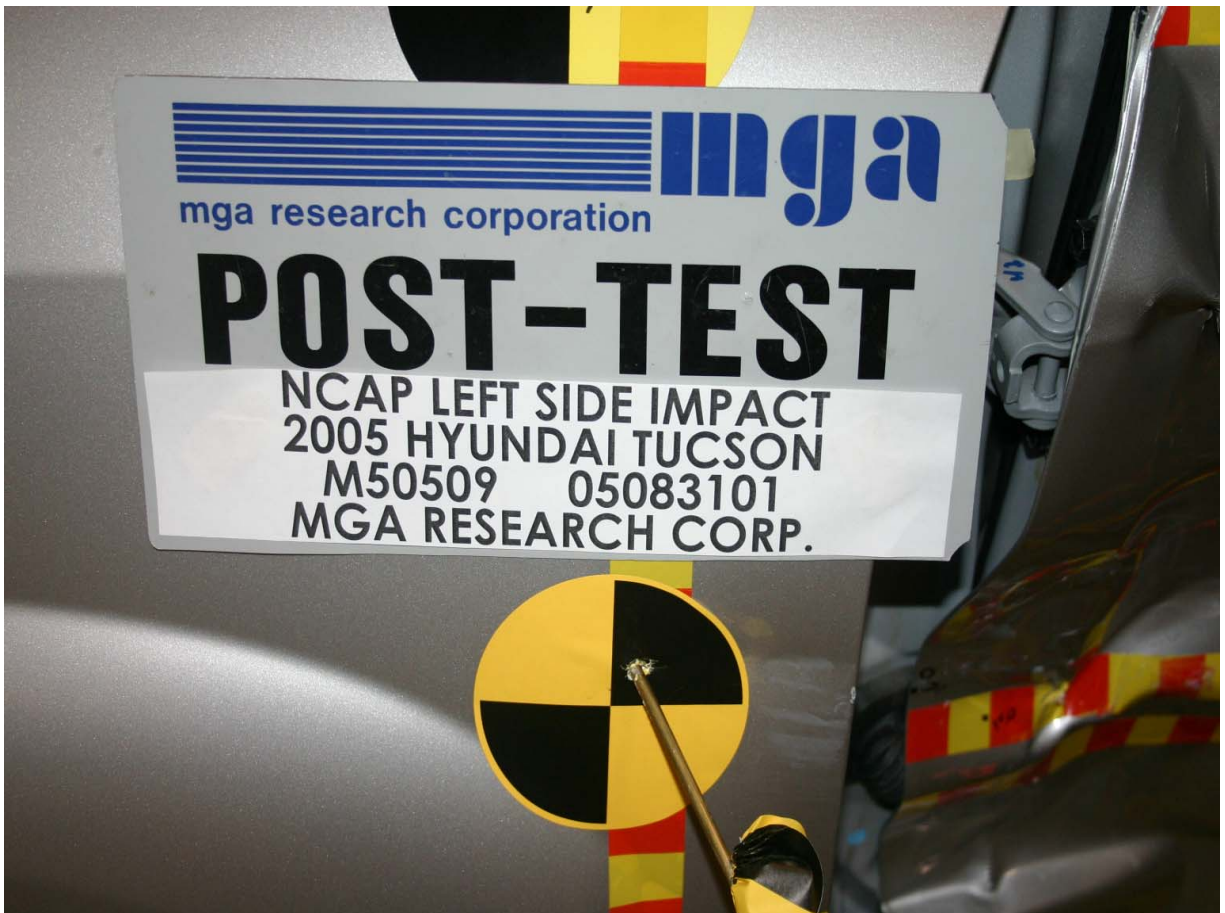
Post-Test Left Impact Point

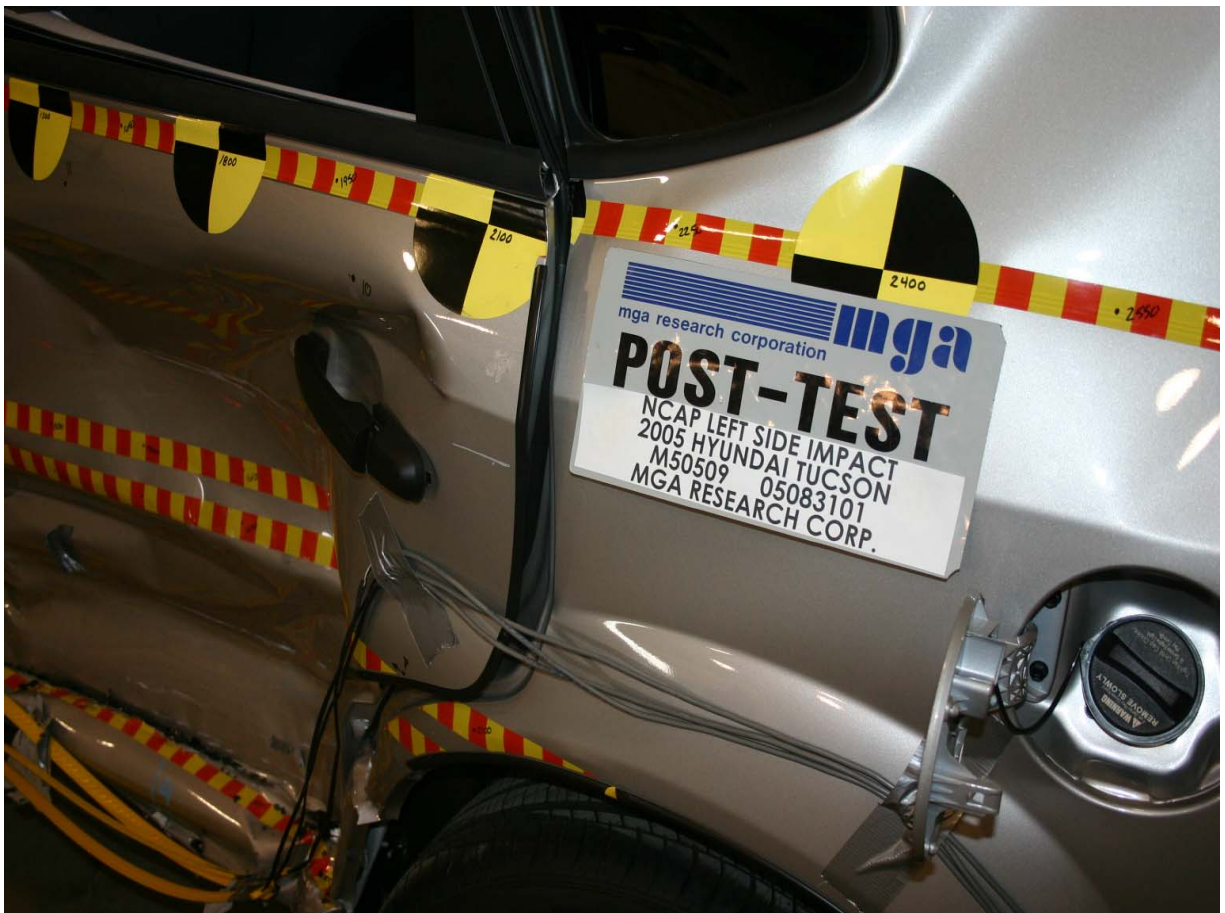
Post-Test Left Rear Door

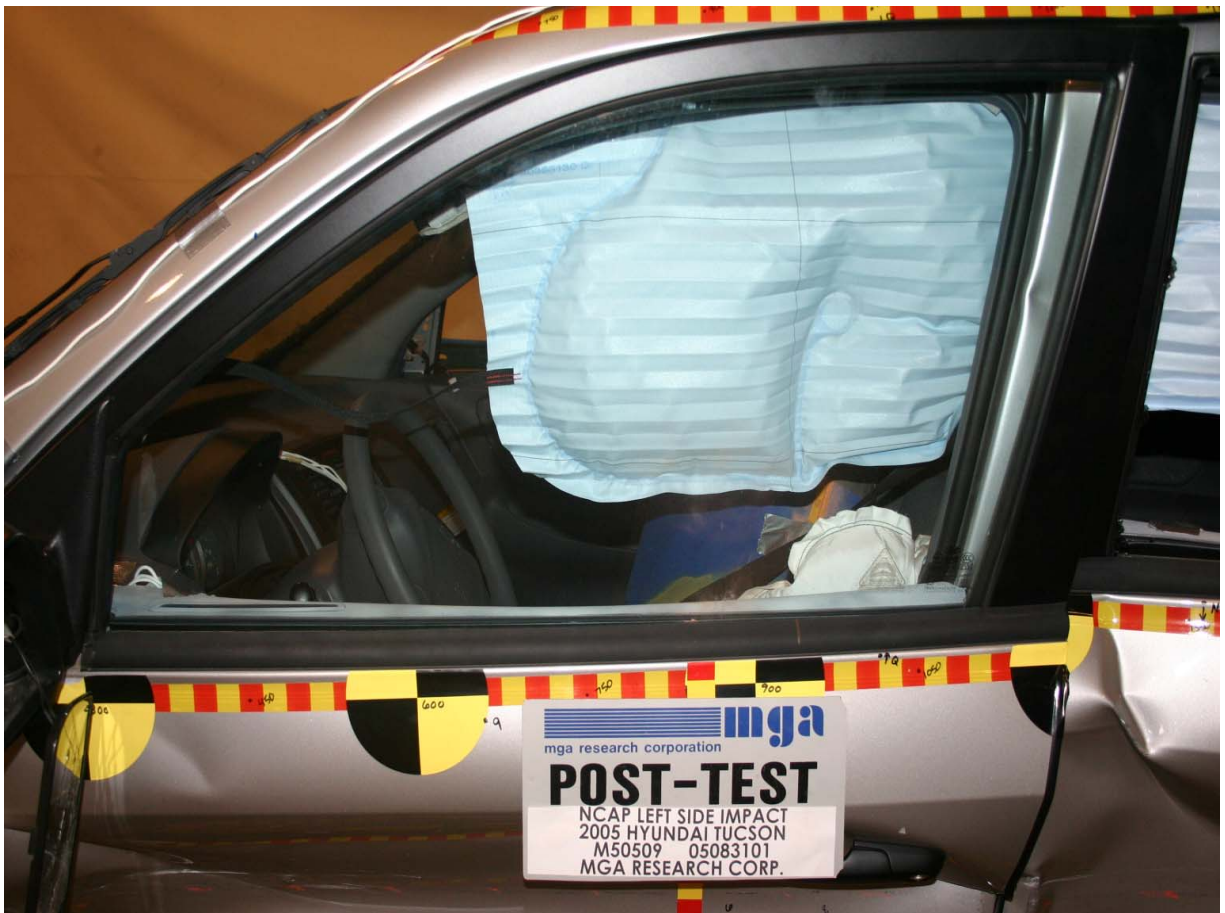
Post-Test Driver Dummy (Through Window)

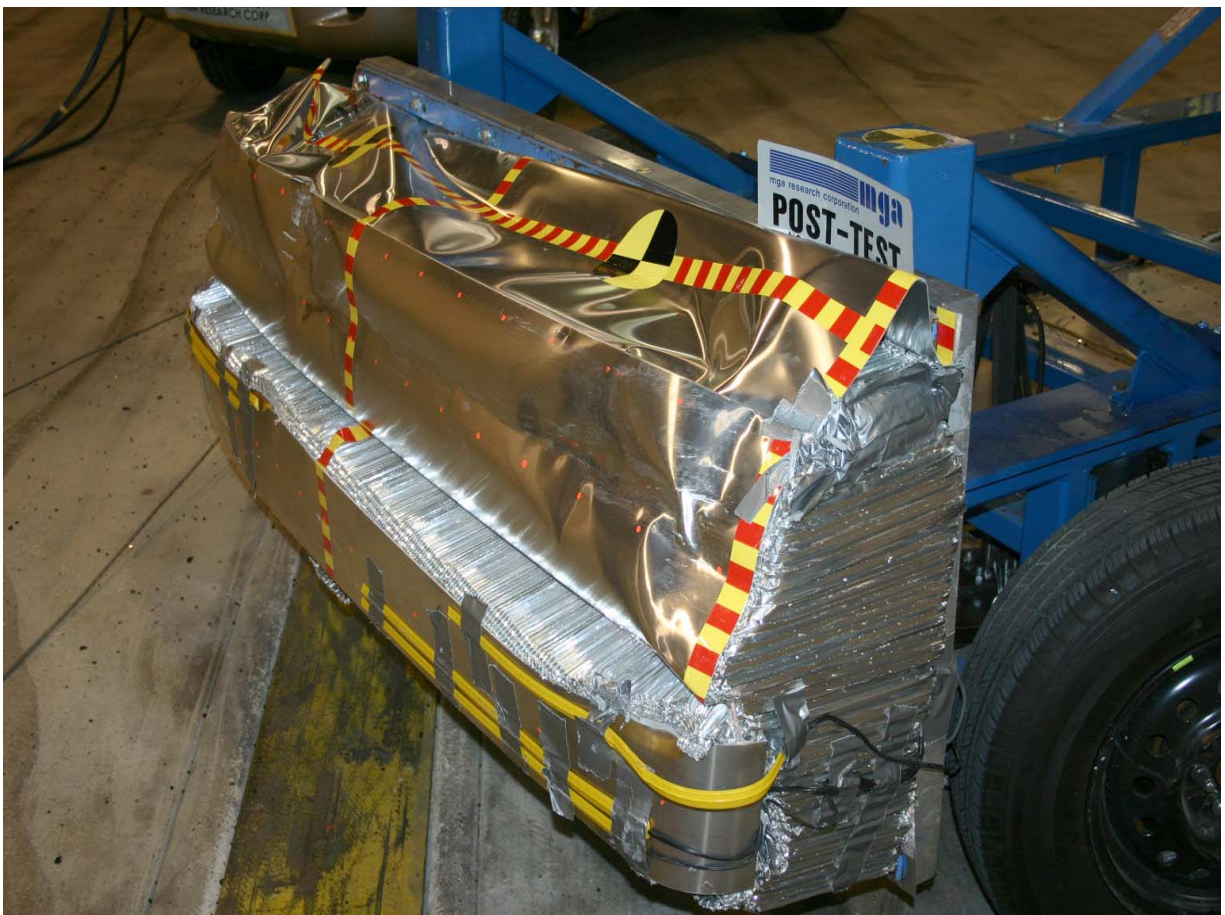
Post-Test Left Side View of Deformable Barrier

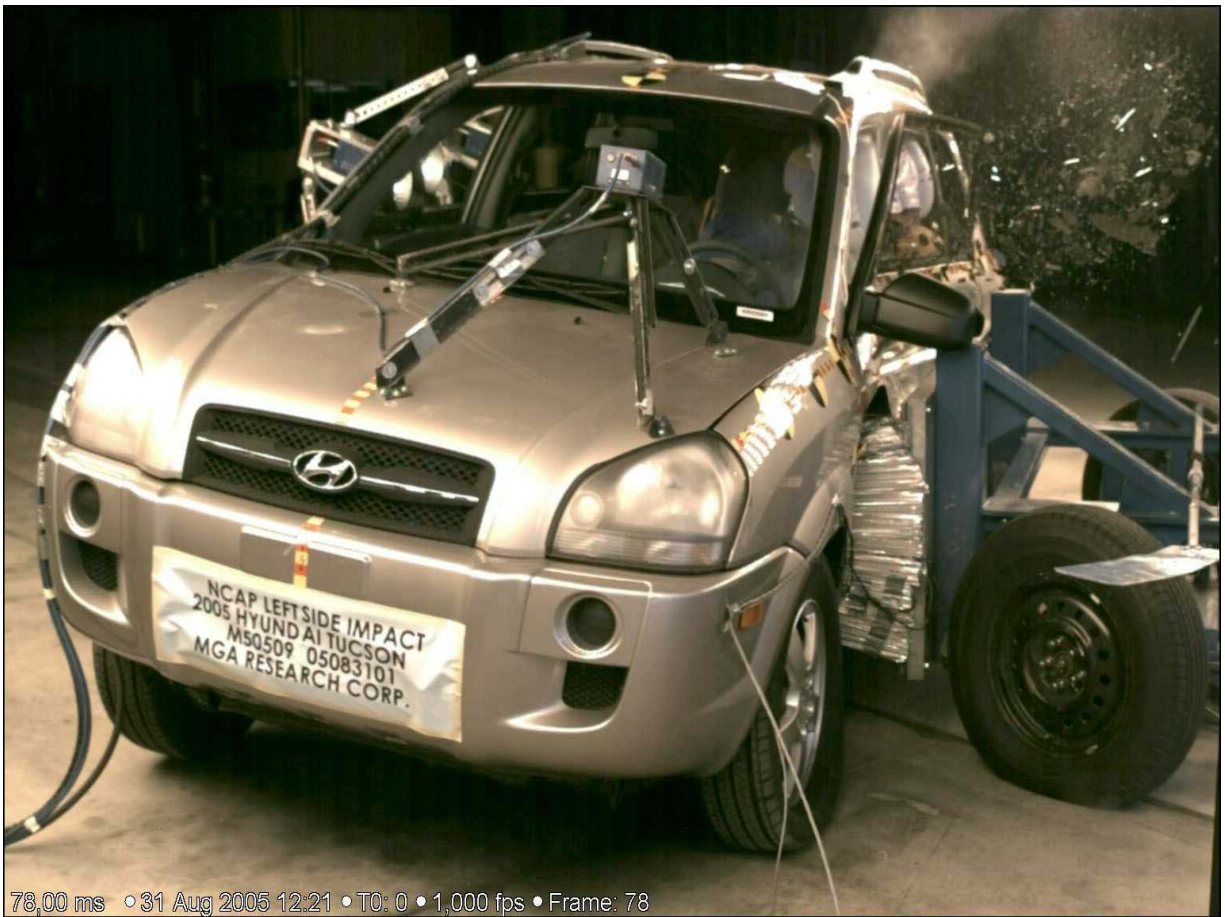
78,00 ms • 31 Aug 2005 12:21 • T0: 0 • 1,000 fps • Frame: 78

Vehicle Impact
