REPORT NUMBER: 214-CAL-06-01

**SAFETY COMPLIANCE TESTING FOR FMVSS 214
SIDE IMPACT PROTECTION
INDICANT**

**FUJI HEAVY INDUSTRIES, LTD.
2006 SUBARU B9 TRIBECA
MPV**

NHTSA NUMBER: C65502

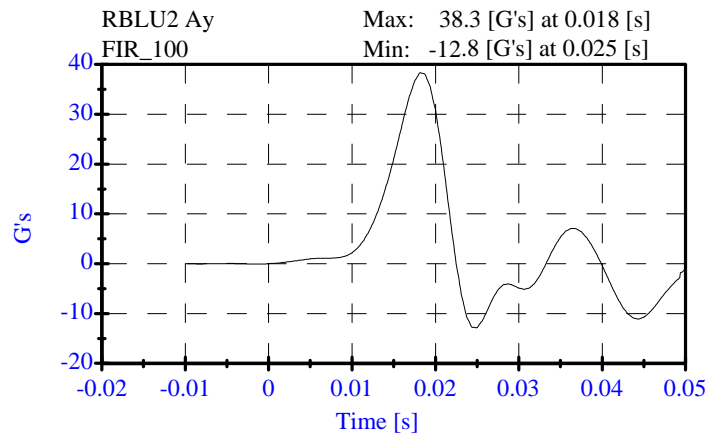
**Thorax Impact
Pre-Test
CONFIGURED FOR LEFT SIDE IMPACT**

<u>TEST PARAMETER</u>	<u>SPECIFICATION</u>	<u>TEST RESULTS</u>	<u>STATUS</u>
Lab Temperature:	18.9-25.5 C	21.1 C	Passed
Lab Humidity:	10-70 %	37.00 %	Passed
Probe Velocity:	4.27- 4.33 m/s	4.28 m/s	Passed
Upper Rib Acceleration:	37.00-46.00 G's	38.28 G's	Passed
Lower Rib Acceleration:	37.00-46.00 G's	37.70 G's	Passed
Lower Spine Acceleration:	15.00-22.00 G's	19.28 G's	Passed

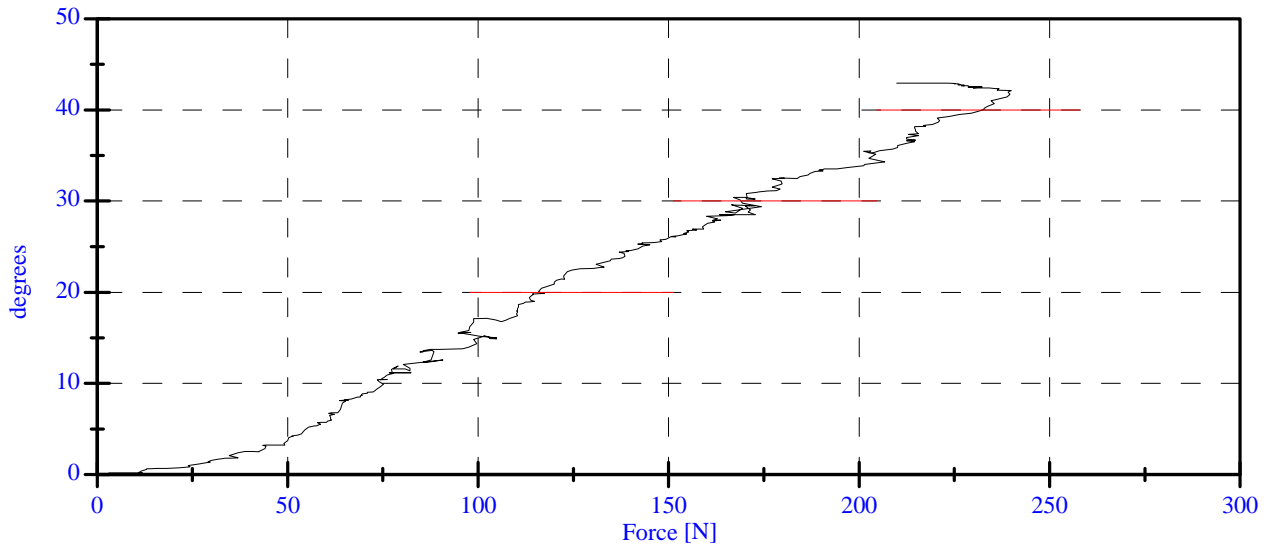
LUMBAR SPINE FLEXION TEST

<u>TEST PARAMETER</u>	<u>SPECIFICATION</u>	<u>TEST RESULTS</u>	<u>STATUS</u>
Lab Temperature:	18.9-25.5 C	21.1 C	Passed
Lab Humidity:	10-70 %	33.00 %	Passed
Force at 0 Deg:	0.00-26.69 N	3.01 N	Passed
Force at 20 Deg:	97.86-151.24 N	116.35 N	Passed
Force at 30 Deg:	151.24-204.62 N	168.84 N	Passed
Force at 40 Deg:	204.62-258.00 N	232.82 N	Passed
Return Angle	12 Deg Max	3.55 deg	Passed
