REPORT NUMBER TR-P25102-01-NC

**NEW CAR ASSESSMENT PROGRAM
SIDE IMPACT TEST**

**FORD MOTOR COMPANY
2006 FORD FREESTAR SE
5-DOOR MPV**

FINAL REPORT

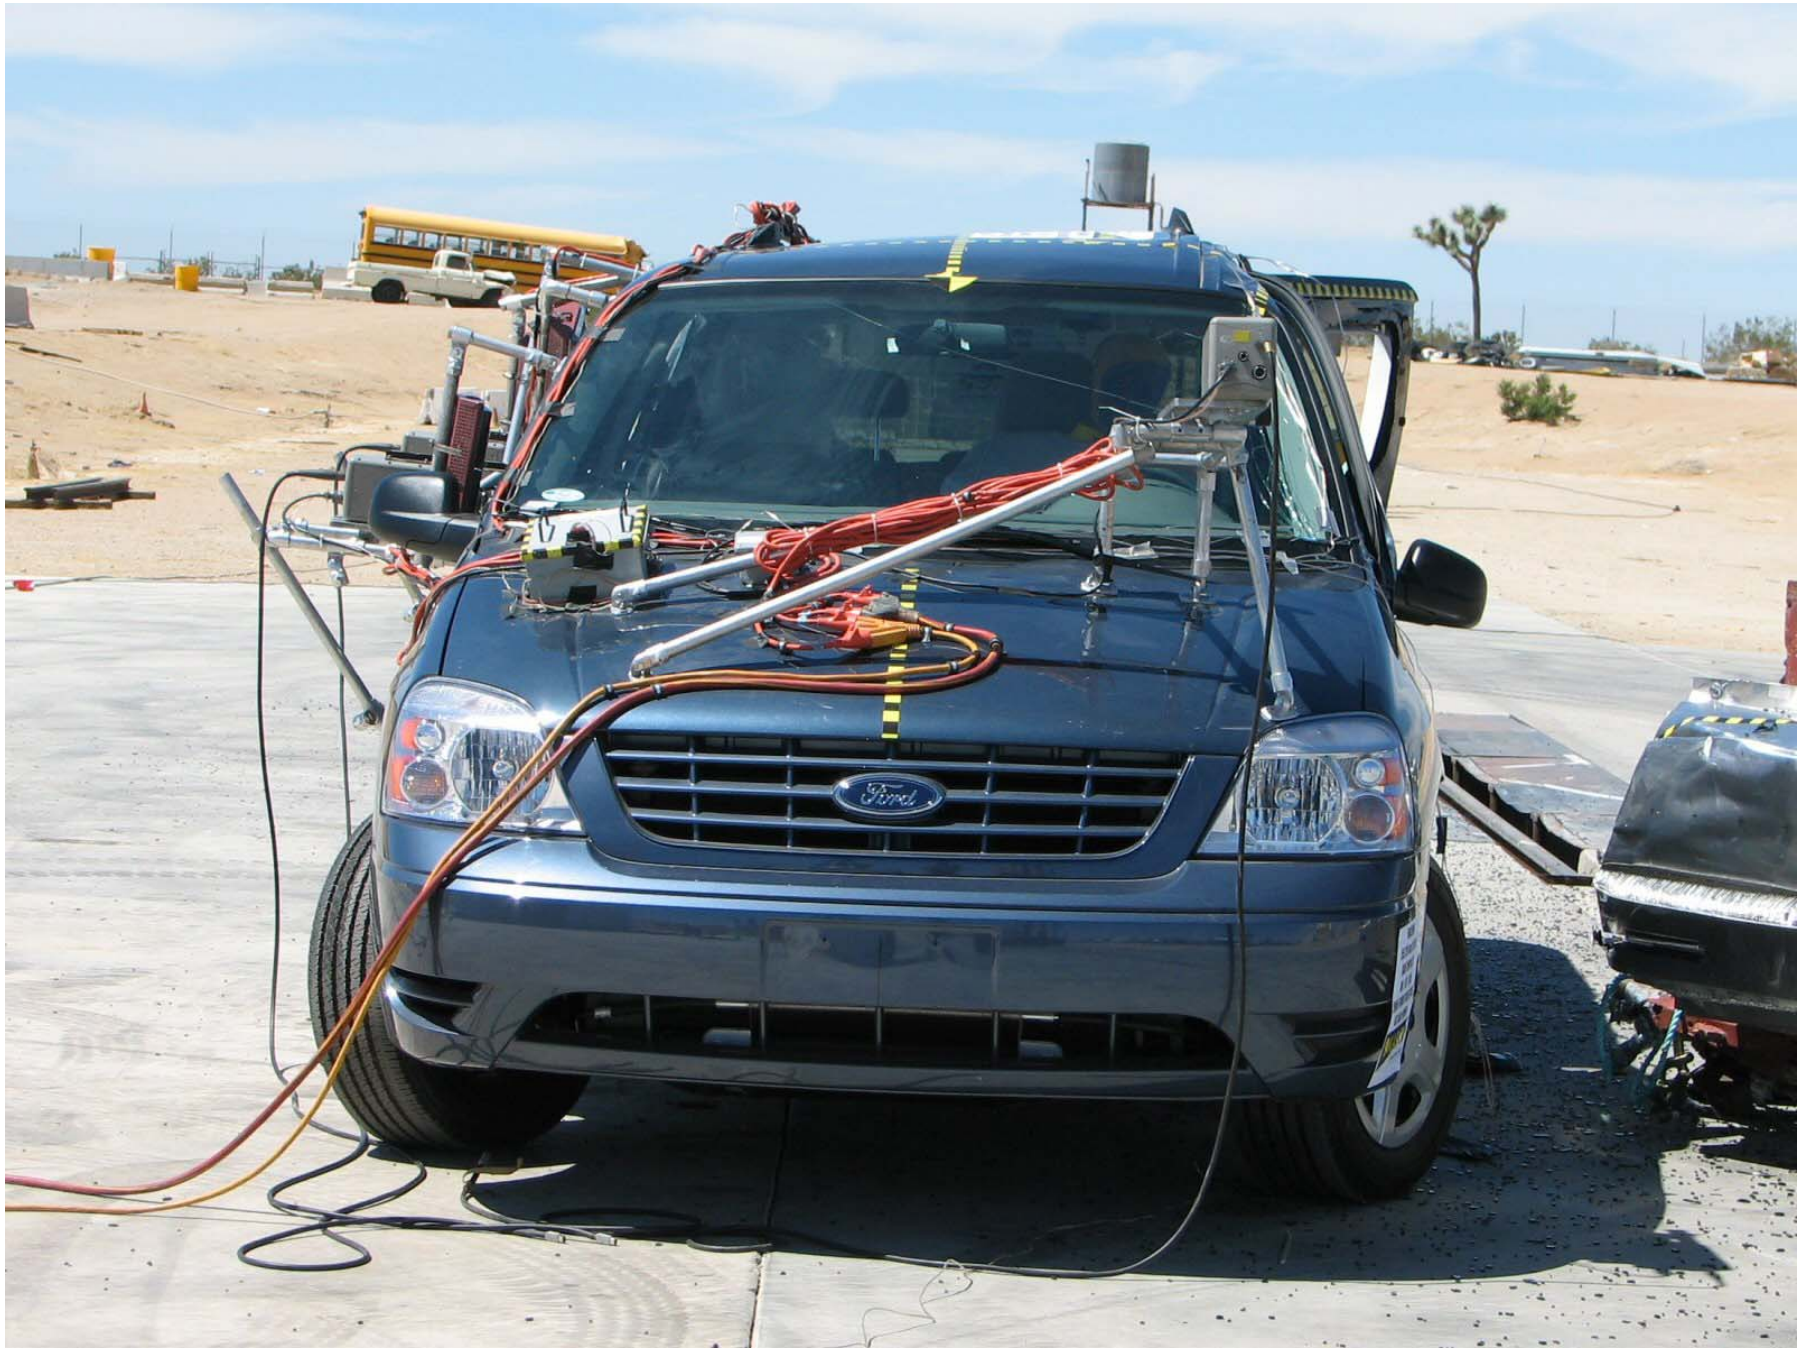
Figure A-6: Post-Test Front View

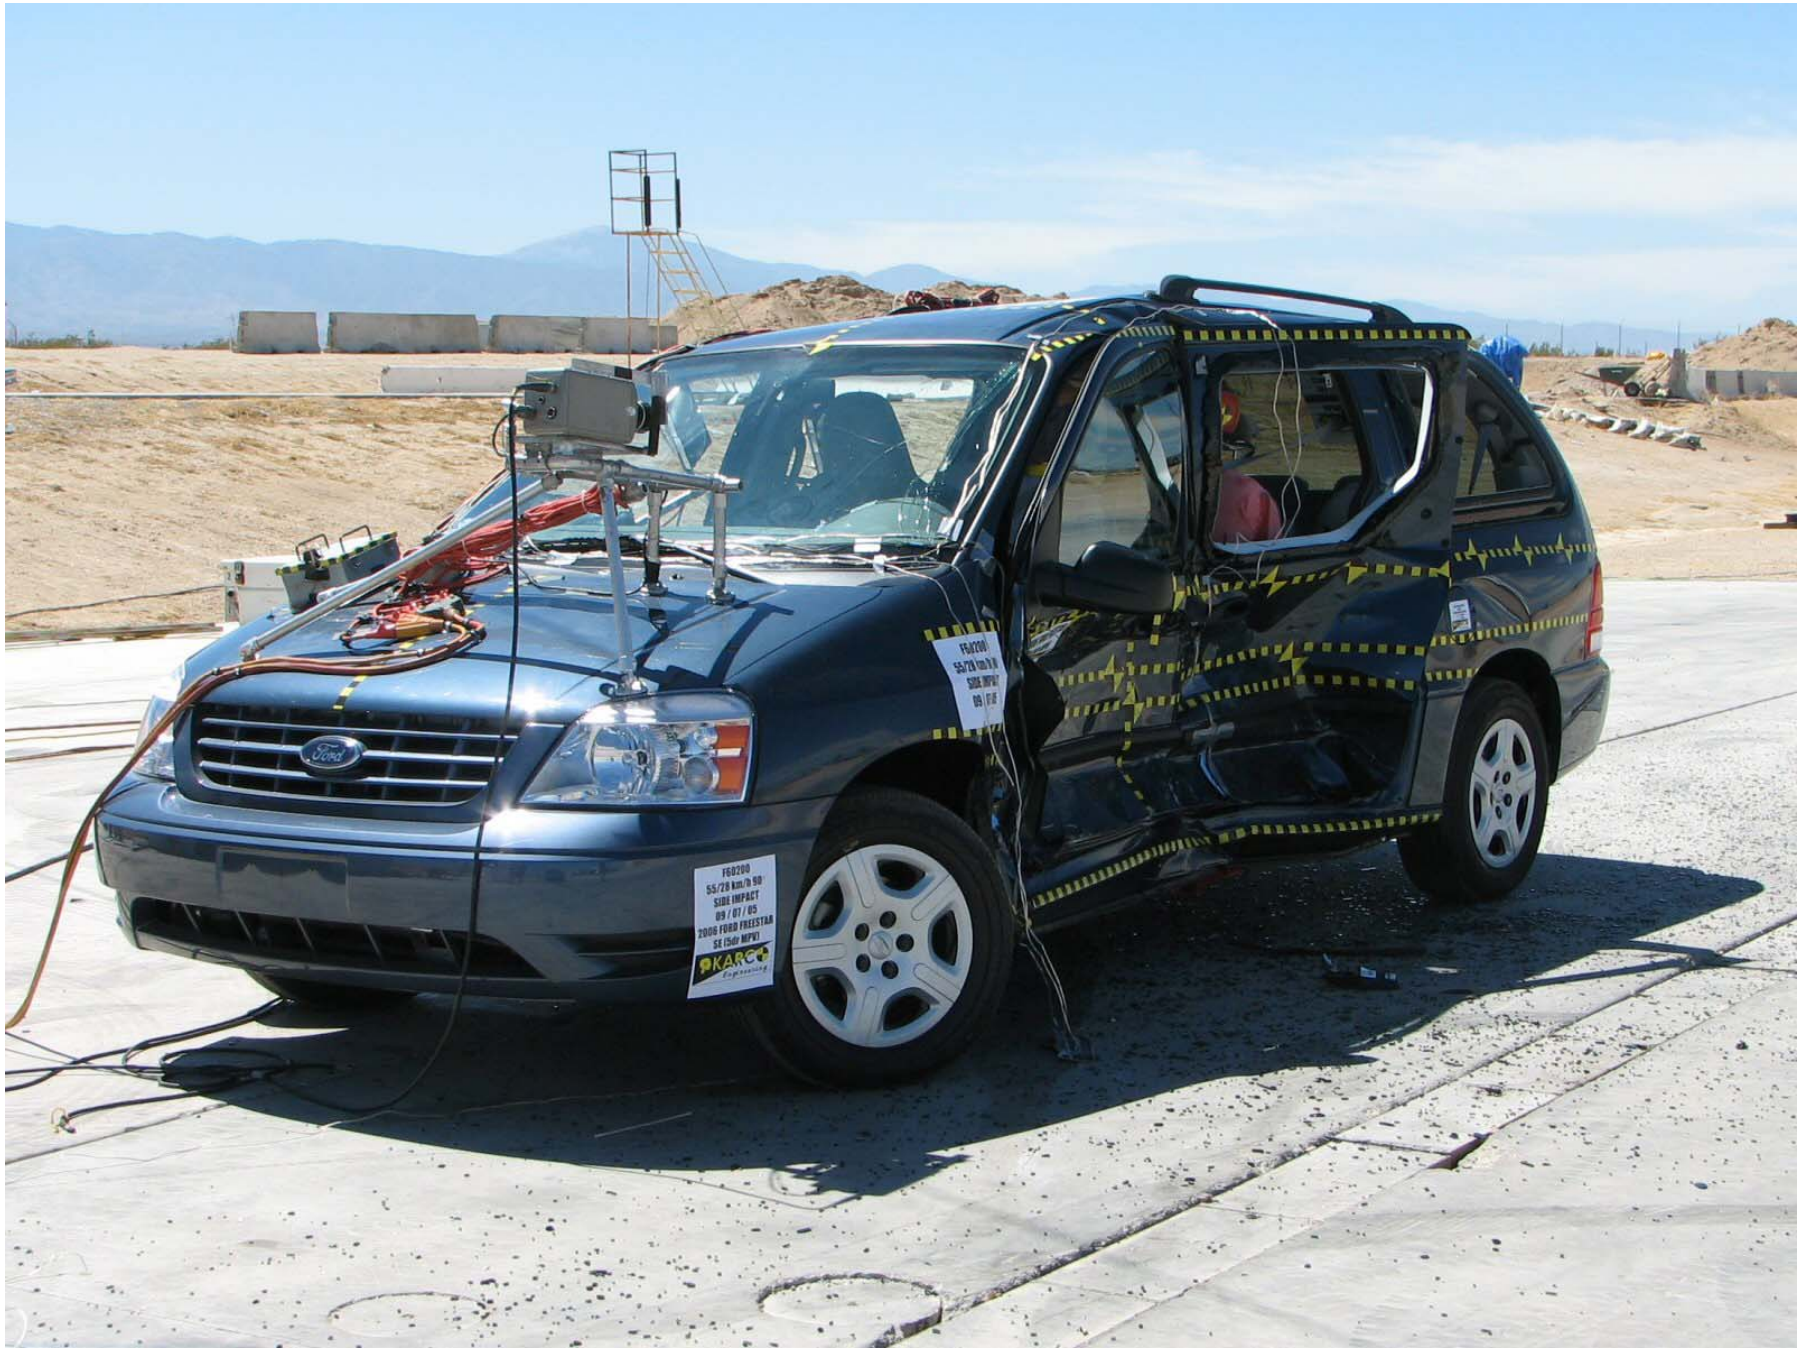
Figure A-8: Post-Test Left Front $\frac{3}{4}$ View

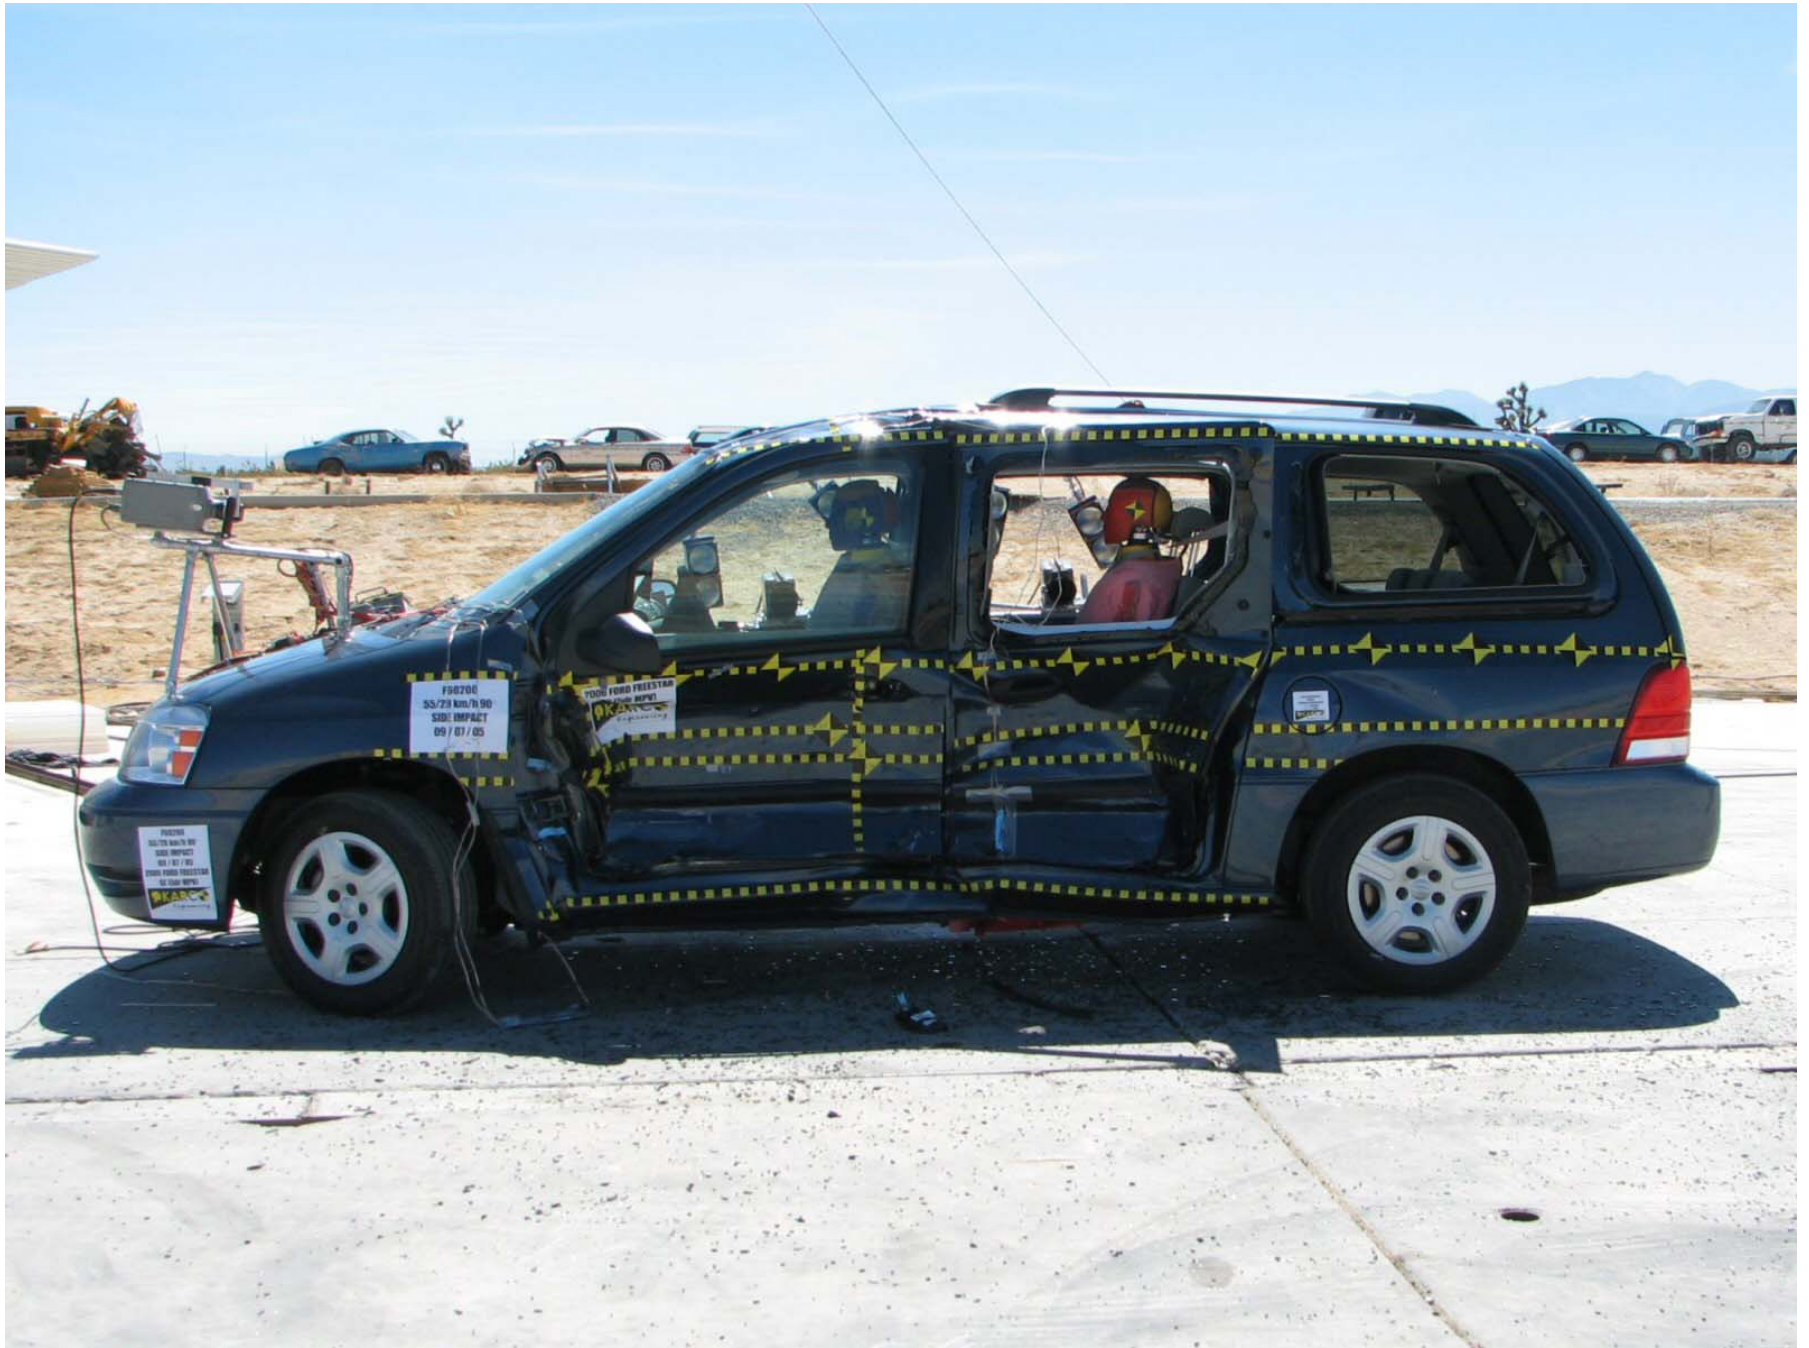
Figure A-10: Post-Test Left Side View

The driver and passenger doors remained closed during impact. The test vehicle sustained a maximum static crush of 427 mm at level 3, 1350 mm rearward of the left vertical impact point. The driver SID/Hybrid III, Serial No. 275 and the passenger SID/Hybrid III, Serial No. 274 were calibrated prior to this test. The SID/Hybrid III injury criteria is summarized as follows:

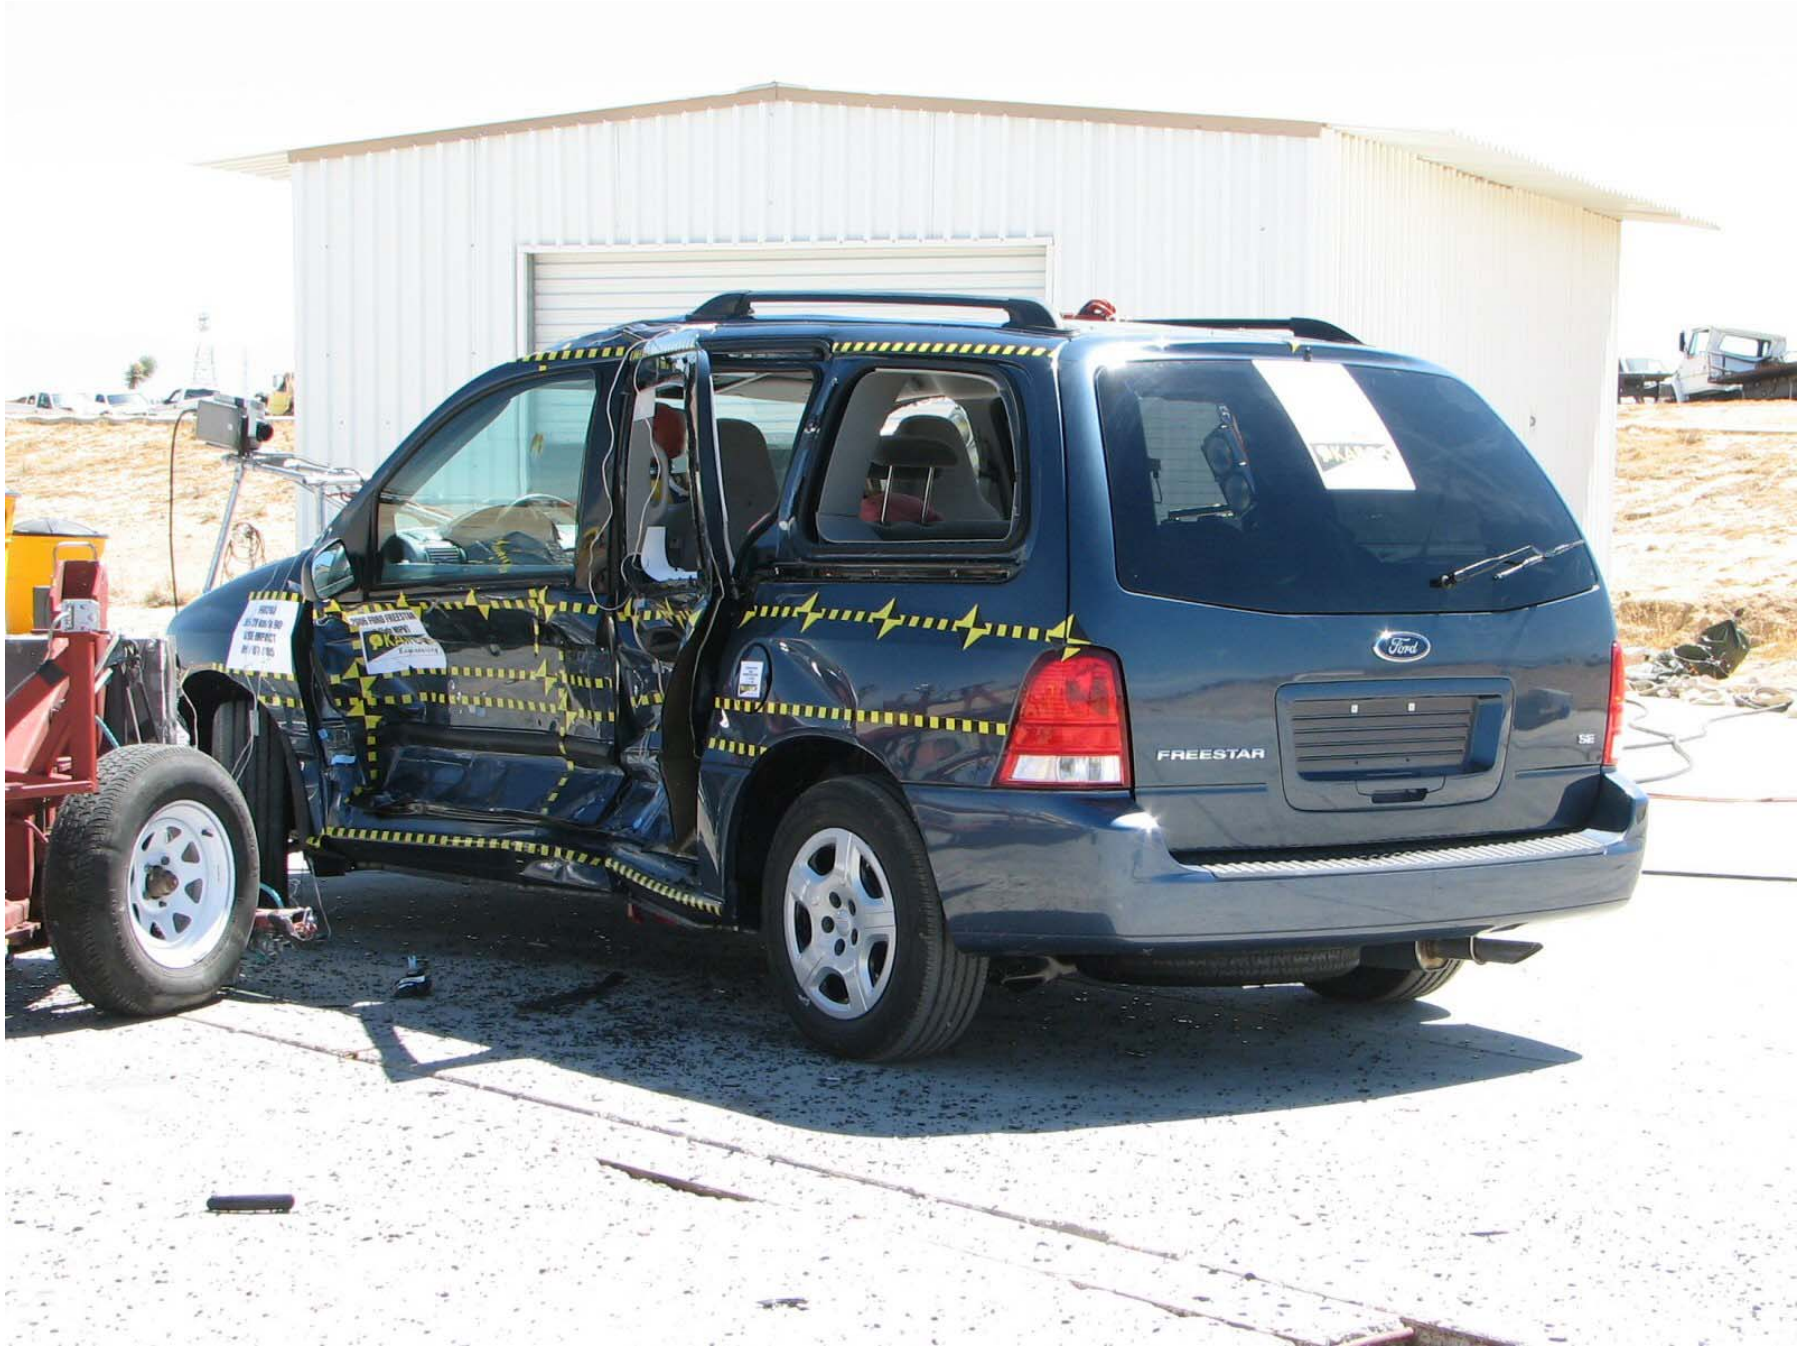
Figure A-12: Post-Test Left Rear 3/4 View

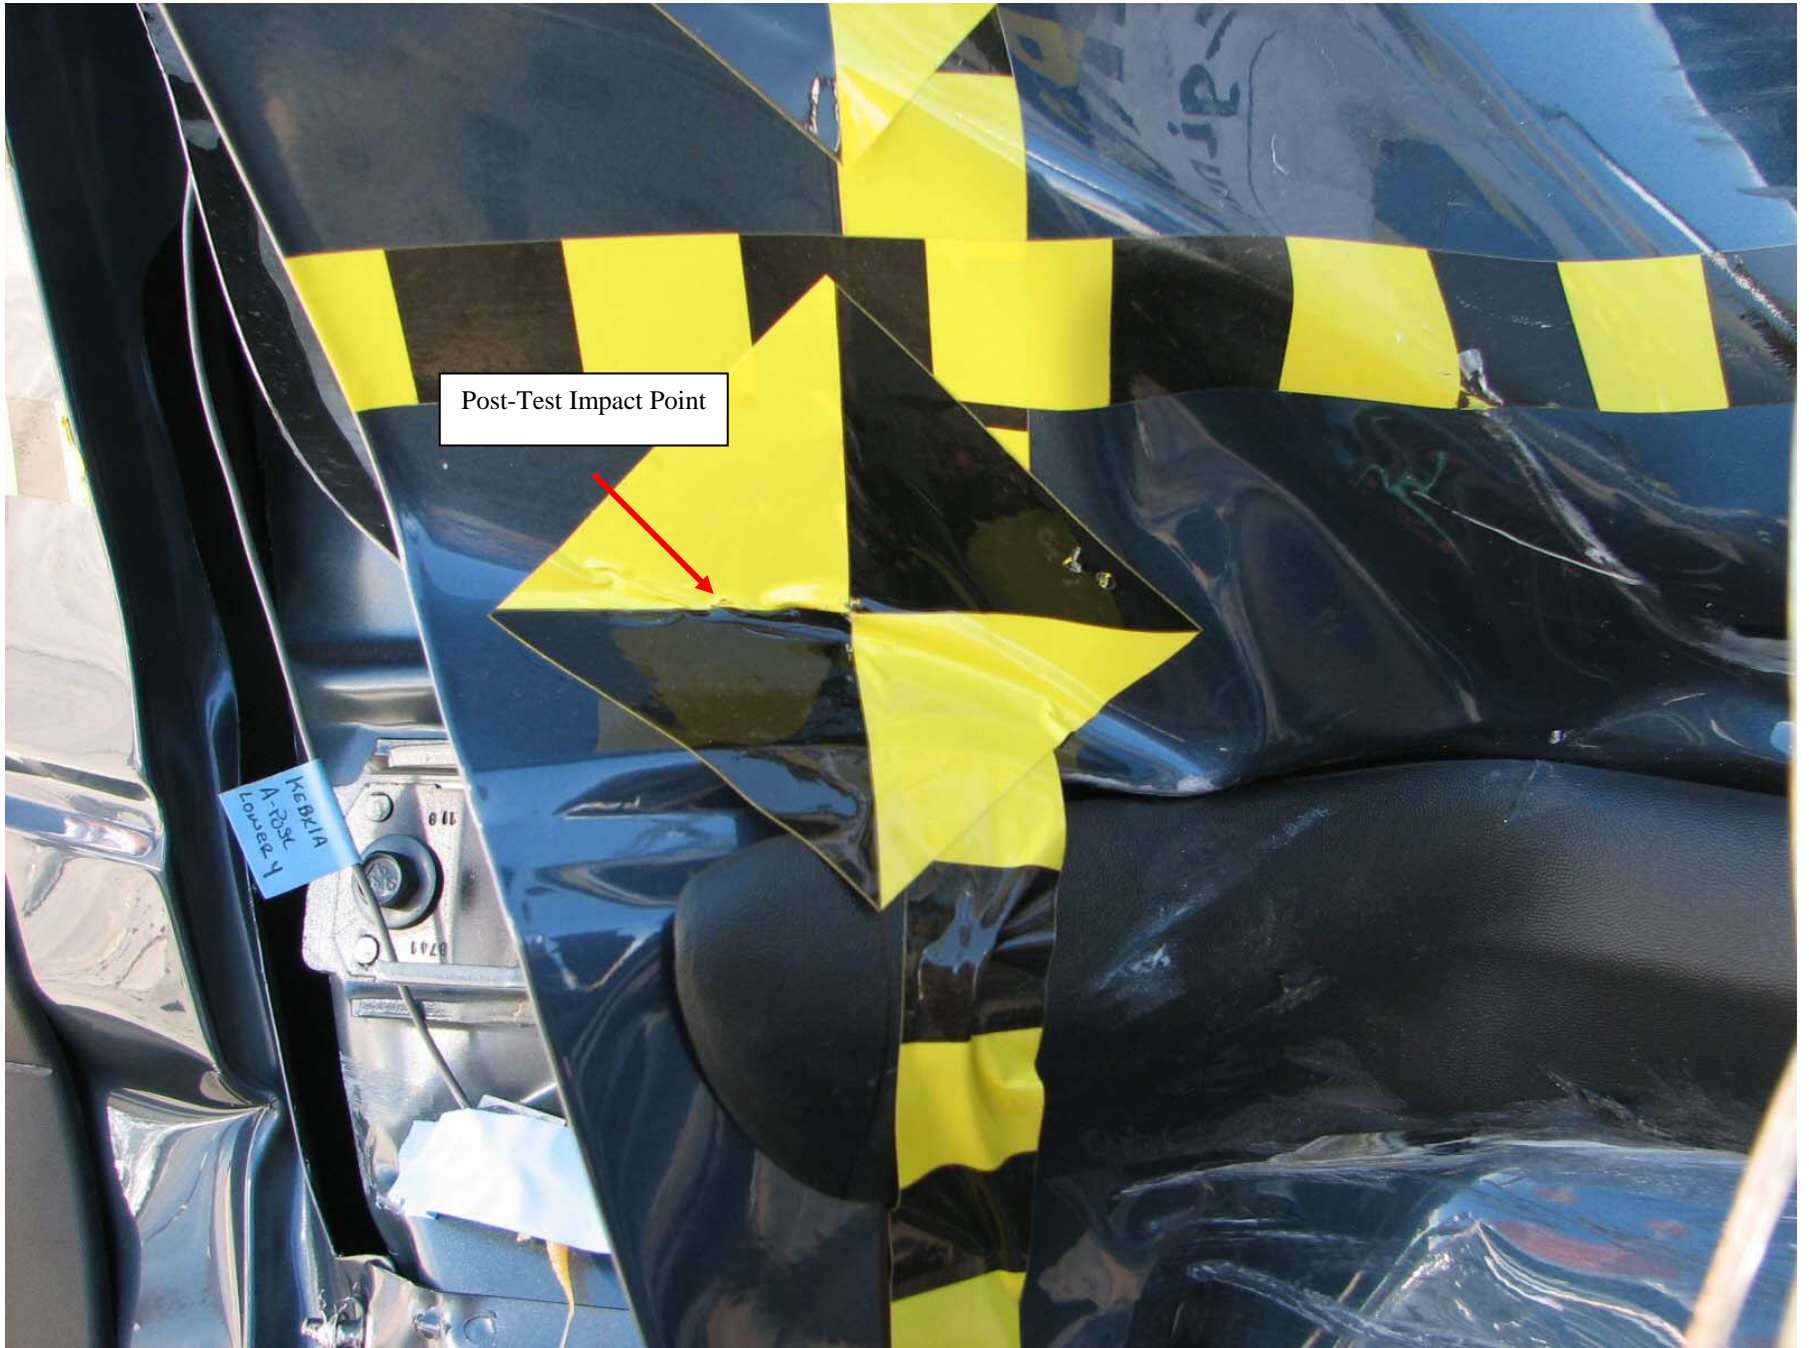
Figure A-26: Post-Test Left Impact Point

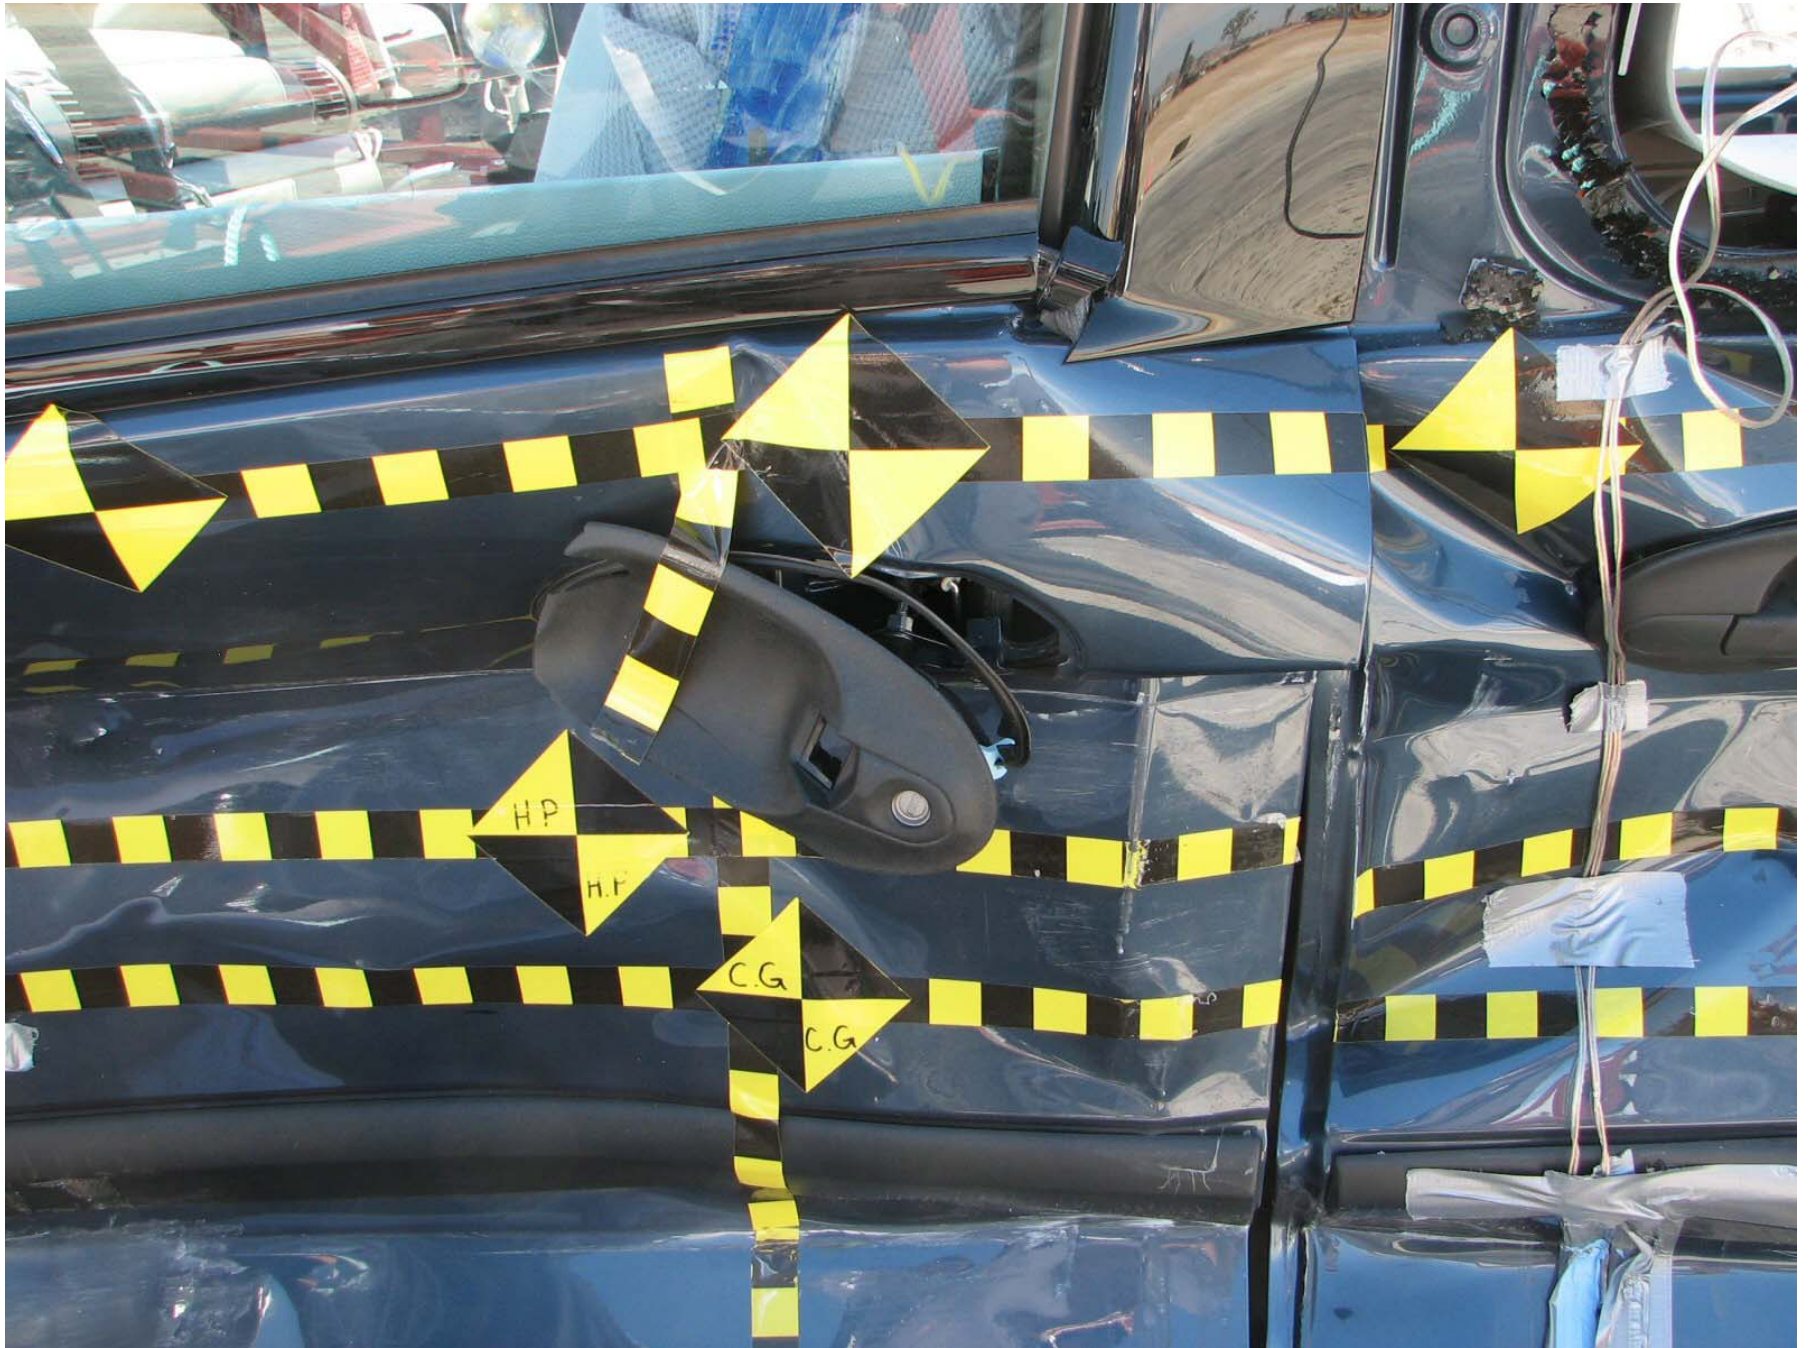
Figure A-32: Post-Test Left Front Door

Description	Front	Rear
Left Side Door Opening	Remained Closed and latched, jammed	Remained closed and latched, jammed
Right Side Door Opening	Remained closed and latched, operational	Remained closed and latched, operational
Seat Movement (mm)	None	None
Seat Back Failure	None	None

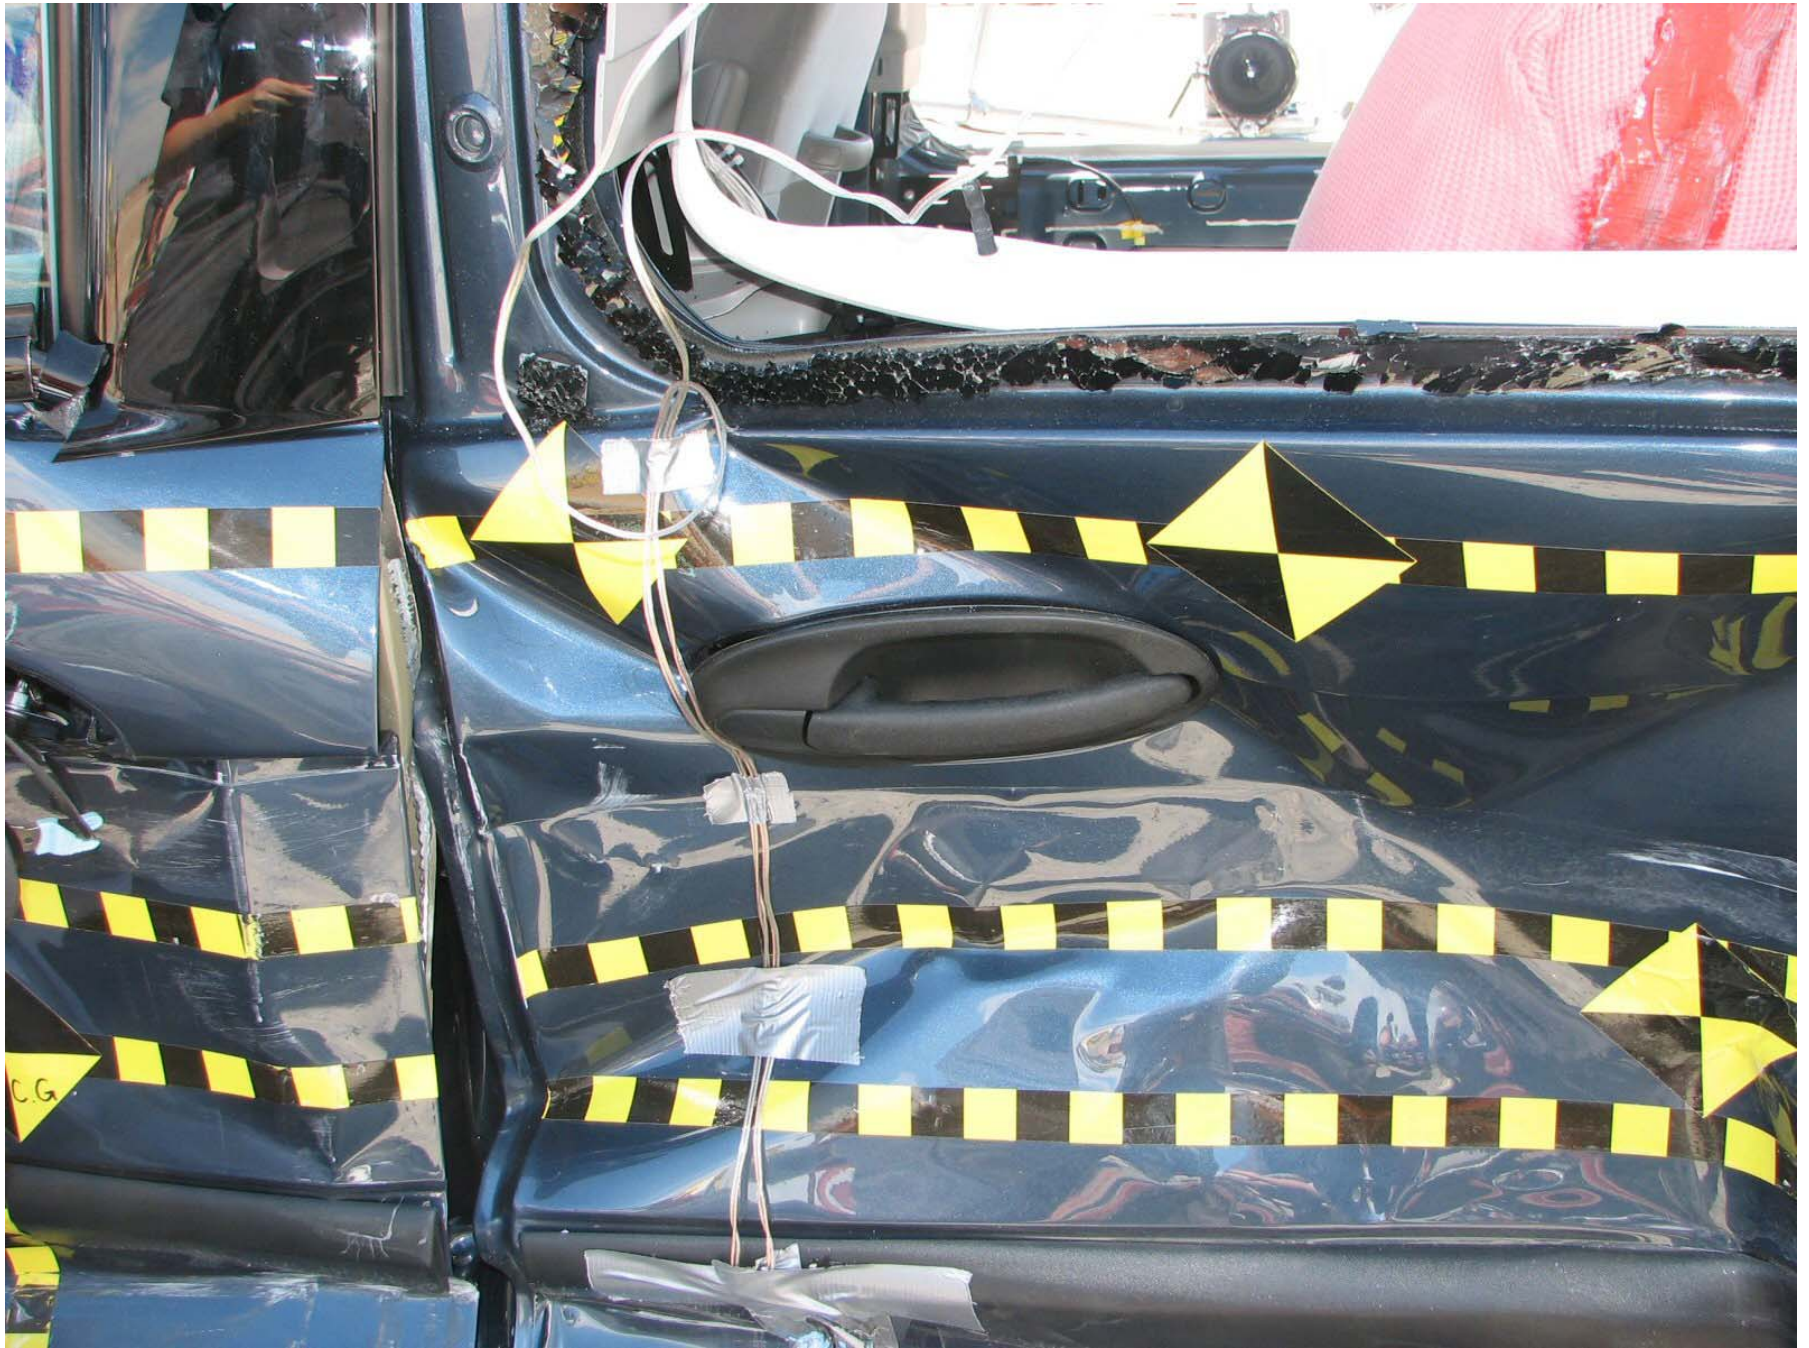
Figure A-34: Post-Test Left Rear Door

Critical Areas of Performance	Observations and Conclusions
Pillar Performance	No separation
Sill Separation	None
Windshield Damage	None
Window Damage	Driver front window intact, rear passenger window broken.
Other Notable Effects	None

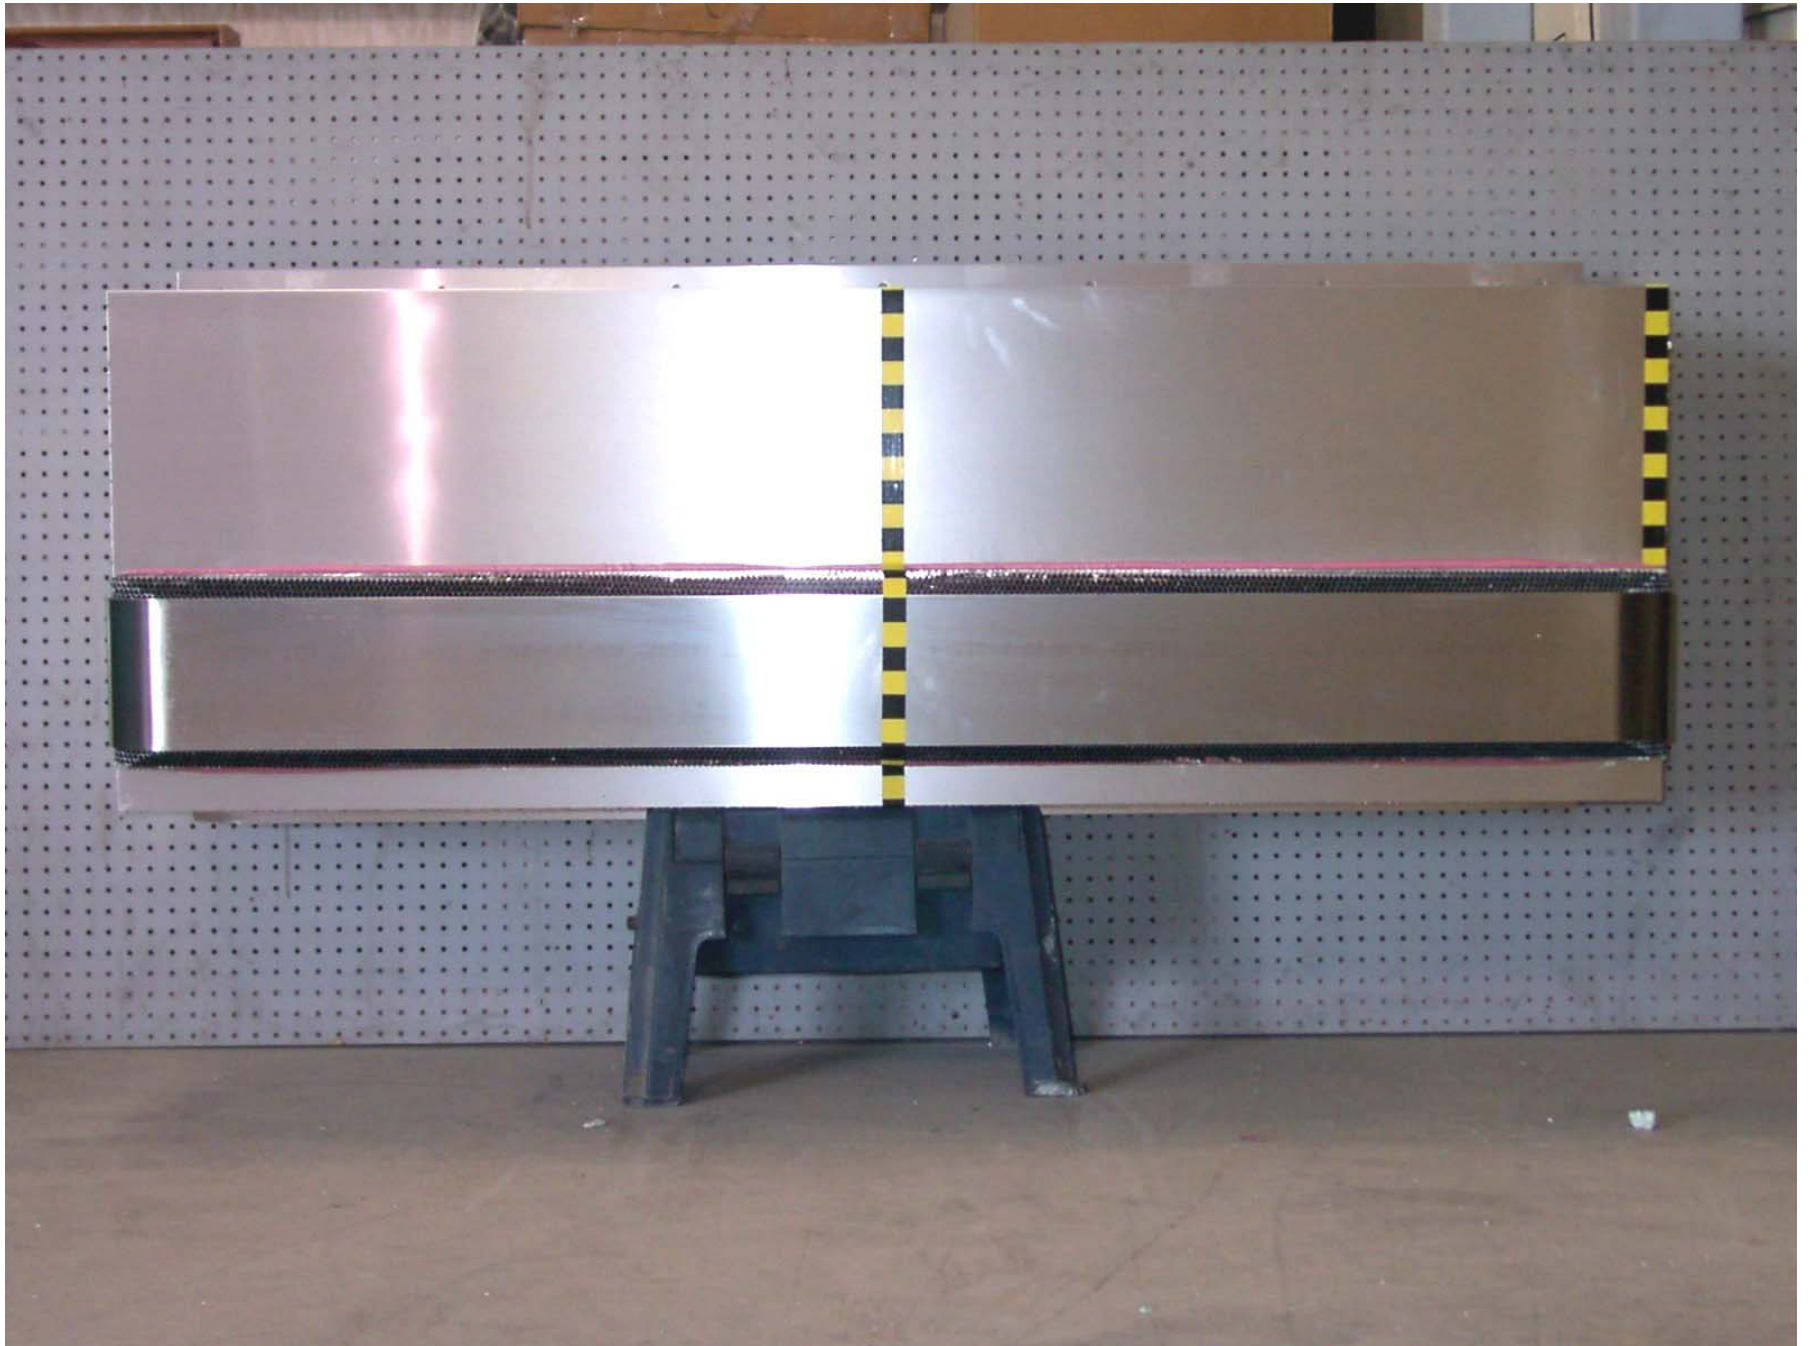
Figure A-54: Post-Test Front View of Deformable Barrier

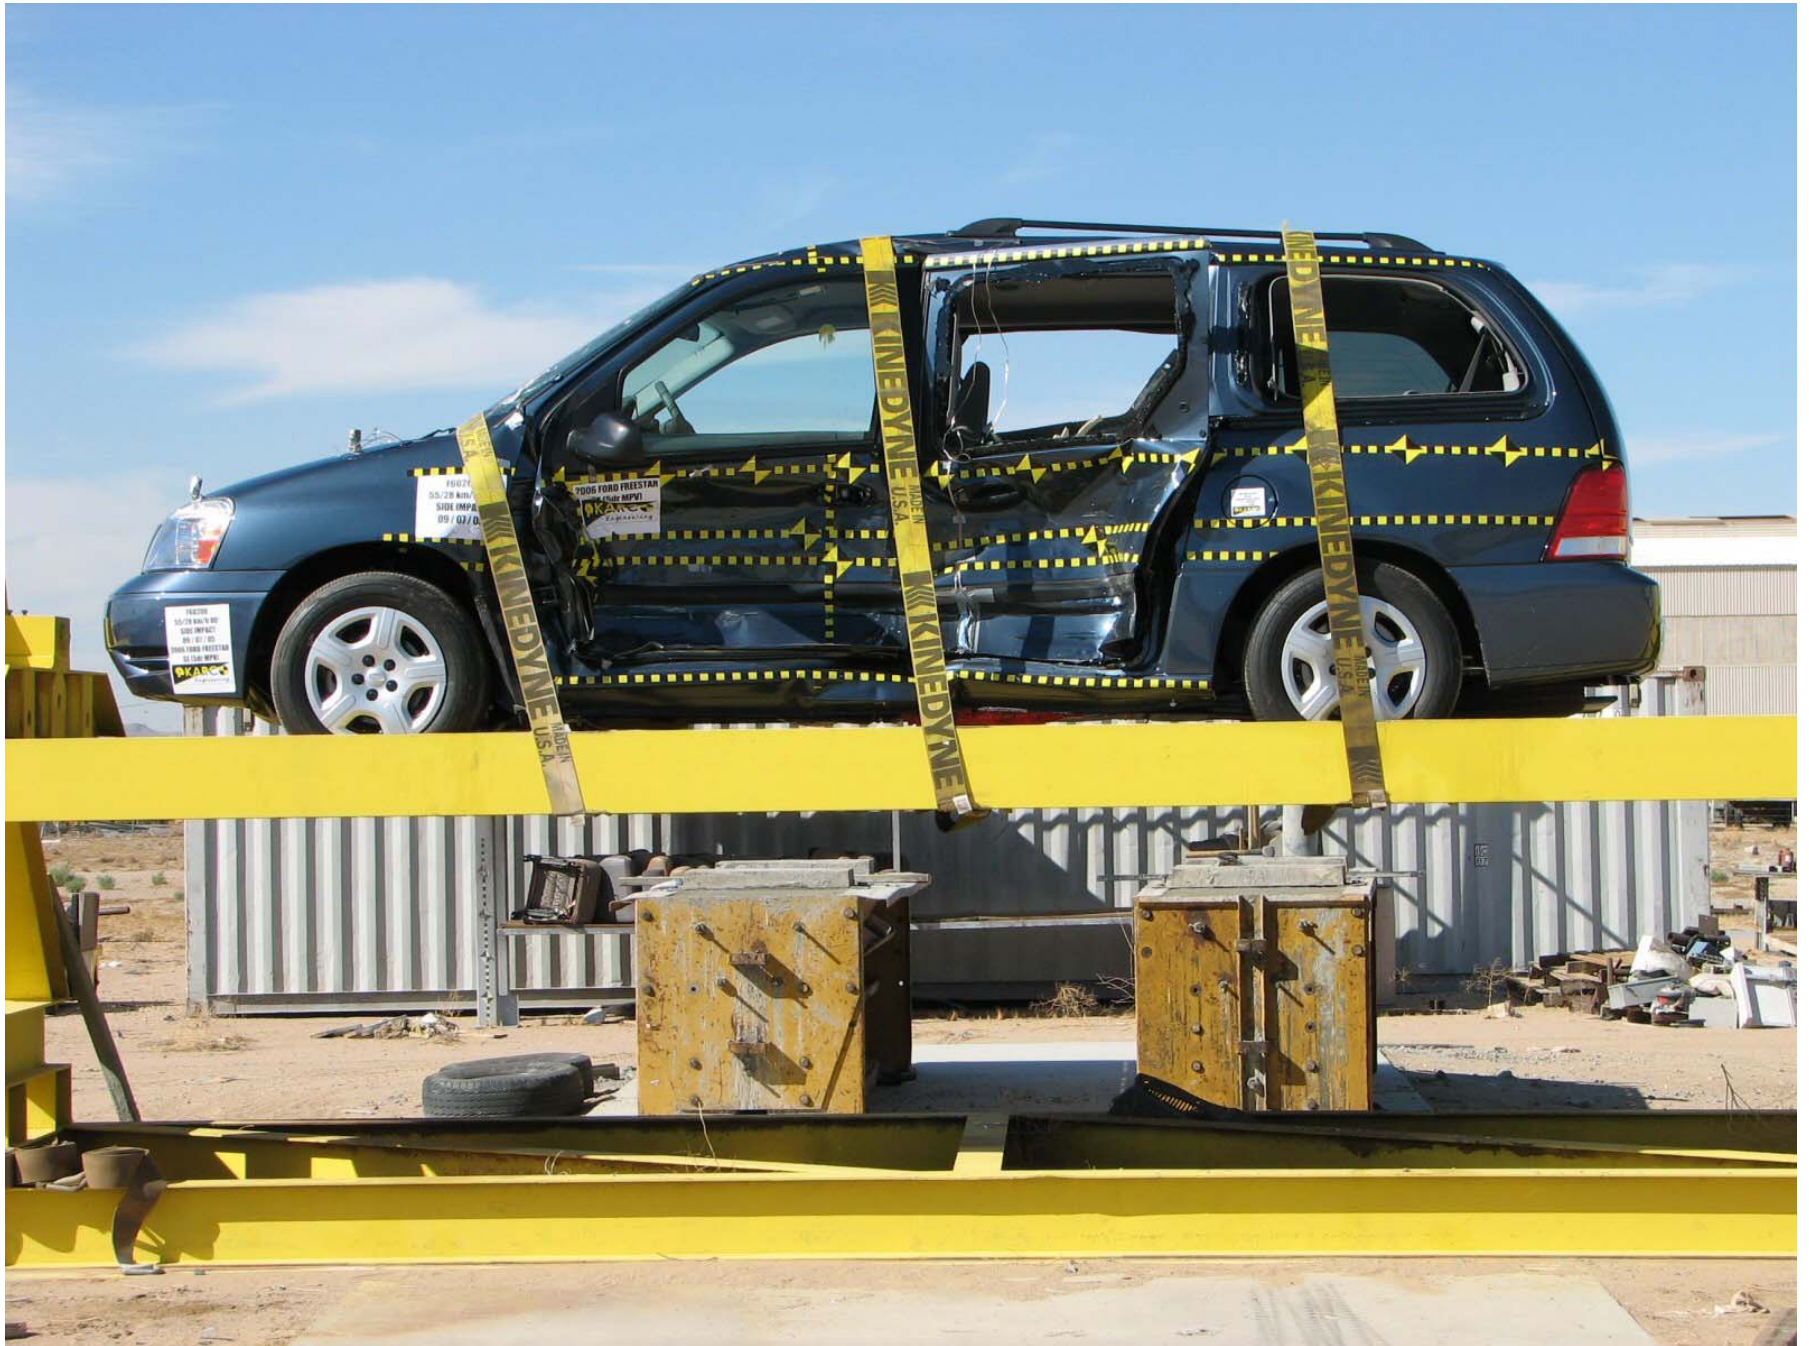
Figure A-61: Vehicle on Rollover Device (0°)

1. The specified fixture rollover rate for each 90° of rotation is 60 to 120 seconds.
 2. The position hold time at each position is 300 seconds (minimum).
 3. Details of Stoddard Solvent spillage locations.
- No solvent leakage occurred during static rollover testing.
