REPORT NUMBER TR-P25102-01-NC

**NEW CAR ASSESSMENT PROGRAM
SIDE IMPACT TEST**

**FORD MOTOR COMPANY
2006 FORD FREESTAR SE
5-DOOR MPV**

FINAL REPORT

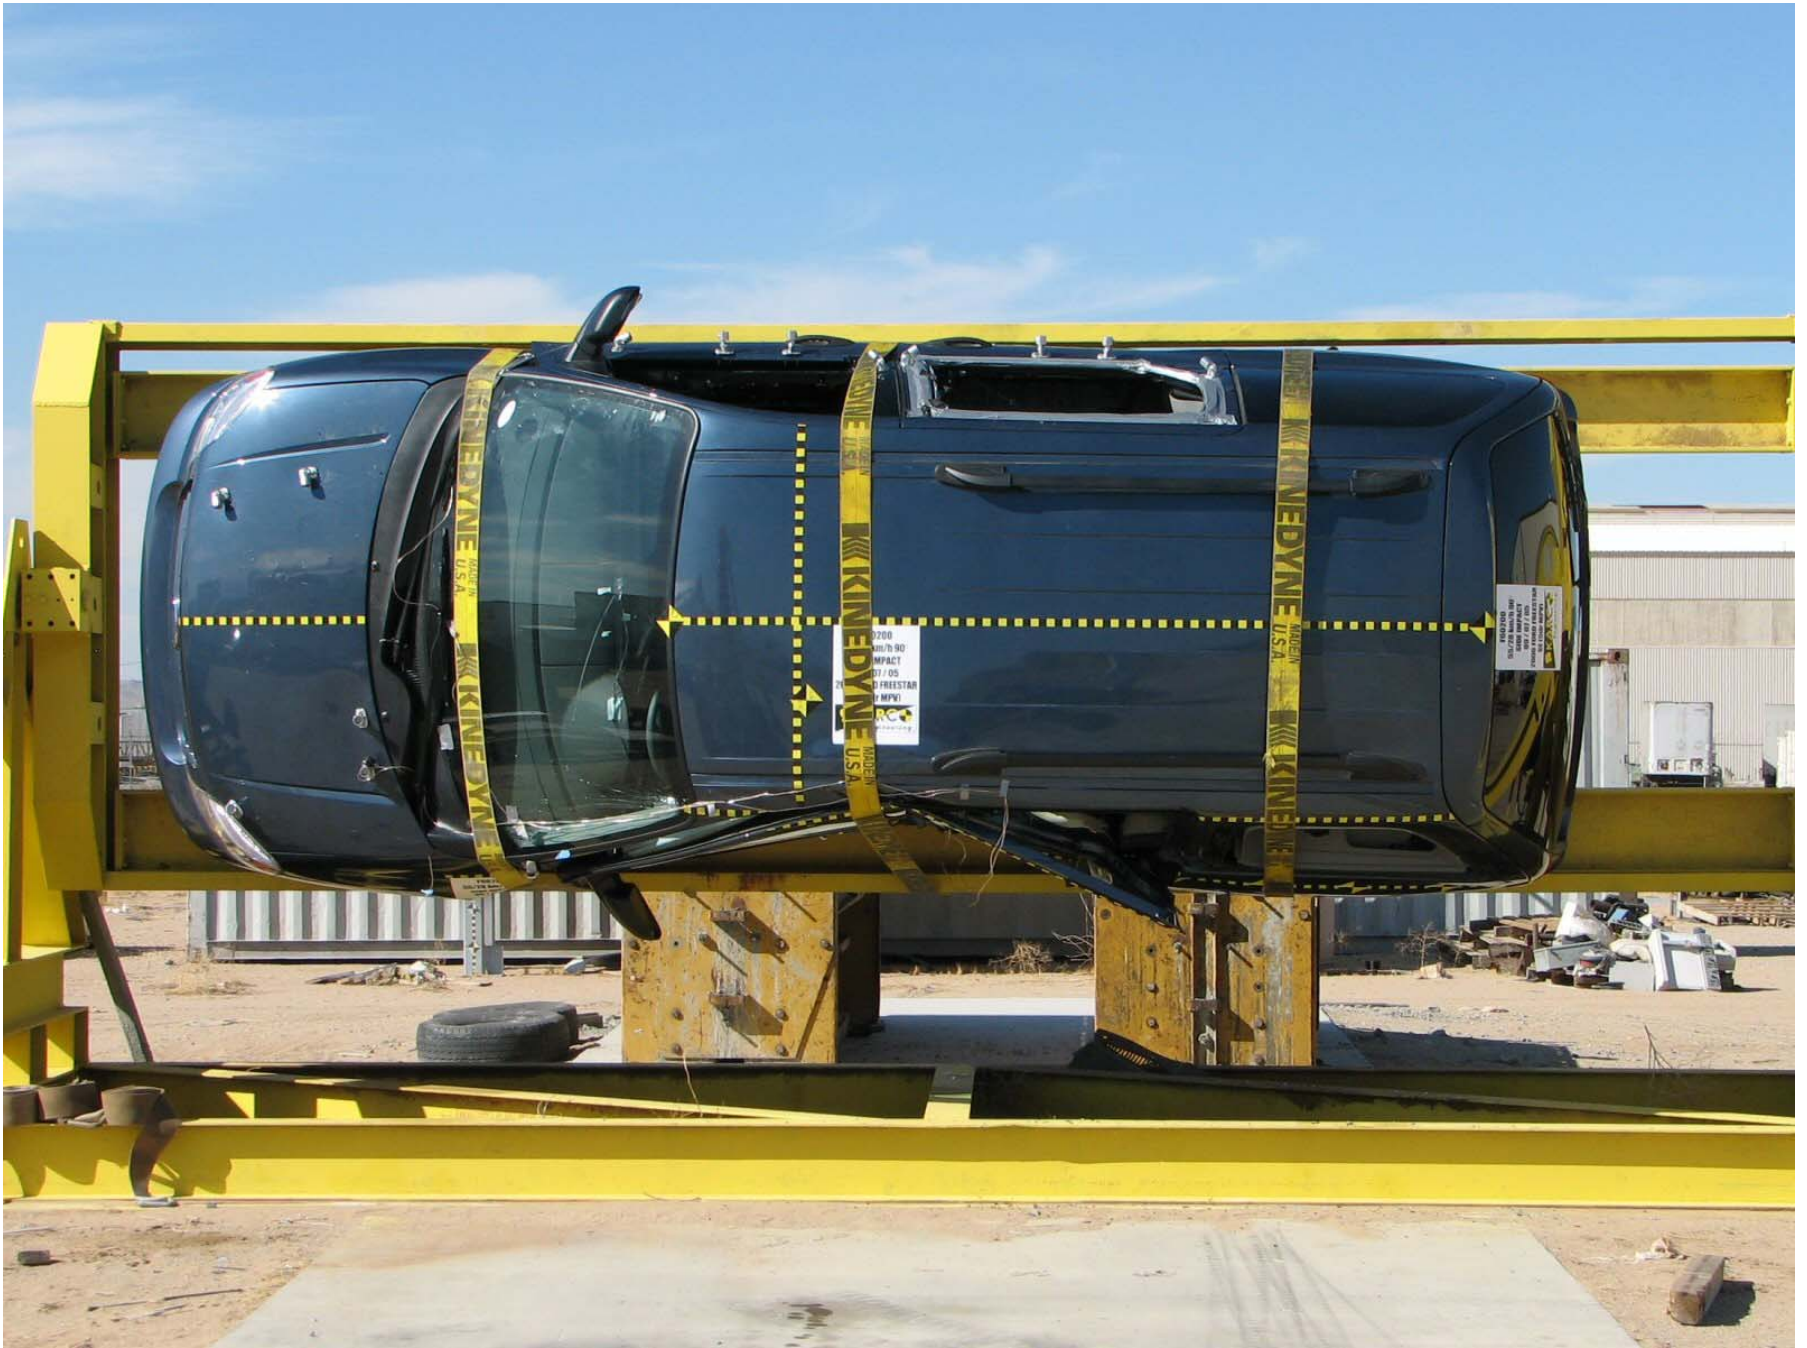
Figure A-62: Vehicle on Rollover Device (90°)

1. The specified fixture rollover rate for each 90° of rotation is 60 to 120 seconds.
 2. The position hold time at each position is 300 seconds (minimum).
 3. Details of Stoddard Solvent spillage locations.
- No solvent leakage occurred during static rollover testing.

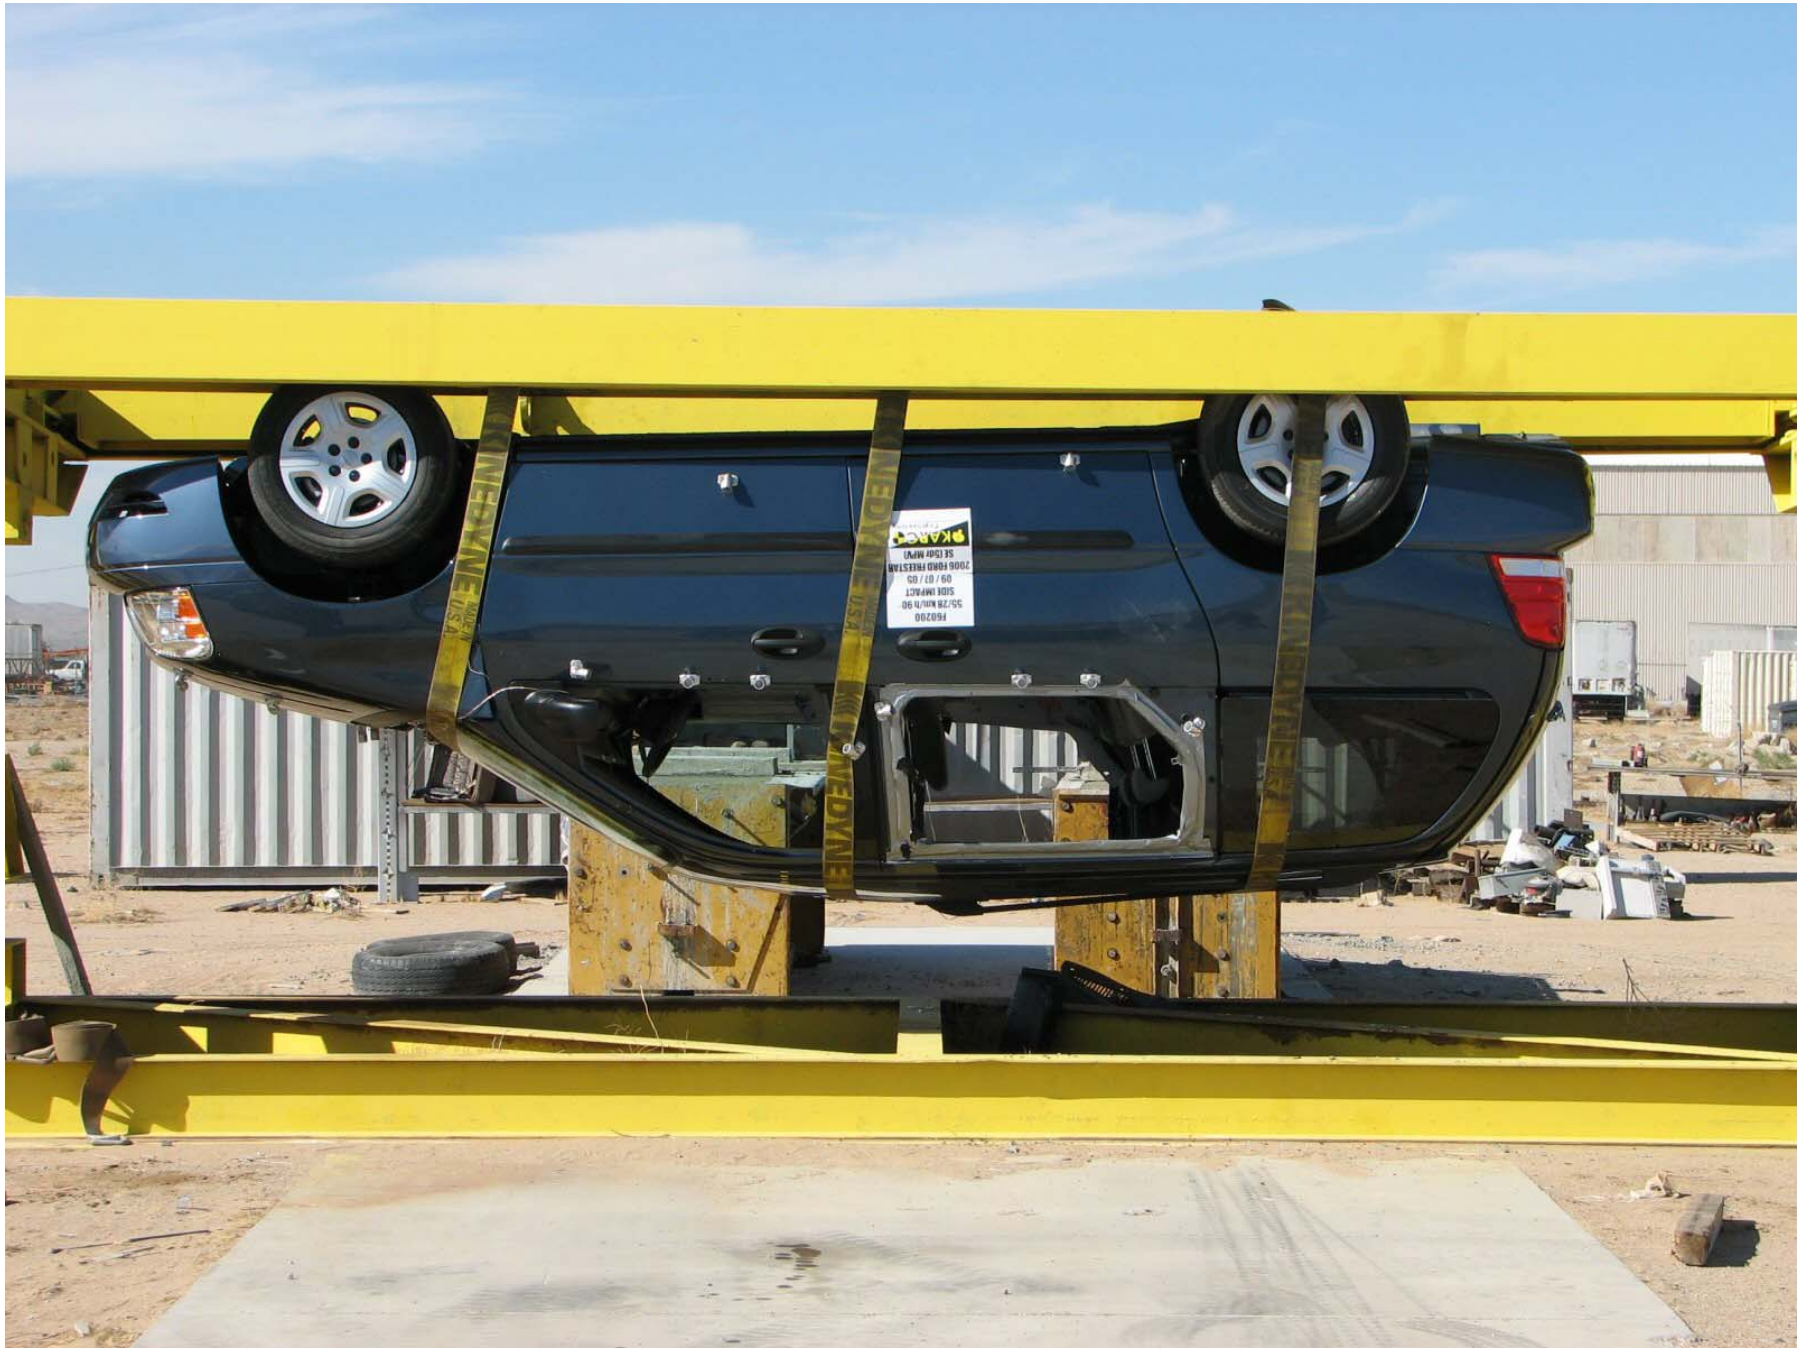
Figure A-63: Vehicle on Rollover Device (180°)

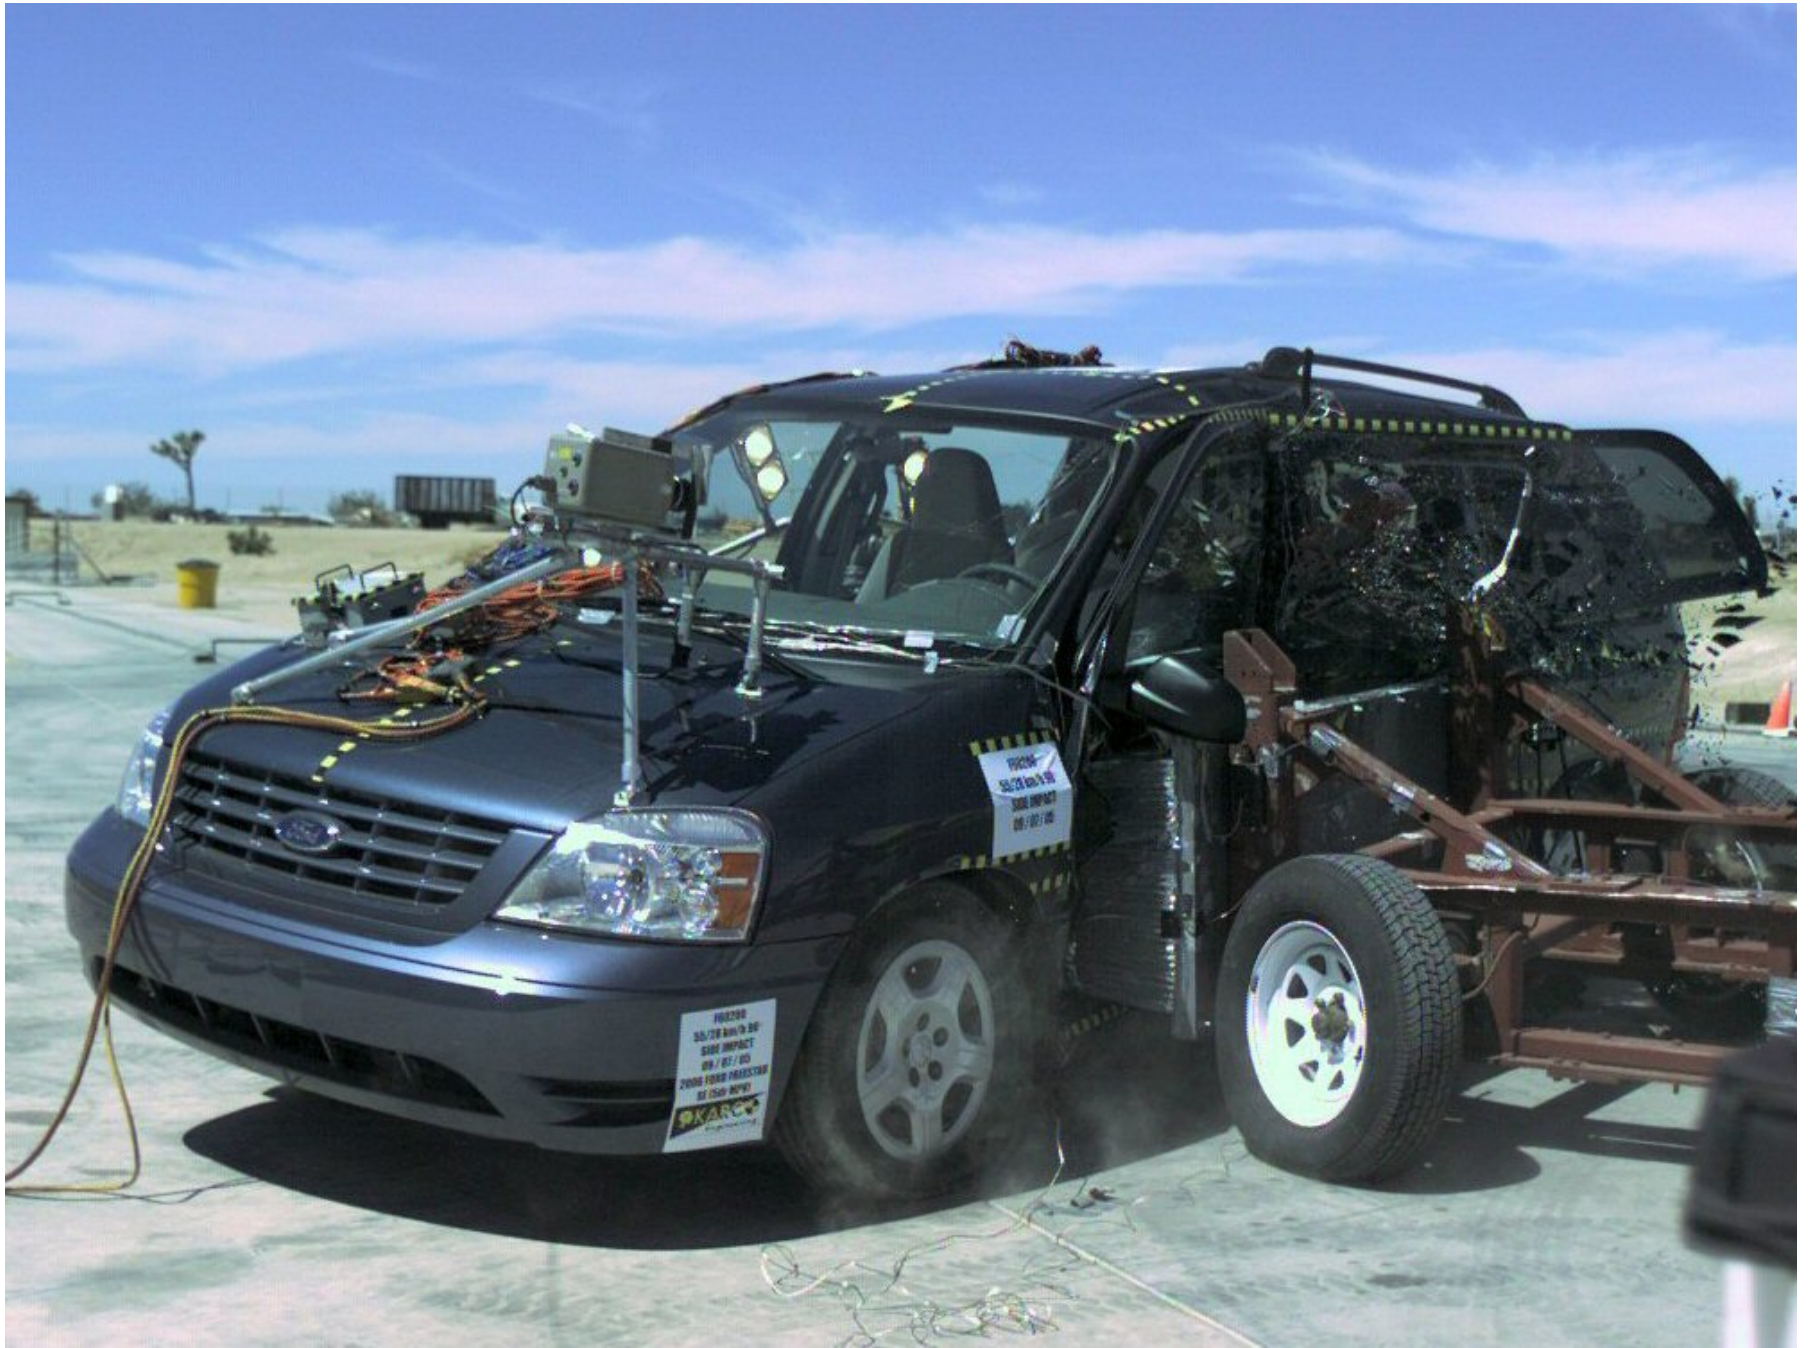
Figure A-65: Vehicle Impact

A model year 2006 Ford Freestar SE 5-Door MPV was impacted on the left (driver's) side by a Moving Deformable Barrier (MDB) which was moving forward in a 27° crabbed position to the tow road guidance system at a velocity of 62.41 km/h. The specified impact velocity range is from 61.14 to 62.75 km/h. The test (target) vehicle was stationary and positioned 63° to the line of forward motion. The weight of the vehicle as tested was 2170 kg and the test weight of the MDB was 1361 kg. The test was conducted at KARCO Engineering, LLC in Adelanto, California, on September 7, 2005.
