REPORT NUMBER TR-P25125-01-NC

**NEW CAR ASSESSMENT PROGRAM
SIDE IMPACT TEST**

**HONDA MFG. OF ALABAMA, LLC
2006 HONDA ODYSSEY
5-DOOR MPV**

NHTSA NUMBER: H65302

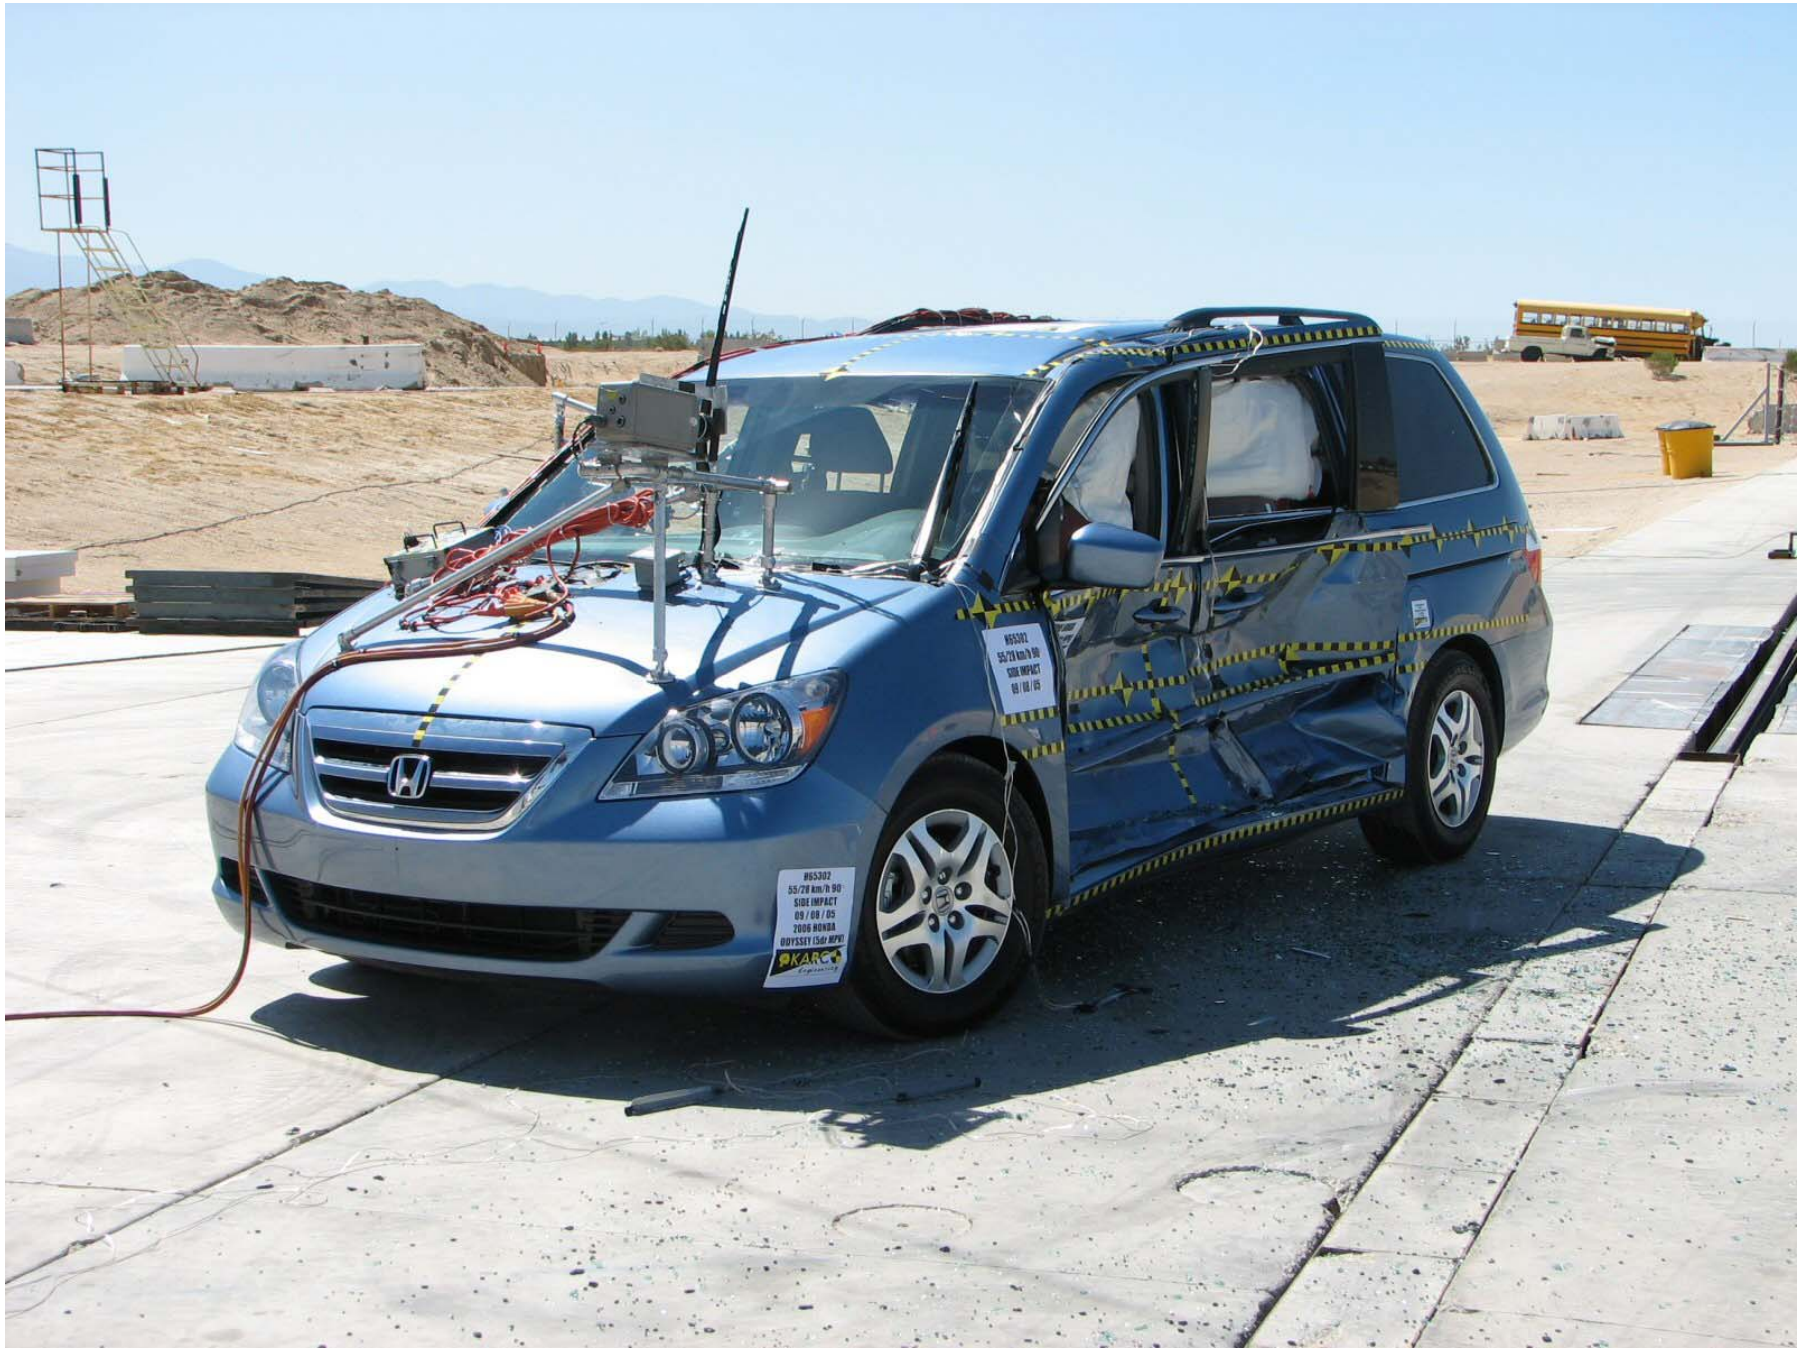
Figure A-8: Post-Test Left Front $\frac{3}{4}$ View

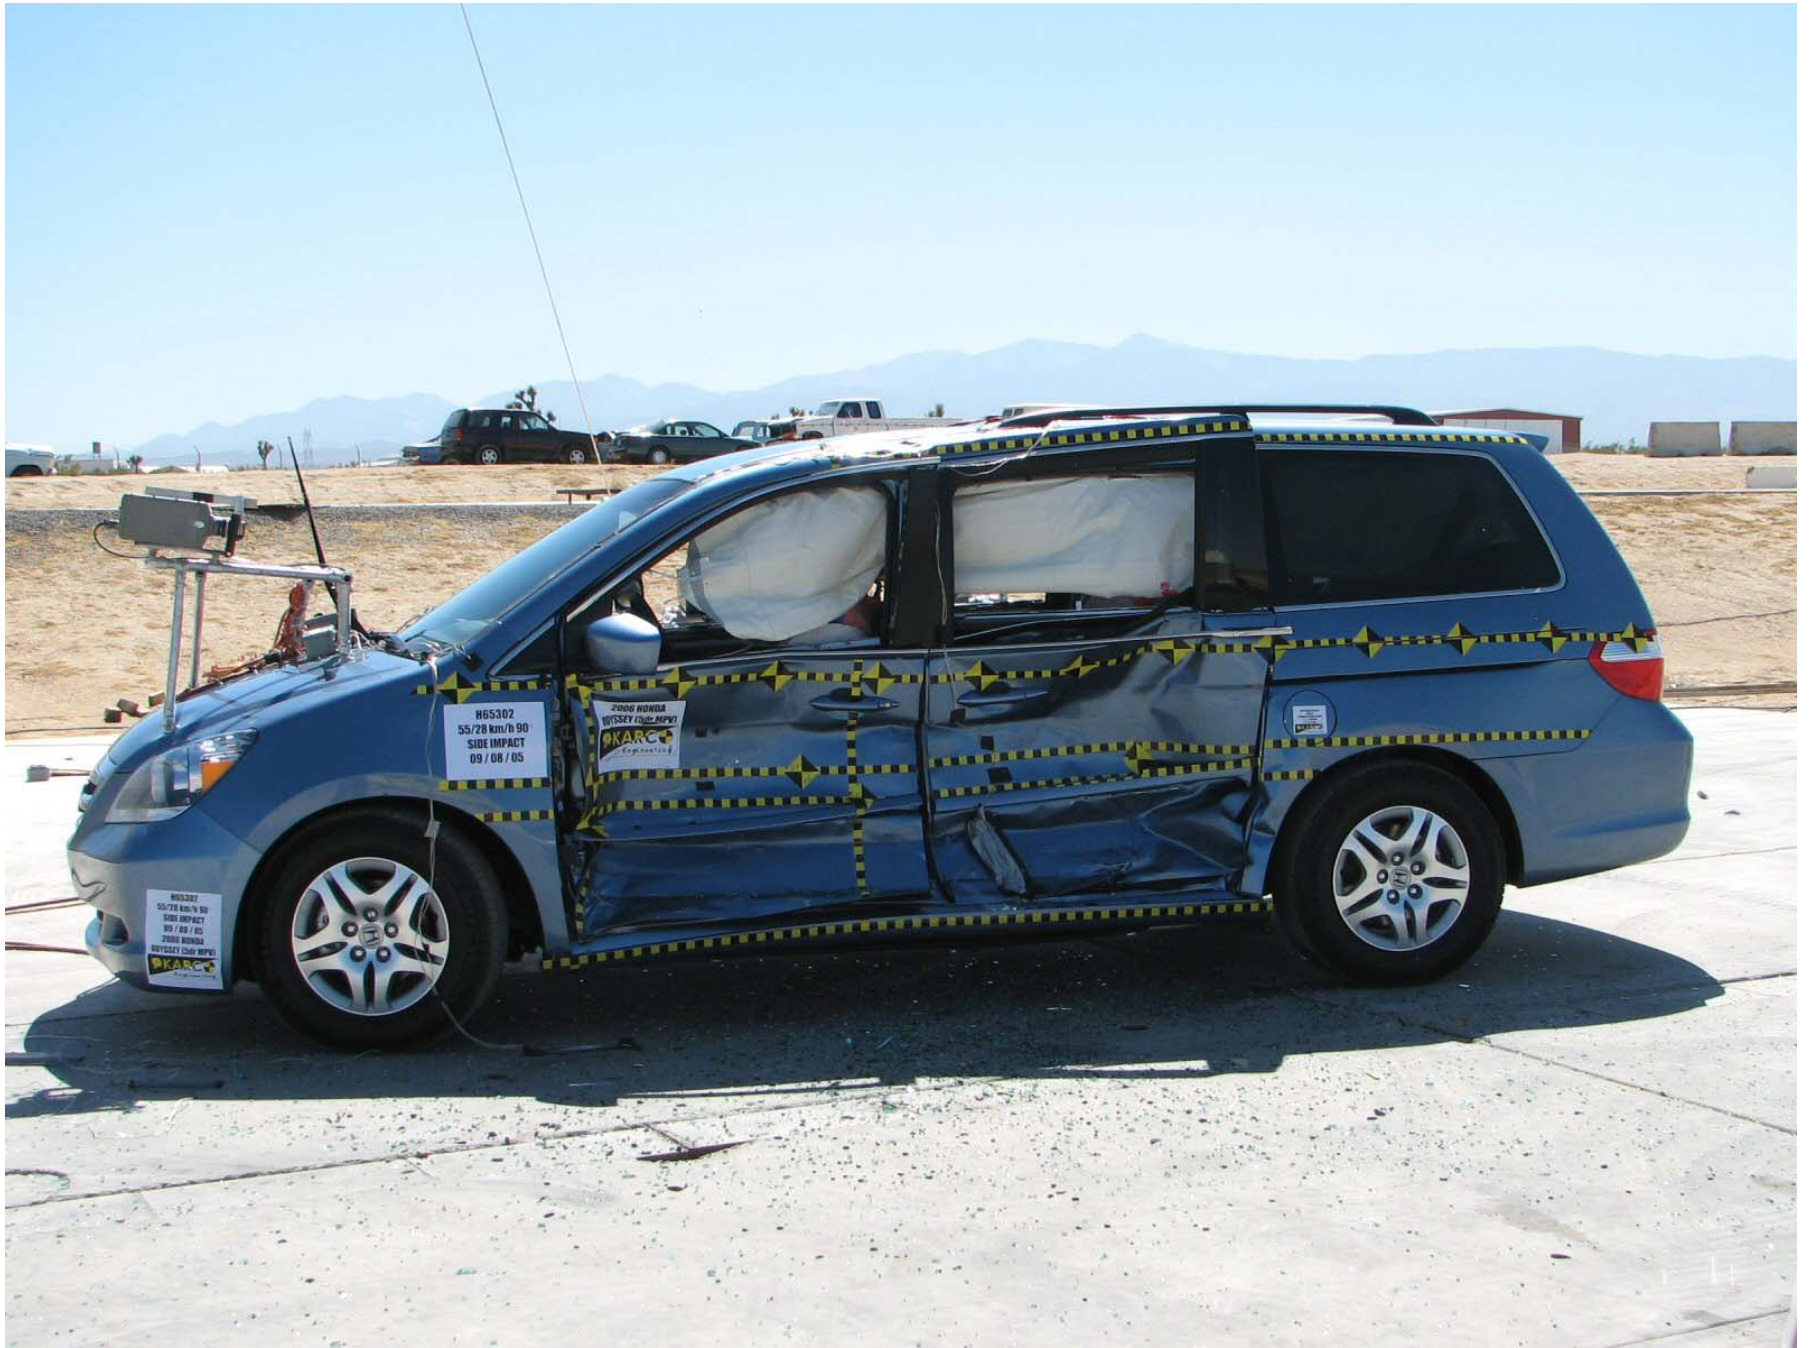
Figure A-10: Post-Test Left Side View

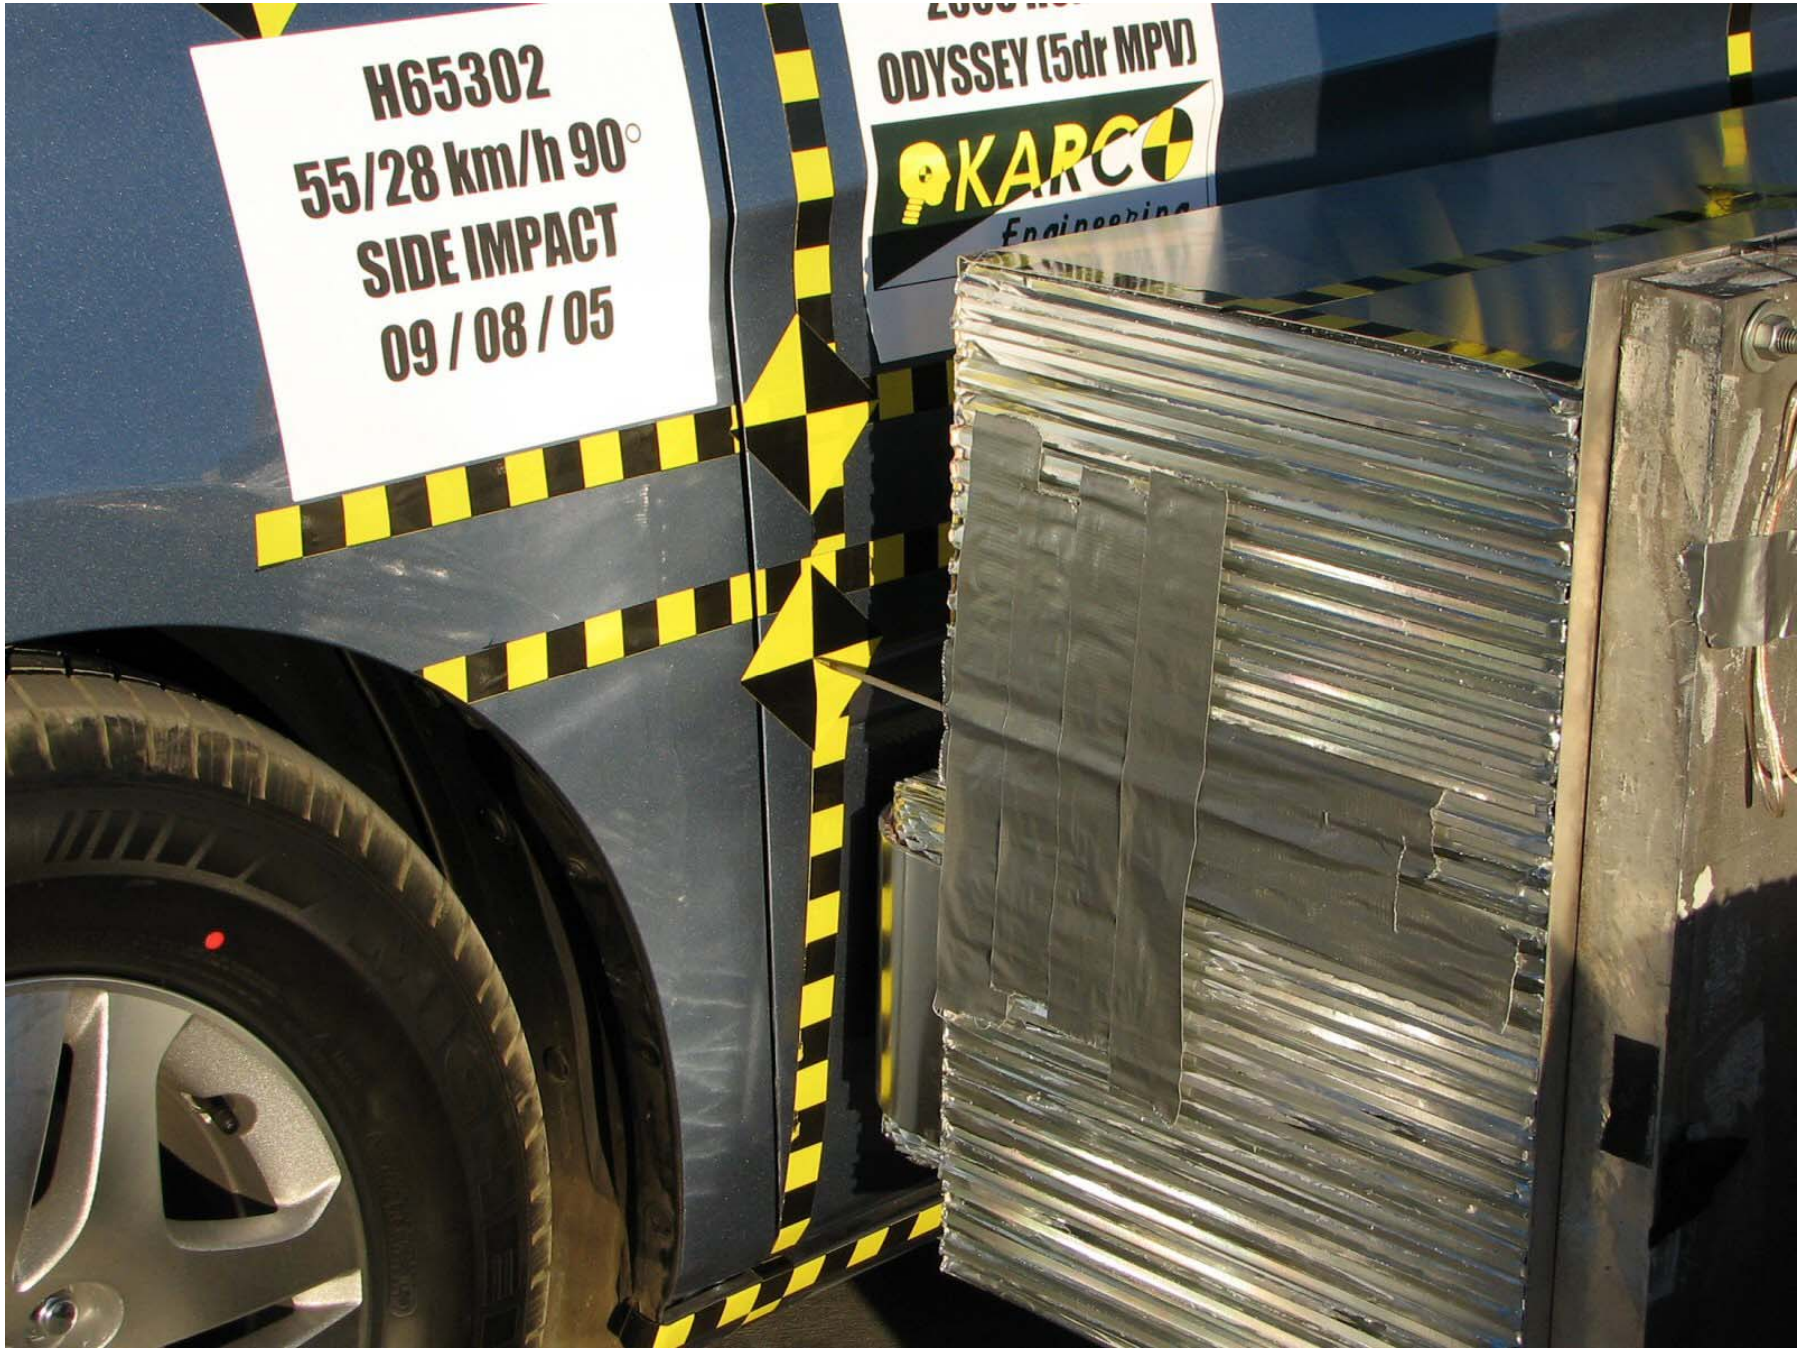
Figure A-26: Post-Test Left Impact Point

The driver and passenger doors remained closed and latched during impact. The test vehicle sustained a maximum static crush of 298 mm at level 3, 1350 mm rearward of the left vertical impact point. The driver SID/Hybrid III, Serial No. 274 and the passenger SID/Hybrid III, Serial No. 275 were calibrated prior to this test. The SID/Hybrid III injury criteria is summarized as follows:

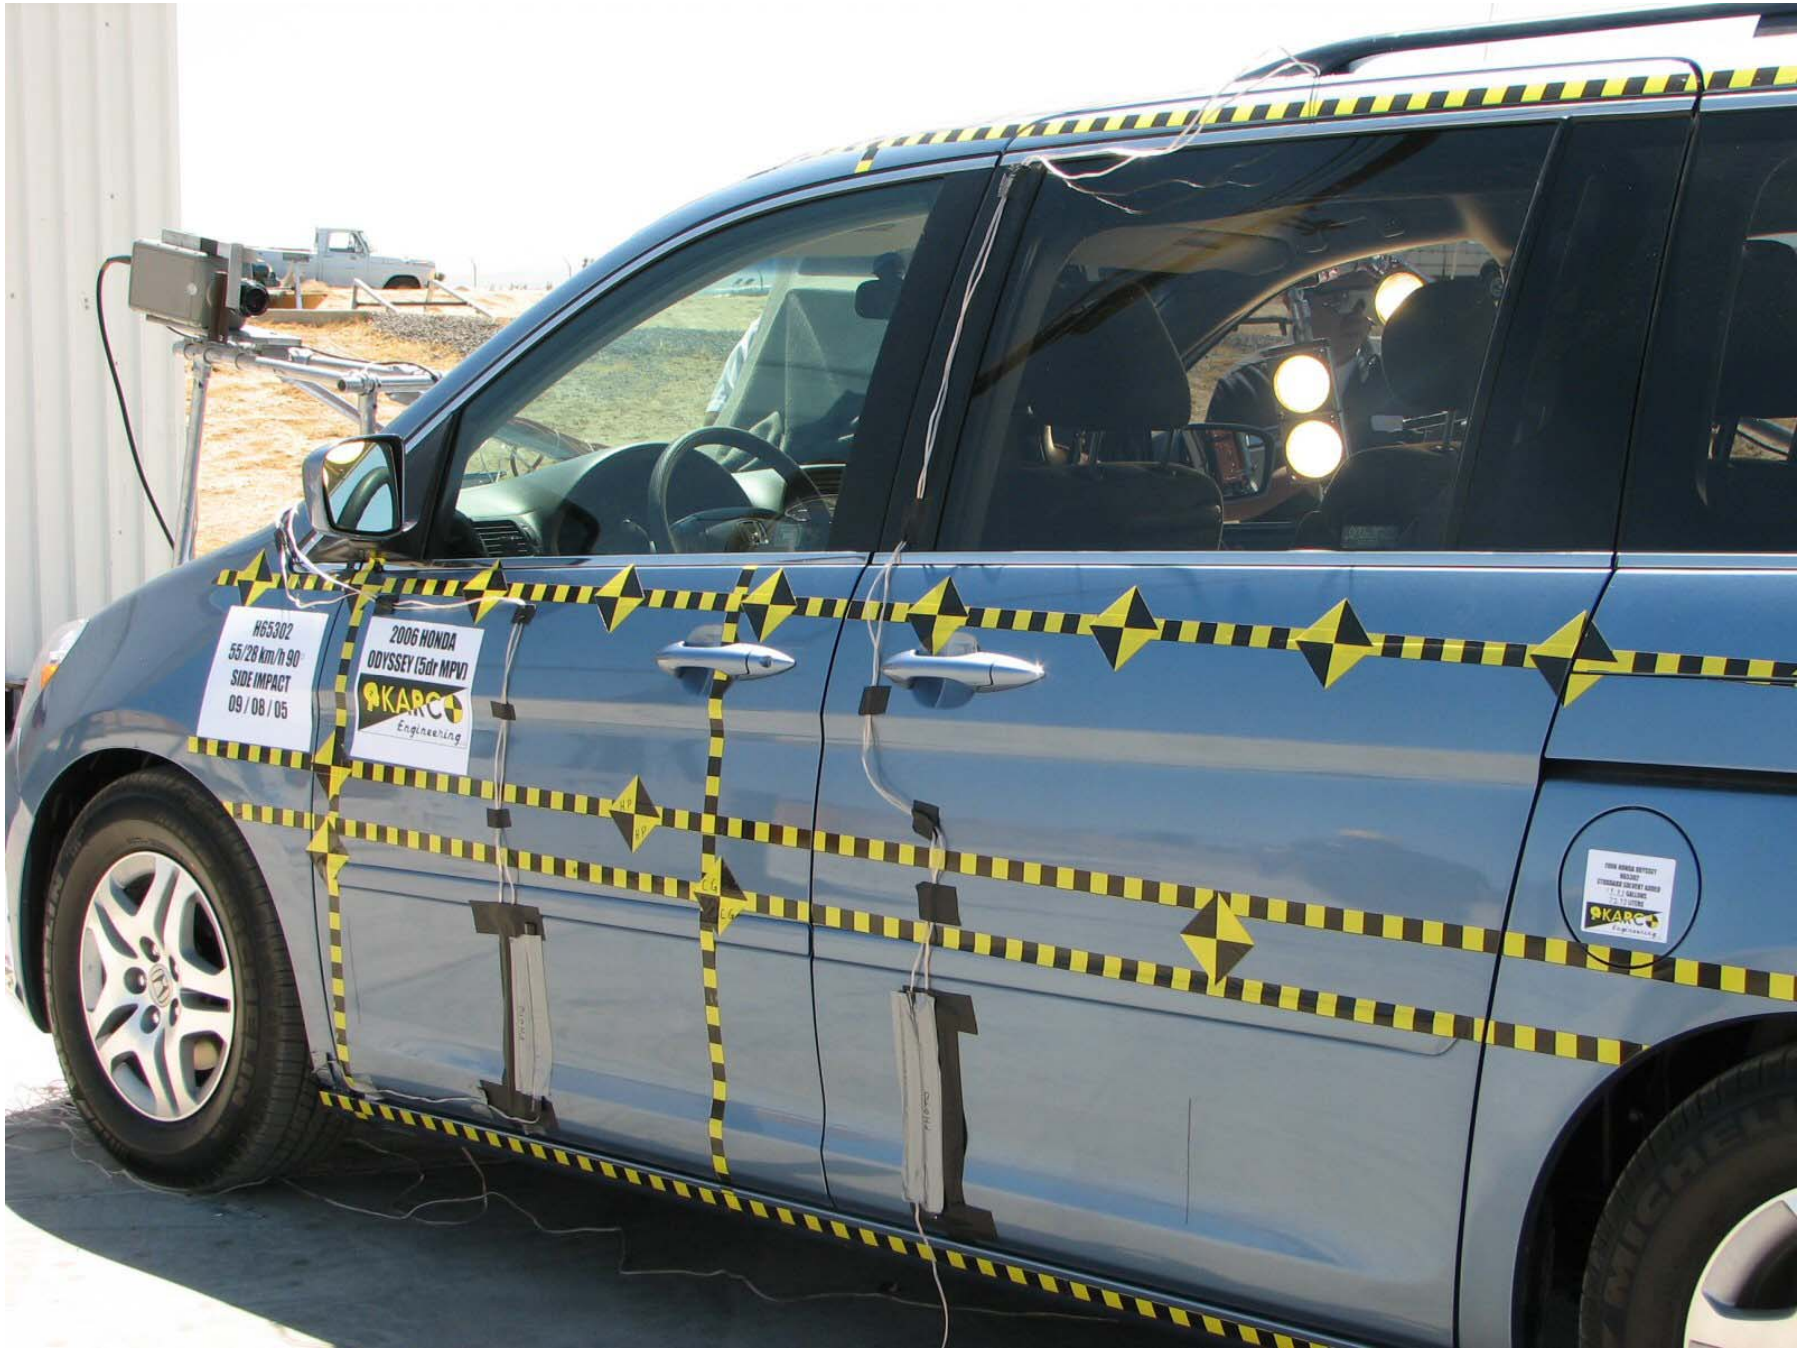
Figure A-30: Post-Test Rear ¾ View of Left Side Doors

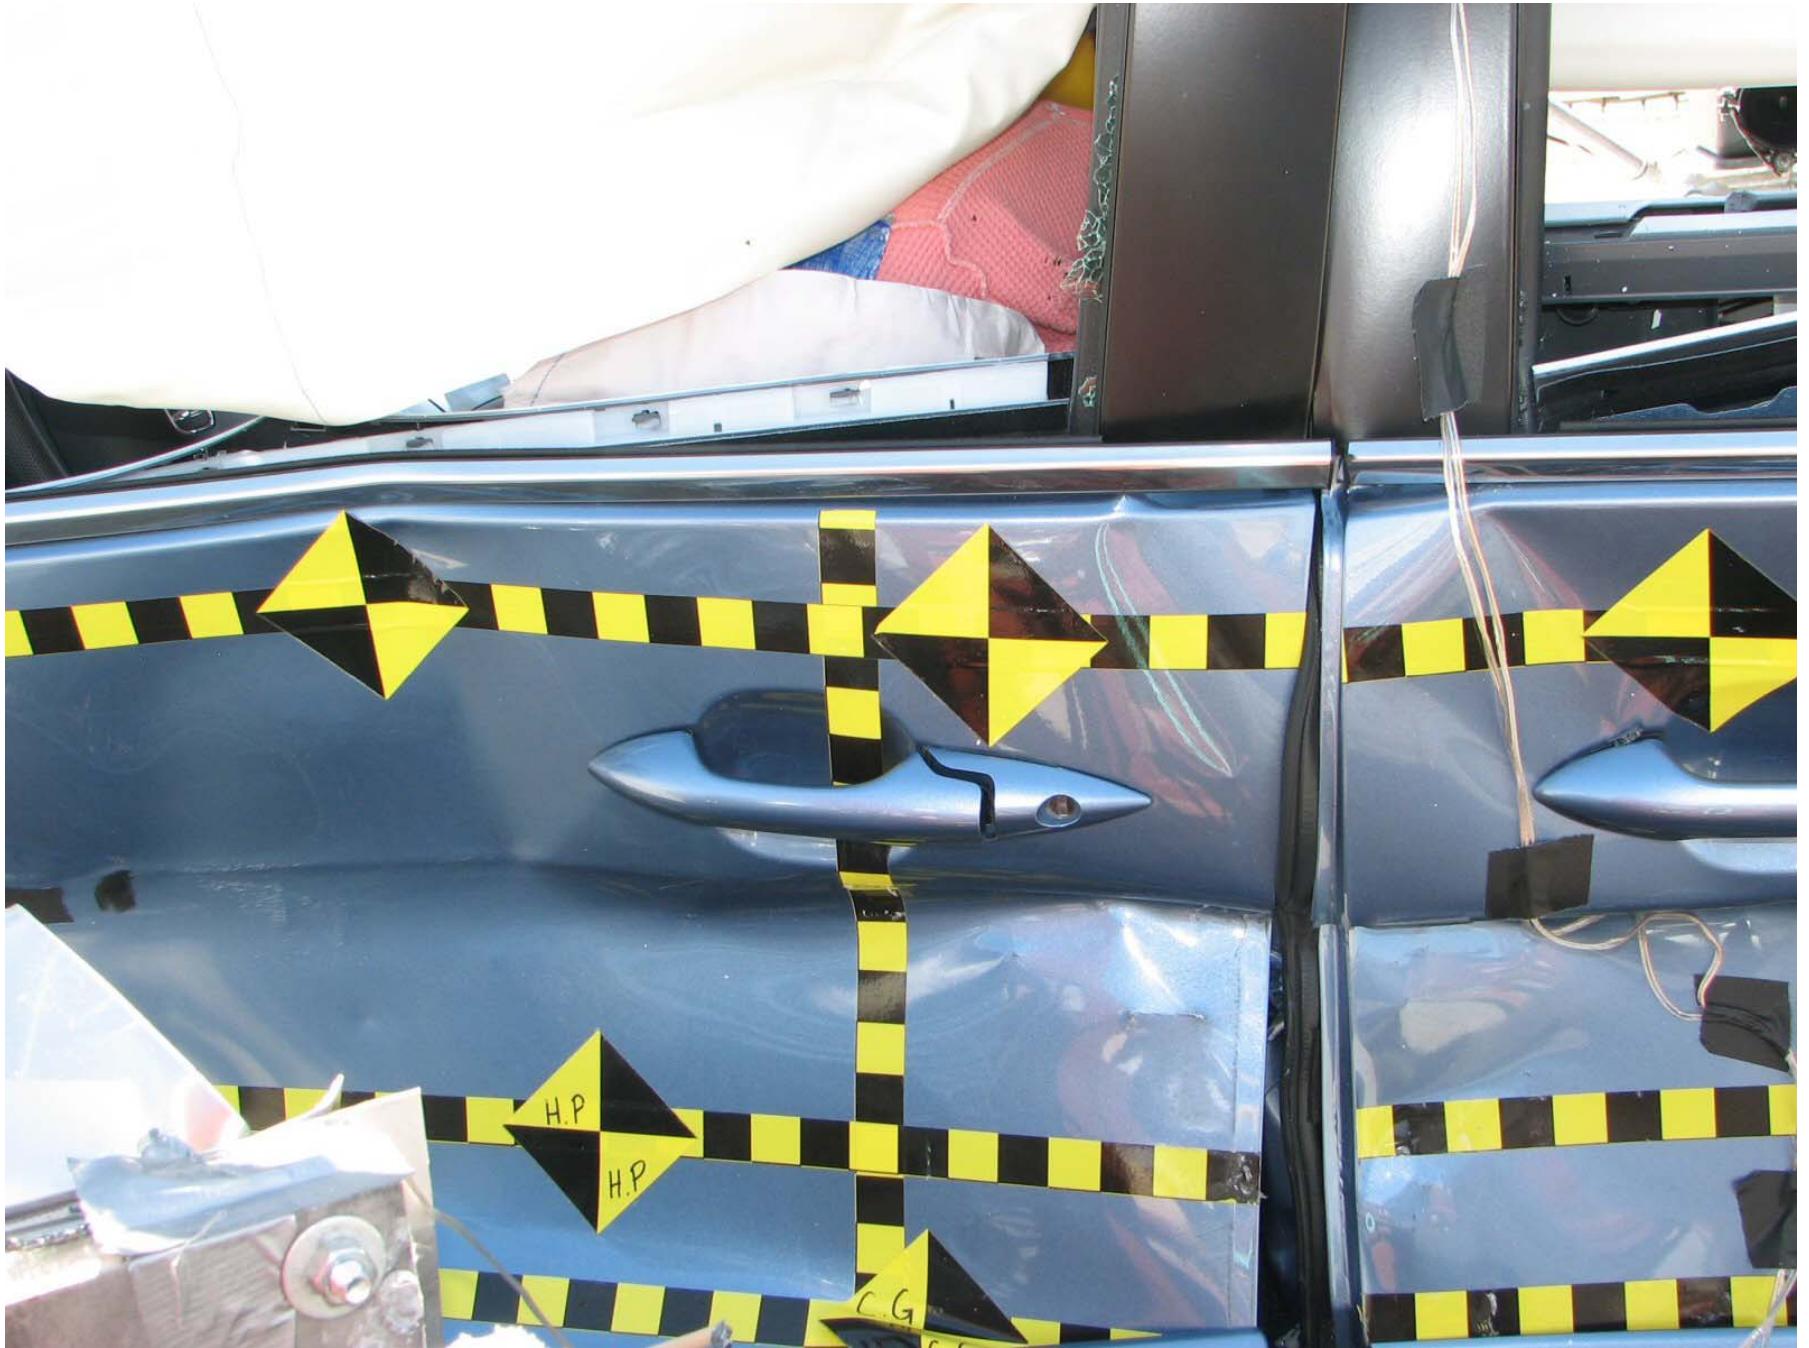
Figure A-32: Post-Test Left Front Door

Description	Front	Rear
Left Side Door Opening	Door remained closed and latched, jammed	Door remained closed and latched, jammed
Right Side Door Opening	Remained closed and latched, operational	Remained closed and latched, operational
Seat Movement (mm)	None	None
Seat Back Failure	None	None

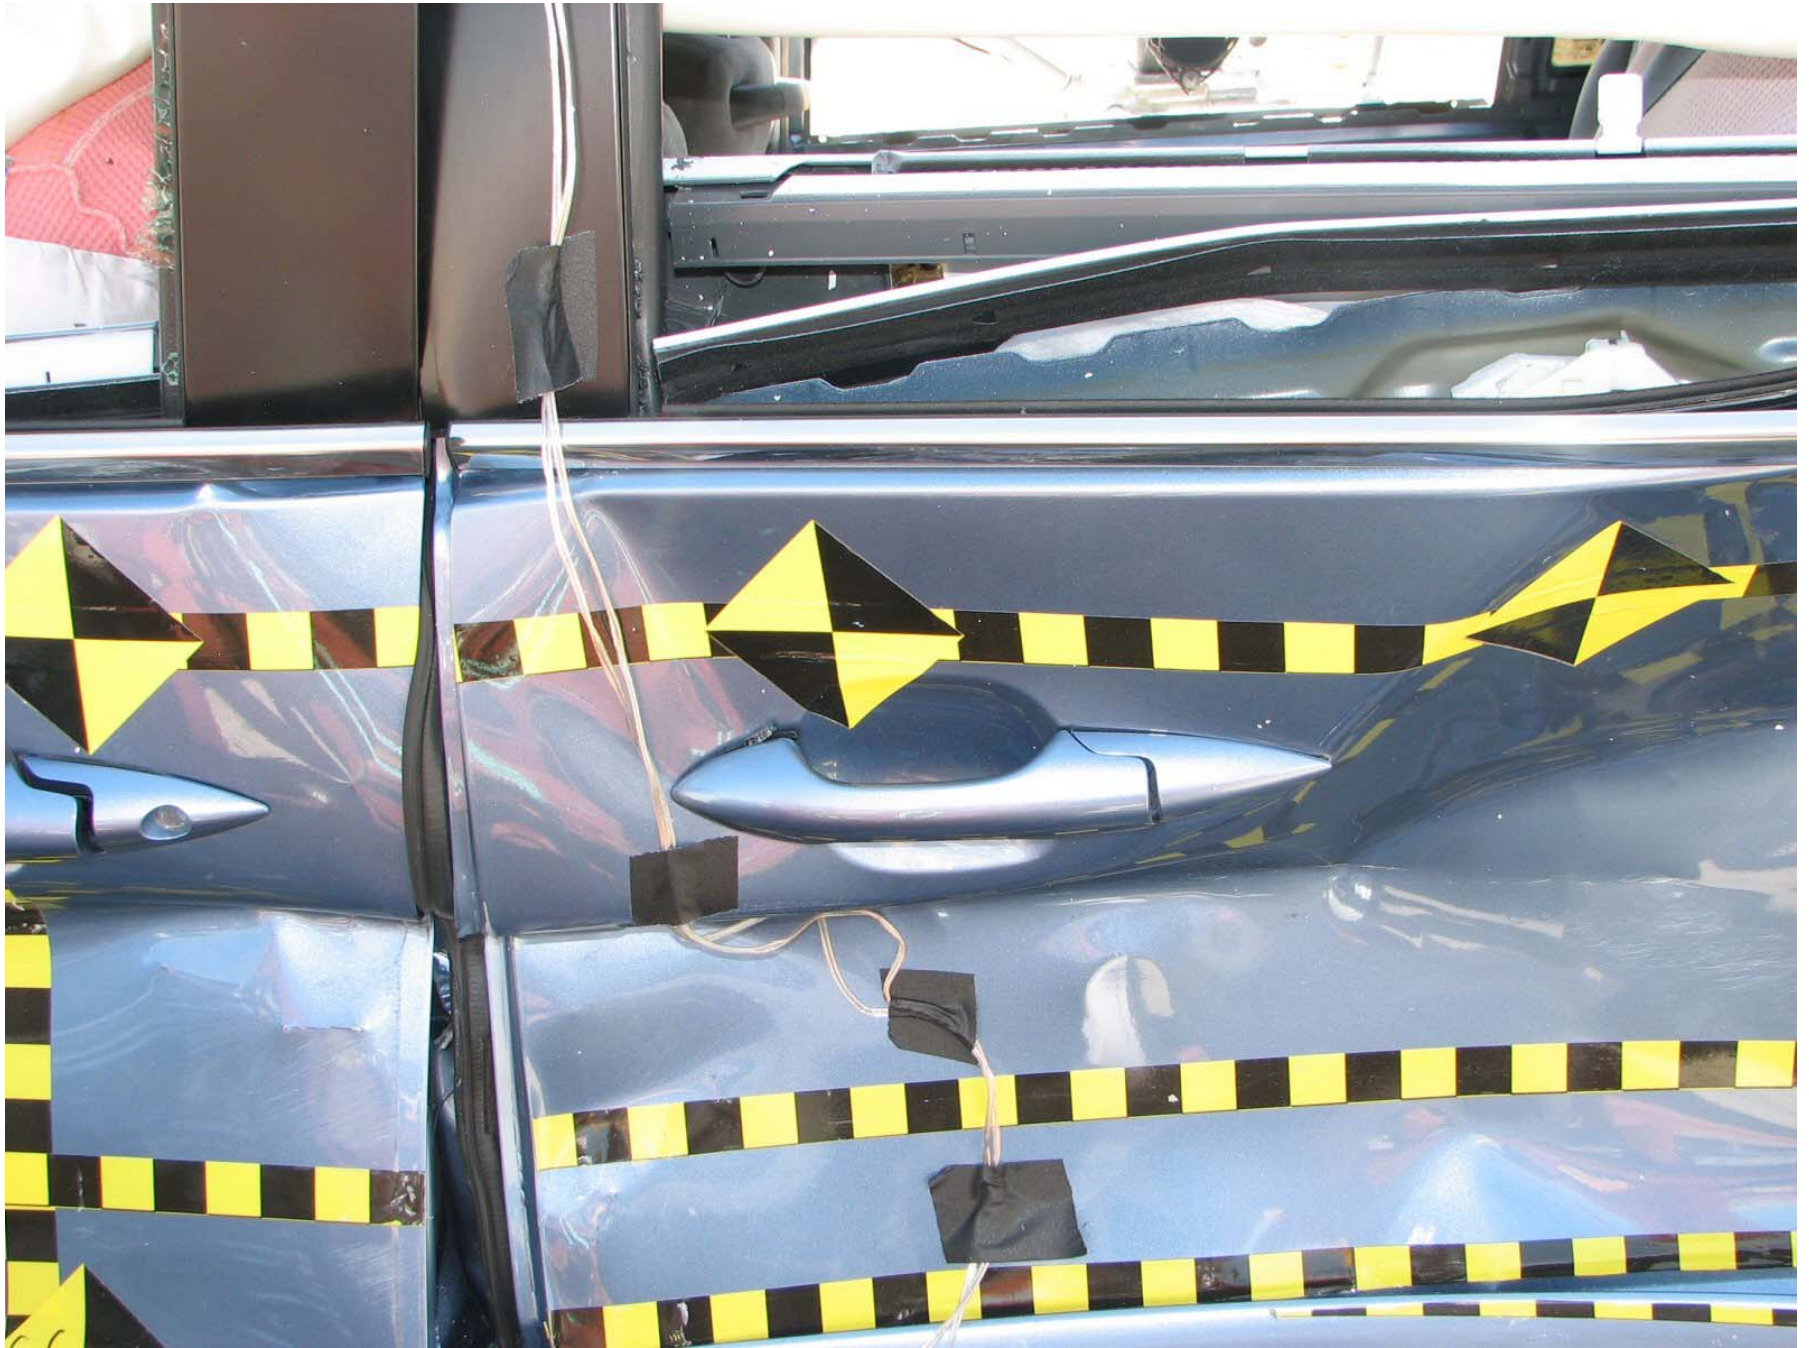
Figure A-34: Post-Test Left Rear Door

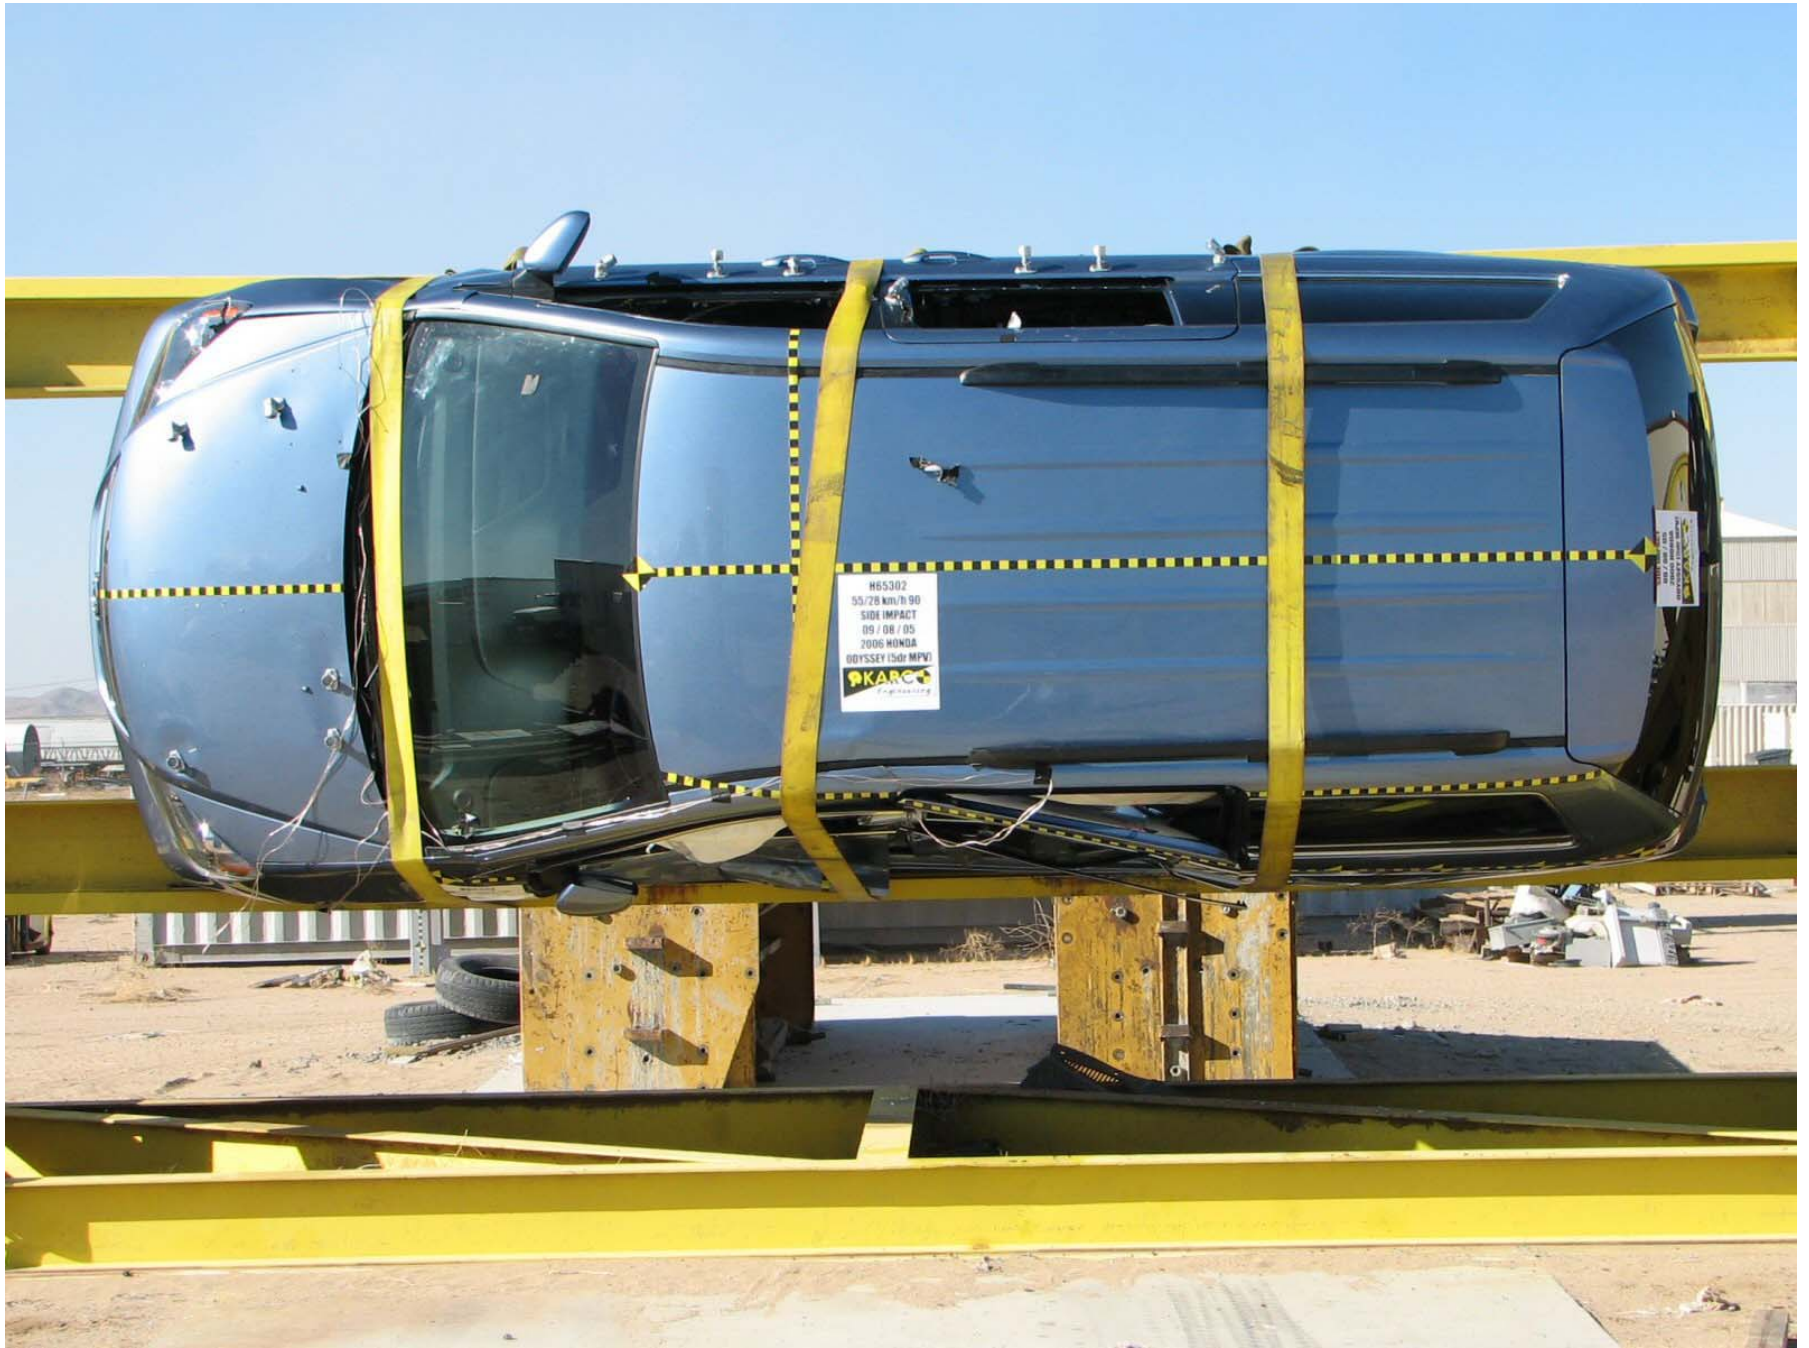
Figure A-61: Vehicle on Rollover Device (0°)

1. The specified fixture rollover rate for each 90° of rotation is 60 to 120 seconds.
 2. The position hold time at each position is 300 seconds (minimum).
 3. Details of Stoddard Solvent spillage locations.
- No solvent leakage occurred during static rollover testing.

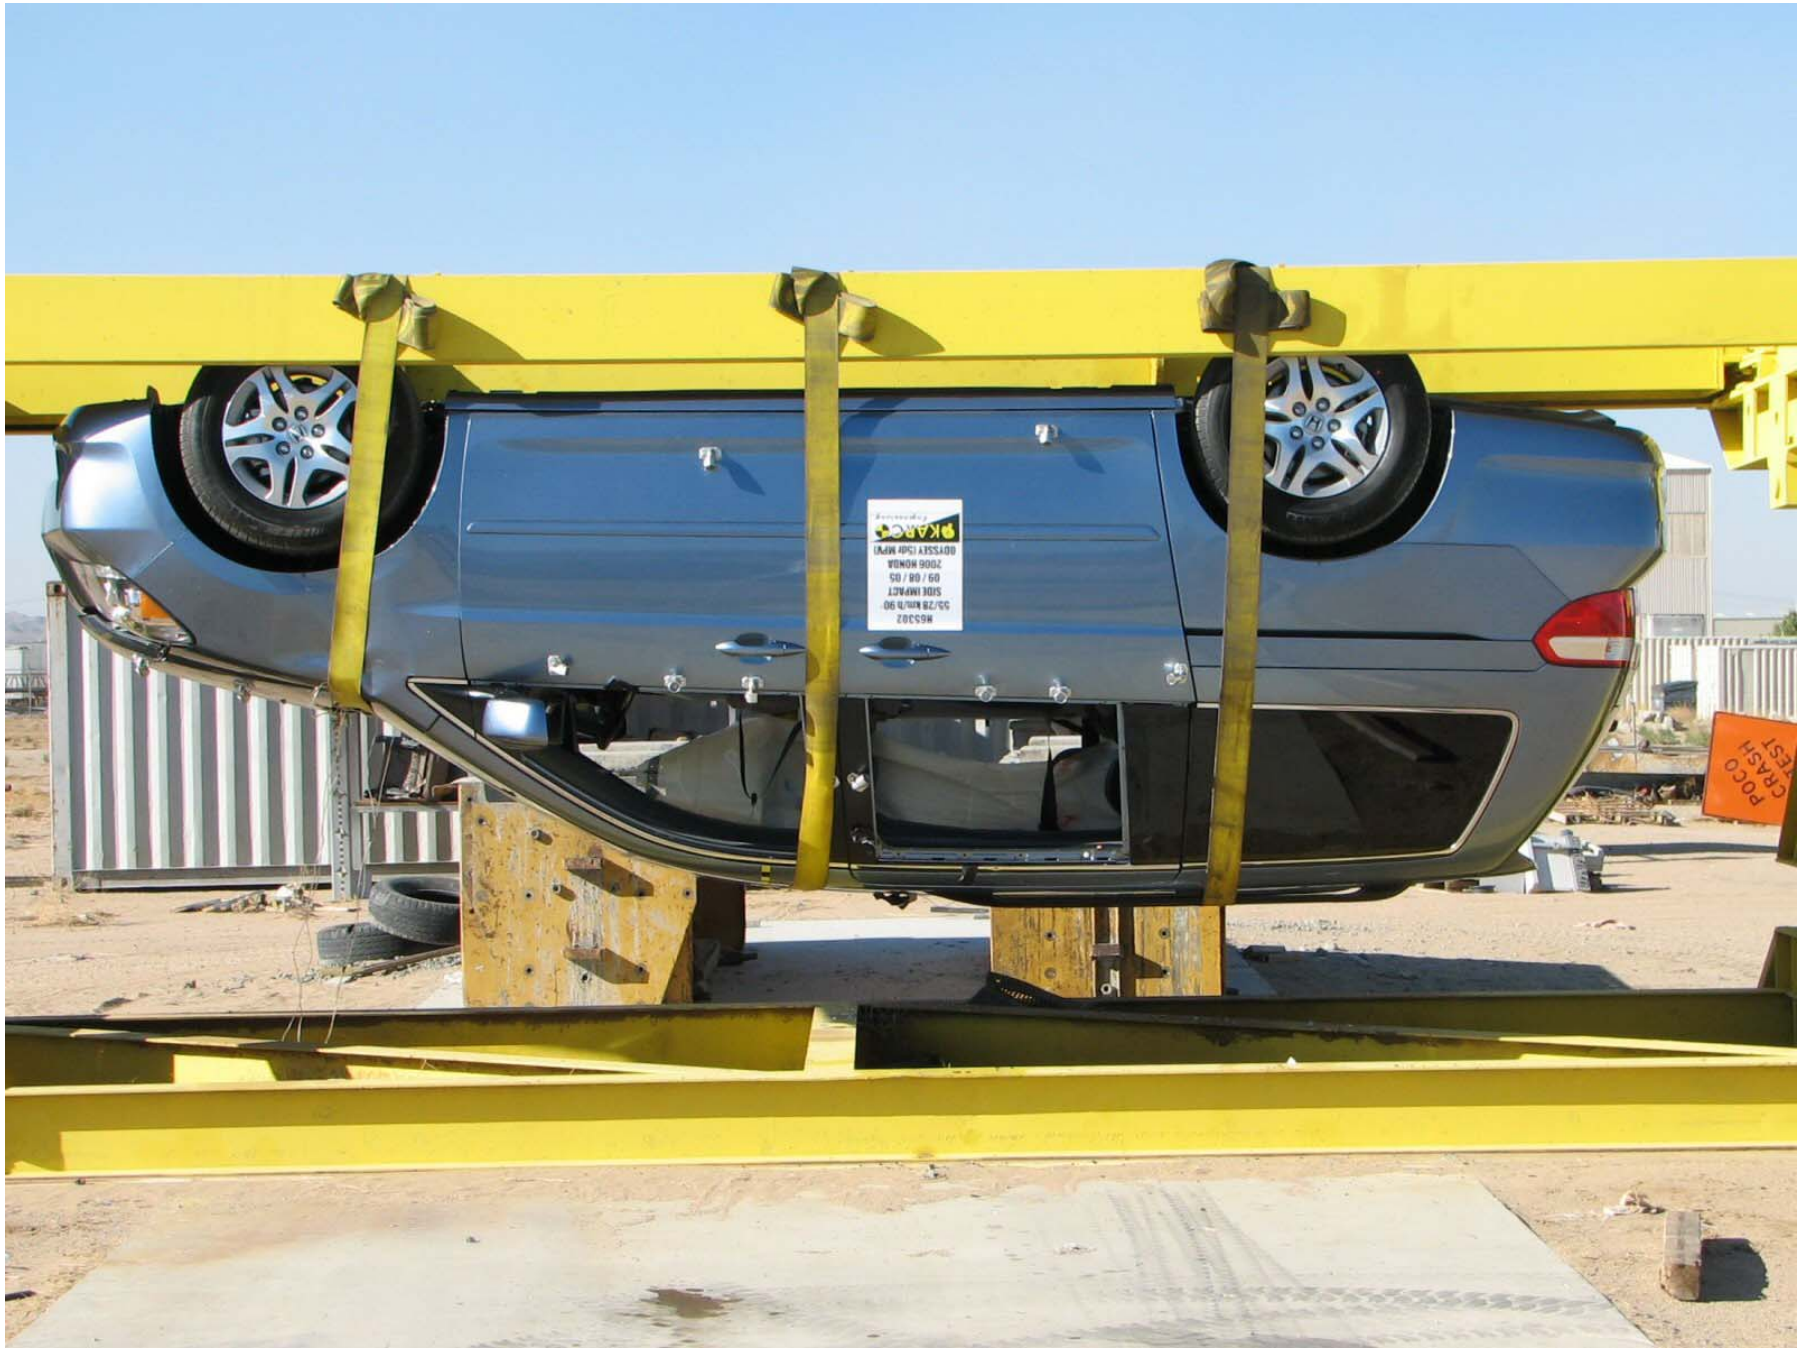
Figure A-62: Vehicle on Rollover Device (90°)

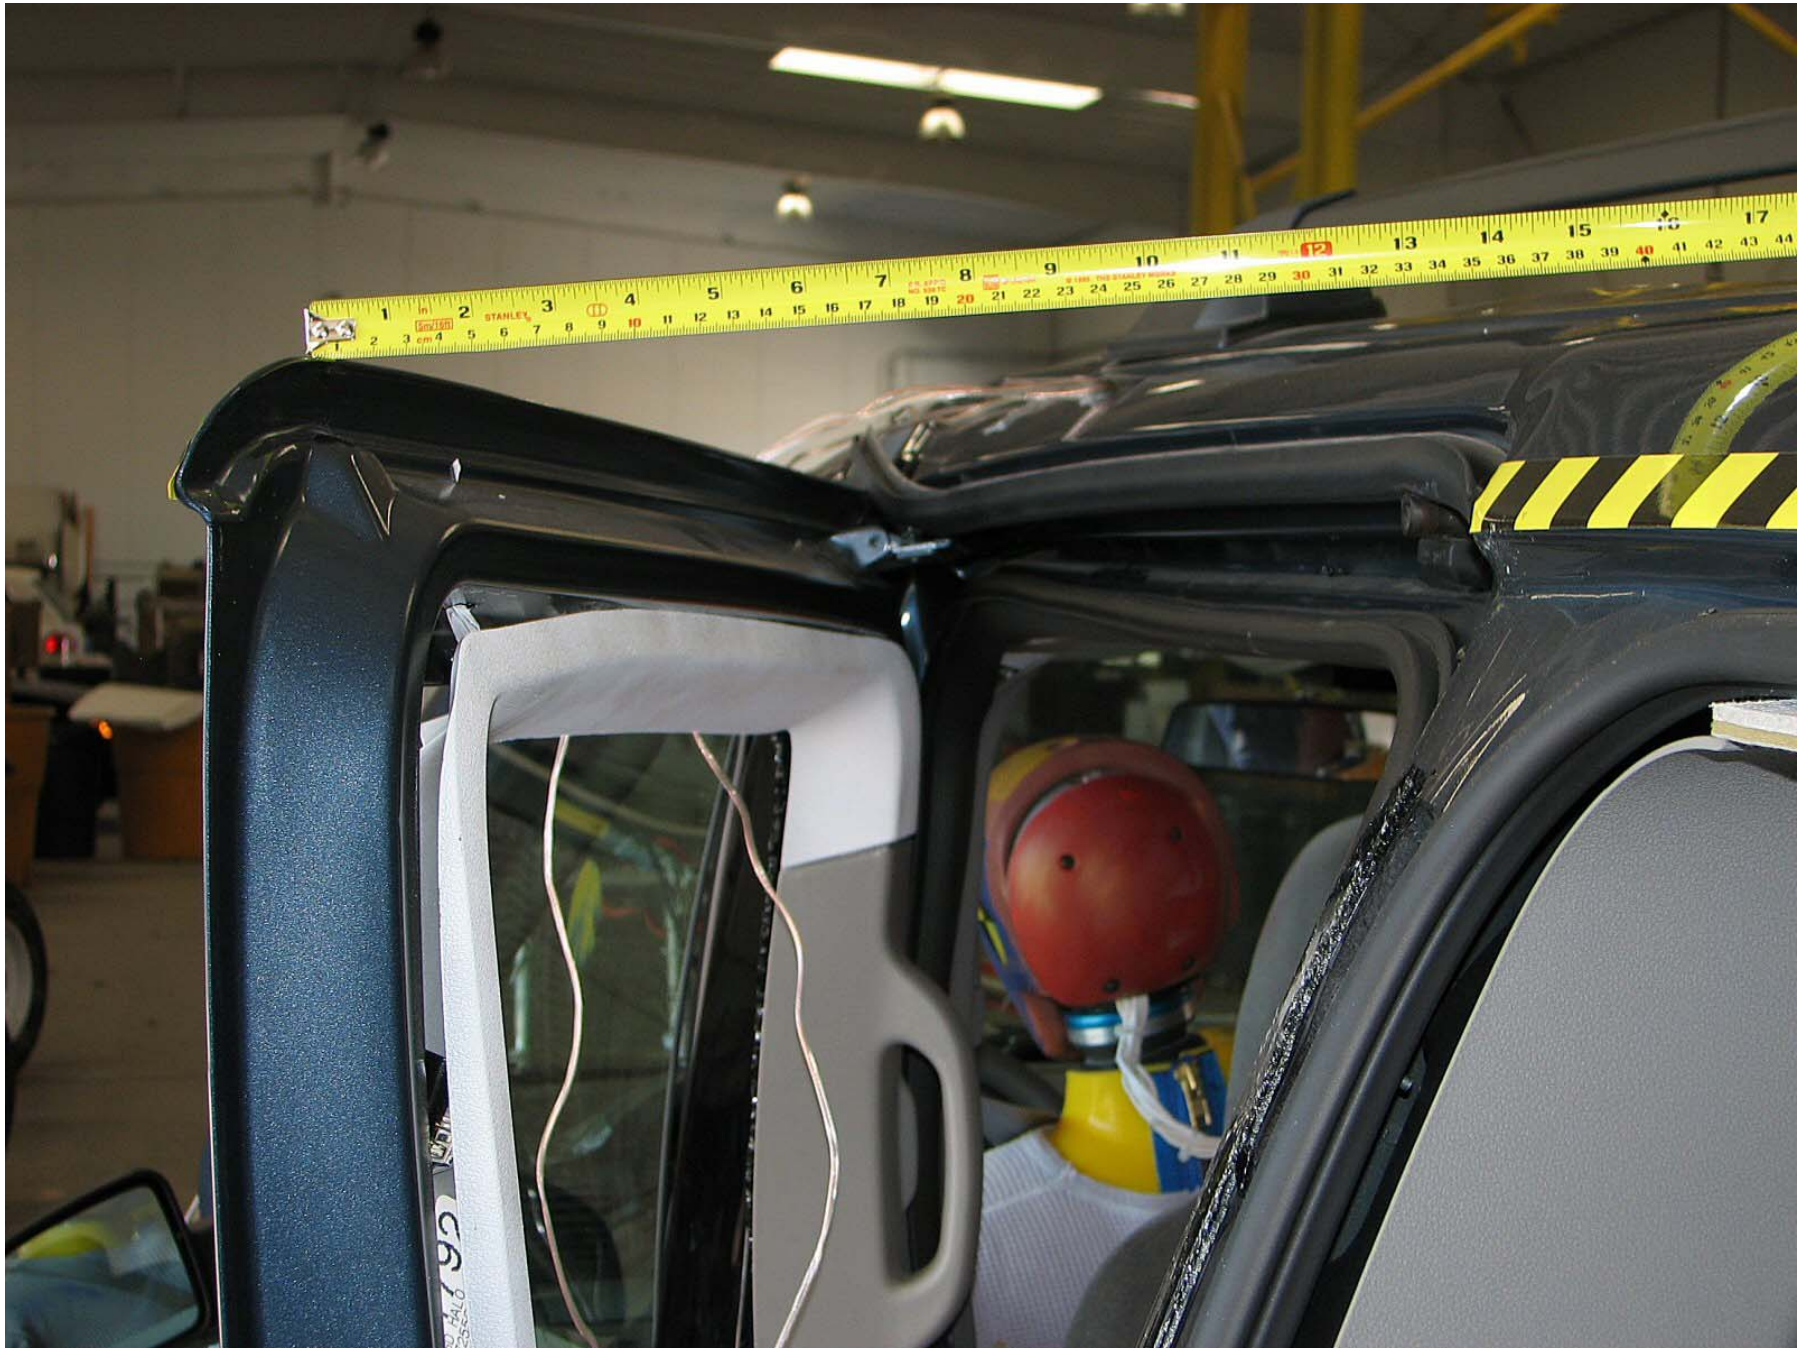
Figure A-64: Vehicle on Rollover Device (270°)

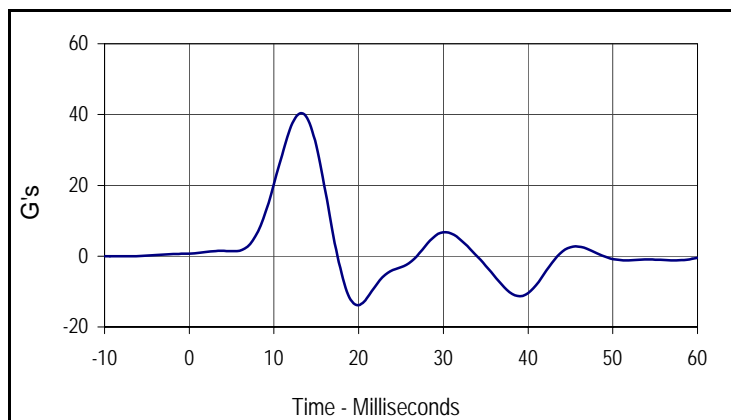
Tested Parameter	Units	Specification	Result	Pass/Fail
Laboratory Temperature	°C	18.9 to 25.6	21.1	Pass
Laboratory Relative Humidity	%	10 to 70	30	Pass
Probe Velocity	m/s	4.21 to 4.33	4.25	Pass
Upper Rib Acceleration	G's	37.0 to 46.0	40.4	Pass
Lower Rib Acceleration	G's	37.0 to 46.0	40.2	Pass
Thoracic Spine Acceleration	G's	15.0 to 22.0	19.5	Pass
Overall Test Results			Pass

Curve Description			
Upper Rib Primary			
CURNO	Type	SAE Class	Units
001	FIL	FIR100	G's
Max	Time	Min	Time
40.4	13.1	-13.8	20.0

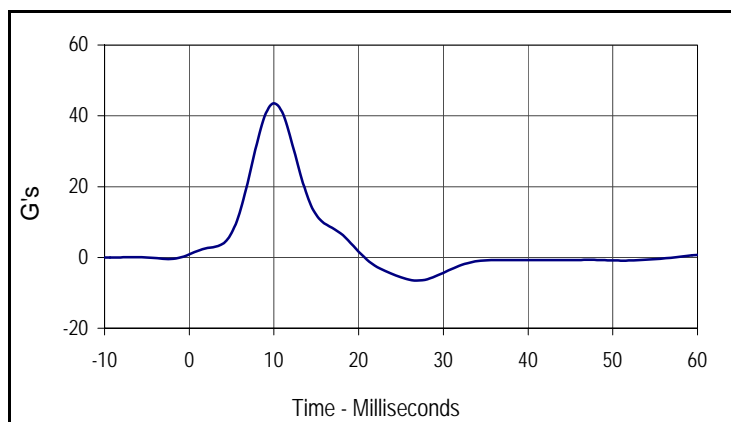
Tested Parameter	Units	Specification	Result	Pass/Fail
Laboratory Temperature	°C	18.9 to 25.6	21.1	Pass
Laboratory Relative Humidity	%	10 to 70	30	Pass
Probe Velocity	m/s	4.21 to 4.33	4.27	Pass
Peak Pelvis Acceleration	G's	40.0 to 60.0	43.6	Pass
Acceleration Time Above 20 G's	Msec.	3.0 to 7.0	6.88	Pass
Overall Test Results				Pass

Curve Description			
Pelvis Primary Y			
CURNO	Type	SAE Class	Units
001	FIL	FIR100	G's
Max	Time	Min	Time
43.6	10.0	-6.5	26.9
