REPORT NUMBER TR-P25125-01-NC

**NEW CAR ASSESSMENT PROGRAM
SIDE IMPACT TEST**

**HONDA MFG. OF ALABAMA, LLC
2006 HONDA ODYSSEY
5-DOOR MPV**

NHTSA NUMBER: H65302

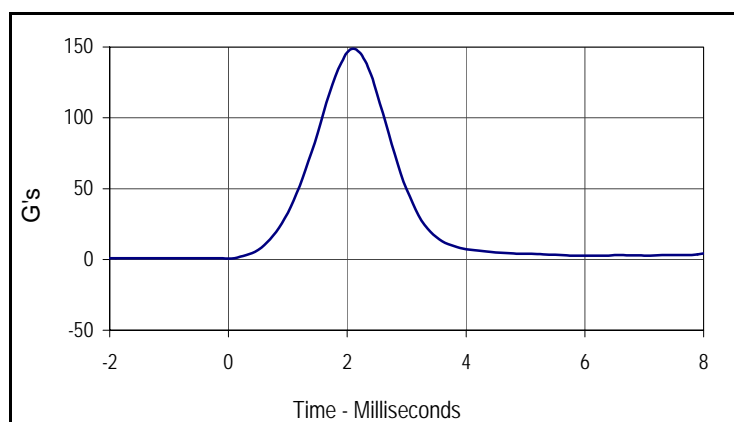
Tested Parameter	Units	Specification	Result	Pass/Fail
Laboratory Temperature	°C	18.9 to 25.6	21.1	Pass
Laboratory Relative Humidity	%	10 to 70	30	Pass
Peak Resultant Acceleration	G's	120.0 to 150.0	148.8	Pass
Peak Longitudinal Acceleration	G's	≤15.0	5.8	Pass
Is Acceleration Unimodal?	Yes/No	Yes	Yes	Pass
Oscillations After Main Pulse	%	<15	2.8	Pass
Overall Test Results				Pass

Curve Description			
Head Resultant			
CURNO	Type	SAE Class	Units
001	RES	1000	G's
Max	Time	Min	Time
148.8	2.1	0.6	0.0

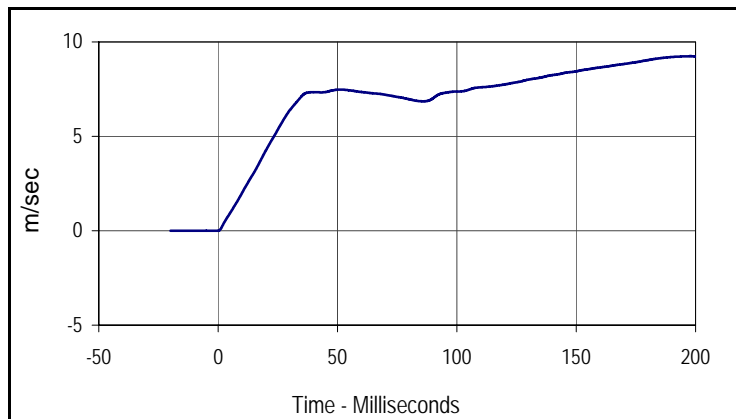
Tested Parameter	Units	Specification	Result	Pass/Fail	
Laboratory Temperature	°C	20.6 to 22.2	21.1	Pass	
Laboratory Relative Humidity	%	10 to 70	30	Pass	
Pendulum Velocity	m/sec	6.89 to 7.13	6.94	Pass	
Pendulum Deceleration	10 Msec.	m/sec	1.96 to 2.55	2.00	Pass
	20 Msec.	m/sec	4.12 to 5.10	4.25	Pass
	30 Msec.	m/sec	5.73 to 7.01	6.38	Pass
	40 to 70	m/sec	6.27 to 7.64	7.48	Pass
"D" Plane Rotation	Max	Degrees	66.0 to 82.0	78.5	Pass
Max Rotation Time After Peak Moment	Msec.	2.0 to 16.0	8.6	Pass	
Rotation Time From Peak to Zero Angle	Msec.	58.0 to 67.0	60.4	Pass	
Moment About Occipital Condyle	Nm	73.0 to 88.0	85.4	Pass	
Positive Moment Decay, Time To 0 Nm	Msec.	49.0 to 64.0	49.7	Pass	
Overall Test Results				Pass

Curve Description			
Pendulum Velocity			
CURNO	Type	SAE Class	Units
001	FIL	180	m/sec
Max	Time	Min	Time
9.2	197.9	0.0	-0.3

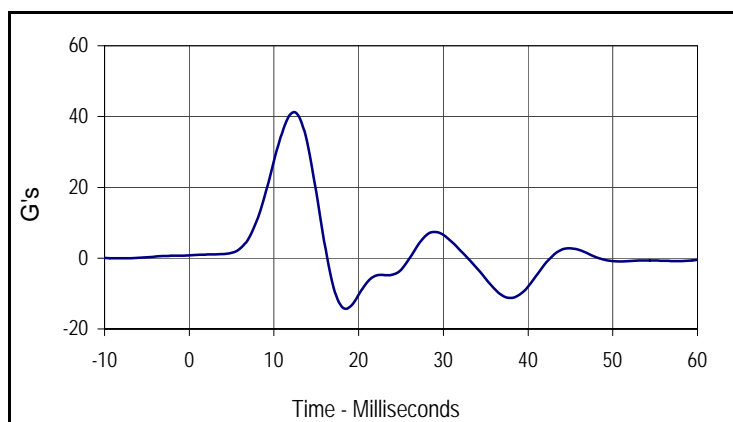
Tested Parameter	Units	Specification	Result	Pass/Fail
Laboratory Temperature	°C	18.9 to 25.6	21.1	Pass
Laboratory Relative Humidity	%	10 to 70	30	Pass
Probe Velocity	m/s	4.21 to 4.33	4.24	Pass
Upper Rib Acceleration	G's	37.0 to 46.0	41.2	Pass
Lower Rib Acceleration	G's	37.0 to 46.0	41.1	Pass
Thoracic Spine Acceleration	G's	15.0 to 22.0	19.8	Pass
Overall Test Results			Pass

Curve Description			
Upper Rib Primary			
CURNO	Type	SAE Class	Units
001	FIL	FIR100	G's
Max	Time	Min	Time
41.2	12.5	-14.2	18.8

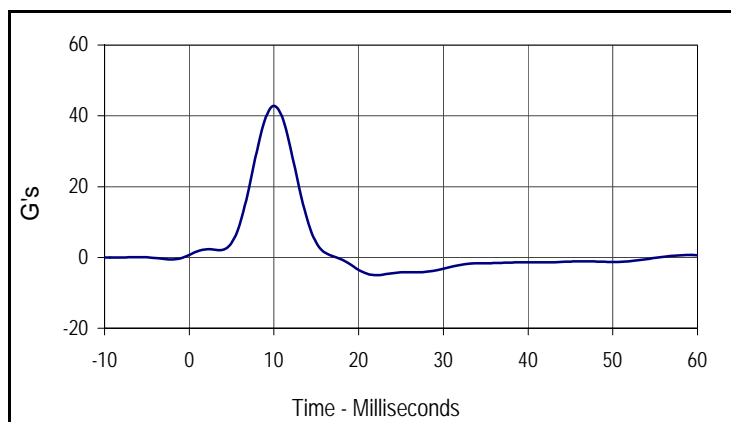
Tested Parameter	Units	Specification	Result	Pass/Fail
Laboratory Temperature	°C	18.9 to 25.6	21.1	Pass
Laboratory Relative Humidity	%	10 to 70	30	Pass
Probe Velocity	m/s	4.21 to 4.33	4.29	Pass
Peak Pelvis Acceleration	G's	40.0 to 60.0	42.8	Pass
Acceleration Time Above 20 G's	Msec.	3.0 to 7.0	5.63	Pass
Overall Test Results				Pass

Curve Description			
Pelvis Primary Y			
CURNO	Type	SAE Class	Units
001	FIL	FIR100	G's
Max	Time	Min	Time
42.8	10.0	-5.0	21.9

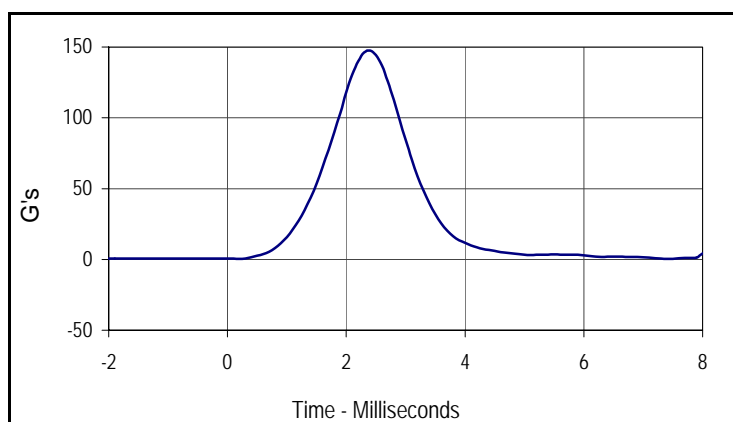
Tested Parameter	Units	Specification	Result	Pass/Fail
Laboratory Temperature	°C	18.9 to 25.6	21.1	Pass
Laboratory Relative Humidity	%	10 to 70	30	Pass
Peak Resultant Acceleration	G's	120.0 to 150.0	147.6	Pass
Peak Longitudinal Acceleration	G's	≤15.0	5.3	Pass
Is Acceleration Unimodal?	Yes/No	Yes	Yes	Pass
Oscillations After Main Pulse	%	<15	2.4	Pass
Overall Test Results				Pass

Curve Description			
Head Resultant			
CURNO	Type	SAE Class	Units
001	RES	1000	G's
Max	Time	Min	Time
147.6	2.4	0.5	0.2

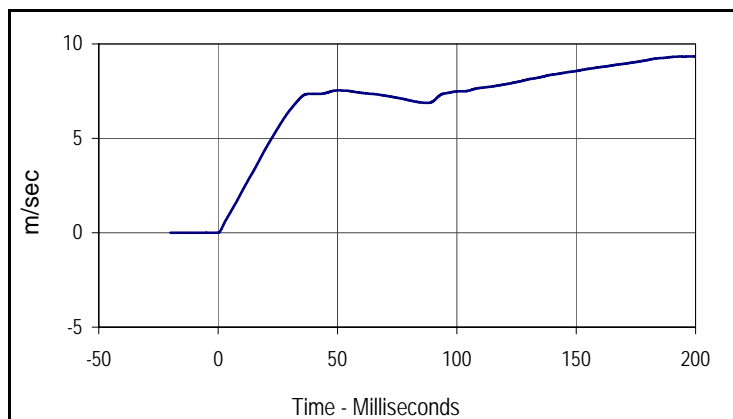
Tested Parameter	Units	Specification	Result	Pass/Fail	
Laboratory Temperature	°C	20.6 to 22.2	21.1	Pass	
Laboratory Relative Humidity	%	10 to 70	30	Pass	
Pendulum Velocity	m/sec	6.89 to 7.13	6.93	Pass	
Pendulum Deceleration	10 Msec.	m/sec	1.96 to 2.55	2.20	Pass
	20 Msec.	m/sec	4.12 to 5.10	4.48	Pass
	30 Msec.	m/sec	5.73 to 7.01	6.49	Pass
	40 to 70	m/sec	6.27 to 7.64	7.54	Pass
"D" Plane Rotation	Max	Degrees	66.0 to 82.0	77.5	Pass
Max Rotation Time After Peak Moment	Msec.	2.0 to 16.0	9.4	Pass	
Rotation Time From Peak to Zero Angle	Msec.	58.0 to 67.0	59.4	Pass	
Moment About Occipital Condyle	Nm	73.0 to 88.0	75.8	Pass	
Positive Moment Decay, Time To 0 Nm	Msec.	49.0 to 64.0	50.4	Pass	
Overall Test Results				Pass

Curve Description			
Pendulum Velocity			
CURNO	Type	SAE Class	Units
001	FIL	180	m/sec
Max	Time	Min	Time
9.3	198.8	0.0	-0.5

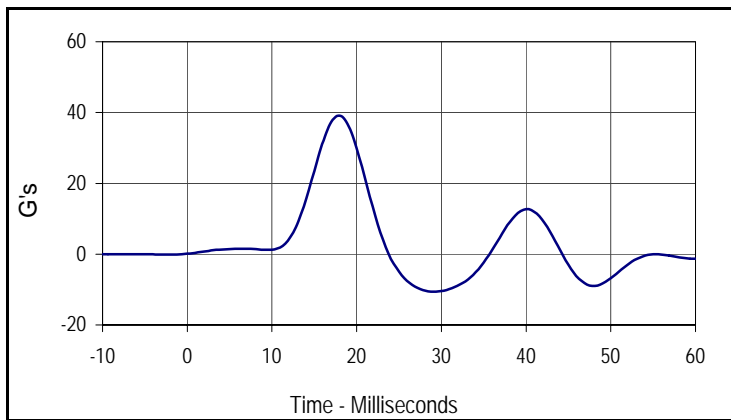
Tested Parameter	Units	Specification	Result	Pass/Fail
Laboratory Temperature	°C	18.9 to 25.6	21.1	Pass
Laboratory Relative Humidity	%	10 to 70	30	Pass
Probe Velocity	m/s	4.21 to 4.33	4.30	Pass
Upper Rib Acceleration	G's	37.0 to 46.0	39.0	Pass
Lower Rib Acceleration	G's	37.0 to 46.0	38.8	Pass
Thoracic Spine Acceleration	G's	15.0 to 22.0	18.8	Pass
Overall Test Results			Pass

Curve Description			
Upper Rib Primary Y			
CURNO	Type	SAE Class	Units
001	FIL	FIR100	G's
Max	Time	Min	Time
39.0	18.1	-10.6	29.4

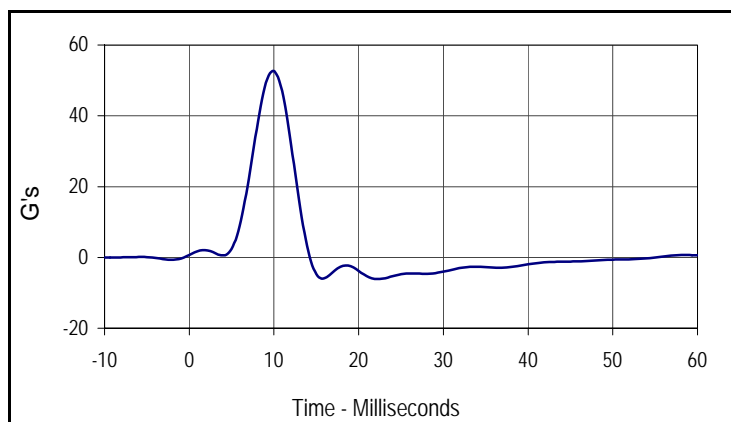
Tested Parameter	Units	Specification	Result	Pass/Fail
Laboratory Temperature	°C	18.9 to 25.6	21.1	Pass
Laboratory Relative Humidity	%	10 to 70	30	Pass
Probe Velocity	m/s	4.21 to 4.33	4.25	Pass
Peak Pelvis Acceleration	G's	40.0 to 60.0	52.7	Pass
Acceleration Time Above 20 G's	Msec.	3.0 to 7.0	6.25	Pass
Overall Test Results				Pass

Curve Description			
Pelvis Primary Y			
CURNO	Type	SAE Class	Units
001	FIL	FIR100	G's
Max	Time	Min	Time
52.7	10.0	-6.1	22.5

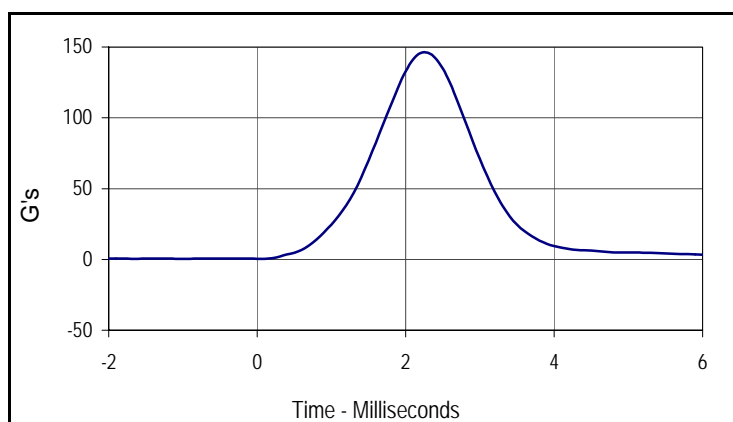
Tested Parameter	Units	Specification	Result	Pass/Fail
Laboratory Temperature	°C	18.9 to 25.6	21.1	Pass
Laboratory Relative Humidity	%	10 to 70	30	Pass
Peak Resultant Acceleration	G's	120.0 to 150.0	145.9	Pass
Peak Longitudinal Acceleration	G's	≤15.0	8.2	Pass
Is Acceleration Unimodal?	Yes/No	Yes	Yes	Pass
Oscillations After Main Pulse	%	<15	3.4	Pass
Overall Test Results				Pass

Curve Description			
Head Resultant			
CURNO	Type	SAE Class	Units
001	RES	1000	G's
Max	Time	Min	Time
145.9	2.3	0.4	0.1

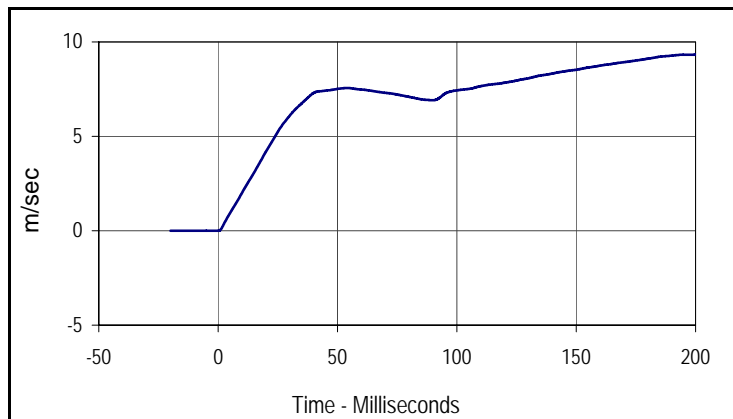
Tested Parameter	Units	Specification	Result	Pass/Fail	
Laboratory Temperature	°C	20.6 to 22.2	21.1	Pass	
Laboratory Relative Humidity	%	10 to 70	30	Pass	
Pendulum Velocity	m/sec	6.89 to 7.13	6.94	Pass	
Pendulum Deceleration	10 Msec.	m/sec	1.96 to 2.55	2.01	Pass
	20 Msec.	m/sec	4.12 to 5.10	4.19	Pass
	30 Msec.	m/sec	5.73 to 7.01	6.10	Pass
	40 to 70	m/sec	6.27 to 7.64	7.56	Pass
"D" Plane Rotation	Max	Degrees	66.0 to 82.0	75.2	Pass
Max Rotation Time After Peak Moment	Msec.	2.0 to 16.0	9.6	Pass	
Rotation Time From Peak to Zero Angle	Msec.	58.0 to 67.0	58.8	Pass	
Moment About Occipital Condyle	Nm	73.0 to 88.0	84.5	Pass	
Positive Moment Decay, Time To 0 Nm	Msec.	49.0 to 64.0	50.0	Pass	
Overall Test Results				Pass

Curve Description			
Pendulum Velocity			
CURNO	Type	SAE Class	Units
001	FIL	180	m/sec
Max	Time	Min	Time
9.3	200.0	0.0	-0.1

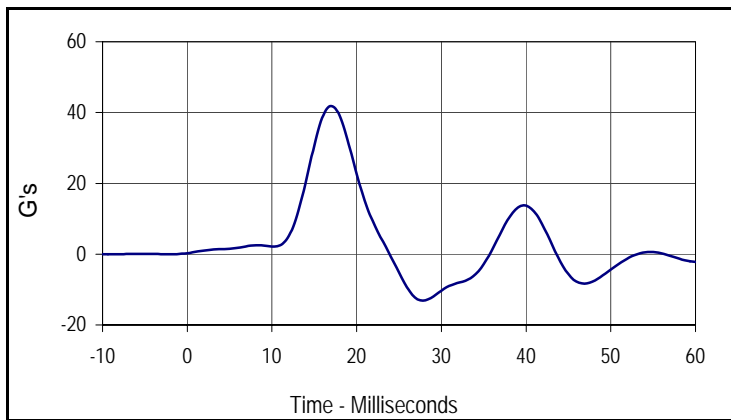
Tested Parameter	Units	Specification	Result	Pass/Fail
Laboratory Temperature	°C	18.9 to 25.6	21.1	Pass
Laboratory Relative Humidity	%	10 to 70	30	Pass
Probe Velocity	m/s	4.21 to 4.33	4.25	Pass
Upper Rib Acceleration	G's	37.0 to 46.0	41.8	Pass
Lower Rib Acceleration	G's	37.0 to 46.0	38.9	Pass
Thoracic Spine Acceleration	G's	15.0 to 22.0	17.8	Pass
Overall Test Results			Pass

Curve Description			
Upper Rib Primary Y			
CURNO	Type	SAE Class	Units
001	FIL	FIR100	G's
Max	Time	Min	Time
41.8	16.9	-13.1	28.1

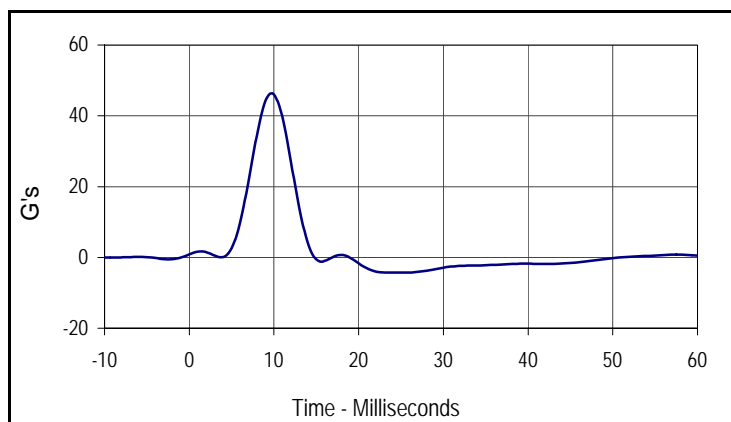
Tested Parameter	Units	Specification	Result	Pass/Fail
Laboratory Temperature	°C	18.9 to 25.6	21.1	Pass
Laboratory Relative Humidity	%	10 to 70	30	Pass
Probe Velocity	m/s	4.21 to 4.33	4.28	Pass
Peak Pelvis Acceleration	G's	40.0 to 60.0	46.0	Pass
Acceleration Time Above 20 G's	Msec.	3.0 to 7.0	6.25	Pass
Overall Test Results				Pass

Curve Description			
Pelvis Primary Y			
CURNO	Type	SAE Class	Units
001	FIL	FIR100	G's
Max	Time	Min	Time
46.0	10.0	-4.3	25.6

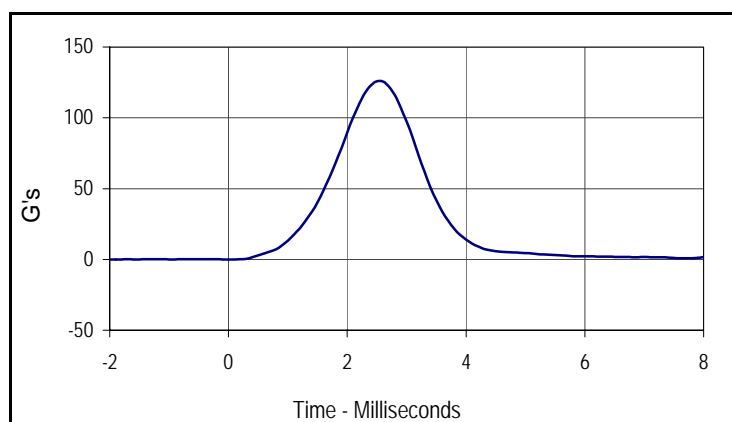
Tested Parameter	Units	Specification	Result	Pass/Fail
Laboratory Temperature	°C	18.9 to 25.6	21.1	Pass
Laboratory Relative Humidity	%	10 to 70	30	Pass
Peak Resultant Acceleration	G's	120.0 to 150.0	125.8	Pass
Peak Longitudinal Acceleration	G's	≤15.0	4.5	Pass
Is Acceleration Unimodal?	Yes/No	Yes	Yes	Pass
Oscillations After Main Pulse	%	<15	3.5	Pass
Overall Test Results				Pass

Curve Description			
Head Resultant			
CURNO	Type	SAE Class	Units
001	RES	1000	G's
Max	Time	Min	Time
125.8	2.5	0.0	0.0

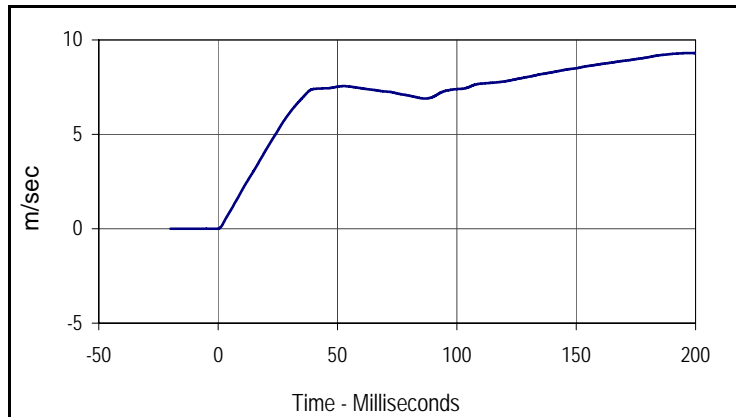
Tested Parameter	Units	Specification	Result	Pass/Fail	
Laboratory Temperature	°C	20.6 to 22.2	21.1	Pass	
Laboratory Relative Humidity	%	10 to 70	30	Pass	
Pendulum Velocity	m/sec	6.89 to 7.13	7.01	Pass	
Pendulum Deceleration	10 Msec.	m/sec	1.96 to 2.55	2.04	Pass
	20 Msec.	m/sec	4.12 to 5.10	4.17	Pass
	30 Msec.	m/sec	5.73 to 7.01	6.16	Pass
	40 to 70	m/sec	6.27 to 7.64	7.55	Pass
"D" Plane Rotation	Max	Degrees	66.0 to 82.0	77.7	Pass
Max Rotation Time After Peak Moment	Msec.	2.0 to 16.0	8.2	Pass	
Rotation Time From Peak to Zero Angle	Msec.	58.0 to 67.0	60.0	Pass	
Moment About Occipital Condyle	Nm	73.0 to 88.0	85.4	Pass	
Positive Moment Decay, Time To 0 Nm	Msec.	49.0 to 64.0	50.0	Pass	
Overall Test Results				Pass

Curve Description			
Pendulum Velocity			
CURNO	Type	SAE Class	Units
001	FIL	180	m/sec
Max	Time	Min	Time
9.3	200.0	0.0	-0.4
