**REPORT NUMBER: NCAPSIDE-MGA-2006-002**

**NEW CAR ASSESSMENT PROGRAM  
SIDE IMPACT TEST**

**TOYOTA MOTOR CORPORATION  
2006 TOYOTA SCION XB  
NHTSA NUMBER: M65103**

**PREPARED BY:  
MGA RESEARCH CORPORATION  
5000 WARREN ROAD  
BURLINGTON, WI 53105**

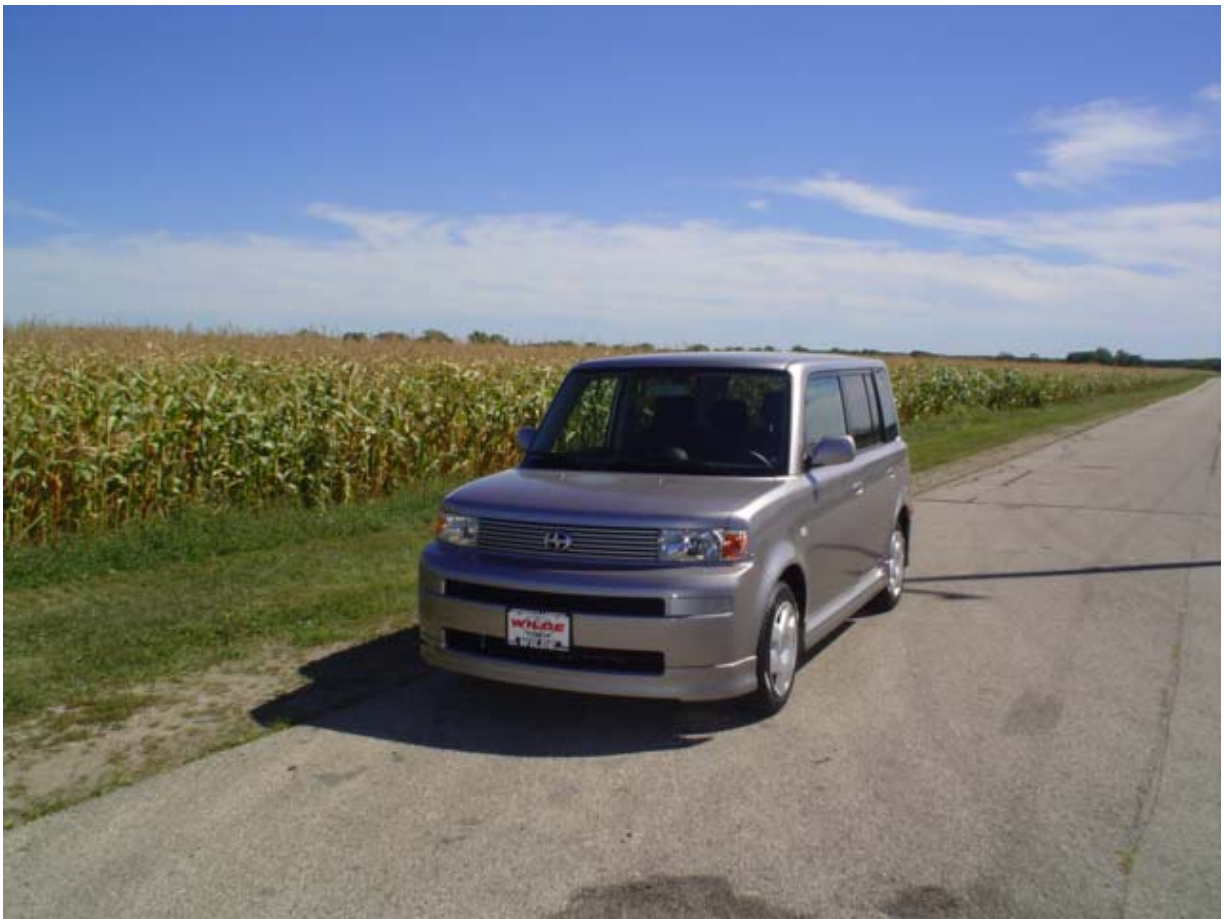
Left Front  $\frac{3}{4}$  View, As Received

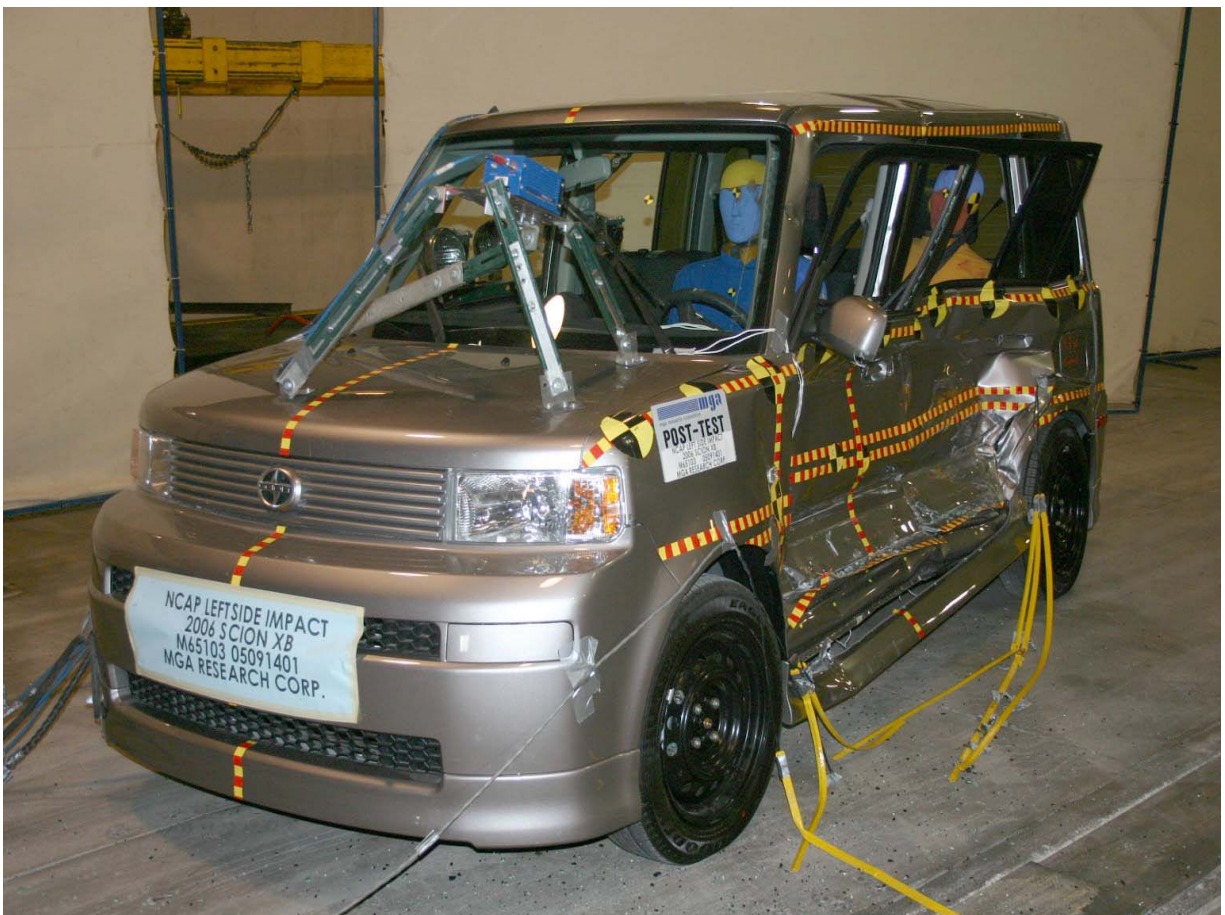
Post-Test Left Front  $\frac{3}{4}$  View

The test vehicle sustained a maximum static crush of 272 mm at level 2, 450 mm rearward of the left vertical impact point. The driver and passenger SID/HIIIs, Serial Nos. 904 and 271 respectively, were calibrated just prior to this test.

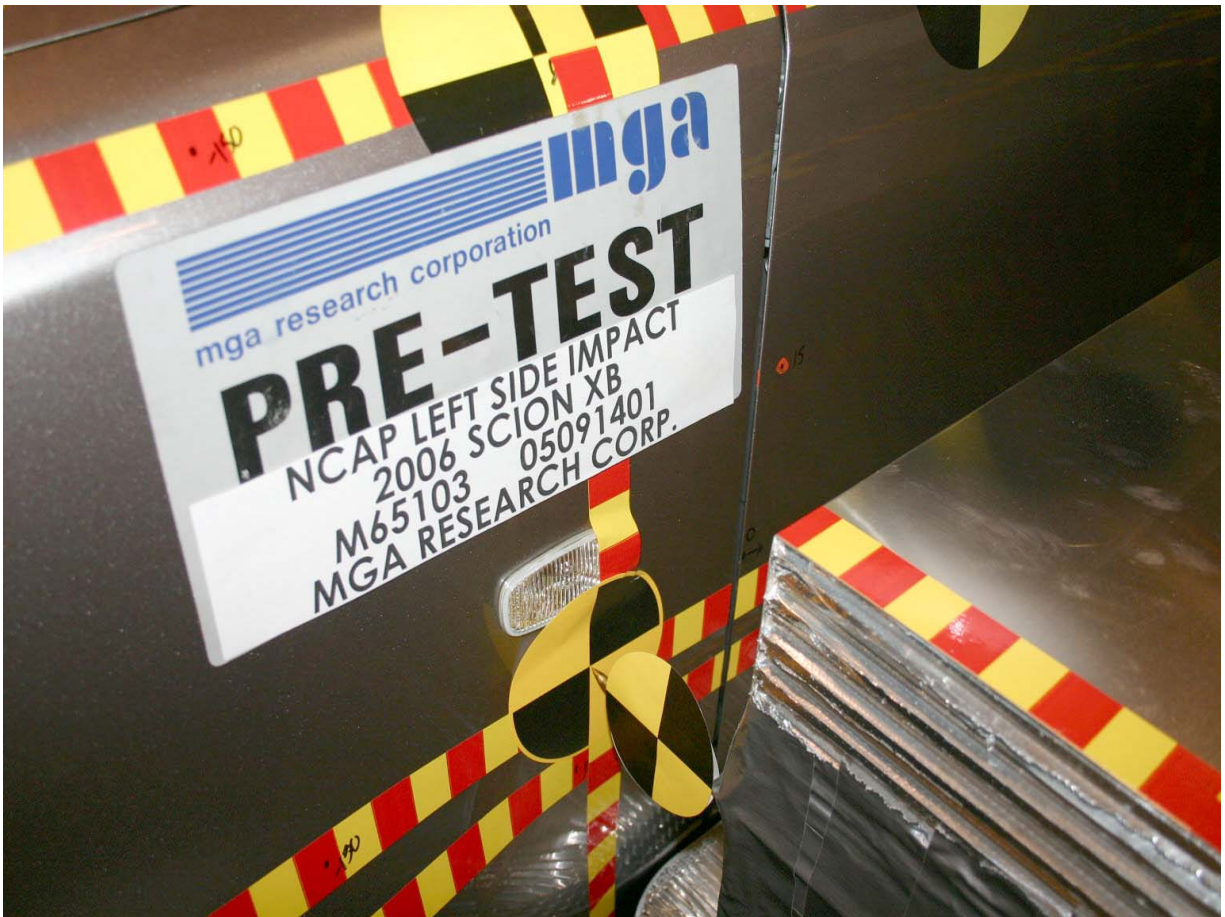
Pre-Test Left Impact Point

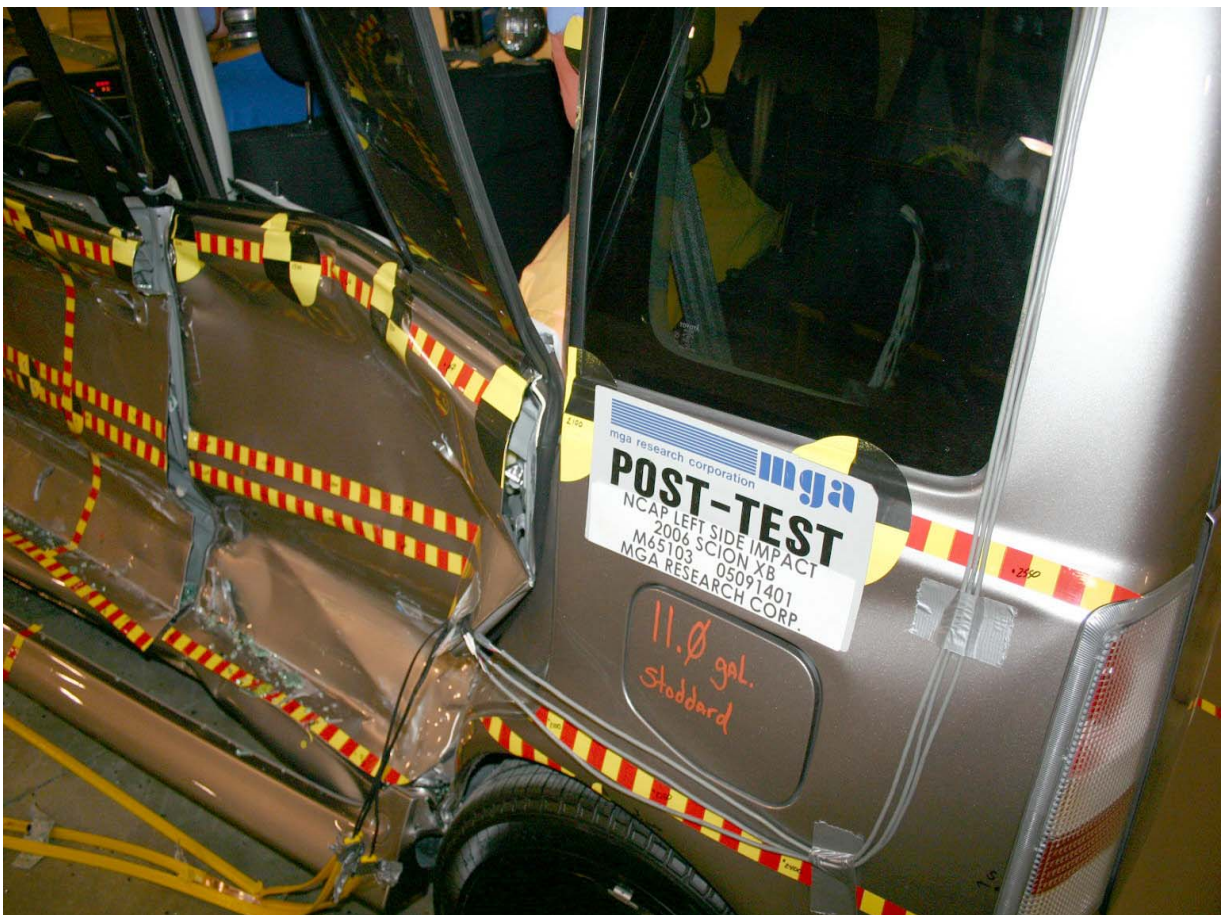
Post-Test Left Rear Door

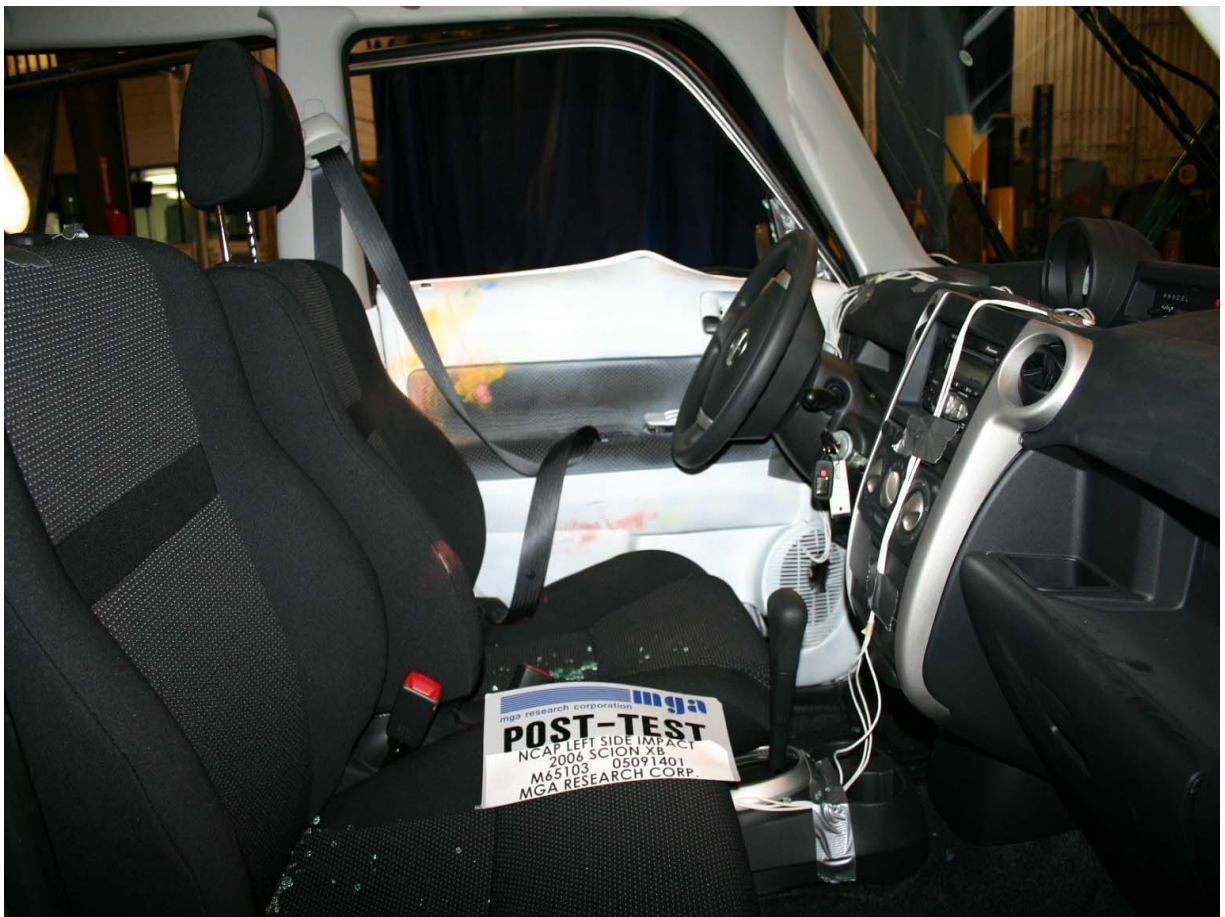
Post-Test Front Door Panel (Interior)

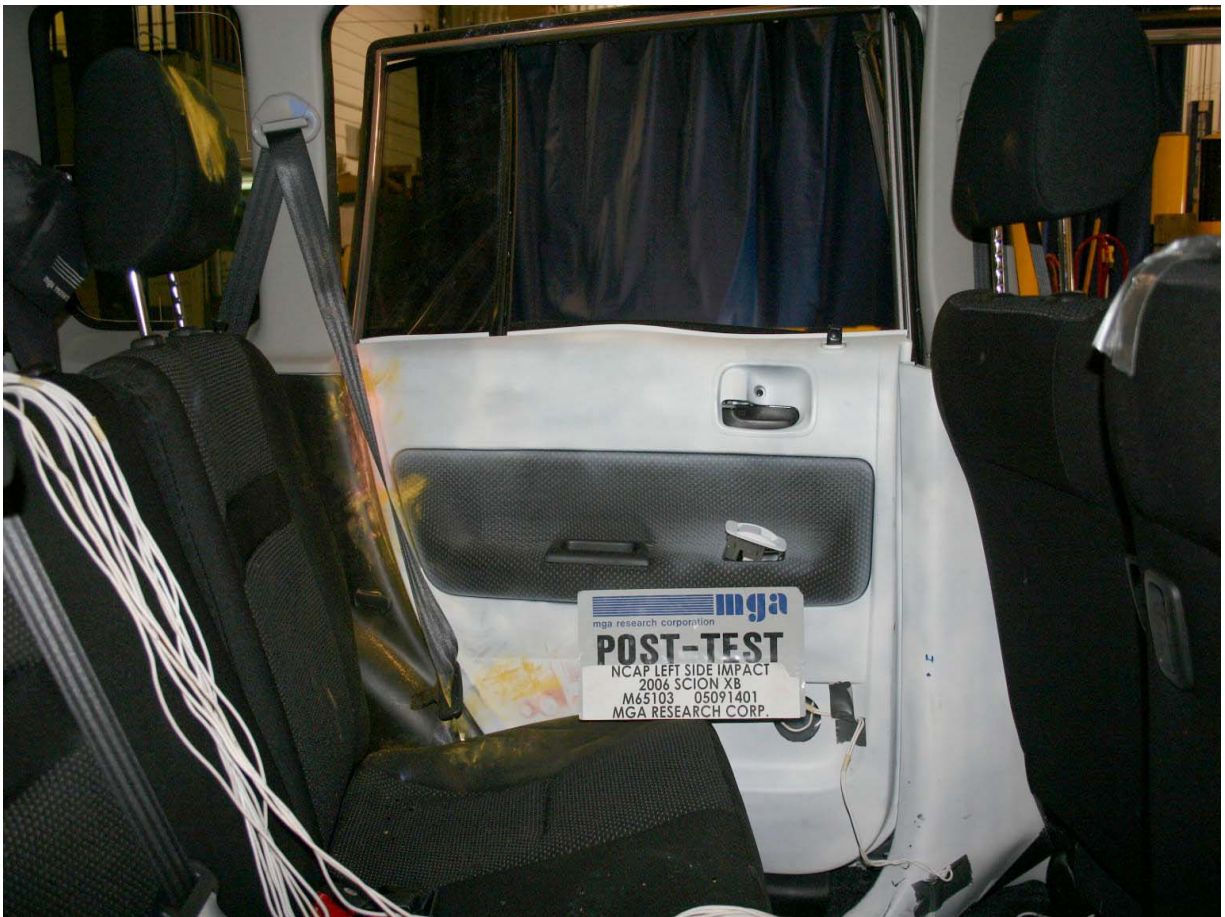
Post-Test Rear Door Panel (Interior)

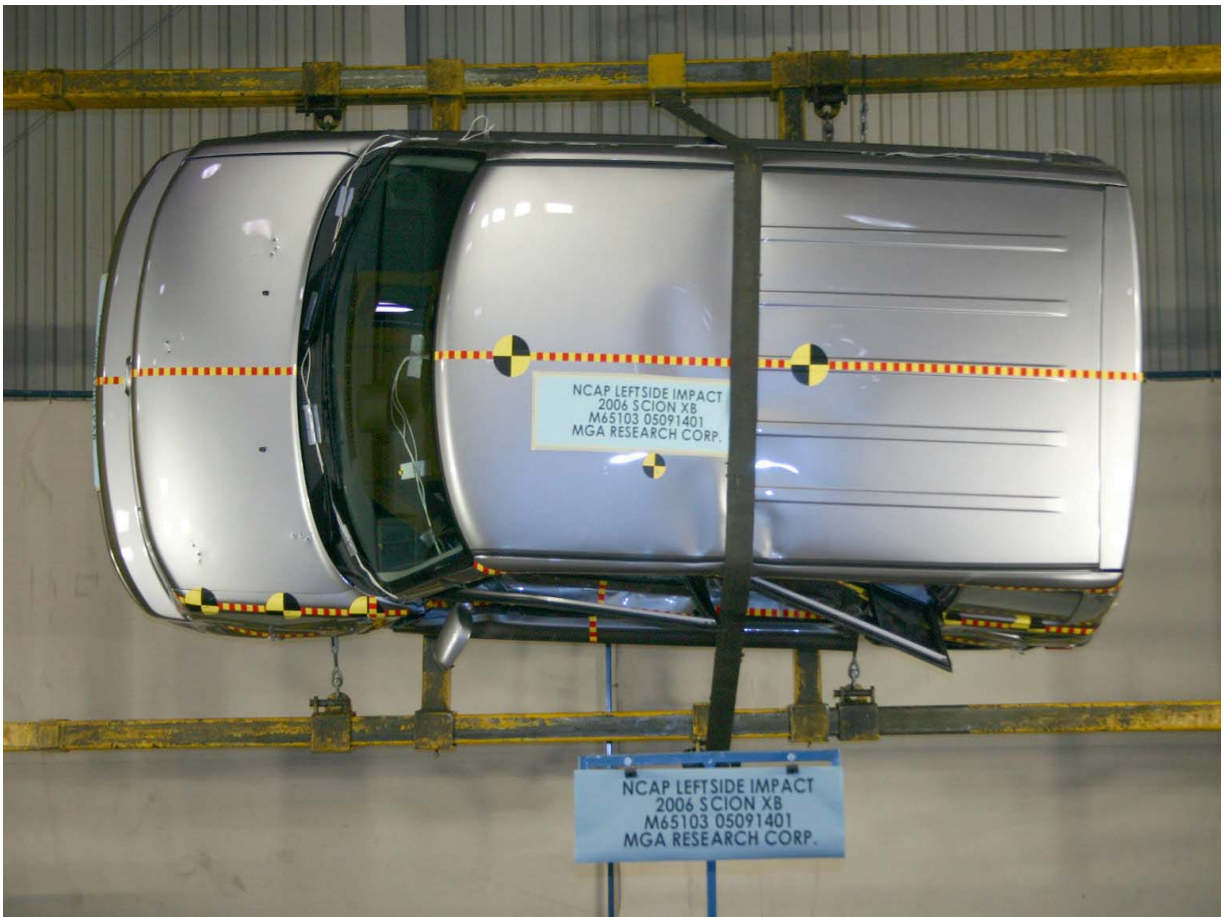
Vehicle on Rollover Device (90 Degrees)

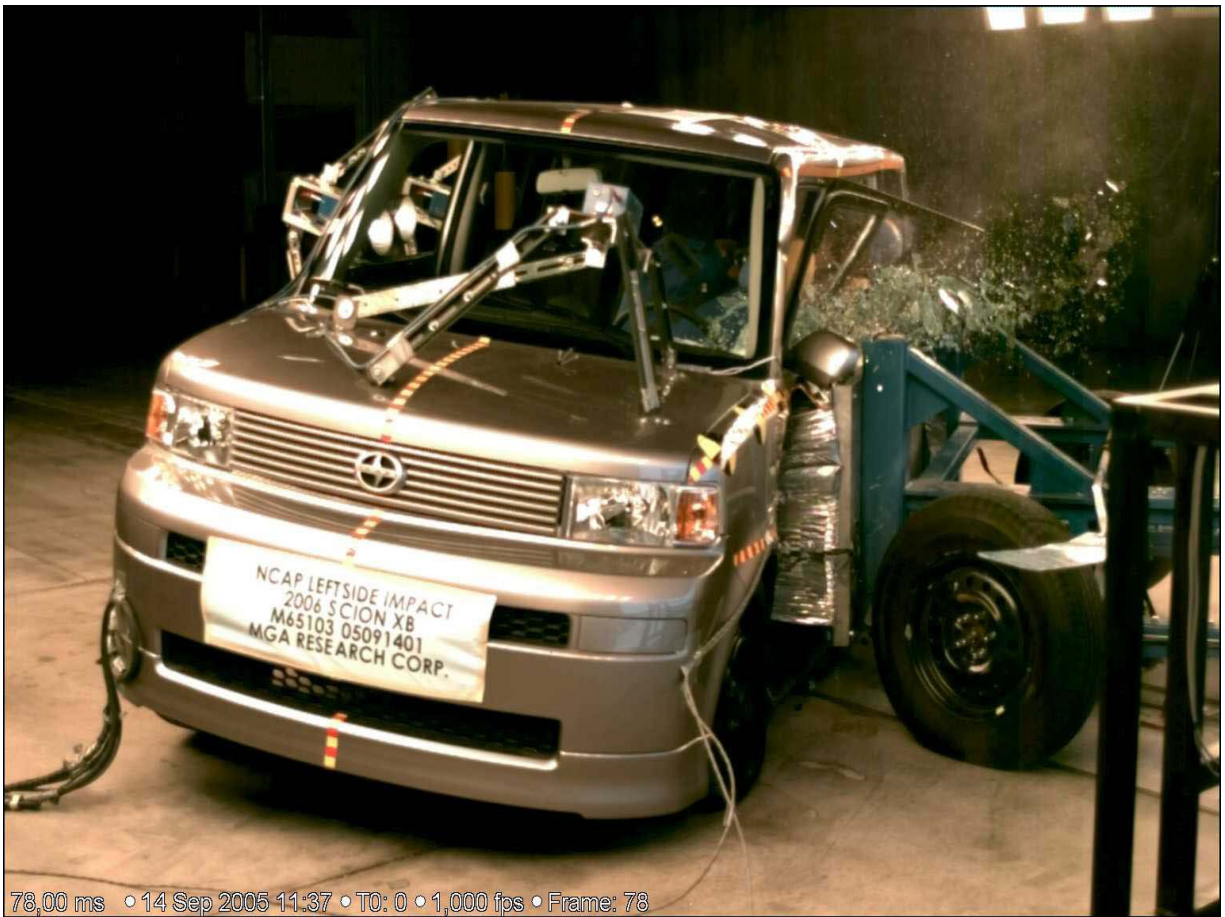
Vehicle Impact

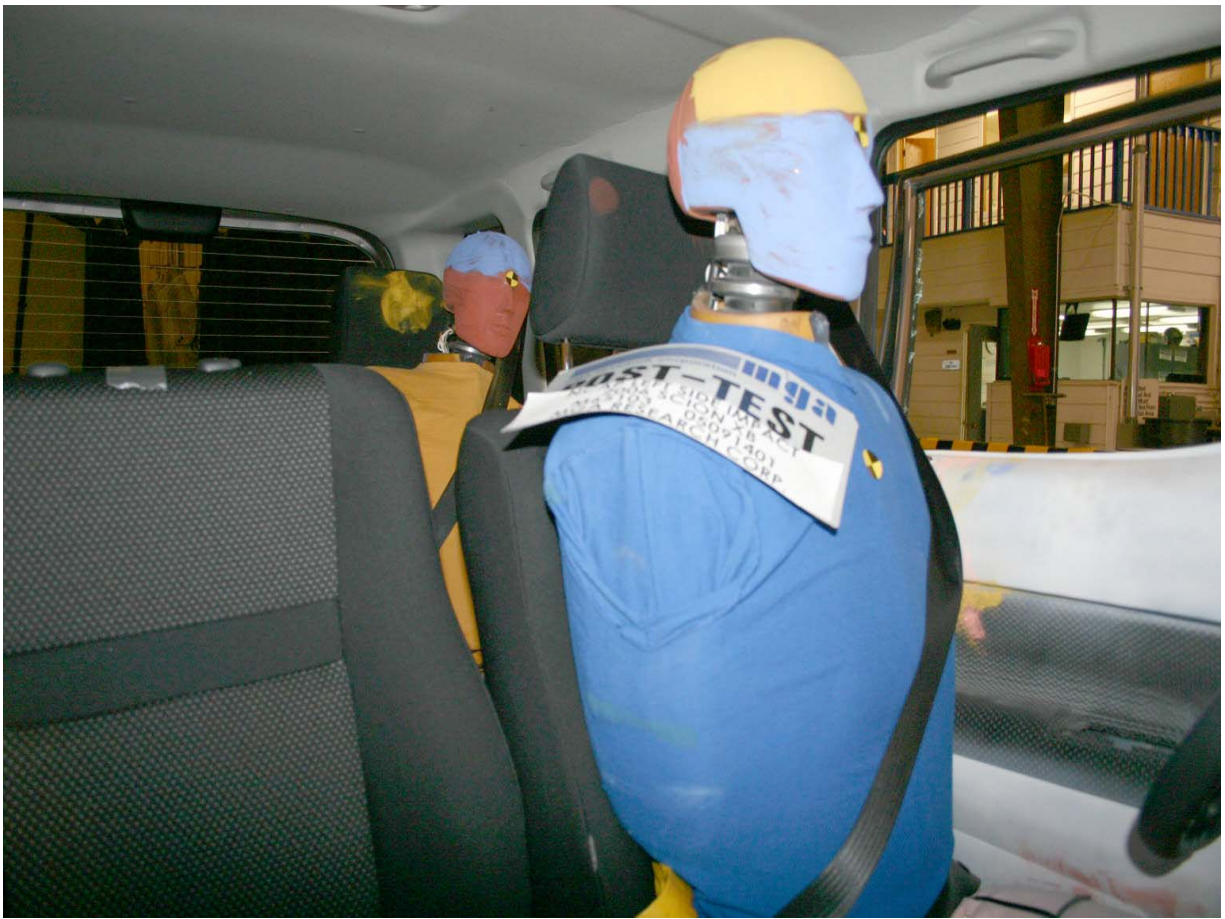
Post-Test Driver Dummy Head Contact

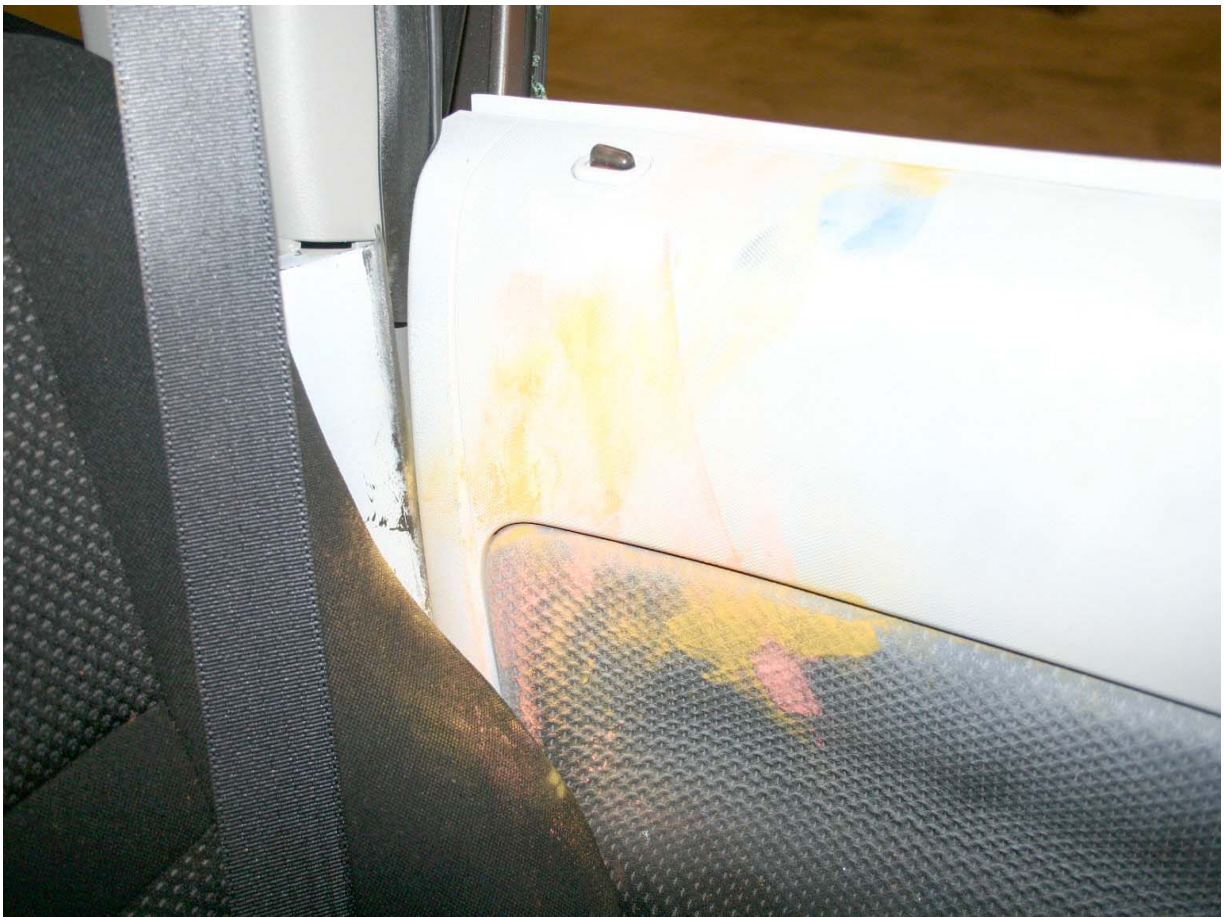
Post-Test Driver Dummy Upper Torso Contact

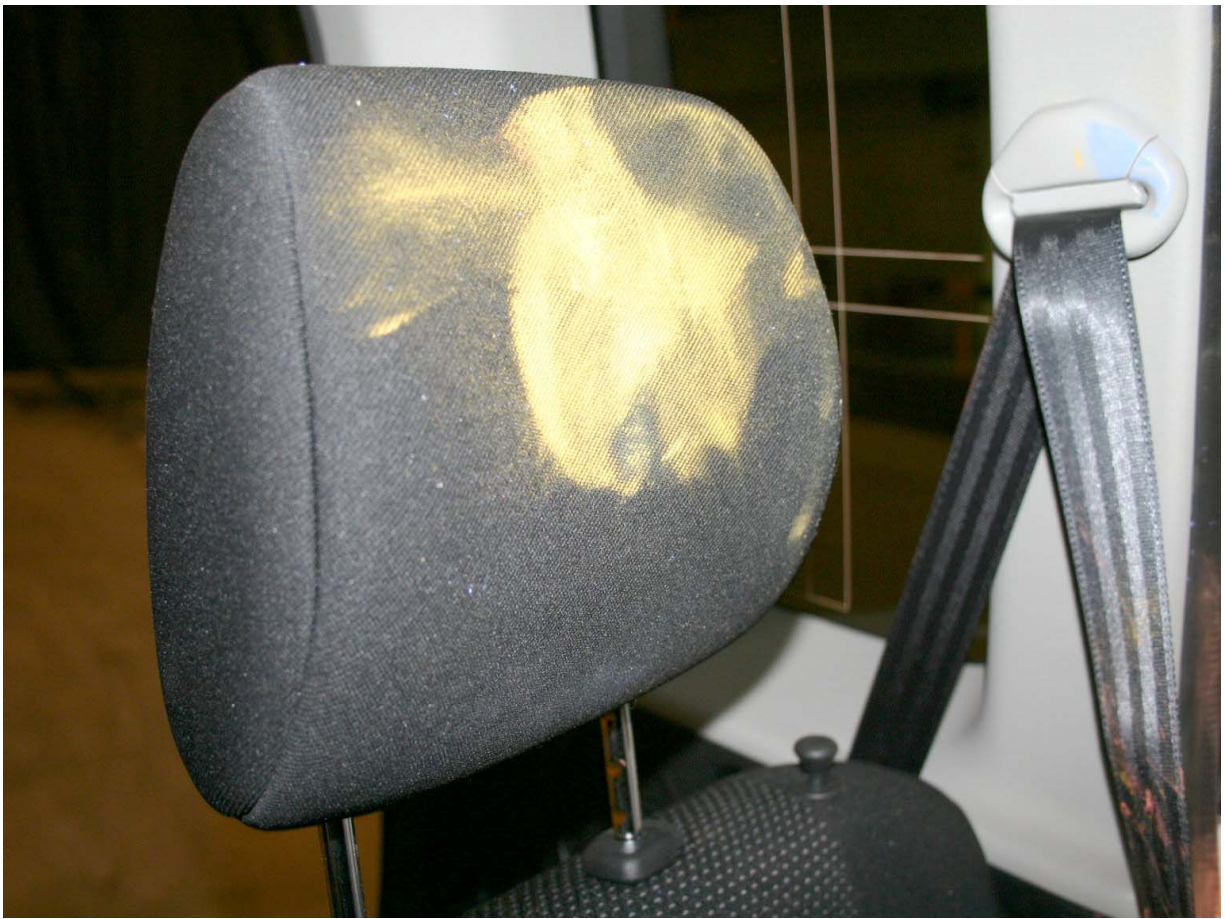
Post-Test Passenger Dummy Head Contact

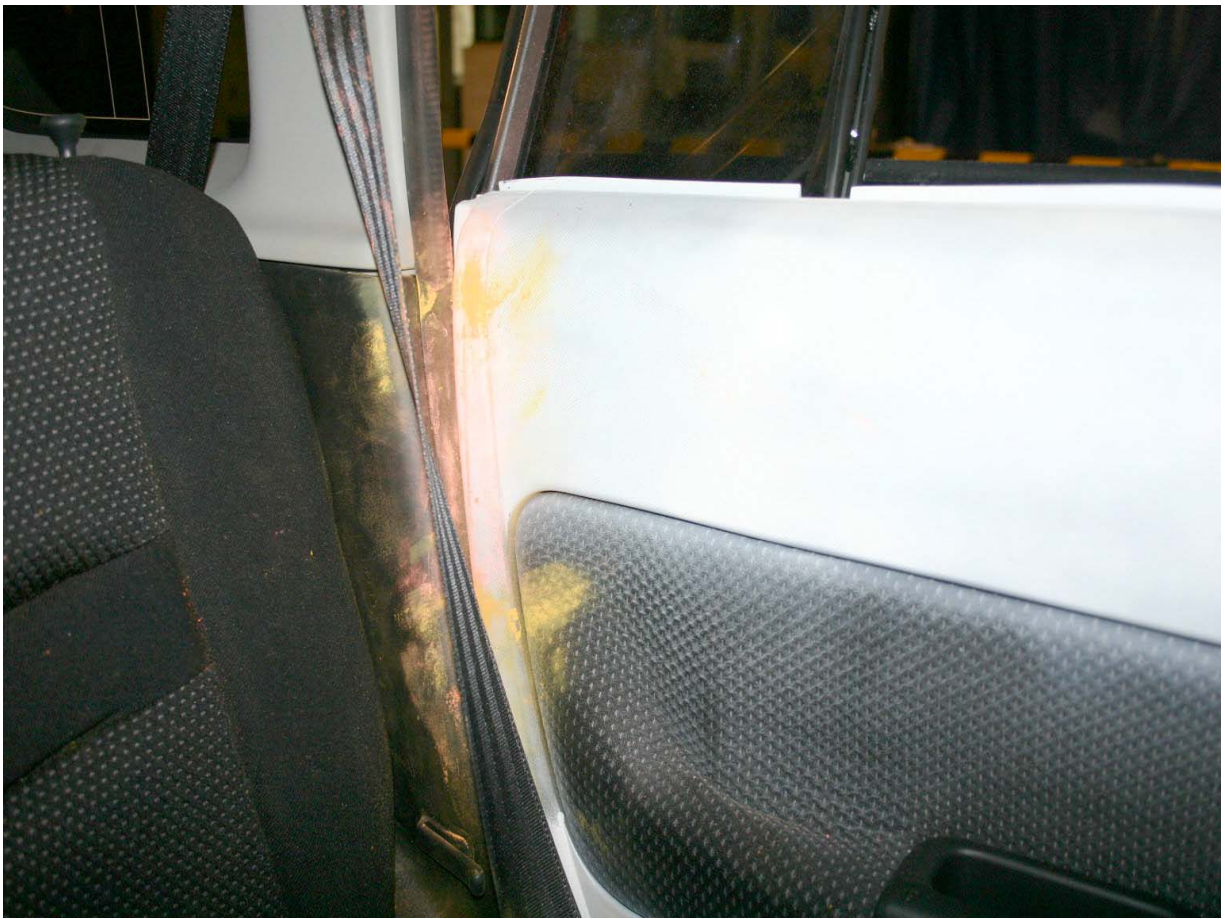
Post-Test Passenger Dummy Upper Torso Contact
