**REPORT NUMBER: TO1-MGA-2004-029**

**OBLIQUE RIGID SIDE POLE IMPACT  
ES-2RE DRIVER POSITION  
TEST DATE: September 1, 2005  
Task Order #T0001 / RFP #0004**

**2005 DODGE RAM 2500  
NHTSA NUMBER: R50327**

**PREPARED BY:  
MGA RESEARCH CORPORATION  
5000 WARREN ROAD  
BURLINGTON, WI 53105**

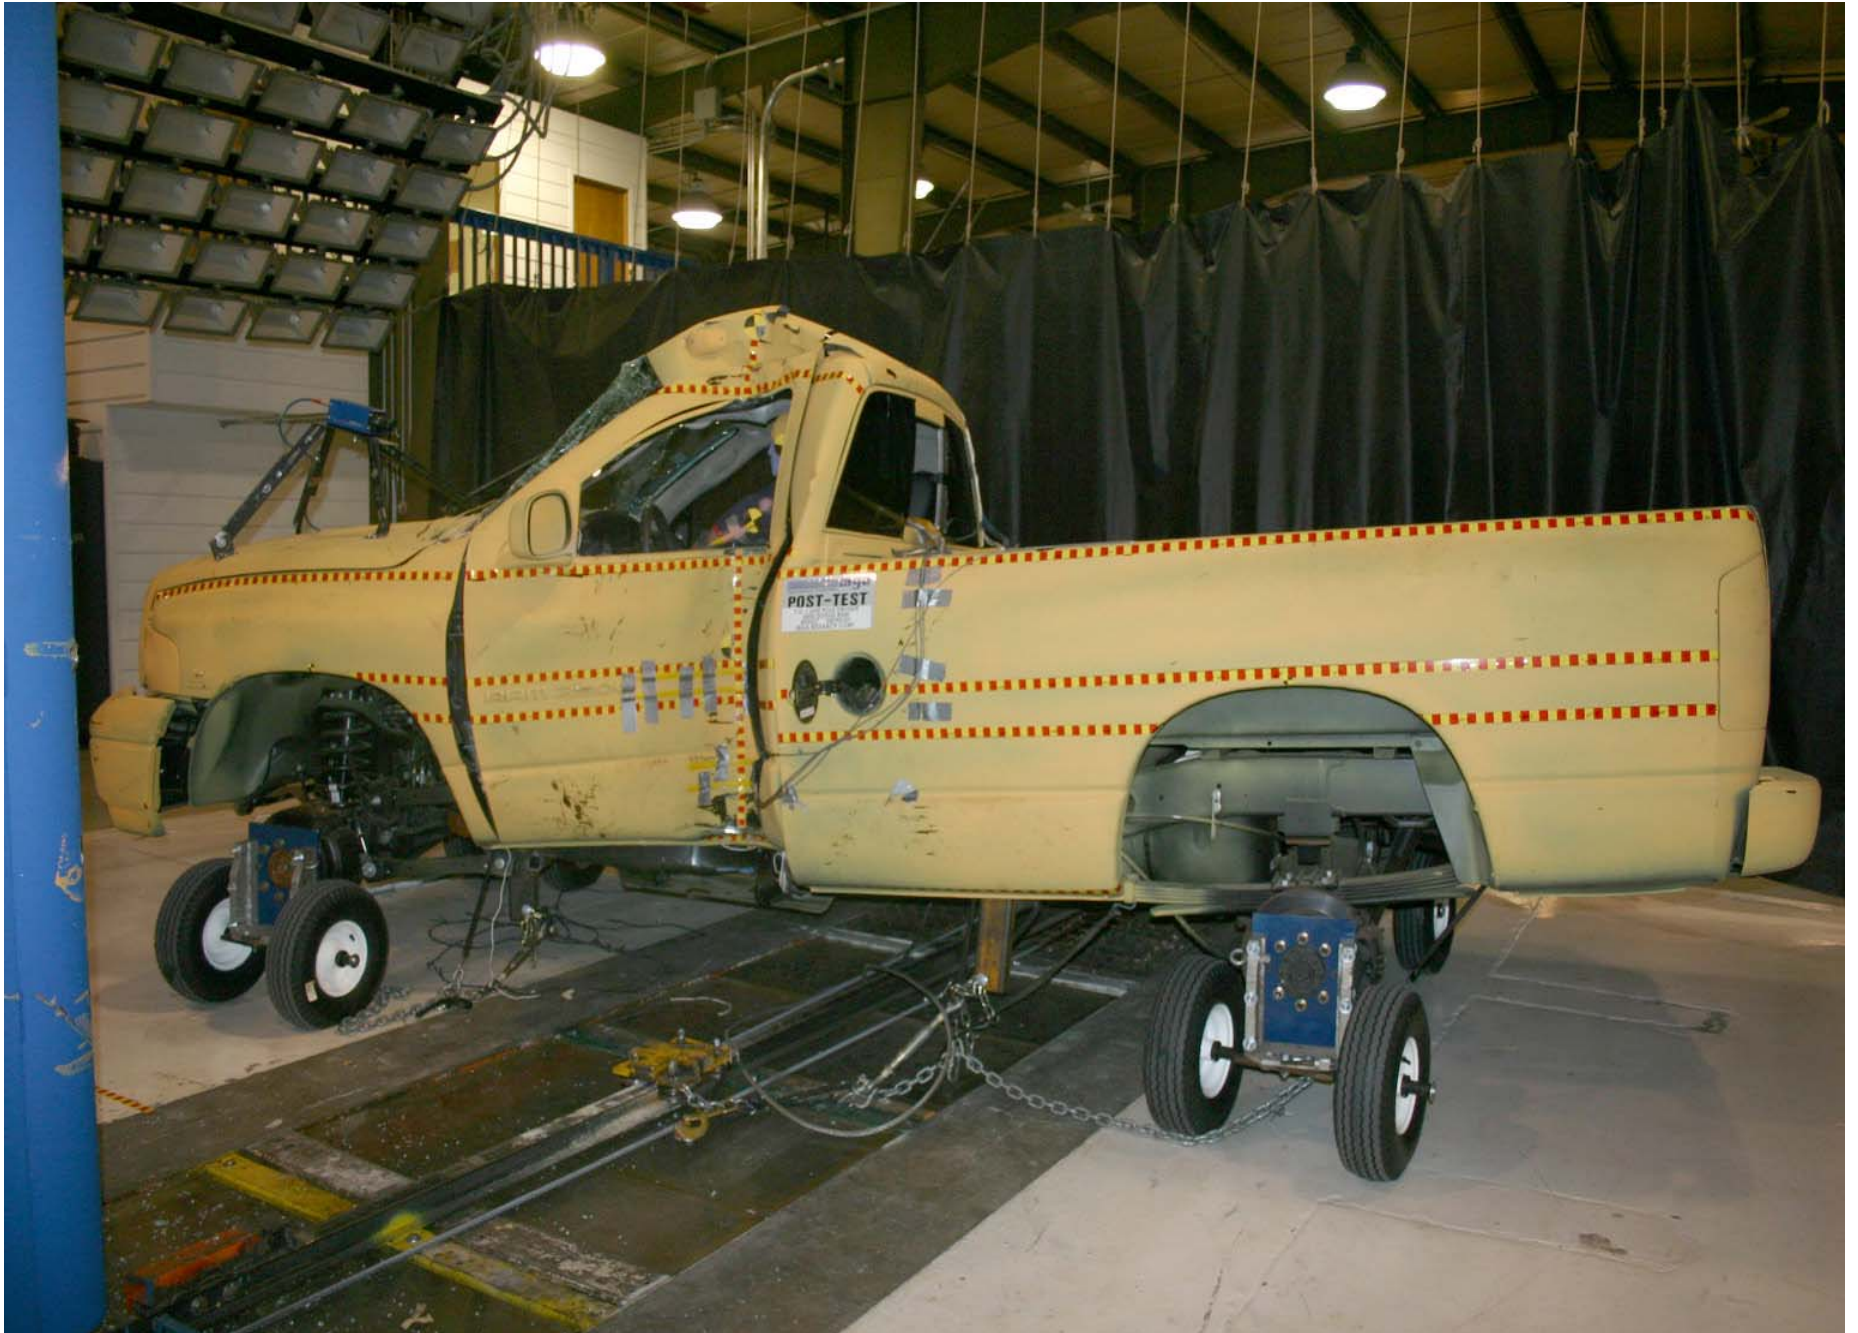
Post-Test Left Side View of Test Vehicle

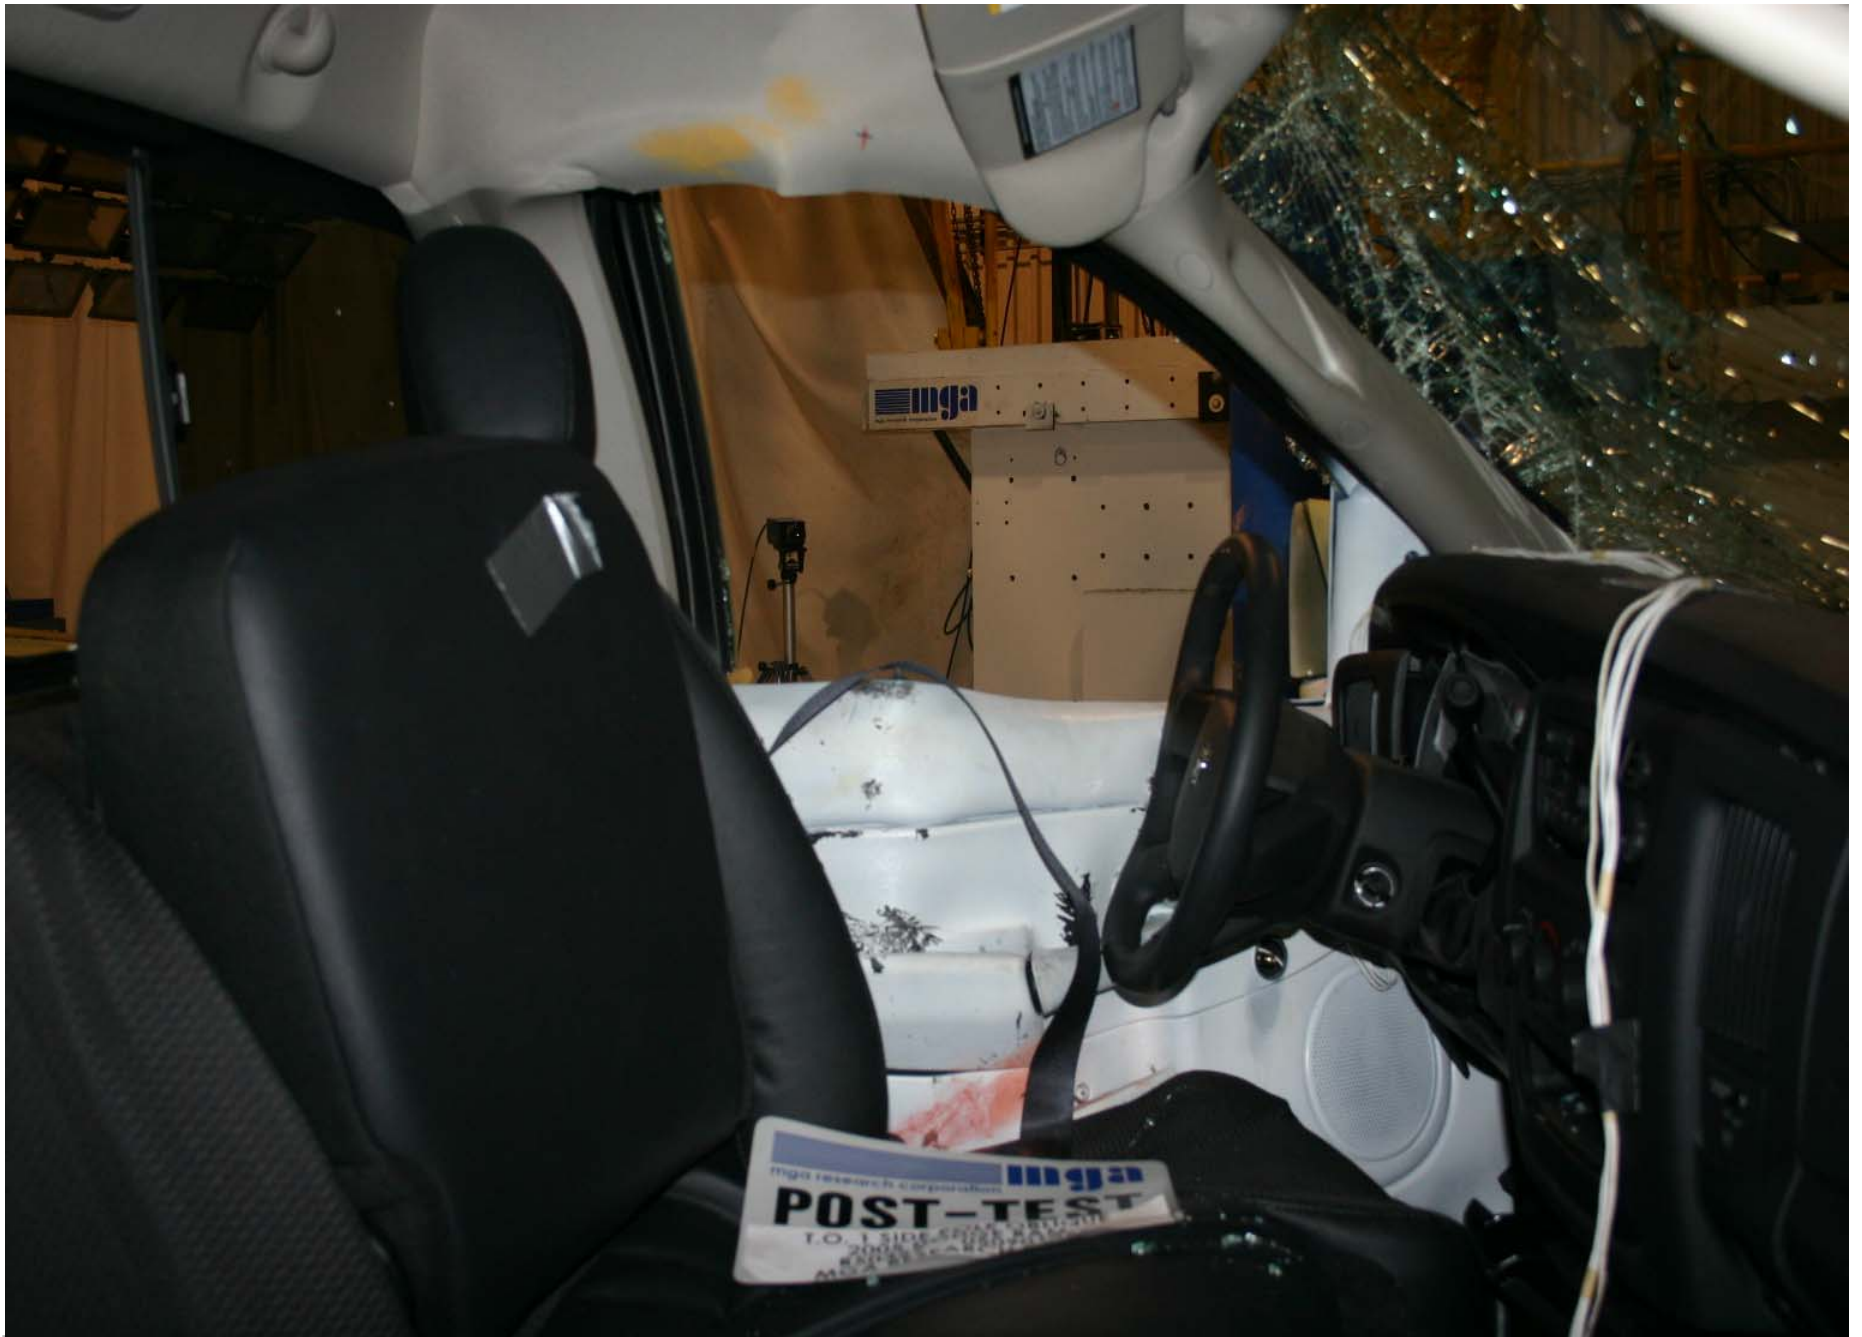
| Description | Left Front |
|---|---|
| Upper Torso Contact | Door Panel, Pole |

Post-Test Driver Dummy Contact

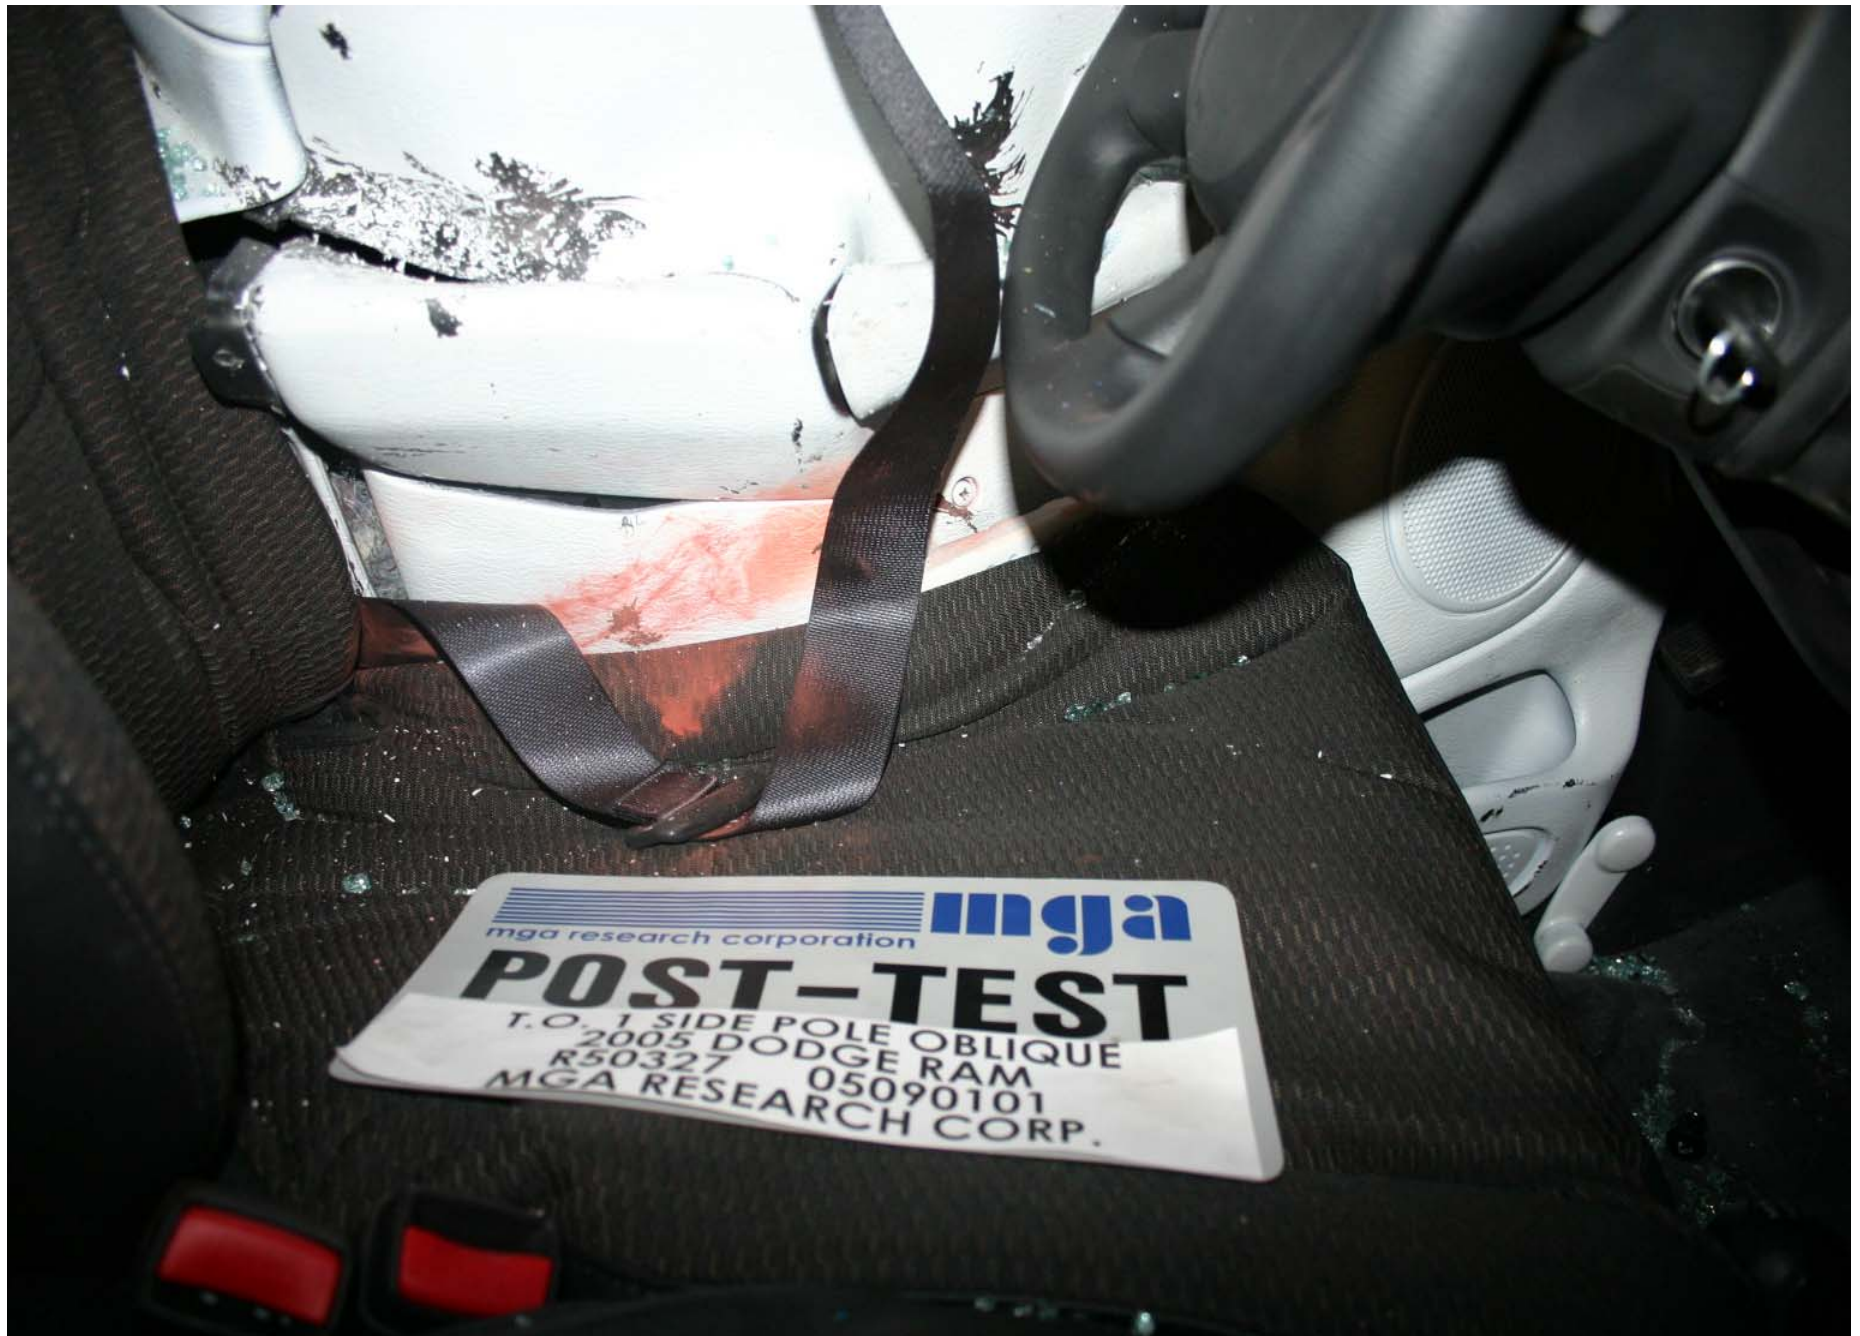
| Description | Left Front |
|---|---|
| Lower Torso Contact | Door Panel |

Post-Test Driver Dummy Lower Body Contact

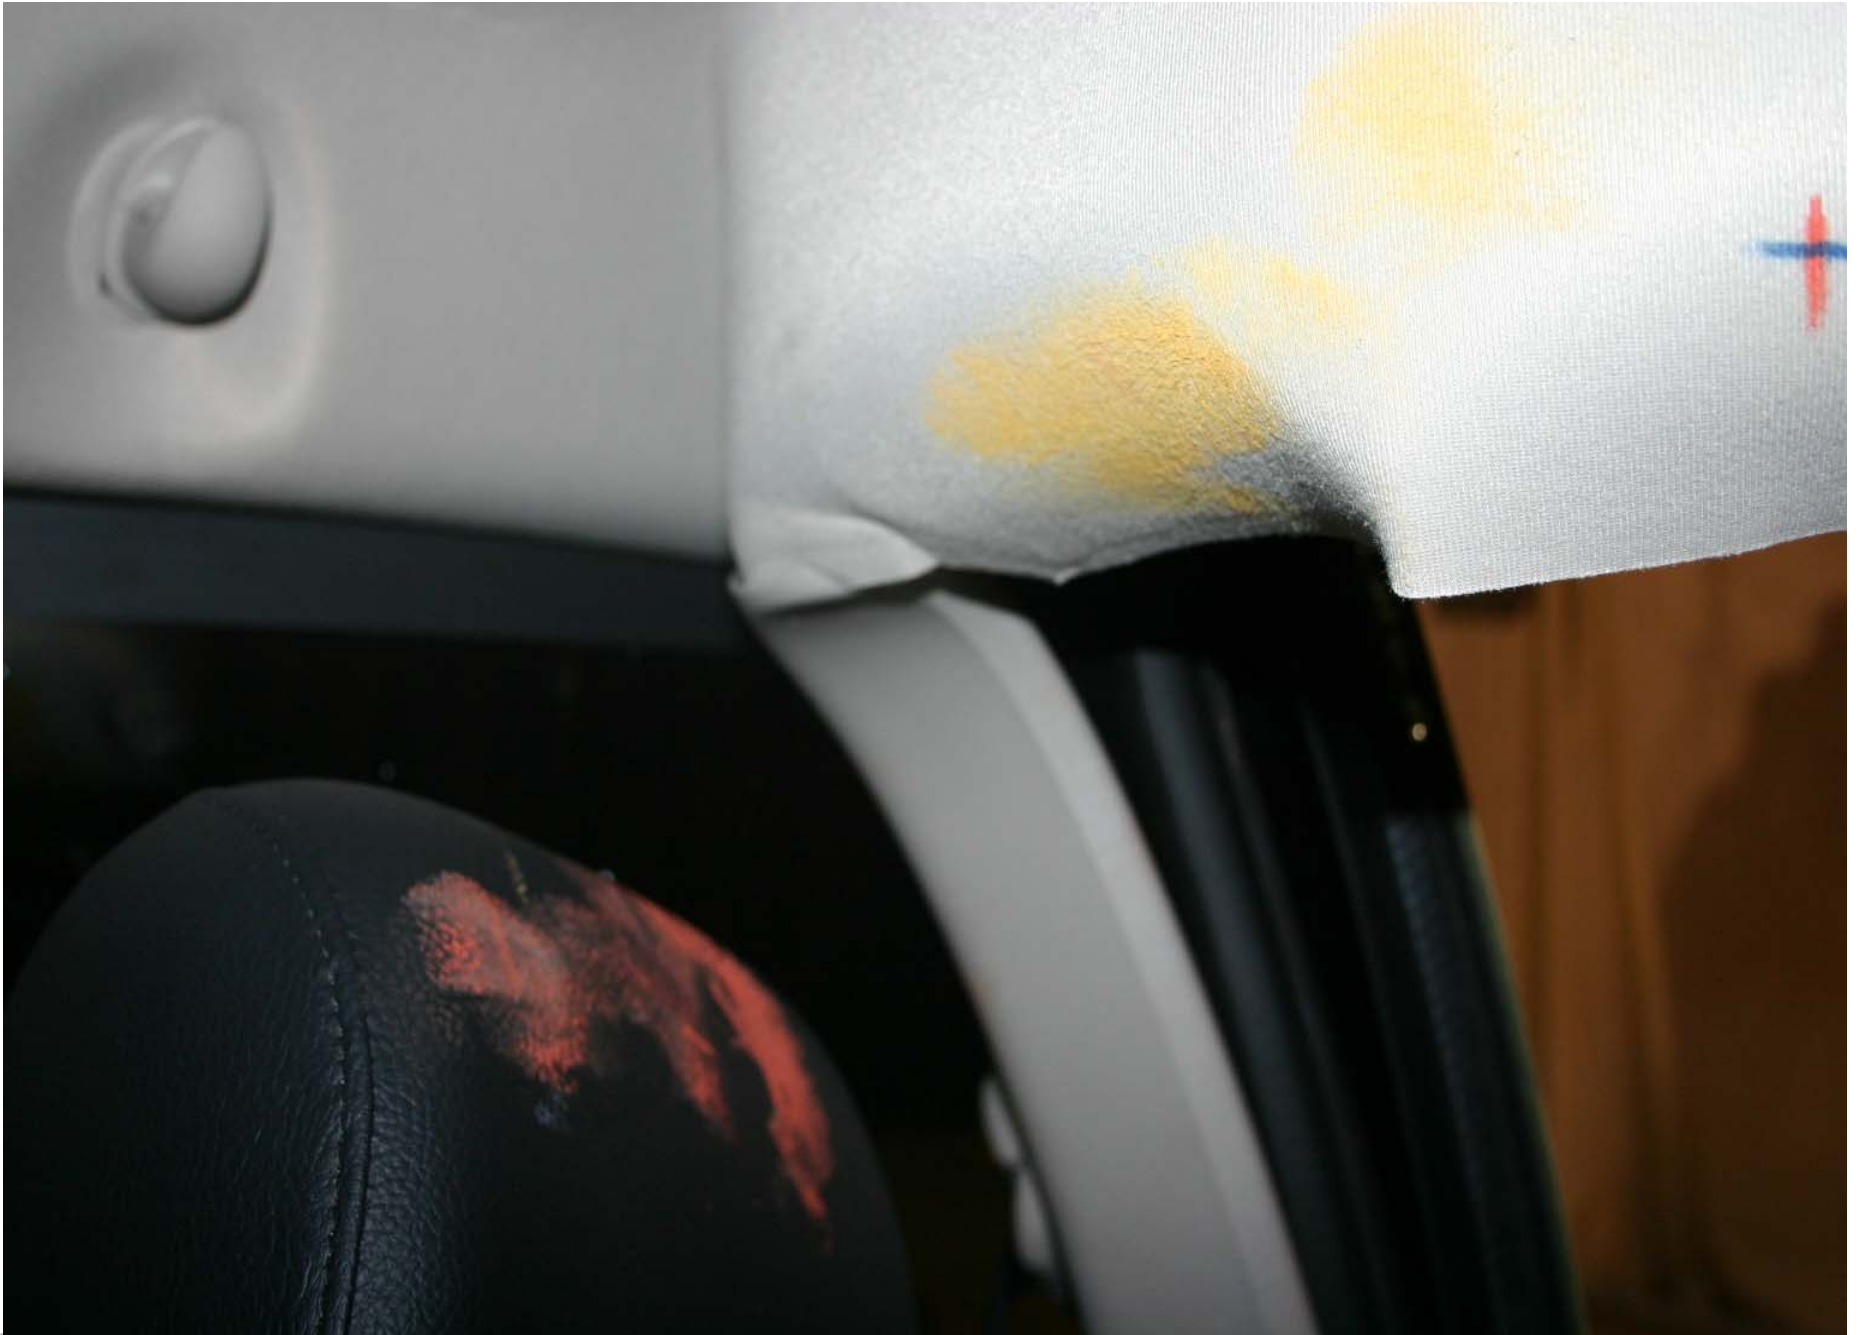
| Description | Left Front |
|---|---|
| Head Contact | Side Header, Headrest, Pole |

Post-Test Driver Dummy Head Contact

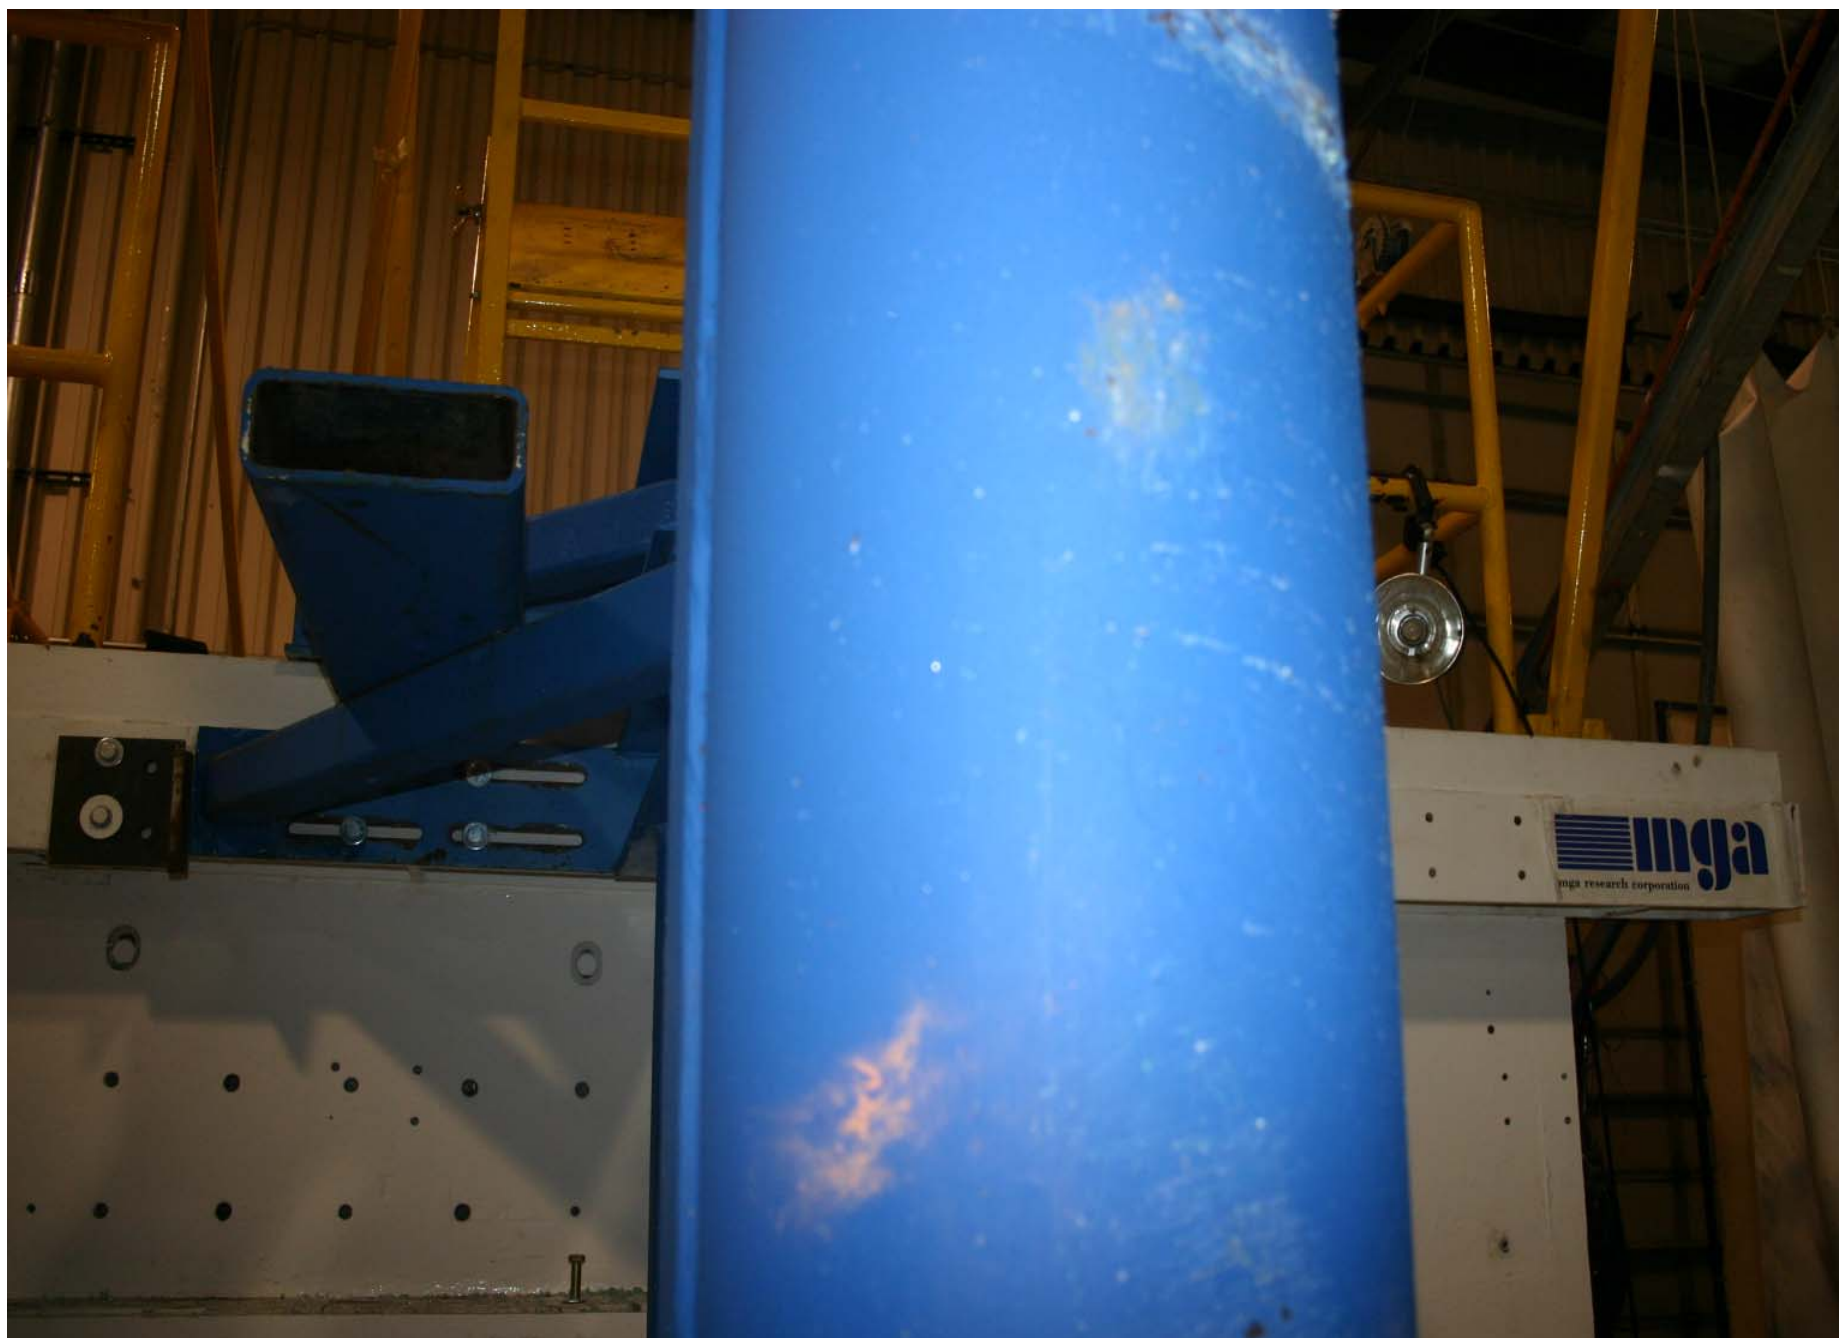
Post-Test Driver Dummy Head Contact With Pole
