**REPORT NUMBER: TO1-MGA-2004-030**

**OBLIQUE RIGID SIDE POLE IMPACT  
ES-2RE DRIVER POSITION  
TEST DATE: September 2, 2005  
Task Order #T0001 / RFP #0004**

**2005 SATURN ION 4 DOOR  
NHTSA NUMBER: R50169**

**PREPARED BY:  
MGA RESEARCH CORPORATION  
5000 WARREN ROAD  
BURLINGTON, WI 53105**

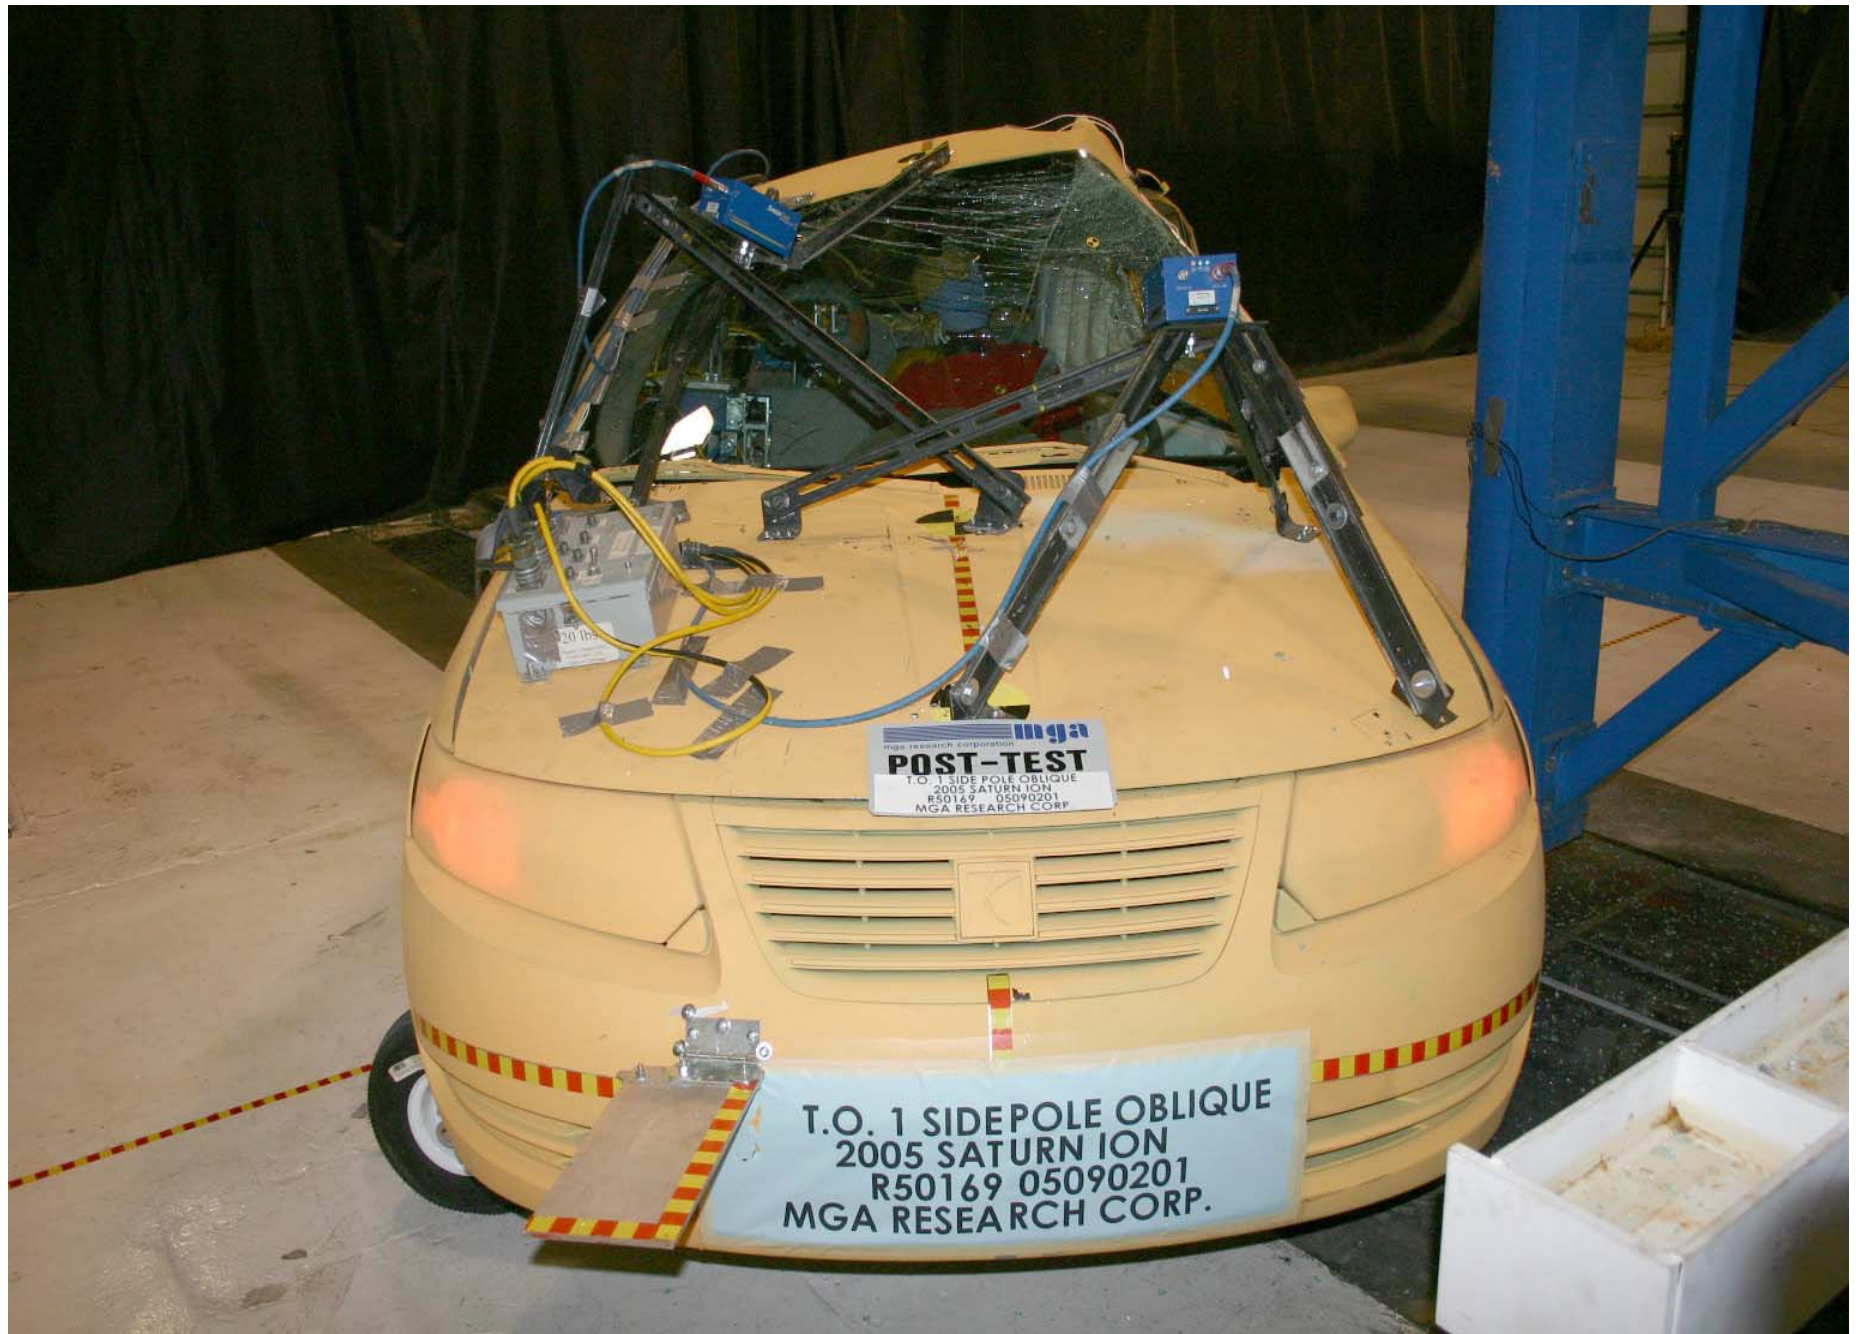
Post-Test Front View of Test Vehicle

| Critical Areas of Performance | Observations and Conclusions |
|---|---|
| Windshield Damage | Windshield Broke |

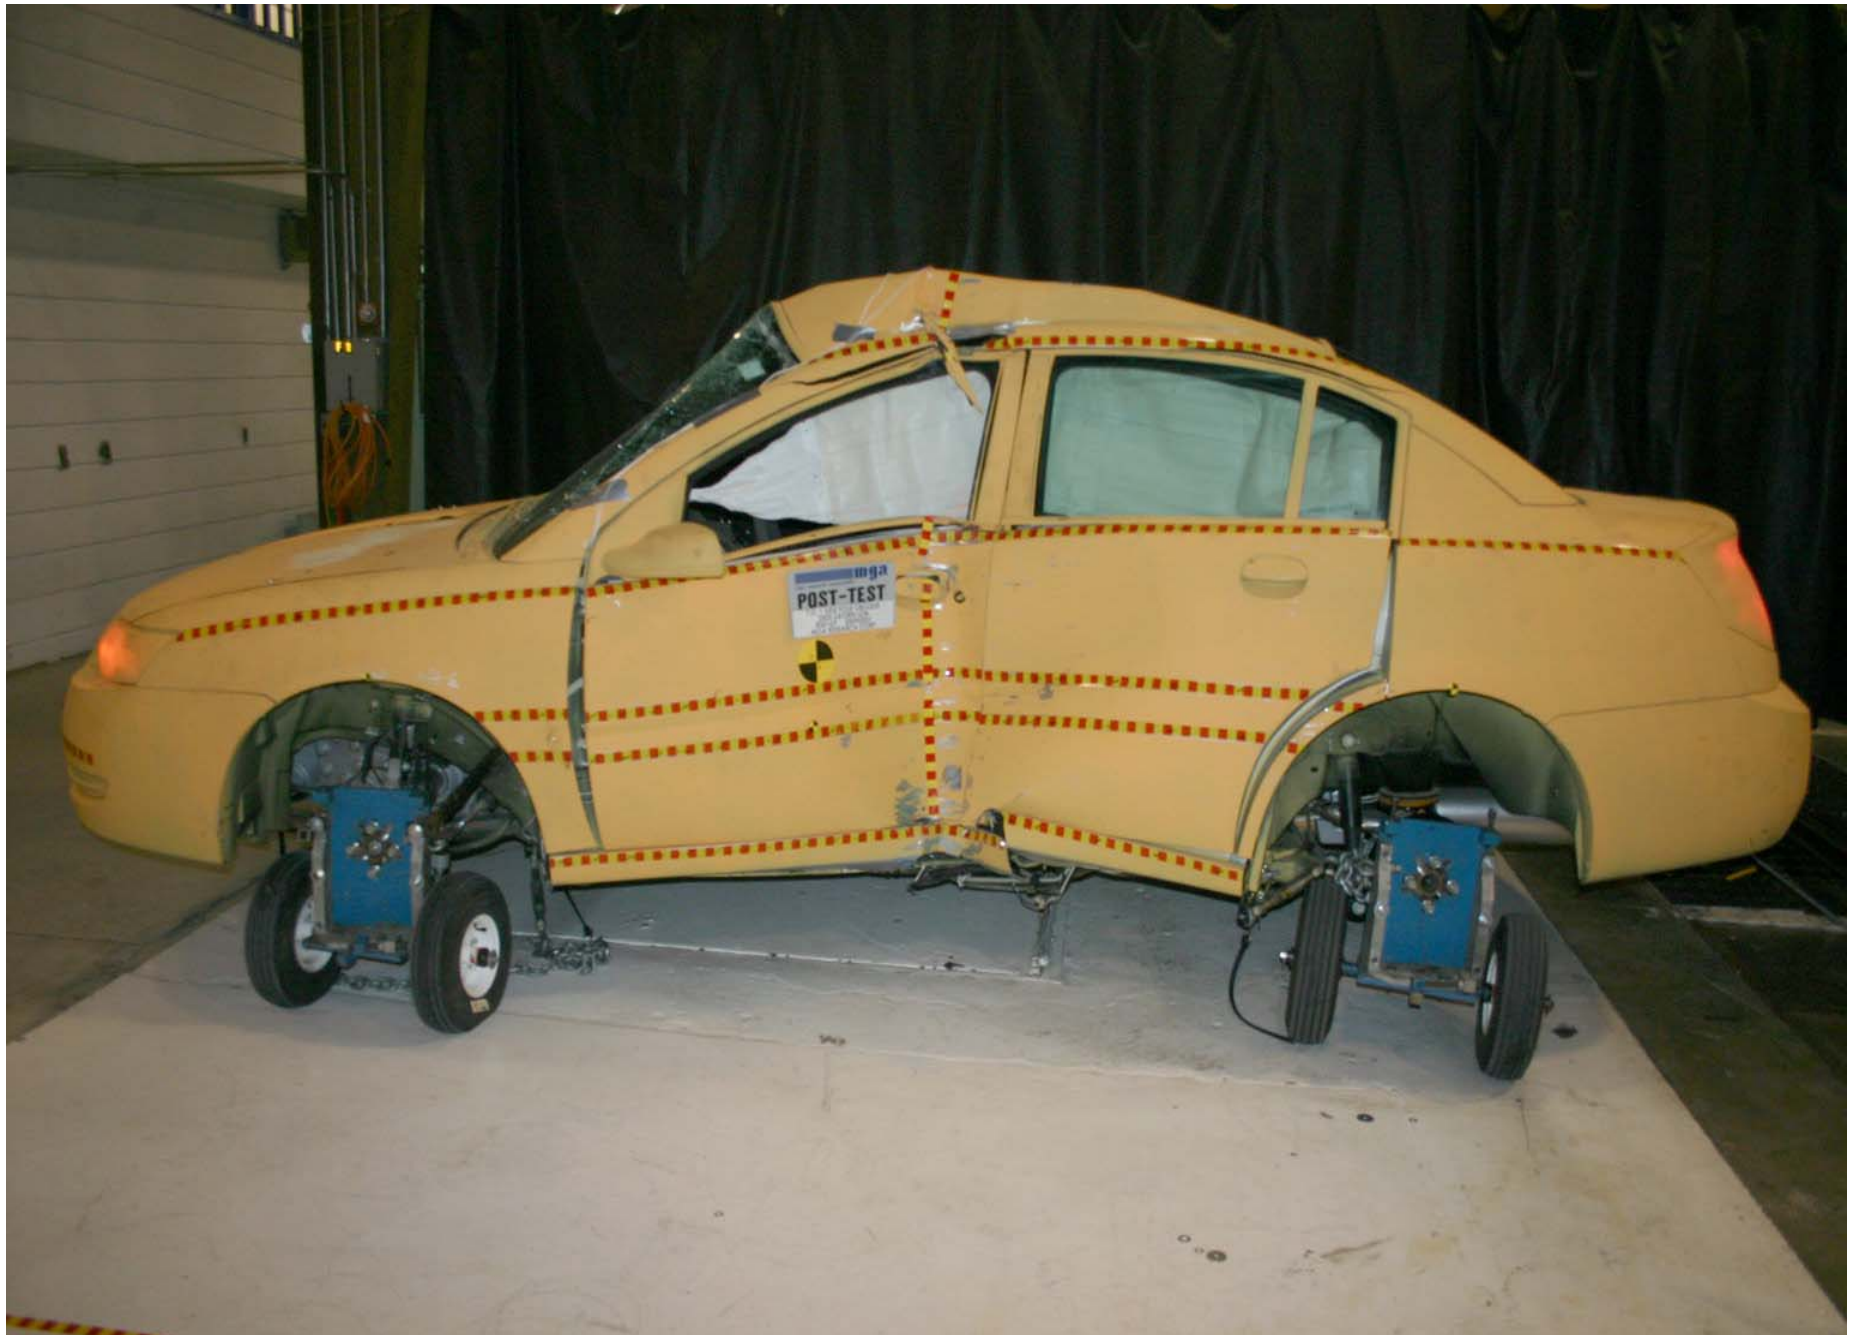
Post-Test Left Side View of Test Vehicle

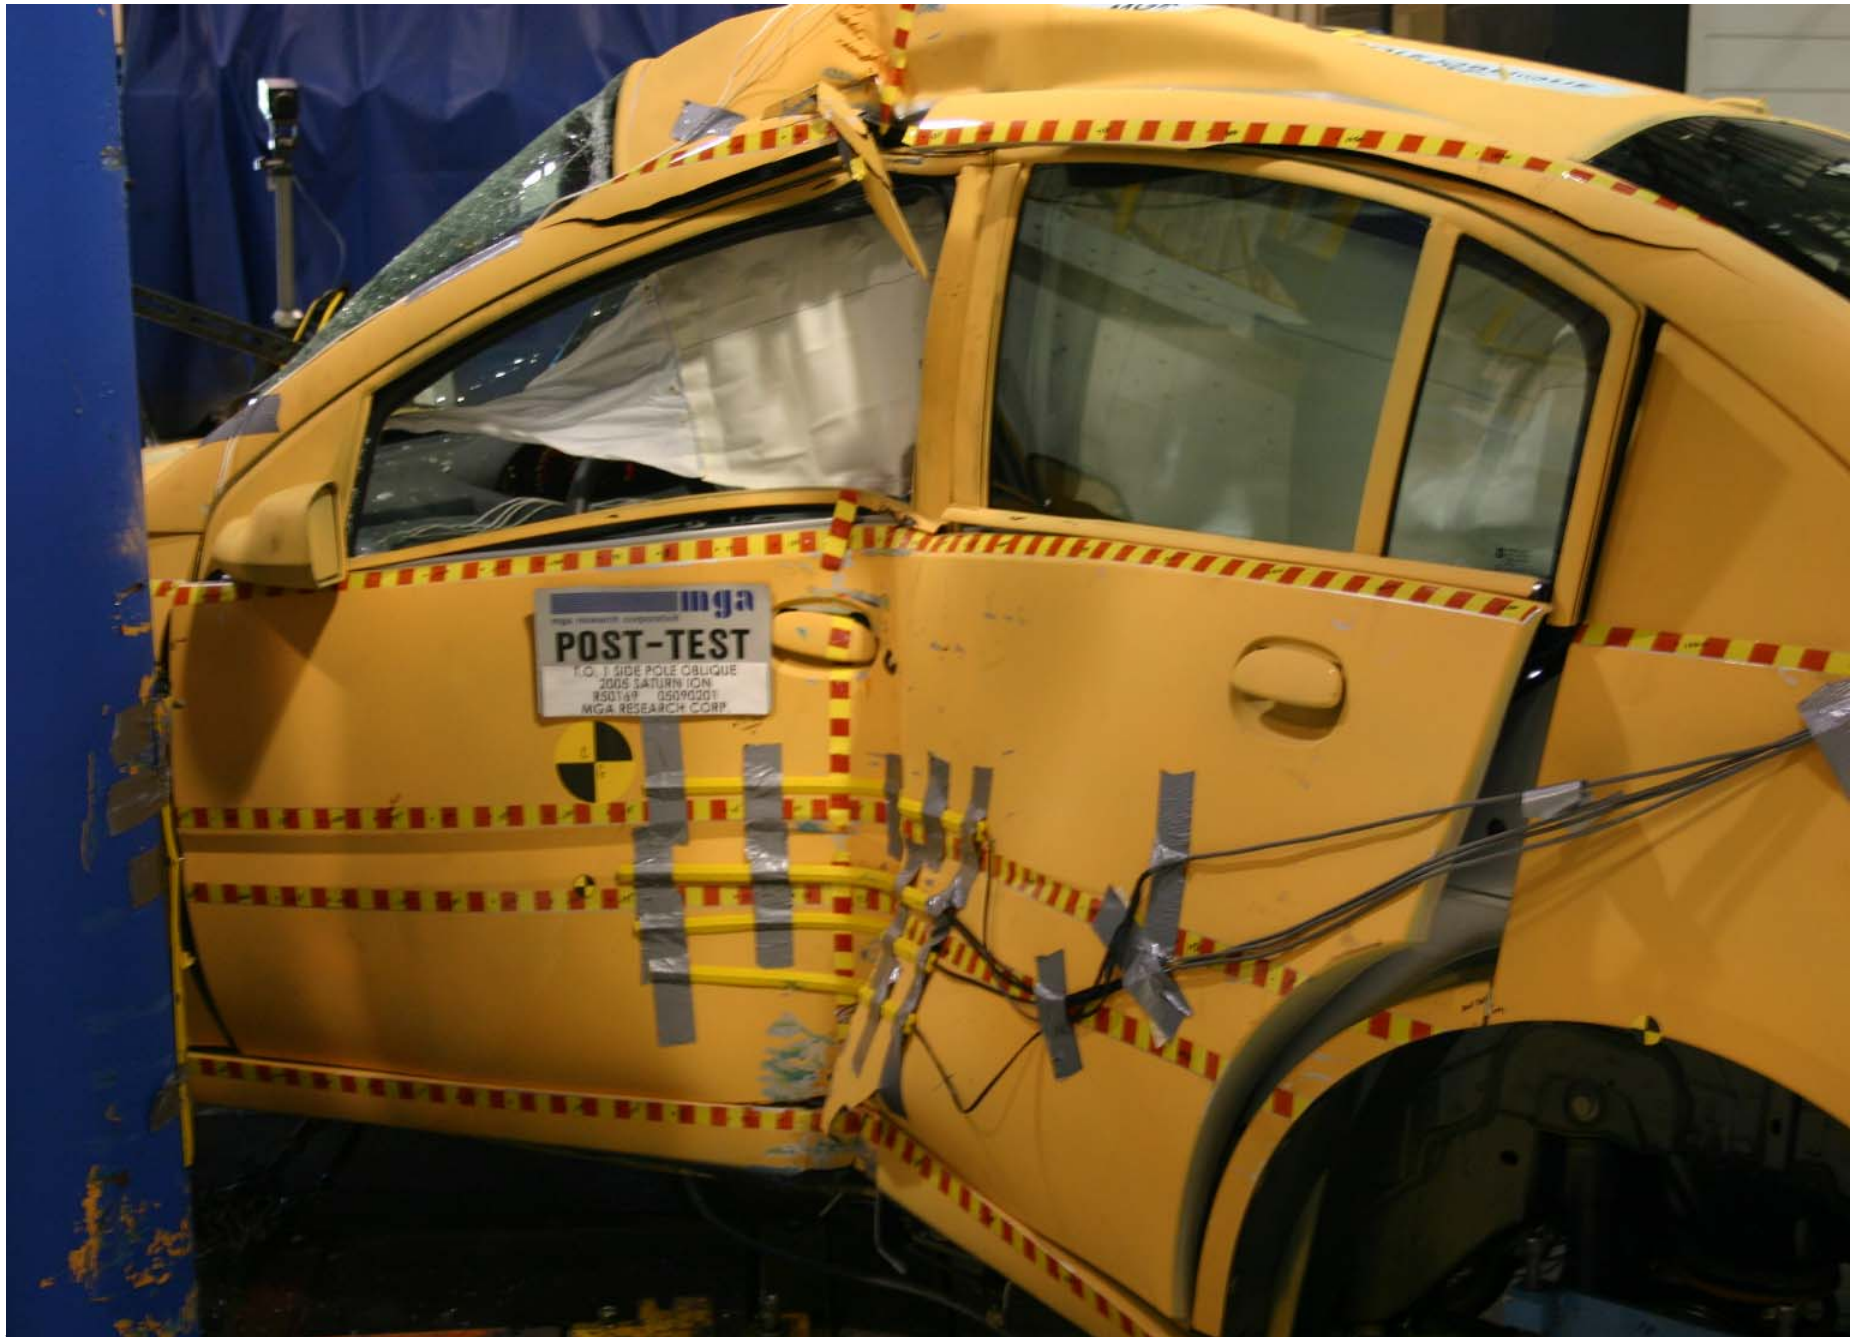
Post-Test Left Side View of Test Vehicle (Close-Up)

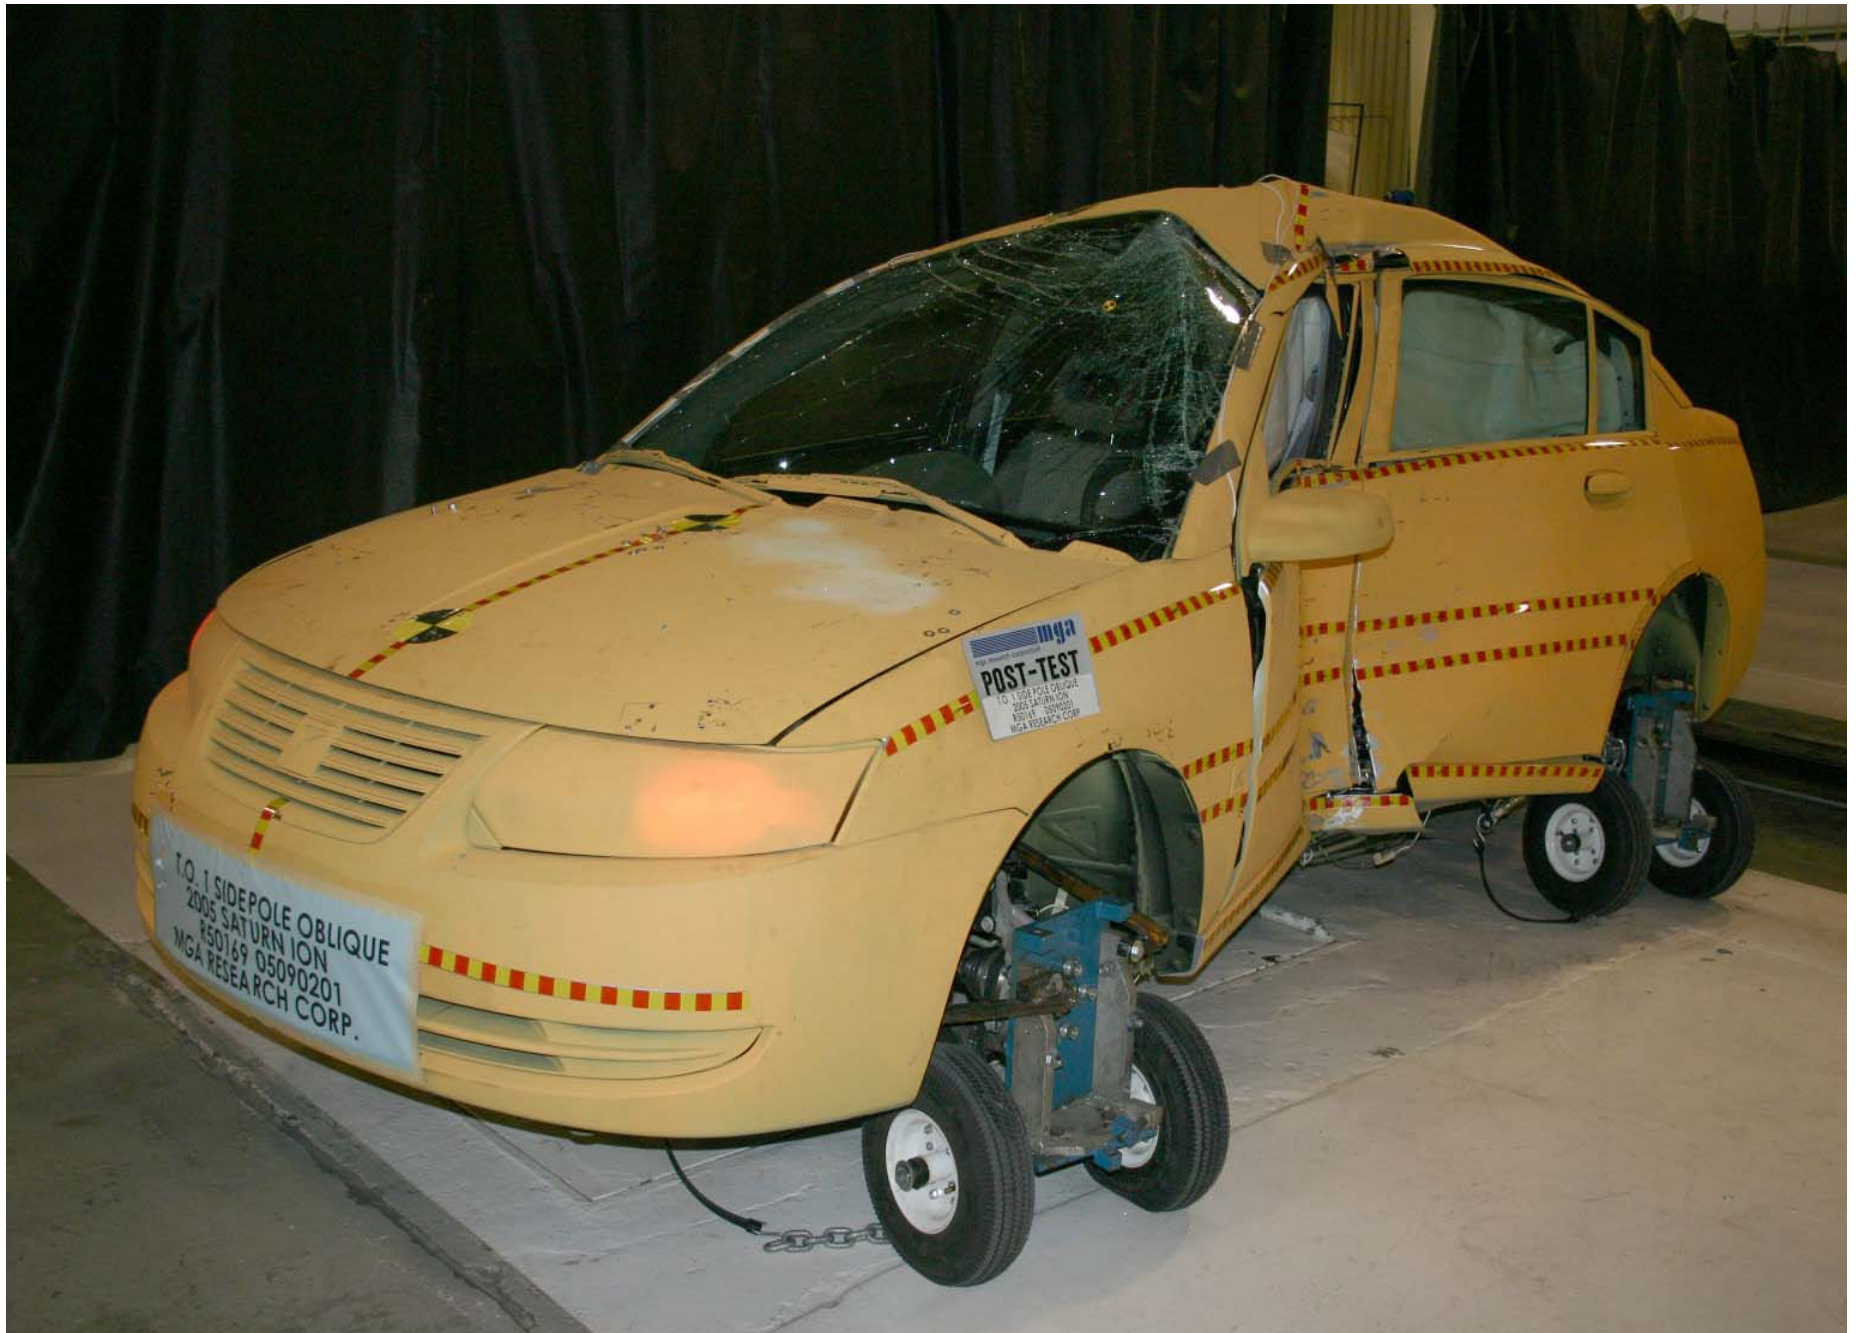
Post-Test Left  $\frac{3}{4}$  Front View of Test Vehicle

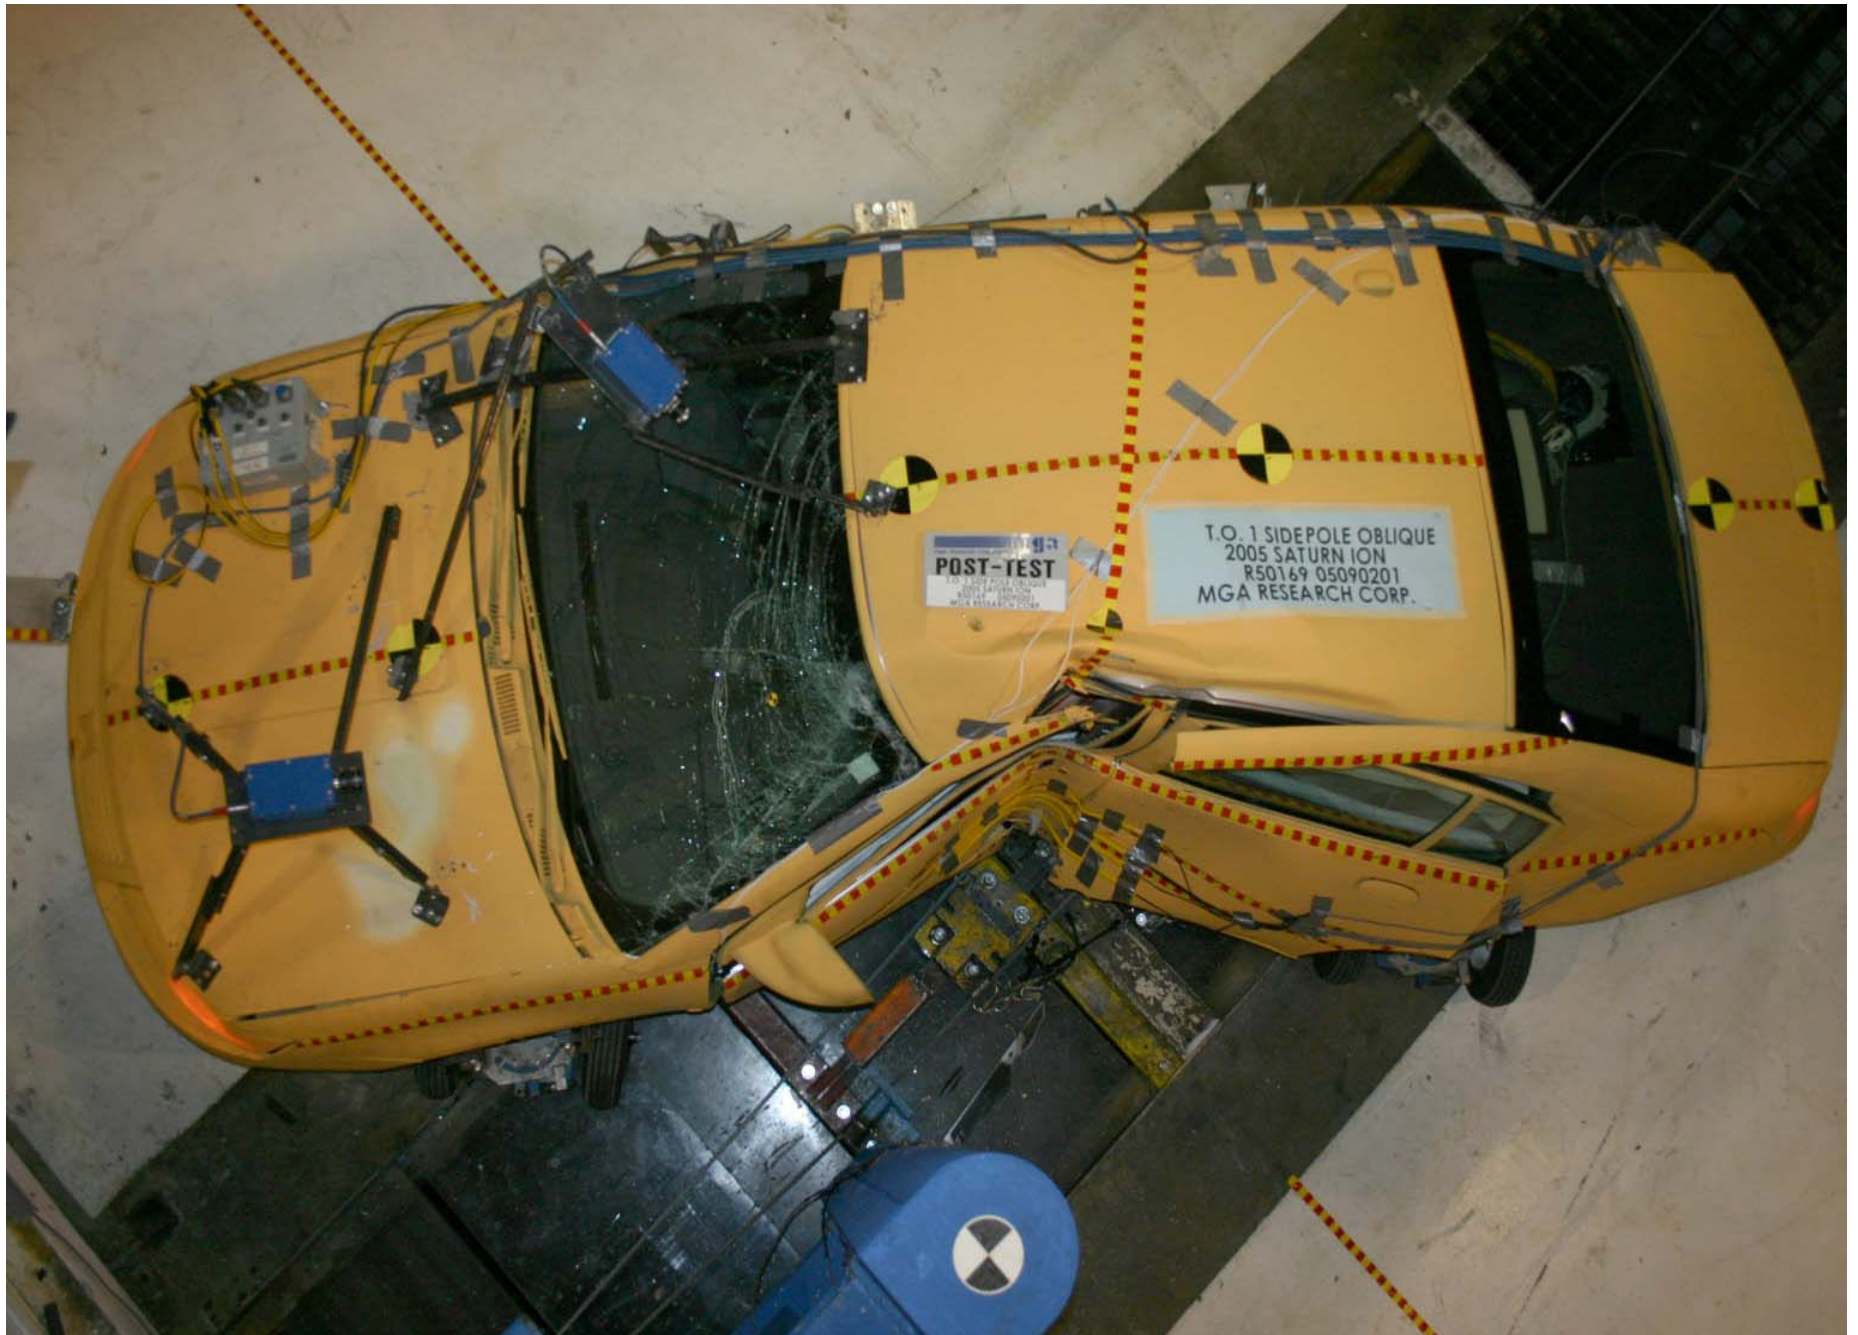
Post-Test Pole and Vehicle Overhead View

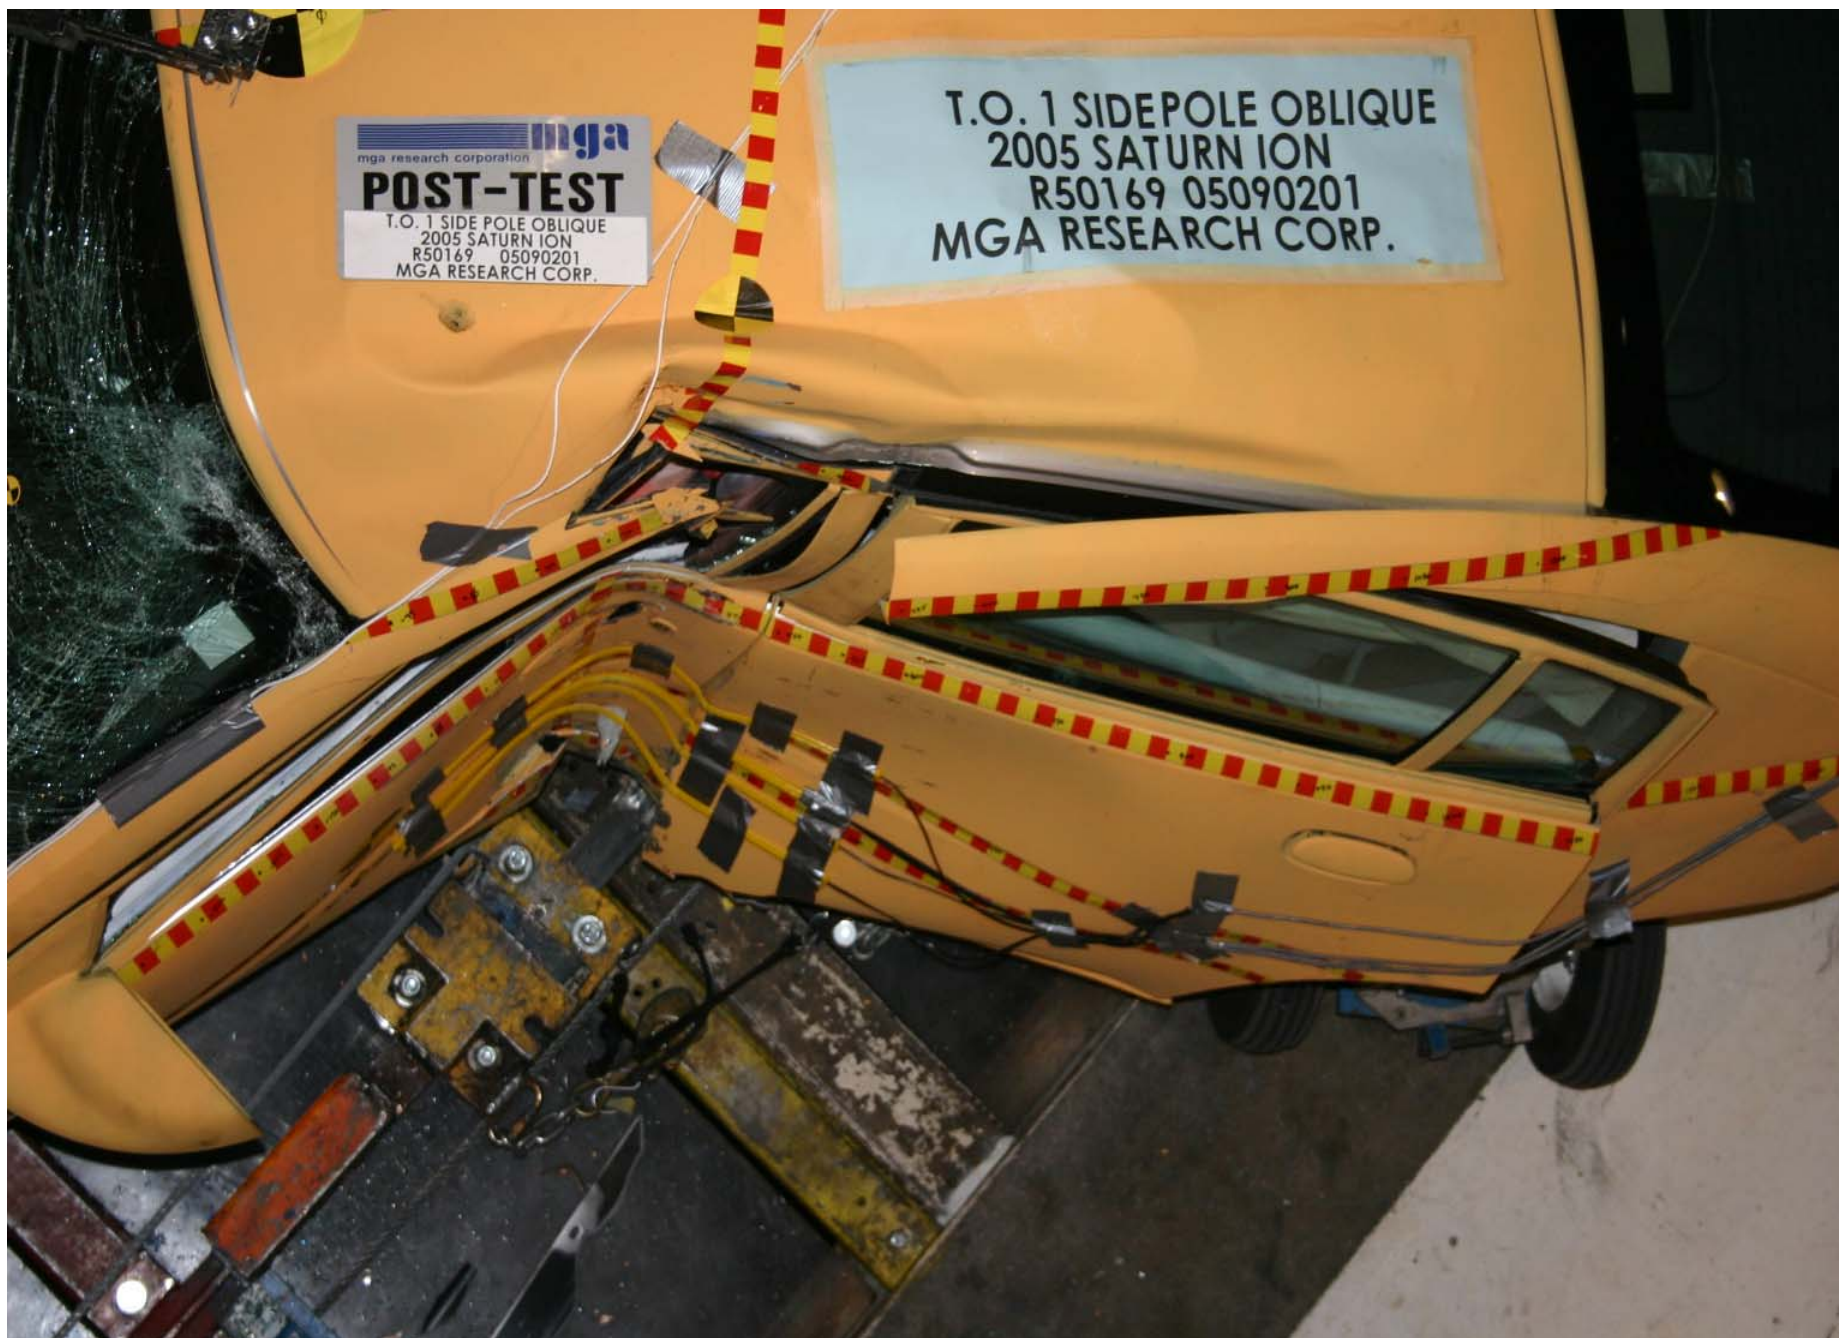
Post-Test Vehicle Overhead View (Close-Up)

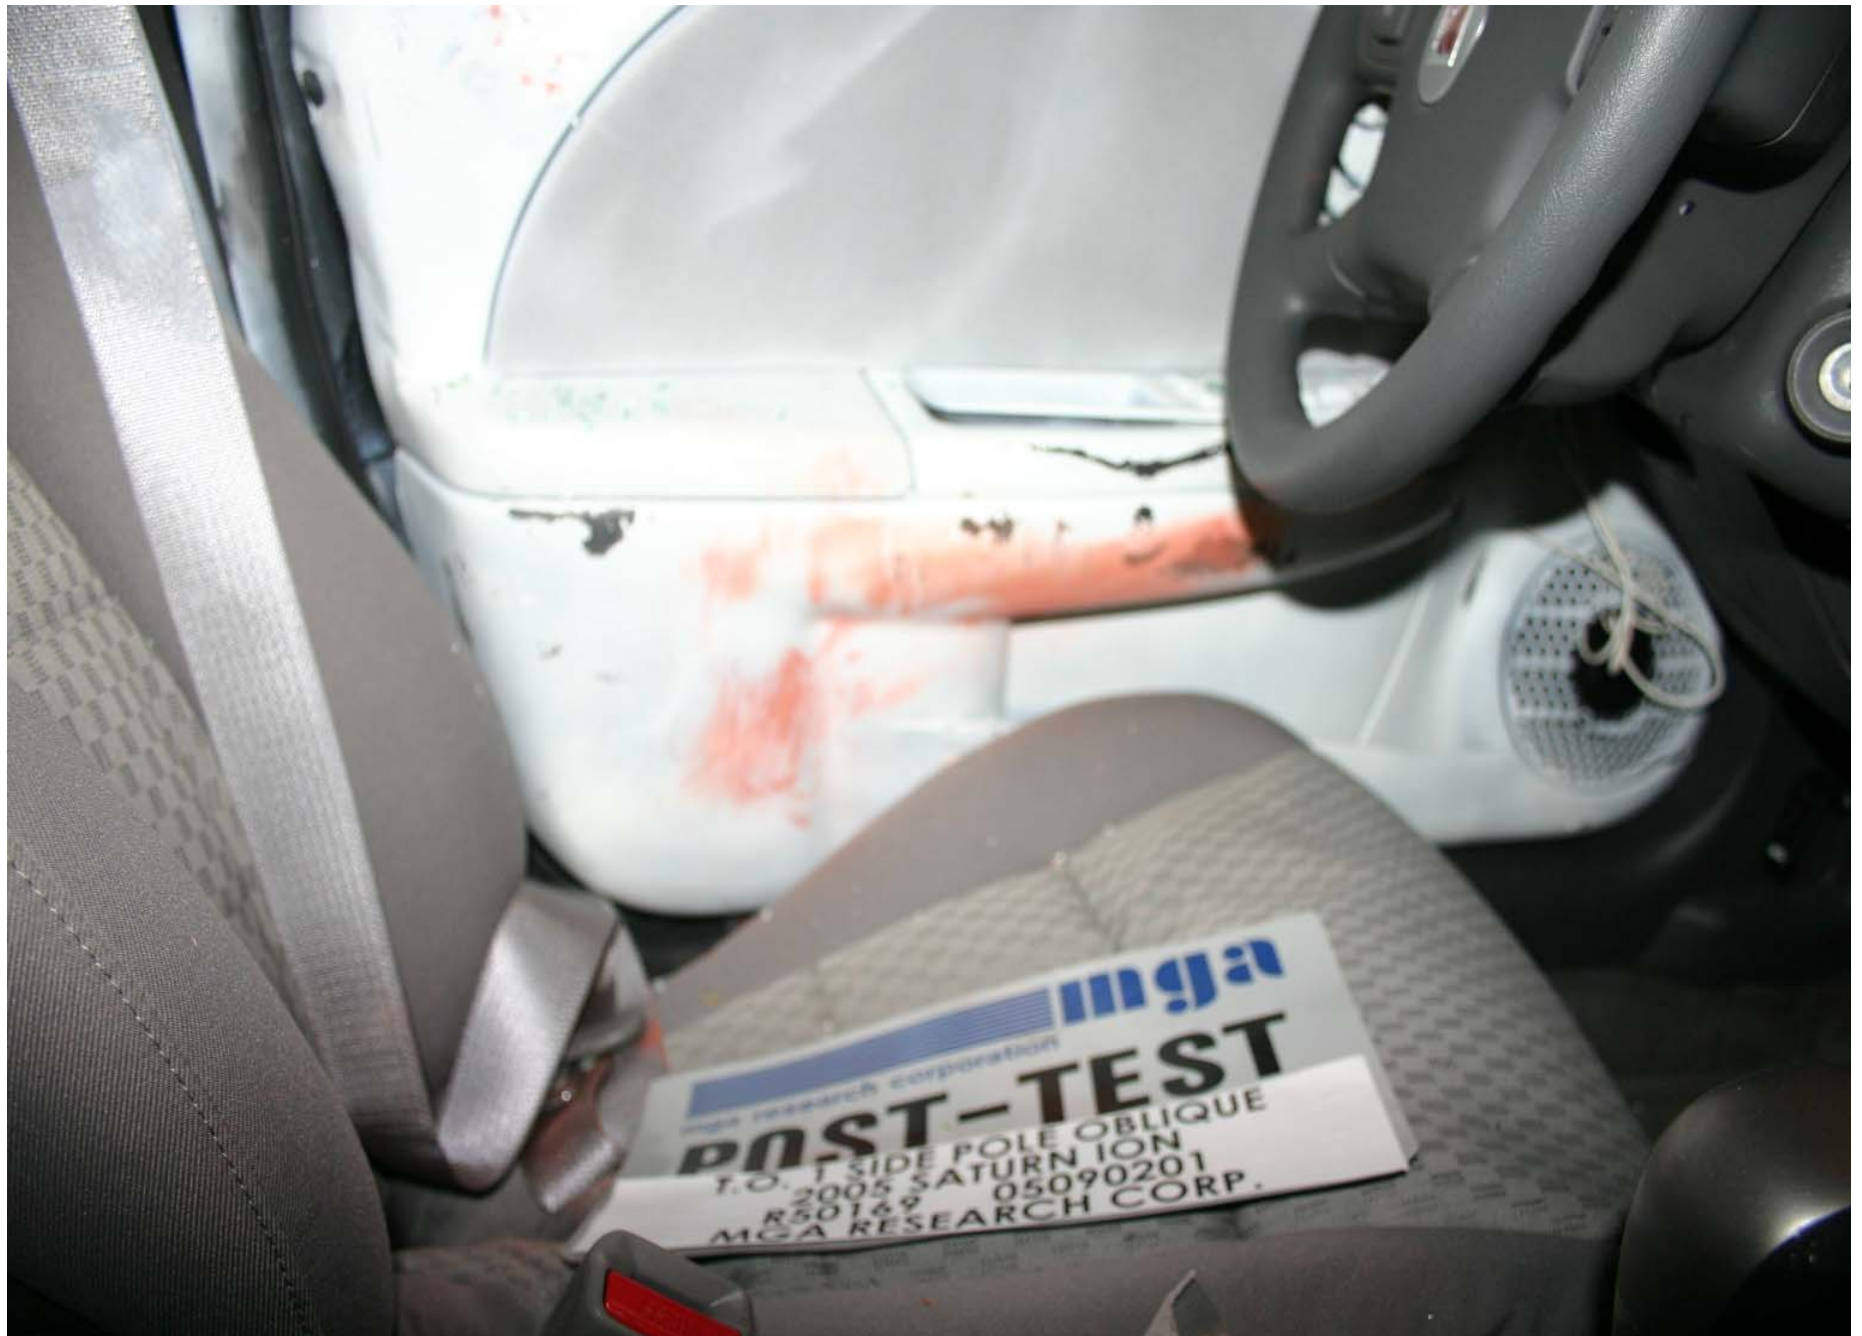
Post-Test Driver Dummy Lower Body Contact

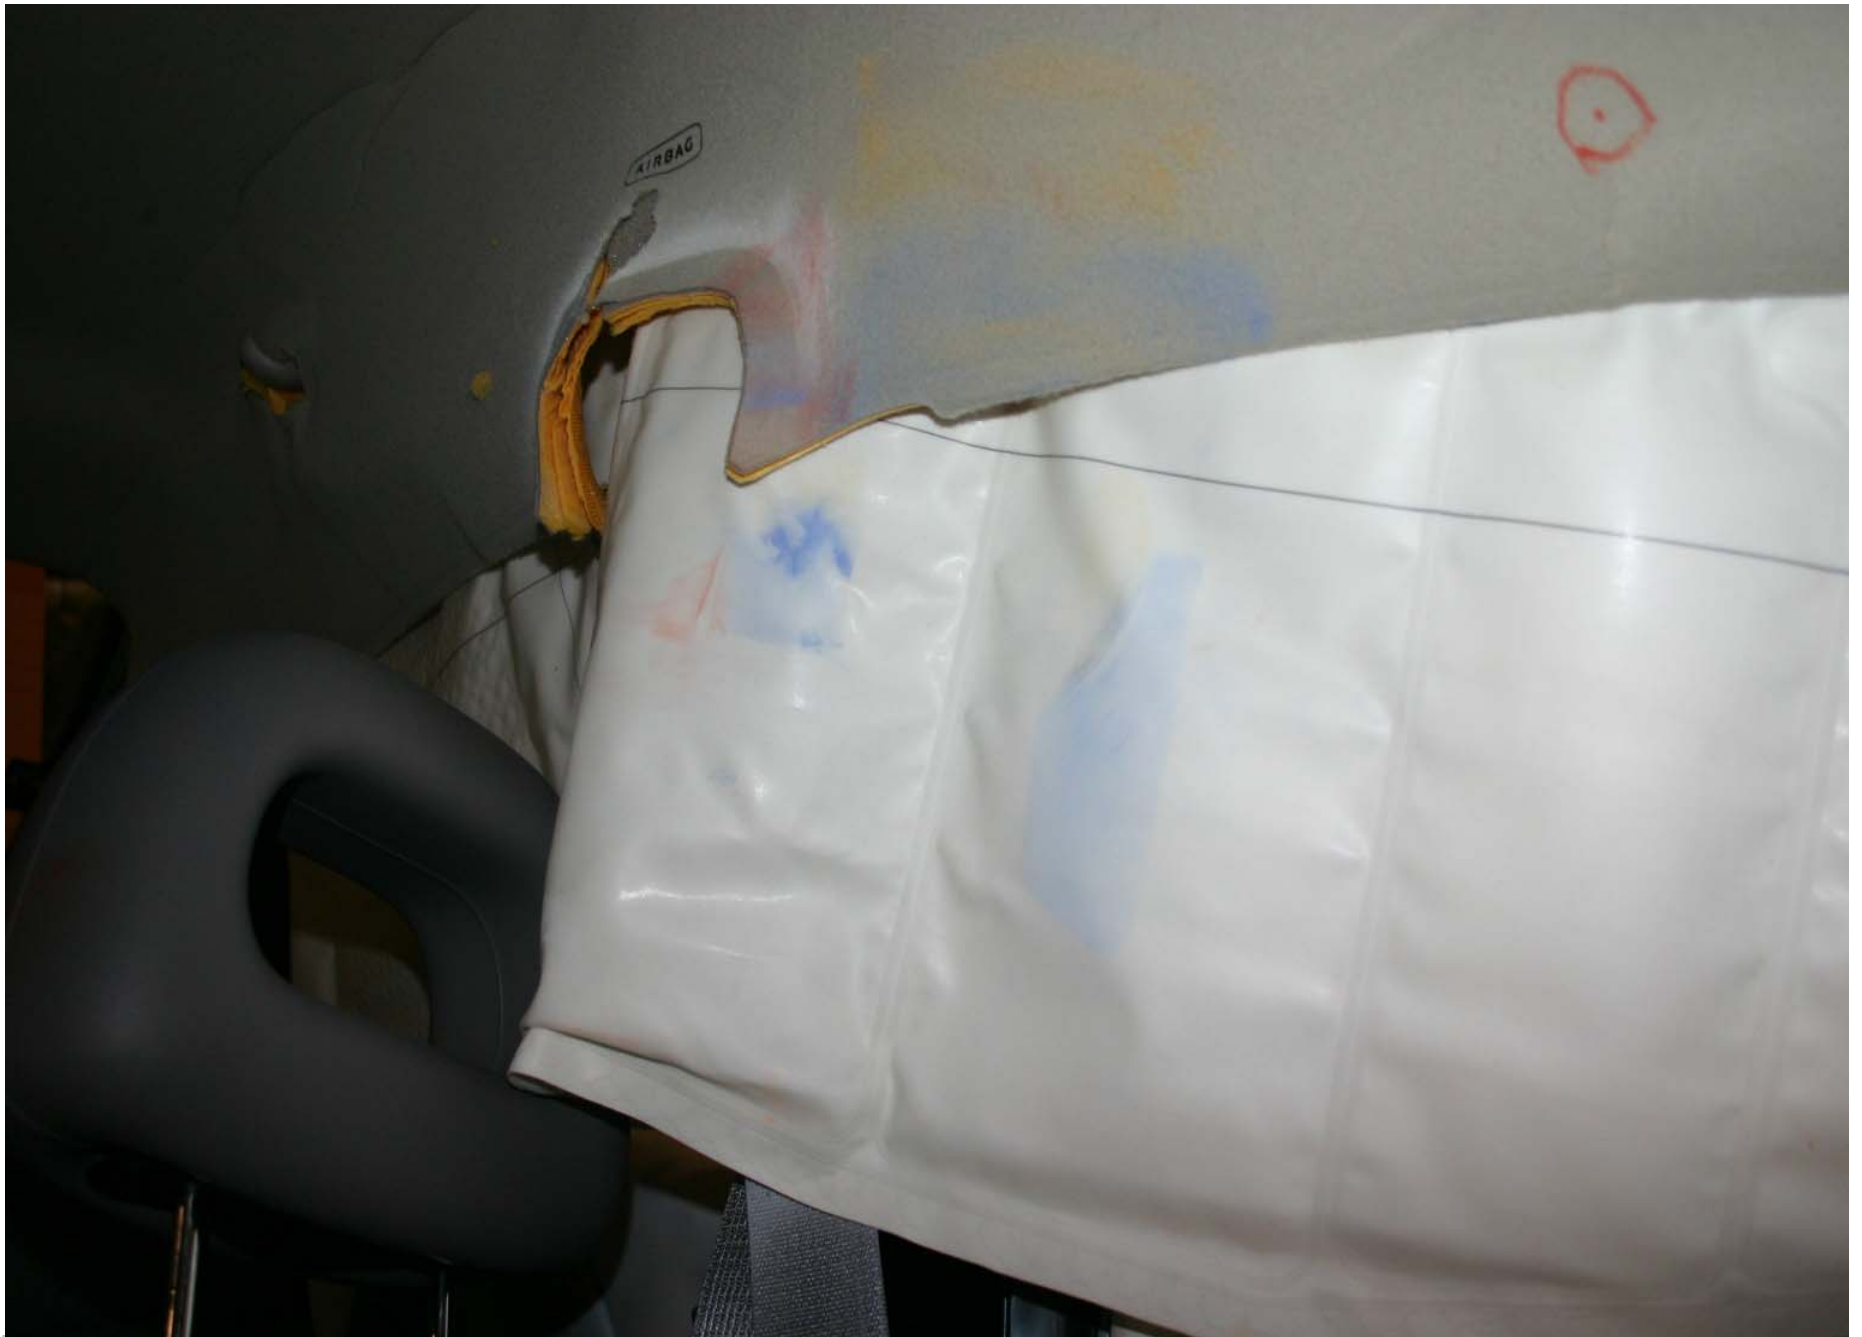
Post-Test Driver Dummy Head Contact

| Description | Left Front |
|---|---|
| Head Contact | Curtain Airbag, Passenger Headrest, Headliner |

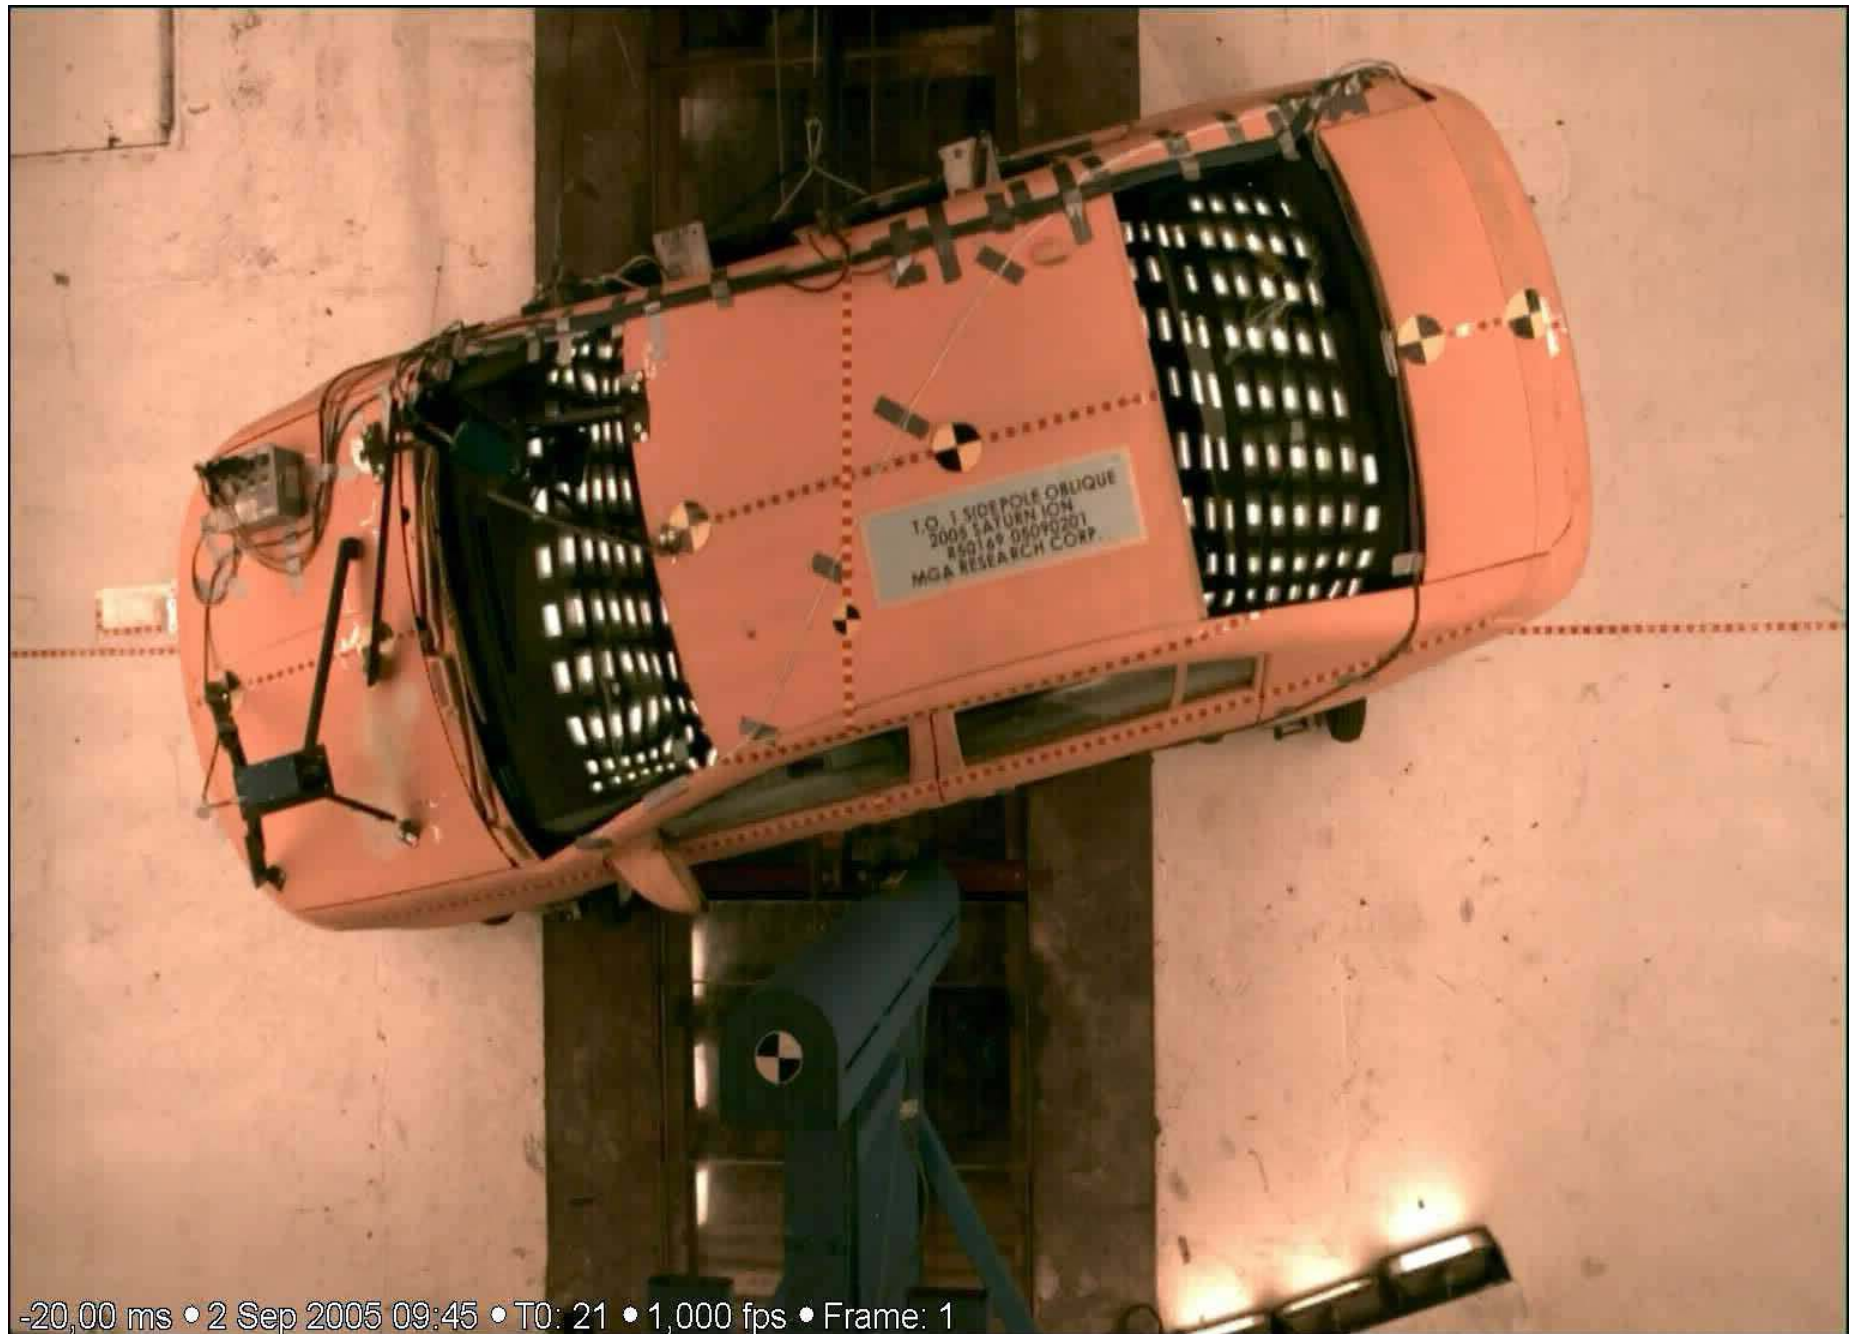
Post-Test Point of Impact View
