**REPORT NUMBER: NCAP-MGA-2006-001**

**NEW CAR ASSESSMENT PROGRAM  
FRONTAL BARRIER IMPACT TEST**

**TOYOTA MOTOR CORPORATION  
2006 TOYOTA SCION XB  
NHTSA NUMBER: M65102**

**PREPARED BY:  
MGA RESEARCH CORPORATION  
5000 WARREN ROAD  
BURLINGTON, WI 53105**

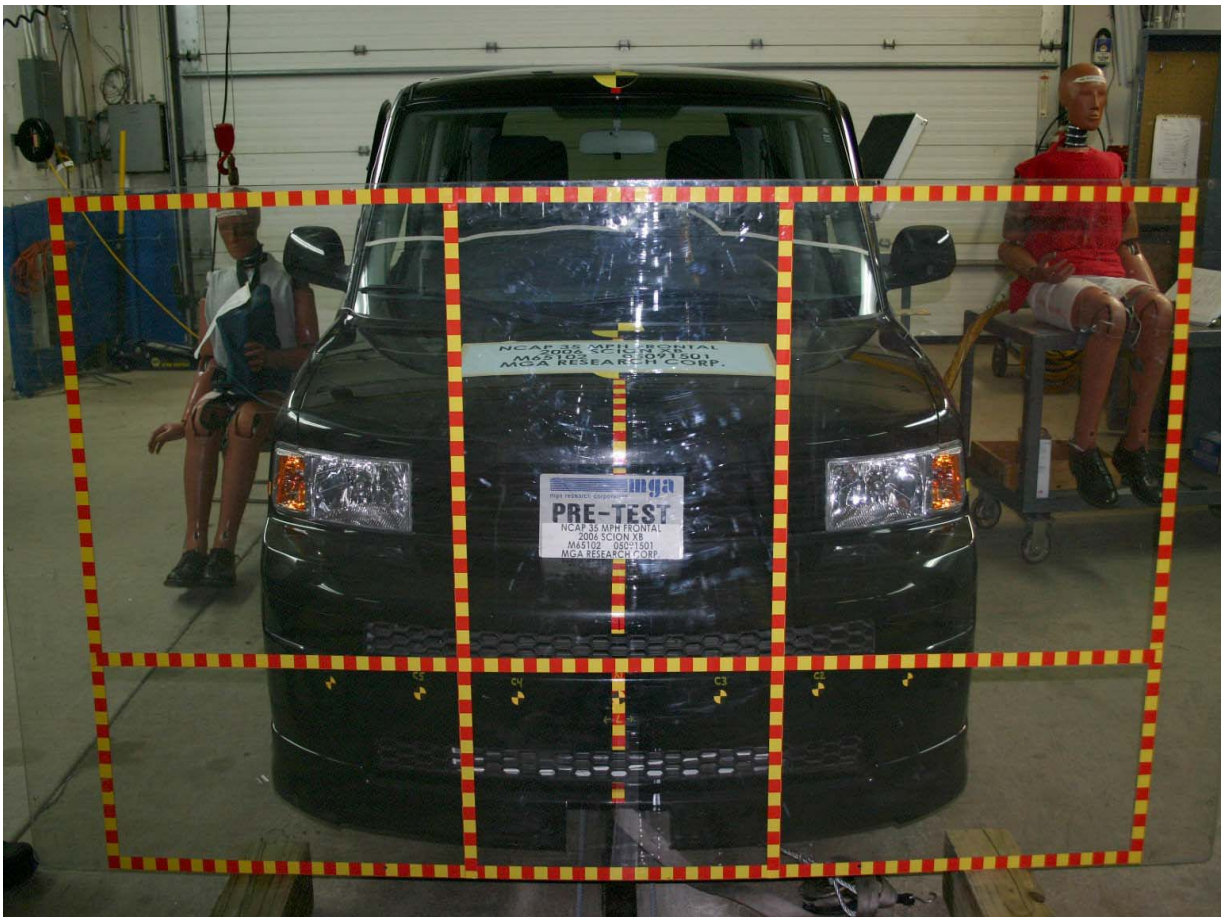
Load Cell Location

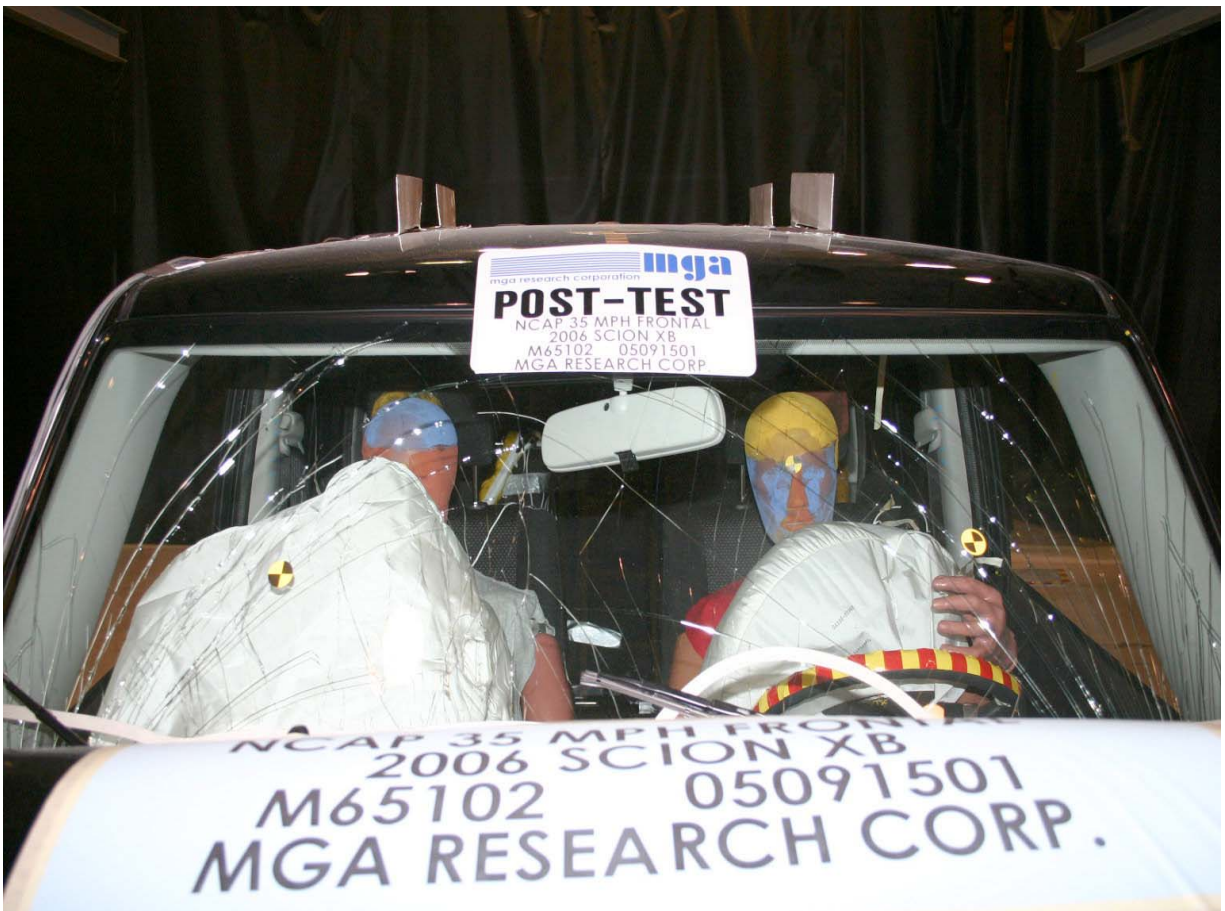
Post-Test Windshield View

There was 100 percent windshield retention and no intrusion into the protected zone of the windshield during the event. There was no Stoddard Solvent leakage after the event or during any phase of the static rollover.

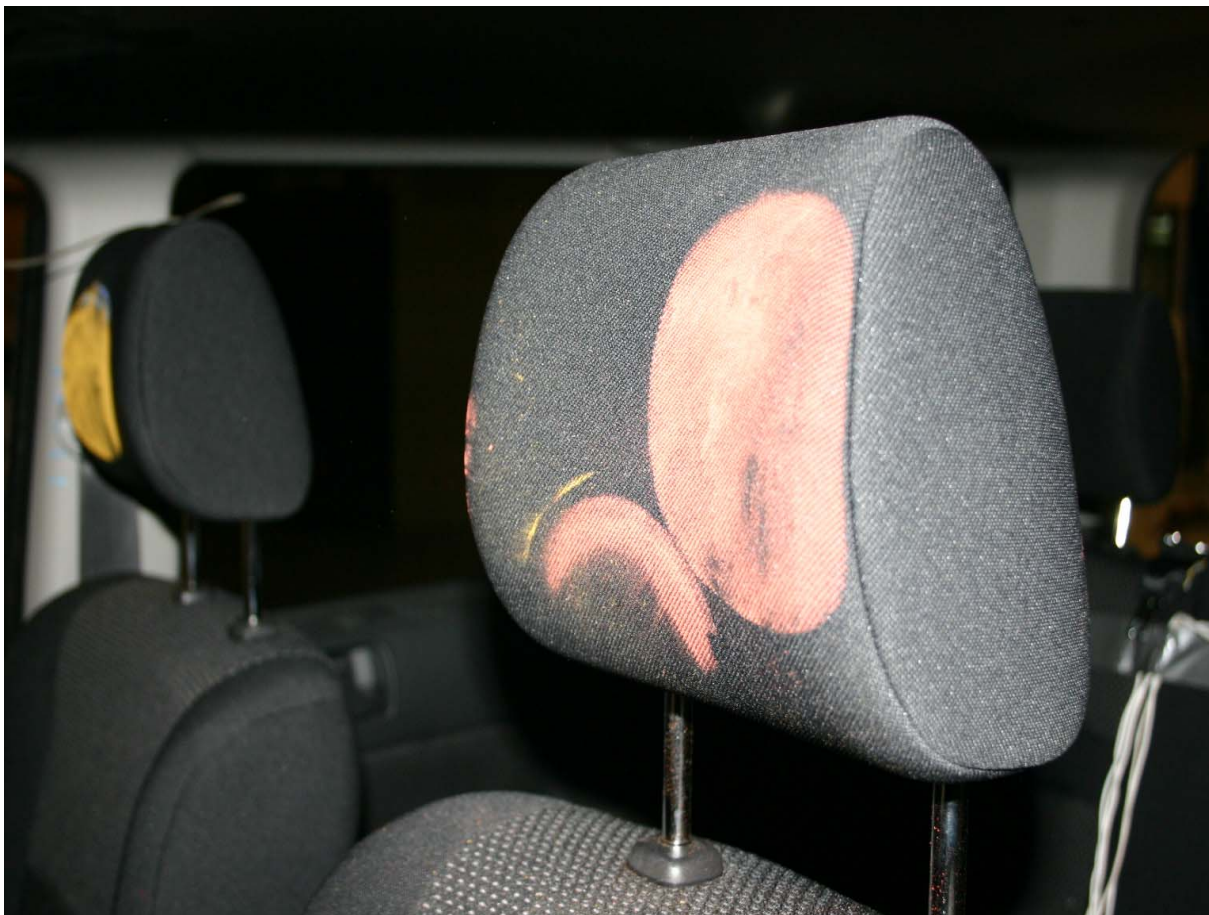
Post-Test Driver Dummy Head Contact

The driver's head, chest, and abdomen contacted the airbag. The driver's head also contacted the headrest. The driver's knees contacted the bolster. The passenger's head and chest contacted the airbag. The passenger's head also contacted the headrest. The passenger's knees contacted the glove box.

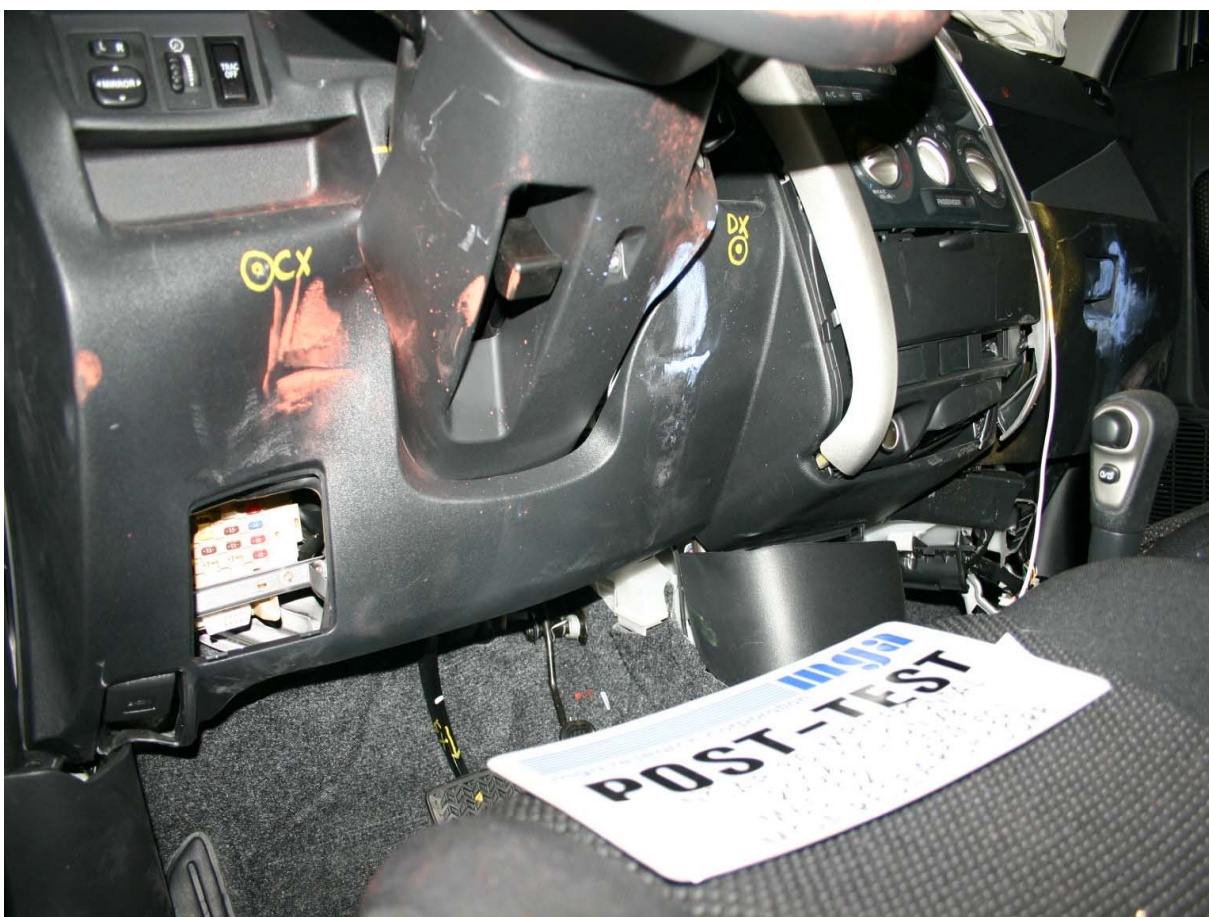
Post-Test Driver Dummy Knee Contact

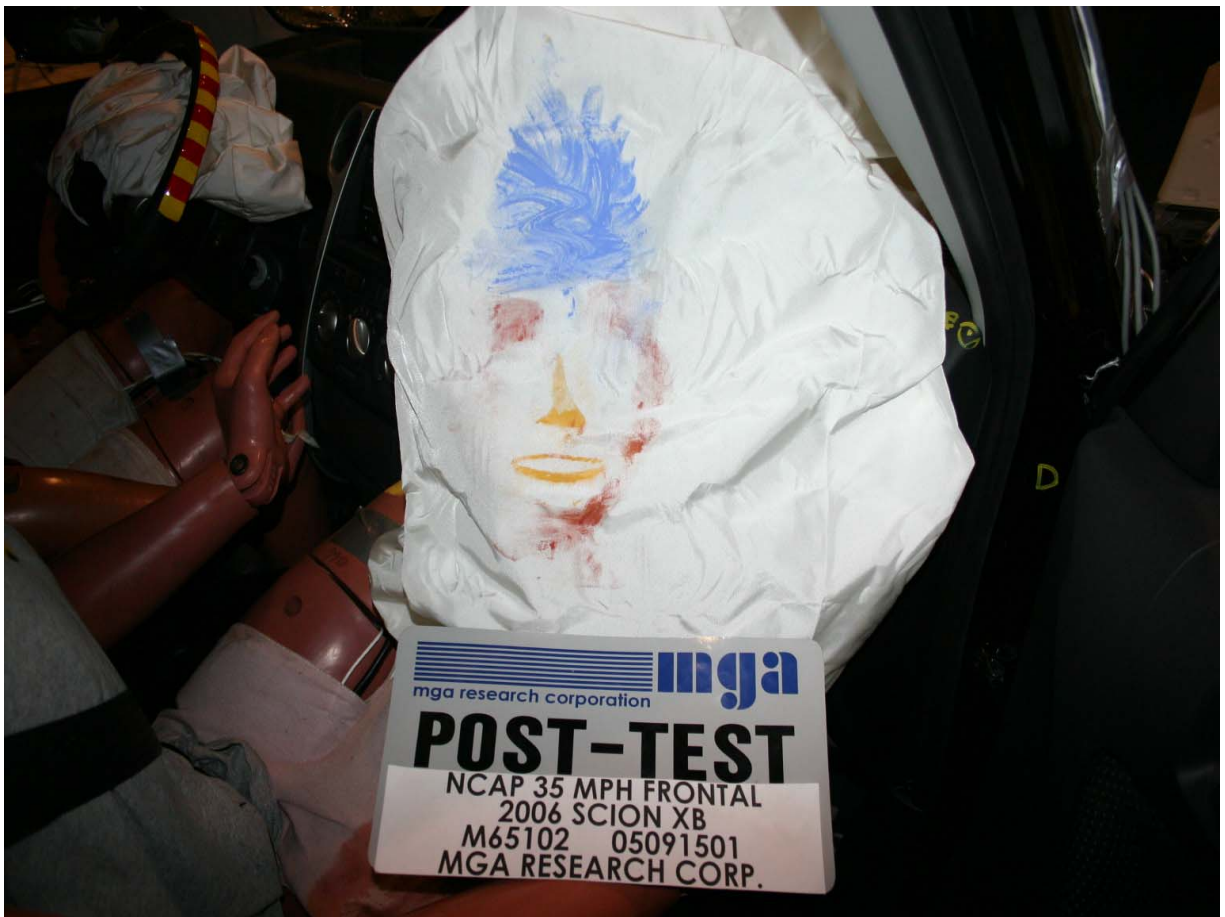
Post-Test Driver Dummy Airbag Contact

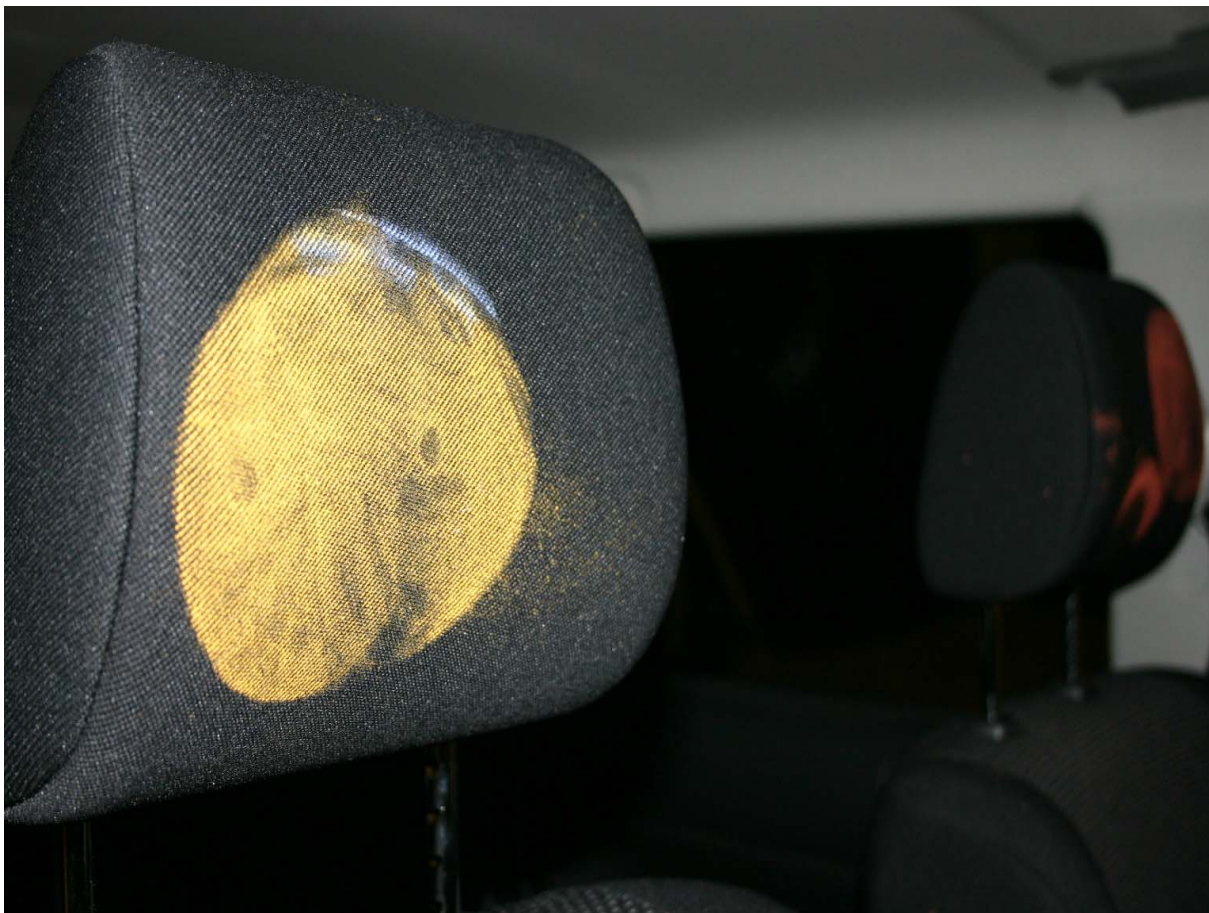
Post-Test Passenger Dummy Head Contact

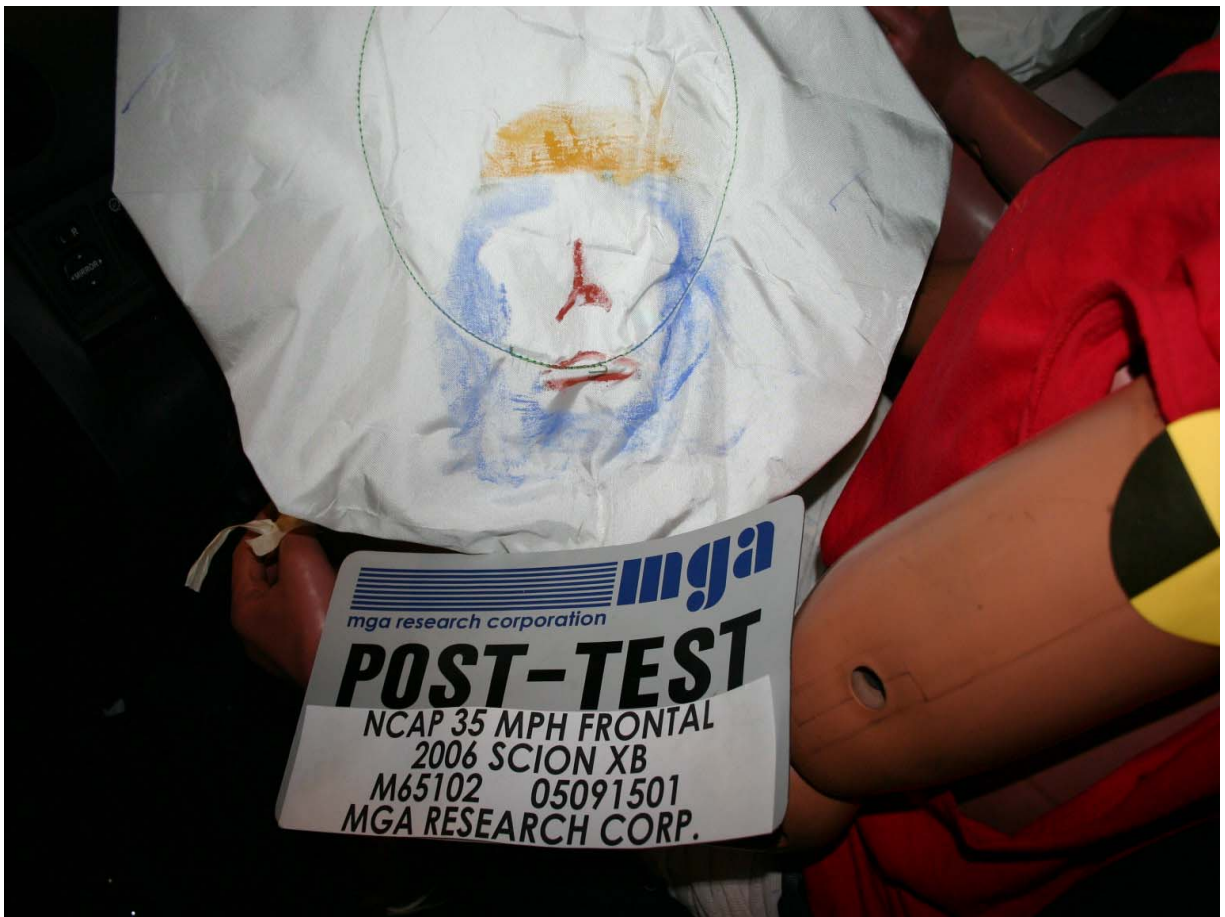
Post-Test Passenger Dummy Airbag Contact

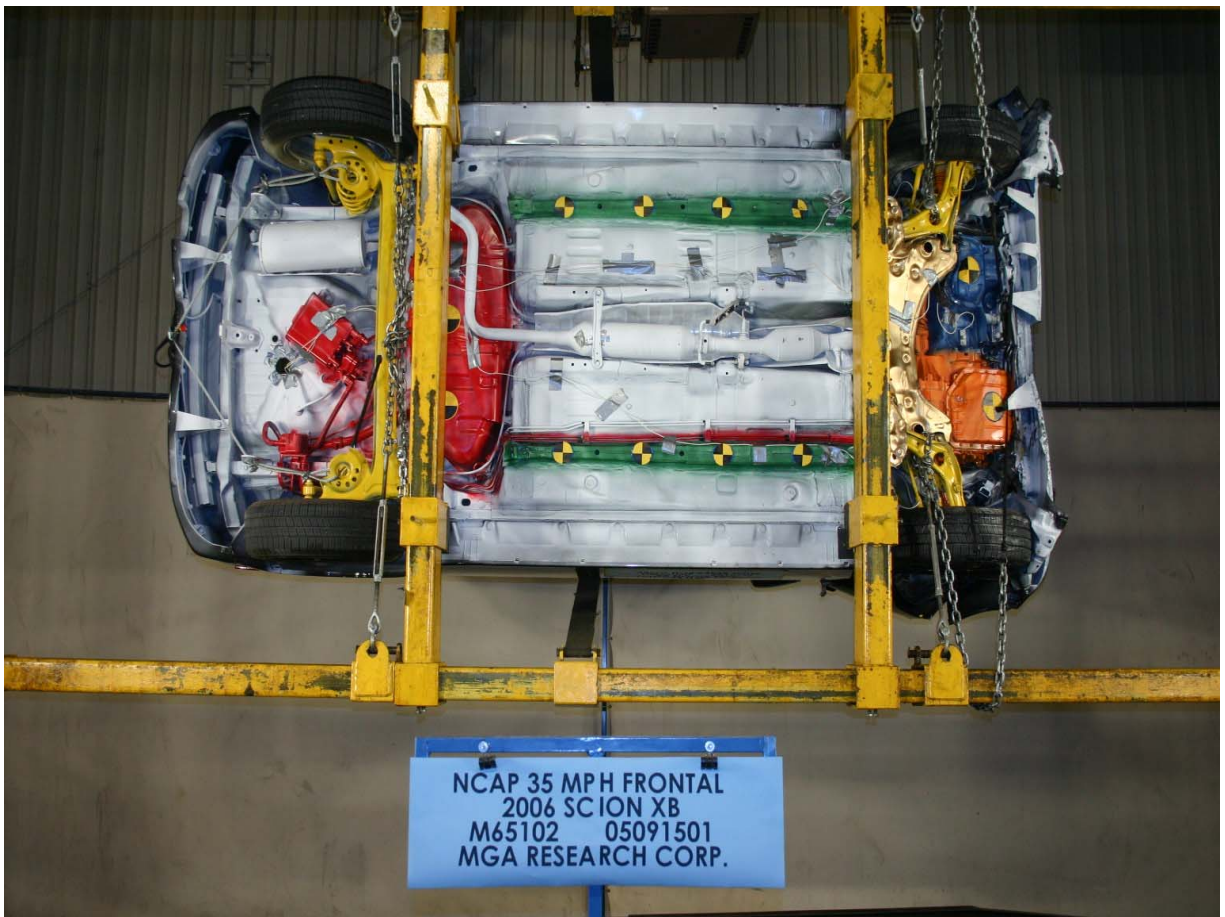
Vehicle on Rollover Device at 90 Degrees

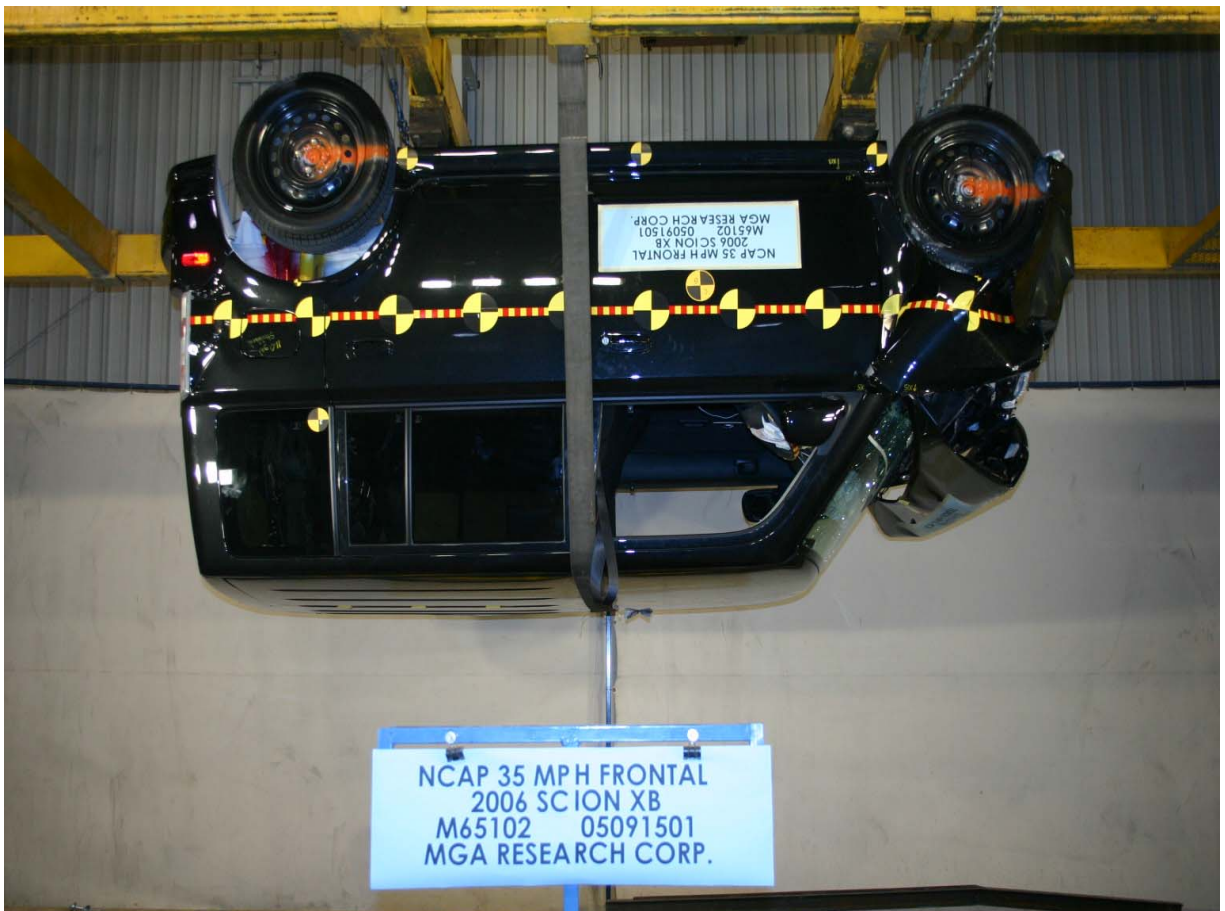
Vehicle on Rollover Device at 180 Degrees

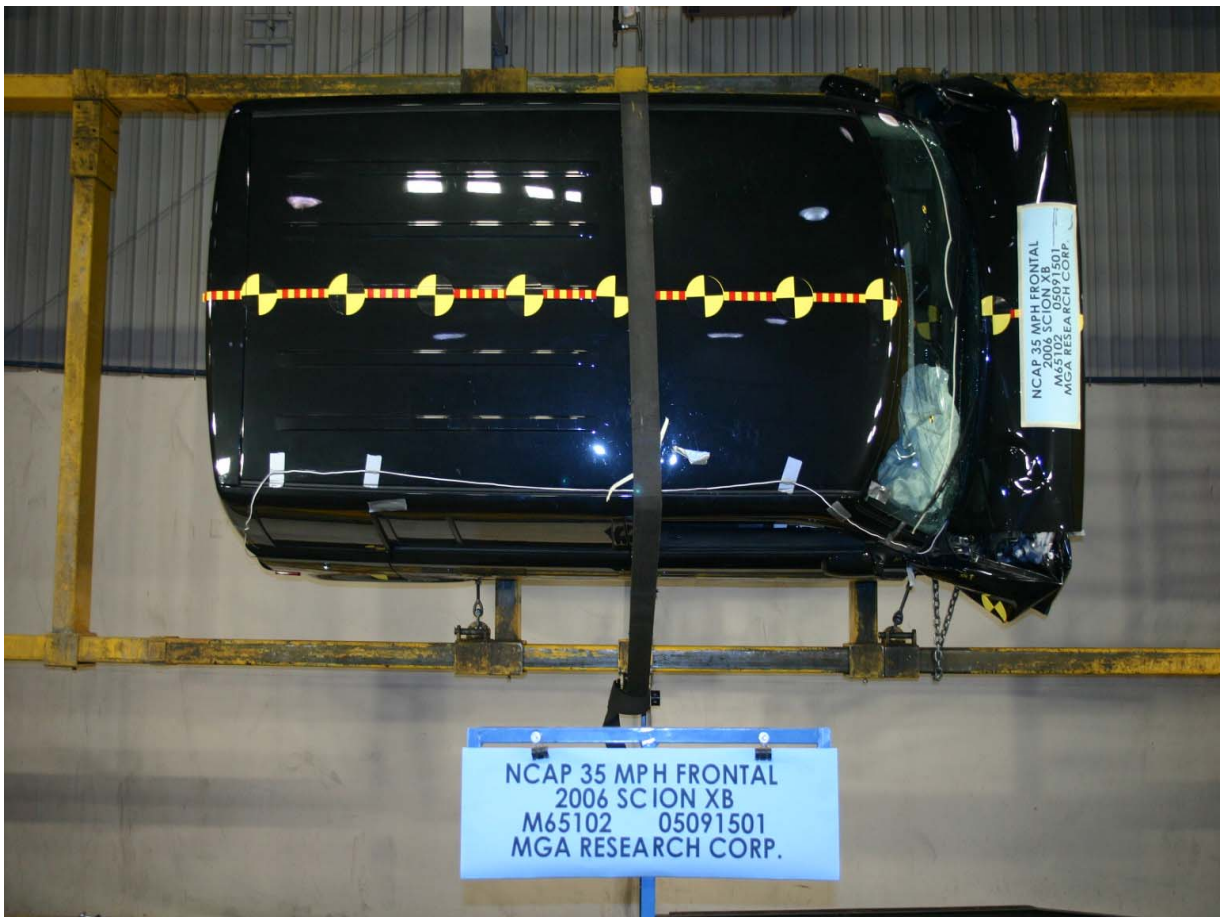
Vehicle on Rollover Device at 270 Degrees

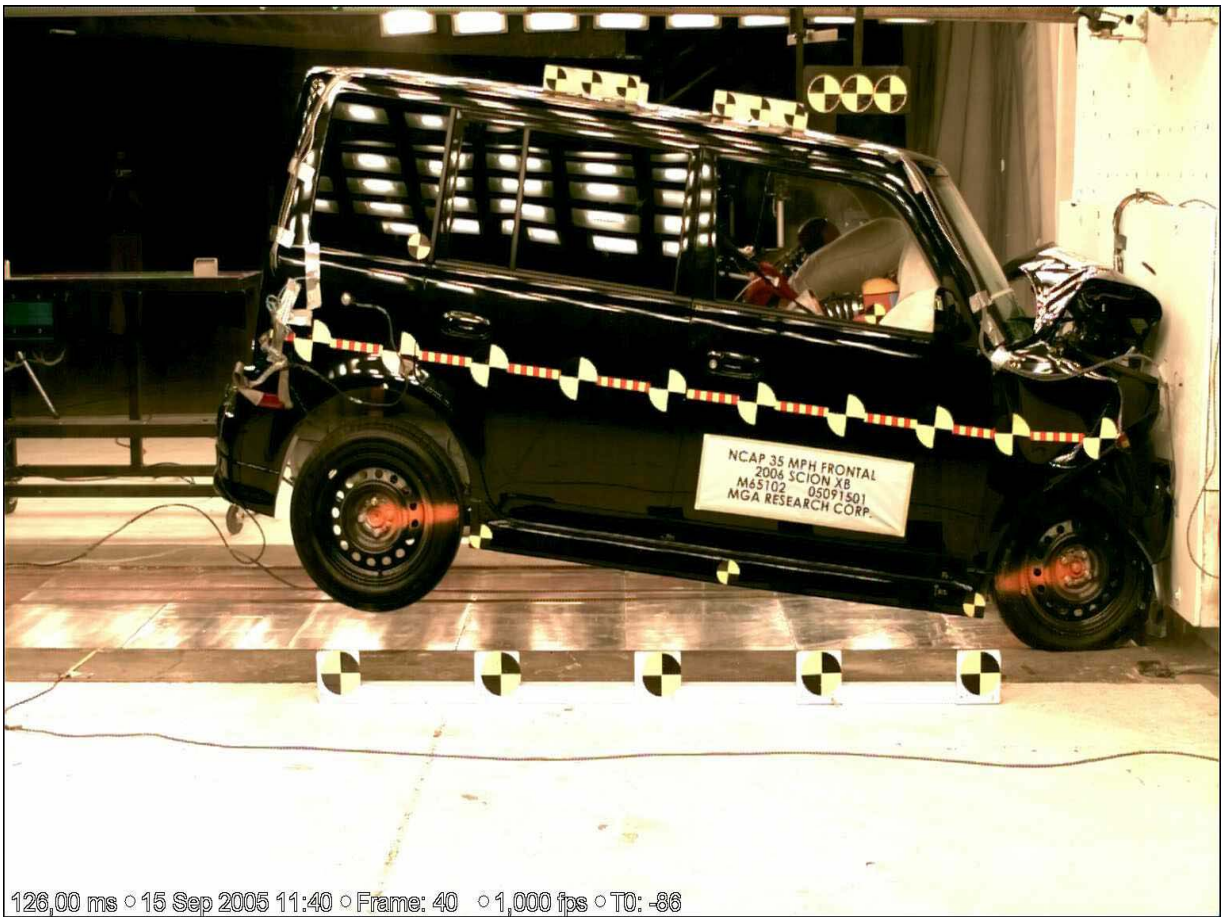
Vehicle Impact

A load cell barrier was impacted by a 2006 Toyota Scion XB at a velocity of 56.3 kph. The test was performed at MGA Research Corporation on September 15, 2005. Pre-and post-test photographs of the vehicle and dummies can be found in Appendix A.
