**REPORT NUMBER: NCAPSIDE-MGA-2006-003**

**NEW CAR ASSESSMENT PROGRAM  
SIDE IMPACT TEST**

**VOLKSWAGEN AG GERMANY  
2006 VOLKSWAGEN PASSAT  
NHTSA NUMBER: M65801**

**FINAL REPORT**

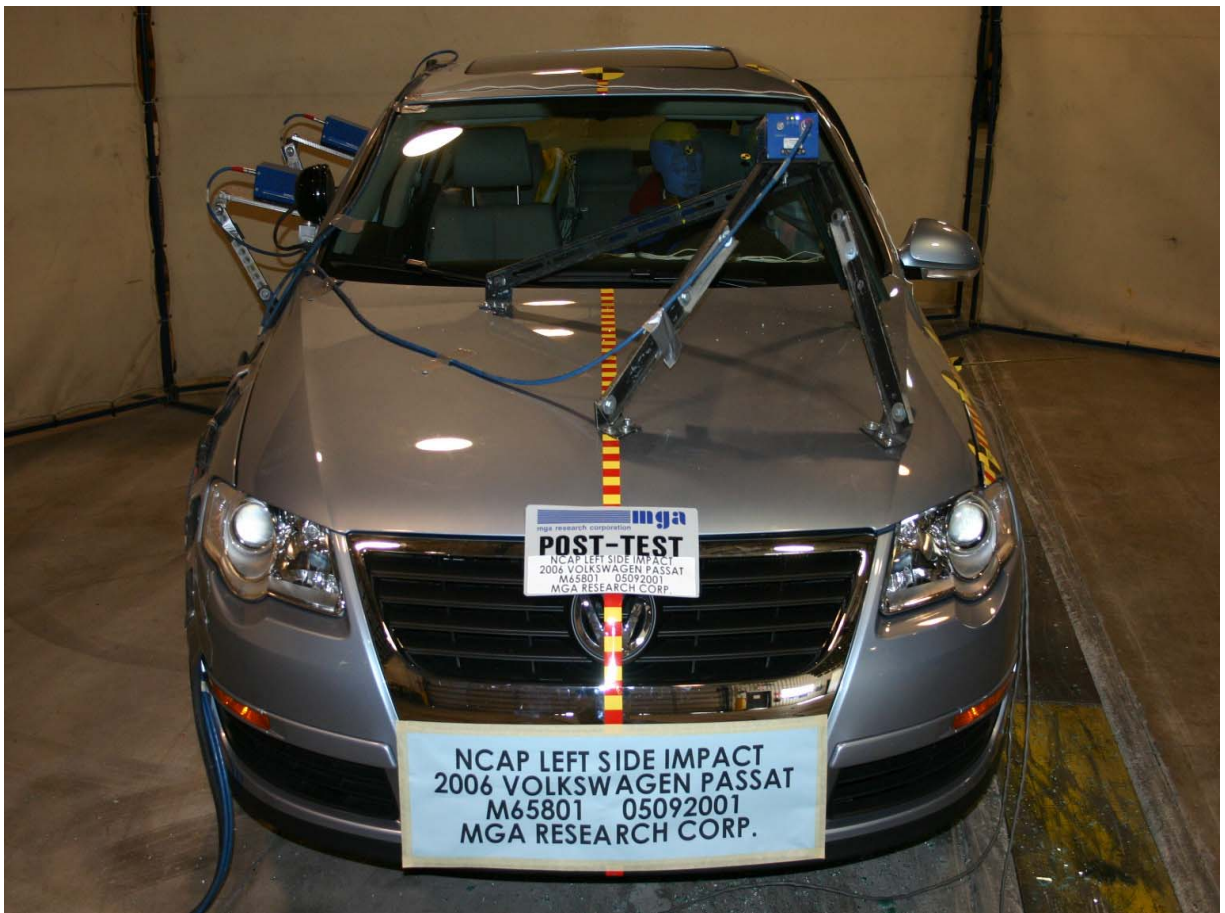
Post-Test Front View

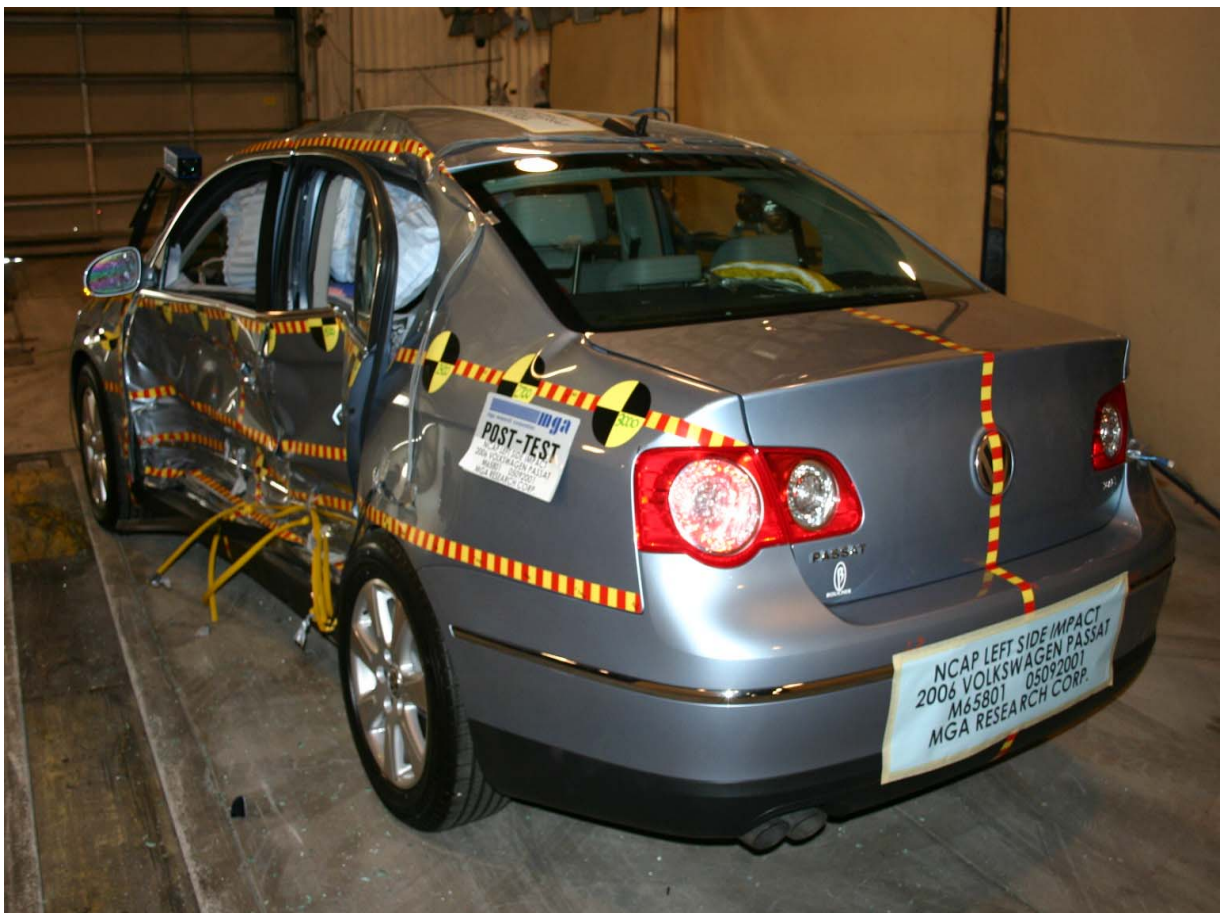
Post-Test Left Rear  $\frac{3}{4}$  View

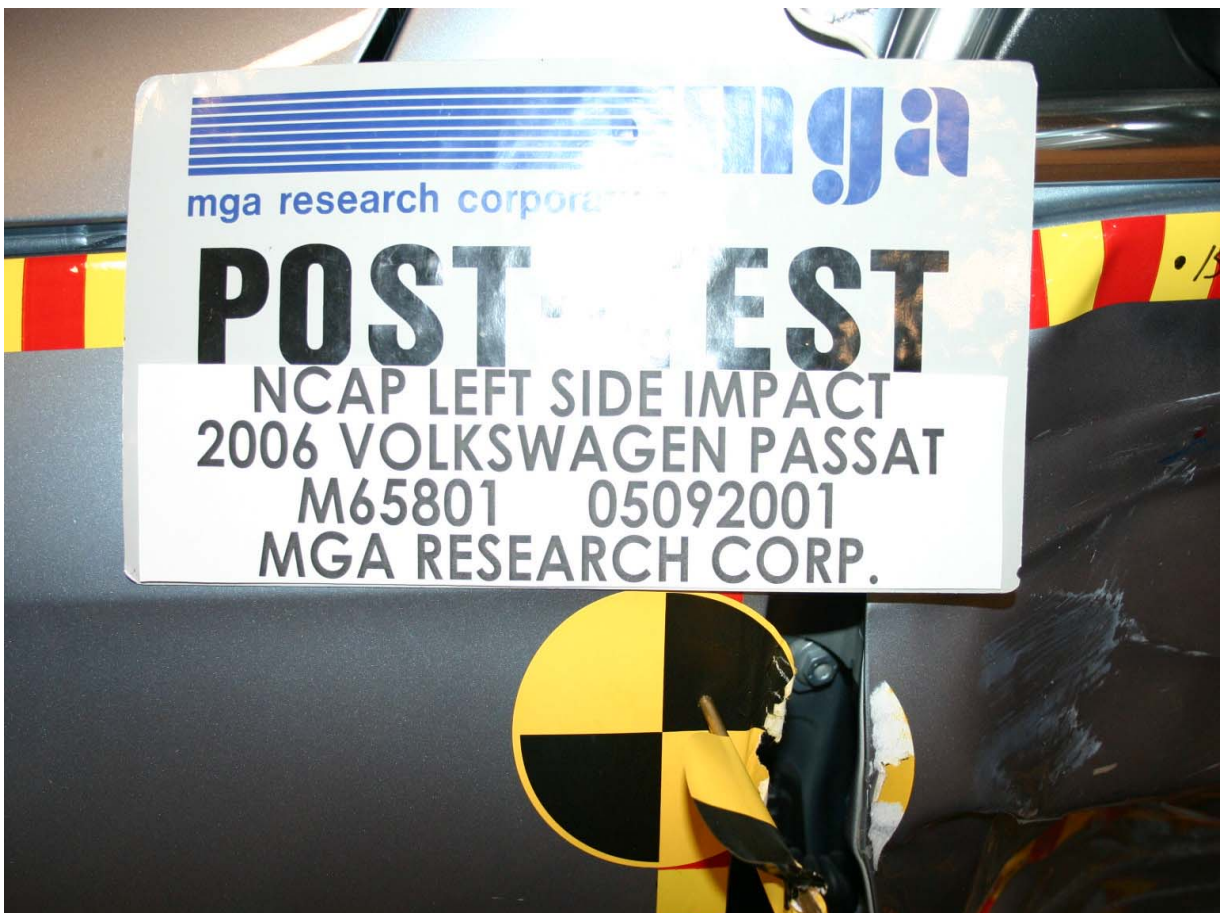
Post-Test Left Impact Point

The test vehicle sustained a maximum static crush of 297 mm at level 2, 1650 mm rearward of the left vertical impact point. The driver and passenger SID/HIIIs, Serial Nos. 271 and 904 respectively, were calibrated just prior to this test.

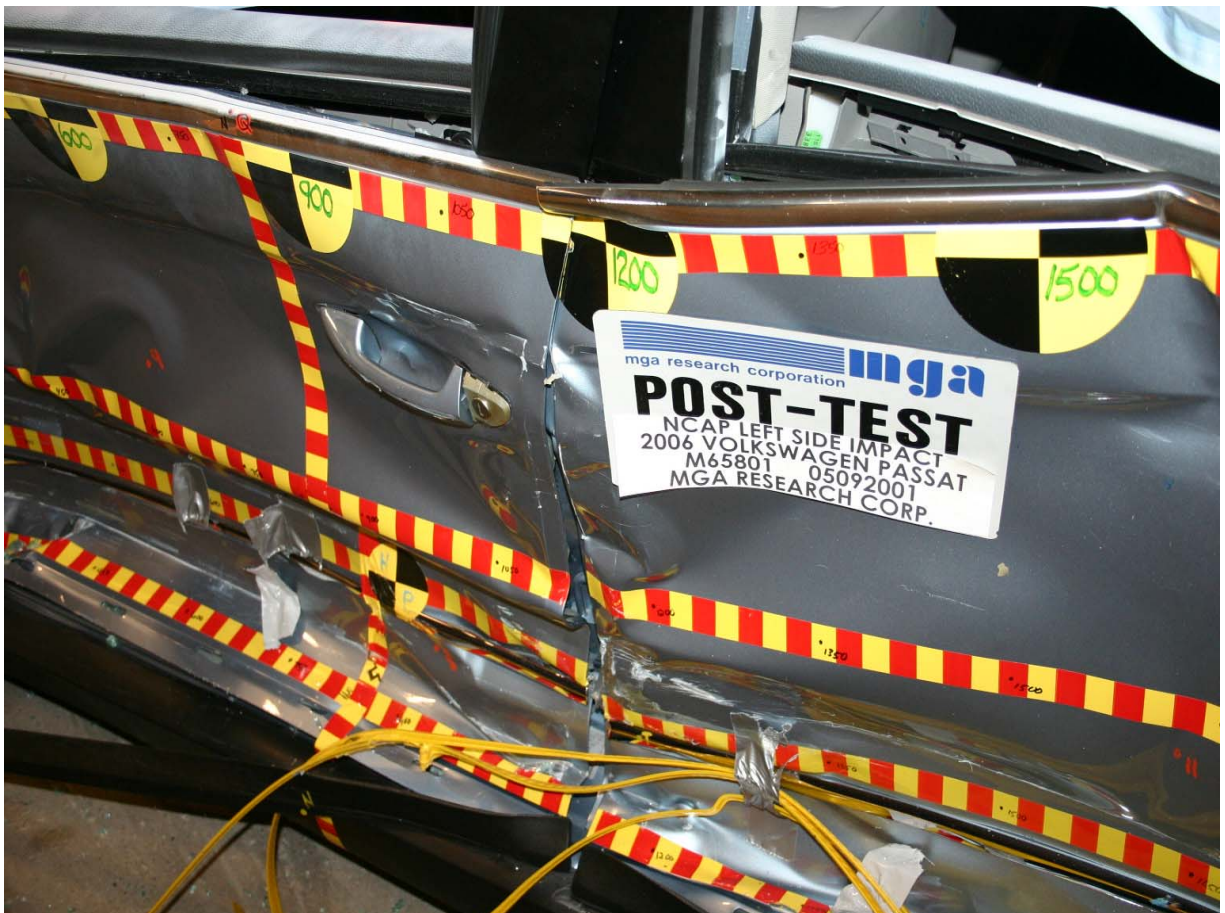
Post-Test Left Front Door

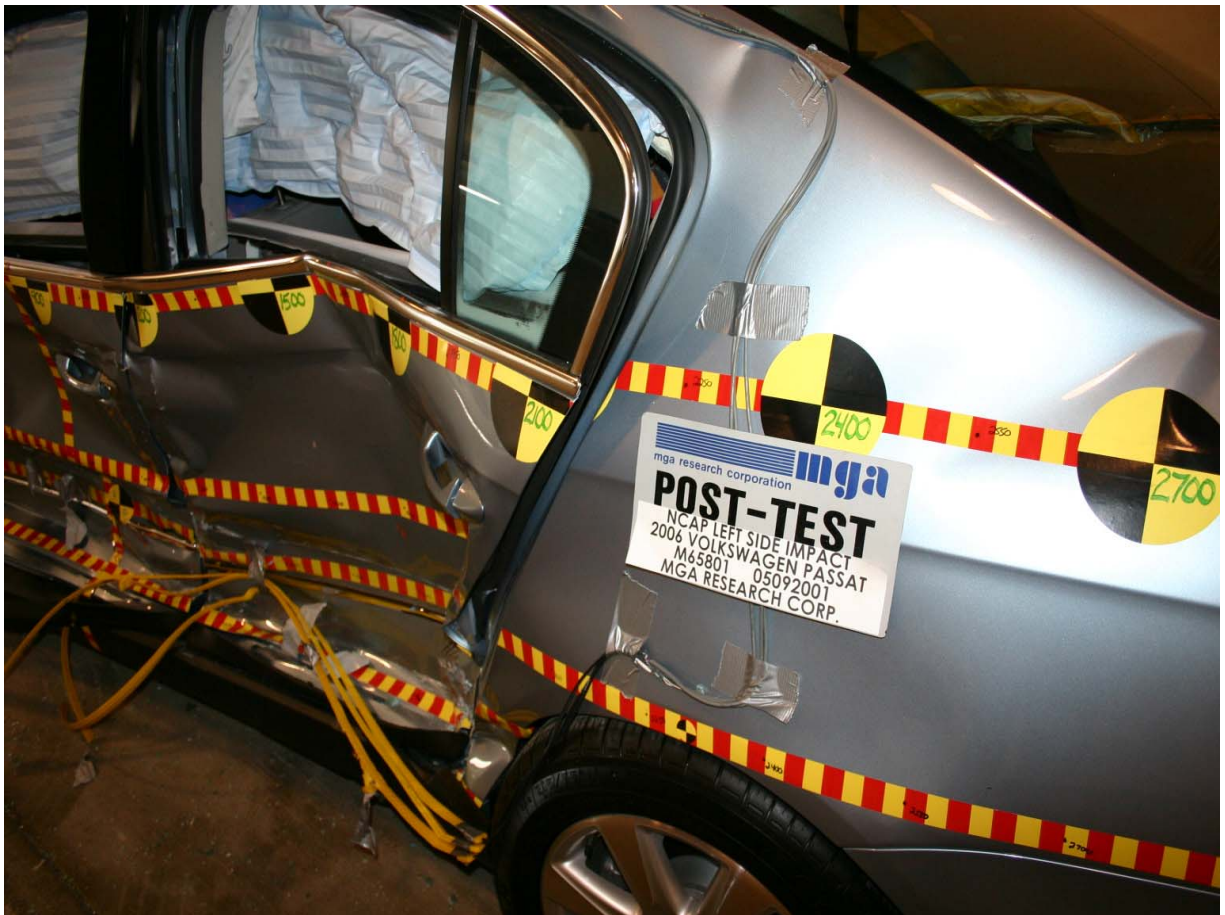
Post-Test Left Rear Door

| Critical Areas of Performance | Observations and Conclusions |
|---|---|
| Window Damage | Left Rear Passenger Window Broke |

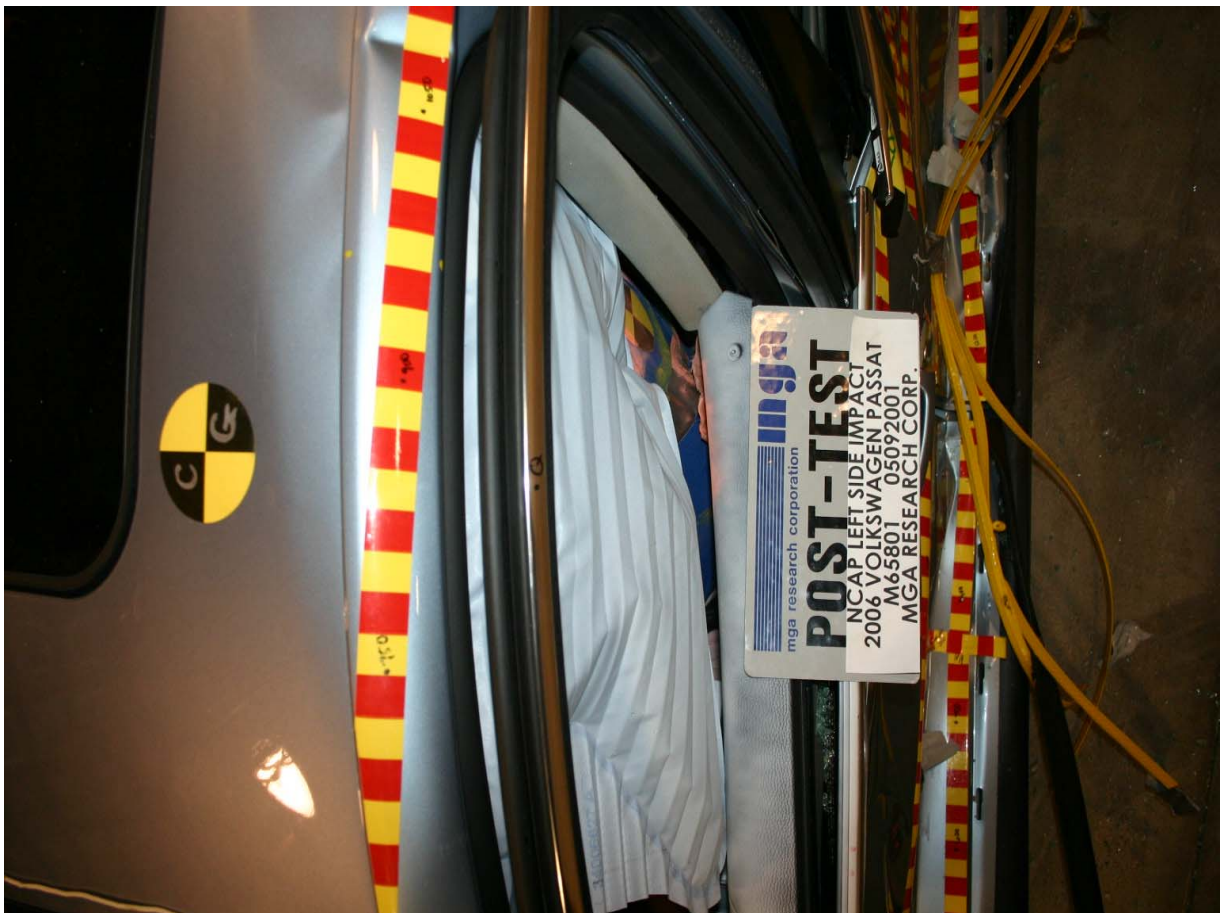
Post-Test Driver Dummy Clearance From Door

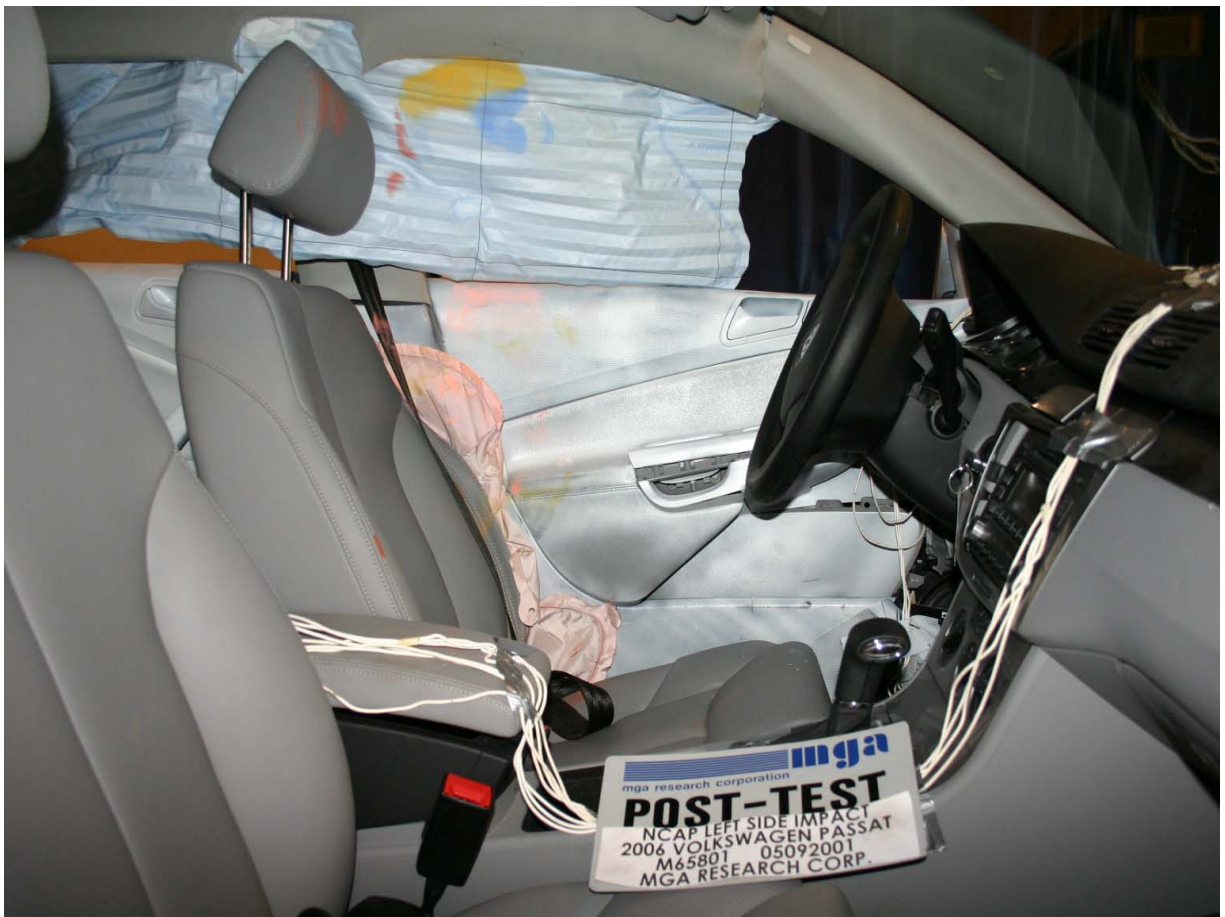
Post-Test Front Door Panel (Interior)

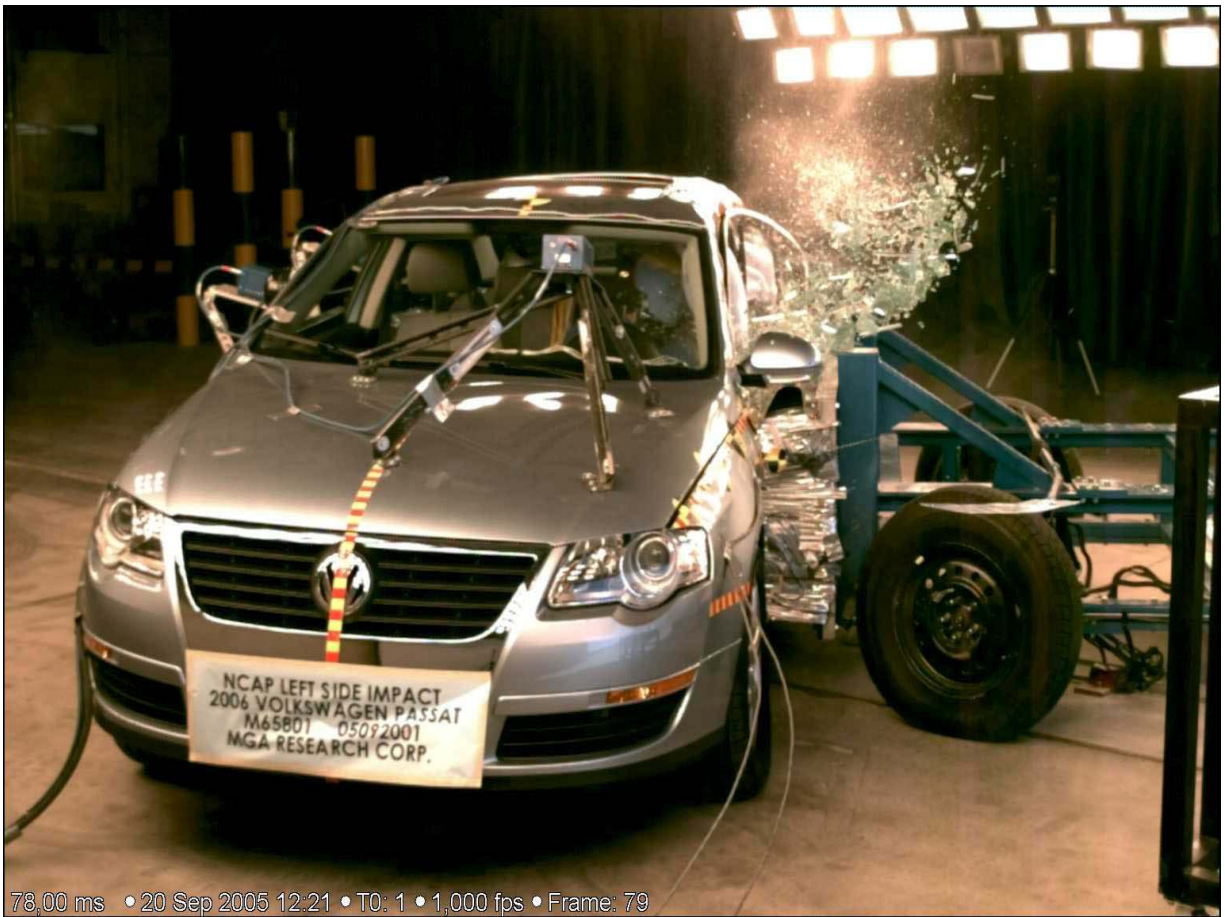
78,00 ms • 20 Sep 2005 12:21 • T0: 1 • 1,000 fps • Frame: 79

Vehicle Impact
