**REPORT NUMBER: NCAP-MGA-2006-003**

**NEW CAR ASSESSMENT PROGRAM  
FRONTAL BARRIER IMPACT TEST**

**MITSUBISHI MOTOR CORPORATION  
2006 MITSUBISHI LANCER  
NHTSA NUMBER: M65600**

**PREPARED BY:  
MGA RESEARCH CORPORATION  
5000 WARREN ROAD  
BURLINGTON, WI 53105**

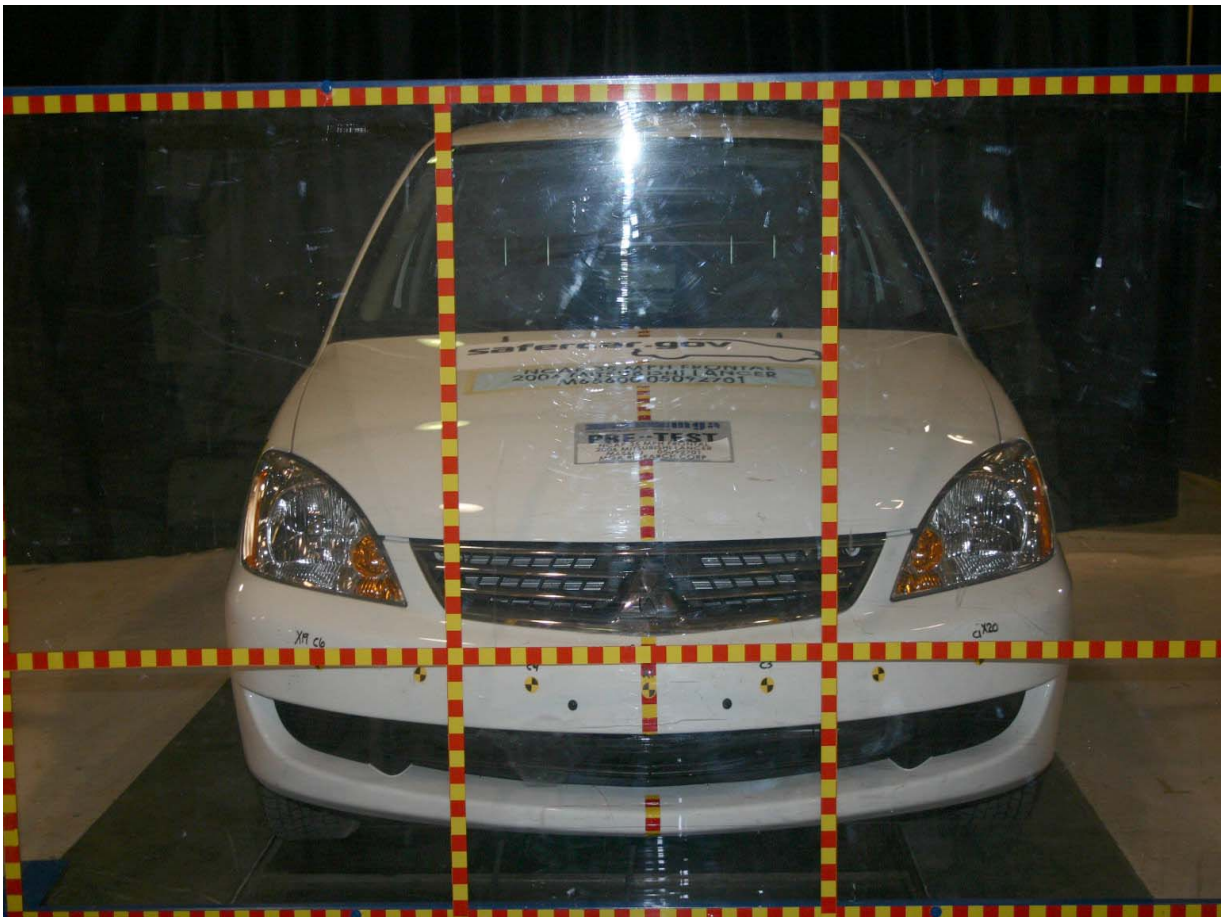
Load Cell Location

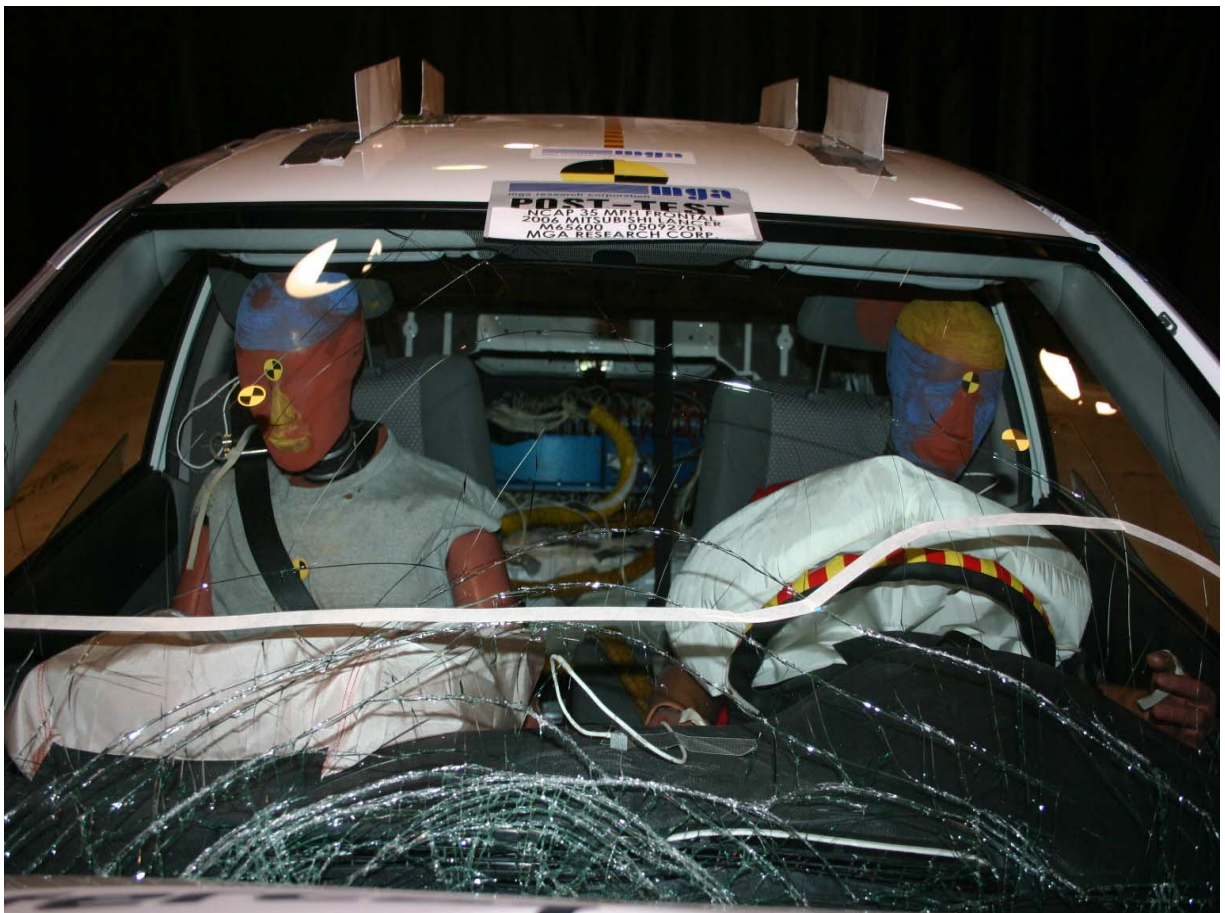
Post-Test Windshield View

There was 98 percent windshield retention and no intrusion into the protected zone of the windshield during the event. There was no Stoddard Solvent leakage after the event or during any phase of the static rollover.

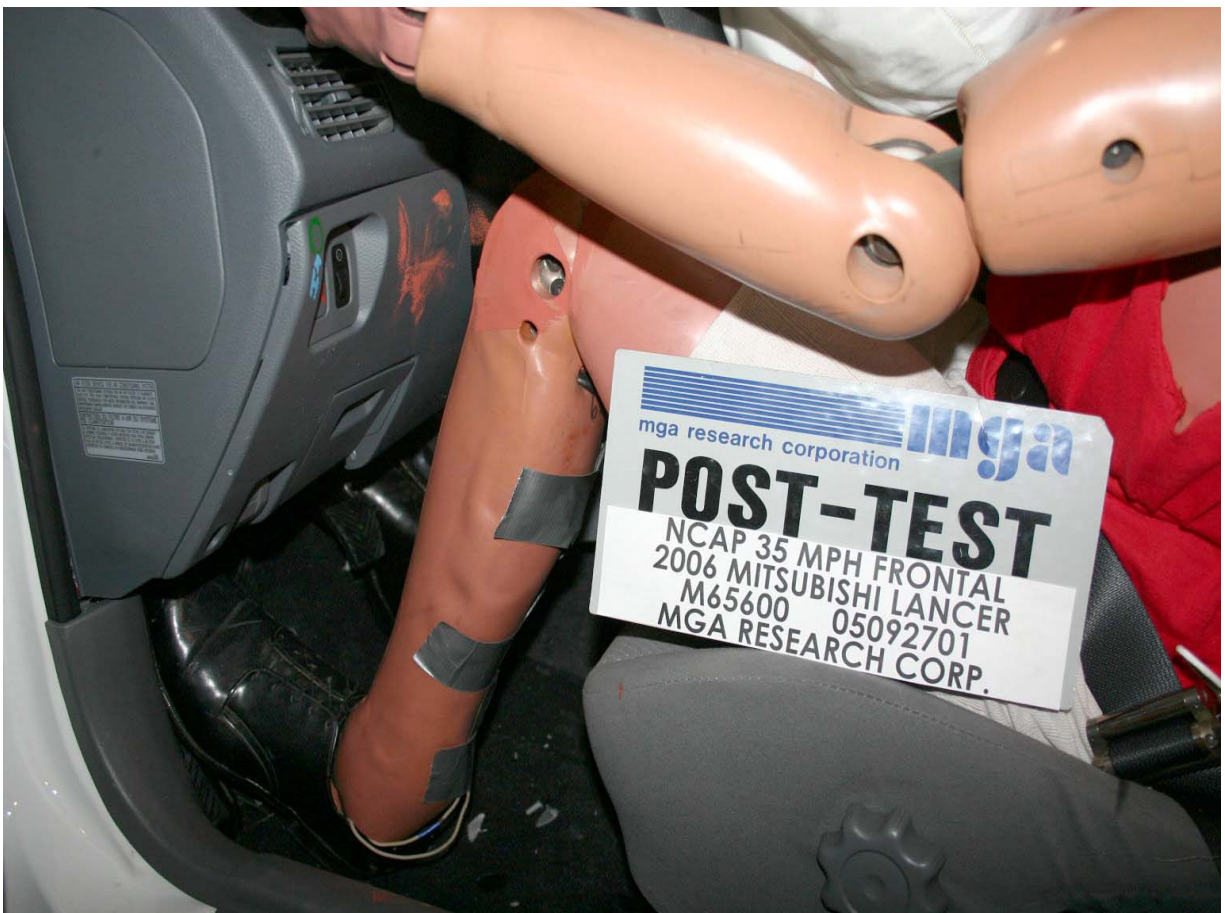
Post-Test Driver Side Knee Bolster

The driver's head, chest, and abdomen contacted the airbag. The driver's head also contacted the headrest. The driver's knees contacted the bolster. The passenger's head and chest contacted the airbag. The passenger's head also contacted the headrest and headliner. The passenger's knees contacted the glove box.

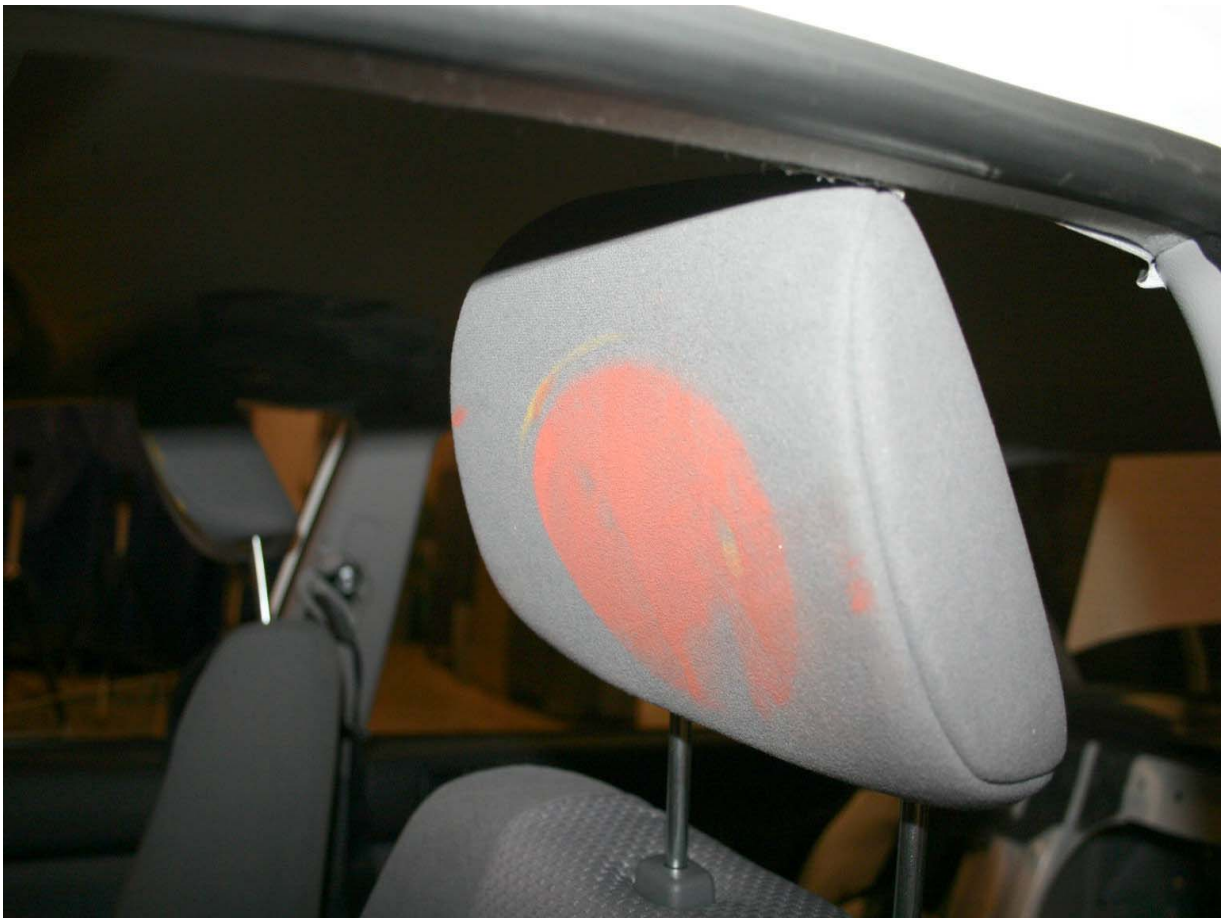
Post-Test Driver Dummy Head Contact

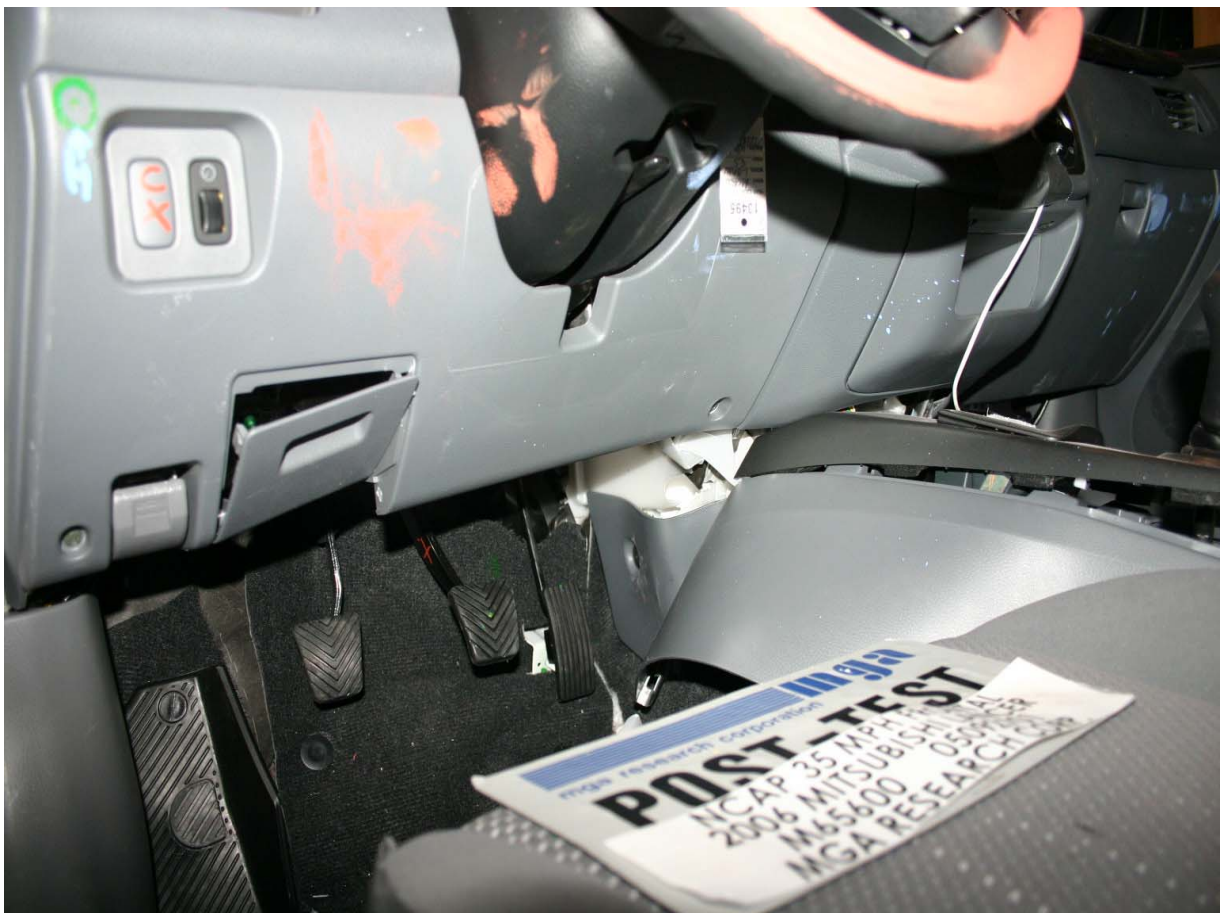
Post-Test Driver Dummy Knee Contact

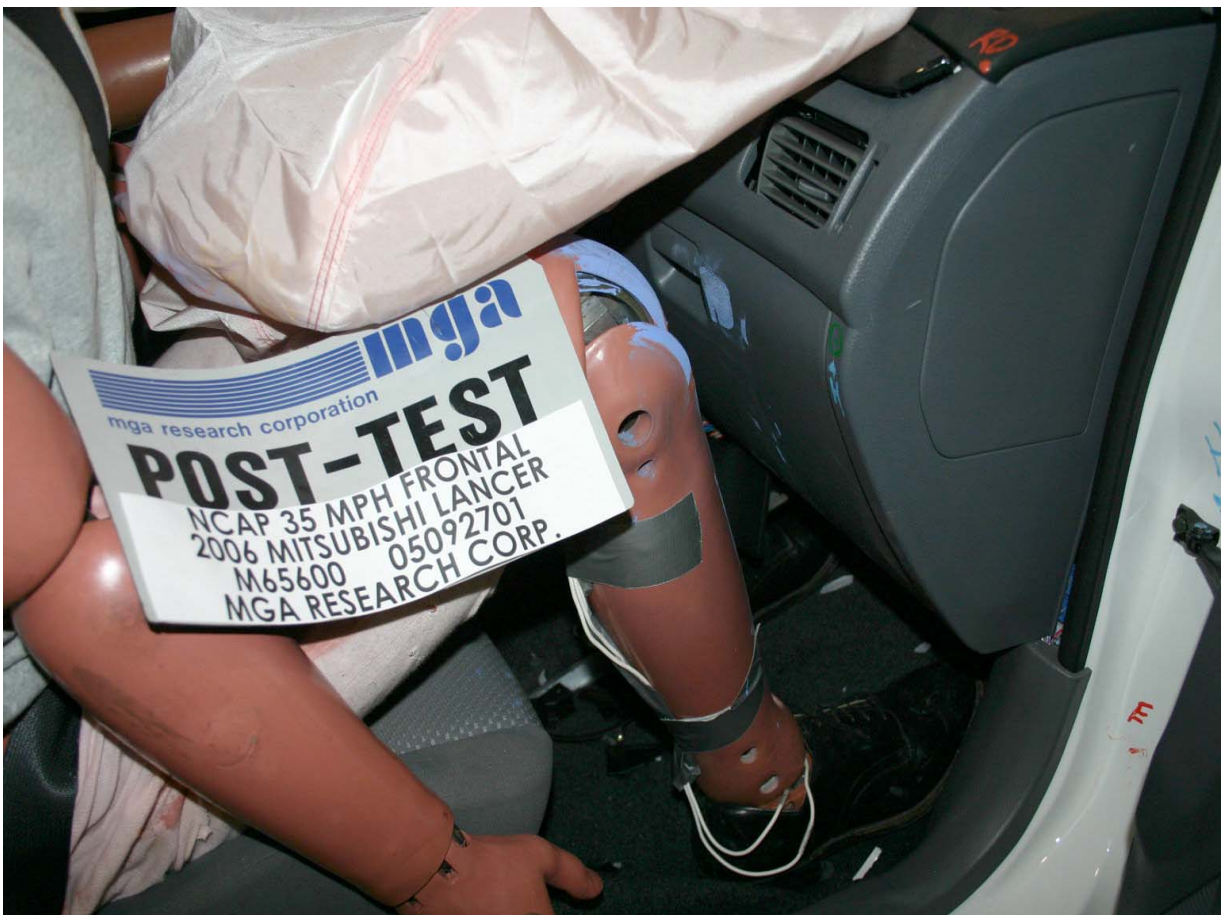
Post-Test Passenger Side Glove Box

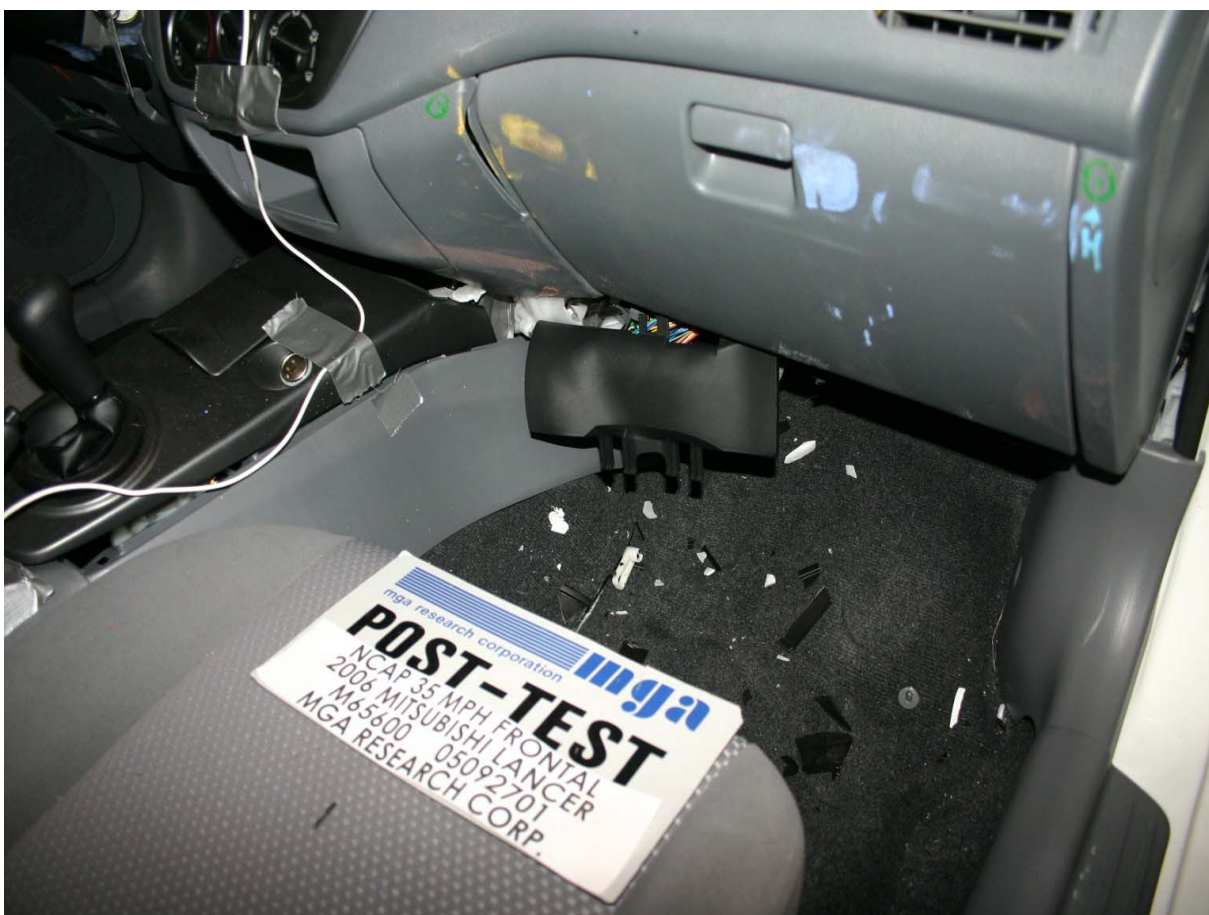
Post-Test Passenger Dummy Knee Contact

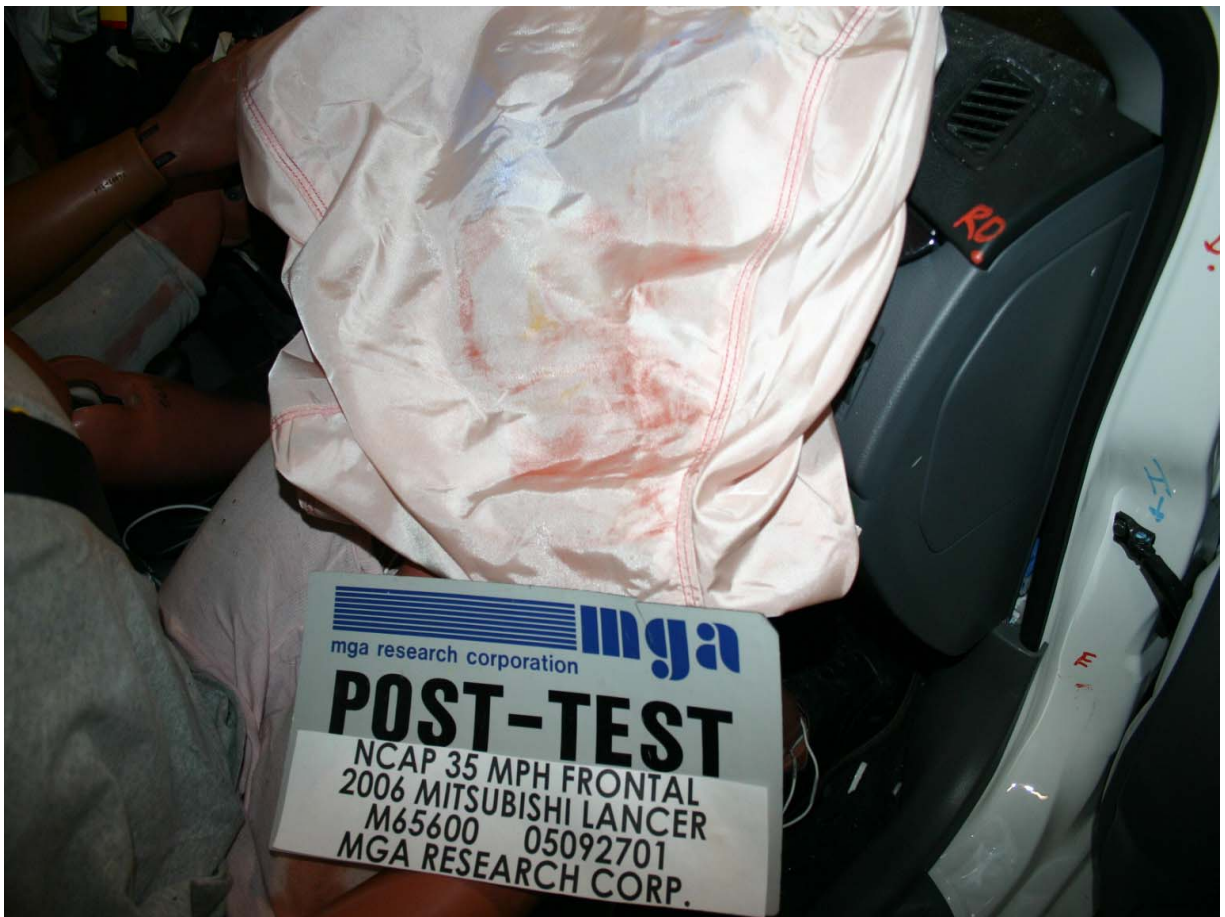
Post-Test Passenger Dummy Airbag Contact

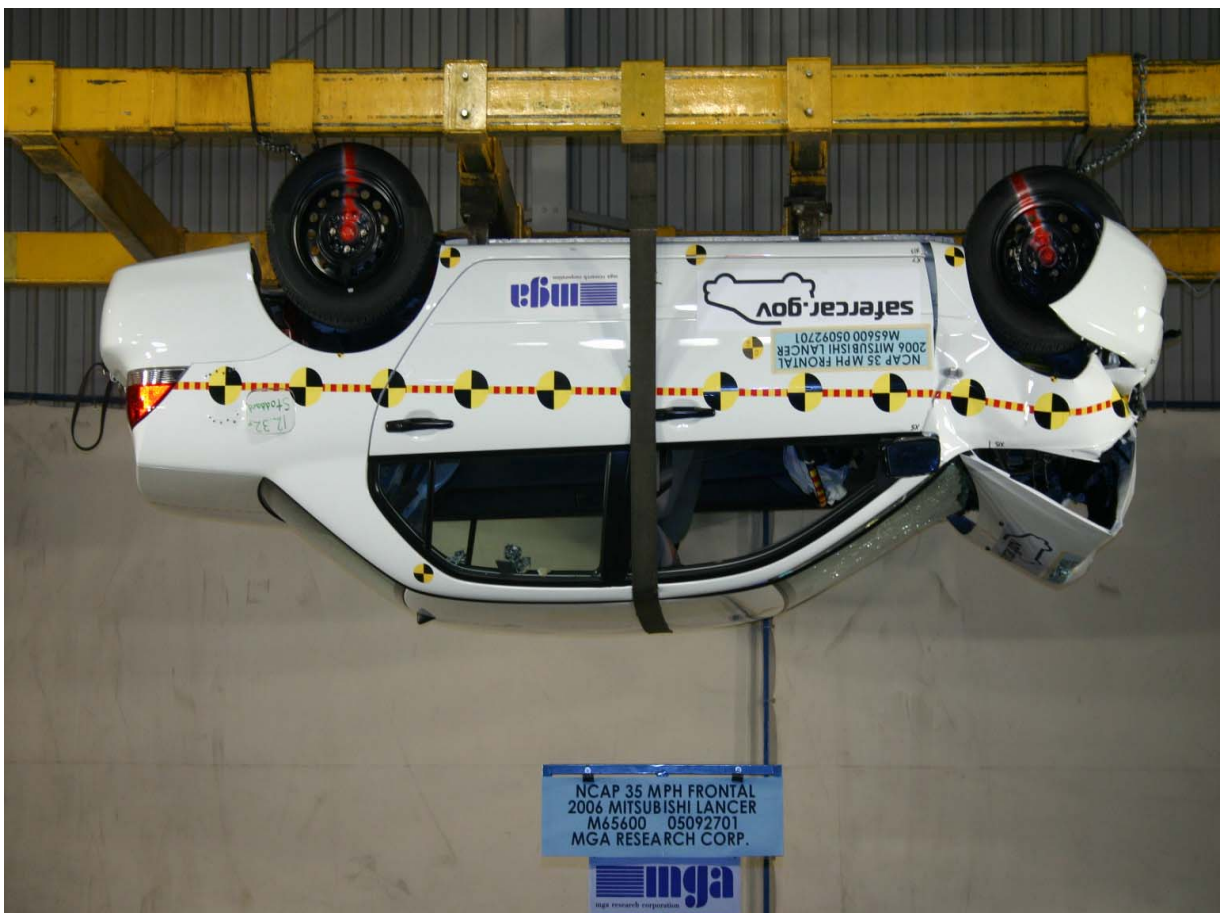
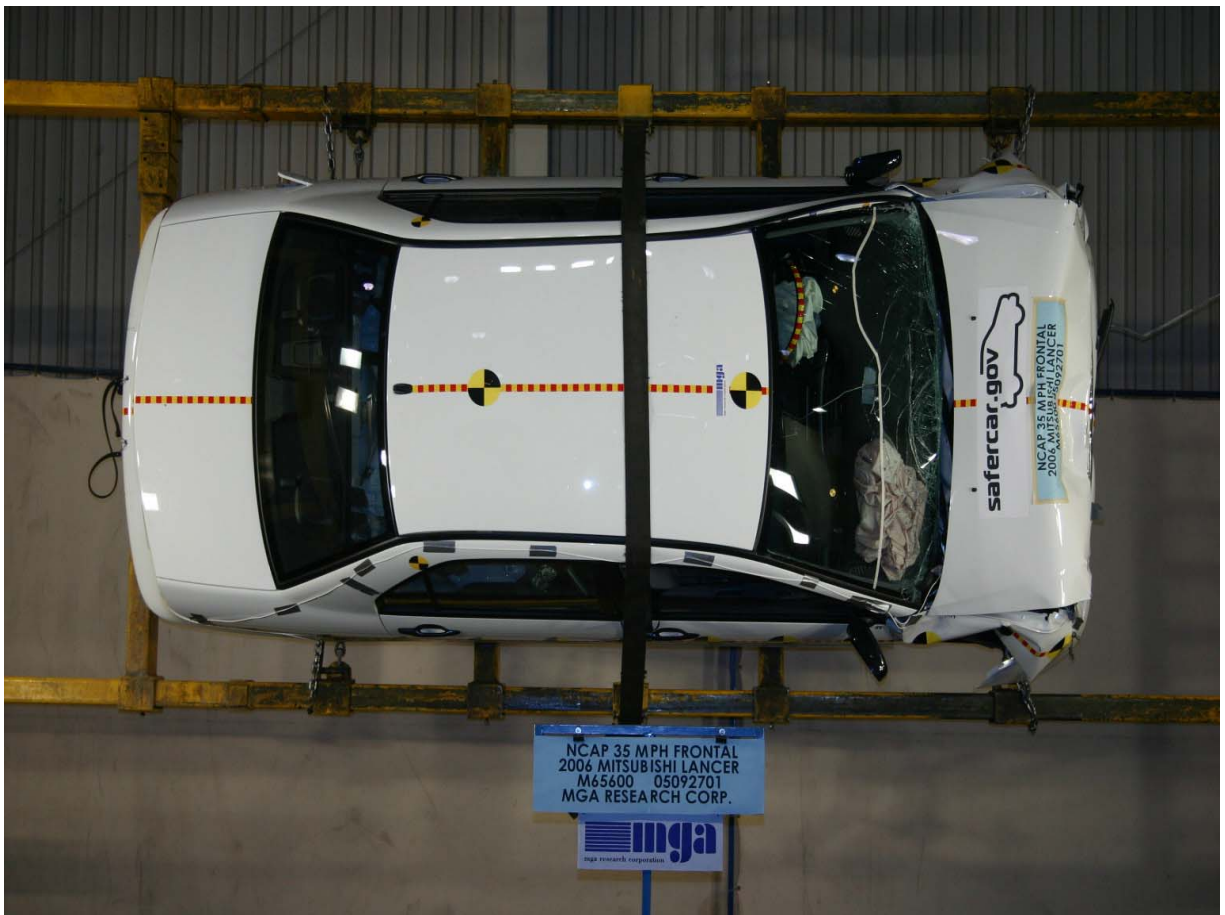
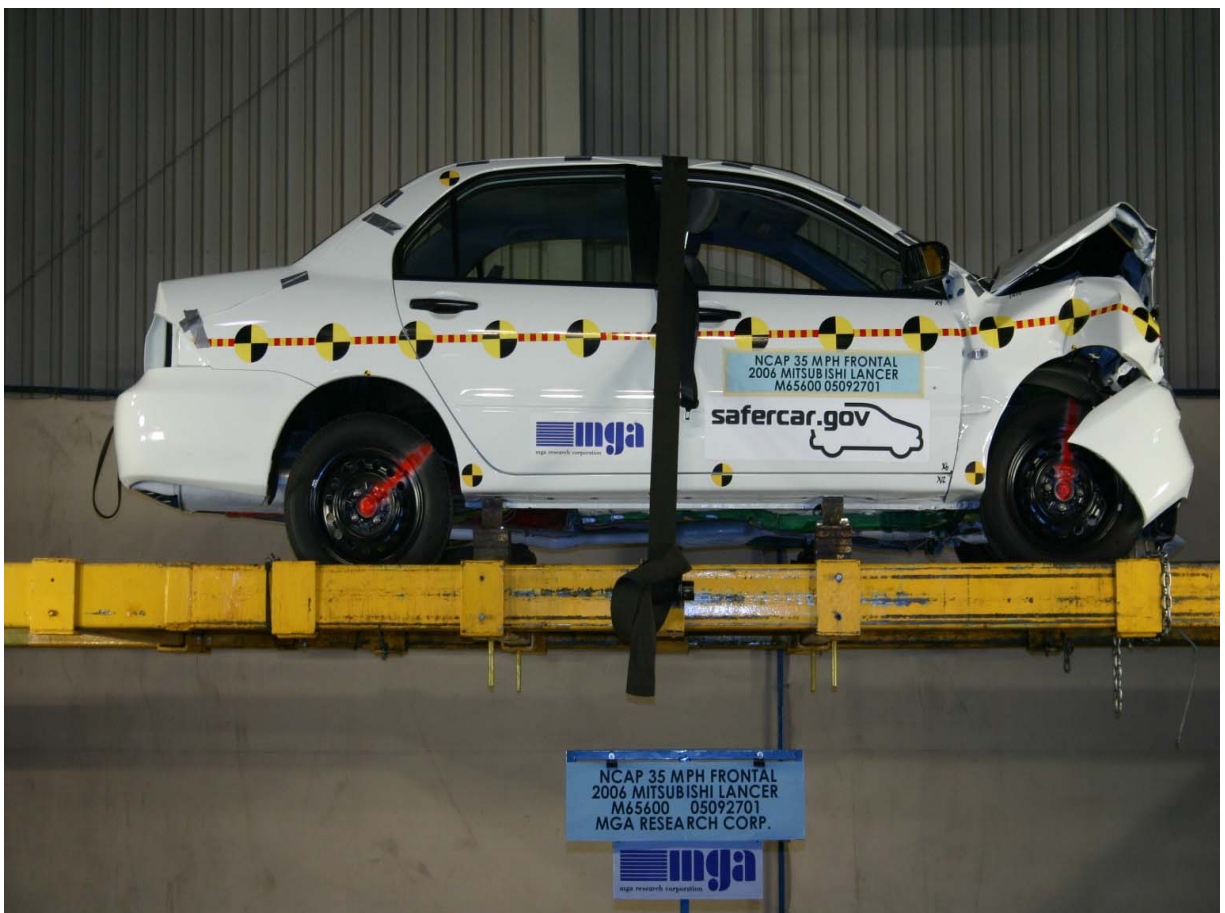
Vehicle on Rollover Device at 90 Degrees

Vehicle on Rollover Device at 180 Degrees

Vehicle on Rollover Device at 270 Degrees

Vehicle on Rollover Device at 360 Degrees
