**REPORT NUMBER: NCAPSIDE-MGA-2006-004**

**NEW CAR ASSESSMENT PROGRAM  
SIDE IMPACT TEST**

**KIA MOTORS CORPORATION  
2006 KIA RIO  
NHTSA NUMBER: M60510**

**PREPARED BY:  
MGA RESEARCH CORPORATION  
5000 WARREN ROAD  
BURLINGTON, WI 53105**

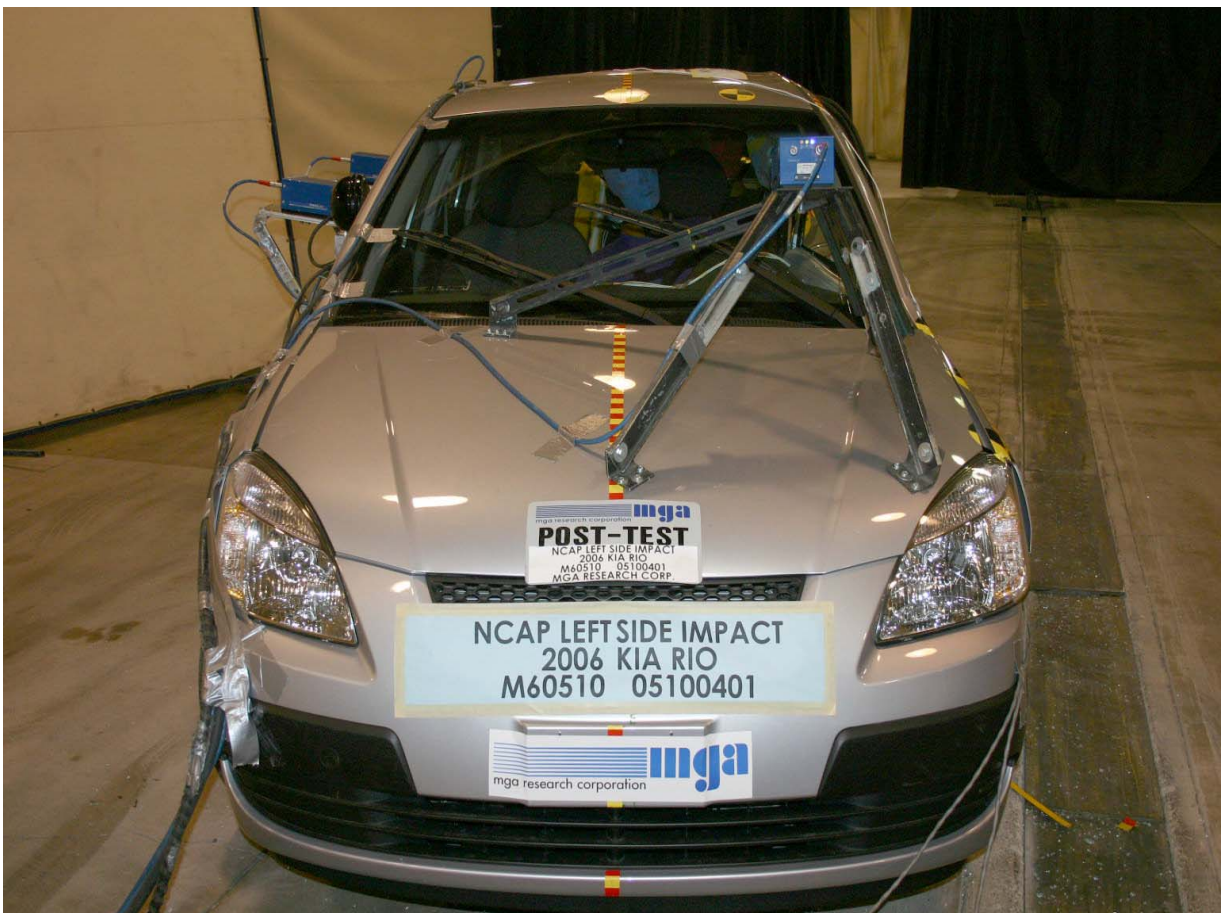
Post-Test Front View

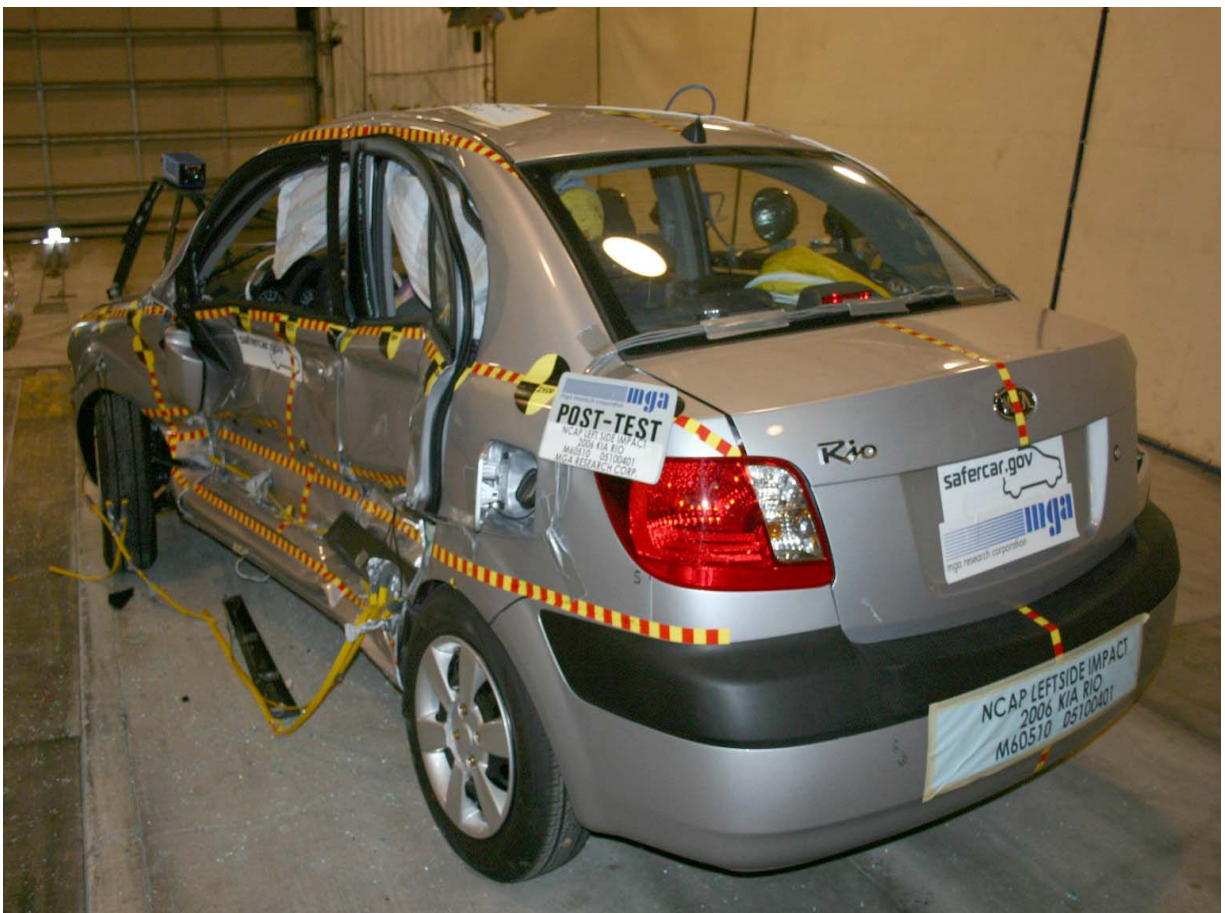
Post-Test Left Rear 3/4 View

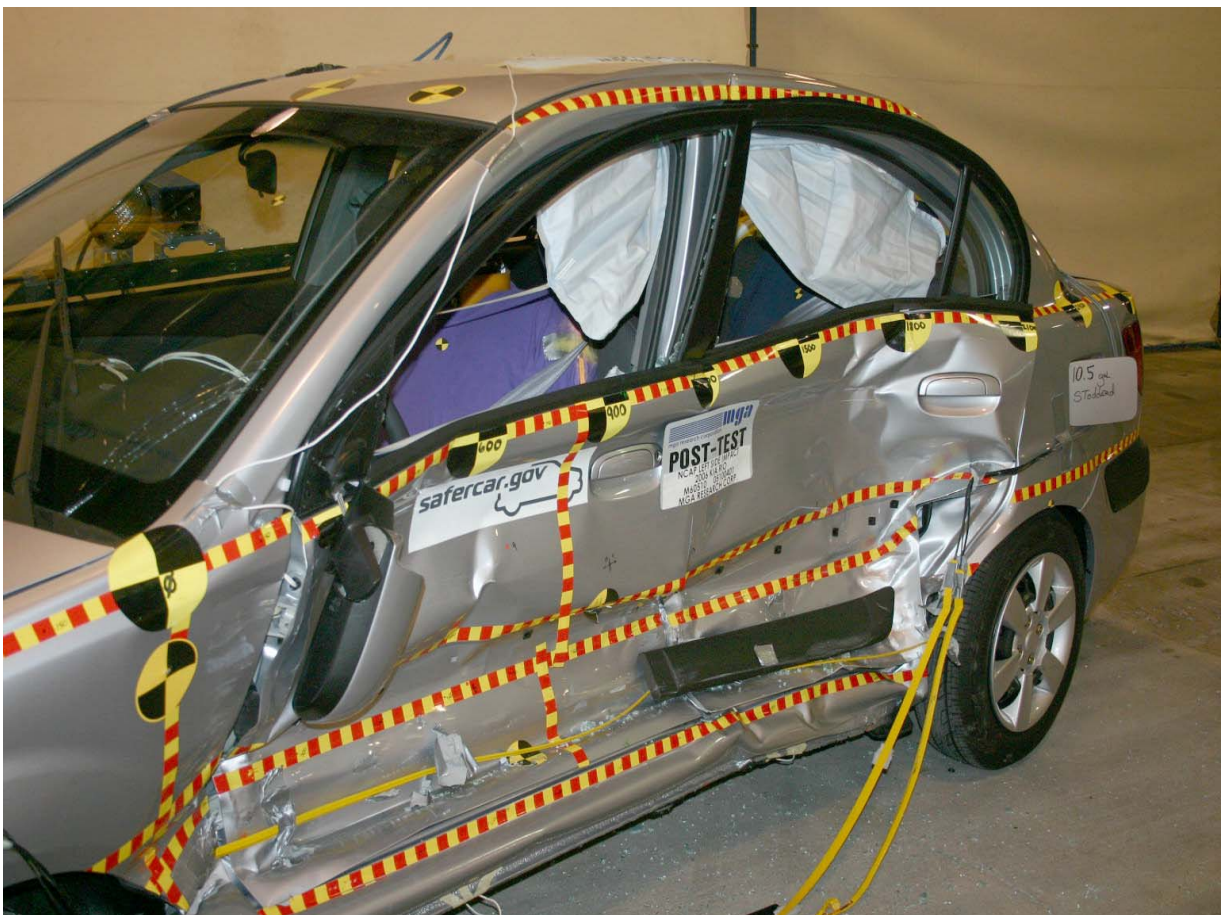
Post-Test Front  $\frac{3}{4}$  View of Left Side Doors

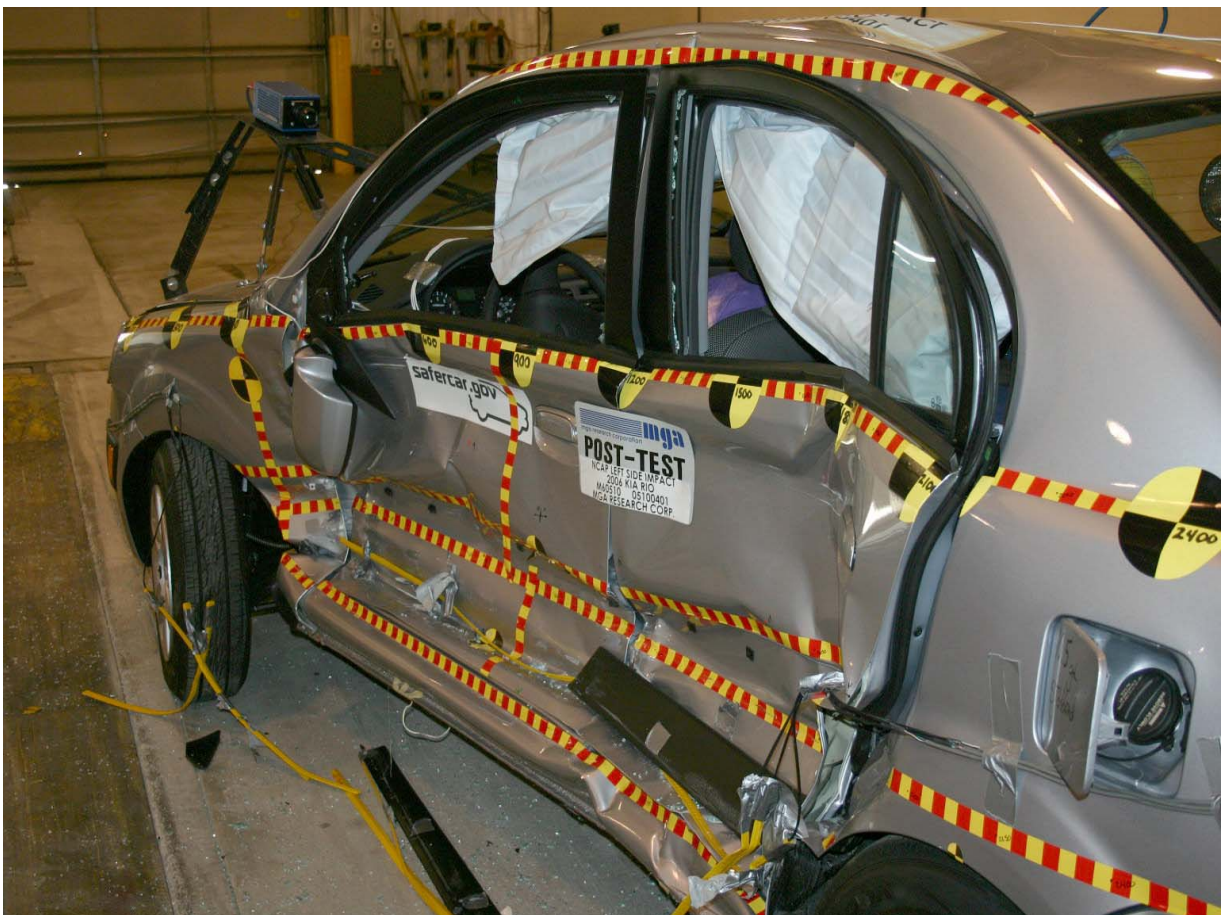
Post-Test Rear  $\frac{3}{4}$  View of Left Side Doors

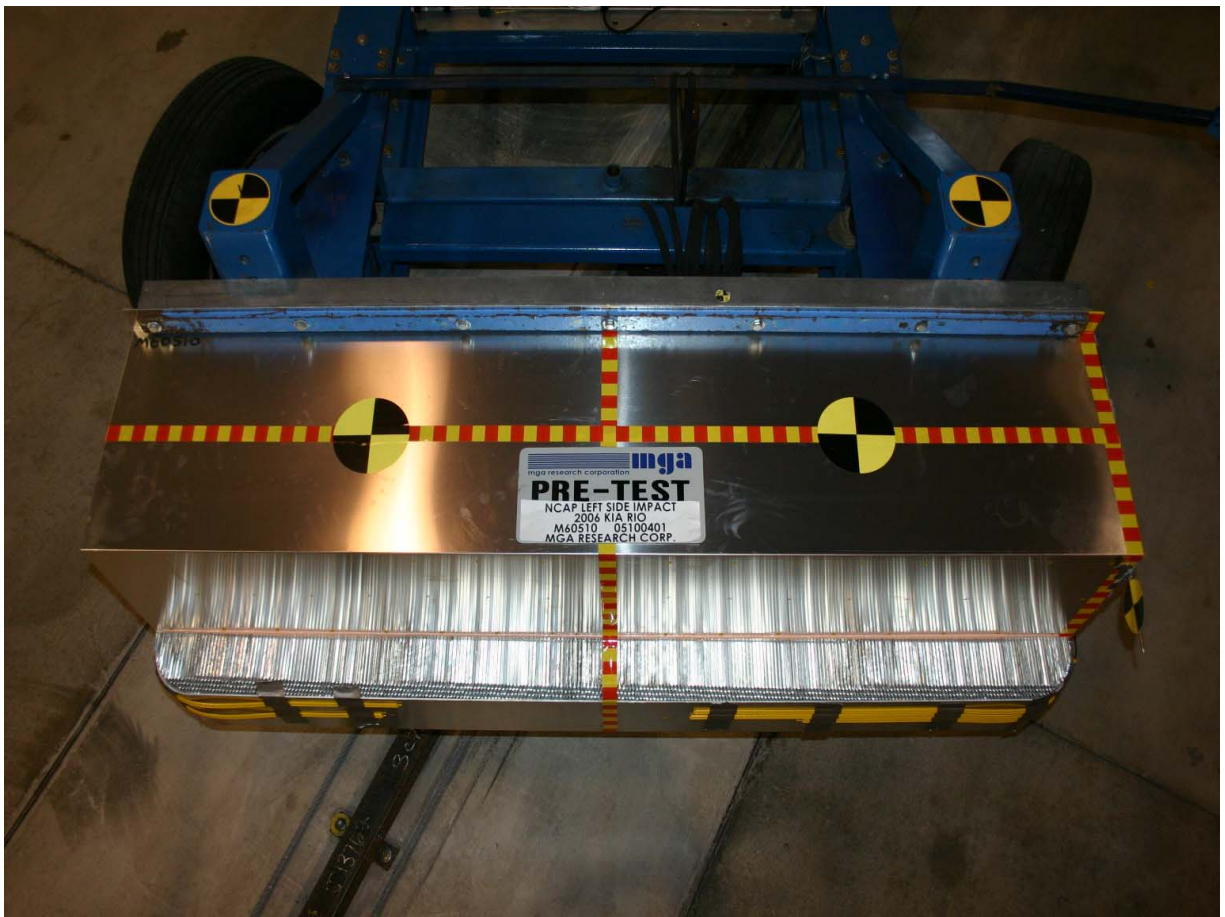
Pre-Test Top View of Deformable Barrier

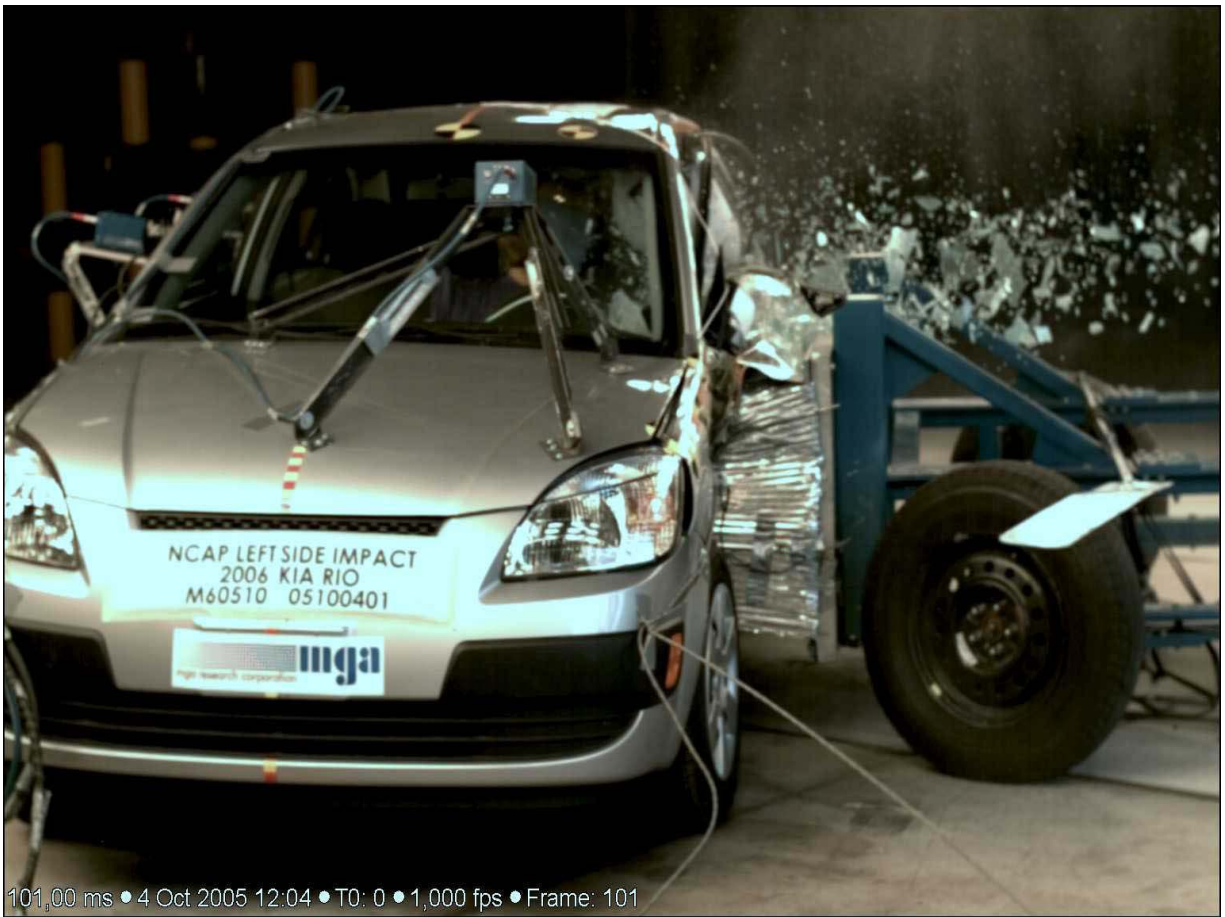
101,00 ms • 4 Oct 2005 12:04 • T0: 0 • 1,000 fps • Frame: 101

Vehicle Impact
