**NEW CAR ASSESSMENT PROGRAM  
FRONTAL BARRIER IMPACT TEST**

**VOLKSWAGEN AG GERMANY  
2006 VOLKSWAGEN NEW PASSAT  
4-DOOR SEDAN**

**NHTSA NUMBER: M65800**

**FINAL REPORT**

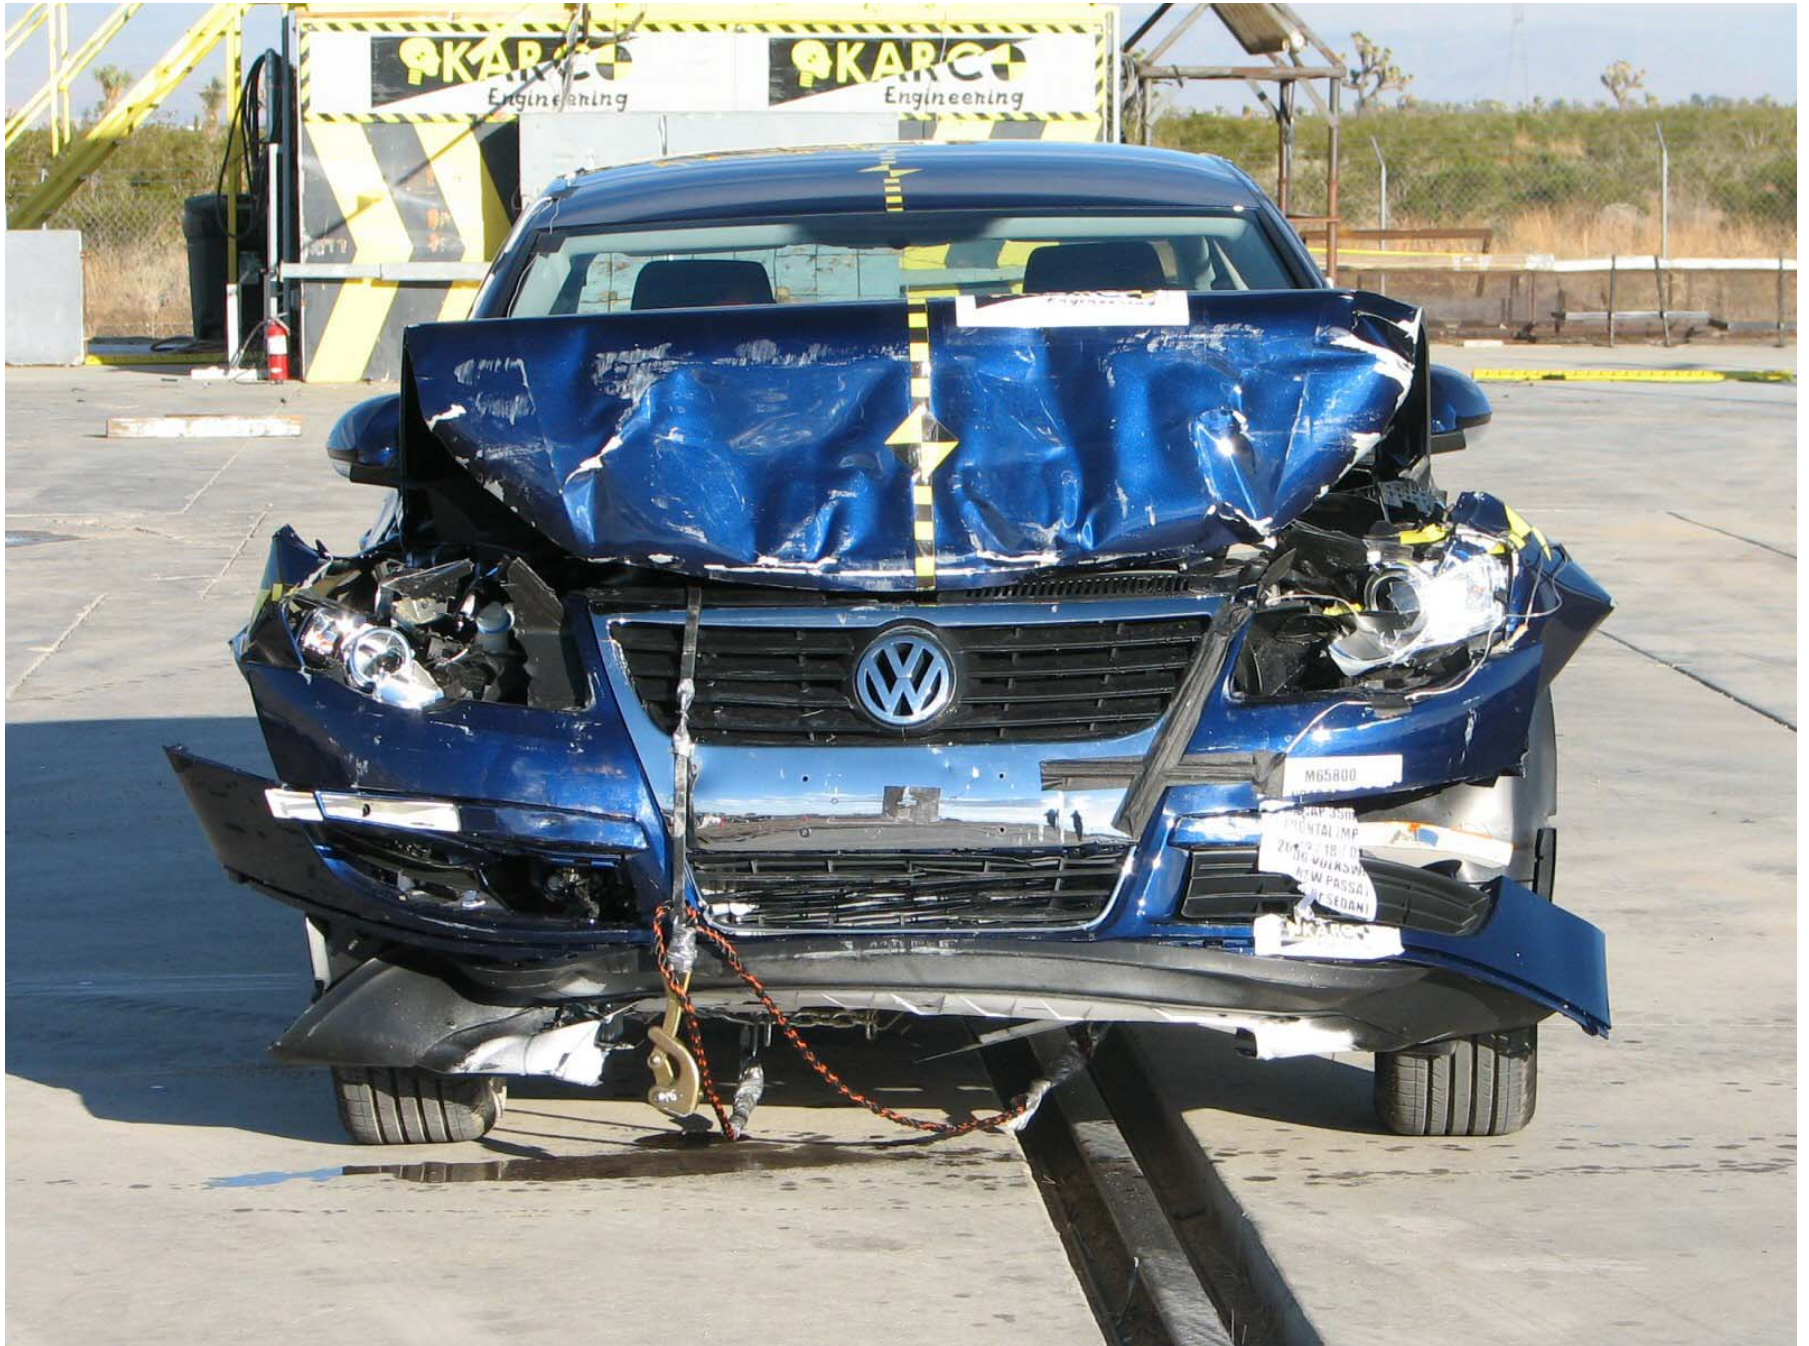
Figure A-7: Post-Test Front View (Vehicle Moved)

The maximum static crush of the vehicle was 398 mm at the vehicle centerline and both the driver and the passenger side doors remained closed and latched during the impact event and were operable after the impact.

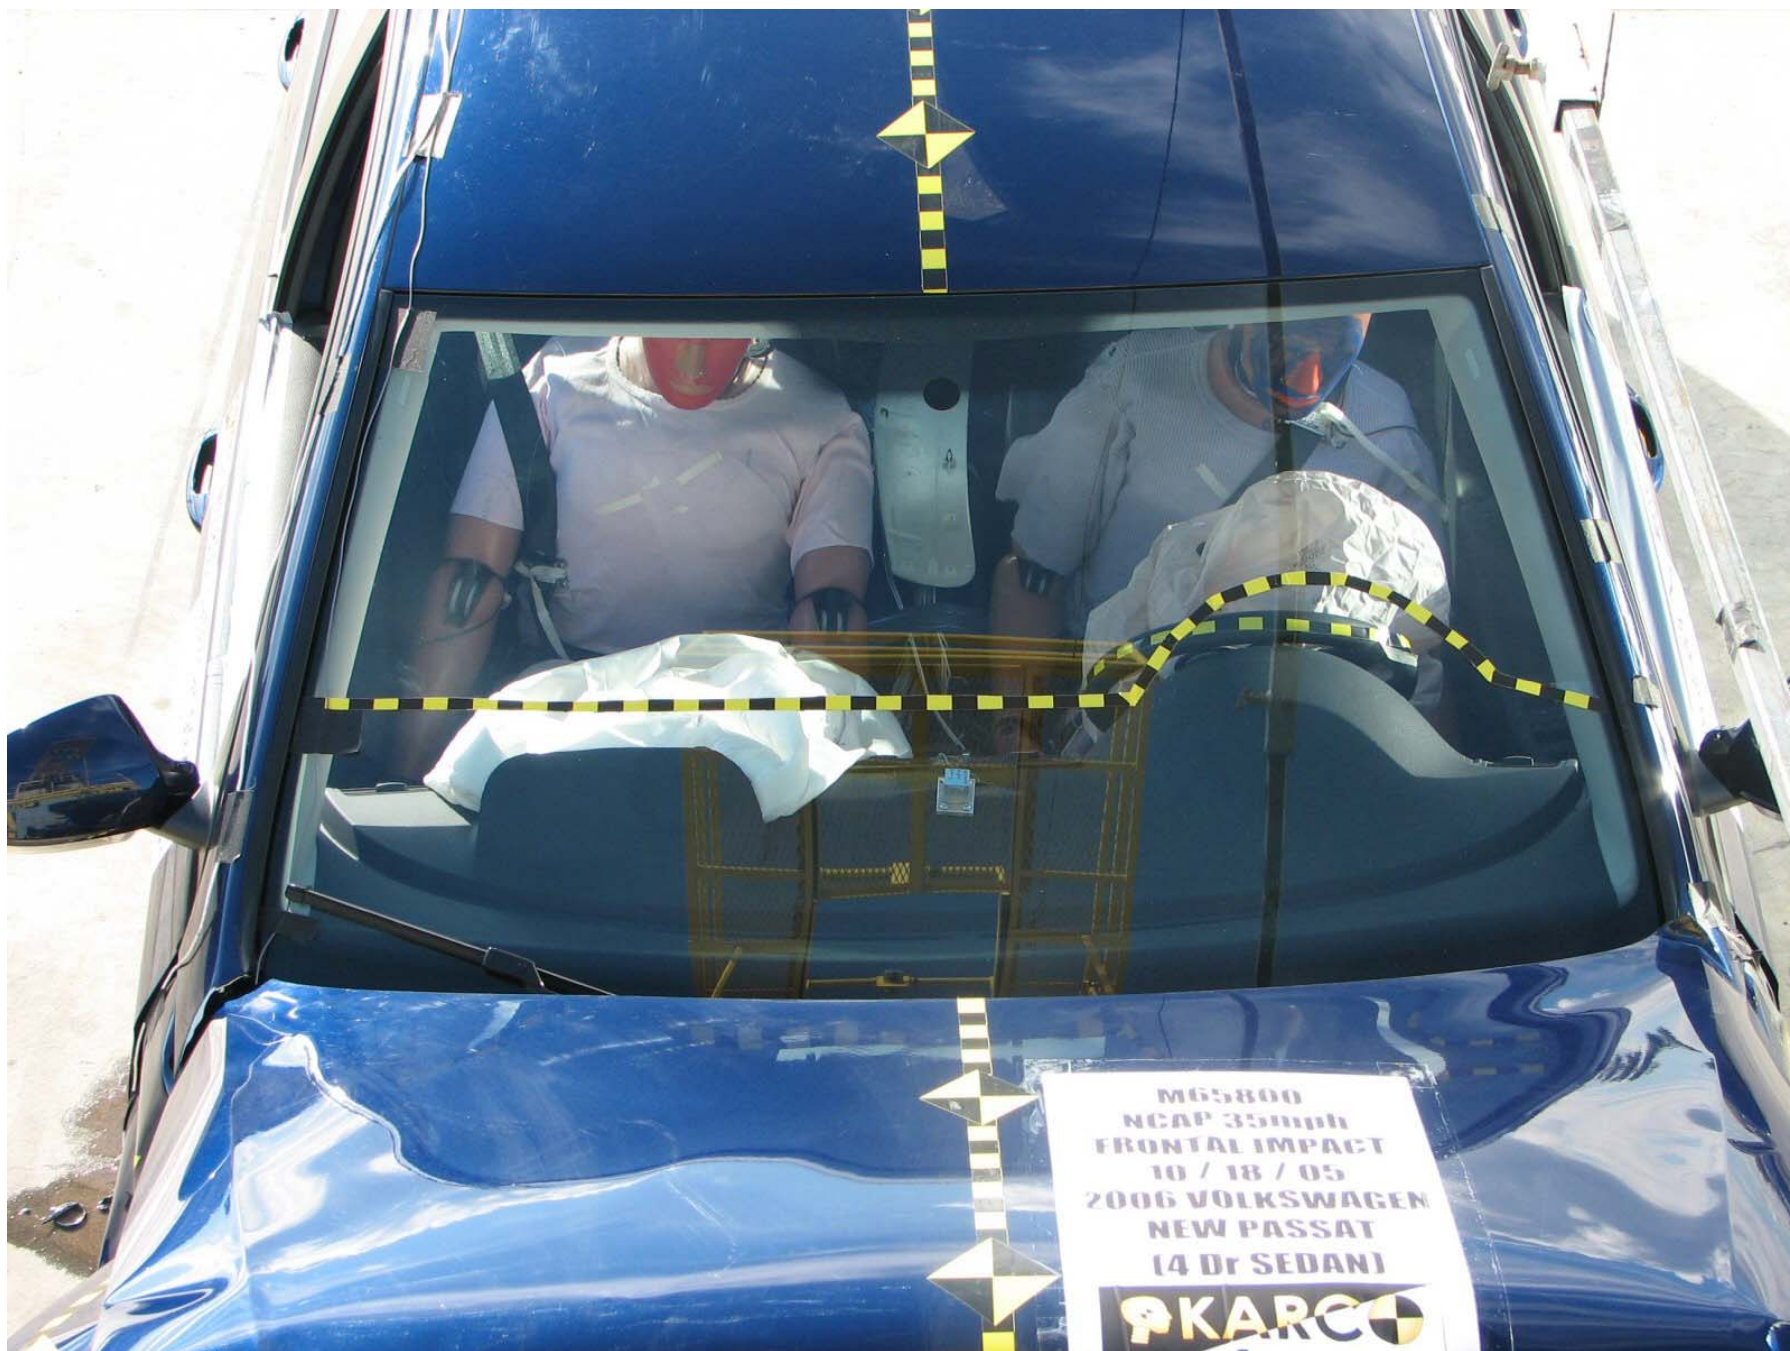
Figure A-19: Post-Test Windshield

There was 100 percent windshield retention and no intrusion into the protected zone of the windshield during the impact event. There was no Stoddard solvent leakage after the event or during any phase of the static rollover.

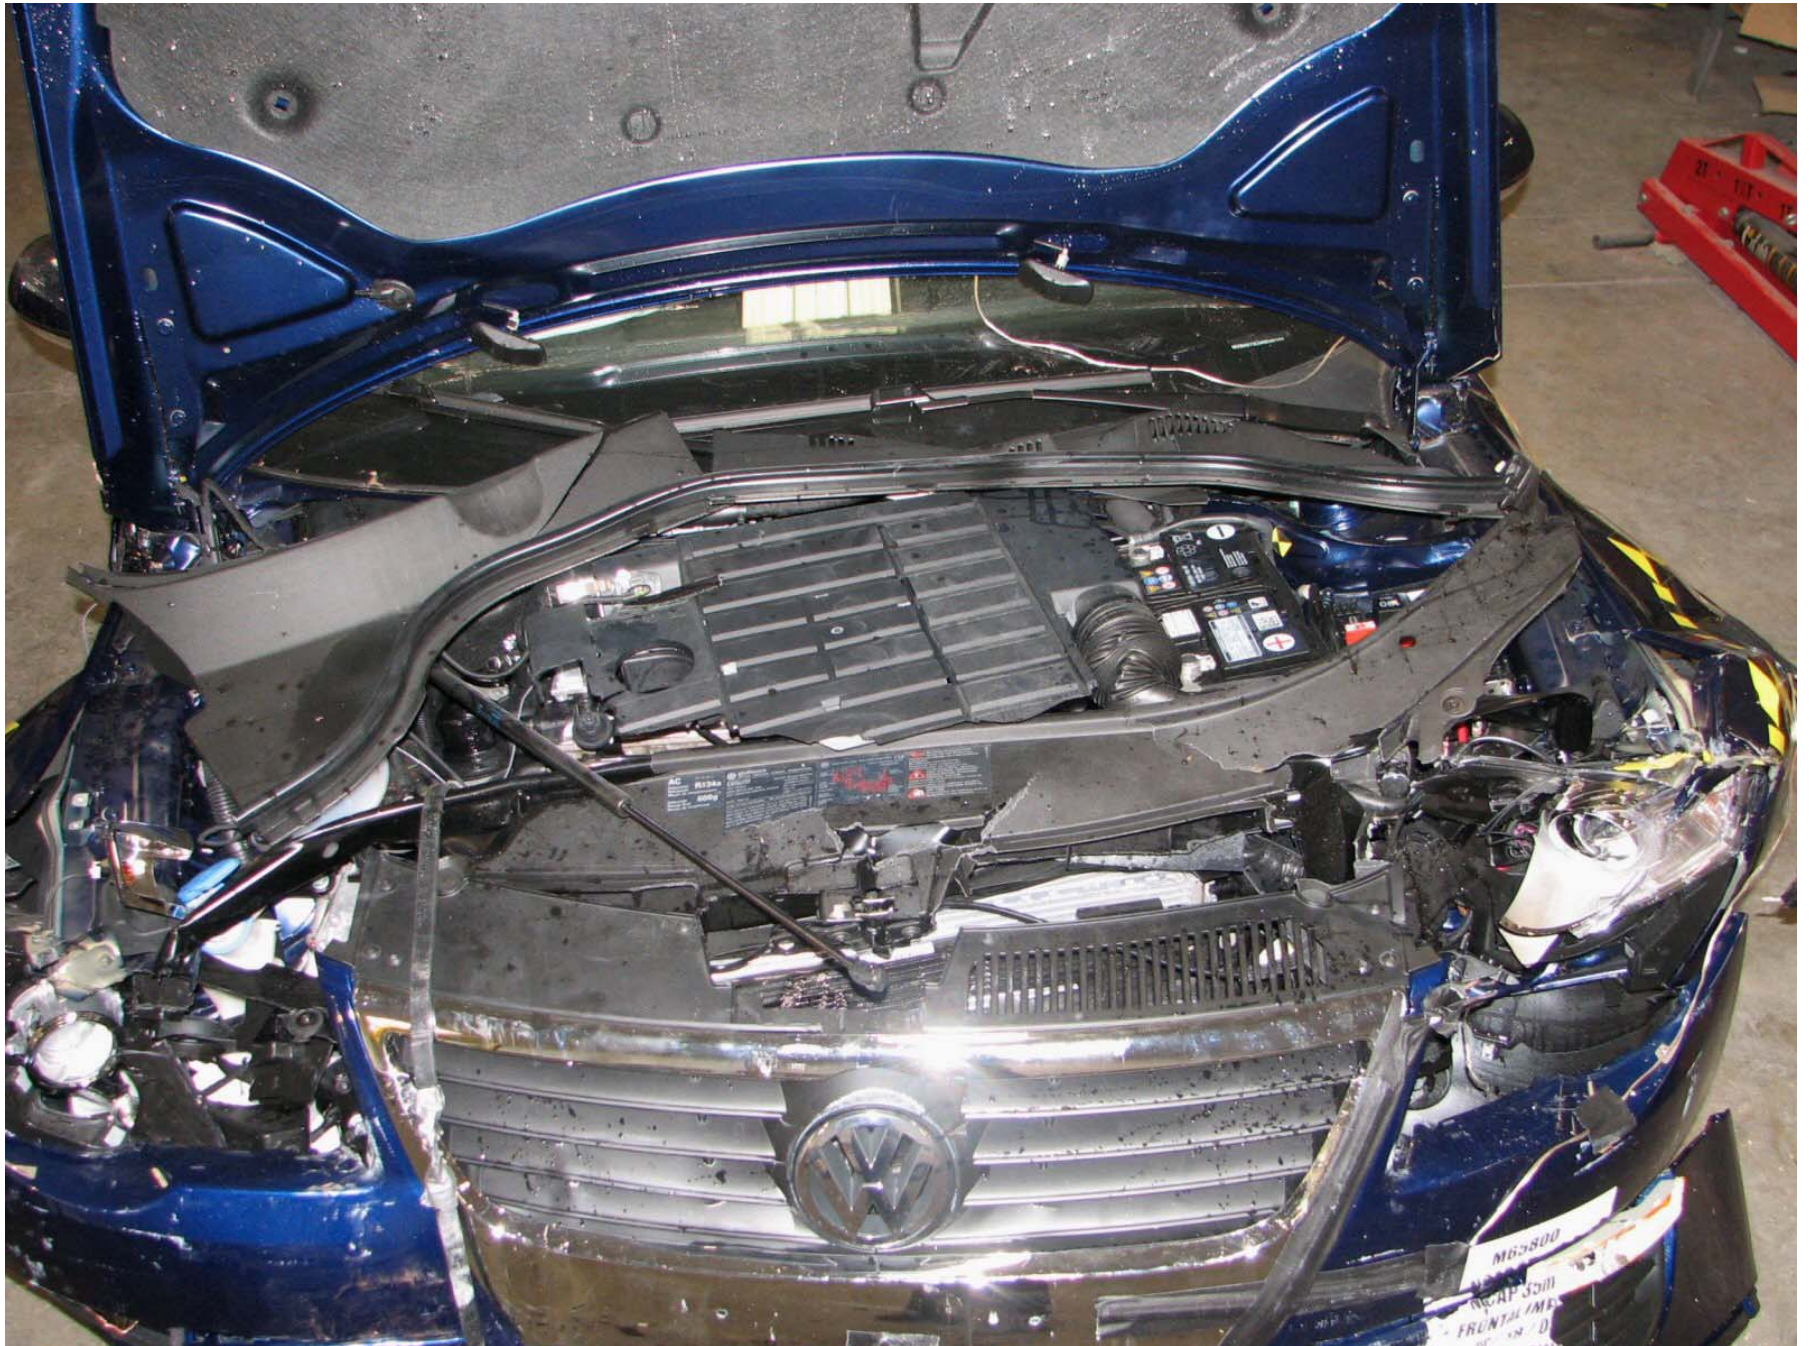
Figure A-21: Post-Test Engine Compartment (Vehicle Moved)

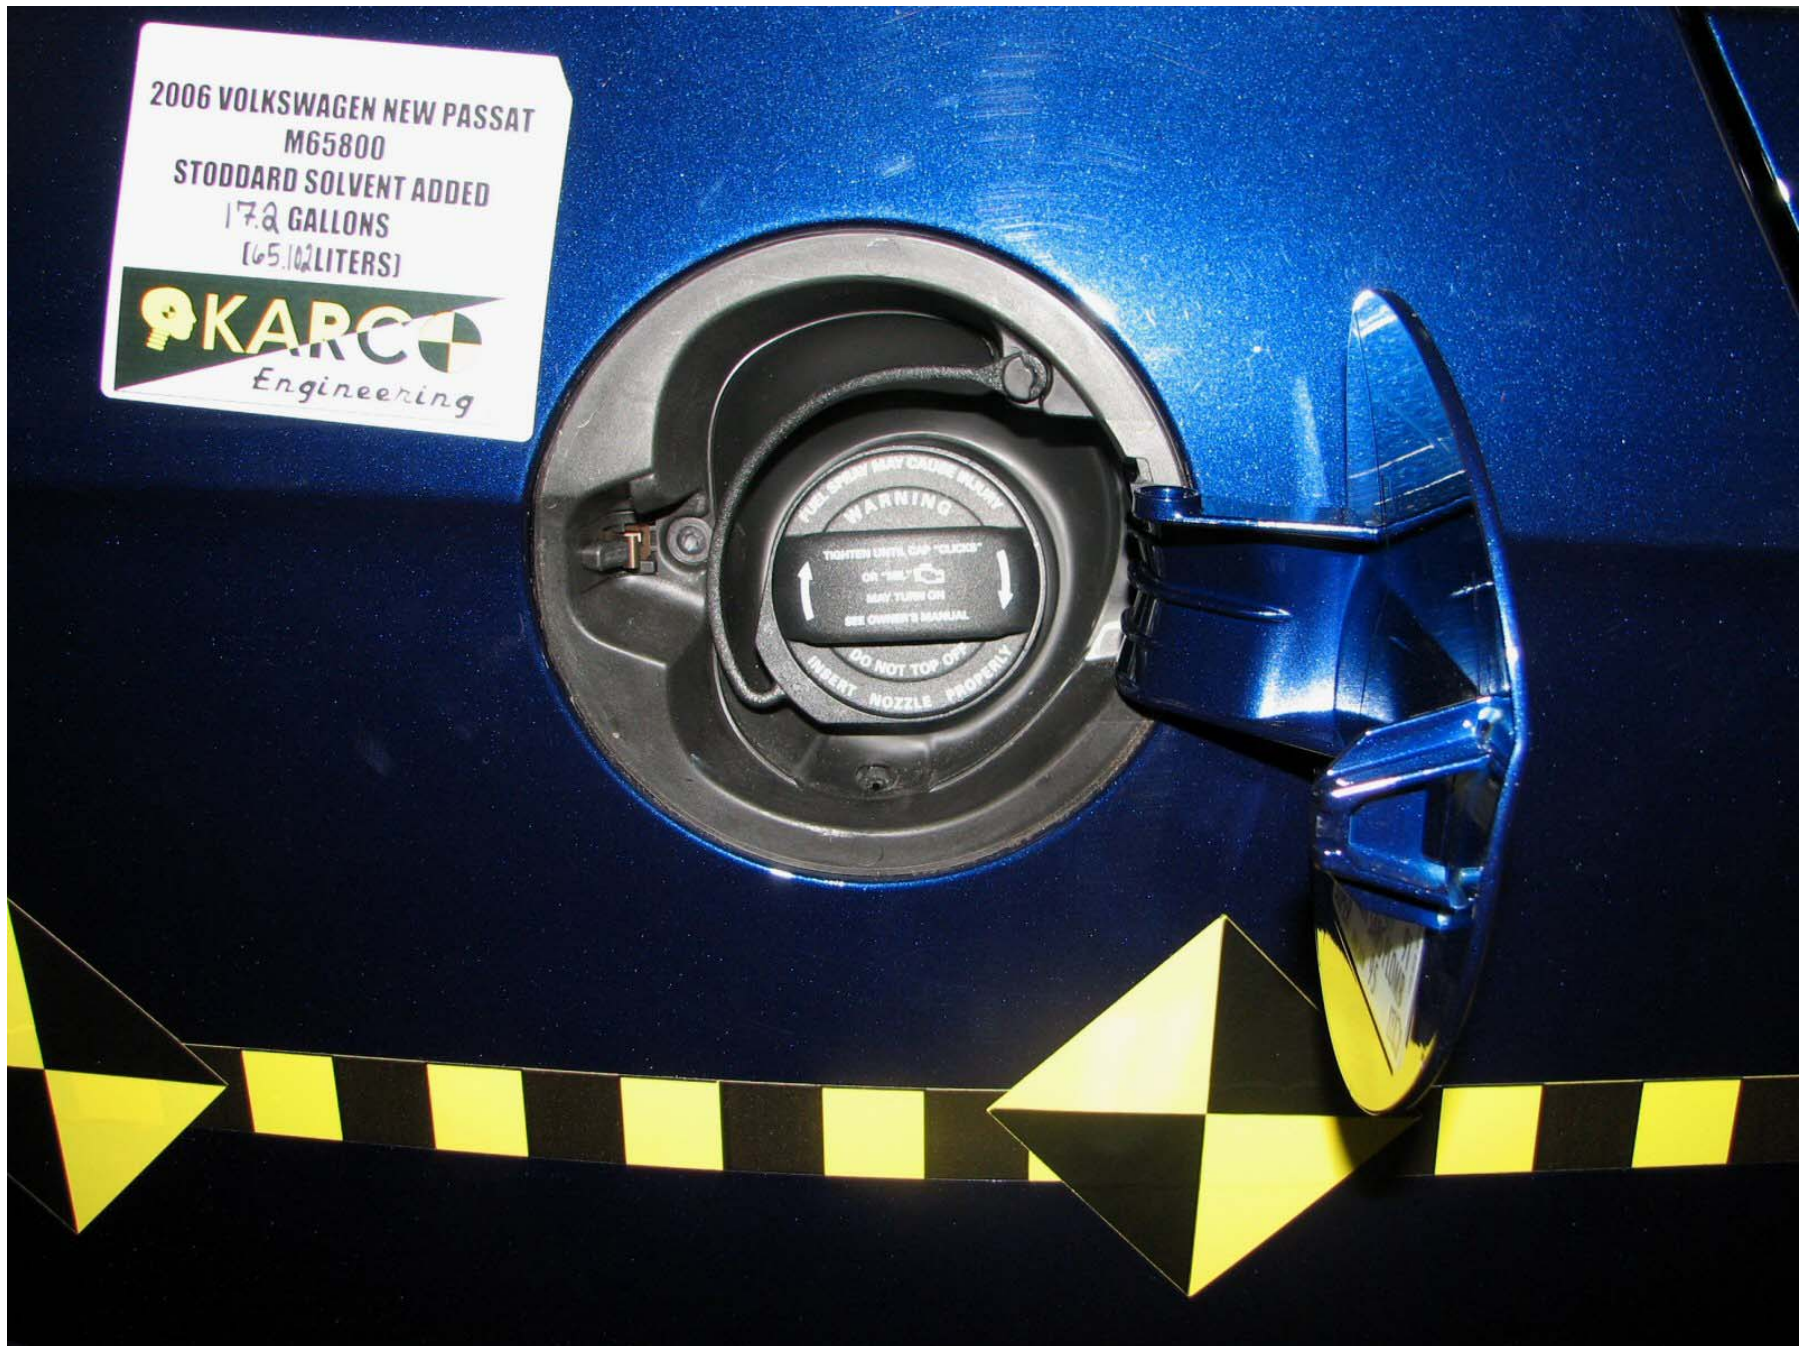
Figure A-22: Pre-Test Fuel Cap

2006 VOLKSWAGEN NEW PASSAT  
M65800  
STODDARD SOLVENT ADDED  
17.2 GALLONS  
(65.102 LITERS)

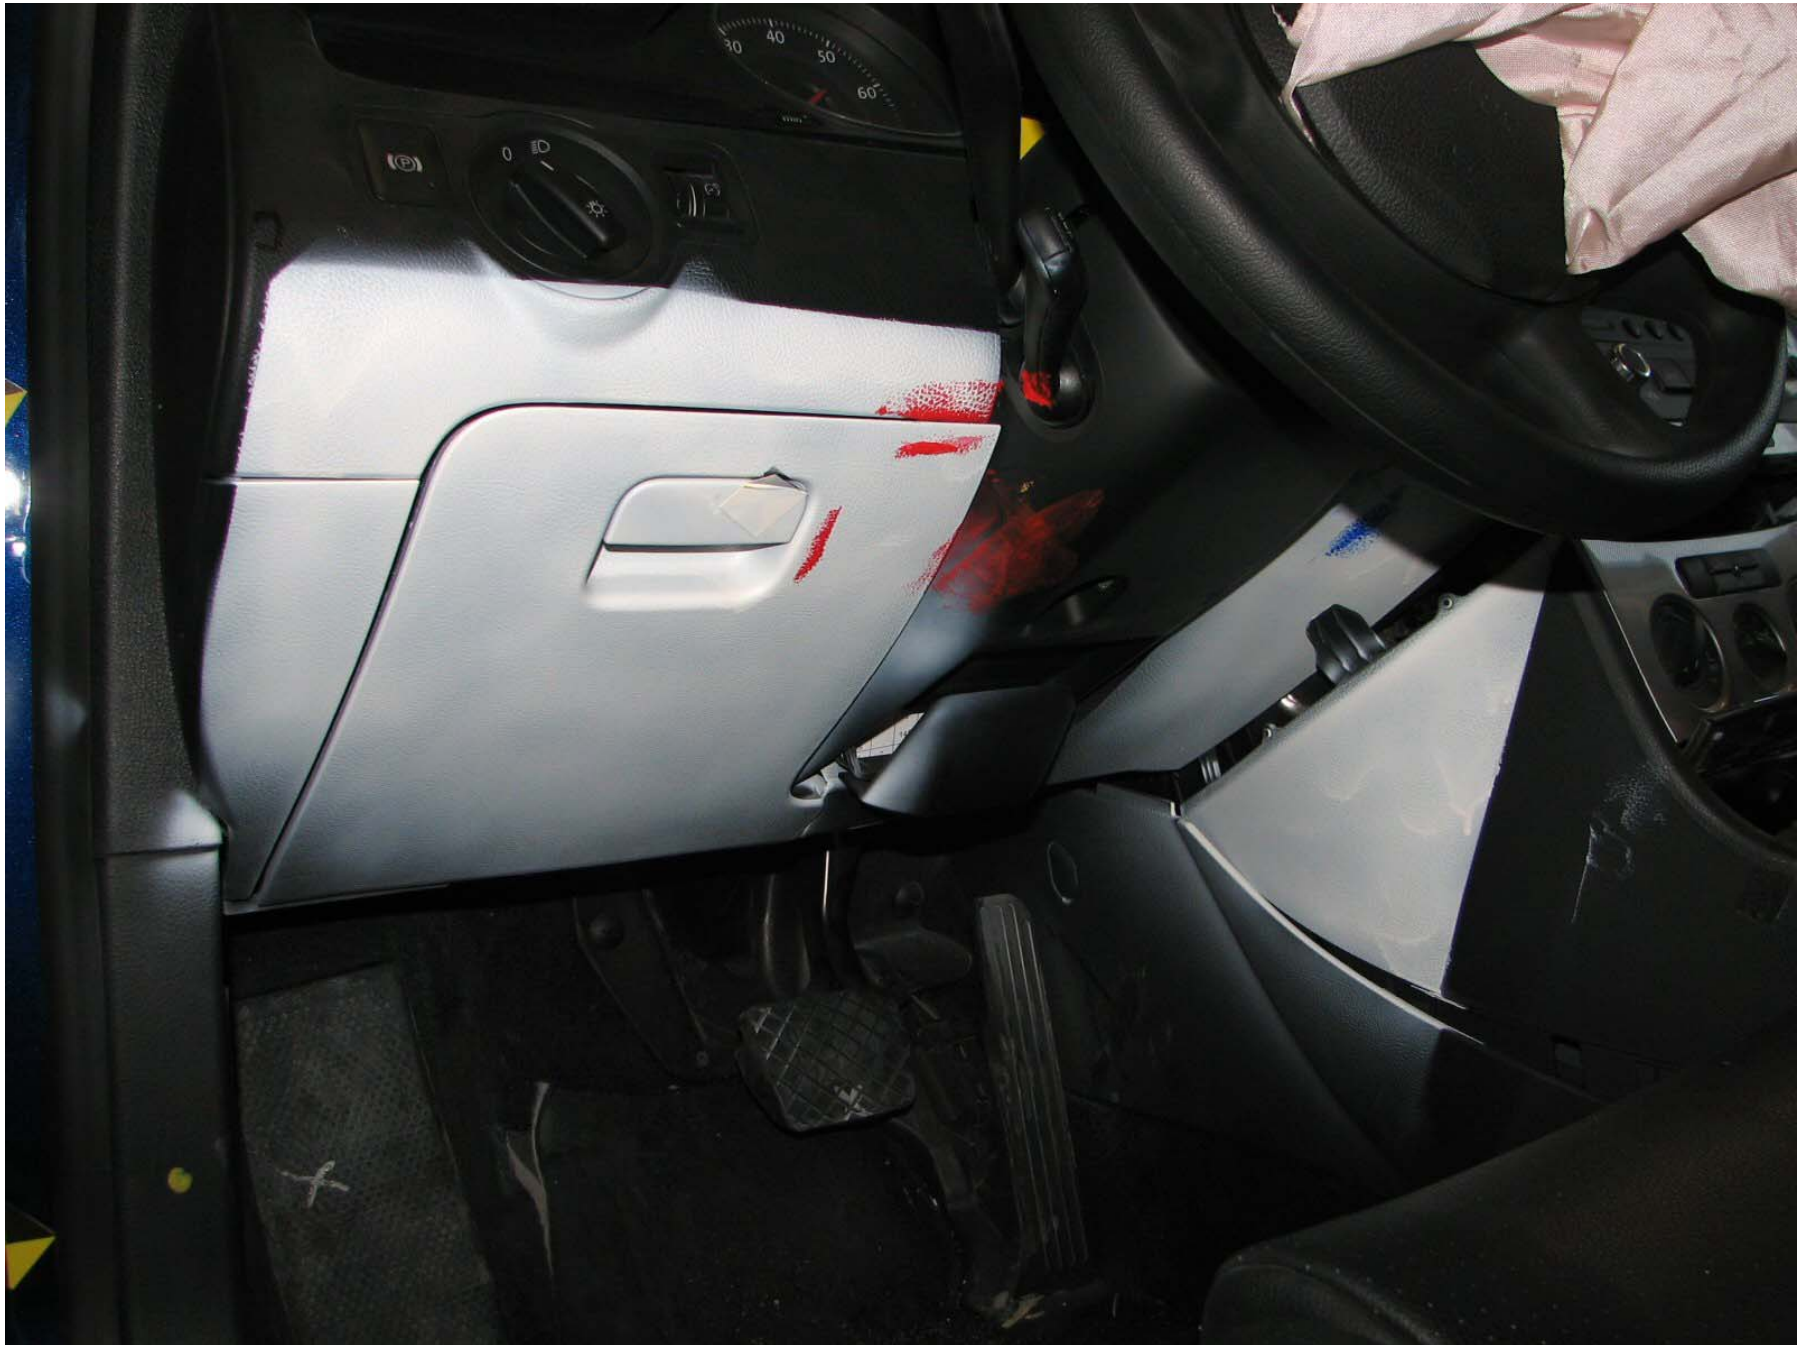
Figure A-39: Post-Test Driver Side Knee Bolster

The driver's visible contact points were as follows: The driver ATD's head contacted the airbag, the abdomen had no contact. Both knees contacted the knee bolster.

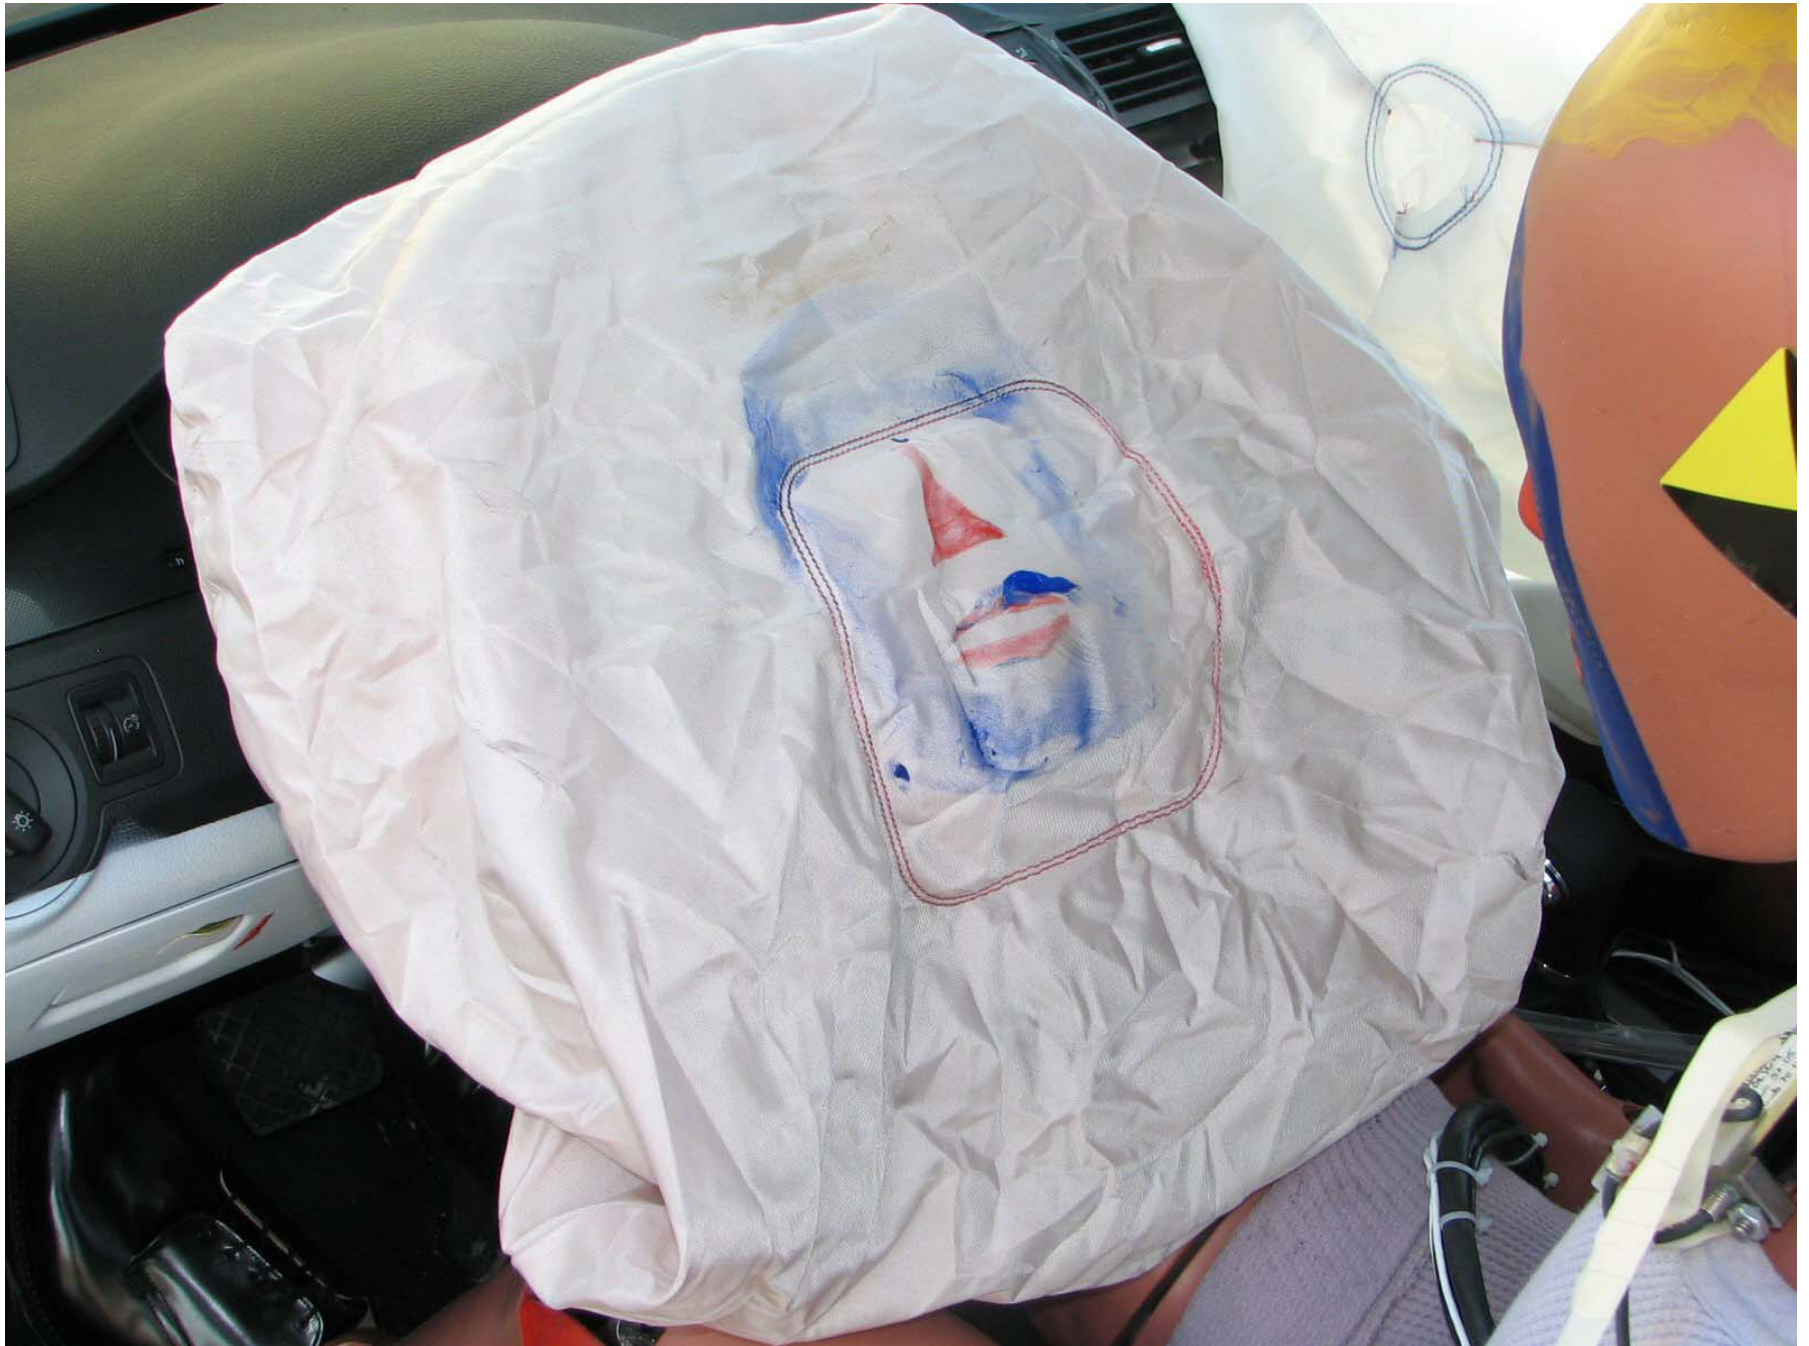
Figure A-43: Post-Test Driver Dummy Airbag Contact

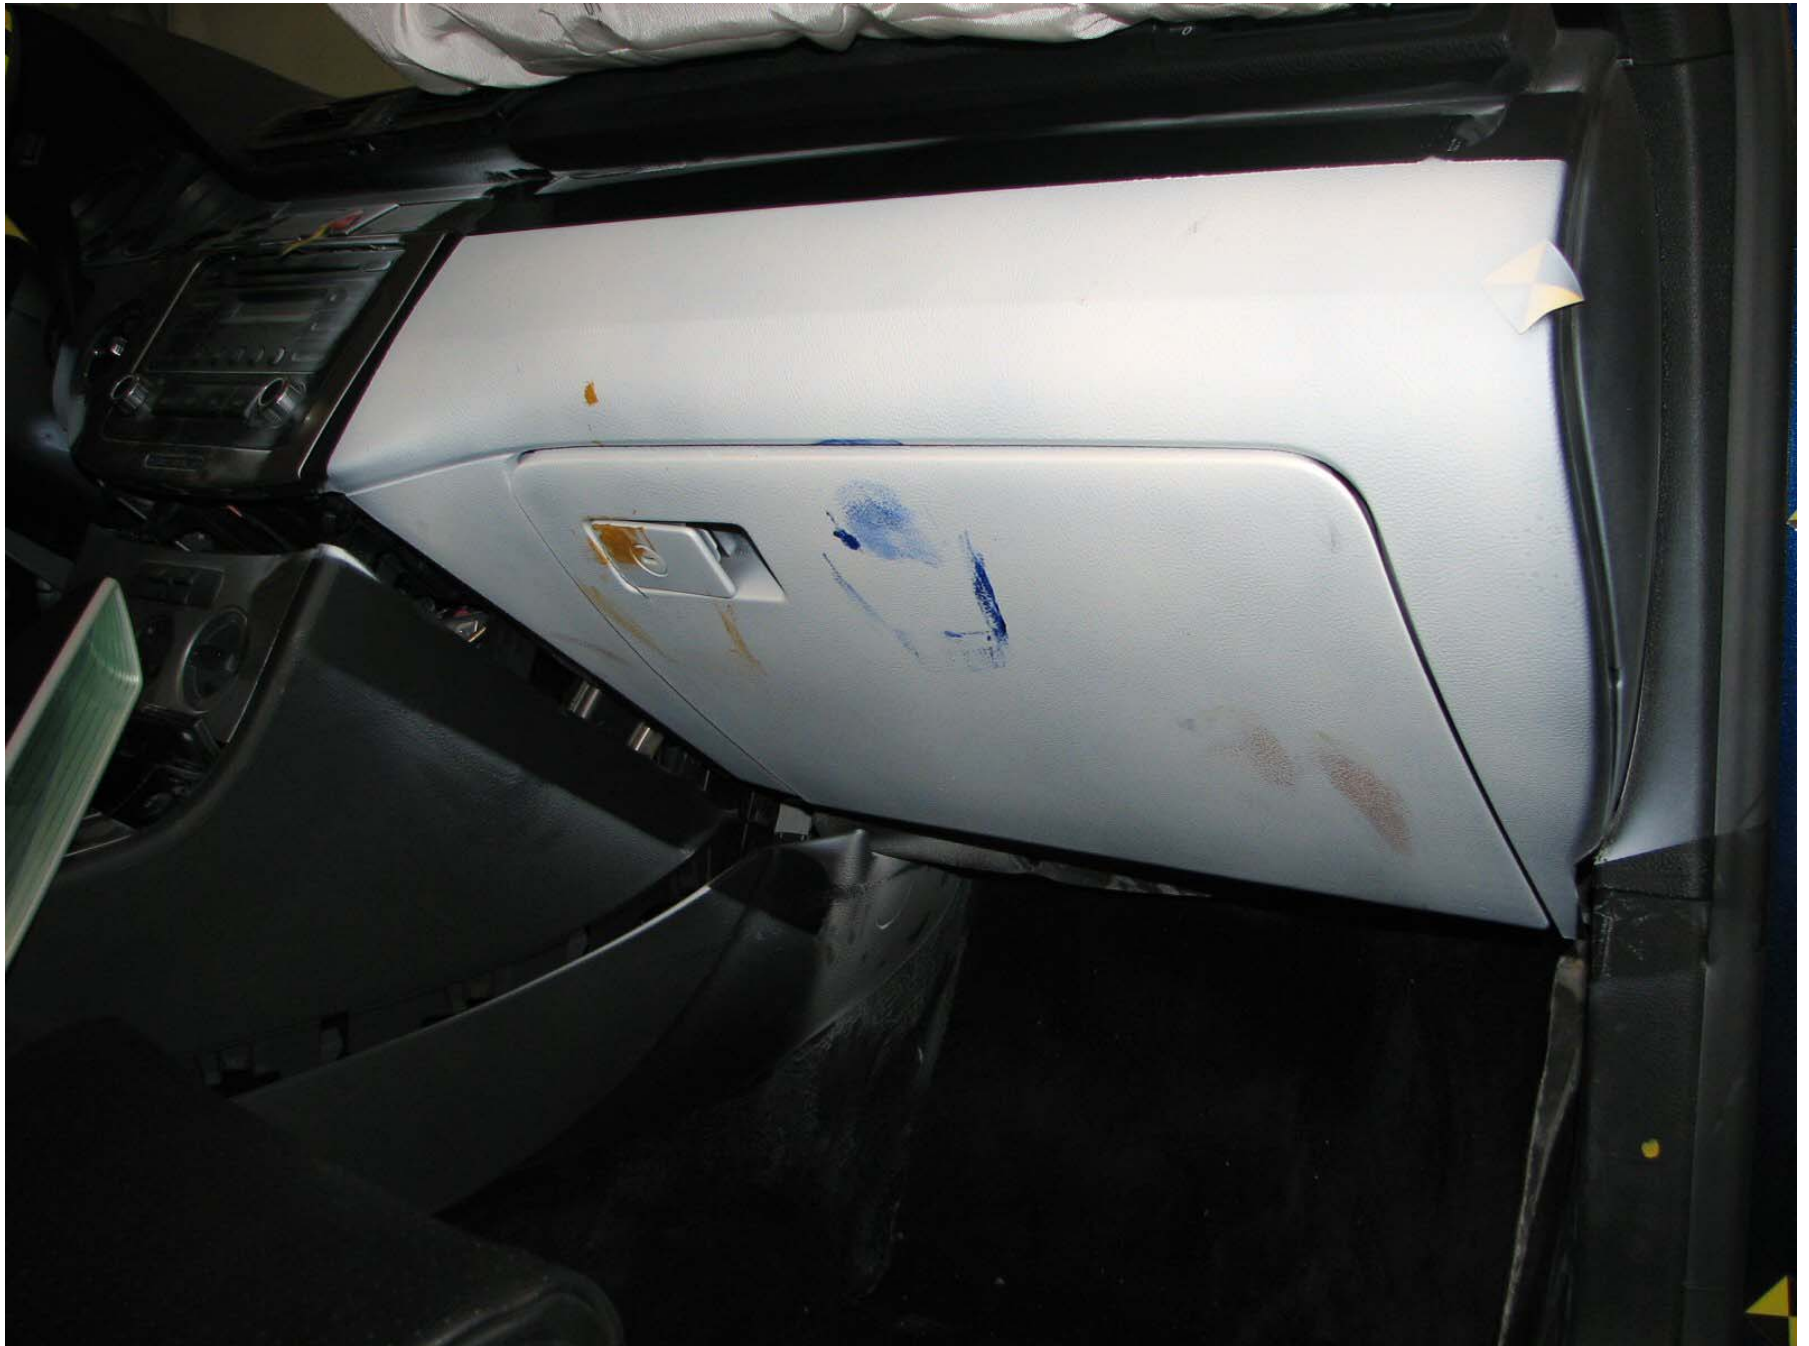
Figure A-53: Post-Test Passenger Side Glove Box

The passenger's visible contact points were as follows: The passenger ATD's head and chest contacted the airbag, the abdomen had no contact. Both knees contacted the glove box.

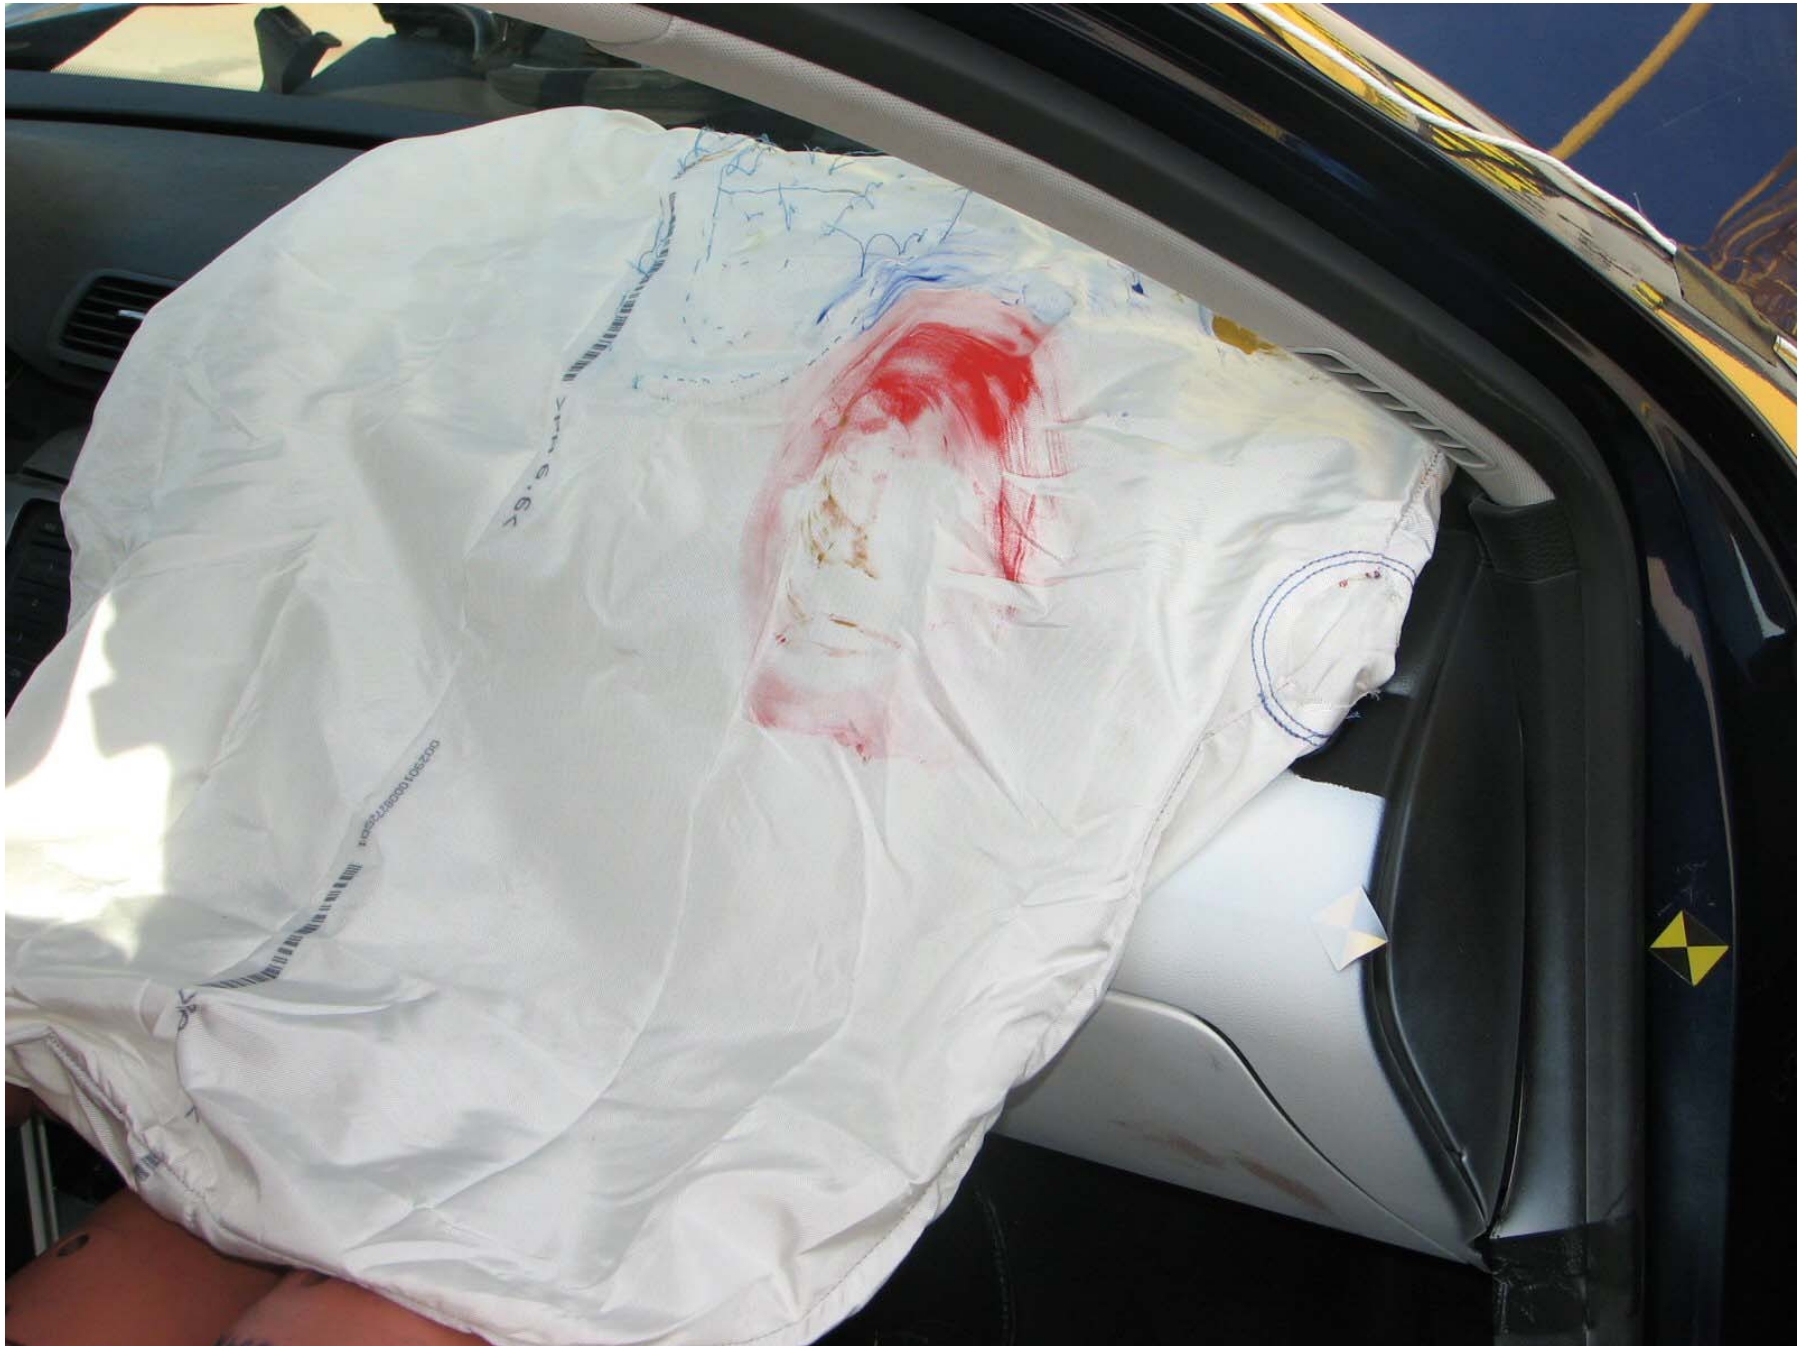
Figure A-57: Post-Test Passenger Dummy Airbag Contact

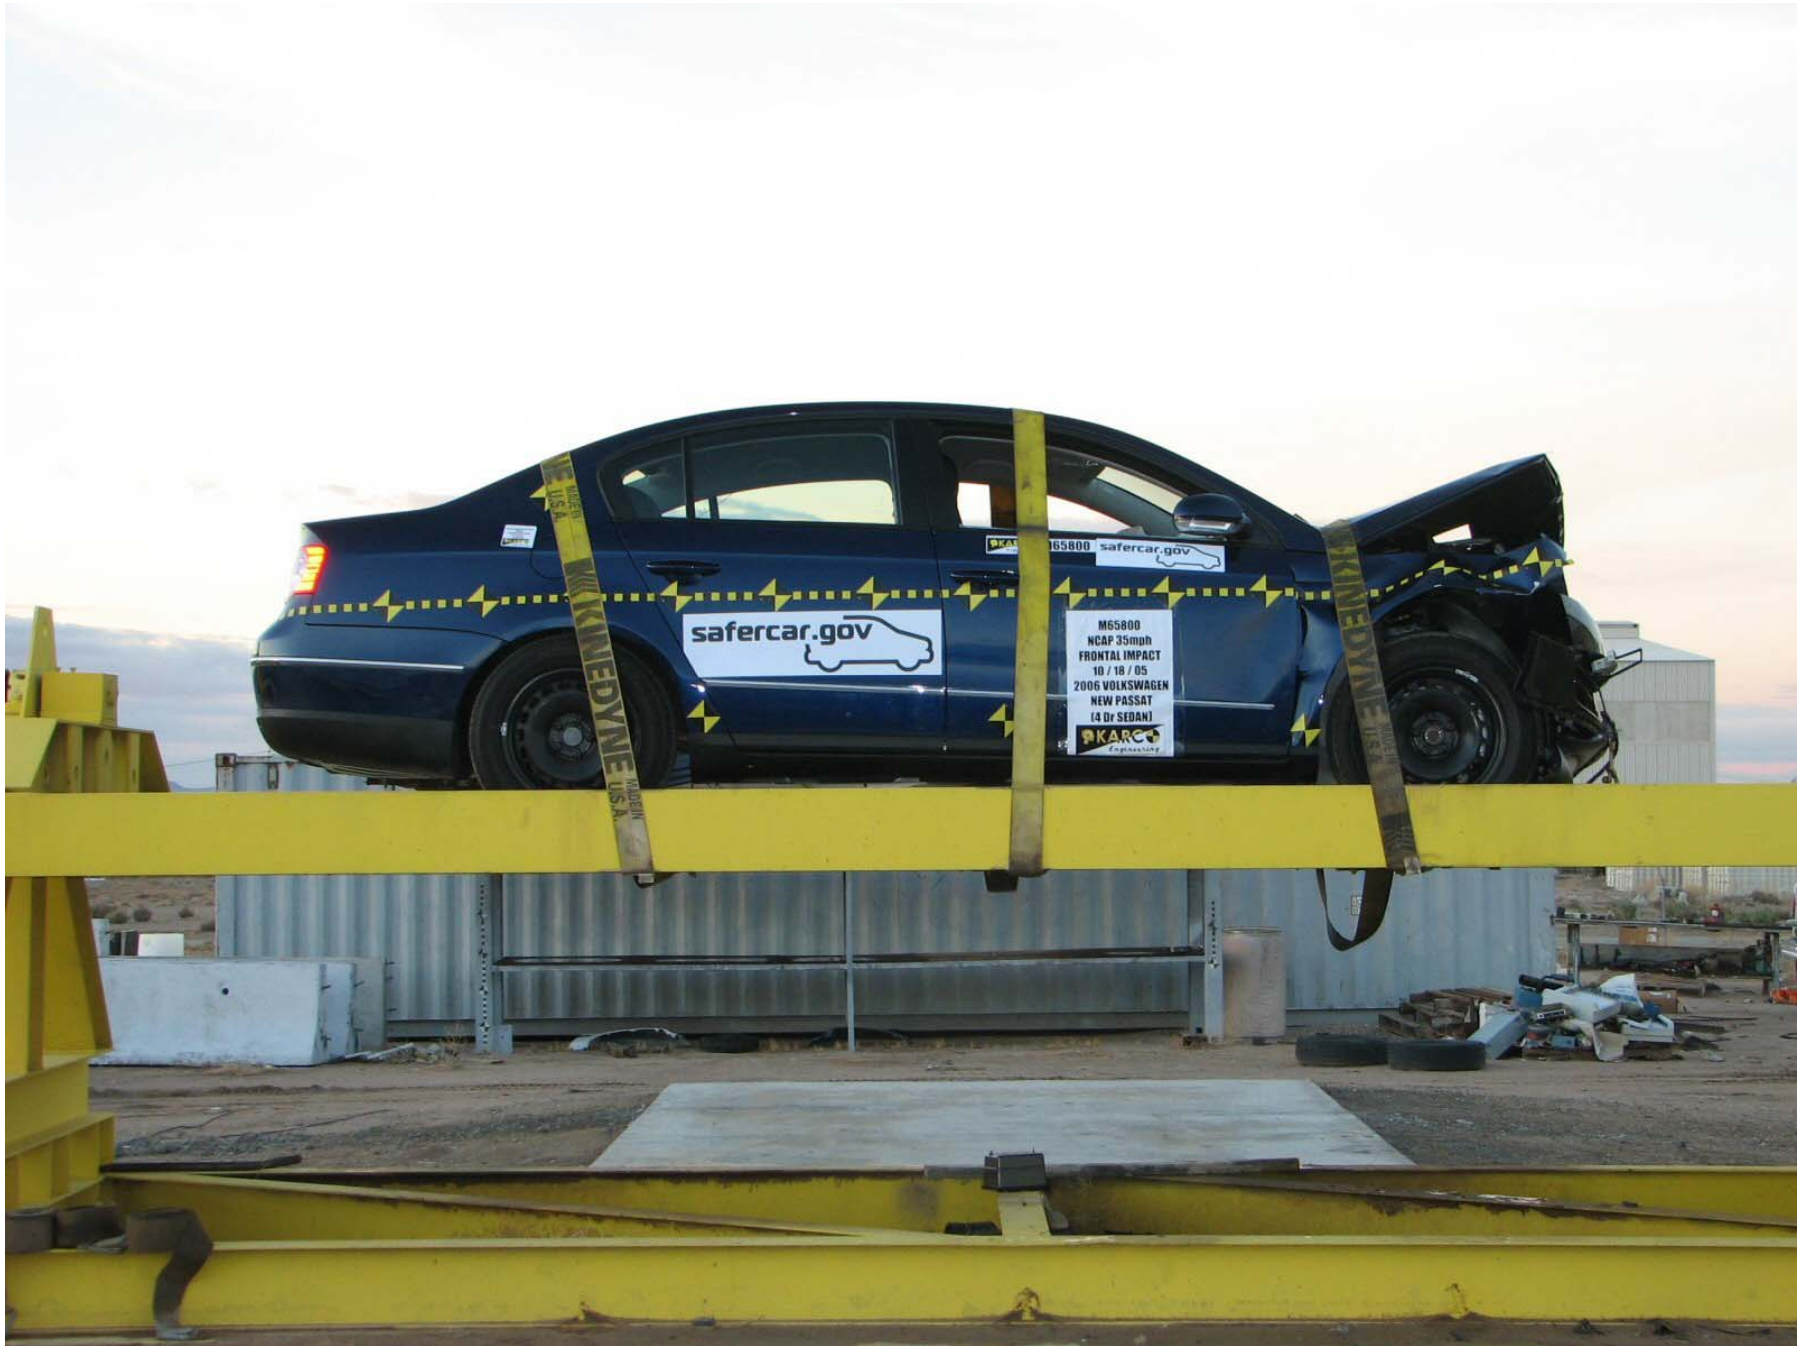
Figure A-58: Vehicle on Rollover Device (0°)

1. The specified fixture rollover rate for each 90° of rotation is 60 to 120 seconds.
2. The position hold time at each position is 300 seconds (minimum).
3. No solvent leakage occurred during rollover.
