**NEW CAR ASSESSMENT PROGRAM  
FRONTAL BARRIER IMPACT TEST**

**VOLKSWAGEN AG GERMANY  
2006 VOLKSWAGEN NEW PASSAT  
4-DOOR SEDAN**

**NHTSA NUMBER: M65800**

**FINAL REPORT**

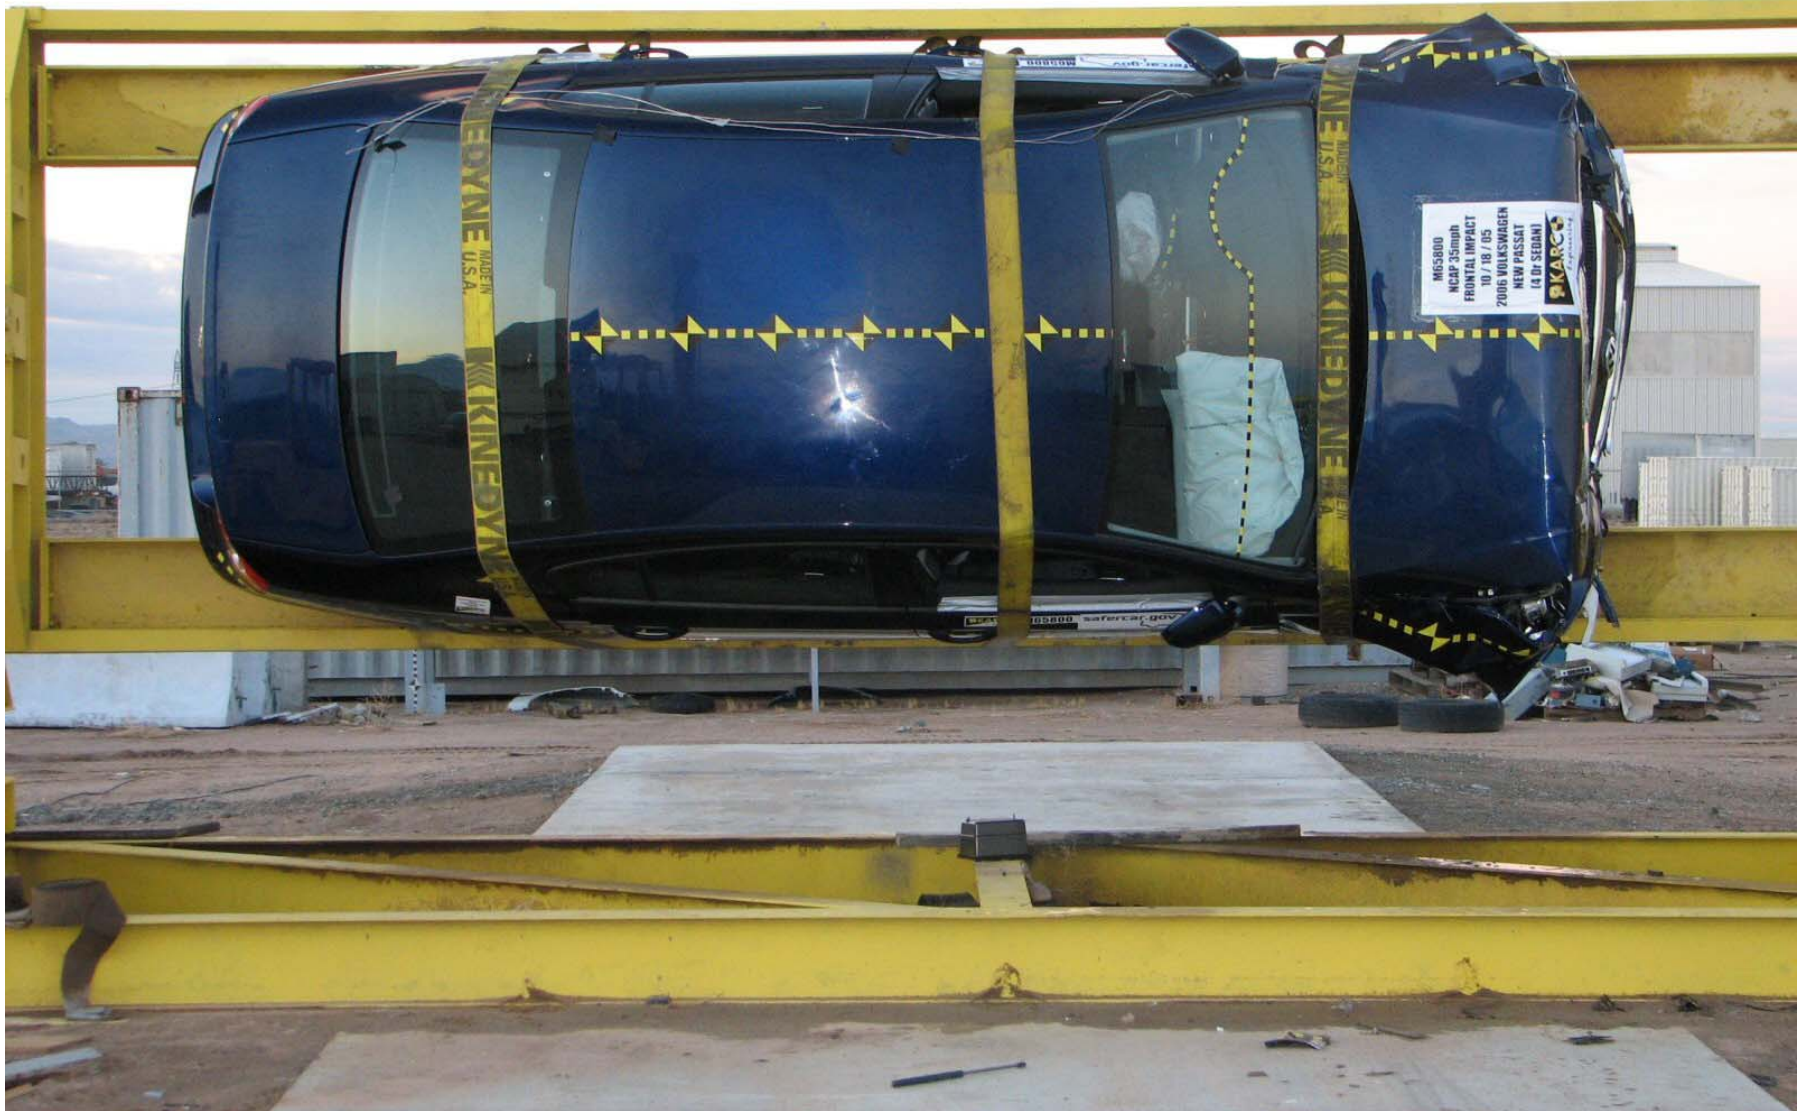
Figure A-59: Vehicle on Rollover Device (90°)

1. The specified fixture rollover rate for each 90° of rotation is 60 to 120 seconds.
2. The position hold time at each position is 300 seconds (minimum).
3. No solvent leakage occurred during rollover.

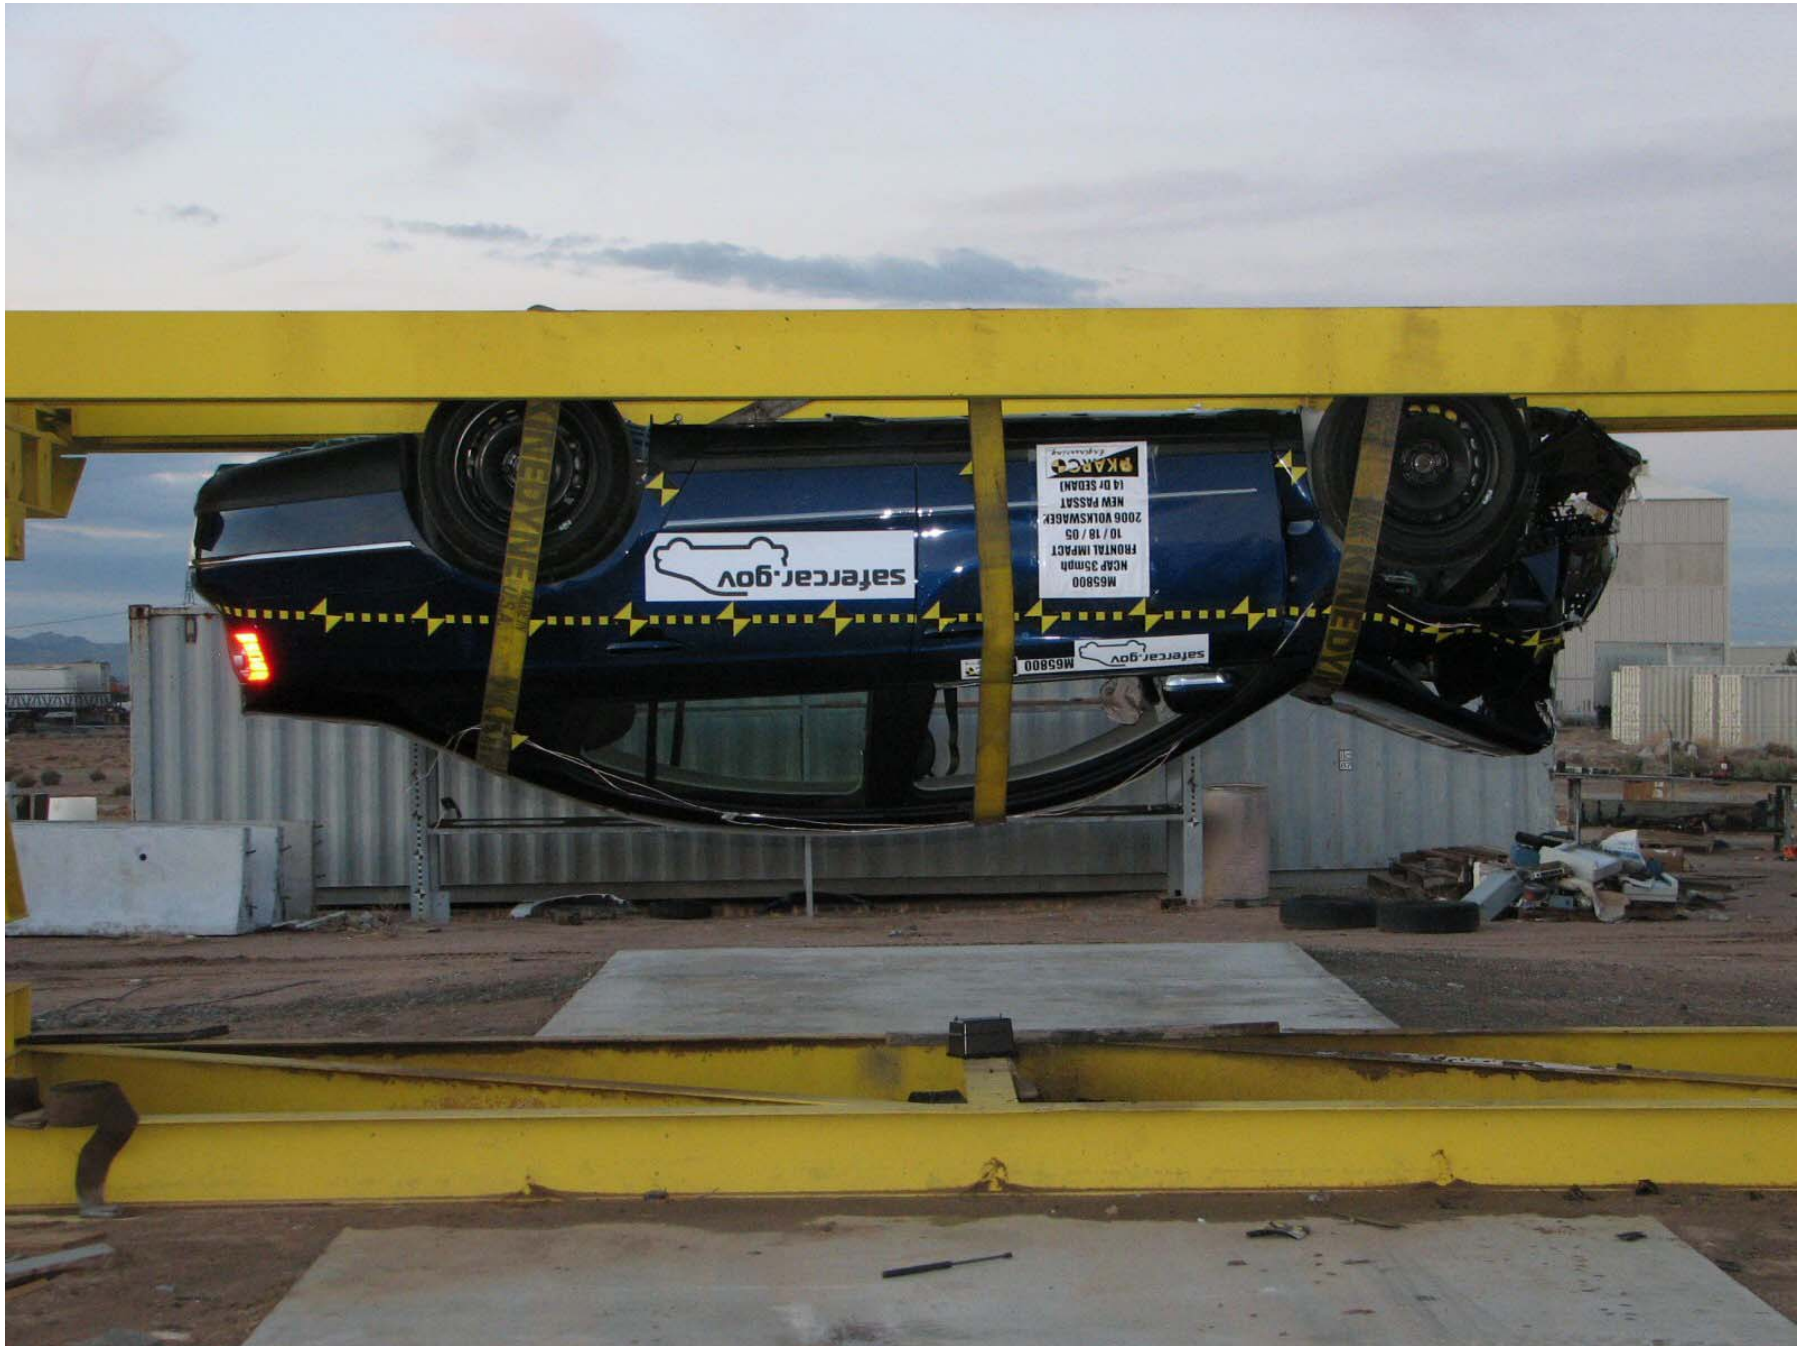
Figure A-60: Vehicle on Rollover Device (180°)

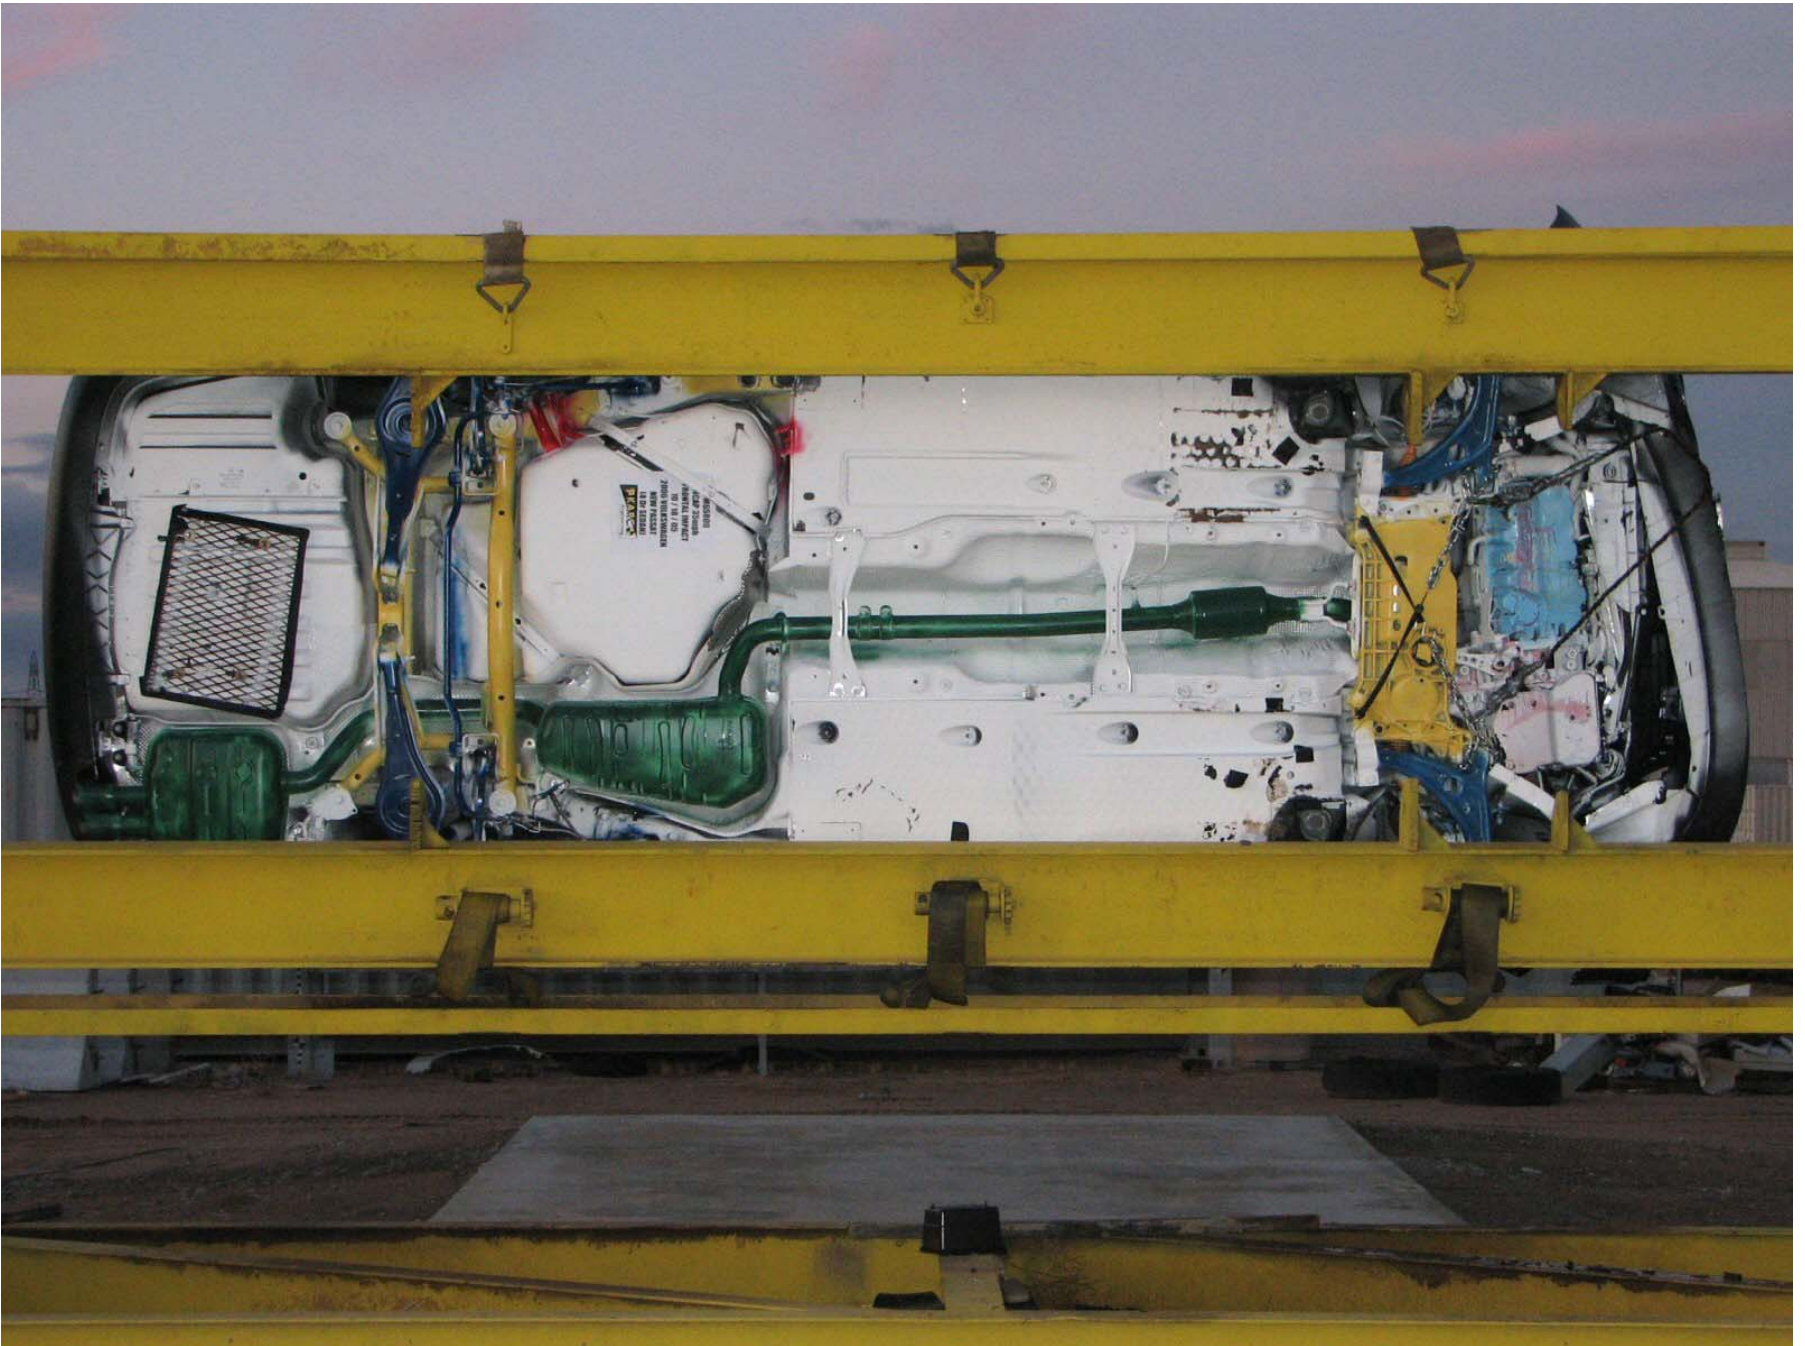
Figure A-61: Vehicle on Rollover Device (270°)

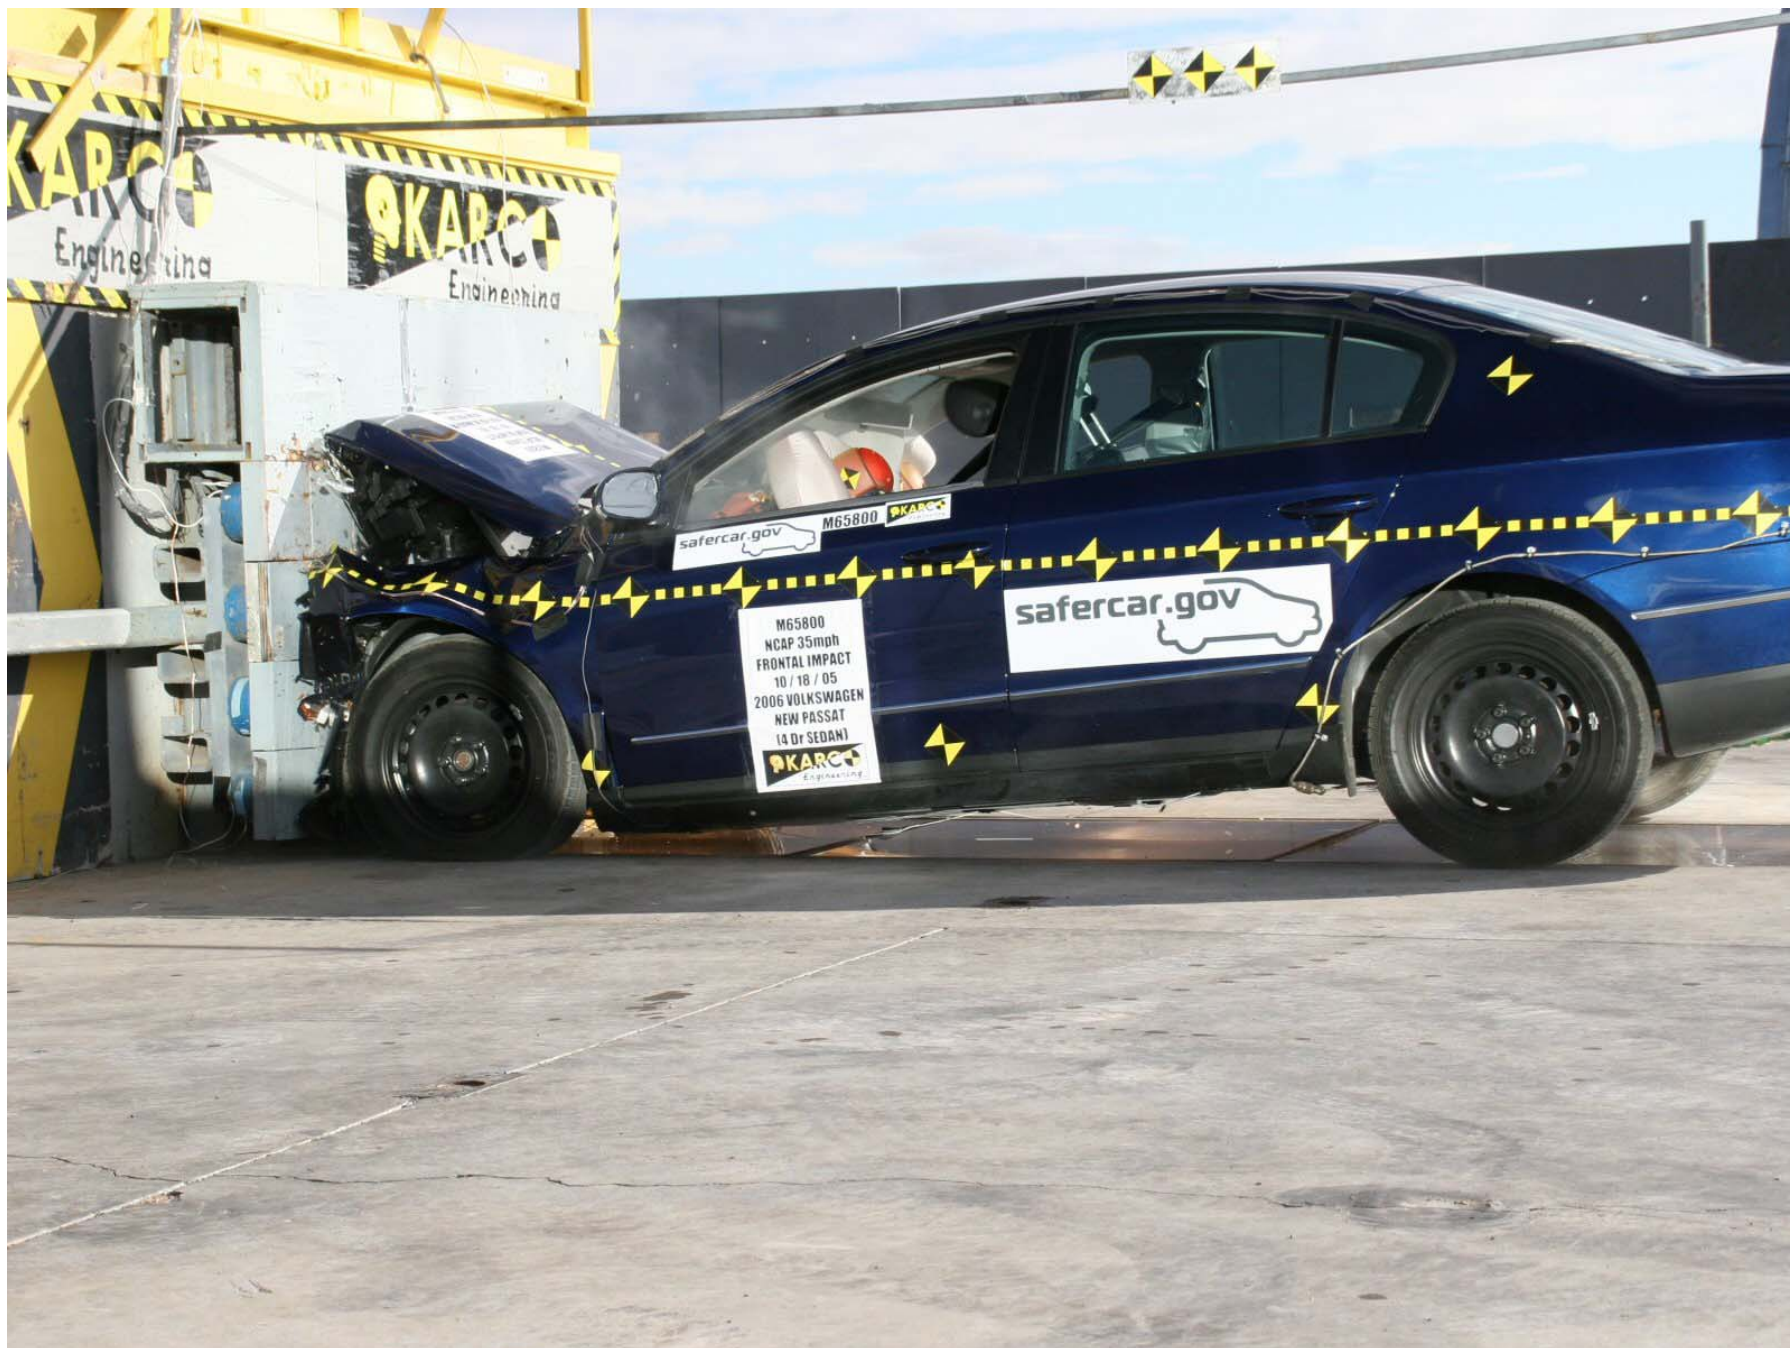
Figure A-62: Vehicle Impact

A load cell barrier consisting of 36 load cells was impacted by a 2006 Volkswagen New Passat 4-Door Sedan at a velocity of 56.09 km/h. The test was performed at Karco Engineering, LLC on October 18, 2005.
